UNDERWATER BRIDGE INSPECTION REPORT

STRUCTURE NO. 6200966 (OTT-19-0833)
SR 19 OVER TOUSSAINT RIVER
OTTAWA COUNTY, OH
DISTRICT 2

May 2020

COLLINS
ENGINEERS INC.

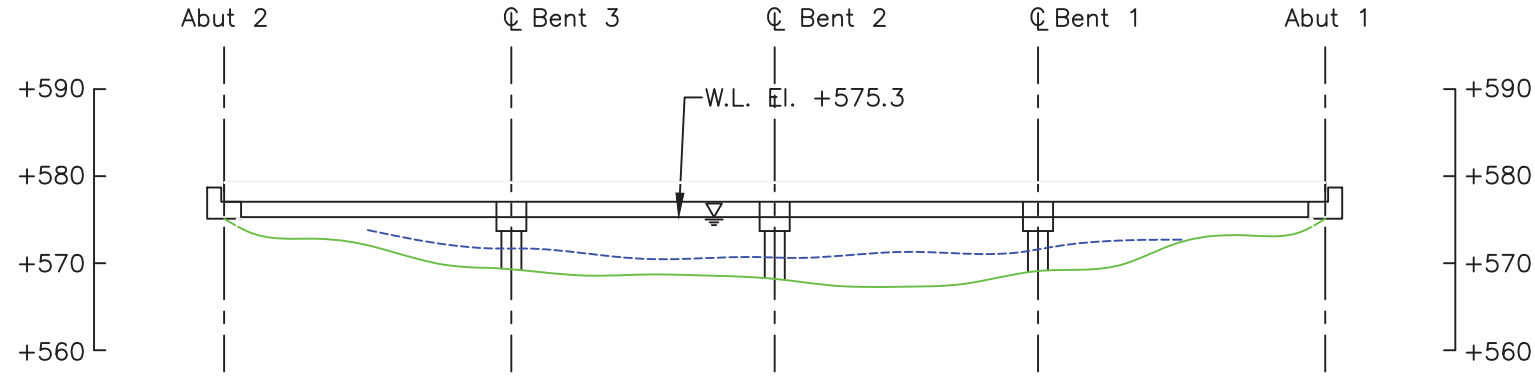
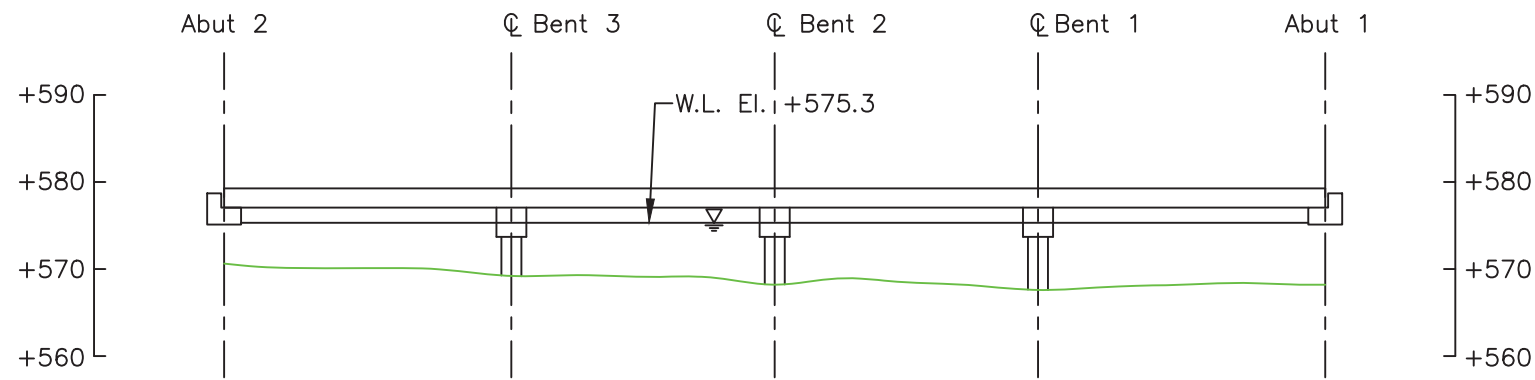
SR-19 OVER TOUSSAINT RIVER
STRUCTURE NO. 6200966 (OTT-19-0833)
CROSS SECTIONS - UPSTREAM
OTTAWA COUNTY, OHIO

Overall, the inspected substructure units of Structure No. 6200966 (OTT-19-0833) were in good condition. A comparison of the soundings recorded during the previous inspection on June 25, 2015 and the soundings taken during this inspection revealed no significant change in the channel bottom profile in the vicinity of the structure. Although no channel deficiencies were observed, the channel bottom should continue to be monitored during future underwater inspections to verify that localized scour or overall channel degradation is not occurring and that the pier footings remain adequately embedded in the channel bottom.

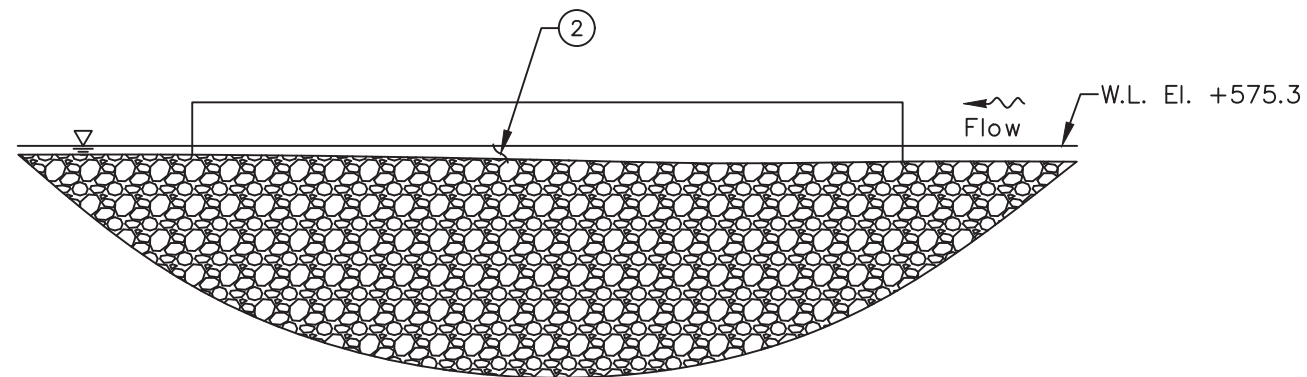
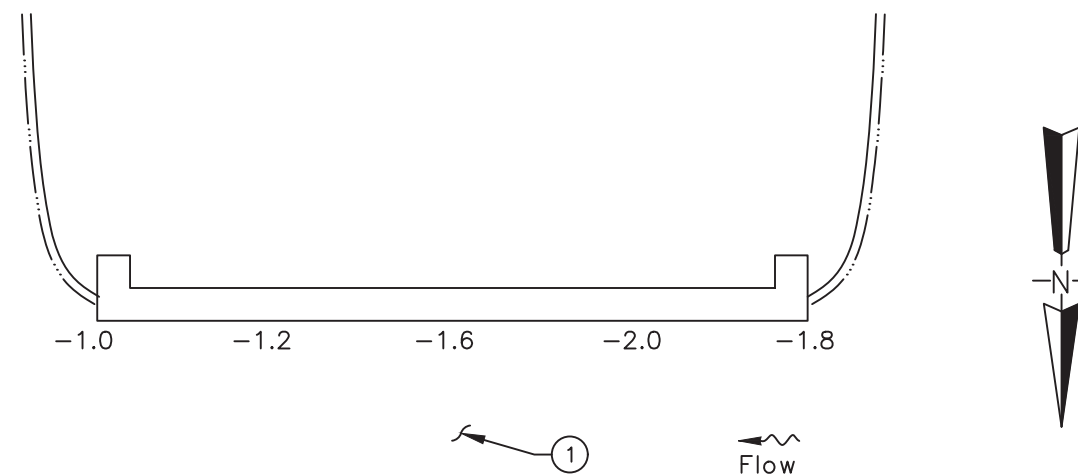
SR-19 OVER TOUSSAINT RIVER
 STRUCTURE NO. 6200966 (OTT-19-0833)
 ABUTMENT 1
 OTTAWA COUNTY, OHIO

The channel bottom material consisted of riprap up to 18 in. diameter with no probe rod penetration. Heavy scaling was observed up to 1 in. deep from the channel bottom to the bottom of deck. Refer to Figure 6 in Exhibit 1 for detailed inspection notes of Abutment 1.

- ① The channel bottom material consisted of rip-rap up to 18 in. diameter with no probe rod penetration.
- ② Heavy scaling up to 1 in. deep was observed from the channel bottom to the bottom of deck.

The scaling observed on Abutments 1 and 2 is not a structural concern at this time given its size compared to the overall pier size, and as a result, no repairs are recommended. This area should be monitored during future inspections for increasing extent or severity of the scaling and exposure of reinforcing steel. If the extent or severity of the scaling is observed to be increasing or reinforcing steel becomes exposed, it may be necessary to repair the area at that time.

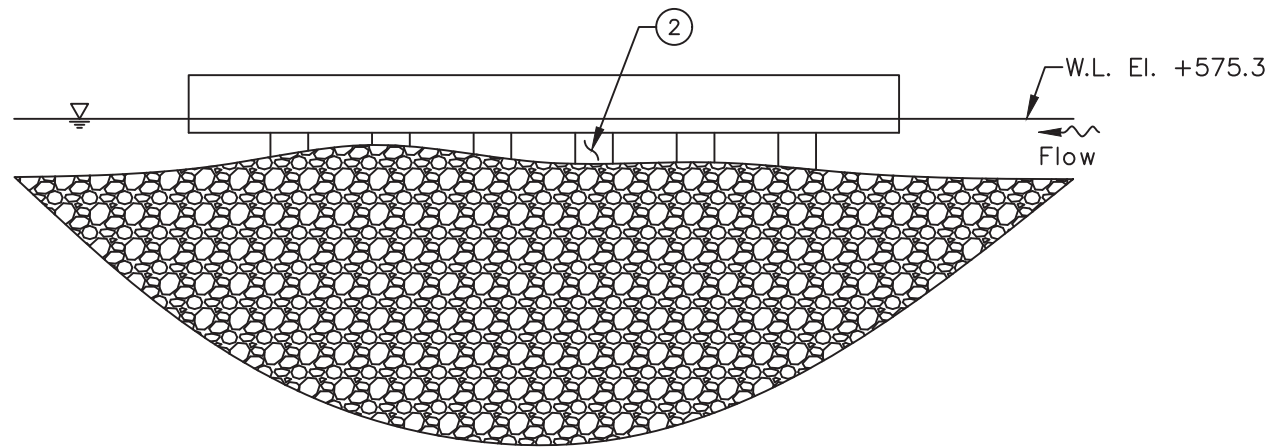
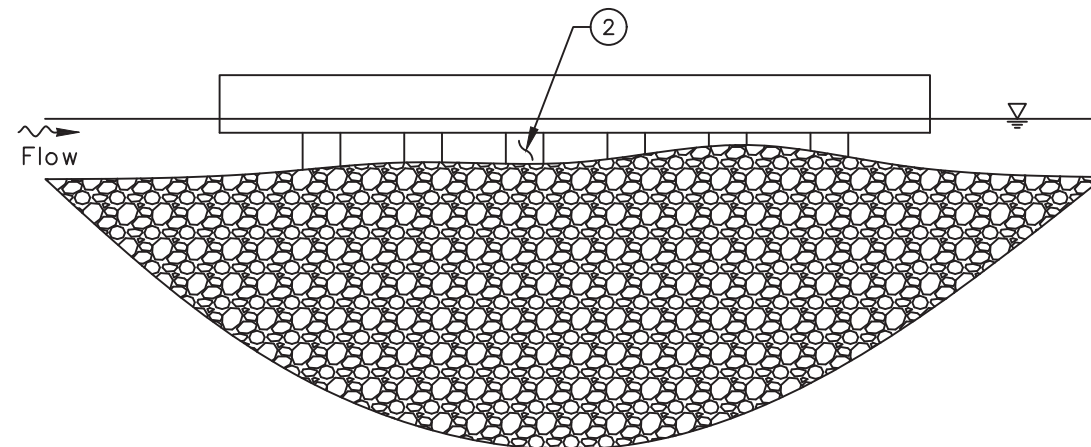
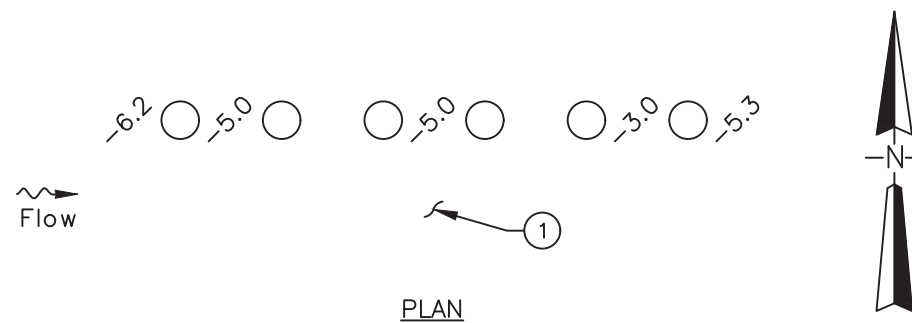
The channel bottom material consisted of sand and cobbles with approximately 2 in. probe rod penetration. The submerged portions of the bent exhibited light surface corrosion with no pitting. Refer to Figure 7 in Exhibit 1 for detailed inspection notes of Bent 1. Refer to Photograph 8 in Exhibit 2 for views of the typical concrete condition at the waterline.

- ① The channel bottom material consisted of sand and cobbles with approximately 2 in. probe rod penetration.
- ② The submerged portions of the bent exhibited light surface corrosion with no pitting.

The corrosion on the piles of Bent 1 is not a structural concern at this time, and as a result, no repairs are recommended. It is recommended that the extent and severity of the corrosion be closely monitored during future inspections. Should the extent or severity of the corrosion progress, it may be necessary to repair the piles by cleaning the piles and installing wraps or encasements. It is also recommended that during future inspections the remaining thickness of the steel piles be measured with the use of an ultrasonic thickness measuring device.

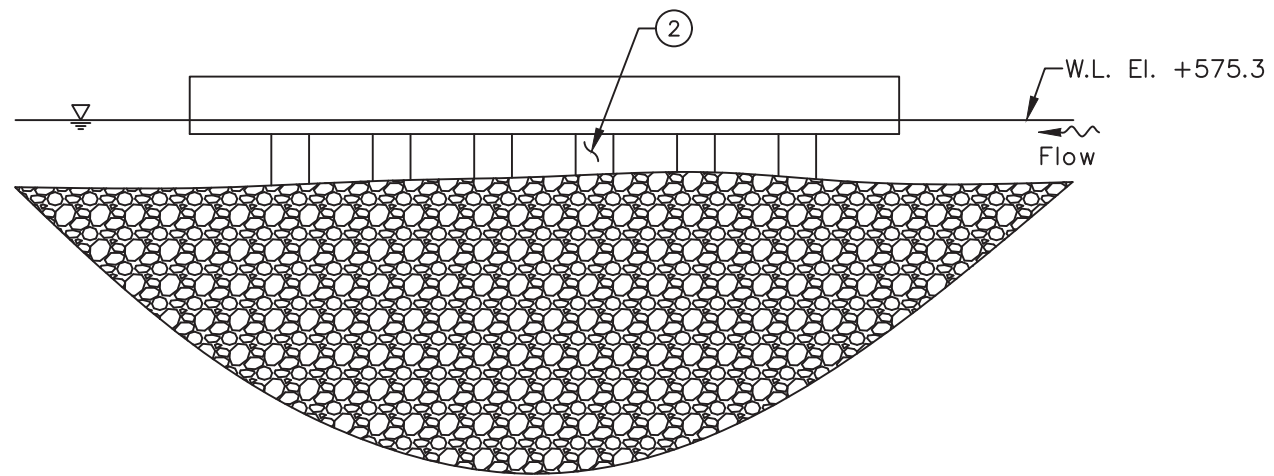
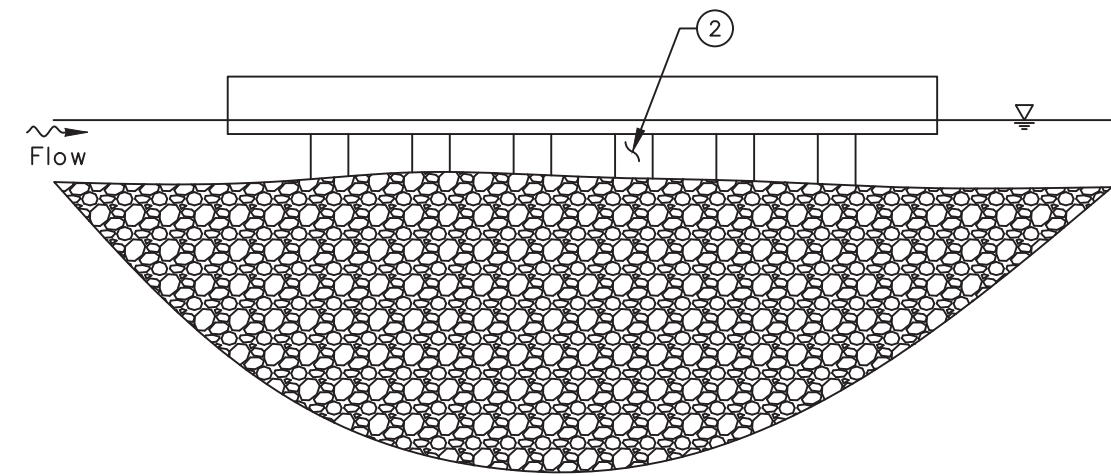
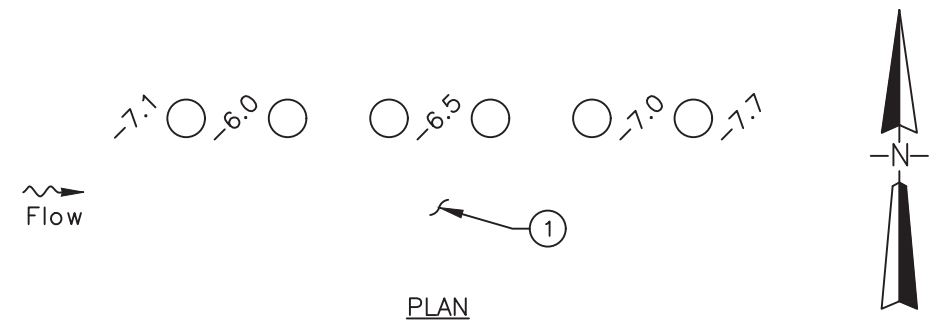
The channel bottom material consisted of sand and cobbles with approximately 2 in. probe rod penetration. The submerged portions of the bent exhibited light surface corrosion with no pitting. Refer to Figure 8 in Exhibit 1 for detailed inspection notes of Bent 2.

- ① The channel bottom material consisted of sand and cobbles with approximately 2 in. probe rod penetration.
- ② The submerged portions of the bent exhibited light surface corrosion with no pitting.

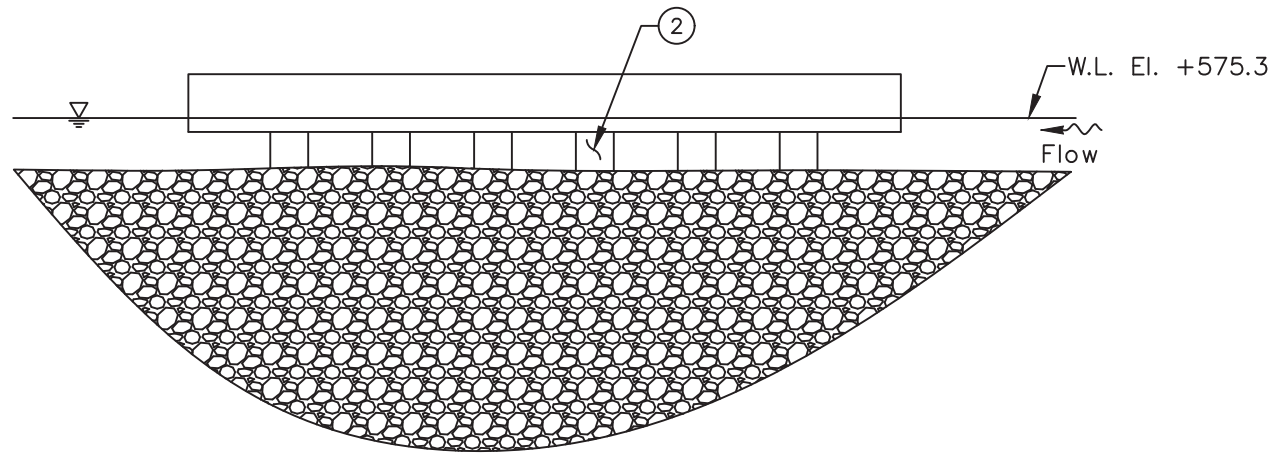
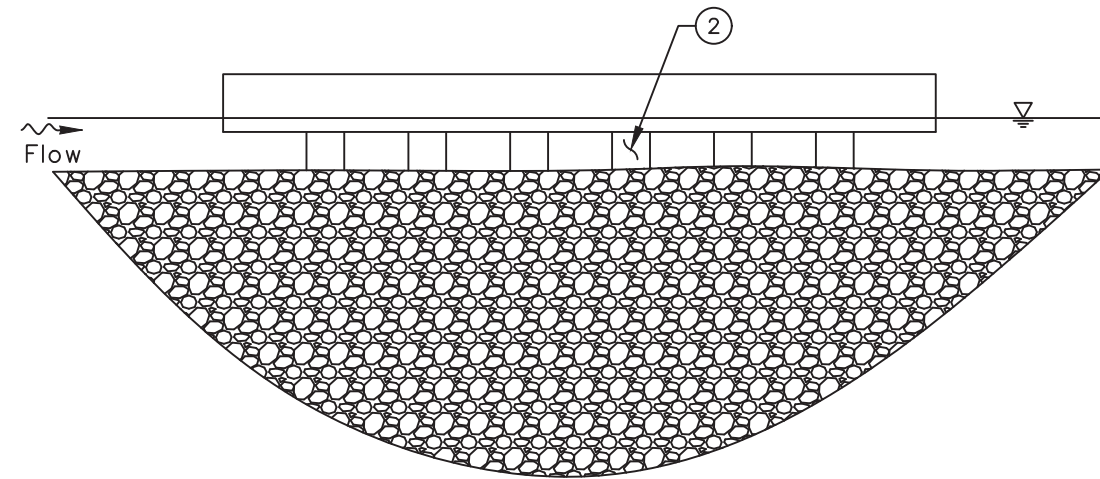
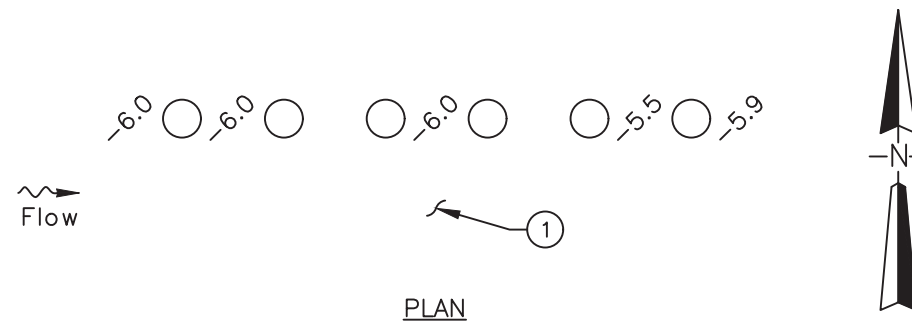
The channel bottom material consisted of sand and cobbles with approximately 2 in. probe rod penetration. The submerged portions of the bent exhibited light surface corrosion with no pitting. Refer to Figure 9 in Exhibit 1 for detailed inspection notes of Bent 2.

- ① The channel bottom material consisted of sand and cobbles with approximately 2 in. probe rod penetration.
- ② The submerged portions of the bent exhibited light surface corrosion with no pitting.

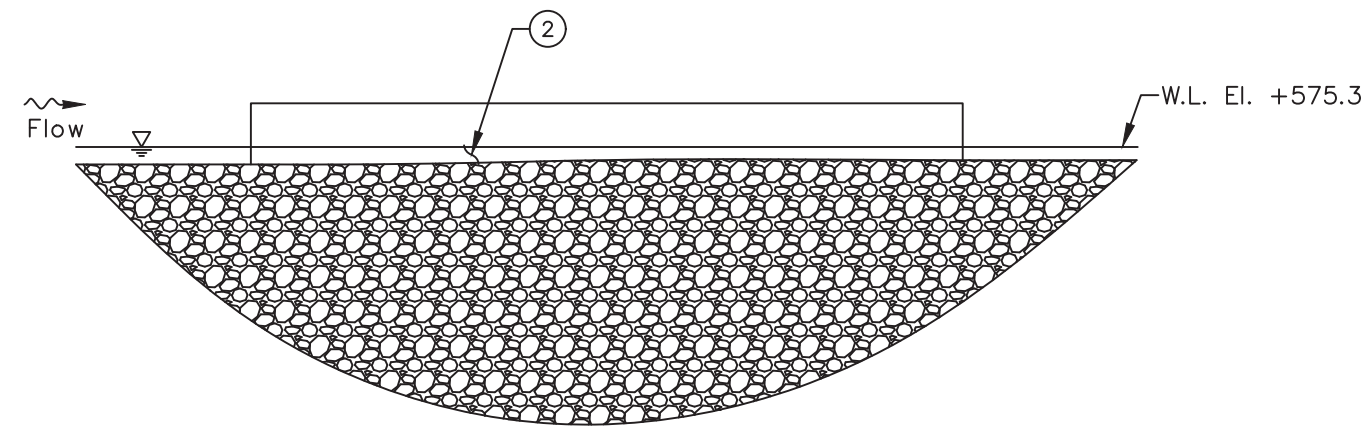
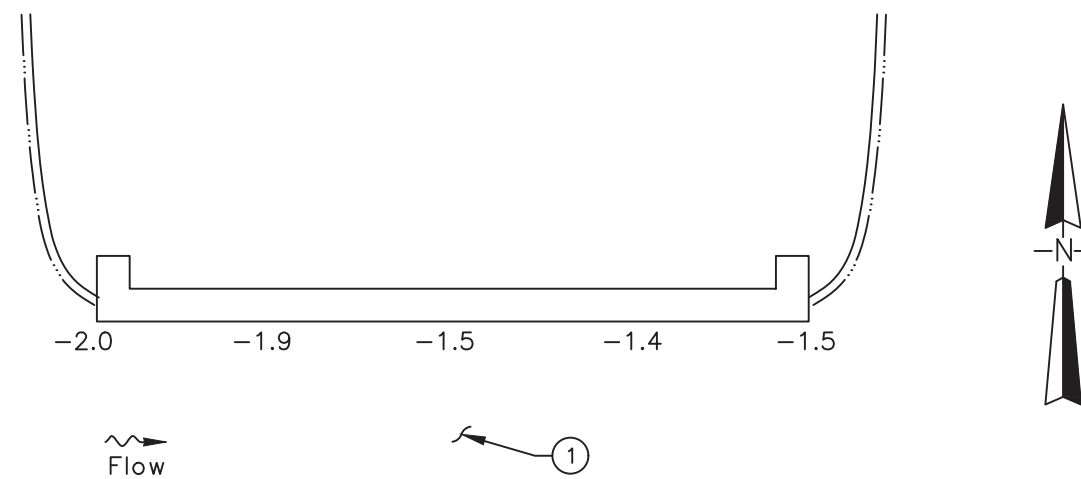
SR-19 OVER TOUSSAINT RIVER
 STRUCTURE NO. 6200966 (OTT-19-0833)
 ABUTMENT 2
 OTTAWA COUNTY, OHIO

The channel bottom material consisted of riprap up to 18 in. diameter with no probe rod penetration. Heavy scaling was observed up to 1 in. deep from the channel bottom to the bottom of deck. Refer to Figure 10 in Exhibit 1 for detailed inspection notes of Abutment 2. Refer to Photograph 7 in Exhibit 2 for views of the typical concrete condition at the waterline.

- ① The channel bottom material consisted of rip-rap up to 18 in. diameter with no probe rod penetration.
- ② Heavy scaling up to 1 in. deep was observed from the channel bottom to the bottom of deck.

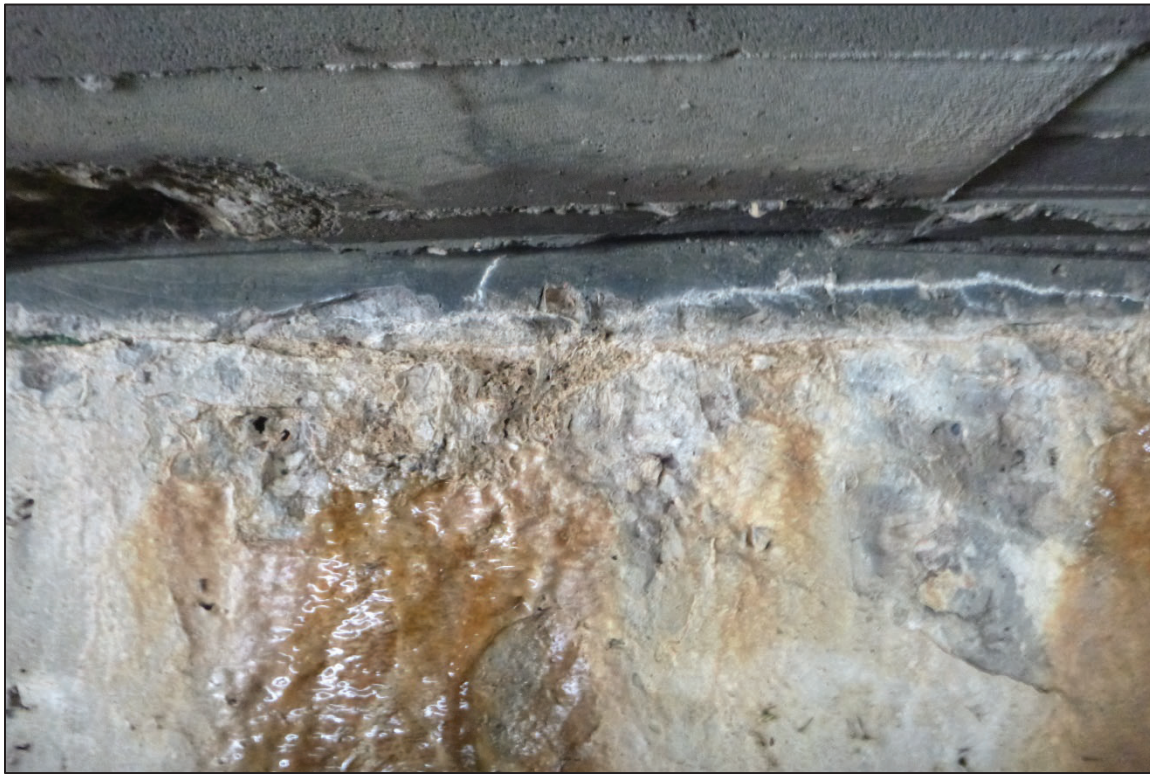
Photograph No. 7: View of the Typical Concrete Condition of the Abutments at the Waterline, Looking North.

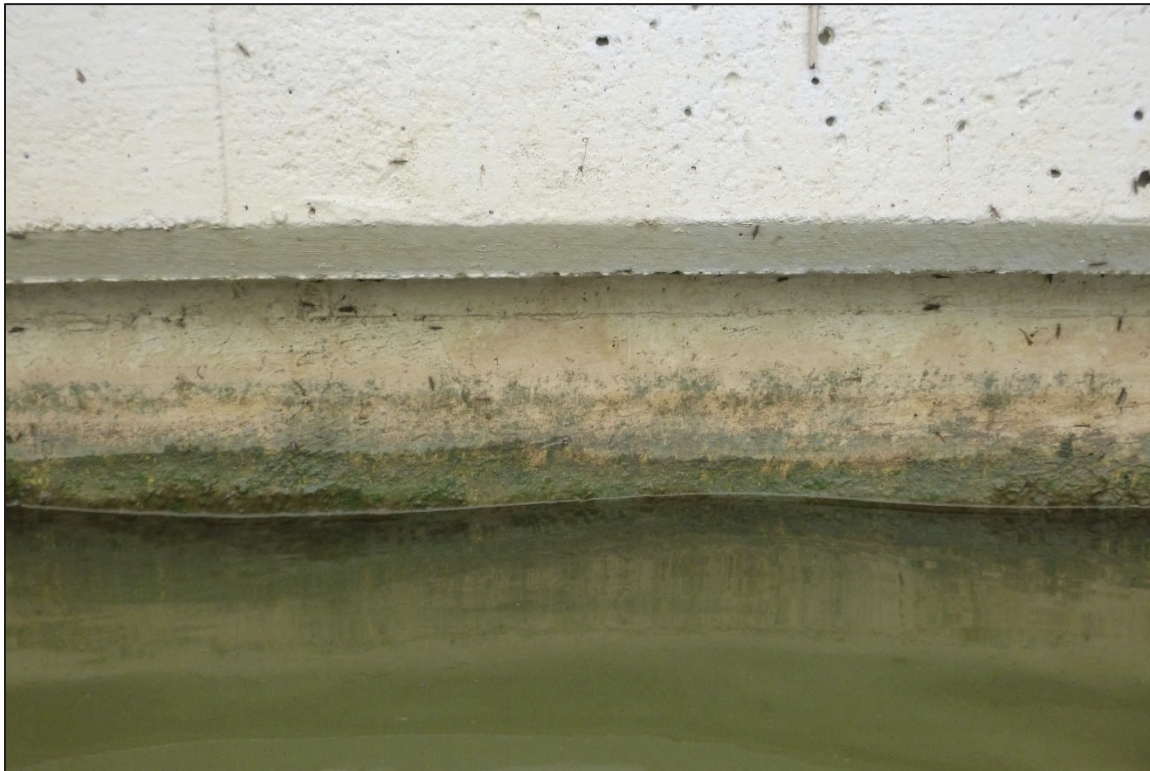
Photograph No. 8: View of the Typical Concrete Condition at the Upstream Nose of Pier 1 at the Waterline, Looking East.
