# UNDERWATER BRIDGE INSPECTION REPORT

STRUCTURE NO. 6201776 (OTT-357-0016)

SR 357 OVER PUT-IN-BAY

April 2020

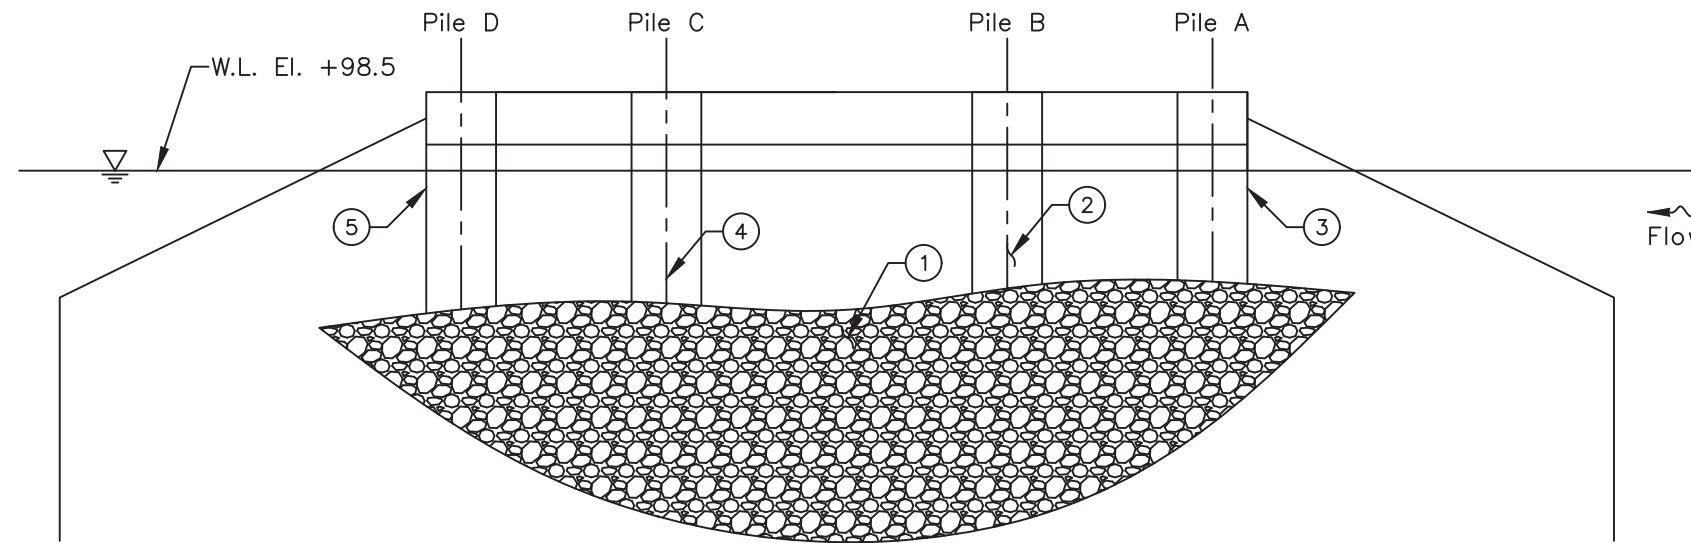
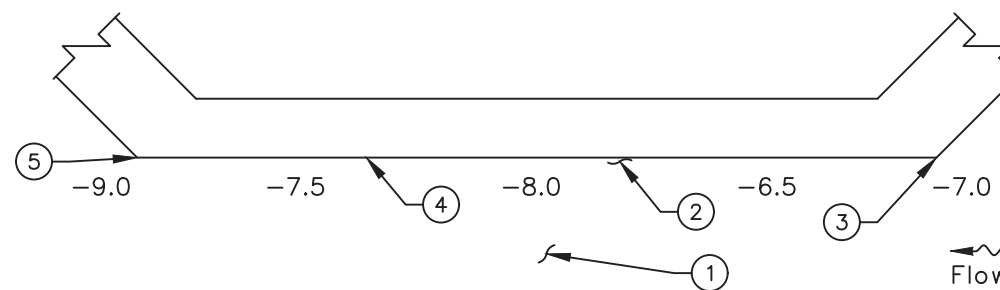
SR-357 OVER PUT-IN-BAY  
 STRUCTURE NO. 6201776 (OTT-357-0016)  
 ABUTMENT 1  
 OTTAWA COUNTY, OHIO

The channel bottom material consisted of sand with scattered gravel up to 4 in. diameter with no probe rod penetration. The steel sheet-piles and H-piles exhibited light surface corrosion with pitting up to 1/16 in. deep. A spall was observed on the southeast corner of the pile cap measuring approximately 6 in. horizontal by 6 in. vertical by 5 in. deep with one exposed horizontal steel reinforcement exhibiting light surface corrosion. Area of heavy surface corrosion was observed on Pile 'A' measuring approximately 1.5 ft vertical by 6 in. horizontal with a corrosion hole in the center of the area measuring 3 in. vertical by 1 in. horizontal. The area was located approximately 2.5 ft about the channel bottom. A spall was observed on the southwest corner of the pile cap measuring approximately 3 ft horizontal by 3 in. vertical 2 in. deep with no exposed steel reinforcement. Refer to Figure 6 in Exhibit 1 for detailed inspection notes of Abutment 1. Refer to Photographs 7 and 8 in Exhibit 2 for views of Abutment 1.

- ① The channel bottom material consisted of sand with gravel up to 4 in. diameter with no probe rod penetration.
- ② Steel sheet-pile and pile typically exhibited light surface corrosion with pitting up to 1/16 in. deep.
- ③ Spall measuring approximately 6 in. long by 6 in. wide by 5 in. deep was found with one exposed horizontal rebar exhibiting light surface corrosion.
- ④ Area of heavy surface corrosion with rust nodules measuring 1.5 ft vertical by 6 in. horizontal located on Pile 'A' at 2.5 ft above channel bottom. Centered in area is a corrosion hole measuring approximately 3 in. vertical by 1 in. horizontal.
- ⑤ Spall measuring 3 ft horizontal by 3 in. vertical by 2 ft deep was found along bottom face of cap at southwest corner of Abutment 1 with no exposed steel reinforcement.

The spalls and associated concrete delaminations at Abutments 1 and 2 are not structural concerns at this time; however, they should be repaired to prevent further deterioration. The repairs should include removal of unsound concrete to a minimum of 1 inch behind the reinforcing steel, cleaning and replacing reinforcing steel as required, and placing concrete designed to provide high durability with low permeability.

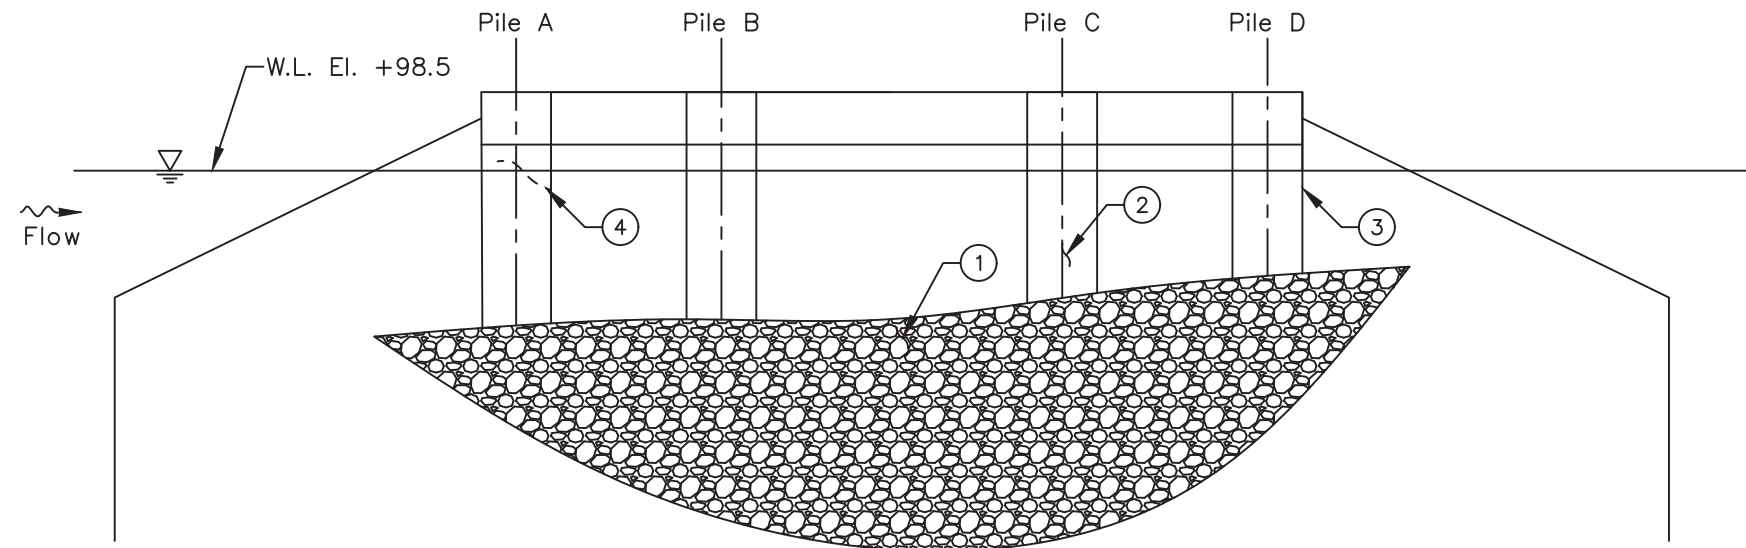
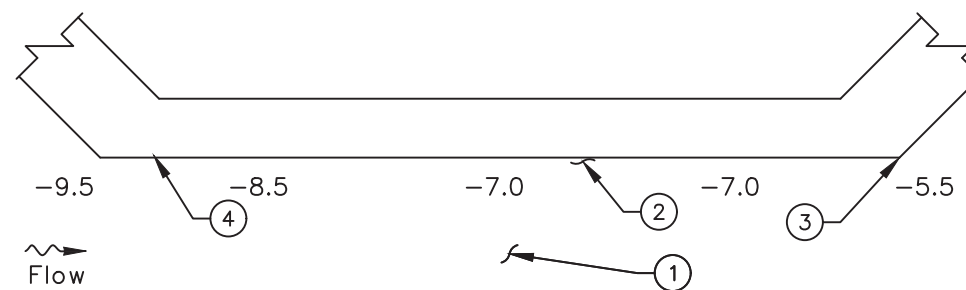
SR-357 OVER PUT-IN-BAY  
 STRUCTURE NO. 6201776 (OTT-357-0016)  
 ABUTMENT 2  
 OTTAWA COUNTY, OHIO

The channel bottom material consisted of sand with scattered gravel up to 4 in. diameter with no probe rod penetration. The steel sheet-piles and H-piles exhibited light surface corrosion with pitting up to 1/16 in. deep. A spall was observed on the northeast corner of the pile cap measuring approximately 3 ft horizontal by 1 ft vertical by 2 in. deep with no exposed steel reinforcement. A crack was observed on the northwest corner of the wingwall measuring approximately 1.5 ft long by up to a maximum of 1/4 in. wide. Refer to Figure 7 in Exhibit 1 for detailed inspection notes of Abutment 2. Refer to Photographs 9 through 12 in Exhibit 2 for views of Abutment 2 and typical concrete and steel conditions at the waterline.

- ① The channel bottom material consisted of sand with gravel up to 4 in. diameter with no probe rod penetration.
- ② Steel sheet-pile and pile typically exhibited light surface corrosion with pitting up to 1/16 in. deep.
- ③ Spall measuring 3 ft horizontal by 1 ft vertical by 2 ft deep was found along bottom face of cap at the northeast corner with no observed steel rebar.
- ④ Crack measuring 1.5 ft long by 1/4 in. wide located on the northwest corner of Abutment 2.

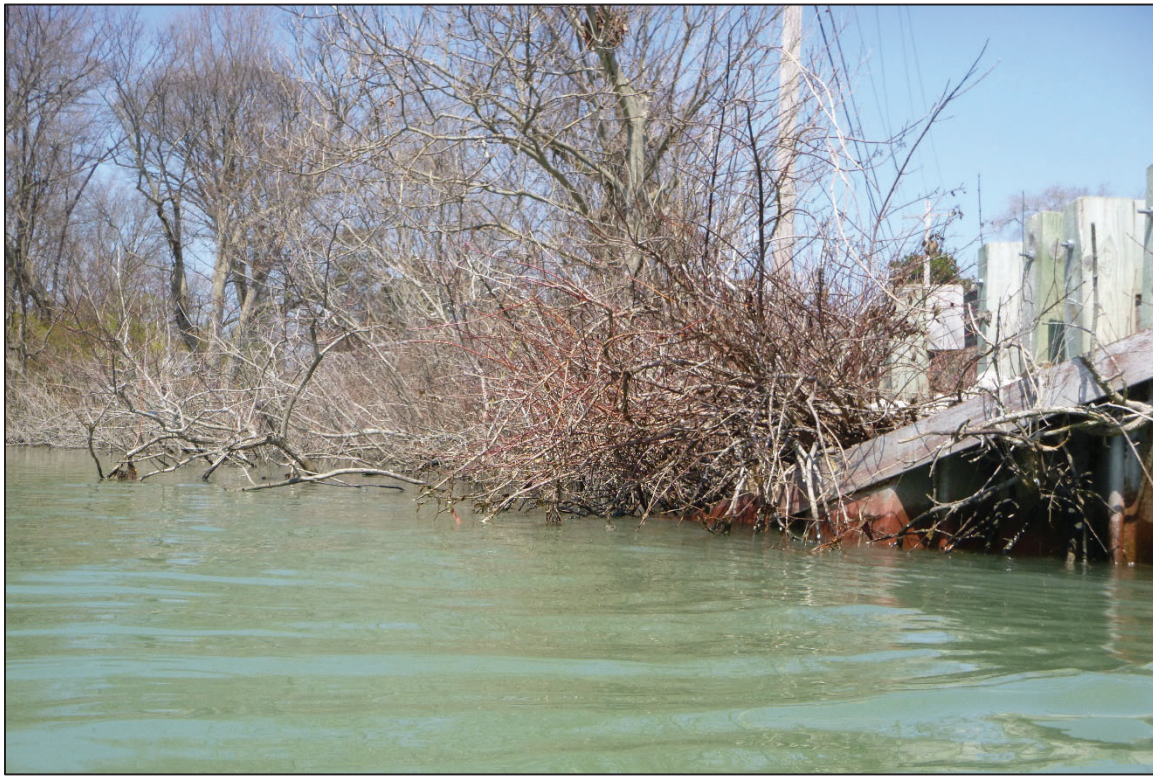
<b>Shoreline Conditions:</b>	The north and south shorelines consisted of sparsely vegetated moderate slopes that is well protected with no signs of erosion.

Photograph No. 3: View of the North Embankment Upstream of the Structure, Looking North.

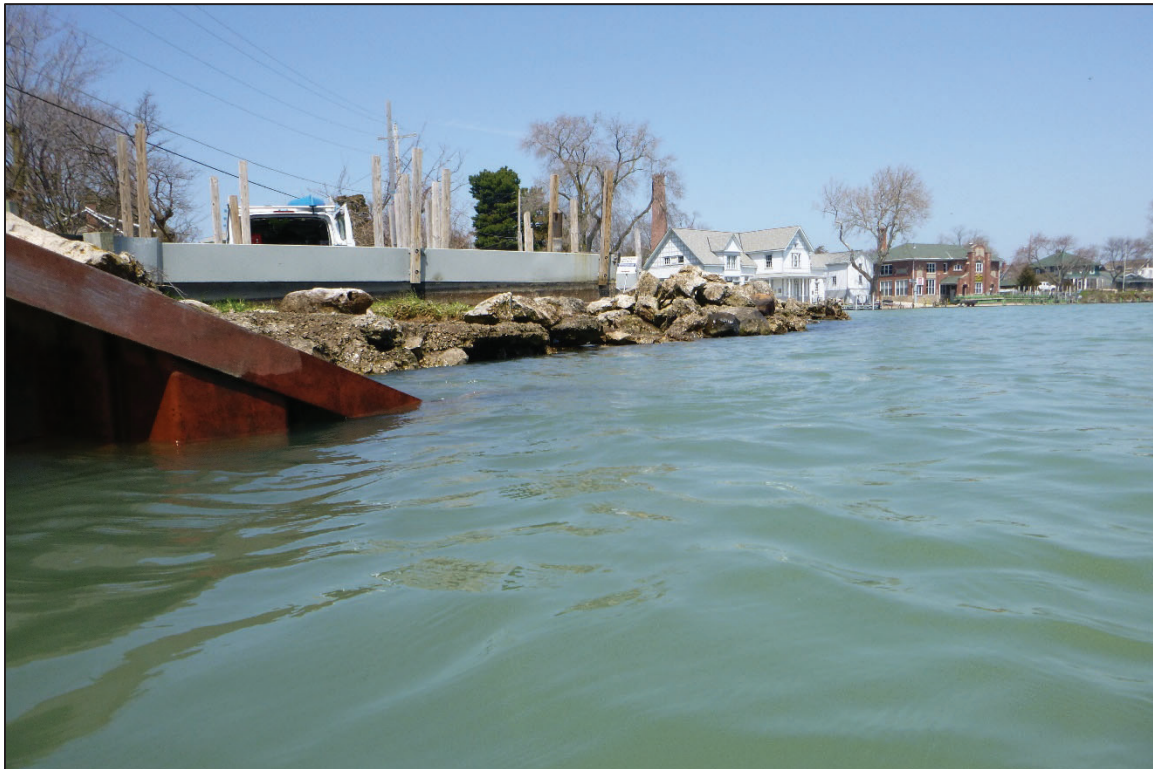
Photograph No. 4: View of the North Embankment Downstream of the Structure, Looking North.

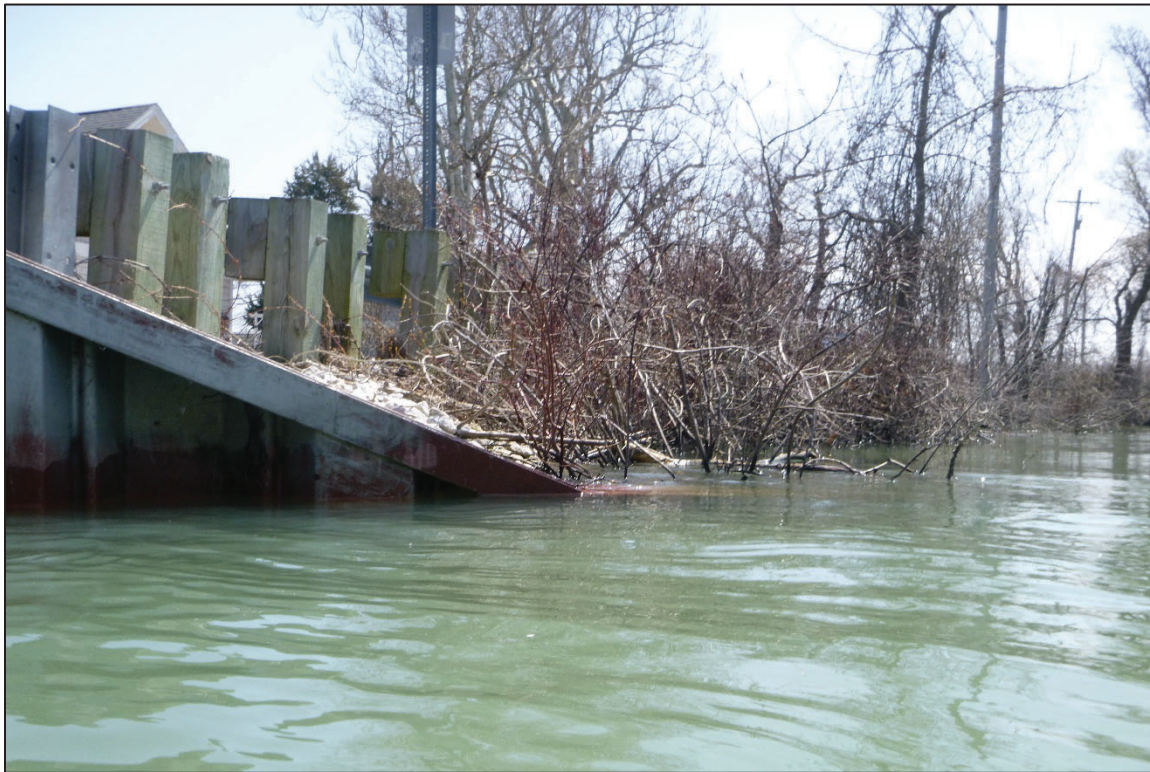
Photograph No. 5: View of the South Embankment Upstream of the Structure, Looking Southeast.

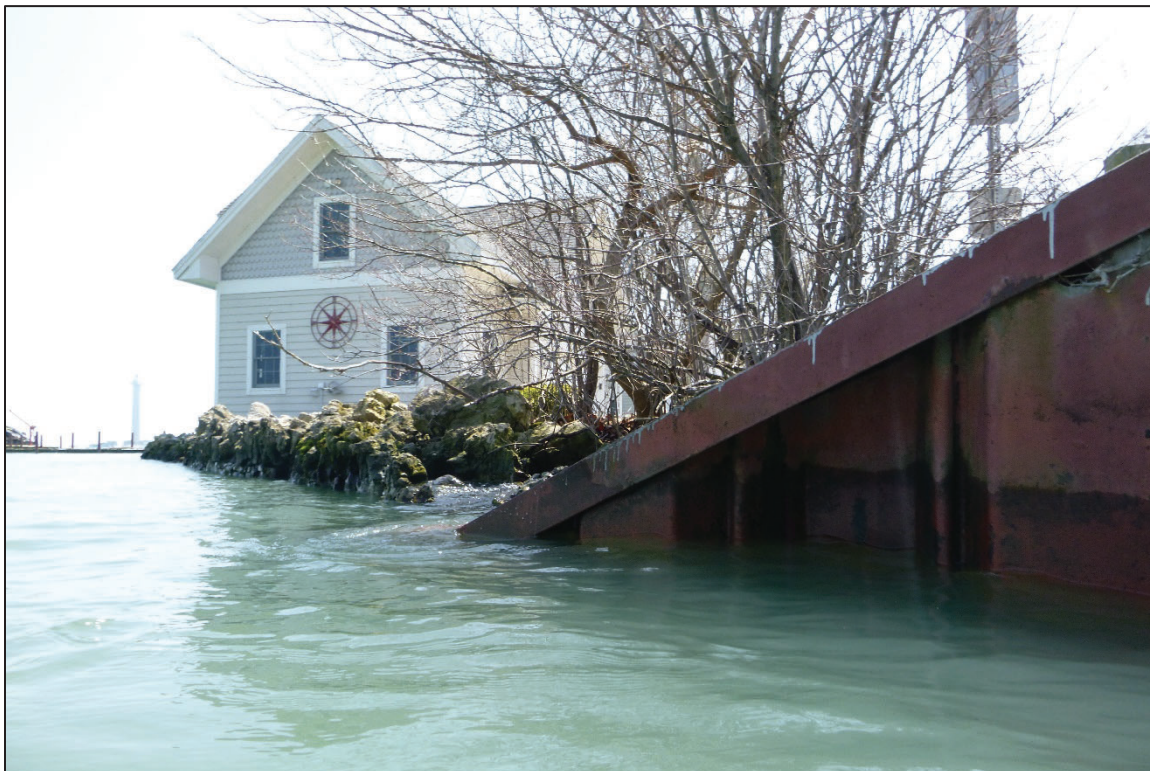
Photograph No. 6: View of the South Embankment Downstream of the Structure, Looking South.

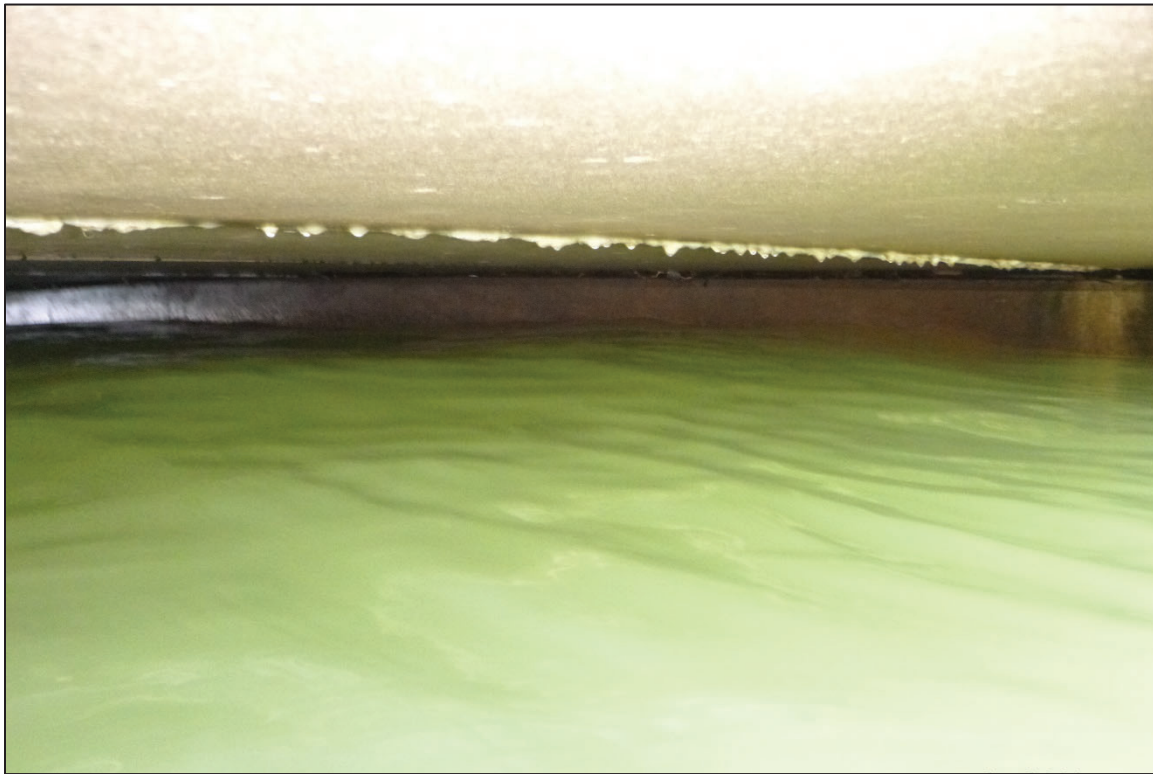
Photograph No. 7: View of Abutment 1, Looking Southeast.

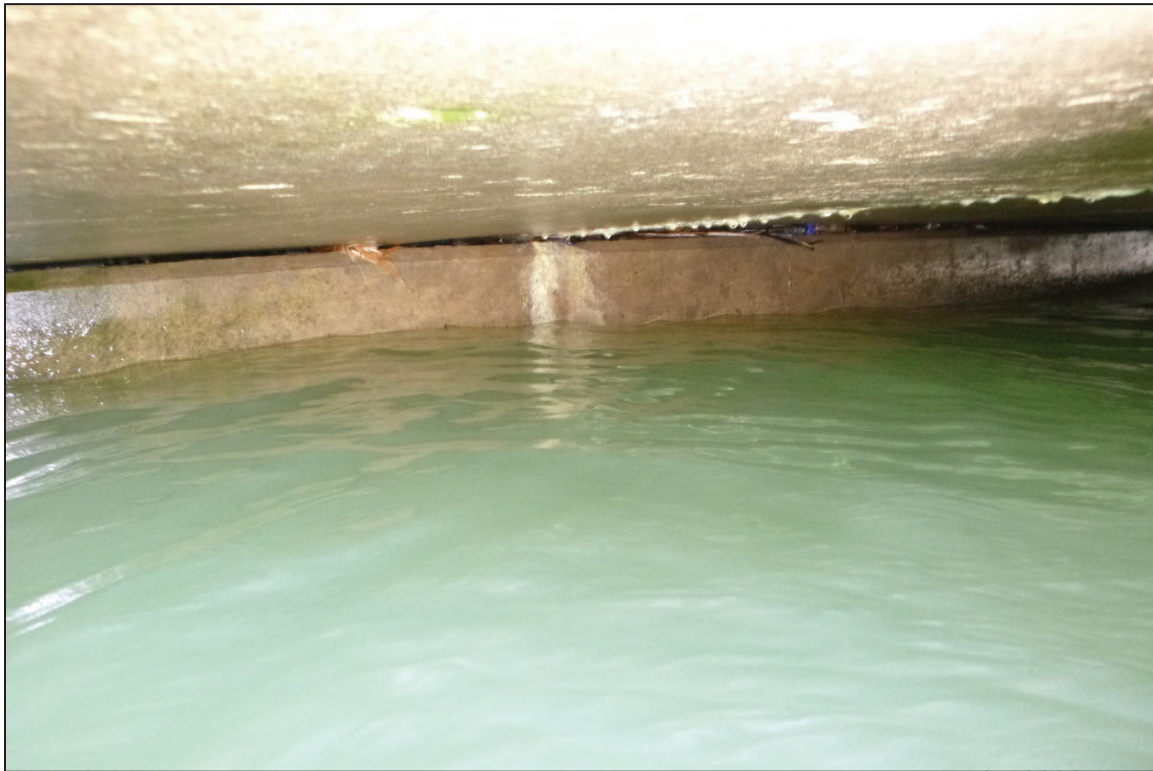
Photograph No. 8: View of Abutment 1, Looking South.

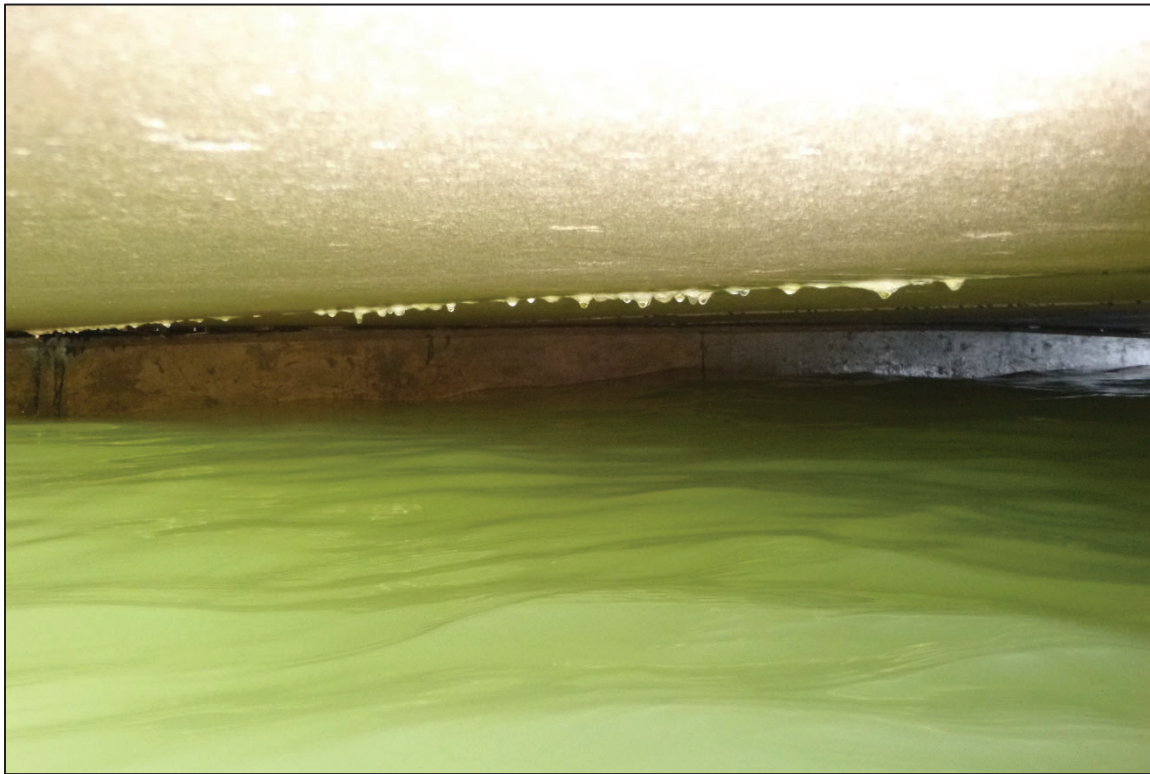
Photograph No. 9: View of Abutment 2, Looking North.

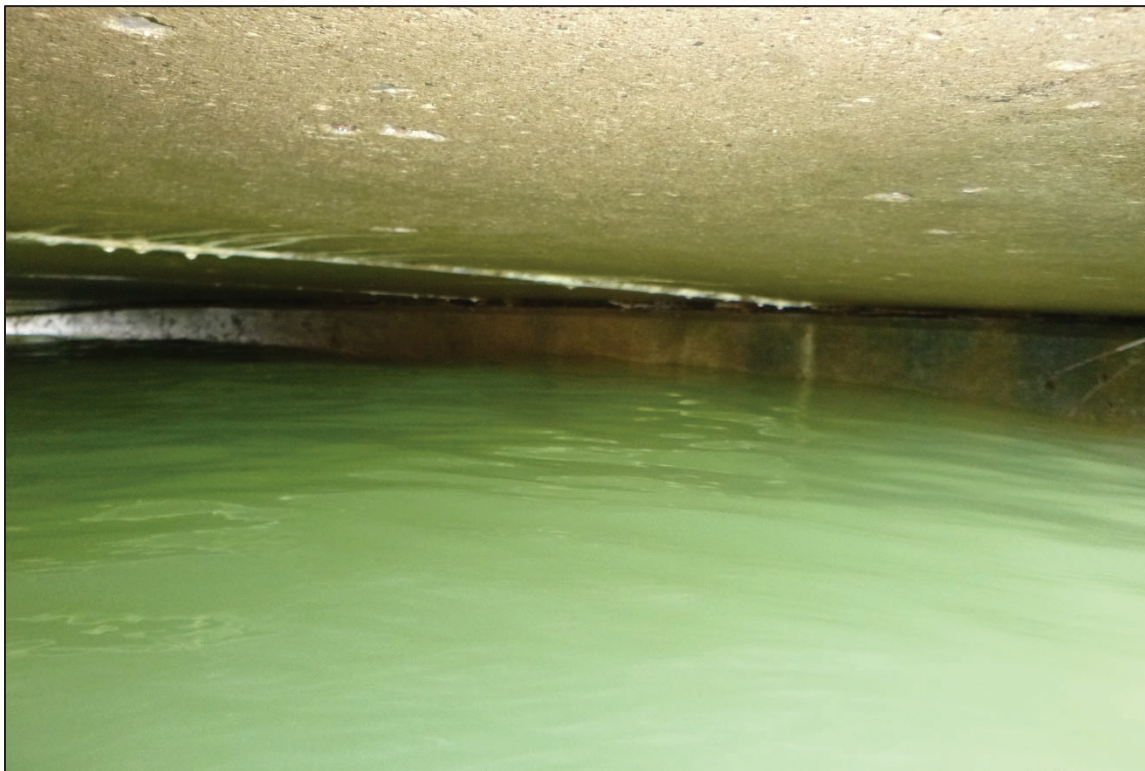
Photograph No. 10: View of Abutment 2, Looking Northwest.

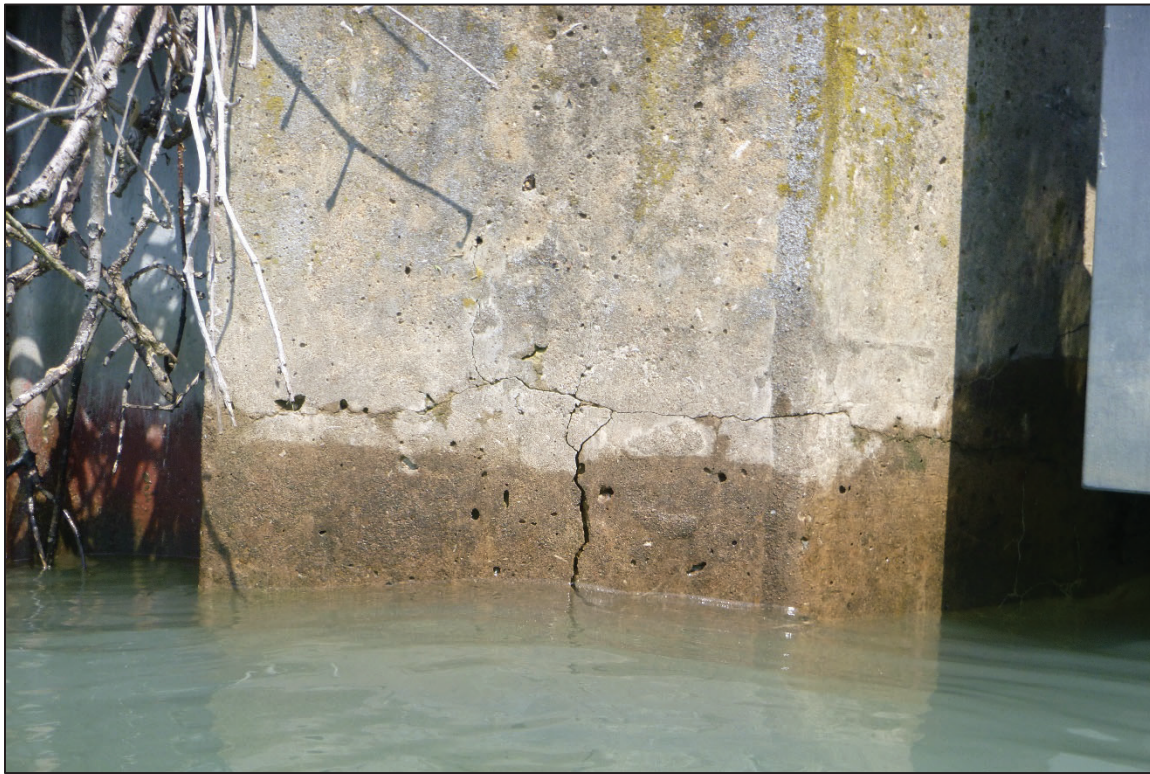
- 
- A spall was observed on the northeast corner of the pile cap measuring approximately 3 ft horizontal by 1 ft vertical by 2 in. deep with no exposed steel reinforcement.
  - A crack was observed on the northwest corner of the wingwall measuring approximately 1.5 ft long by up to a maximum of 1/4 in. wide.

Photograph No. 11: View of the Typical Concrete Condition and Crack at the Waterline on the Abutment 2, Looking North.

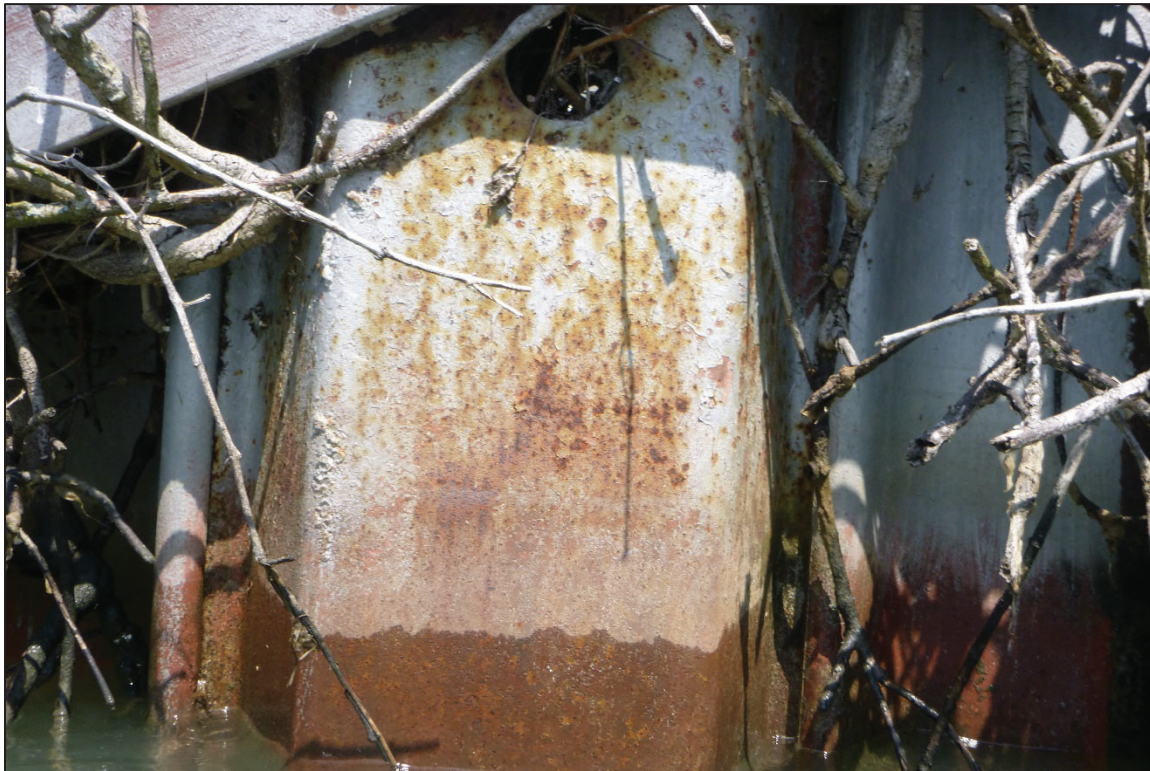
- **Abutment 2:**
  - The channel bottom material consisted of sand with scattered gravel up to 4 in. diameter with no probe rod penetration.
  - The steel sheet-piles and H-piles exhibited light surface corrosion with pitting up to 1/16 in. deep.

Photograph No. 12: View of the Typical Steel Condition at the Waterline on the Abutment 2, Looking North.

The corrosion on the pile of Abutment 1 is not a structural concern at this time, and as a result, no repairs are recommended. However, since the available design plans and construction documentation did not indicate the thickness of the piles, the percentage of section loss due to corrosion is unknown. It is therefore recommended that the extent and severity of the corrosion be closely monitored during future inspections. Should the extent or severity of the corrosion progress, it may be necessary to repair the piles by cleaning the piles and installing wraps or encasements. It is also recommended that during future inspections the remaining thickness of the steel piles be measured with the use of an ultrasonic thickness measuring device.
