UNDERWATER BRIDGE INSPECTION REPORT

STRUCTURE NO. 7200579 (SAN-6-1751)
US-6 OVER SANDUSKY RIVER
SANDUSKY COUNTY, OH
DISTRICT 2

May 2020

COLLINS
ENGINEERS INC.

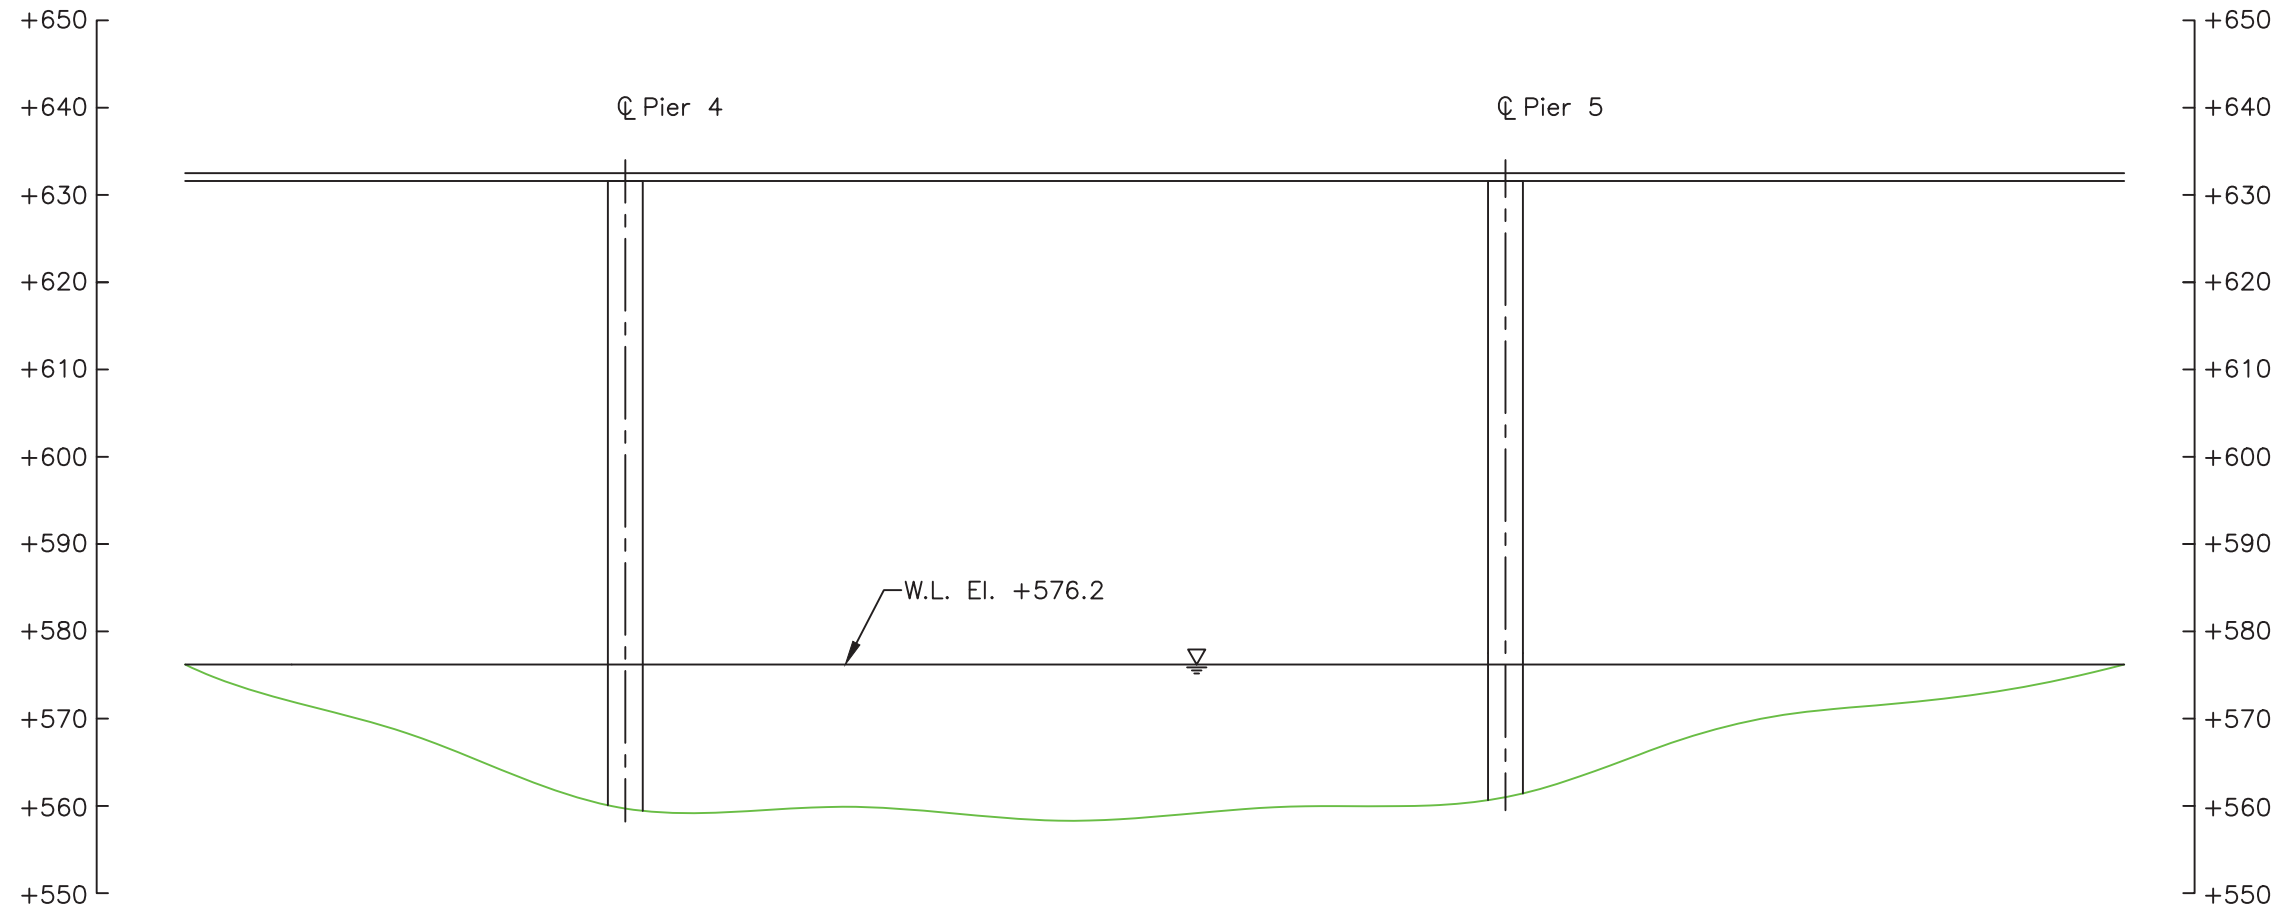
CHANNEL CROSS SECTION
50 FT UPSTREAM
(LOOKING DOWNSTREAM)

Overall, the inspected substructure units of Structure No. 7200579 (SAN-6-1751) were in satisfactory condition. A comparison of the soundings recorded during the previous inspection on November 18, 2015 and the soundings taken during this inspection revealed footing exposure of the substructure units. To prevent further deterioration of the bearing material, corrective actions should be taken at this time. Corrective actions may include placement of properly design riprap, installation of spur dikes, or other means of erosion control depending on site conditions. The channel bottom configuration should continue to be closely monitored during future underwater inspections to verify that the footing exposure and undermining is not increasing and that all footings remain adequately embedded in the channel bottom.

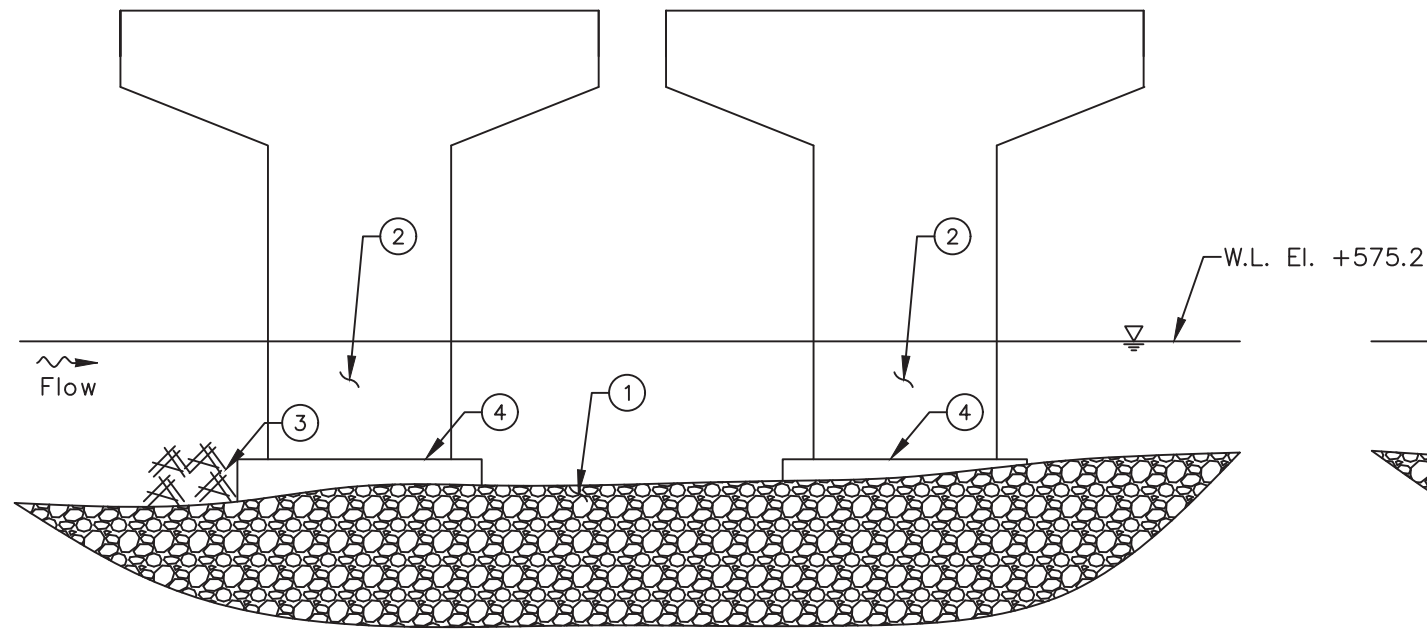
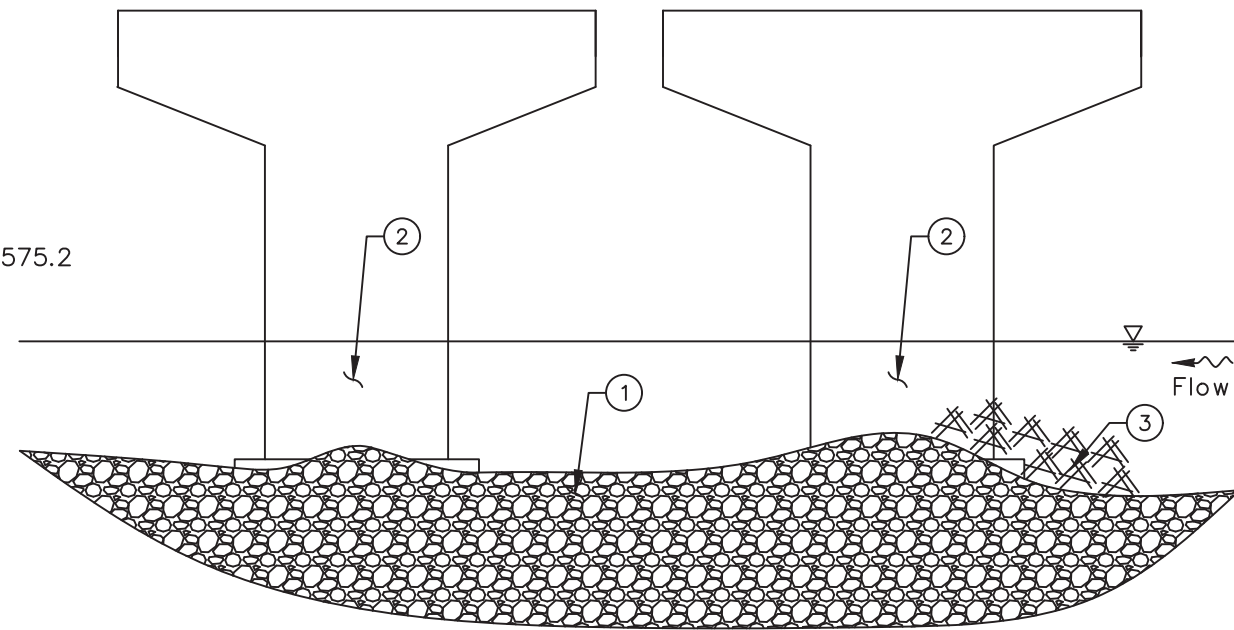
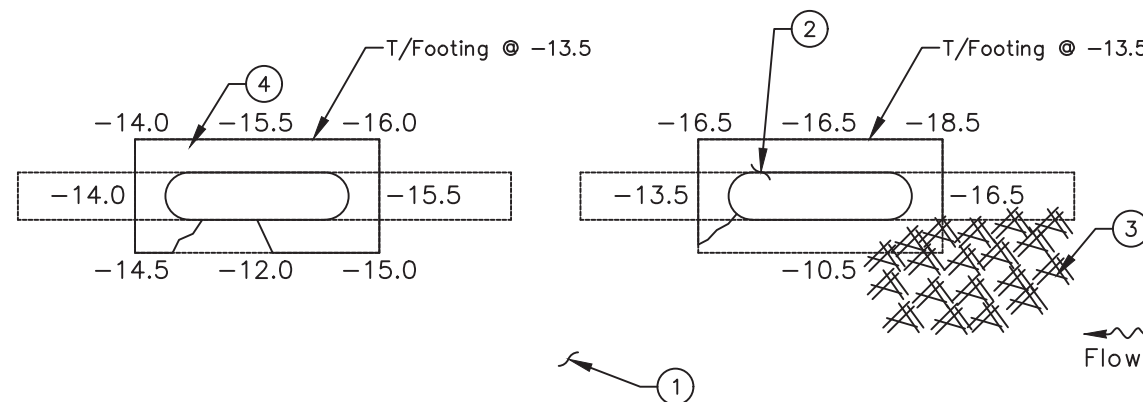
US-6 OVER SANDUSKY RIVER
 STRUCTURE NO. 7200579 (SAN-6-1751)
 PIER 4
 SANDUSKY COUNTY, OHIO

- ② The submerged portions of the pier exhibited light scaling up to 1/16 in. deep.
- ③ Heavy timber debris accumulation consisting of logs up to 24 in. diameter was observed on the southeast corner of the upstream nose on the south pier extending up to 20 ft off the face of the pier from the channel bottom to approximately 1 ft above the waterline.

- ④ The top of footing was observed at -13.5 ft and was exposed on the south pier from the upstream nose around the east face to the northwest corner. On the north pier the footing was exposed from approximately 5 ft south of the midpoint along the west face towards the south around the east face with the exposed footing ending 5 ft south of the northwest corner. The maximum vertical exposure was observed to be 5.0 ft at the southeast corner of the south pier.

- Install scour protection at Piers 4 and 5.
- Monitor timber debris at Piers 4 and 5.

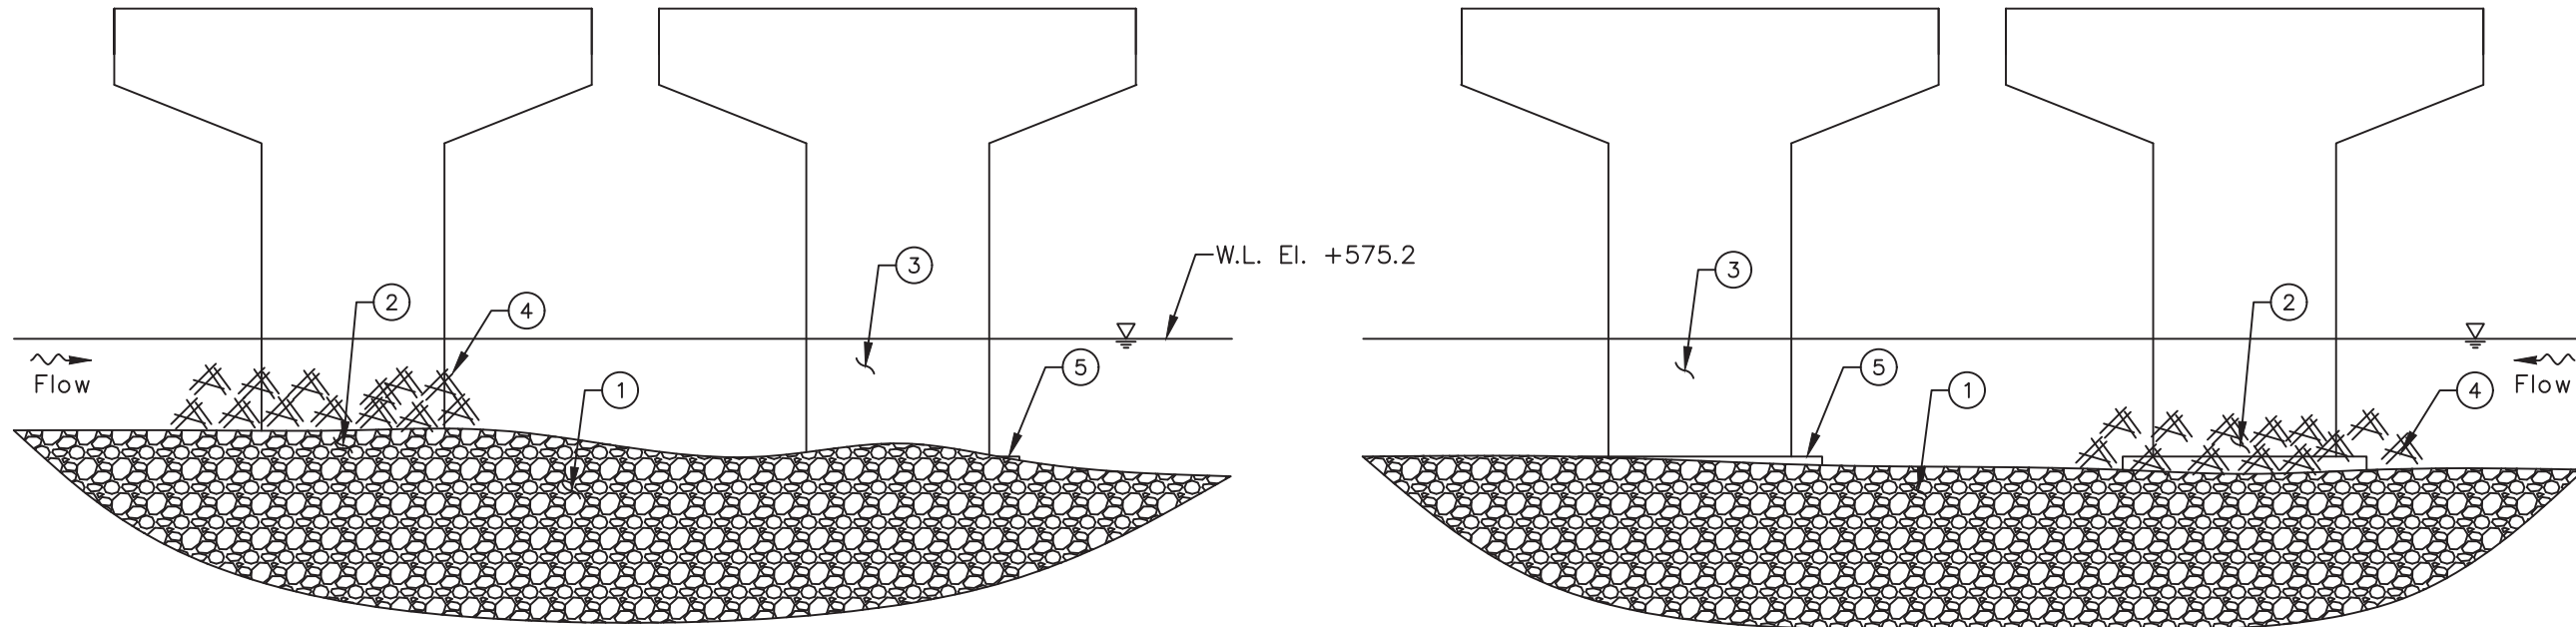
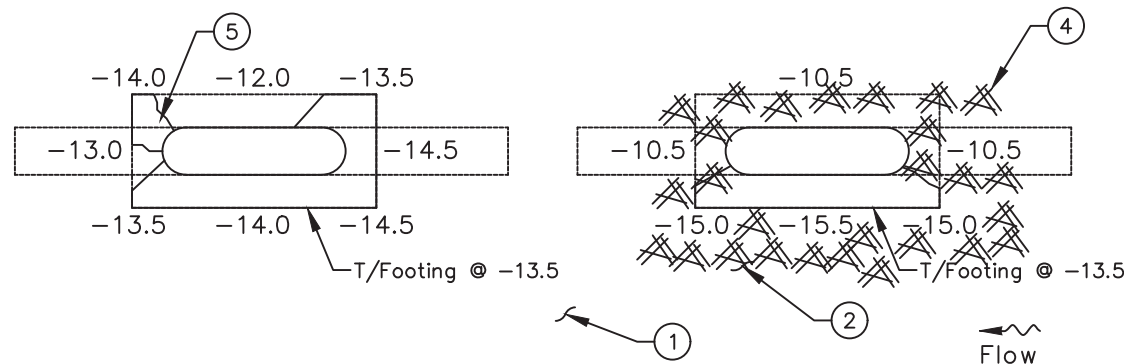
- ④ Moderate timber debris accumulation consisting of branches up to 6 in. diameter was observed around the south pier extending up to 10 ft off the face from the channel bottom to approximately 10 ft below the waterline.

- ⑤ The top of footing was observed at -13.5 ft and was exposed on the upstream pier from the upstream nose around the east face to the northwest corner. On the downstream pier the footing was exposed from approximately 5 ft south of the midpoint along the west face towards the south around the east face with exposed footing ending 5 ft south of the northwest corner. The maximum vertical exposure was observed to be 2.0 ft at the midpoint along the west face of the south pier.

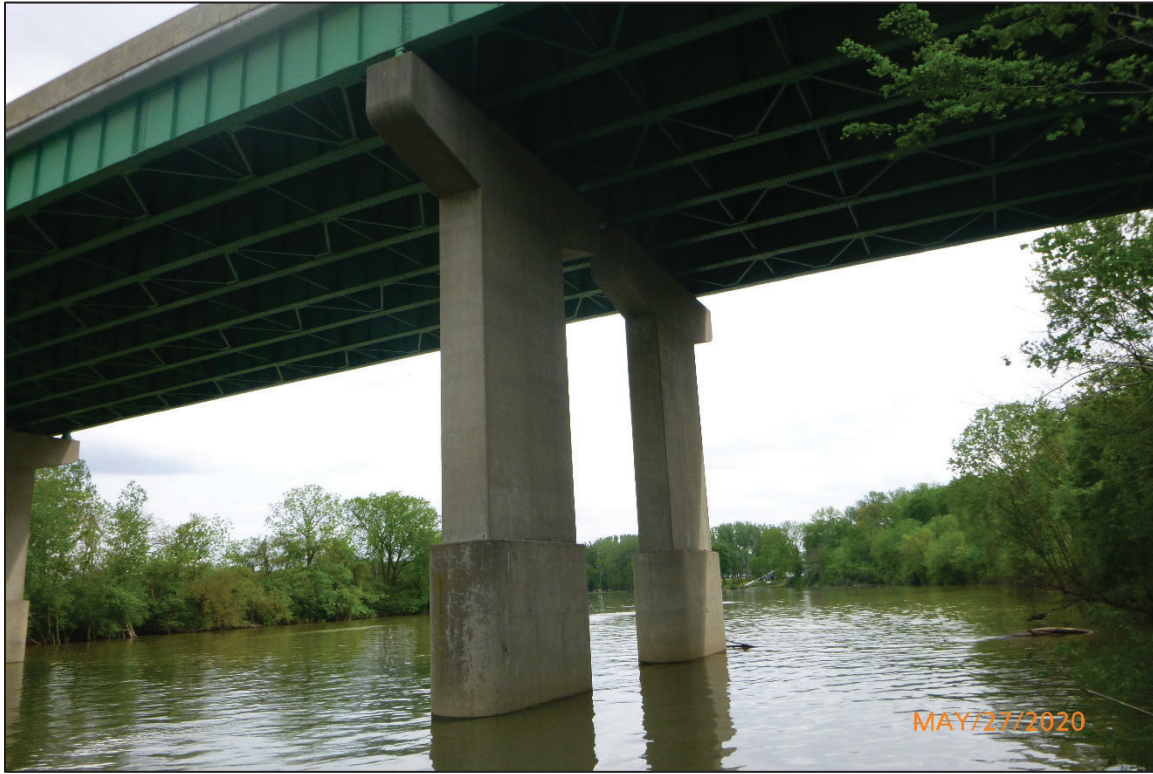
The channel bottom material consisted of soft silt and clay with up to 12 in. probe rod penetration on the east face of the pier and on the west face of the pier the channel bottom material consisted of gravel up to 6 in. diameter with up to 1 in. probe rod penetration. The submerged portions of the pier exhibited light scaling up to 1/16 in. deep. Heavy timber debris accumulation consisting of logs up to 24 in. diameter was observed on the southeast corner of the upstream nose on the south pier extending up to 20 ft off the face of the pier from the channel bottom to approximately 1 ft above the waterline. The top of footing was observed at -13.5 ft and was exposed on the south pier from the upstream nose around the east face to the northwest corner. On the north pier the footing was exposed from approximately 5 ft south of the midpoint along the west face towards the south around the east face with the exposed footing ending 5 ft south of the northwest corner. The maximum vertical exposure was observed to be 5.0 ft at the southeast corner of the south pier. Refer to Figure 8 in Exhibit 1 for detailed inspection notes of Pier 4. Refer to Photographs 9 through 11 in Exhibit 2 for views of Pier 4 and typical concrete condition at the waterline.

Photograph No. 9: View of the West Face of Pier 4, Looking Southeast.

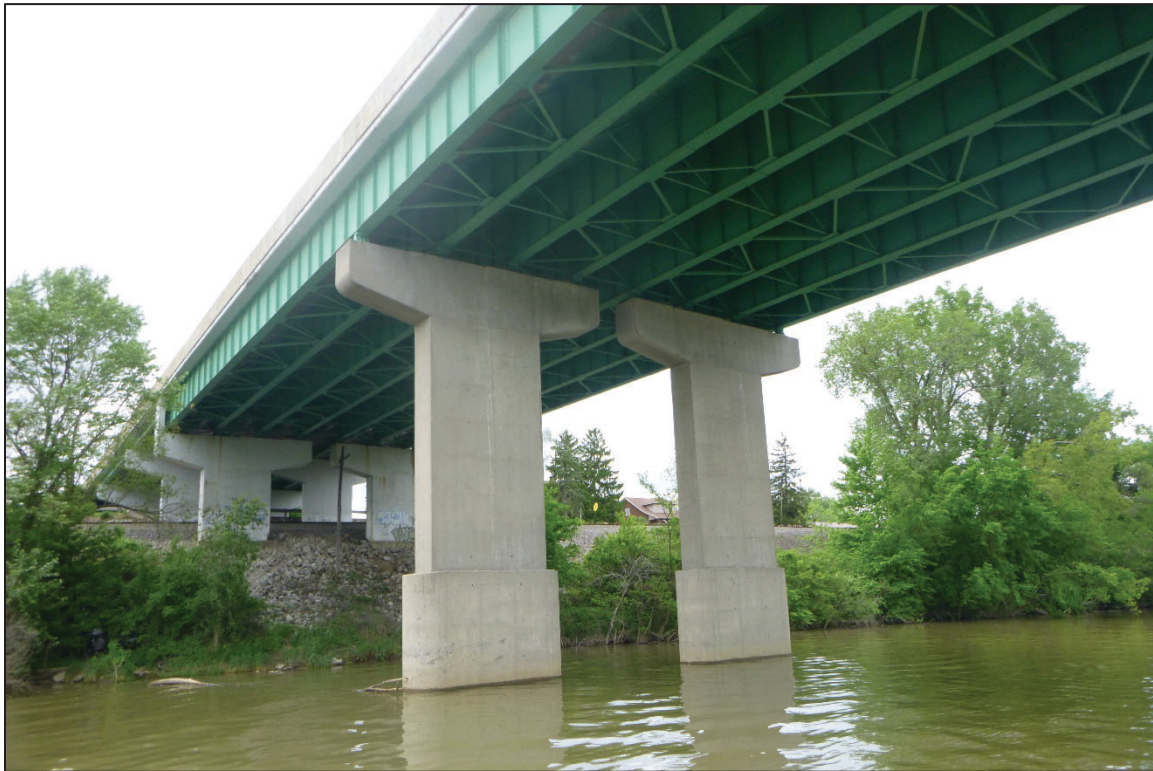
Photograph No. 10: View of the East Face of Pier 4, Looking Northwest.

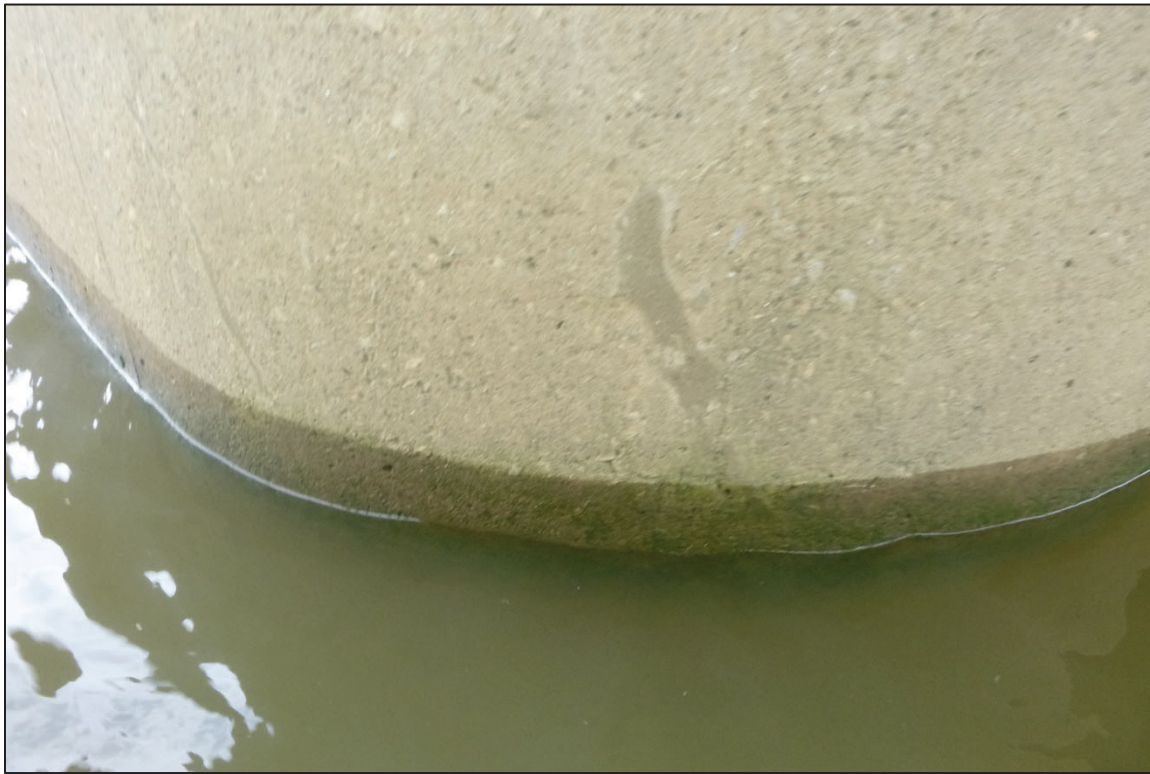
- The submerged portions of the pier exhibited light scaling up to 1/16 in. deep.
 - Heavy timber debris accumulation consisting of logs up to 24 in. diameter was observed on the southeast corner of the upstream nose on the south pier extending up to 20 ft off the face of the pier from the channel bottom to approximately 1 ft above the waterline.

Photograph No. 11: View of the Typical Concrete Condition at the Waterline on the Upstream Nose of Pier 4, Looking West.

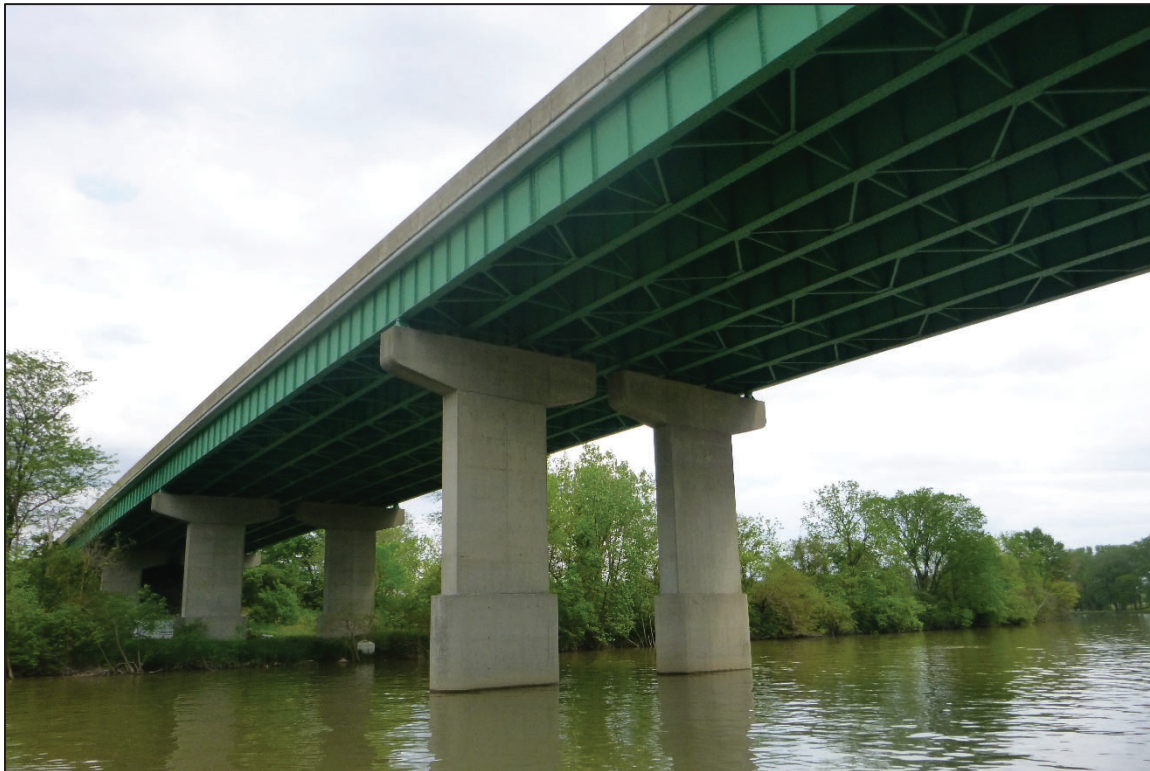
The channel bottom material around the north pier consisted of sand and gravel up to 2 in. diameter with up to 2 in. probe rod penetration on the east face of the pier. The channel bottom material around the south pier consisted of timber debris with branches up to 6 in. diameter with no probe rod penetration. The submerged portions of the pier exhibited light scaling up to 1/16 in. deep. Moderate timber debris accumulation consisting of branches up to 6 in. diameter was observed around the south pier extending up to 10 ft off the face from the channel bottom to approximately 10 ft below the waterline. The top of footing was observed at -13.5 ft and was exposed on the upstream pier from the upstream nose around the east face to the northwest corner. On the downstream pier the footing was exposed from approximately 5 ft south of the midpoint along the west face towards the south around the east face with the exposed footing ending 5 ft south of the northwest corner. The maximum vertical exposure was observed to be 2.0 ft at the midpoint along the west face of the south pier. Refer to Figure 9 in Exhibit 1 for detailed inspection notes of Pier 5. Refer to Photographs 12 and 13 in Exhibit 2 for views of Pier 5.

Photograph No. 12: View of the West Face of Pier 5, Looking Southeast.

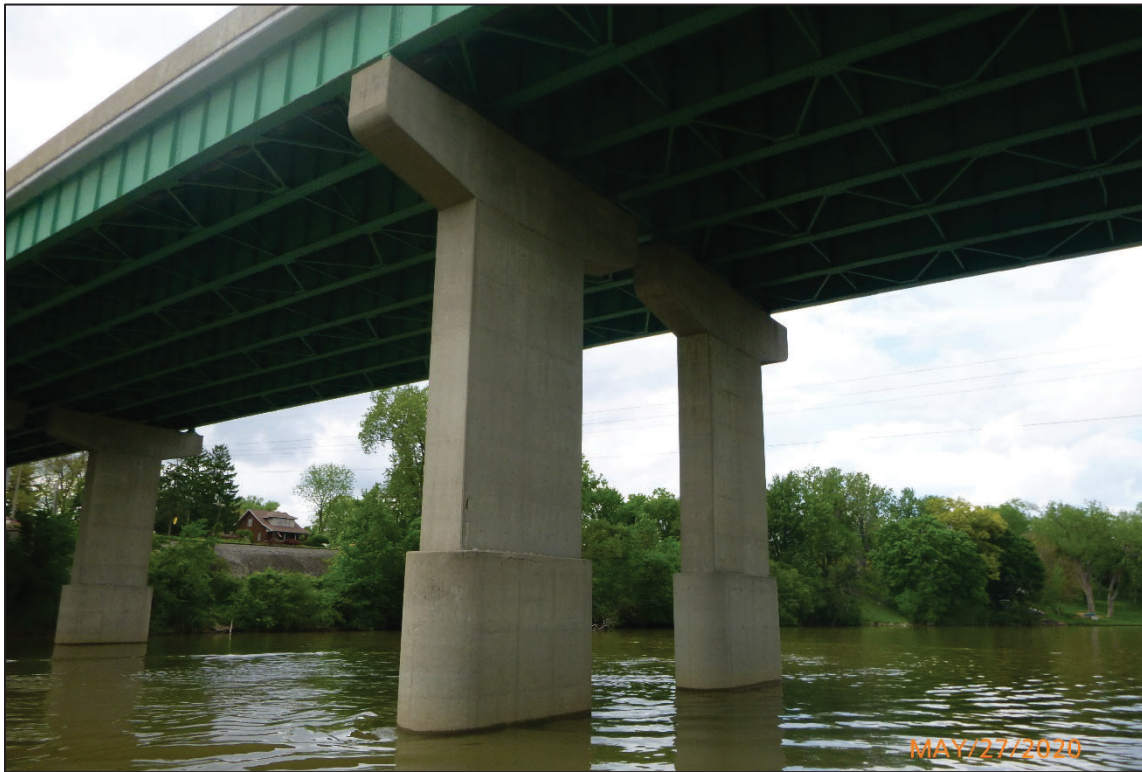
Photograph No. 13: View of the East Face of Pier 5, Looking Northwest.
