# UNDERWATER BRIDGE INSPECTION REPORT

STRUCTURE NO. 7202431 (SAN-53-1745)  
SR 53 OVER MUDDY CREEK  
SANDUSKY COUNTY, OH  
DISTRICT 2

May 2020

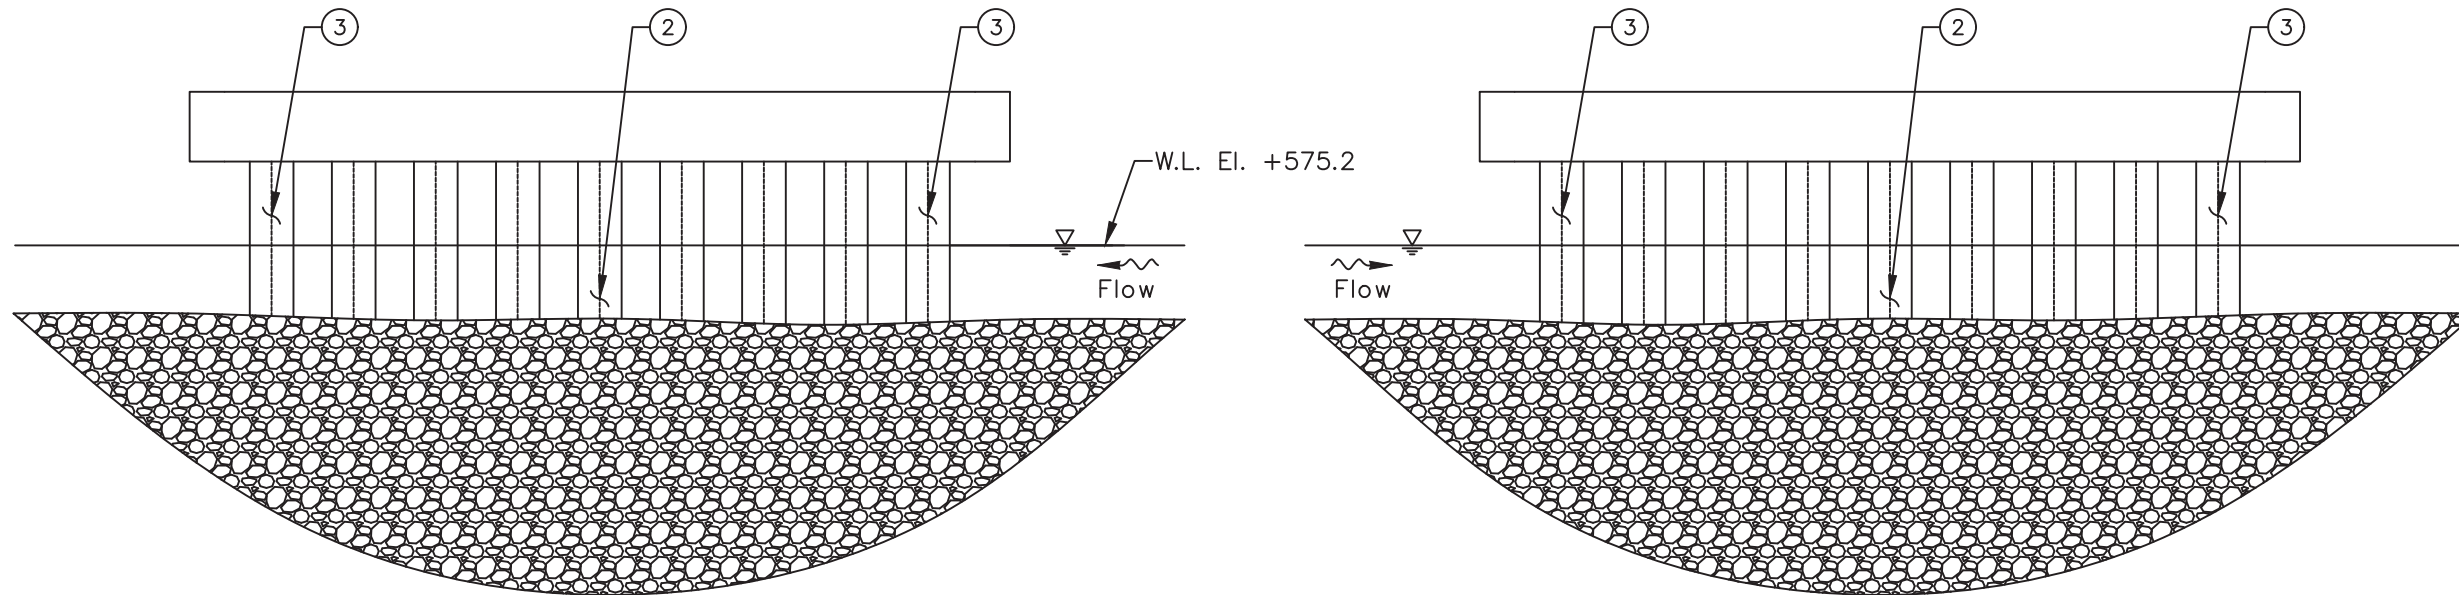
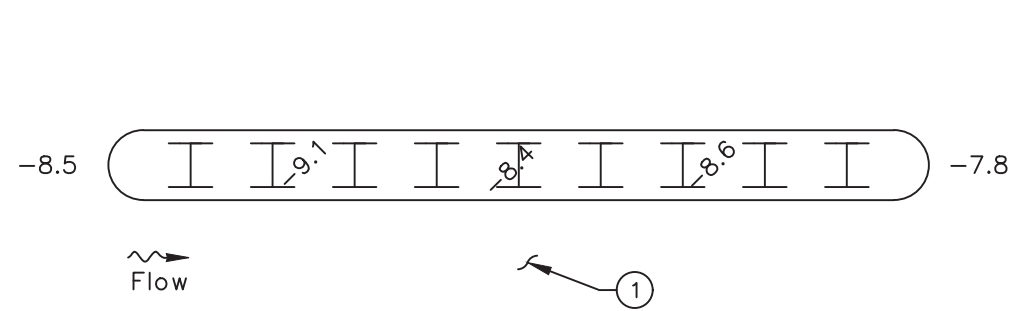
- ① The channel bottom material consisted of rip-rap up to 24 in. diameter with no probe rod penetration.
- ② The submerged portions of the steel H-Piles exhibited light surface corrosion with rust nodules up to 2 in. diameter from the channel bottom to -2 ft.
- ③ The upstream and downstream nose pile exhibited loss of coating with typically 1/32 in. pitting with a maximum of 1/8 in. from channel bottom to bottom of cap.

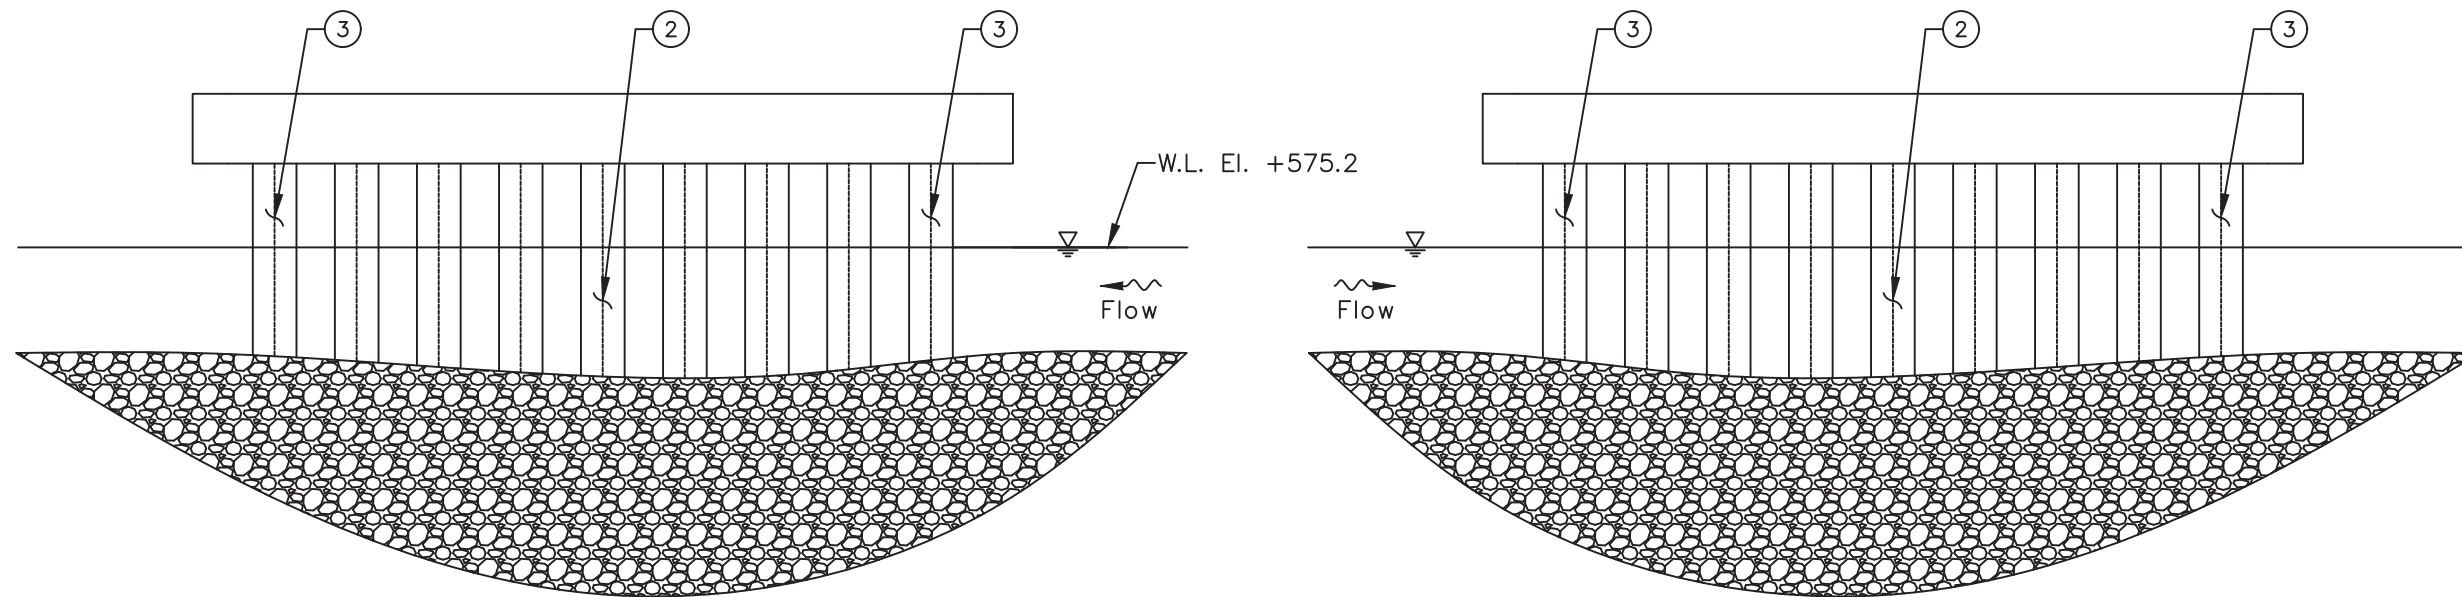
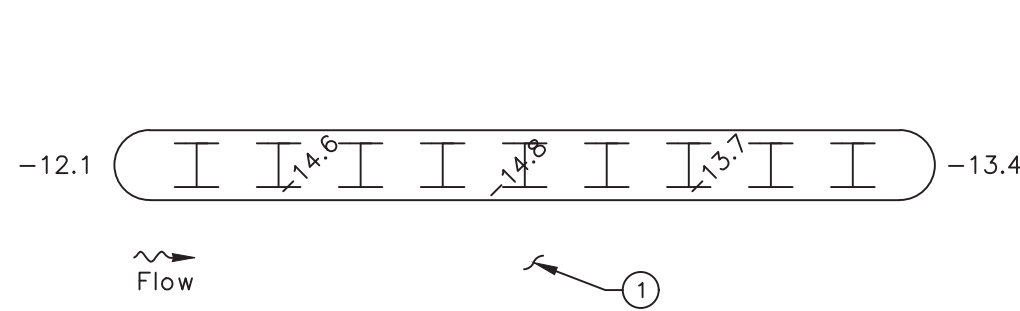
- ① The channel bottom material consisted of rip-rap up to 24 in. diameter with no probe rod penetration.
- ② The submerged portions of the steel H-Piles exhibited light surface corrosion with rust nodules up to 2 in. diameter from the channel bottom to -2 ft.
- ③ The upstream and downstream nose pile exhibited loss of coating with typically 1/32 in. pitting with a maximum of 1/8 in. from channel bottom to bottom of cap.

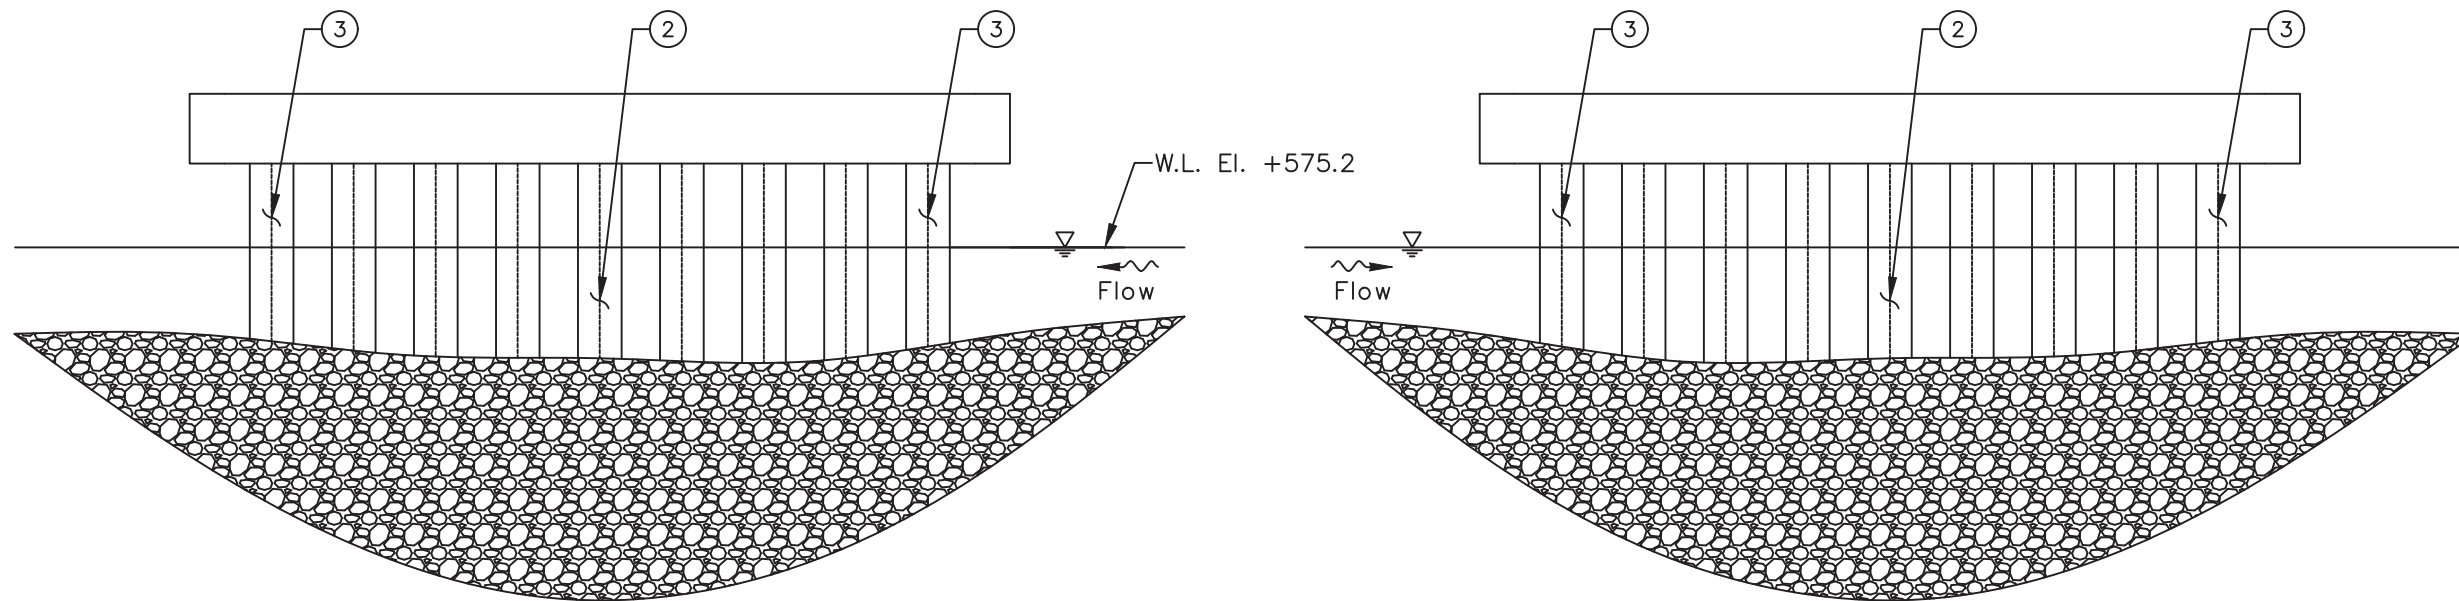
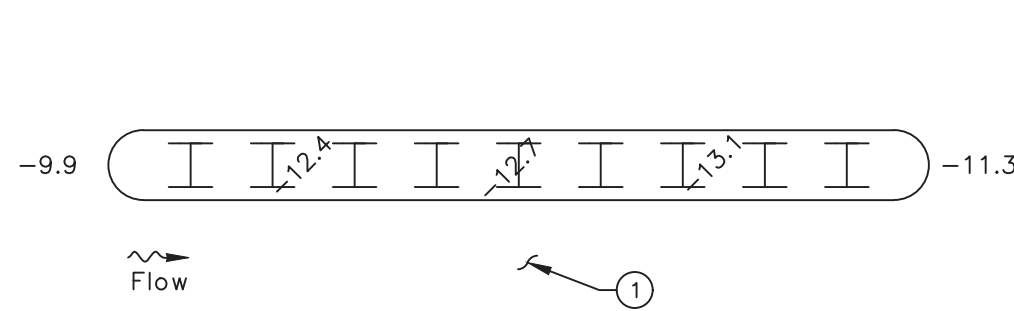
- ① The channel bottom material consisted of rip-rap up to 24 in. diameter with no probe rod penetration.
- ② The submerged portions of the steel H-Piles exhibited light surface corrosion with rust nodules up to 2 in. diameter from the channel bottom to -2 ft.
- ③ The upstream and downstream nose pile exhibited loss of coating with typically 1/32 in. pitting with a maximum of 1/8 in. from channel bottom to bottom of cap.

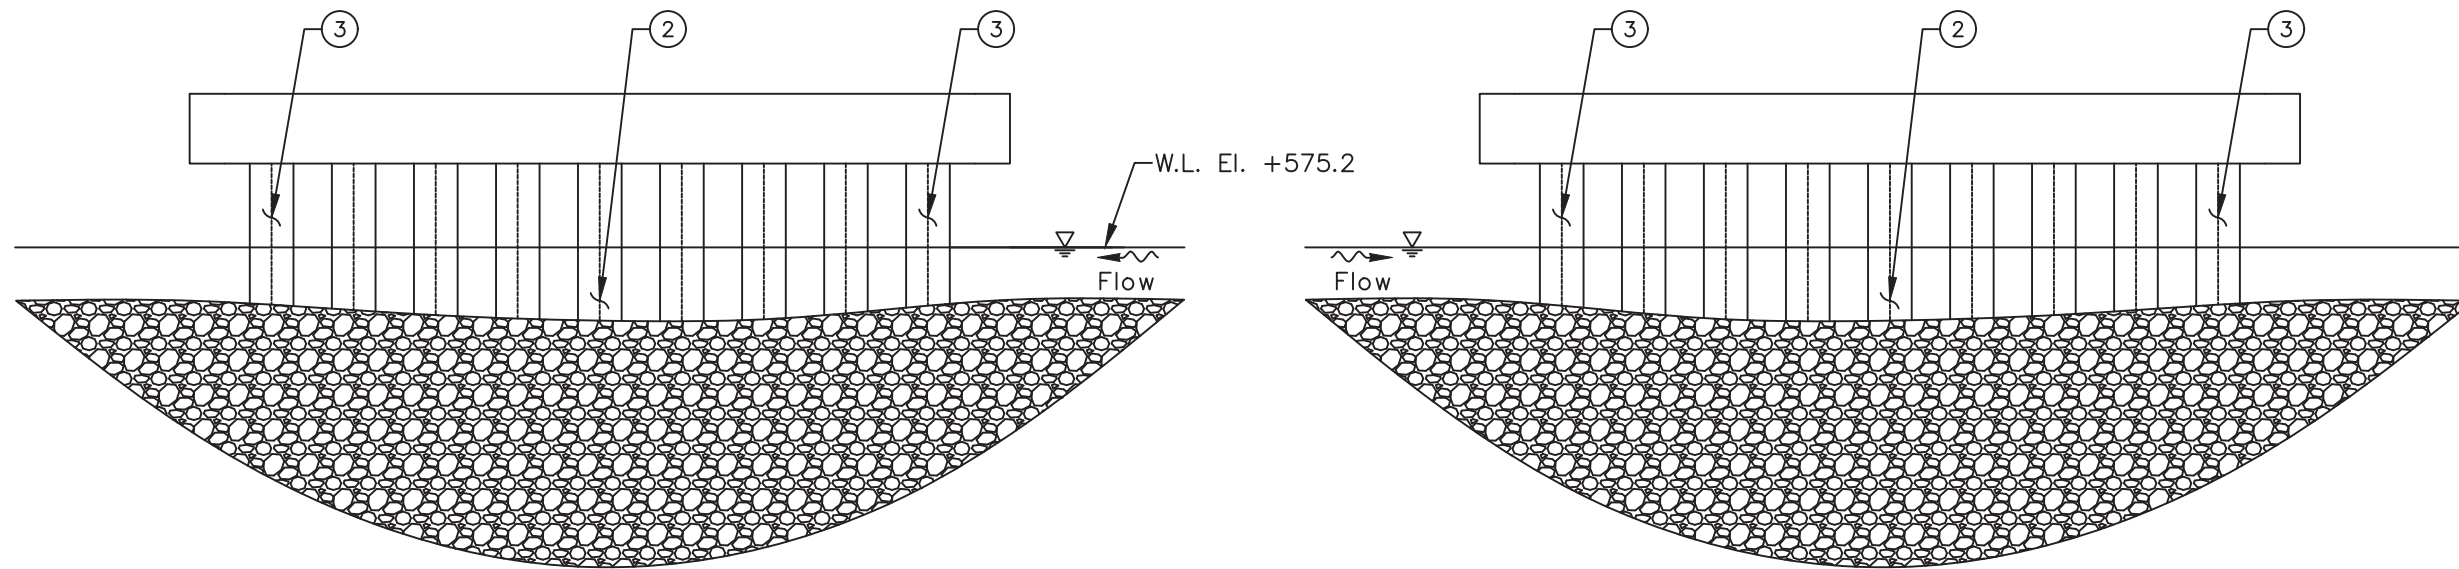
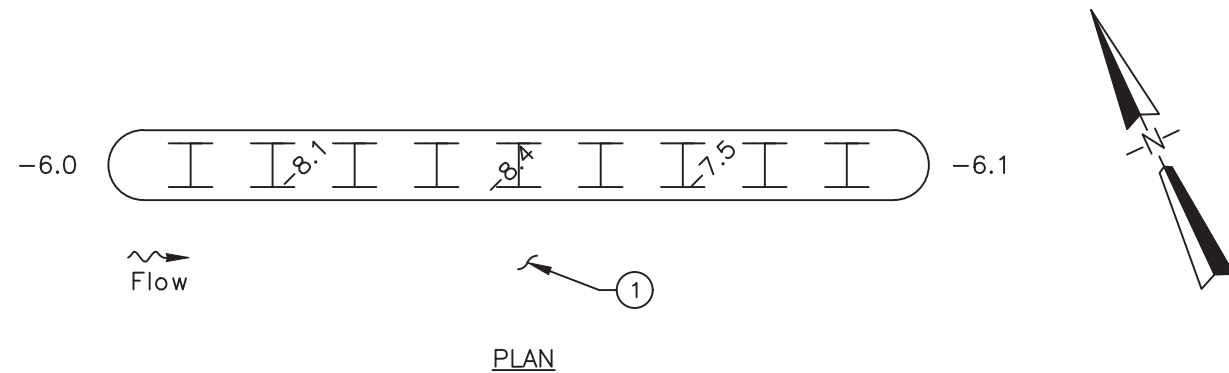
- ① The channel bottom material consisted of rip-rap up to 24 in. diameter with no probe rod penetration.
- ② The submerged portions of the steel H-Piles exhibited light surface corrosion with rust nodules up to 2 in. diameter from the channel bottom to -2 ft.
- ③ The upstream and downstream nose pile exhibited loss of coating with typically 1/32 in. pitting with a maximum of 1/8 in. from channel bottom to bottom of cap.

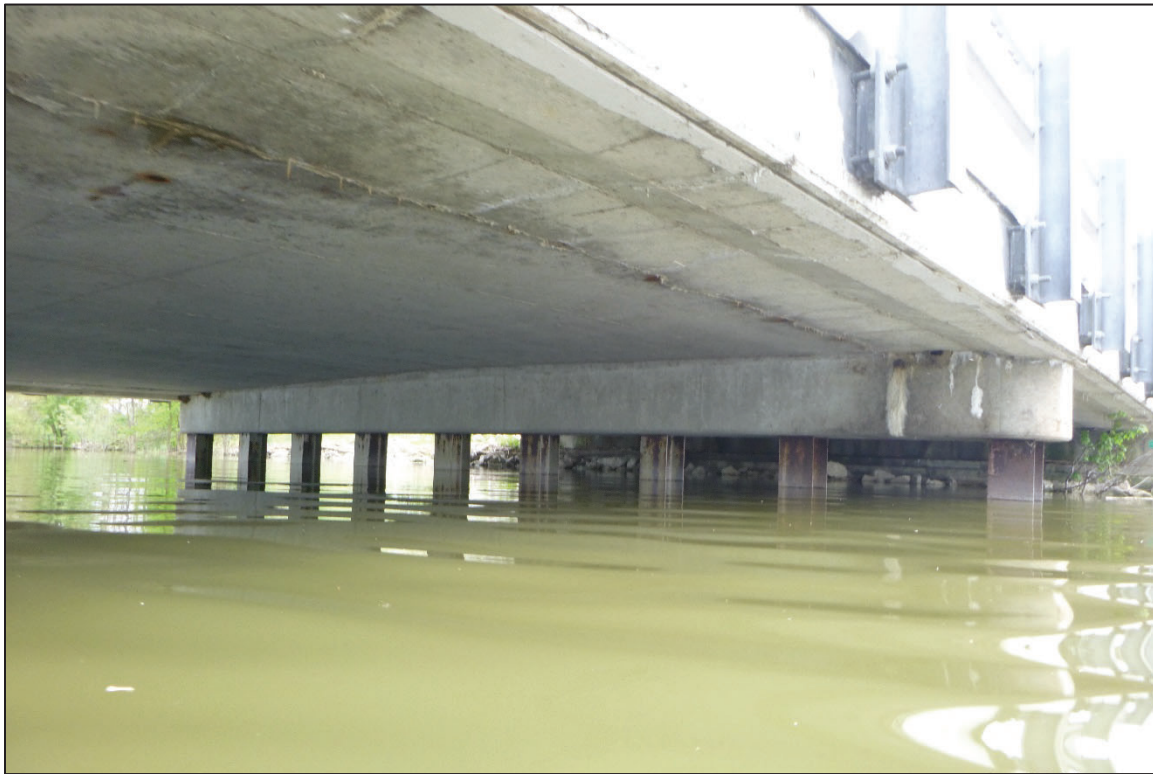
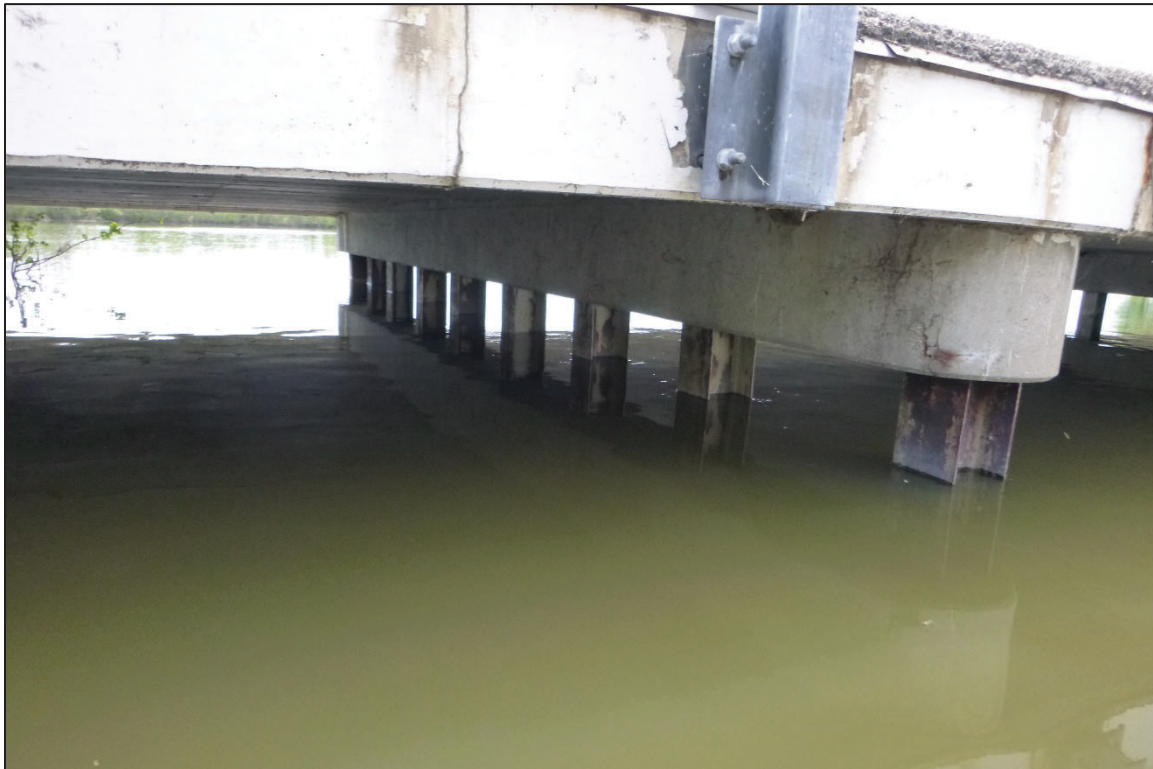
The channel bottom material consisted of rip-rap up to 24 in. diameter with no probe rod penetration. The submerged portions of the steel H-piles exhibited light surface corrosion with rust nodules up to 2 in. diameter from channel bottom to -2 ft. The upstream and downstream nose pile exhibited loss of coating with typically 1/32 in. pitting with a maximum of 1/8 in. from channel bottom to bottom of cap. Refer to Figure 6 in Exhibit 1 for detailed inspection notes of Bent 1. Refer to Photographs 9 and 10 in Exhibit 2 for views of Bent 1.

Photograph No. 9: View of the North Face of Bent 1, Looking Southeast.

Photograph No. 10: View of the South Face of Bent 1, Looking Northwest.

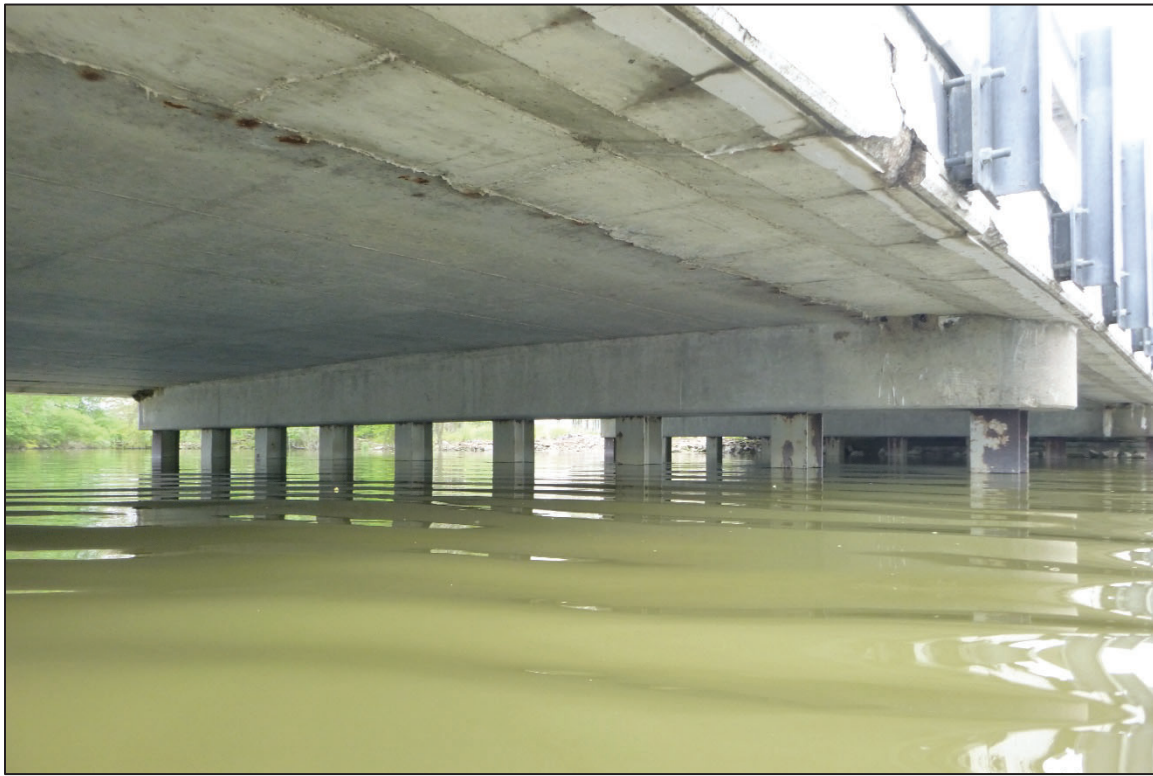
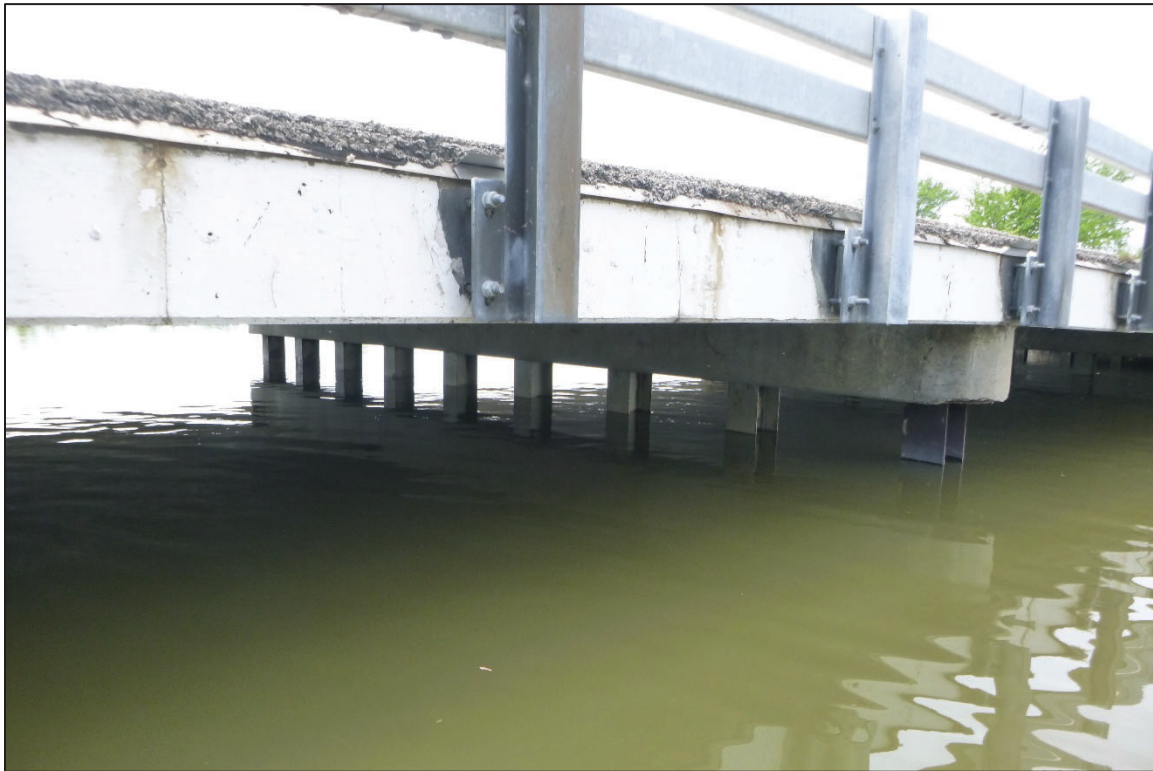
The channel bottom material consisted of rip-rap up to 24 in. diameter with no probe rod penetration. The submerged portions of the steel H-piles exhibited light surface corrosion with rust nodules up to 2 in. diameter from channel bottom to -2 ft. The upstream and downstream nose pile exhibited loss of coating with typically 1/32 in. pitting with a maximum of 1/8 in. from channel bottom to bottom of cap. Refer to Figure 7 in Exhibit 1 for detailed inspection notes of Bent 2. Refer to Photographs 11 and 12 in Exhibit 2 for views of Bent 2.

Photograph No. 11: View of the North Face of Bent 2, Looking Southeast.

Photograph No. 12: View of the South Face of Bent 2, Looking Northwest.

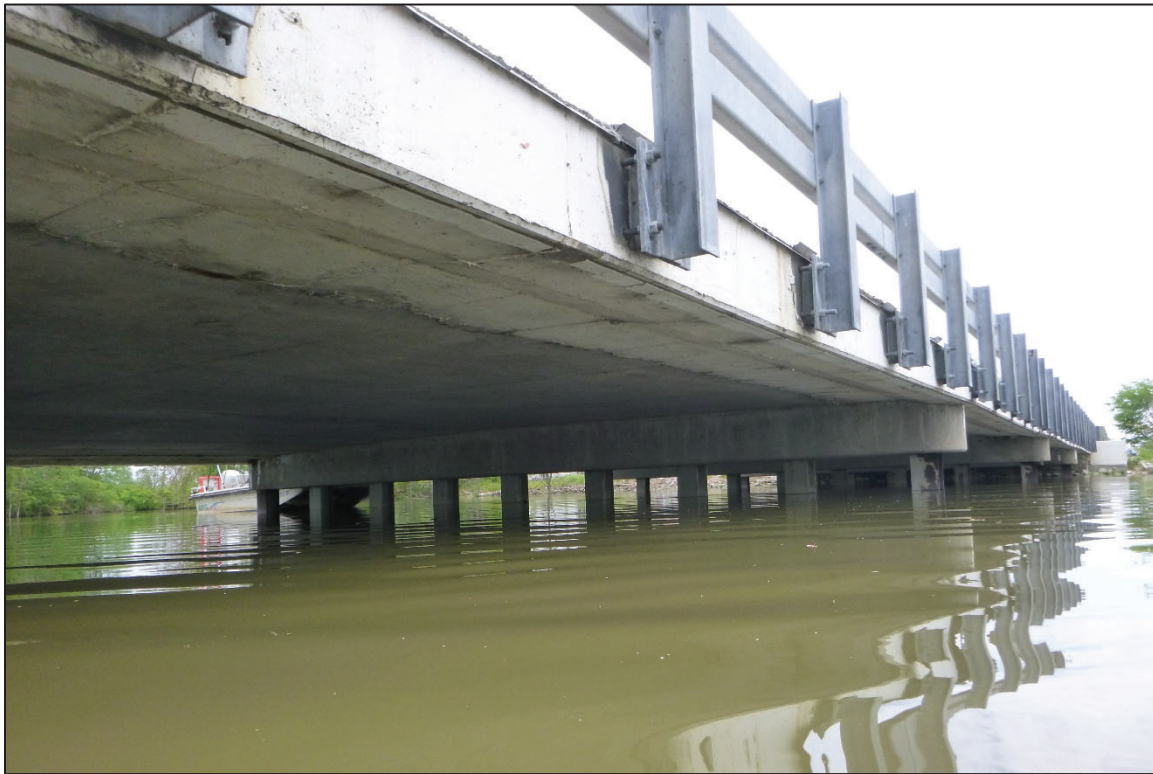
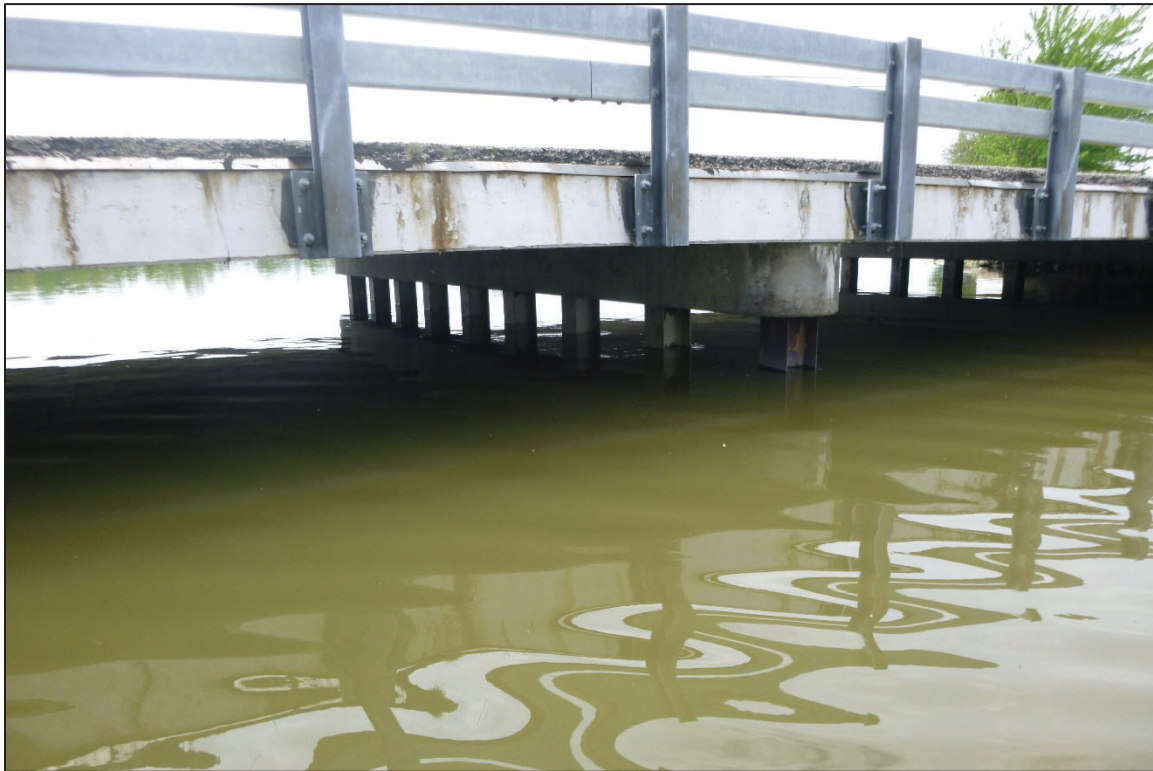
The channel bottom material consisted of rip-rap up to 24 in. diameter with no probe rod penetration. The submerged portions of the steel H-piles exhibited light surface corrosion with rust nodules up to 2 in. diameter from channel bottom to -2 ft. The upstream and downstream nose pile exhibited loss of coating with typically 1/32 in. pitting with a maximum of 1/8 in. from channel bottom to bottom of cap. Refer to Figure 8 in Exhibit 1 for detailed inspection notes of Bent 3. Refer to Photographs 13 and 14 in Exhibit 2 for views of Bent 3.

Photograph No. 13: View of the North Face of Bent 3, Looking Southeast.

Photograph No. 14: View of the South Face of Bent 3, Looking Northwest.

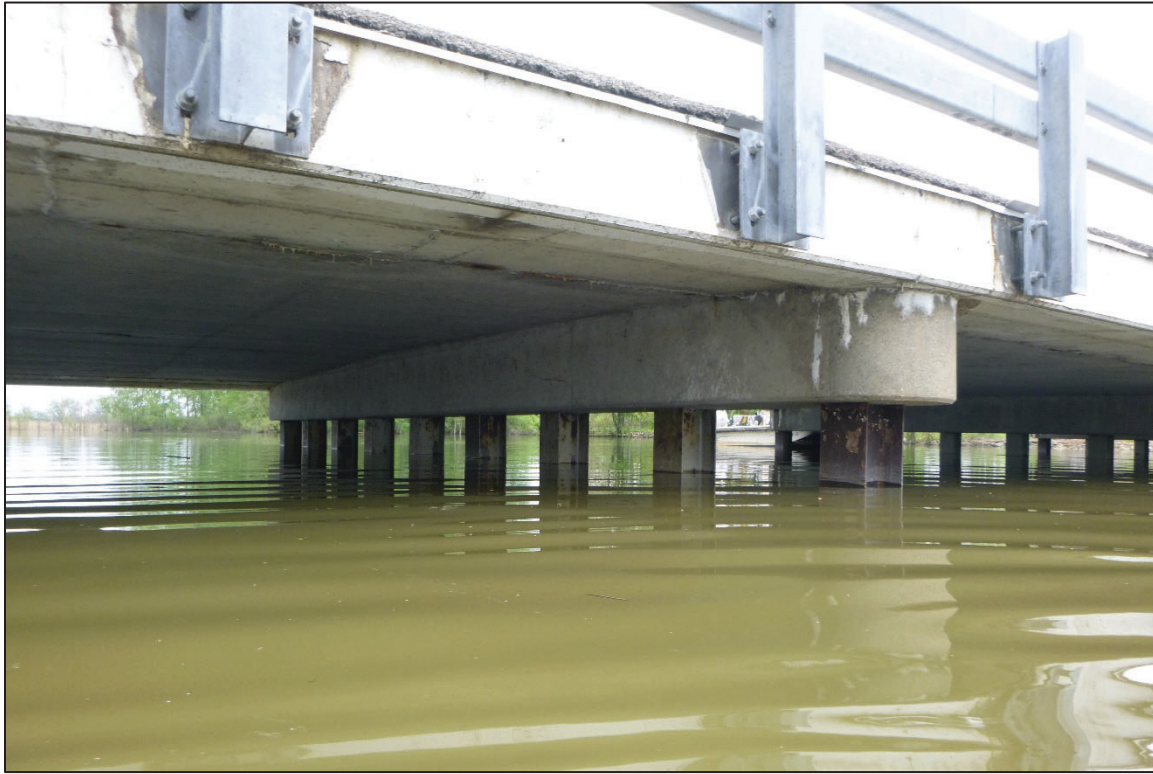
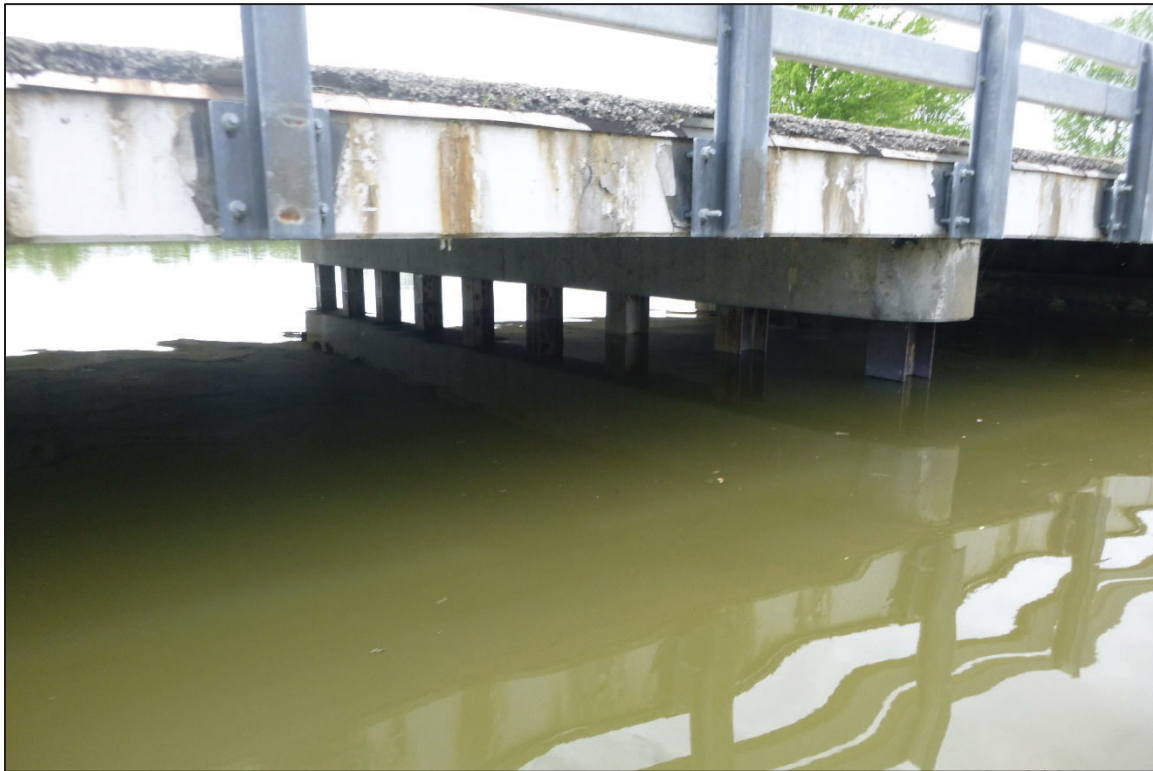
The channel bottom material consisted of rip-rap up to 24 in. diameter with no probe rod penetration. The submerged portions of the steel H-piles exhibited light surface corrosion with rust nodules up to 2 in. diameter from channel bottom to -2 ft. The upstream and downstream nose pile exhibited loss of coating with typically 1/32 in. pitting with a maximum of 1/8 in. from channel bottom to bottom of cap. Refer to Figure 9 in Exhibit 1 for detailed inspection notes of Bent 4. Refer to Photographs 15 through 18 in Exhibit 2 for views of Bent 4 and typical steel condition at the waterline.

Photograph No. 15: View of the North Face of Bent 4, Looking Southeast.

Photograph No. 16: View of the South Face of Bent 4, Looking Northwest.

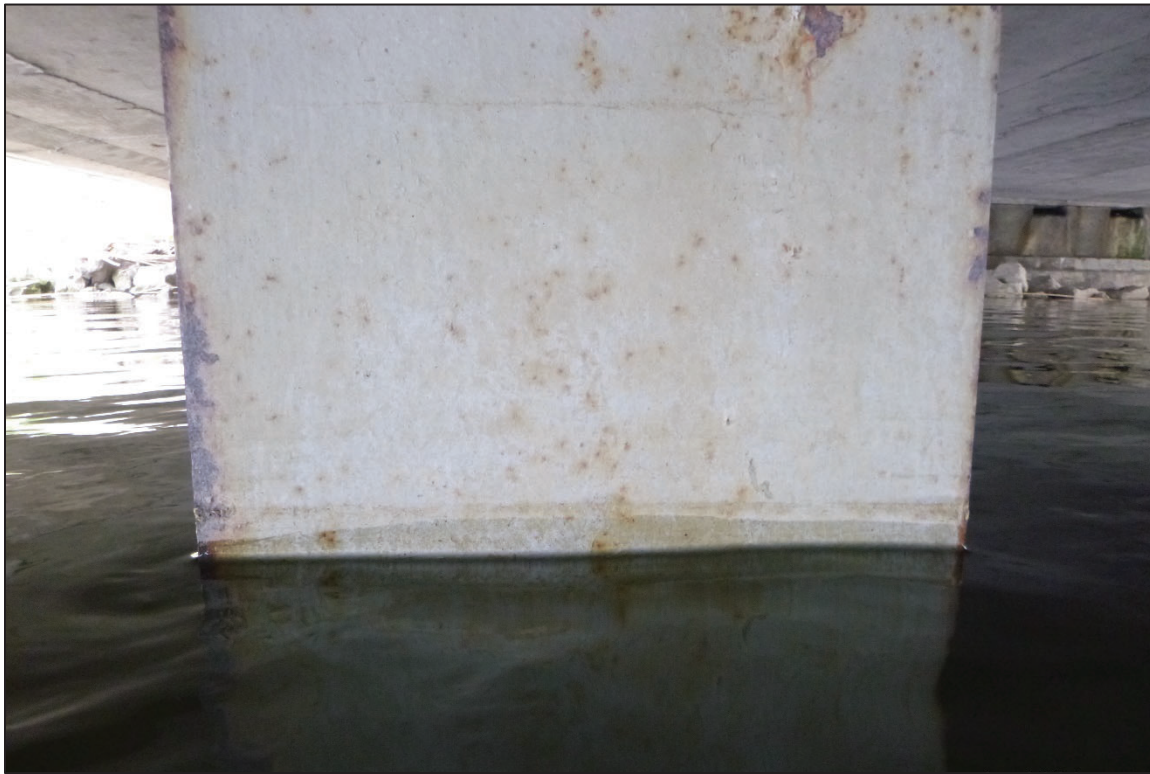
Photograph No. 17: View of the Typical Steel Condition at the Waterline on the Bent 4, Looking North.

- Monitor light surface corrosion on steel H-piles.

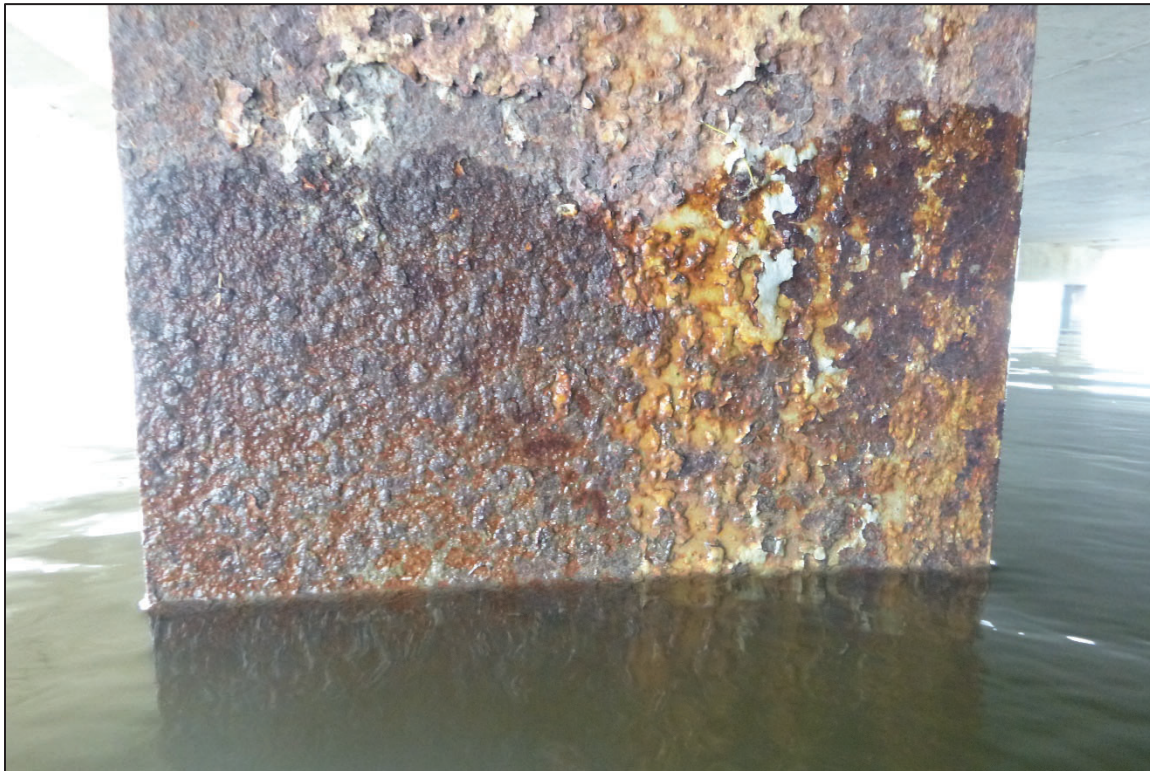
- 
- The upstream and downstream nose pile exhibited loss of coating with typically 1/32 in. pitting with a maximum of 1/8 in. from channel bottom to bottom of cap.
  - **Bent 4:**
    - The channel bottom material consisted of rip-rap up to 24 in. diameter with no probe rod penetration.
    - The submerged portions of the steel H-piles exhibited light surface corrosion with rust nodules up to 2 in. diameter from channel bottom to -2 ft.
    - The upstream and downstream nose pile exhibited loss of coating with typically 1/32 in. pitting with a maximum of 1/8 in. from channel bottom to bottom of cap.

Photograph No. 18: View of the Typical Steel Condition at the Waterline on the Upstream Nose of Bent 1, Looking South.
