# UNDERWATER BRIDGE INSPECTION REPORT

STRUCTURE NO. 7402910 (SEN-224-1207)  
US-224 OVER SANDUSKY RIVER  
SENECA COUNTY, OH  
DISTRICT 2

May 2020

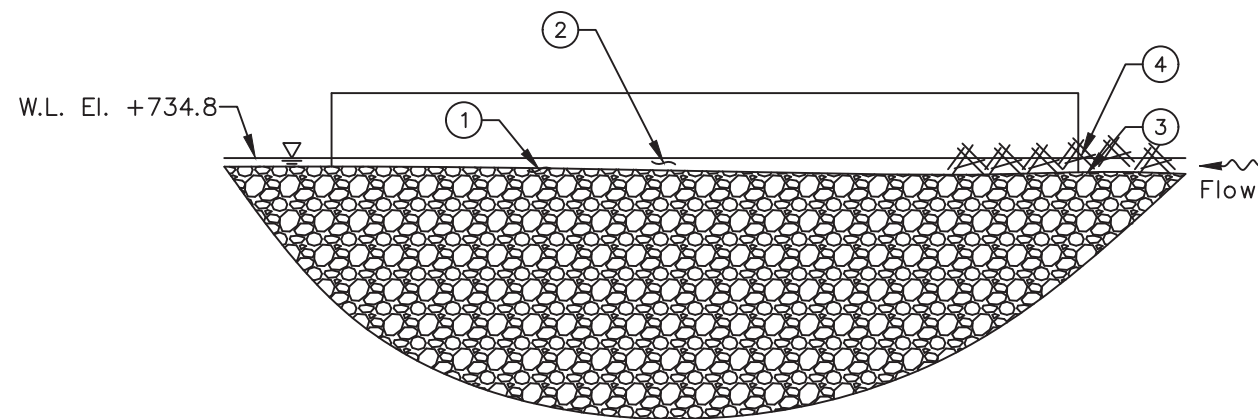
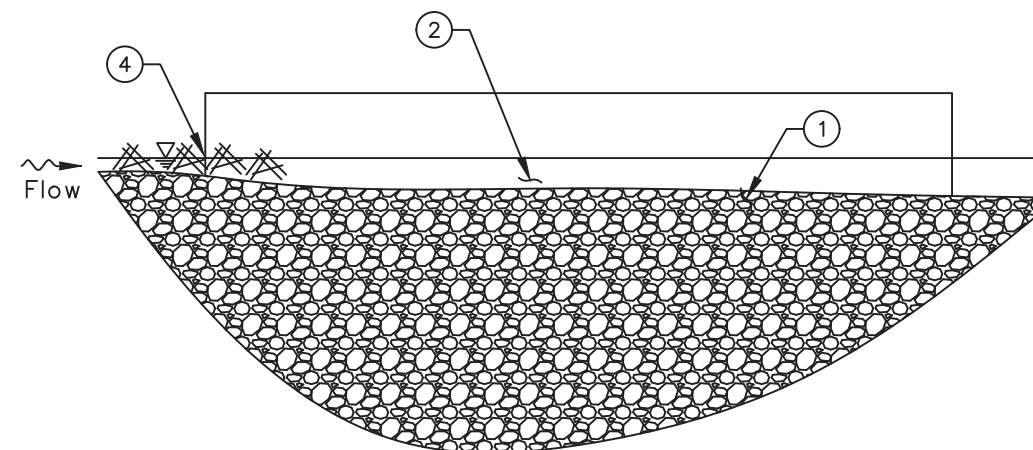
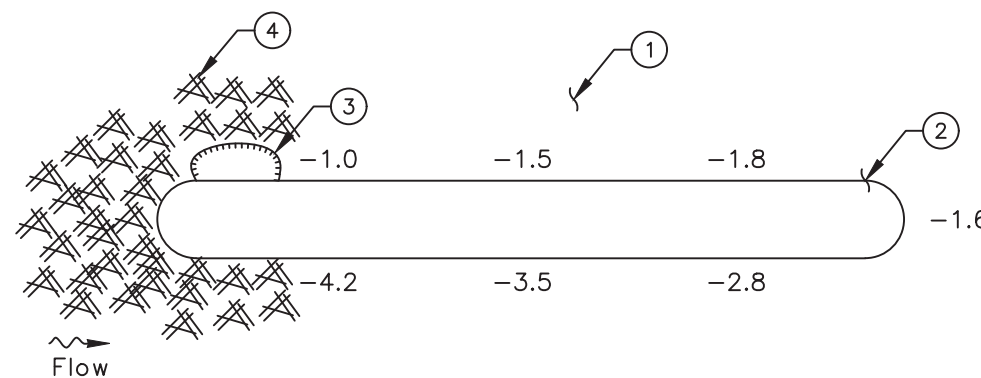
US-224 OVER SANDUSKY RIVER  
 STRUCTURE NO. 7402910 (SEN-224-1207)  
 PIER 1  
 SENECA COUNTY, OHIO

The channel bottom material around the pier consisted of timber debris with twigs and silt overly with up to 6 in. probe rod penetration. The submerged portions of the pier were smooth and south with no defects noted. A scour depression measuring approximately 10 ft diameter by 2 ft deep was observed on the southwest corner of the pier just downstream of the timber debris. Severe timber debris accumulation consisting of logs up to 2 ft diameter were observed on the upstream nose extending up to a 15 ft radius around the upstream nose from channel bottom to 4 ft about the waterline. Refer to Figure 6 in Exhibit 1 for detailed inspection notes of Pier 1. Refer to Photographs 9 and 10 in Exhibit 2 for views of Pier 1.

- ① The channel bottom material consisted of timber debris with silt overlay with approximately 6 in. probe rod penetration.
- ② The submerged portions of the pier were sound and smooth with no defects observed.
- ③ A scour depression measuring approximately 10 ft diameter by 2 ft deep was observed on the southwest corner of the pier just downstream of the timber debris.
- ④ Severe timber debris consisting of logs up to 2 ft diameter were observed on the upstream nose extending up to 15 ft radius around the upstream nose from channel bottom to 4 ft above the waterline.

The timber debris accumulations at Piers 1 through 4 is obstructing channel flow, is the cause of scour, and should be removed at this time. Removal of the timber debris will reduce excessive lateral loads on the pier, limit further debris accumulation, and reduce the likelihood of channel bottom degradation resulting from obstructed flow.

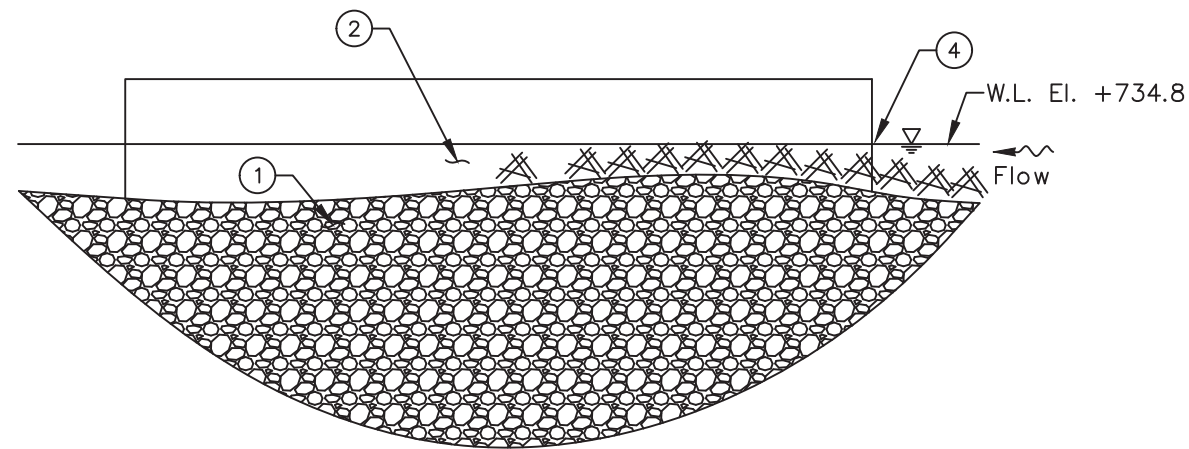
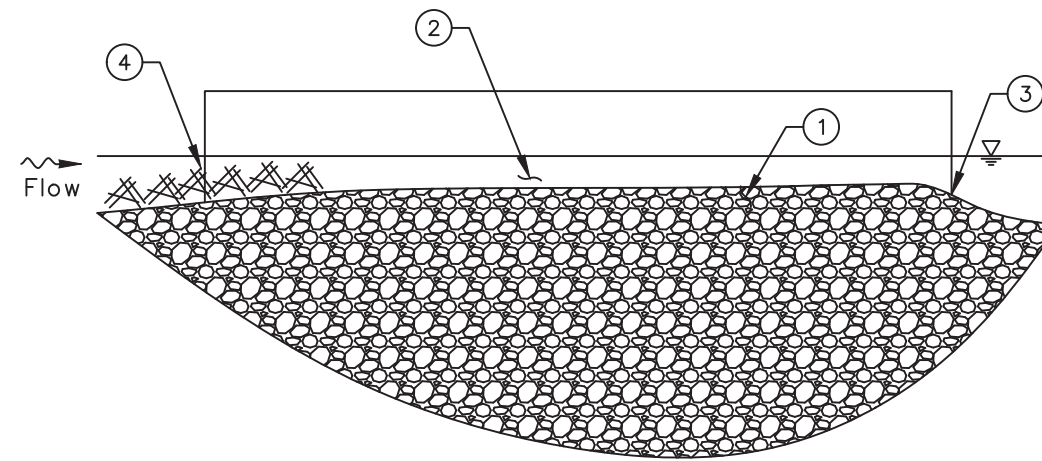
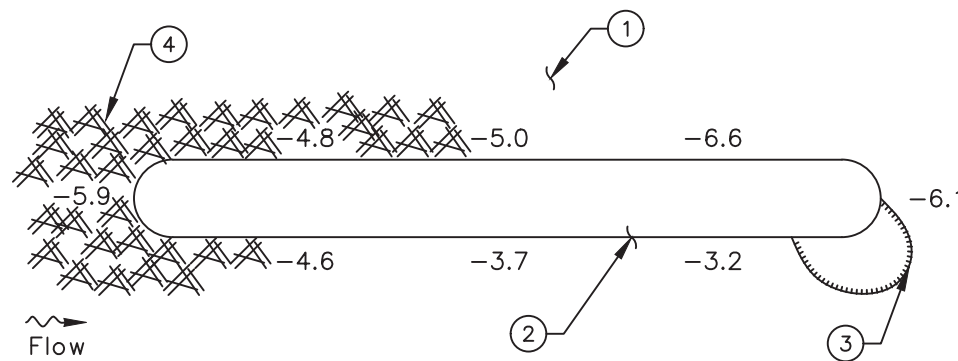
US-224 OVER SANDUSKY RIVER  
 STRUCTURE NO. 7402910 (SEN-224-1207)  
 PIER 2  
 SENECA COUNTY, OHIO

The channel bottom material around the pier consisted of timber debris with twigs and silt overly with up to 6 in. probe rod penetration. The submerged portions of the pier were smooth and south with no defects noted. A scour depression measuring approximately 10 ft diameter by 2 ft deep was observed on the northeast corner of the pier just downstream of the timber debris. Heavy timber debris accumulation consisting of logs up to 2 ft diameter were observed on the upstream nose extending up to a 10 ft radius around the upstream nose from channel bottom to 2 ft about the waterline. Refer to Figure 7 in Exhibit 1 for detailed inspection notes of Pier 2. Refer to Photographs 11 and 12 in Exhibit 2 for views of Pier 2.

- ① The channel bottom material consisted of timber debris with silt overlay with approximately 6 in. probe rod penetration.
- ② The submerged portions of the pier were sound and smooth with no defects observed.
- ③ A scour depression measuring approximately 10 ft diameter by 2 ft deep was observed on the northeast corner of the pier just downstream of the timber debris.
- ④ Heavy timber debris consisting of logs up to 2 ft diameter were observed on the upstream nose extending up to 10 ft radius around the upstream nose and along the north face from channel bottom to 2 ft above the waterline.

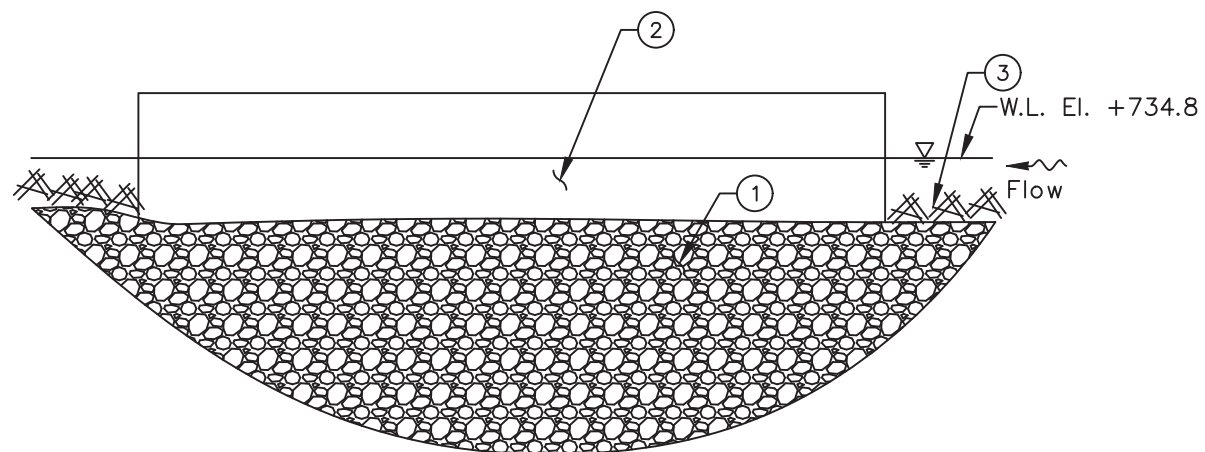
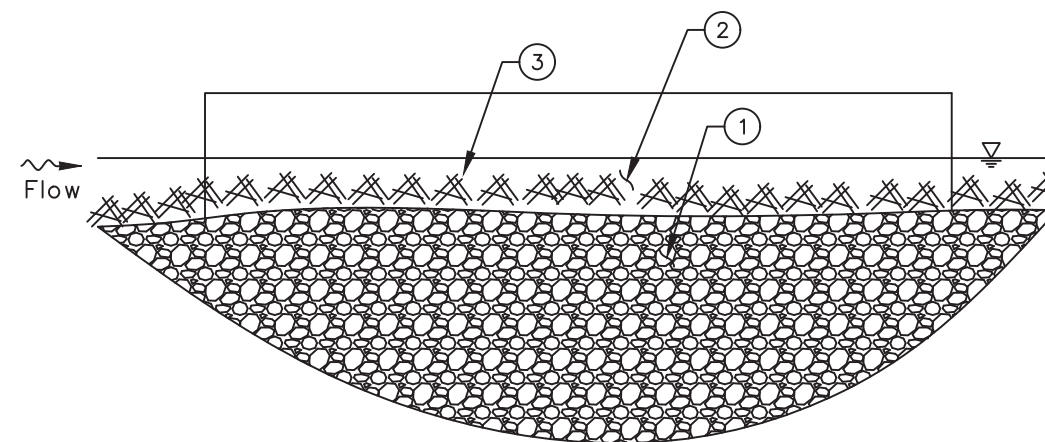
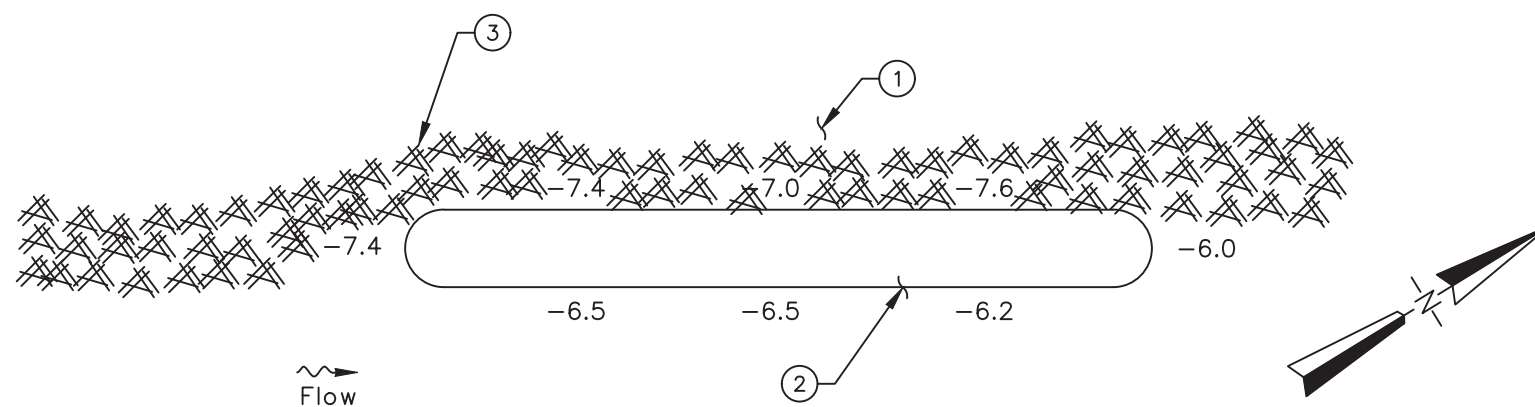
US-224 OVER SANDUSKY RIVER  
 STRUCTURE NO. 7402910 (SEN-224-1207)  
 PIER 3  
 SENECA COUNTY, OHIO

The channel bottom material around the pier consisted of timber debris with twigs and silt overly with up to 6 in. probe rod penetration. The submerged portions of the pier were smooth and south with no defects noted. Moderate timber debris accumulation consisting of logs up to 1 ft diameter were observed on the upstream nose extending along the north face from the channel bottom to 2 ft about the waterline. Refer to Figure 8 in Exhibit 1 for detailed inspection notes of Pier 3. Refer to Photographs 13 and 14 in Exhibit 2 for views of Pier 3.

- ① The channel bottom material consisted of timber debris with silt overlay with approximately 6 in. probe rod penetration.
- ② The submerged portions of the pier were sound and smooth with no defects observed.
- ③ Moderate timber debris consisting of logs up to 1 ft diameter were observed on the upstream nose extending along the north face from channel bottom to 2 ft above the waterline.

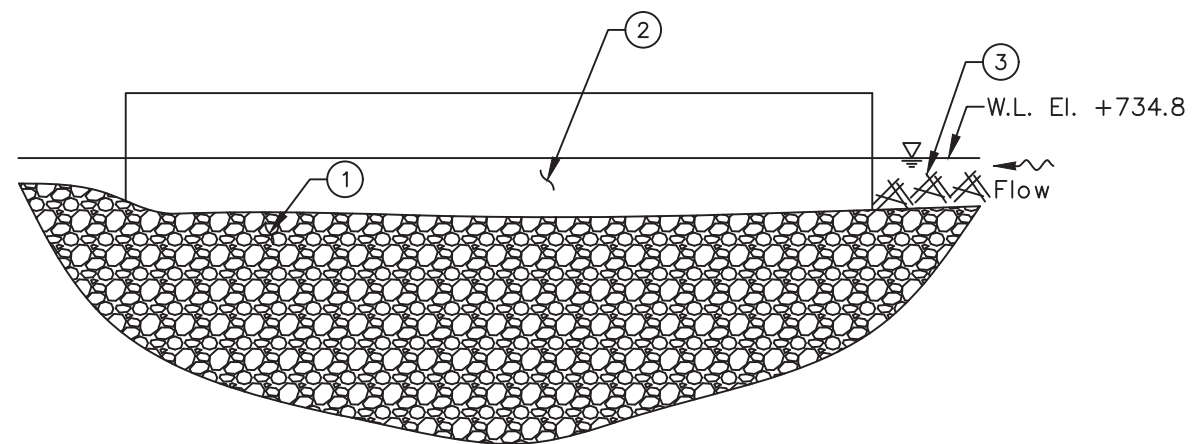
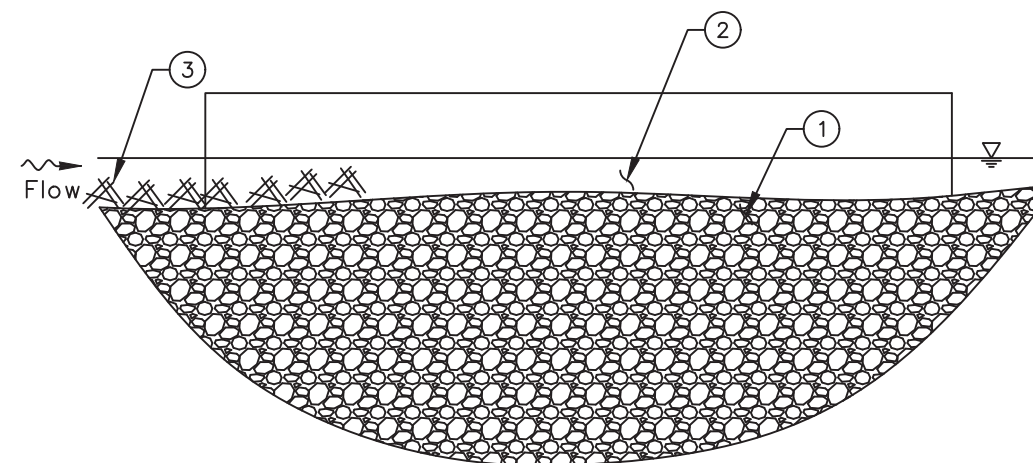
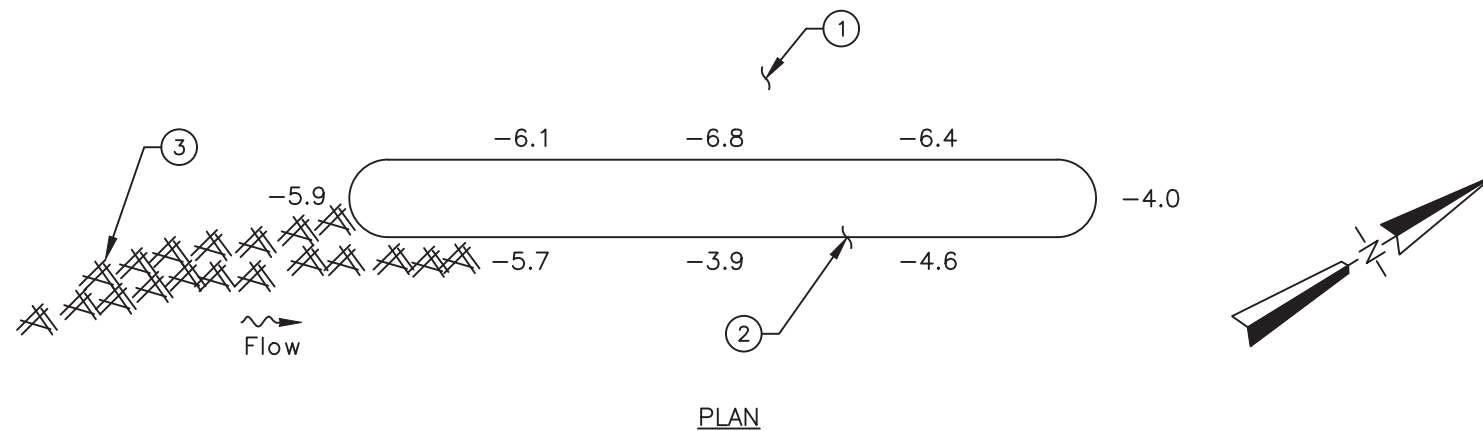
US-224 OVER SANDUSKY RIVER  
 STRUCTURE NO. 7402910 (SEN-224-1207)  
 PIER 4  
 SENECA COUNTY, OHIO

The channel bottom material around the pier consisted of timber debris with twigs and silt overly with up to 6 in. probe rod penetration. The submerged portions of the pier were smooth and south with no defects noted. Light timber debris accumulation consisting of branches up to 6 in. diameter were observed on the upstream nose extending up to a 5 ft radius around the upstream nose from the channel bottom to 2 ft about the waterline.

- ① The channel bottom material consisted of timber debris with silt overlay with approximately 6 in. probe rod penetration.
- ② The submerged portions of the pier were sound and smooth with no defects observed.
- ③ Light timber debris consisting of branches up to 6 in. diameter were observed on the upstream nose extending up to a 5 ft radius from channel bottom to the waterline.

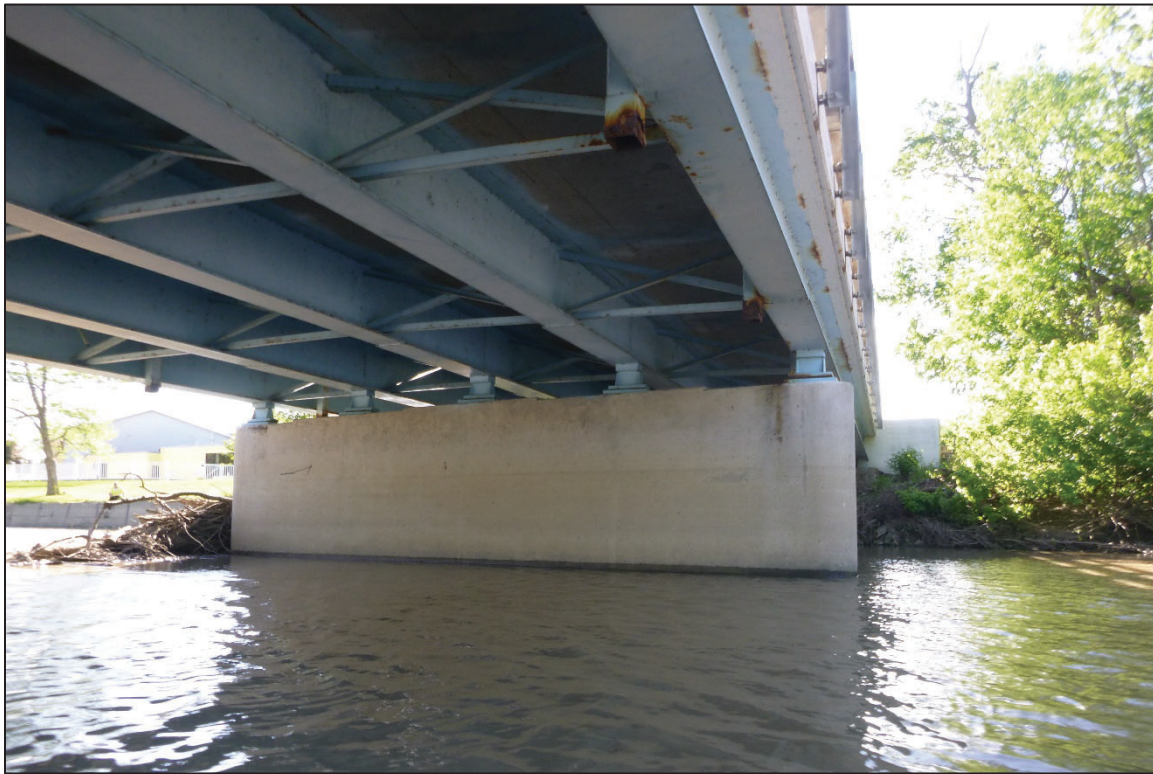
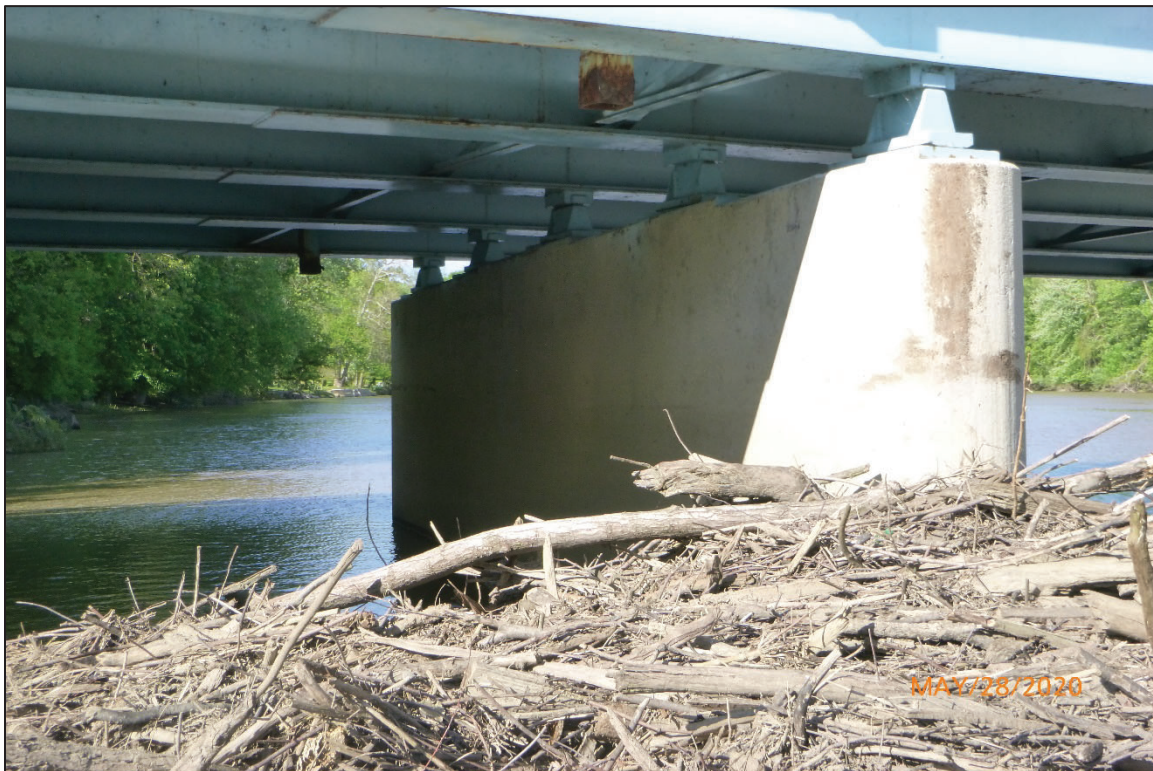
Photograph No. 9: View of the East Face of Pier 1, Looking Southwest.

Photograph No. 10: View of the West Face of Pier 1, Looking Northeast.

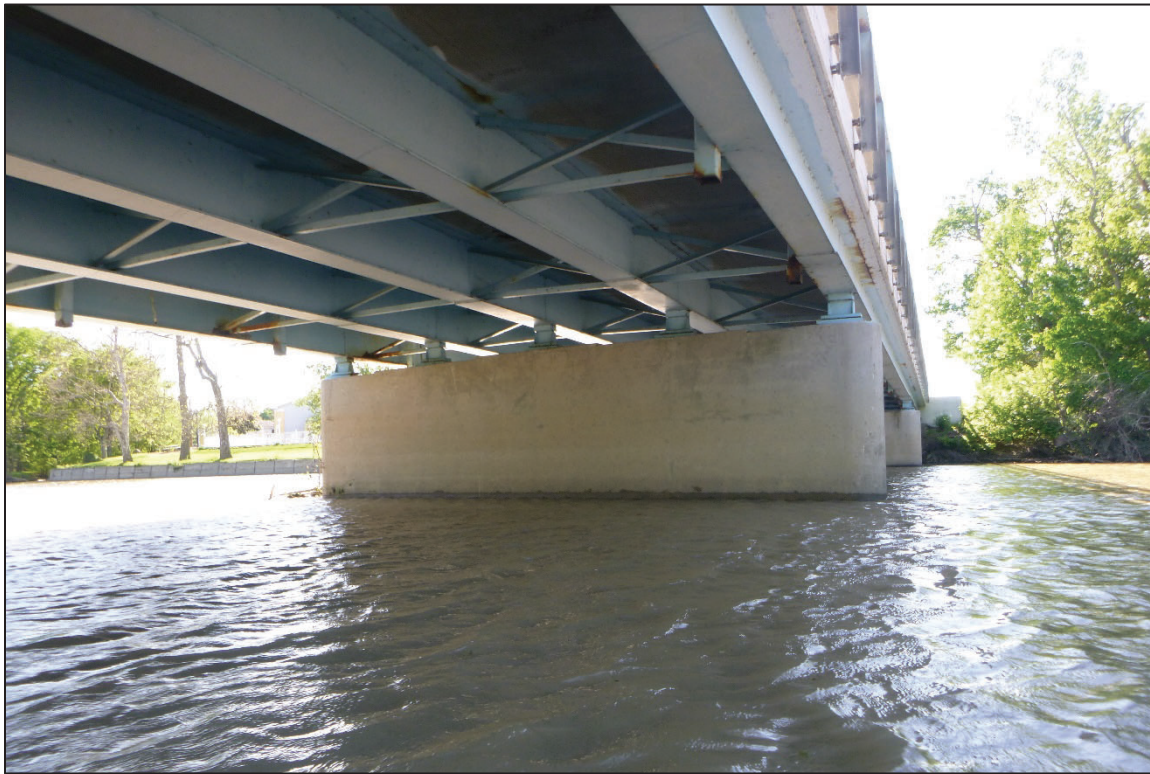
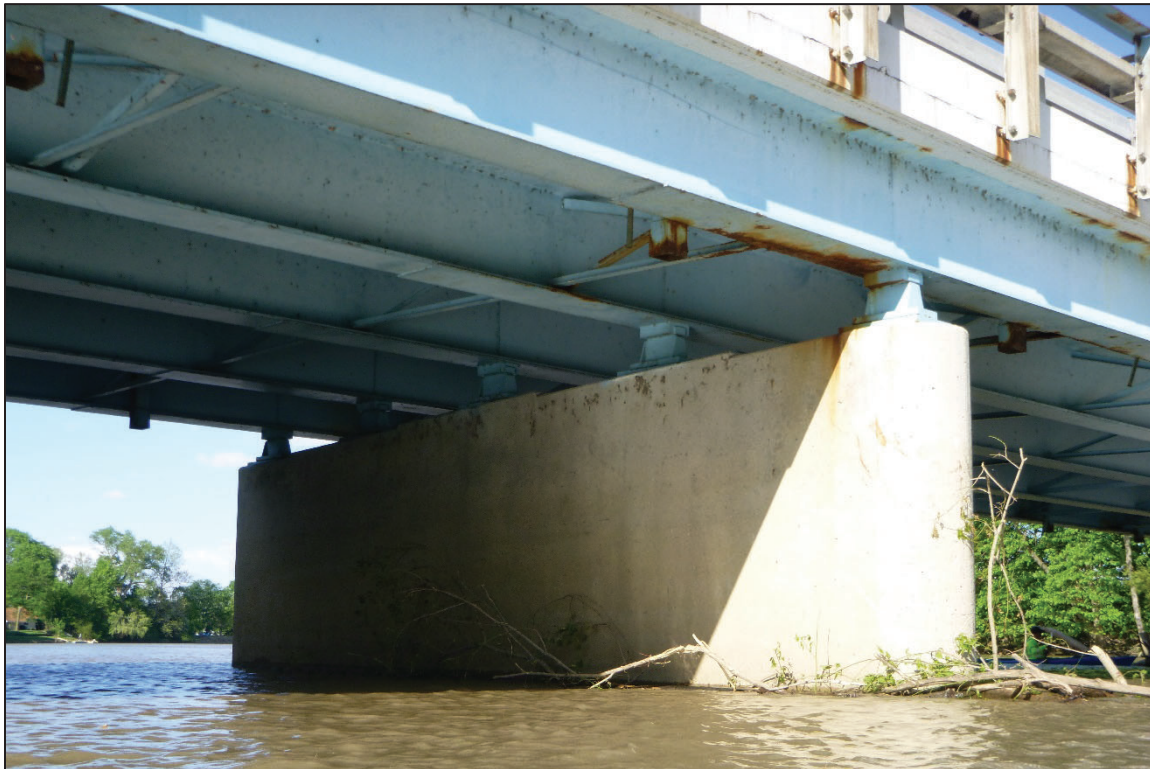
Photograph No. 11: View of the West Face of Pier 2, Looking Southwest.

Photograph No. 12: View of the East Face of Pier 2, Looking Northeast.

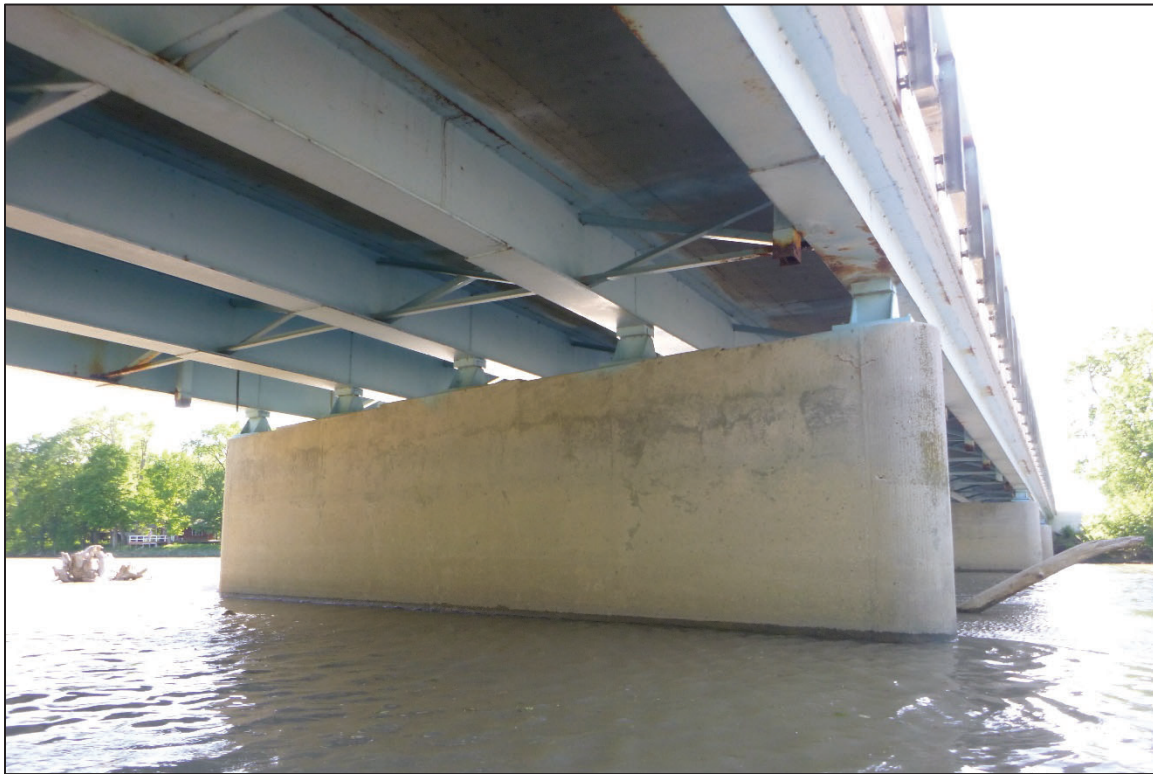
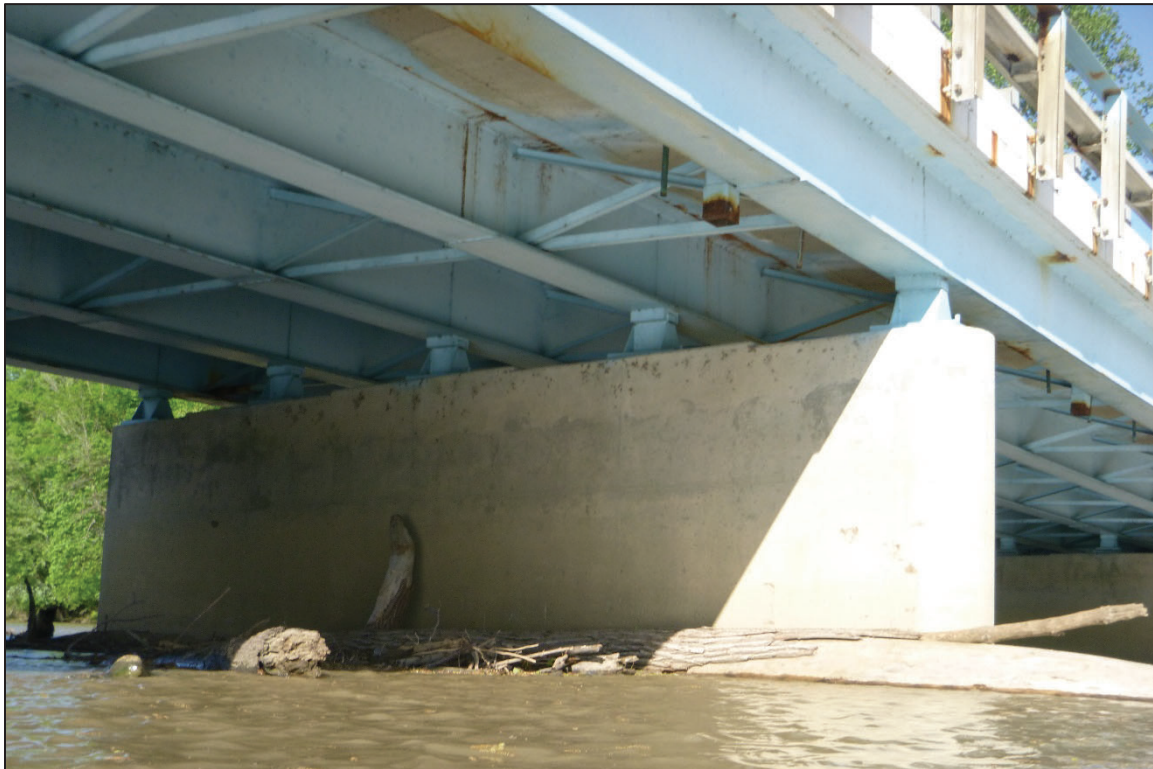
Photograph No. 13: View of the East Face of Pier 3, Looking Southwest.

Photograph No. 14: View of the West Face of Pier 3, Looking Northeast.

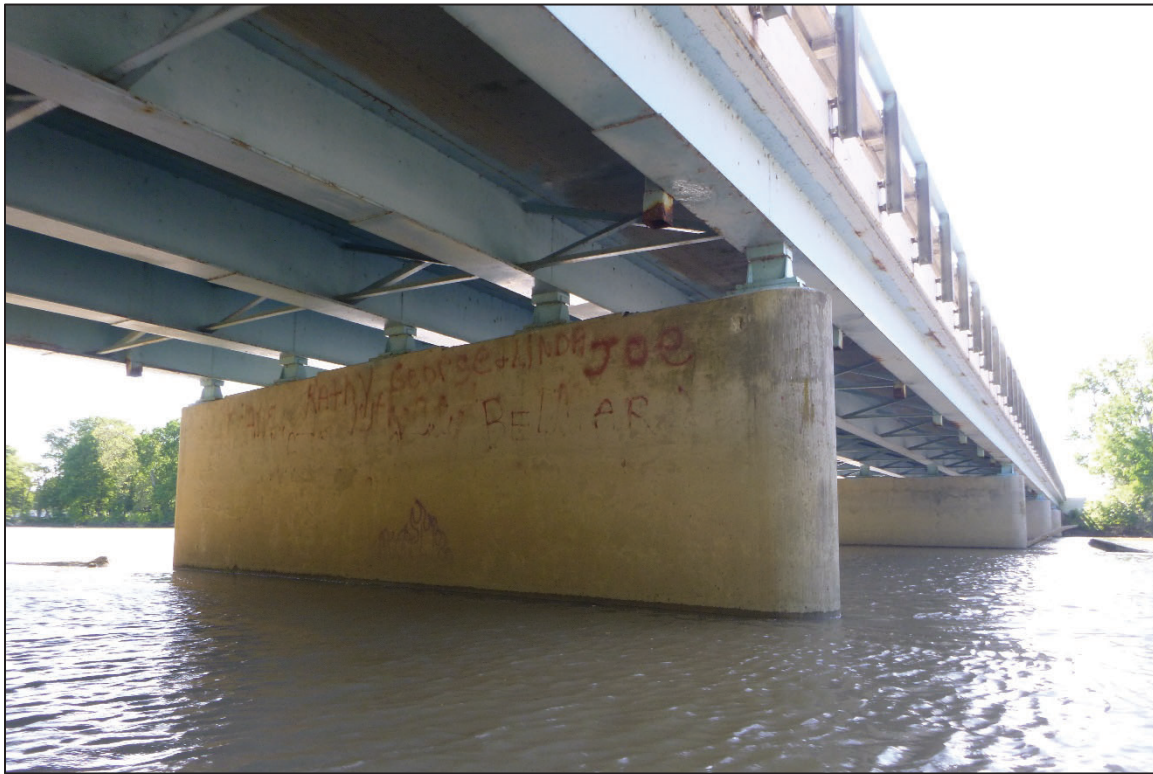
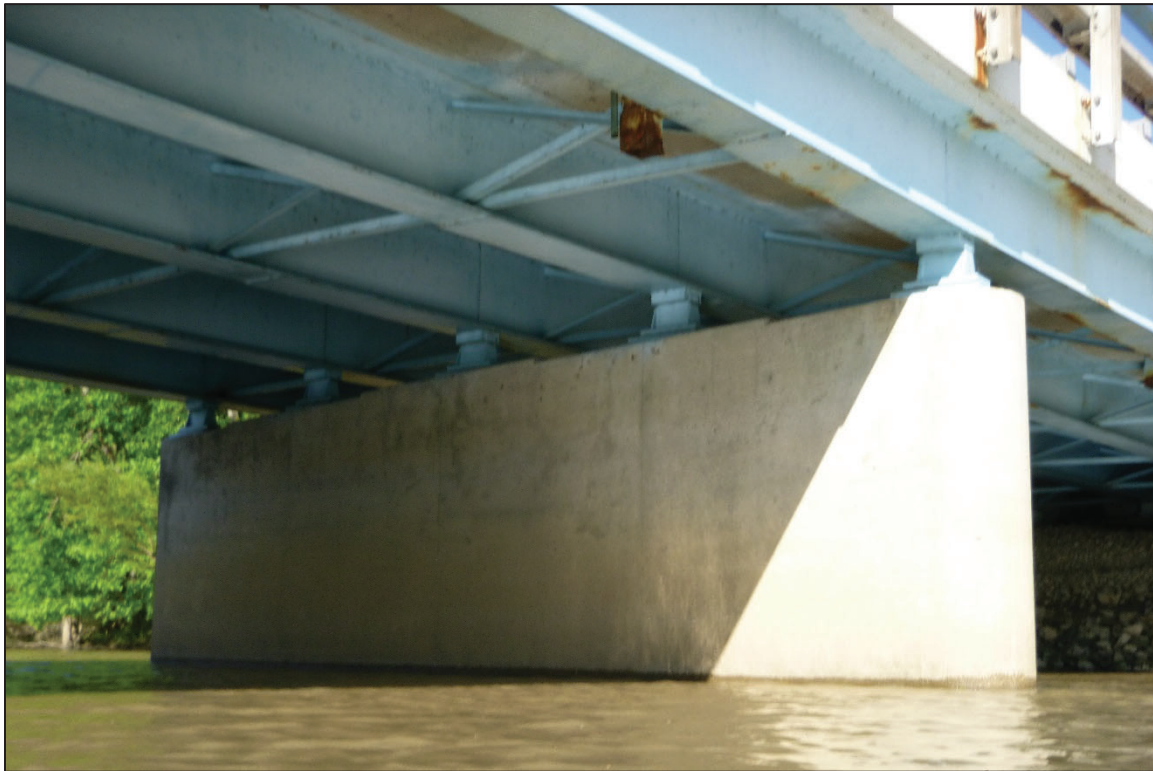
Photograph No. 15: View of the East Face of Pier 4, Looking Southwest.

Photograph No. 16: View of the West Face of Pier 4, Looking Northeast.

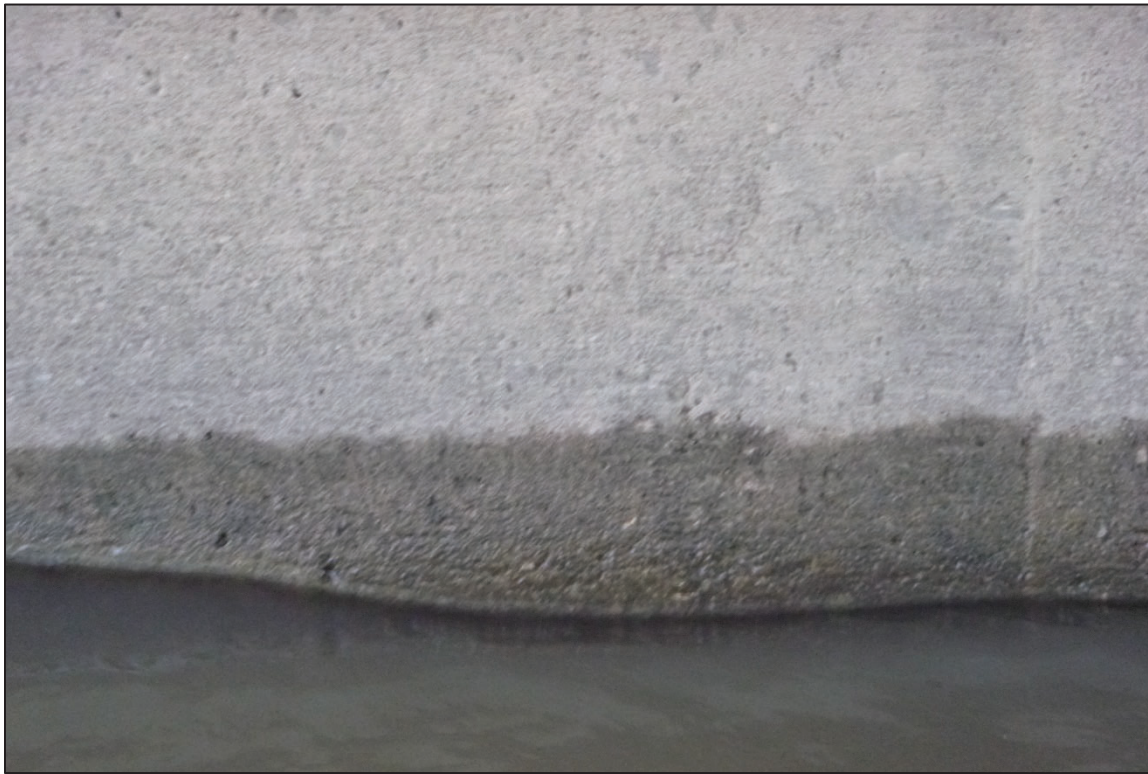
Photograph No. 17: View of the Typical Concrete Condition at the Waterline, Looking West.
