# UNDERWATER BRIDGE INSPECTION REPORT

STRUCTURE NO. 8706751 (WOO-475-0386L)  
I-475 SB OVER MAUMEE RIVER  
WOOD COUNTY, OH  
DISTRICT 2

April 2020

**COLLINS**  
**ENGINEERS** INC.

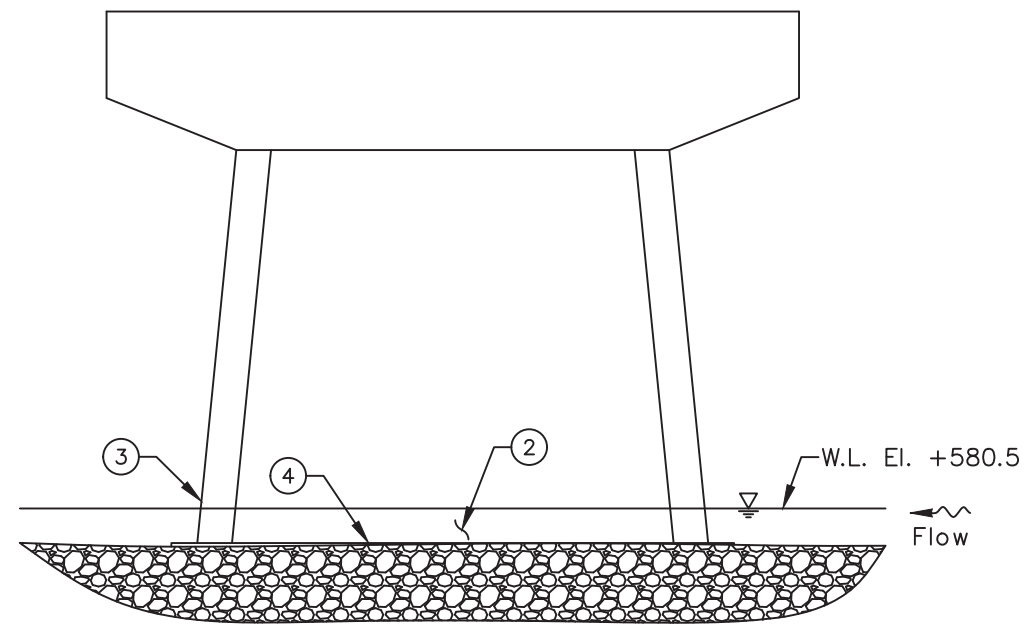
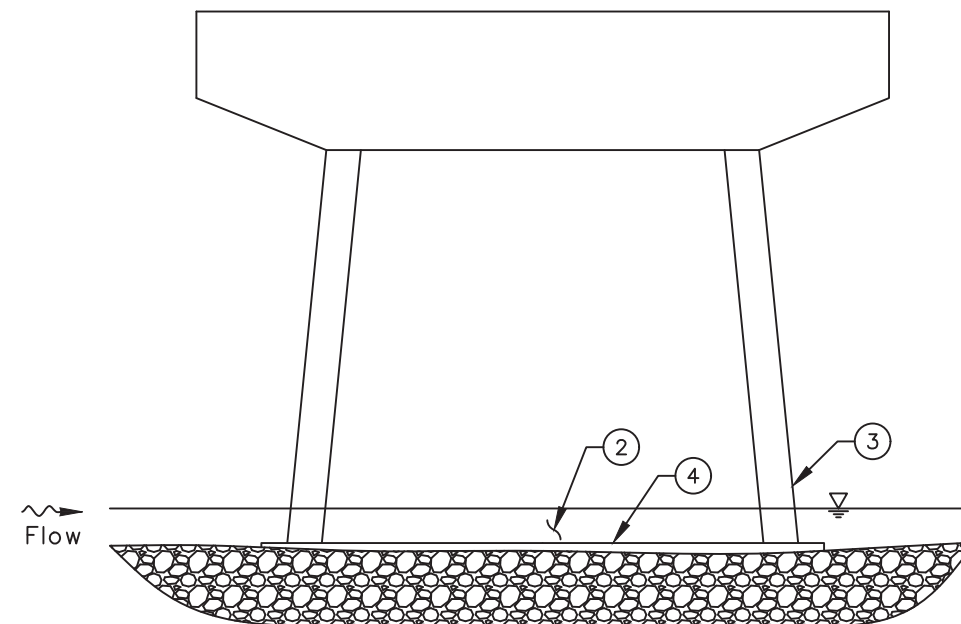
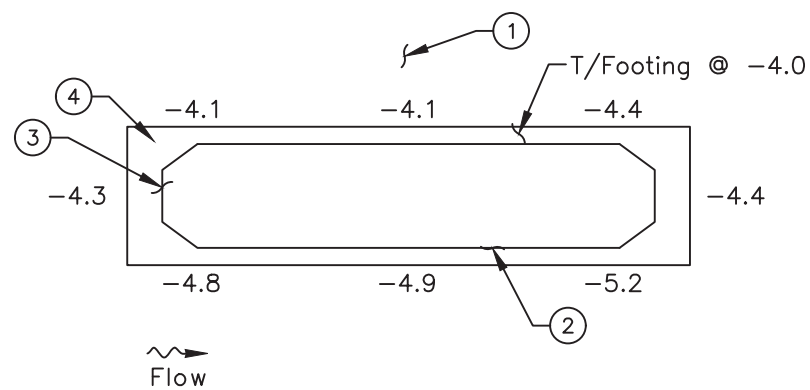
I-475 SB OVER MAUMEE RIVER  
 STRUCTURE NO. WOO-475-0386L  
 PIER S2  
 WOOD COUNTY, OHIO

- ① The channel bottom material consisted of cobbles and riprap up to 12 in. diameter with no probe rod penetration.
- ② The submerged portions of the pier exhibited light scaling up to 1/16 in. from the channel bottom to 8 ft above the waterline.
- ③ The steel ice-breakers exhibited light surface corrosion with rust nodules up to 2 in. diameter and pitting up to 1/32 in. diameter from the channel bottom to 8 ft above the waterline.
- ④ Top of footing was exposed at 4.0 ft below the waterline around the entire perimeter with a maximum vertical exposure of 1.2 ft on the southeast corner.

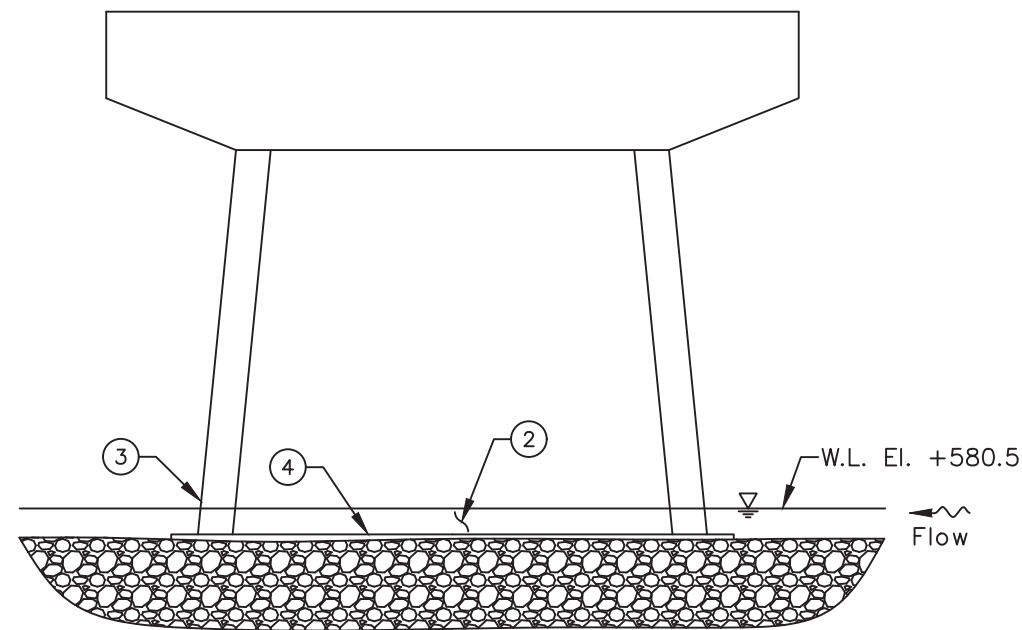
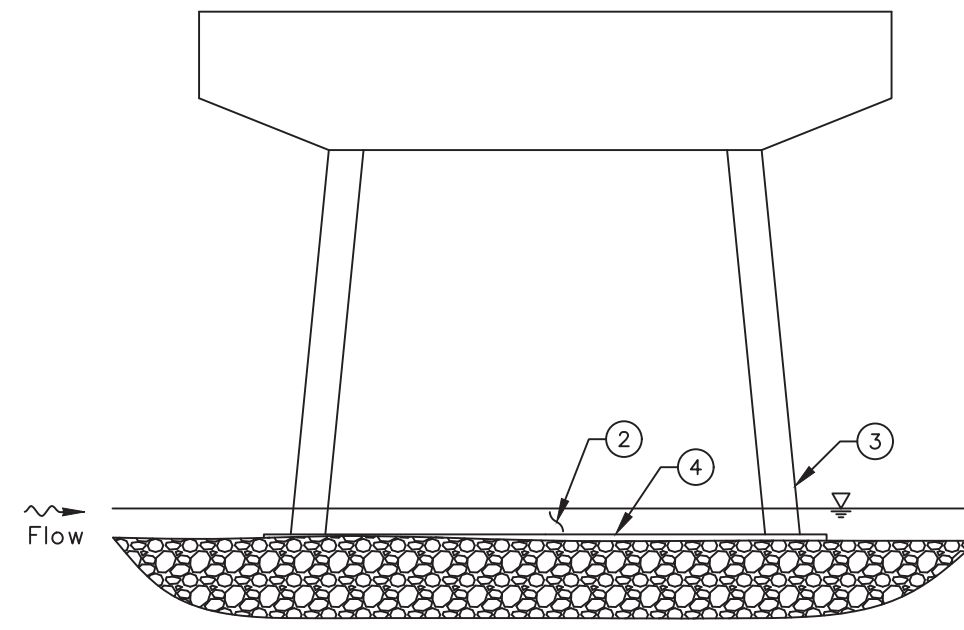
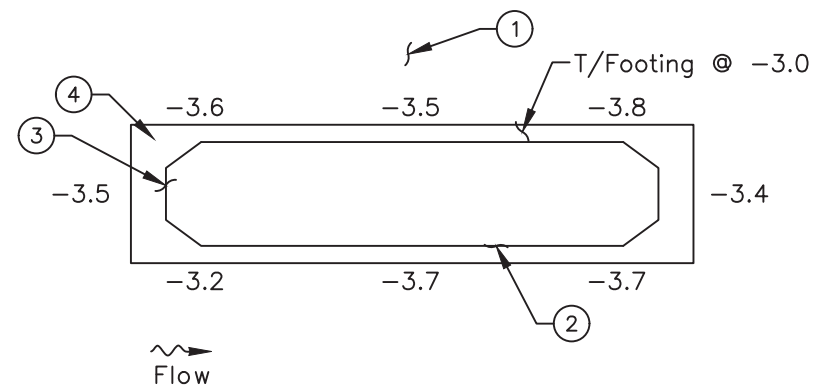
I-475 SB OVER MAUMEE RIVER  
 STRUCTURE NO. WOO-475-0386L  
 PIER S3  
 WOOD COUNTY, OHIO

- ① The channel bottom material consisted of cobbles and riprap up to 12 in diameter with no probe rod penetration.
- ② The submerged portions of the pier exhibited light scaling up to 1/16 in. from the channel bottom to 8 ft above the waterline.
- ③ The steel ice-breakers exhibited light surface corrosion with rust nodules up to 2 in. diameter and pitting up to 1/32 in. diameter from the channel bottom to 8 ft above the waterline.
- ④ Top of footing was exposed at 3.0 ft below the waterline around the entire perimeter with a maximum vertical exposure of 2.7 ft at the midpoint along the south face.

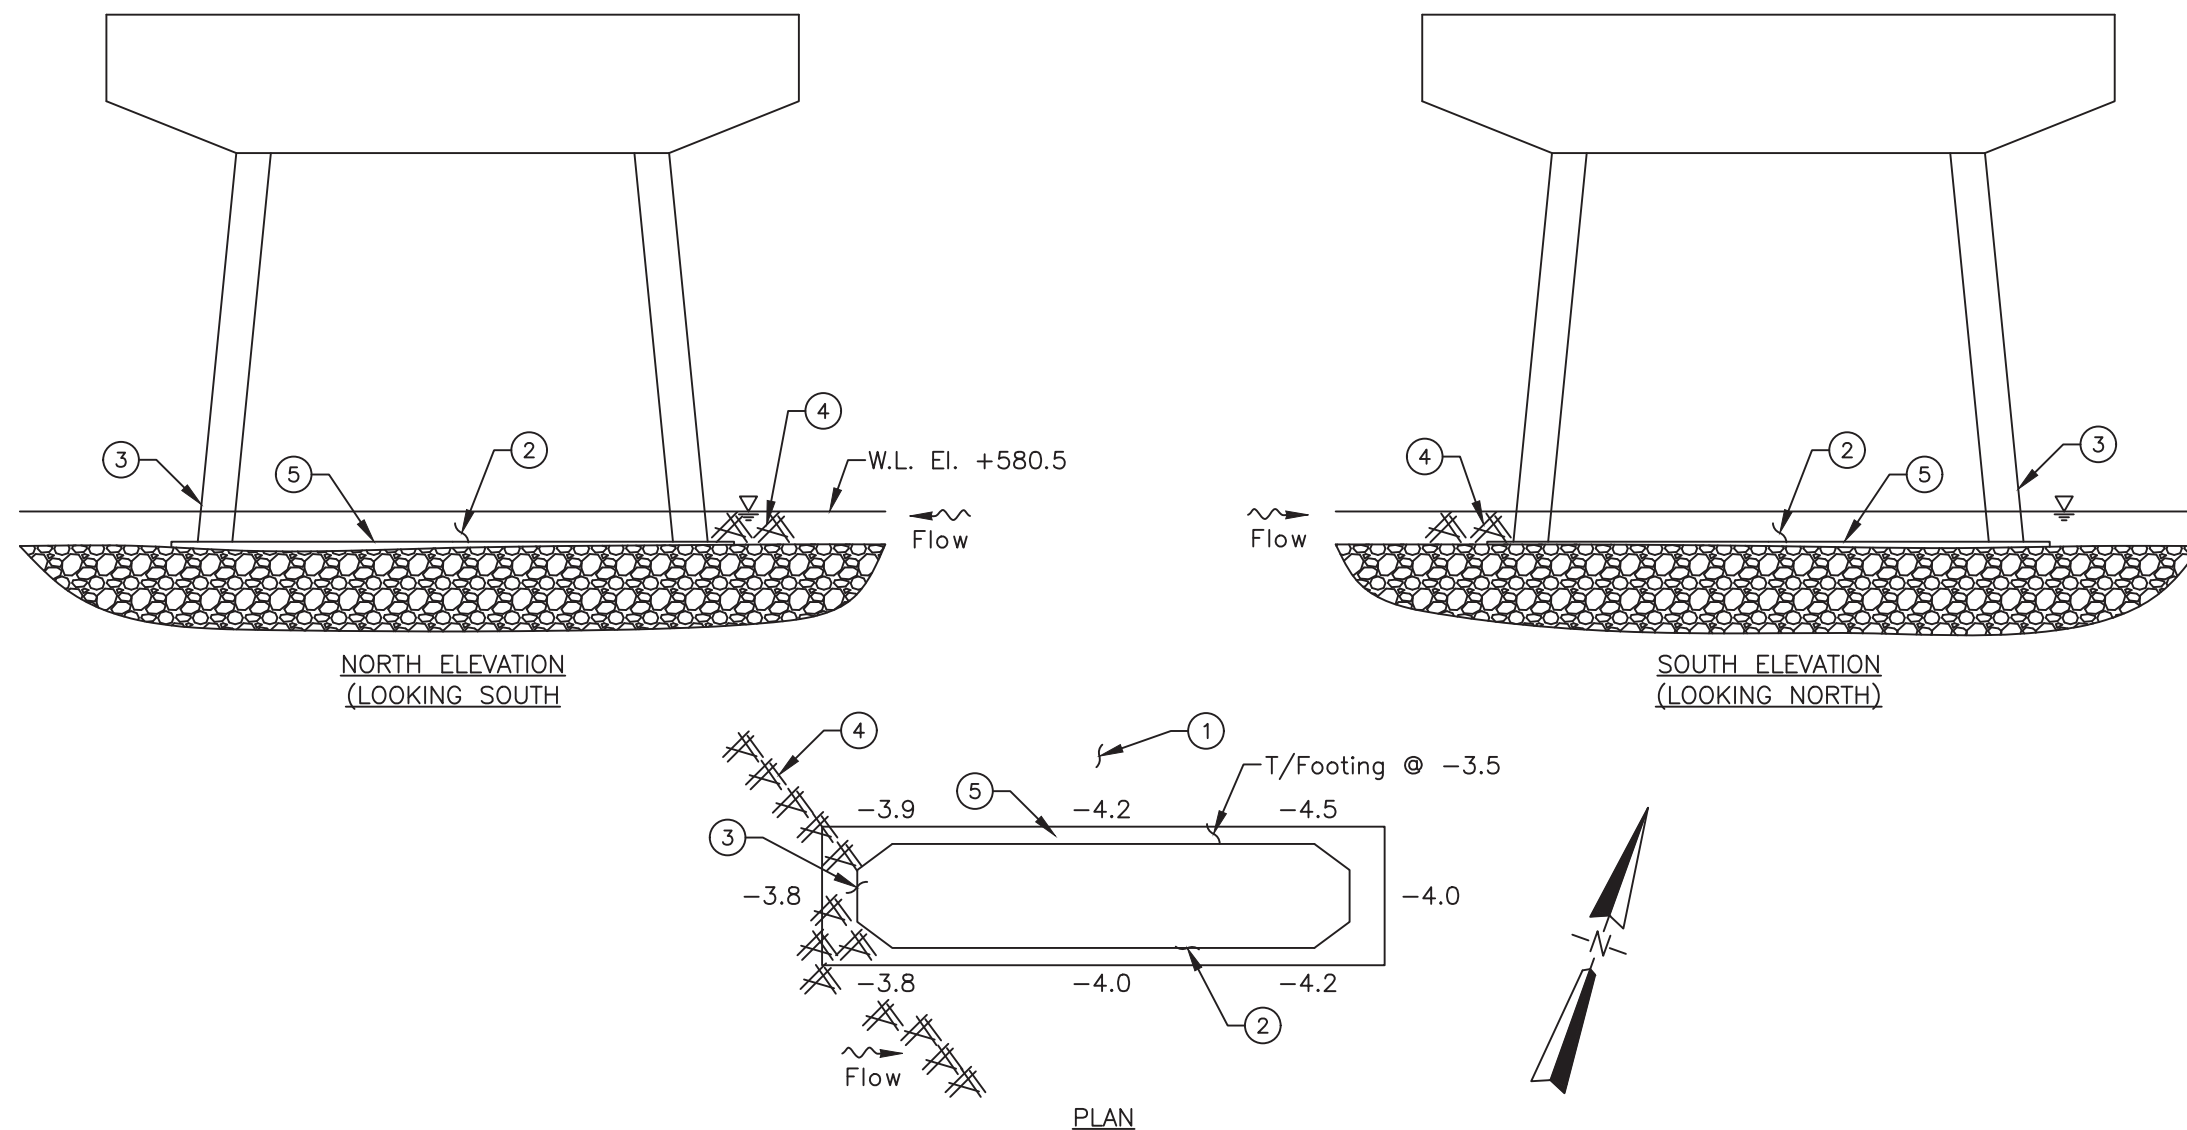
I-475 SB OVER MAUMEE RIVER  
 STRUCTURE NO. WOO-475-0386L  
 PIER S4  
 WOOD COUNTY, OHIO

- ① The channel bottom material consisted of cobbles and riprap up to 12 in. diameter with no probe rod penetration.
- ② The submerged portions of the pier exhibited light scaling up to 1/16 in. from the channel bottom to 8 ft above the waterline.
- ③ The steel ice-breakers exhibited light surface corrosion with rust nodules up to 2 in. diameter and pitting up to 1/32 in. diameter from the channel bottom to 8 ft above the waterline.
- ④ Timber debris was observed at the upstream nose of the pier.
- ⑤ Top of footing was exposed at 3.5 ft below the waterline around the entire perimeter with a maximum vertical exposure of 1.0 ft on the northeast corner.

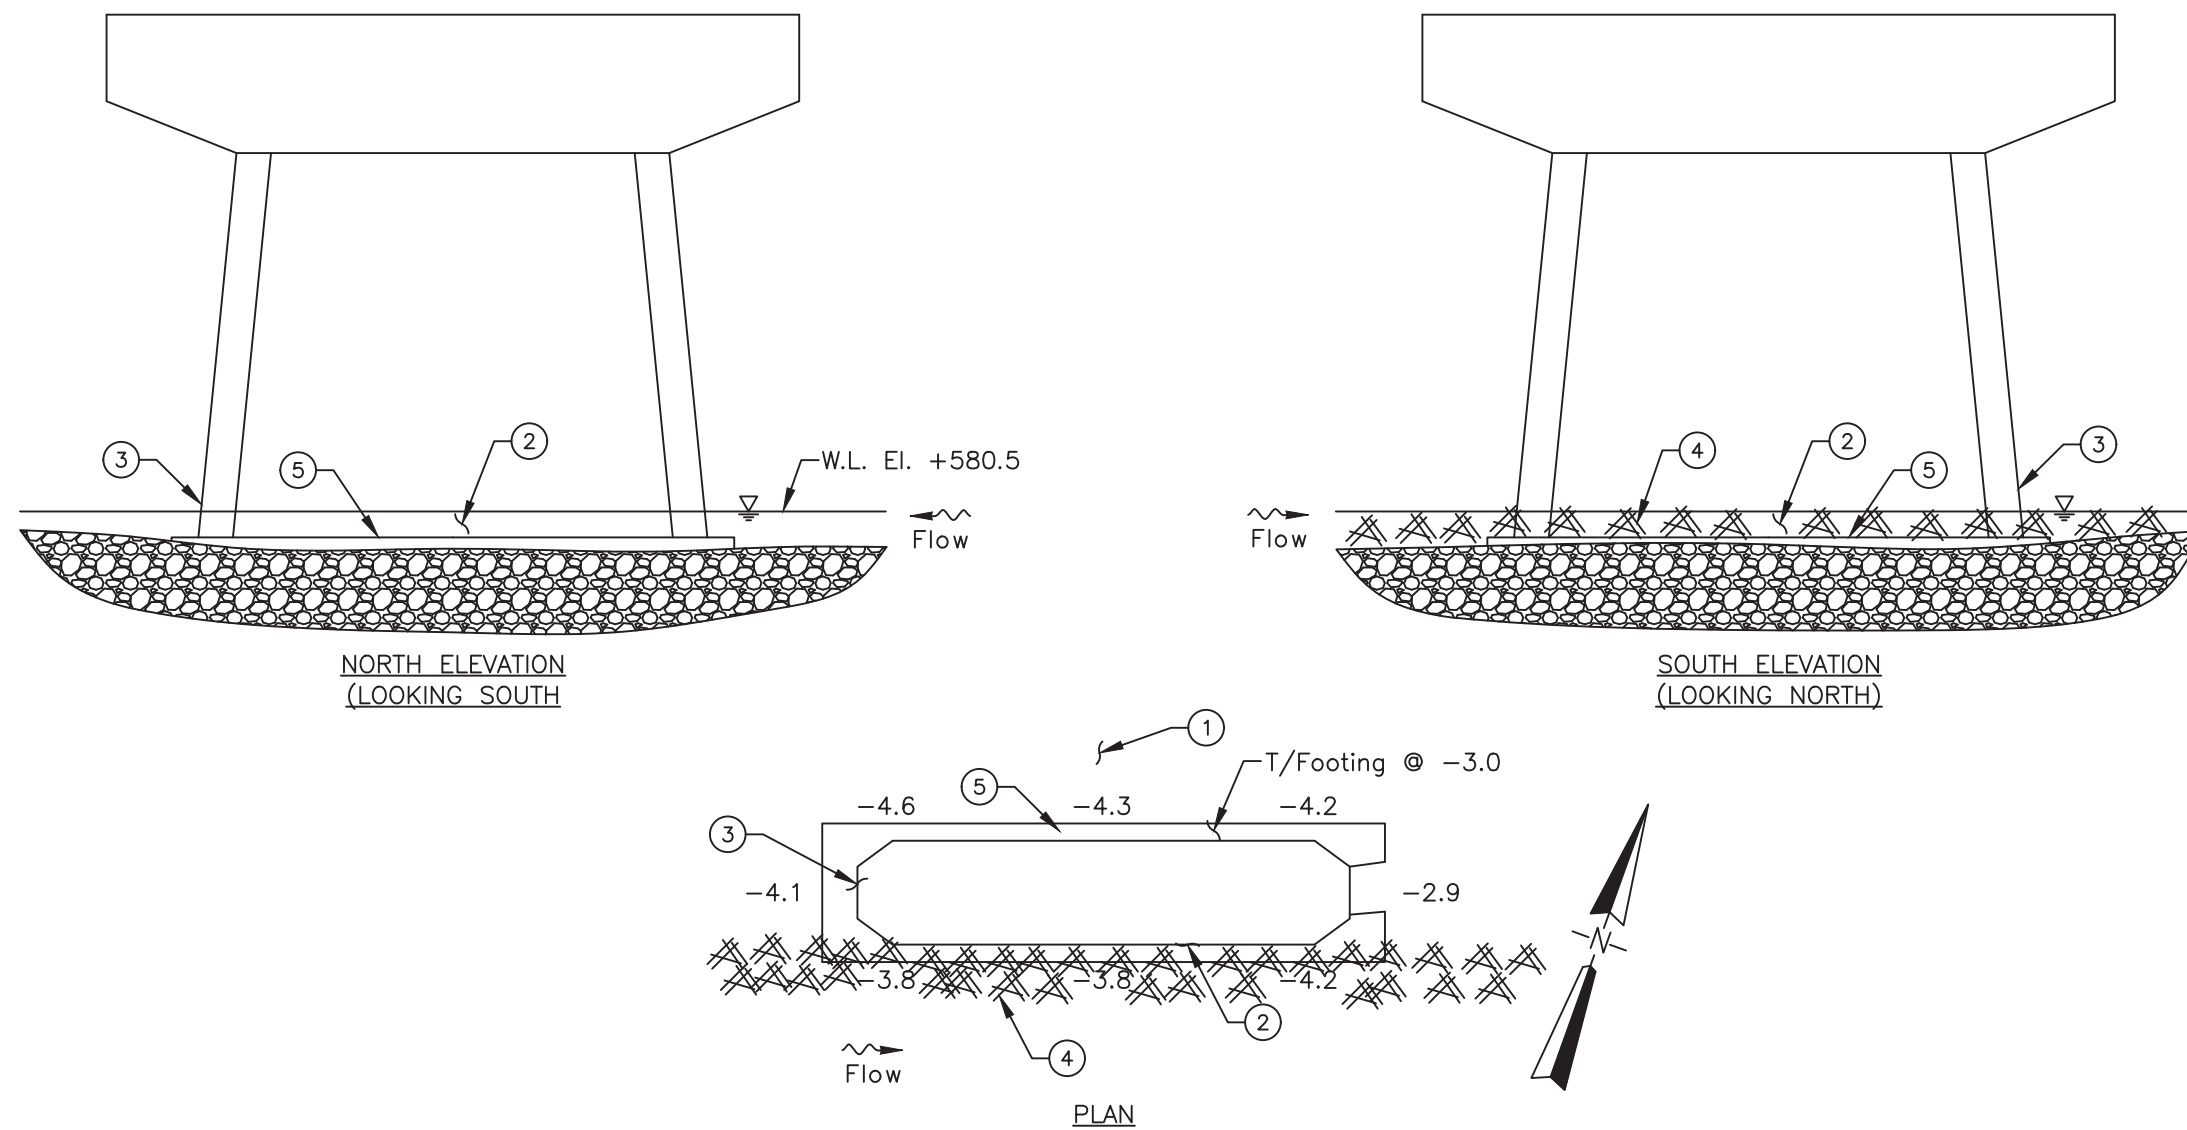
- Moderate timber debris measuring up to 18 in. diameter was observed along the south face extending up to 10 ft upstream and downstream of each nose and +5 ft off the face from the channel bottom to the waterline.

- ① The channel bottom material consisted of cobbles and riprap up to 12 in. diameter with no probe rod penetration.
- ② The submerged portions of the pier exhibited light scaling up to 1/12 in. from the channel bottom to 8 ft above the waterline.
- ③ The steel ice-breakers exhibited light surface corrosion with rust nodules up to 2 in. diameter and pitting up to 1/32 in. diameter from the channel bottom to 8 ft above the waterline.
- ④ Moderate accumulation of timber debris up to 18 in. was observed along the south face extending 10 ft upstream and downstream of each nose and 5 ft off the face, and extending from the channel bottom to the waterline.
- ⑤ Top of footing was exposed at 3.0 ft below the waterline from the southeast corner around the upstream nose ending at the northeast corner with a maximum vertical exposure of 1.6 ft on the northwest corner.

The timber debris accumulations at Pier 5 is obstructing channel flow and should be removed at this time. Removal of the timber debris will reduce excessive lateral loads on the pier, limit further debris accumulation, and reduce the likelihood of channel bottom degradation resulting from obstructed flow.

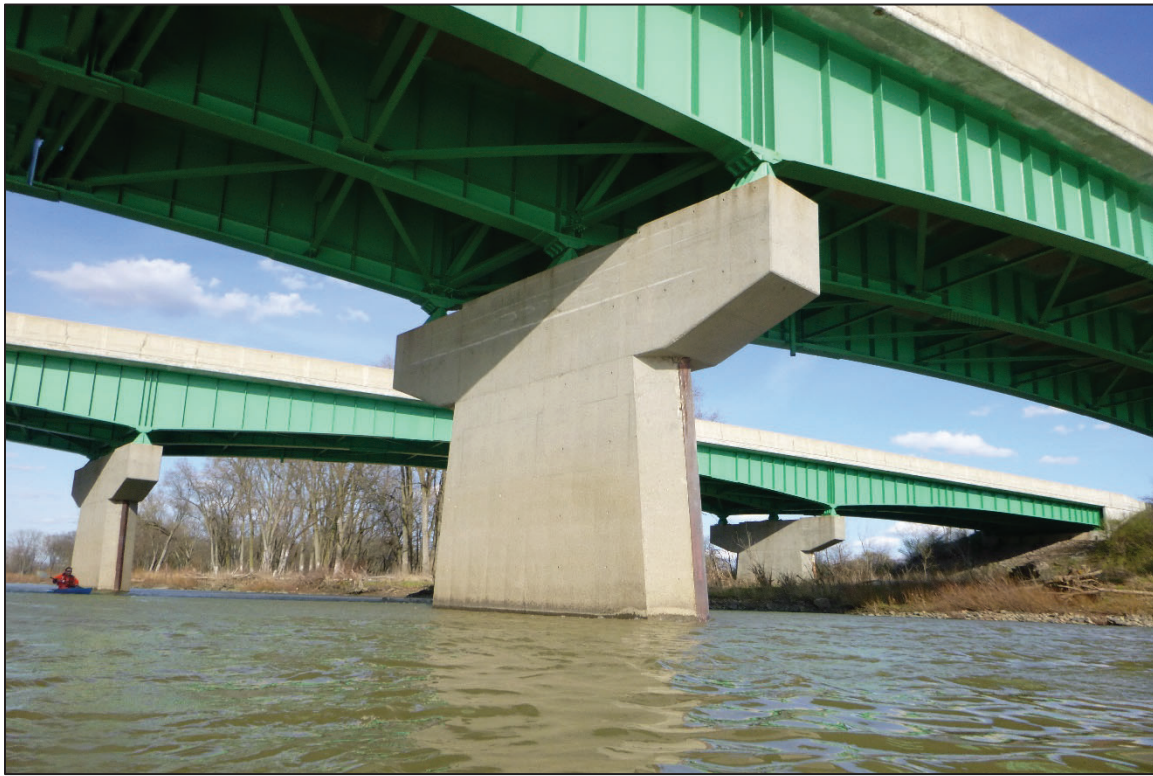
The channel bottom material consisted of cobbles and riprap up to 12 in. diameter and no probe rod penetration. The submerged portions of the pier exhibited light scaling up to 1/16 in. deep extending from the channel bottom to +8 ft above the waterline. The steel icebreaker exhibited light surface corrosion with rust nodules up to 2 in. diameter and pitting up to 1/32 in. deep extending from the channel bottom to +8 ft. Top of footing was exposed at 4.0 ft below the waterline around the entire perimeter with a maximum vertical exposure of 1.2 ft on the southeast corner. Refer to Figure 8 in Exhibit 1 for detailed inspection notes of Pier 2. Refer to Photographs 9 and 10 in Exhibit 2 for views of Pier 2.

Photograph No. 9: View of the North Face of Pier 2, Looking Southeast.

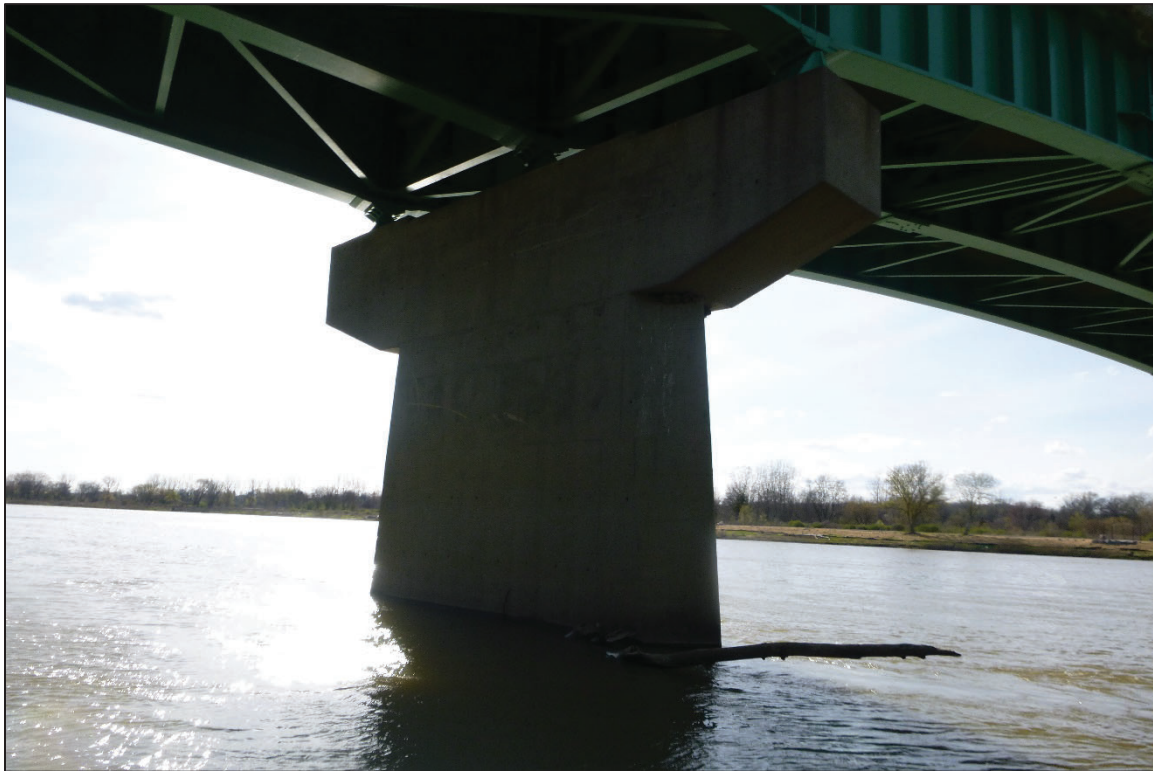
Photograph No. 10: View of the South Face of Pier 2, Looking Northwest.

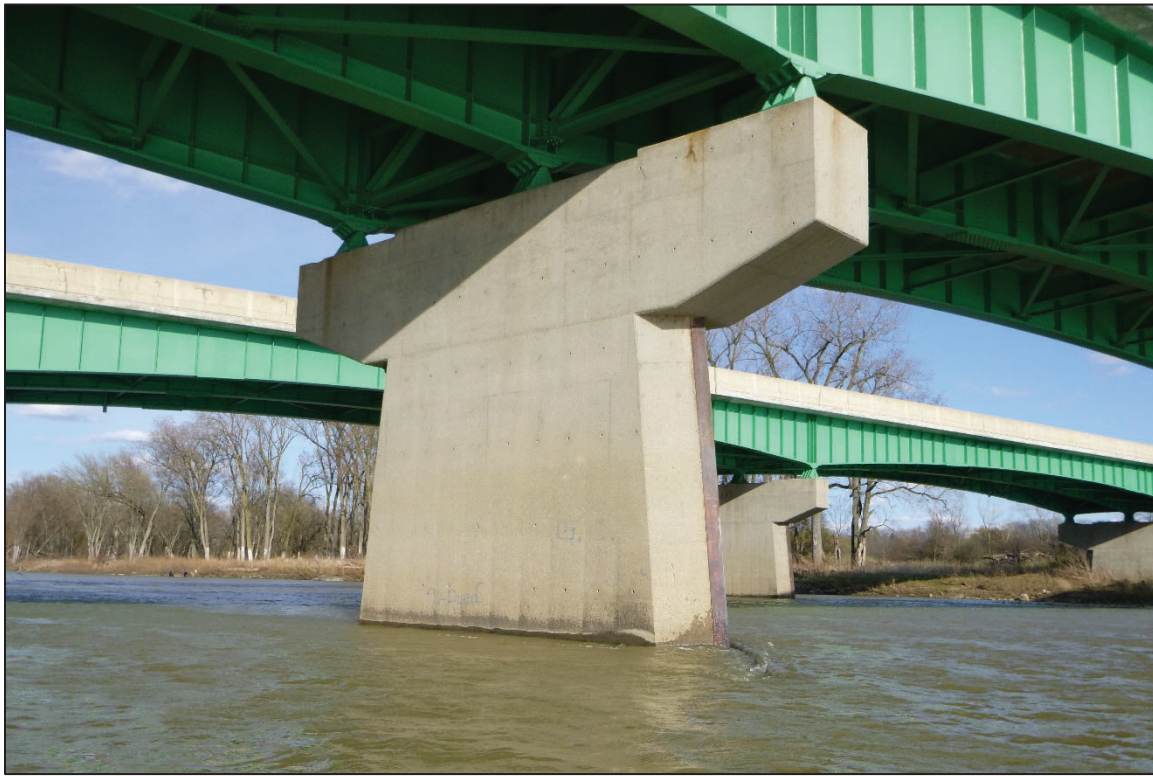
The channel bottom material consisted of cobbles and riprap up to 12 in. diameter and no probe rod penetration. The submerged portions of the pier exhibited light scaling up to 1/16 in. deep extending from the channel bottom to +8 ft above the waterline. The steel icebreaker exhibited light surface corrosion with rust nodules up to 2 in. diameter and pitting up to 1/32 in. deep extending from the channel bottom to +8 ft. Top of footing was exposed at 3.0 ft below the waterline around the entire perimeter with a maximum vertical exposure of 2.7 ft at the midpoint along the south face. Refer to Figure 9 in Exhibit 1 for detailed inspection notes of Pier 3. Refer to Photographs 11 and 12 in Exhibit 2 for views of Pier 3.

Photograph No. 11: View of the North Face of Pier 3, Looking Southeast.

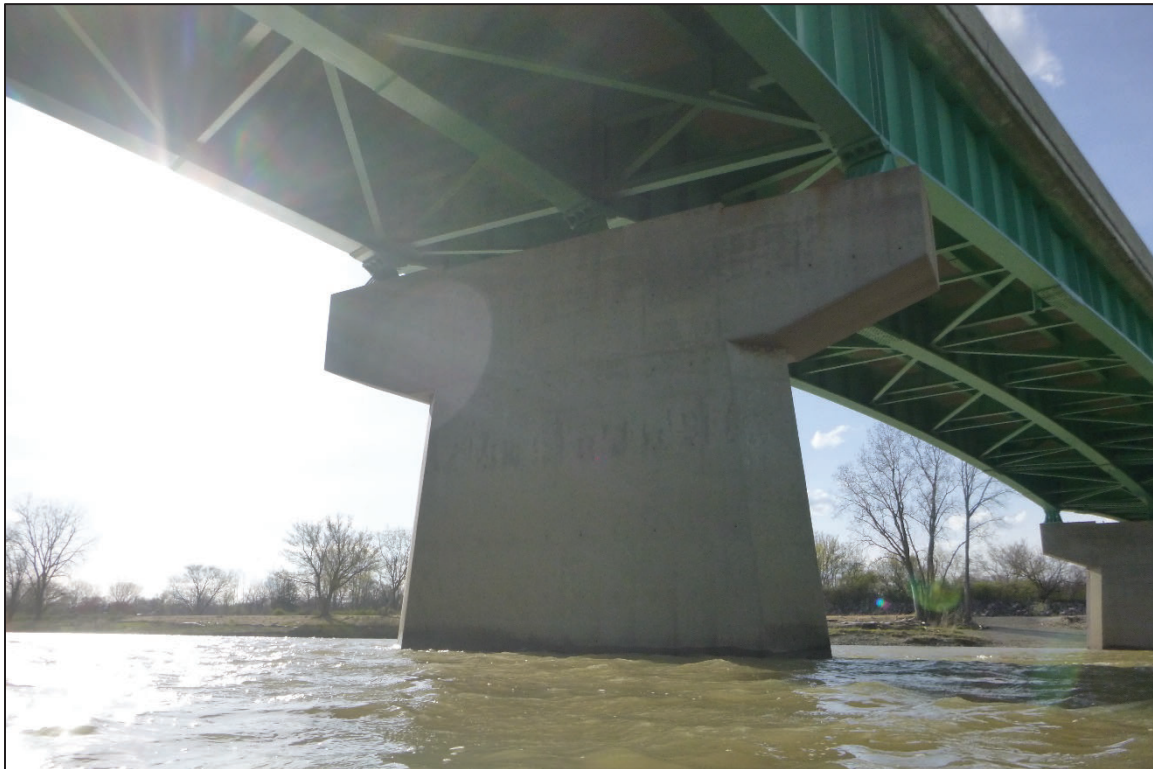
Photograph No. 12: View of the South Face of Pier 3, Looking Northwest.

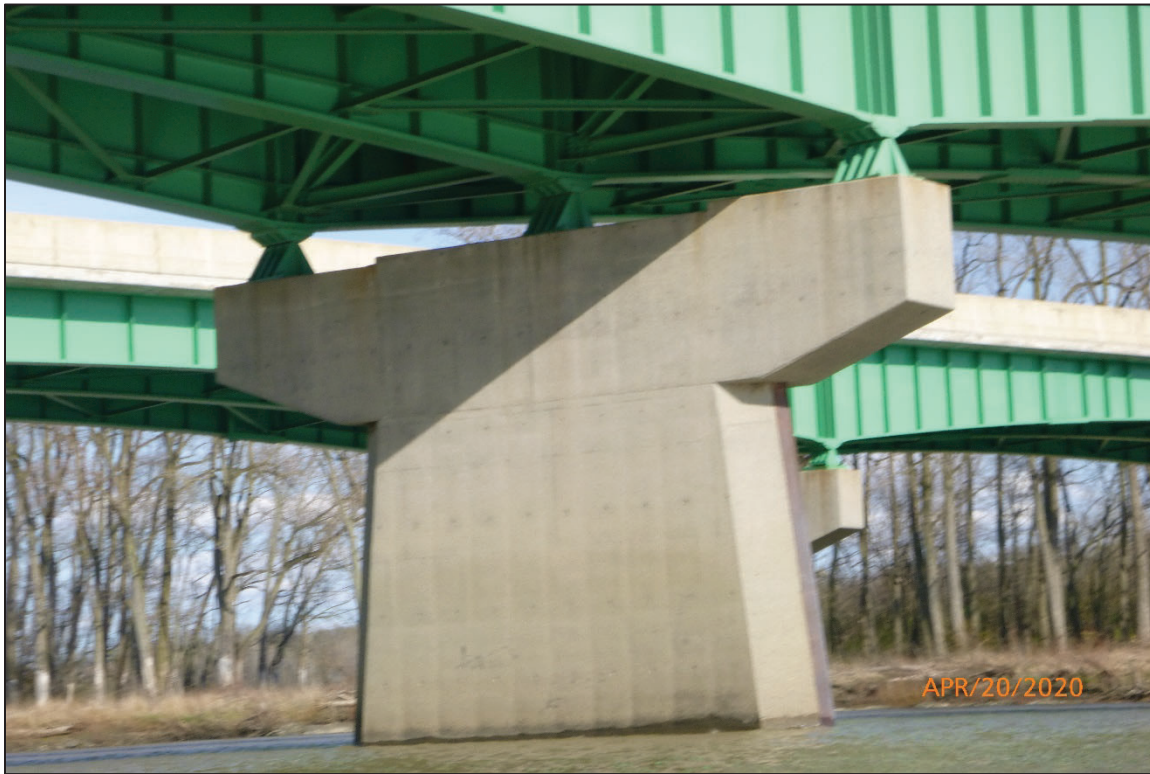
The channel bottom material consisted of cobbles and riprap up to 12 in. diameter and no probe rod penetration. The submerged portions of the pier exhibited light scaling up to 1/16 in. deep extending from the channel bottom to +8 ft above the waterline. The steel icebreaker exhibited light surface corrosion with rust nodules up to 2 in. diameter and pitting up to 1/32 in. deep extending from the channel bottom to +8 ft. Top of footing was exposed at 3.5 ft below the waterline around the entire perimeter with a maximum vertical exposure of 1.0 ft on the northeast corner. Refer to Figure 10 in Exhibit 1 for detailed inspection notes of Pier 4. Refer to Photographs 13 and 14 in Exhibit 2 for views of Pier 4.

Photograph No. 13: View of the North Face of Pier 4, Looking Southeast.

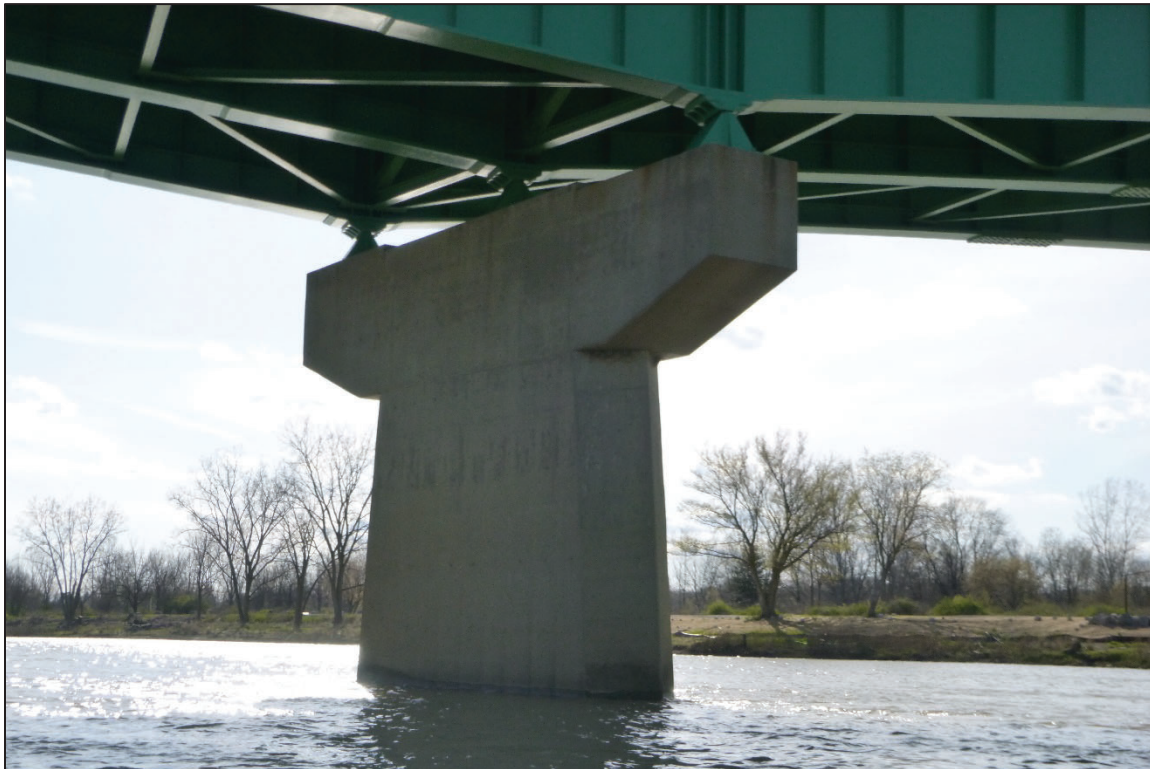
Photograph No. 14: View of the South Face of Pier 4, Looking Northwest.

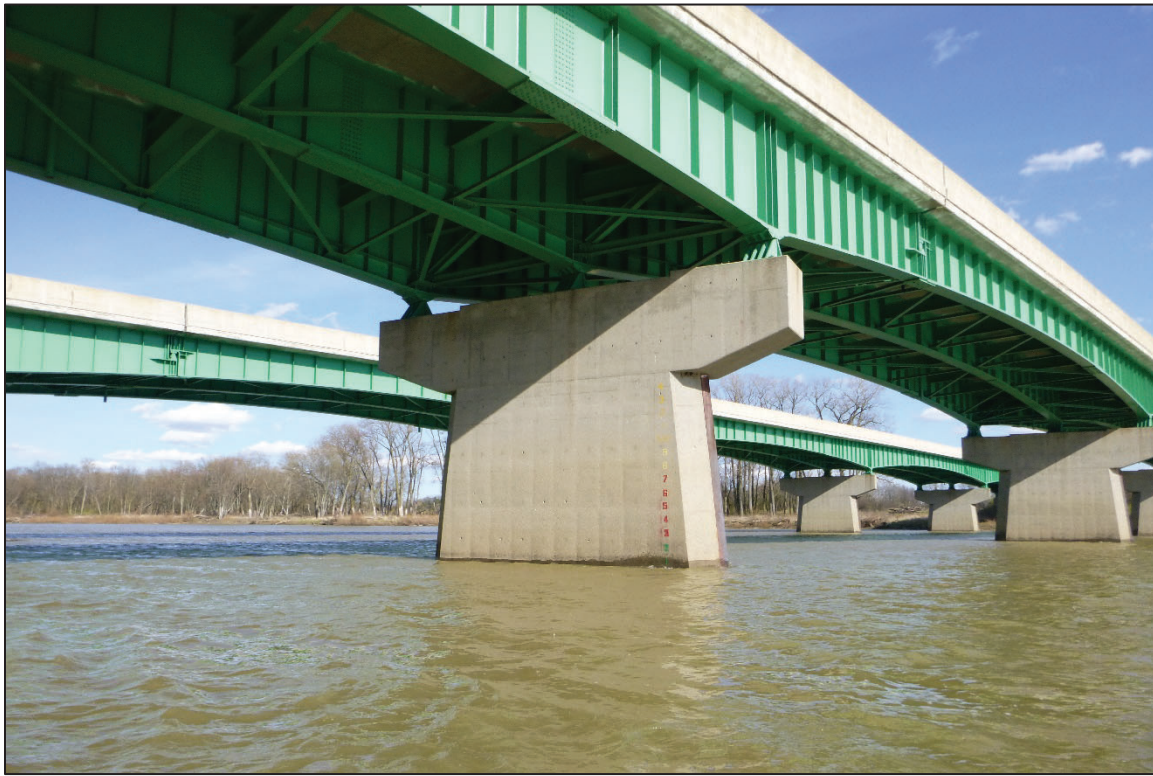
nodules up to 2 in. diameter and pitting up to 1/32 in. deep extending from the channel bottom to +8 ft. Moderate timber debris measuring up to 18 in. diameter was observed along the south face extending up to 10 ft upstream and downstream of each nose and +5 ft off the face from the channel bottom to the waterline. Top of footing was exposed at 3.0 ft below the waterline from the southeast corner around the upstream nose ending at the northeast corner with a maximum vertical exposure of 1.6 ft on the northwest corner. Refer to Figure 11 in Exhibit 1 for detailed inspection notes of Pier 5. Refer to Photographs 15 through 17 in Exhibit 2 for views of Pier 5 and typical concrete and steel condition at the waterline.

Photograph No. 15: View of the North Face of Pier 5, Looking Southeast.

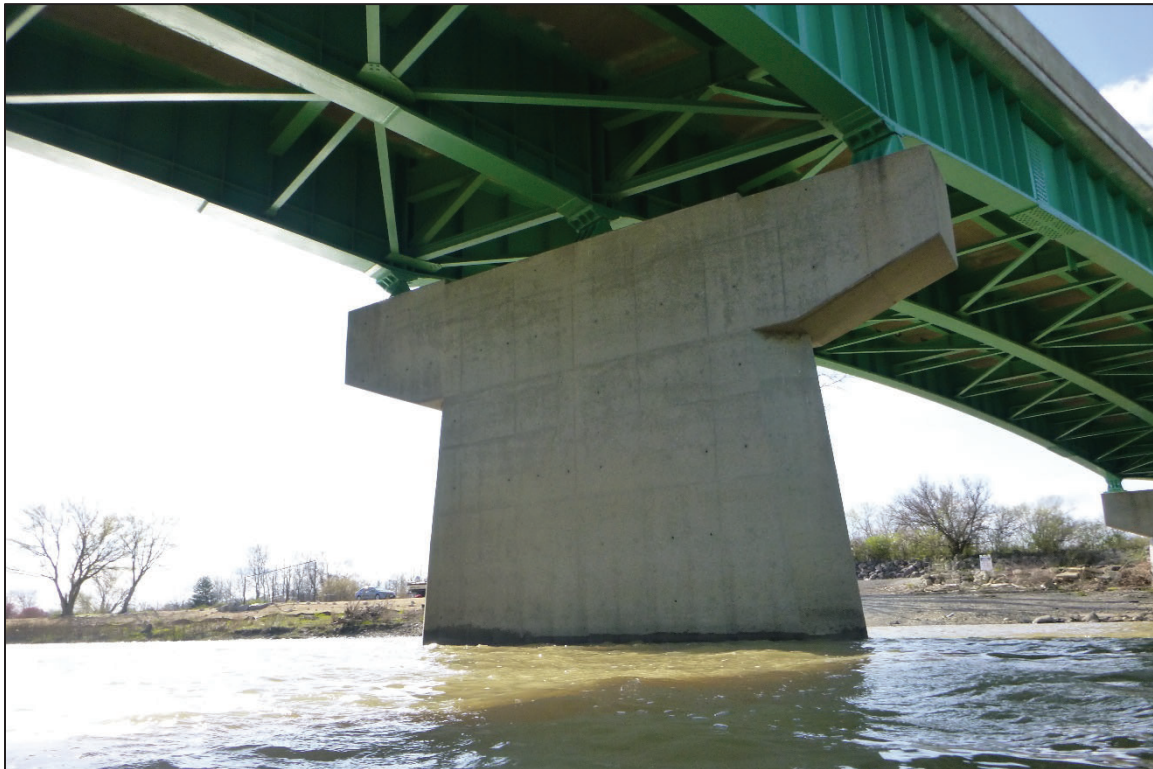
Photograph No. 16: View of the South Face of Pier 5, Looking Northwest.

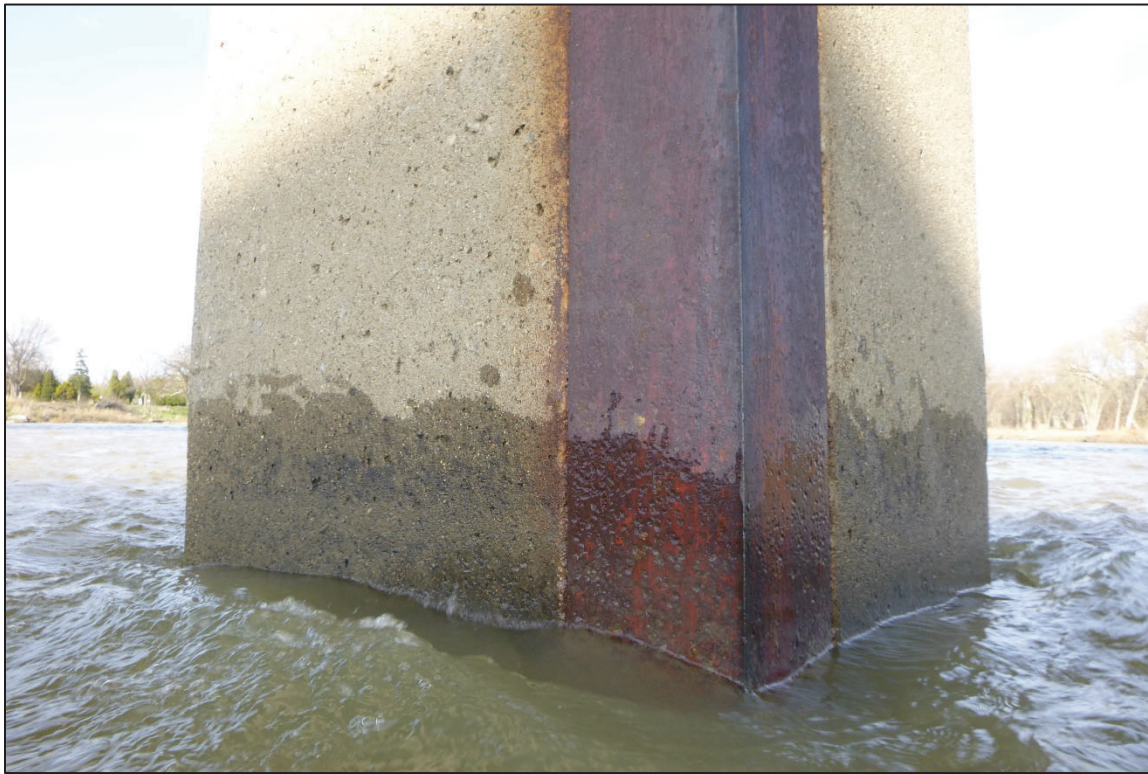
Photograph No. 17: View of the Typical Concrete and Steel Icebreaker Condition at the Waterline, Looking East.

The scaling observed on Piers 2 through 5 is not a structural concern at this time given its size compared to the overall pier size, and as a result, no repairs are recommended. This area should be monitored during future inspections for increasing extent or severity of the scaling and exposure of reinforcing steel. If the extent or severity of the scaling is observed to be increasing or reinforcing steel becomes exposed, it may be necessary to repair the area at that time.

The surface corrosion and pitting of the icebreaker steel observed at Piers 2 through 5 is not a structural concern at this time given its size compared to the overall icebreaker size, and as a result, no repairs are recommended. These areas should be monitored during future inspections for increasing extent or severity of the corrosion and pitting. If the extent or severity of the corrosion and pitting is observed to be increasing, it may be necessary to repair the areas at that time.
