UNDERWATER BRIDGE INSPECTION REPORT

STRUCTURE NO. 8706786 (WOO-475-0386R)
I-475 NB OVER MAUMEE RIVER
WOOD COUNTY, OH
DISTRICT 2

April 2020

COLLINS
ENGINEERS INC.

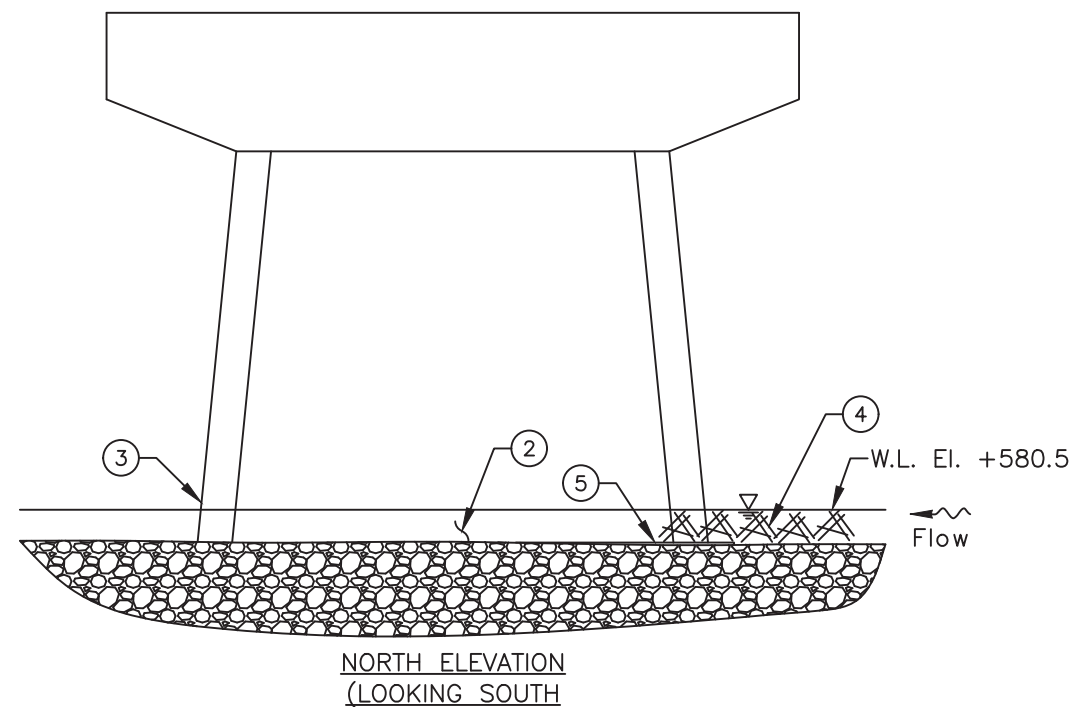
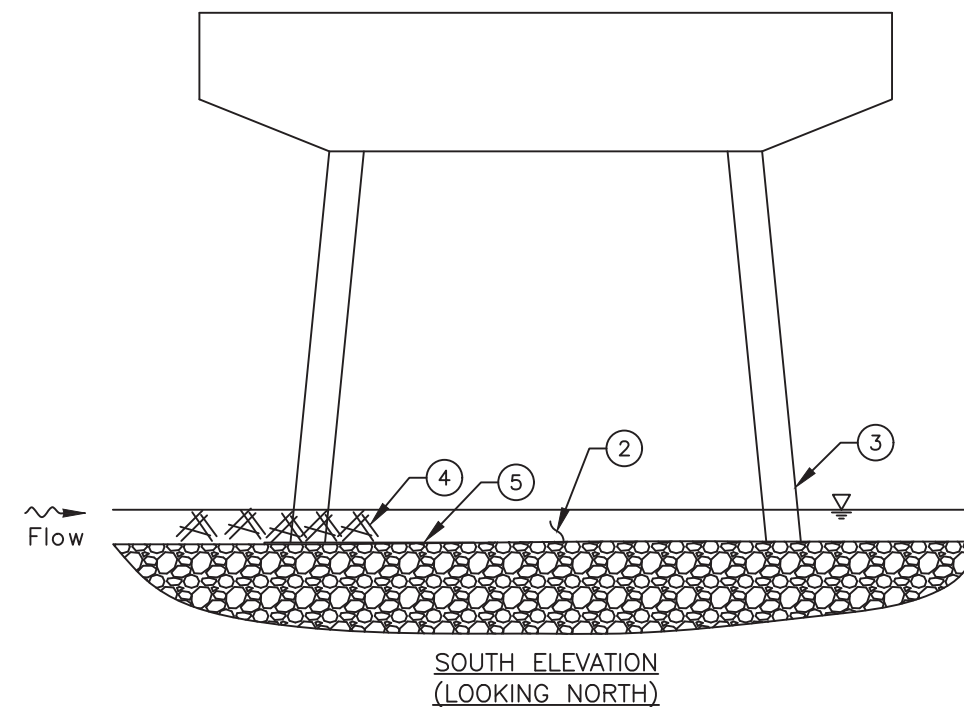
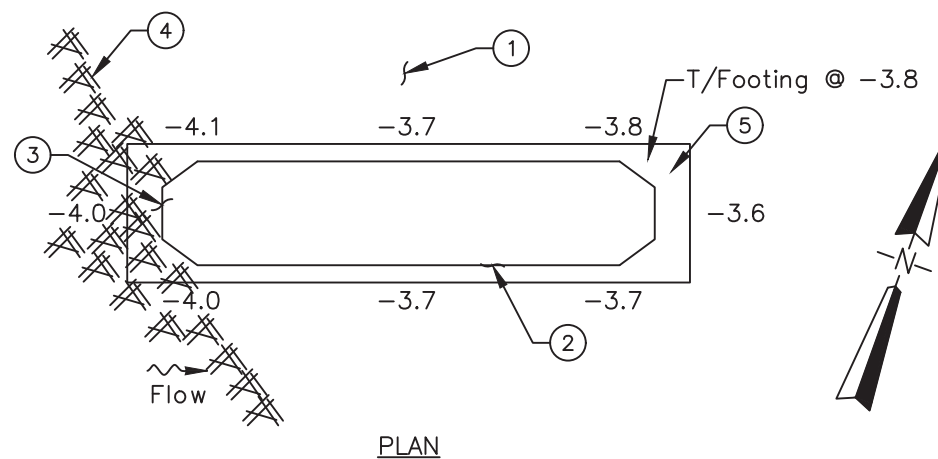
I-475 NB OVER MAUMEE RIVER
 STRUCTURE NO. WOO-475-0386R
 PIER N2
 WOOD COUNTY, OHIO

The channel bottom material consisted of cobbles and riprap up to 12 in. diameter and no probe rod penetration. The submerged portions of the pier exhibited light scaling up to 1/16 in. deep extending from the channel bottom to +8 ft above the waterline. The steel icebreaker exhibited light surface corrosion with rust nodules up to 2 in. diameter and pitting up to 1/32 in. deep extending from the channel bottom to +8 ft. Moderate timber debris consisting of logs up to 36 in. diameter extending up to 5 ft upstream of the upstream nose and +10 ft off both faces from the channel bottom to the waterline. Top of footing was exposed at 3.8 ft below the waterline around the entire perimeter with a maximum vertical exposure of 0.3 ft on the northwest corner. Refer to Figure 8 in Exhibit 1 for detailed inspection notes of Pier 2. Refer to Photographs 9 and 10 in Exhibit 2 for views of Pier 2.

- ① The channel bottom material consisted of cobbles and riprap up to 12 in. diameter with no probe rod penetration.
- ② The submerged portions of the pier exhibited light scaling up to 1/16 in. from the channel bottom to 8 ft above the waterline.
- ③ The steel ice-breakers exhibited light surface corrosion with rust nodules up to 2 in diameter and pitting up to 1/32 in. diameter from the channel bottom to 8 ft above the waterline.
- ④ Moderate accumulation of timber debris, consisting of logs up to 36 in. diameter, extending up to 5 ft upstream of the upstream nose and 10 ft off both faces, and extending from the channel bottom to the waterline.
- ⑤ Top of footing was exposed at 3.8 ft below the waterline around the entire perimeter with a maximum vertical exposure of 0.3 ft on the northwest corner.

The timber debris accumulations at Pier 2 is obstructing channel flow and should be removed at this time. Removal of the timber debris will reduce excessive lateral loads on the pier, limit further debris accumulation, and reduce the likelihood of channel bottom degradation resulting from obstructed flow.

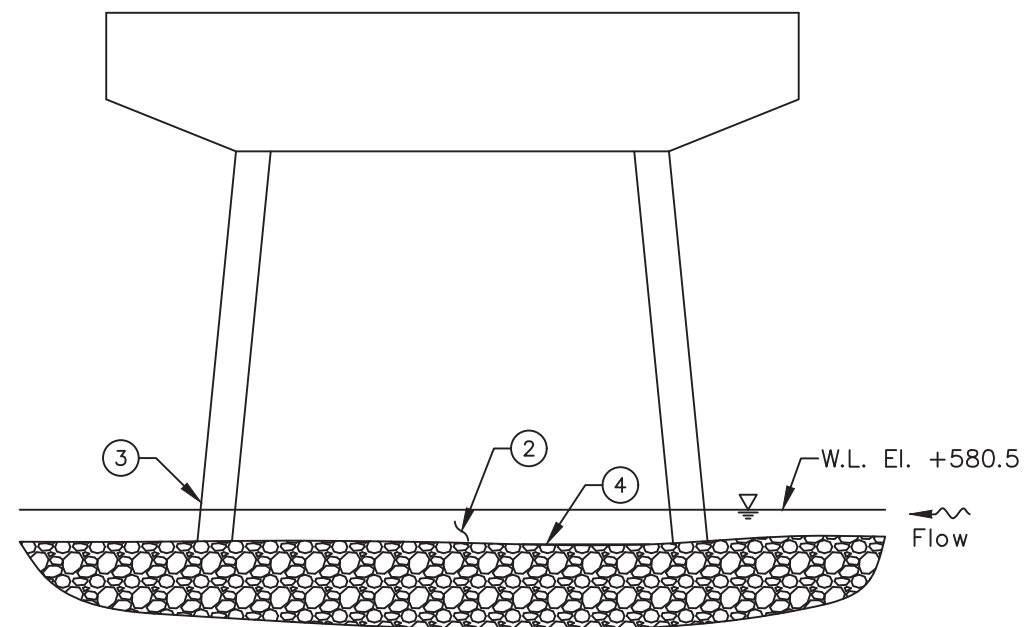
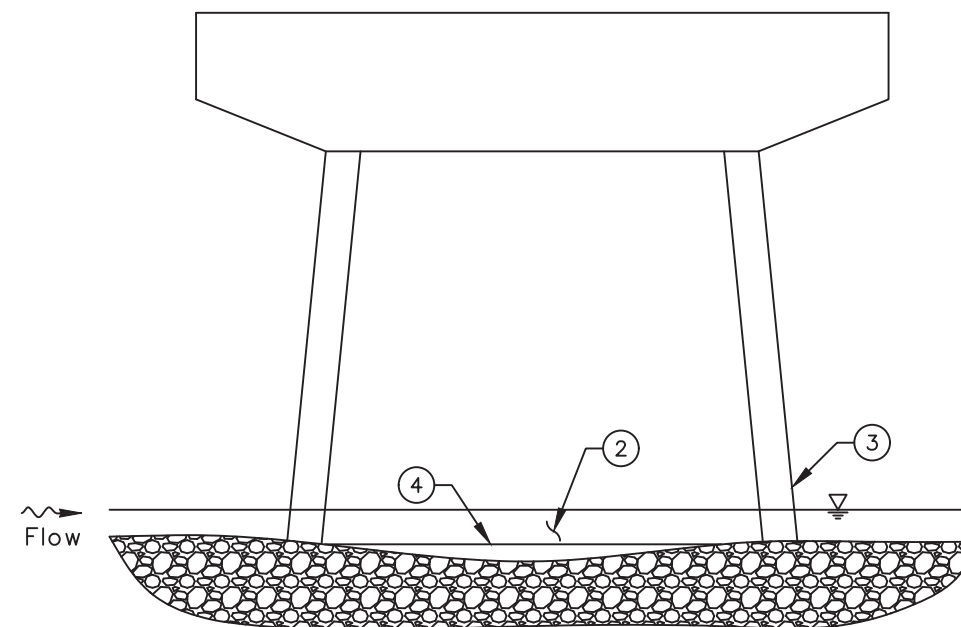
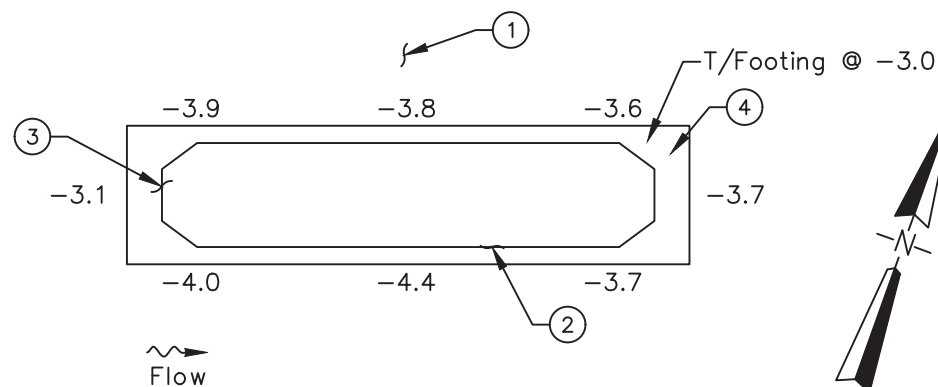
I-475 NB OVER MAUMEE RIVER
 STRUCTURE NO. WOO-475-0386R
 PIER N3
 WOOD COUNTY, OHIO

The channel bottom material consisted of cobbles and riprap up to 12 in. diameter and no probe rod penetration. The submerged portions of the pier exhibited light scaling up to 1/16 in. deep extending from the channel bottom to +8 ft above the waterline. The steel icebreaker exhibited light surface corrosion with rust nodules up to 2 in. diameter and pitting up to 1/32 in. deep extending from the channel bottom to +8 ft. Top of footing was exposed at 3.0 ft below the waterline around the entire perimeter with a maximum vertical exposure of 1.4 ft at the midpoint along the south face. Refer to Figure 9 in Exhibit 1 for detailed inspection notes of Pier 3. Refer to Photographs 11 and 12 in Exhibit 2 for views of Pier 3.

- ① The channel bottom material consisted of cobbles and riprap up to 12 in diameter with no probe rod penetration.
- ② The submerged portions of the pier exhibited light scaling up to 1/16 in. from the channel bottom to 8 ft above the waterline.
- ③ The steel ice-breakers exhibited light surface corrosion with rust nodules up to 2 in. diameter and pitting up to 1/32 in. diameter from the channel bottom to 8 ft above the waterline.
- ④ Top of footing was exposed at 3.0 ft below the waterline around the entire perimeter with a maximum vertical exposure of 1.4 ft at the midpoint along the south face.

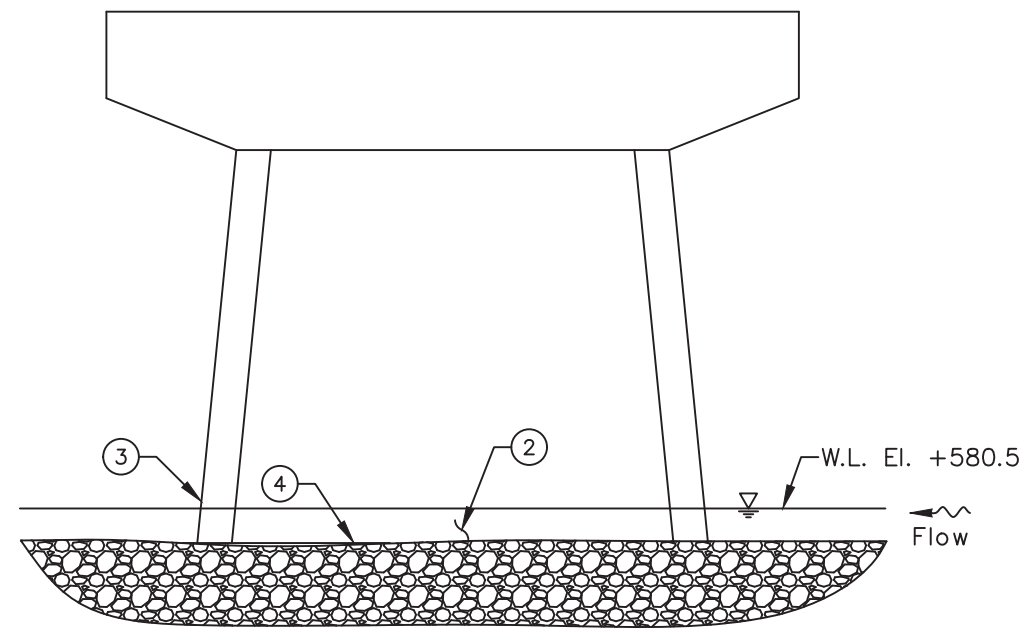
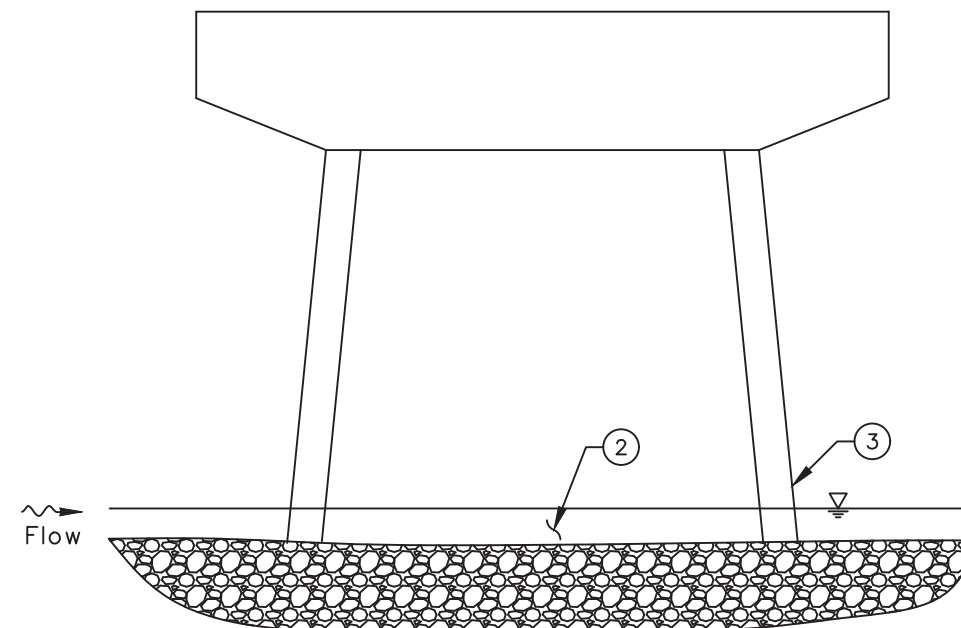
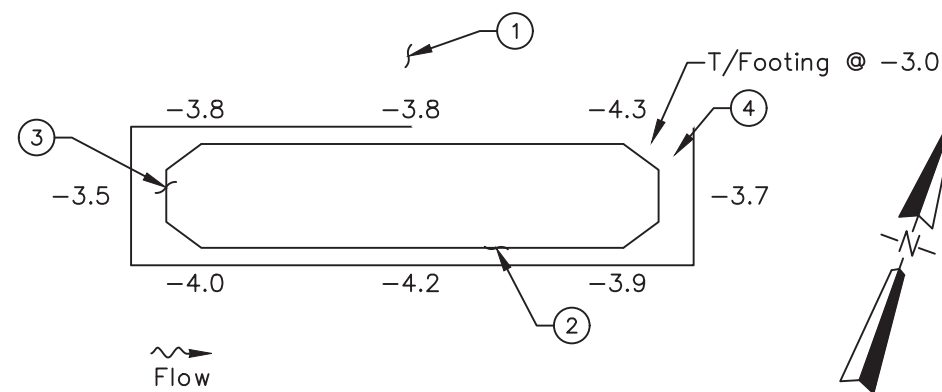
I-475 NB OVER MAUMEE RIVER
 STRUCTURE NO. WOO-475-0386R
 PIER N4
 WOOD COUNTY, OHIO

The channel bottom material consisted of cobbles and riprap up to 12 in. diameter and no probe rod penetration. The submerged portions of the pier exhibited light scaling up to 1/16 in. deep extending from the channel bottom to +8 ft above the waterline. The steel icebreaker exhibited light surface corrosion with rust nodules up to 2 in. diameter and pitting up to 1/32 in. deep extending from the channel bottom to +8 ft. Top of footing was exposed at 3.0 ft below the waterline around the entire perimeter with a maximum vertical exposure of 1.3 ft on the northeast corner. Refer to Figure 10 in Exhibit 1 for detailed inspection notes of Pier 4. Refer to Photographs 13 and 14 in Exhibit 2 for views of Pier 4.

- ① The channel bottom material consisted of cobbles and riprap up to 12 in. diameter with no probe rod penetration.
- ② The submerged portions of the pier exhibited light scaling up to 1/16 in. from the channel bottom to 8 ft above the waterline.
- ③ The steel ice-breakers exhibited light surface corrosion with rust nodules up to 2 in. diameter and pitting up to 1/32 in. diameter from the channel bottom to 8 ft above the waterline.
- ④ Top of footing was exposed at 3.0 ft below the waterline around the entire perimeter with a maximum vertical exposure of 1.3 ft on the northeast corner.

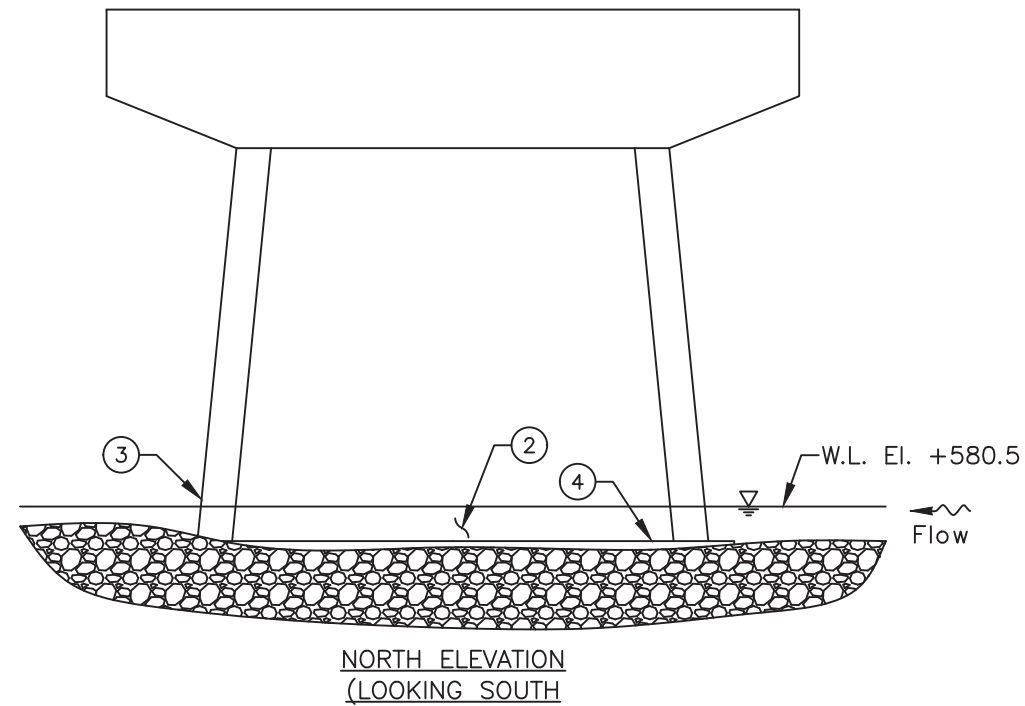
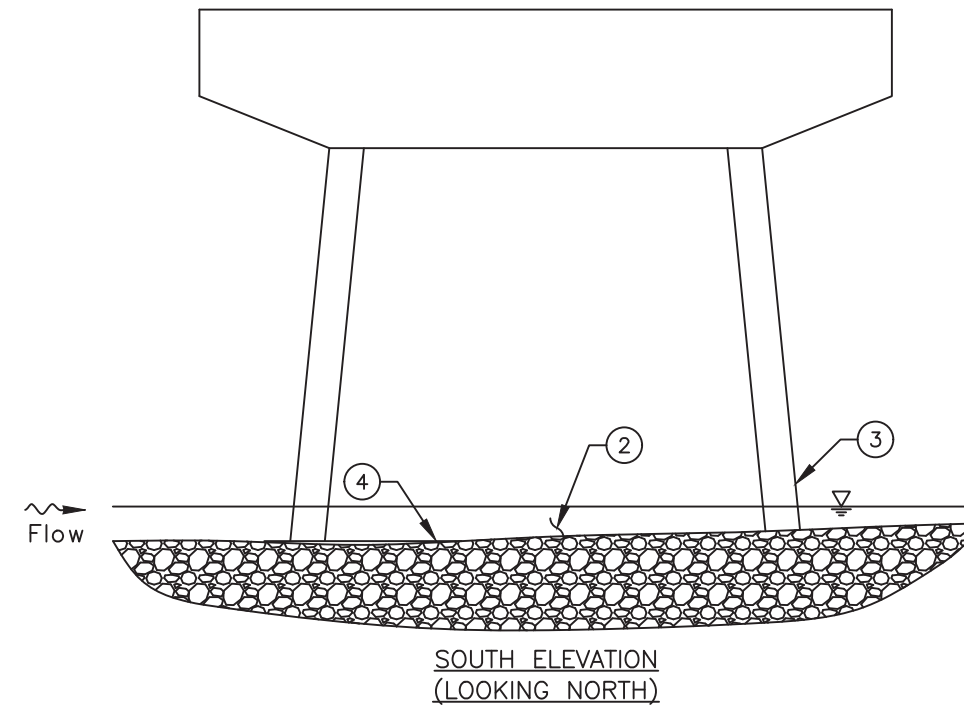
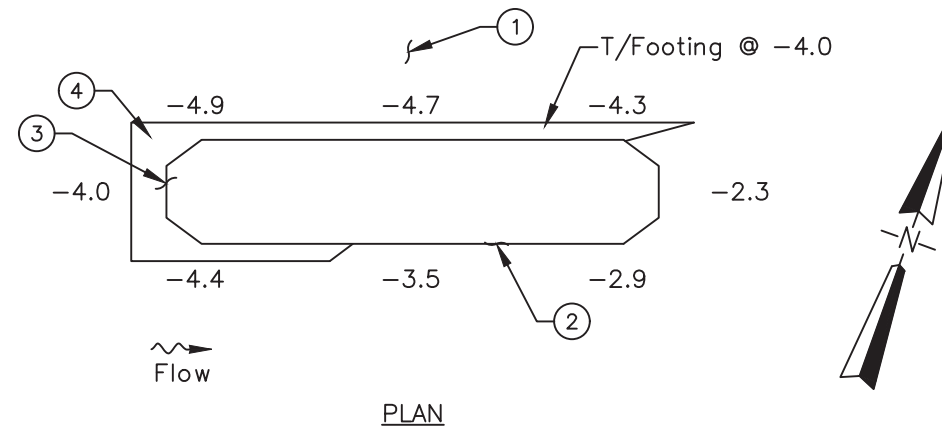
channel bottom to +8 ft above the waterline. The steel icebreaker exhibited light surface corrosion with rust nodules up to 2 in. diameter and pitting up to 1/32 in. deep extending from the channel bottom to +8 ft. Top of footing was exposed at 4.0 ft below the waterline from the midpoint of the south face around the upstream nose ending at the northeast corner with a maximum vertical exposure of 0.9 ft on the northwest. Refer to Figure 11 in Exhibit 1 for detailed inspection notes of Pier 5. Refer to Photographs 15 through 17 in Exhibit 2 for views of Pier 5 and typical concrete and steel condition at the waterline.

- ① The channel bottom material consisted of cobbles and riprap up to 12 in. diameter with no probe rod penetration.
- ② The submerged portions of the pier exhibited light scaling up to 1/16 in. from the channel bottom to 8 ft above the waterline.
- ③ The steel ice-breakers exhibited light surface corrosion with rust nodules up to 2 in. diameter and pitting up to 1/32 in. diameter from the channel bottom to 8 ft above the waterline.
- ④ Top of footing was exposed at 4.0 ft below the waterline from the midpoint of the south face around the upstream nose ending at the northeast corner with a maximum vertical exposure of 0.9 ft on the northwest corner.

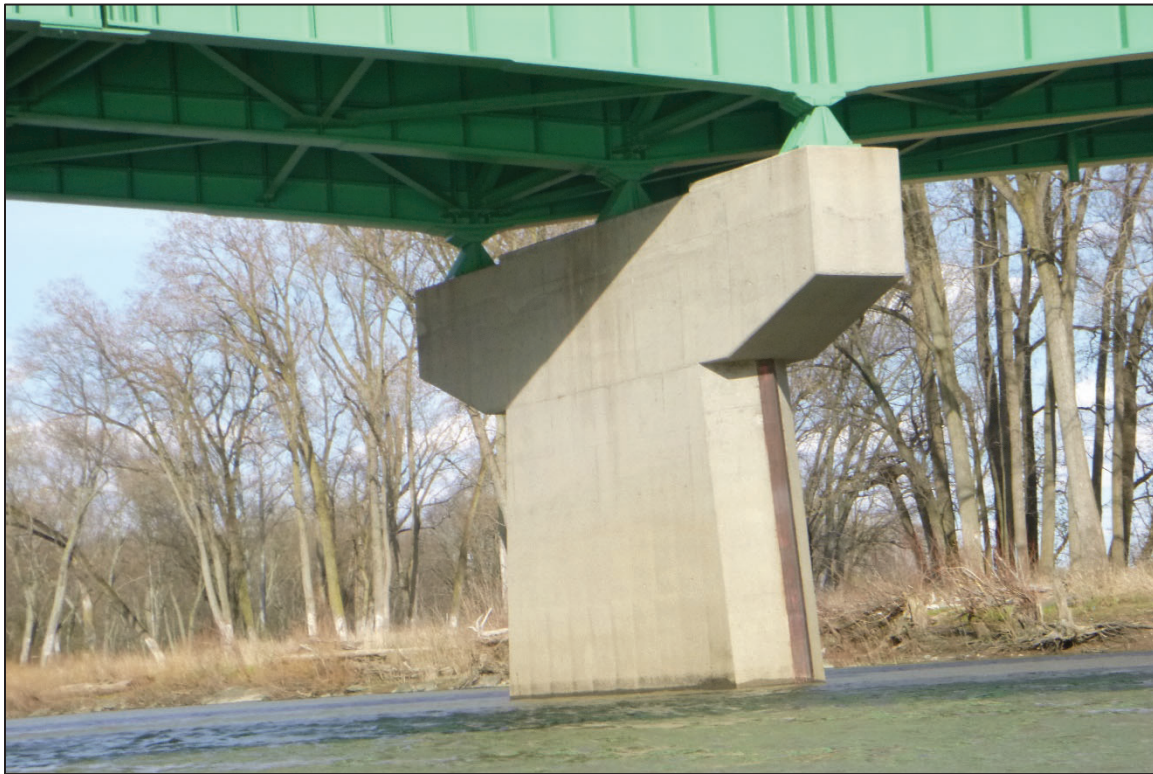
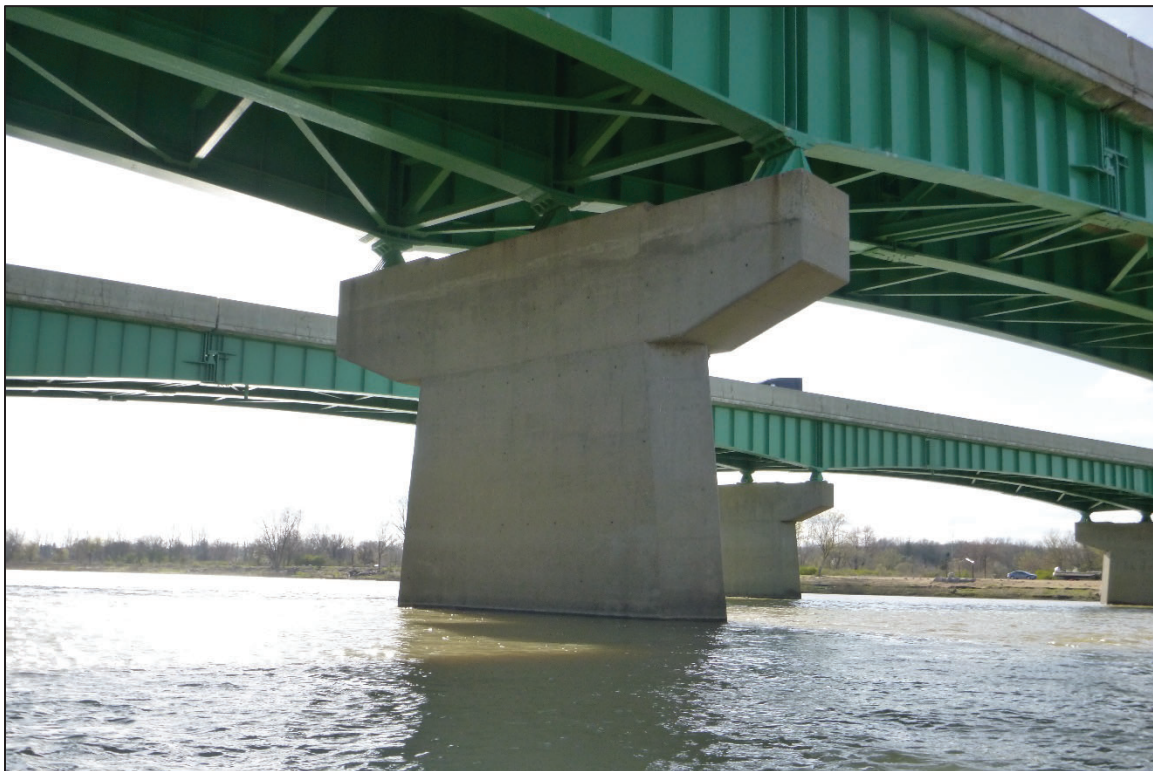
Photograph No. 9: View of the North Face of Pier 2, Looking Southeast.

Photograph No. 10: View of the South Face of Pier 2, Looking Northwest.

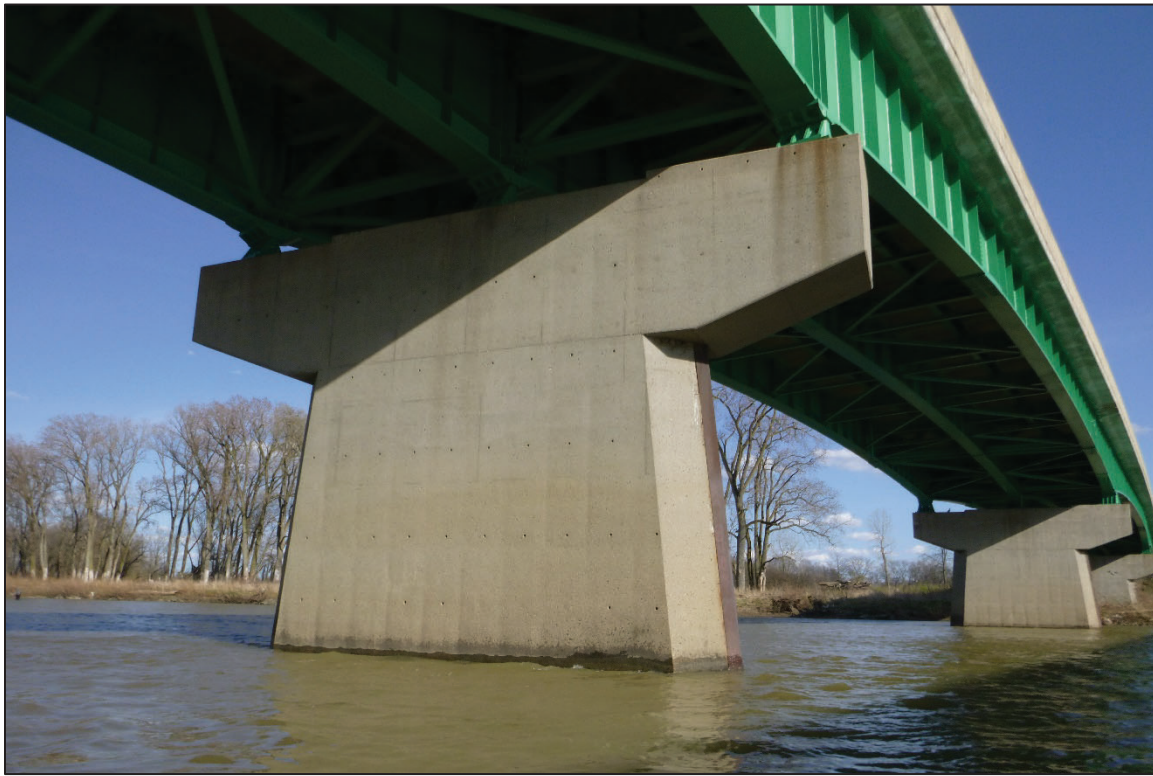
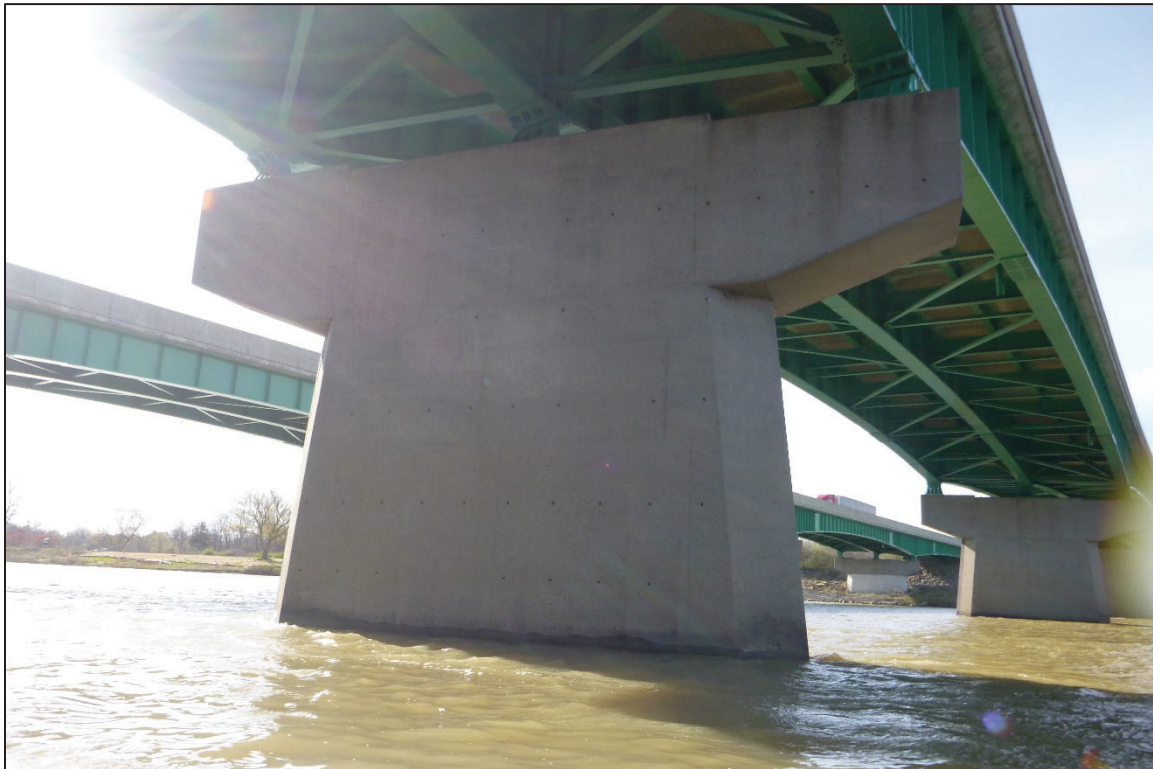
Photograph No. 11: View of the North Face of Pier 3, Looking Southeast.

Photograph No. 12: View of the South Face of Pier 3, Looking Northwest.

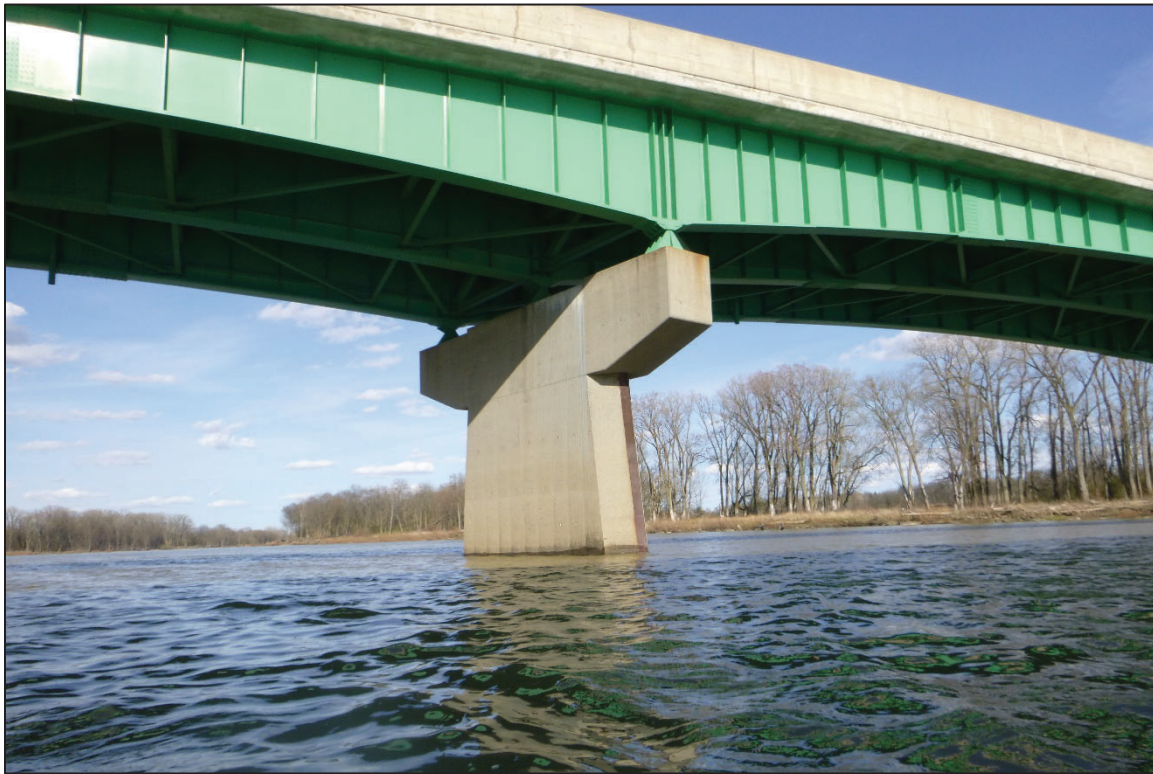
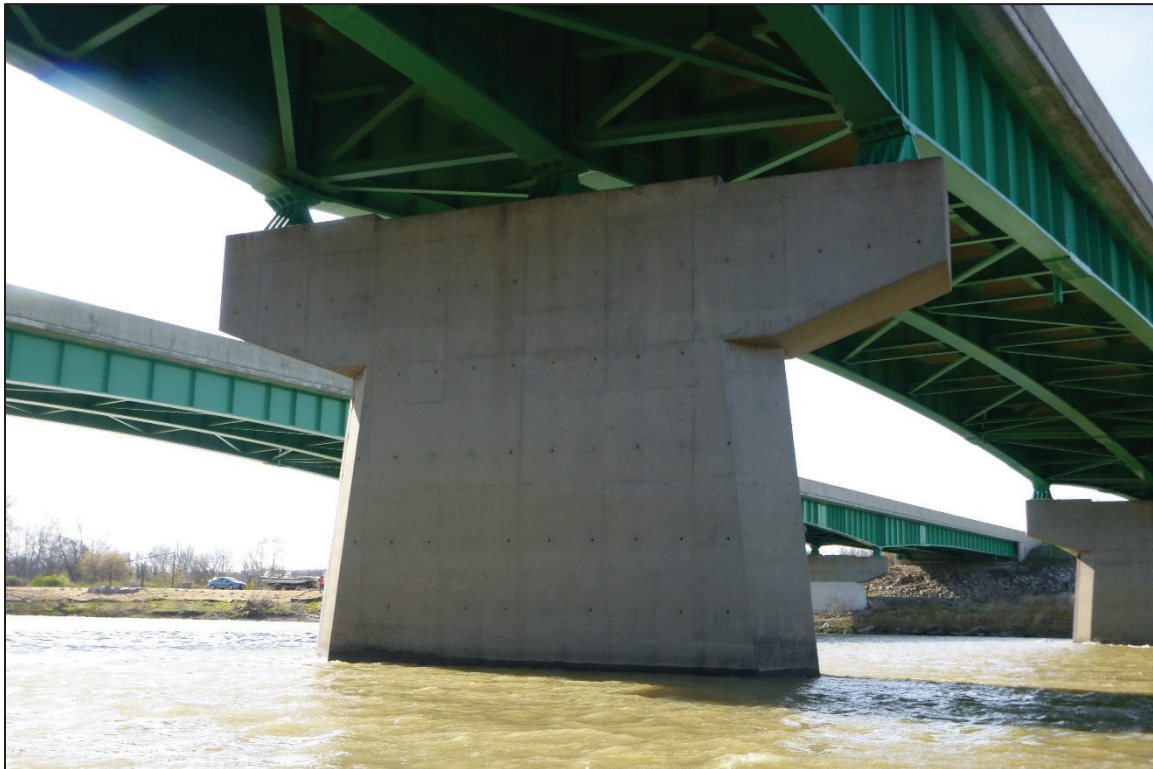
Photograph No. 13: View of the North Face of Pier 4, Looking Southeast.

Photograph No. 14: View of the South Face of Pier 4, Looking Northwest.

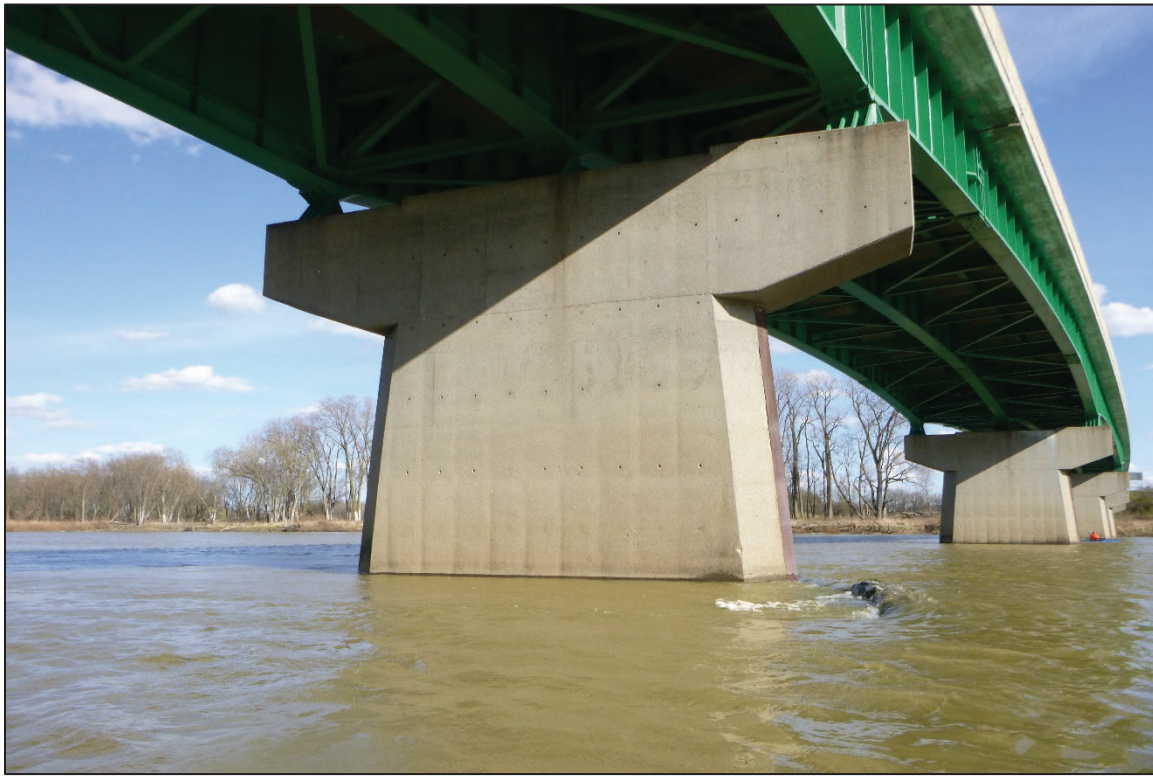
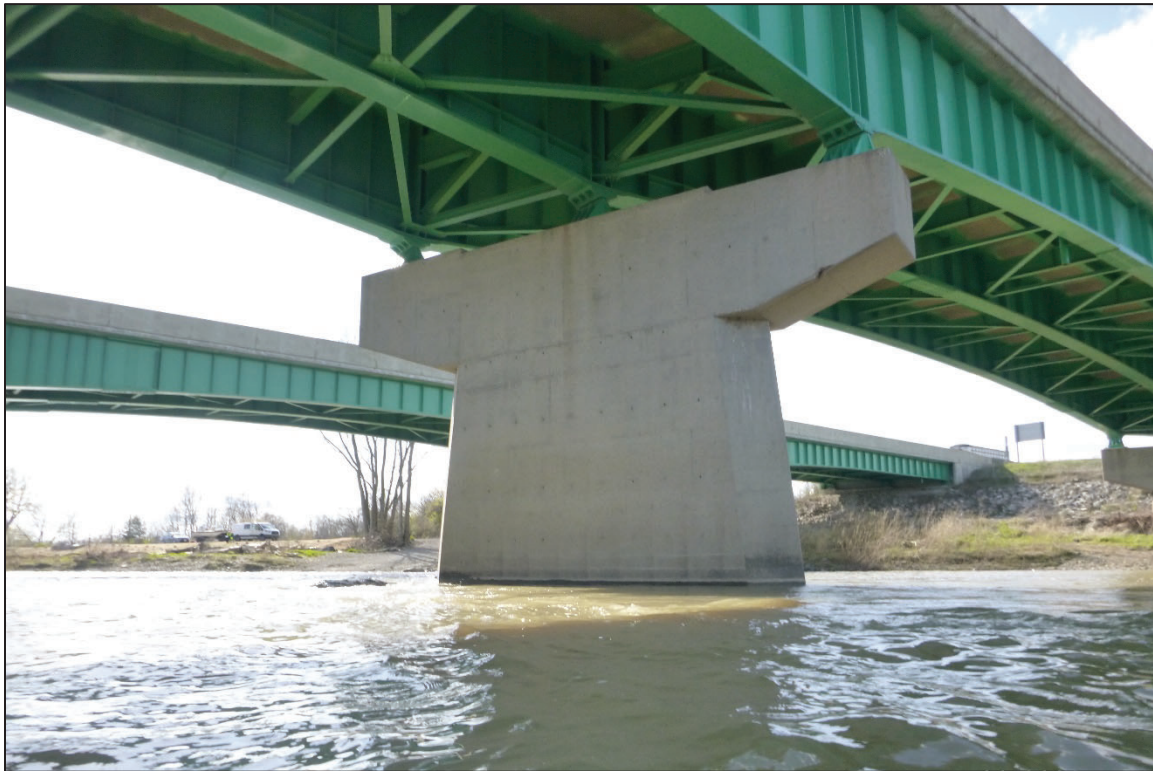
Photograph No. 15: View of the North Face of Pier 5, Looking Southeast.

Photograph No. 16: View of the South Face of Pier 5, Looking Northwest.

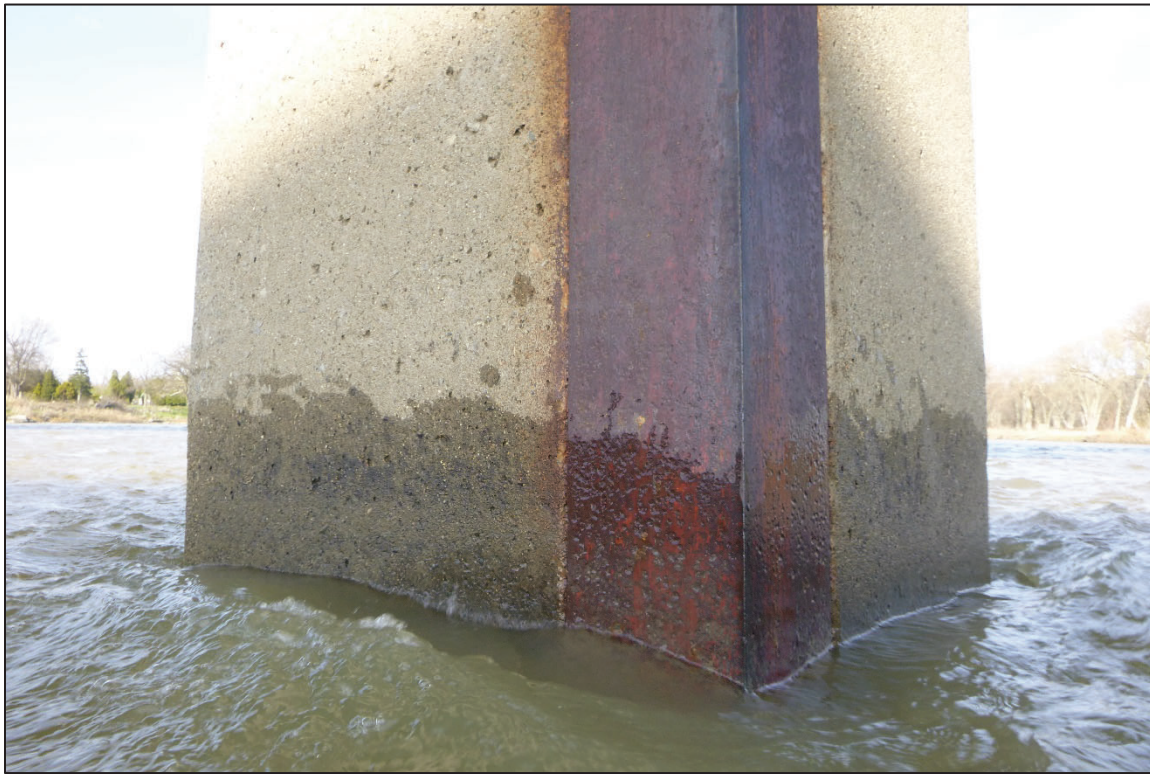
Photograph No. 17: View of the Typical Concrete and Steel Condition at the Waterline, Looking East.

The scaling observed on Piers 2 through 5 is not a structural concern at this time given its size compared to the overall pier size, and as a result, no repairs are recommended. This area should be monitored during future inspections for increasing extent or severity of the scaling and exposure of reinforcing steel. If the extent or severity of the scaling is observed to be increasing or reinforcing steel becomes exposed, it may be necessary to repair the area at that time.

The surface corrosion and pitting of the icebreaker steel observed at Piers 2 through 5 is not a structural concern at this time given its size compared to the overall icebreaker size, and as a result, no repairs are recommended. These areas should be monitored during future inspections for increasing extent or severity of the corrosion and pitting. If the extent or severity of the corrosion and pitting is observed to be increasing, it may be necessary to repair the areas at that time.
