FRAMING PLAN

| MISCELLANEOUS STEEL REPAIR DETAILS | | |

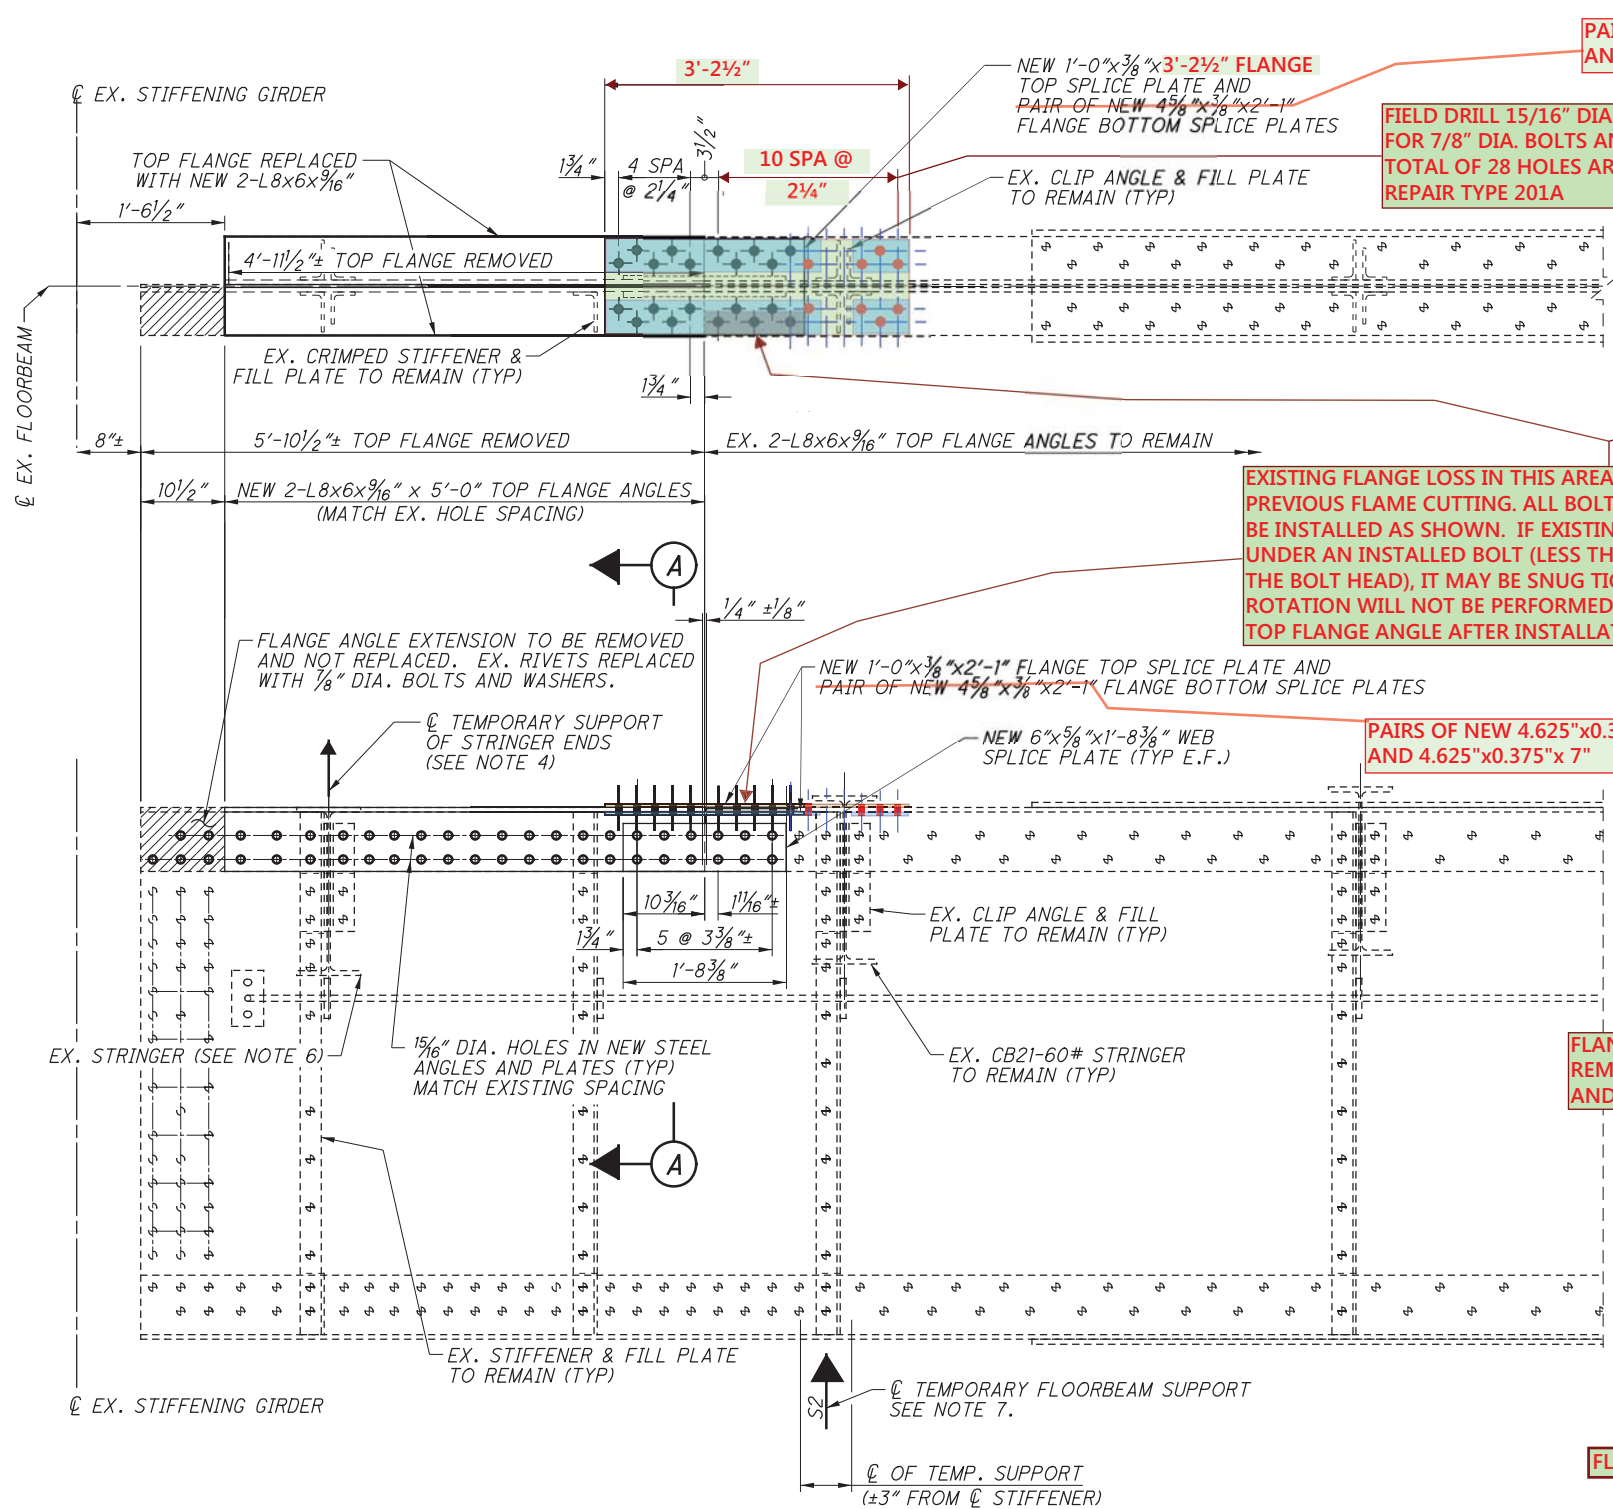
REPAIR TYPE 201

FLANGE ANGLE REMOVED AND REPLACED

PAIRS OF NEW 4.625"x0.375"x2'-3.25" AND 4.625"x0.375"x 7"

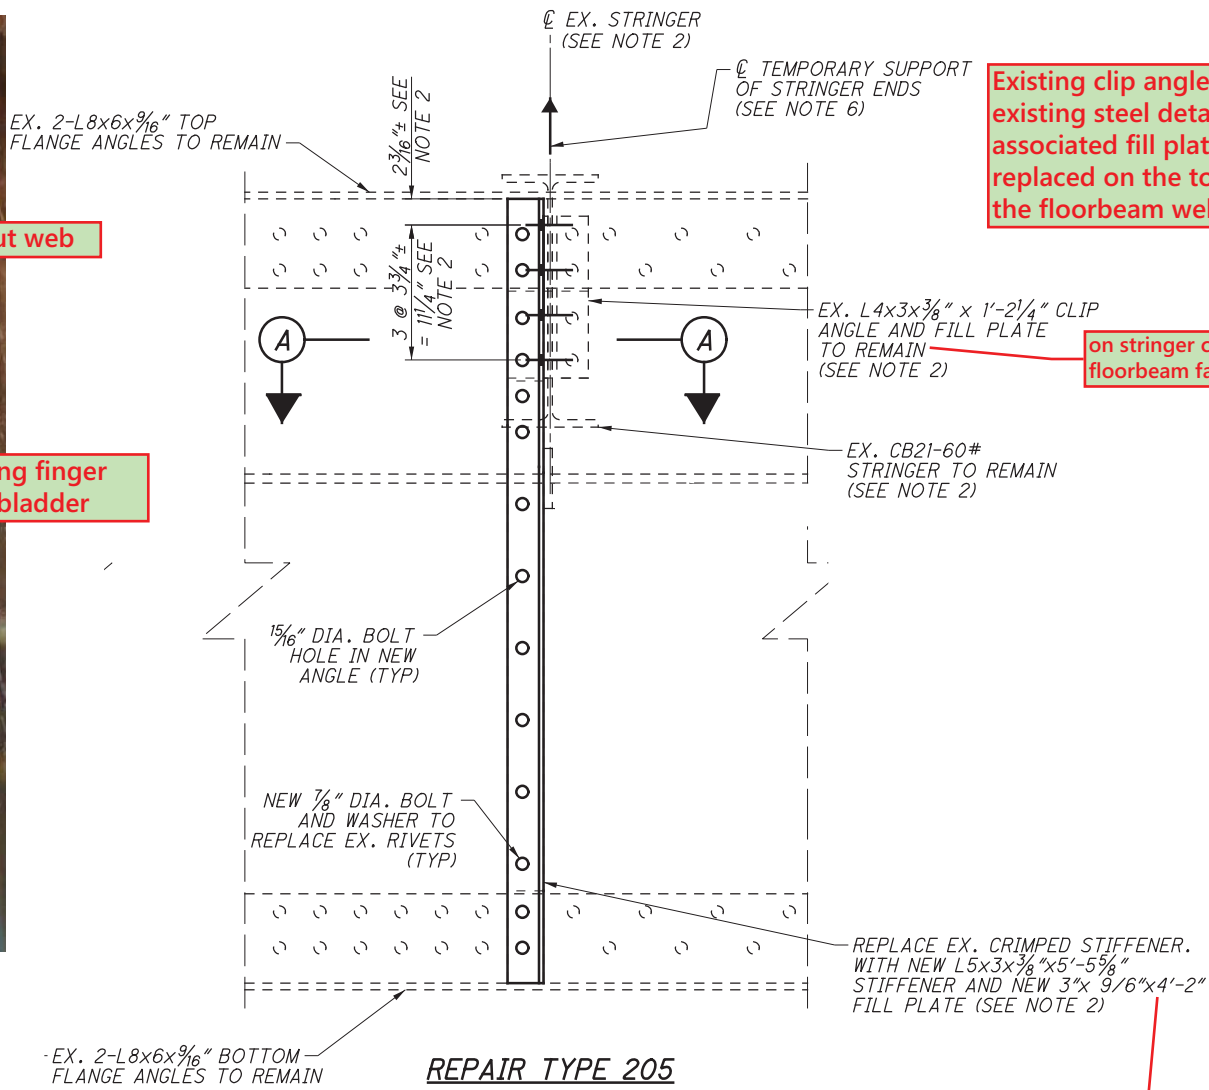
## REPAIR TYPE 205

## Poor Stiffener Condition
