2017 LUC-00280-0331\_ZL (Z RAMP) ROUTINE INSPECTION  
REPORT  
BRIDGE INSPECTION REPORT

Structure File Number: 4806018

Inventory Bridge Number: LUC 00280 03.310 ZL

IR-280 RAMP Z over SB RAMP TO FRONT ST, NSRR

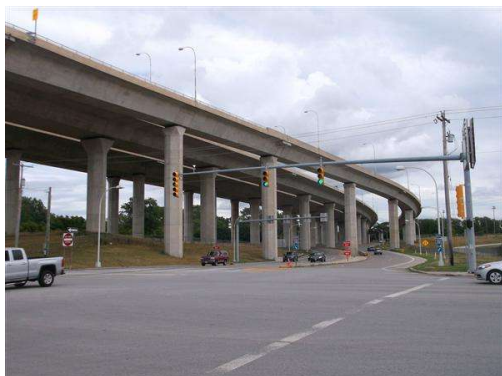
Photo 1 West elevation view of Ramp Z looking southeast.

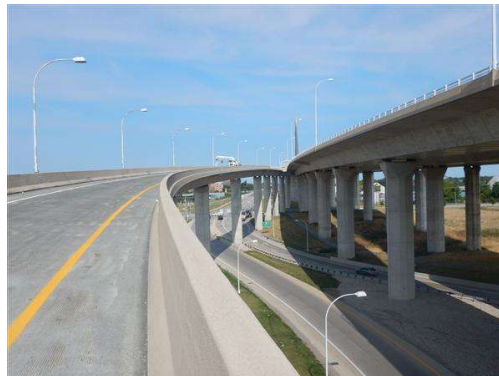
Photo 2 East elevation view of Ramp Z looking north including access equipment utilized.

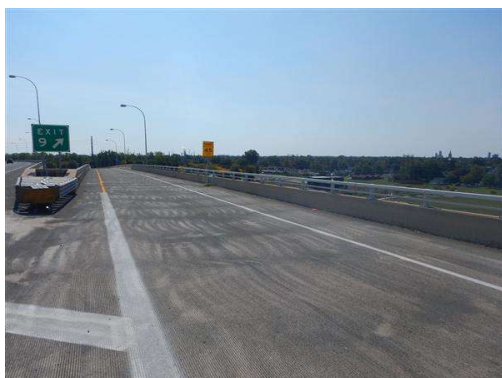
Photo 3 North end view of Ramp Z looking south.

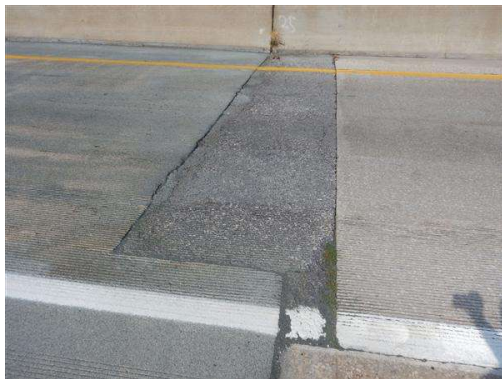
Photo 1

Moderate transverse cracks adjacent to approach slab and approach roadway pavement. Both northern and southern edges of the relief joint displayed minor cracking, spalling, and deterioration. Light vegetation was present at the east edge of the relief joint adjacent to the approach slab. See Photo 1.

General condition of relief joint with moderate cracking, spalling and deterioration including vegetation.

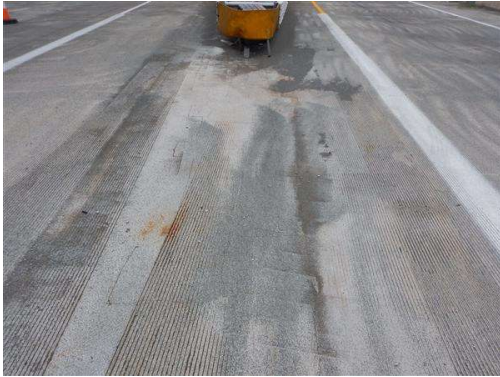
Ramp Z (LUC-280-0331ZL) deck sketches show from Pier 5Z (Sta. 6+97.32) to Abutment 25Z (Sta. 31+86.05). The remaining deck sketches were included on the LUC-280-0283L report. The entire deck quantity is rated in this report. The longitudinal joint is rated in the LUC-280-0283L report as per the 2016 inspection. Hairline transverse and map cracking, with efflorescent leaching in areas, was located along the length of the longitudinal closure pour. See Photo 1.

Photo 1 Longitudinal joint with map cracking and efflorescent leaching over the length.

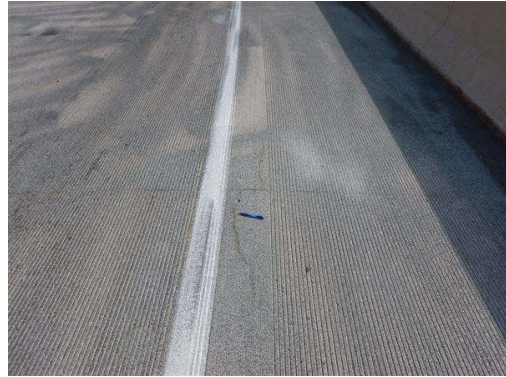
Areas of moderate (0.013 in. to 0.020 in.) transverse cracking along a majority of the roadway segment joint locations were noted in the wearing surface along the length of the bridge. Moderate longitudinal and map cracks were located in the overhang/shoulder areas of the deck near the railings in Spans 17Z to 20Z. See Photos 2 and 3.

Photo 2 Typical longitudinal crack in the shoulder of the deck in Span 20Z.

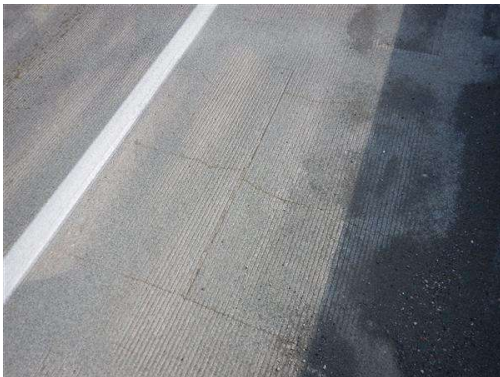
Photo 3 Map cracking in the shoulder of the deck in Span 19Z.

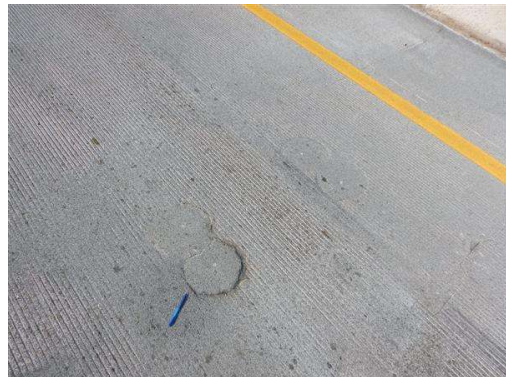
Numerous lift hole and deck patches were noted along the length of the bridge and displayed moderate cracking (0.013 in. to 0.025 in.), spalling and discoloration around the perimeter of these patches. See Photo 4. Other patches along the bridge were determined to be delaminated/ unsound with moderate cracking in both the shoulder and travel lane areas of the deck. See Photo 5. These patches appeared to be reflective and were present in the wearing surface as well.

Numerous lift hole and deck patches were noted in the wearing surface along the length of the bridge and displayed moderate cracking (0.013 in. to 0.025 in.), spalling and discoloration around the perimeter of these patches. See Photo 4. Other patches along the bridge were determined to be delaminated/unsound with moderate cracking in both the shoulder and travel lane areas of the deck. See Photo 5.

Photo 4 Typical top of deck lift hole patches with cracking and spalling.

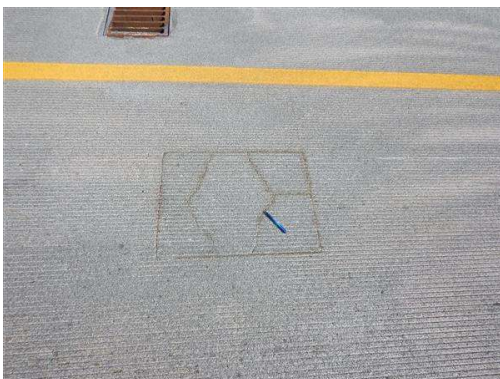
Photo 5 Delaminated and unsound patch with map cracking located in Span 17Z.

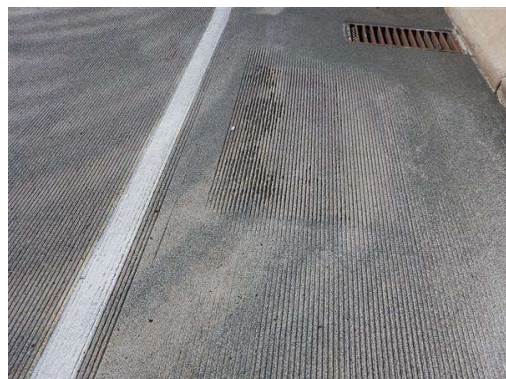
A few areas of the wearing surface exhibited scaling and abrasion in the west shoulder regions of the roadway in Spans 8Z, 11Z, 14Z, 16Z, 18Z and 19Z. See Photo 6.

Photo 6 Scaling and abrasion in the wearing surface of the Span 8Z shoulder.

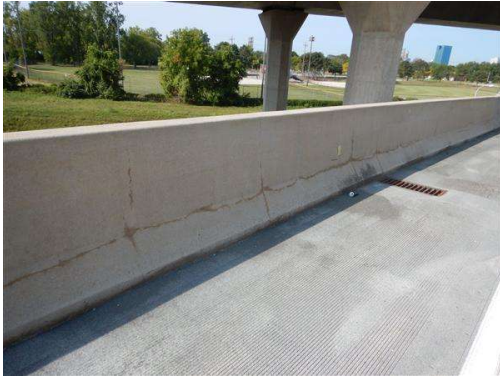
Typical areas of hairline to moderate vertical and horizontal cracking were noted along the length of the concrete parapet on both sides of the roadway. See Photo 7. Numerous areas of cracks had efflorescence, rust stains and/or discoloration/leaching.

Photo 7 Moderate vertical and horizontal cracking and efflorescent leaching along the west parapet.

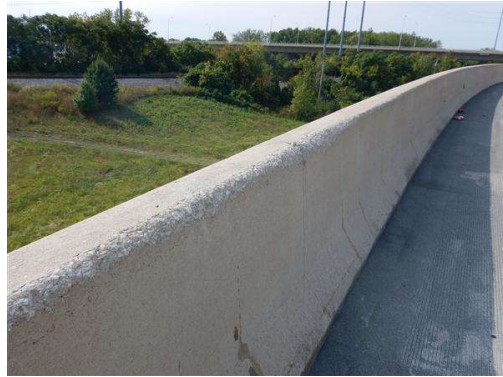
Several areas of minor spalls/gouges were noted along the length of the bridge in Spans 16Z, 23Z and 24Z. A few areas of scaling along the top edge of the west parapet was found in Spans 22Z and 23Z. See Photo 8.

Photo 8 Scaling along the top edge of the west parapet in Span 24Z.

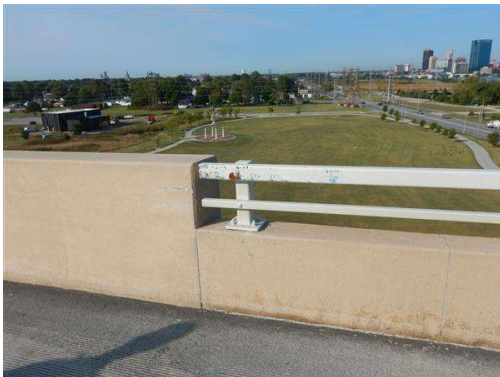
A few areas of minor deterioration and rust on the steel railing were noted along the length of the bridge. Collision damage and minor scraping to the concrete and steel railings was noted in Span 6Z. See Photo 9.

Photo 9 Collision damage to the concrete and steel railings in Span 6Z.

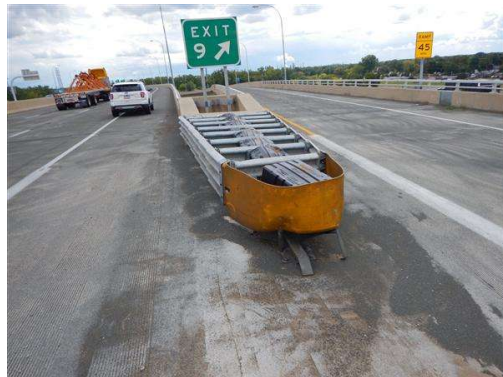
The attenuator at the Pier 4Z/Ramp Z exit where the SB South Approach railing begins at Pier 21SB was damaged from collision impact. See Photo 10.

Photo 10 Damaged attenuator at the Ramp Z exit.

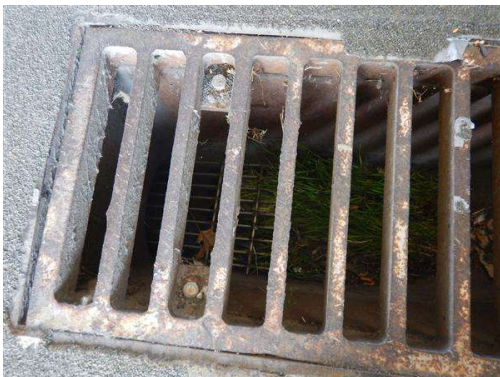
Moderate amounts of debris was observed in a majority of the scuppers at the deck level. The scuppers appeared to be adequately open and functioning. Several grates within the scuppers were out of their vertical position and not serving their intended function of filtering debris from entering the drainage pipes. See Photo 11.

Photo 11 Partially filled scupper with displaced grate within the element.

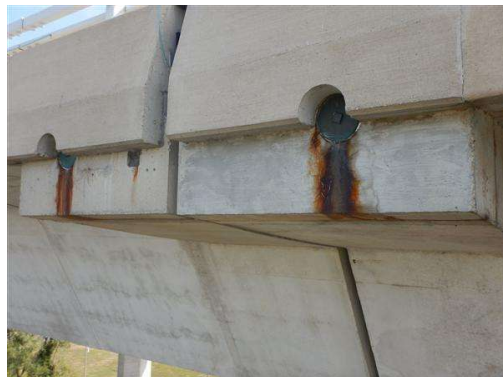
The drainage caps on the edge face of the pier end segments were leaking on a majority of the scupper locations. These locations consisted of varying levels, moderate to heavy, of rust staining and efflorescence in the concrete. See Photo 12.

Photo 12 Heavy rust staining and efflorescence on the edge face of the end segments.

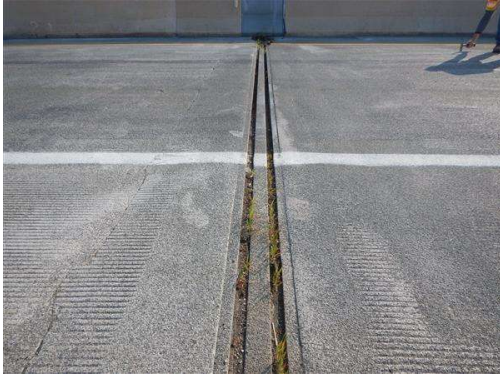
Photo 13

No leakage of the glands within the modular joints was observed. The joints at Piers 9Z, 12Z, and 22Z were significantly filled over the entire width of the roadway with vegetation growing along the joints. See Photo 13. The remaining joints at Piers 4Z, 7Z, 15Z, 19Z and Abutment 25Z were partially filled with debris over the entire width of the roadway.

Heavy debris with vegetation over the length of the expansion joint at Pier 9Z.

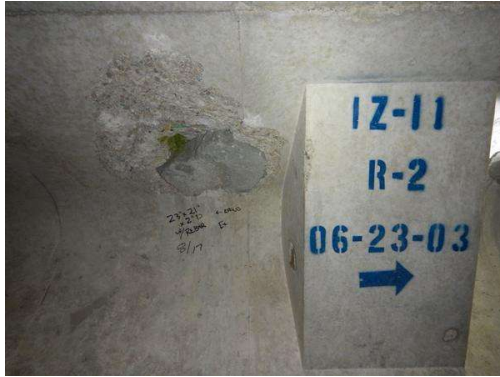
Photo 1 Lift hole with spalled concrete and exposed reinforcement and efflorescence in Span 1Z.

Numerous areas of delaminated and spalled patches in the lift holes located at the top flange/ceiling slab along the edges of the interior segment were typical along the length of the bridge. See Photos 1 through 3 in the Superstructure section. Other patches in the interior top flange/ceiling slab were observed to have efflorescence around the perimeter.

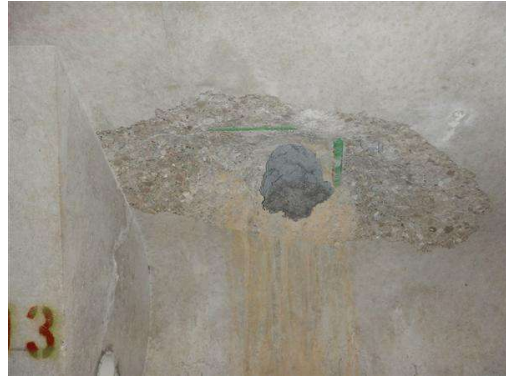
Photo 2 Severe spall at lift hole location with exposed reinforcement in Span 1Z.

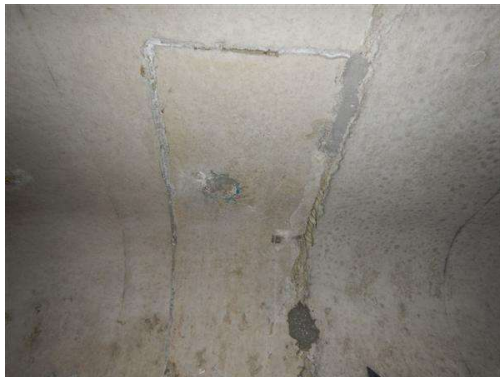
Photo 3 Typical lift hole condition and construction joint with efflorescence.

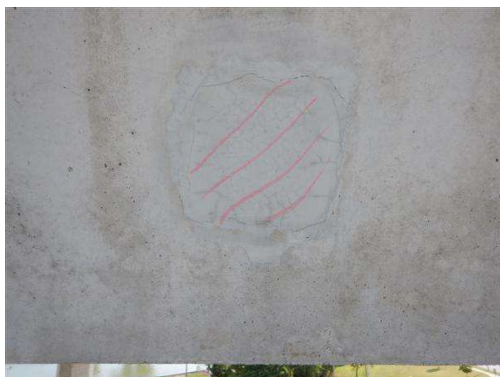
Numerous areas of unsound patches were observed in the lift holes located at the top flange/ceiling slab along the edges of the interior segment. In Spans 1Z and 2Z, these areas were previously patched with several of these patches observed to be delaminated and unsound and spalled with exposed reinforcement. See Photos 1 and 2. A majority of the patches were leaching with efflorescence and rust staining over the length of the bridge. Other patches and construction joints in the interior of the segments, both web and top/bottom flanges/slabs exhibited efflorescence around the perimeters. See Photo 3. Along the exterior web and bottom flange/slab, several delaminated and spalled areas as well as delaminated patches were noted along the length of the bridge. See Photos 4 and 5.

Photo 5 Delaminated patch on the exterior web of the box segment in Span 2Z.

On the exterior web, multiple delaminated, cracked and spalled patches were noted along the length of the bridge. See Photo 5 of the Superstructure section. Additional hairline map and longitudinal cracking was present along the exterior webs and bottom flange/floor slabs of the box segments over the length of the bridge.

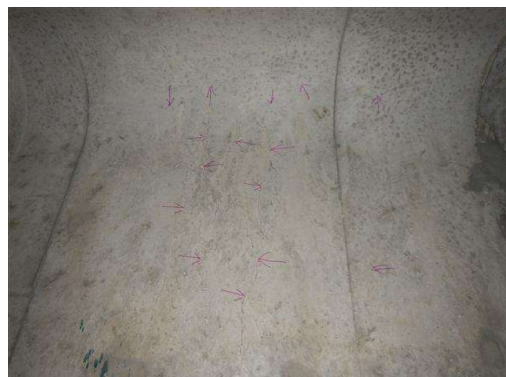
Photo 6 Area of hairline map cracking in the interior web of the box segment in Span 12Z.

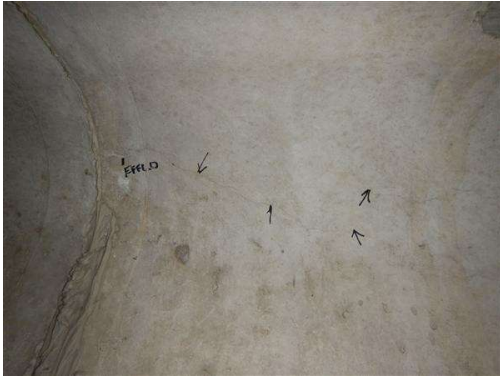
Photo 7 Interior upper corner crack typical throughout the length of the bridge.

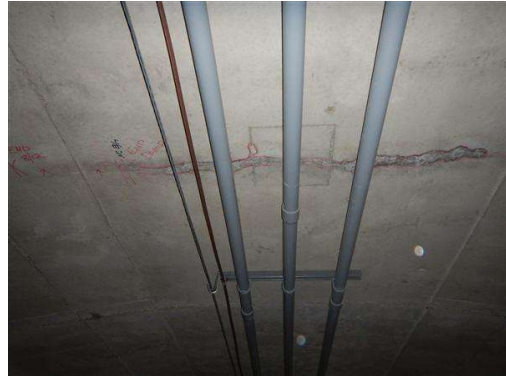
Photo 8 Transverse hairline crack in the top slab of the interior box segment with inactive efflorescence and discoloration.

Longitudinal hairline cracking was present along both corner edges between the web and the top flange/slab of every segment. The cracks varied in length and were typically 0.005 to 0.020 in. in width. Approximately half of the cracks exhibited efflorescence; however, based on previously installed marks, did not appear to be actively leaching. See Photo 7 in the Superstructure section. Additional hairline vertical and horizontal cracking was present along the interior webs and bottom flange/floor slabs of the box segments over the length of the bridge. See Photo 6 in the Superstructure section. Hairline transverse cracking with efflorescence and discoloration were present at various locations along the bridge adjacent or in conjunction with the segment joints. See Photo 8 in the Superstructure section.

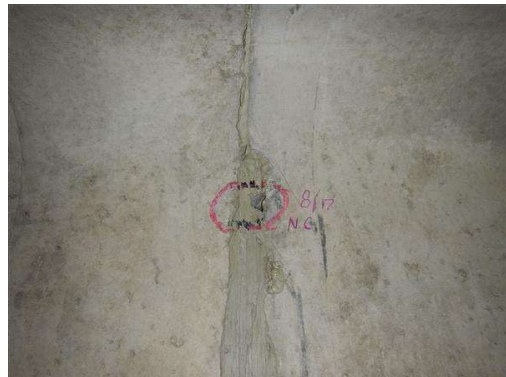
Voids were present in the segment construction joints, both interior and exterior, varying in size and depth. See Photo 10. Spalls and delaminated areas were noted throughout the interior and exterior of the of the segments in the pier segment closure pours and future exterior stressing blocks located at the top of the webs and along the floor slab. Some of the spall areas were greater than 1 in. in depth and contained exposed reinforcement. See Photos 11 and 12.

Photo 10 Typical void at the interior construction joint of the box segment.

Voids were present in the segment closure joints, varying in size and depth. See Photo 10 in the Superstructure section. Spalls and delaminated areas were additionally noted throughout the interior of the segments, pier segment closure pours, diaphragms and future exterior stressing blocks located at the top of the webs and along the floor slab. Some of the spalled areas were greater than 1 in. in depth and contained exposed reinforcement. See Photos 11 and 12 in the Superstructure section.

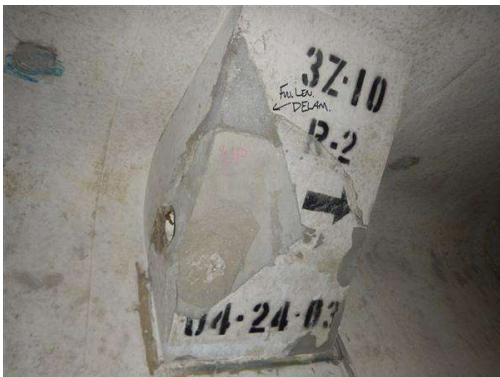
Photo 11 Delaminated area on exterior stressing block in Span 3Z.

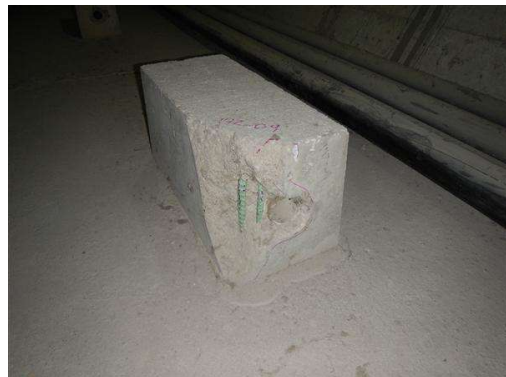
Photo 12 Bottom exterior stressing block with spalled concrete and exposed reinforcement.

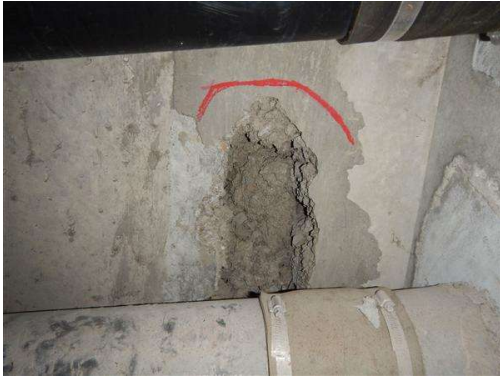
Small areas of honeycombed concrete were also noted on both the interior and exterior of the segments along the length of the bridge. A hole with poorly consolidated concrete in Span 15Z was located in the east interior web. See Photo 13.

Photo 13 Area of poorly consolidated concrete in the closure pour joint at Pier 15Z.

Small areas of honeycombed concrete was also noted on the interior of the segments along the length of the bridge. A hole with poorly consolidated concrete was noted in Span 15Z at the pier segment closure joint in the east interior web. See Photo 13 in the Superstructure section.

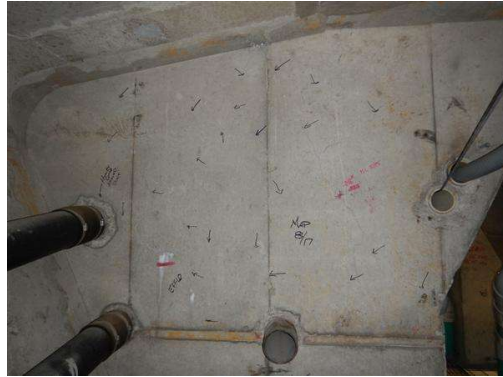
The interior diaphragms exhibited typical hairline to moderate vertical and map cracking ranging from 0.005 to 0.04 in. in width. Efflorescence and leaching was present at some locations although the areas did not appear to be active with the exception of the diaphragm at Pier 2Z. See Photos 14 and 15. Several diaphragms additionally had areas of delaminated and

Photo 14 Area of map cracking ranging in width from hairline to 0.016 in. with efflorescence in diaphragm at Pier 21Z.

The diaphragms exhibited typical hairline to moderate vertical and map cracking ranging from 0.005 to 0.04 in. in width. Efflorescence and leaching/discoloration was present at some crack locations. See Photo 14 in the Superstructure section. Additional areas of delaminated and unsound concrete were noted on the vertical faces of the diaphragms.

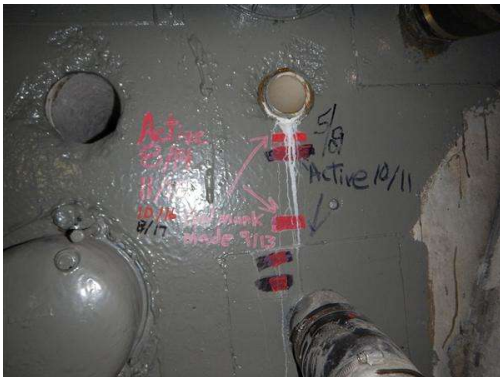
Photo 15 Active efflorescence in the diaphragm at Pier 2Z.

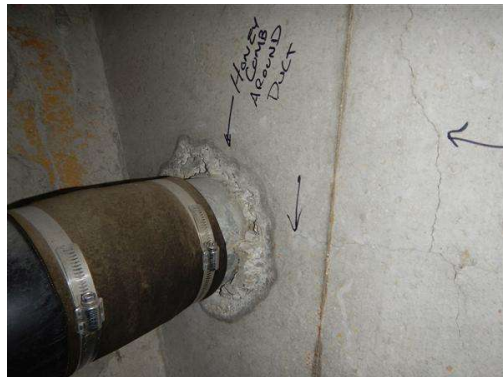
unsound concrete on the vertical faces. An area of honeycombed/poorly consolidated concrete was noted around the T1/2/3 ducts in the diaphragm at Pier 21Z. See Photo 16.

Photo 16 Honeycombed concrete around the PT duct in the diaphragm at Pier 21Z.

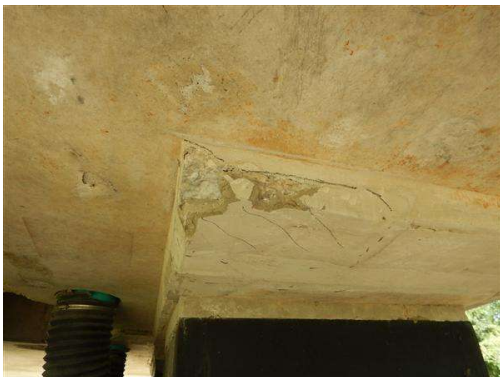
The plinths on Piers 4Z, 5Z, 12Z, 21Z, 22Z and Abutment 25Z exhibited areas of unsound, spalled or delaminated concrete with moderate to severe cracking in over 5% of the bearing area. See Photos 17 through 19.

Photo 17 Spall and delaminated concrete in the southeast plinth at Pier 4Z.

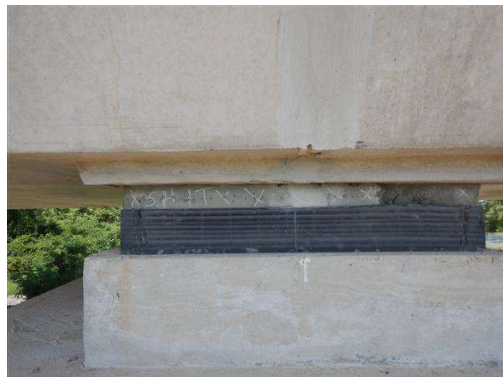
Photo 18 Spalled concrete in the plinth of the east bearing at Pier 5Z.

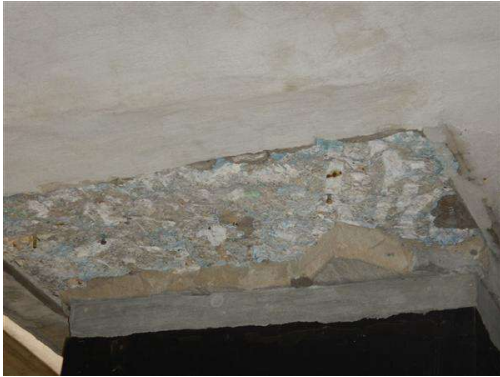
Photo 19 Spalled concrete in the plinth with exposed reinforcement at the western bearing at Pier 12Z.

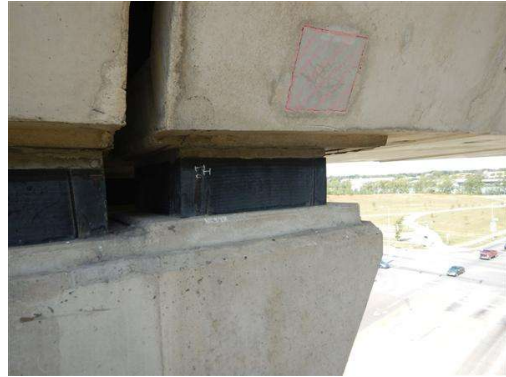
The northwest bearing at Pier 8Z was not fully bearing with the plinth concrete over an area measuring 3 in. wide x 2 in. deep x 1 ft. in length. A few bearings have strips missing or starting to pop out (patch pin grooves) in the edge of the elastomeric pad at Piers 4Z, 5Z, 7Z and 21Z. See Photo 20. These grooves are used to hold the internal shims in place during the fabrication process and do not contribute structurally to the bearing pad.

Photo 20 Missing patch pin groove strips on both Pier 21Z elastomeric bearings.

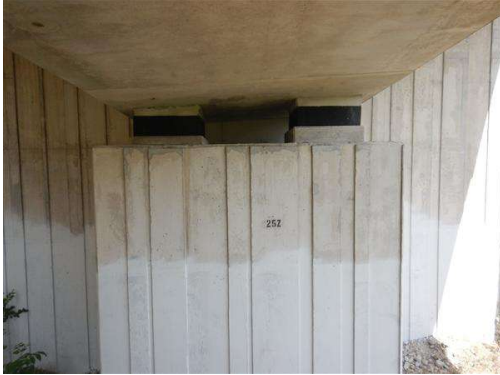
The abutment bent exhibited areas of hairline vertical cracking. See Photo 1.

Photo 1 Typical condition of the Abutment 25Z bent and wall.

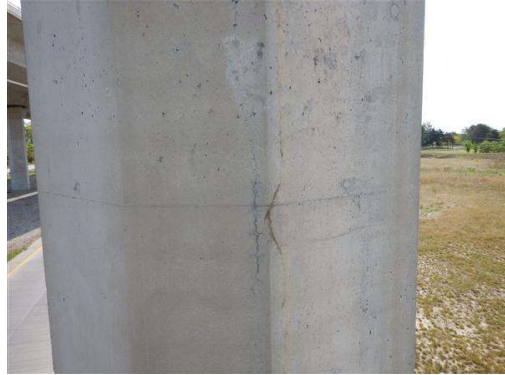
Typical hairline to medium (0.025 in.) width vertical, horizontal and map cracking areas were present on the pier columns. A few small spalls and areas of delaminations were noted on the pier columns as well. See Photos 2 and 3.

Photo 2 Typical narrow vertical cracks in the pier columns.

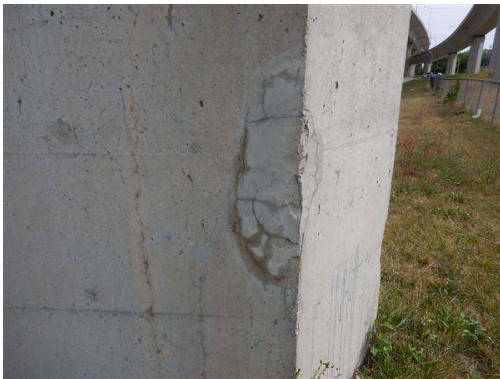
Photo 3 Delaminated area and cracking in the pier column concrete at Pier 9Z.

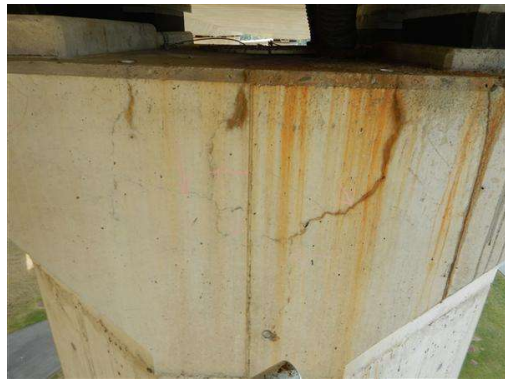
Typical hairline to medium (0.025 in) width vertical and map cracking areas were noted on the pier caps. See Photo 4.

Photo 4 Typical cracking and efflorescence/staining in the pier caps.

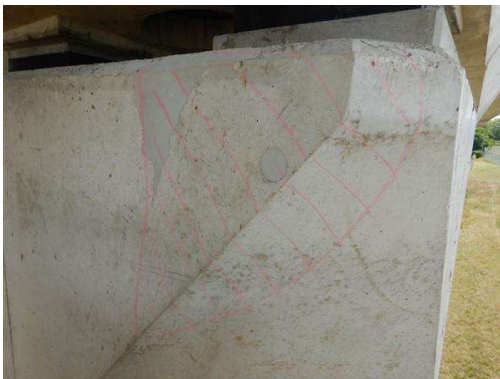
Photo 5 Delaminated concrete on the northwest corner of the Pier 11Z cap.

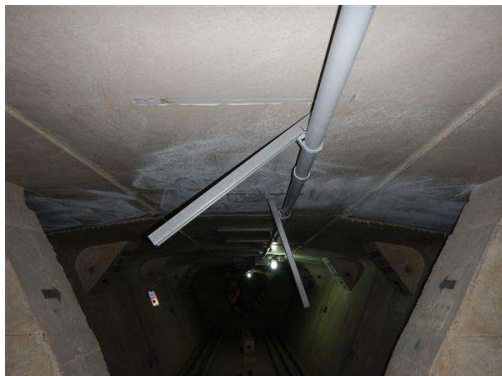
Photo 1

Brackets, clips and fasteners for the interior electrical conduit had areas where they were disconnected from the top flange/ceiling slab. See Photo 1. A few locations along the length of the bridge exhibited broken and/or disconnected conduit at joints. See Photo 2.

Electrical conduit brackets disconnected from the top flange/ceiling concrete.

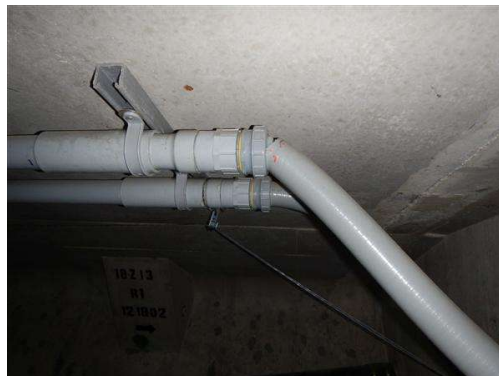
Photo 2

Electrical conduit broken at the elbow joint near Pier 14Z.

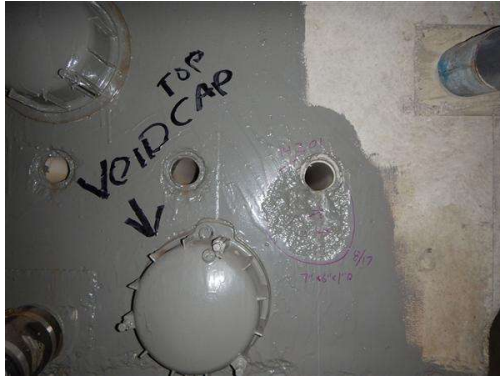
12 PT end cap locations were noted to have small void areas within the grout in the cap. These areas were determined and verified by gently tapping on the plastic end caps with a hammer. See Photos 1 and 2. Based on the previous inspection, an additional 5 PT caps were noted to be between 1/2 to 2/3 fully grouted. 3 PT end blocks located between spans over the piers exhibited delaminated areas within the concrete. See Photo 3.

Photo 1 Small void noted in the T2 tendon end cap at Pier 14Z.

It would be recommended to remove the plastic PT caps or utilize a form of NDT/ultrasound to determine the exact extent and accuracy of the voids. With the caps being covered in waterproofing material and plastic, hollow areas within the cap were difficult to detect with certainty. In addition, the brittle nature of the plastic material could lead to cracking of the end caps if struck too hard with a hammer.

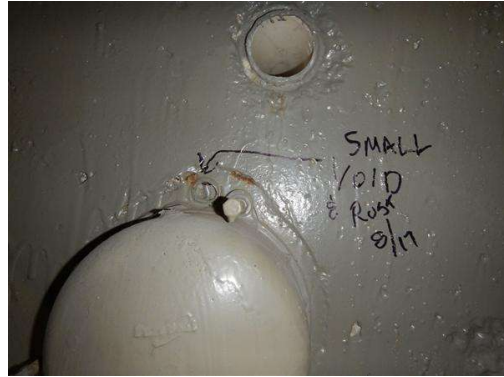
Photo 2 Small void in the grout tube and rust present on the T2 tendon duct located at Pier 20Z.

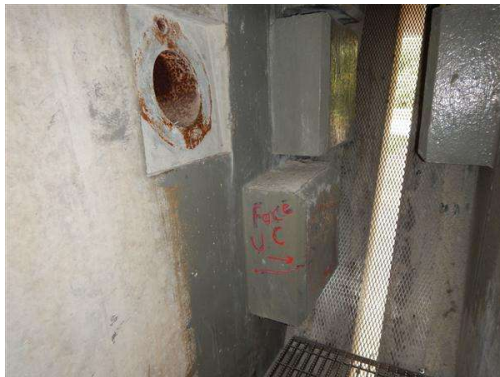
Photo 3 Delaminated concrete at the PT end blockout at Pier 15Z.

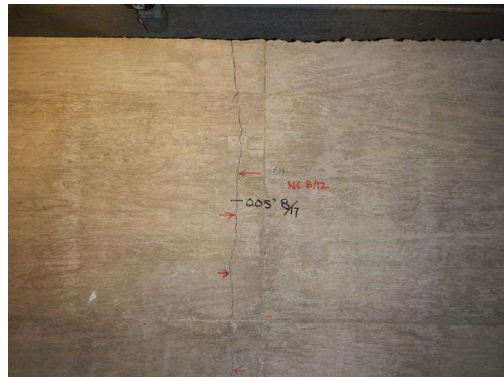
A mass of ballast concrete located in Span 5Z exhibited vertical cracking along the face and transverse cracking along the top of the block. Cracks ranged in width from hairline to 0.06 in. in width along the length of the block. See Photo 4.

Photo 4 Typical vertical cracking on the concrete ballast block in Span 5Z.

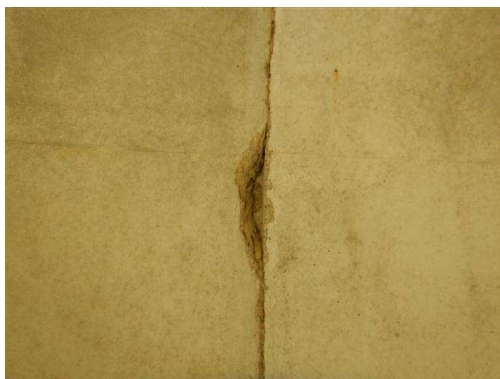
Voids were present in the segment closure joints, varying in size and depth. See Photo 5. Small areas of honeycombed concrete was also noted on the exterior of the segments along the length of the bridge.

Photo 5 Typical exterior void between segment closure joints.

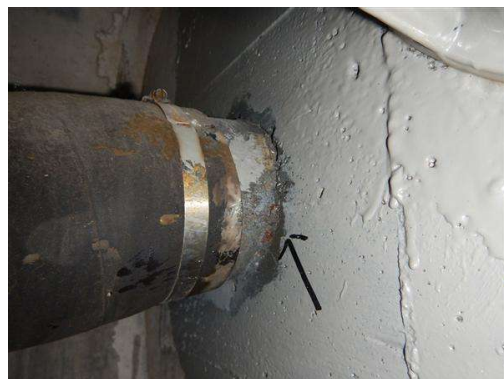
Photo 6 Rust present on the PT duct and clamps at the diaphragm connection at Pier 7Z.

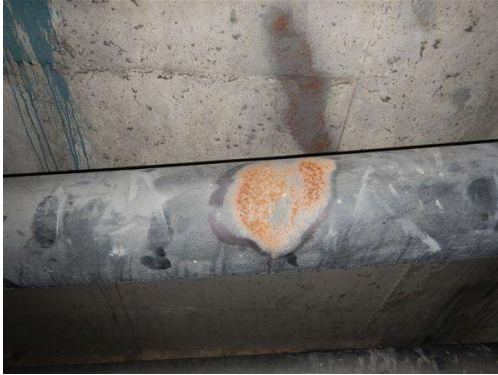
Photo 7 Typical rust deposit on the PTFE tendon sheathing.

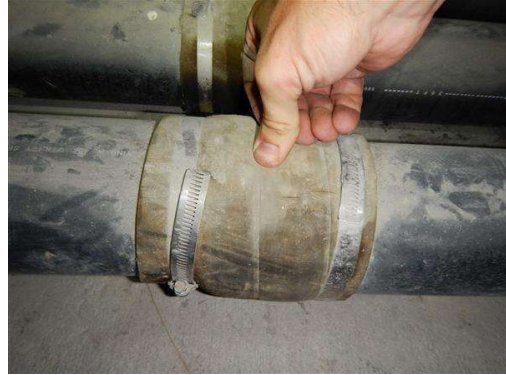
Photo 8 Weakened grout within the coupler between tendon ducts in Span 1Z.

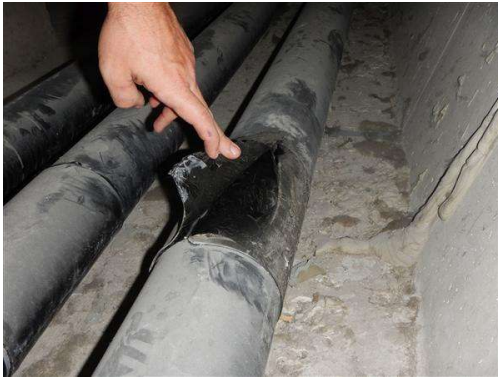
Photo 9 Splice material not properly adhered to the PTFE tendon sections in Span 23Z.
