2017 LUC-00280-0426\_AL (RAMP A) ROUTINE INSPECTION  
REPORT  
BRIDGE INSPECTION REPORT

Structure File Number: 4805860

Inventory Bridge Number: LUC 00280 04.260 AL

IR-280 RAMP A over CHAMPLAIN, NSRR

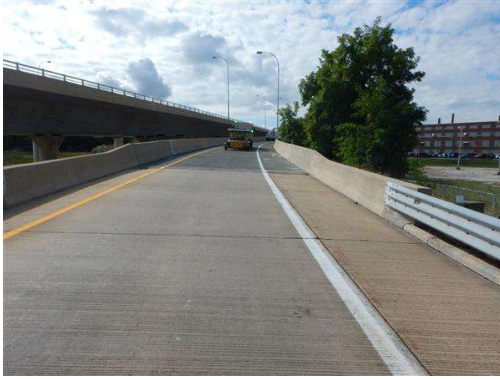
Photo 1

End view of the Ramp A looking South

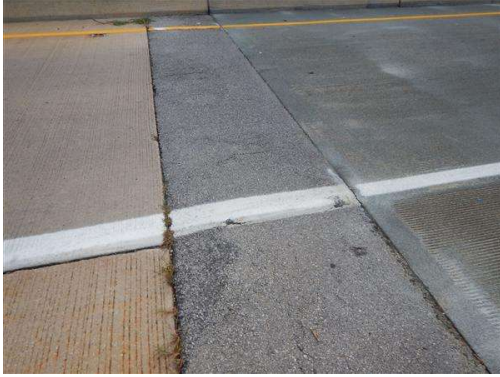
Photo 1

The relief joint was in good condition with minor longitudinal cracks in the joint asphalt. The northern edge of the relief joint and roadway/approach slab concrete exhibited minor spalling and vegetation growth. See Photo 1.

General Condition of the relief joint with cracking looking East

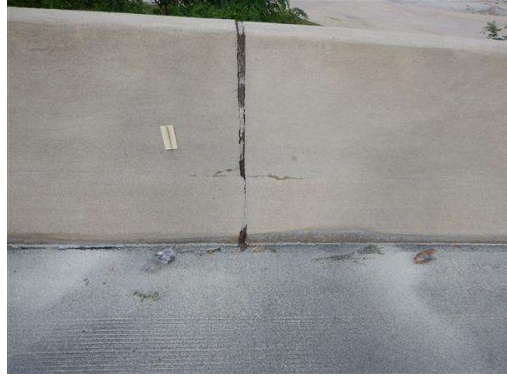
Photo 2

The concrete barriers along both sides of the roadway exhibited typical longitudinal and vertical hairline cracks over the length of the approach slab. See Photo 2.

Typical hairline longitudinal cracks on the West parapet

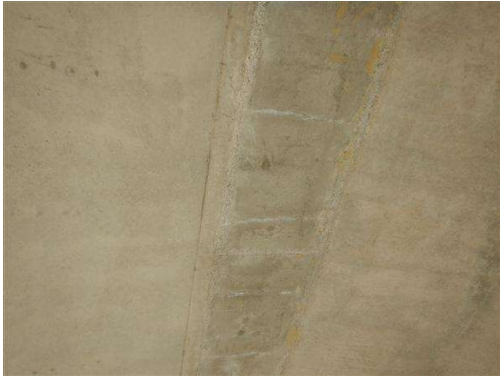
Numerous transverse closure pour joints in the top flange/deck displayed area of cracking with efflorescence over the length of the bridge. See Photo 1. The top flange/deck of the segments exhibited efflorescence and rust staining along the length of the bridge. See Photo 2. The defects in the bottom of the deck slab are documented and detailed in the superstructure inspection of this report and the interior final notes asset file.

Photo 1 Bottom of the deck slab closure pour transverse cracks exhibiting efflorescence between Spans 15A & 16A looking South

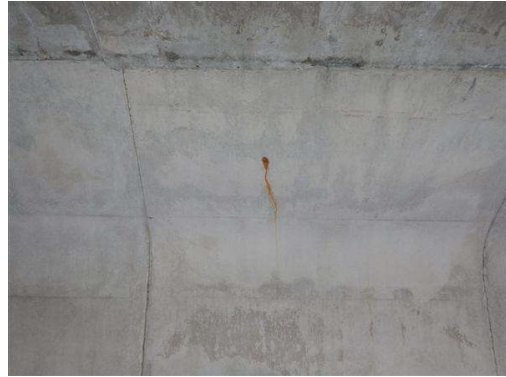
Photo 2 Rust stains on the deck slab looking West

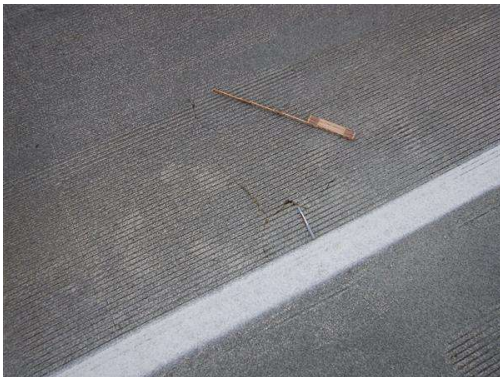
Areas of moderate transverse and map cracking (0.013" to 0.025") along the length of the bridge were observed. See Photo 3. Moderate longitudinal cracks were noted in the middle of traffic lane wearing surface in Span 8A. See Photo 4.

Photo 3 Transverse and map cracks in the wearing surface between Spans 4A & 5A

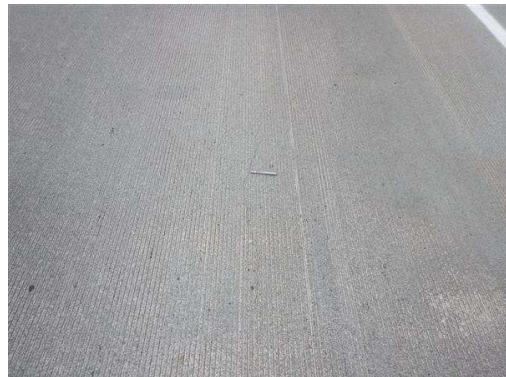
Photo 4 Longitudinal cracks in the wearing surface

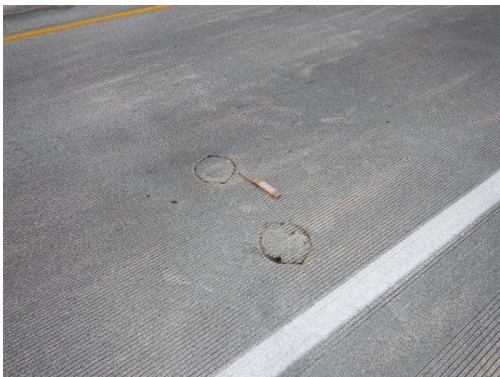
Numerous lift hole and deck patches with spalls of 1" in depth and HL cracks with discoloration around the perimeter were noted along the length of the structure. See Photo 5. Several deck patches along the bridge were depressed and exhibited hairline to moderate cracking. See Photo 6

Photo 5 Concrete patches with spalls and discoloration between Spans 4A & 5A

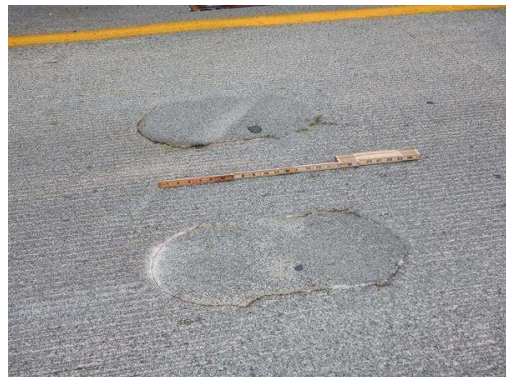
Photo 6 Depressed concrete patches at Spans 3A & 4A

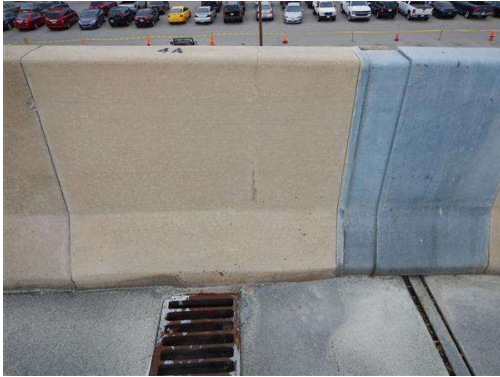
Typical areas of hairline vertical and map cracking were noted along the length of the concrete parapet on both sides of the roadway. See Photo 7.

Photo 7 Horizontal and vertical cracks in the concrete parapet in the Spans 4A & 5A looking West

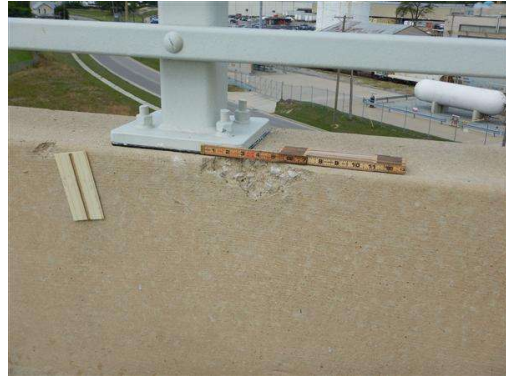
A few areas of spalling or delamination were noted along the length of parapet in Spans 1A, 8A and 9A. A concrete spall was noted (7"x2.5"x1") under the steel railing. See Photo 8. A concrete delamination (12"x5") was also noted in Span 8A. See Photo 9. A spall measuring 12"x2"x2" was observed on the East parapet in Span 1A near Abutment 1A. See Photo 10.

Photo 8 Concrete spall under steel railing in Spans 8A & 9A looking West

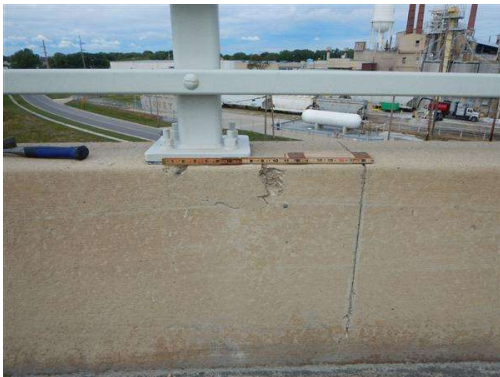
Photo 9 Delaminated concrete under the steel railing in Spans 8A & 9A looking West

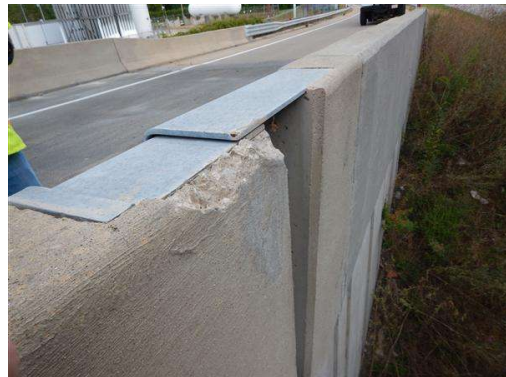
Photo 10 Concrete spall on the East parapet at Abutment 1

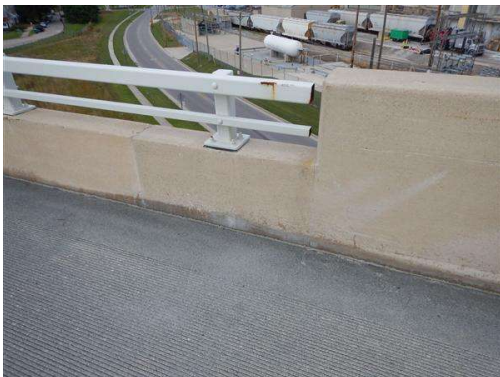
Map cracking in the barrier transition and minor rust with on the steel railing were noted in the Span 7A. See Photo 11.

Photo 11 At the barrier transition, minor rust on steel railing and map cracks in barrier in Spans 7A & 8A looking West

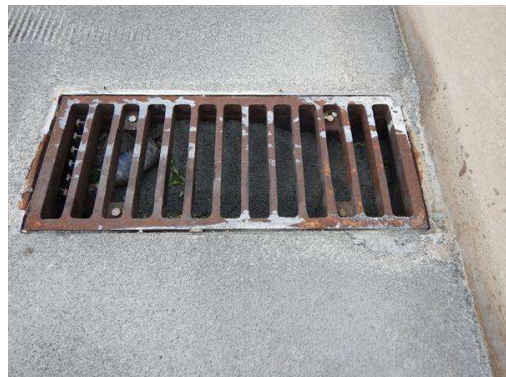
Moderate amount of debris was observed in most scuppers at the deck level, some of which had vegetation growing. All the scuppers appeared to be partially or fully filled and not serving their intended purpose. See Photo 12.

Photo 12 Scuppers clogged with debris on the west side of the bridge between Spans 4A & 5A

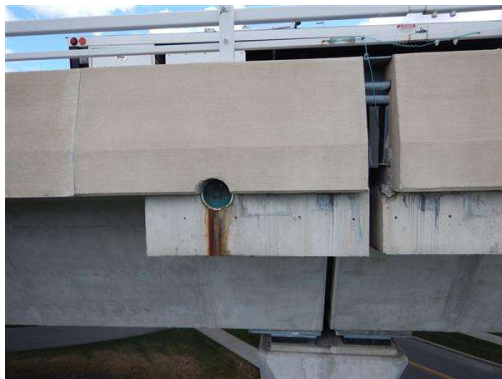
Drainage caps on the edge face of the end segments were leaking on a majority of the scupper locations. These locations consisted of varying levels, moderate to heavy rust with efflorescence in the concrete. See Photo 13.

Photo 13 Drainage cap on the edge face of the end segment in Span 13A looking East

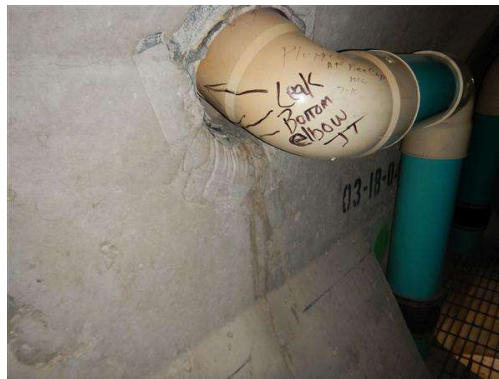
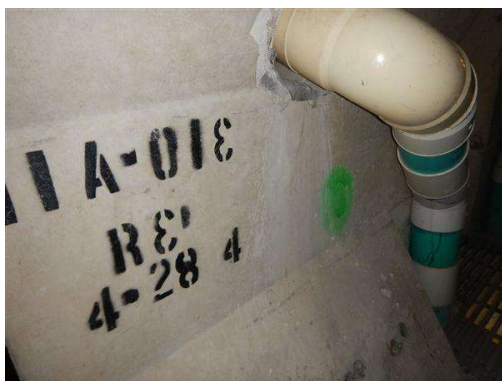
Interior drainage pipes within the interior of the box segments at Piers 4A and 11A exhibited evidence of past leakage with leaching of efflorescence. See Photos 14 and 15.

Photo 14 Interior drainage pipe at Pier 4A, rust staining

Photo 15 Interior drainage pipe at Pier 11A, efflorescence in concrete

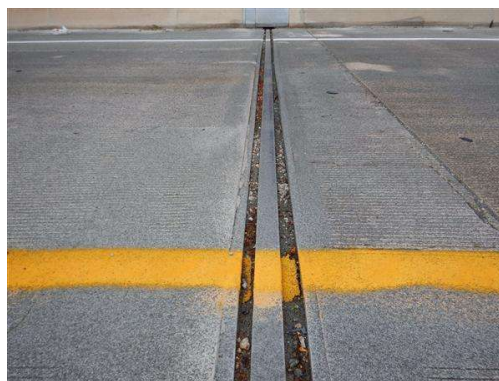
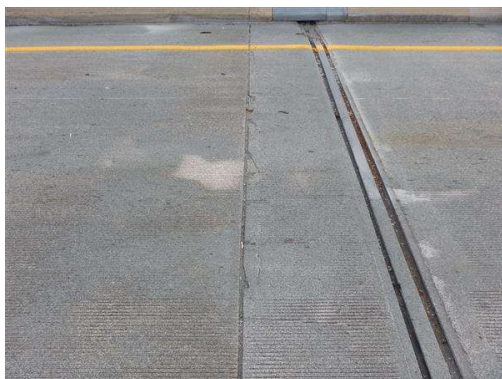
The expansion joint at Abutment 1A was noted to be open 5.75" @ 57°. The joints at Piers 7A, 9A were partially filled with debris over the full width of the roadway. Abutment 1A joint had a minor concrete spall on the North side of the header concrete. See Photos 16 and 17.

Photo 16 Expansion joint filled with debris at Pier 7A looking West

Photo 17 Concrete spalls in the header at the expansion joint at Abutment 1A looking West

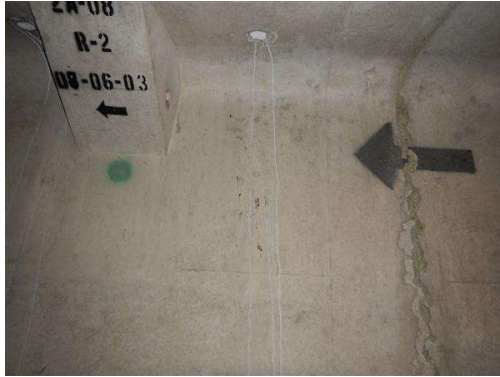
Numerous areas of unsound patches were observed in the lift holes at the top flange/slab along the edges of the interior segment. A majority of these areas exhibited efflorescence over the length of the bridge. See Photo 1. Other patches and construction joints in the interior segments and ducts exhibited delaminated and spalled concrete. See Photos 1 and 2. Along the exterior web and bottom flange/slab, several delaminated and spalled areas and patches with exposed reinforcement were noted along the length of the bridge at patch locations and joints. See Photos 4 and 5.

Photo 1 Leaching efflorescence from lift holes in Span 2A looking West

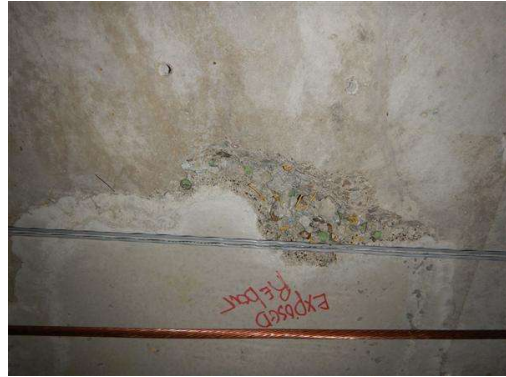
Photo 2 Concrete spall in the top flange slab with rebar exposed in Span 10A, Segment 04

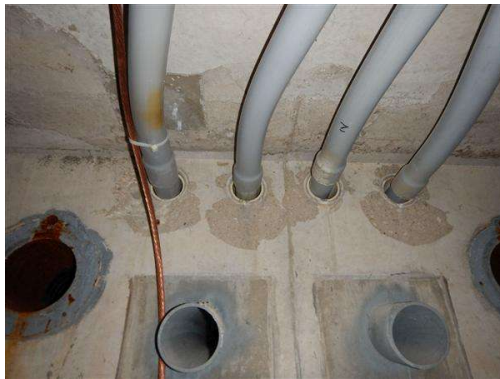
Photo 3 Concrete spalls around the ducts at the Pier 13A

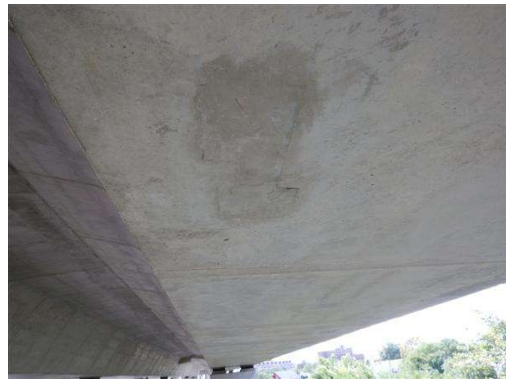
Photo 4 Concrete patches in the bottom flange of Spans 13A & 14A

Along the exterior web and bottom flange/slab, several delaminated and spalled areas and patches with exposed reinforcement were noted along the length of the bridge at patch locations and joints. See Photos 4 and 5 in the Superstructure section.

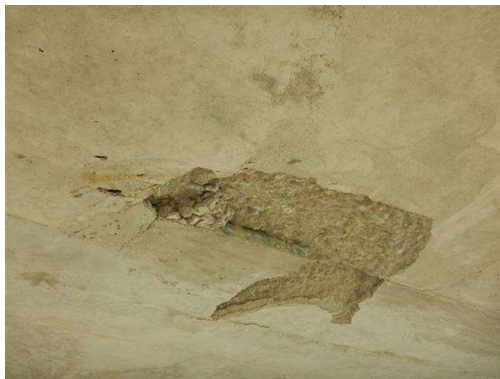
Photo 5 Concrete spall with rebar exposed in the bottom flange of Span 15A, Segment 12

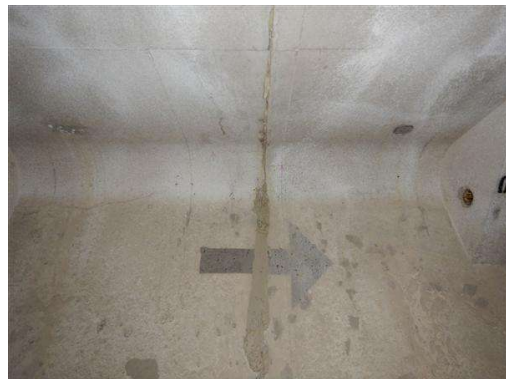
Photo 6 Typical hairline horizontal cracks with efflorescence in the interior segment at Pier 4A

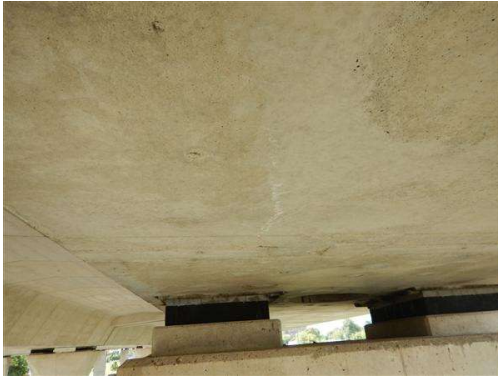
Photo 7 Longitudinal cracks with efflorescence in the bottom flange near Pier 8A

Hairline cracks with leaching efflorescence in the bottom flange/slab of the exterior segments were noted. See Photo 7 in the Superstructure section. Hairline to moderate cracking in the exterior pier segments were typical on a majority of the elements. See Photo 8 in the Superstructure section.

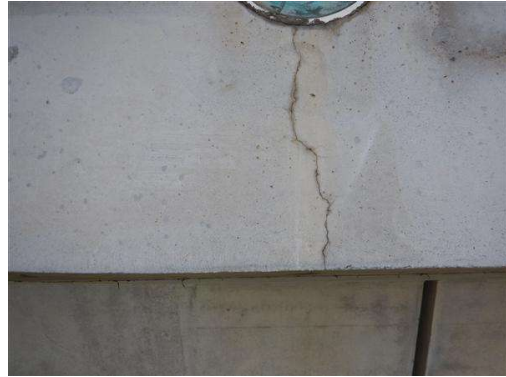
Longitudinal hairline to moderate cracking was present along both interior and exterior corner edges between the web and top flange/slab of every segment. These cracks varied in length and were typically 0.005" to 0.030" in width. Cracks exhibited efflorescence at some locations. See Photos 6 and 7. Additional hairline vertical cracks were in the Abutment wall and in the webs and top and bottom flange. The exterior pier end segments had moderate cracking near the drainage cap location. See Photo 8.

Photo 8 Cracks in exterior pier segment at Pier 17A on the West side looking East

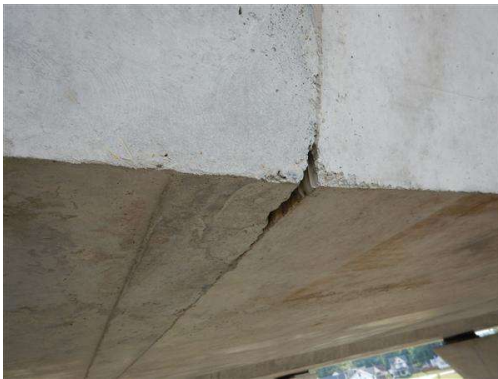
Voids were present in the segment construction/closure joints, both interior and exterior, varying size and depth. Some of the voids were observed to be up to 5" deep. Spalls and delaminated areas were noted throughout the interior and exterior of the box segments and on future stressing blocks located on the webs and along the floor slab. See Photos 9 through 11.

Photo 9 Void in the bottom flange between Segments 10A & 11A in Span 14A

Voids were present in the segment closure joints, varying size and depth. See Photo 9 in the Superstructure section. Small areas of honeycombed concrete was also noted on the exterior segments along the length of the bridge.

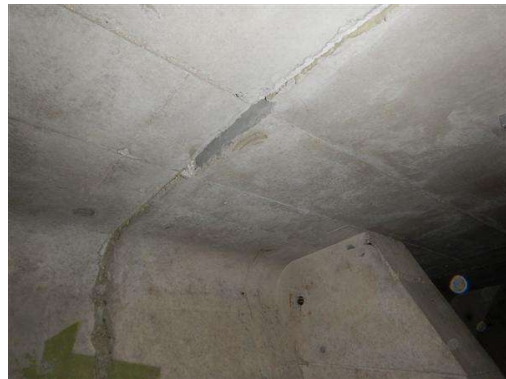
Photo 10 Concrete cut out of 20"x2.5"x5" in Segment 1A at Pier 17A at the shear key in the top slab

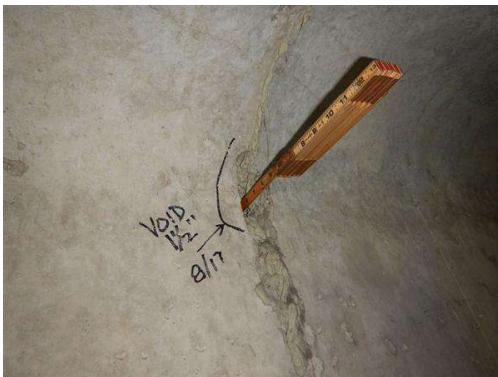
Photo 11 Void in web segment joint at Segment 5A in Span 1A.

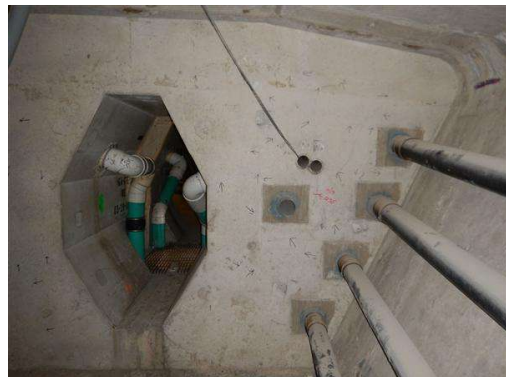
Photo 12 Map cracks ranging from 0.016" to 0.030" with efflorescence on the Pier 17A Diaphragm

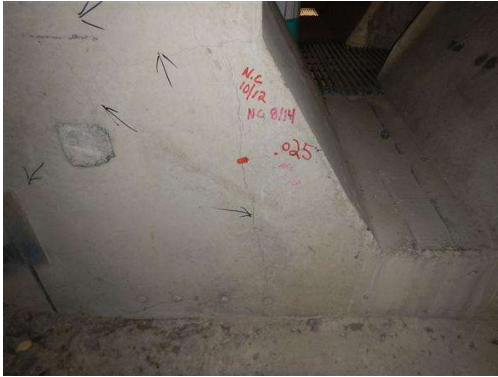
The interior diaphragm vertical faces exhibited hairline to moderate map cracking ranging from 0.005" to 0.030" in width. Efflorescence and discoloration were present at some locations although these areas did not appear to be active. See Photos 12 and 13. Several diaphragms exhibited areas of spalling, some with exposed reinforcement. See Photo 14. The diaphragm at Pier 15A exhibited a 2" deep, unfilled form-tie hole in the lower vertical face near the tendons. See Photo 15.

Photo 13 Typical cracks in the vertical face of the interior diaphragm at Pier 9A

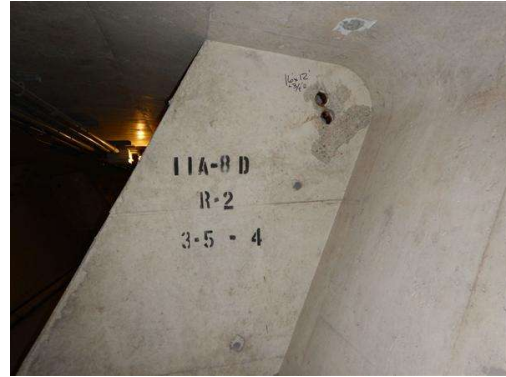
Photo 14 Concrete spall in diaphragm at Segment 8D in Span 11A, measuring 16"x12"x3/4",

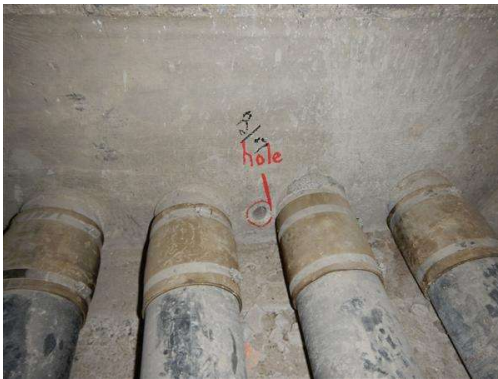
Photo 15 Form-tie hole at Pier 15A not fully grouted

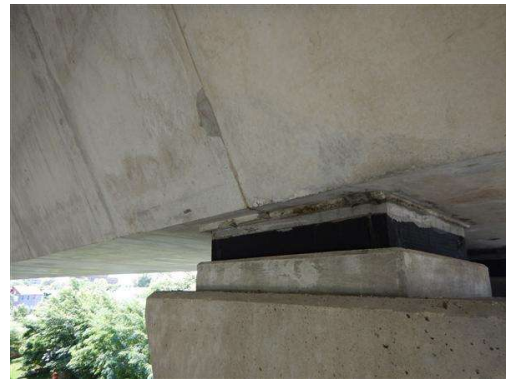
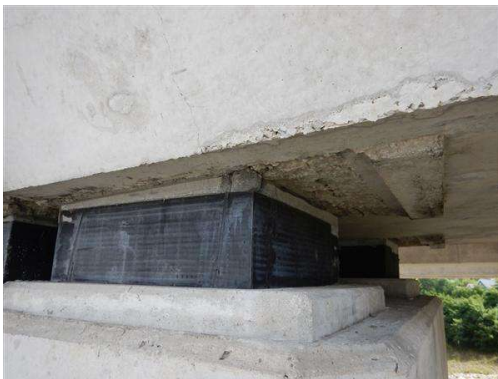
The plinths at Piers 7A to 15A exhibited typical areas of unsound, spalled or delaminated concrete and moderate to severe cracking in over 5% of the bearing area. See Photos 16 and 17.

Photo 16 Cracks and delaminated concrete in the plinth of Pier 12A East bearing

Photo 17 Concrete spall on the West bearing, SW Corner at Pier 7A

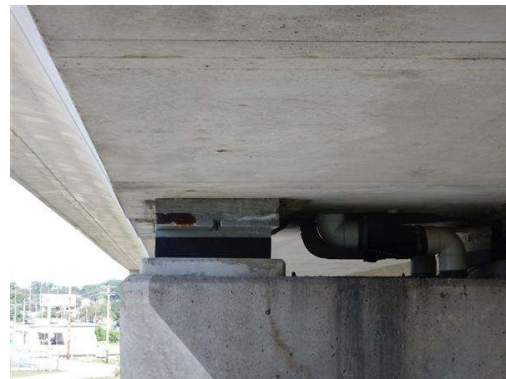
The west bearing sliding plate had an area of rust over a 6" long section at Pier 11A. See Photo 18. The sliding plate at the

Photo 18 Steel sliding plate with rust at the Pier 11A west bearing

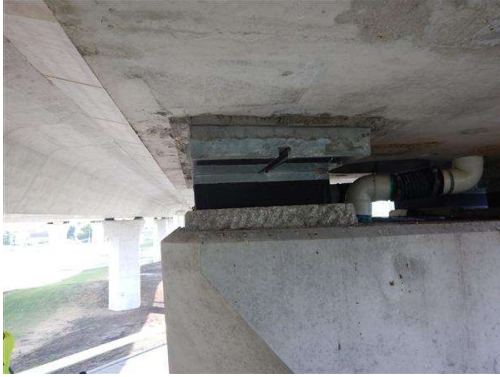
Photo 19

At Pier 14A, the west bearing was rotated 5° to the east. See Photo 19. The Pier 16A east bearing was noted to lean 3/8" to the east and the west bearing was noted to lean 3/8" to the east. The east bearing at Pier 17A was also noted to lean 1/2" to the east.

Pier 14A West bearing rotated to 5°  
towards the east

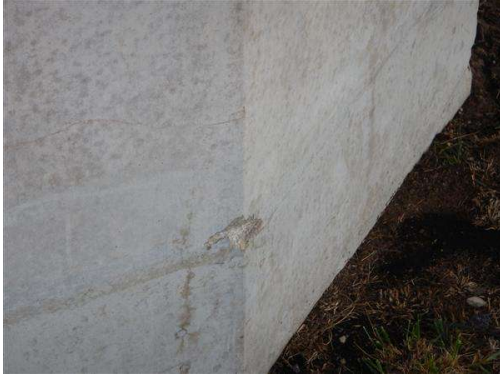
Photo 1

Typical hairline to medium (0.030 in) width vertical, horizontal and map cracking areas were present in the pier columns. A few small spalls were noted in the pier columns. See Photo 1. Minor honeycombing areas in the concrete were typical at a majority the columns. See Photo 2.

Concrete spall in the column at Pier 14A

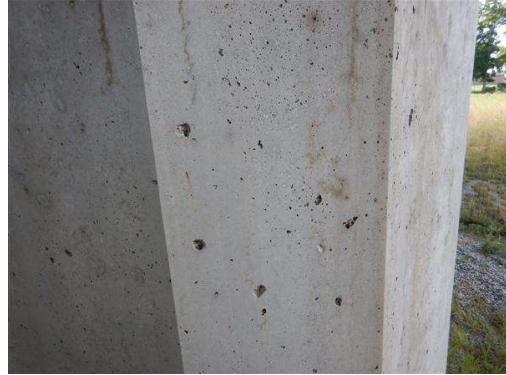
Photo 2

Typical honeycombing on all the columns

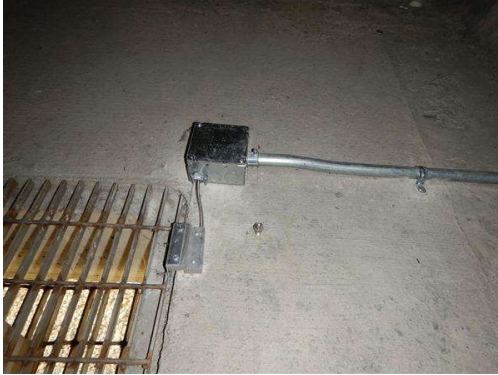
Photo 1 Security system was attached to the access hatch at Pier 1A

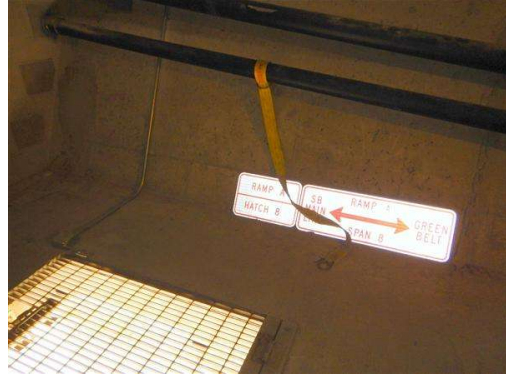
Photo 2 Safety lanyard attached to the PT duct at Pier 8A

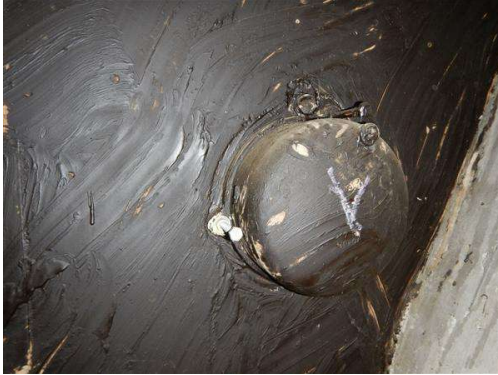
PT end cap locations were noted to have small void areas within the grout in the cap. These areas were determined by gently tapping on the plastic end caps with a hammer. A few caps were observed to have missing bolts connecting the cap with the duct at the diaphragm. See Photo 1.

Photo 1 Bolt missing and noted void in PT anchor cap at Pier 1A.

It is recommended that a form of NDT or ultrasound be utilized to determine the exact extent and accuracy of the voids. With the caps being covered with waterproofing material and being plastic, hollow areas within the cap were difficult to detect with certainty. In addition, the brittle nature of the material could lead to cracking of the end caps if struck too hard with a hammer.

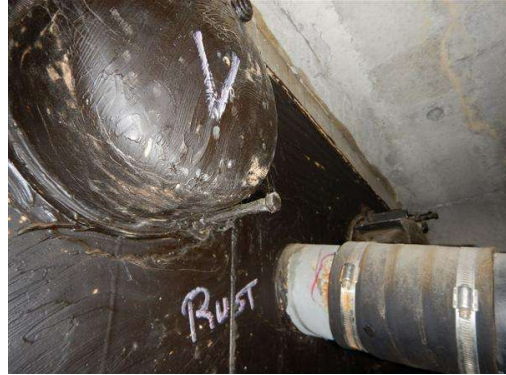
External tendons were in good condition with no notable defects on the majority of the elements. A few areas of rusting were noted on the steel PT ducts at the diaphragm connections and clamps connecting the sheathing to steel ducts. See Photo 2.

Photo 2 Small voids in PT caps and PT clamp and duct rusting at Pier 1A looking Southwest

As noted above in the PT end cap section, it would be recommended to have a form of NDT or ultrasound be utilized to determine the exact extent and accuracy of the voids.

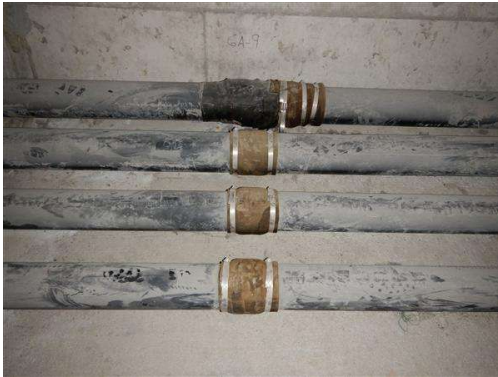
Numerous future stressing ducts in the diaphragm exhibited moderate to heavy rust with the stain leaching down the concrete in some locations. See Photo 3.

Photo 3 Bulging PT ducts

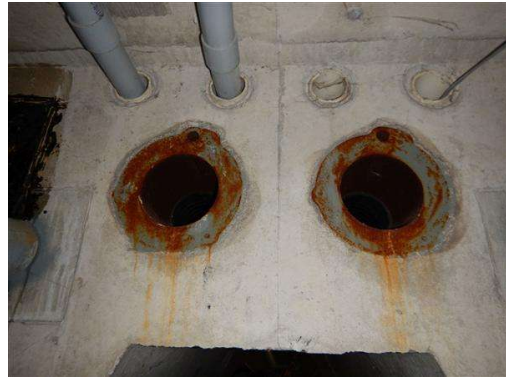
Photo 4 Typical moderate rust on the future PT ducts located in the diaphragms at Pier 1A
