2017 LUC-00280-0434\_DR (RAMP D) ROUTINE INSPECTION  
REPORT  
BRIDGE INSPECTION REPORT

Structure File Number: 4805879

Inventory Bridge Number: LUC 00280 04.340 DR

I-280,RAMP D over CHAMPLAIN NSRR.

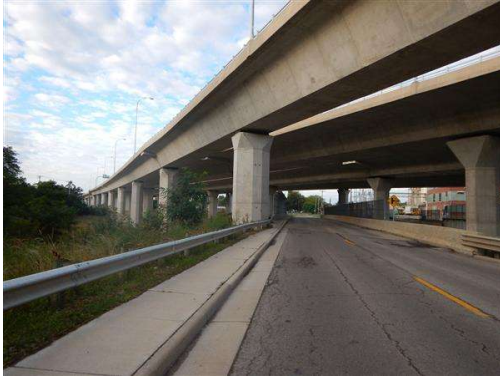
Photo 1 Ramp D Elevation View looking southwest.

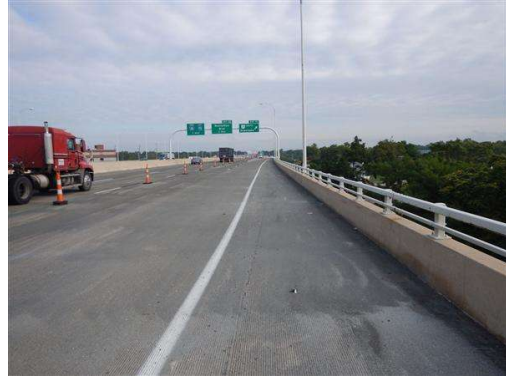
Photo 2 End View of Ramp D looking north.

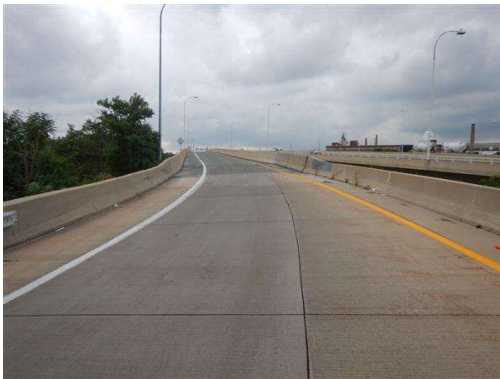
Photo 3 End View of Ramp D looking south.

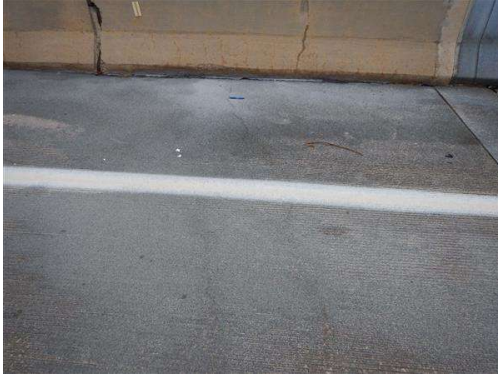
Moderate transverse cracking ranging in length from 4 ft. to full width in the approach slab. A hole from a rodent, likely a ground hog, was noted at the southwest side of the approach slab. See Photo 1.

Photo 1 Moderate transverse cracking in the approach slab running full width.

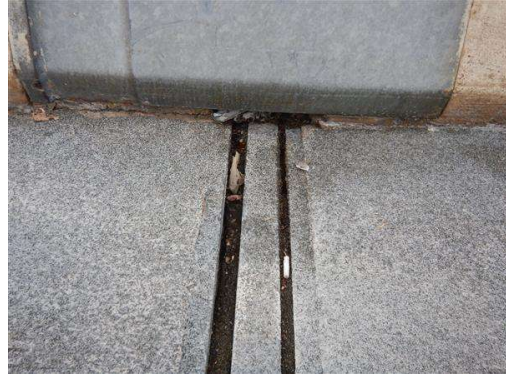
Potential areas of settlement were observed on both the east and west edges of the approach slab. Foam was installed under the east barrier to fill a gap between the approach slab and barrier. The west barrier had foam installed under the approach slab and barrier at the expansion joint location. See Photo 2. Additionally both barriers exhibited vertical and horizontal displacement over the length of the approach slab.

Photo 2 Foam filling void between barrier and approach slab at the west end of the expansion joint.

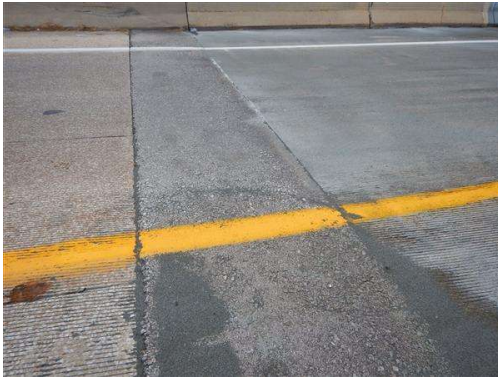
The relief joint was in good condition with minor transverse cracks in the joint asphalt. Both northern and southern edges of the relief joint and roadway/approach slab concrete exhibited minor spalling and deterioration along the length of the joint. See Photo 3.

Photo 3 Typical condition of the relief joint at the end of the approach slab.

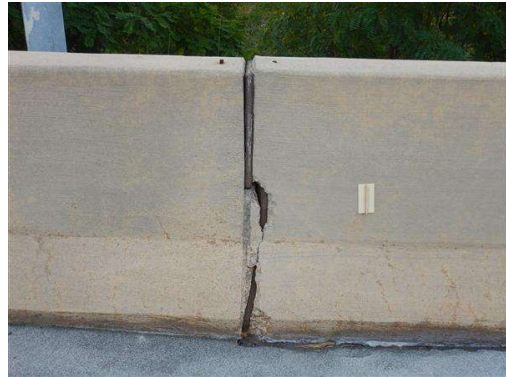
At the middle of the approach slab, the east barrier displayed signs of settlement in the embankment with vertical and horizontal displacement measured at the joint. The concrete was spalled and cracked in this area. See Photo 4. In addition, a 14 in. x 7 in. x 3.5 in. deep spall with exposed reinforcement was observed on the backside of the east barrier at the south end of the approach slab near the abutment backwall. See Photo 5. The west barrier at the end of the approach slab also had measurable vertical and horizontal displacement between the adjoining section of concrete barrier. See Photo 6.

Photo 4 East barrier with vertical displacement/rotation, spalling and cracking of the concrete at the midspan of the approach slab.

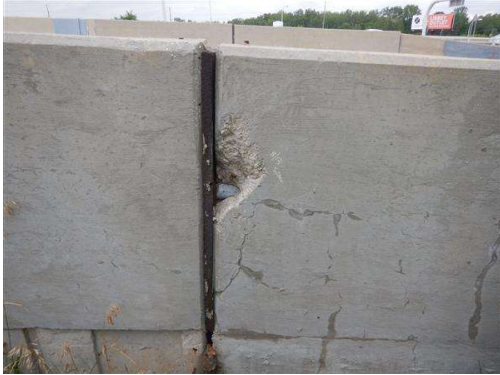
Photo 5

Backside of the east barrier near the abutment backwall with spalled concrete and exposed reinforcement.

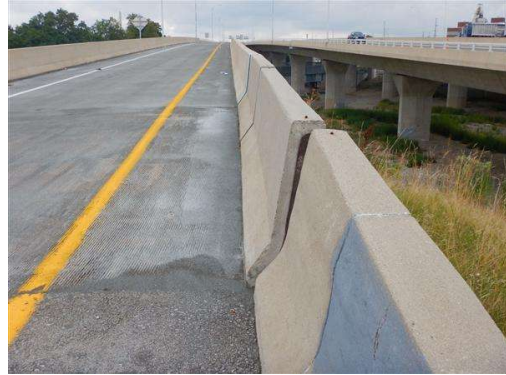
Photo 6

West barrier with vertical and horizontal displacement present at the end of the approach slab.

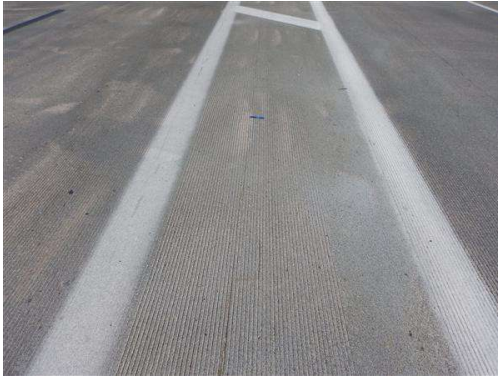
Ramp D (LUC-280-0434DR) deck sketches show from Pier 1D (Sta. 1+90.99) to Abutment 13D (Sta. 17+62.68). The entire deck quantity is rated in this report. The longitudinal joint is rated in the LUC-280-0375R report as per the 2016 inspection. Hairline transverse and map cracking, with efflorescent leaching in areas, was noted along the length of the longitudinal closure pour. See Photo 1.

Photo 1 Longitudinal joint with cracking and efflorescent leaching.

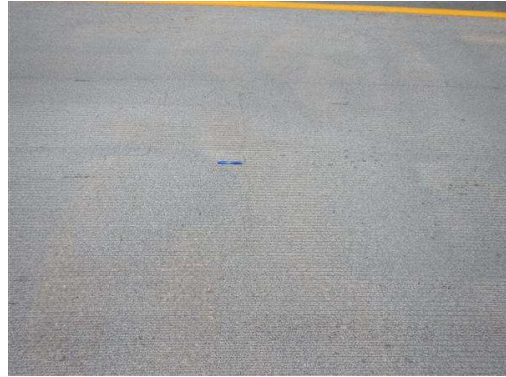
Areas of moderate (0.013 in. to 0.025 in.) transverse cracking along the majority of the roadway segment joints were noted along the length of the bridge. See Photo 2.

Areas of moderate (0.013 in. to 0.025 in.) transverse cracking along the majority of the roadway segment joints were noted in the wearing surface along the length of the bridge. See Photo 2. Moderate (0.013 in. to 0.016 in.) longitudinal and map cracks were noted in the middle of the traffic lane wearing surface in Spans 8D, 10D, 11D and 13D. See Photo 5.

Photo 2 Typical transverse cracking along the width of the roadway in Span 9D.

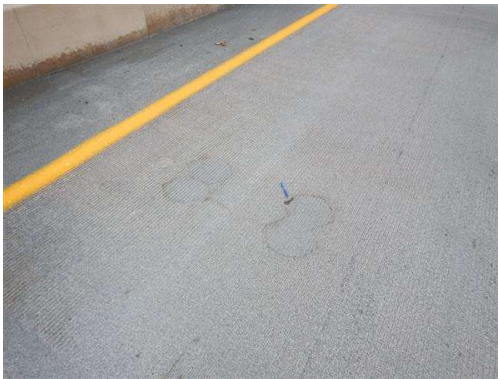
Numerous lift holes and deck patches were noted along the length of the bridge and displayed moderate cracking (0.013 in. to 0.025 in.), spalling and discoloration around the perimeter or these patches. See Photo 3. Other patches along the bridge were determined to be delaminated or unsound with hairline to moderate cracking within a portion of these patches. See Photo 4.

Numerous lift holes and deck patches were noted in the wearing surface along the length of the bridge and displayed moderate cracking (0.013 in. to 0.025 in.), spalling and discoloration around the perimeter or these patches. See Photo 3. Other patches along the bridge were determined to be delaminated or unsound with hairline to moderate cracking within a portion of these patches. See Photo 4.

Photo 3 Lift hole patch in the deck/wearing surface with cracks and spalling around the perimeter in Span 8D.

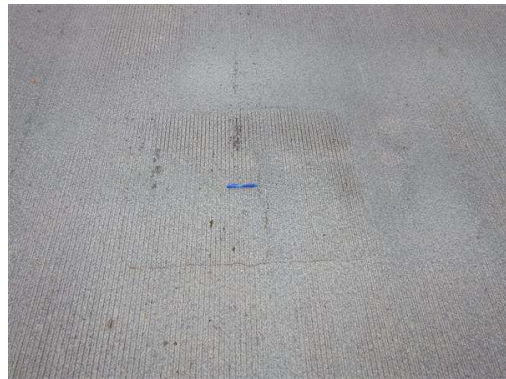
Photo 4 Delaminated patch in the deck/wearing surface with hairline map cracking in the patch in Span 8D.

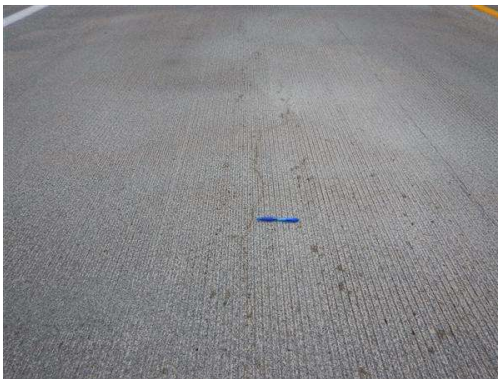
Photo 5 Typical longitudinal and map cracks located in the middle of the travel lane in Span 10D.

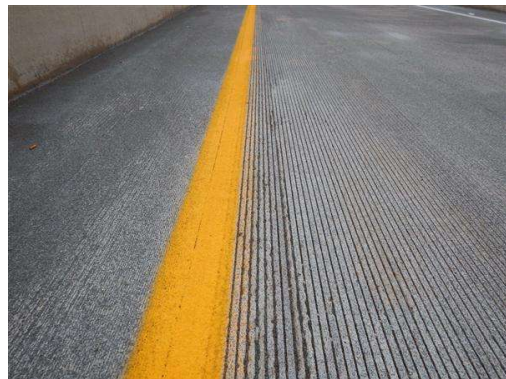
A few areas of the wearing surface exhibited scaling and abrasion at the edges of the travel lanes near the painted lane lines along the length of the bridge. See Photo 6.

Photo 6 Area of scaling and abrasion in the wearing surface along the east side of the travel lane in Span 9D.

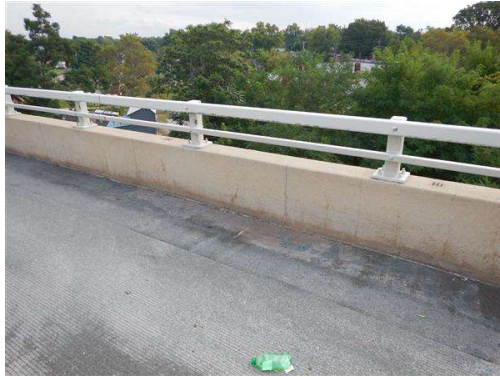
Typical areas of hairline to moderate vertical cracking was noted along the length of the concrete parapet on both sides of the roadway. See Photo 7. Numerous areas of cracks had efflorescence, rust stains and/or discoloration and leaching.

Photo 7 Typical vertical cracking and discoloration in the concrete parapet along the length of the bridge.

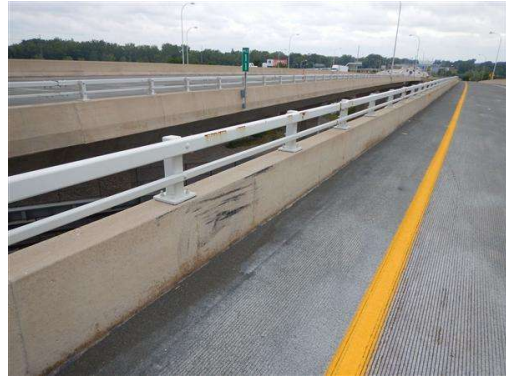
Several areas of minor spalls/gouges were noted along the length of the bridge. Three areas of collision damage and minor scraping to the parapets were noted in Spans 5D, 8D and 9D. See Photo 8. A few areas of concrete scaling were observed along the length of the bridge of the top and vertical faces of the parapets. See Photo 9.

Photo 8 Collision damage/scraping to the west parapet and steel railing in Span 9D.

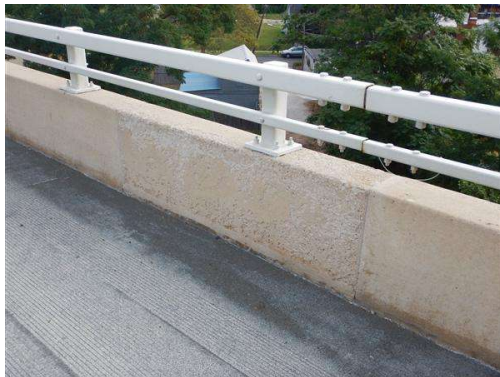
Photo 9 Area of concrete scaling along the vertical face of the east parapet in Span 3D.

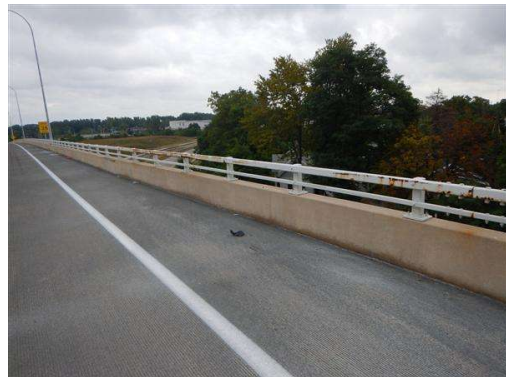
Multiple areas of missing paint, minor deterioration and rust on the steel railing were noted along the length of the bridge. See Photo 10.

Photo 10 Area of minor deterioration and rust on the steel railing in Span 8D.

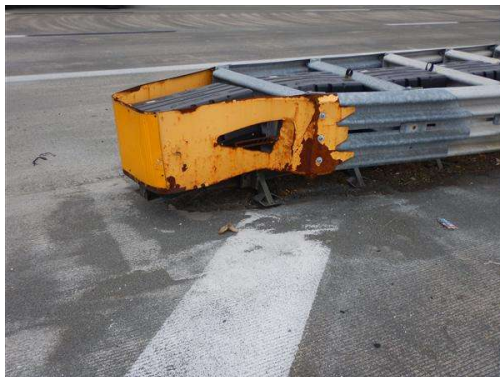
The attenuator at the Pier 5D/Ramp D exit where the NB North Approach railing begins at Pier 53NB is damaged due to collision impact. See Photo 11.

Photo 11 Collision damage to the attenuator at the Ramp D exit.

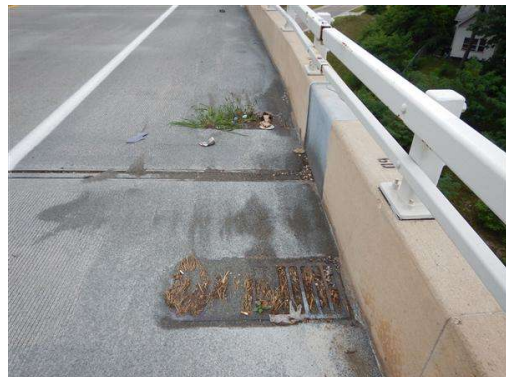
Moderate to severe amounts of debris was observed in a majority of the scuppers, some of which had vegetation growing from the debris. See Photo 12. All deck scuppers appeared to be filled and not serving their intended function.

Photo 12 Heavy debris and vegetation present in the deck scuppers at Pier 7D.

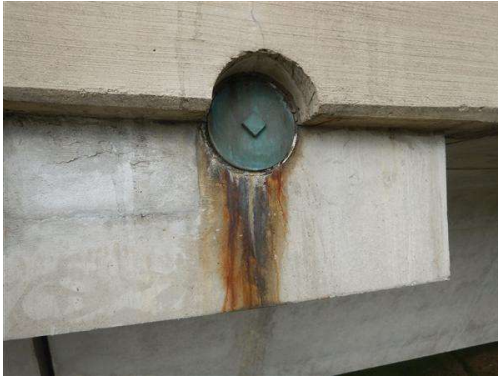
The drainage caps at the edge face of the pier end segments were leaking on a majority of the scupper locations. These locations consisted of varying levels, moderate to heavy, of rust staining and efflorescence in the concrete. See Photo 13.

Photo 13 Heavy rust staining and efflorescence on the edge face of the pier end segments.

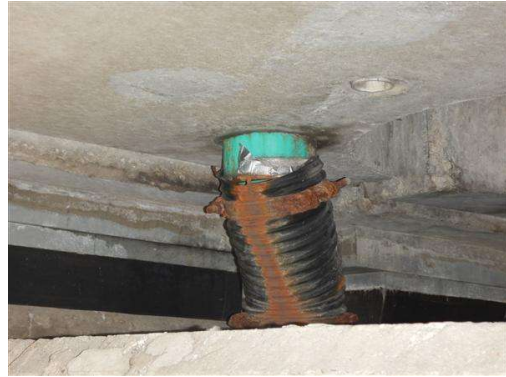
At Pier 4D, the deck drainage pipe was disconnected from the outflow PVC pipe draining into the pier column. The brackets connecting the two pipes were also rusted and corroded. See Photo 14.

Photo 14 Disconnected drainage pipes and rusted clamps at Pier 4D.

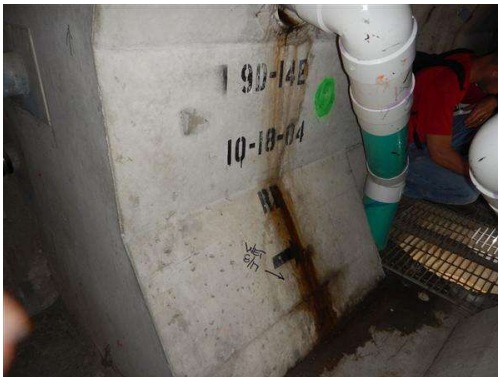
The deck drainage pipes within the interior of the segment at Piers 1D, 3D, 7D and 9D exhibited areas of leakage or evidence of past leakage with wet concrete, rust staining and efflorescence present. See Photo 15.

Photo 15 Interior drainage pipe at Pier 1D with wet concrete, rust staining and efflorescence.

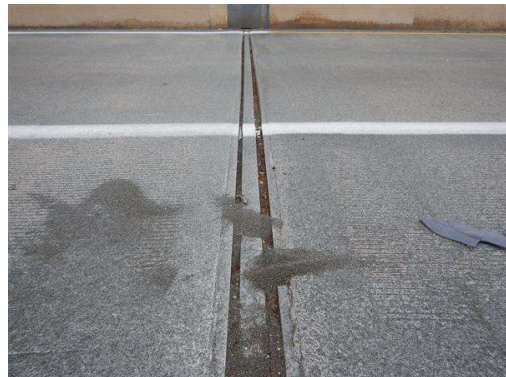
No leakage of the glands within the modular joints was observed. The joints at Piers 7D and 10D and Abutment 13D were partially filled over the entire width of the roadway. See Photo 16.

Photo 16 Typical condition of the expansion joints along the width of the roadway.

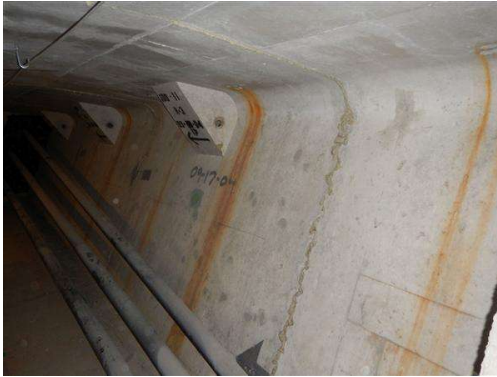
Photo 1 Typical lift hole patches with rust staining leaching from the holes.

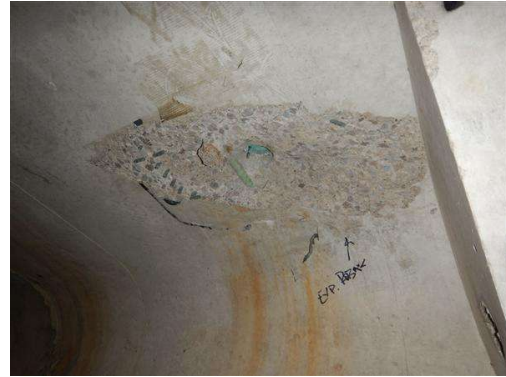
Photo 2 Spalled concrete and exposed reinforcement at a lift hole in Span 10D.

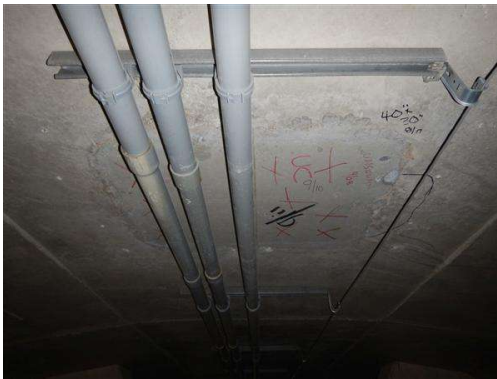
Photo 3 Delaminated concrete and efflorescence in top flange patch located in Span 2D.

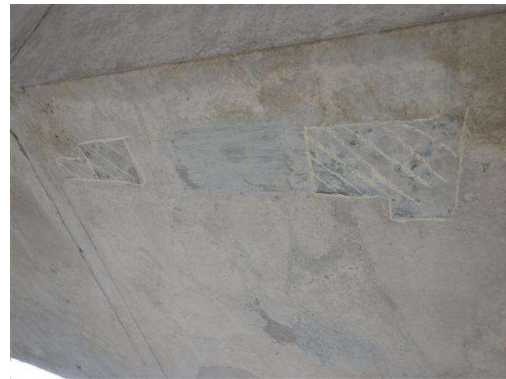
Numerous areas of unsound patches were observed in the lift holes located at the top flange/slab along the edges of the interior segment. A majority of these areas exhibited rust staining and efflorescence as well as spalled concrete and exposed reinforcement in some locations over the length of the bridge. See Photos 1 and 2. Other patches and construction joints in the interior segment exhibited efflorescence around the perimeters and some locations of delaminated concrete within these patches/joints. See Photo 3. One lift hole was not patched at the interior face and contained a large bolt that was embedded into the grout in Span 3D. Along the exterior web and bottom flange/slab, several delaminated and spalled areas and patches were noted along the length of the bridge at patch locations and joints. See Photo 4 and 5.

Photo 4 Delaminated concrete at exterior hold down patch in the bottom flange of Span 6D.

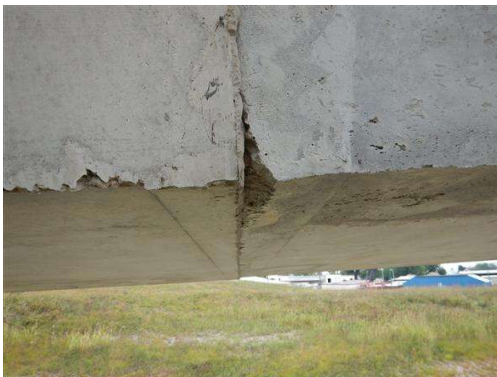
Photo 5 Spalled concrete at segment joint in Span 12D.

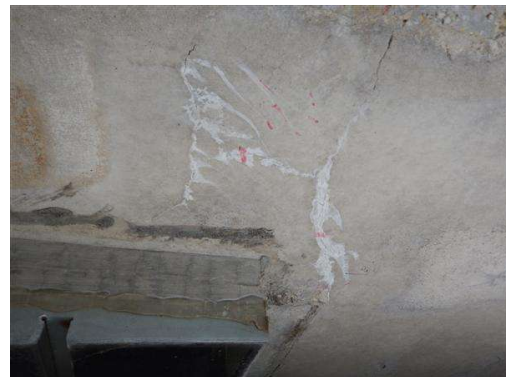
Photo 6 Area of efflorescence in the bottom flange and closure pour near bearing in Span 3D.

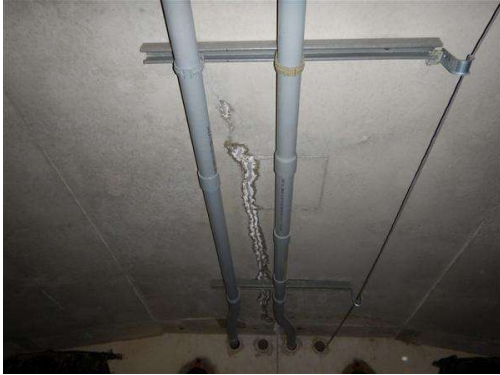
Photo 7 Longitudinal cracking in the top flange/slab concrete with heavy efflorescence.

Longitudinal hairline to moderate cracking was present along both interior corner edges between the web and top flange/slab of every segment. These cracks varied in length and were typically 0.005 in. to 0.025 in. in width. Approximately half of the cracks exhibited efflorescence; however, based on previously installed marks, they did not appear to be actively leaching. Additional hairline vertical and longitudinal cracking was present along the interior webs, bottom and top flanges/slab of the box segments and construction/closure pour joints over the length of the bridge. Areas with efflorescent leaching and discoloration were noted at some of these locations. See Photos 6 and 7 in the Superstructure section.

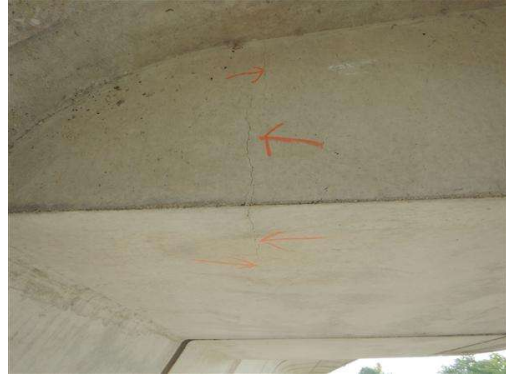
Longitudinal hairline to moderate cracking was present along both interior corner edges between the web and top flange/slab of every segment. These cracks varied in length and were typically 0.005 in. to 0.025 in. in width. Approximately half of the cracks exhibited efflorescence; however, based on previously installed marks, they did not appear to be actively leaching. Additional hairline vertical and longitudinal cracking was present along the interior and exterior webs, bottom and top flanges/slab of the box segments and construction/closure pour joints over the length of the bridge. Areas with efflorescent leaching and discoloration were noted at some of these locations. See Photos 6 and 7. The exterior pier end segments had typical hairline vertical and horizontal cracking on the edge face of the concrete near the drainage cap locations and additionally along the width of the box segment flanges. See Photo 8.

Photo 8 Typical cracking along the width of the end pier segment flanges.

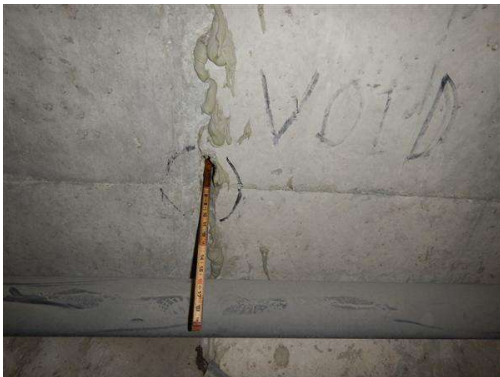
Voids were present in the segment construction/closure joints, both interior and exterior, varying in size and depth. See Photos 9 and 10. Spalls and delaminated areas were noted throughout the interior and exterior of the box segments and future exterior stressing blocks located at the top of the webs and along the floor slab. Some of the spall areas were greater than 1 in. in depth and contained exposed reinforcement.

Photo 9 Typical interior void between segment joints.

Voids were present in the segment construction/closure joints varying in size and depth. See Photo 9 in the Superstructure section. Spalls and delaminated areas were noted throughout the interior of the box segments and future exterior stressing blocks located at the top of the webs and along the floor slab. Some of the spall areas were greater than 1 in. in depth and contained exposed reinforcement.

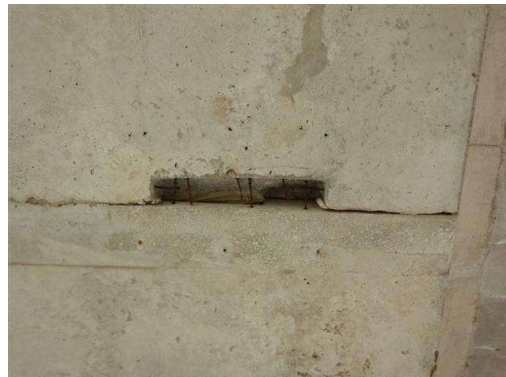
Photo 10 Typical exterior void between segment joints.

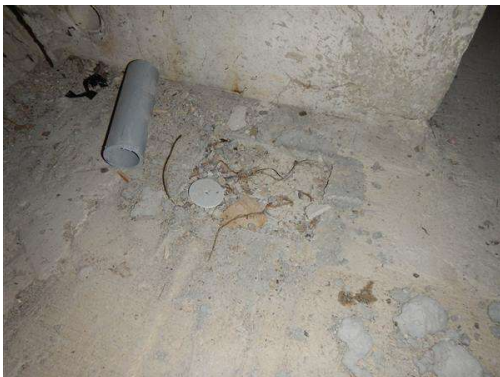
Small areas of honeycombed concrete were also noted on the interior and exterior of the segments along the length of the bridge. One location in Span 2D along the diaphragm in the bottom flange/slab contained a 1 SF area of patched concrete at a hold down hole that was partially filled. See Photo 11.

Photo 11 Hold down hole in the bottom flange of the Span 2D segment partially filled with grout.

Small areas of honeycombed concrete were also noted on the interior of the segments along the length of the bridge. One location in Span 2D along the diaphragm in the bottom flange/slab contained a 1 SF area of patched concrete at a hold down hole that was partially filled. See Photo 11 in the Superstructure section.

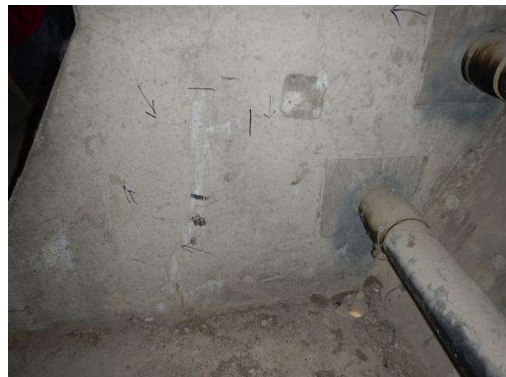
Photo 12 Typical cracking on the vertical face of the interior diaphragm.

The diaphragm vertical faces exhibited typical hairline to moderate vertical and map cracking. Efflorescence and leaching/discoloration were present at some locations although the areas did not appear to be active. See Photos 12 and 13 in the Superstructure section. Several diaphragms additionally had areas of delaminated and unsound concrete on the vertical faces. See Photo 14 in the Superstructure section.

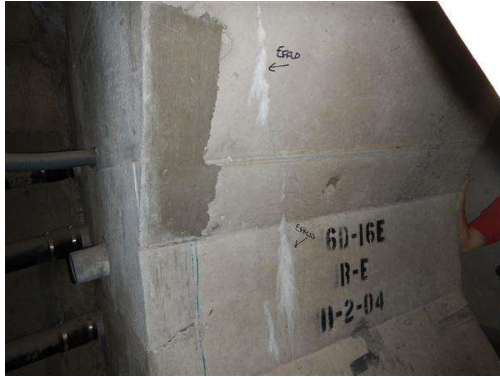
Photo 13 Cracking and efflorescence at the vertical face of the walk through area of the diaphragm at Pier 3D.

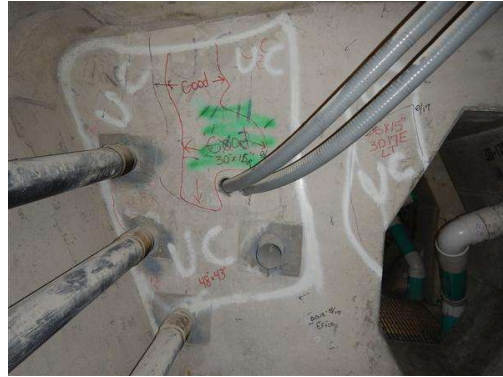
The interior diaphragm vertical faces exhibited typical hairline to moderate vertical and map cracking ranging from 0.005 in. to 0.030 in. in width. Efflorescence and leaching/discoloration were present at some locations although the areas did not appear to be active. See Photos 12 and 13. Several diaphragms additionally had areas of delaminated and unsound concrete on the vertical faces. See Photo 14.

Photo 14 Area of delaminated concrete and cracking on the diaphragm at Pier 3D.

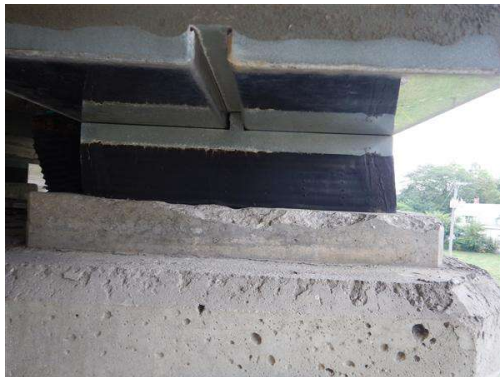
A measured at Pier 4D gap between the pad and plinth concrete was observed and measured where the pad was not fully bearing on the concrete. The bearing gap was 5 in. in length and 4 in. in depth along the west edge of the west bearing, while the gap along the east edge of the east bearing measured 5 in. in length and 2 in. in depth.

The pedestal at the east bearing location on Pier 4D had areas of spalled concrete with portions extending underneath the pad location. The bearing pads on this pier were also racked to the west by 1/4 in. on the southwest bearing and 3/4 in. on the southeast bearing. See Photo 15. In addition, the north bearings at Pier 4D were contracted to within 1/4 in. from the end edge of the sliding plates. See Photo 16.

Photo 15 Spall in the east bearing pedestal at Pier 4D and pad leaning toward the west.

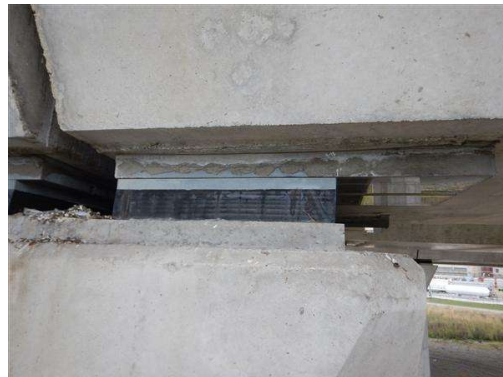
Photo 16 Pier 4D northeast bearing contracted to within 1/4 in. of the edge of the sliding plate.

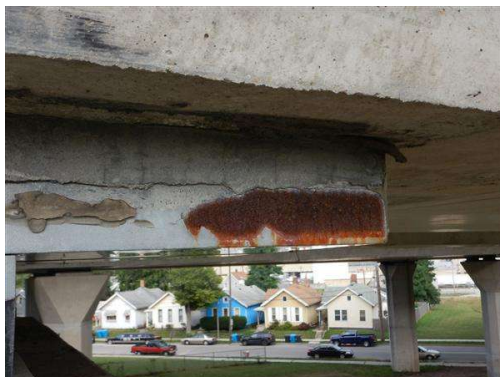
The east edge surface of the Pier 1D sliding plate had an area of rust over a 6 in. long section. See Photo 17.

Photo 17 Pier 1D steel sliding plate with an area of rust on the east edge.

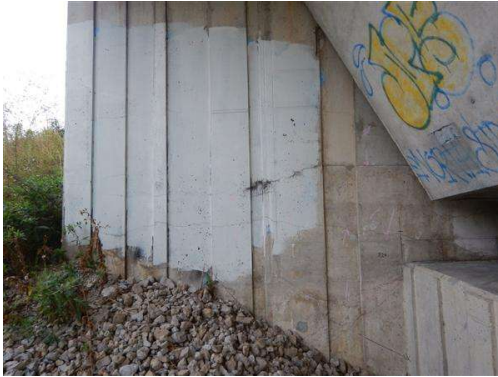
The abutment wall exhibited areas of hairline to narrow width horizontal and map cracking with efflorescence present in some of the crack locations. See Photo 1. A diagonal crack was observed on the edge of the backwall with efflorescence noted along the length of the crack. See Photo 2.

Photo 1 Typical horizontal and map cracking along the full height of the Abutment 13D backwall.

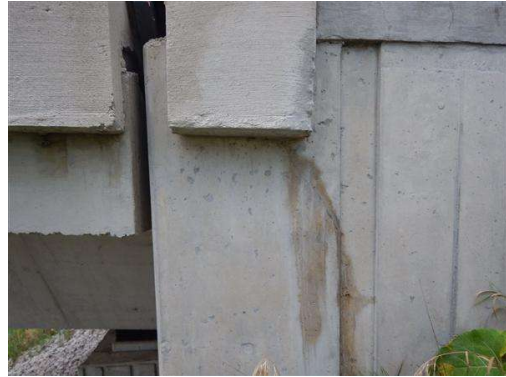
Photo 2 Diagonal cracking with efflorescence on the east end of the Abutment 13D backwall.

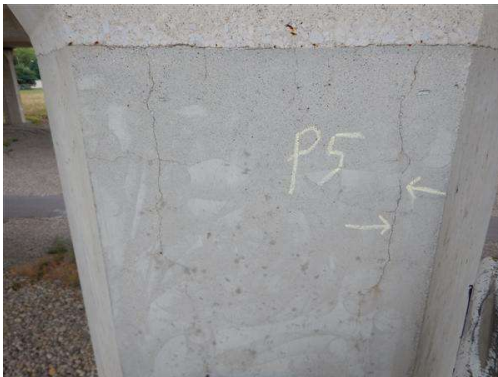
Typical hairline to medium (0.040 in.) width vertical, horizontal and map cracking areas were present on the pier columns. Photo 3. A few small spalls and areas of delaminations were noted on the pier columns. See Photo 4.

Photo 3 Typical hairline to medium width vertical and map cracks on the pier columns.

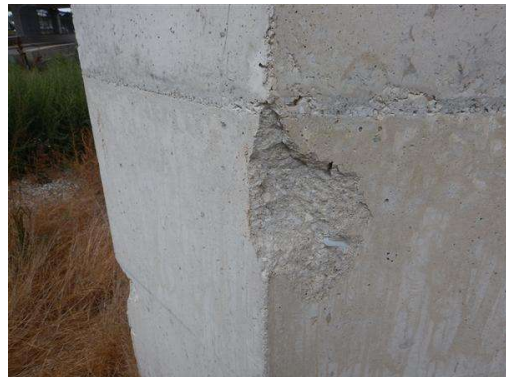
Photo 4 1 ft. x 1 ft. x 2.5 in. deep spall near ground level on the Pier 9D column.

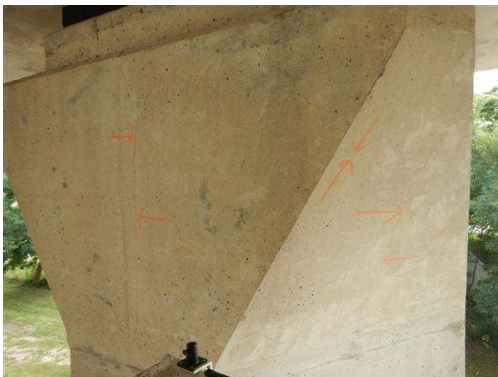
Typical hairline to medium (0.030 in.) width vertical and map cracking areas were noted on the pier caps. See Photo 5.

Photo 5 Typical hairline to medium width vertical cracking in the pier cap.

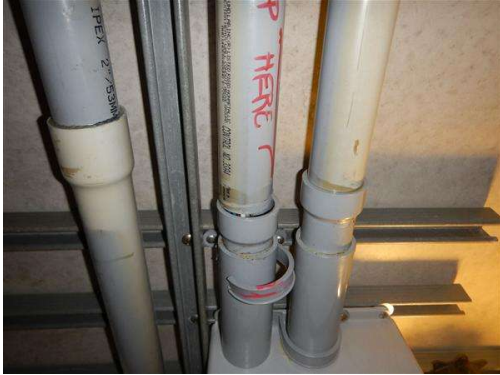
Photo 1

Bracket clips and fasteners for the interior electrical conduit had areas where they were disconnected or broken along the length of the bridge. A few locations along the conduit also exhibited broken and/or disconnected conduit at joints. See Photo 1.

Broken electrical conduit clip and conduit disconnected at joint in Span 4D.

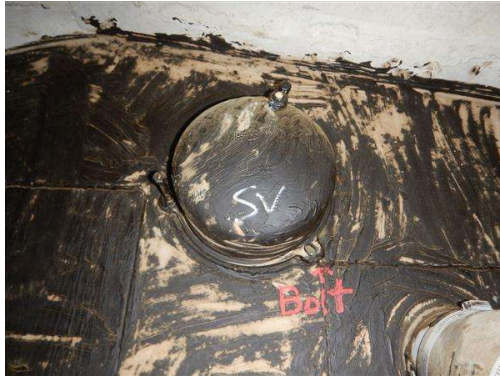
10 PT end cap locations were noted to have small void areas within the grout in the cap. These areas were determined and verified by gently tapping on the plastic end caps with a hammer. See Photo 1. A few end caps were observed to have missing bolts connecting the cap with the duct at the diaphragm.

Photo 1 Small void in the PT end cap of T3 tendon and missing cap bolt at Pier 2D.

It would be recommended to remove the plastic PT caps or utilize a form of NDT/ultrasound to determine the exact extent and accuracy of the voids. With the caps being covered in waterproofing material and plastic, hollow areas within the cap were difficult to detect with certainty. In addition, the brittle nature of the plastic material could lead to cracking of the end caps if struck too hard with a hammer.

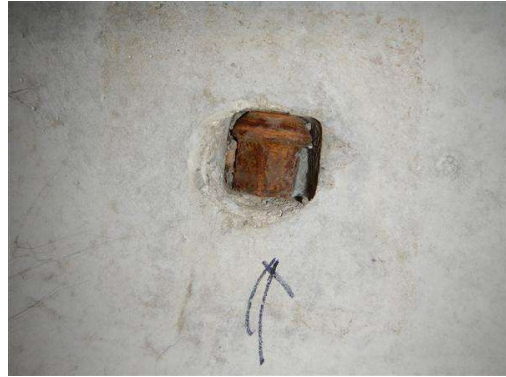
Numerous areas of unsound patches were typical in the lift holes located at the top flange/slab along the edges of the interior segment along the length of the bridge. A majority of these areas exhibited rust staining and efflorescence as well as spalled concrete and exposed reinforcement in some locations. See Photos 1 and 2 in the Superstructure section. Other patches and construction joints in the interior segment exhibited efflorescence around the perimeters and some locations of delaminated concrete within these patches/joints. See Photo 3 in the Superstructure section. In Span 3, one lift hole contained a large bolt that was embedded into the grout above and was not fully patched. See Photo 2.

Photo 2 Large bolt encased in the lift hole concrete with the hole not patched.

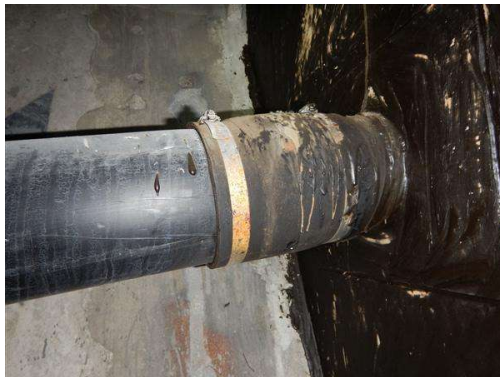
Photo 3 Typical rust on clamps connecting PT ducts with sheathing.

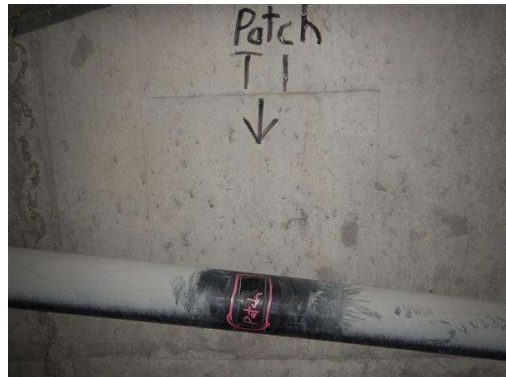
Photo 4 Patch added to the tendon in Span 7D due to previously documented gouge.

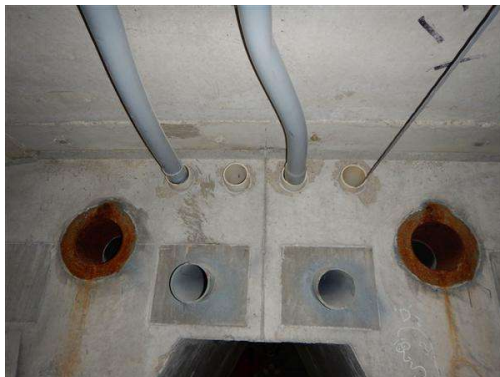
Photo 5 Typical moderate rusting on the future PT ducts located in the diaphragms.
