2017 LUC-00280-0283\_L (SB SOUTH APPROACH) ROUTINE  
INSPECTION REPORT  
BRIDGE INSPECTION REPORT

Structure File Number: 4805836

Inventory Bridge Number: LUC 00280 02.830 L

IR-280 over NSRR, RAMP Z, FRONT ST

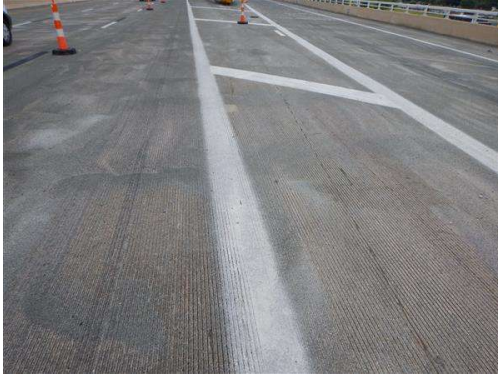
The Southbound South approach (LUC280-0283L) extends from Abutment 1SB (STA. 200+18.54) to Pier 26SB (STA. 233+62.50). The entire deck quantity is rated in this report. The longitudinal joint is rated in this report as per the 2016 inspection. Hairline transverse and map cracking, with efflorescent leaching in areas, was noted along the length of the longitudinal closure pour joint. See Photo 1.

Photo 1 Longitudinal cracks in the longitudinal joint between Spans 21SB and 22SB looking South

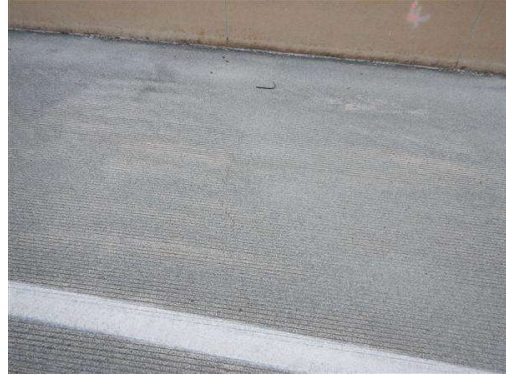
Areas of moderate transverse and map cracking (0.013" to 0.025") along the length of the bridge were observed. See Photos 1 and 2. Numerous lift hole and deck patches with spalls and hairline cracks and discoloration around perimeter were noted along the length of the structure. See Photos 3 through 5.

Photo 2 Transverse cracks in the shoulder between Spans 22SB and 23SB

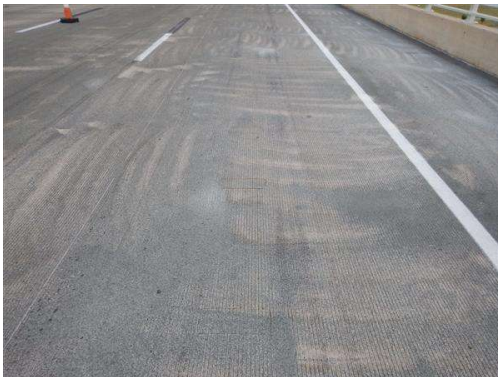
Photo 3 Typical concrete patches in the traffic lane between Spans 24SB and 25SB

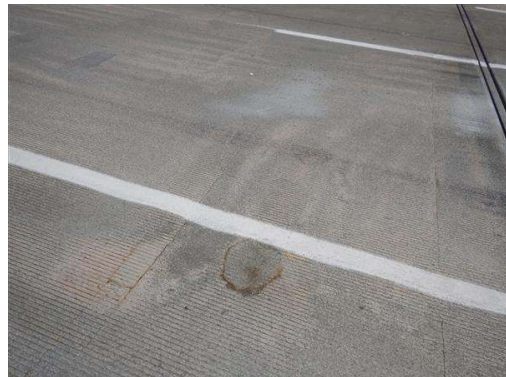
Photo 4 Concrete patch with spalls and discoloration around perimeter between Spans 24SB and 25SB

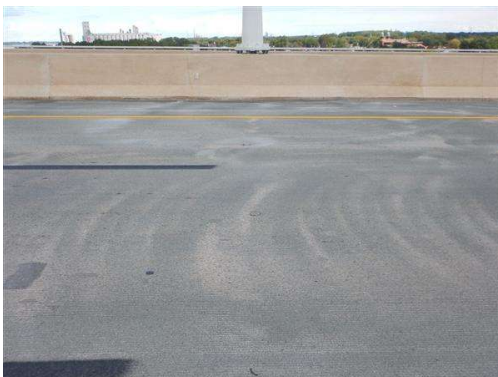
Photo 5 Lift hole patch with spall between Spans 24SB and 25SB

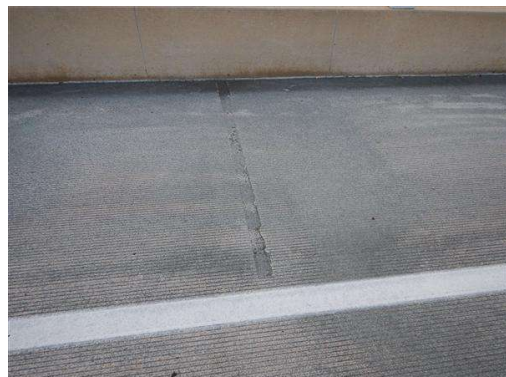
A depression of 0.25" was observed at multiple locations on the deck. See Photo 6. Holes were observed in West lane between Spans 18SB and 19SB. See Photo 7.

Photo 6 0.25" depression in the shoulder between Spans 24SB and 25SB

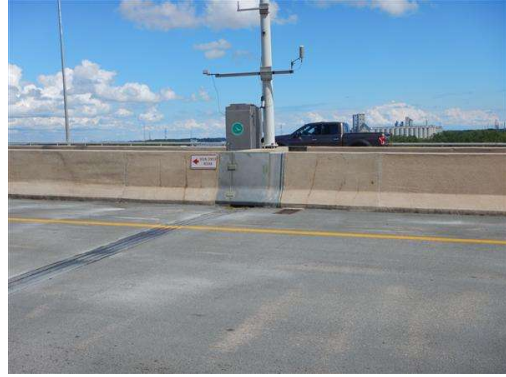
Typical areas of hairline vertical and map cracking were noted along the length of the concrete parapet on both the sides of the roadway. See Photo 8. Numerous areas of cracks had efflorescence, rust stains and/or discoloration/leaching.

Photo 8 Typical vertical cracking with rust stains along the East parapet looking East

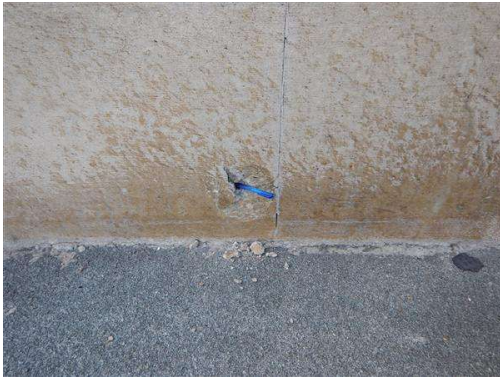
A few areas of minor spalls/gouges were noted in Spans 5SB, 12SB and 24SB. See Photos 9 and 10.

Photo 9 Spall in the parapet in Span 24SB

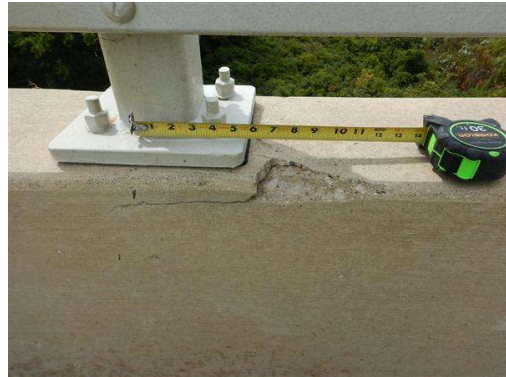
Photo 10 Spall beneath the steel railing in Span 5SB

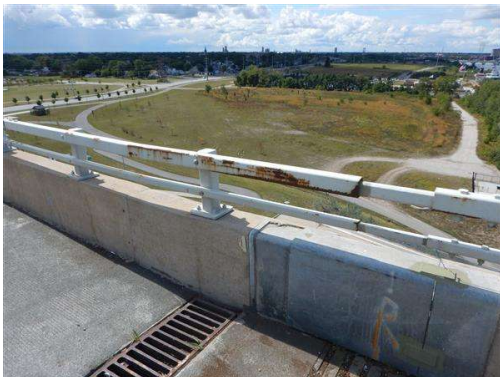
The steel railing exhibited a few areas of deterioration and heavy rust with section loss along the length of the bridge. See Photos 11 and 12.

Photo 11 Rust on the steel railing (5' long) in Span 25SB looking West

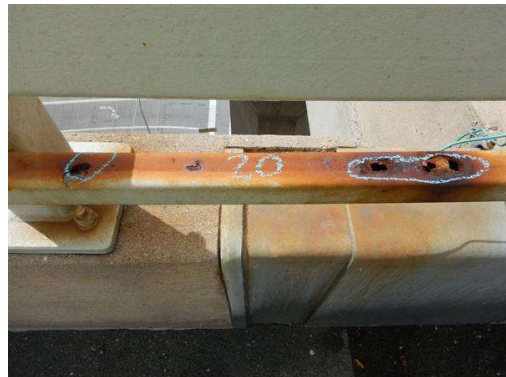
Photo 12 Rust and section loss on the steel railing in Span 5SB looking West

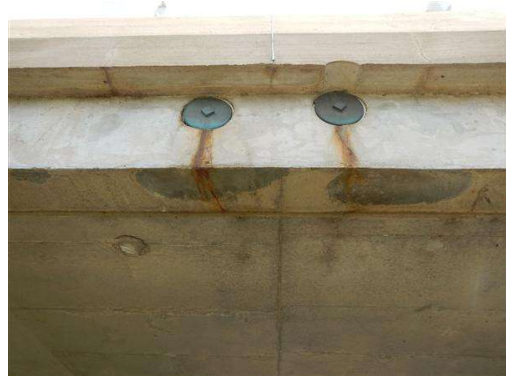
The drainage caps on the face of the pier end segments were leaking on a majority of the scupper locations. Varying levels of rust and efflorescence were noted at these locations. See Photo 14.

Photo 14 Typical rust staining and efflorescence on the edge face of the end segments

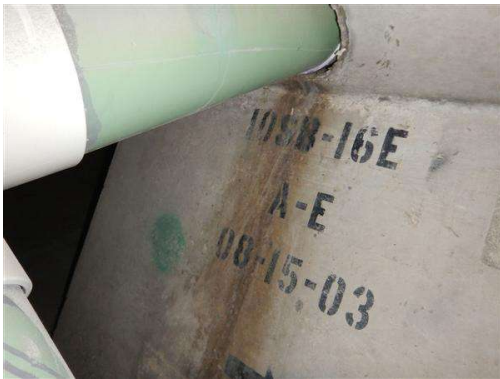
Drainage pipes within the interior of the box segments at Piers 10SB, 11SB and 17SB exhibited leakage with the rust staining. See Photo 15.

Photo 15 Interior drainage pipe at Pier 10SB

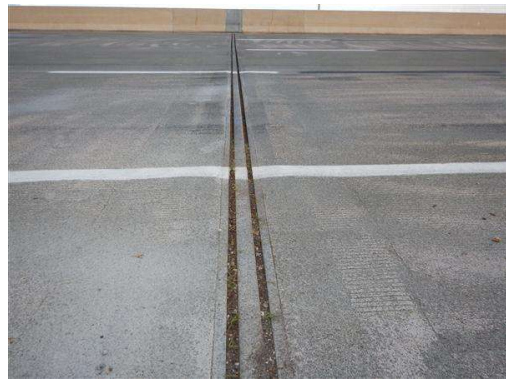
Photo 16 Expansion joint at Pier 24SB filled with debris and growing vegetation looking West

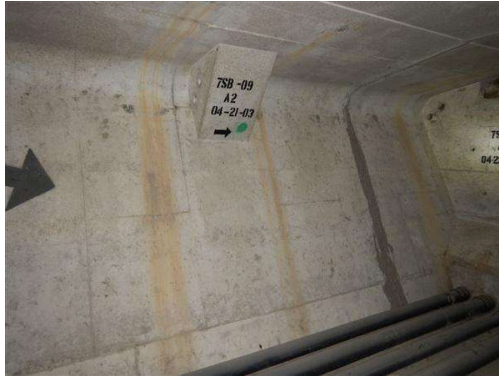
Numerous delaminated or unsound patches were observed in the lift holes at the top flange/slab along the edges in the interior of the segments. A majority of these areas exhibited efflorescence over the length of the bridge. See Photos 1 and 2. At multiple locations, concrete spalls with exposed reinforcement were observed. See Photo 3. Other patches and construction joints in interior of the segments, both webs and top/bottom flanges/slabs exhibited delaminated and spalled concrete. See Photos 4 and 5. Cracks and spalls with efflorescence were observed in the base of the deviator wall at multiple locations along the bridge. See Photo 6. In Spans 5SB and 7SB, rebar was noted sticking out of the closure joints in the web. See Photo 7. In Span 22SB, a PVC was left in the web and extends the full width of the concrete. See Photo 8.

Photo 1 Rust stains from lift holes in Span 7SB

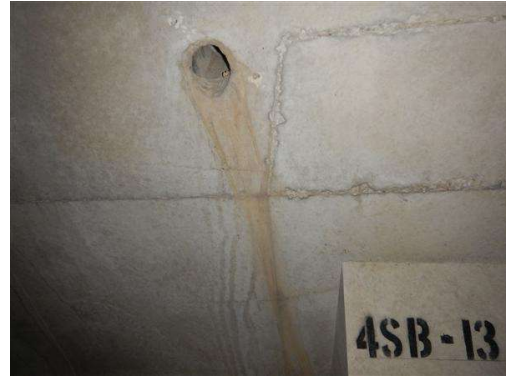
Photo 2 9" deep lift hole unfilled with rust stains in Span 4SB

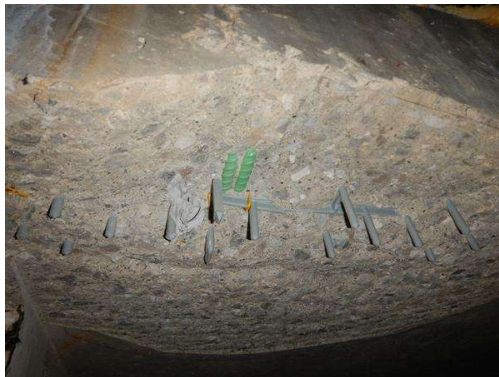
Photo 3 Spall with exposed reinforcement at the expansion joint in Span 8SB looking South

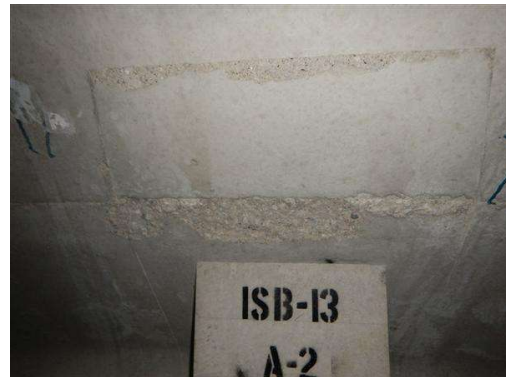
Photo 4 Spall in the top flange over PT block in Span 1SB looking Northwest

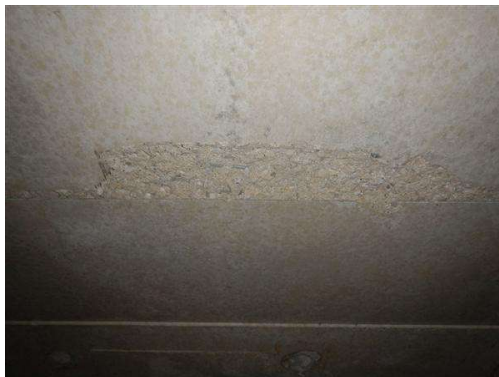
Photo 5 Spall (30"x6"x0.5") on the top flange/ceiling in Span 16SB

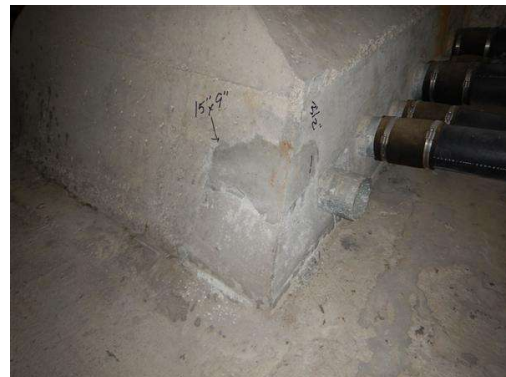
Photo 6 Unsound concrete patches at the base of the deviator wall in Span 9SB looking Southwest

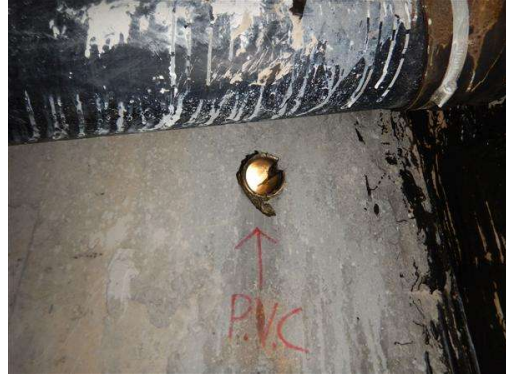
Photo 8 PVC pipe in the web in Span 22SB looking West

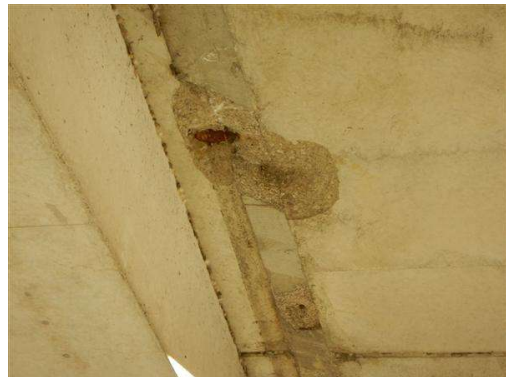
Along the exterior web and bottom flange/slab, several delaminated and spalled patches were noted along the length of the bridge. Some of the concrete spalls had exposed reinforcement. See Photos 9 through 14.

Photo 10 Spall with exposed reinforcement in the cantilever portion of Span 25SB looking East

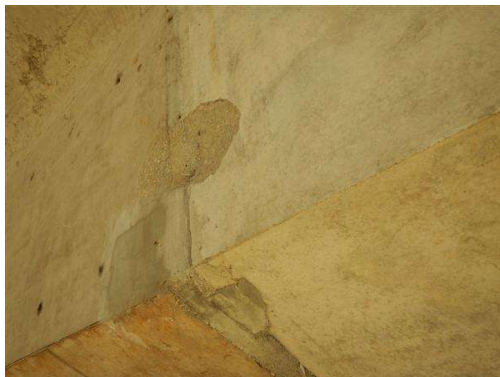
Photo 11 Spall in the East web between Segments 1 and 2 in Span 25SB

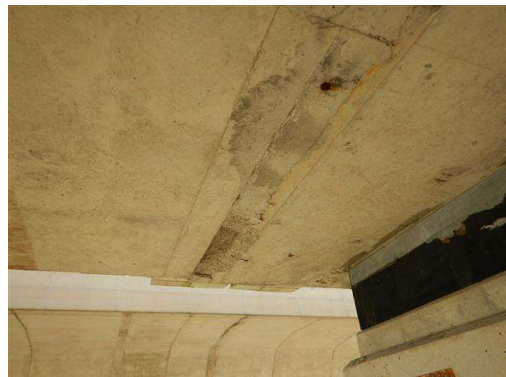
Photo 12 Spall in the bottom flange closure pour between Segments 1 and 2 in Span 24SB

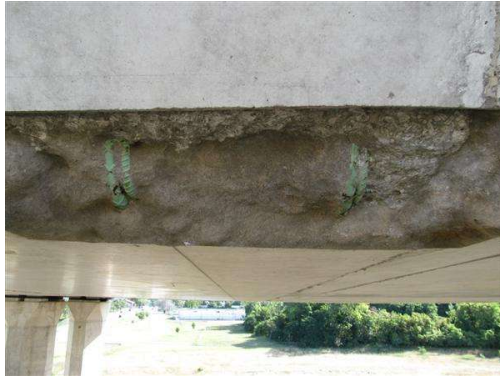
Photo 13 Spall with exposed reinforcement in the bottom flange between Segments 9 and 10 in Span 17SB

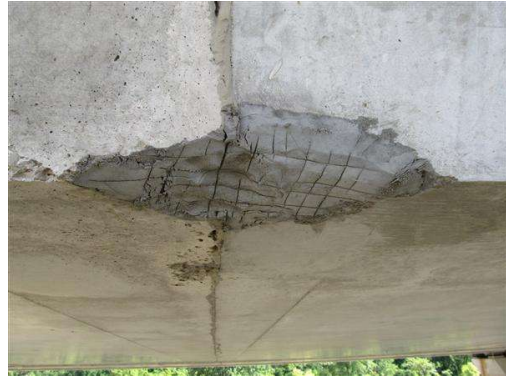
Photo 14 Poor patch on the bottom flange between Segments 9 and 10 on east side of Span 14SB

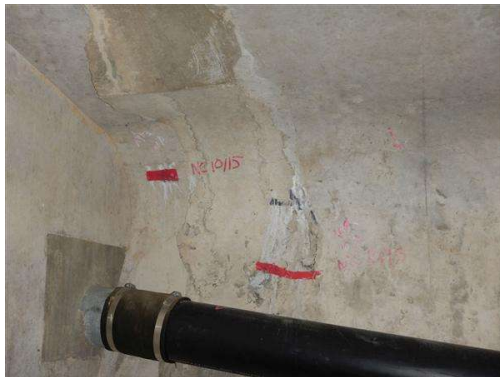
Longitudinal hairline to moderate cracking was present along both interior and exterior corner edges between the web and top flange/slab of a majority of segments. These cracks varied in length and were typically 0.005" to 0.030". See Photo 15. Additionally, hairline vertical and longitudinal cracks were present along the interior and exterior webs and bottom flange/slabs of the box segments over the length of the bridge. See Photos 16 through 19.

Photo 15 Cracks with efflorescence in the web to top slab corner in Span 8SB looking East

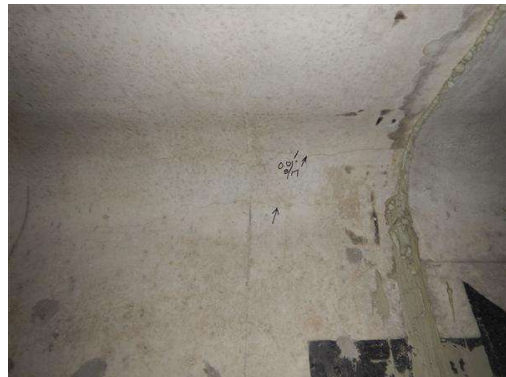
Photo 16 Typical interior upper corner web cracks

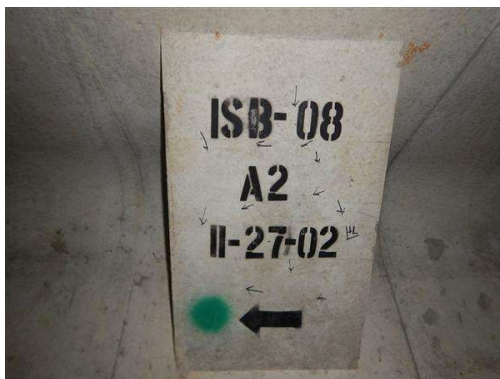
Photo 17 Typical map cracking on future PT blocks in webs

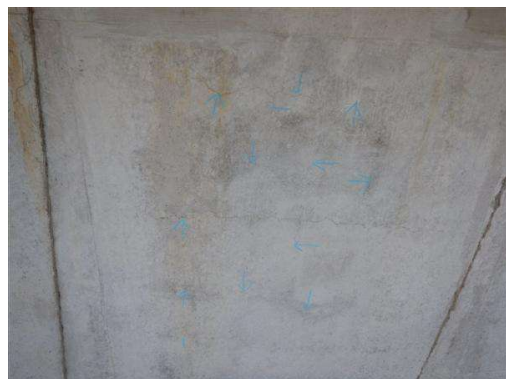
Photo 18 Typical hairline map cracking on the exterior webs along the length of the bridge

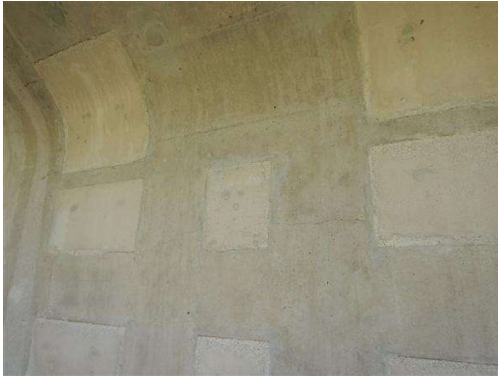
Photo 19 Longitudinal cracks in the West web closure pour in Span 8SB looking East

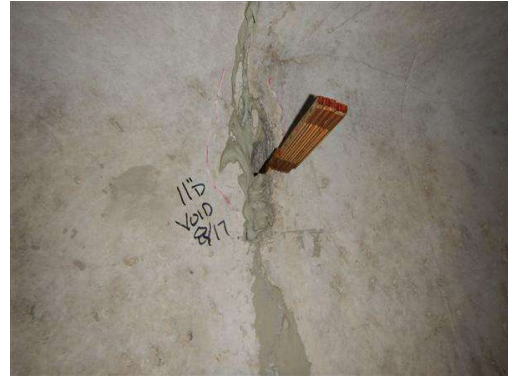
Voids were present in the segment construction joints, both interior and exterior, varying size and depth. Some of the voids were observed to be up to 11" deep. See Photo 20. In the Span 21SB, a 5" deep void with exposed reinforcement was observed. See Photo 21. Spalls and delaminated areas were noted throughout the interior and exterior of the segments in the pier segment closure pours and the future exterior stressing blocks located at the top of the webs and along the floor slab. See photos 22 and 23. In the Span 15SB, a spall was observed on the edge of a future floor slab PT block. See Photo 24.

Photo 20 11" deep void in the interior construction joint in Span 14SB

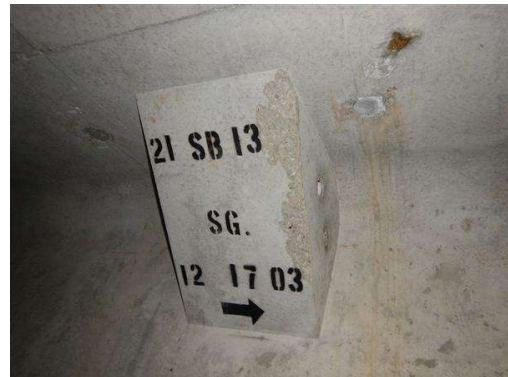
Photo 22 Typical spalls in the future PT blocks

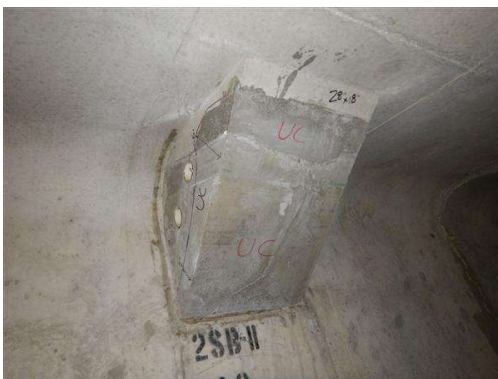
Photo 23 Delaminated concrete patches on future PT block in Span 2SB looking West

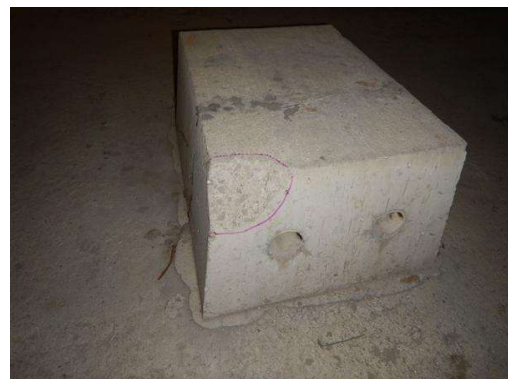
Photo 24 Spall on floor slab PT block in Span 15SB looking North

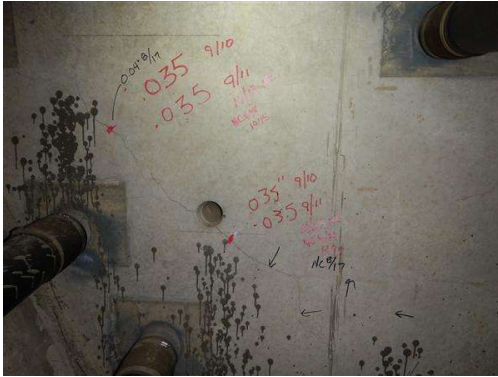
The interior diaphragms exhibited typical hairline to moderate vertical and map cracking ranging from 0.005" to 0.04" in width. Efflorescence was noted at some locations although these areas did not appear to be active. Additionally, several diaphragms had areas of delaminated concrete on the vertical faces. See Photos 25 and 26. At Span 25SB, the floor strut diaphragm on the North face had concrete spalls with exposed reinforcement. See Photo 27.

Photo 25 Map cracking on the vertical face of diaphragm at Pier 2SB looking North

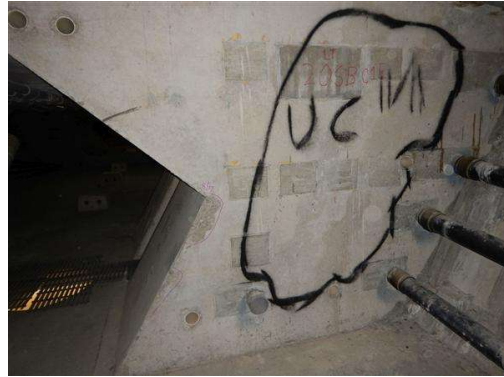
Photo 26 Delaminated concrete area in the vertical face of the diaphragm at Pier 20SB looking South

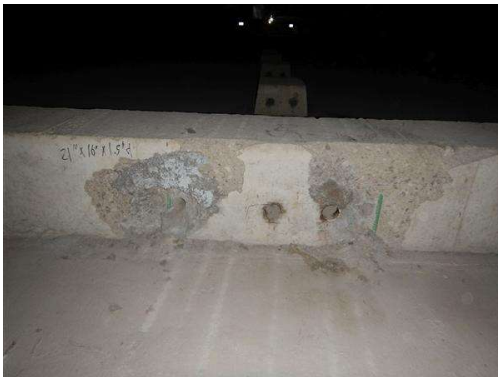
Photo 27 Spall with exposed reinforcement on the North face of bottom strut diaphragm in Span 25SB looking South

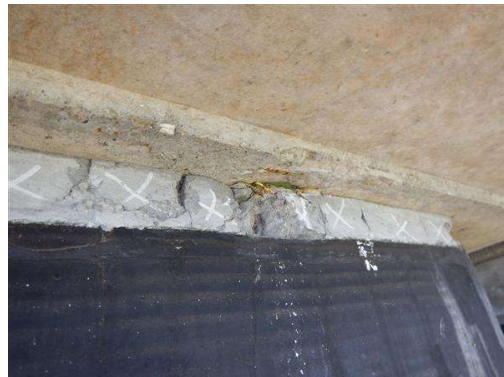
The plinths of Piers 2SB, 3SB, 9SB, 13SB, 14SB, 23SB and Abutment 1SB exhibited areas of unsound, spalled or delaminated concrete with moderate to severe cracking in over 5% of the bearing area. See Photo 28. The Southeast bearing at Pier 9SB had efflorescence in the plinth and rust in the bearing plate. See Photo 29. At Pier 3SB, the Northwest bearing was shifted 4" to North and the Northeast bearing was shifted 4.5" to North. A concrete spall of 24"x4"x1" was observed in the Northwest bearing pedestal. See Photo 30. At Pier 20SB, the Northwest bearing was shifted 17" to the South and 1" to the North. See Photo 31. At Pier 26SB, the Northeast bearing was shifted 7.5" to North and 16" South while the West bearing was shifted 7.5" North. See Photo 32. Additionally, the East and West bearings were tilted 0.25" to the West.

Photo 28 Spalls and delaminated concrete in the East bearing plinth at Pier 9SB

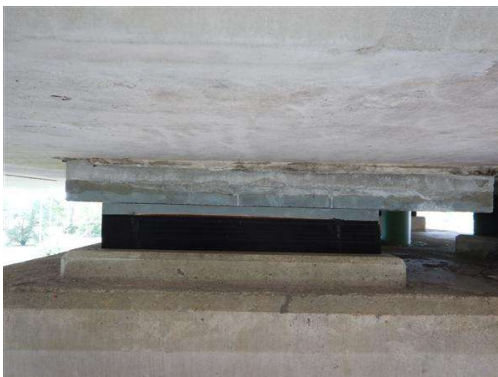
Photo 29 Rust on bearing plate and efflorescence in the plinth of the Southeast bearing East face at Pier 9SB

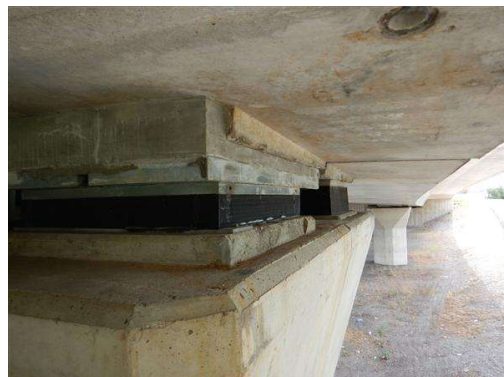
Photo 30 Spall in the West bearing pedestal at Pier 3SB

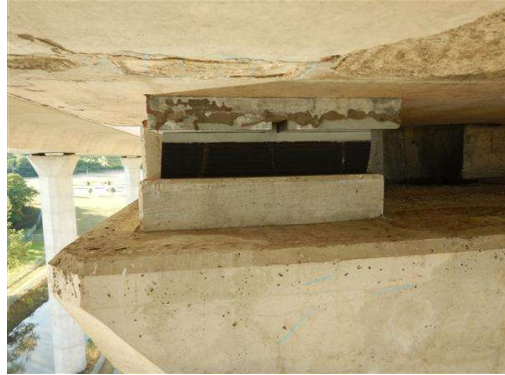
| Photo 32 | East bearing at Pier 26SB shifted 7.5" North |

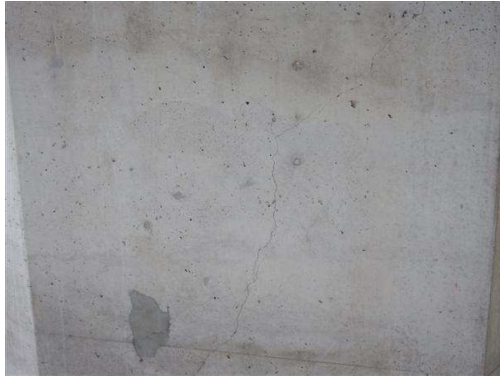
Typical hairline to medium (0.030") width vertical and map cracking areas were noted on the pier columns. See Photo 1. Concrete spalls at the edge of the construction joint were observed on a majority of the columns. See Photo 2. At Pier 15SB, multiple concrete popouts were observed in the column. See Photo 3. Honeycombed concrete areas were observed on a majority of the pier columns.

Photo 1 Typical cracking, efflorescence and rust staining on the pier columns

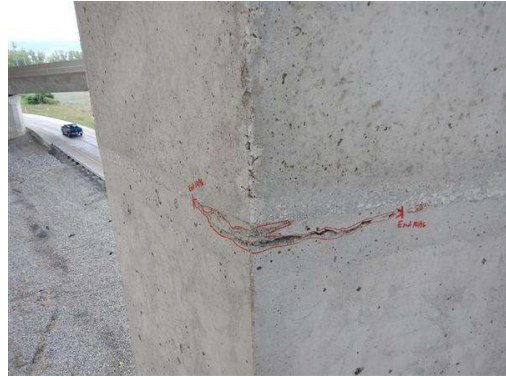
Photo 2 Spall at the construction joint of the column at Pier 13SB

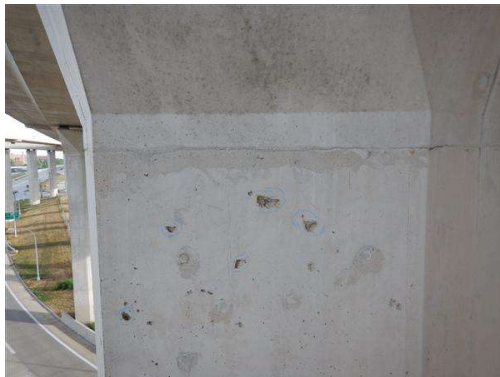
Photo 3 Concrete popouts at Pier 15SB

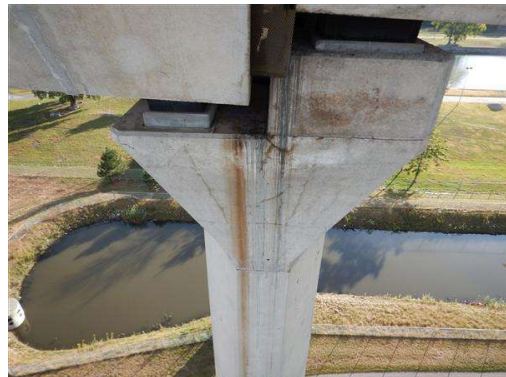
Typical hairline to medium (0.025") width vertical and map cracking with efflorescence areas were noted on a majority of the pier caps. See Photo 4. At some locations bird debris was noted on the pier cap. See Photo 5. At Pier 11SB, a concrete spall (36"x48"x5") with exposed reinforcement was observed. See Photo 6. Heavy rust on drainage pipe clamp was observed at Pier 16SB. See Photo 7.

Photo 4 Typical cracking, efflorescence and rust staining on the pier caps

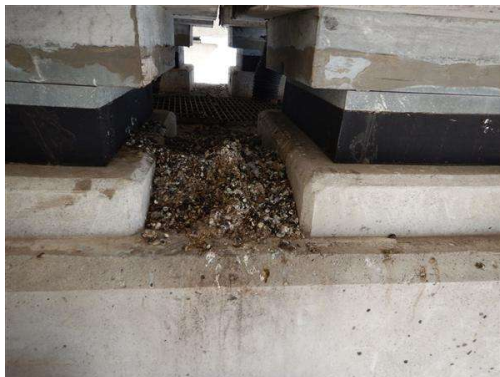
Photo 5 Bird debris on pier cap at Pier 18SB looking West

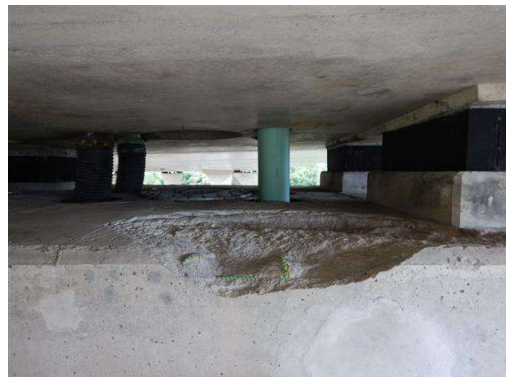
Photo 6 Spall (36"x48"x5") with exposed reinforcement at Pier 11SB

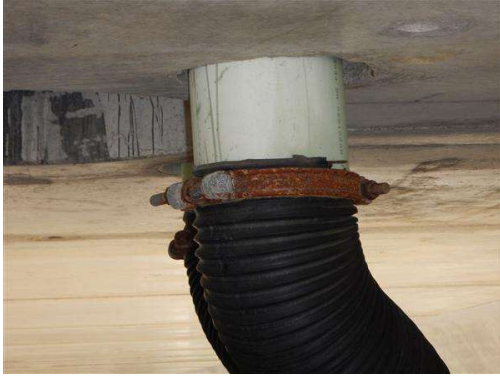
Photo 7

Heavy rust on drainage pipe clamp at Pier  
16SB looking South

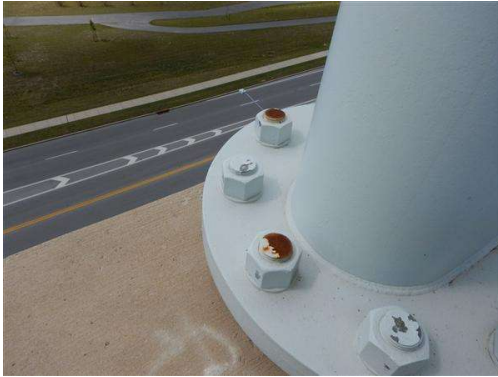
The sign supports were in good condition except the 2 bolts at the base of the sign post in Span 23SB that have started to rust.. See Photo 1.

Photo 1 Rusted bolts on the base of the West sign post in Span 23SB looking West

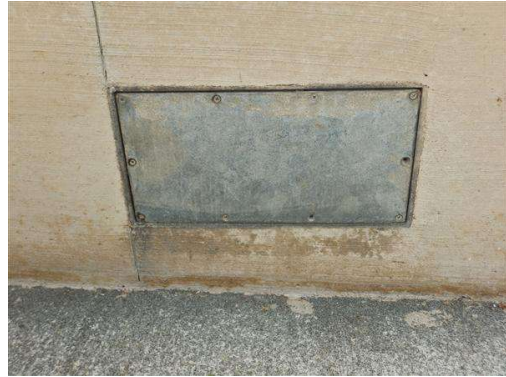
In Spans 5SB, 6SB, 8SB, 9SB and 11SB, screws were missing or loose on the junction box covers in West parapet. See Photo 2. In Span 23SB, the ground wire was disconnected at the base of the sign support. See Photo 3. Paint failure or defect to galvanized coating system of light poles on West parapet was commonly observed. See Photo 4.

Photo 2 Missing and loose screws in the electrical panel in Span 5SB

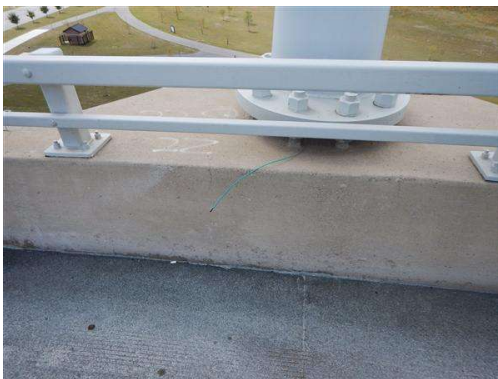
Photo 3 Disconnected grounding wire in Span 23SB

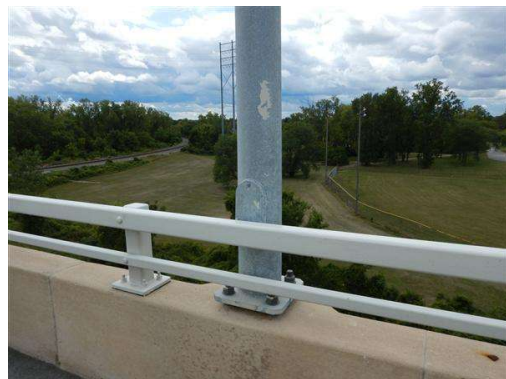
Photo 4 Paint or coating failure on electrical pole on west parapet in Span 8SB looking West

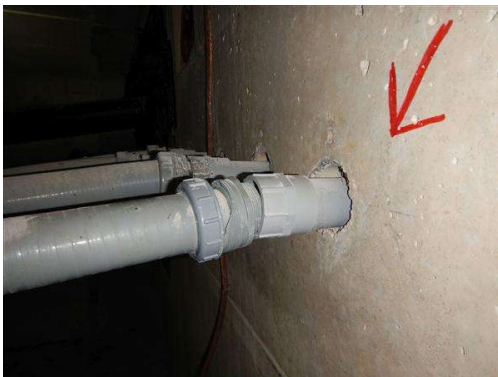
In Span 3, conduits were separated/broken in the interior electrical system. See Photo 5. Electrical conduit brackets were broken in Spans 3SB and 8SB. See Photo 6. In Span 13SB, a bolt was missing from electrical conduit strut. See Photo 7. An electrical conduit strut was loose in Span 25SB. See Photo 8. Loose grates were observed at multiple column access hole locations. See Photo 9. At Pier 25SB, the junction box was loose and the mounting tab was broken. See Photo 10.

Photo 5 Broken or separated electrical conduits in Span 3SB

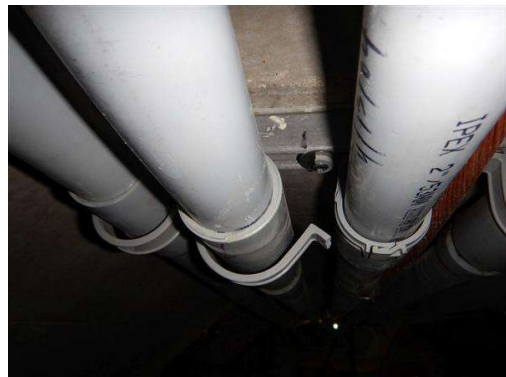
Photo 6 Broken electrical conduit bracket in Span 8SB looking South

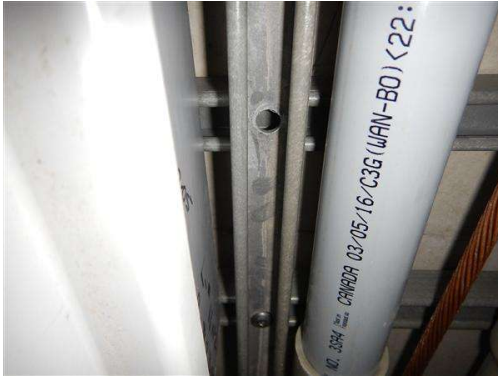
Photo 7 Missing bolt from electrical conduit strut in Span 13SB looking North

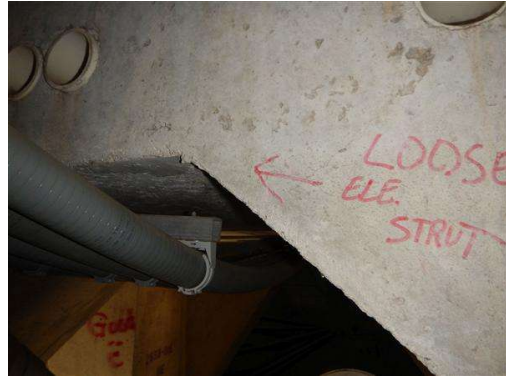
Photo 8 Loose electrical conduit strut in Span 25SB looking North

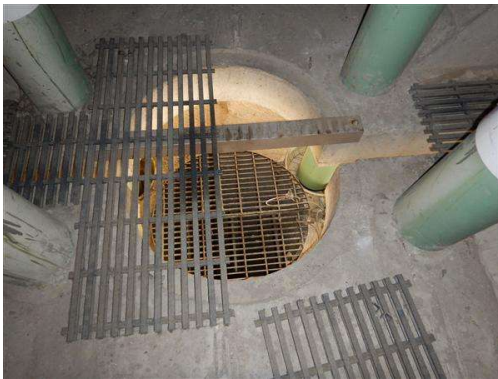
Photo 9 Loose grate at Pier 17SB

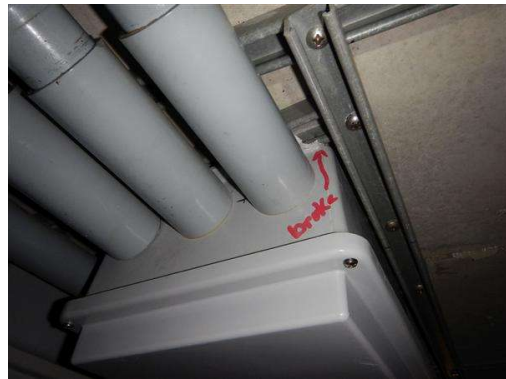
Photo 10 Loose junction box and broken mounting tab in Span 25SB looking North

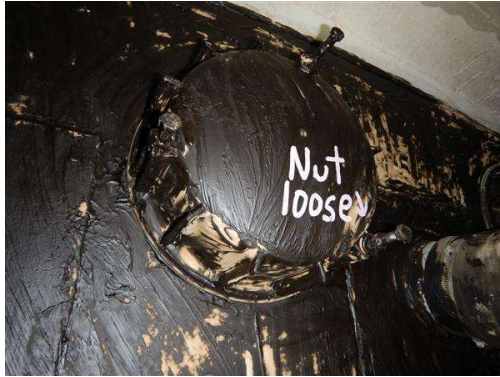
Numerous PT end cap locations were noted to have small void areas within the grout in the cap. These areas were determined and verified by gently tapping on the plastic end caps with a hammer. A few caps were observed to have loose/missing bolts connecting the cap with the duct at the diaphragm. See Photos 1 and 2.

Photo 1 Loose bolt on PT anchor head at Pier 12SB looking North

It is recommended that a form of NDT or ultrasound be utilized to determine the exact extent and accuracy of the voids. With the caps being covered with waterproofing material and being plastic, hollow areas within the cap were difficult to detect with certainty. In addition, the brittle nature of the material could lead to cracking of the end caps if struck too hard with a hammer.

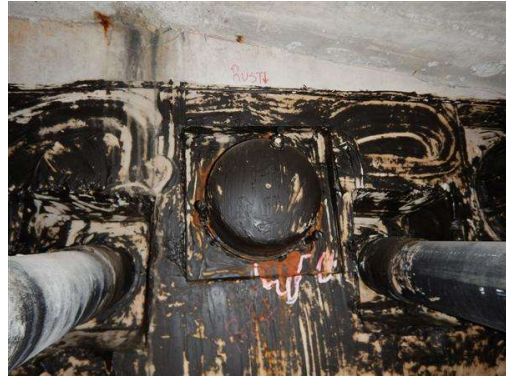
Photo 2 Voids and rust around the perimeter of the PT anchor cap at Pier 6SB looking South

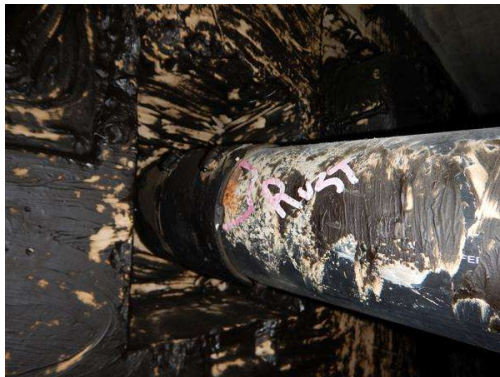
The external tendons were in good condition with minimal notable defects. A few areas of rusting were observed on the steel PT ducts at the diaphragm connections and clamps connecting the PTFE sheathing to the steel ducts. See Photo 3.

Photo 3 Rust on PT duct at Pier 3SB looking North

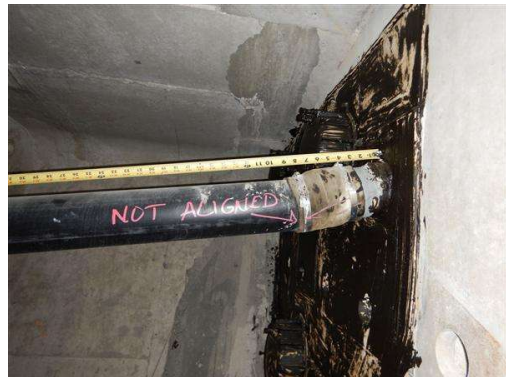
A couple of the exterior tendon couplers connecting sections of the sheathing together appeared misaligned slightly over the length of the bridge. See Photo 4. PT duct splices appeared to be soft, cracking and bulging at multiple locations. See Photo 5.

Photo 4 PT cable T3 not aligned at Pier 18SB looking East

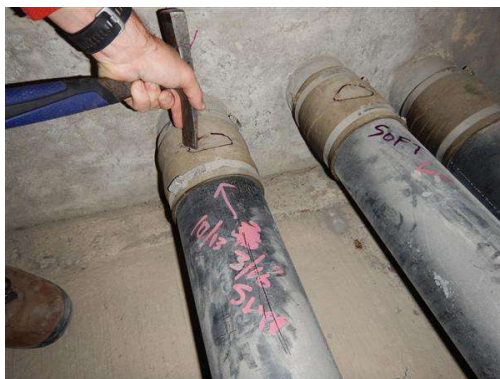
Photo 5 Soft PT duct splices at Pier 7SB looking South

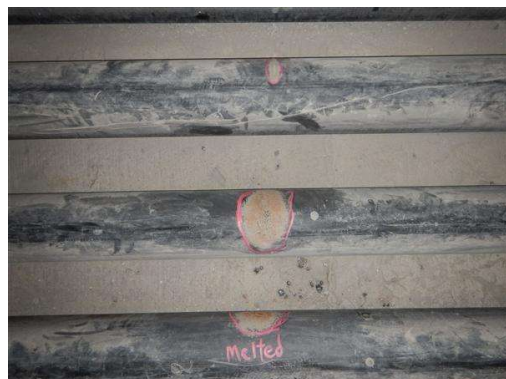
At Pier 23SB, the plastic ducts on the T2, T3, & T4 PT tendons was observed to be melted. See Photo 6

Photo 6 Plastic on PT duct appeared melted in Span 23SB
