STATE OF OHIO DEPARTMENT OF TRANSPORTATION  
BRIDGE INSPECTION REPORT

Inventory Bridge Number: LUC 00280 02.830 R

IR-280 over NSRR,RAMP Z FRONT ST.

Inspection Date: 09/17/2017

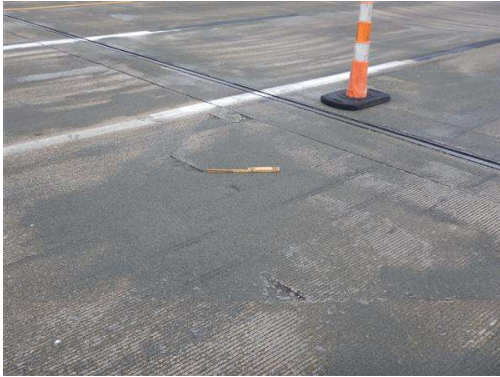
Three (3) spalls of varying size were noted in the approach slab. See Photo 1. Insignificant to moderate map cracks were observed throughout the approach slab. See Photo 2.

Photo 1 Concrete spalls of varying sizes in approach slab looking West

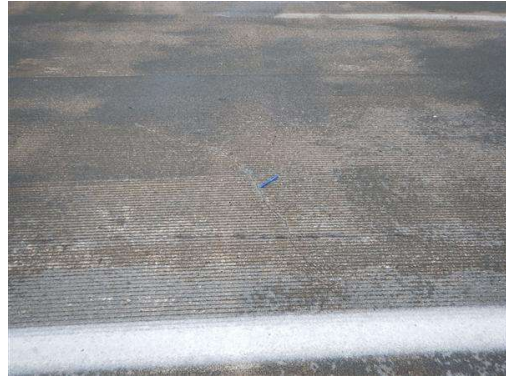
Photo 2 Moderate map cracks in the approach slab looking West

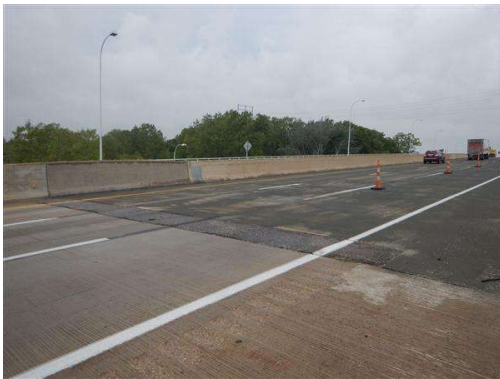
The relief joint was in fair condition with minor longitudinal cracks in the asphalt joint. Growing vegetation was observed on the East side of the joint. See Photo 3.

Photo 3 Growing vegetation on the East side of the relief joint looking West

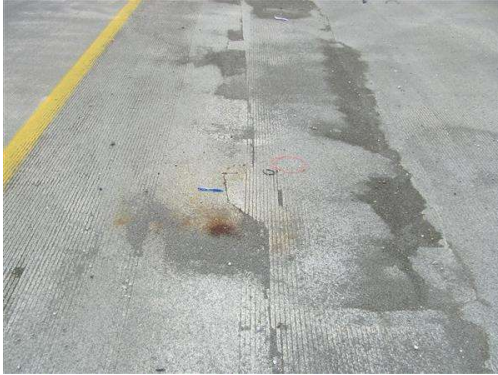
The Northbound South approach deck extends from Abutment 1NB (STA. 200+18.54) to Pier 26NB (STA. 233+62.50). The entire deck quantity is rated in this report. The longitudinal joint is rated in this report as per the 2016 inspection. Hairline to 0.030" wide transverse and map cracking, with efflorescent leaching in areas, was noted along the length of the longitudinal closure pour joint. See Photo 1.

Photo 1 Typical transverse closure pour joint cracking with efflorescence

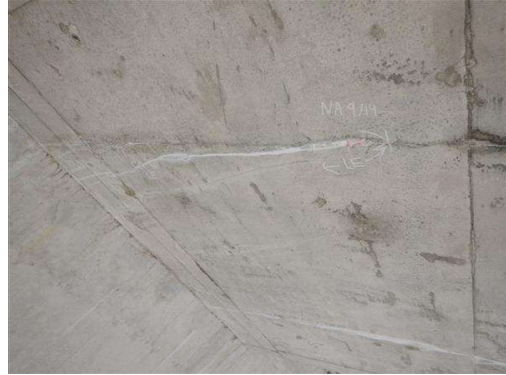
Numerous transverse closure pour joints in the top flange/deck displayed areas of cracking with heave efflorescence over the length of the bridge. See Photo 2.

Photo 2 Bottom of the deck slab closure pour transverse cracks with heavy efflorescence looking North

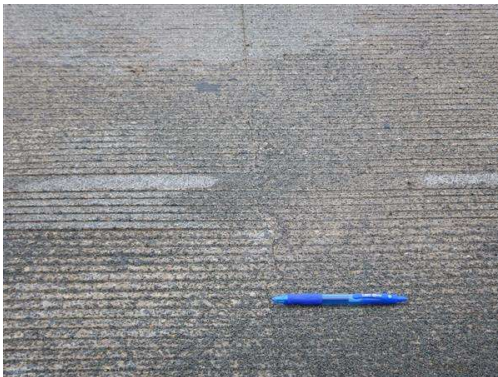
Areas of moderate transverse and map cracking (0.013" to 0.025") along the length of the bridge were observed. A majority of the transverse cracks were seen at the construction and expansion joints. See Photos 3 and 4. Numerous lift hole and deck patches with spalls and hairline cracks with discoloration around the perimeter were noted along the length of the bridge. See Photos 5 through 7. These patches and cracks appeared to be reflective and were present in the wearing surface.

Photo 3 Transverse cracks at the construction joint between Spans 1NB and 2NB

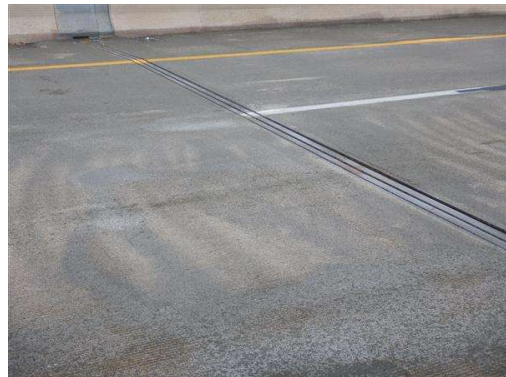
Photo 4 Transverse cracks at the expansion joint between Spans 8NB and 9NB looking West

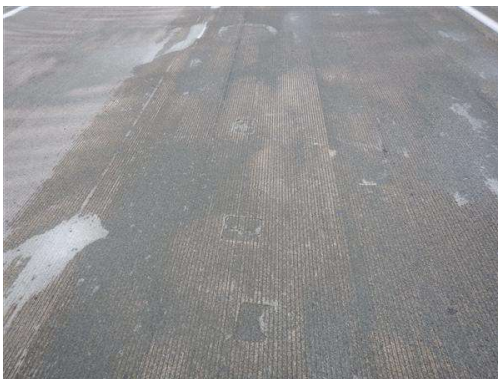
Photo 5 Concrete patches with map cracking around the perimeter between Spans 1NB and 2NB

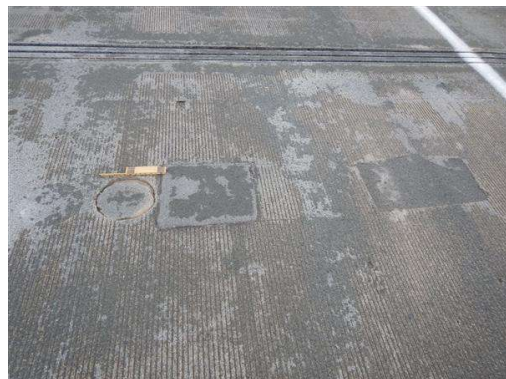
Photo 6 Depressed concrete patch with discoloration around perimeter between Spans 1NB and 2NB

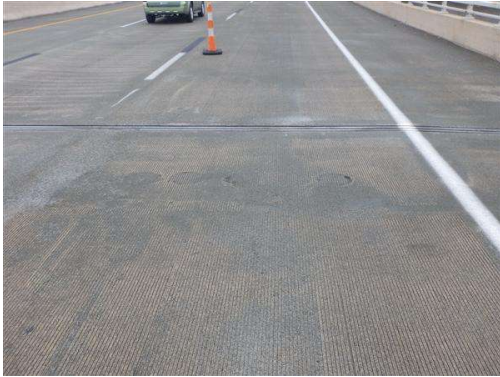
Photo 7 Lift hole patches with spall between Spans 8NB and 9NB

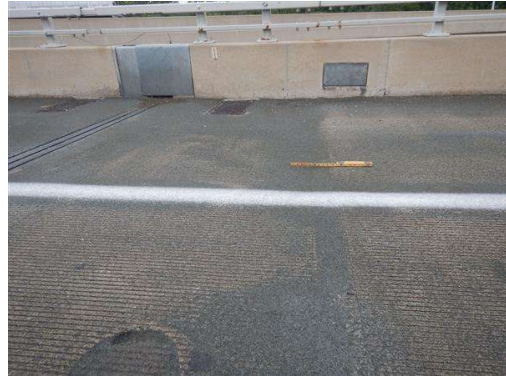
At a few locations, the deck was noted to not provide a smooth riding surface. See Photo 8. Signs of scaling and advanced deck wear were observed throughout the structure. See Photos 9 and 10.

Photo 8 Deck discontinuity between segments and not smooth riding surface between Spans 8NB and 9NB

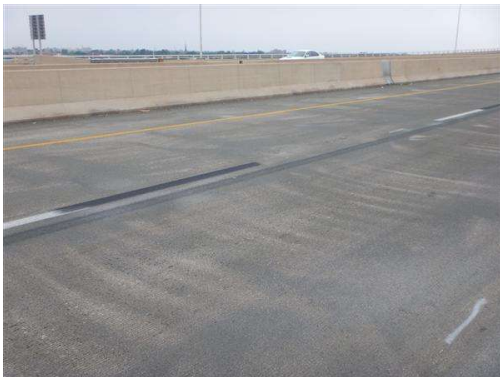
Photo 9 Scaling of the deck surface between Spans 19NB and 20NB looking West

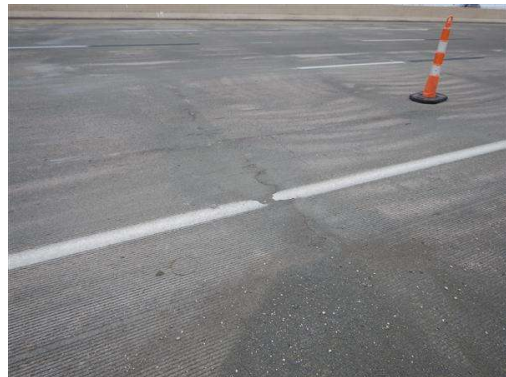
Photo 10 Deck surface worn out between Spans 14NB and 15NB looking West

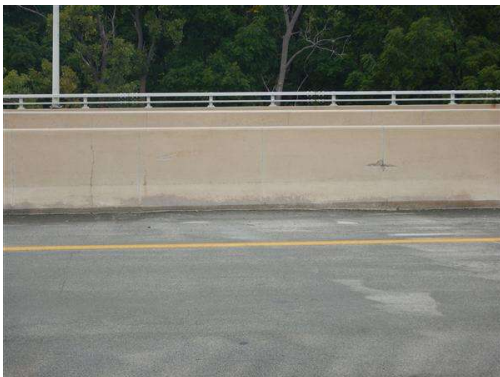
Typical areas of hairline and map cracking were noted along the length of the parapet on both sides of the roadway. See Photos 11 and 12.

Photo 11 Typical vertical cracks and spall in West parapet of Span 4NB looking West

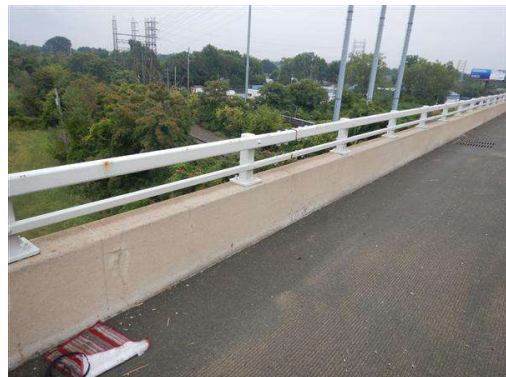
Photo 12 Typical vertical and horizontal cracks in the East parapet of Span 5NB looking East

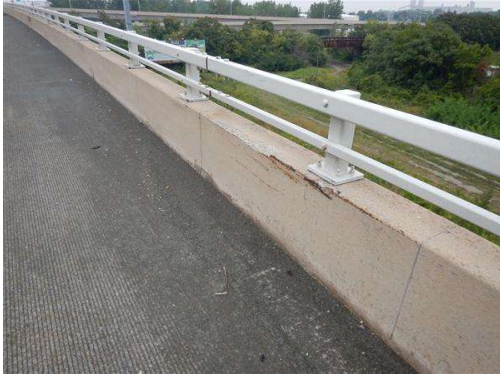
Spalls and minor rust stains were noted on the parapet due to a collision in Span 3. See Photo 13. Delaminated/spalled concrete (26"x1.5") was observed in Span 9. See Photo 14. Minor rust and section loss in the steel railing was noted along the length of the bridge. See Photo 15.

Photo 13 Collision damage (2.5' long) on East parapet of Span 3NB looking Northeast

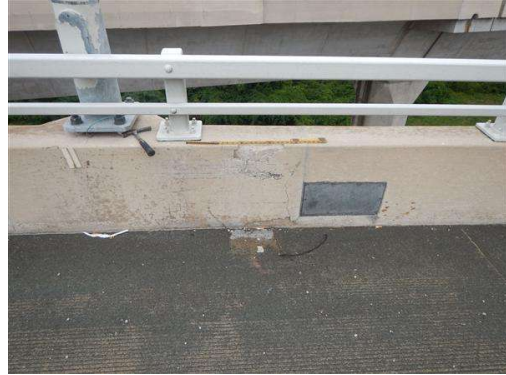
Photo 14 Delaminated/spalled concrete (26"x2.5") in Span 9NB of East parapet looking East

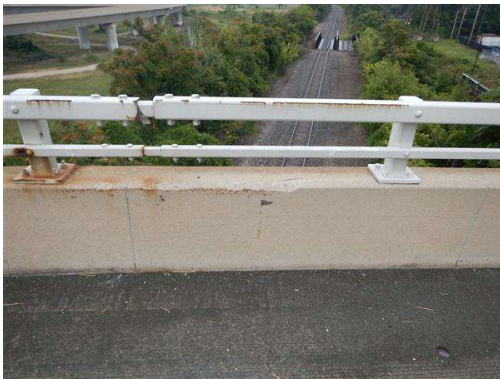
Photo 15 Minor rust and section loss in the steel railing in Span 5NB looking East

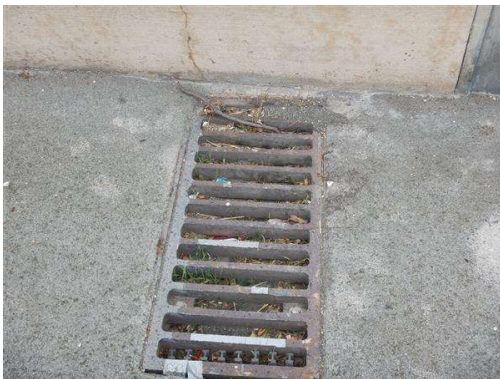
A moderate amount of debris was observed in a majority of the scuppers at the deck level, some of which had vegetation growing. Most of the scuppers appeared to be partially or fully filled and not serving their intended purpose. See Photos 16 and 17.

Photo 17 Scuppers fully clogged with debris in Span 22NB

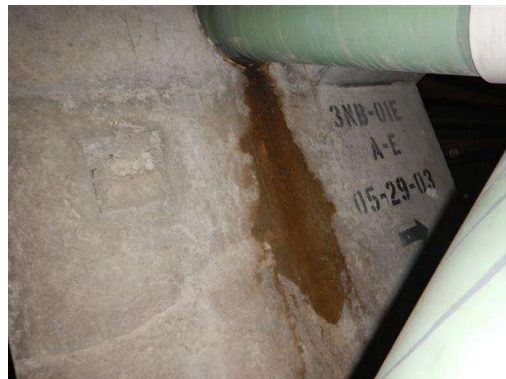
The interior drainage pipes at Pier 3NB exhibited leakage with rust stains. See Photo 18.

Photo 18 Interior drainage pipe with rust staining at Pier 3NB

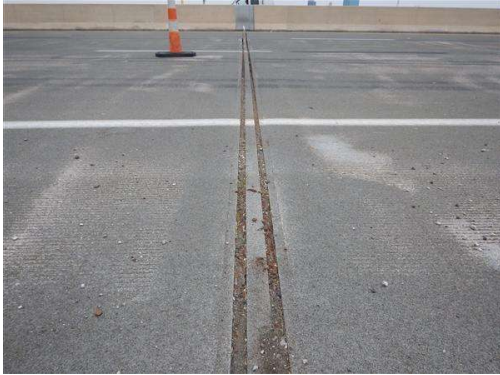
| Photo 19 | Expansion joint at Pier 20NB filled with debris and growing vegetation looking West |

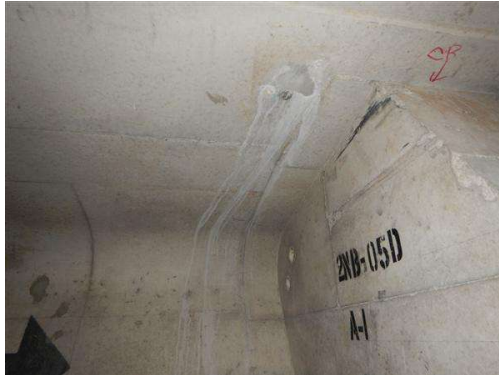
Numerous areas of delaminated or unsound patches were observed in the lift holes at the top flange/slab along the edges of the interior of the segments. A majority of these areas exhibited efflorescence over the length of the bridge. See Photos 1 and 2. Other patches and construction joints in the interior exhibited delaminated and spalled concrete. At multiple locations, temporary jacking blocks were removed, exposing reinforcement. These areas were painted, but not patched. See See Photos 3 through 8.

Photo 1 Efflorescence leaching from lift holes at 2NB looking West

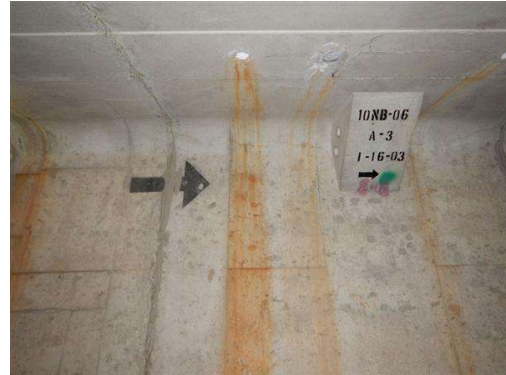
Photo 2 Rust stains at lift holes at 10NB looking West

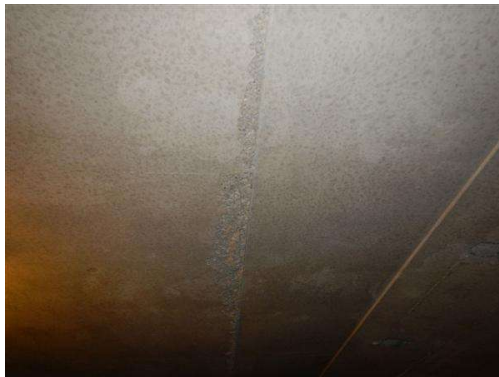
Photo 3 Spall along the construction joint in top flange in Span 3NB looking North

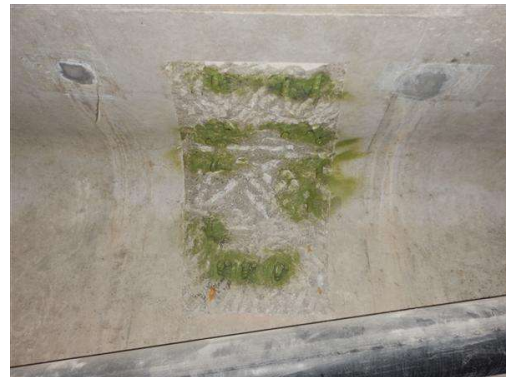
Photo 4 Temporary jacking block removed exposing reinforcement and no patch in Span 15NB looking East

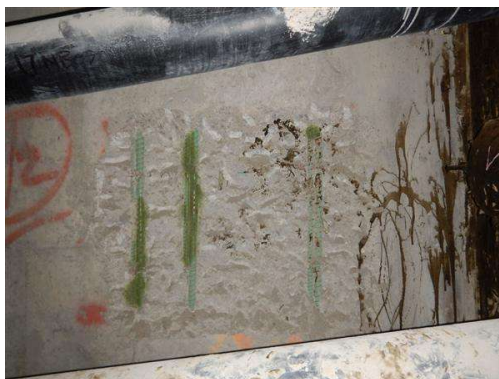
Photo 5 Spall (3'x3'x3") in web exposing reinforcement in Span 17NB looking East

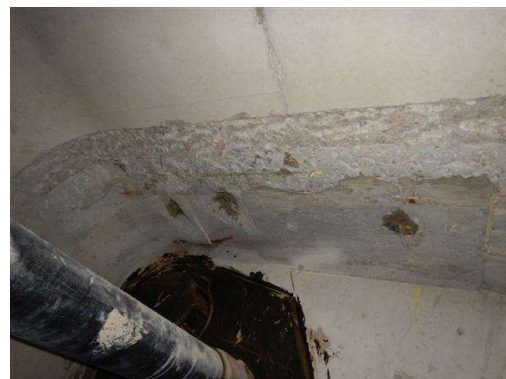
Photo 6 Full width spall in top flange in Span 17NB looking South

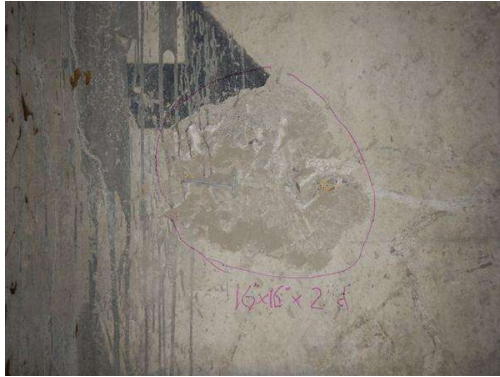
Photo 7 Spall (16"x16"x2") in web in Span 19NB looking West

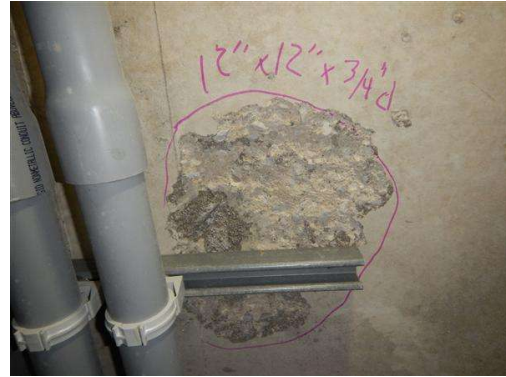
Photo 8 Spall (12"x12"x0.75") in top flange of Span 22NB

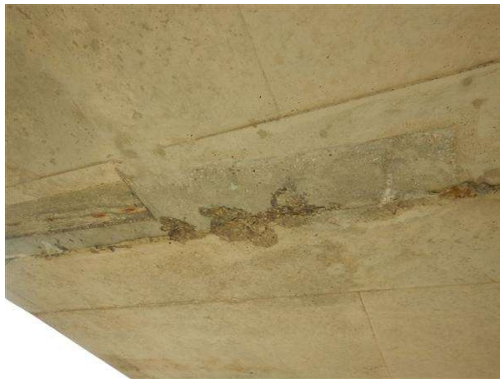
Along the exterior of the web and bottom flange, several delaminated and spalled areas with exposed reinforcement were noted along the length of the bridge. See Photos 9 through 12. The exterior pier PT end segments exhibited vertical and map hairline cracking, some with efflorescence and rust staining, at multiple locations.

Photo 9 Spall (4'x 8"x1") with 0.01" crack in the bottom flange of Spans 21 NB and 22NB

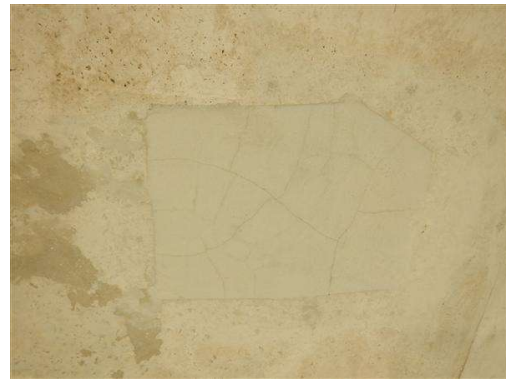
Photo 10 Concrete patch with map cracks in the bottom flange of Spans 21NB and 22NB

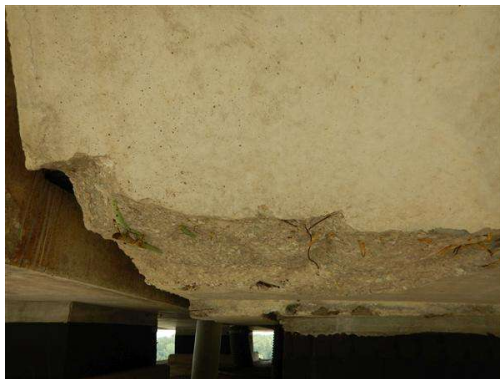
Photo 11 Spall (3'x28"x4") with exposed reinforcement in the bottom flange of Spans 22NB and 23NB

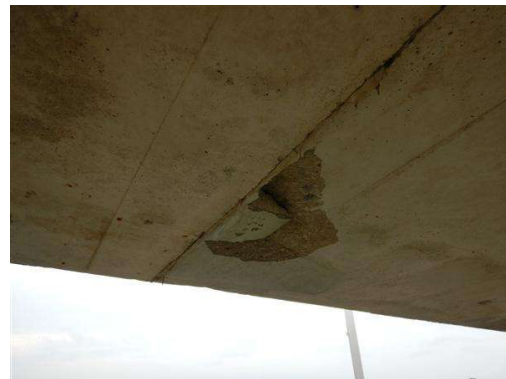
Photo 12 Spall (20"x15"x2") with exposed reinforcement in bottom flange of Spans 24NB and 25NB

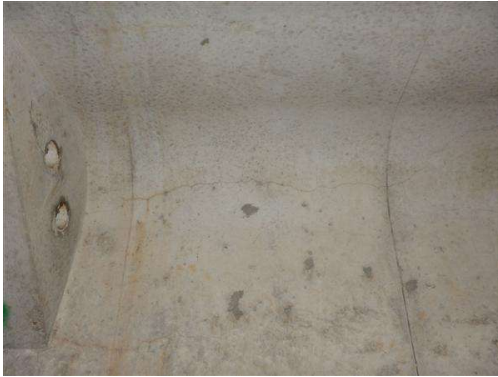
Longitudinal hairline to moderate cracking was present along both interior and exterior corner edges between the web and the top flange/slab of a majority of segments. These cracks varied in length and were typically between 0.05" and 0.030" in width. At some locations, these cracks exhibited leaching efflorescence. See Photos 13 and 14.

Photo 13 Longitudinal cracks in web in Span 9NB looking East

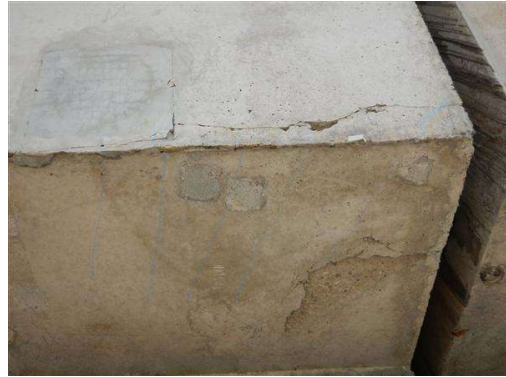
Photo 14 Longitudinal crack with concrete popout in the web at Pier 23NB

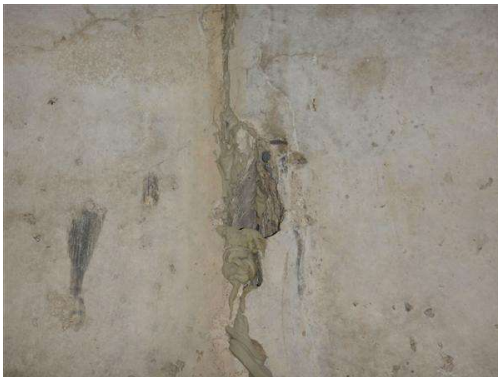
Voids were present in the segment construction closure joints, both interior and exterior, varying in size and depth. Some of the voids were observed to be 19" deep. See Photos 15 through 17. Spalls and delaminated areas were noted throughout the the interior and exterior of the segments and on future stressing blocks located on the webs and along the floor slab. See Photos 18 through 20. At a few locations, exposed reinforcement in the bottom flange/slab was noted in the interior of the box segments. See Photo 21.

Photo 15 10 inch deep void in web of Span 12NB looking East

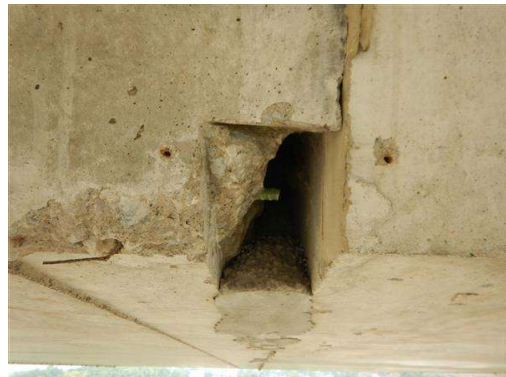
Photo 16 Void (15"x3.5"x6") in the bottom flange of Spans 21 NB and 22NB

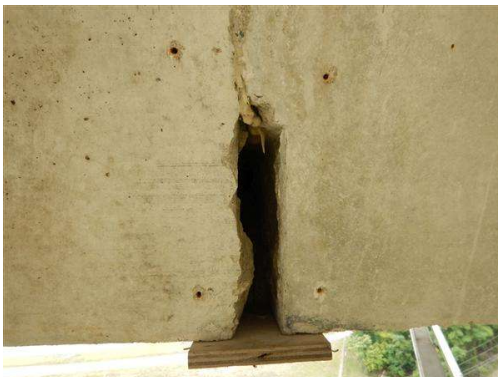
Photo 17 Void (19" deep) at the construction joint between Spans 23NB and 24NB

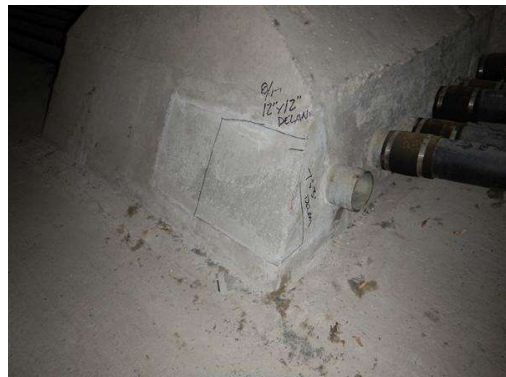
Photo 18 Delamination (12"x12") in the deviator wall of Span 5NB looking Southwest

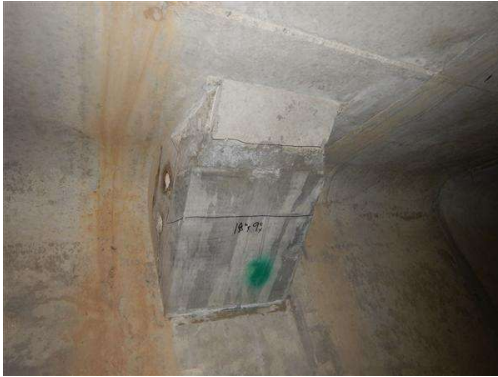
Photo 19 Delamination (18"x18") and spall (6"x6"x1") in web exterior PT block in Span 10NB looking East

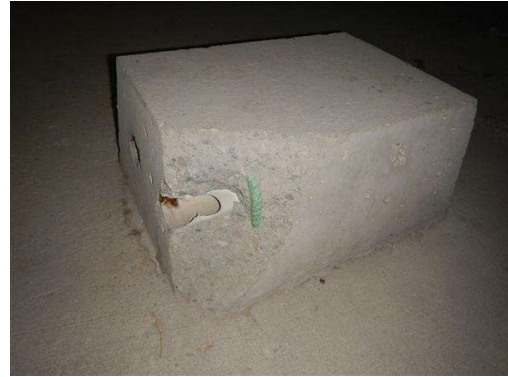
Photo 20 Spall with exposed reinforcement on future PT block in Span 21NB looking East

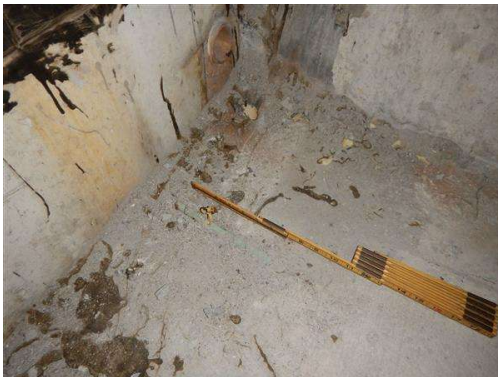
Photo 21 Exposed reinforcement on the floor of Span 18NB looking Northeast

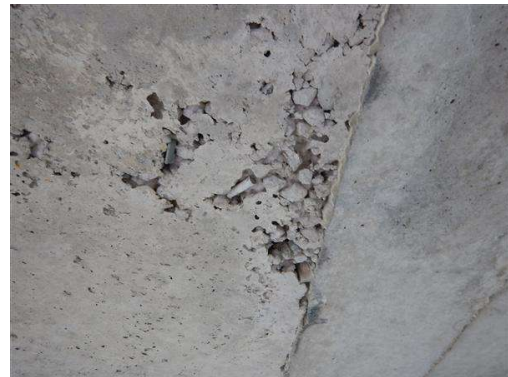
Small areas of honeycombed concrete were also noted on the interior and exterior of the segments along the length of the bridge. See Photo 22.

Photo 22 Honeycombed concrete in the bottom flange of Spans 6NB and 7NB

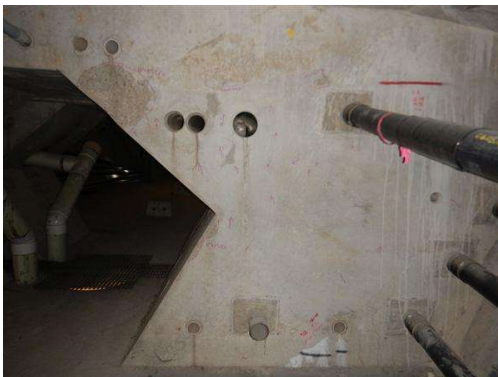
The interior diaphragm vertical faces exhibited hairline to moderate cracking (0.005" to 0.030") in width. Efflorescence and discoloration were present at some locations, although these areas did not appear to be active. See Photos 23 and 24. The PT concrete end block at Pier 15NB had a spall with exposed reinforcement. See Photo 25.

Photo 23 Map cracking (0.005" to 0.030") in the diaphragm in Span 10NB looking North

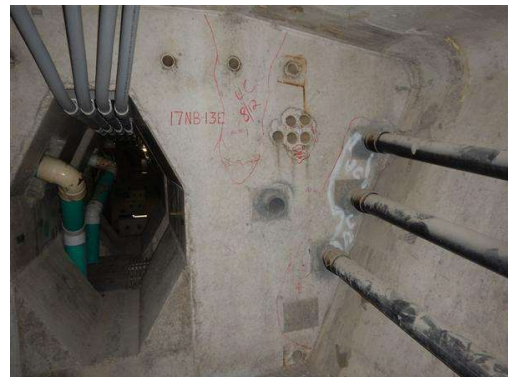
Photo 24 Delaminated concrete patch (12"x39") and map cracking in diaphragm in Span 17NB looking North

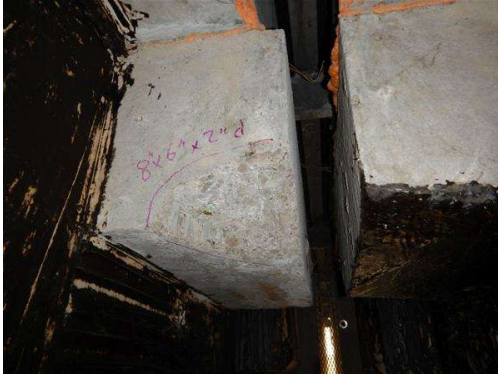
Photo 25 Spall with exposed reinforcement in the PT concrete end block in Span 15NB looking West

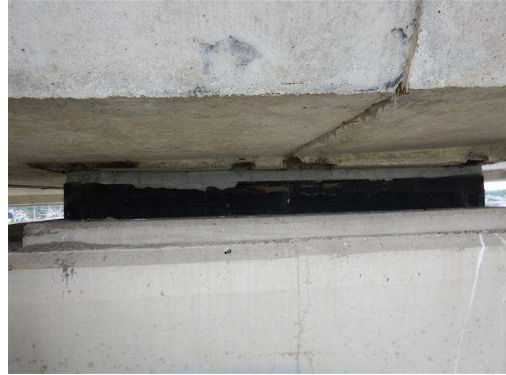
The plinths at Piers 9NB, 11NB, 19NB and 24NB exhibited areas of unsound, spalled or delaminated concrete and moderate to severe cracking in over 5% of the bearing areas. See Photo 26.

Photo 26 Four (4) spalls in the plinth at Pier 24NB

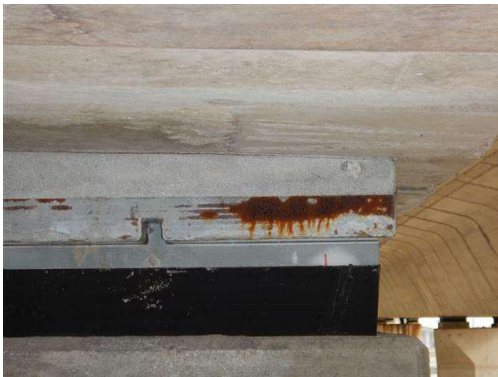
The bearings at Piers 10NB and 14NB had areas of rust over a 6" in length. The East bearing at Pier 11NB had efflorescence on the load plate. See Photos 27 and 28.

Photo 27 Rust on the East bearing plate at Pier 14NB

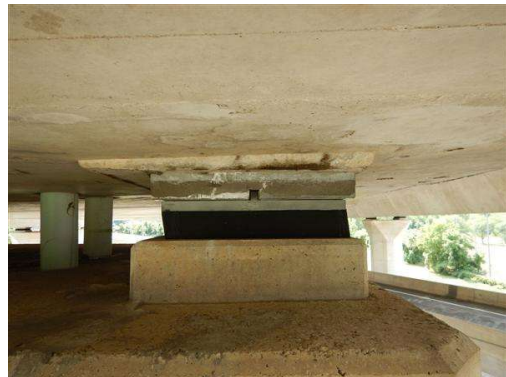
Photo 28 Efflorescence on the plinth and bearing plate at Pier 11NB East bearing

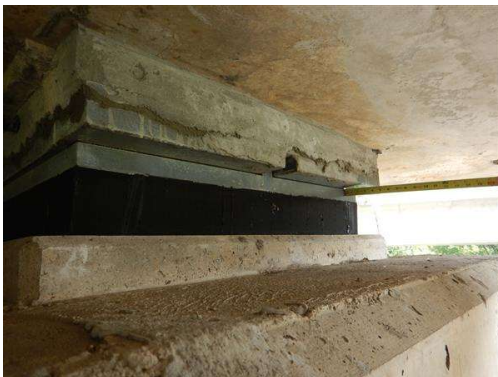
The East bearing at Pier 9NB was noted to be shifted 3" South and the West bearing was observed to be shifted 2" South. At Pier 11NB, the East bearing was bulging out to the North. See Photos 29 and 30.

Photo 29 East bearing shifted 3" South at Pier 9NB looking East

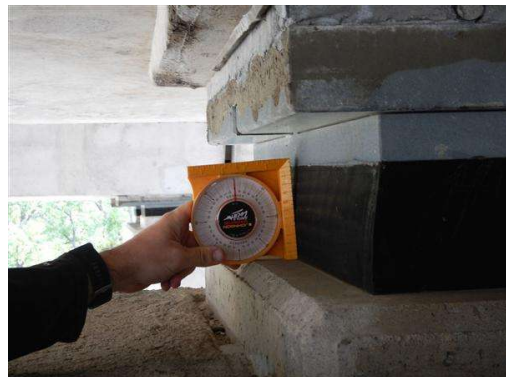
Photo 30 East bearing bulging out North at Pier 11NB looking West

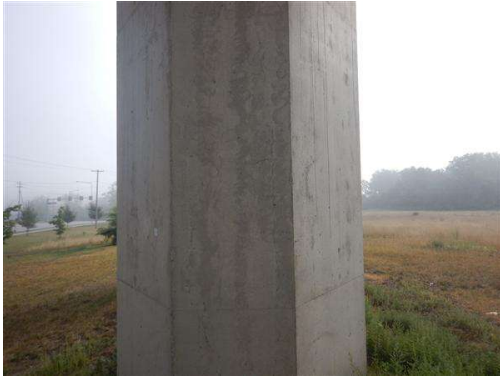
Typical hairline to moderate vertical, horizontal and map cracking was present on a majority of the pier columns. A few small spalls were noted in the pier columns. Minor honeycombed concrete was typical at a majority of the columns as well. See Photos 1 through 3.

Photo 1 Vertical cracks in the column at Pier 19NB

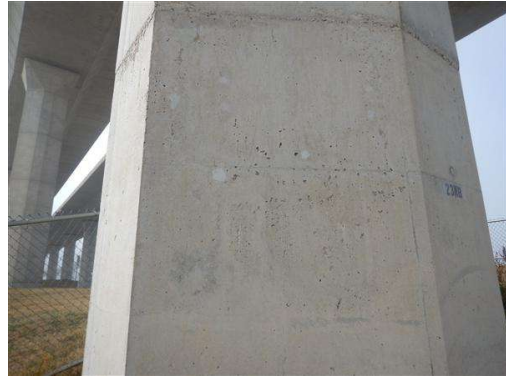
Photo 2 Typical honeycombing on a majority of columns

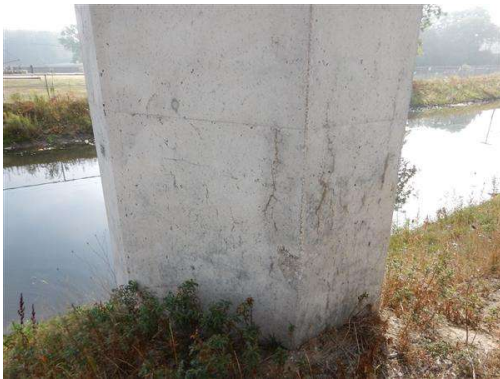
Photo 3 Spall and map cracking at Pier 25NB

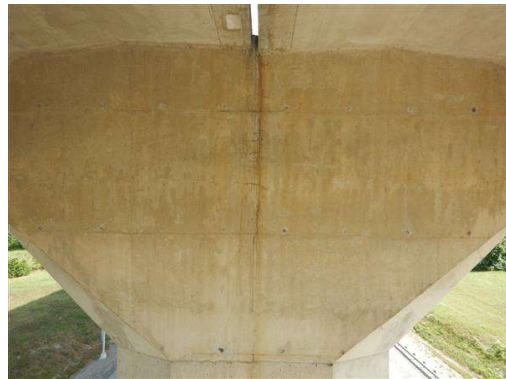
Typical hairline to moderate (0.050") width vertical and map cracks were noted in the pier caps. Wider cracks, vertical and ,ap, were noted in the hammerhead caps at Piers 4NB through 8NB. See Photos 4 and 5. At some locations, bird debris was observed on the pier caps. Heavy rust on the drainage pipe clamp was noted at Pier 16NB. See Photos 6 and 7.

Photo 4 Typical hairline to moderate cracking with rust staining or efflorescence on pier caps

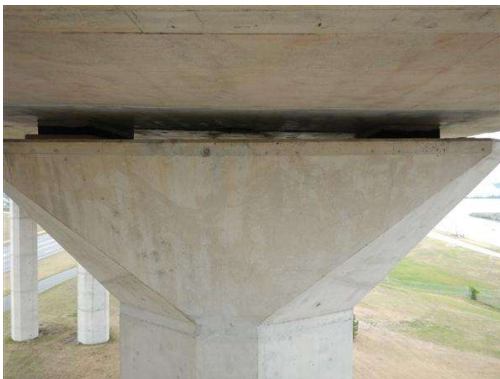
Photo 5 Hairline to moderate map cracks on the South face of Pier 21NB

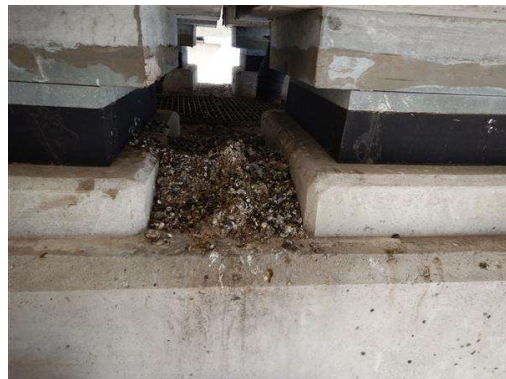
Photo 6 Bird debris on the cap at Pier 18NB looking West

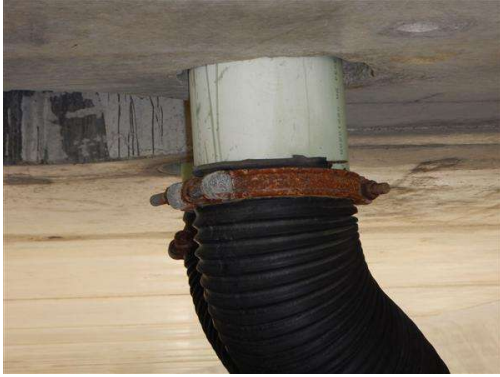
Photo 7

Heavy rust on drainage pipe clamp at Pier  
16NB looking South

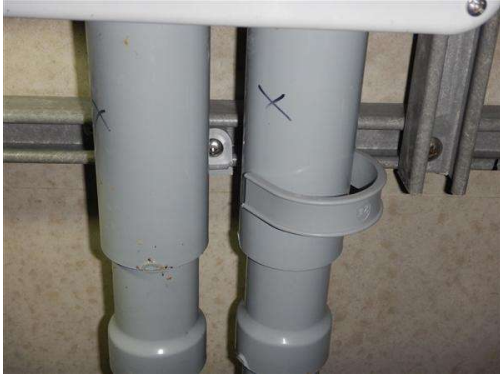
An electrical conduit bracket was broken at Pier 1 NB. See Photo 1.

| Photo 1 | Broken electrical conduit bracket at Pier 1NB |

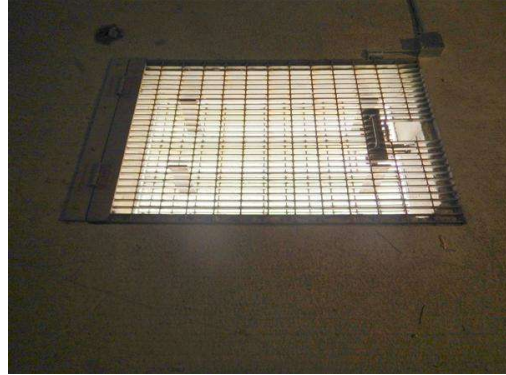
| Photo 2 | Access hatch not tied down at Pier 3NB |

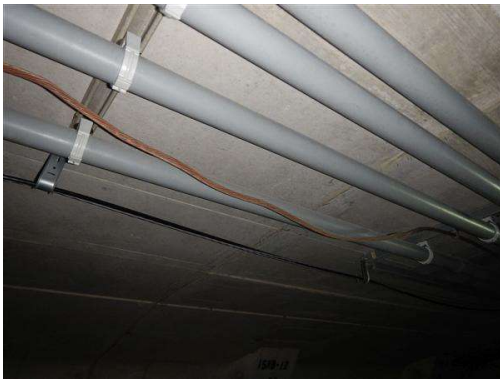
| Photo 3 | Ground cable is hanging at Pier 15NB |

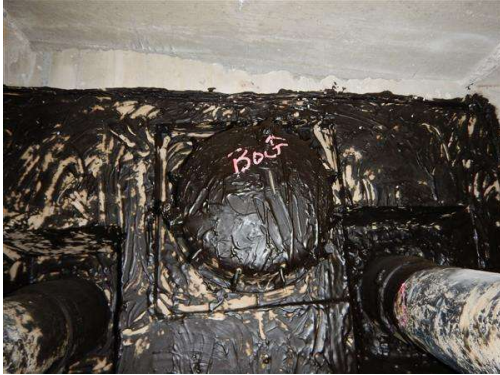
Numerous PT end cap locations were noted to have small voids within the grout cap. These areas were identified and/or verified by gently tapping on the plastic end caps with a hammer. A few caps were observed to have missing bolts connecting the cap with the duct at the diaphragm. Several locations had rust on the tendon ducts. See Photo 1.

Photo 1 Bolt missing and rust on tendon duct at PT anchor cap at Pier 3NB looking North

It is recommended that a form of NDT be utilized to determine the exact extent and accuracy of the voids. With the caps being covered with waterproofing material and being plastic, hollow areas within the cap were difficult to detect with certainty. In addition, the brittle nature of the material could lead to cracking if the end caps if struck too hard with a hammer.

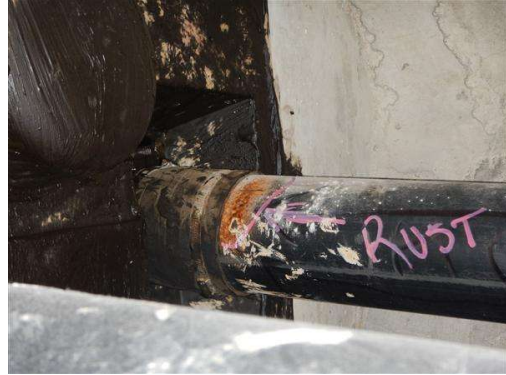
The external tendons were in good condition with no notable defects on a majority of the elements. A few areas were noted on the steel PT ducts at the diaphragm connections connecting the sheathing to the steel ducts with rusting present on the clamps/ducts. See Photo 2.

Photo 2 PT clamp rust at Pier 5NB looking North

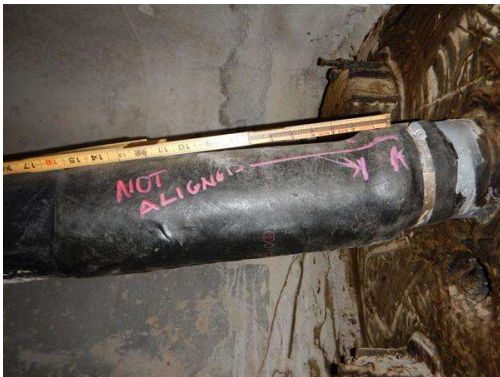
Photo 3 PT duct pipe not aligned at Pier 19NB looking East

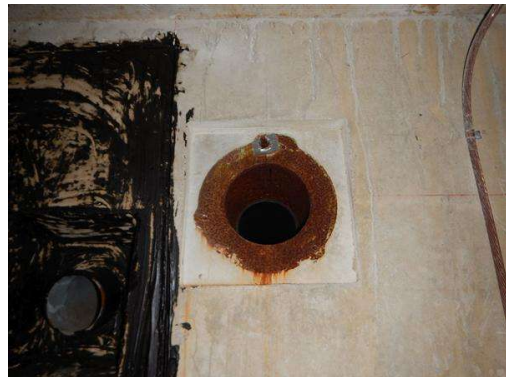
Numerous future stressing ducts in the diaphragms exhibited moderate to heavy rust with the stain leaching down the face of the diaphragm in some locations. See Photo 4.

Photo 4 Heavy rust on the future PT ducts at Pier 3NB looking North

As noted above in the PT end cap section, it is recommended to perform some form of NDT to determine the exact extend and accuracy of the voids.
