2017 LUC-00280-0346 (SB/NB MAIN SPAN) ROUTINE  
INSPECTION REPORT  
BRIDGE INSPECTION REPORT

Inventory Bridge Number: LUC 00280 03.460

IR-280 over MAUMEE RIVER AND NSRR

Inspection Date: 09/15/2017

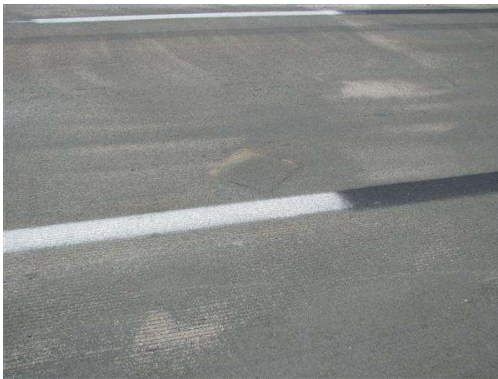
Areas of moderate transverse and map cracking (0.013" to 0.025") along the length of the bridge were observed. See Photo 2.

Photo 2 Transverse cracks in the deck in Span 28NB

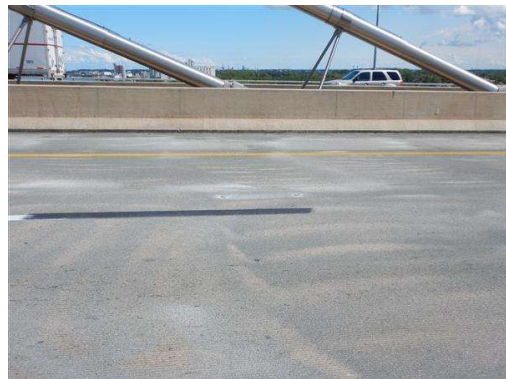
Areas of moderate transverse and map cracking (0.013" to 0.025") along the length of the bridge were observed. See Photo 5. Numerous deck patches were noted along the length of the bridge and displayed moderate cracking (0.0130" to 0.020") with spalling and discoloration around the perimeter. See Photo 6.

Photo 5 Transverse cracks in the traffic lane in Span 28SB

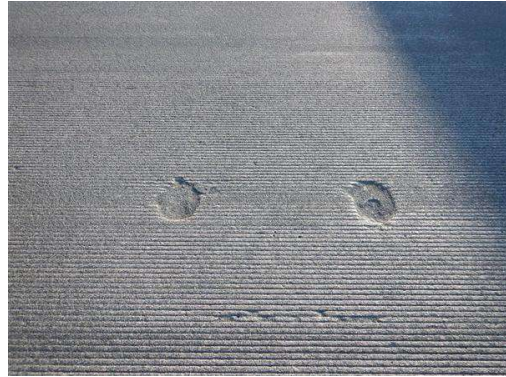
Additional delaminated or unsound patches with moderate cracking were noted in the shoulder and travel lane areas of the deck. See Photos 7 through 9.

Photo 7 Concrete patch (4'x2') in the traffic lane in Span 28SB

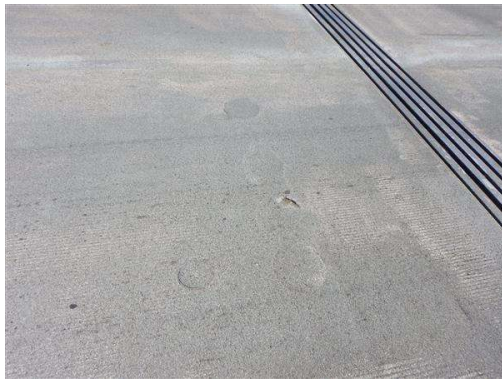
Photo 8 Spalls (7"x5"x0.75") in Span 28SB

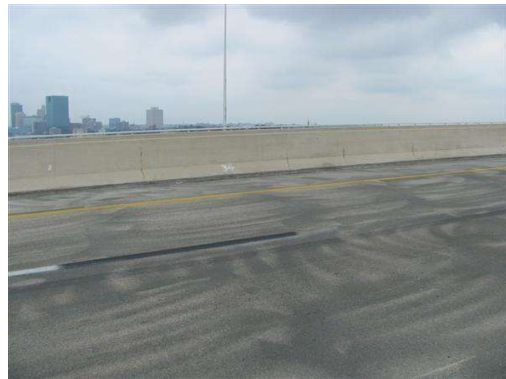
Photo 9 Concrete patches in the West traffic lane of Span 26SB

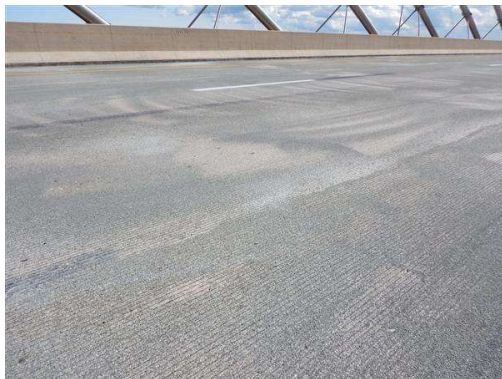
A few areas of wearing surface exhibited slight scaling and abrasion in the West traffic lane in Span 26NB. See Photo 10.

Photo 10 Scaling and abrasion in the wearing surface in Span 26NB looking West

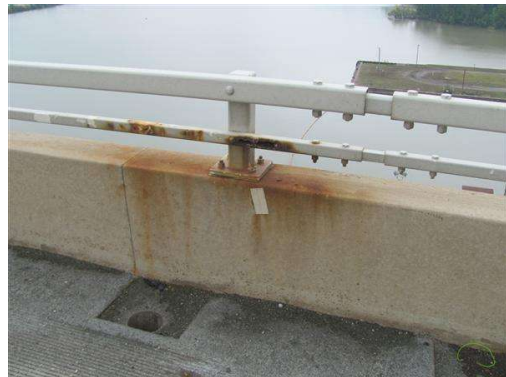
A few areas of delaminated concrete and spalls were noted in Span 27NB. See Photo 15.

Photo 15 Spalls on the top of the East parapet in Span 27NB looking East

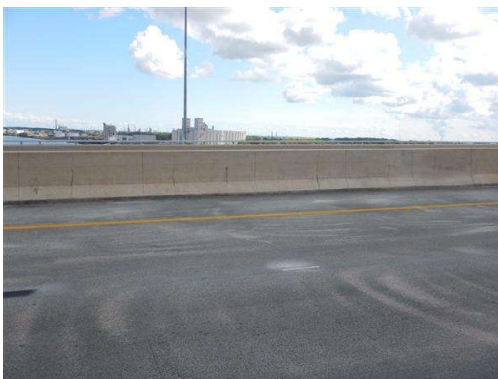
Several areas of deterioration and heavy rust on the steel railing were noted on the East steel railing along the length of the bridge. See Photo 16.

Photo 16 Deterioration and heavy rust in the East steel railing of Span 27NB looking East

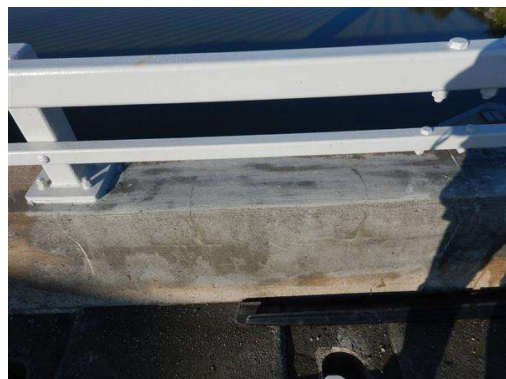
Typical areas of hairline to moderate vertical and horizontal cracking were noted along the length of the concrete parapets on both sides of the roadway. See Photos 17 and 18. In the Span 27SB, five (5) newly installed concrete barriers sections had

Photo 17 Typical hairline vertical cracks in the East parapet of Span 28SB looking East

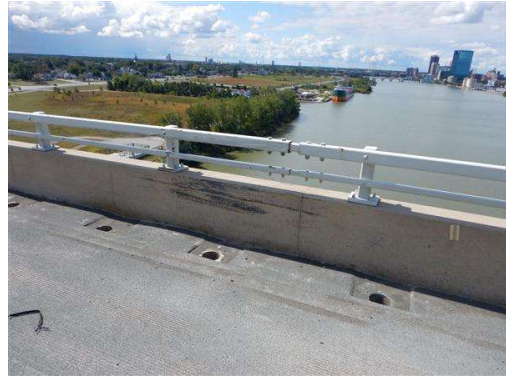
vertical cracks. See Photo 19. Collision damage on the East parapet in Span 27SB was observed. See Photo 20.

Photo 19 Vertical cracks in newly installed West parapet sections in Span 27SB

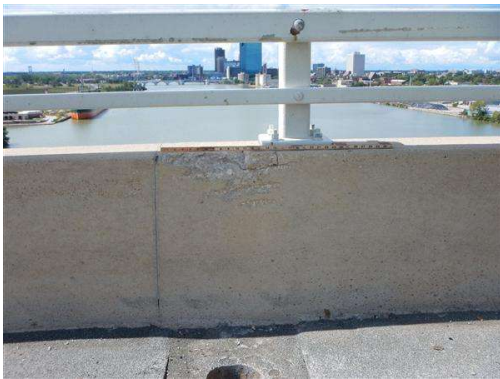
Photo 20 Collision damage to the West parapet in Span 27SB

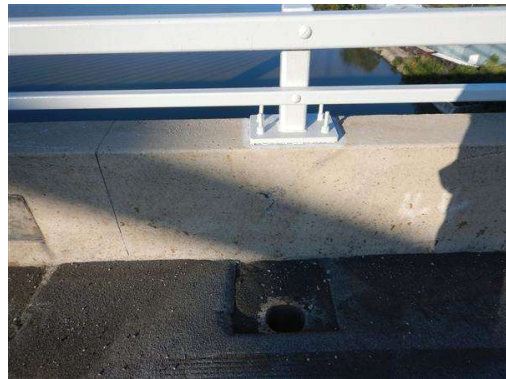
A few areas of delaminated concrete and spalls were noted along the length of the bridge in Spans 27SB, 28SB and 29SB. See Photos 21 through 23.

Photo 21 Spall underneath the steel railing in Span 27SB looking West

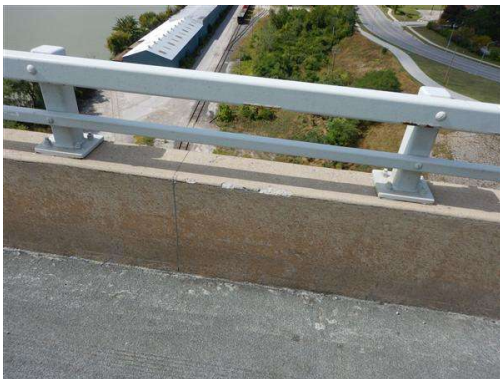
Photo 22 Spall in the West parapet in Span 28SB looking West

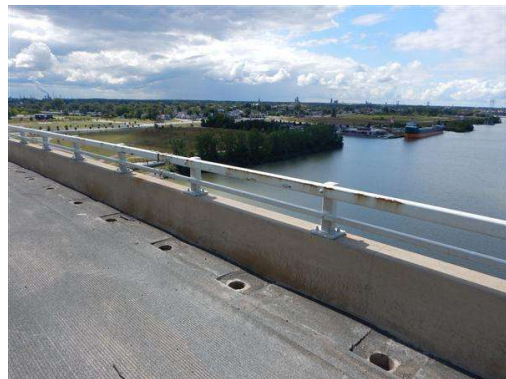
Photo 23 Gouges and 2" saw cut unfilled in Span 29SB of West parapet

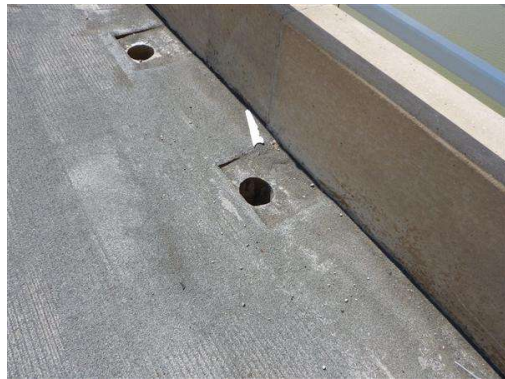
A majority of scuppers on the deck appeared to be partially or fully filled with debris and not serving their intended function. See Photo 27. In Span 27SB, nine (9) drains were missing PVC pipes. See Photo 28.

Photo 27 Scupper filled with debris and growing vegetation at Pier 29SB

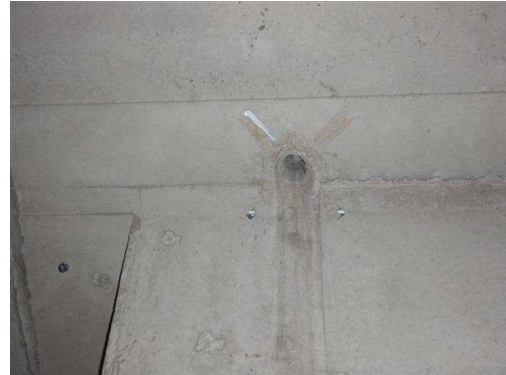
Numerous unsound or delaminated patches were observed in the lift holes at the top flange/slab along the edges of the interior of the segments. A majority of these areas exhibited efflorescence over the length of the bridge. See Photo 1. At Piers 26NB and 28NB, lift holes were noted to be missing grout. See Photo 2. At multiple locations, spalls with exposed reinforcement were observed in the webs and bottom flange/slab. See Photos 3 through 7. Additional patches and construction joints in the interior of the segments, both webs and top/bottom flanges/slabs exhibited delaminated and spalled concrete. See Photos 8 through 10. Delaminated/unsound concrete patches, cracking and honeycombed concrete were observed on the deviator walls along the length of the bridge. See Photos 11 and 12. The construction access hole patch in the Span 27NB top flange/slab had cracks with efflorescence. See Photo 13.

Photo 1 Leaching efflorescence from lift holes in Span 26NB

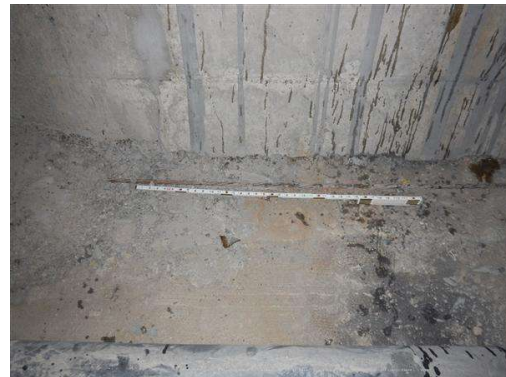
Photo 3 Spalls with exposed reinforcement at the expansion joint at Pier 26NB

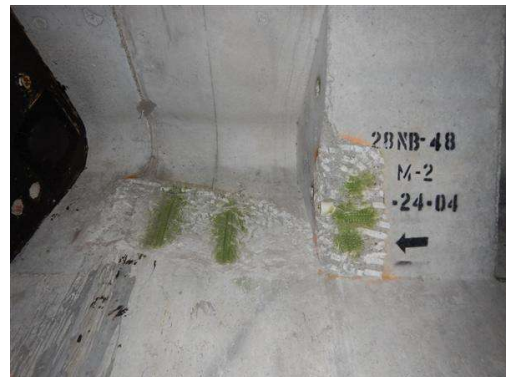
Photo 5 Exposed reinforcement on the bottom flange/slab in Span 29NB looking South

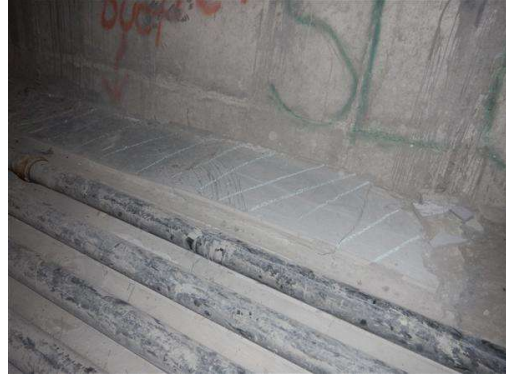
Photo 7 Spalls with exposed reinforcement at expansion joint at Pier 29NB looking South

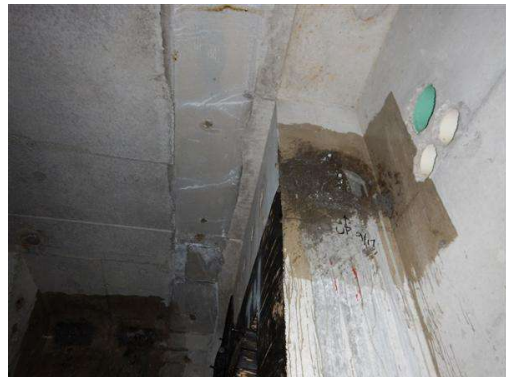
Photo 9 Typical spalls in the top flange/slab looking North

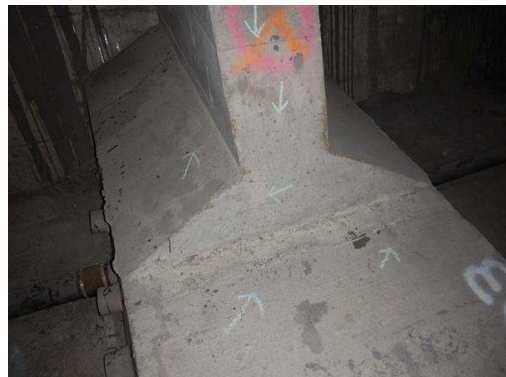
Photo 11 Spalls on the deviator wall at Pier 27NB looking West

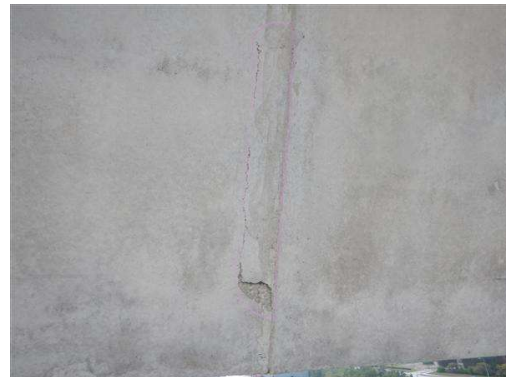
Along the exterior web and bottom flange/slab, several delaminated and spalled patches were noted along the length of the bridge. See Photos 15 through 17.

Photo 15 Delaminated concrete patch (12"x12") in the exterior bottom flange of Span 27NB

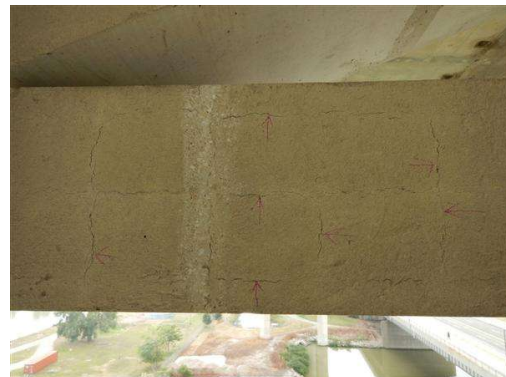
Photo 17 Spall (6"x6"x0.5") at the core hole in Segment 16 of Span 29NB

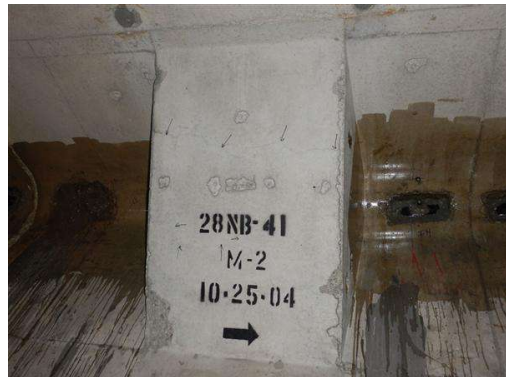
Longitudinal hairline to moderate cracking was present along both interior and exterior corner edges between the web and top flange/slab of every segment. These cracks varied in length and were typically 0.005" to 0.030" in width. See Photo 20. Additional hairline cracks, vertical and longitudinal, were present along the interior and exterior webs and bottom flange/slabs of the box segments over the length of the bridge. See Photos 21 through 24.

Photo 21 Typical interior, upper corner cracks along the length of the bridge looking East

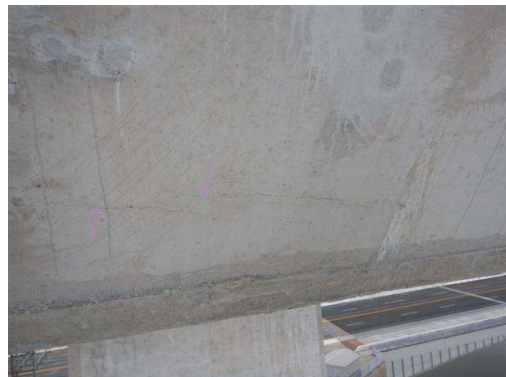
Photo 23 Longitudinal cracks with leaching efflorescence in the exterior bottom flange/slab in Span 27NB

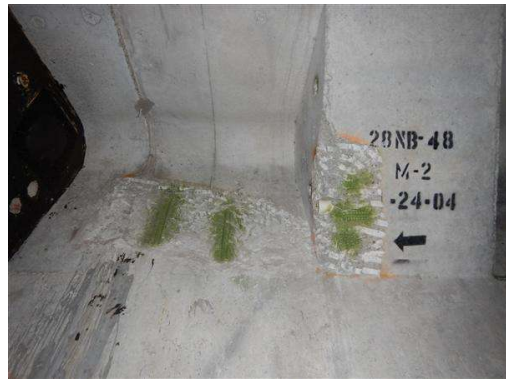
Photo 27 Spalls with exposed reinforcement in future PT block on the bottom flange/slab of Span 29NB looking South

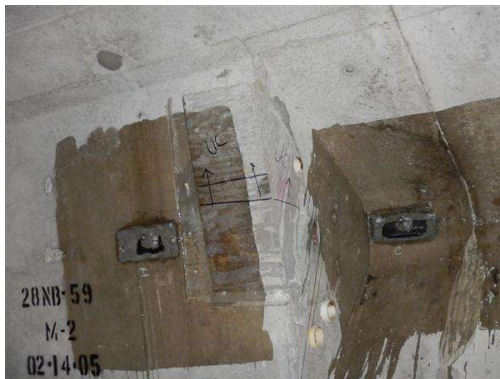
Photo 28 Typical spall with exposed reinforcement in the future PT blocks in webs

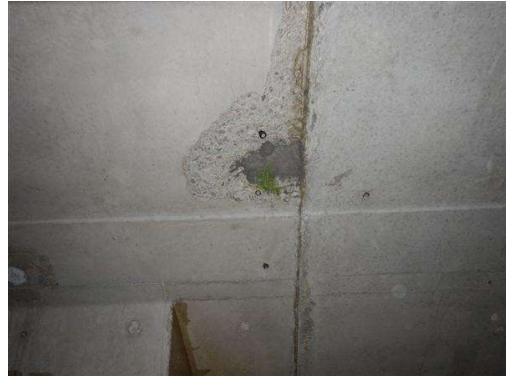
Numerous unsound or delaminated patches were observed in the lift holes at the top flange/slab along the edges of the interior segment. A majority of these areas exhibited efflorescence over the length of the bridge. See Photo 30. A hole in the web was left unfilled in Span 28SB that extends the full width of the concrete. See Photo 31.

Photo 31 Unfilled hole in web of Span 28SB

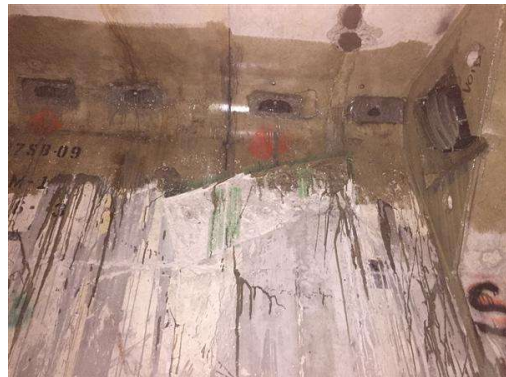
At multiple locations concrete spalls with exposed reinforcement were observed in the webs and bottom flange/slab. See Photos 32 through 34. Additional patches and construction joints in the interior of the segments, both webs and top/bottom flanges/slabs exhibited cracking and delaminated and spalled concrete. See Photos 35 and 36. Concrete spalls were observed on the bottom flange/slab strut legs along the length of the bridge. See photo 37. Spalls with exposed reinforcement were observed in the corner blocks in the webs along the length of the bridge. See Photo 38. The construction access hole patch in Span 27SB, had cracks with efflorescence. See Photo 39.

Photo 33 Typical spall with exposed reinforcement in the exterior PT block and web along the length of the bridge

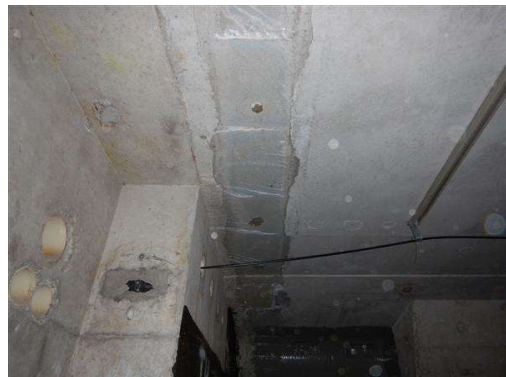
Photo 35 Delaminated/unsound patch and spalls in the top flange/slab in Span 28SB

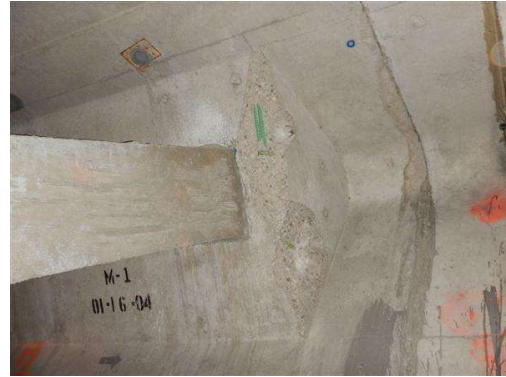
Photo 37 Typical spall in the strut legs along the length of the bridge

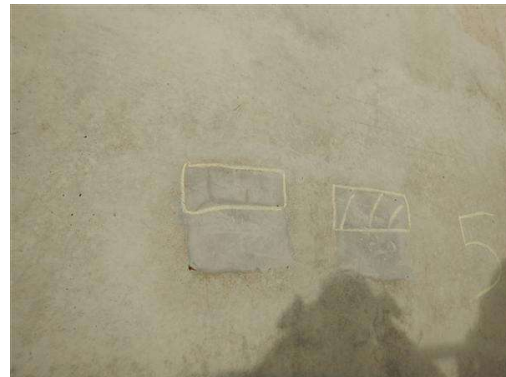
Photo 39 Construction access hole patch with cracks and efflorescence in Span 27SB

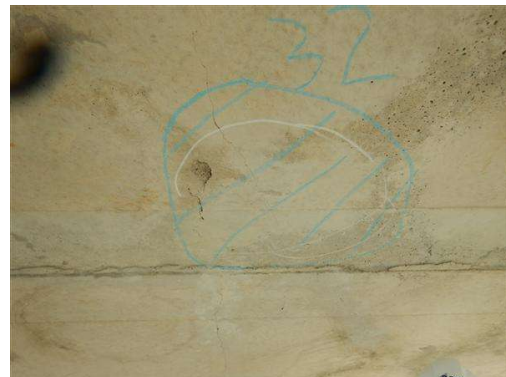
Along the exterior web and bottom flange/slab, several delaminated and spalled patches were noted along the length of the bridge. Some of the spalls had exposed reinforcement. See Photos 40 through 44.

Photo 41 Spall (27"x5"x0.5") in the exterior East web of Span 28SB looking West

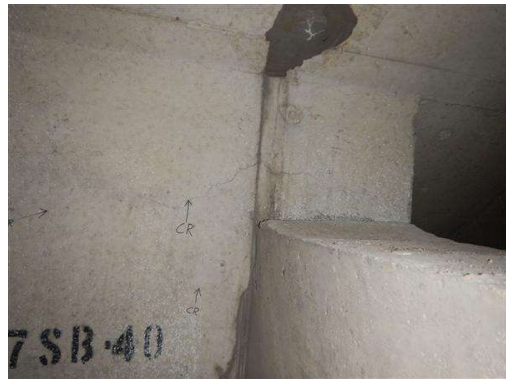
Photo 45 Longitudinal cracks with efflorescence in the top flange/slab of Span 28SB

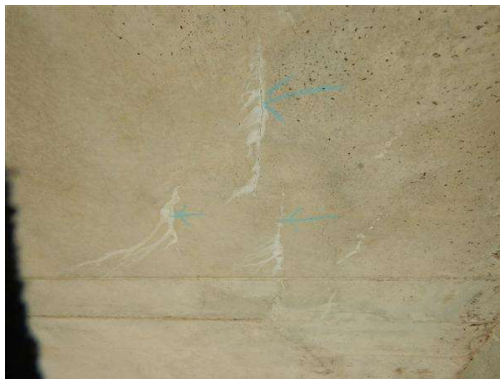
Longitudinal hairline to moderate cracking was present along both interior and exterior corner edges between the web and top flange/slab of every segment. These cracks varied in length and were typically 0.005" to 0.030" in width. See Photo 45. Additional hairline cracks, vertical and longitudinal, were present along the interior and exterior webs and bottom flange/slabs of the box segments over the length of the bridge. See Photos 46 and 47.

Photo 46 Typical cracks on the diaphragm blocks along the length of the bridge

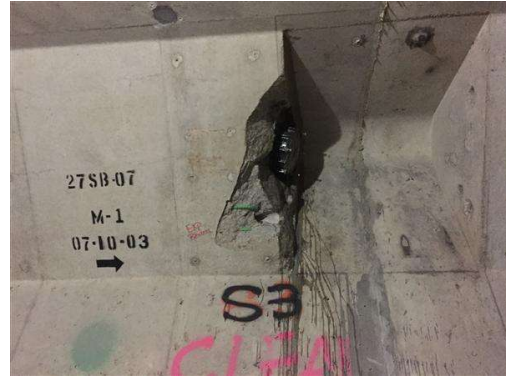
Voids and cutouts were present in the segment construction joints, both interior and exterior, varying size and depth. Some of the voids were observed to be up to 3" deep. See Photos 48 and 49. Spalls and delaminated areas were noted throughout the interior and exterior of the segments in the pier segment closure pours and the future exterior PT blocks located on the webs and on the floor slab. See Photos 50 and 51. Spalls with exposed reinforcement in the corbels were observed along the length of the bridge. See Photo 52.

Photo 49 Cutout (3" deep) in the exterior East web between Segments 57 and 58, in Span 28SB looking West

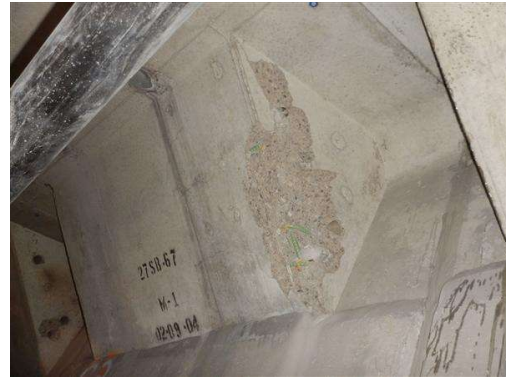
Photo 51 Typical spall with exposed reinforcement in the temporary PT blocks on bottom flange/slab along the length of the bridge

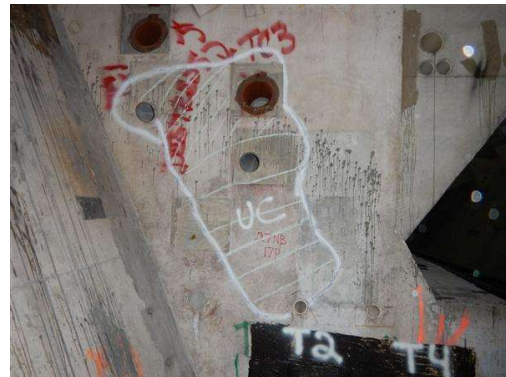
The interior diaphragms exhibited typical hairline to moderate vertical and map cracking (0.05" to 0.04"). Efflorescence and leaching was present at some locations, although these areas did not appear to be active. Additionally, several diaphragms had areas of delaminated/unsound concrete on the vertical faces. See Photo 53 and 54.

Photo 53 Map cracking on the vertical face of diaphragm at Pier 26NB

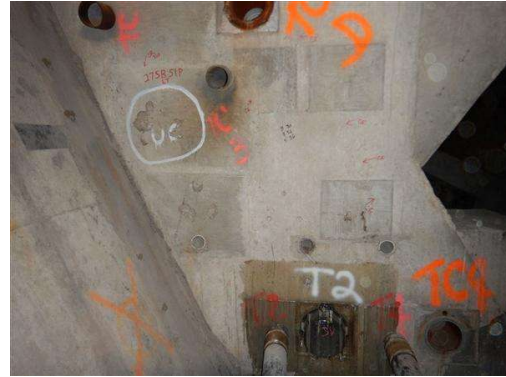
The interior diaphragms exhibited typical hairline to moderate vertical and map cracking (0.005" to 0.045"). Efflorescence and leaching was present at some locations, although these areas did not appear to be active. Additionally, several diaphragms had areas of delaminated/unsound concrete on the vertical faces. See Photos 55 and 56.

Photo 55 Delaminated concrete area in the vertical face of the diaphragm in Span 27SB

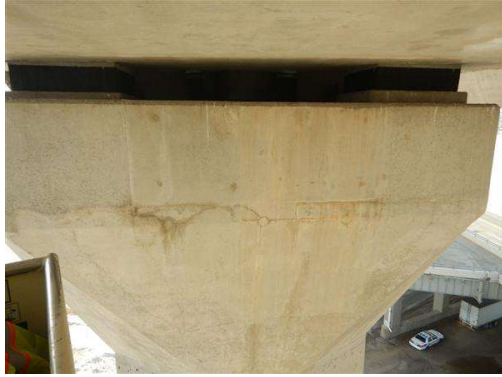
Photo 1 Typical cracking and rust stains in the Northbound pier caps

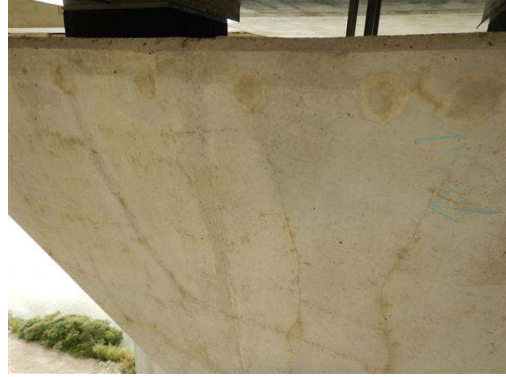
Photo 2 Typical cracking and rust stains in the Southbound pier caps

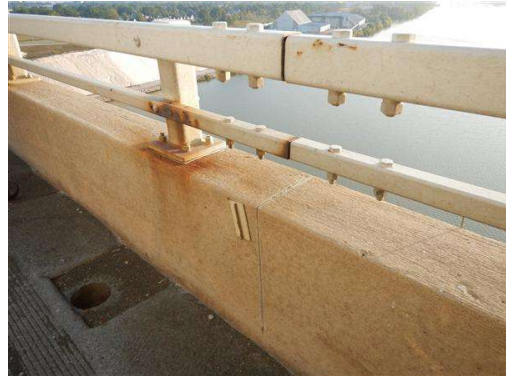
Photo 2 Broken or missing reflectors along the length of the bridge

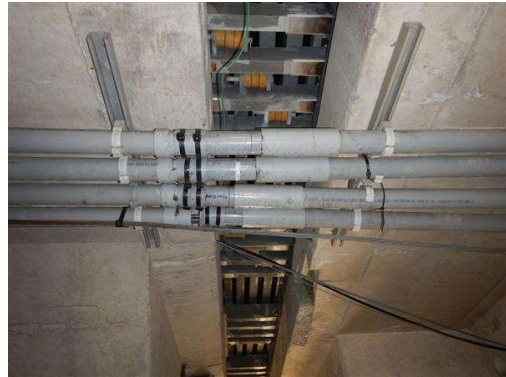
Photo 4 Separated electrical conduits and broken clamps at Pier 26NB

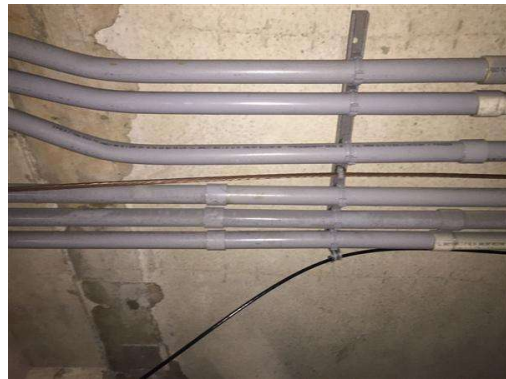
Photo 10 Broken electrical conduit clamp in Span 26SB

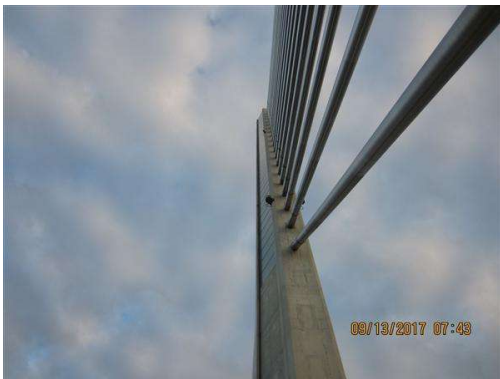
Photo 11 Aerial warning light on the Northeast side of the pylon not functioning during daylight hours

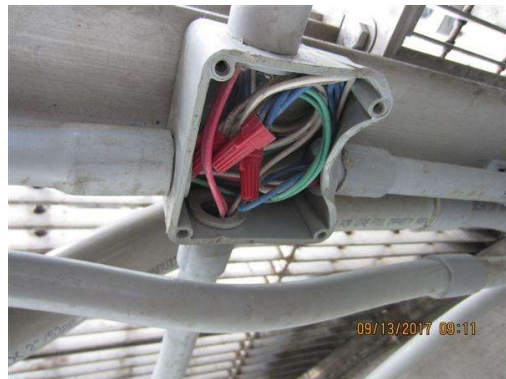
Photo 12 Missing cover on a damaged junction box exposing wires

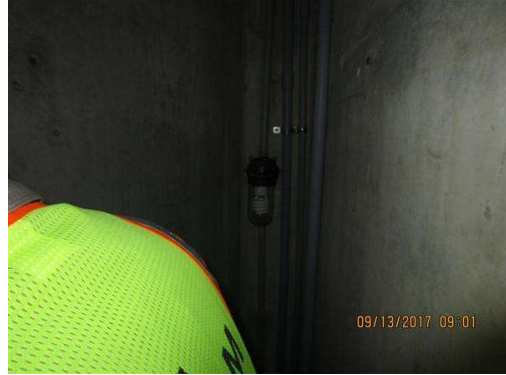
Photo 14 Burned out service lights in the personnel liftway

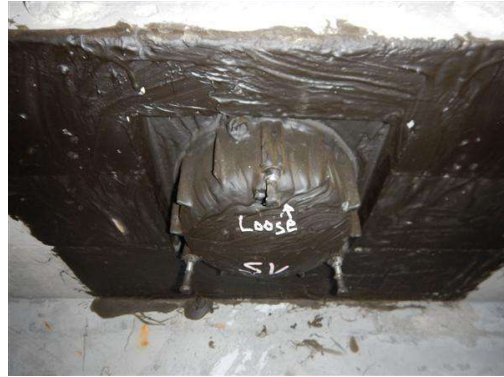
Photo 2 Loose bolt on PT anchor cap at Pier 28NB

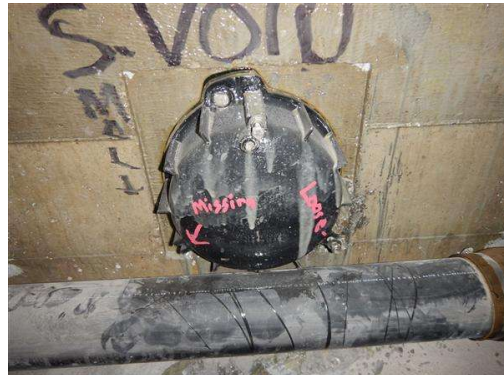
Photo 4 Loose and missing bolt on PT anchor cap in Span 27SB

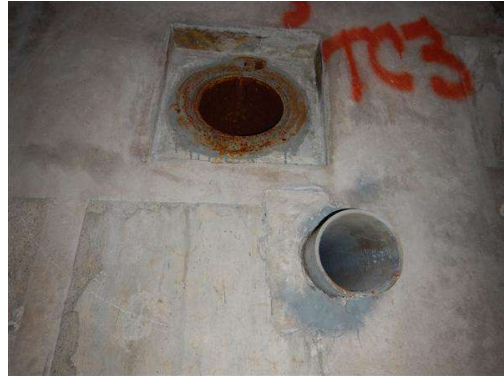
Photo 8 Typical rust on the future PT ducts on diaphragms looking Northeast

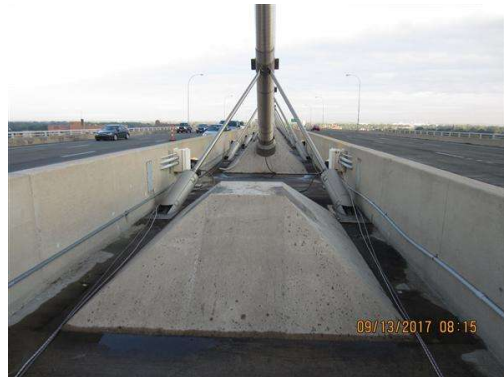
Photo 10 Typical hairline cracks on top of deck Stay Cable Anchors

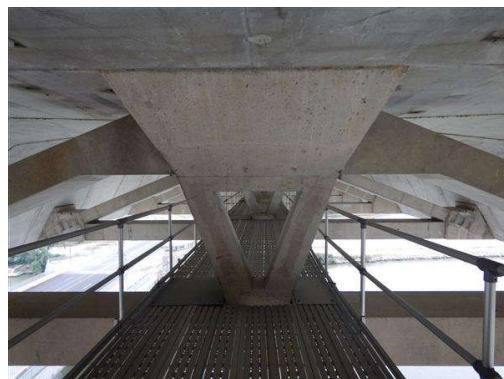
Photo 12 Typical map cracking on the bottom of Deck Stay Cable Anchor

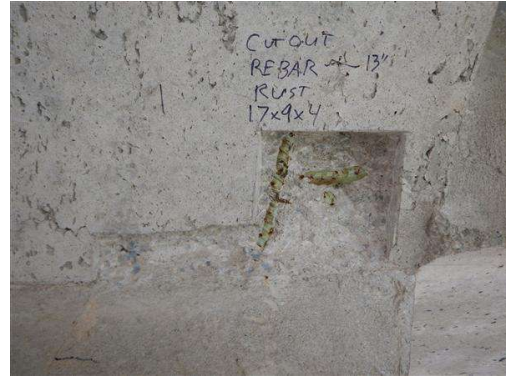
Photo 14 Concrete cutout with exposed reinforcement on the bottom (South face) of deck Stay Cable Anchor 16A

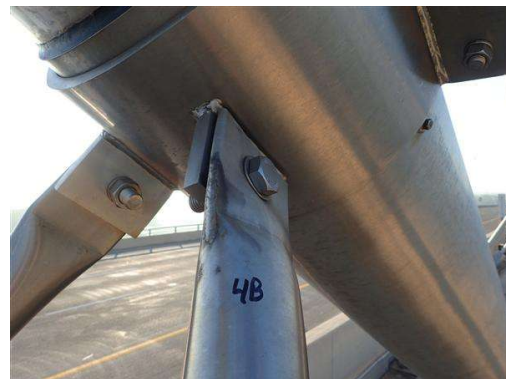
Photo 18 Welded repair to the West damper support at the lower sleeve cable clamp connections Cable Stay 4B

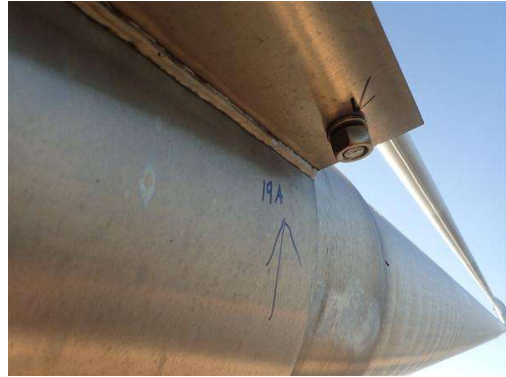
Photo 20 South bolt on the West cable damper clamp loose at Cable Stay 19A

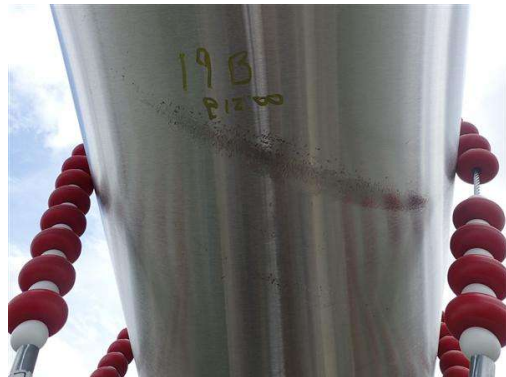
Photo 22 Scrape/surface gouge (12"x3") along the bottom face of the main sheath, near the upper splice on Cable Stay 19B

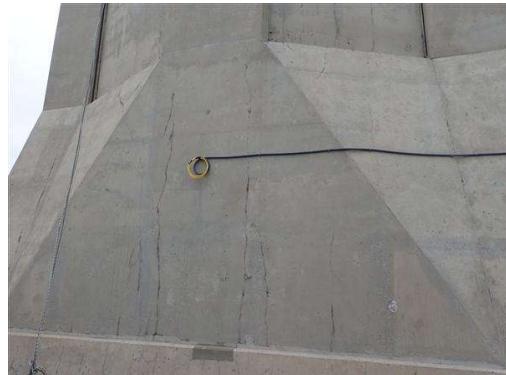
Photo 28 Two (2) full height x 0.0625" vertical cracks with random intermittent cracking in the West face of the Upper Pylon below Cable Stay 1

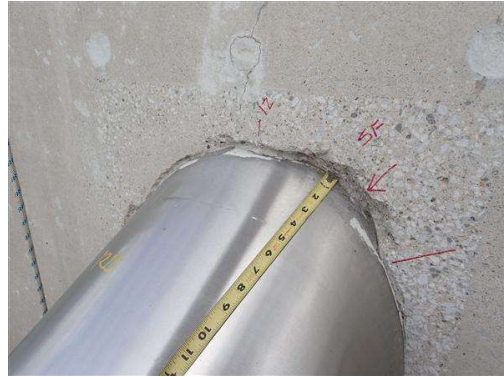
Photo 30 1.5"x1" edge spall around the stay cable from 12 to 2 o'clock on the Upper Pylon South face at Cable Stay 12
