2017 LUC-00280-0375\_L (SB NORTH APPROACH) ROUTINE  
INSPECTION REPORT  
BRIDGE INSPECTION REPORT

Structure File Number: 4806115

I-280 over SUMMIT TO CHAMPLAIN NSRR

Inspection Date: 09/17/2017

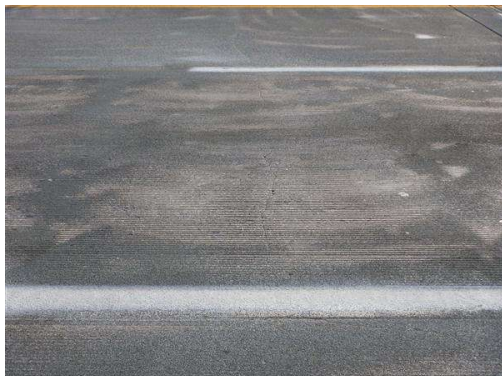
Insignificant to moderate transverse and map cracking were observed throughout the approach slab. See Photos 1 and 2.

Photo 1 Transverse crack in the traffic lane of approach slab looking East

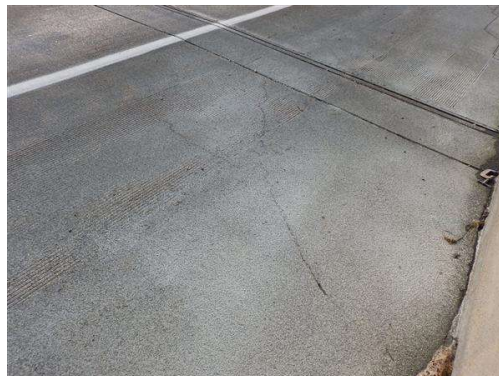
Photo 2 Cracks in the shoulder of approach slab

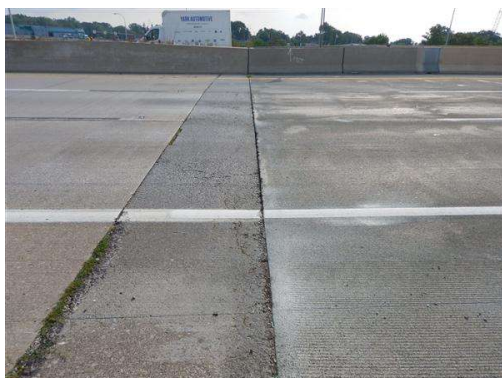
Transverse cracks and spalls were observed in the asphalt relief joint. Growing vegetation was noted along the width of the roadway. See Photo 3.

Photo 3 Cracks and growing vegetation in relief joint looking East

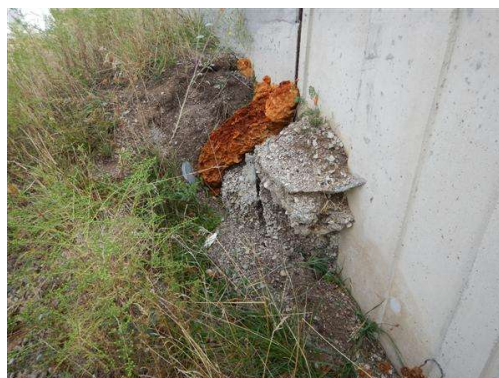
Erosion along the cast-in-place wingwall at the back of the approach slab was observed. See Photo 4.

Photo 4 Erosion along wingwall at the back side of the approach slab

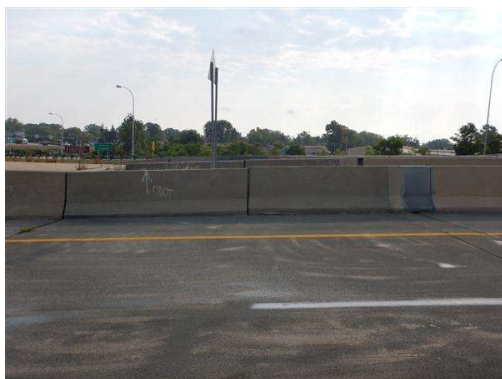
The concrete barriers along both sides of the roadway exhibited typical longitudinal and vertical hairline cracks over the length of the approach slab. The East parapet exhibited 0.75" of vertical and longitudinal displacement/rotation. See Photos 5 and 6.

Photo 5 East barrier displaced/rotated by 0.75" looking East

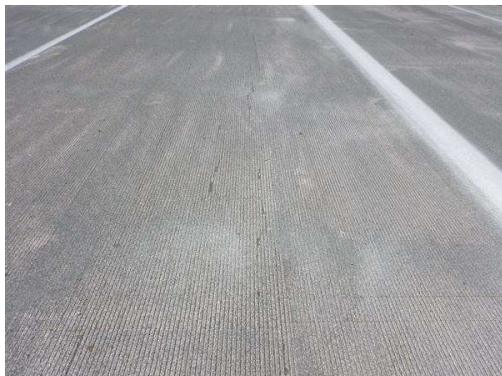
The Southbound North approach extends from Pier 30SB (Station 248+87.50) to Abutment 59SB (Station 288+67.40). The entire deck quantity is rated in this report. The longitudinal joint is rated in this report as per the 2016 inspection. Hairline to 0.030" wide transverse, longitudinal and map cracking, with efflorescent leaching in areas, was noted along the length of the longitudinal closure pour joint. See Photo 1.

Photo 1 Transverse and map cracks along longitudinal joint in Span 46SB

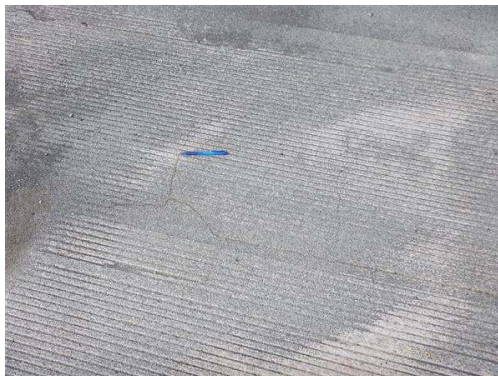
Areas of moderate transverse and map cracking (0.013" to 0.025") along the length of the bridge were observed. See Photo 2.

Photo 2 Map cracking along closure pour in Span 48SB

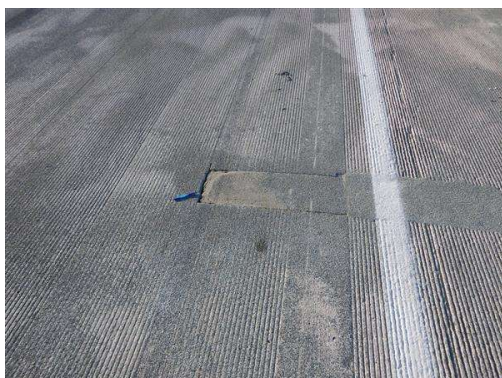
Numerous lift hole and deck patches along the length of the bridge displayed moderate cracking (0.013" to 0.030"), spalling and discoloration around the perimeter. See Photos 3 through 6. These patches and cracks appeared to be reflective and were present in the wearing surface.

Photo 3 Concrete patch with 0.5" deep spall in Span 35SB

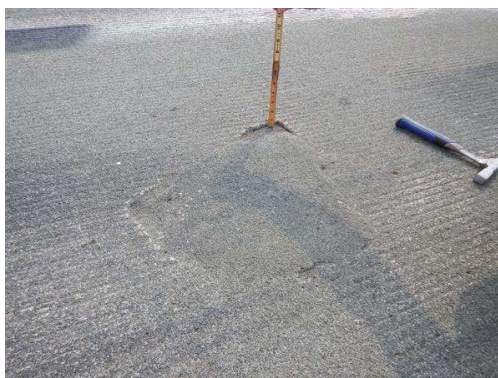
Photo 4 Spall (12"x12"x1") in Span 51SB

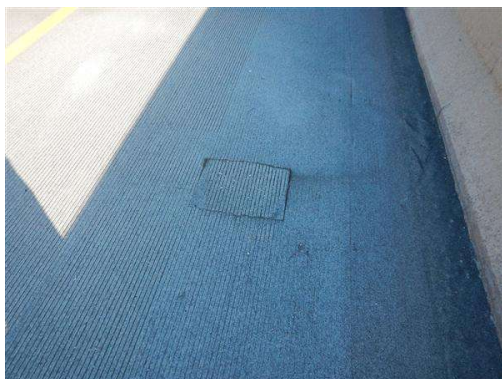
Photo 5 Concrete patch with spalls and discoloration around perimeter in the shoulder in Span 31SB

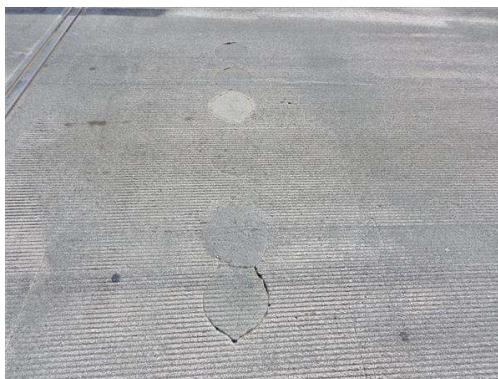
Photo 6 Liftholes with spalls around perimeter in Span 48SB

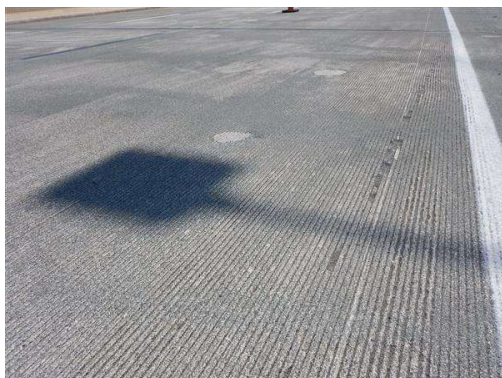
Scaling of the deck was observed in the shoulder and traffic lanes of Spans 36SB and 39SB. See Photos 7 and 8.

Photo 7 Scaling and damage to grooving (10') in Span 39SB

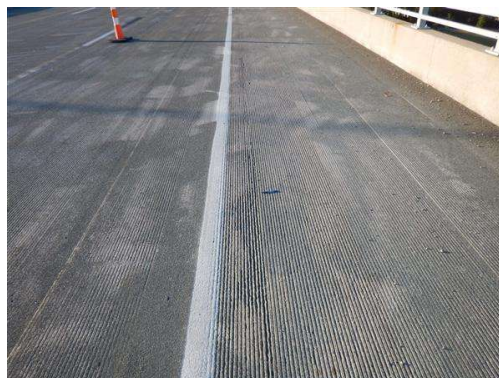
Photo 8 Scaling of deck in the shoulder in Span 36SB

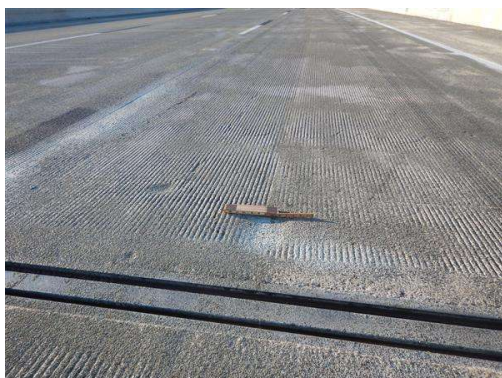
Concrete depressions were noted on the deck ranging from 0.25" to 0.375" in depth in Spans 30SB, 33SB, 35SB, 36SB and 39SB. See Photos 9 and 10.

Photo 9 Depression (0.25\") in deck/wearing surface in Span 36SB

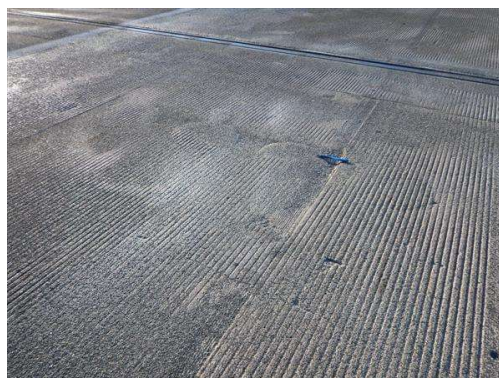
Photo 10 Depression (0.375\") in deck/wearing surface in Span 35SB

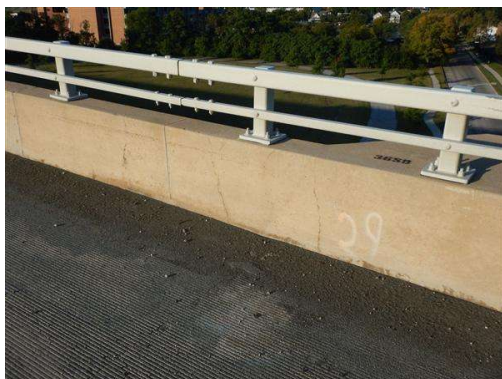
Typical areas of hairline to moderate vertical and horizontal cracking were noted along the length of the concrete parapet on both sides of the roadway. See Photo 11.

Photo 11 Typical full height vertical cracks in the West parapet looking West

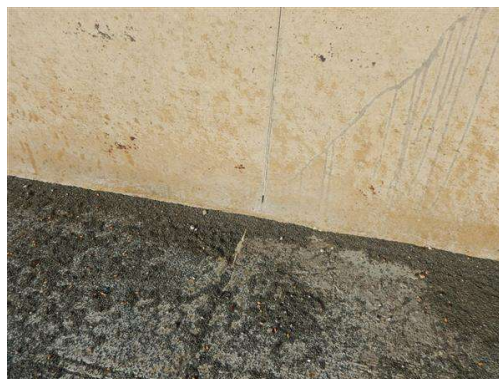
Numerous areas of cracking had efflorescence, rust staining and/or discoloration/leaching. The bottom saw cut was not filled in the West parapet in Span 33SB. See Photo 12.

Photo 12 Bottom of saw cut in the West parapet in the Span 33SB was not filled

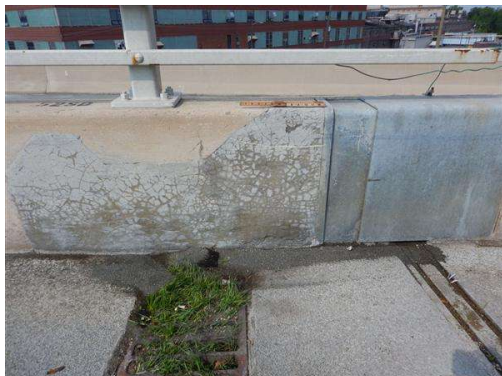
Several areas of delamination, spalls and gouges were noted in Spans 37SB and 51SB. See Photos 13 through 15. A few areas of scaling along the top edge of the West parapet were noted in Spans 32SB and 34SB. See Photo 16. Spalls were observed in the vertical joints of the West parapet along the length of the bridge. See Photo 17.

Photo 13 Delamination and vertical cracks on face of the West parapet in Span 51SB looking West

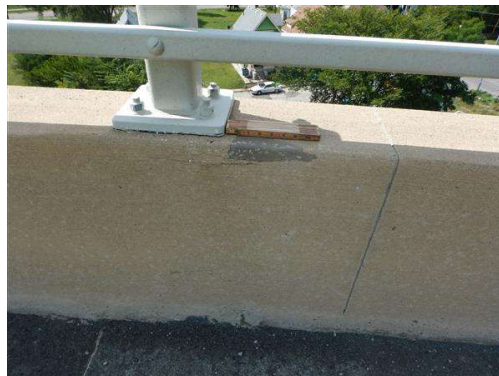
Photo 14 Delamination in parapet beneath the steel railing post in Span 37SB looking West

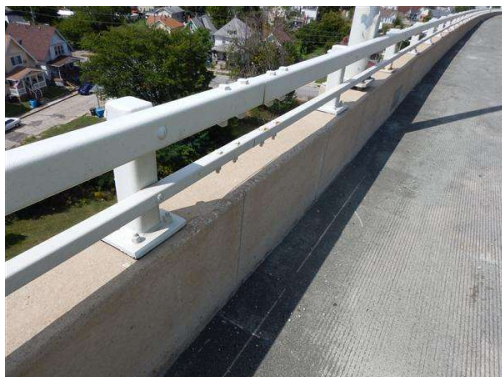
Photo 15 Minor spalls on the edge of the parapet in Span 37SB

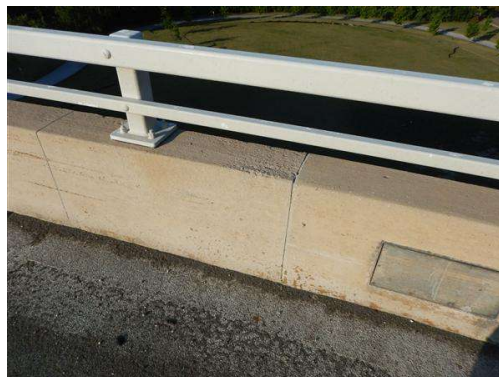
Photo 16 Scaling on the top of the West parapet in Span 34SB

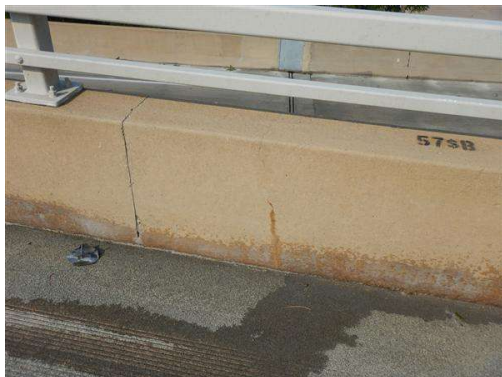
Photo 17 Typical spalls in the vertical joint of the West parapet looking West

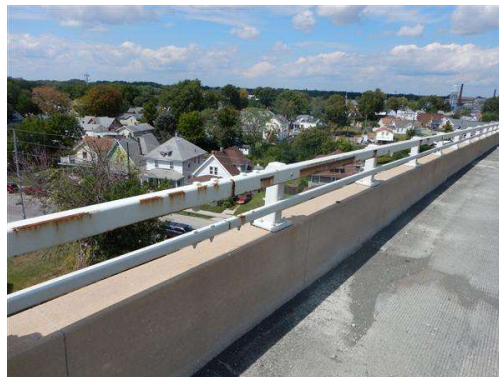
A few areas of deterioration and heavy rust were noted on the West steel railing along the length of the bridge See Photo 18. Minor paint damage was found at multiple locations. See Photo 19.

Photo 18 Typical condition of the steel railing with rust staining and minor deterioration along the length of the bridge

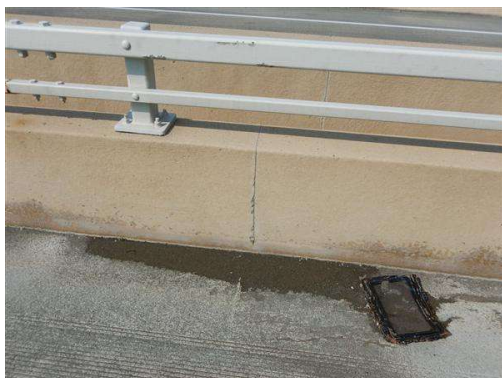
Photo 19 Typical minor paint damage on steel railing along the length of the bridge

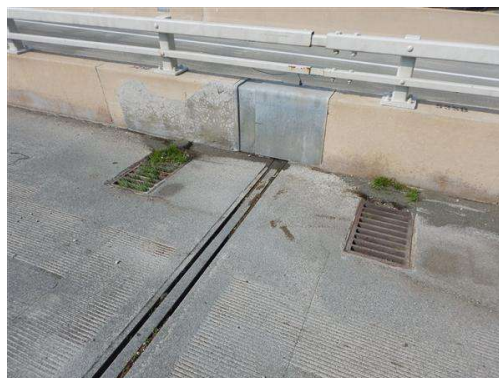
Photo 20 Fully filled scuppers with vegetation growing in Span 52SB looking West

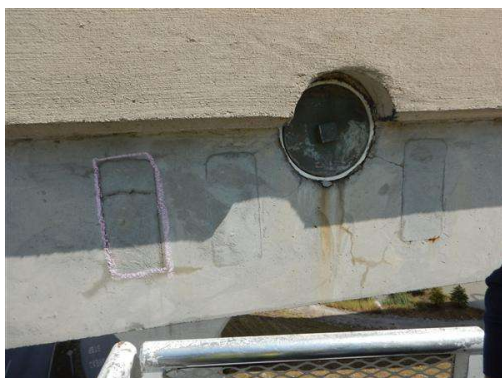
The drainage caps on the face of the pier end segments were leaking at majority of the scupper locations. Varying levels of rust and efflorescence were noted at these locations. See Photo 21.

Photo 21 Rust stains and efflorescence on the edge face of the end segments along with delaminated concrete patches

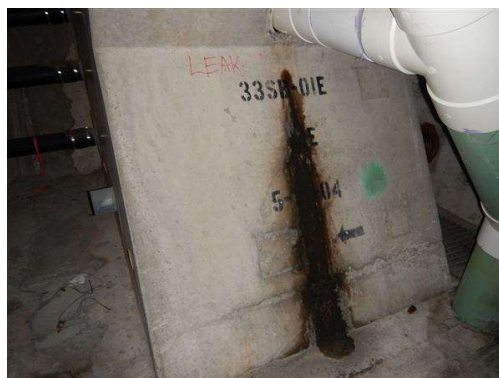
The drainage pipes within the interior of the box segments at Pier 32SB and 33SB exhibited leakage with rust and/or water staining. See Photos 22 and 23.

Photo 22 Interior drainage pipe at Pier 33SB with rust staining

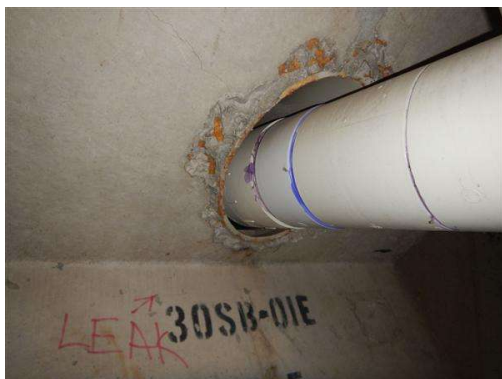
Photo 23 Interior drainage leak and minor rust stains at Pier 30SB

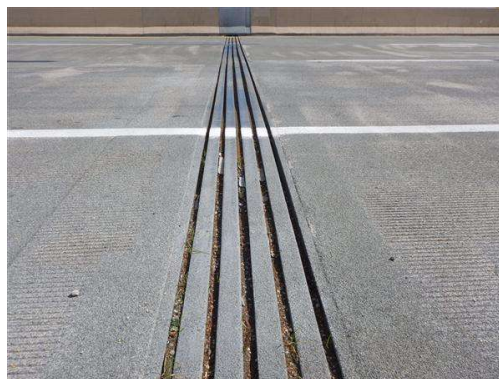
All the expansion joints over the length of the bridge were either partially or fully filled over the entire width of the roadway with vegetation growing along the joints in certain locations. See Photo 243 The joint at the Abutment 59SB had a concrete spall on the North side of the header concrete. See Photo 25.

Photo 24 Expansion joint at Pier 30SB filled with debris and growing vegetation looking East

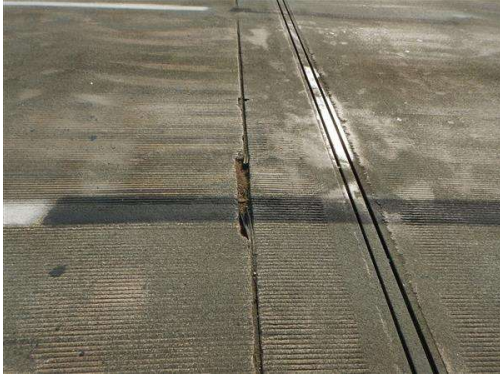
Photo 25

Spalls in the expansion joint header at  
Abutment 59SB

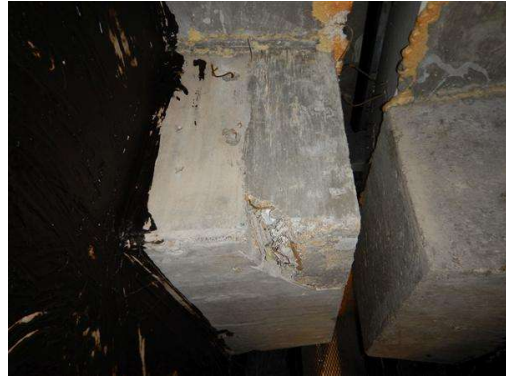
Photo 2 Spall with exposed reinforcement in the PT block in Span 48SB

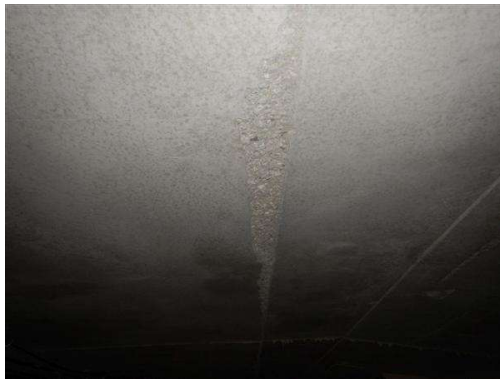
Photo 3 Typical spall in the top flange/slab in Span 30SB

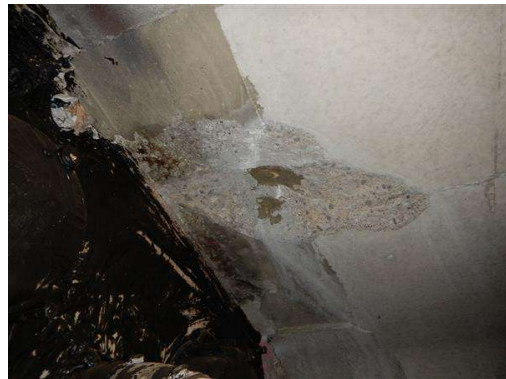
Photo 4 Spall in the top flange/slab in Span 41SB

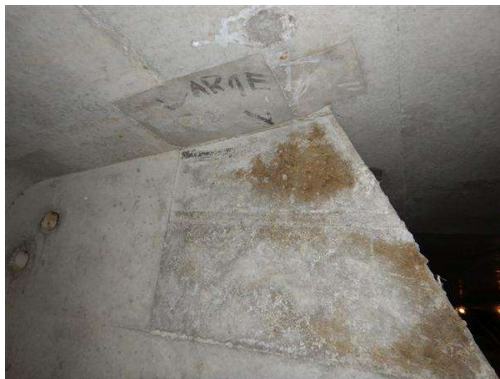
Photo 5 Crack in the top of the deviator wall in Span 32SB

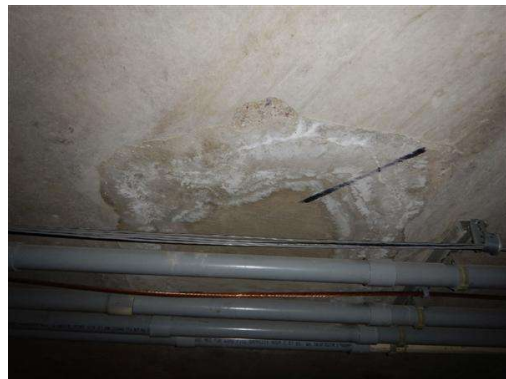
Numerous delaminated or unsound patches were observed in the lift holes at the top flange/slab along the edges of the interior segments. A majority of these areas exhibited efflorescence over the length of the bridge. See Photo 1. At multiple locations, spalls with exposed reinforcement were observed. See Photo 2. Other patches and construction joints in the interior of the segments, both webs and top/bottom flanges/slabs exhibited delaminated and spalled concrete. See Photos 3 and 4. At multiple locations, cracks and spalls were observed in the deviator wall, primarily at the edges of the joints between the top and bottom flanges/slabs. See Photo 5. The access hole patch in Span 37SB exhibited spalling with cracks and efflorescence. See Photo 6.

Photo 6 Construction access hole patch with spalls and efflorescence in Span 37SB

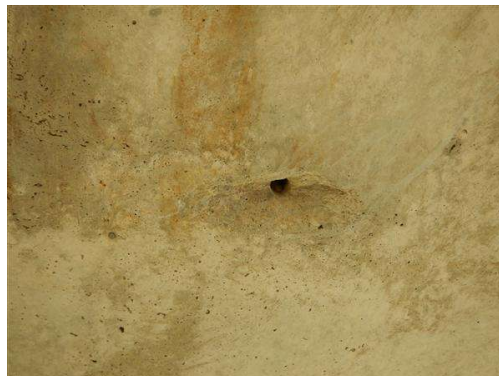
Photo 8 Spall at the drain hole in Span 36SB

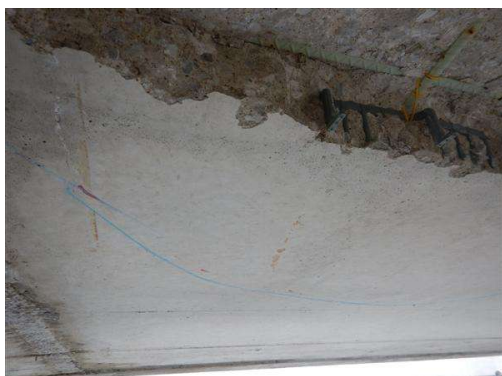
Photo 9 Spall of (5'x20.5'x3.5') in the bottom flange of Span 52SB

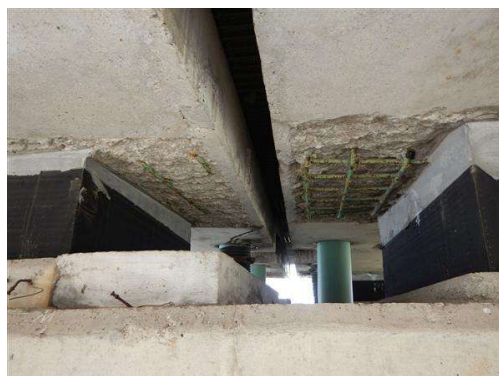
Photo 10 Spall with exposed reinforcement in the bottom flange at Pier 33SB bearings

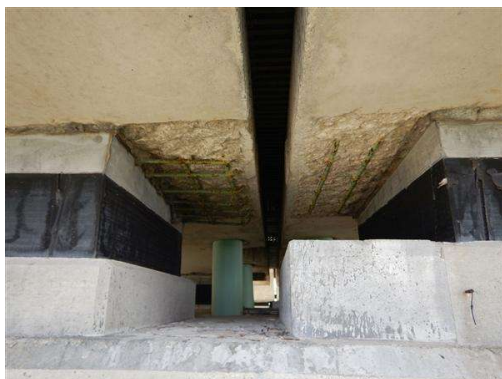
Photo 11 Spall of (3.5'x12'x2') in the bottom flange at bearings at Pier 36SB

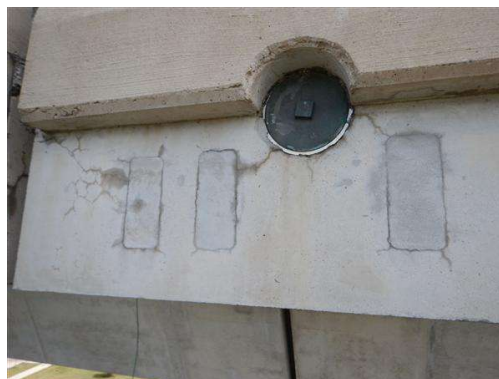
Along the exterior web and bottom flange/slab, several delaminated and spalled patches were noted along the length of the bridge. See Photos 7 through 9. At Piers 33SB, 36SB and 52SB, at the bottom flange near the bearings, concrete spalls with exposed reinforcement were noted. See Photos 10 and 11. The exterior PT end blocks at Piers 33SB and 36SB had multiple patches with cracking. See Photo 12.

Photo 12 Concrete patches with cracks, efflorescence and discoloration on PT end block at Pier 36SB

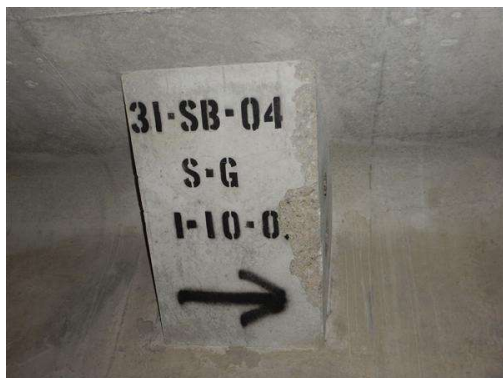
Photo 13 Typical cracking and spalling on future external PT blocks

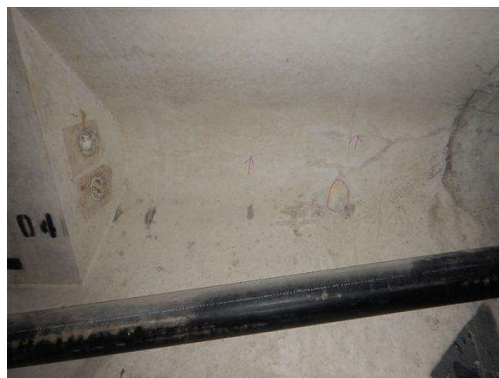
Photo 14 Interior upper corner cracks typical along the length of the bridge

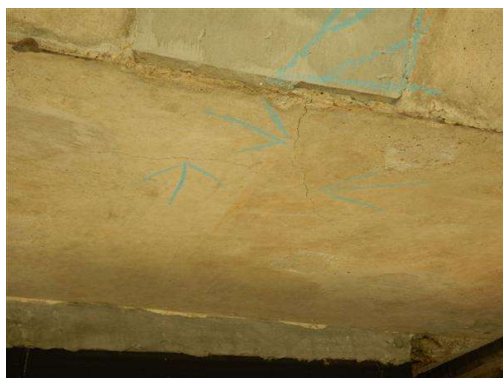
Photo 15 Cracks in the bottom flange at Pier 38SB

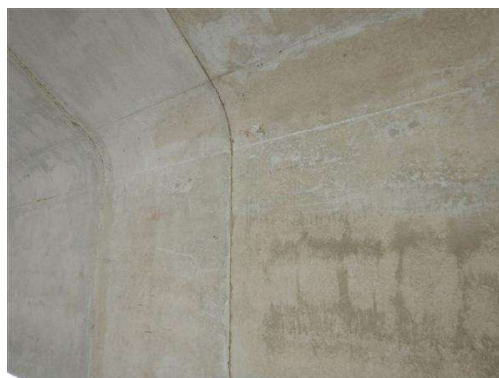
Photo 16 Typical longitudinal and map cracks with efflorescence in the exterior webs

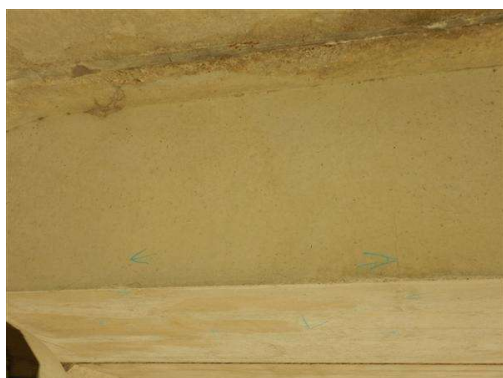
Photo 17 Full height vertical cracks on South face of PT pier end segment at 38SB

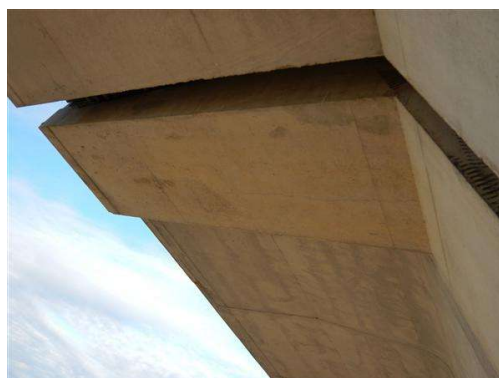
Photo 18 Longitudinal cracks in the bottom face of PT pier end segment at Pier 30SB

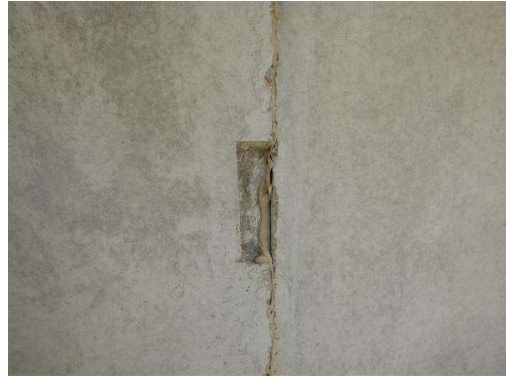
Photo 20 Concrete cut out (9"x3"x1.5") in the web in Span 34SB

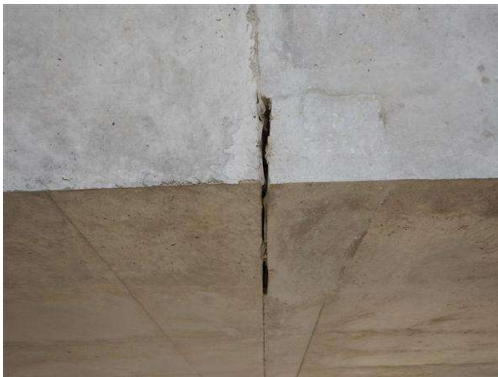
Photo 21 Missing epoxy/joint filler between Segments 12 and 13 in Span 37SB

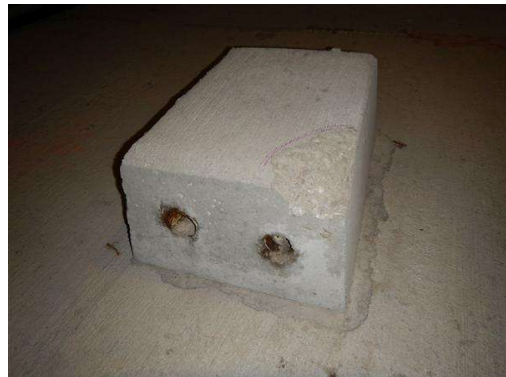
Photo 22 Spall on exterior floor PT stressing block in Span 34SB looking South

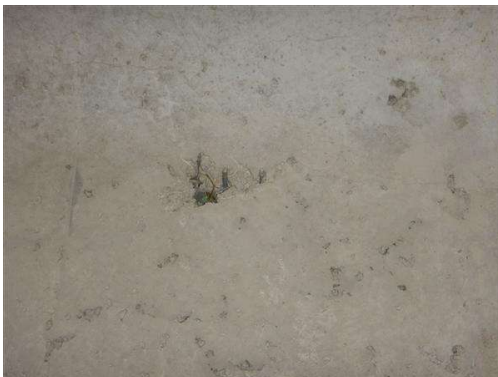
Small areas honeycombed concrete were also noted on the interior and exterior of the segments along the length of the bridge. See Photo 23.

Photo 23 Typical honeycombed concrete in the webs looking East

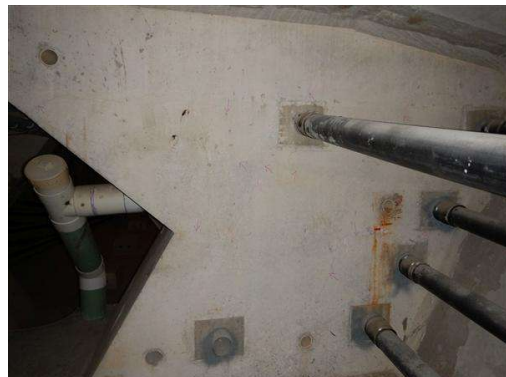
Photo 24 Map cracking and rust stains on vertical face of diaphragm at Pier 30SB looking South

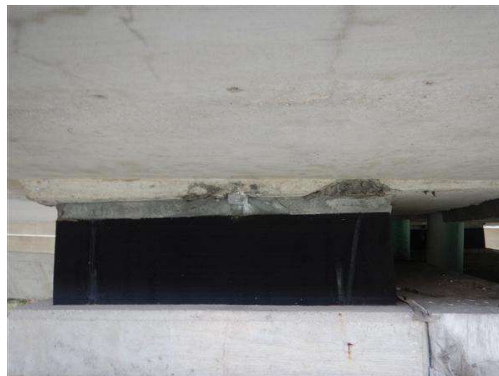
Photo 26 Spall in the West bearing plinth at Pier 56SB

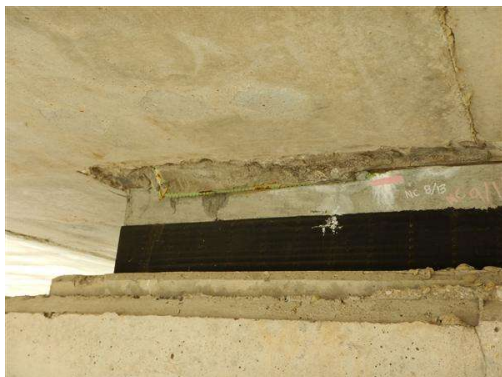
Photo 27 Spalls with exposed reinforcement at East bearing at Pier 34SB

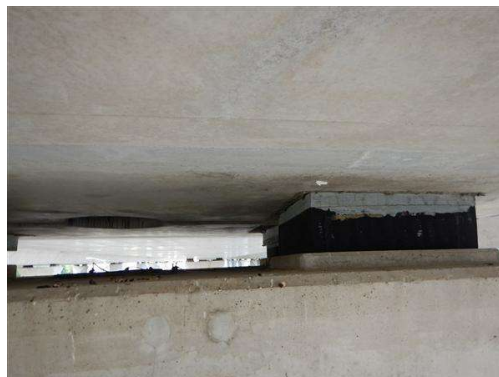
Photo 28 Vertical cracks in the plinth of East bearing at Pier 51SB

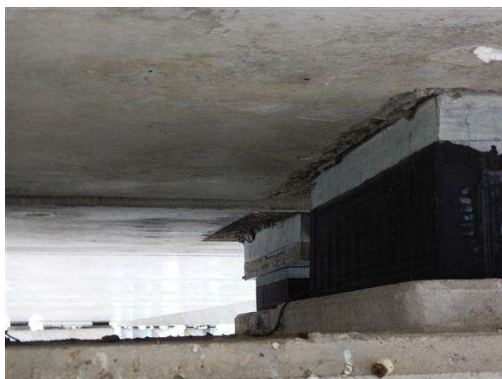
Photo 29 Honeycombed concrete around the edges of each bearing at Pier 51SB

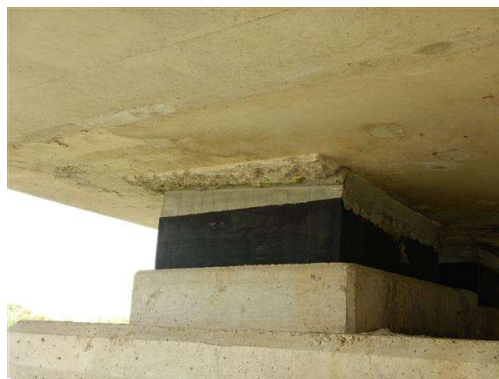
Photo 30 Spalls with exposed reinforcement at North bearing at Pier 38SB

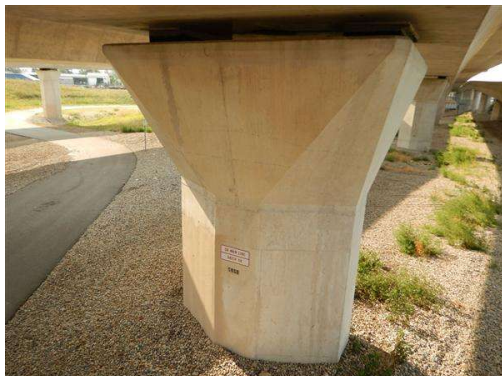
Typical hairline to medium (0.025") width vertical, horizontal and map cracking was noted on a majority of the pier columns. Honeycombed concrete areas were observed on a majority of the pier columns. See Photo 1.

Photo 1 Typical honeycombed and hairline cracks on the columns

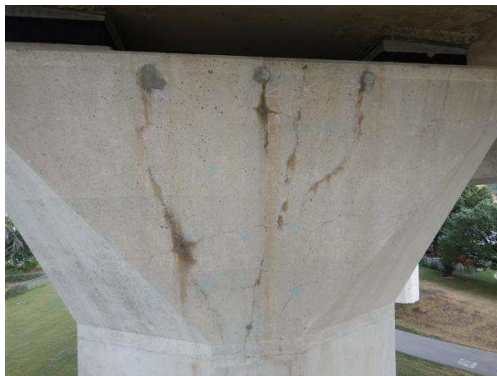
Photo 2 Typical vertical and longitudinal cracks with rust stains in the pier caps

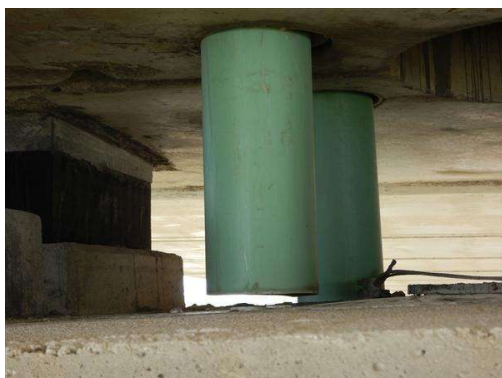
Photo 3 Drainage pipe on Southeast side at Pier 38SB does not extend into the cap

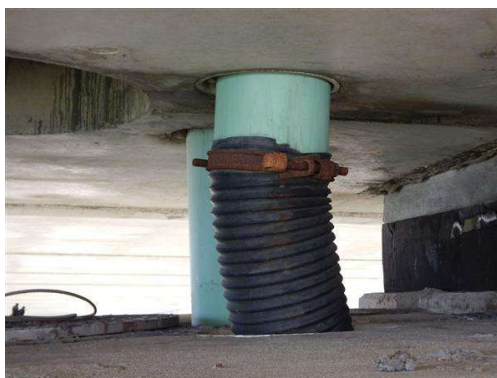
on the drainage pipe clamp on Southeast side was observed at Pier 38SB. See Photo 4. The bird screen was hanging at Pier 30SB on the West face. See Photo 5.

Photo 4 Heavy rust on drainage pipe clamp at Pier 38SB

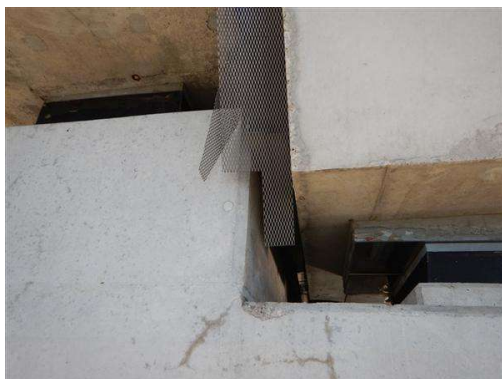
Photo 5 Hanging bird screen on the West face of Pier 30SB

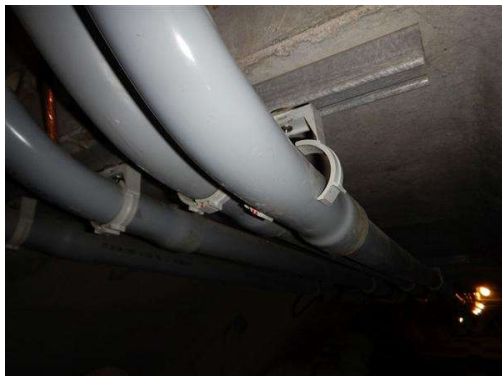
An electrical conduit bracket was broken in Span 33SB. See Photo 1. Electrical conduits were seperated in Span 30SB. See Photo 2. A loose electrical conduit bracket was noted in Span 48SB. See Photo 3. Cables were hanging in Span 56SB. See Photo 4.

Photo 1 Broken electrical conduit bracket in Span 33SB

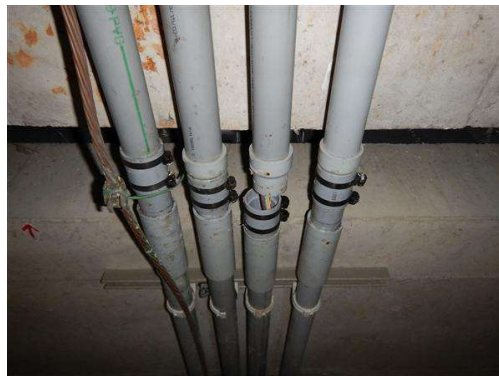
Photo 2 Separated electrical conduits in Span 30SB looking South

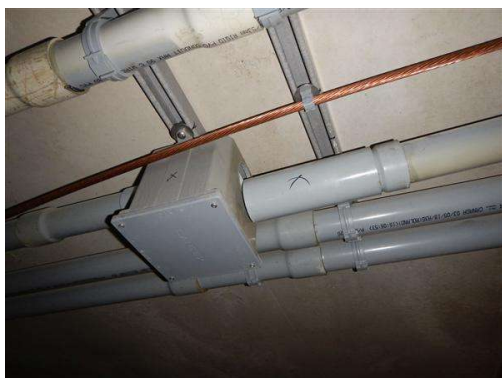
Photo 3 Loose electrical conduit in Span 48SB

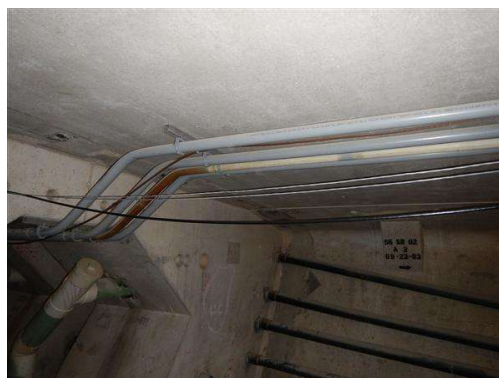
Photo 4 Loose/hanging cables in Span 56SB looking West

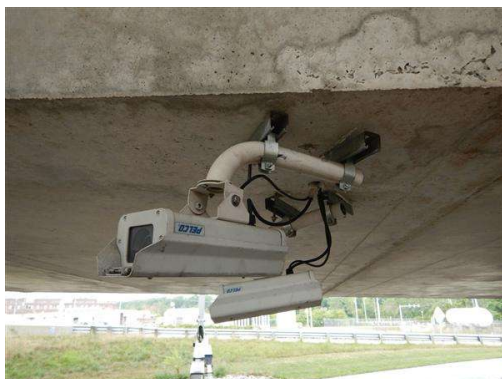
The security camera bracket was loose on the exterior of Span 58SB. See Photo 5

Photo 5 Loose security camera bracket in Span 58SB

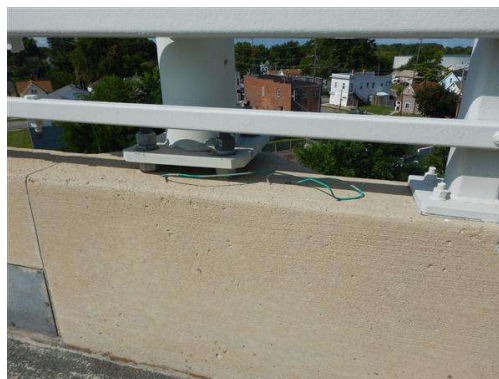
Photo 6 Disconnected grounding wire in Span 44SB

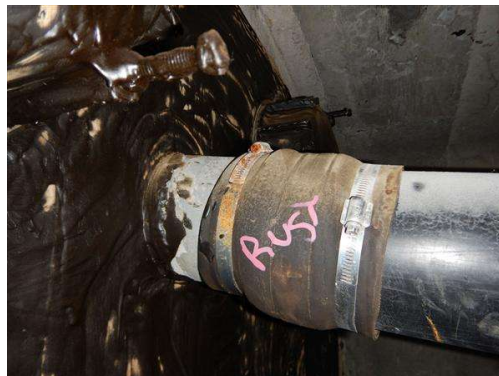
The external tendons were in good condition with minimal notable defects. A few areas of rusting were observed on the steel PT ducts at the diaphragm connections and clamps connecting the PTFE sheathing to the steel ducts. See Photo 2.

Photo 2 Rust on PT duct clamp at Pier 51SB looking West

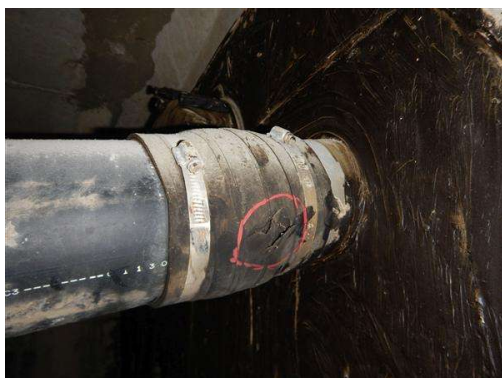
In Span 36SB, at Segment 14P, a tear in the PT duct cover was observed. See Photo 3.

Photo 3 Tear in the PT duct splice at Pier 36SB looking West
