2017 LUC-00280-0375\_R (NB NORTH APPROACH) ROUTINE  
INSPECTION REPORT  
BRIDGE INSPECTION REPORT

Structure File Number: 4806107

Inventory Bridge Number: LUC 00280 03.750 R

IR-280 over SUMMIT TO CHAMPLAIN, NSRR

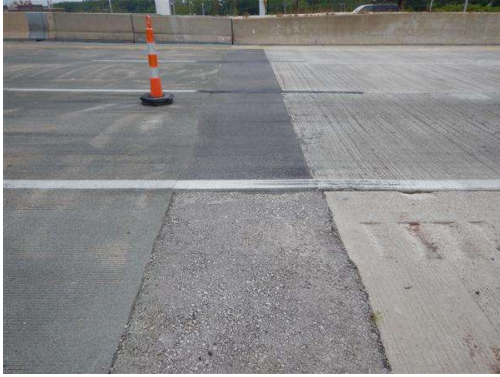
Approach pavement cracked in all the lanes and at some locations patches were spalled. See Photo 1. The riding surface over the length of the slab and expansion joint was noted to be smooth.

Photo 1 Concrete spalls in approach pavement in all lanes looking West

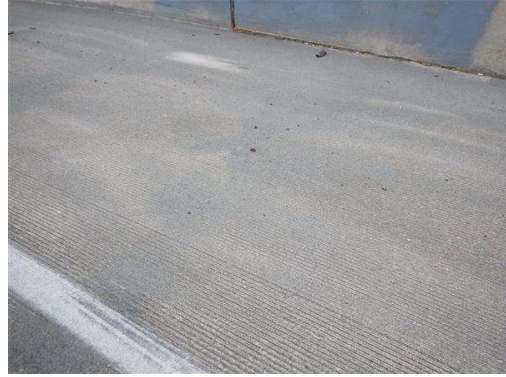
Transverse cracks of 0.030" width were seen on the East shoulder of the approach slab. Minor transverse cracks were observed in all the lanes. See Photo 2.

Photo 2 Transverse cracks in East side of the approach slab looking East

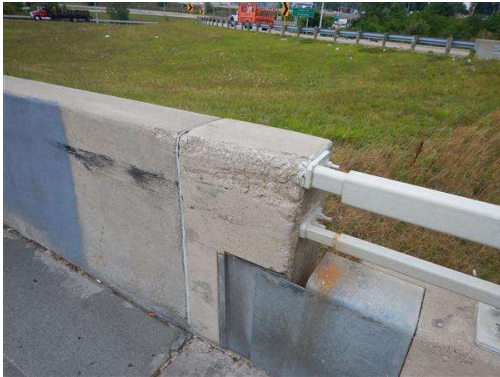
A concrete spall of 21"x8"x0.75" was observed on the east barrier. See Photo 3. A 0.75" header gap was observed in concrete barriers on both sides. See Photo 4. Vegetation growth between joints was seen in the West barrier.

Photo 3 Concrete spall 21"x8"x3/4" in East parapet looking East

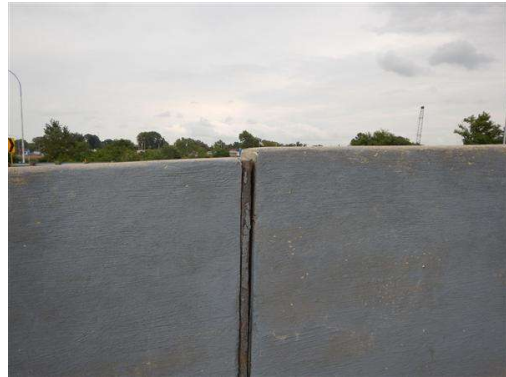
Photo 4 0.75" header gap between concrete barriers looking East

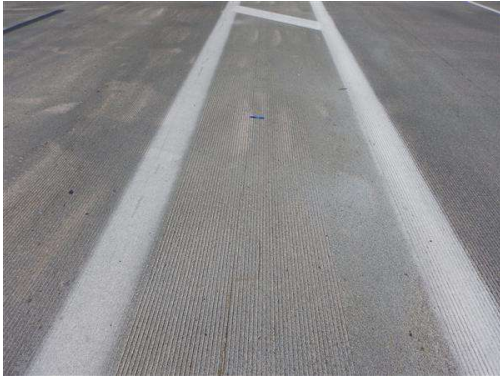
Hairline to moderate (0.025" wide) transverse and map cracking with efflorescence in areas was noted along the length of the longitudinal closure pour joint. See Photo 1.

Photo 1 Hairline to moderate (0.025") cracking with efflorescent leaching in closure pour joint

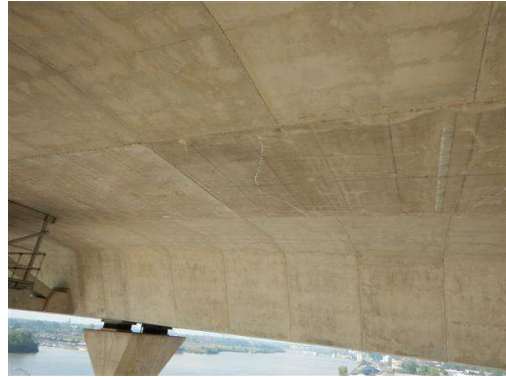
The bottom of the deck slab is rated in the superstructure inspection section of this report and subsequent photos for these defects are also located in the section. Numerous transverse closure pour joints in the top flange/deck displayed areas of cracking, some with heavy efflorescence, over the length of the bridge. See Photo 2.

Photo 2 Bottom of the deck slab closure pour with transverse cracks and efflorescence in Span 29NB

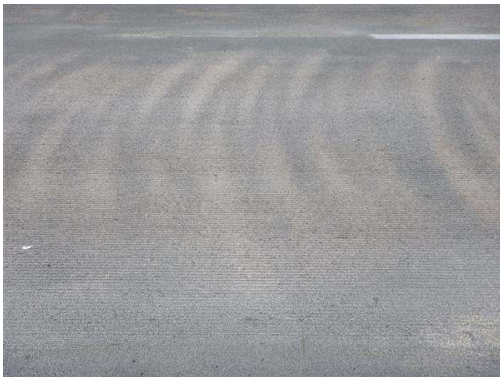
Areas of moderate transverse and map cracking (0.013" to 0.025") along the length of the bridge were observed. A majority of the segmental and expansion joints exhibited transverse cracks. See Photo 3.

Photo 3 Transverse cracks at the segmental joint in Span 56NB

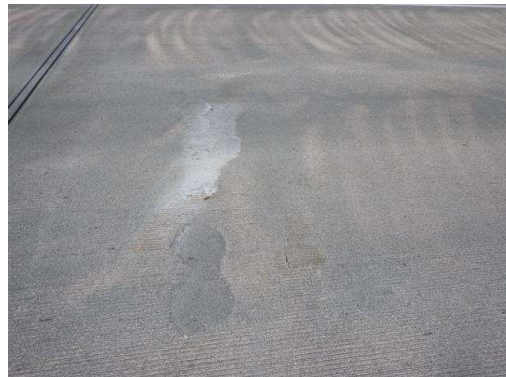
Numerous lift hole and deck patches were noted along the length of the bridge and displayed moderate cracking (0.013" to 0.020"), spalling and discoloration around the perimeter. See Photo 4. Other patches were determined to be delaminated and unsound with moderate cracking in both the shoulder and travel lane areas of the deck. See Photos 5 through 8. These patches and cracks appeared to be reflective and were present in the wearing surface.

Photo 4 Lift hole patches with spalling and efflorescence around the perimeter at Pier 56NB

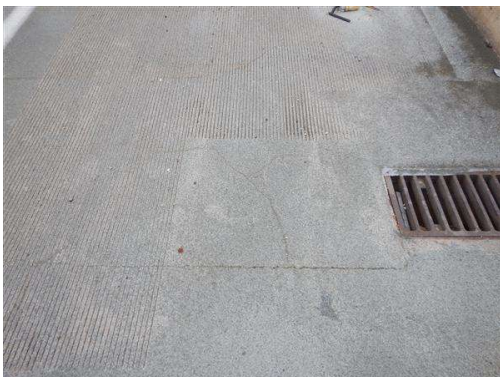
Photo 5 Unsound concrete patch (1'x1') with map cracking at Pier 45NB scupper

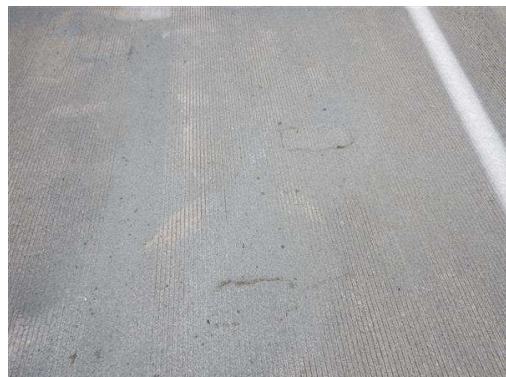
Photo 6 Concrete patches with minor spalls around the perimeter in the Span 45NB

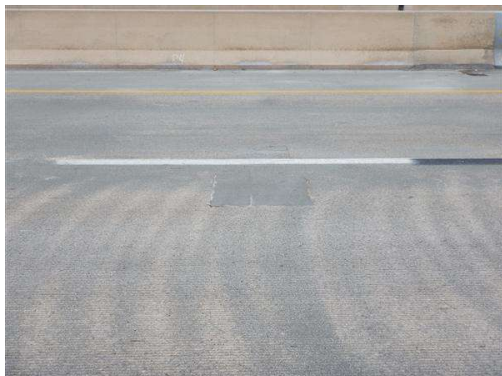
Photo 7 Delaminated concrete patch (5'x3') in the West traffic lane in the Span 55NB looking West

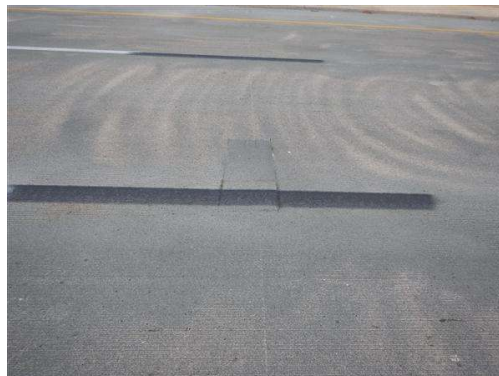
Photo 8 Concrete patch with map cracking in the travel lane in Span 58NB looking West

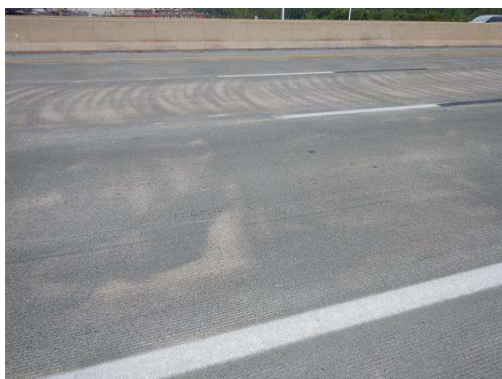
A few areas of the wearing surface exhibited scaling and abrasion in the west traffic lanes of the roadway in spans 54 to 56NB. See Photo 9.

Photo 9 Scaling and abrasion in the wearing surface looking West

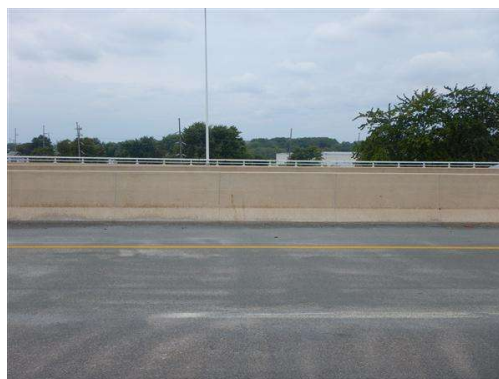
Typical areas of hairline to moderate vertical and horizontal cracking were noted along the length of the concrete parapet on both sides of the roadway. See Photos 10 and 11.

Photo 10 Typical vertical cracks in the West parapet looking West

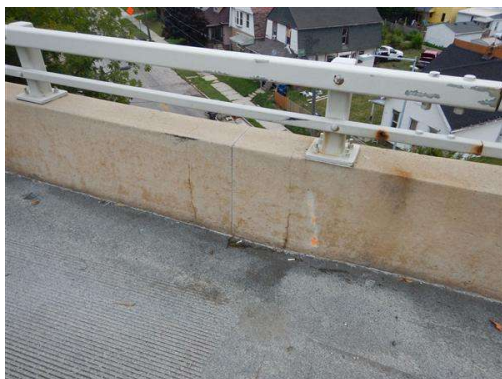
Photo 11 Typical full length vertical cracks in the East parapet looking East

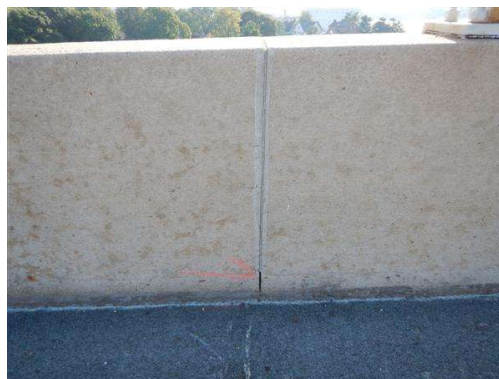
Numerous areas of cracking had efflorescence, rust staining and/or discoloration/leaching. The bottom 2" saw cut was not filled in the East concrete parapets in Spans 37NB through 40NB. See Photo 12.

Photo 12 Bottom 2" saw cut in the East parapet unfilled looking East

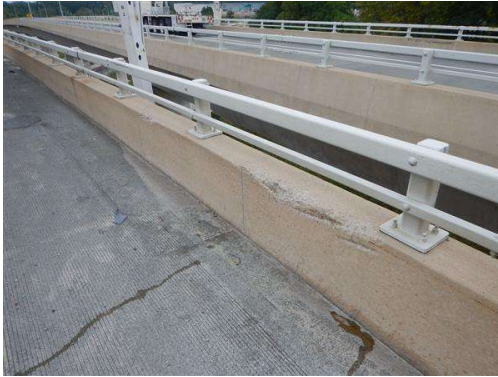
Several areas of delamination, spalls and gouges were noted along the length of the bridge in Spans 40NB through 43NB, 53NB and 55NB. See Photos 13 through 15. A few areas of scaling along the top edge of the East parapet were noted in the Span 40NB. See Photo 16. Concrete pop outs were observed in the Span 42NB. See Photo 17.

Photo 13 Spall (42"x15"x2") on the East parapet in Span 53NB looking East

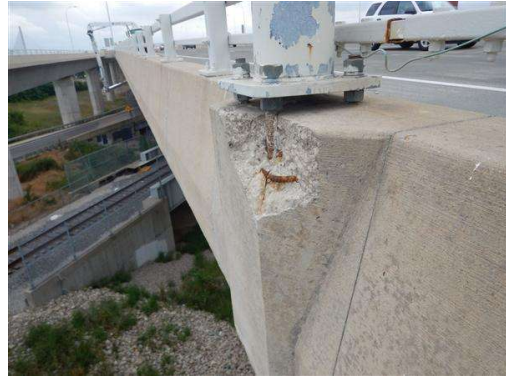
Photo 14 Spall at the light pole with exposed reinforcement in Span 55NB looking South

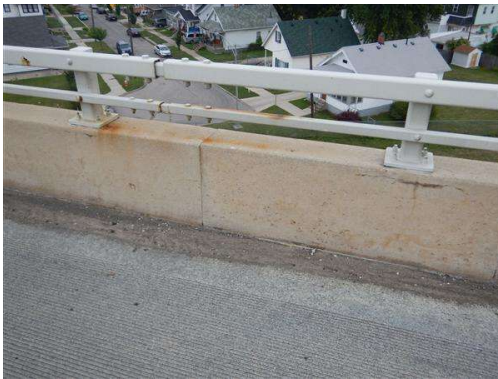
Photo 15 Delamination in East parapet in Span 43 looking East

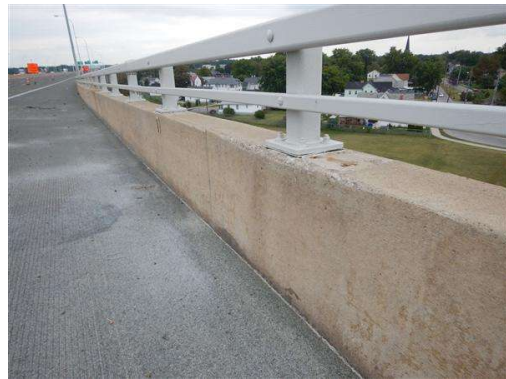
Photo 16 Scaling along the top of East parapet in Span 40NB looking East

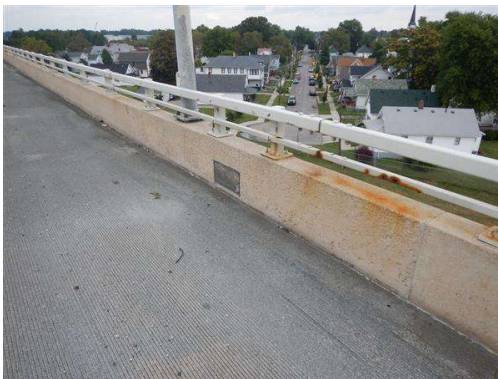
Photo 17 Concrete popouts in East parapet in Span 42NB looking East

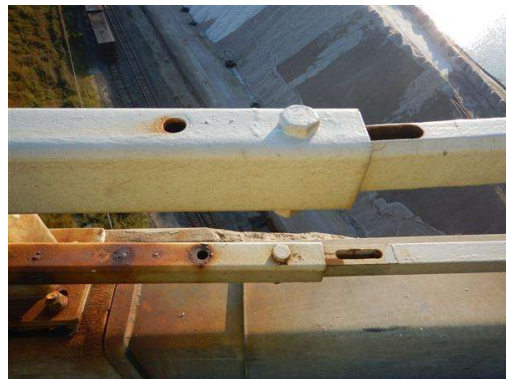
A few areas of deterioration and heavy rust on the steel railing were noted on the East steel railing along the length of the bridge. Minor paint damage was found at multiple locations. In Span 30NB, the splice plate bolt was missing from the railing. See Photos 18 through 21.

Photo 18 Missing splice plate bolt for the steel railing in Span 30NB looking East

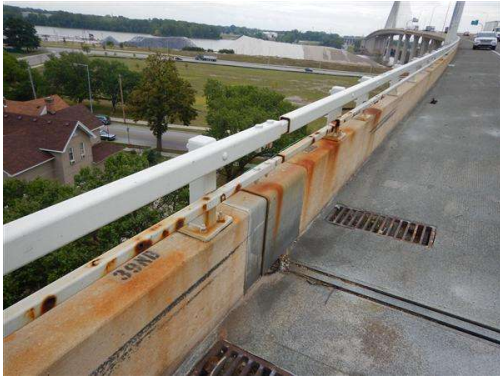
Photo 19 Typical condition of the steel railing along the length of the bridge looking South

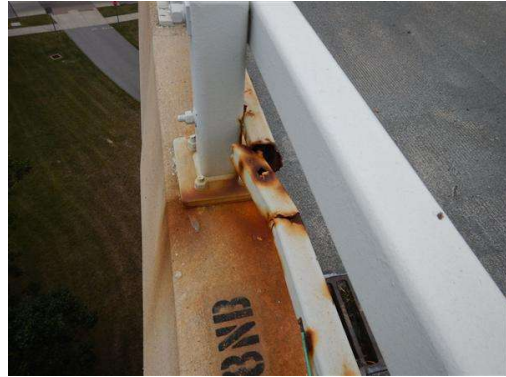
Photo 20 Deterioration in the steel railing due to heavy rust in Span 38NB

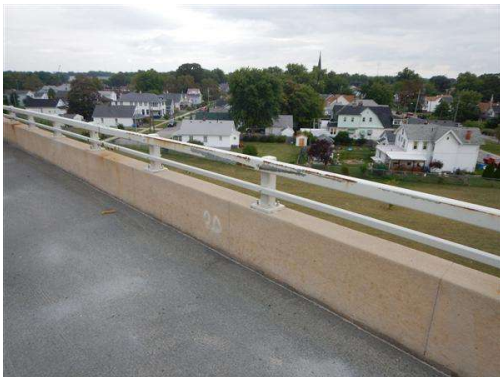
Photo 21 Paint damage to the steel railing in Span 41NB looking East

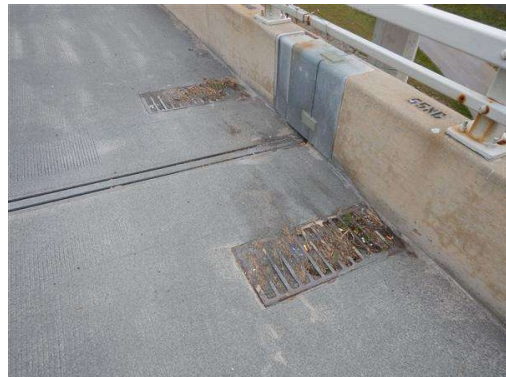
Photo 22 Fully filled scuppers with vegetation growing at Pier 55NB looking East

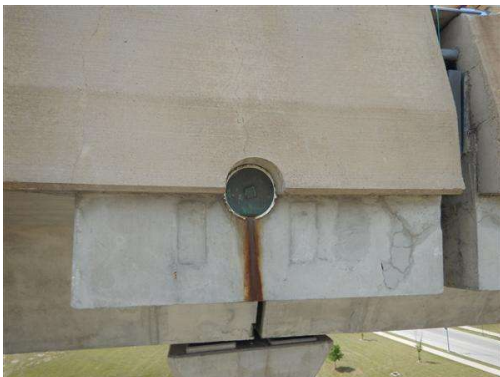
The drainage caps on the face of the pier end segments were leaking on majority of the scupper locations. Varying levels of rust and efflorescence were noted at these locations. See Photo 23.

Photo 23 Heavy rust staining and efflorescence on the edge face of the end segments

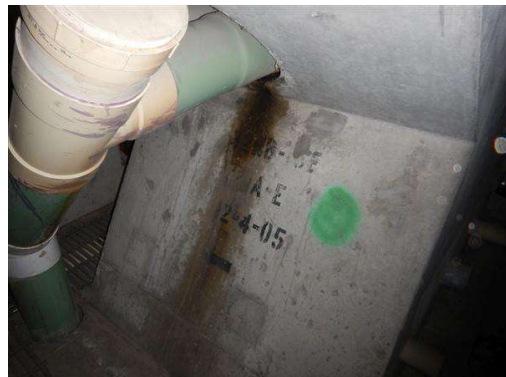
Interior drainage pipes within the interior of the box segments at Piers 32NB, 36NB, 41NB and 44NB exhibited leakage with rust staining. See Photo 24. Leaks were observed in the expansion joint device area at Pier 53NB. See Photo 25.

Photo 24 Interior drainage pipe at Pier 32NB with rust staining

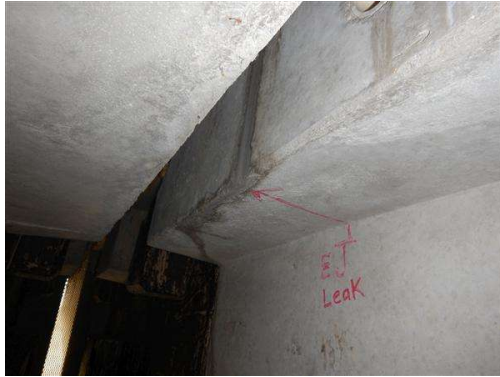
Photo 25 Leaking expansion joint at Pier 53NB

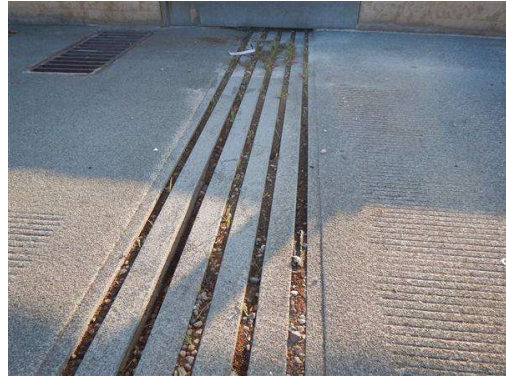
All the expansion joints over the length of the bridge were either partially or fully filled over the entire width of the roadway with vegetation growing along the joints. See Photo 26. The joint at Abutment 59NB had minor concrete spalls on the North side of the header concrete. See Photo 27.

Photo 26 Pier 30NB expansion joint fully filled with debris looking East

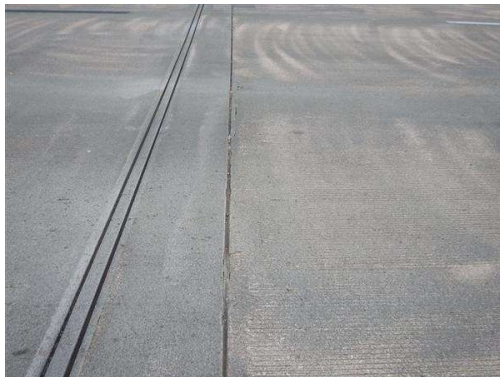
Photo 27 Concrete spalls in the expansion joint header at Abutment 59NB looking West

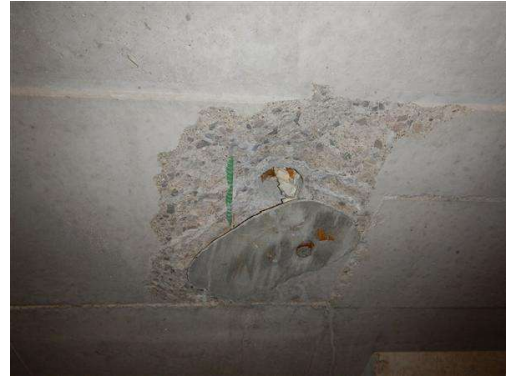
Photo 2 Severe spall at lift hole location with exposed reinforcement in Span 50NB

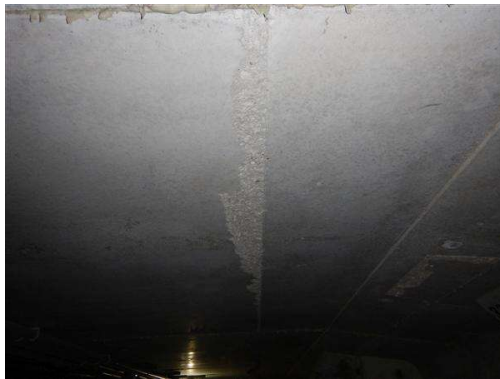
Photo 3 Concrete spall (5"x6"x1") in the top flange/slab in Span 33NB

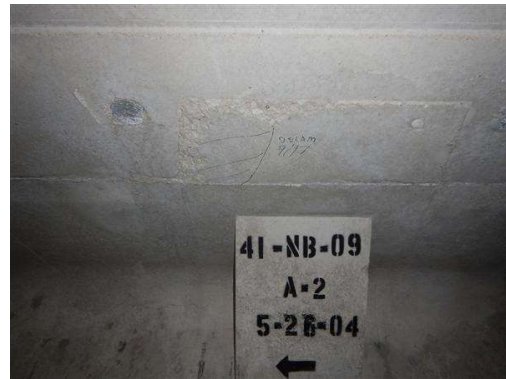
Photo 4 Delamination in the top flange over future PT block in Span 41NB

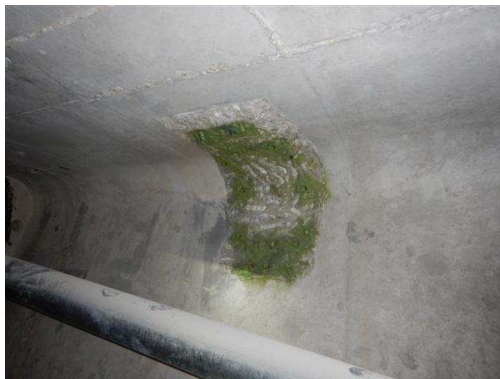
Photo 5 PT block removed with exposed reinforcement in Span 43NB

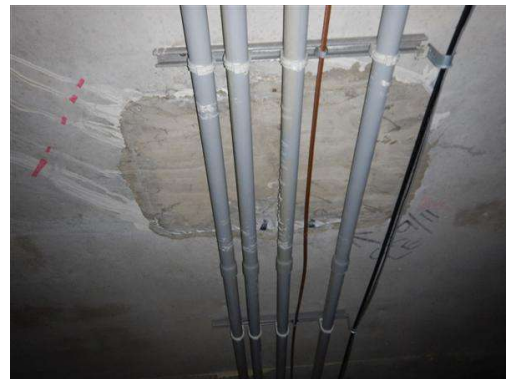
Numerous unsound or delaminated patches were observed in the lift holes at the top flange/ceiling slab along the edges of the interior segment. A majority of these areas exhibited efflorescence over the length of the bridge. See Photo 1. At multiple locations concrete spalls with exposed reinforcement were observed. See Photo 2. Other patches and construction joints in the interior of the segments, both webs and top/bottom flanges/slabs exhibited delaminated and spalled concrete. See Photos 3 and 4. Temporary jacking stiffeners/corbels were removed exposing reinforcement in Spans 43NB and 48NB. These areas have been painted, however the concrete was not patched. See Photo 5. The construction access hole patches in Spans 33NB and 37NB had cracks with efflorescence. See Photo 6.

Photo 6 Construction access hole patch cracks and efflorescence in Span 33NB

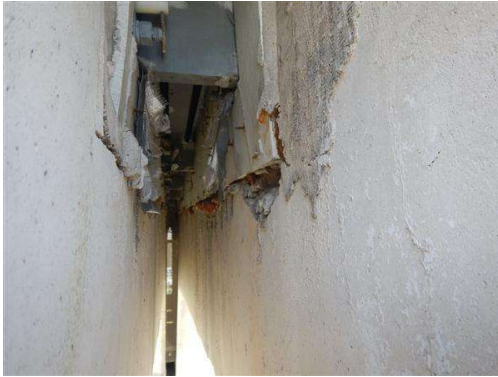
Along the exterior web and bottom flange/slab, several delaminated and spalled patches were noted along the length of the bridge. Grout or epoxy leakage between the segments was observed in Span 34NB. See Photos 7 through 10.

Photo 7 Spall (8"x3"x1.5") in PT block 2 at Pier 42NB looking West

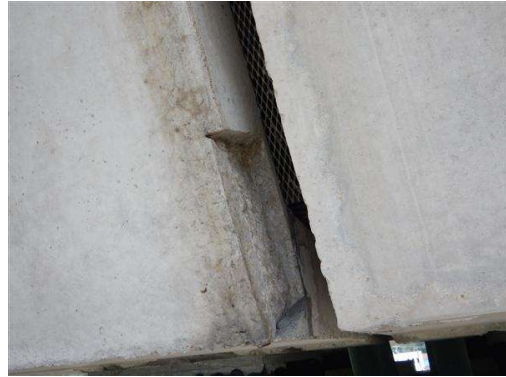
Photo 8 Concrete cut out of the web at the end of the beam at Pier 45NB looking West

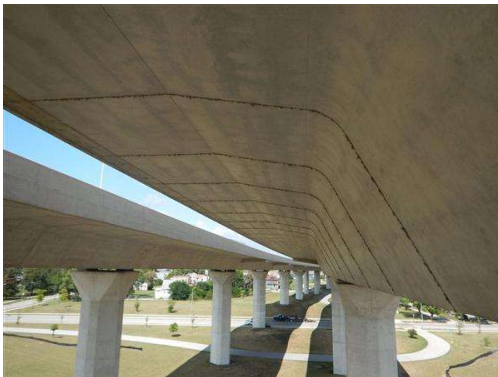
Photo 9 Grout or epoxy leakage between segments in Span 34NB looking North

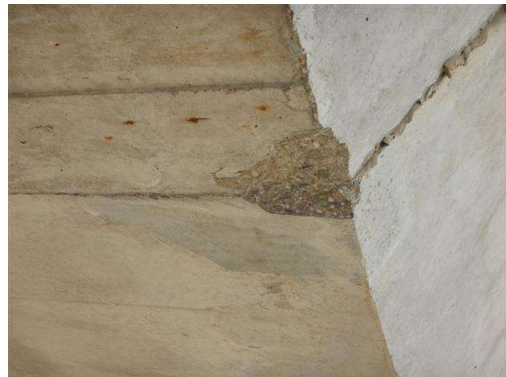
Photo 10 Spall (8"x8"x0.5") between Segments 12 & 13 in Span 34NB

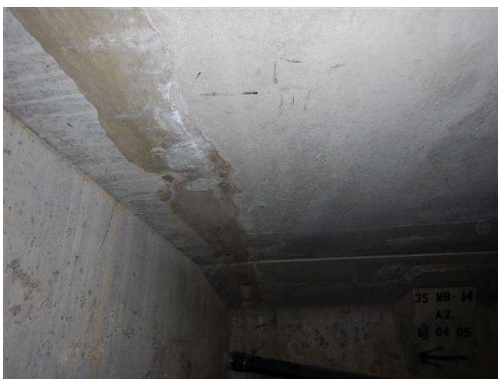
Photo 11 Cracks with efflorescence in the top flange in Span 35NB

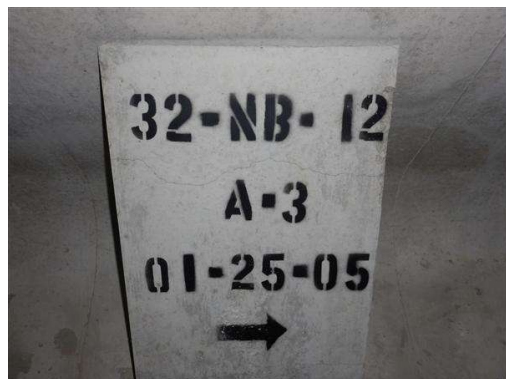
Photo 12 Typical longitudinal cracks on future PT blocks

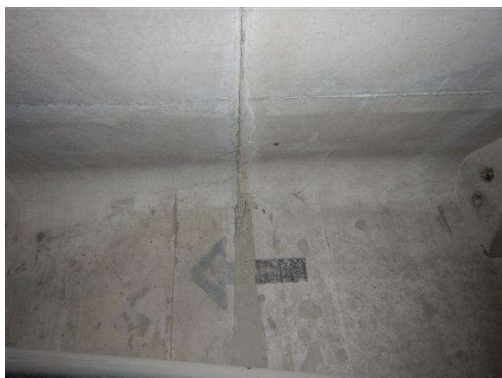
Photo 13 Interior upper corner cracks typical along the length of the bridge

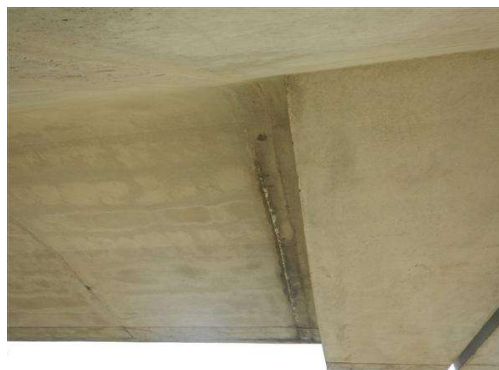
Photo 14 Cracks with efflorescence in the cantilever portion of the slab at Pier 36NB looking East

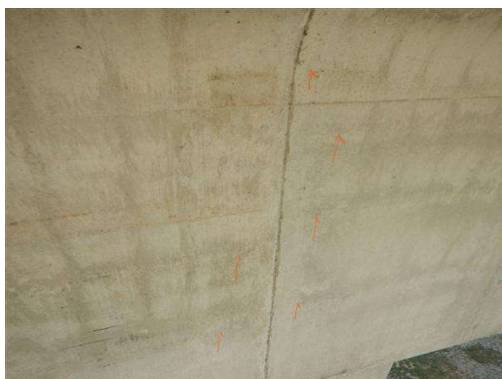
Photo 15 Typical hairline longitudinal cracks in the exterior webs

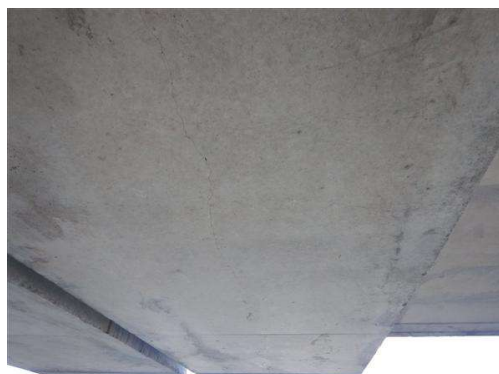
Longitudinal hairline to moderate cracking was present along both interior and exterior corner edges between the web and top flange/slab of a majority of segments. These cracks varied in length and were typically 0.005" to 0.030" in width. See Photo 11. Additional hairline cracks, vertical and longitudinal, were present along the interior and exterior webs and bottom flange/slabs of the box segments over the length of the bridge. See Photos 12 through 15. The exterior PT block segments had typical cracking on a majority of the elements on all faces. See Photos 16 and 17.

Photo 16 Longitudinal and transverse cracks in the bottom of PT block at Pier 42NB

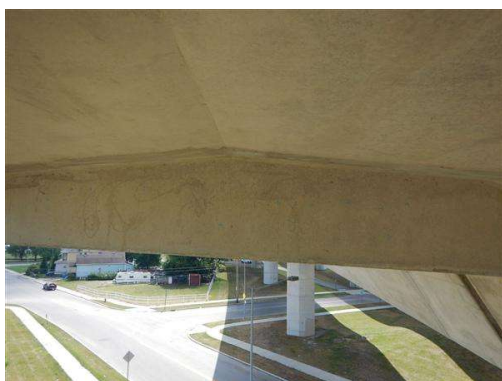
Photo 17 Typical cracking in the vertical faces of the PT end segments at the piers

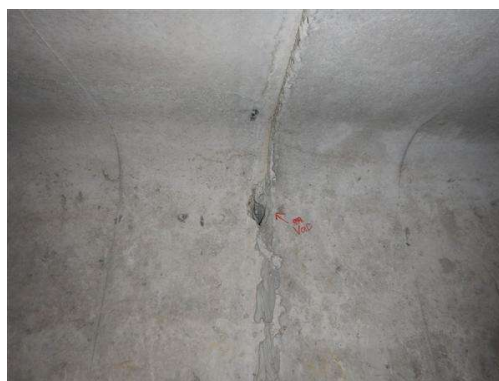
Voids were present in the segment construction joints, both interior and exterior, varying in size and depth. Some of the voids were observed to be up to 9" deep. See Photos 18 and 19. Spalls and delaminated areas were noted throughout the interior and exterior of the segments in the pier segment closure pours and the future exterior stressing blocks located at the top of the webs and along the floor slab. See Photo 20.

Photo 18 9" deep void in the interior construction joint in Span 44NB

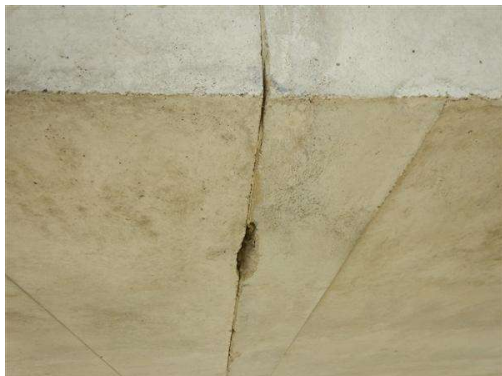
Photo 19 Void in the exterior construction joint in the bottom flange in Span 39NB

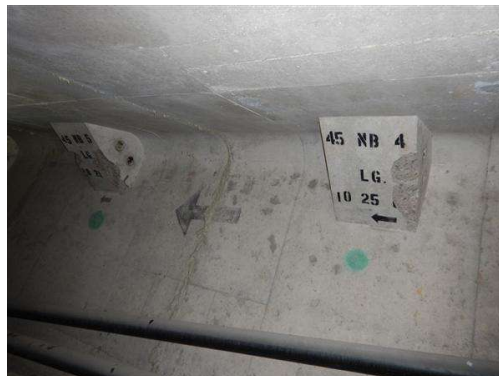
Photo 20 Typical concrete spalls in the future PT blocks

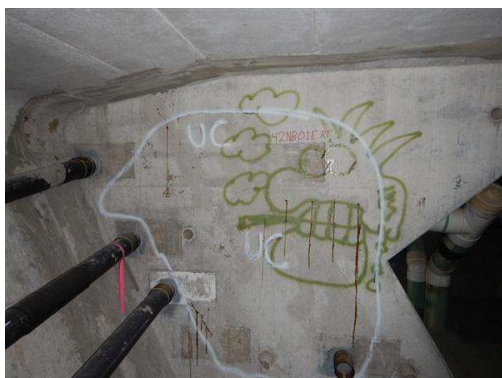
The interior diaphragms exhibited typical hairline to moderate vertical and map cracking ranging from 0.005" to 0.04" in width. Efflorescence and leaching was present at some locations although the areas did not appear to be active. Additionally, several diaphragms had areas of delaminated/unsound concrete on the vertical faces. See Photos 21 and 22.

Photo 21 Delaminated concrete area in the vertical of the diaphragm at Pier 42NB

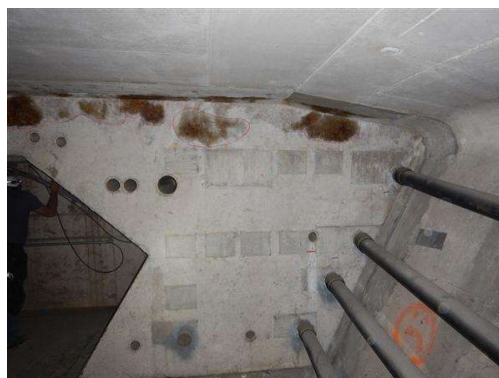
Photo 22 Map cracking and rust stains on vertical face of diaphragm at Pier 58NB

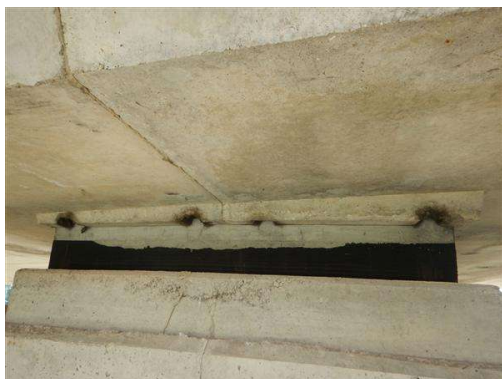
The plinths of Piers 32NB, 35NB, 37NB, 39NB, 46NB and 55NB exhibited areas of unsound, spalled or delaminated concrete with moderate to severe cracking in over 5% of the bearing area. See Photo 23. At the Pier 29NB West bearing, a gap between load plate and sole plate was observed. See Photo 24. The Pier 53NB West bearing was noted leaning 1 5/16" to South and the East bearing was leaning ¼" to the South. At Pier 34NB honeycombed concrete and cracks were observed in the pedestal. The Pier 30NB West bearing was rotated 3.5° to the East and the East bearing was rotated 5° to the South. See Photo 25.

Photo 23 Concrete spalls in East bearing plinth of Pier 37NB

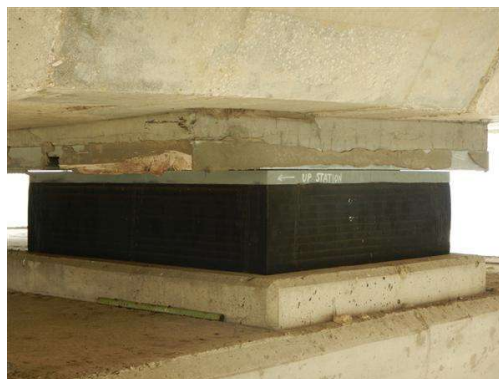
Photo 24 Gap between load plate and sole plate on West bearing at Pier 29NB looking South

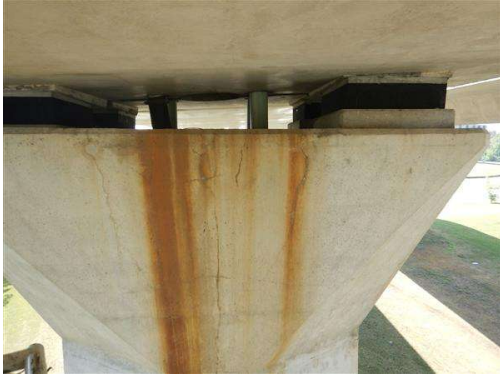
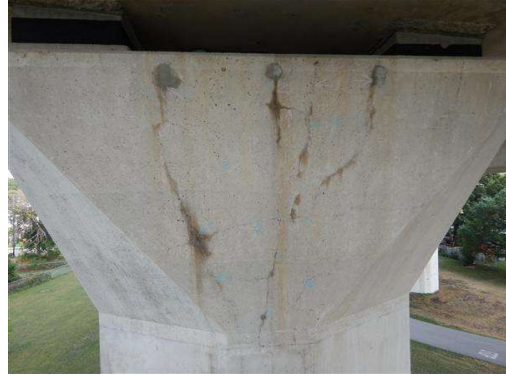
Typical hairline to medium (0.025") width vertical, horizontal and map cracking areas were noted on a majority of the pier caps. See Photos 1 and 2. Numerous caps exhibited delaminated form-tie patches in the North and South faces.

Photo 1 Typical cracking and efflorescence or staining in the pier caps

Photo 2 Typical cracking and efflorescence or staining in the pier caps

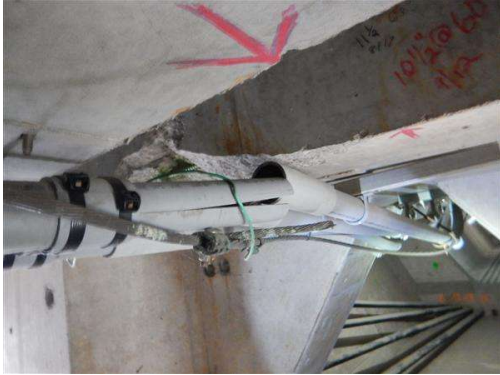
Electrical conduits were noted to be separated or broken in the interior Spans 30NB, 41NB, 44NB, 50NB and 53NB. See Photo 1 and 2. In Span 54NB, the bottom of the electrical conduit was observed to be burnt. See Photo 3.

Photo 1 Broken and separated electrical conduit in Span 30NB

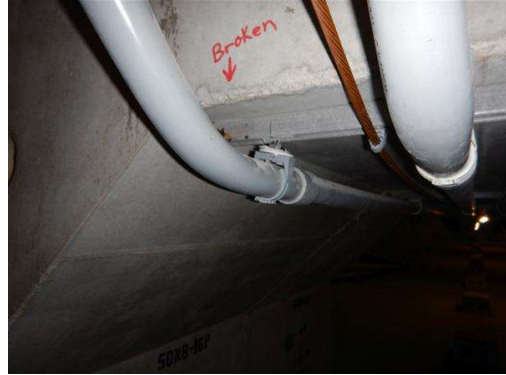
Photo 2 Broken electrical conduit bracket in Span 50NB

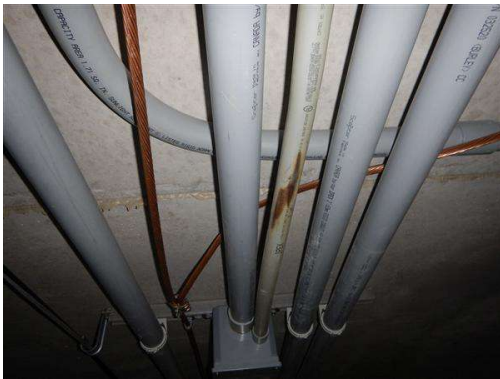
Photo 3 Burned electrical conduit in Span 54NB

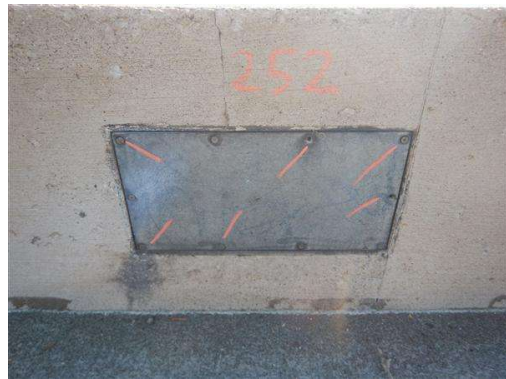
In Spans 30 through 33NB, screws were missing or loose in the junction box covers on the East parapet. See Photo 4. In Span 35NB, the light pole was missing the luminary device. See Photo 5. The ground wire connecting the light pole in Span 39NB was disconnected. See Photo 6. In Span 58NB, a leveling nut was not fully tightened on the light pole base plate. See Photo 7.

Photo 4 Missing and loose screws in the electrical panel in Span 31NB

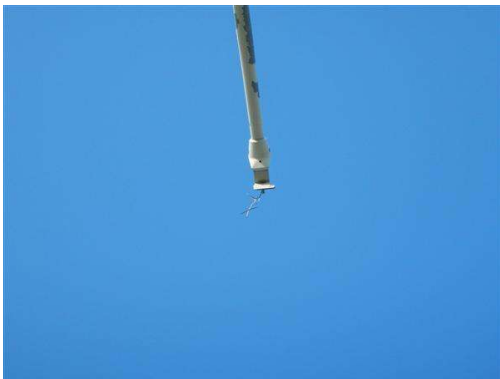
Photo 5 Missing light in Span 35NB

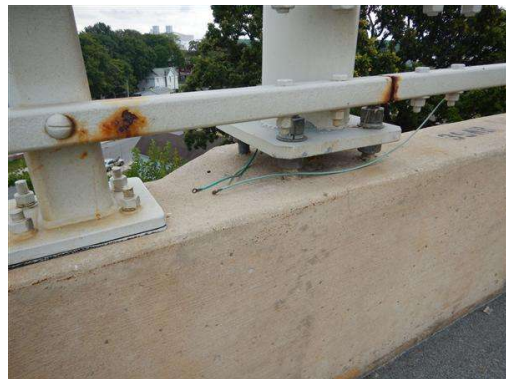
Photo 6 Disconnected grounding wire in Span 39NB

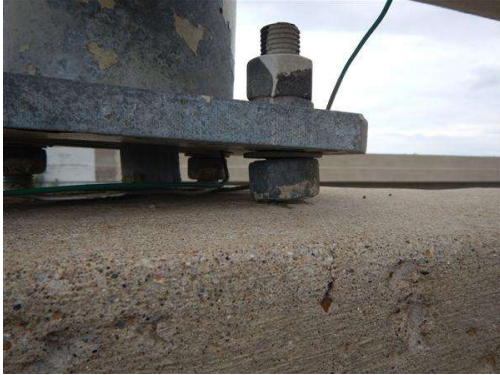
Photo 7

Loose leveling nut on light pole base in  
Span 58NB

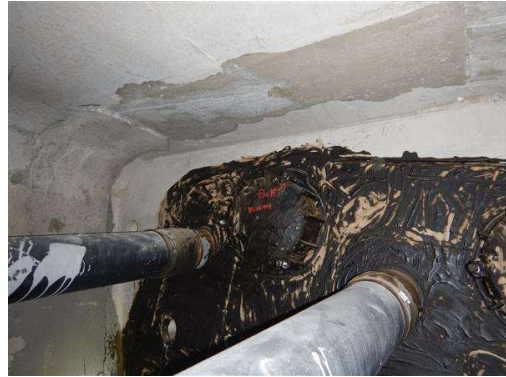
Numerous PT end cap locations were noted to have small void areas within the grout in the cap. These areas were determined and verified by gently tapping on the plastic end caps with a hammer. A few caps were observed to have missing bolts connecting the cap with the duct at the diaphragm. See Photos 1 and 2.

Photo 2 Missing bolt on PT anchor heads and rust on clamps at Pier 55NB

It is recommended that a form of NDT or ultrasound be utilized to determine the exact extent and accuracy of the voids. With the caps being covered with waterproofing material and being plastic, hollow areas within the cap were difficult to detect with certainty. In addition, the brittle nature of the material could lead to cracking of the end caps if struck too hard with a hammer.

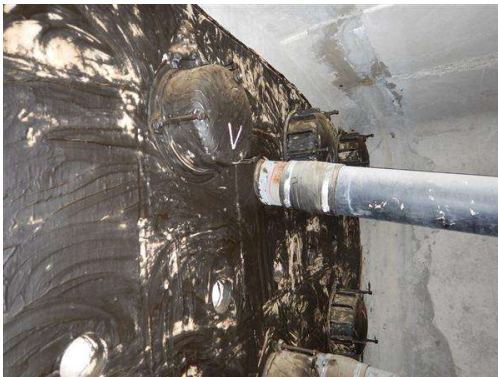
External tendons were in good condition with minimal notable defects. A few areas of rusting were observed on the steel PT ducts at the diaphragm connections and clamps connecting the PTFE sheathing to the steel ducts. See Photo 3.

Photo 3 Rust on PT duct at Pier 52NB

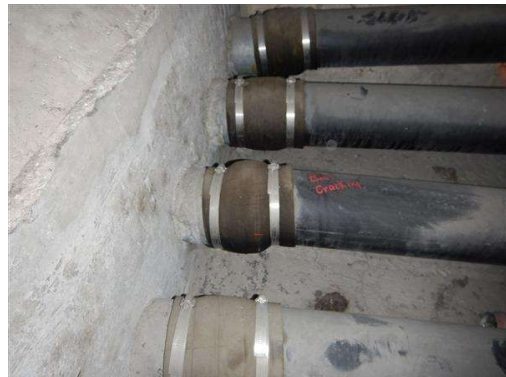
A couple of the exterior tendon couplers connecting sections of the sheathing together appeared misaligned slightly over the length of the bridge. PT duct splices appeared to be cracking, soft and/or bulging at multiple locations. See Photo 4.

Photo 4 Cracking and bulging on PT sleeves at Pier 58NB

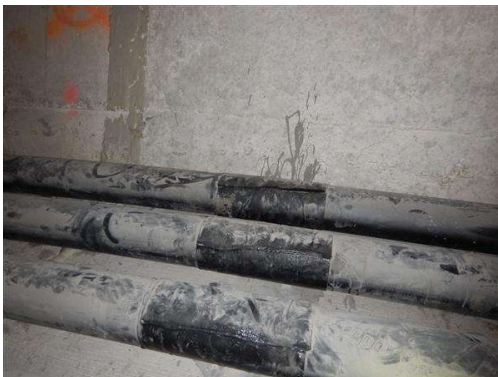
An area of sheathing splice material was not properly adhered to the PTFE tendon sections in Span 55NB at Segment 15. It could not be determined whether this location was allowing access for moisture to penetrate the tendon. See Photo 5.

Photo 5 Splice material not properly adhered to the PT tendon in Span 55NB

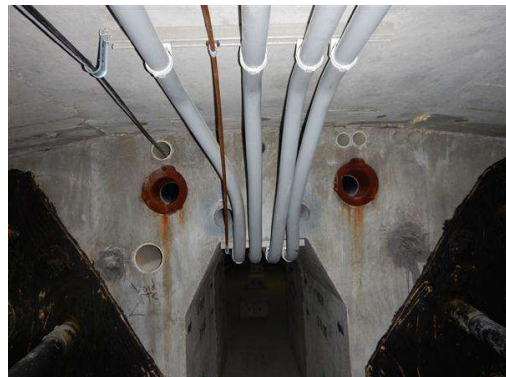
Numerous future prestressing ducts in the diaphragm exhibited moderate to heavy rust with the staining in some locations. See Photo 6.

Photo 6 Typical rust on the future PT ducts located in the diaphragms
