## ODOT PROJECT 190108

### REBAR CLEARANCE ISSUE – 0029L

#### DRB ADVISORY OPINION AMENDED DOCUMENTATION

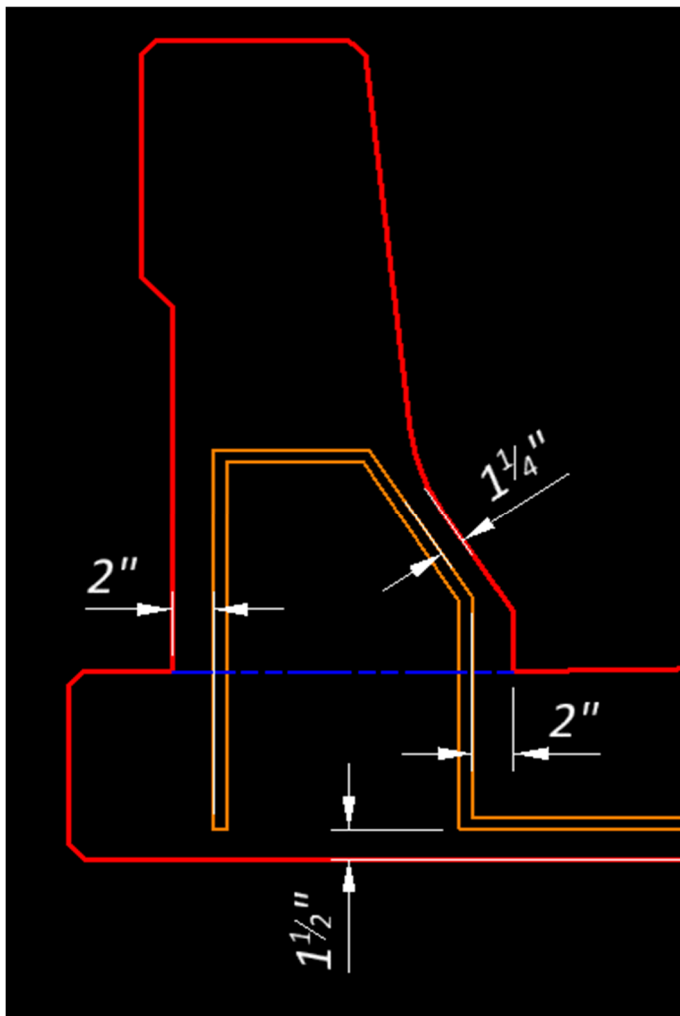
KCC Position – In our opinion, the recent discovery of additional detailing errors associated with the S5149 bars completely explains what KCC and ODOT witnessed in the field. Our position has always been that when contractual tolerances are considered, the thin coverage over bar S5149 could be explained. The new information demonstrates that prior to applying any of the contractual tolerances for placement and construction we started with 1.25" of coverage over the S5149 bars. See detail below.

The fact that the coverage was documented as +/- 1" for the duration of the wall confirms that KCC crews were very consistent in the slipforming of the railing and well within the contractual tolerances allowed in C&MS 509 & 511.

C&MS 509.04.D – Placement tolerance from the surface is (-0", +1/2")

C&MS Table 511.08-1 – Reinforcing steel cover tolerance when slipforming railing is (-1/2", +1/2")
