ODOT POSITION:

Since the previous submittal on the 0029L parapet clearance issue, a plan error in the S5149 vertical dimension was discovered. The plans call out a vertical dimension of 19.25". ODOT verified with the project designer that the vertical dimension should have been 18". The result of this plan error reduces the cover at the sloped front face of the wall to 1.25". The as bid plans show a clearance of 2". This is displayed below:

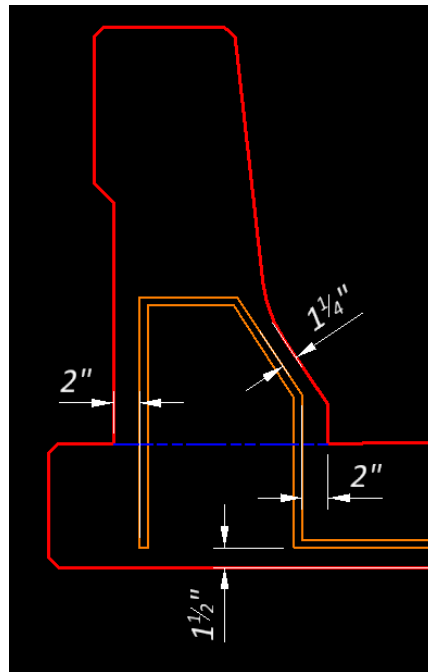
While the department acknowledges the plan error, we still believe that Kokosing shares some responsibility in the issue. A dry run per Item 511.08 was performed. However, neither the plan clearances nor the tolerances specified in Table 511.08-1 were verified. Below is an excerpt from Item 511.08.

As mentioned in the last submittal, the parapet was scanned, and clearances were found to be on average 1" or less. There were 5 or 6 locations where reinforcing steel was exposed. Since the contractor was unaware of the plan error during the dry run clearances of less than 1.5" (see Table 511.08-1) should have been identified as an issue and brought to ODOT's attention. This would have afforded the department the opportunity to correct the error and reduce the cost and impact of a repair after the fact.
