Ohio Department of Transportation, District 3

2021 Signal Evaluation

**Lorain SR 82, SLM 6.43**

**Station Road Intersection**

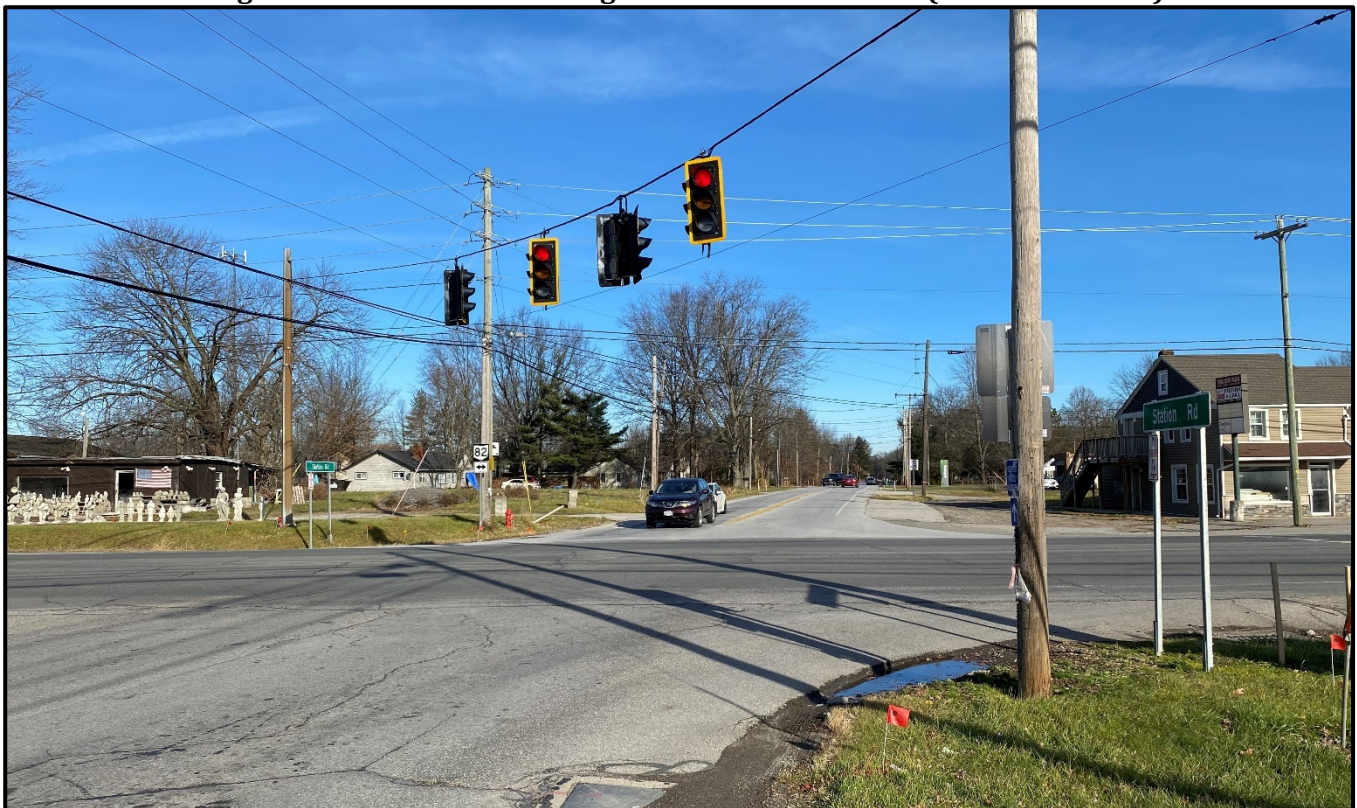
**Image 1 – SR 82 & Station Rd Signal from the Southeast (December 2021)**

- Speeds: 45 mph on SR 82 and Station Rd North, 55 mph on Station Rd South
- Traffic: Traffic was light on a mid-morning field review in December, but traffic on SR 82 has been known to be heavy at peak hours.
- Other Issues: Intersection skew and adjacent direct access create safety challenges.

- Update northbound and southbound yellow change intervals from 5.0 to 6.0 seconds
- Add intersection lighting as a countermeasure to night-time crashes
