Inspection Date: 10/26/2023

Facility Carried: LORAIN ROAD

**Ohio Bridge Inspection Summary Report****LOR-M0010-2044 (4774760)**2: District 56966 - N RIDGEVILLE (LOR county)  
ict  
03

### Bridge Inspection Report

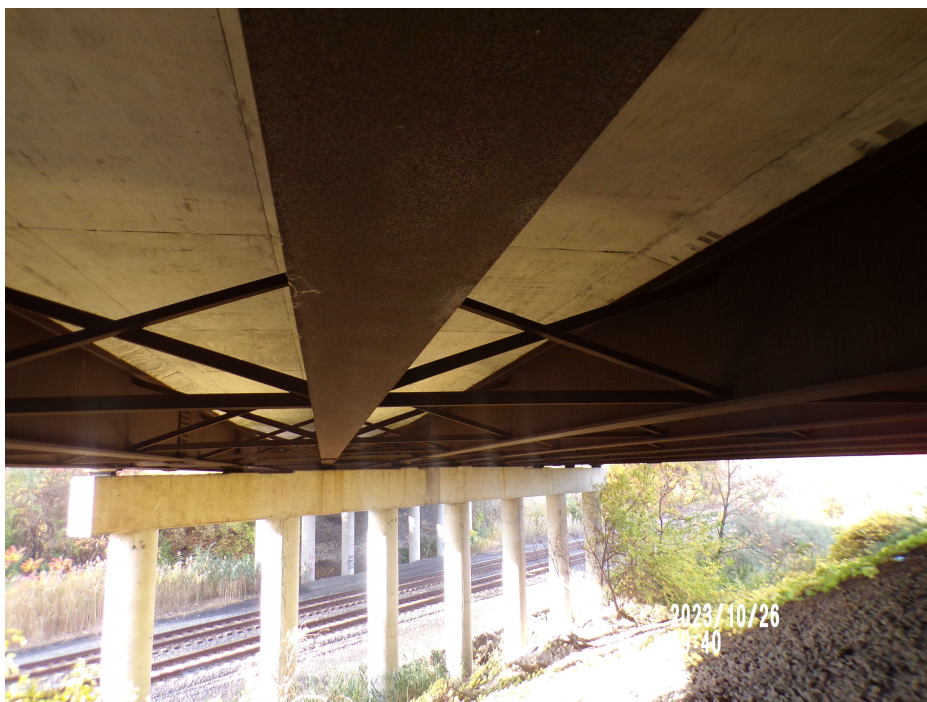
PHOTO 1

Description Deck Underside
