Engineer's Report

Bridge No. MED-42-0310L (SFN 5200962)

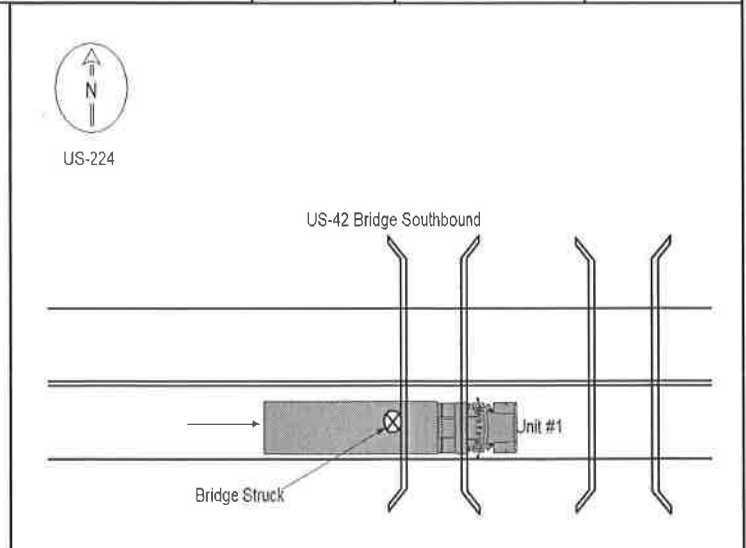
CRASH REPORTED DATE / TIME 06/28/2024 15:01	DISPATCH DATE / TIME 06/28/2024 15:01	ARRIVAL DATE / TIME 06/28/2024 15:20	SCENE CLEARED DATE / TIME 06/28/2024 19:16	REPORT TAKEN BY <input checked="" type="checkbox"/> POLICE AGENCY <input type="checkbox"/> MOTORIST
TOTAL TIME ROADWAY CLOSED	OTHER INVESTIGATION TIME	TOTAL MINUTES 255	OFFICER'S NAME* Yurek, Tara	CHECKED BY OFFICER'S NAME* Bittinger, Jason
			OFFICER'S BADGE NUMBER* 1608	CHECKED BY OFFICER'S BADGE NUMBER* 0877
				SUPPLEMENT (CORRECTION OR ADDITION TO AN EXISTING REPORT SENT TO ODPS)

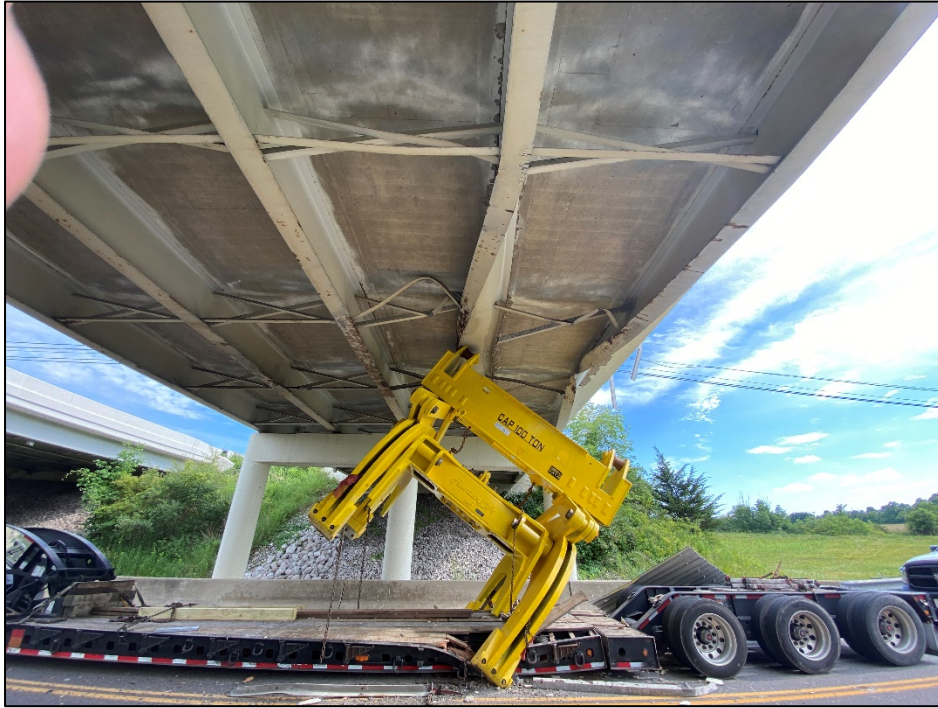
Photo # 1: Post-collision – beam 1 at right.

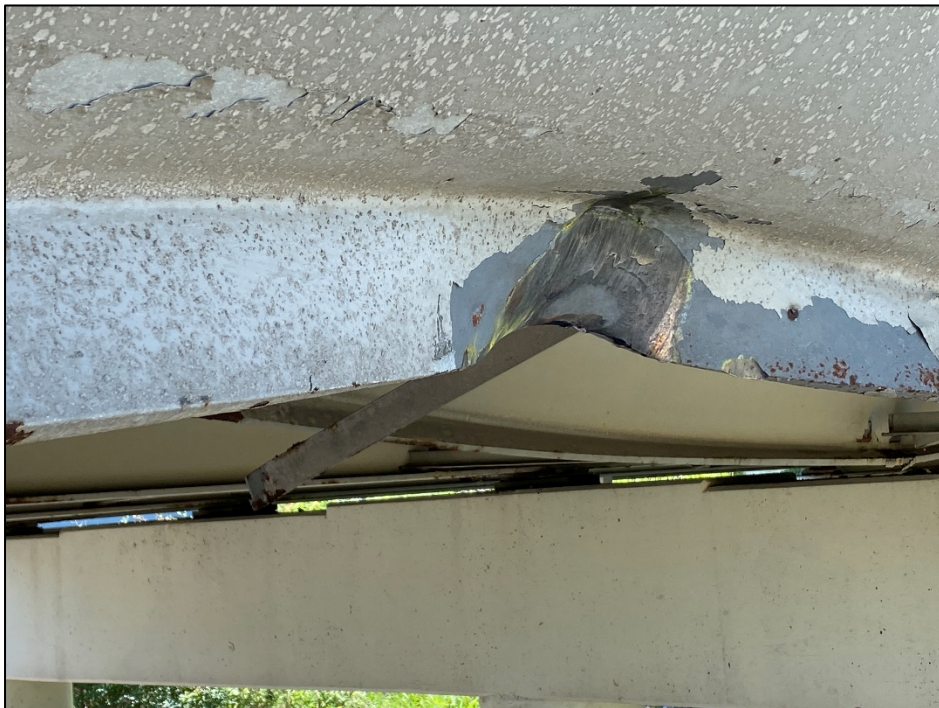
Photo # 4: Localized beam 1 flange damage at point of impact

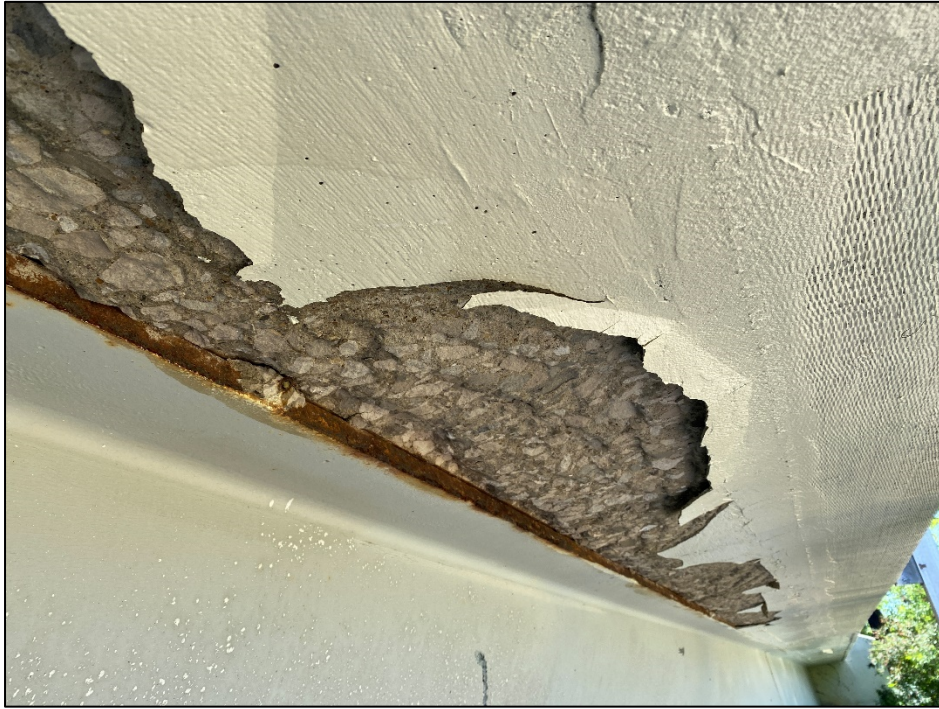
Photo # 5: Beam 1 top flange gap with spalled deck cantilever.

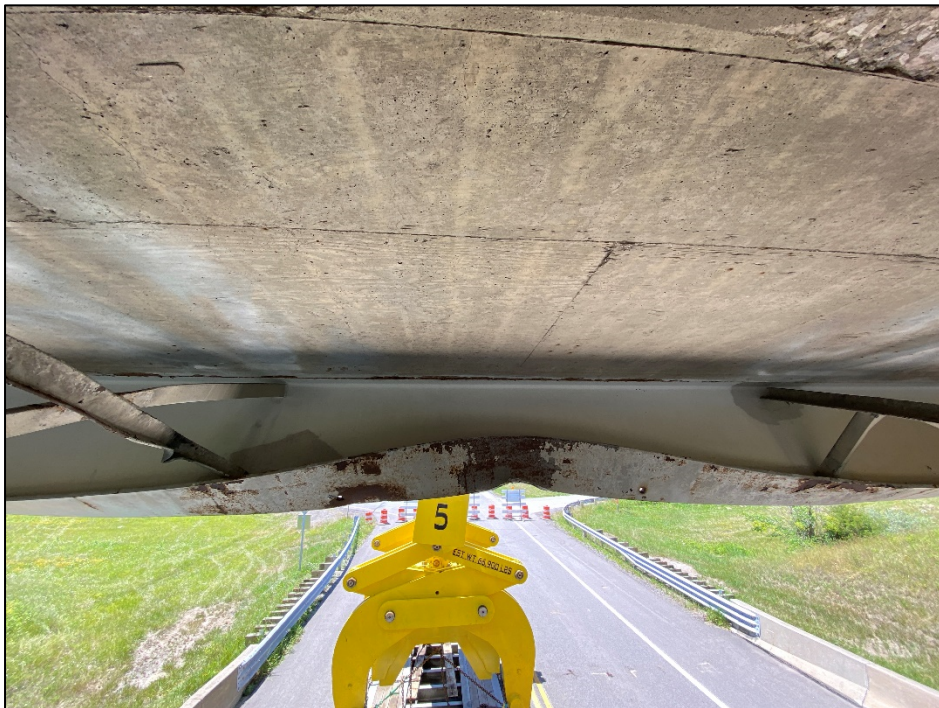
Photo # 6: Beam 1 inside face at point of impact. (Load has been moved from under bridge.)

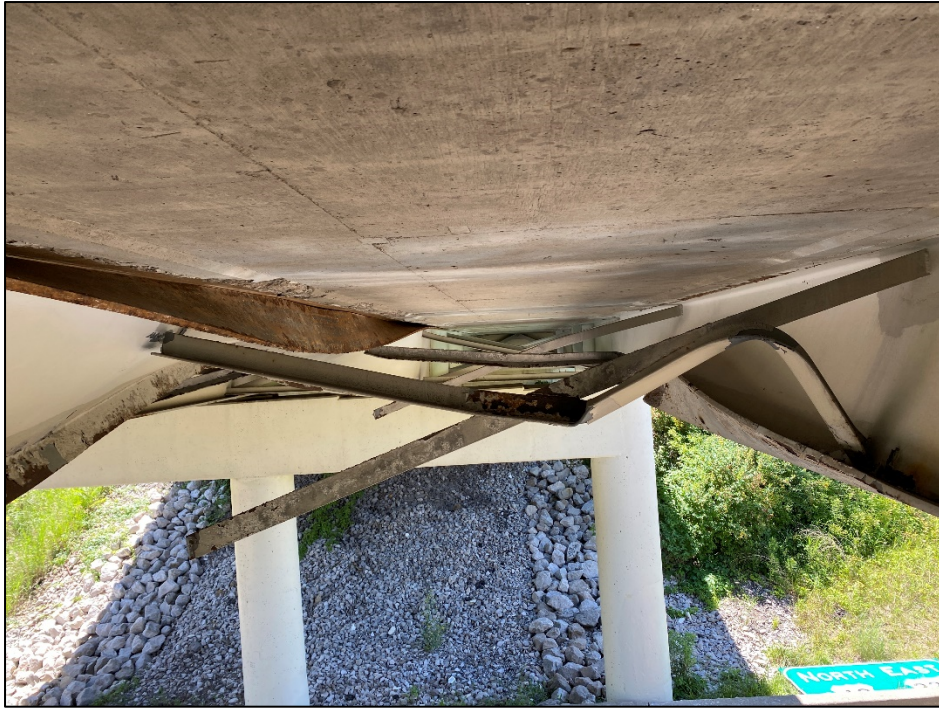
Photo # 7: Bay 1 crossframe 3 (fore) damage looking south.

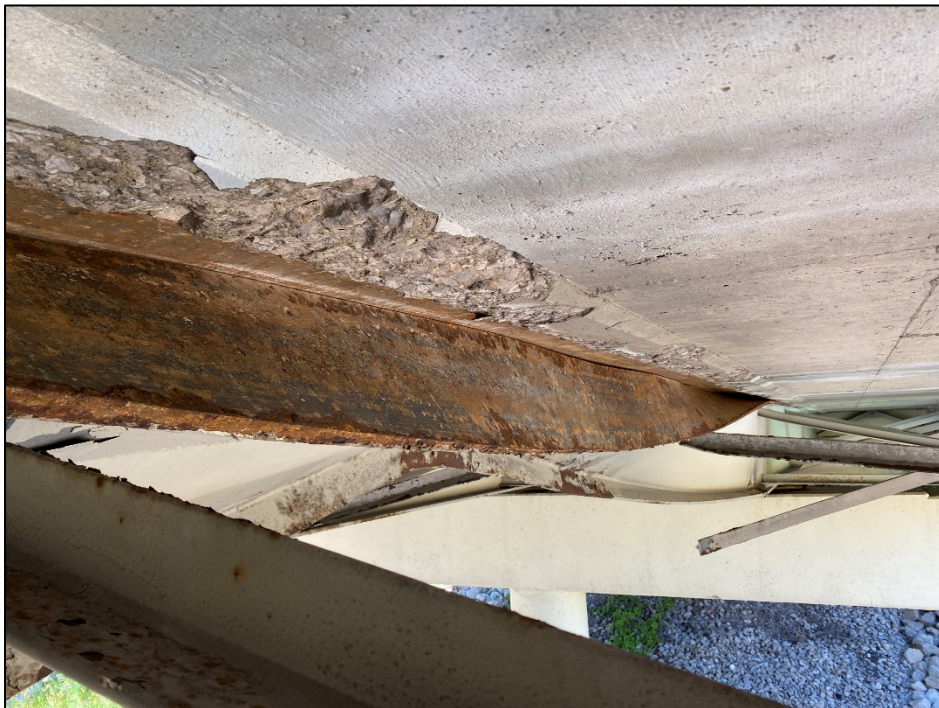
Photo # 8: Beam 2 top flange rotated almost 90 degrees at point of impact.

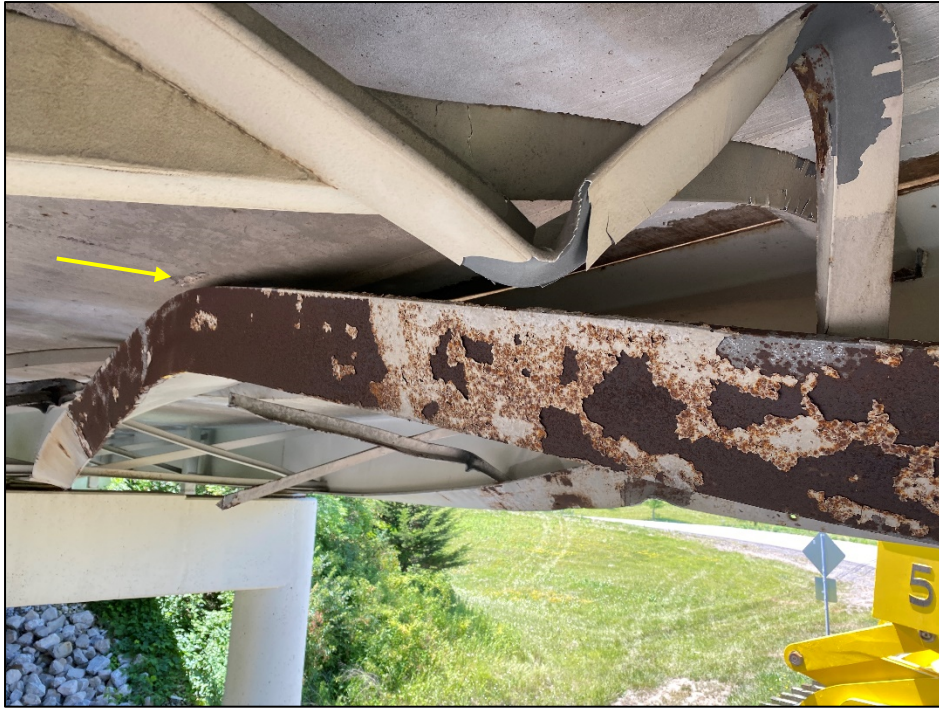
Photo # 9: Beam 2 distortion at point of impact – note damage to deck from beam bottom flange.

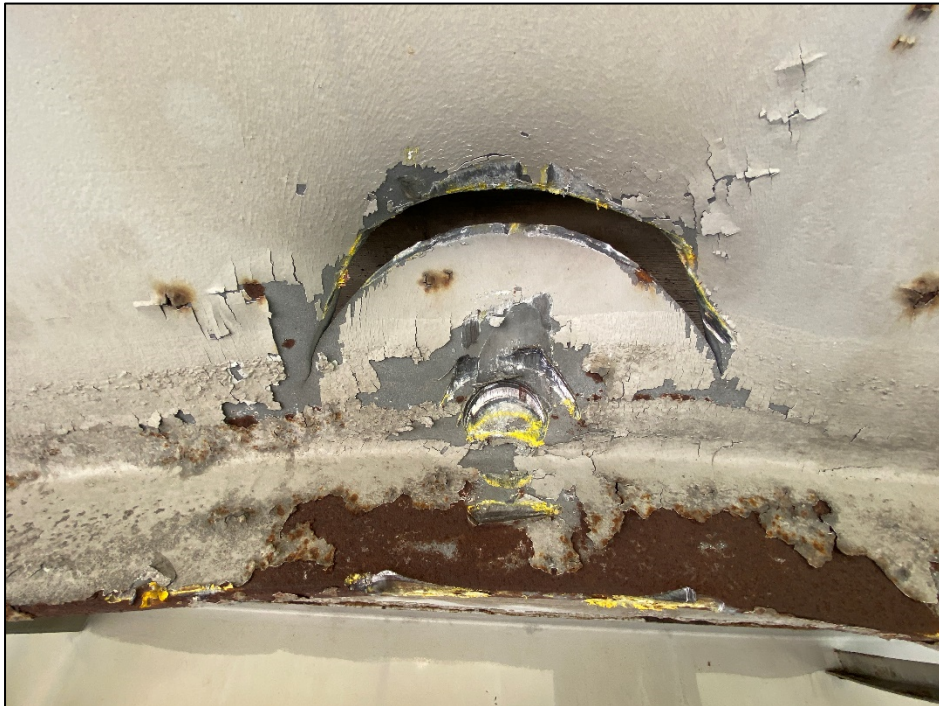
Photo # 10: Beam 2 puncture at point of impact.

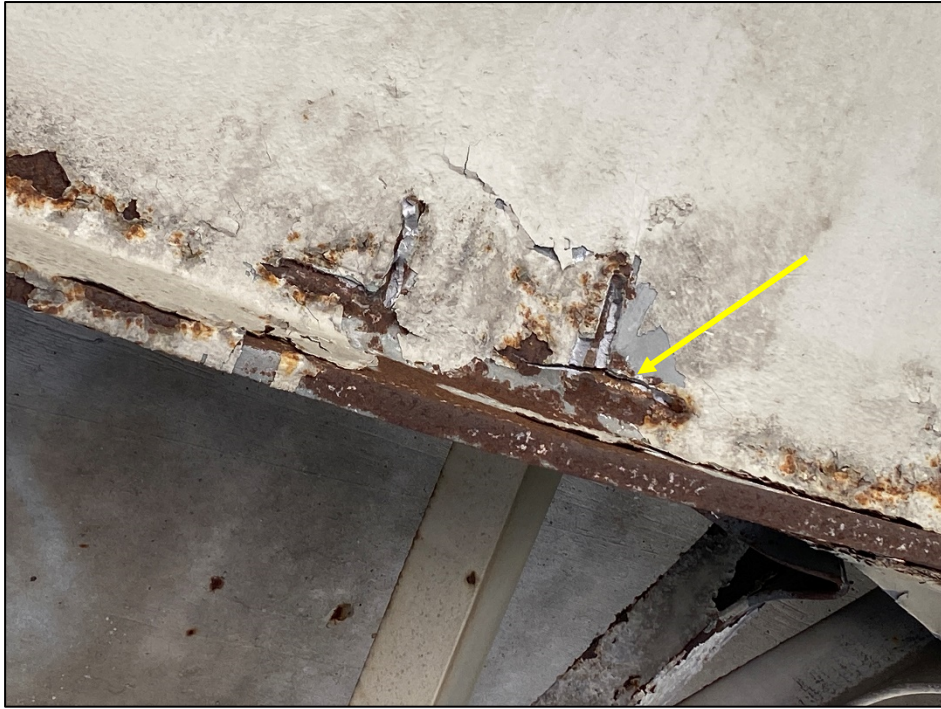
Photo # 11: Beam 2 horizontal crack in web at broken lower crossframe 2 connection weld.

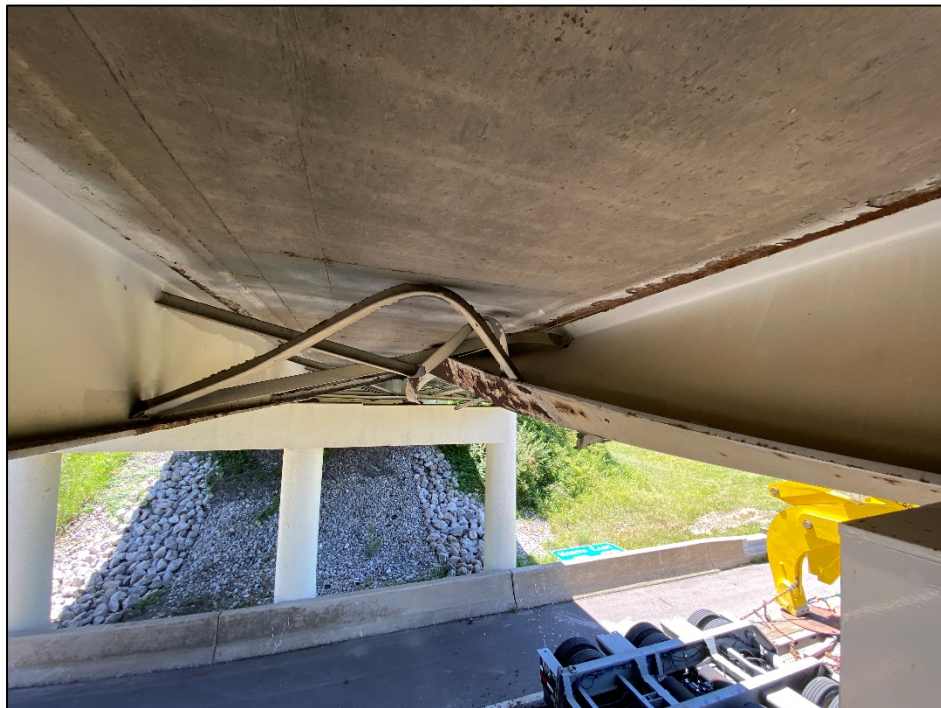
Photo # 12: Bay 2, crossframe 3 damage.

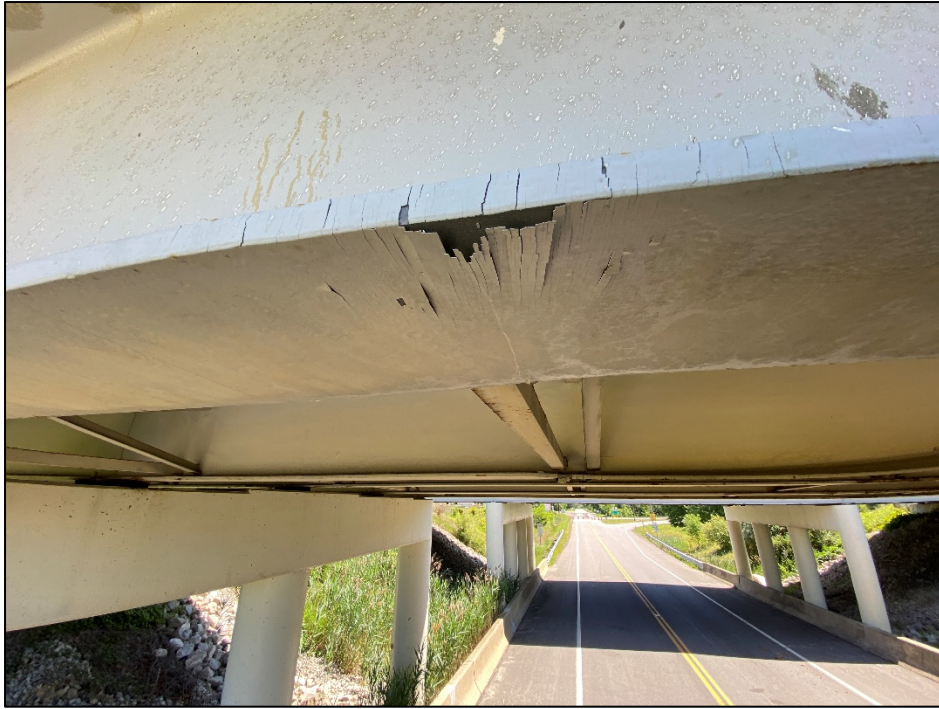
Photo # 13: Stress cracks in paint from lateral deflection at crossframe 4, span 2, beam 1

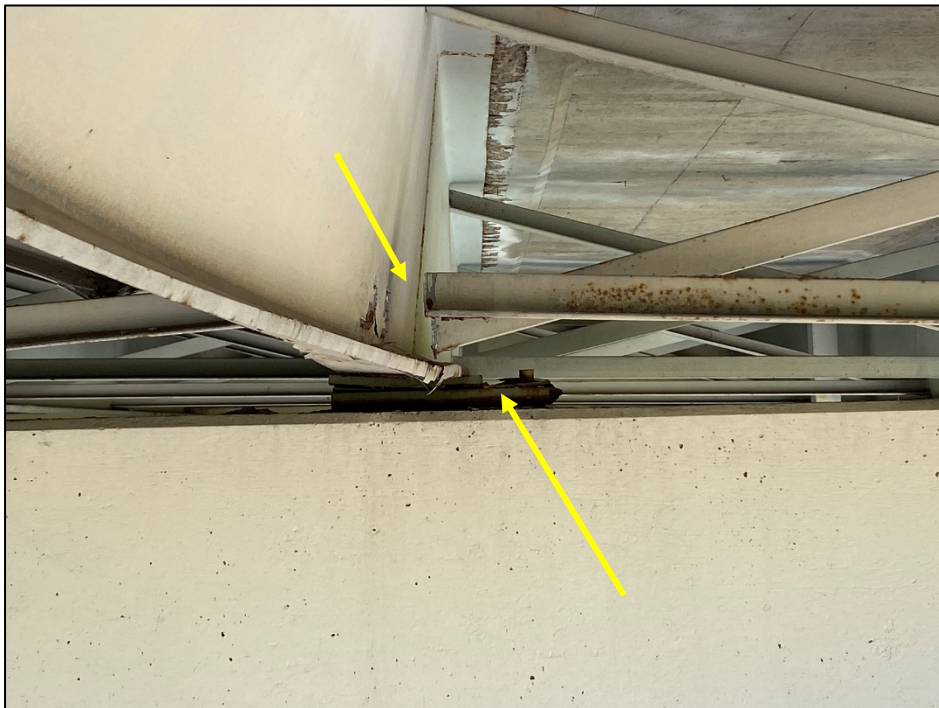
Photo # 14: Beam 2 over pier 1 – note beam deflection, broken crossframe, shifting on sliding plate bearing and deck spalling in span 1.

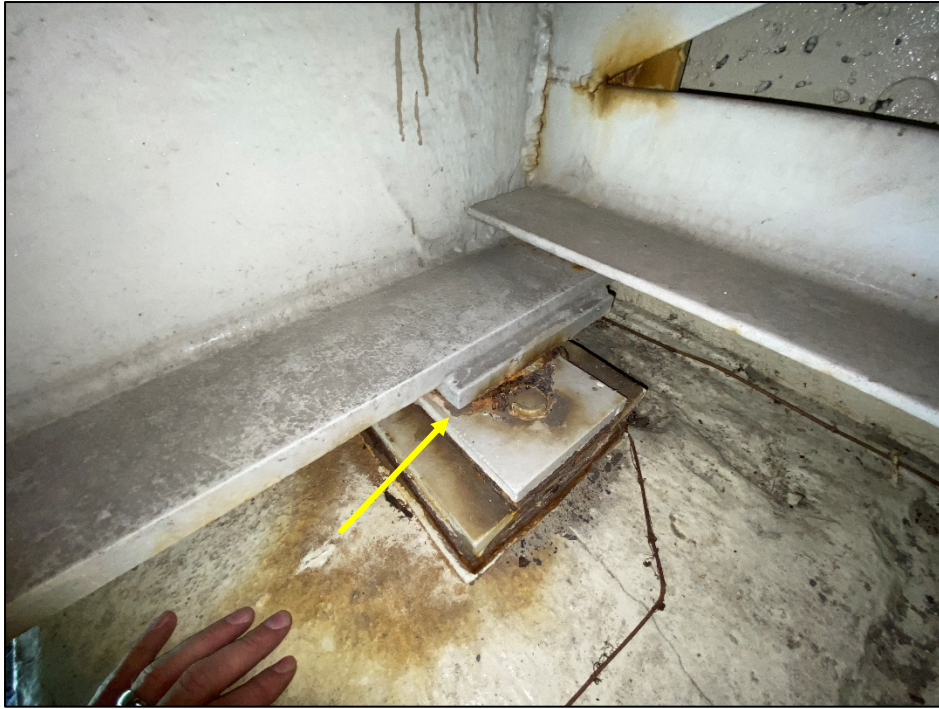
Photo # 15: Displacement of bearing 4 at rear abutment. (Typical to interior beams at rear abutment.)
