To: David E. Griffith, PE  
 From: Reneé Whittenberger, PE, RSP1 and Sela Jones, EIT  
 Date: January 30, 2025  
 Subject: Addendum to Report Recommendations

Upon providing a schematic plan of proposed countermeasures in the *TRU-SR 193-1.67 Roadway Segment Safety Improvement Study*, project team members met with stakeholders to gather feedback prior to the request of implementation funding. The following recommendations were provided in the report:

# TRU SR193 SAFETY STUDY

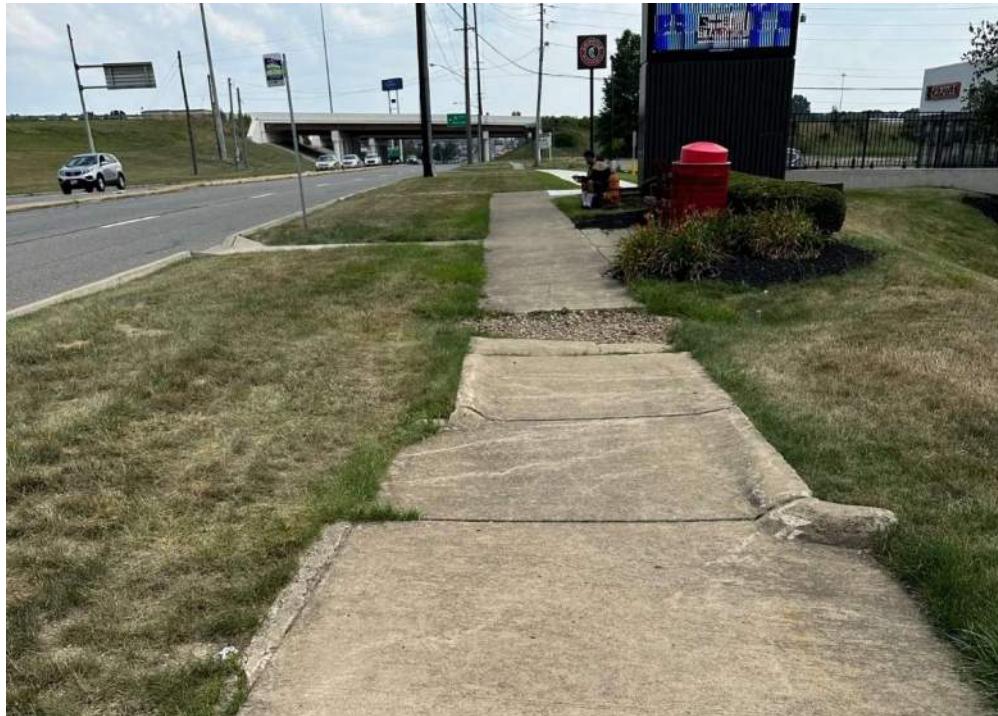
Figure 11. Jagged and missing sidewalk on the west side of Belmont Avenue between Liberty Street and the I-80 westbound ramps

1. Install sidewalks and ADA compliant curb ramps where none presently exist.

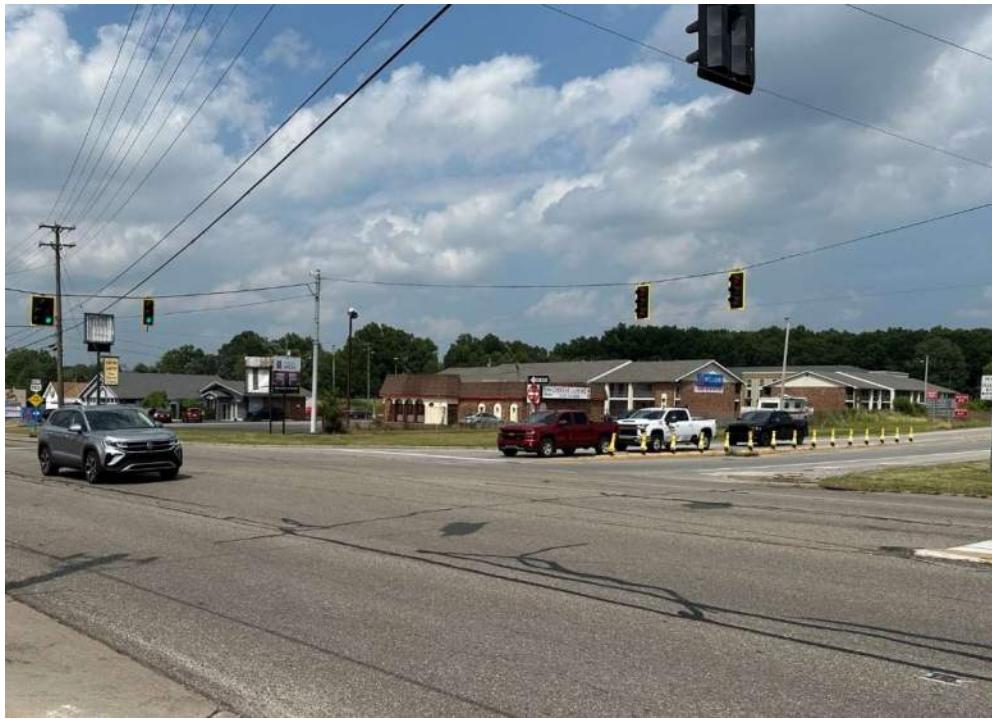
Figure 12. Reflective yellow bollards delineate traffic entering and exiting I-80 westbound ramps

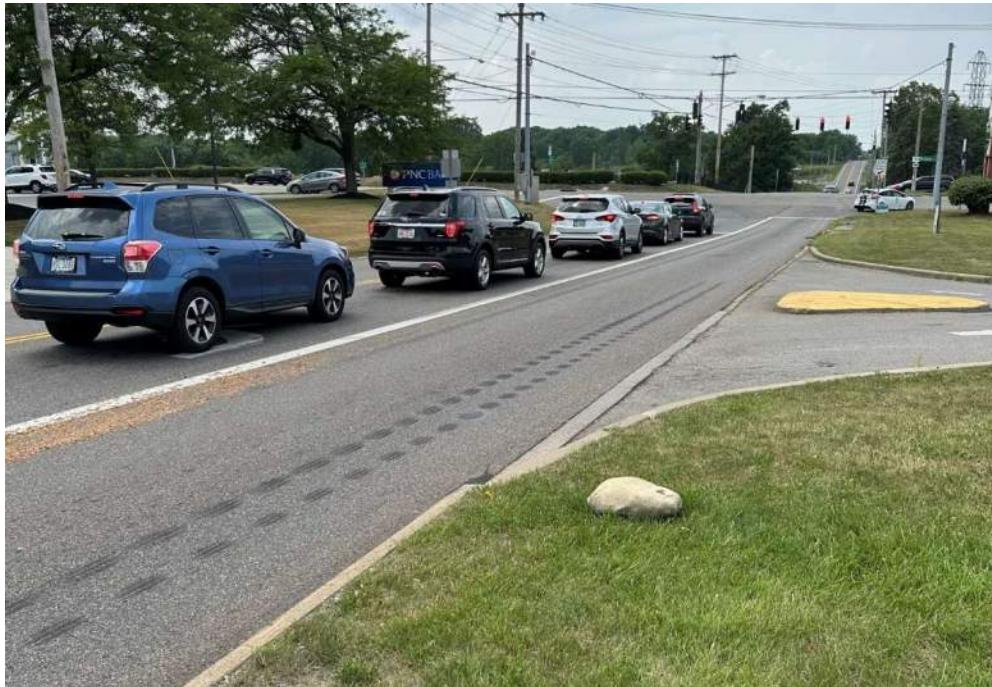
Figure 13. Tire skid mark observed on the westbound approach of Churchill Road

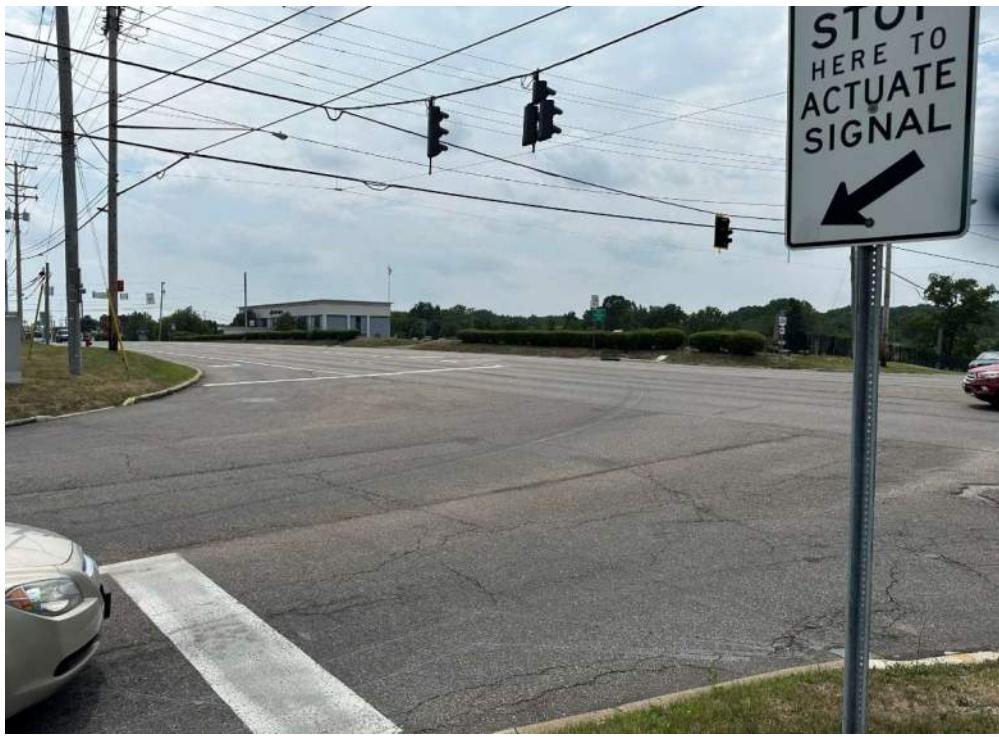
Figure 14. A tire skid mark was produced from westbound traffic on Churchill Road turning left onto Belmont Avenue

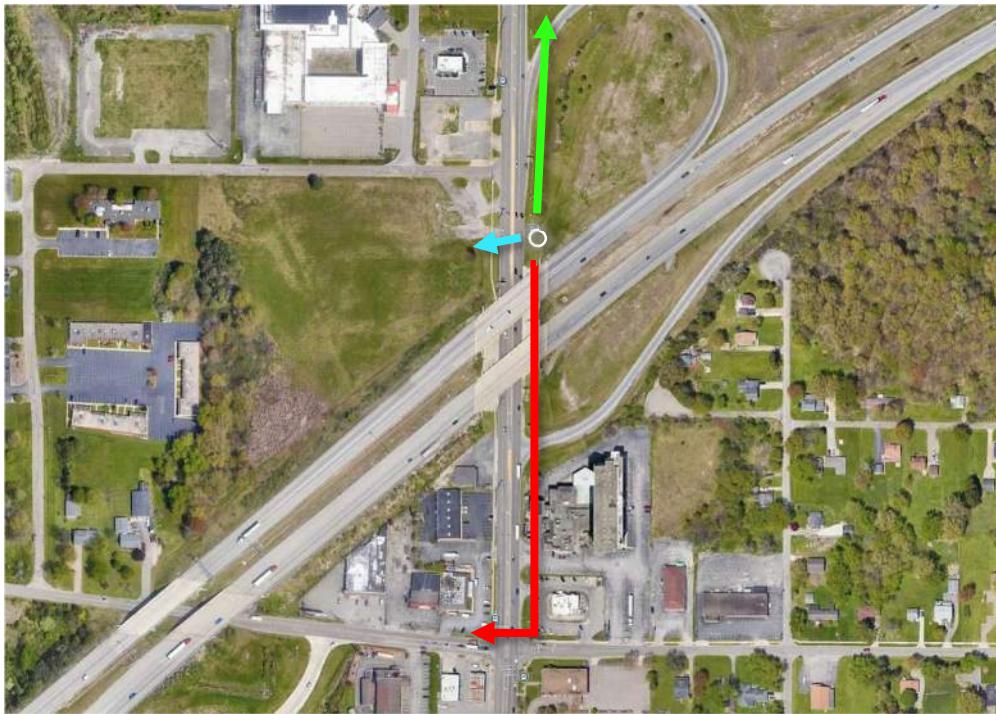
Figure 42. Pedestrian Routes for WRTA Bus Riders

1. Walk north, traveling in the grass and crossing a slip-lane entrance ramp to the interstate which encourages vehicular acceleration (green)
2. Walk south through the grass. If wishing to cross Belmont Avenue, this route leads to the nearest marked crosswalk at Liberty Street (red)
3. Cross Belmont Avenue mid-block with no protection from vehicular traffic (blue)

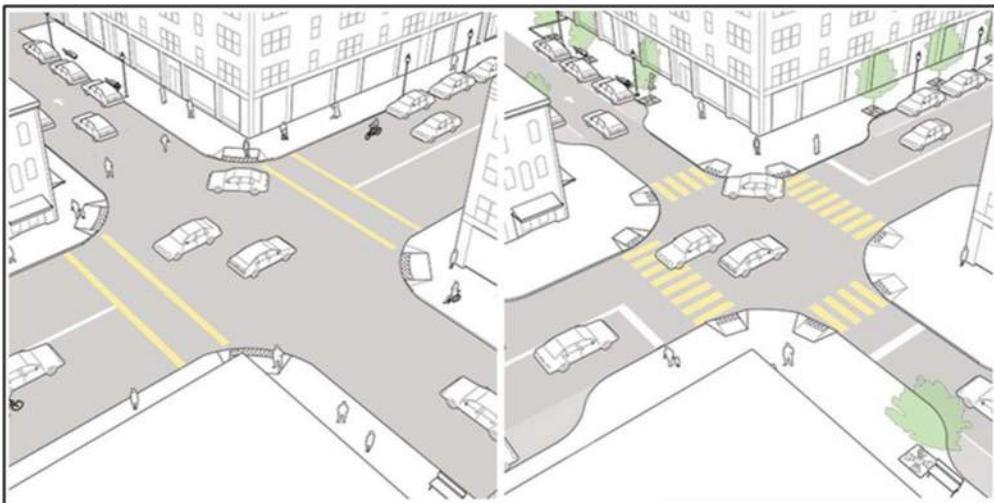
Figure 45. Comparison of traditional vs. high-visibility crosswalk markings

**Figure 45** below compares two styles of crosswalk markings. The left image shows two low-visibility crosswalks in the standard marking style. These markings do not grab drivers' attention, lessening the likelihood that drivers perceive the possible presence of a crossing pedestrian. Also, as cars drive over these markings, the paint fades quickly, lessening their effectiveness over time. In contrast, the right image shows four high-visibility crosswalks in the continental marking style. Not only does this style grab drivers' attention, but the markings can also be designed to align with tire paths, preventing the paint from being worn away as quickly as the standard design.
