BOX GIRDER - PLAN

BOX GIRDER - ELEVATION

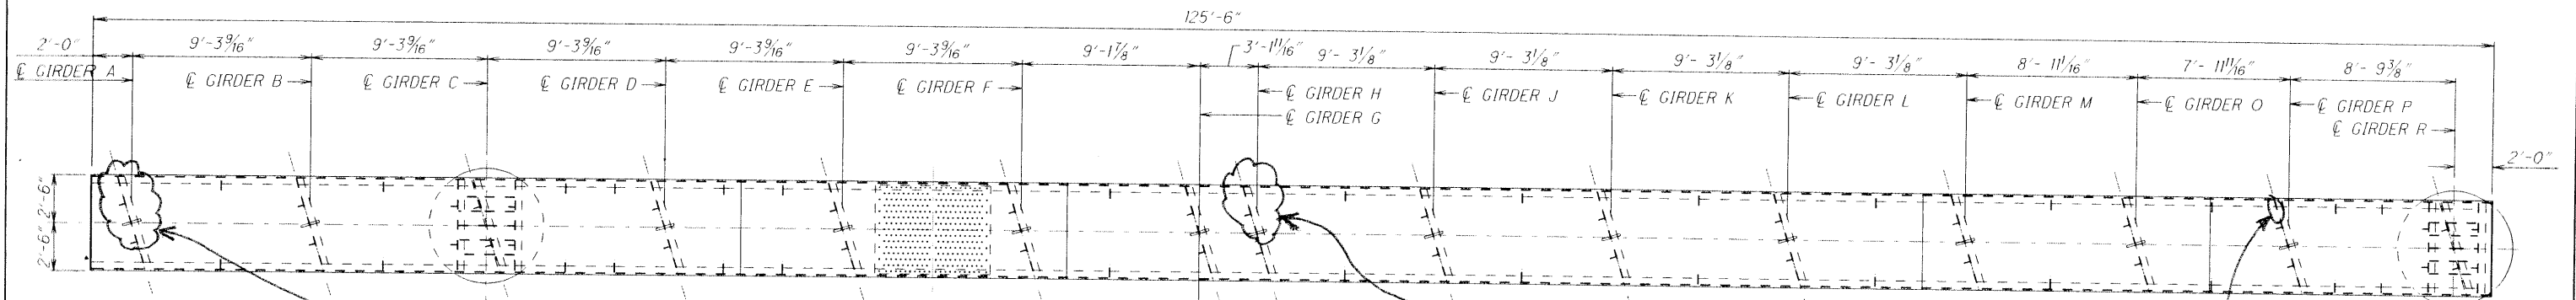
PHOTO # 5319, 5320 & 5321
GAP BETWEEN GIRDER A SHIM PLATE AND TOP FLANGE OF BOX GIRDER

PHOTO # 4008 to 4009
PHOTO OF WHERE PIN WAS INSTALLED & NOT BOLT

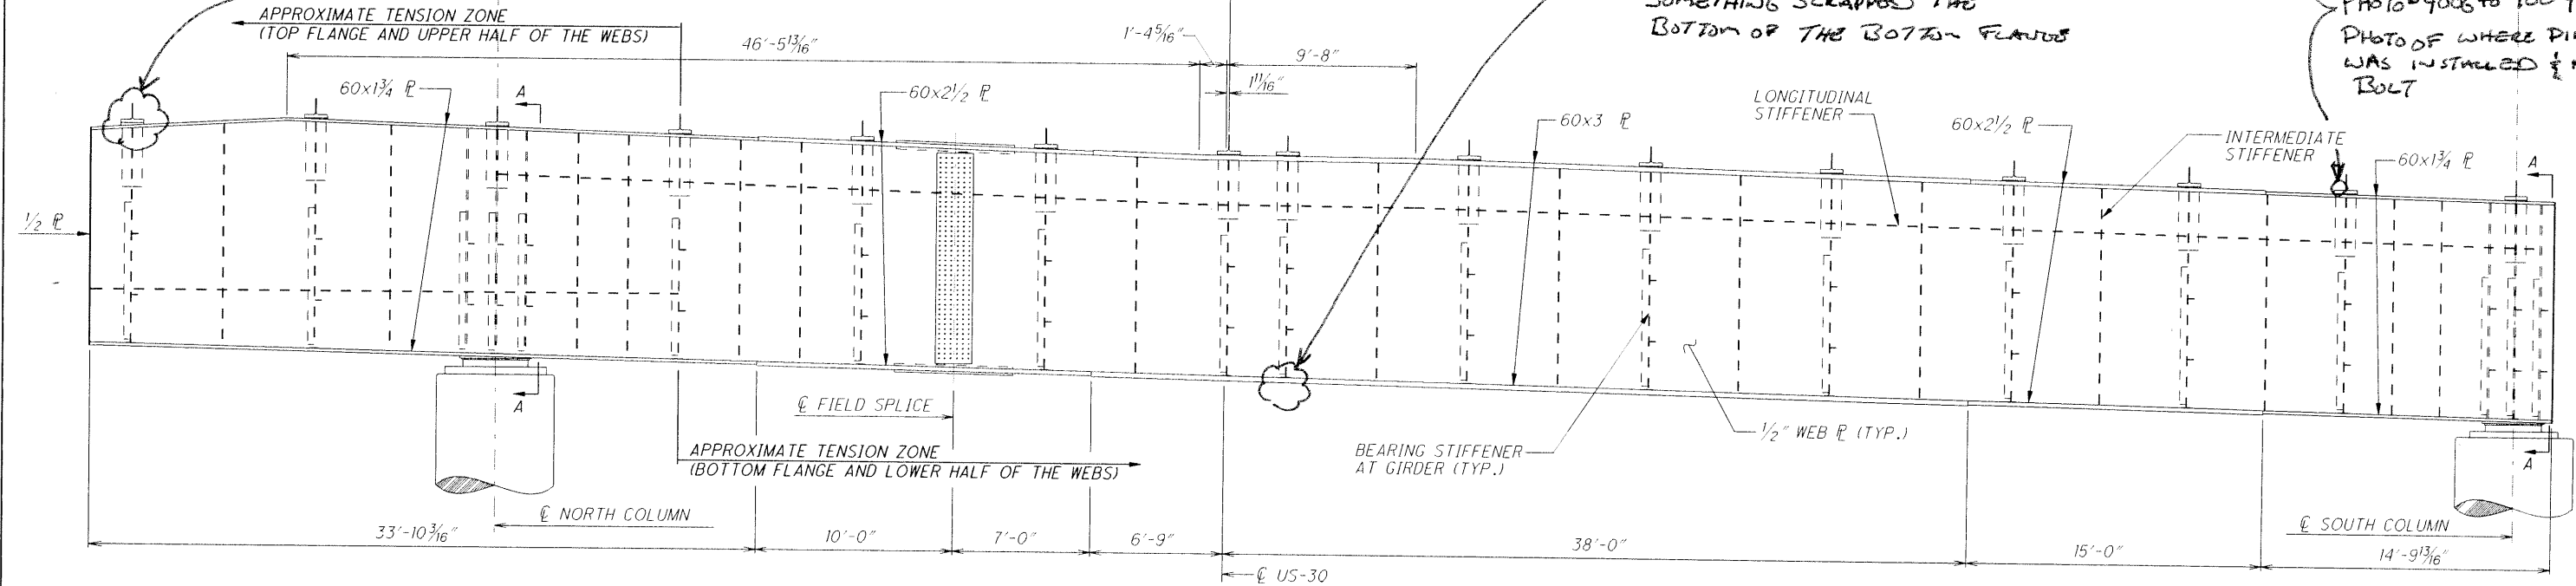
PHOTO # 5325 - 5327
3 BOLTS MISSING WHERE SOMETHING SCRAPPED THE BOTTOM OF THE BOTTOM FLANGE
