**BOX GIRDER - ELEVATION**

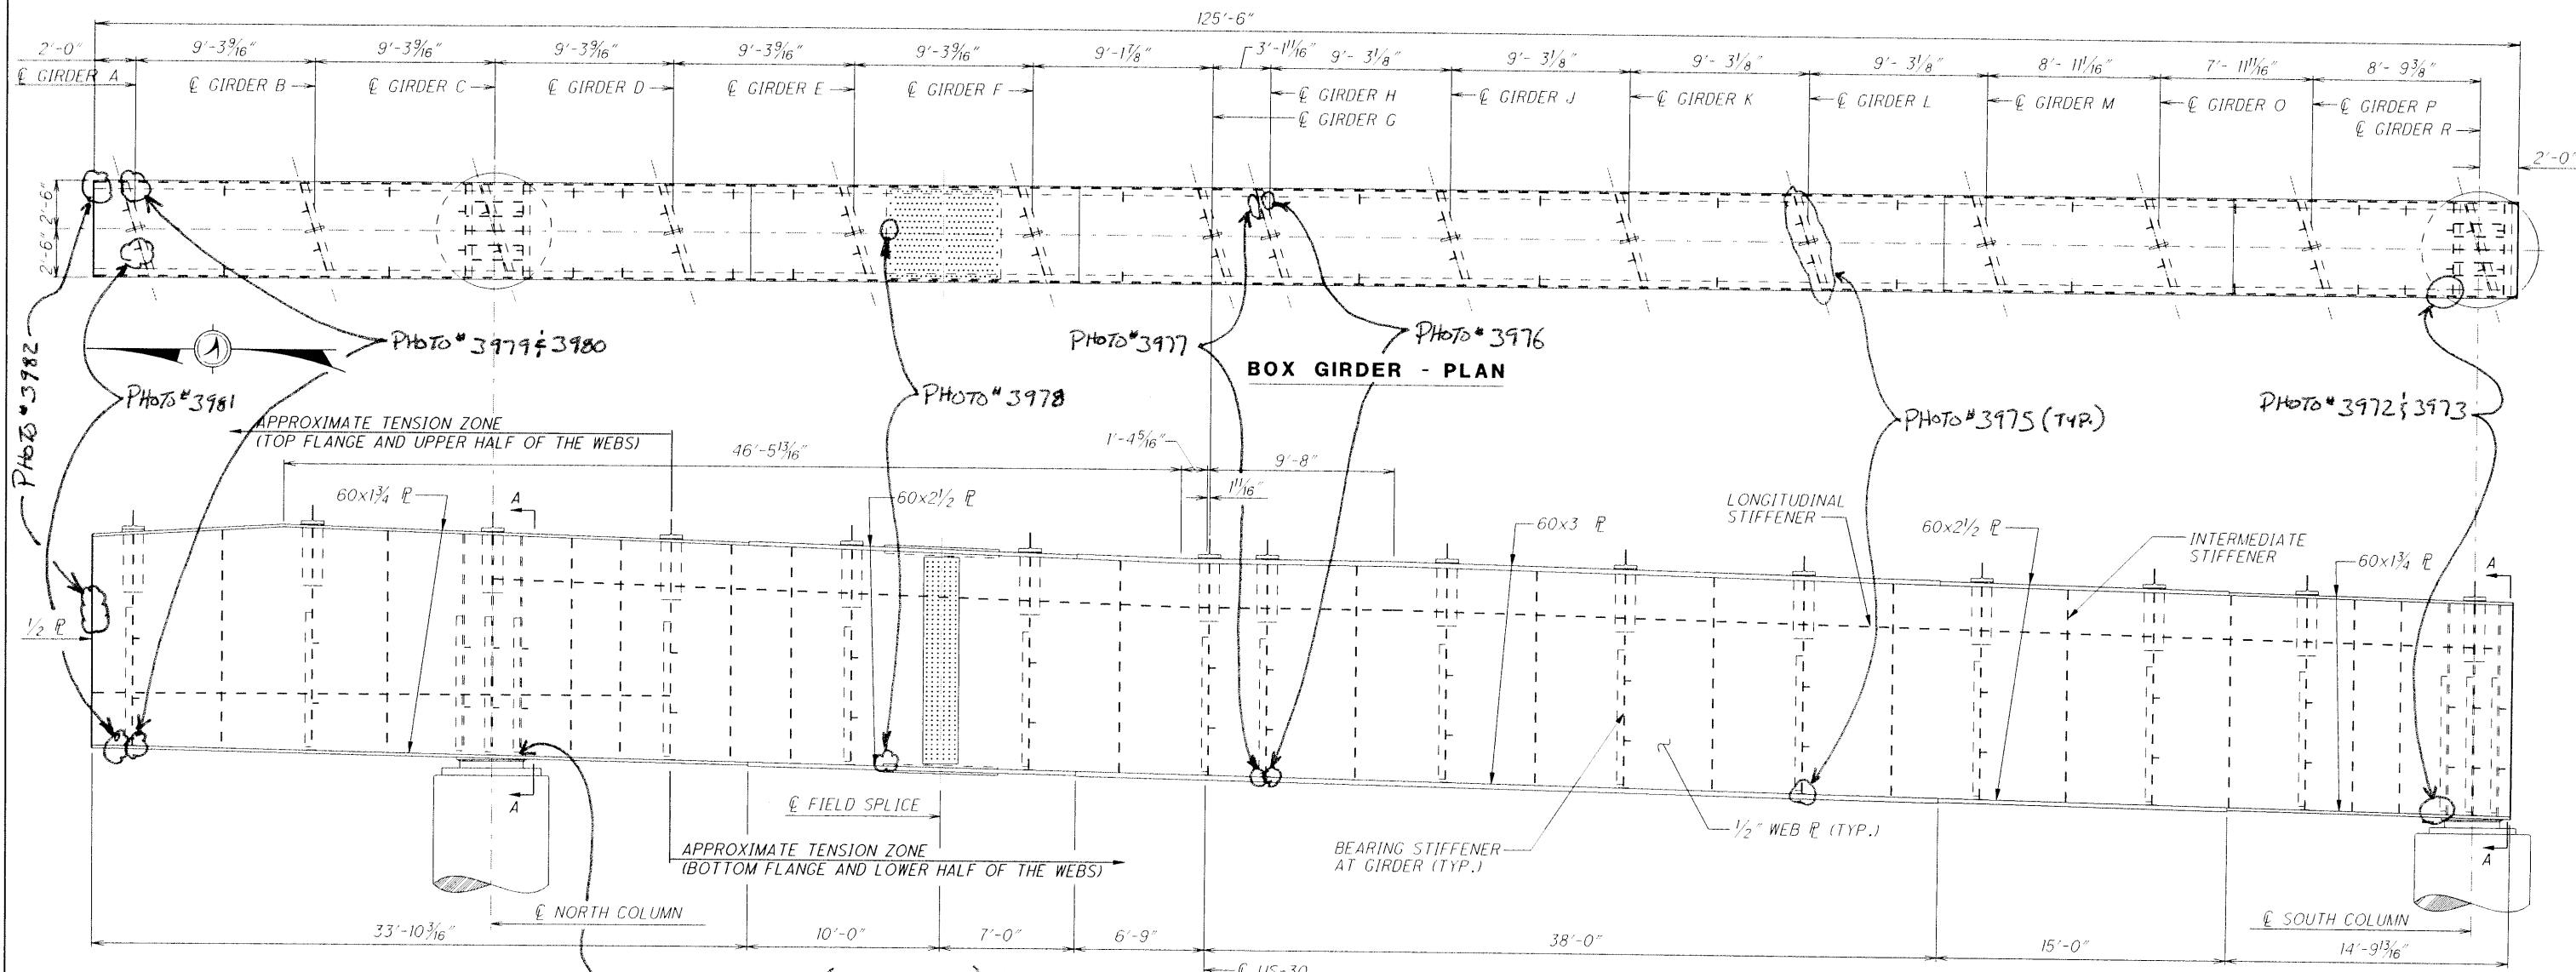
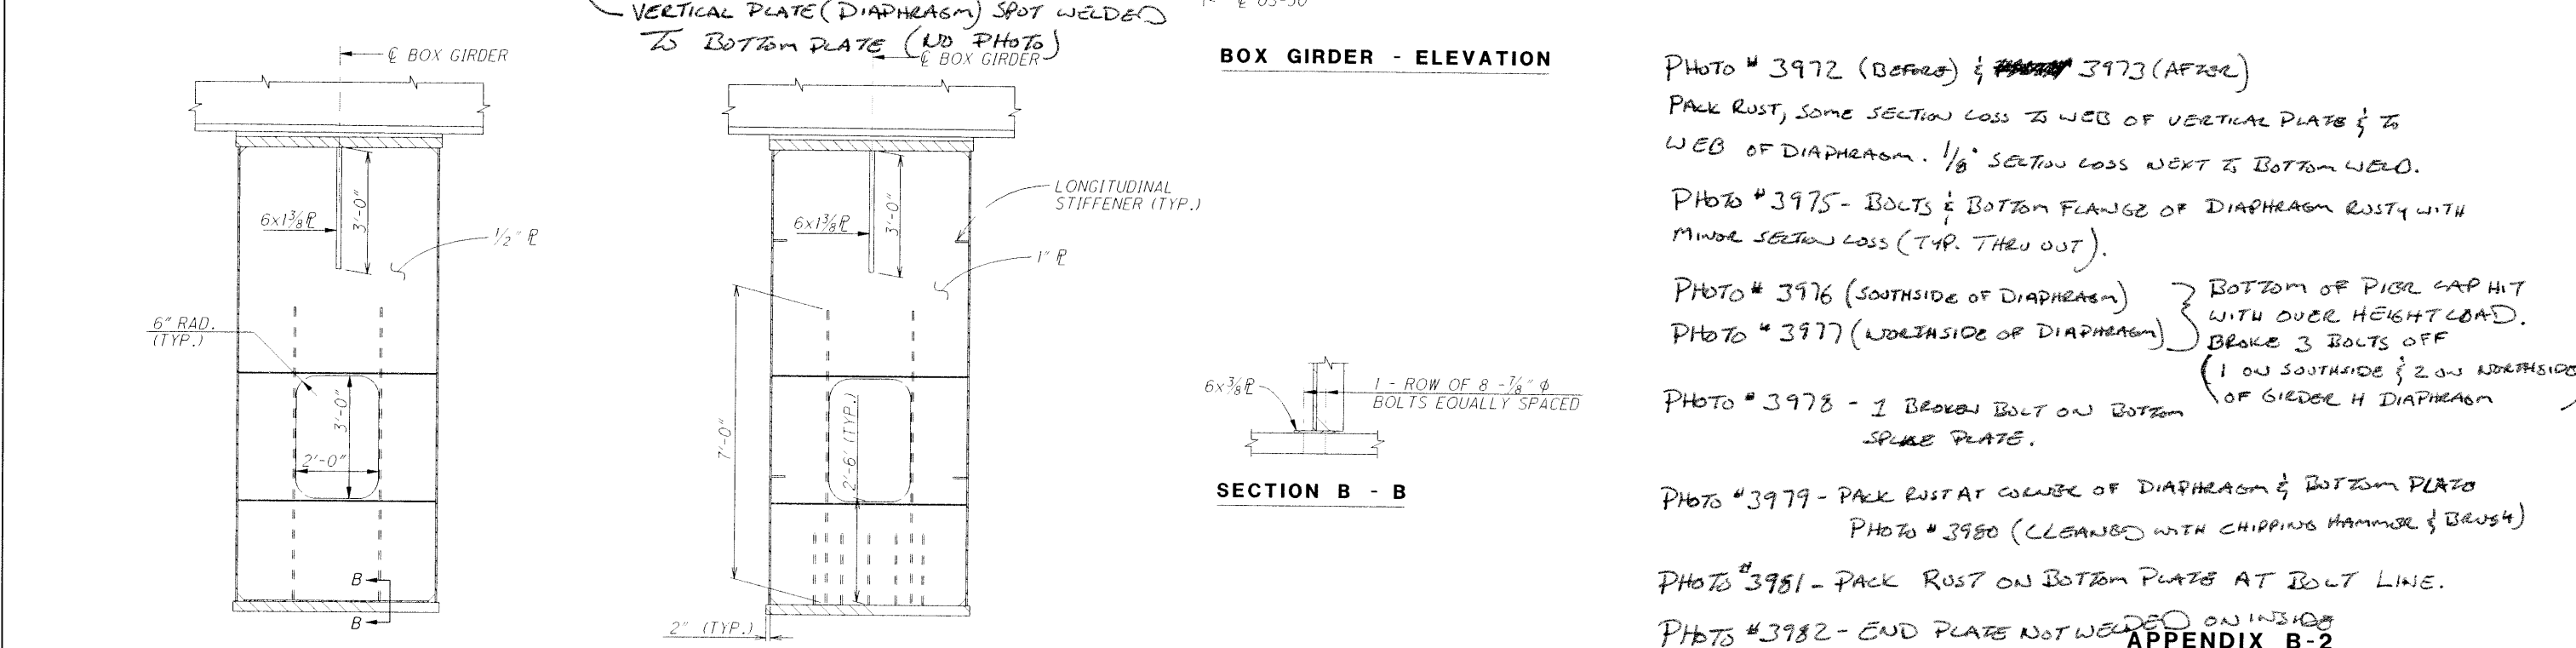
PHOTO # 3972 (BEFORE) & ~~PHOTO~~ 3973 (AFTER)  
 PACK RUST, SOME SECTION LOSS TO WEB OF VERTICAL PLATE & TO WEB OF DIAPHRAGM. 1/8" SECTION LOSS NEXT TO BOTTOM WELD.

PHOTO # 3975 - BOLTS & BOTTOM FLANGE OF DIAPHRAGM RUSTY WITH MINOR SECTION LOSS (TYP. THRU OUT).

PHOTO # 3976 (SOUTH SIDE OF DIAPHRAGM) } BOTTOM OF PIGG CAP HIT WITH OVER HEIGHT LOAD.  
 PHOTO # 3977 (NORTH SIDE OF DIAPHRAGM) } BROKE 3 BOLTS OFF (1 ON SOUTH SIDE & 2 ON NORTH SIDE OF GIRDER H DIAPHRAGM)

PHOTO # 3978 - 1 BROKEN BOLT ON BOTTOM SPLICE PLATE.

PHOTO # 3979 - PACK RUST AT CORNER OF DIAPHRAGM & BOTTOM PLATE  
 PHOTO # 3980 (CLEANED WITH CHIPPING HAMMER & BRUSH)

PHOTO # 3981 - PACK RUST ON BOTTOM PLATE AT BOLT LINE.

PHOTO # 3982 - END PLATE NOT WELDED ON INSIDE
