December 9, 2021

Re: Pre-Demolition Asbestos Survey 7640 Lancaster-Newark Road NE Baltimore, Ohio August Mack Project Number JV2622.731

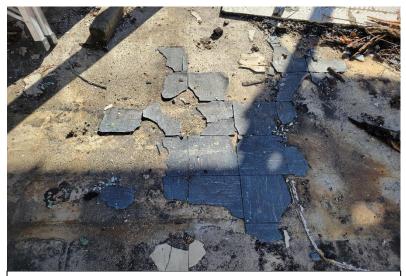
HA #	Material Description	Material Location	Condition	Category	Asbestos %	Quantity
4	9" x 9" Black with white streaks floor tile and mastic	Central and north areas of concrete structure	Significant Damage	RACM*	3% Chrysotile	65 SF
6	9" x 9" Tan floor tile and mastic	Central and north areas of concrete structure	Significant Damage	RACM*	5% Chrysotile	50 SF

* Considered RACMs for the purposes of demolition due to poor condition

Photo 1 – View of asbestos-containing black floor tile in the concrete structure.

August Mack has completed a pre-demolition asbestos survey of the two (2) structures located at 7640 Lancaster-Newark Road NE, Baltimore, Ohio. The purpose of the survey was to determine if ACMs are present on or within the structures prior to demolition. As presented above, two (2) RACMs were identified in the concrete structure. These materials must be removed from the structure by a licensed asbestos abatement contractor prior to demolition in accordance with all state and federal regulatory requirements.

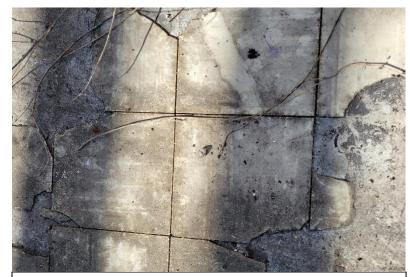
Photo 2 – View of asbestos-containing tan floor tile in concrete structure.

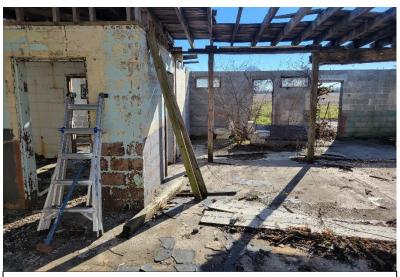
Photo 3 – View of central area of concrete structure looking south.

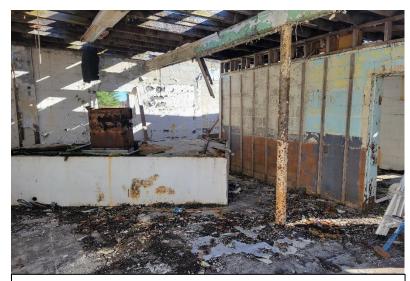
Photo 4 – View of central area of concrete structure looking northeast.
