**LIC-KEYST-0010\_(4564014)**

Feature Inters: SOUTH FORK LICKING RIVER

Location: CITY OF PATASKALA 0.1 MI E OF JCT TWP LN RD

**National Bridge Inventory**

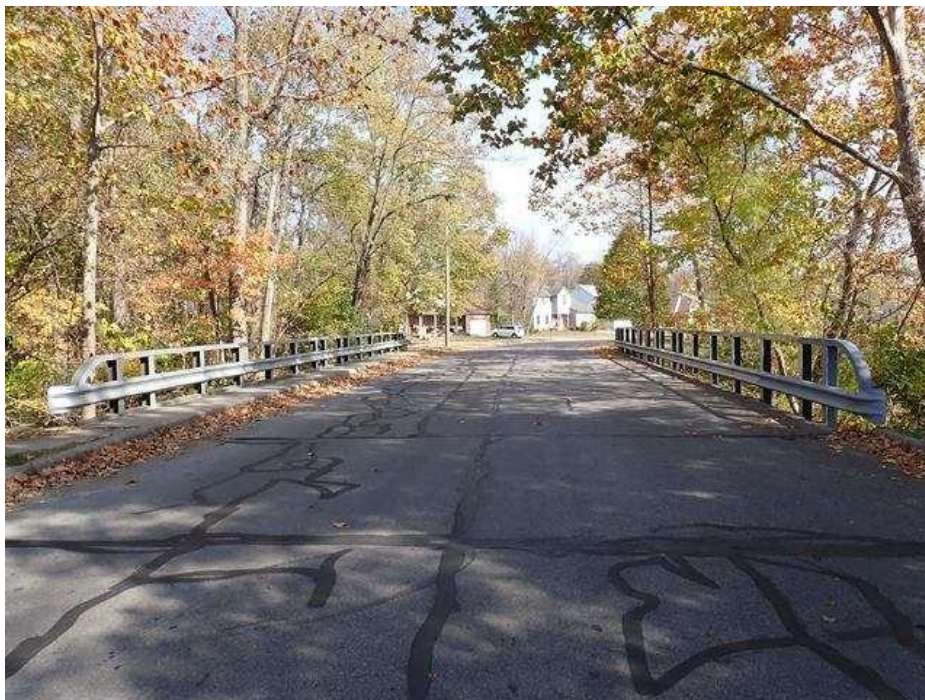
PHOTO 1 Condition

Description End view looking east.

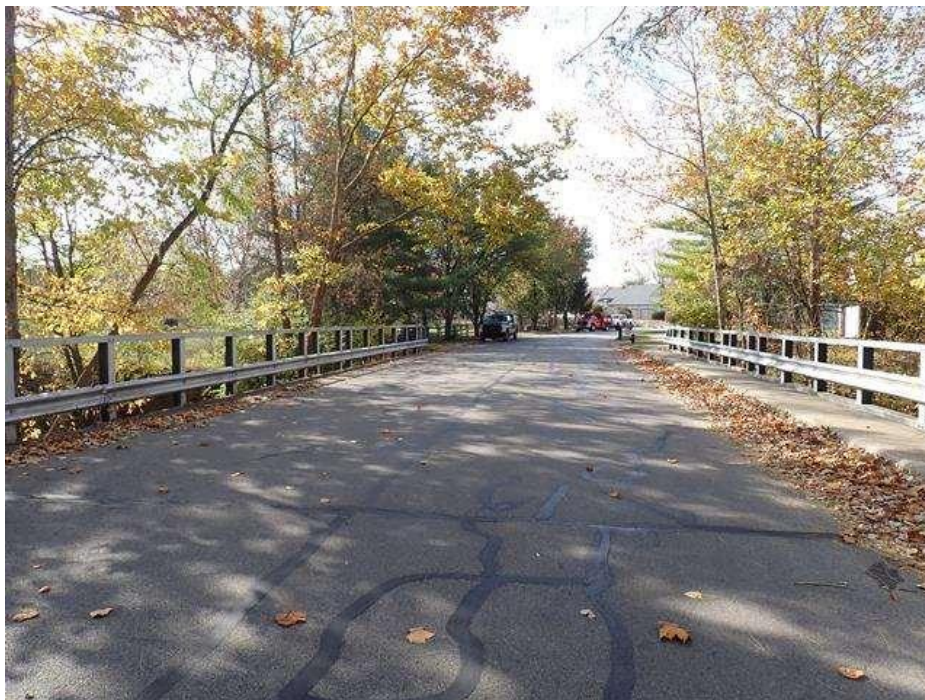
PHOTO 2 Condition

Description End view looking west.

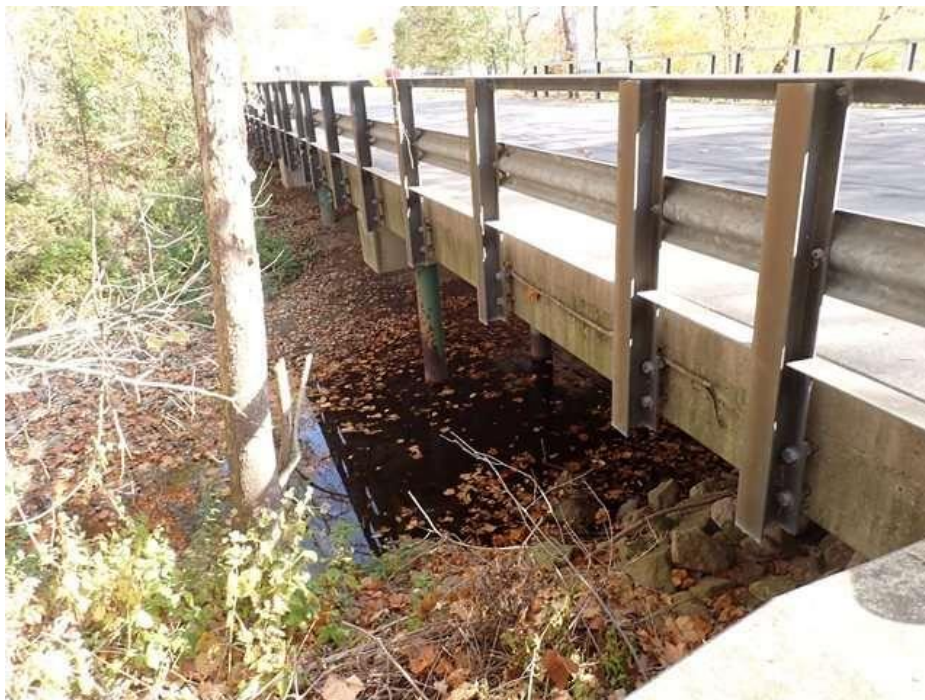
PHOTO 3 Elevation

Description Looking southeast at the bridge elevation, north fascia.

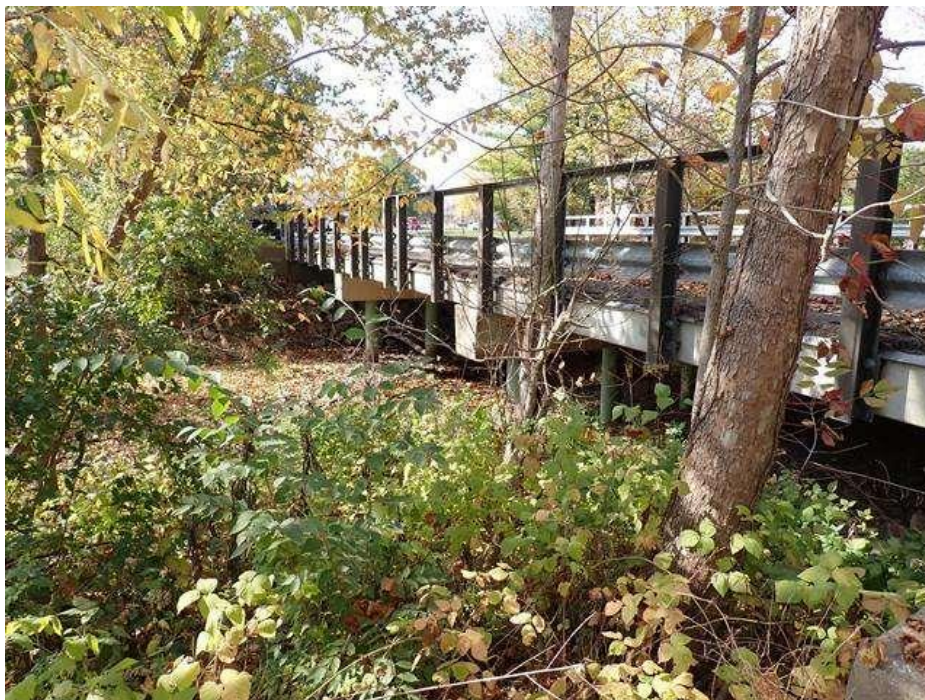
PHOTO 4 Elevation

Description Looking northwest at the bridge elevation, south fascia.

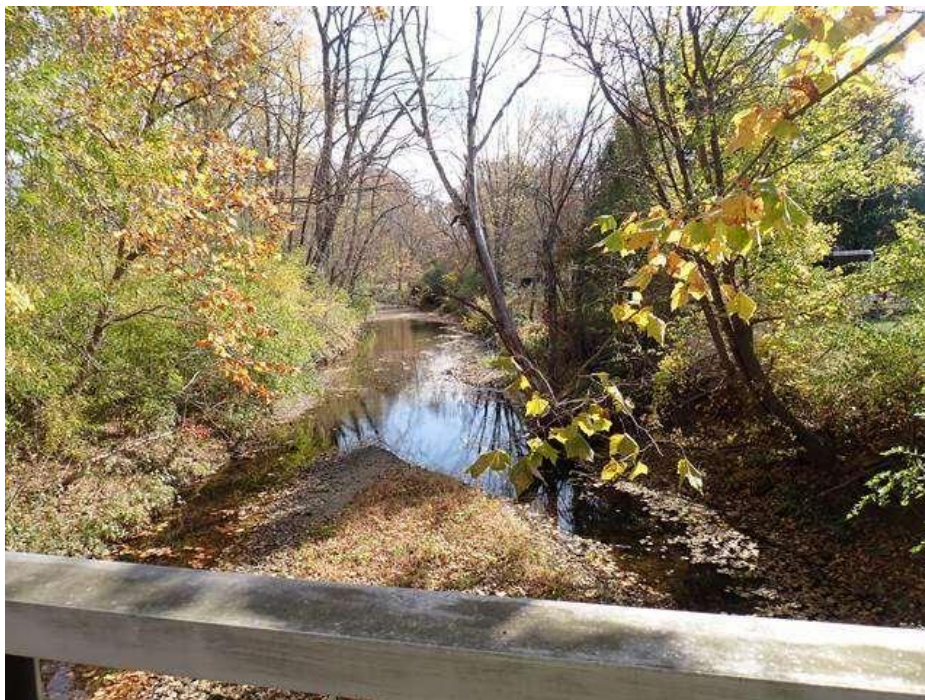
PHOTO 5 Condition

Description Looking south at the downstream channel.

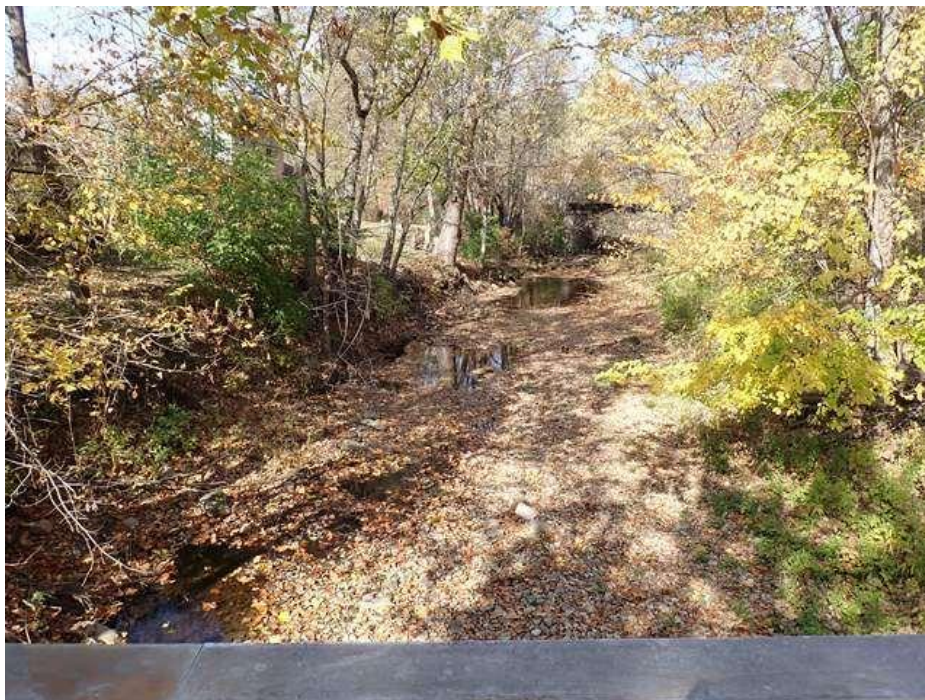
PHOTO 6 Condition

Description Looking north at the upstream channel.

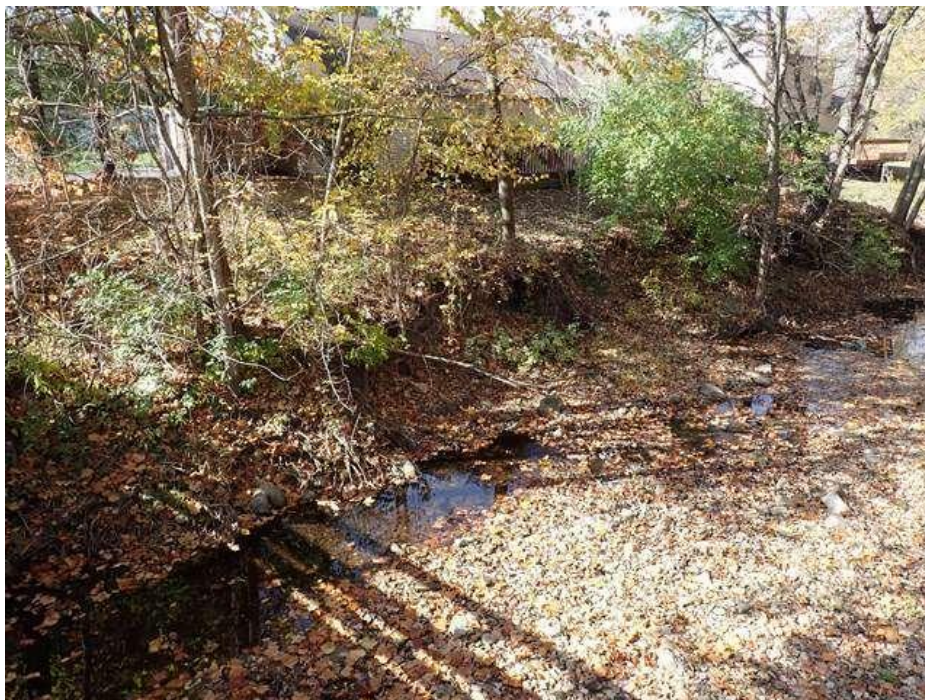
PHOTO 7 Condition

Description Looking northwest at the upstream channel. Note: the northwest channel bank is steep and exhibits vertical cutting.

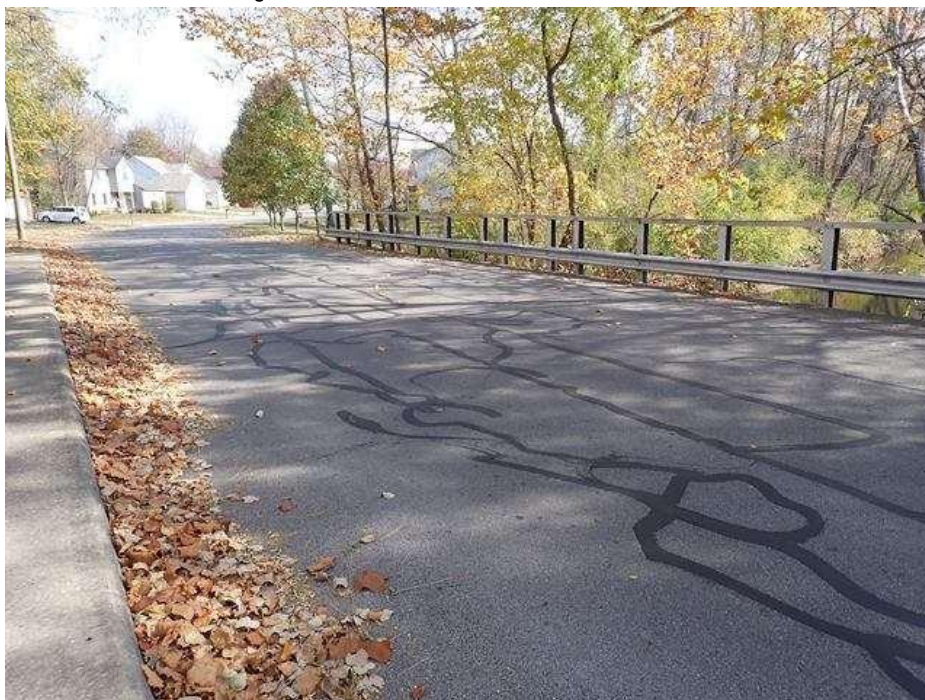
PHOTO 8 Condition

The wearing surface has a minor amount of isolated wide and medium width cracks with some isolated previous failed sealant.

Transverse cracks at bridge limits with previous sealant.

Description Looking southeast at typical wearing surface.

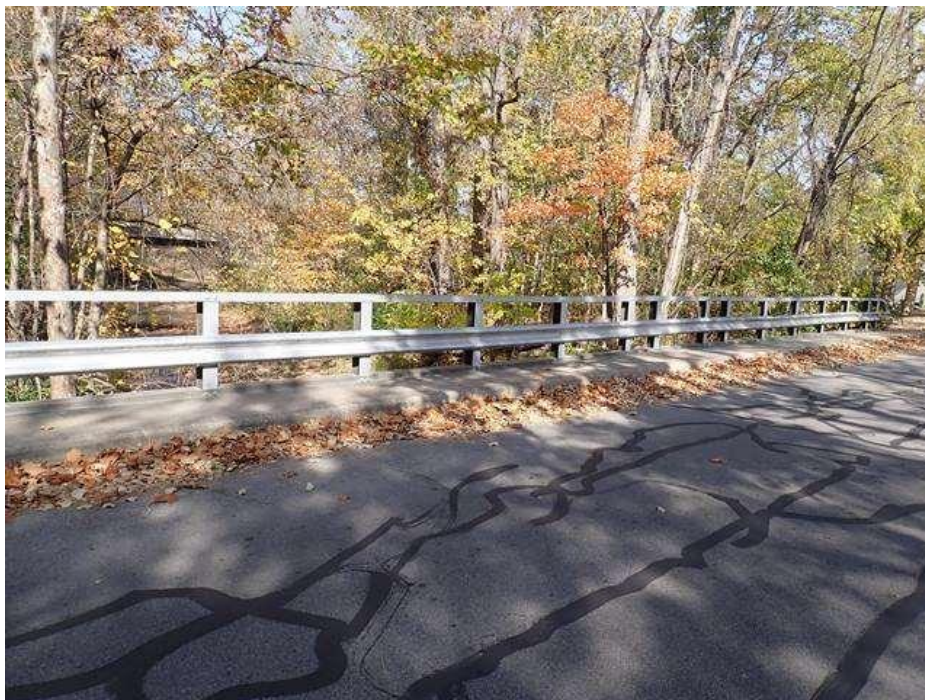
PHOTO 9 Condition

Description Looking northeast at typical bridge railing, north rail.

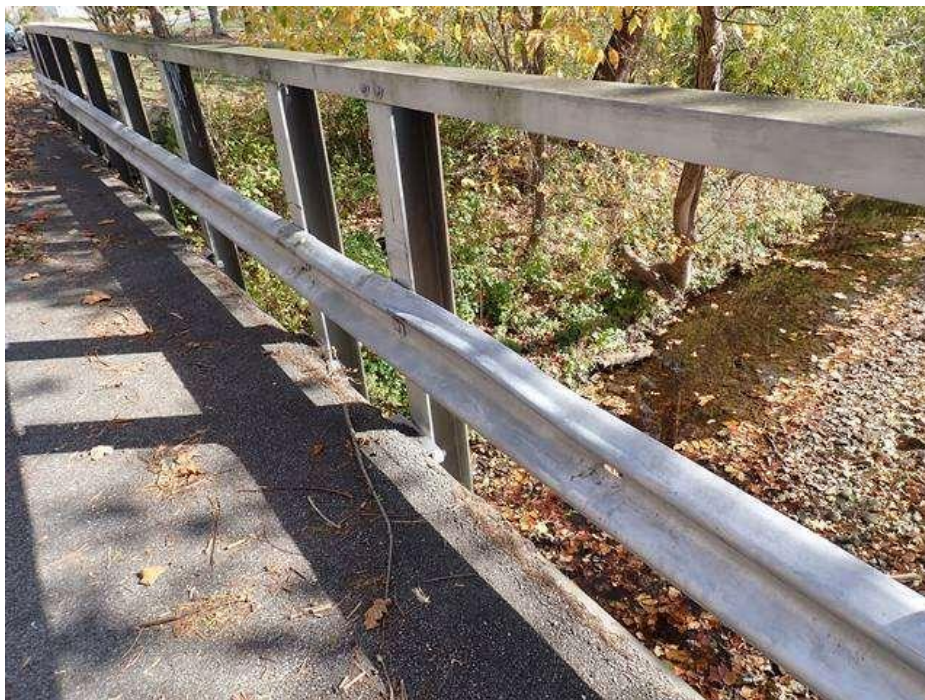
PHOTO 10 Condition

Very minor impact damage along South rail.

Description Looking southeast at the south bridge rail. Note: minor impact damage to the south bridge railing.

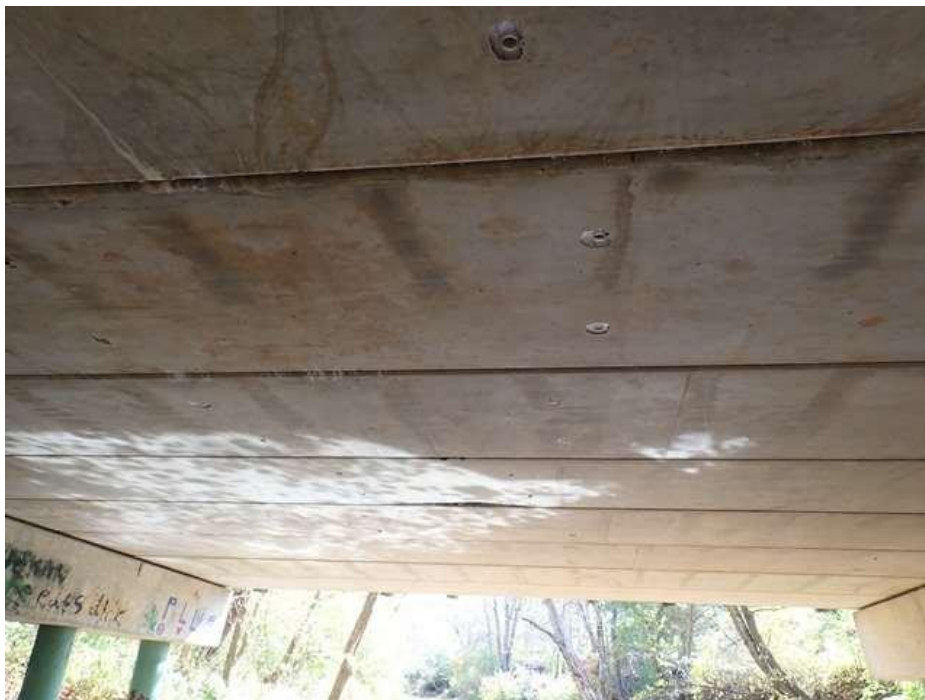
PHOTO 11 Condition

Description Looking south at typical superstructure, underside of span 2.

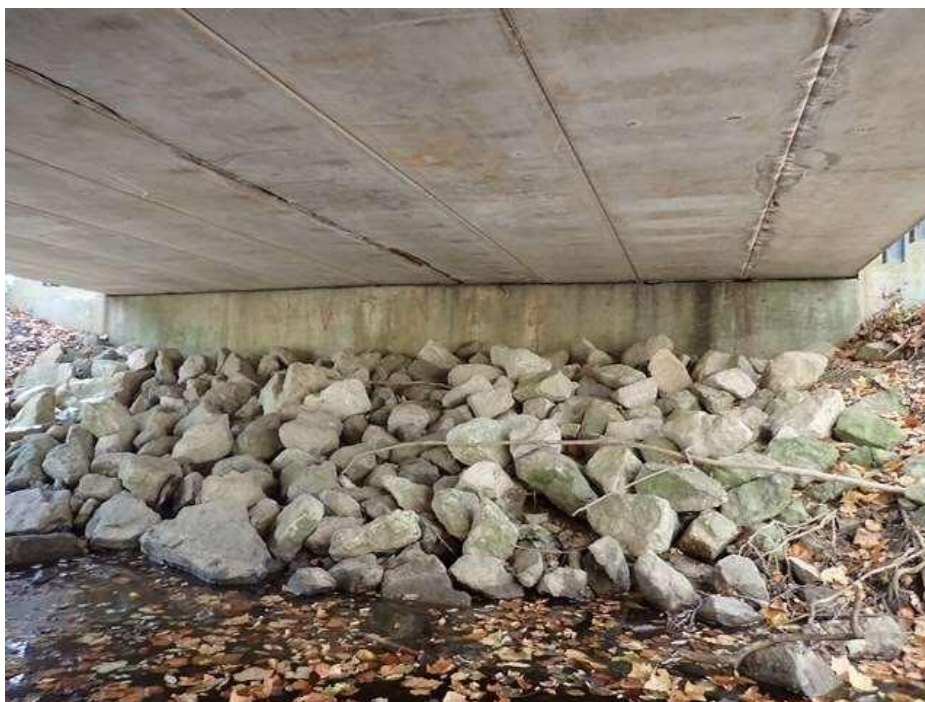
PHOTO 12 Condition

Description Looking west at typical substructure, west abutment.

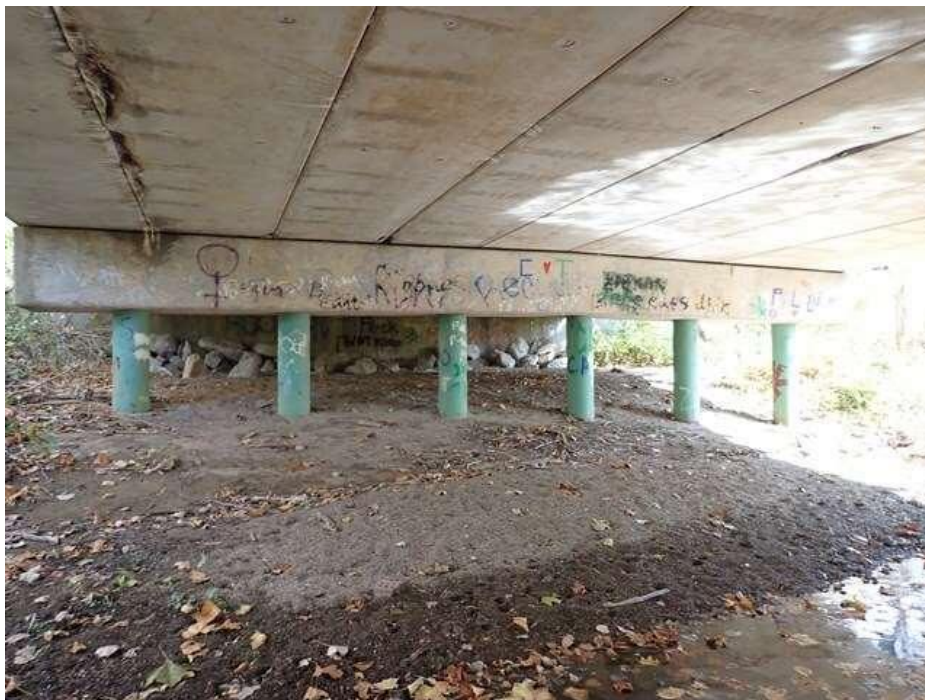
PHOTO 13 Condition

Description Looking east at typical substructure, pier 2.

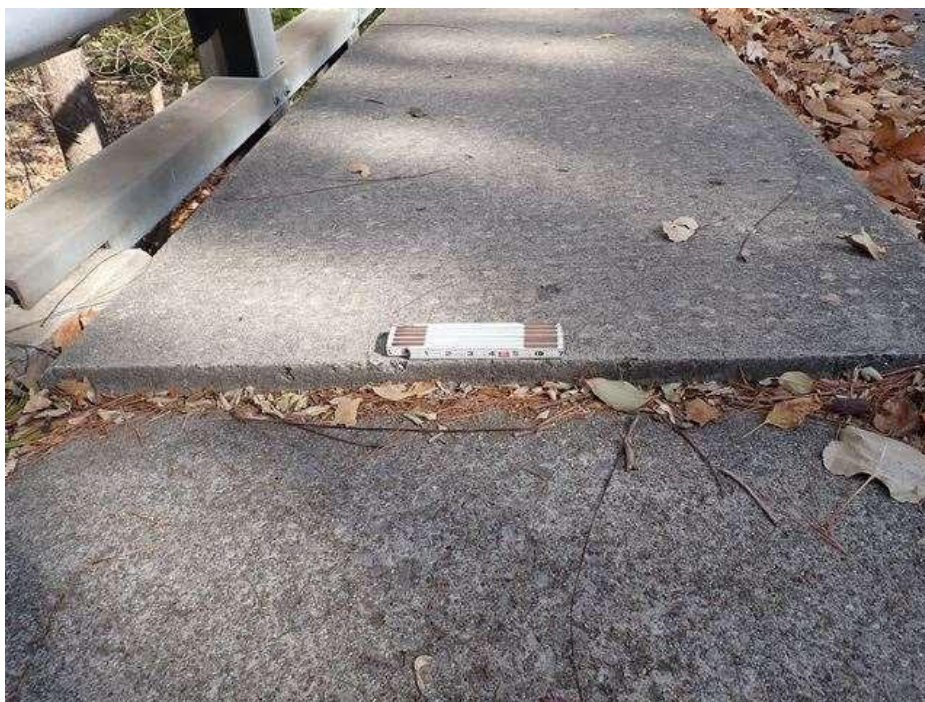
PHOTO 14 Condition

Vertical sidewalk settlement up to 2" at Northeast and Northwest corners.

Description Looking east at the pedestrian sidewalk. Note: the sidewalk has settled up to 2" at both ends of the bridge.

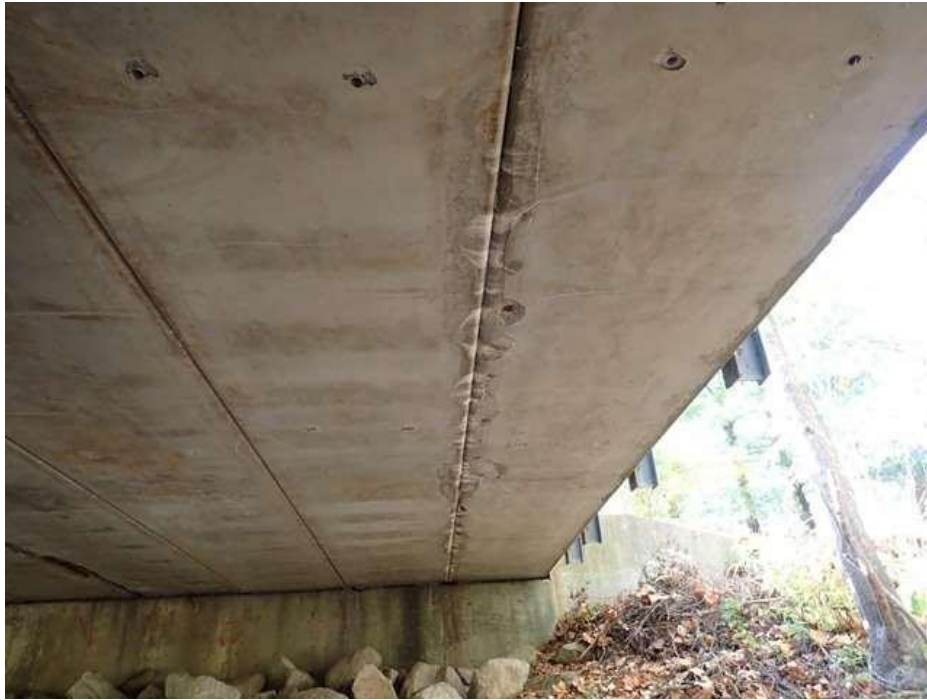
PHOTO 15 Condition

Span 1: Beam 1 south side bottom corner delaminated along 60% of beam, Beam 2 north side at pier 1 has a delamination approximately 2 foot long, Beam 4 at pier 1 north side has delamination approximately 1-foot-long south side bottom corner spall along 25% of beam at each end (50% of total length) with 1 exposed strand, Beam 5 70% of N bottom corner delaminated and spalled with 1 exposed strand.

Description Looking west at the south edge of beam 1 in span 1. Note: typical concrete delamination along the underside of the beam.

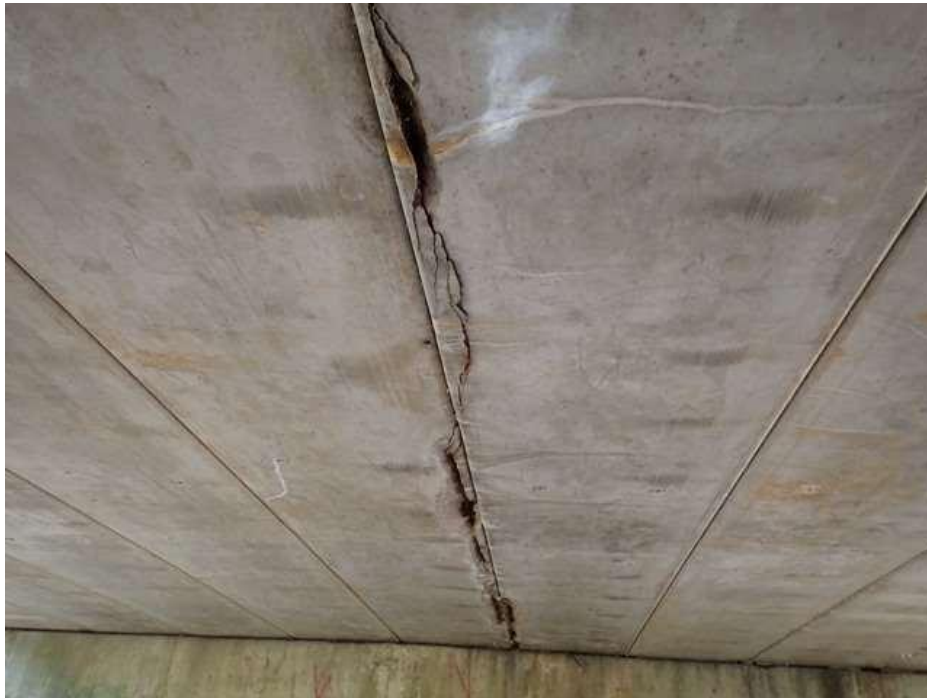
PHOTO 16 Condition

Description Looking west at the north edge of beam 5 in span 1. Note: one exposed and corroding strand.

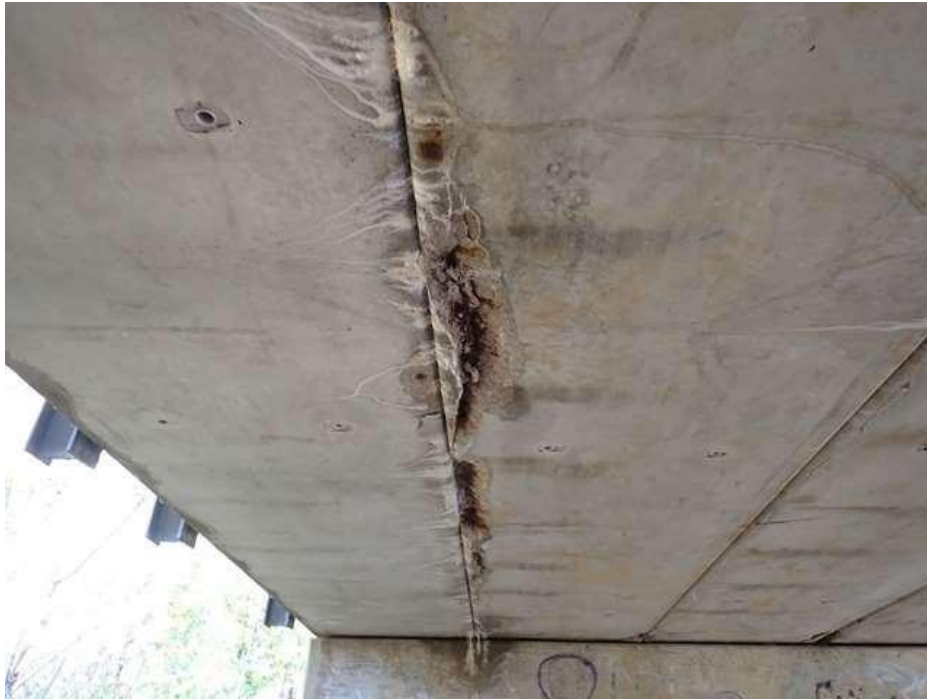
PHOTO 17 Condition

Span 2: Beam 2 beam bottom corner is 50% delaminated and spalled along north edge with one exposed and broken strand. Beams 2, 3 and 4 have delaminated and spalled areas at beam bottom corners at both piers with one exposed strand at each beam at pier 2. Beam 3 has 5' of delaminated area along north edge. Beam 5 has a 3' long spall with one exposed and corroding strand at mid span.

Description Looking east at the north edge of beam 2 in span 2. Note: delamination/spalling with one exposed and corroding strand.

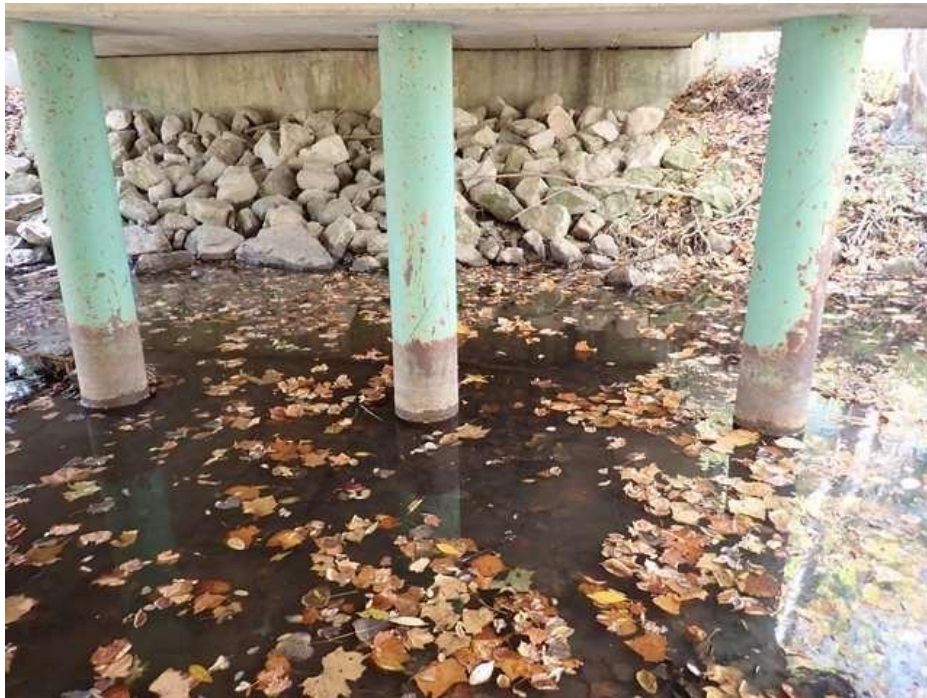
PHOTO 18 Condition

Pier 1 has moderate surface corrosion on piles along waterline with no significant section loss.

Description Looking west at columns 1 through 3 at pier 1. Note: typical corrosion at the waterline.

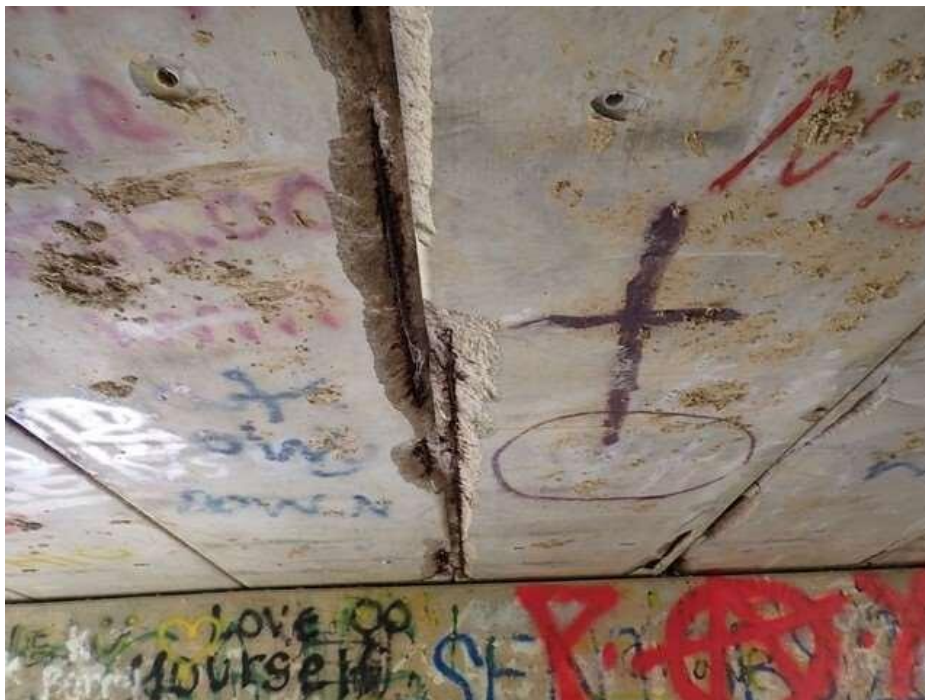
PHOTO 19 Condition

Span 3: Beam 1 has one large spall with one exposed strand on south edge with rust staining and efflorescence over 50% of beam and a 4' long x 6" wide spall with one exposed strand near the east abutment. Beam 2 has a 1 sf area of delamination near the pier cap on the north edge and along 60% of north edge. Beam 3 has 3 foot delamination/spall on north beam edge at pier, at south beam edge there is a 5' spall with 2 exposed strands near pier, delamination for approximately 10% of length, 4 foot spall with 2 exposed strands on south edge. Beam 4 north face has a 4' spall at mid span with one exposed strand, 4' spall with one exposed strand at pier, beam 4 south face has a 15' spall with one exposed strand. Beam 5 has spalled areas along 50% of north beam edge with 1 exposed/broken strand. Beam 7 north edge exhibits a 3' long delamination 6' from pier 2.

Description Looking west at beams 5 and 6 in span 3. Note: both beams exhibit a 15' long edge spall with one exposed and corroding strand each.
