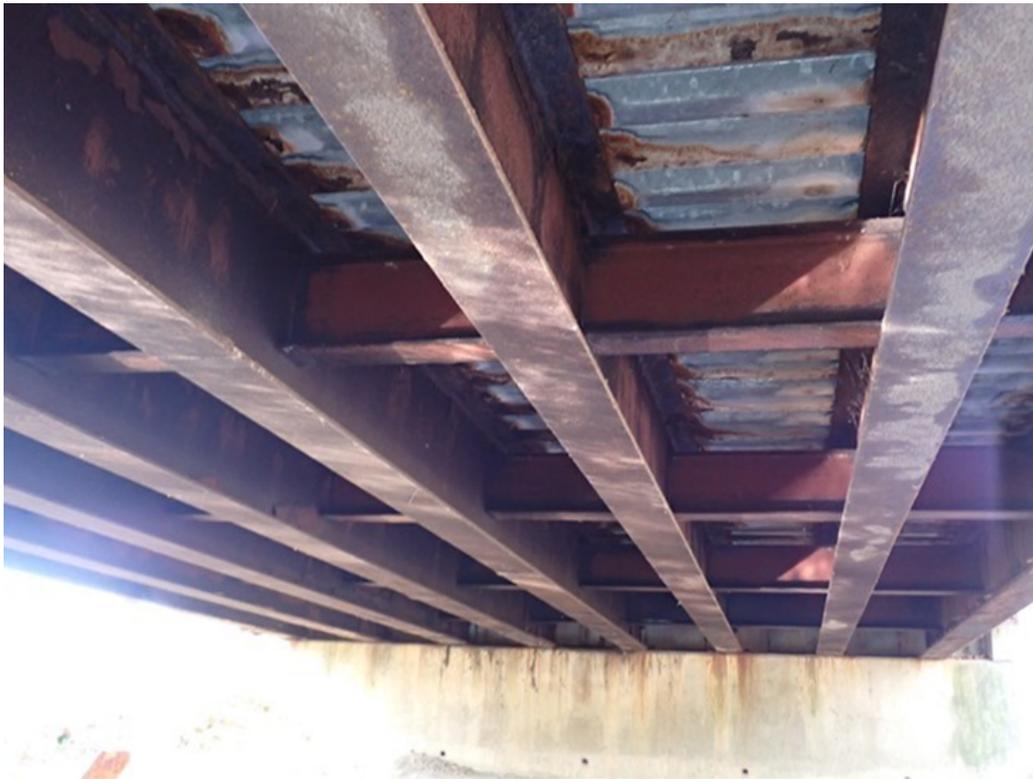
(Photo Looking West at Rear Abutment
and Underside of Superstructure)

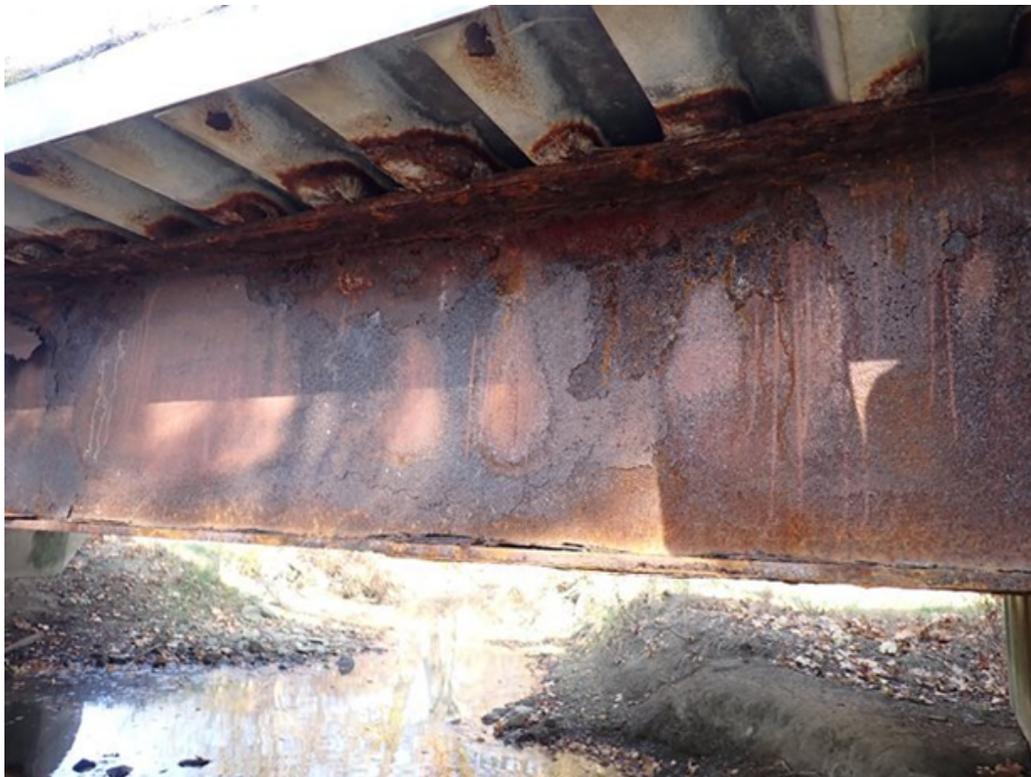
Typical Steel Beam Condition

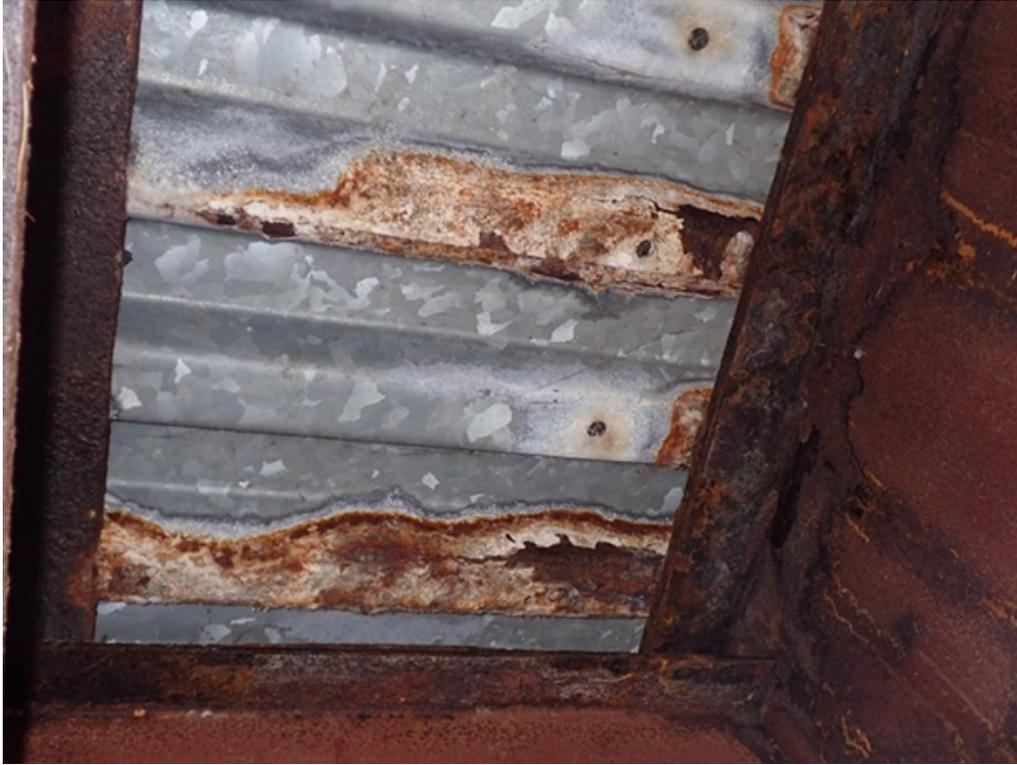
View of Typical Corrugated Metal Deck Condition

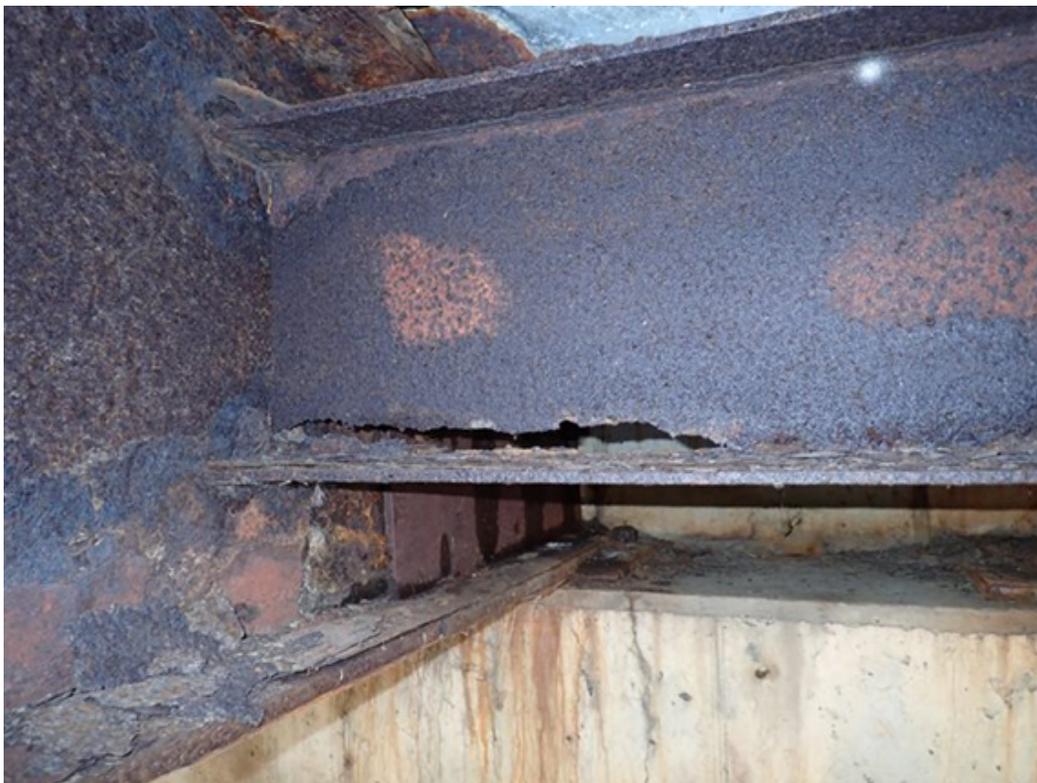
(Photo Looking West at Typical Diaphragm Condition)

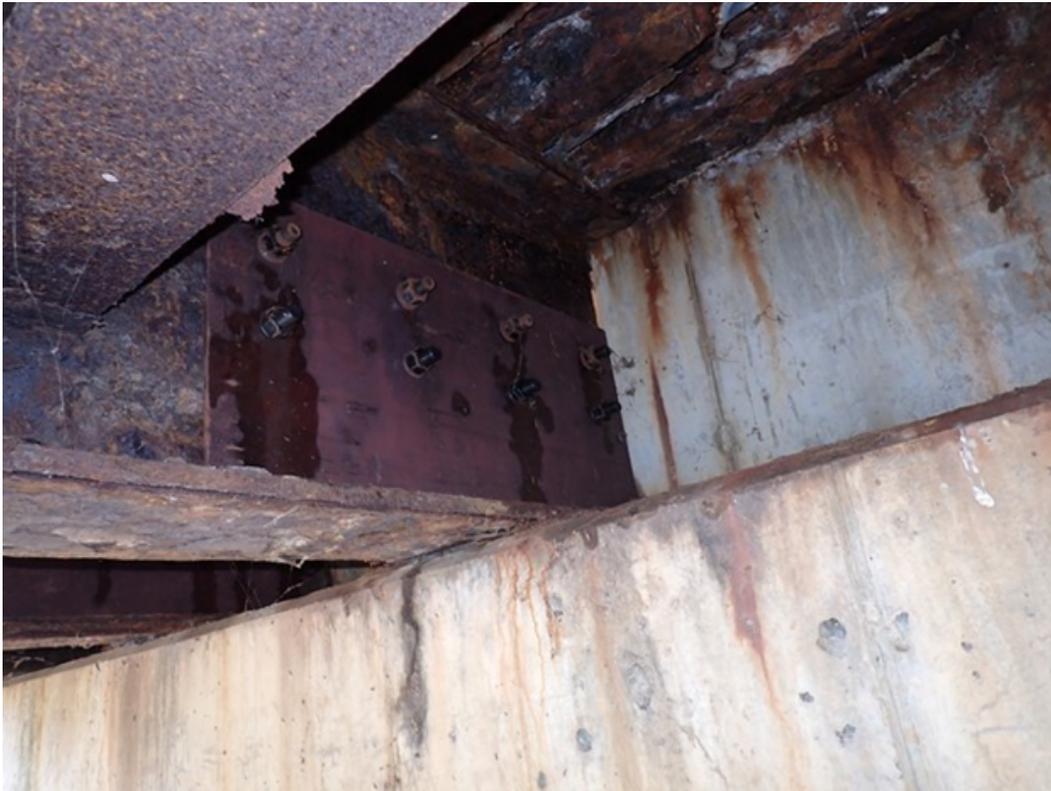
(Photo Looking Southwest at Recent Steel Beam Repair)

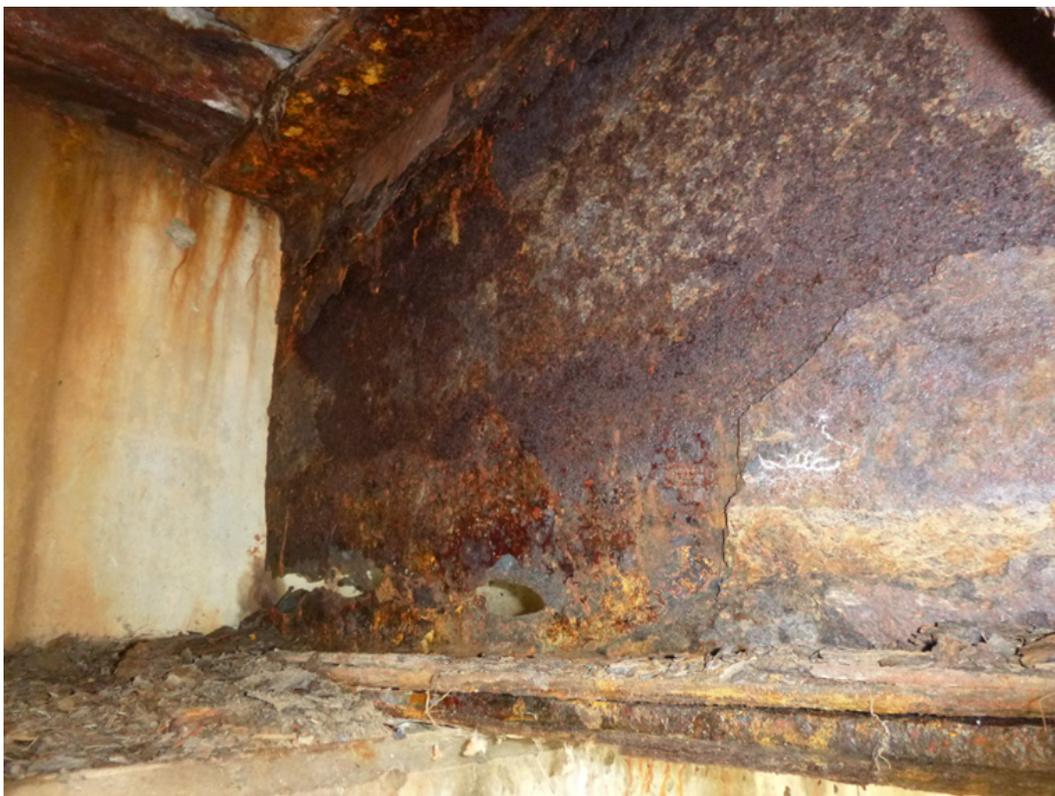
Special Inspection Pre-Repair Image of Steel Beam End Section Loss

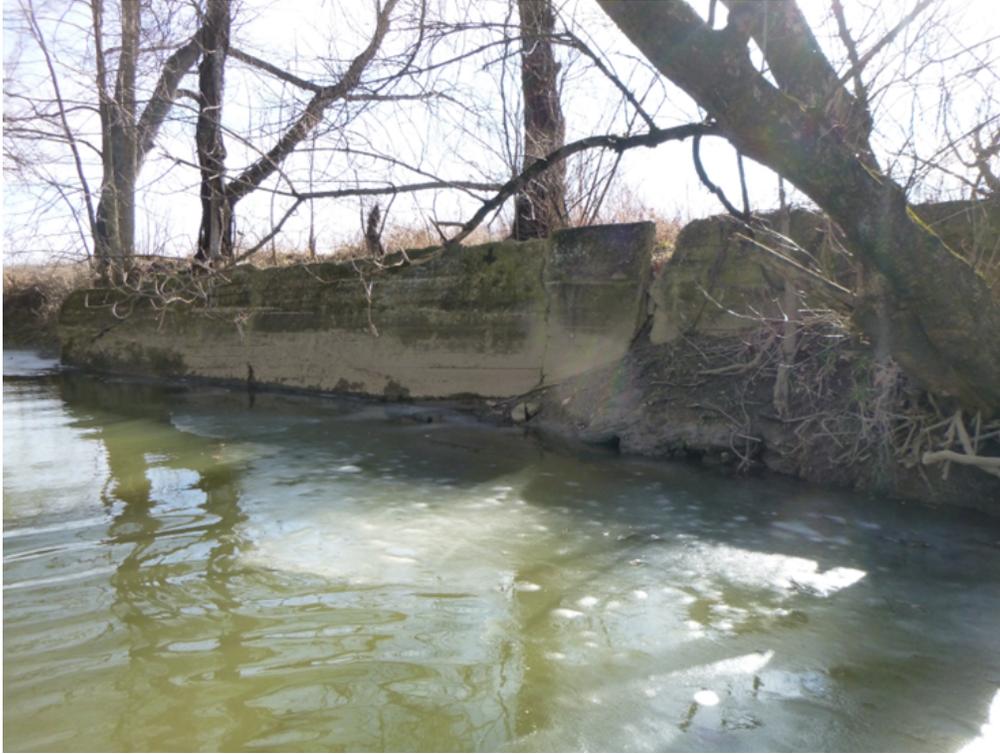
Existing Downstream Retaining Wall Along West Bank of Muddy Fork (Privately Owned)
