Inspector: Prendeville, Brendan  
Inspection Date: 10/30/2024

National Bridge Inventory

**LIC-T0038-0315 (4563808)**

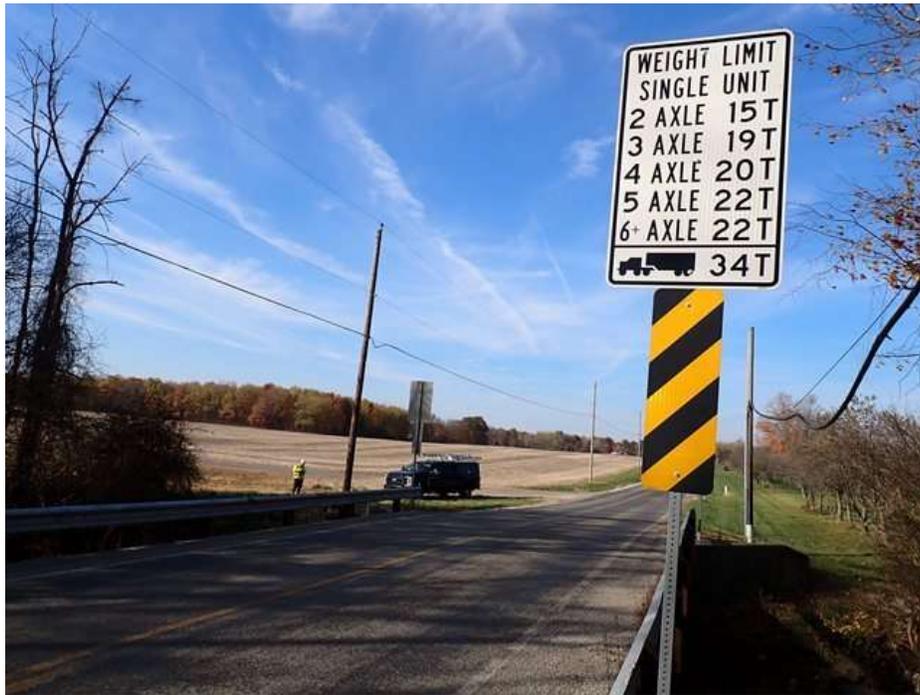
PHOTO 1 Condition

Description Looking west at the load posting sign at the east approach.

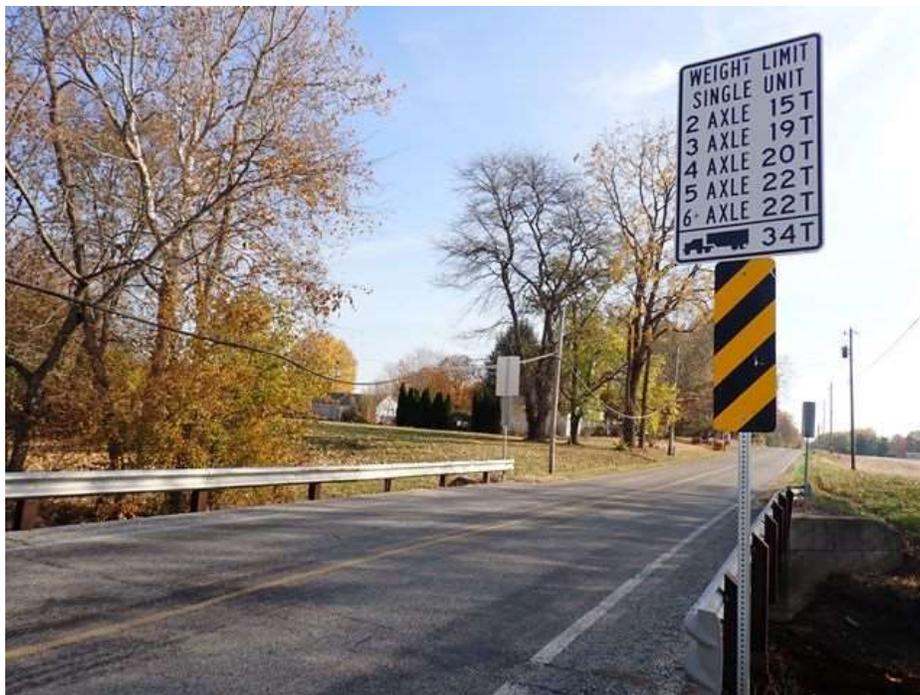
PHOTO 2 Condition

Description Looking east at the load posting sign at the west approach.

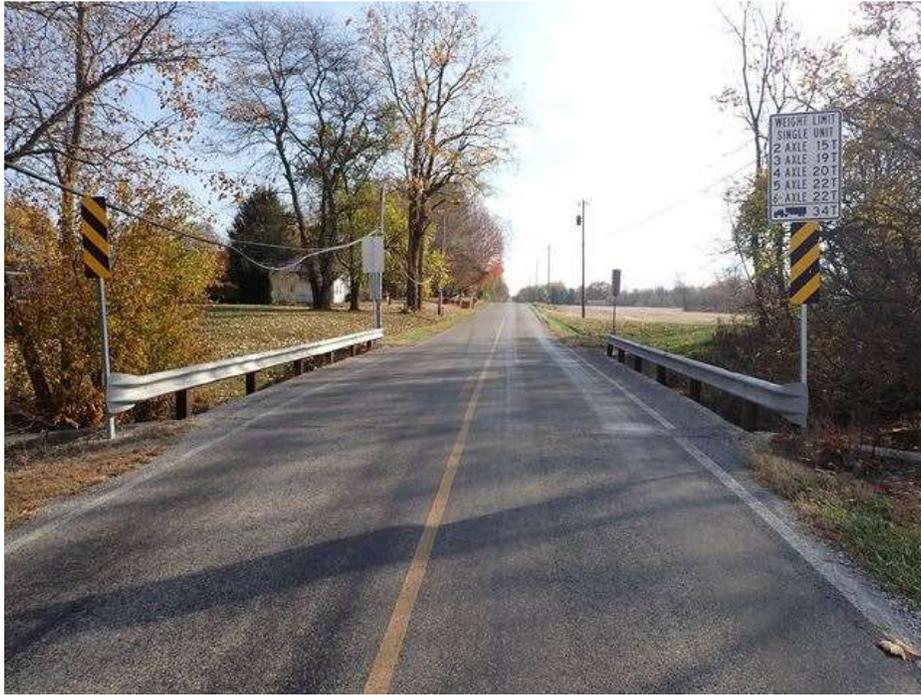
PHOTO 3 Condition  
Description End view looking east.

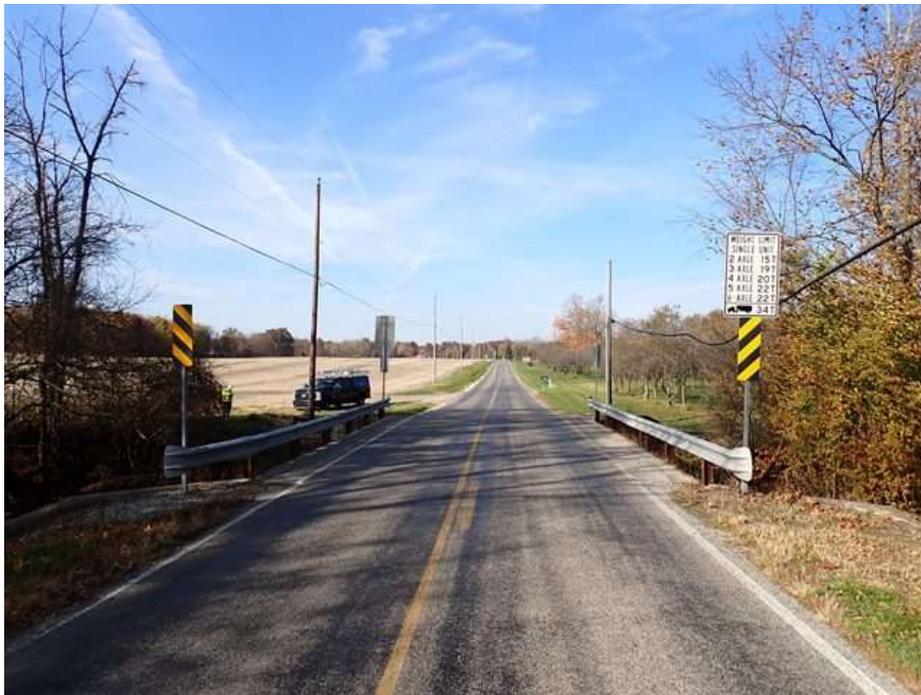
PHOTO 4 Condition  
Description End view looking west.

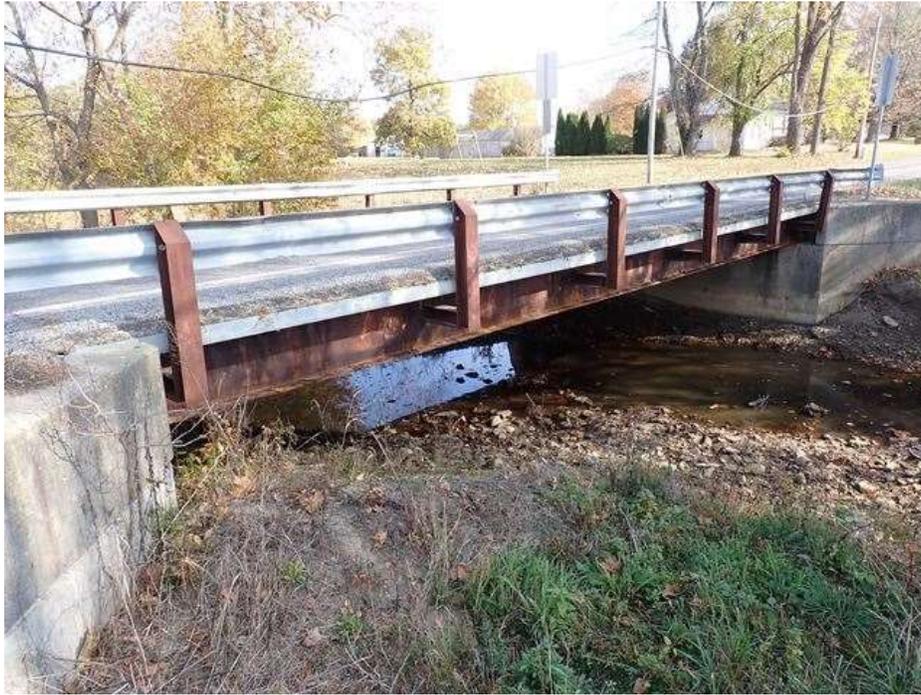
PHOTO 5 Elevation

Description Looking northeast at the bridge elevation, south fascia.

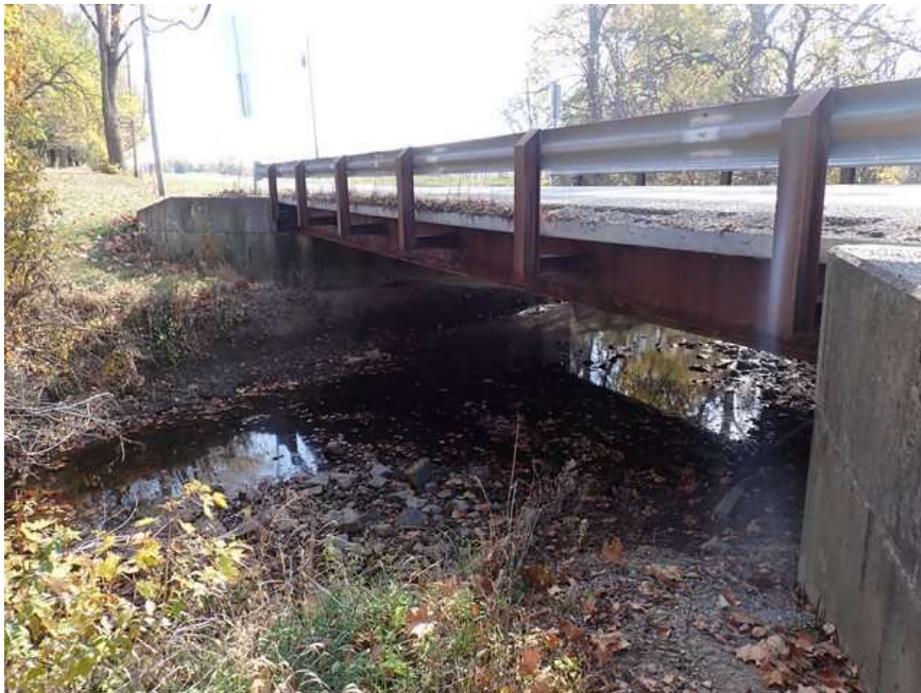
PHOTO 6 Elevation

Description Looking southeast at the bridge elevation, north fascia.

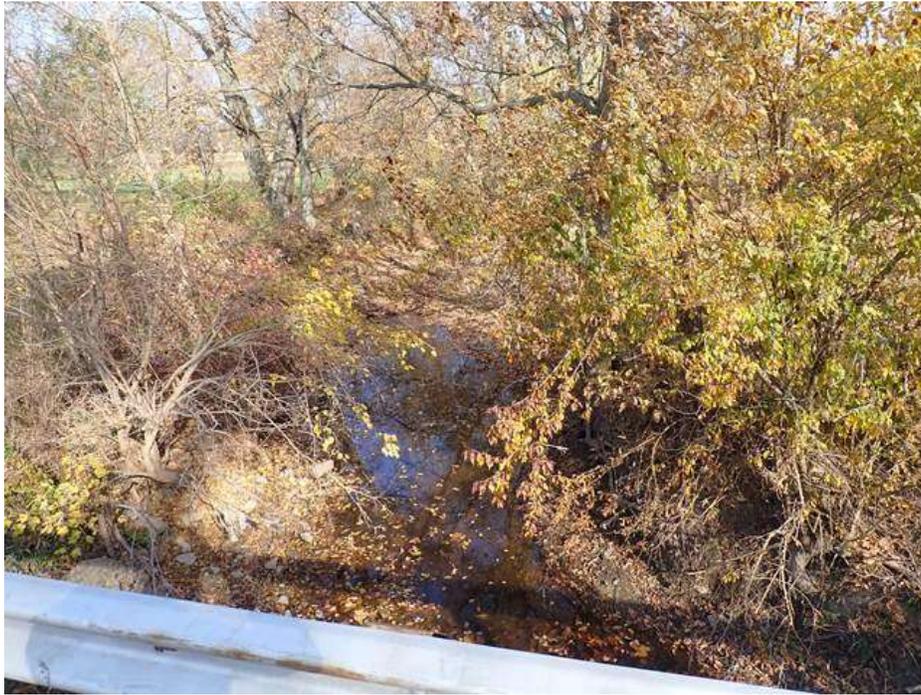
PHOTO 7 Condition

Description Looking north at the upstream channel.

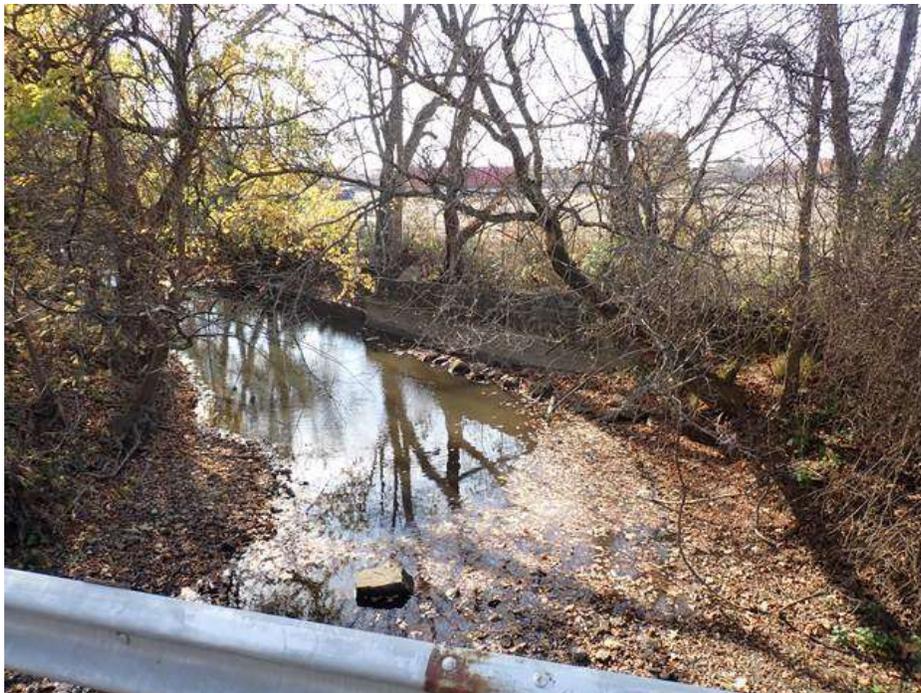
PHOTO 8 Condition

Description Looking south at the downstream channel.

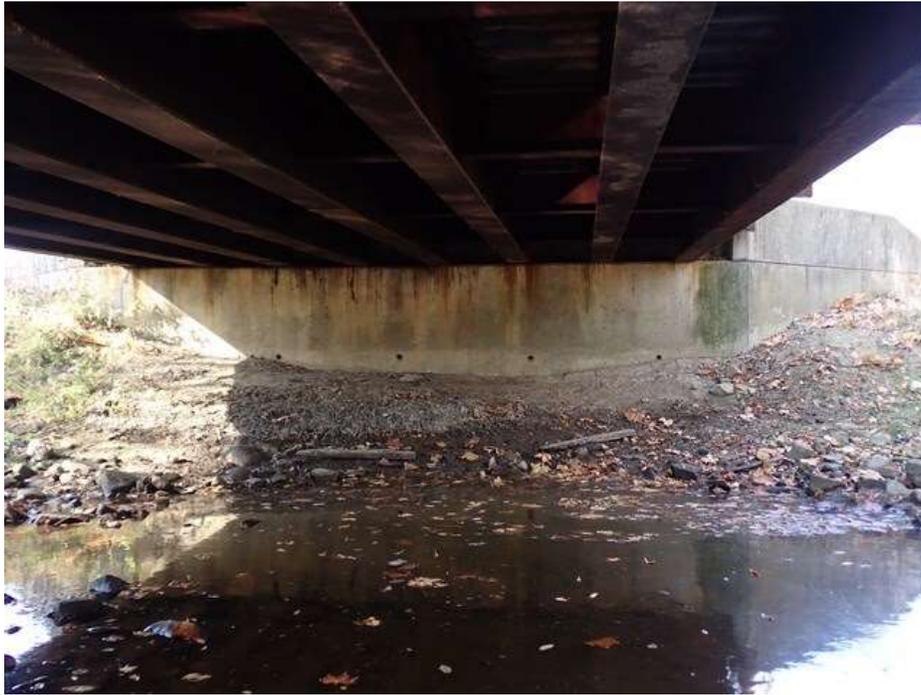
PHOTO 9 Condition

Description Looking west at typical substructure, west abutment.

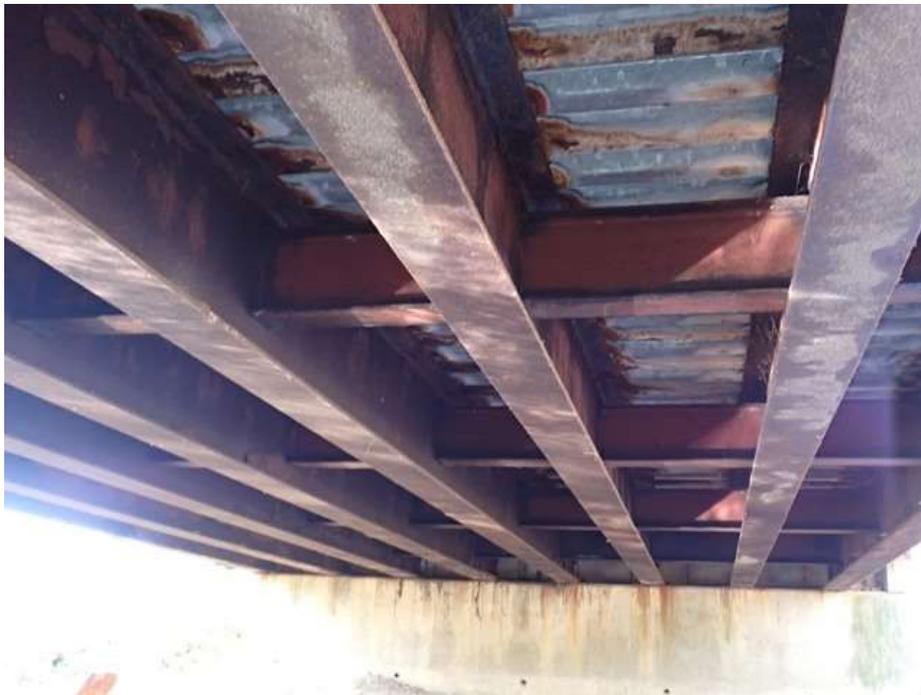
PHOTO 10 Condition

Corrugated metal decking has large amount of heavy rust with heavy pitting and moderate section loss.

Description Looking west at typical superstructure, underside of bridge. Note: metal SIP forms along the underside of the bridge deck.

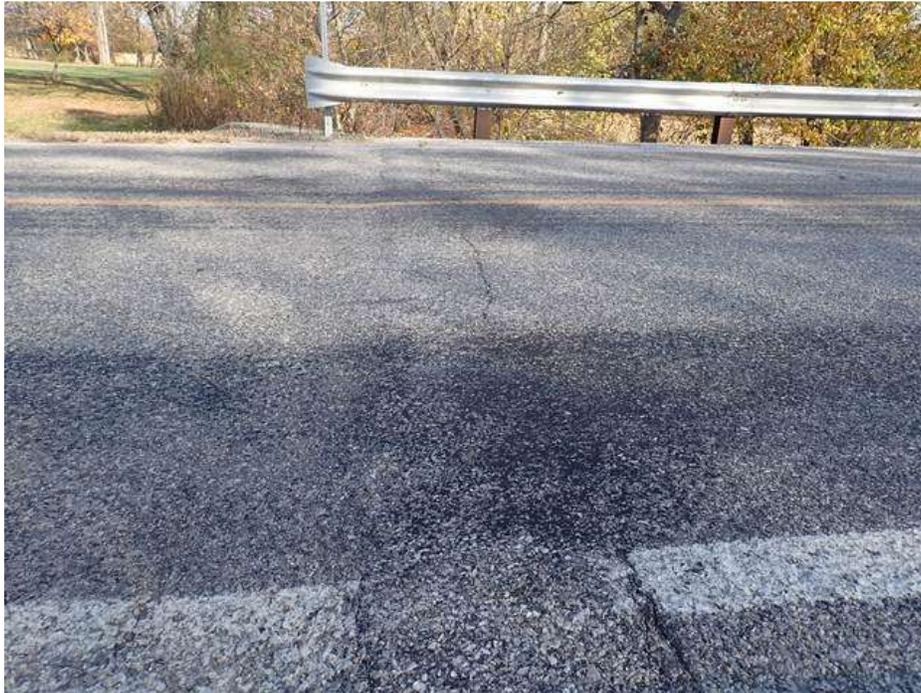
PHOTO 11 Condition

Sliding plate joint has been paved over.

Description Looking north at the joint over the west abutment. Note: the joints at both abutments have been paved over.

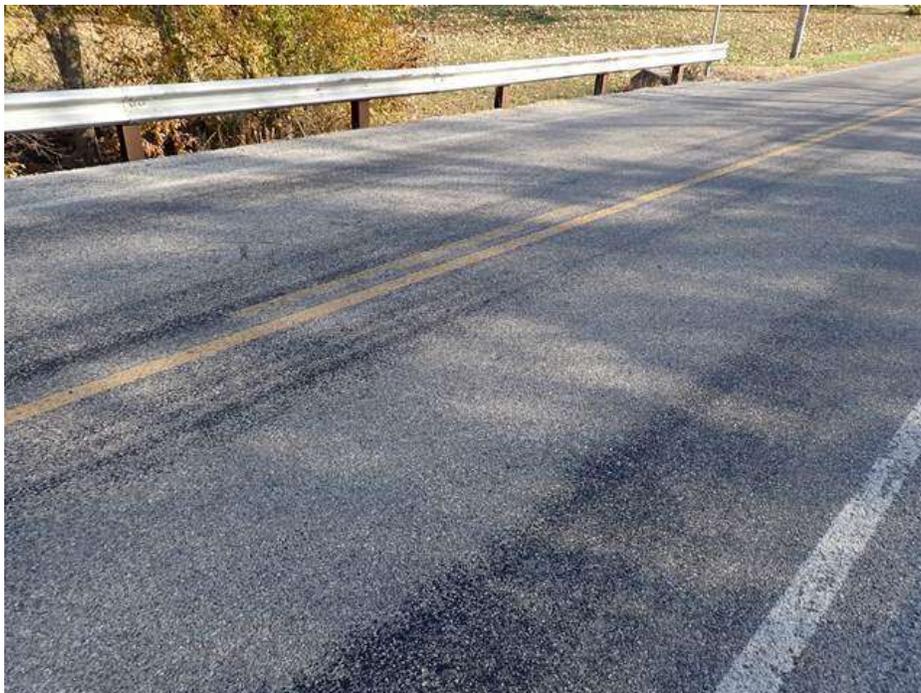
PHOTO 12 Condition

Bridge wearing surface has new chip seal (2021). Transverse cracks present at both bridge limits. Visible wearing surface settlement at bridge limits.

Description Looking northeast at typical wearing surface.

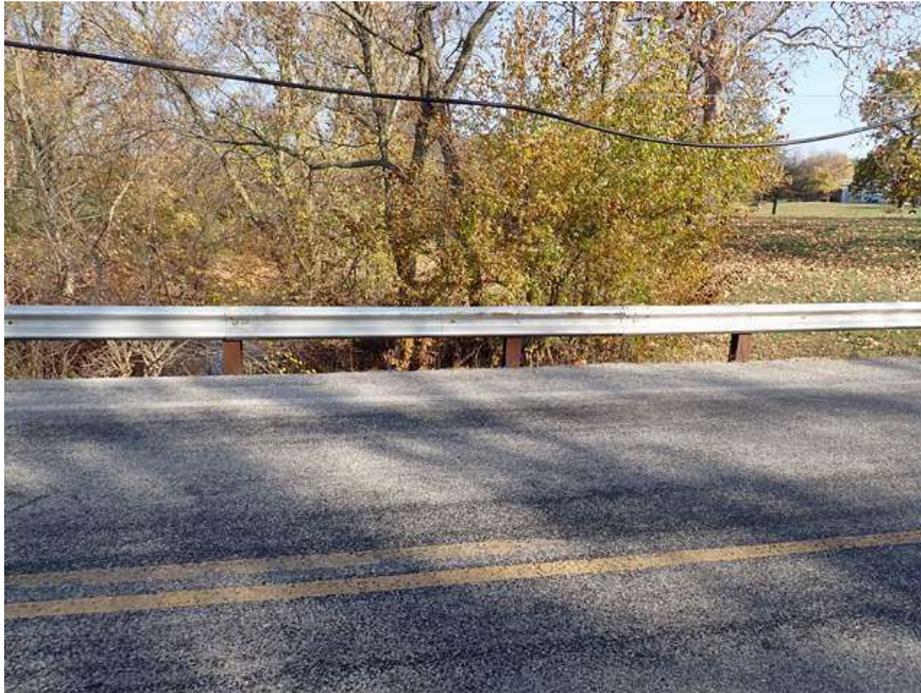
PHOTO 13 Condition

Description Looking north at typical bridge railing, north rail.

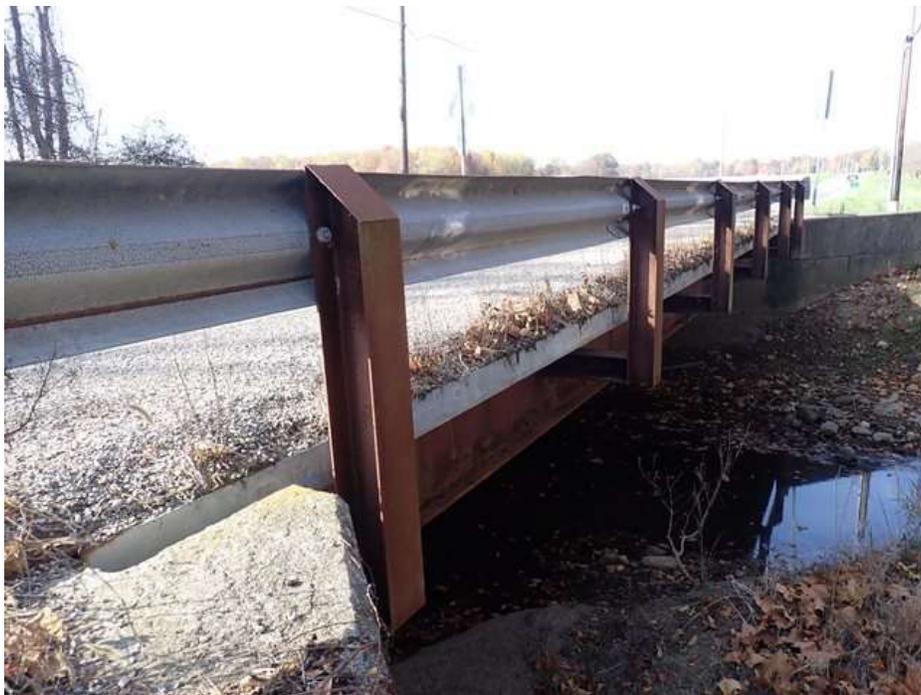
PHOTO 14 Condition

Bridge railing has a large amount of heavy rusting with moderate pitting and moderate section loss on the rail posts. Horizontal steel member connecting fascia beam to railing post has heavy corrosion.

Description Looking southwest at the typical backside of the bridge railing, north rail. Note: typical surface corrosion with pitting and minor section loss to the rail posts.

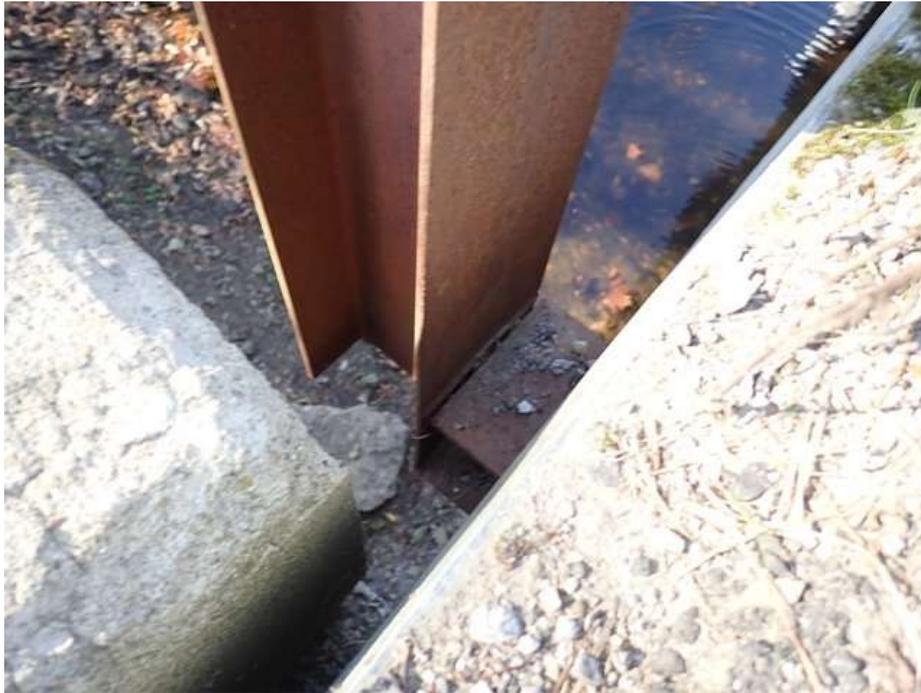
PHOTO 15 Condition

Isolated areas of minor impact damage along both rails, worst at the southeast corner. The top transverse weld between the post and connection strut is broken.

Description Looking southwest at the southeast bridge rail post. Note: impact damage has broken the transverse weld between the rail post and connection strut.

Beware of the failed web at the SE corner railing post, recommend repair for vehicular safety. Emailed City 11-22-23 to inform of recommendation.

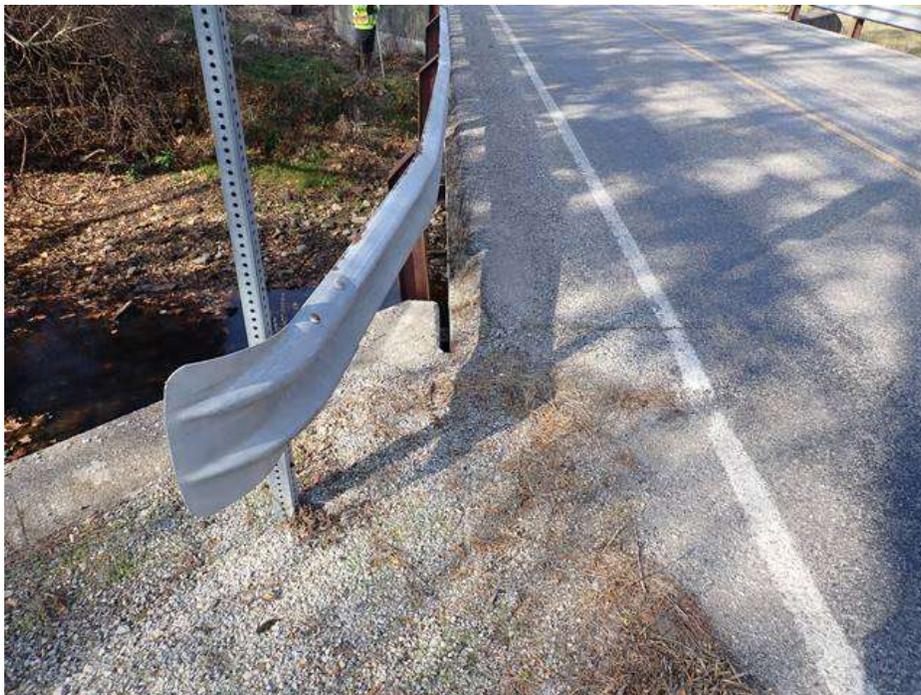
PHOTO 16 Condition

Description Looking west at the southeast bridge railing impact damage.

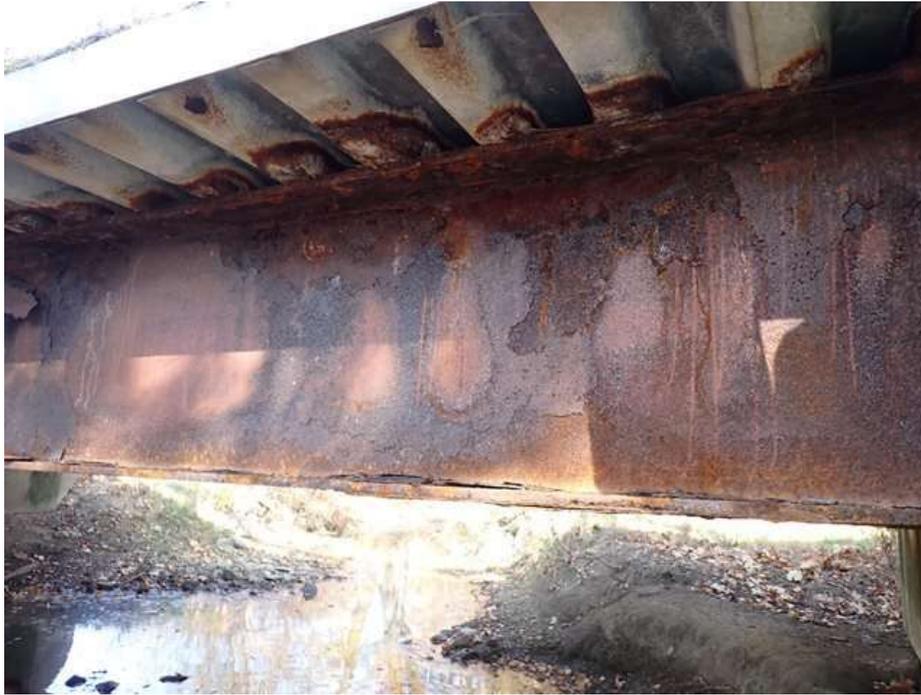
PHOTO 17 Condition

Laminating corrosion for each beam end was removed with a hammer. Beams have a large amount of heavy laminating corrosion with moderate section loss. Beam ends have up to 50% typical loss of section for up to 6 ft length in the web and flanges. Beams exhibit 1/8" section loss to the bottom flange (3/4" nominal) exists sporadically.

Description Looking north at the exterior face of beam 8. Note: typical laminating corrosion along both faces of all beams.

Consider programming bridge for superstructure replacement in the next 5 years.

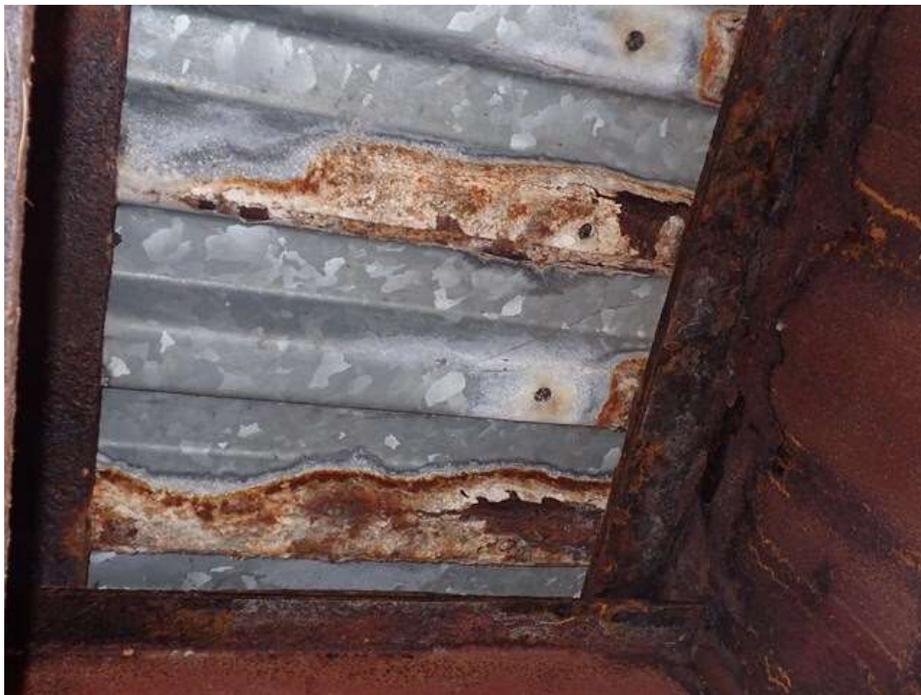
PHOTO 18 Condition

Description Looking west at the metal SIP forms between beams 1 and 2 near the east abutment. Note: typical surface corrosion with minor section loss.

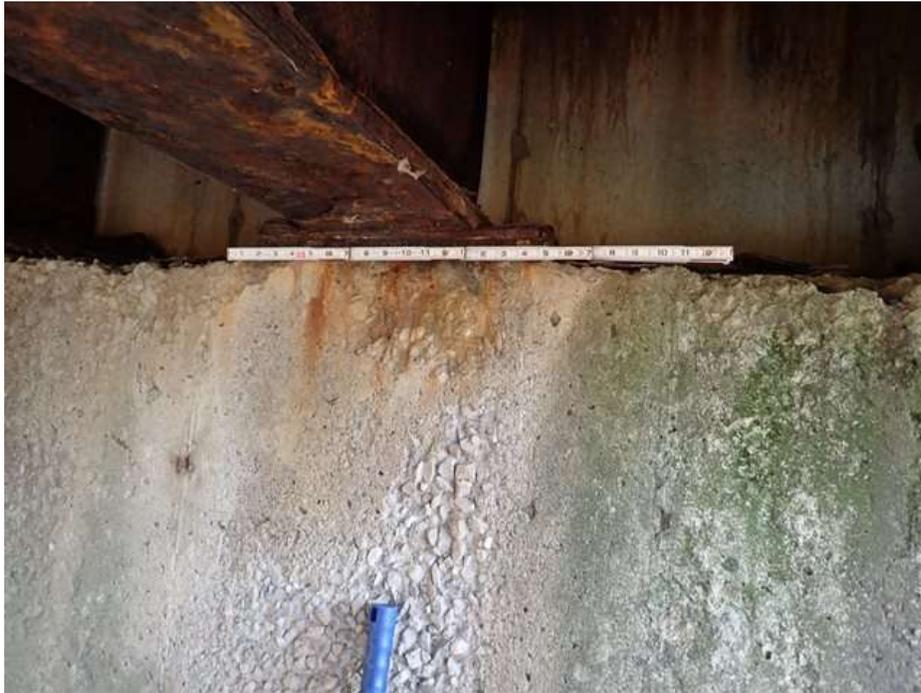
PHOTO 19 Condition

The east abutment has a moderate amount of minor spalling and honeycombing without exposed rebar.

Description Looking east at the east abutment breastwall under beam 7. Note: spalling under the beam bearing.

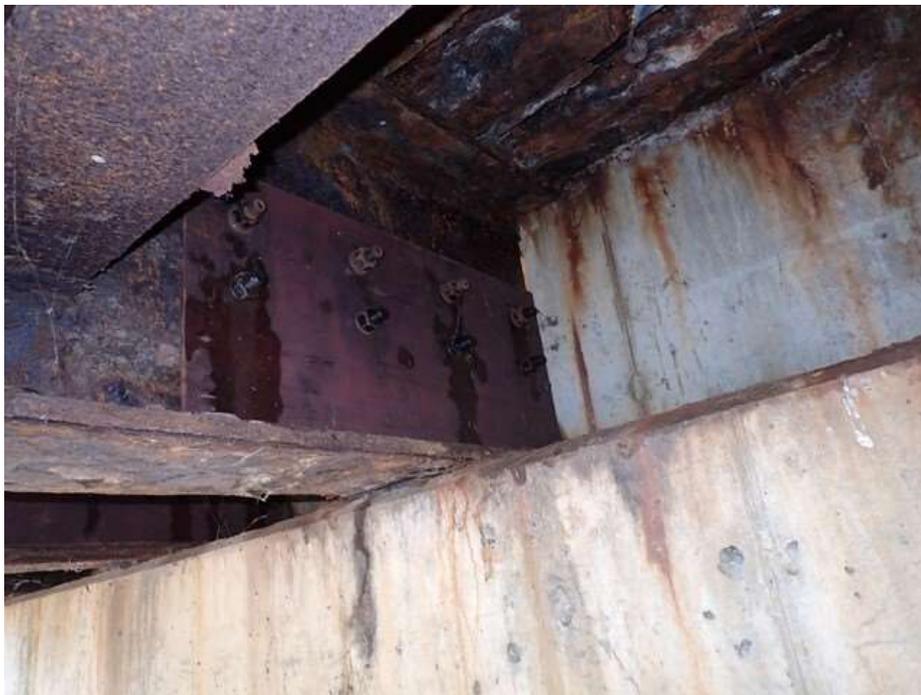
PHOTO 20 Condition

\*\*\* 2/21/2024 Special Inspection indicated large corrosion holes in beam ends. Repair plates (for shear load path) installed on 3/6/2024 as a result. The repair plates are 30" long x 16" tall x 3/8" thick are bolted to the beam end webs of beams 2 through 7. Load rating and Steel Condition Rating changed due to this special inspection \*\*\*\*

Description Looking southwest at the end of beam 6 at the west abutment. Note: steel plates have been bolted to the beam ends of beams 2 through 7 at the west abutment.

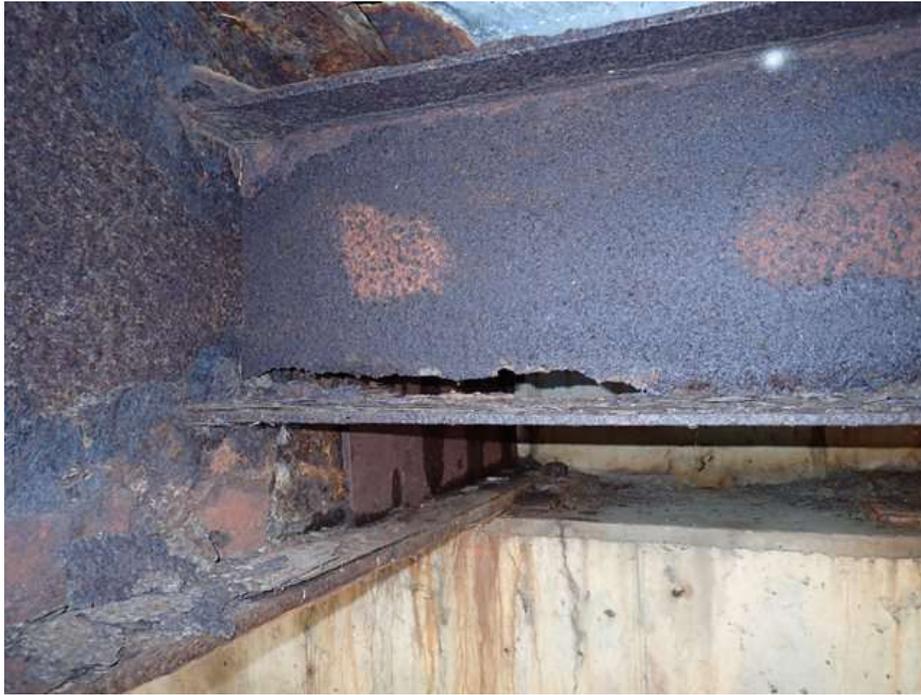
PHOTO 21 Condition

Diaphragms have a large amount of heaving rust with minor to moderate pitting and section loss with isolated areas of corrosion holes.

Description Looking west at the diaphragm between beams 3 and 4 at the west abutment. Note: corrosion hole at the bottom of the web
