Deteriorating 78" Culvert in need of repair.

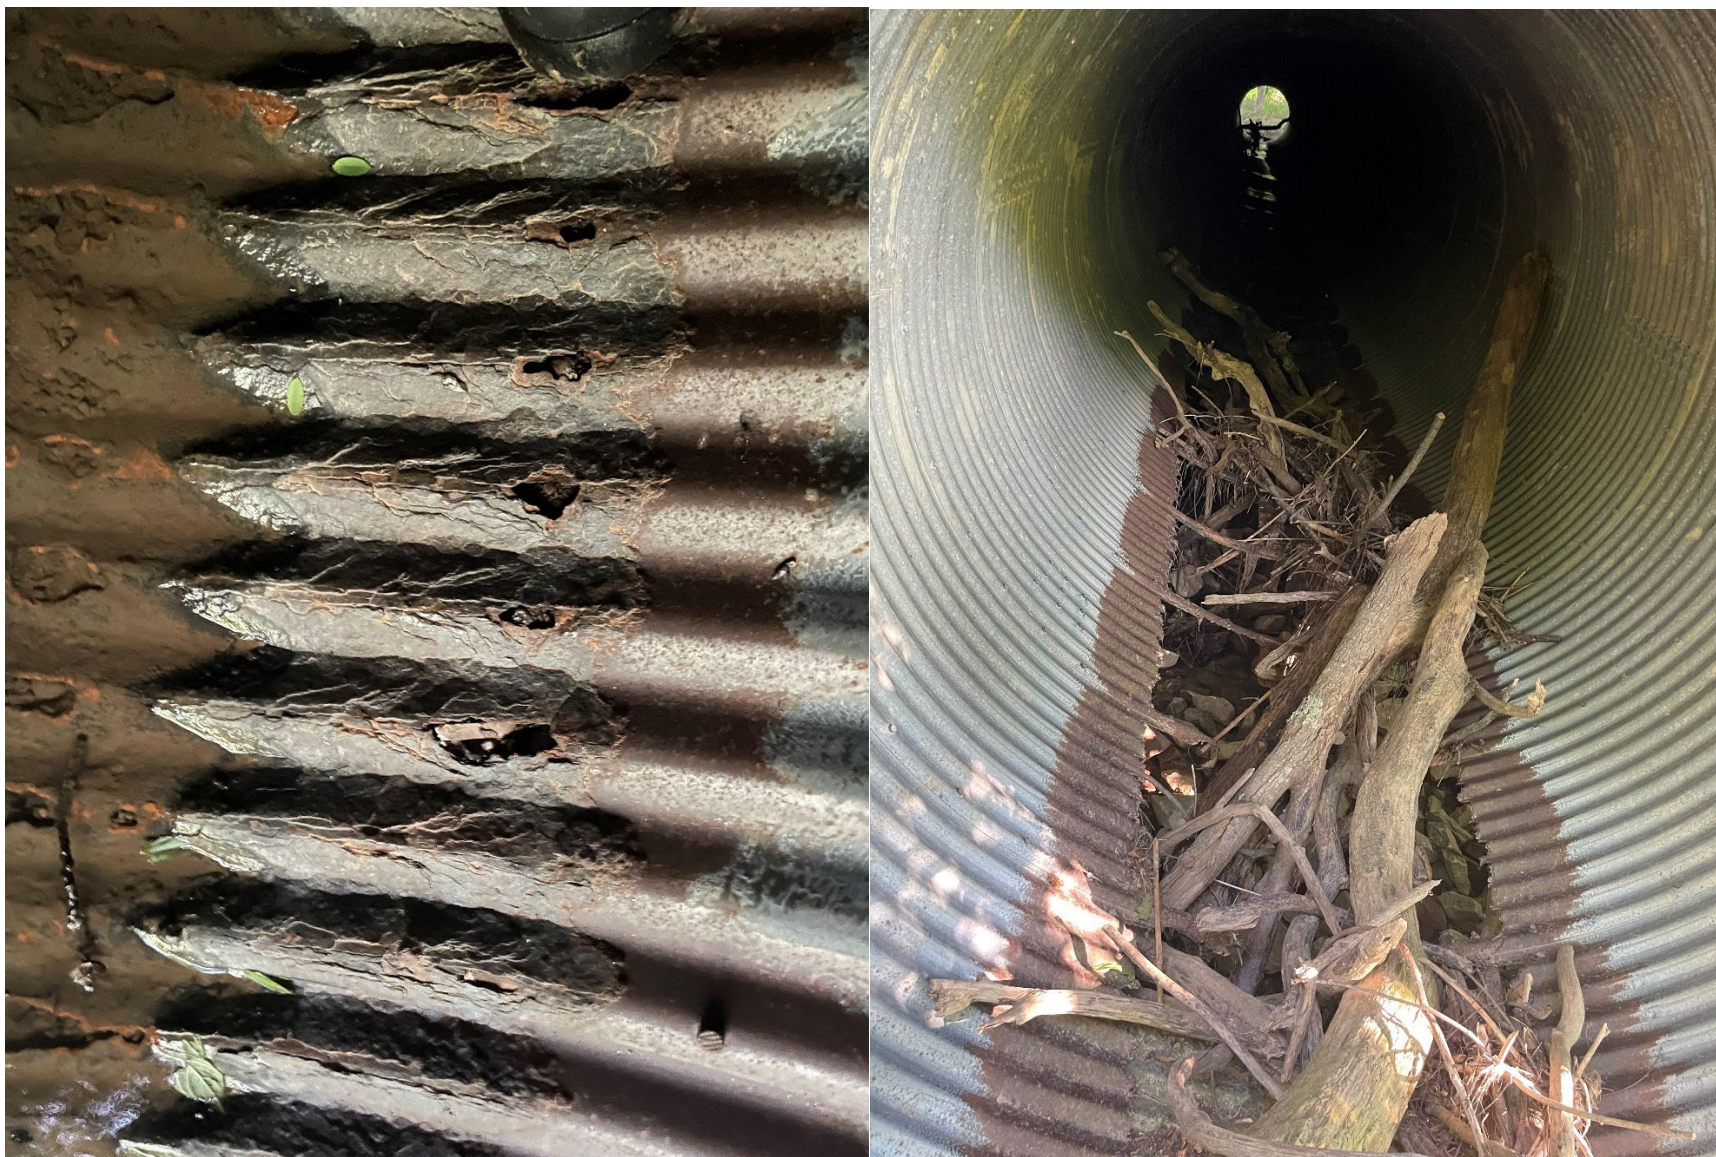
78" culvert is failing near outlet causing erosion under culvert and surrounding area.

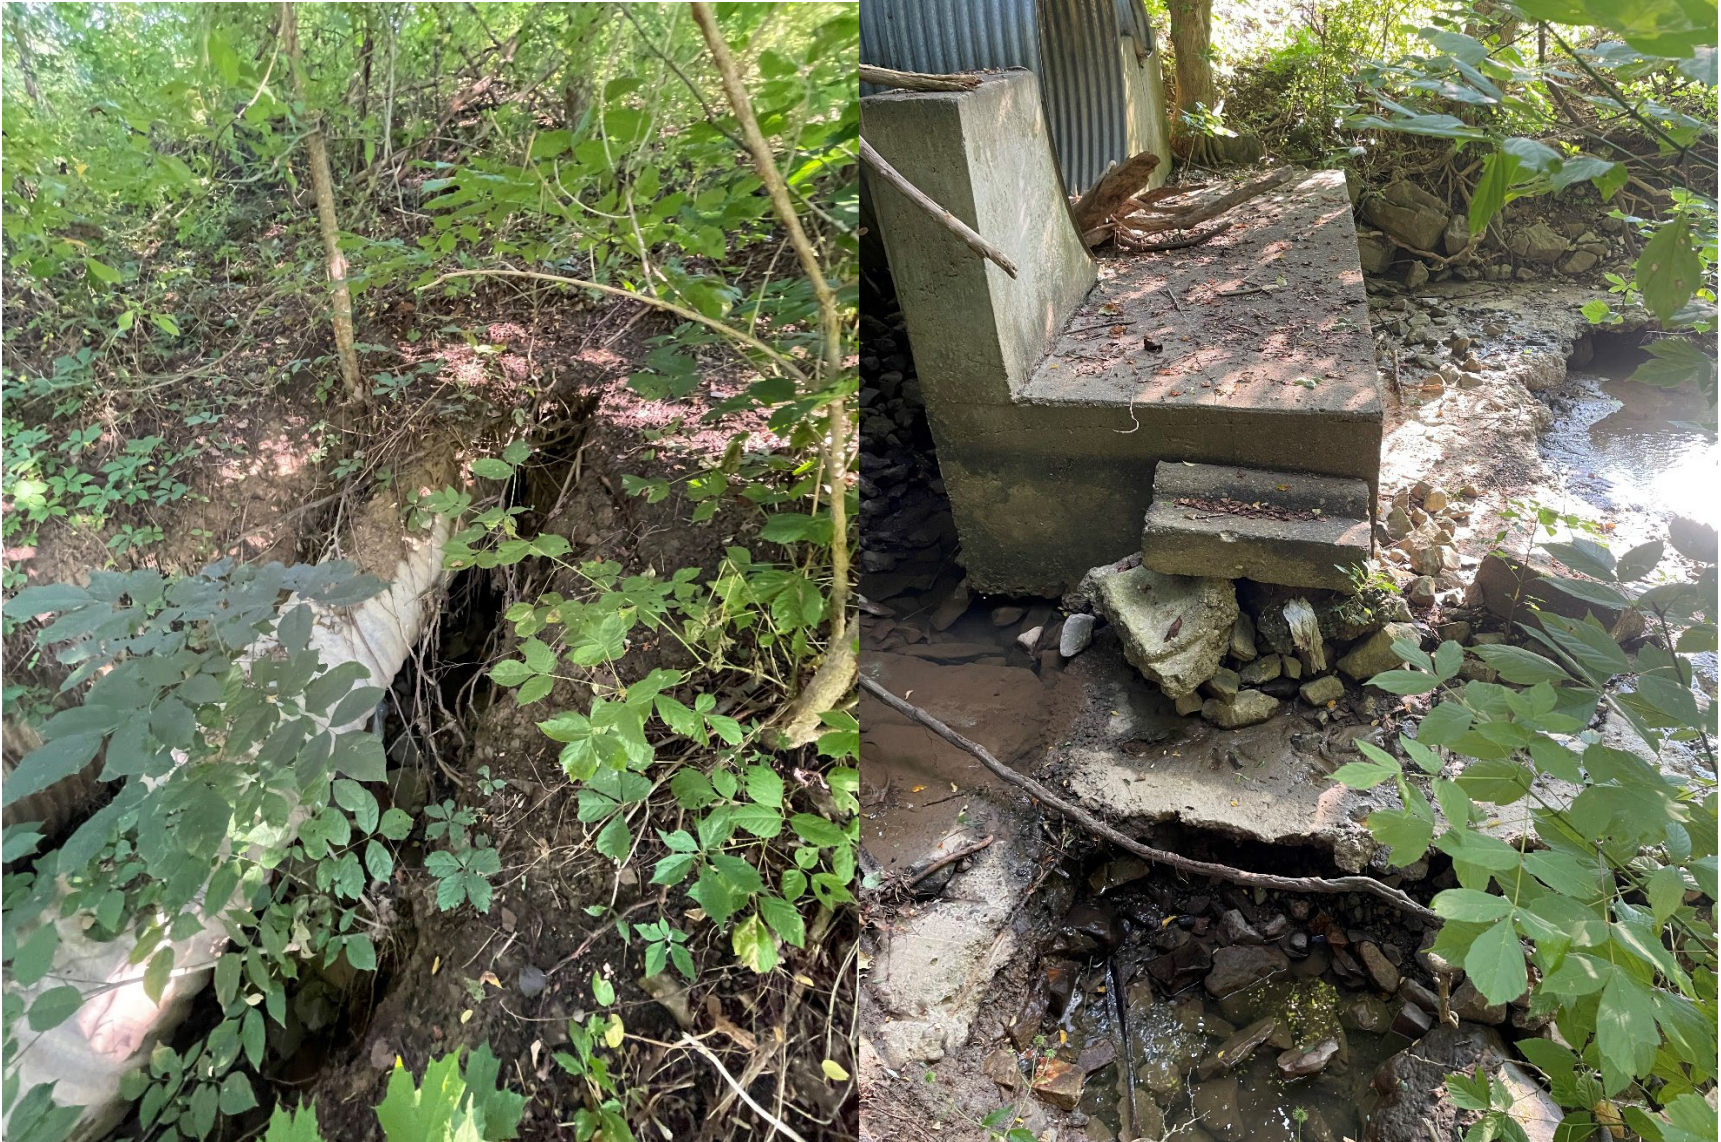
Current flow in the 78" culvert is emptying through failed culvert floor and eroding headwall and surrounding area.

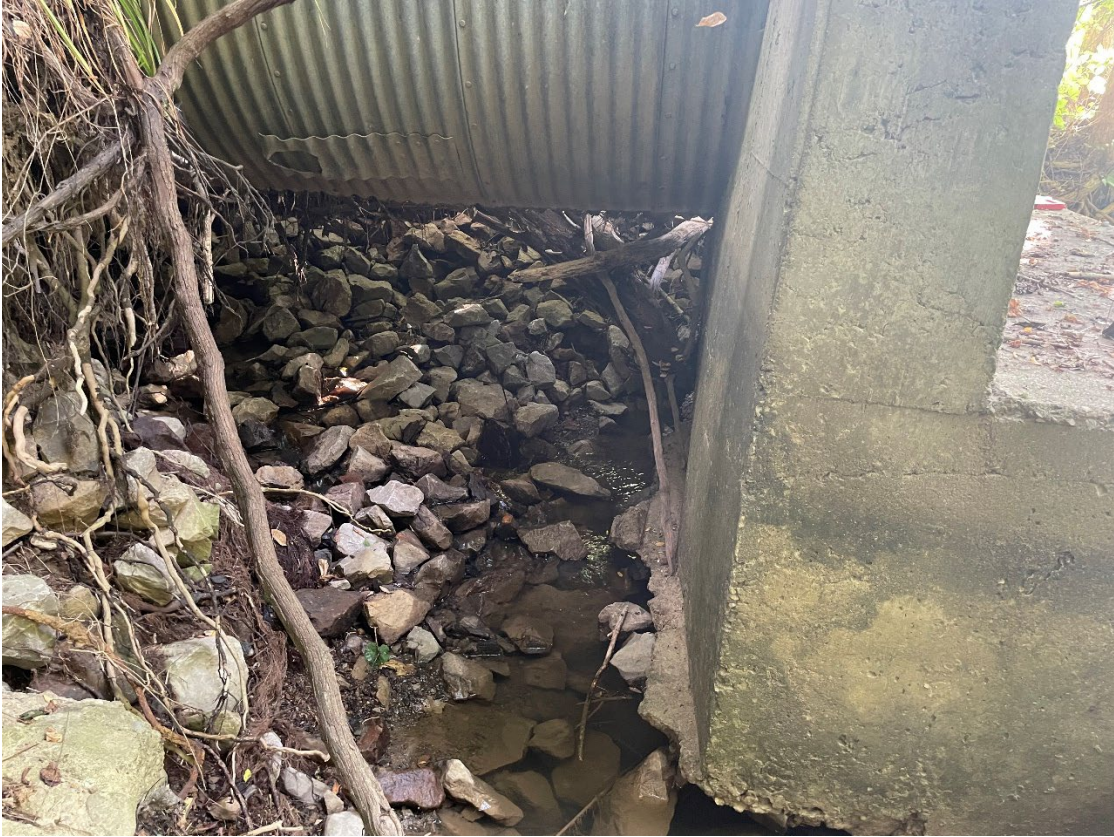
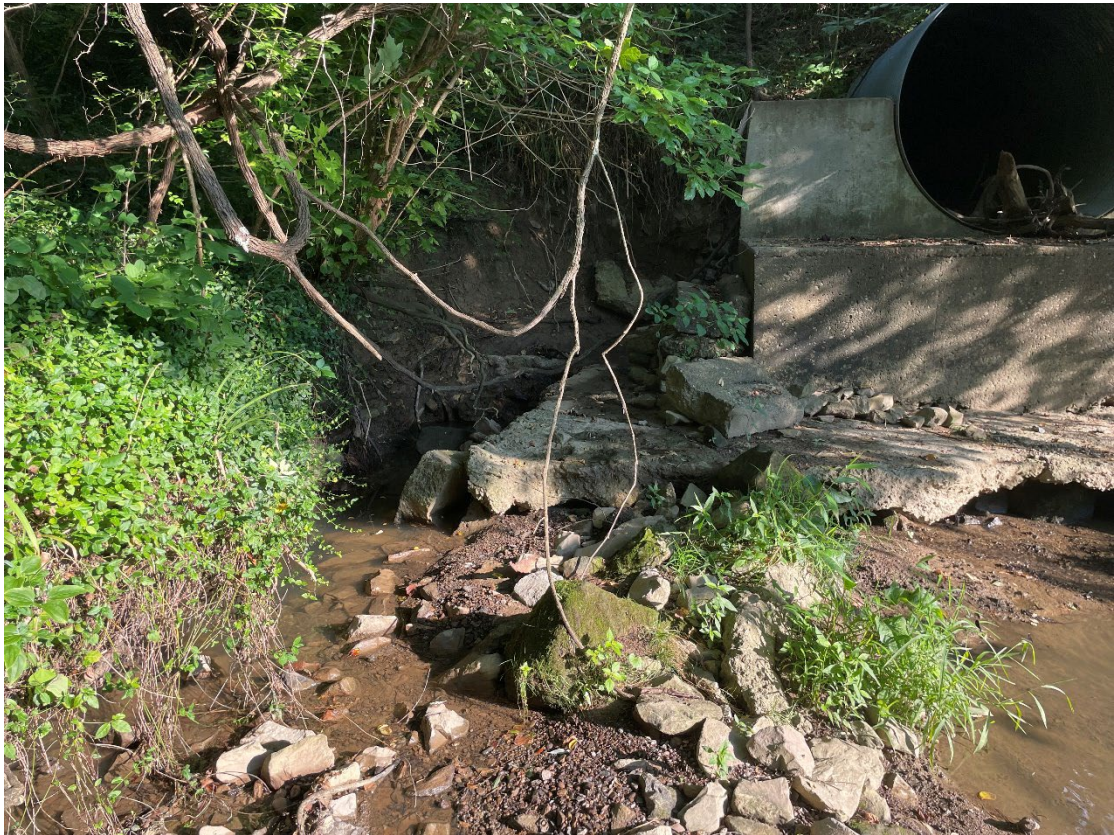
The 78" culvert is emptying through failed culvert floor and eroding the surrounding area.

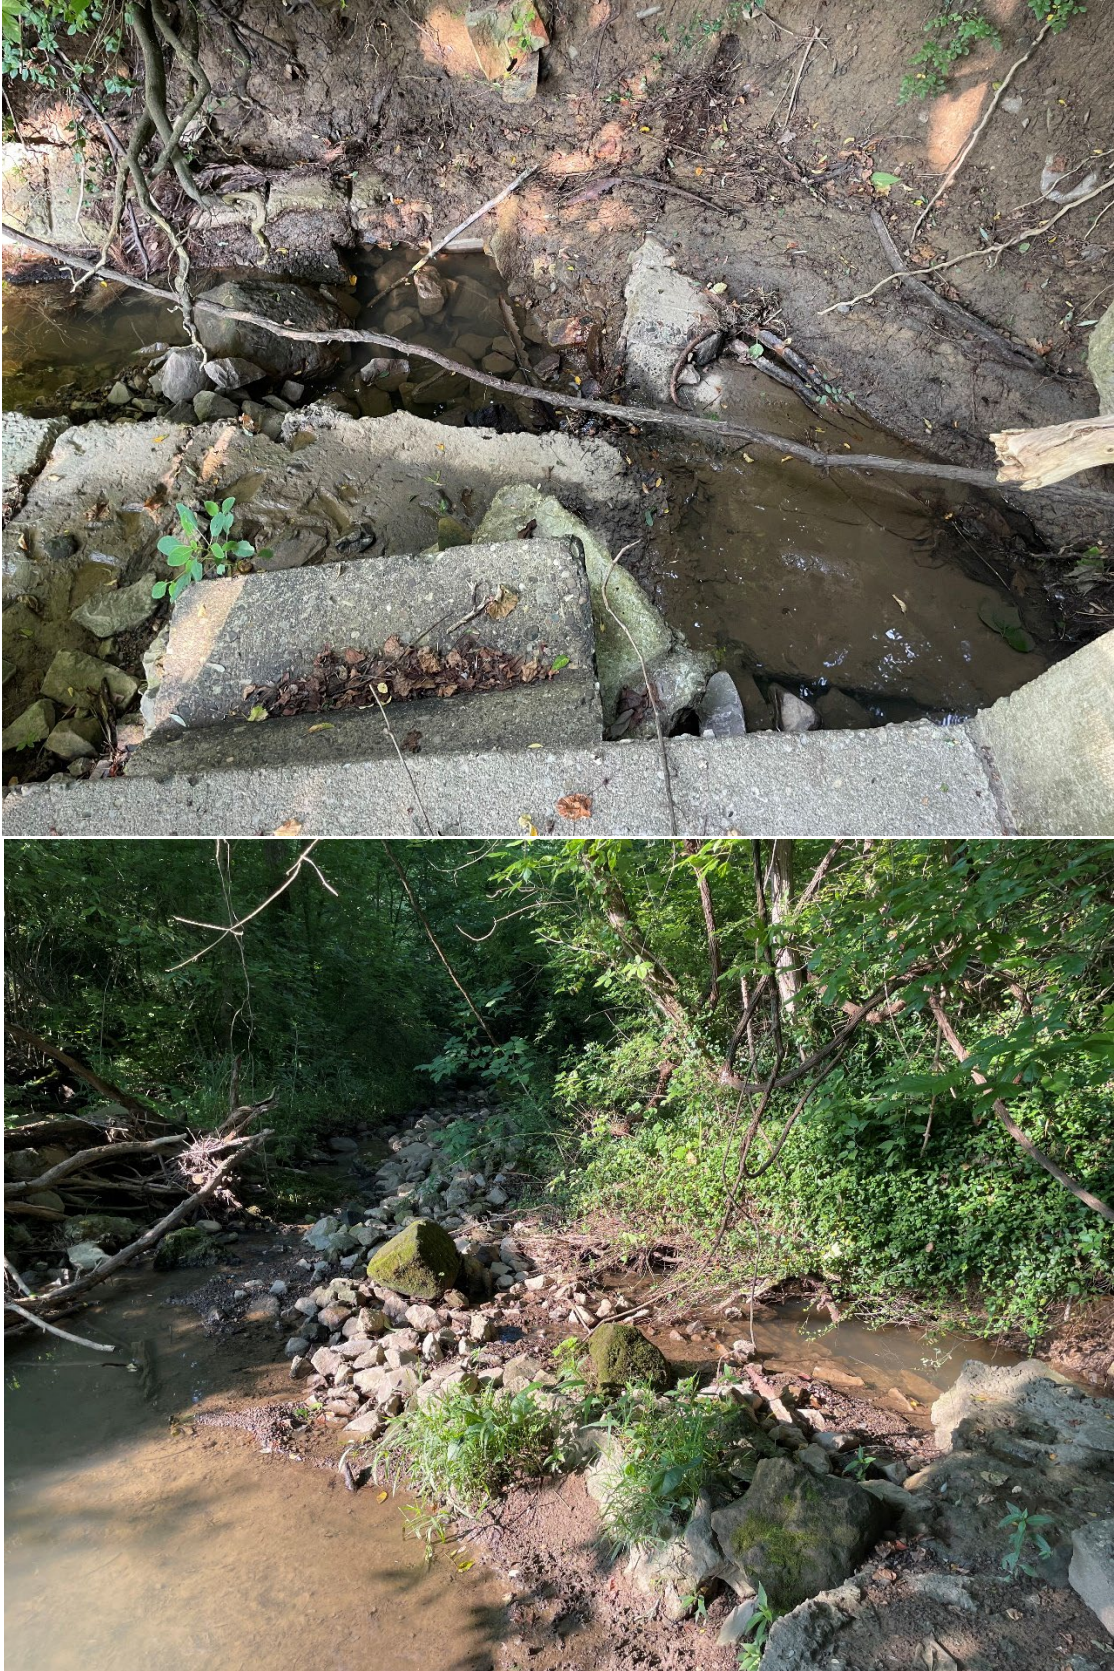
The 78" culvert is emptying through failed culvert floor and eroding the surrounding area.

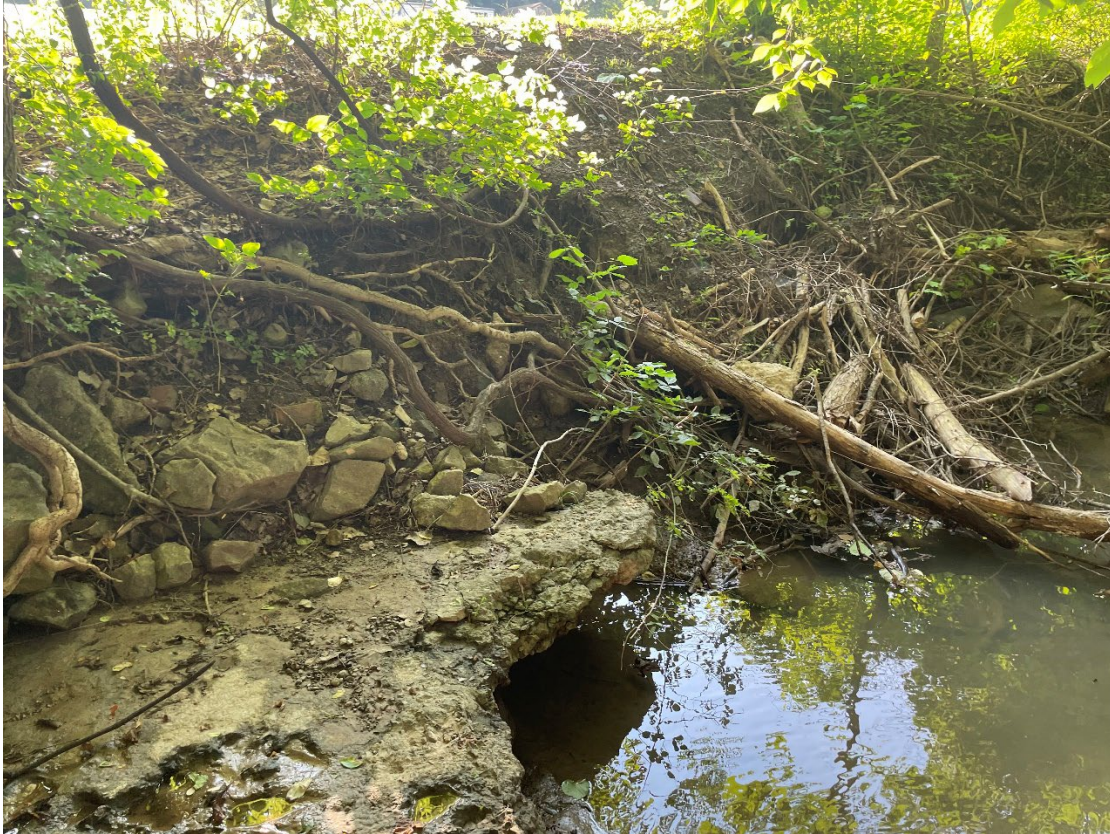
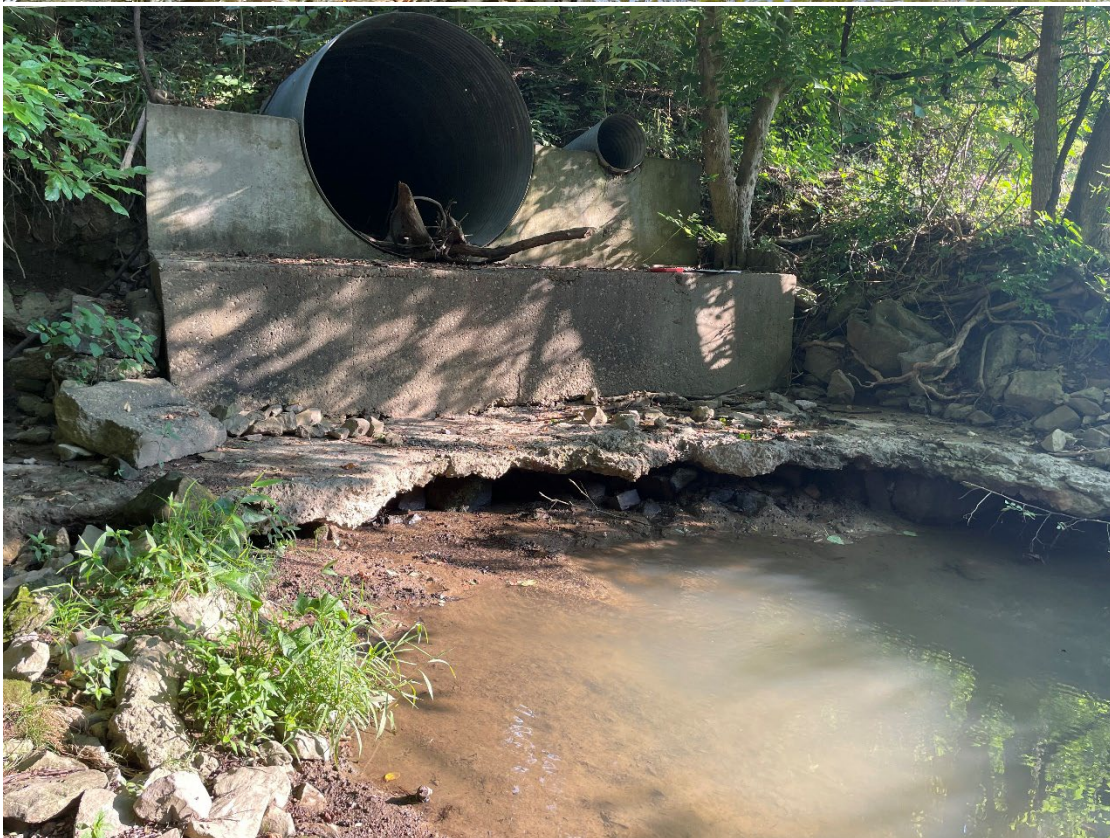
The 78" culvert is emptying through failed culvert floor and eroding the surrounding area.

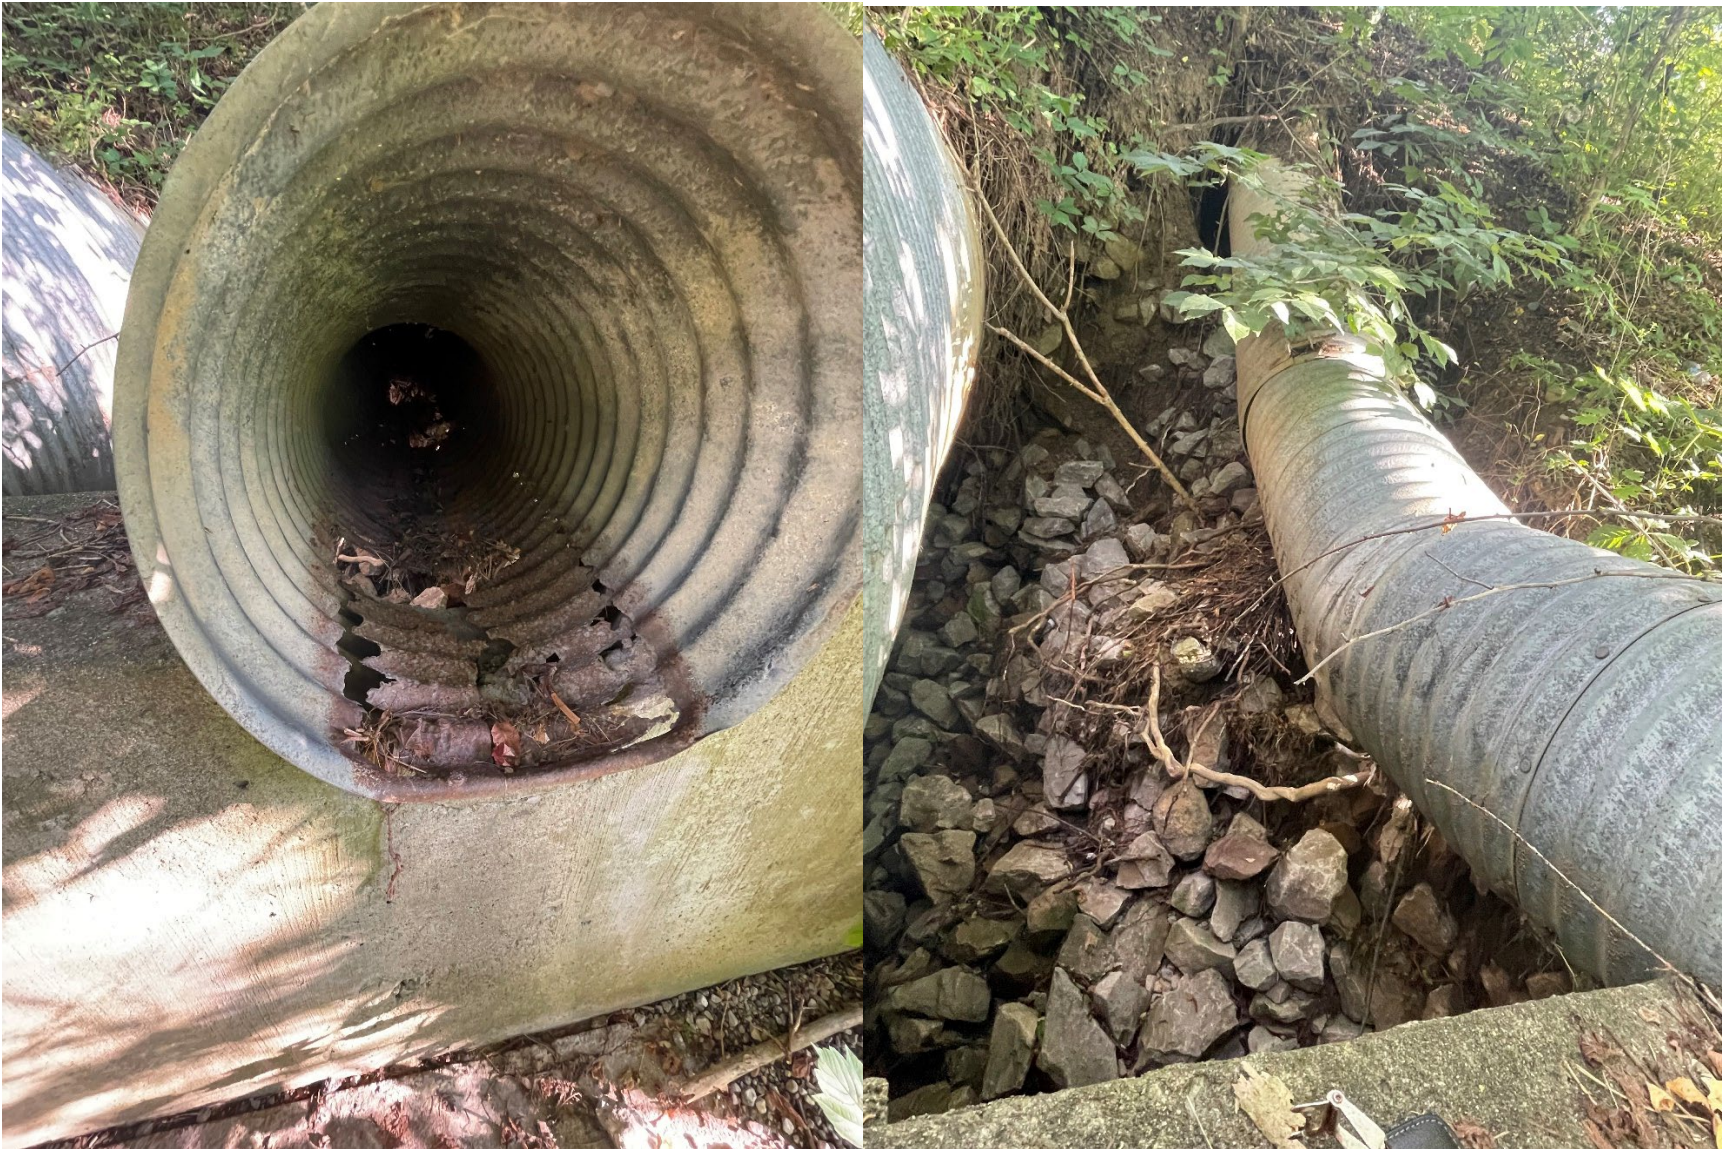
The ground under the 18" culvert providing flow from the nearby catch basin has eroded causing the pipe to sink, preventing flow to the outlet.

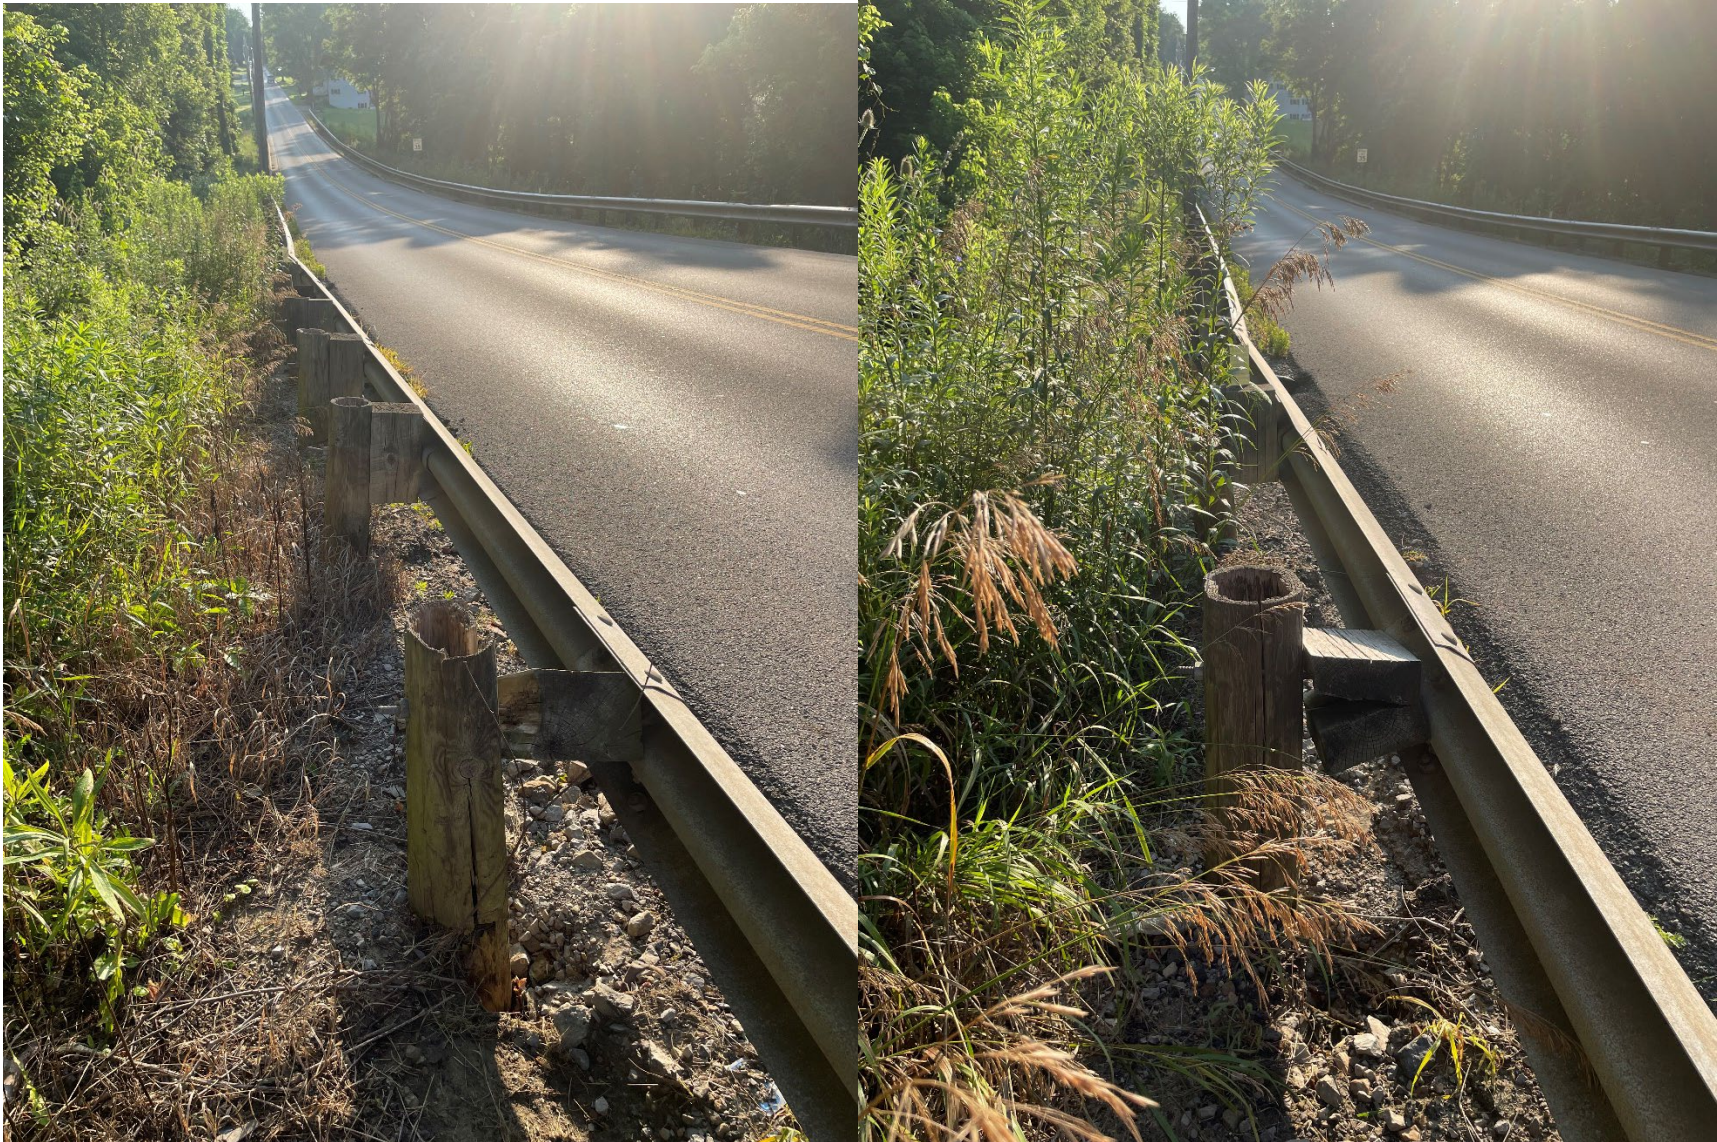
Deteriorated roadway guardrails near the culverts are in need of repair/replacement.

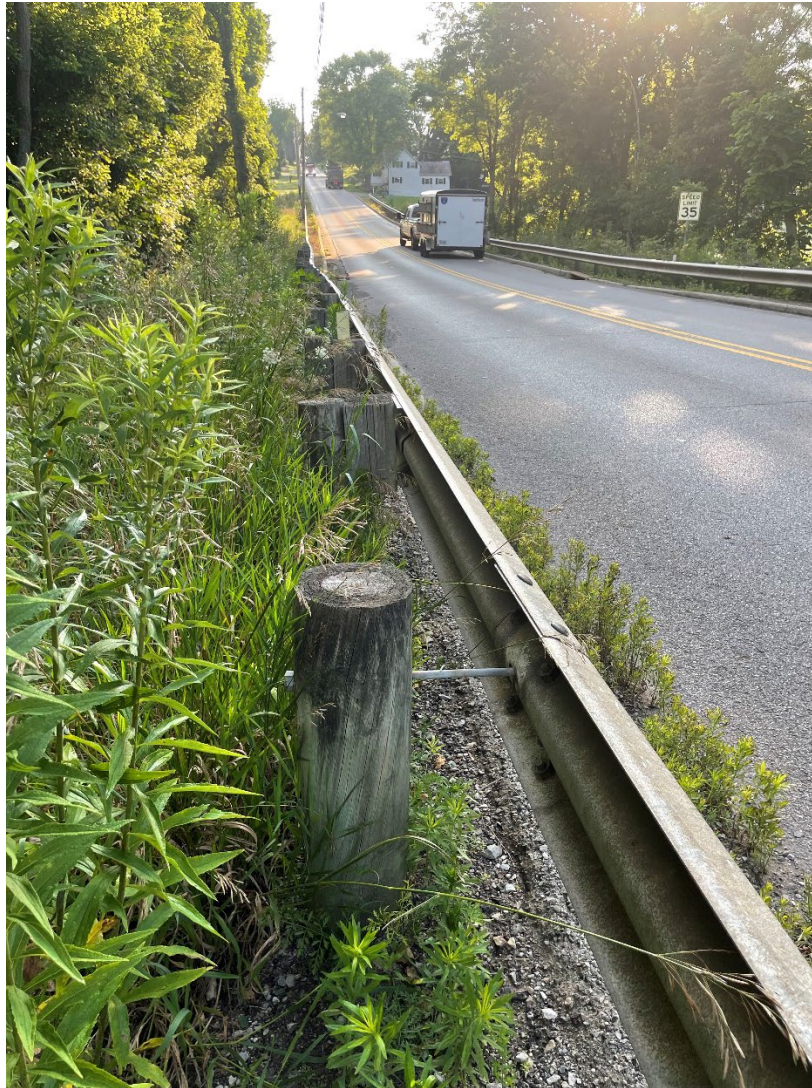
Deteriorated roadway guardrail near the culverts

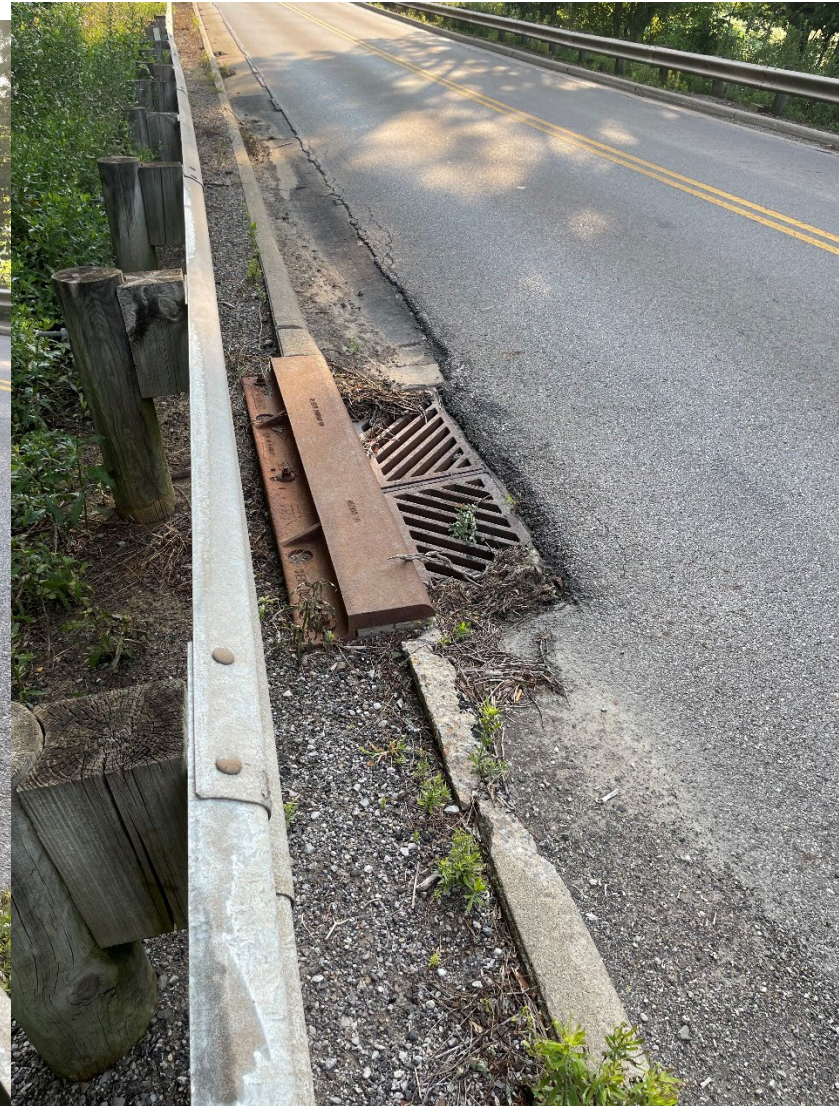
Failing catch basin that provides flow to the 18" culvert.
