**GUE-70-0994R
3001385**

**Identification and Inspection
of Fatigue Cracks
in the Built-up Welded Beams**

Re-inspection

**10-4 and 10-6-2011
By: Albert Abel
Bridge Specialist II**

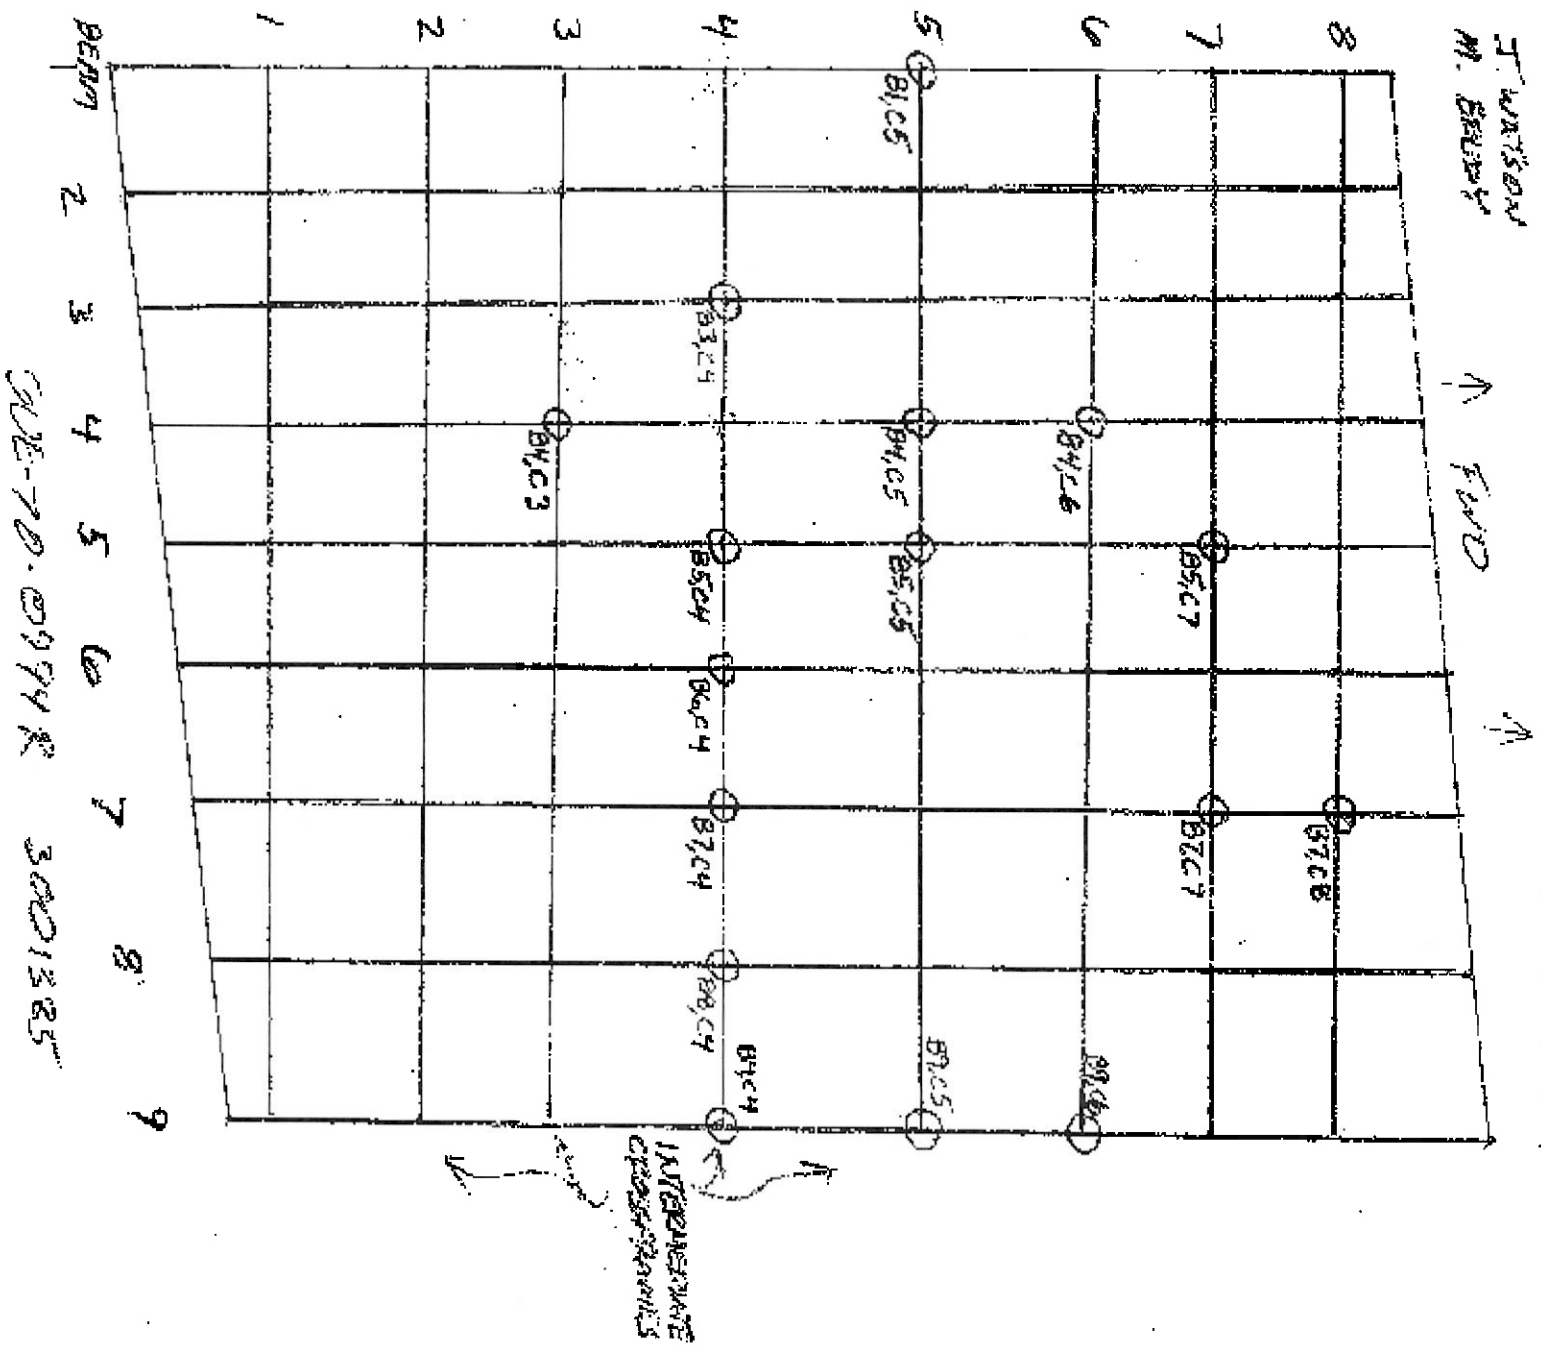
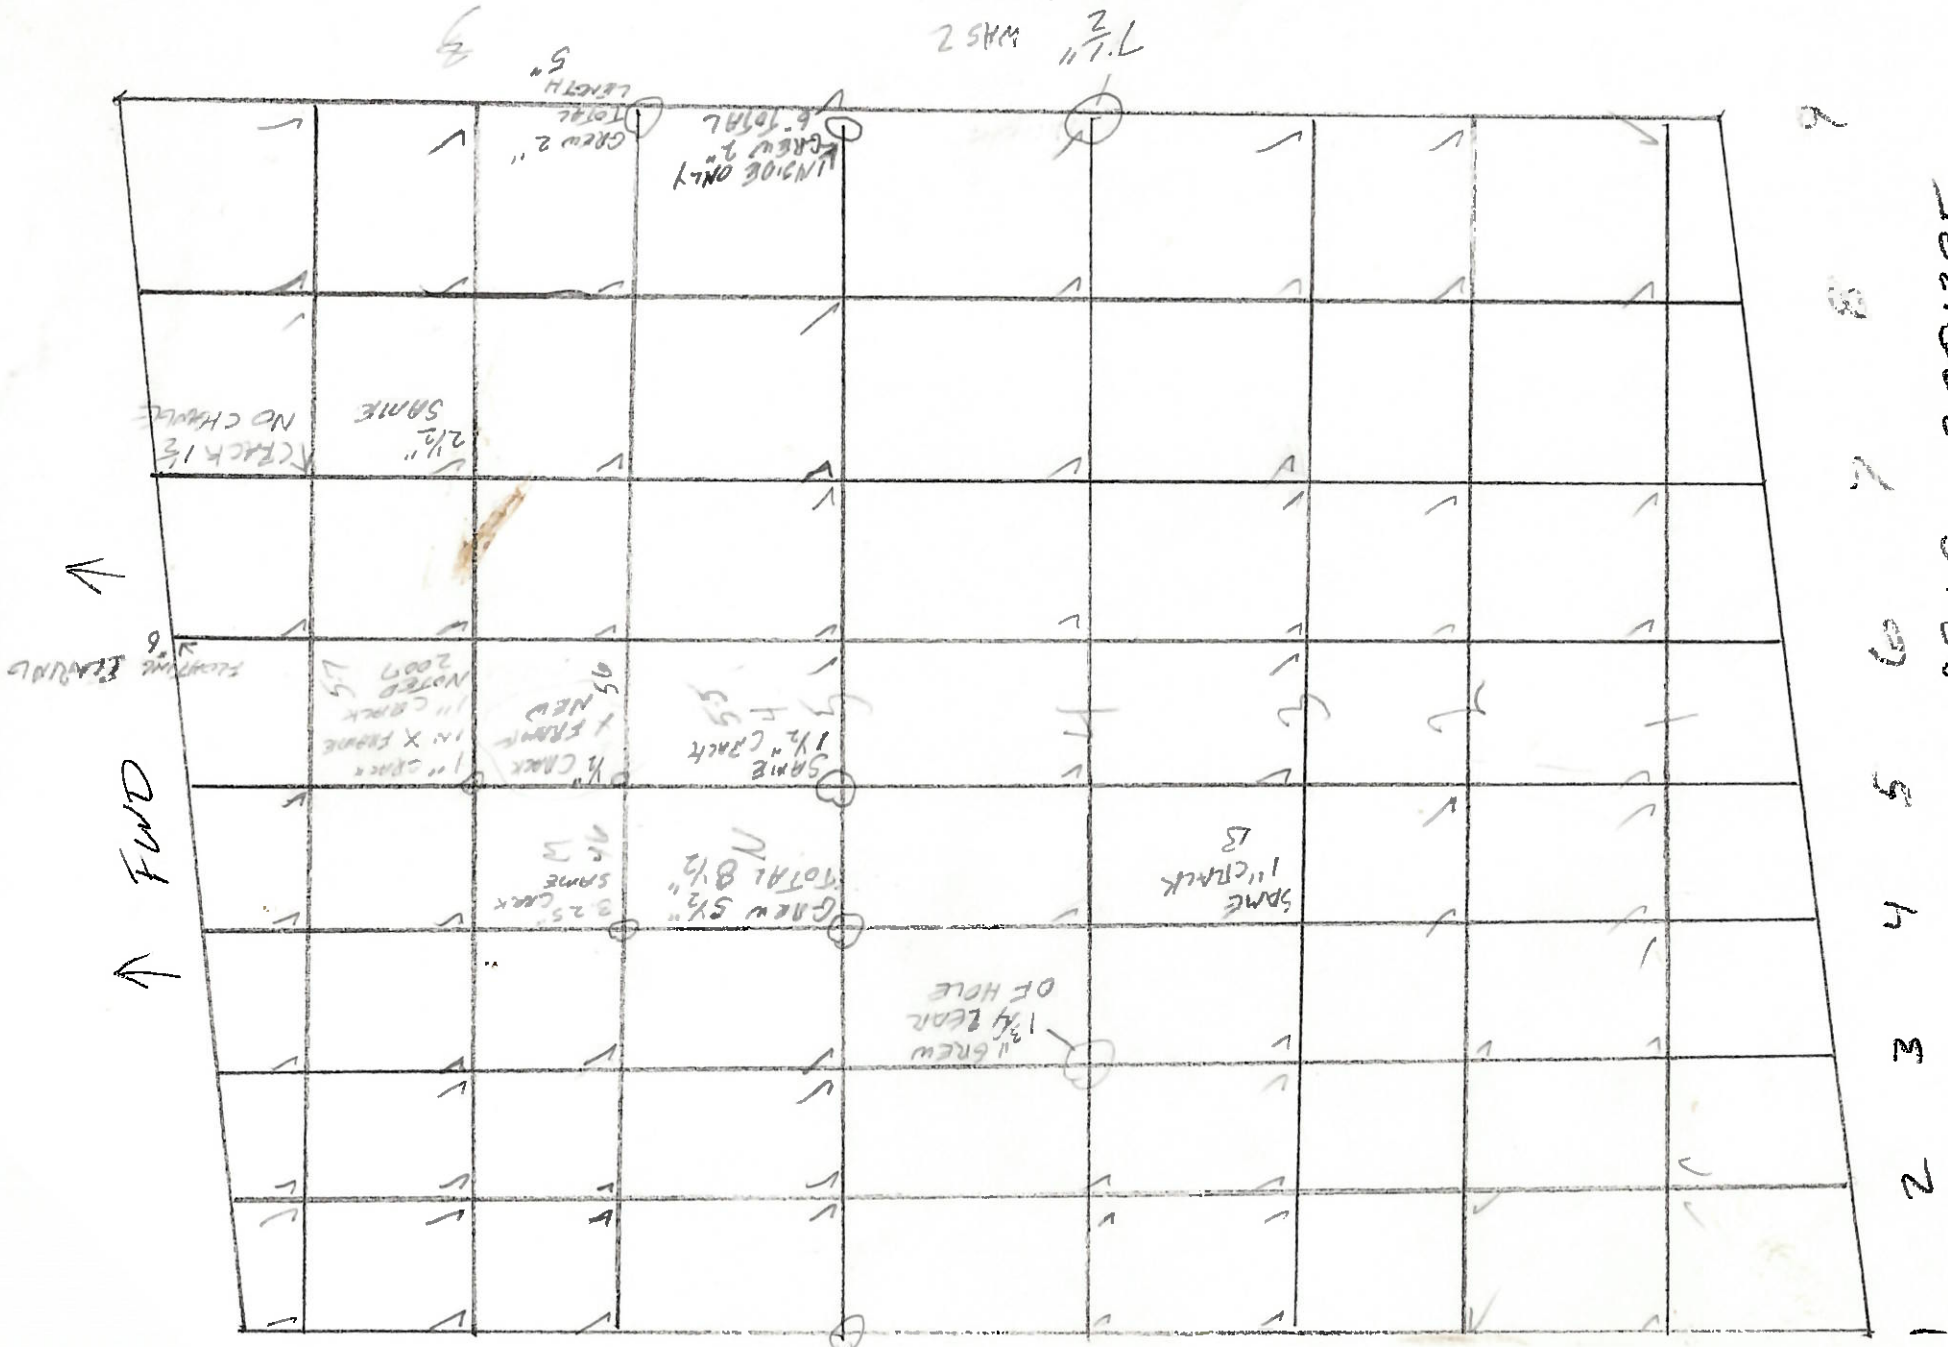
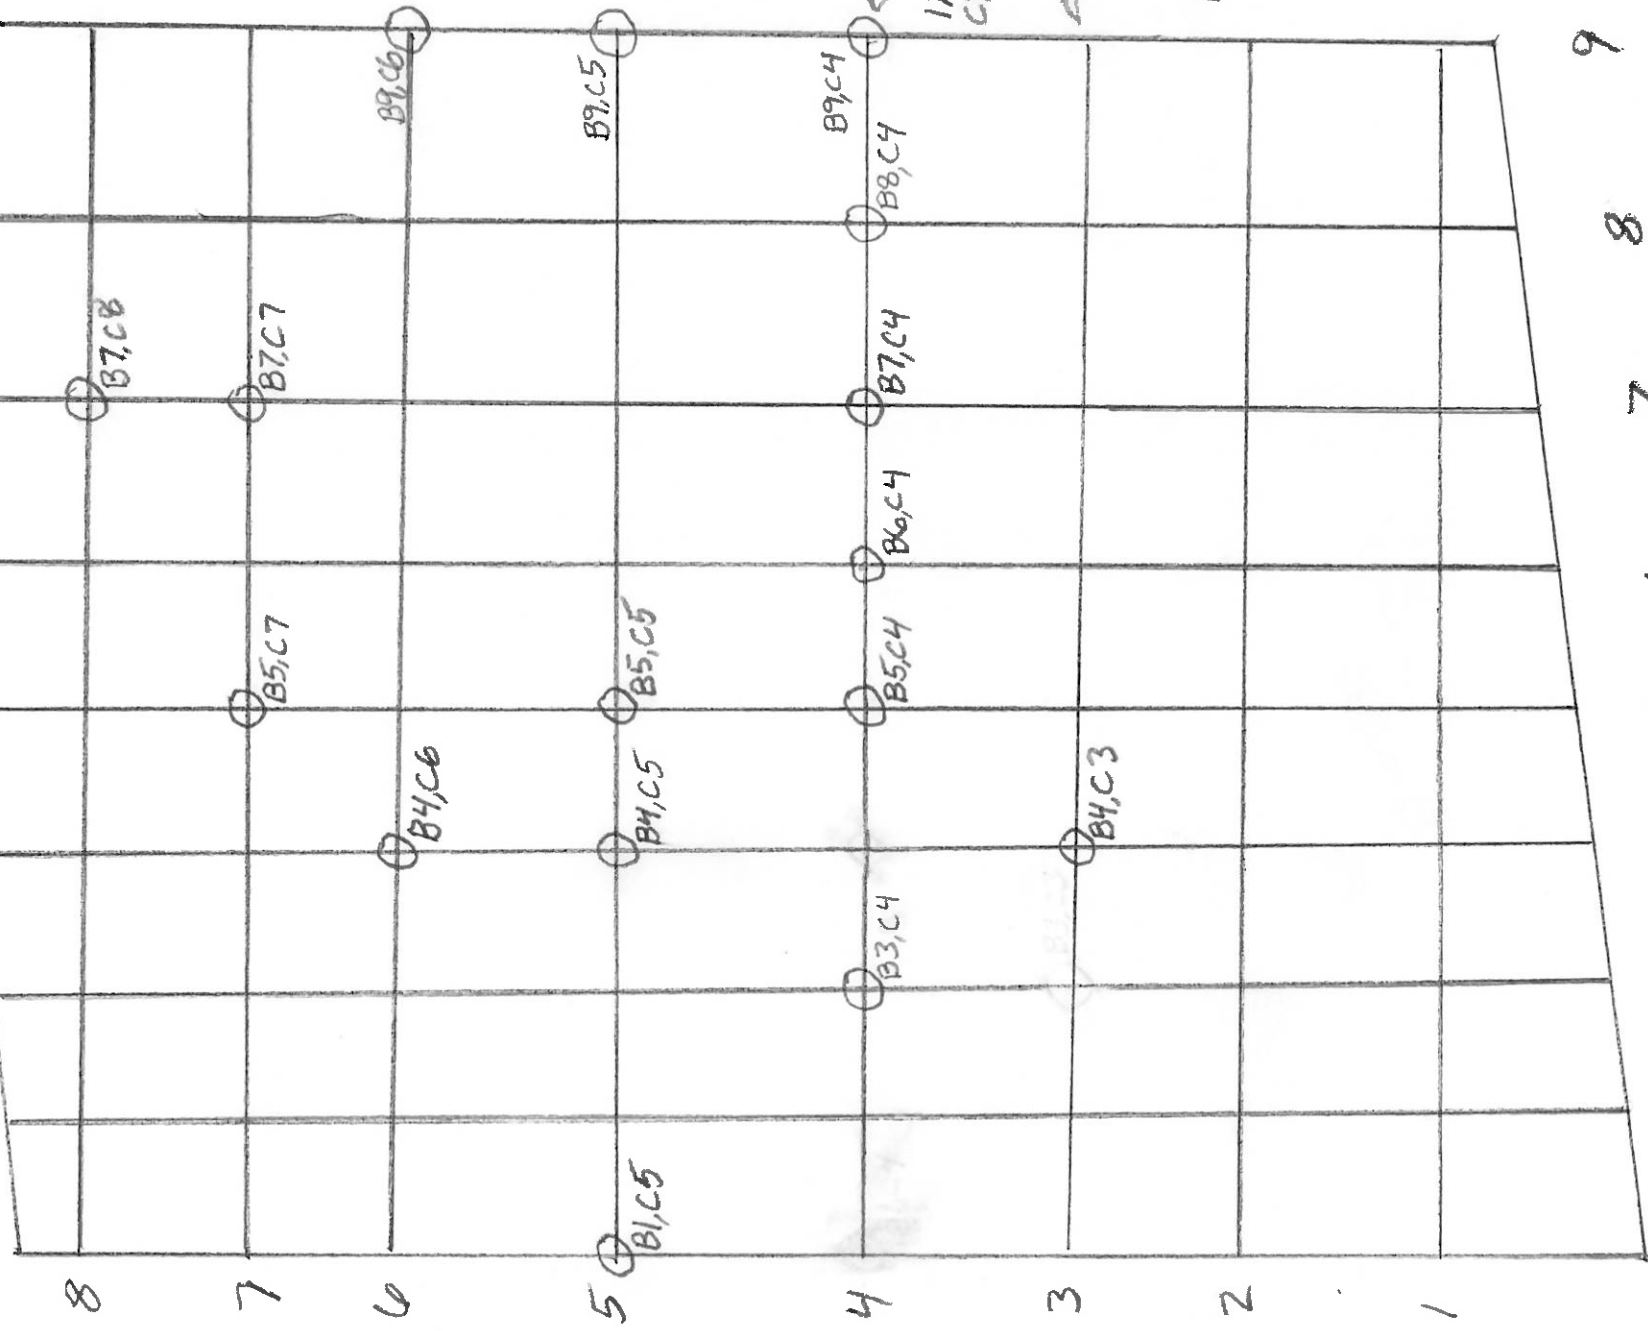
ACK LOCATION SKETCH

- B1,C5 1.5" long crack on the right interior face of beam but no crack on the exterior side of the beam, no change.
- B3,C4 The crack grew 1.75" longer rear of drilled hole and is now a total of 2.25"

- B4,C3 1" crack, no change.
- B4,C5 The crack grew 5.5" longer past the drilled holes and is now 8.5" long.
- B4,C6 3.25" long crack, no change.
- B5,C4 Possible crack, no change.

- B5,C5 1.5" crack, no change.
- B5,C6 New 0.5" crack in crossframe weld.
- B5,C7 1" long crack, no change.
- B6,C4 2" long crack, no change.
- B7,C4 1" long crack, no change.

- B7,C7 2.5" long crack, no change.
- B7,C8 1.5" long crack, no change.
- B8,C4 1.75" long crack, no change.
- B9,C4 The crack grew 5.5" longer past drilled holes and in now a total of 7.5" long.

- B9,C5 Crack showing on the interior side of beam only, has grew 2" longer and is now a total of 6" long.
- B9,C6 The crack grew 2" longer and is now a total of 5" long.

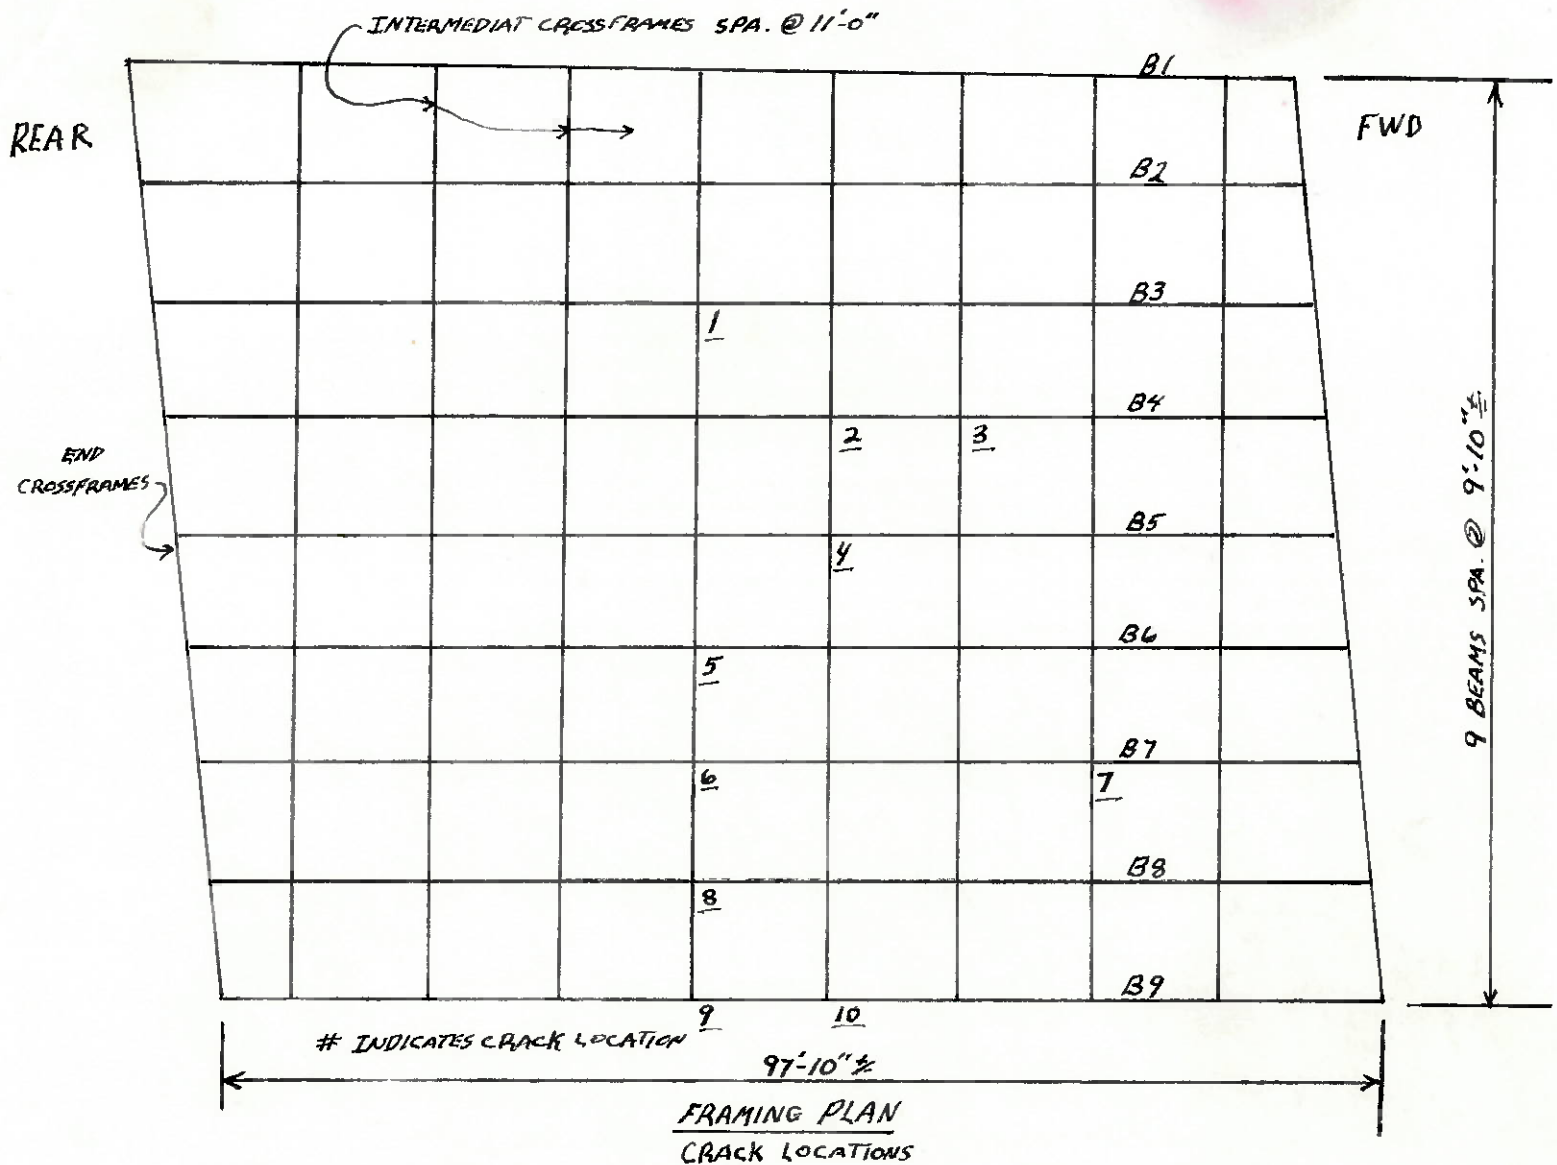
- #1. 1.5" long crack, .75" hole drilled at ends.
- #2. 3" long crack, .75" hole drilled at ends.
- #3. 3.25" long crack, .75" holes drilled at ends.
- #4. 1.5" long crack, .75" holes drilled at ends.
- #5. 2" long crack, .75" holes drilled at ends.
- #6. 1" long crack, .75" holes drilled at ends.
- #7. 1" long crack detected on right side of the beam, this crack was not drilled..
- #8. 1.75" long crack, .75" holes drilled at ends.
- #9. 2" long crack, .75" holes drilled at ends.
- #10. 2" long crack, this crack was not drilled.

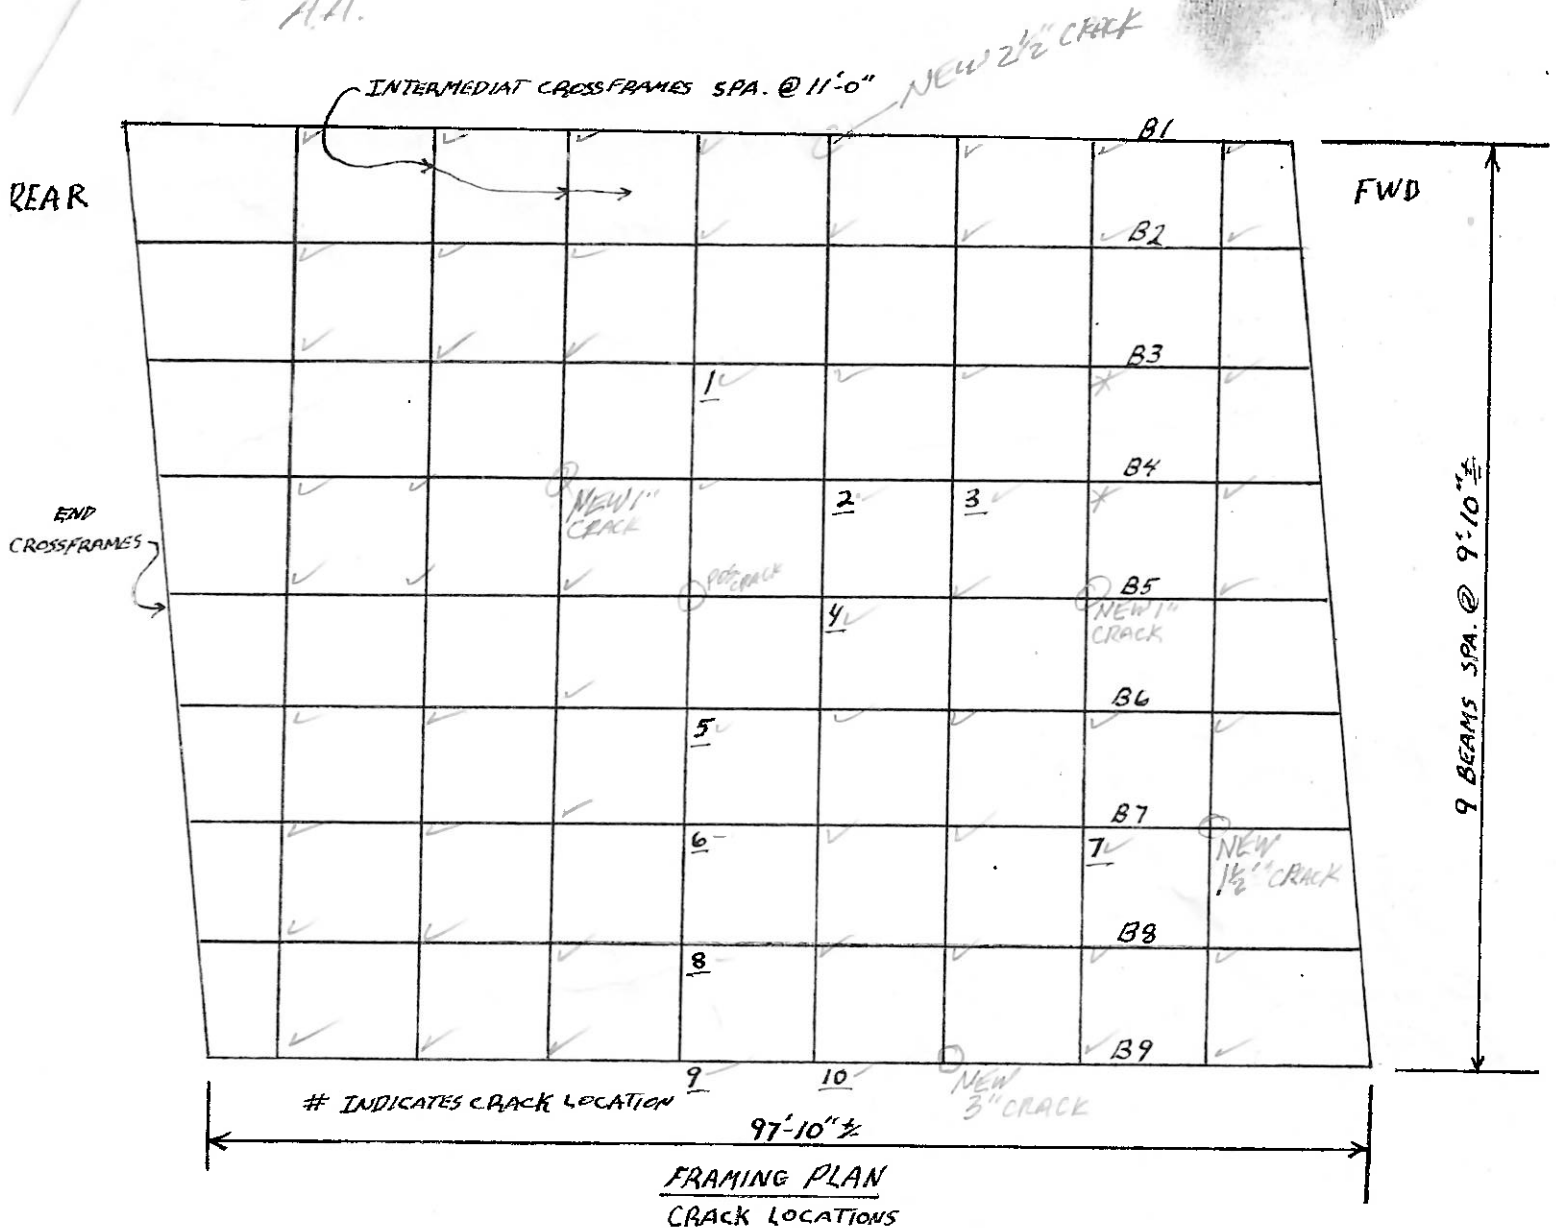
* - X-FRAME WAS TO CLOSE TO FLANGE TO CHECK - TRY NORTH FACE OF BEAMS NEXT TIME

- #1. 1.5" long crack, .75" hole drilled at ends. NO CHANGE
- #2. 3" long crack, .75" hole drilled at ends. NO CHANGE
- #3. 3.25" long crack, .75" holes drilled at ends. NO CHANGE
- #4. 1.5" long crack, .75" holes drilled at ends. NO CHANGE
- #5. 2" long crack, .75" holes drilled at ends. - POSSIBLE 1 1/2" CRACK PAST FWD HOLE RT SIDE OF WEB (NOT SURE)
- #6. 1" long crack, .75" holes drilled at ends. - 3/8" NEW CRACKS PAST HOLES
- #7. 1" long crack detected on right side of the beam, this crack was not drilled.. NOW 2 1/2" LONG
- #8. 1.75" long crack, .75" holes drilled at ends. NO CHANGE
- #9. 2" long crack, .75" holes drilled at ends. NO CHANGE
- #10. 2" long crack, this crack was not drilled. - NOW 4" LONG

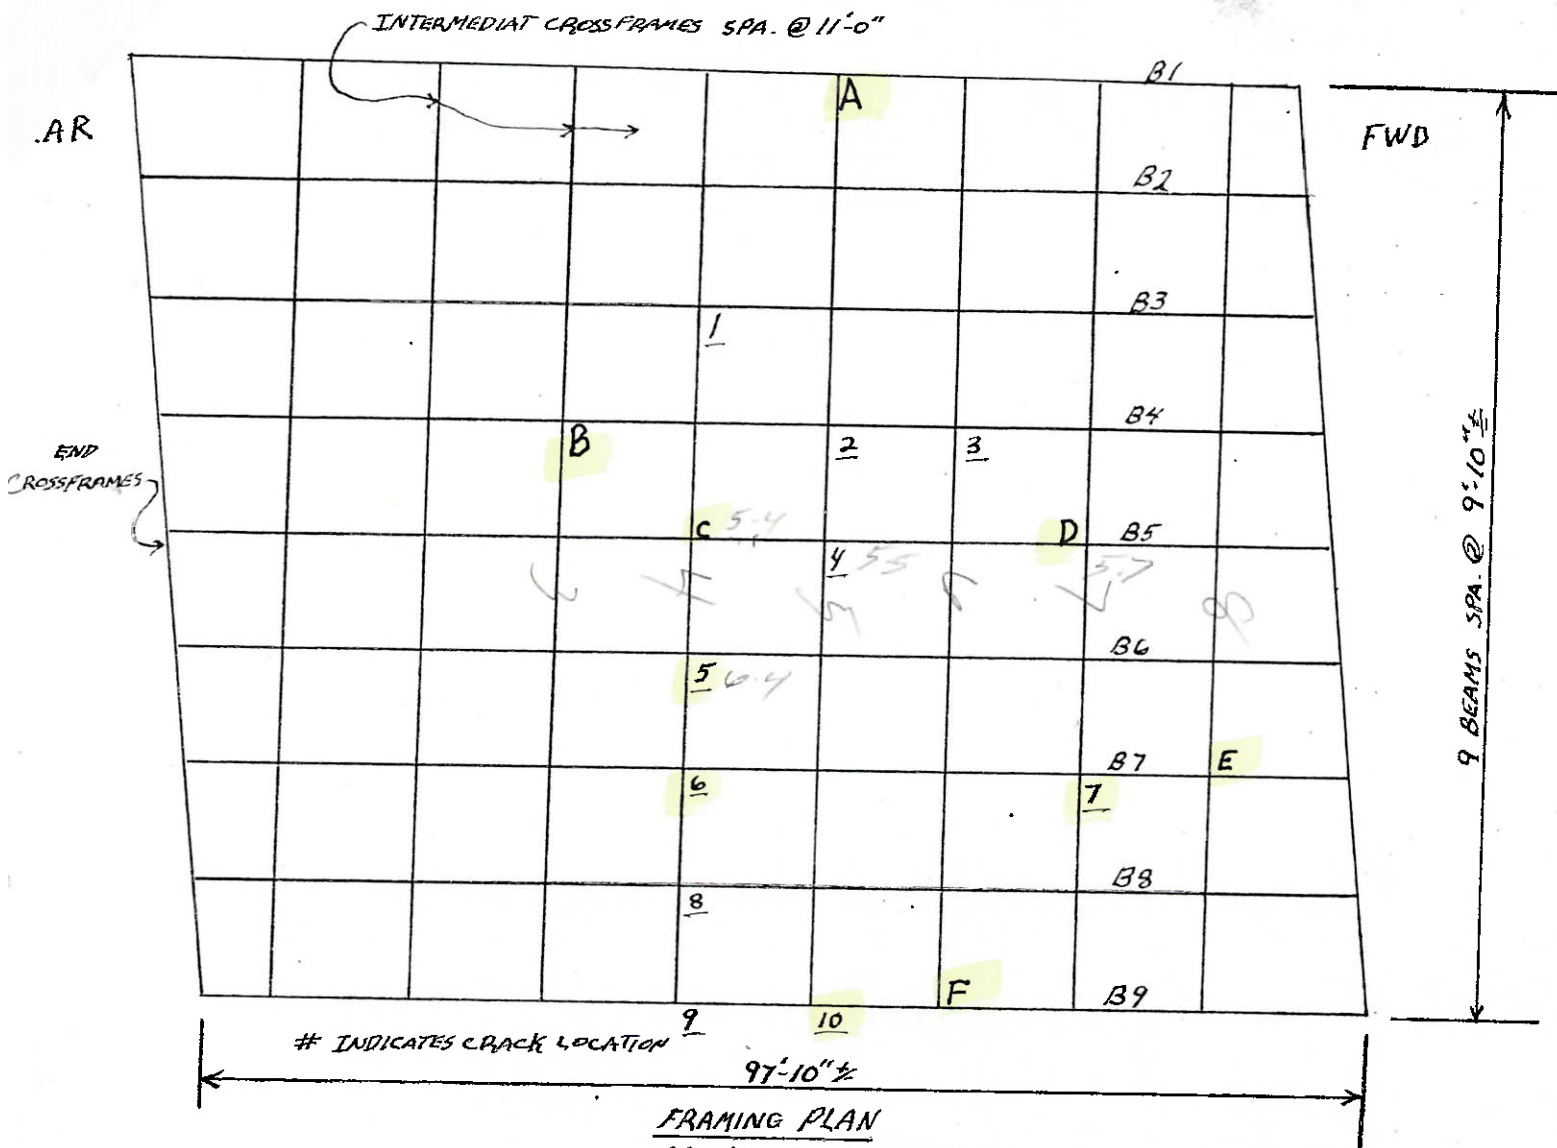
EXISTING CRACKS (2000)

- #1. 1.5" long crack, .75" hole drilled at ends. (no change)
- #2. 3" long crack, .75" hole drilled at ends. (no change)
- #3. 3.25" long crack, .75" holes drilled at ends. (no change)
- #4. 1.5" long crack, .75" holes drilled at ends. (no change)
- #5. 2" long crack, .75" holes drilled at ends. (possible .25" crack past forward drill hole on right side of web)
- #6. 1" long crack, .75" holes drilled at ends. (possible .375" cracks past both forward and rear drill holes)
- #7. 1" long crack detected on right side of the beam, this crack was not drilled. (crack has grown to 2.5" in length.)
- #8. 1.75" long crack, .75" holes drilled at ends. (no change)
- #9. 2" long crack, .75" holes drilled at ends. (no change)
- #10. 2" long crack, this crack was not drilled. (crack has grown to 4" in length)

NEW CRACKS (2007)

- A. New 2.5" long crack
- B. New 1" long crack
- C. Possible new crack forming, dye indication was faint.
- D. New 1" long crack
- E. New 1.5" crack
- F. New 3" long crack

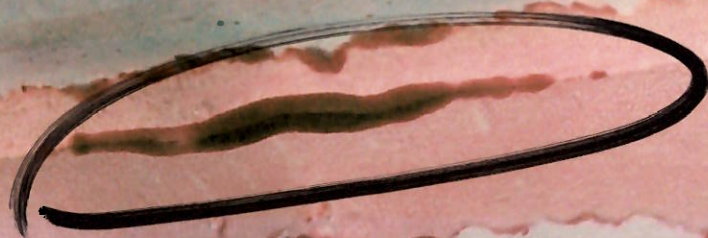
B 9 NORTH
INT. # 10

Existing crack # 10 has grown from 2" to 4" in length.

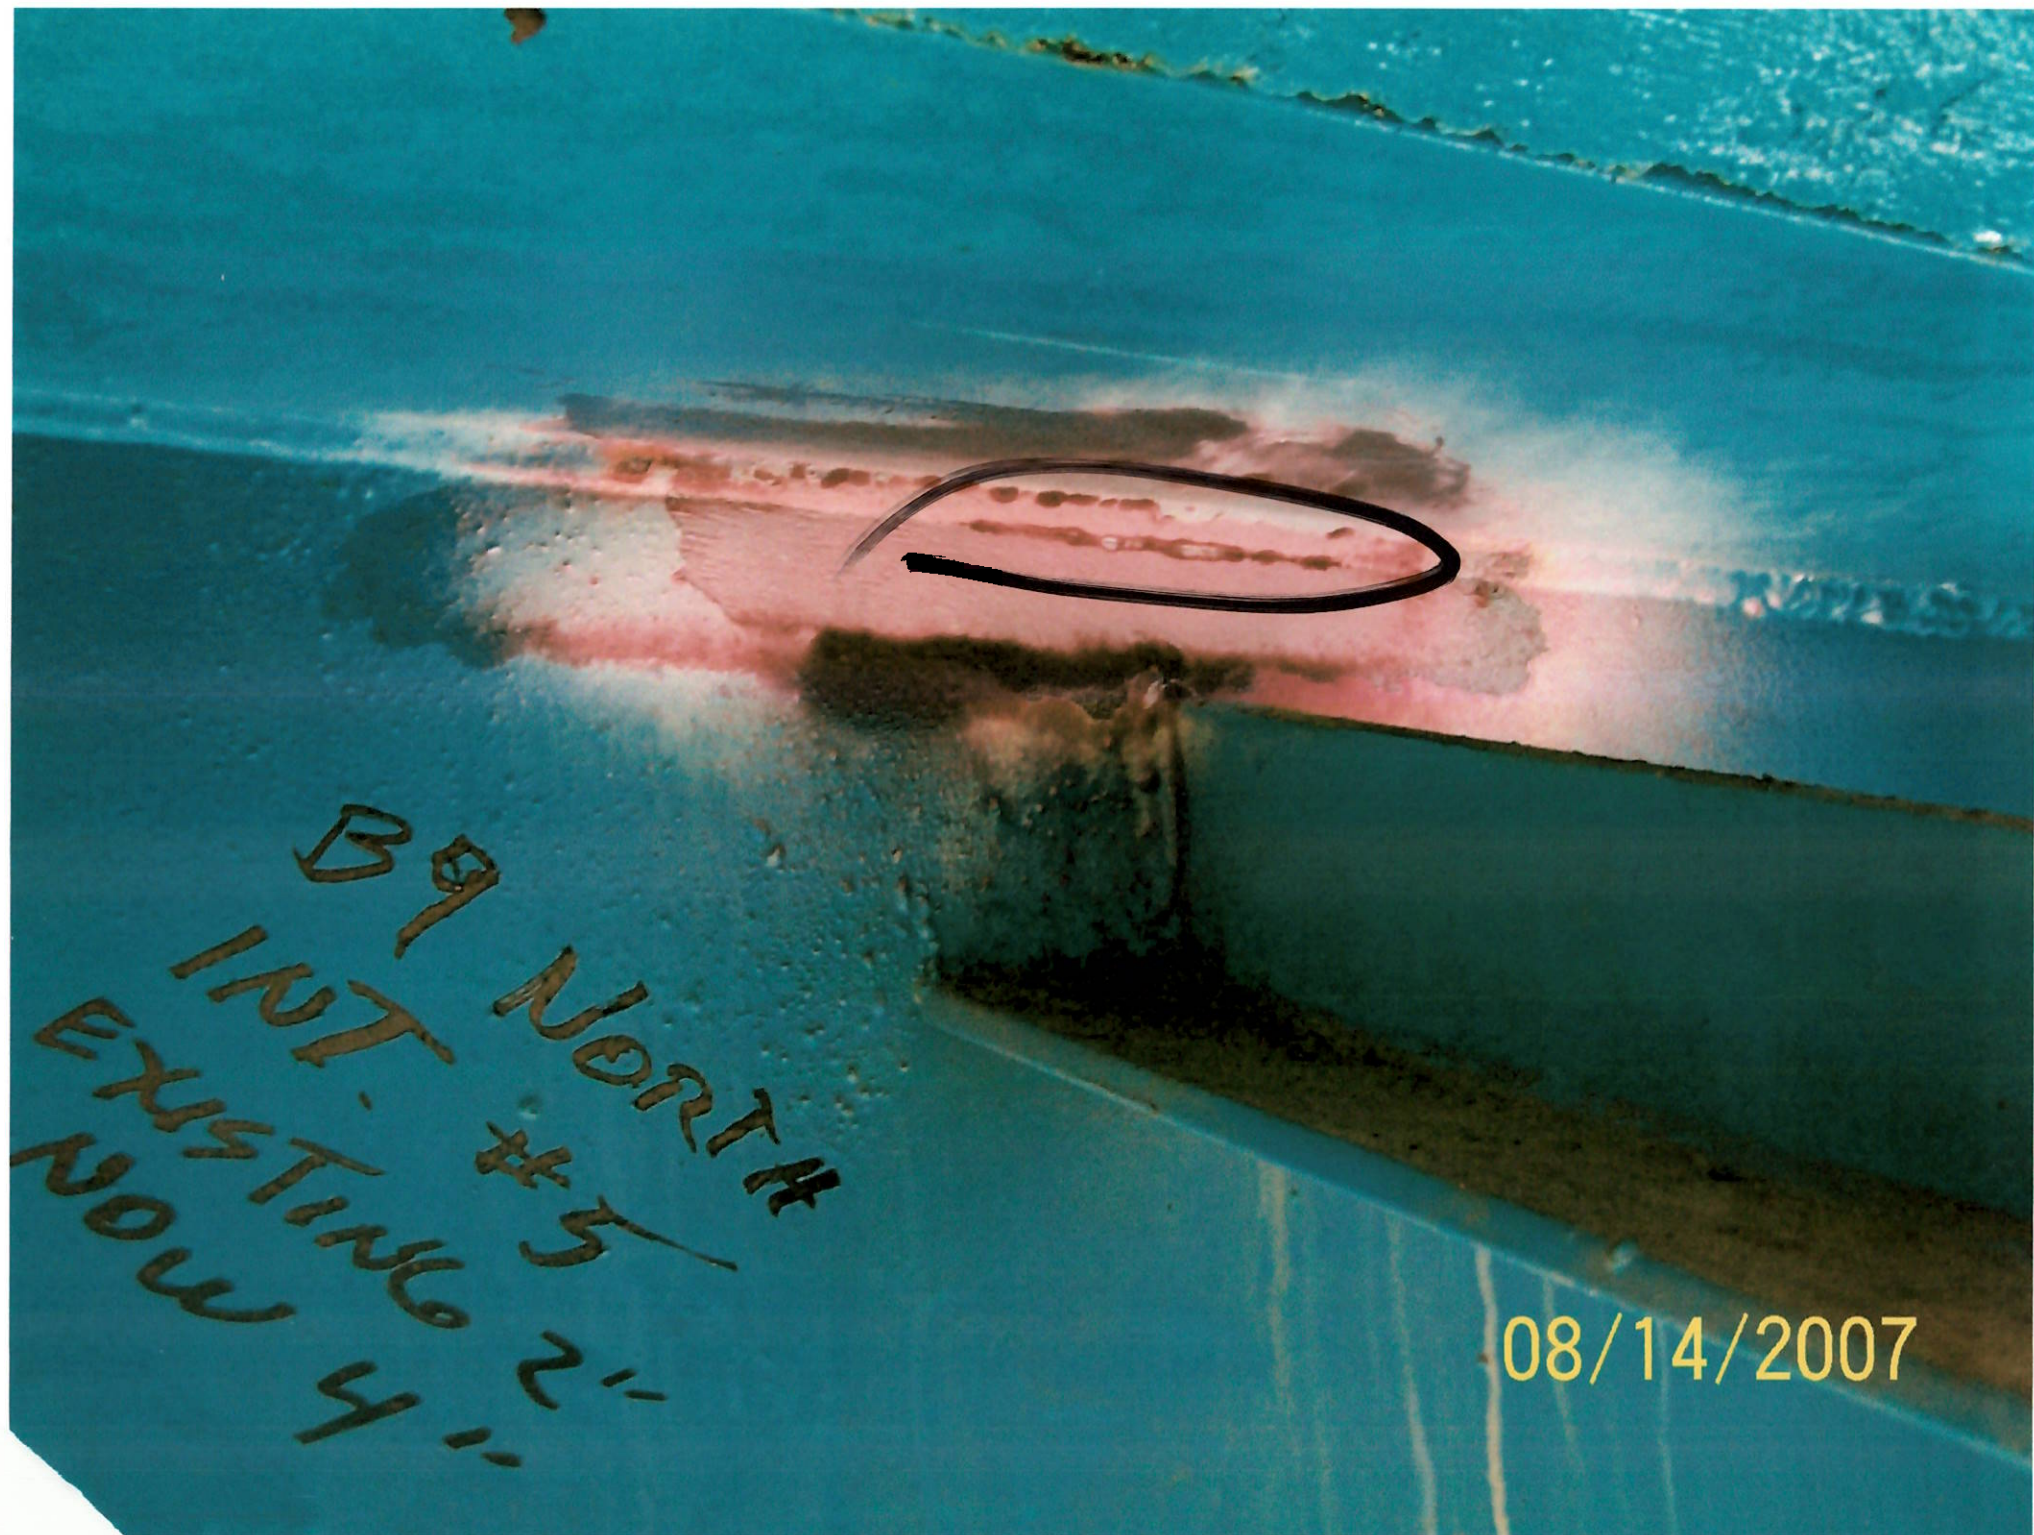
B9 North #5
INT. #5
EXISTING 2"
NOW 4"
