SUE QUALITY LEVEL A
 TEST HOLE #1
 NEW ALBANY, OH
 12" D.I. WATER

Project:	FRA 161 NOISE WALL	Date Performed:	1/11/2024
SAM, LLC Project #	1023078248	Client:	ARCADIS
Project Location:	NEW ALBANY, OHIO 43084	Surface Material & Thickness:	NATURAL GROUND
Utility Location:	SR 161 NEW ALBANY CONDIT ROAD UNDERPASS	Marker Elevation:	924.82
Utility Sta./Offset:	N/A	Surface Condition:	GOOD
Record Utility:	12" DUCTILE IRON WATER	Trench Material:	CLAY
Utility Owner:	CITY OF NEW ALBANY	Utility Bedding Material:	CLAY
Contact:	N/A	Utility Found:	12" DUCTILE IRON WATER
Phone/Email:	N/A	Utility Condition:	GOOD
Field Crew:	TW/VS	Utility Depth:	7.08'
Field Conditions:	CLOUDY/ COLD

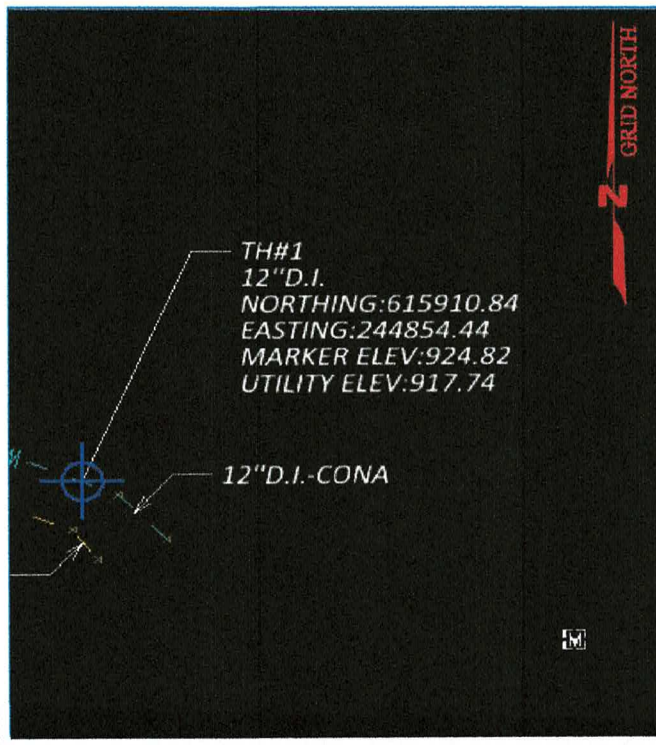
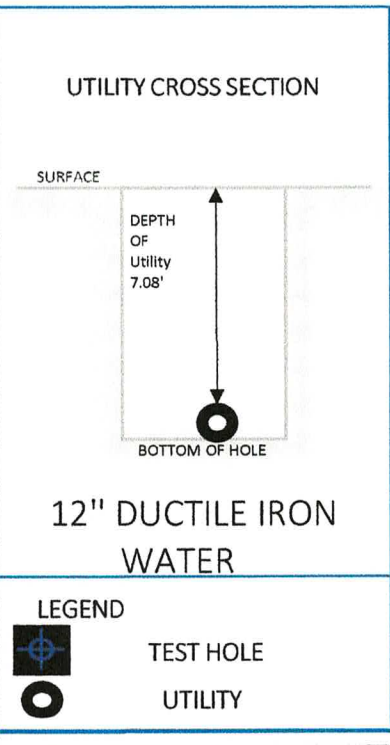
- SAM, LLC laid out this Test Hole by designating the water prior to excavation of the utility.
- Field crew unable to get visual ID on pipe due to large amounts of backfilling water.

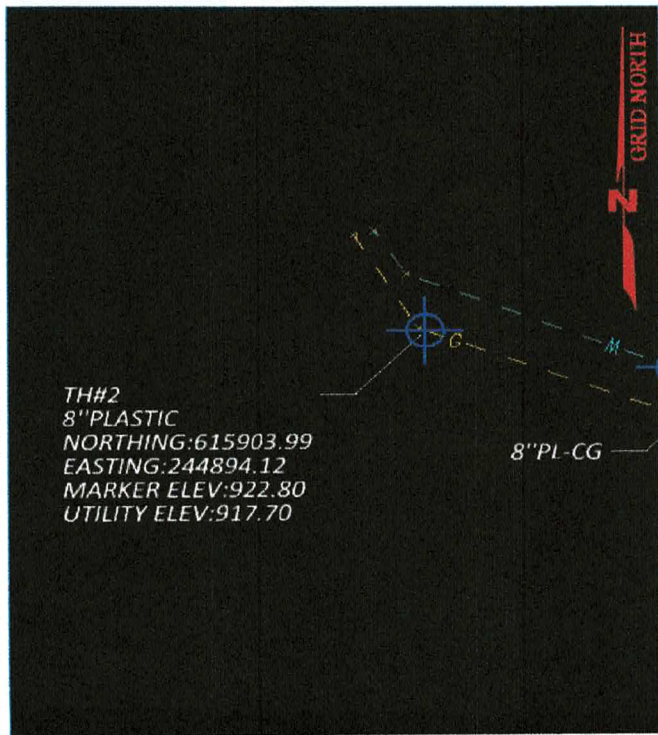
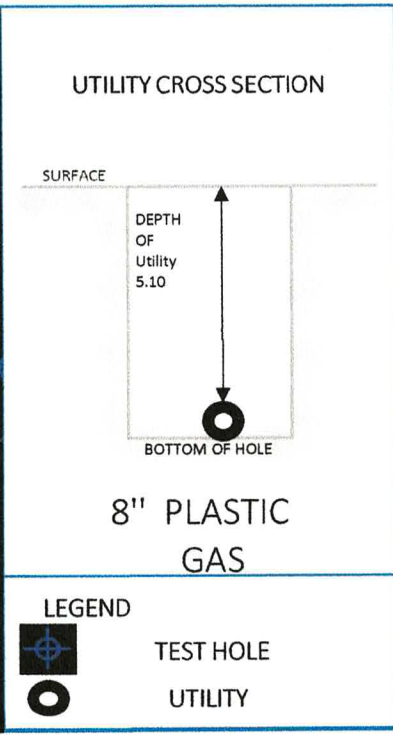
SUE QUALITY LEVEL A
 TEST HOLE #2
 NEW ALBANY, OH
 8" PLASTIC GAS

1. SAM, LLC laid out this Test Hole by designating the gas prior to excavation of the utility.
2. Field crew unable to get visual ID on pipe due to large amounts of backfilling water.

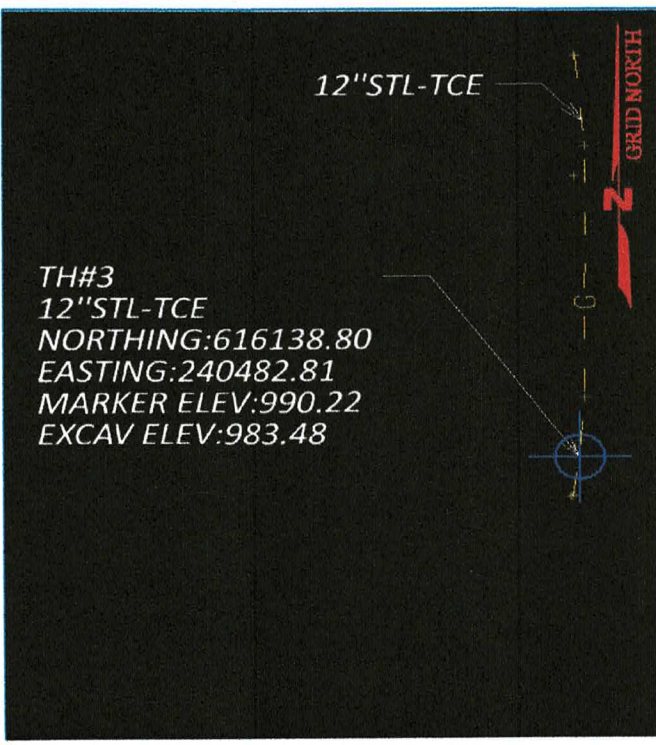
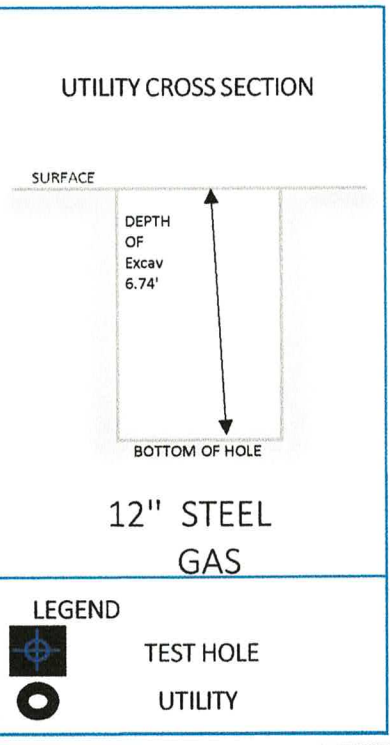
**SUE QUALITY LEVEL A
 TEST HOLE #3
 NEW ALBANY, OH
 12" STEEL GAS**

1. SAM, LLC laid out this Test Hole by designating the gas prior to excavation of the utility.
 2. Dug to a depth of 6.74' was unable to continue due to ground conditions. The crew encountered a rock shelf while performing vacu excavation. SAM field staff spoke with Christian Grillo and were advised to not use the jack hammer to penetrate the rock to expose the pipeline. SAM field staff made additional efforts to locate the gas line north of the off ramp and surveyed the 2 other locations where vacu excavation took place by others. This confirmed the horizontal alignment for the pipeline and provided electronic depths that coincide with information from TC Energy stating "The south side of 161 this line is approx. 12' to top of pipe and on the North side of 161 the line is approx. 15'6" to Top of pipe"

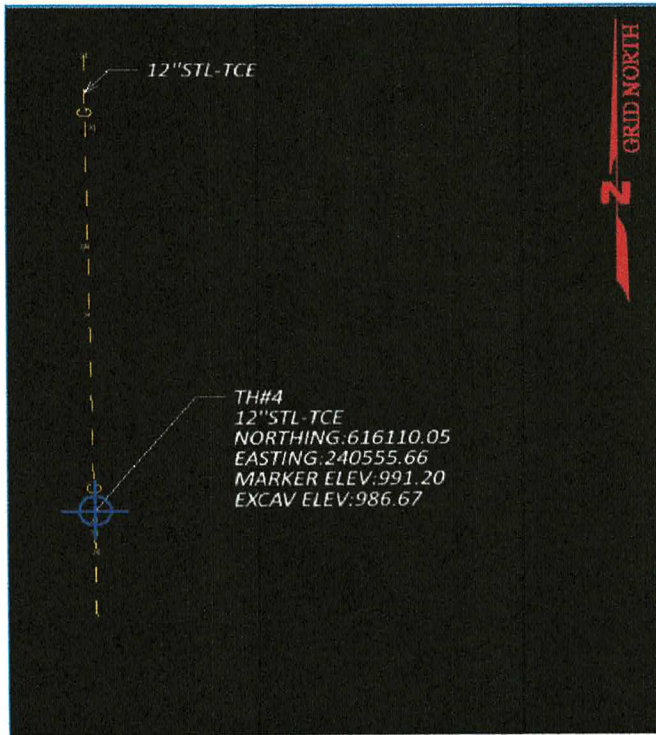
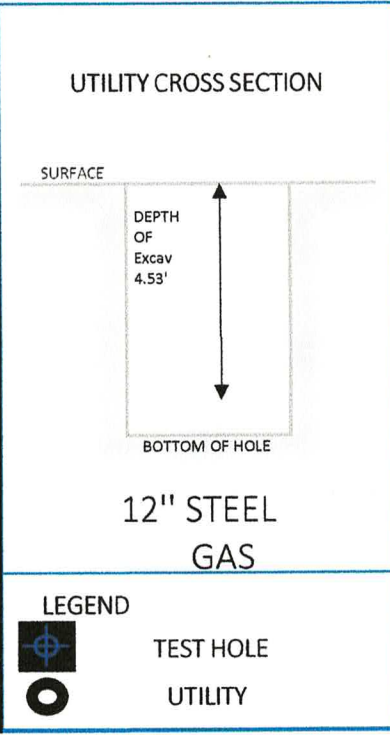
SUE QUALITY LEVEL A
 TEST HOLE #4
 NEW ALBANY, OH
 12" STEEL GAS

1. SAM, LLC laid out this Test Hole by designating the gas prior to excavation of the utility.
2. Dug to a depth of 4.53' probe to 6.33' was unable to continue due to ground conditions and obstructions. The crew encountered a rock shelf while performing vaccum excavation. SAM field staff spoke with Christian Grillo and were advised to not use the jack hammer to penetrate the rock to expose the pipeline. SAM field staff made additional efforts to locate the gas line north of the off ramp and surveyed the 2 other locations where vaccum excavation took place by others. This confirmed the horizontal alignment for the pipeline and provided electronic depths that coincide with information from TC Energy stating "The south side of 161 this line is approx. 12' to top of pipe and on the North side of 161 the line is approx. 15'6" to Top of pipe"

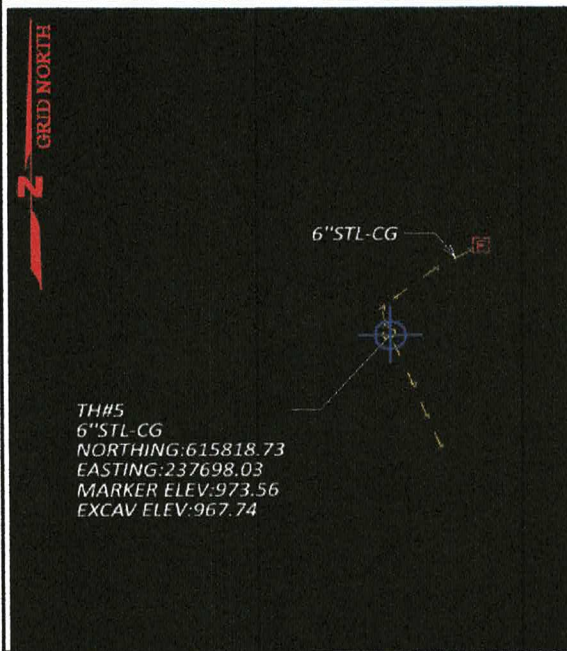
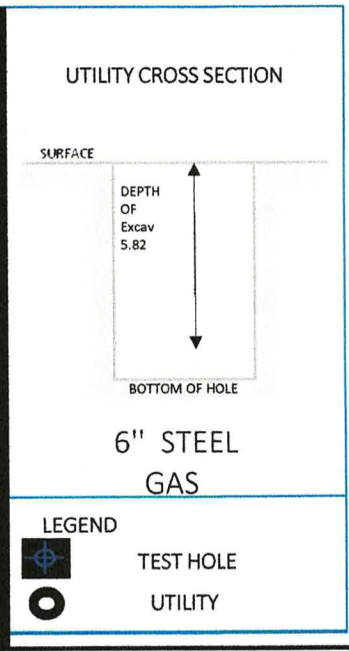
SUE QUALITY LEVEL A
 TEST HOLE #5
 NEW ALBANY, OH
 6" STEEL GAS

2. Dug to a depth of 5.82' and probed to 7.86' was unable to continue due to ground conditions and obstructions. No pipeline was exposed. This test hole was on a NiSource/Columbia Gas line on the north side of FRA 161 and was difficult to detect directly under FRA 161 and was only detected on the slopes of either side of the highway. Per a Teams call with Arcadis/SAM/Columbia there is only one gas line crossing just west of Harlem Road.

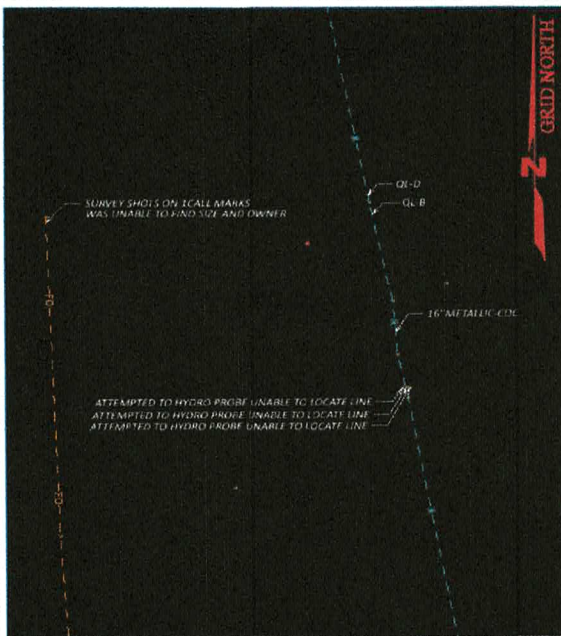
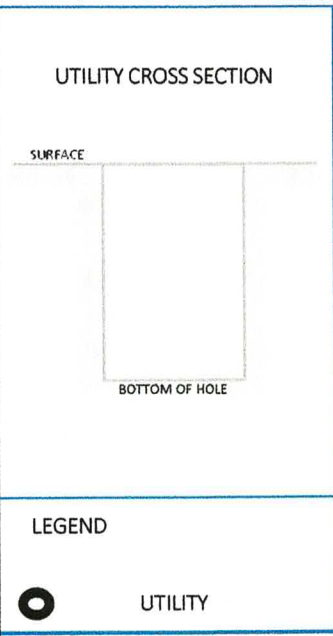
SUE QUALITY LEVEL A
 HARLEM RD WATER
 NEW ALBANY, OH
 16" METALLIC WATER

1. The water is 73' feet from the CL of Harlem Rd.
2. It is estimated at 15' in depth near the fence line
3. The water is under the 54" CMP storm drain that crosses the area

Our equipment could not detect the water line with accuracy where Tom had it marked by the ROW fence, but north of the ROW we could detect it. We feel comfortable saying the horizontal alignment is "close" but not to the level as we did at the ramp or the other utilities. We have a signal at the blow off valve back away from 161 but the signal dies there. We took a depth measurement at the valve but hit an obstruction at 6'. Due to the "weak" signal we had with our pipe and cable locator and some GPR data we have depicted the location in the SUE base map.

We did attempt to dig and hydro probe on the one-call marks but encountered lots of roots and then rock below that at 3' at the preferred location and along the line in other locations. We depicted some of the probing locations for reference. Being that there is minimal hope for finding this line with out some major additional efforts, and being that there is an engineered drawing, I would advise to use the water record to build the vertical profile into your design for this area. I know all of this is not ideal, but we put a lot of effort into just getting this far.
