FRA-62-3.26

Abbreviated Safety Study Intersection of US-62 at SR-665 Pleasant Townships | Franklin County Crash Data (2016-2020)

Prepared for:
ODOT Highway Safety Program
1980 West Broad Street
Columbus, Ohio 43223
(614) 466-7045

Prepared by:
Lanham Engineering, LLC
2421 Reginald Ct.
Powell, OH 43065
(614) 216-0448

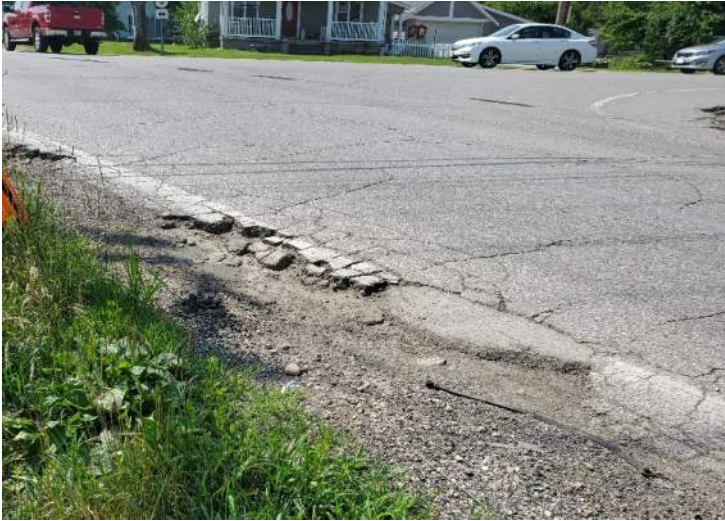
Photo 1: Broken Pavement on Shoulder

- The *Signal Ahead* warning signs on the southbound (860') and northbound (1,100') approaches are placed significantly farther from the intersection than the 325 feet suggested in the Ohio Manual of Uniform Traffic Control (OMUTCD) for 55 mph roads.
- The shoulders showed some cracking and breakage (see **Photo 1**).

- Place dual “Signal Ahead” (W3-3) signs on the eastbound and westbound approaches at the distance recommended by the OMUTCD.
- Replace worn signs and pavement markings to enhance visibility at the signal.

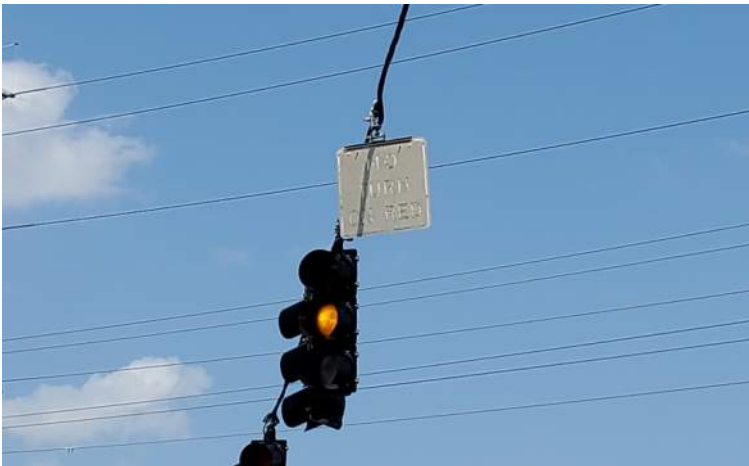
Photo 2: Worn Signs

- Access to the convenience store is permitted along the entire property along SR-665. This did not appear to cause significant safety issues at the intersection, however, if traffic along SR-665 increases, vehicles entering and exiting the convenience store could have safety impacts.
- Some signs were worn and difficult to read (see **Photo 2**)

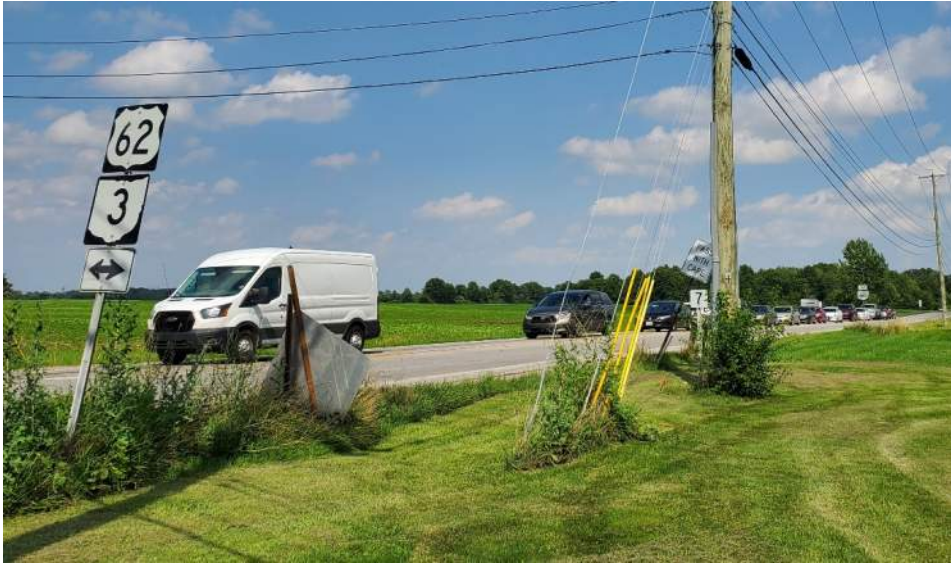
Photo 3: Westbound Queuing

- Queuing often extended to 10 or more vehicles, particularly on the westbound and southbound approaches (see **Photo 3**). These approaches had a higher percentage of vehicles turning left that impacted queuing. In some cases, a left turning vehicle may have to wait the entire phase before finding a gap.

- Left Turn Crashes:** Six left turn crashes occurred within the intersection, four involved a southbound left turning vehicle, and two involved an eastbound left turning vehicle. All but one of these crashes resulted in injury, likely due to the high speeds on both roads. All left turn crashes were due to the left turning vehicle failing to yield to through traffic. Left turn crashes are typically due to drivers accepting smaller gaps due to congestion and poor sight distance. During the field visit, it was observed vehicles, particularly southbound, often could not complete the left turn until the yellow indication appeared.

- Add left turn lanes to all approaches and reconstruct signal to a box span configuration with backplates. The addition of left turn lanes should reduce queuing and improve visibility to for vehicles turning left. Additionally, removing left turning vehicles from the through movement should reduce rear end crashes since through vehicles will not have to stop unexpectedly for a preceding left turning vehicle.
- Construct a single lane roundabout. Roundabouts eliminate left turn crashes, which are prevalent at this intersection. Roundabouts have also been shown to significantly decrease injury crashes, particularly at rural intersections.

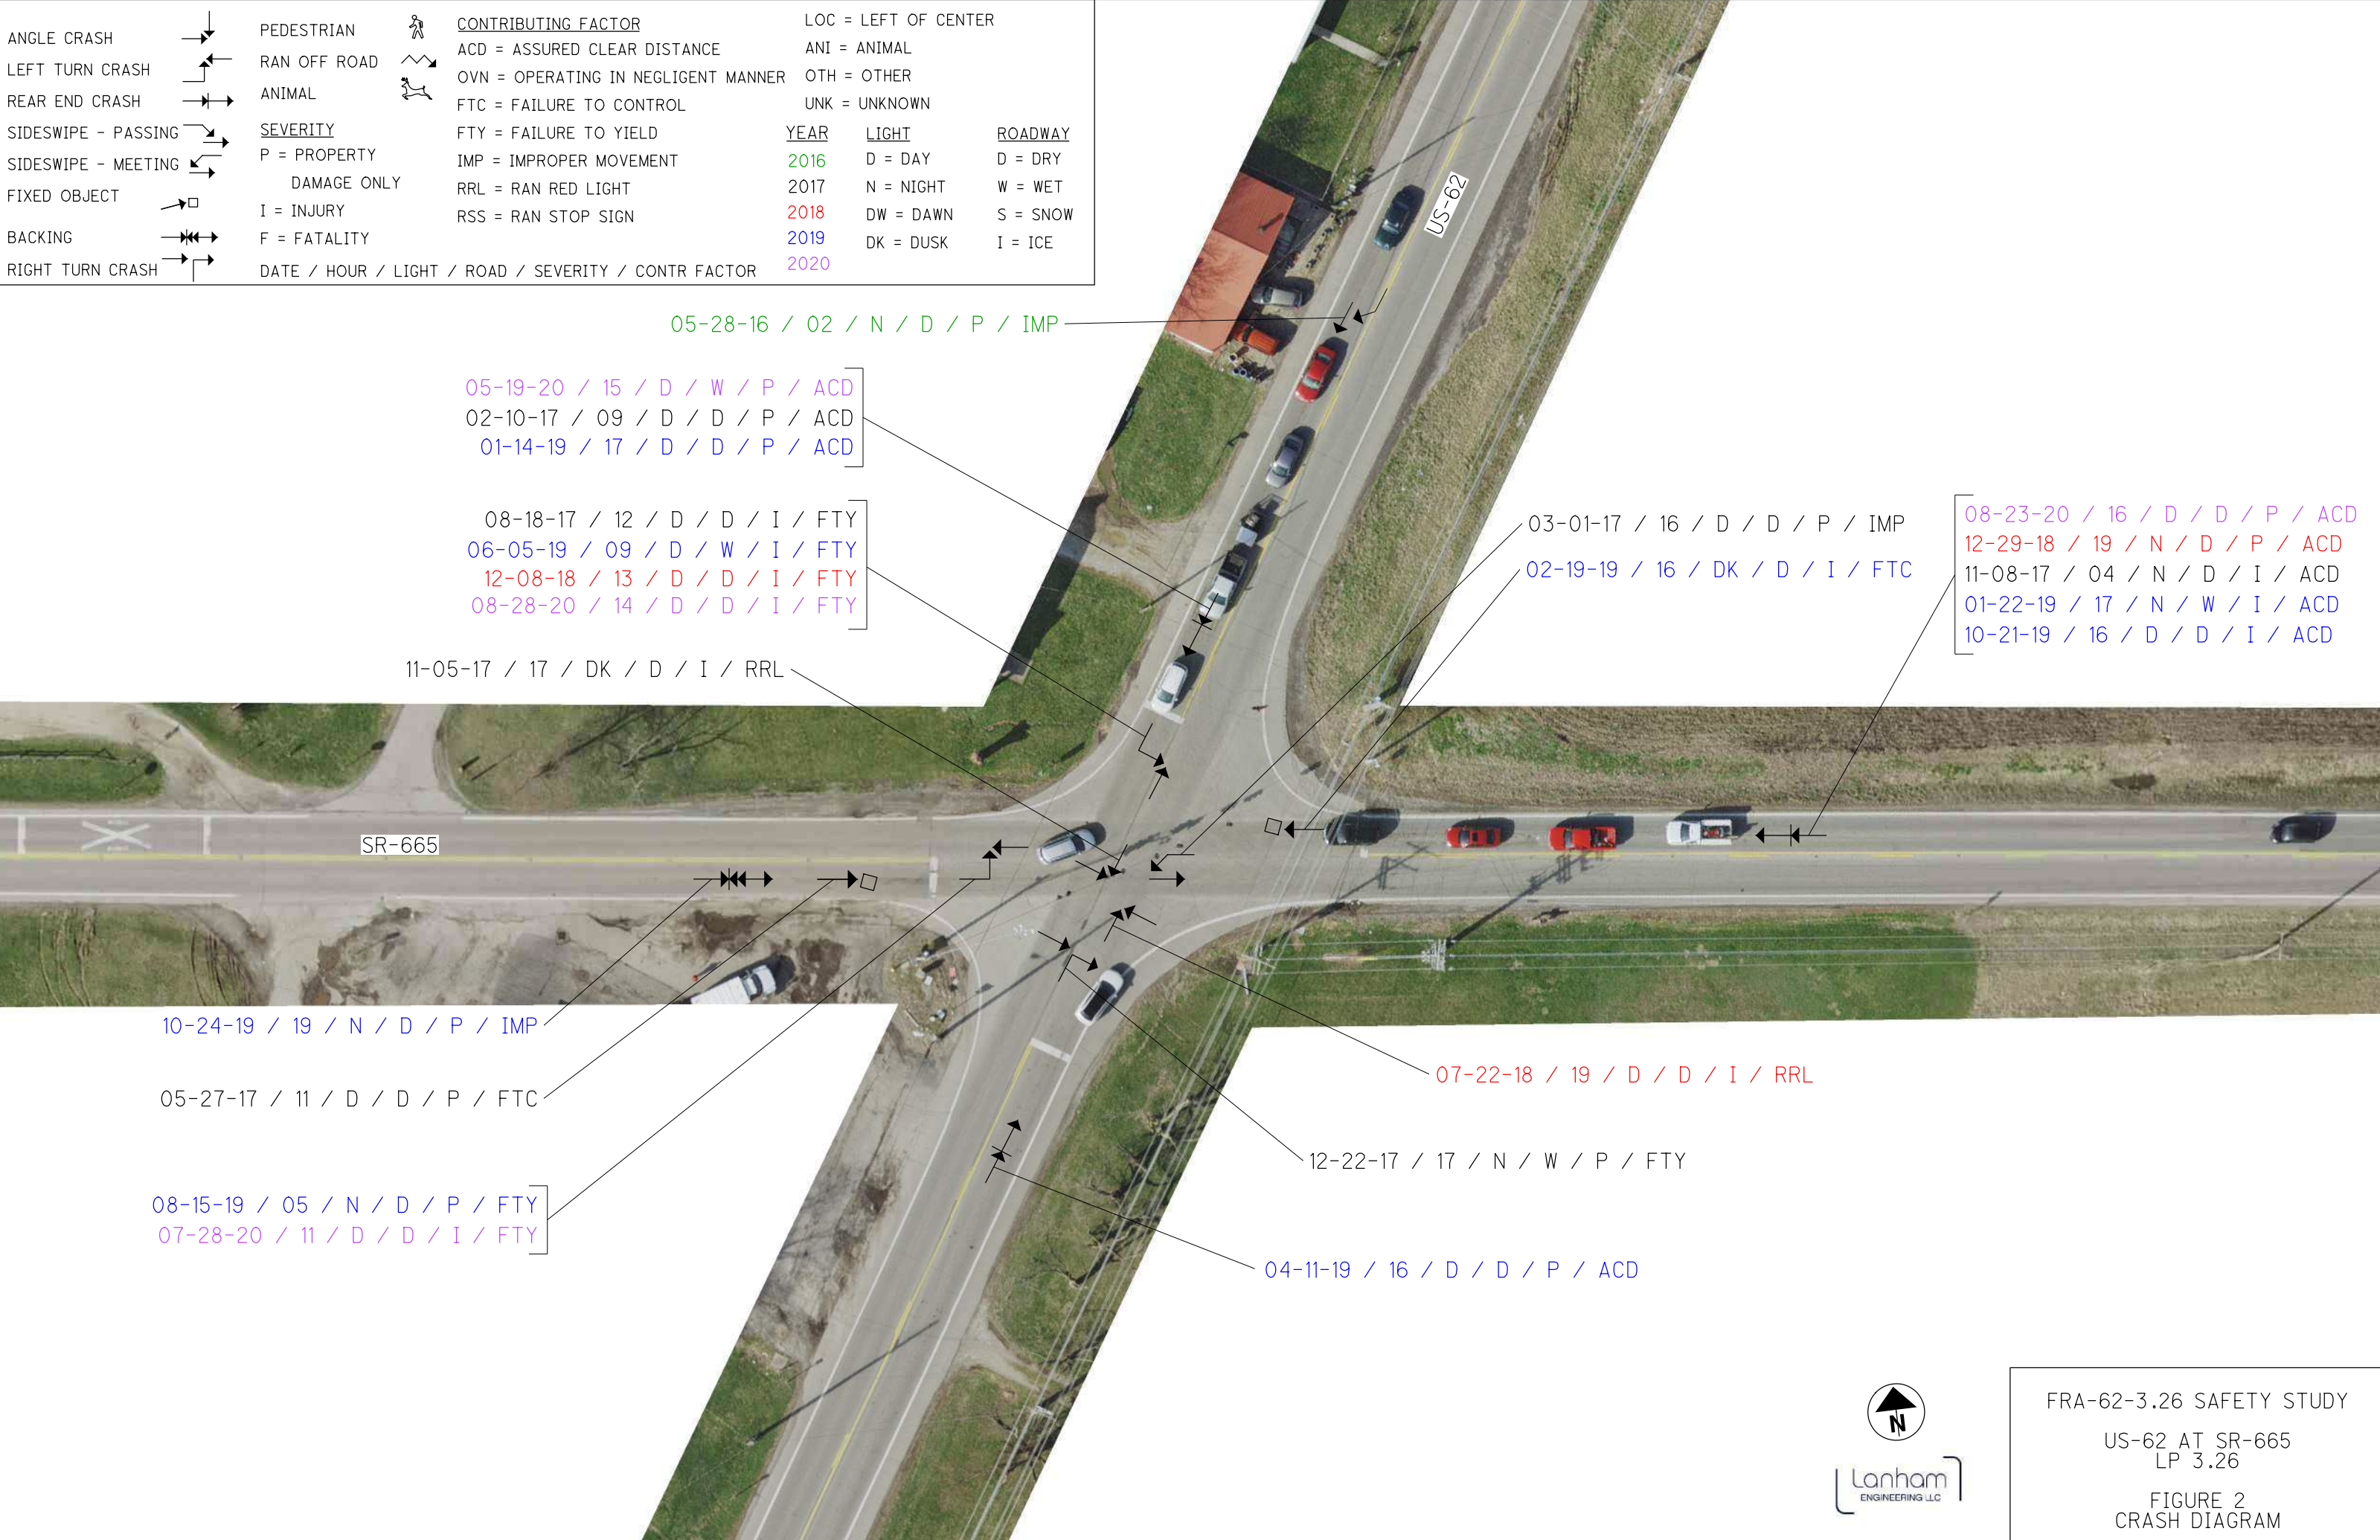
FRA-62-3.26 SAFETY STUDY
 US-62 AT SR-665
 LP 3.26
 FIGURE 2
 CRASH DIAGRAM

- Rear End Crashes:** Rear end crashes were the most frequent crash type at the intersection with three on the southbound approach, one on the northbound approach, and five on the westbound approach. This type of crash is typically due to congestion, inattentive drivers, and signal visibility issues. Over half of the crashes occurred between 4pm and 6pm which tend to be higher travel times, indicating the congestion is a contributing factor. The southbound and westbound approaches have the highest volume of left turning vehicles indicating the lack of left turn lanes may also be a contributing factor. The lack of backplates may impair signal visibility, particularly for SR-665 due to sun glare.

- Angle Crash:** Two angle crashes occurred at the intersection, both involving red signal violations. Both crashes involved injuries. These crashes are typically due to driver inattention, poor signal visibility, and inadequate signal timing. The lack of backplates may be hindering signal visibility, contributing to these crashes.
