ODOT District 8  
2024 Fracture Critical and In-Depth  
Element Level Inspection Report

Bridge No. HAM-50-0376L  
SFN: 3102521

**2024 NON-REDUNDANT STEEL TENSION MEMBER AND IN-DEPTH ELEMENT LEVEL  
PHYSICAL CONDITION REPORT**

Inspected on:  
July 8-10, 2024

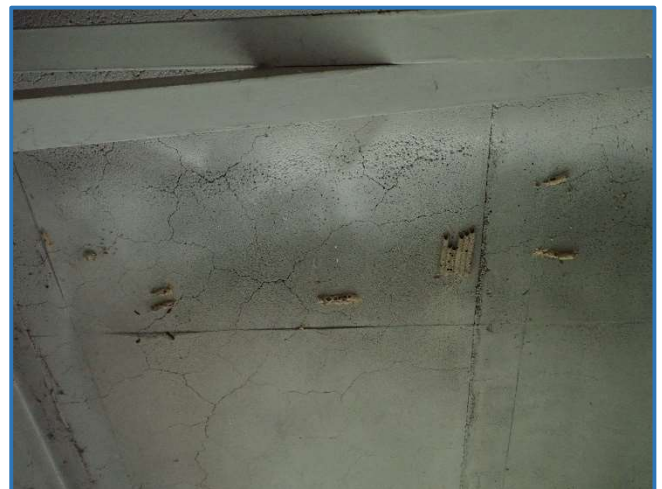
Photo 1 - Typical map cracking in underside deck. Shown Span 4, Bay 3, near Floorbeam 8

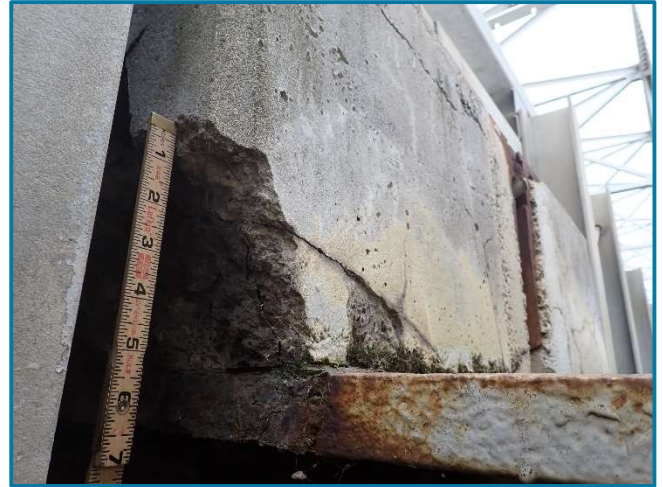
Photo 3 - 6" by 6" by 6" spall on edge of deck on north end, above FBO, in Span 3

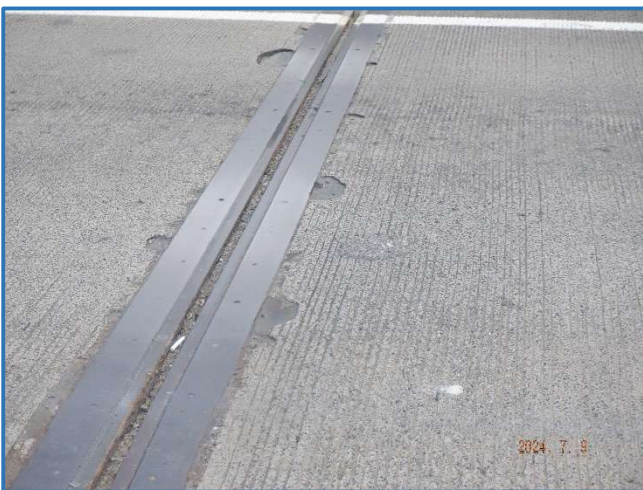
Photo 4 - Spalling along Pier 2 joint

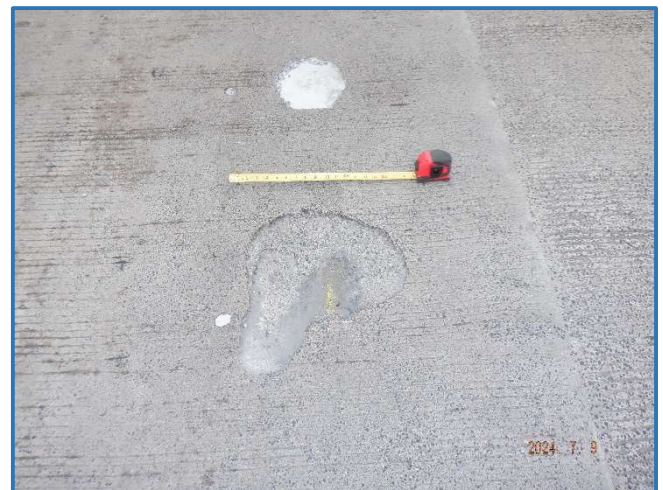
Photo 5 - Spalls in wearing surface on Span 3, left lane, between Panel Points 2 and 3

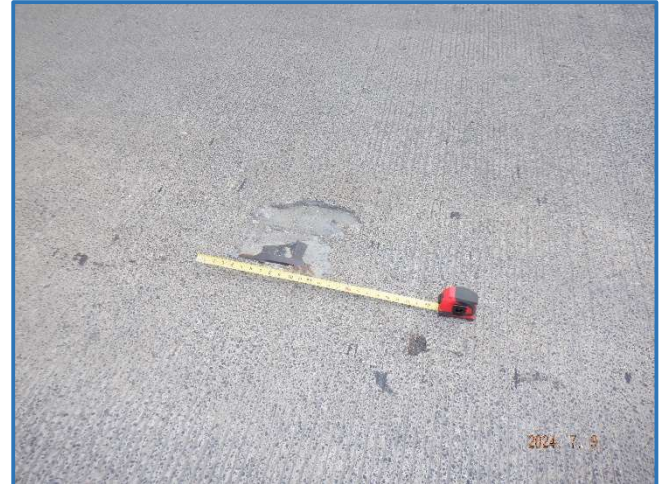
Photo 6 - Spall in Span 1, east side of span

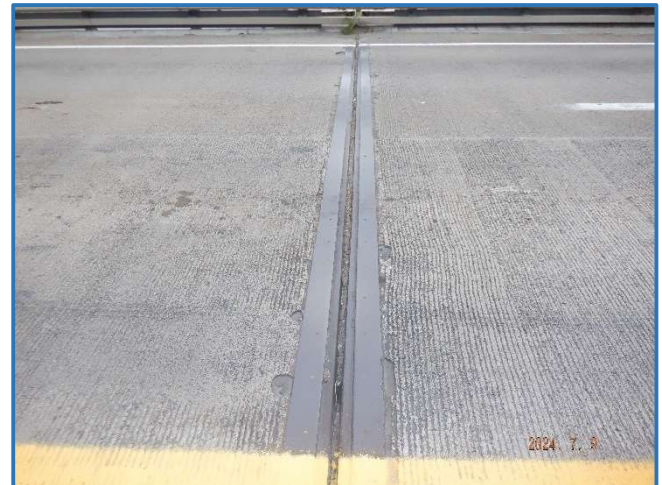
Photo 7 - Typical expansion joint with debris and surface corrosion. Shown is Pier 2 joint, looking north

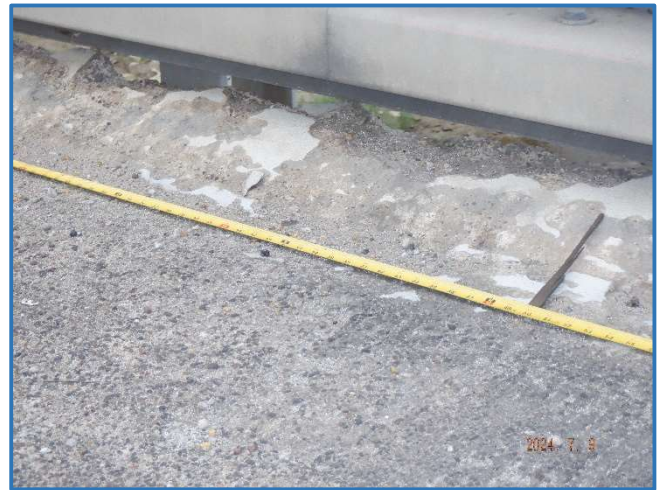
Photo 8 - Spalling of left lane curb in Span 2, between Panel Points 5 and 6

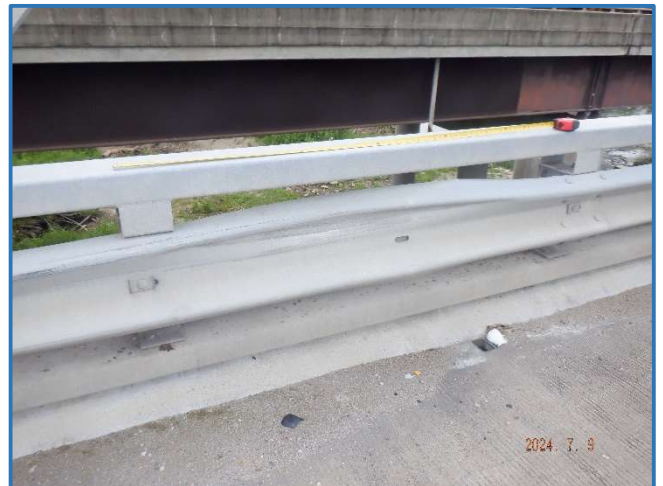
Photo 10 - Impact damage to metal railing, showing Span 3, south railing, between Panel Points 1 and 2

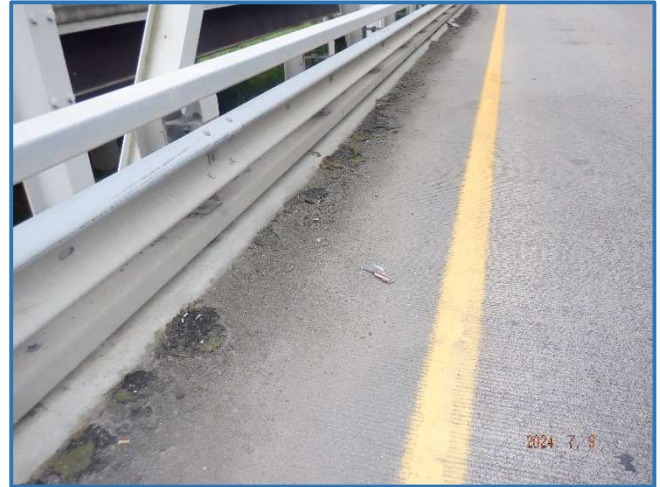
Photo 11 - Typical debris accumulation along edge of bridge deck, shown Span 4, south lane

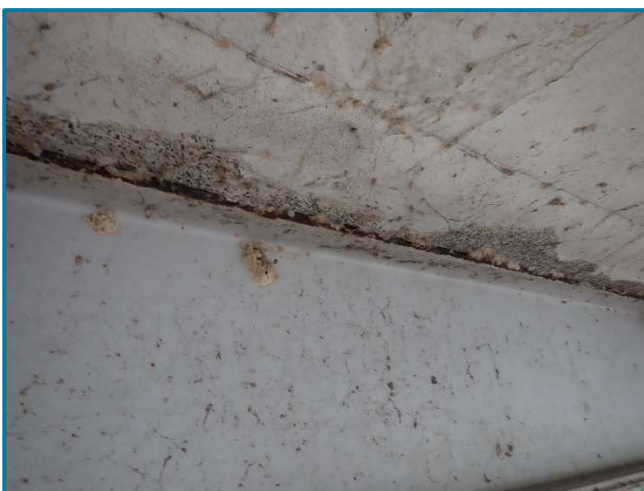
Photo 12 - Typical haunch spalling along outside stringers with surface corrosion along top flange. Shown Span 2, Stringer 1, looking northeast

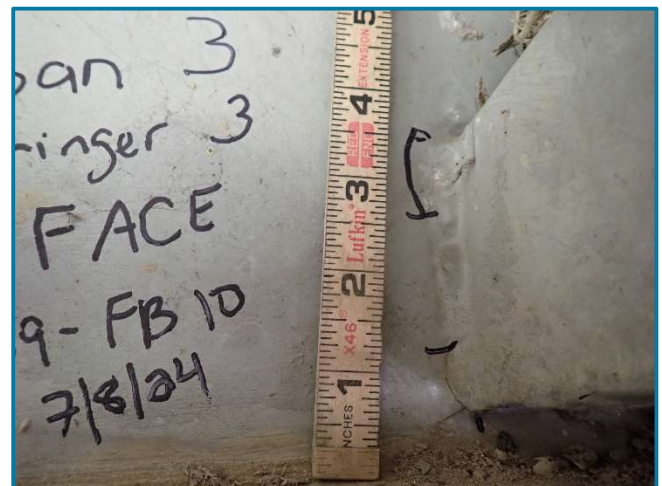
Photo 13 - Crack in weld for 2/3 of length on Stringer 3 connection to diaphragm between Floorbeam 9 and 10, looking north

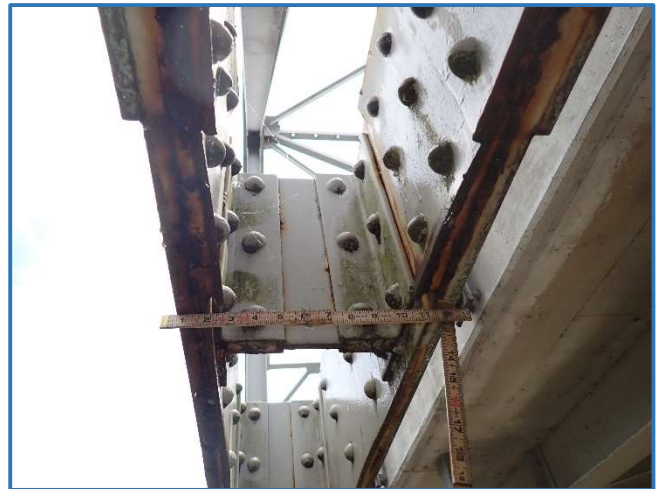
*Photo 14 - 1/2" pack rust in lower chord plates in Span 2, North Truss, member L7L8, looking east*

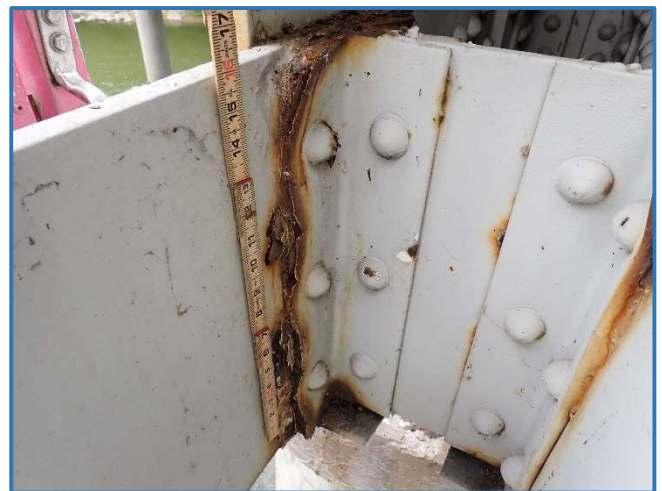
*Photo 16 - 3/4" pack rust between lower chord and diaphragm, Span 2, South Truss, member L0L1*

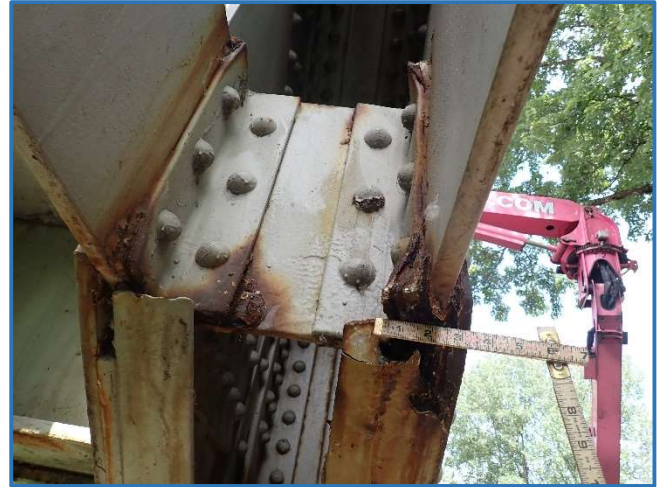
*Photo 17 - Bowing in lower chord northeast diaphragm angle due to pack rust, 1 1/2" over 4", Span 4, North Truss, member L0L1*

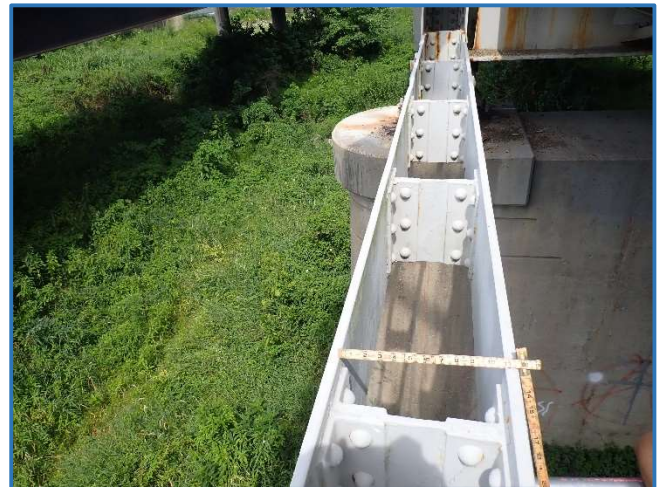
*Photo 18 - Inconsistent diaphragm dimensions; Member L0L1, South Truss, Span 4 shown*

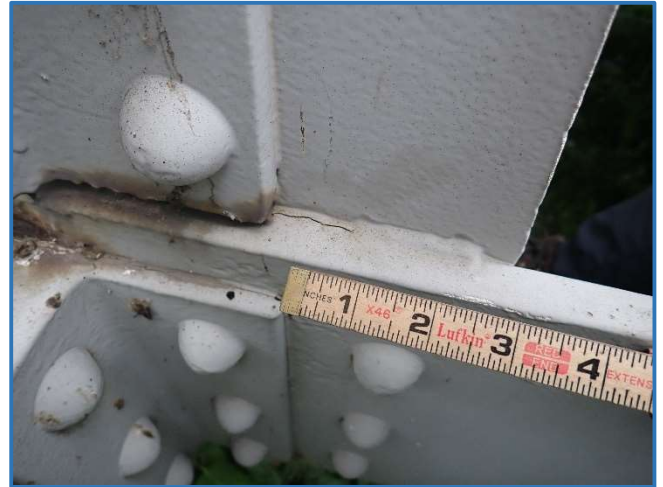
*Photo 19 - Tack weld between lower chord plate and gusset plate, Span 1, South Truss, Panel Point 1, looking north*

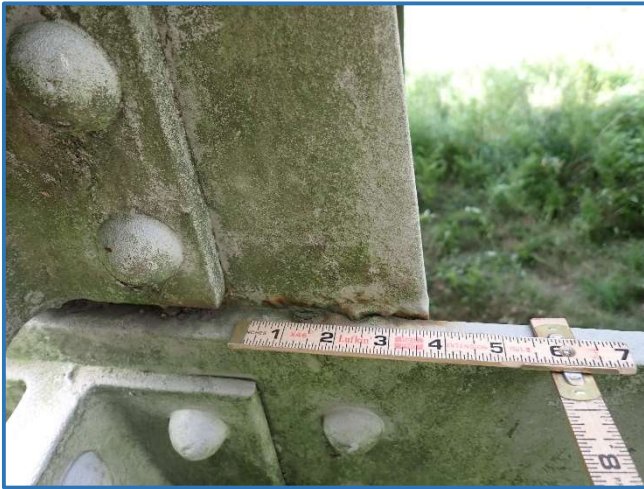
Photo 20 - Broken tack weld between lower chord and gusset plates, Span 4, North Truss, at Panel Point 1, looking south

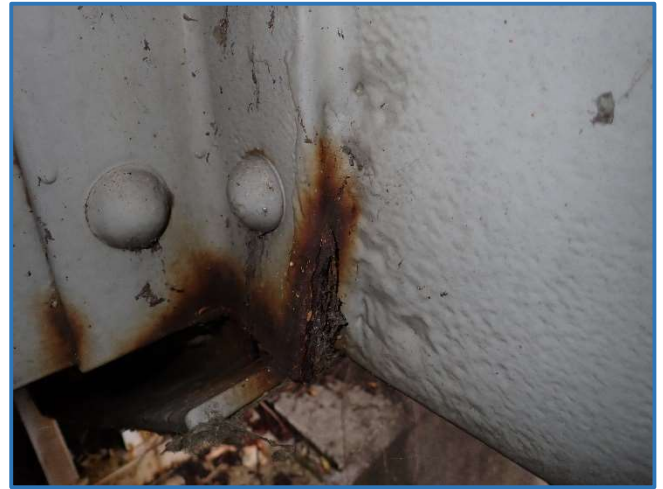
Photo 21 - Area of 2" wide by 4" high x 3/16" deep pitting on the south face of north web plate in Span 1, North Truss, between Panel Point 0 and 1, looking west

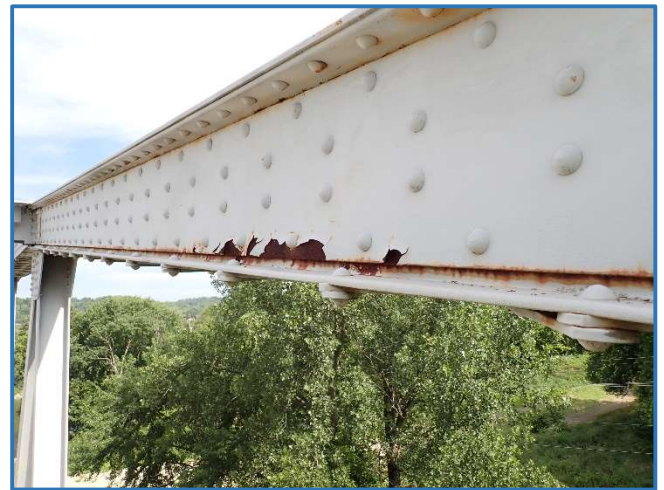
*Photo 26 - Reactivated corrosion between the channel and web plate in Span 3, North Truss, member U7U8, looking northwest*

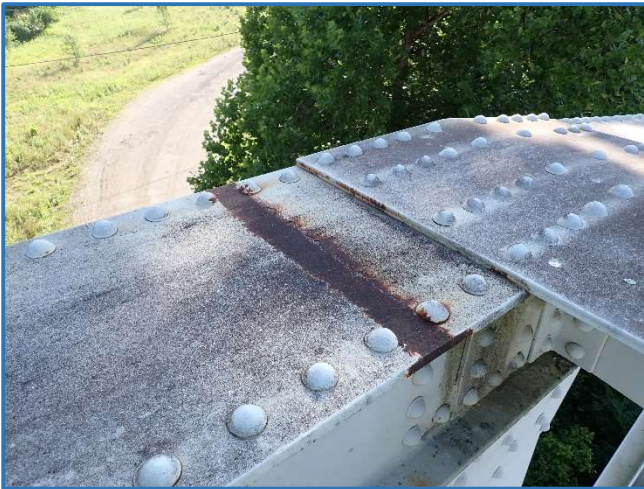
*Photo 27 - 6" long by 4" wide paint failure in Span 4, North Truss, member U5U6, looking northeast*

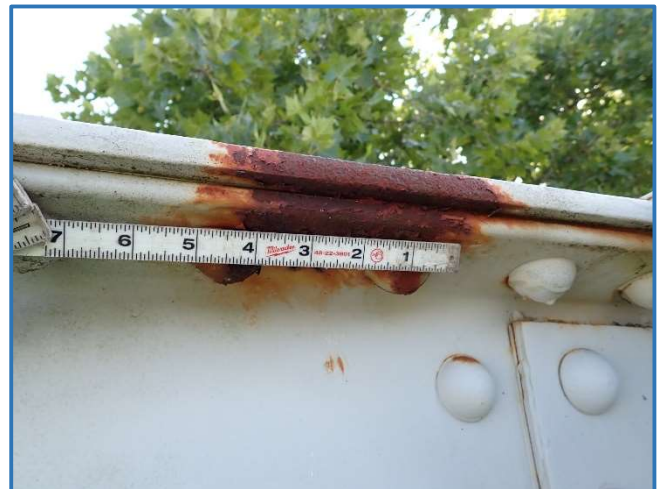
*Photo 28 - 6" long by 4" wide paint failure in Span 4, North Truss, member U6U7, looking north*

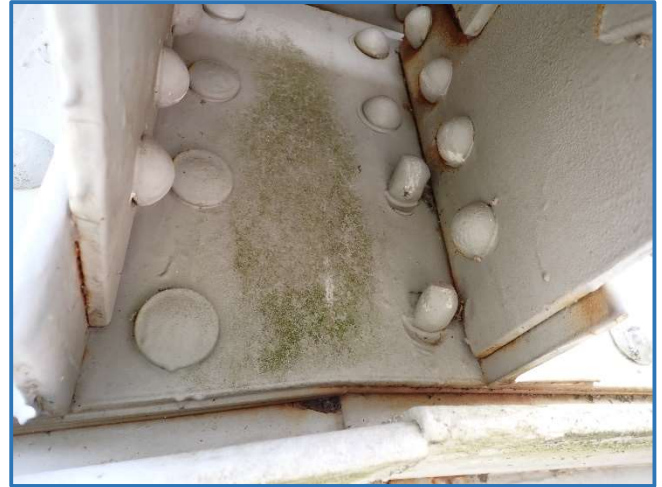
- North Truss, Span 3, Panel Point 3, (2) rivets without heads and (1) rivet with 1/2" exposed shank (see Photo 29).
- North Truss, Span 3, Panel Point 4, 4 rivets without heads on south clip angle and 4 rivets improperly installed (see Photo 30).

Photo 29 – Typical improperly installed rivet heads in stiffener plate, Span 3, North Truss, at Panel Point 3

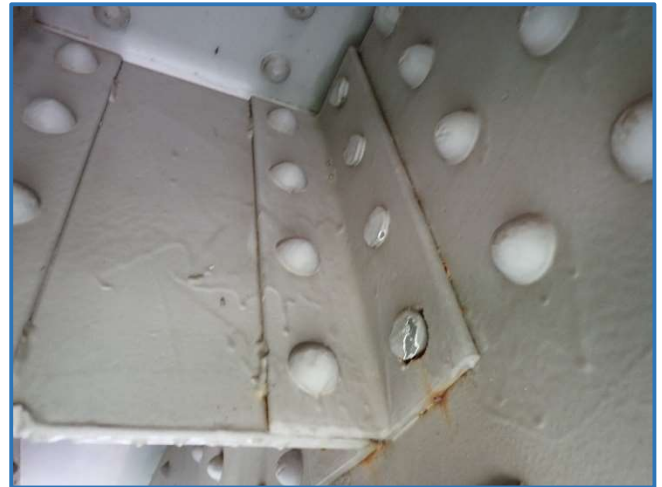
Photo 30 - Typical missing rivet heads on south diaphragm clip angle, Span 3, North Truss, at Panel Point 4, looking southeast

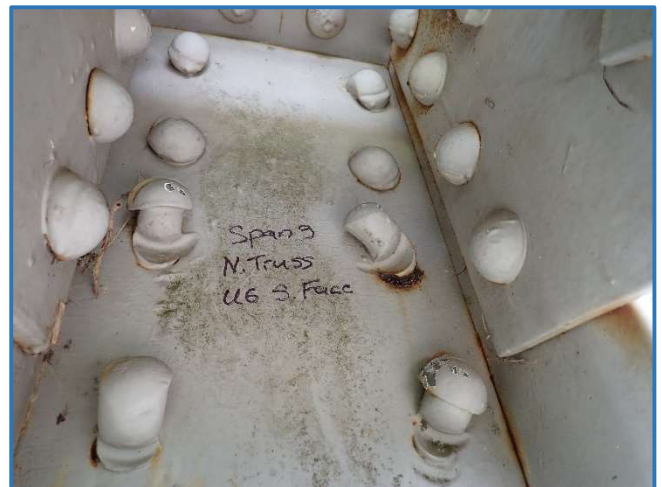
Photo 31 – Improperly installed rivets in stiffener plate, Span 3, North Truss, at Panel Point 6, looking north

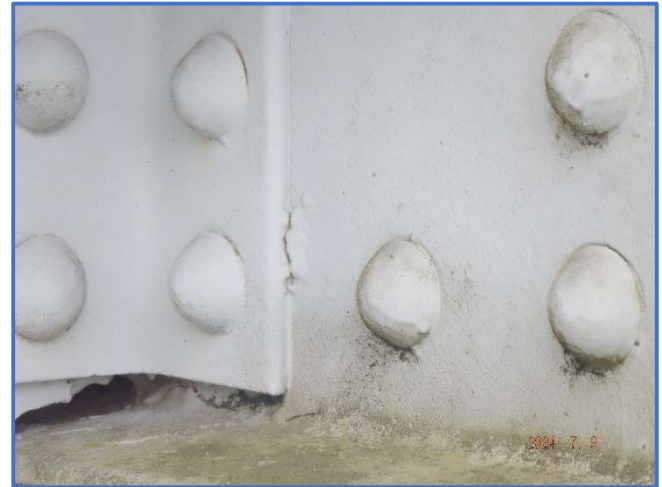
There are also tack welds between the upper chord and the gusset plate clip angles. There is a cracked tack weld between the sway bracing connection angle and upper chord at Panel Point 4 of the South Truss in Span 4 (see Photo 33).

Photo 33 - Crack in tack weld between upper chord and sway bracing connection plate in Span 4, South Truss, at Panel Point 4, looking southeast

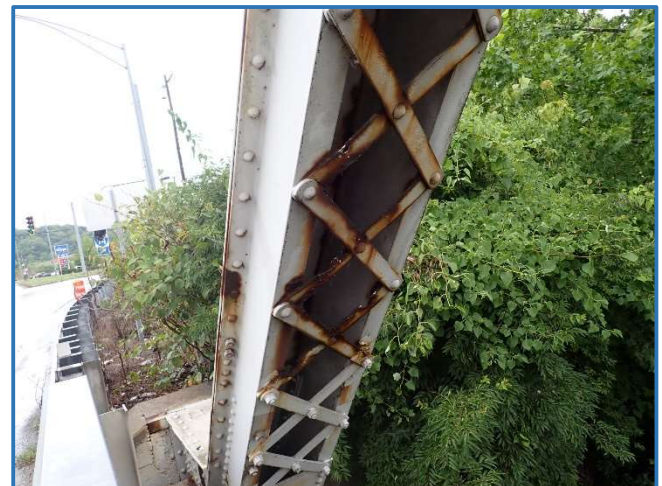
Photo 34 - Typical lacing bars with up to 100% section loss. Shown is the end post in Span 1, North Truss, between Panel Points 0 and 1, looking northwest

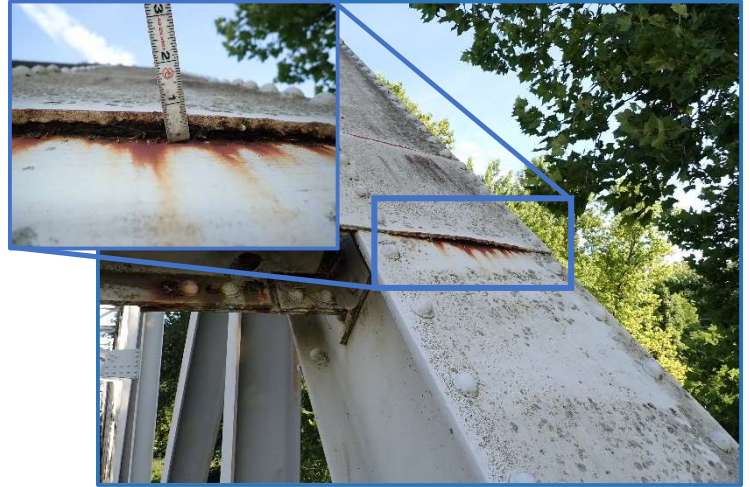
Photo 36 - 1/2" pack rust between portal bracing connection plate and edge post in Span 4, North Truss, on U7L8, looking west

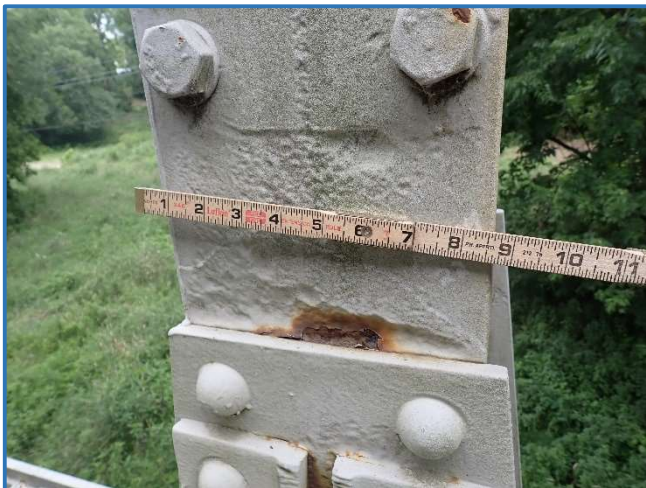
Photo 37 - Pitting with active corrosion and section loss (2" high by 6" wide by 3/8" deep) on vertical just above lower chord connection in Span 3, North Truss, at Panel Point 9, looking west

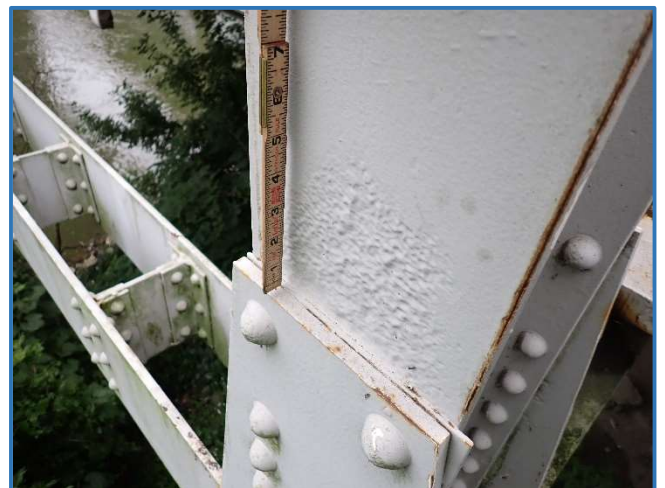
Photo 38 - Painted over pitting up to 3/16" deep on vertical just above lower chord connection, Span 1, North Truss, at Panel Point 1, looking northwest

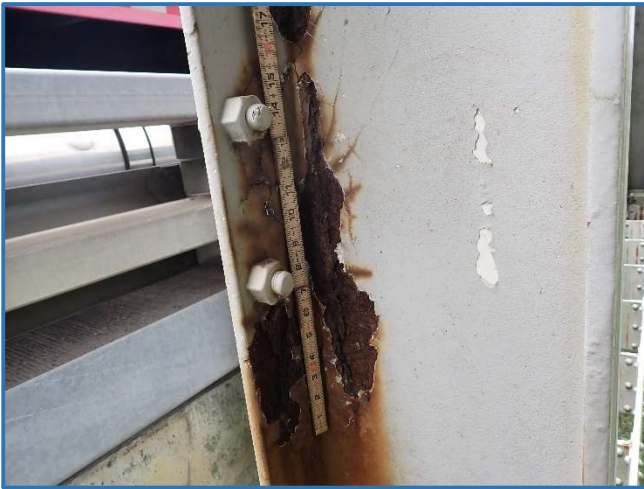
Photo 39 - Laminar corrosion on flange and web of vertical member in Span 3, North Truss, at Panel Point 9, looking west

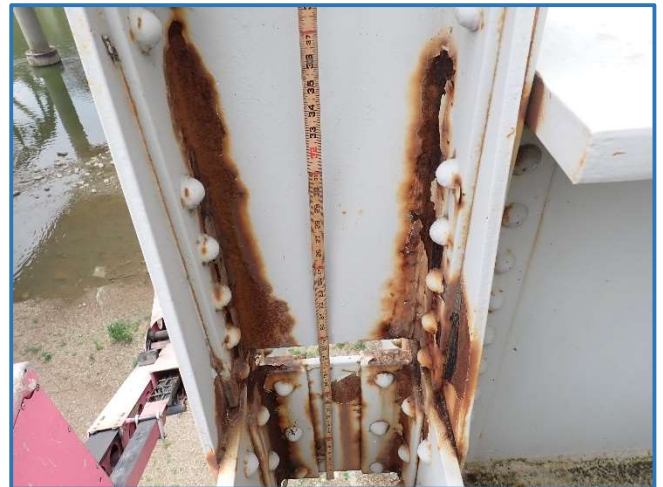
Photo 40 - Active corrosion with section loss along flanges and web of vertical member in Span 2, South Truss, at Panel Point 9, looking west

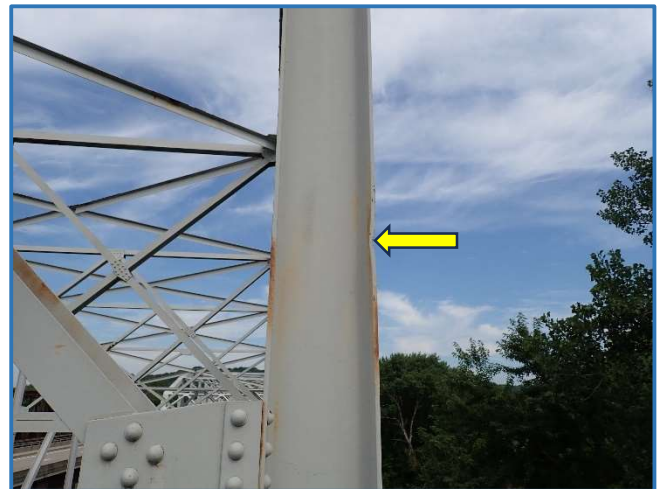
Photo 41 - Impact damage to north flange in Span 3, North Truss, at Panel Point 6, looking west

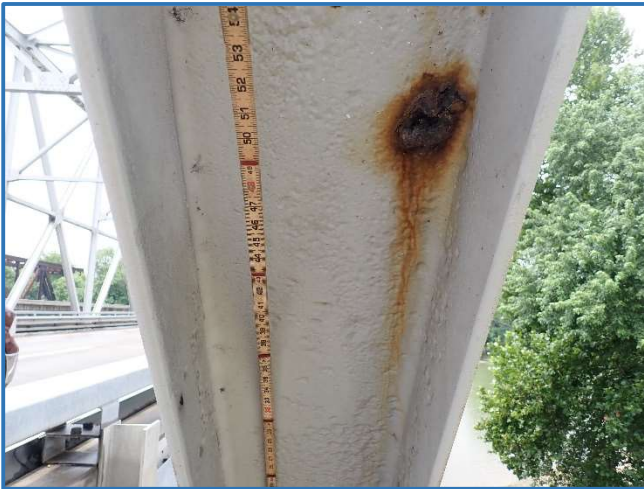
Photo 42 - Pitting on underside of web in Span 2, North Truss, member L8U9, looking west

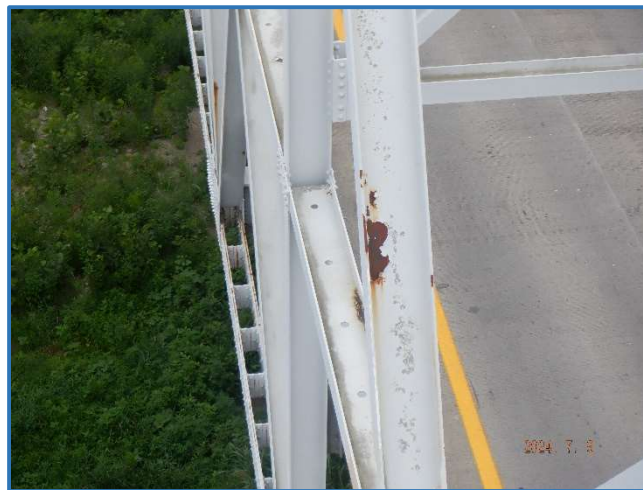
Photo 44 - Paint failure with active corrosion on web of diagonal in Span 3, South Truss, member U5L6, looking west

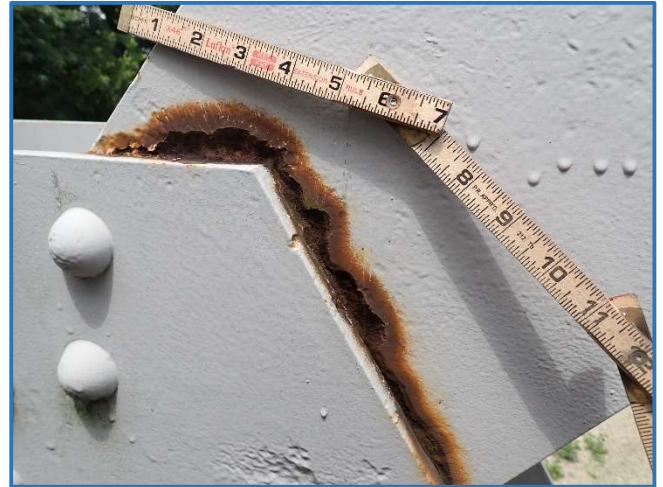
*Photo 45 - 3/16" deep section loss along lower gusset plate on south face of diagonal in Span 2, North Truss, at Panel Point 8, looking north*

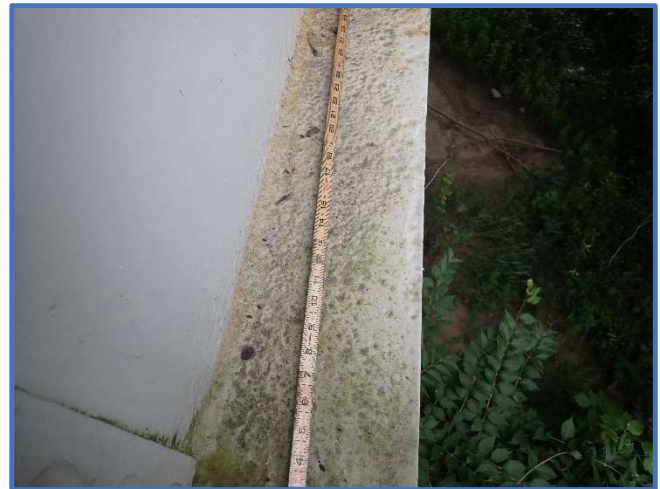
Photo 46 - Typical pitting on top face of bottom flange. Shown is 3.5' long by 1/16" deep pitting on Floorbeam 1, south end, Span 1, looking north

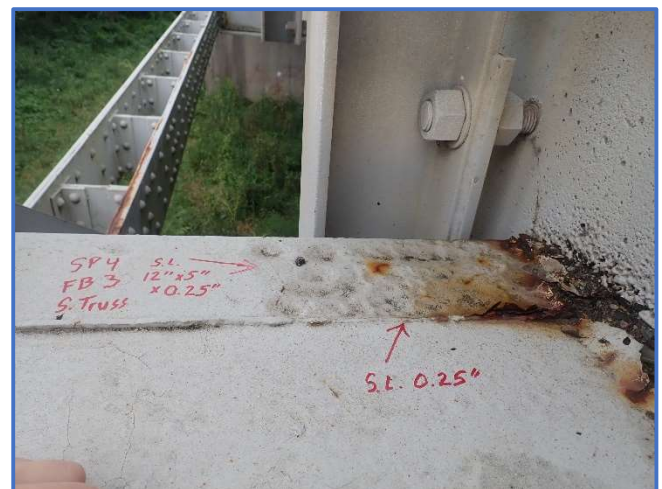
Photo 49 - Pitting with section loss along the top of top flange, at south end of Floorbeam 1, Span 4, looking west

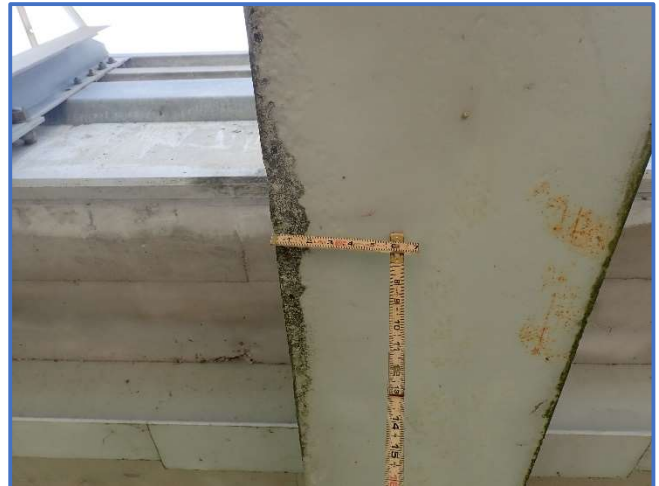
Photo 50 - Pitting along underside of Floorbeam 1, Span 3, looking south

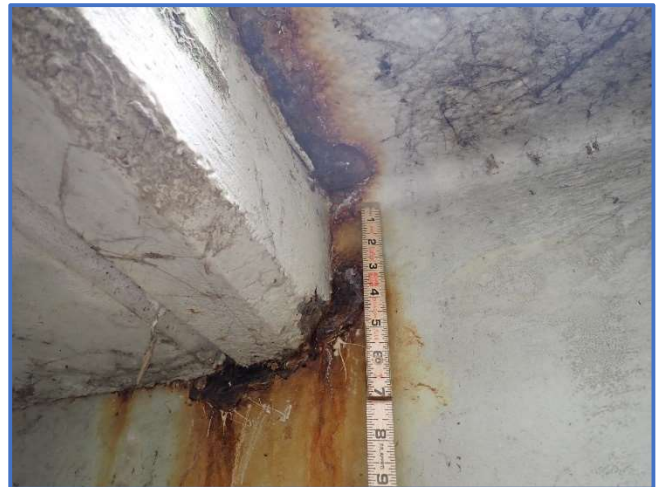
Photo 51 - Corrosion at deck and Floorbeam top flange interface. Shown Span 3, Floorbeam 8, north end, looking west

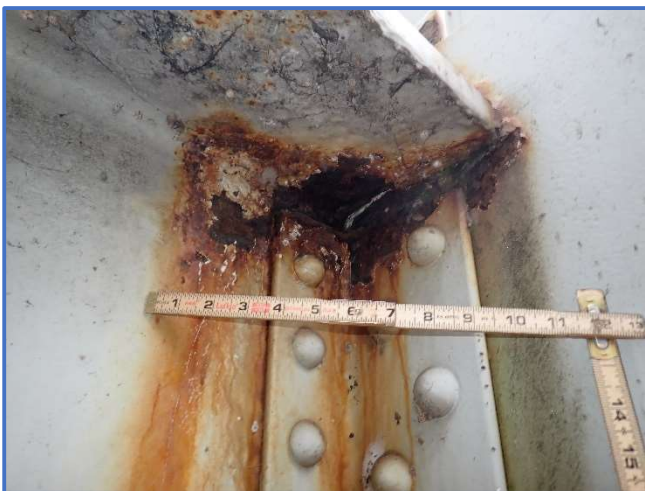
Photo 52 - Corrosion along top flange and clip angle in Span 1, Floorbeam 6 west face, north end, looking north

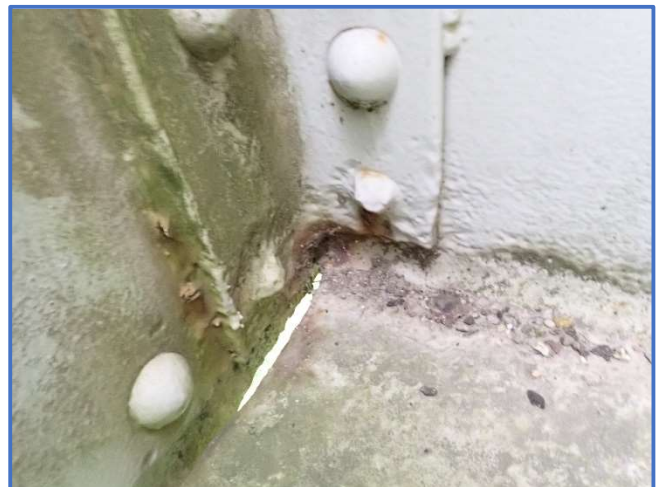
Photo 53 - Up to 50% section loss in rivet heads in Span 3, Floorbeam 4, gusset plate clip angle connection, south end, looking west

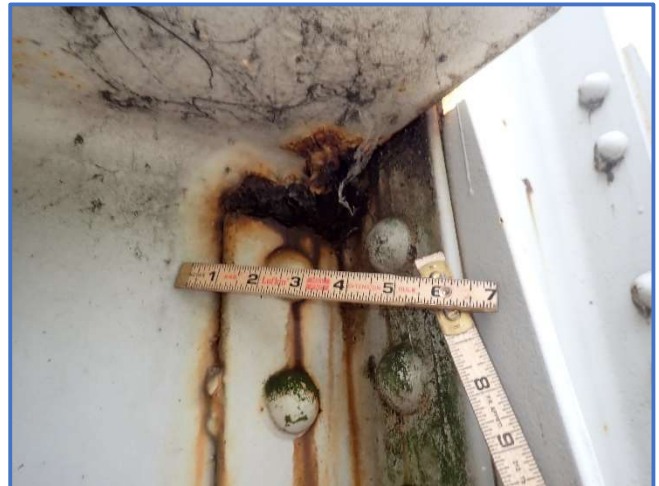
There is a tack weld between the floorbeam and truss clip angle connection in Span 2, Floorbeam 9, north end, east face. No crack was observed in the weld (see Photo 54).

Photo 54 – Corrosion along top flange and clip angle in Span 2, Floorbeam 9 west face, north end, looking west. Note tack weld at clip angle to floorbeam web connection.

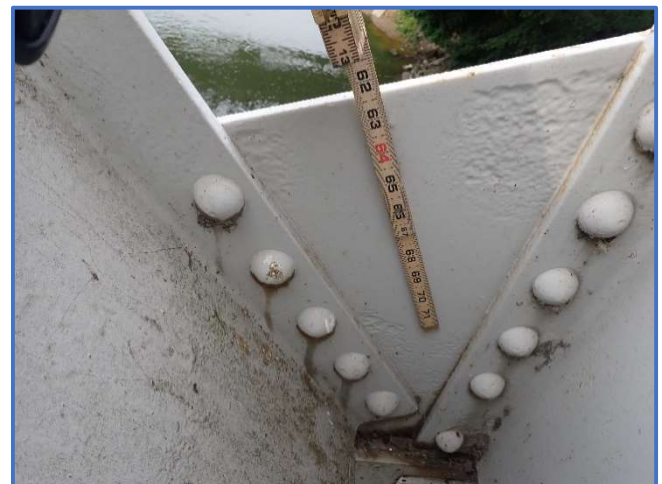
Photo 56 - Typical coated pitting on interior gusset plate. Shown Span 1, South Truss, at Panel Point 4, looking south

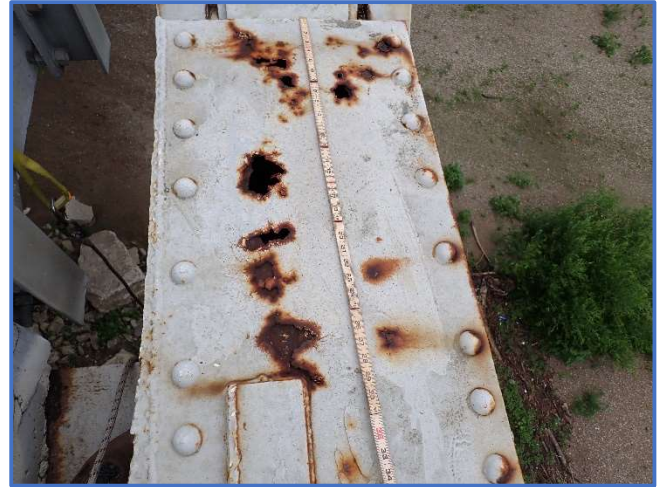
*Photo 58 - Corrosion holes with 100% section loss on top cover plate in Span 2, North Truss, at Panel Point 10, looking west*

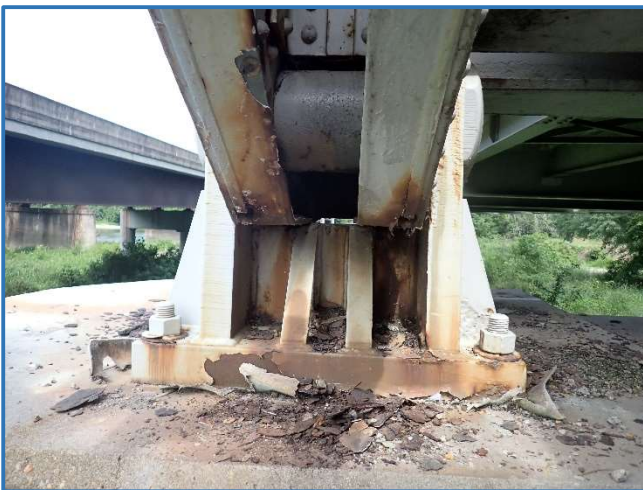
*Photo 59 - Typical corrosion and section loss on bearings. Shown is Span 3, movable bearing on Pier 4, looking east*

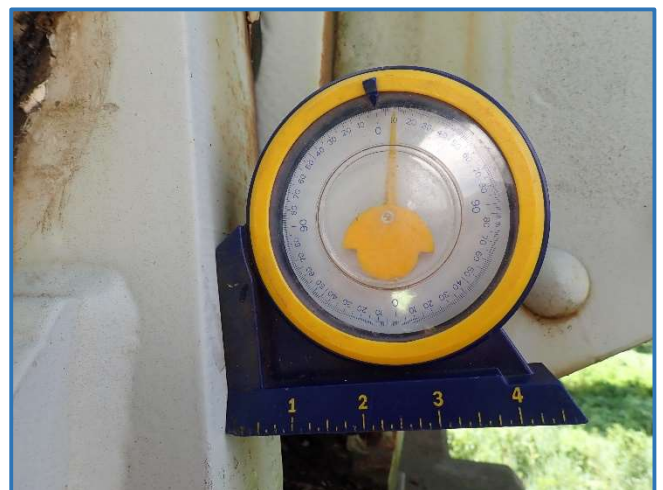
*Photo 60 - 9-degree tilt of bearing in Span 3, north bearing on Pier 4, looking south*

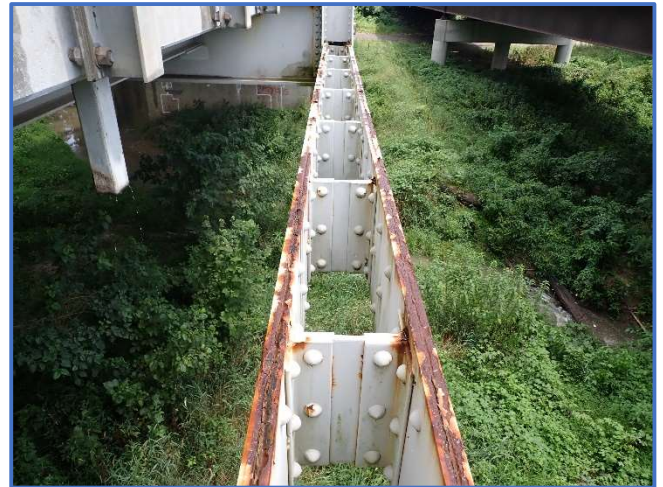
Photo 64 - Typical protective coating condition on lower chord. Shown is Span 3, South Truss, between Panel Points 6 and 7, looking east

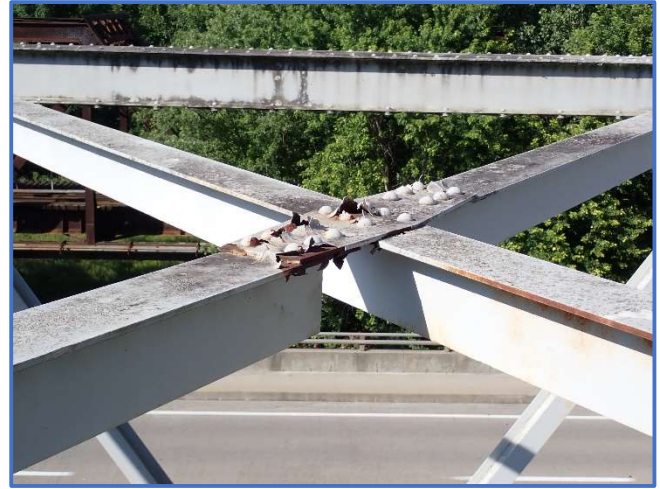
Photo 66 - Typical paint failure of top of upper lateral bracing connection plate with surface corrosion. Shown in Span 4, between Panel Points 3 and 4, looking south

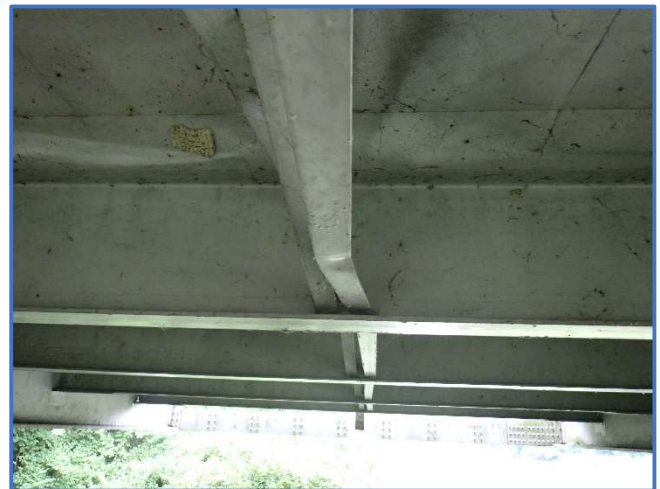
Photo 67 - Deformed diaphragm in Span 1 at Floorbeam 2, looking north

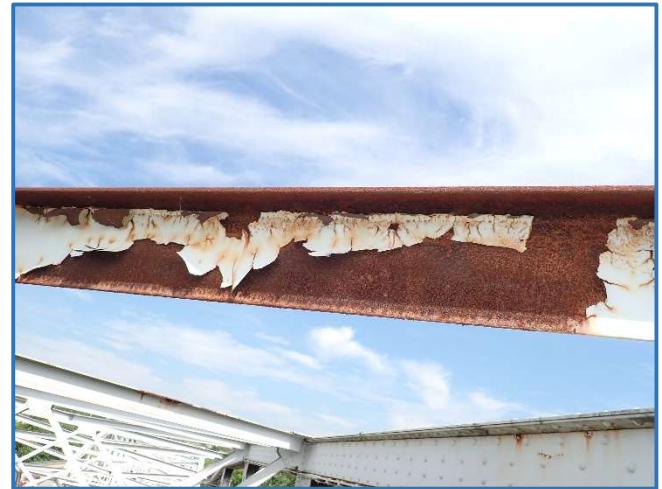
Photo 70 - Paint failure with surface corrosion on upper lateral brace in Span 3, between Panel Points 5 and 6, looking northwest

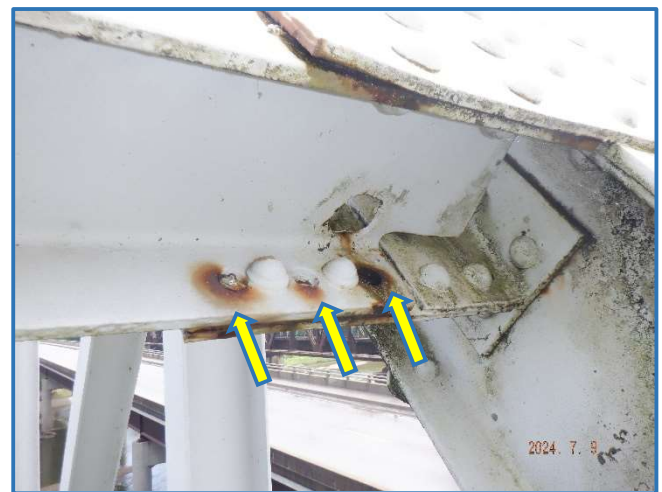
Photo 71 - Misdrilled holes on lower sway brace in portal frame in Span 1, at Panel Point 1, at South Truss connection, looking east

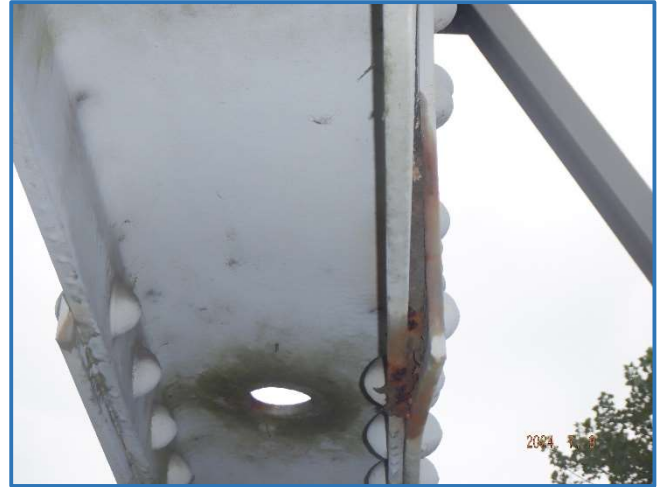
*Photo 73 - Bowing of lower sway bracing connection plate due to pack rust in Span 3 at Panel Point 4, looking north*

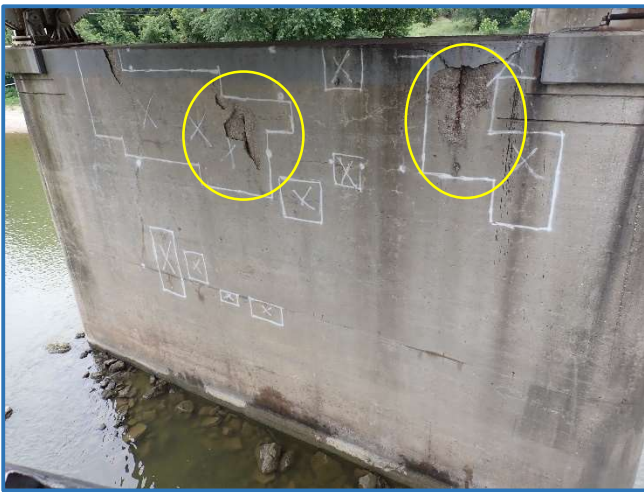
Photo 74 - Large spalls at top of west face of Pier 2

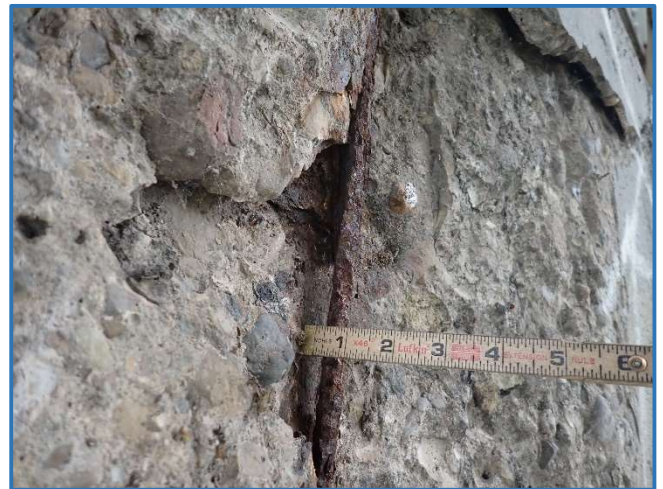
Photo 75 - Spall in west face of Pier 2 with exposed debonded rebar under Stringer 5

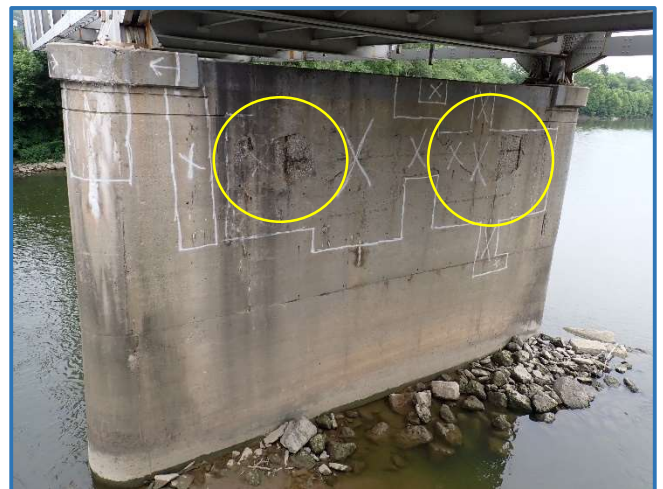
Photo 76 - Large spalls at top of east face of Pier 2

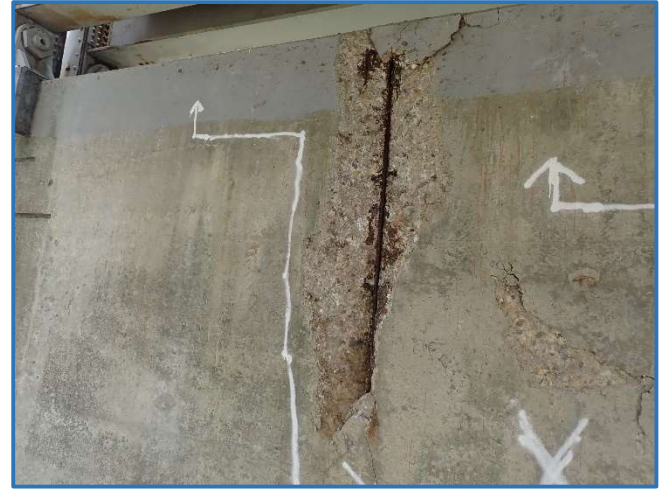
Photo 78 - Spall in west face of Pier 3 under Stringer 2, with exposed rebar with section loss

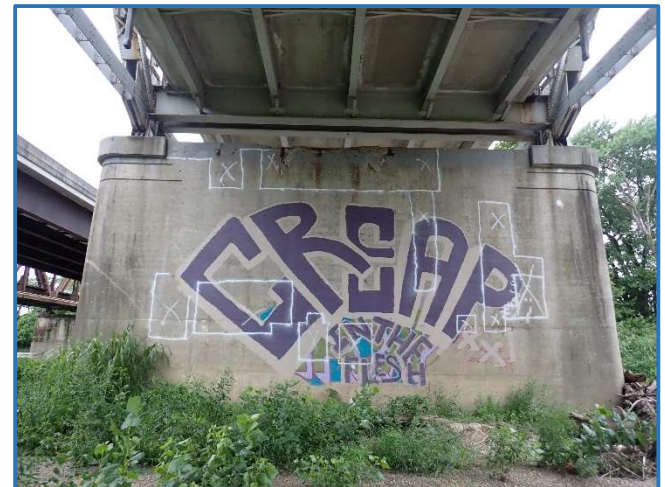
Photo 79 - Widespread delaminated areas and spalls on east face of Pier 3

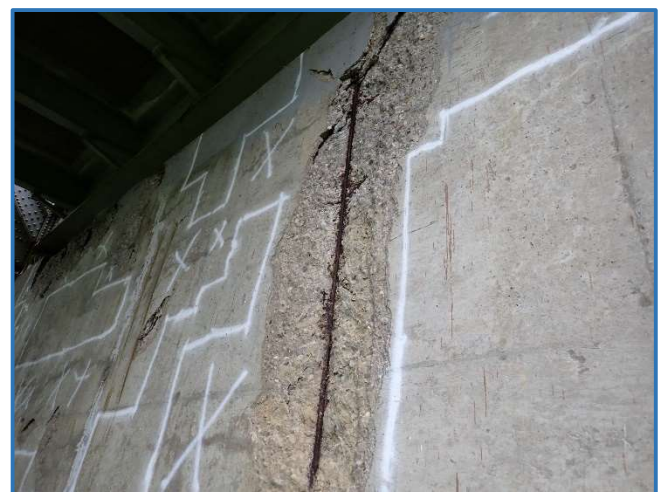
Photo 81 - Spall in west face of Pier 4, under Stringer 4 with exposed, debonded rebar

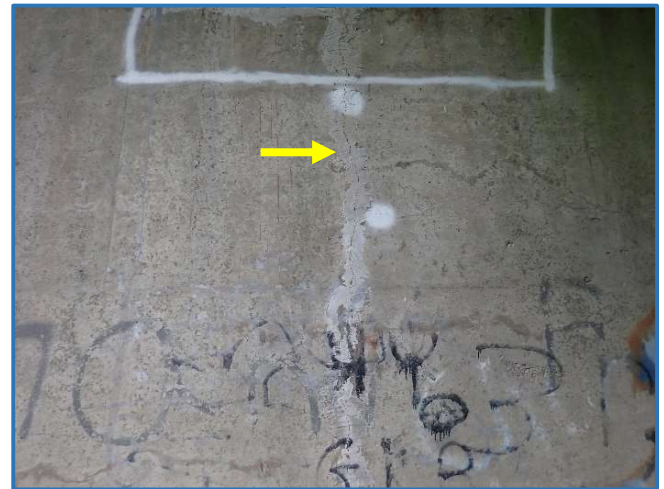
Photo 83 - Crack up to 1/8" wide by full width under Stringer 4 on west face of Pier 4, previously sealed

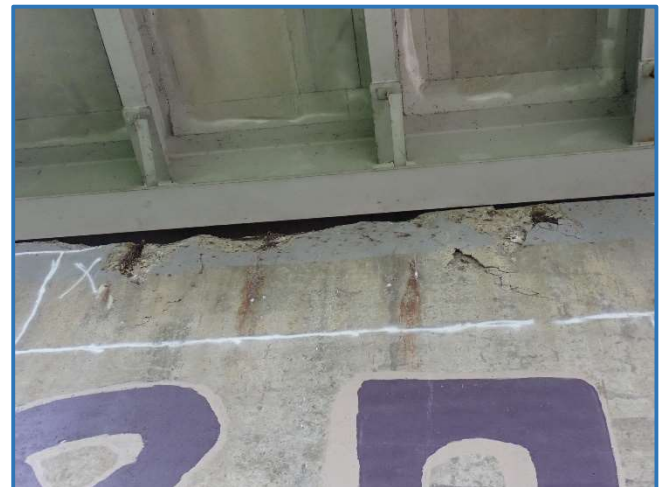
Photo 84 - Spall in top of Pier 3 east face between Stringers 2 and 4, with exposed rebar

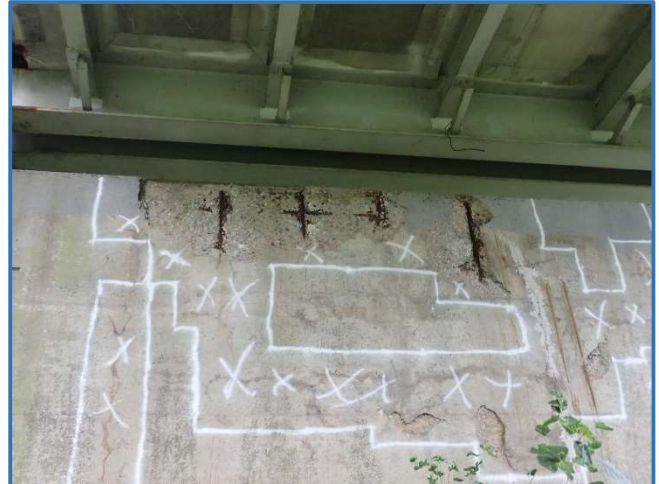
Photo 85 - Spall in Pier 4 west face pier cap, with vertical and transverse rebar exposed

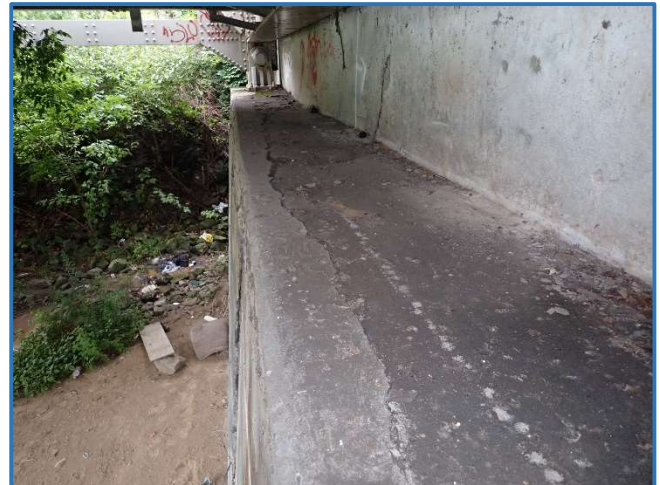
Photo 87 - Bearing seat of rear abutment with delaminations, looking south

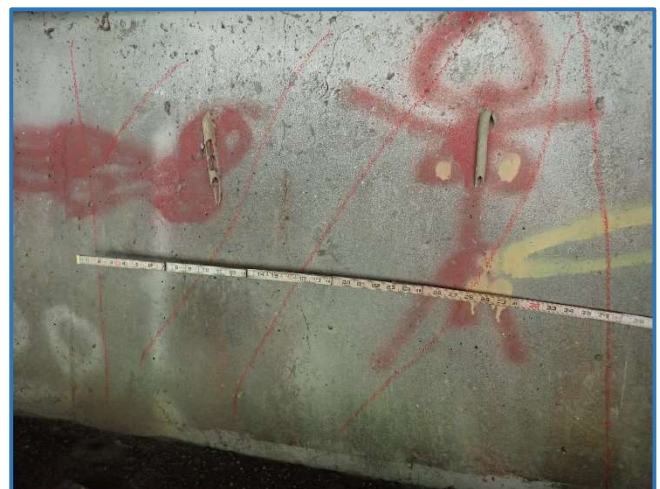
Photo 88 - Delaminated area along backwall of forward abutment

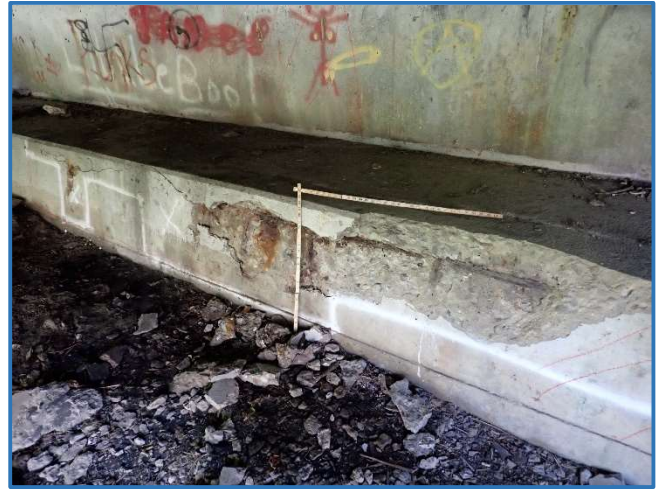
Photo 89 - Delamination and spalling with exposed rebar along bearing seat of forward abutment, looking southeast

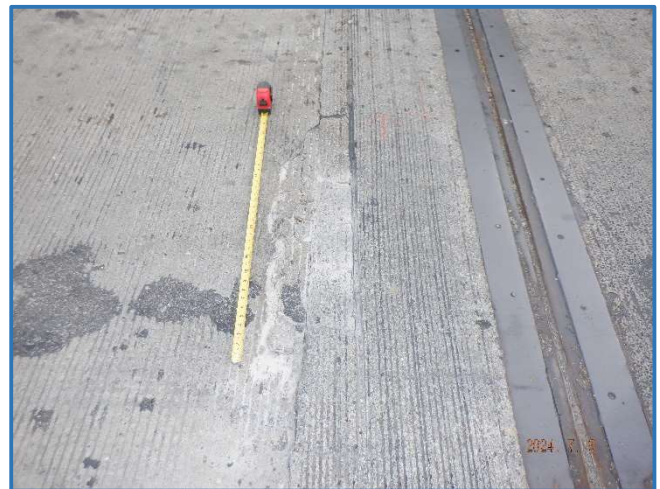
Photo 91 - Spalling in west approach slab, just west of rear abutment, looking north
