ODOT District 8  
2024 Fracture Critical and In-Depth  
Element Level Inspection Report

Bridge No. HAM-50-0376L  
SFN: 3102521

**2024 NON-REDUNDANT STEEL TENSION MEMBER AND IN-DEPTH ELEMENT LEVEL  
PHYSICAL CONDITION REPORT**

Inspected on:  
July 8-10, 2024

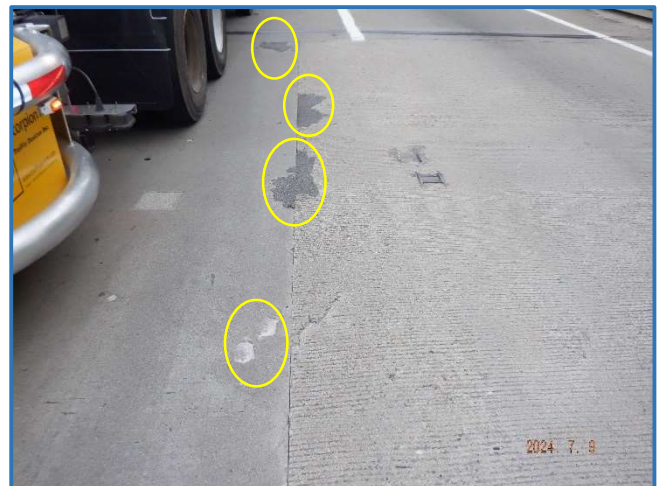
Photo 92 - Spalling in the east approach along center of road, looking west

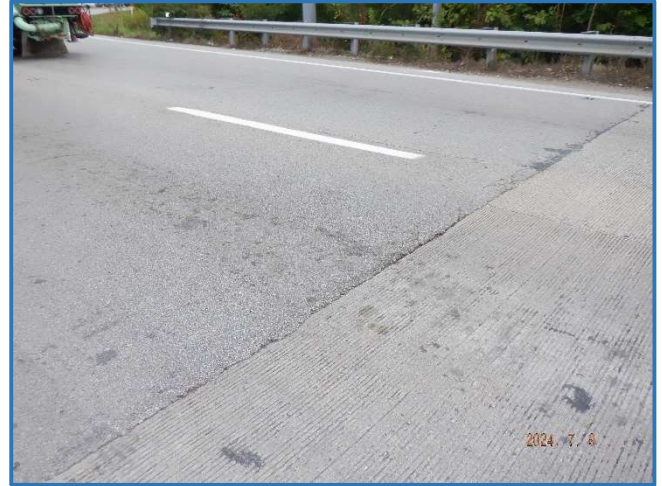
Photo 94 - Map cracking in west approach pavement, looking northwest
