Bridge Deck Condition Report

Bridge 8302294 Northbound

June 6, 2025

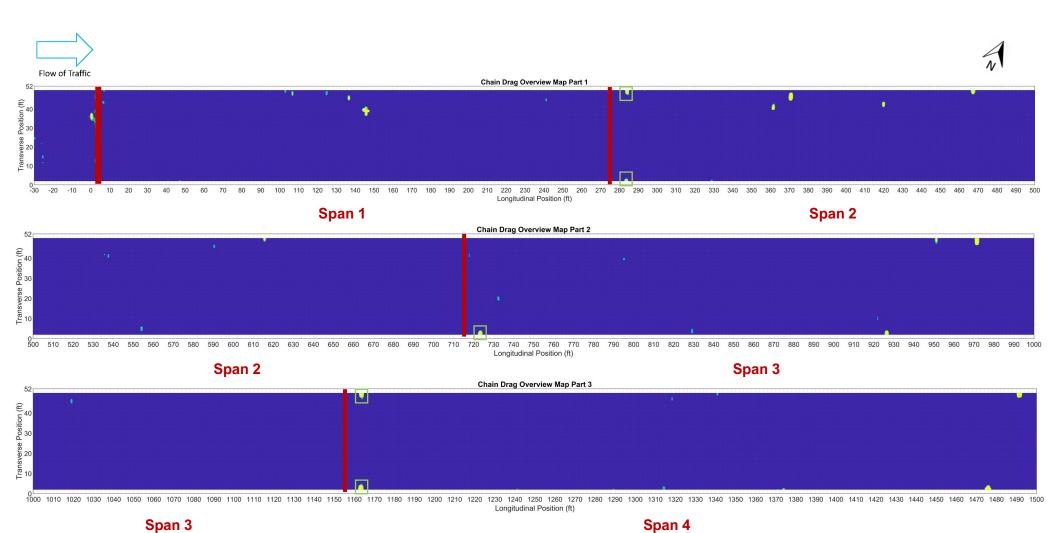
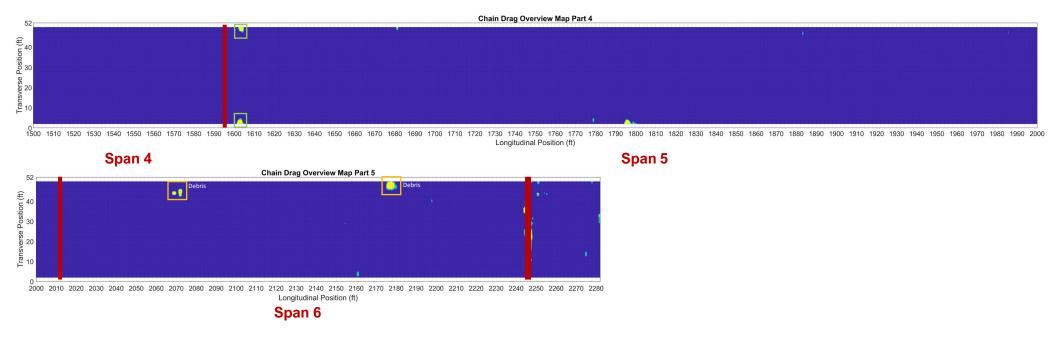
The figure below provides a map of the bridge deck deteriorating from chain dragging acquired by the high-speed data collection system. Overall, the Chain Drag results indicate that the deck is intact with very few isolated areas that are delaminated generally along the edges of the deck.

As noted above, the areas of severe delamination are shown in yellow, while the moderate (incipient) areas are shown in green, with the blue background depicting the intact regions. The locations of the bents are marked in red. The severe areas are located in isolated small areas across the deck. Please note that the areas marked in green rectangles are drainage grates and not delaminated.

Delaminated	Intact	
0.126% (Severe: 0.055%, Moderate: 0.071%)*	99.874%*

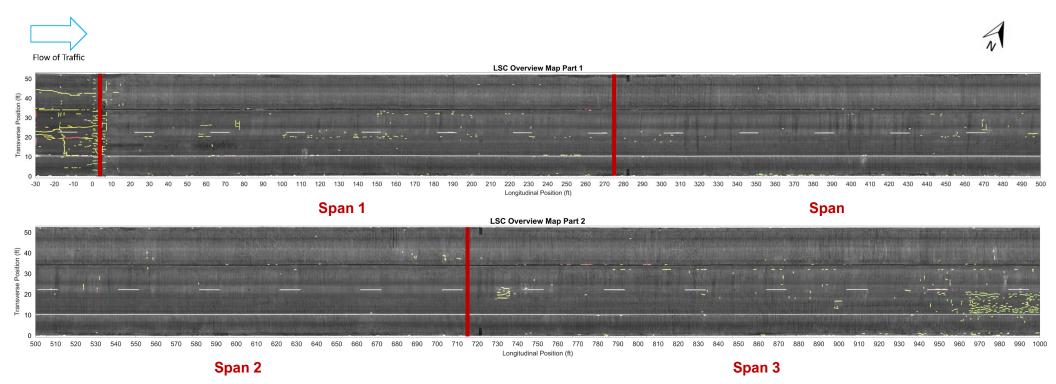
Overall, the results show a low amount of cracking throughout the surface of the deck. The high frequency of cracking does not correlate with the low incidence of delamination from the automated chain drag results. This may indicate cracks are generally only near-surface and do not penetrate through the overlay. It is interesting to note there are significantly more cracks in half of Span 3 (greater than position 970', and at the ends of Spans 4 & 5. These areas should be targeted for review during subsequent inspections for signs of delamination or spalling. It should be noted that significant longitudinal and some transverse cracking shows up in both approach slabs.

At first glance, the northbound lanes may appear to have more cracking than the southbound lanes. However, it's important to note that the southbound lanes exhibit <u>a lot more</u> widespread, smaller-sized cracking, while the northbound lanes contain longer, more concentrated cracks but a lot fewer in total count. The following table tabulates the total length of the cracks throughout the deck, the crack color coding per width is also highlighted below.

Crack Width	Cumulative Cracks Length	
Less than 0.012 in.	826.58 ft.	
Between 0.012 in. and 0.050 in.	915.74ft.	
More than 0.050 in.	95.33 ft.

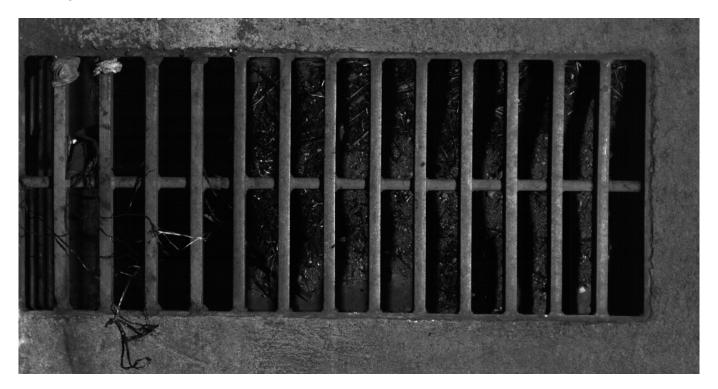
Visual inspection of the surface images indicates that some of the drainage grates are partially clogged with debris, which may hinder effective water drainage.

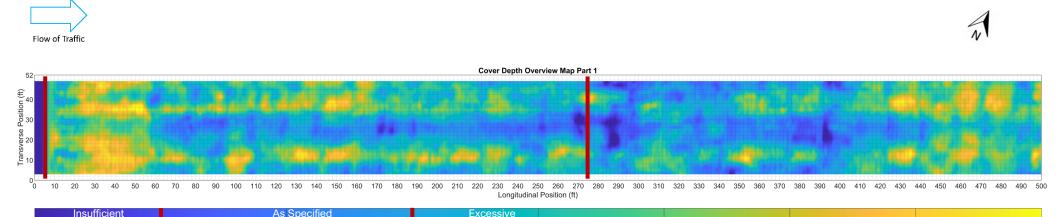
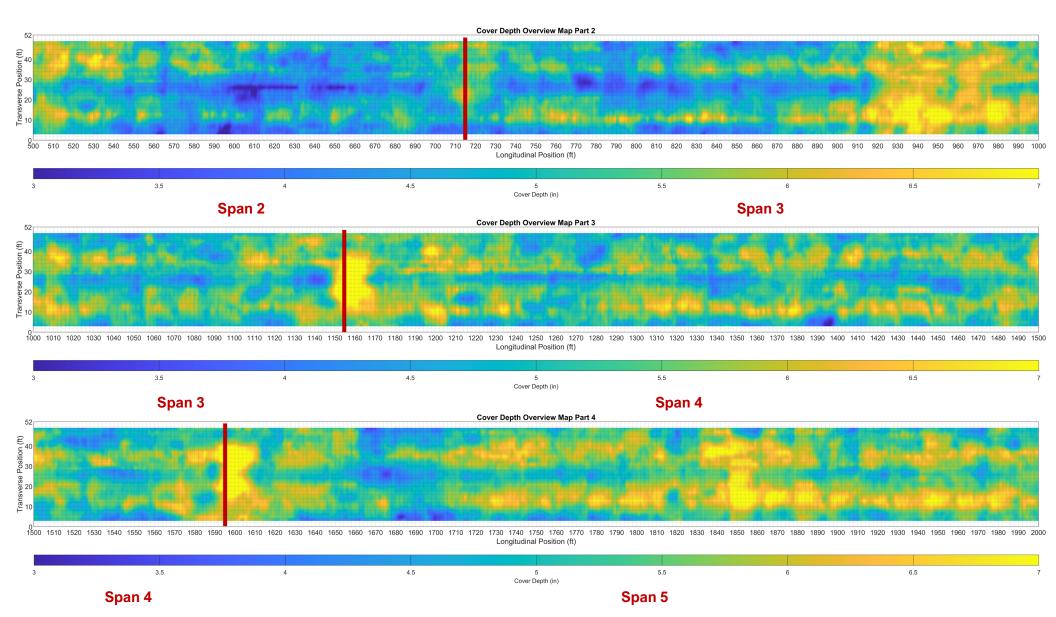
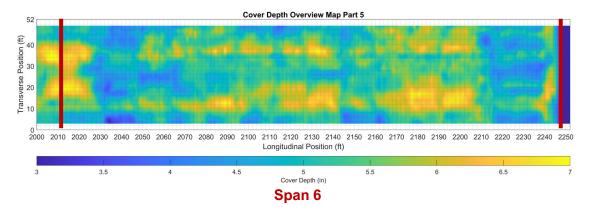
Longitudinal Rebar Cover Dimension

The figure below presents a map of the estimated cover depth based on Ground Penetrating Radar (GPR) data. These estimates represent the depth at which electromagnetic waves reflect off the top mat of rebar. Based on a review of the bridge plans and overlay history, the design cover—including the overlay thickness—is calculated to be approximately 3.5" to 4". Accordingly, a threshold of 4" was selected for the analysis, with a tolerance of ±0.5". This defines the specified cover range as 3.5" to 4.5", where depths below 3.5" are categorized as low cover and depths above 4.5" as excessive cover. Please note that these thresholds can be adjusted based on any number selected by ODOT to re-visualize the data.

It is worth noting that the field data indicates the average cover depth to be at 5.25" across the entire bridge deck with a standard deviation of 0.79". Physical samples from the deck will be used to further calibrate these numbers.

Insufficient	Sufficient	Excessive
Lower than 3.5 in.	Between 3.5 in. and 4.5 in.	Higher than 4.5 in.
0.97%	15.86%	83.17%

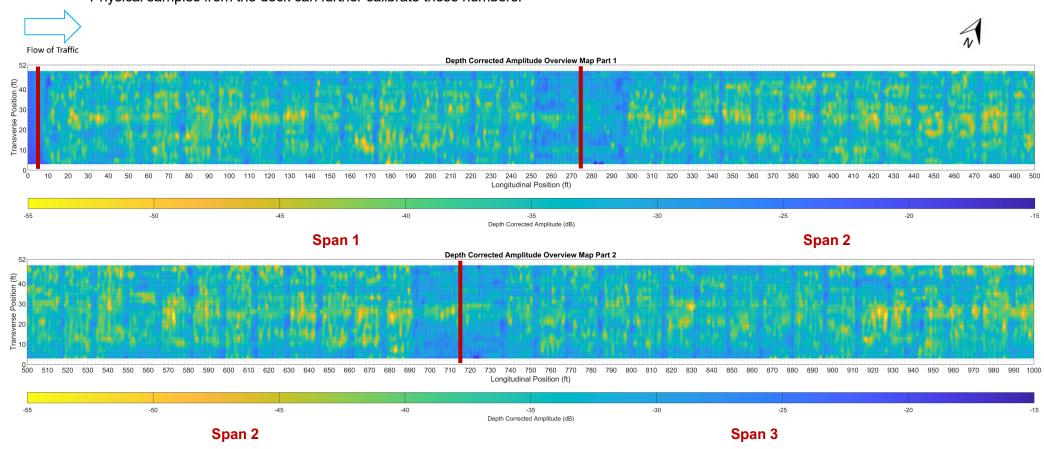
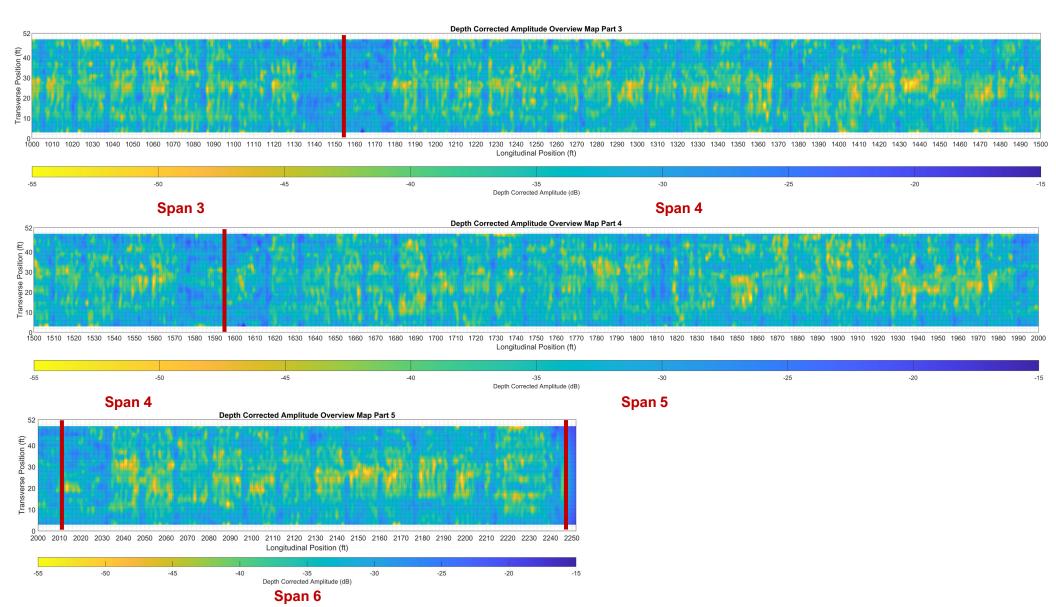
Depth-Corrected Amplitude

The figure below provides a map of the depth-corrected amplitude data. This data is a relative measure of moisture and chloride ingress into the concrete deck. Given the relative nature of GPR data, it is difficult to make absolute conclusions, but it is helpful to examine how the presence of moisture and chlorides varies spatially across the bridge. Overall, the results indicate good to fair conditions when it comes to the level of moisture ingress in over half of the deck, with 44.41% of the deck reflecting high signal attenuation, which historically correlates with areas of higher moisture ingress. These high areas correlate with high levels of cracking in Spans 3, 4, & 5.

Poor	Fair	Good	
Lower than -34 dB	Between -34 dB and -27 dB	Higher than -27 dB	
44.41%	49.16%	6.43%

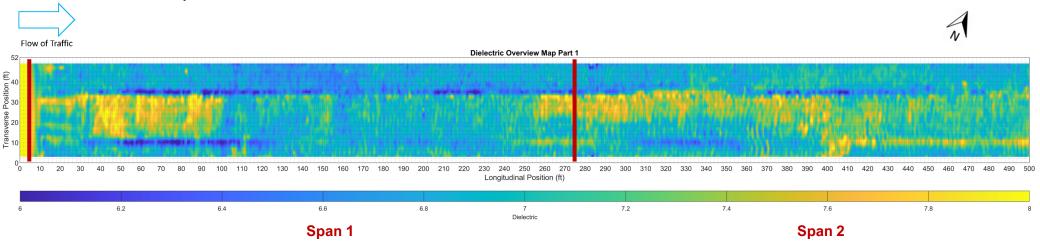
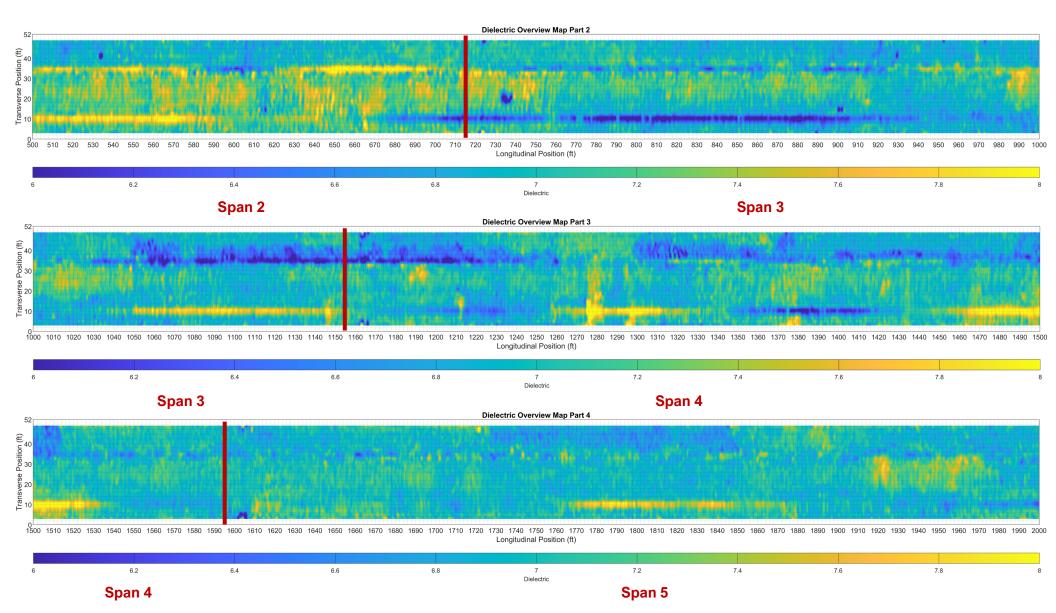
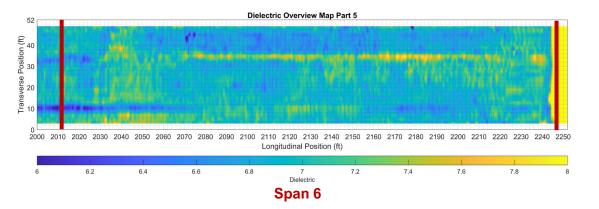
Dielectric

Checking dielectric constant values in another way to utilize Air-coupled GPR data to understand the longer-term condition of the bridge deck. A high dielectric constant reading from concrete, especially when derived from Ground Penetrating Radar (GPR) data can be indicative of conditions that may compromise the integrity or longevity of the concrete deck structure. Here are several reasons why a high dielectric constant in concrete could be considered problematic:

Below Average (OK)	Average for the Deck (OK)	Higher than Average (Potentially Contaminated)
Lower than 7	Between 7 and 7.5	Higher than 7.5
46.19%	44.82%	8.99%

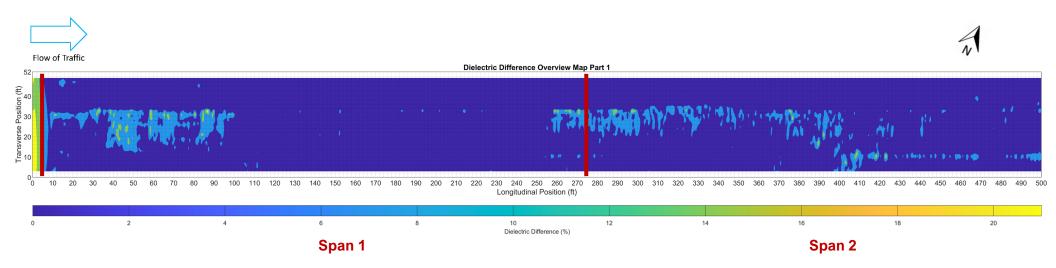
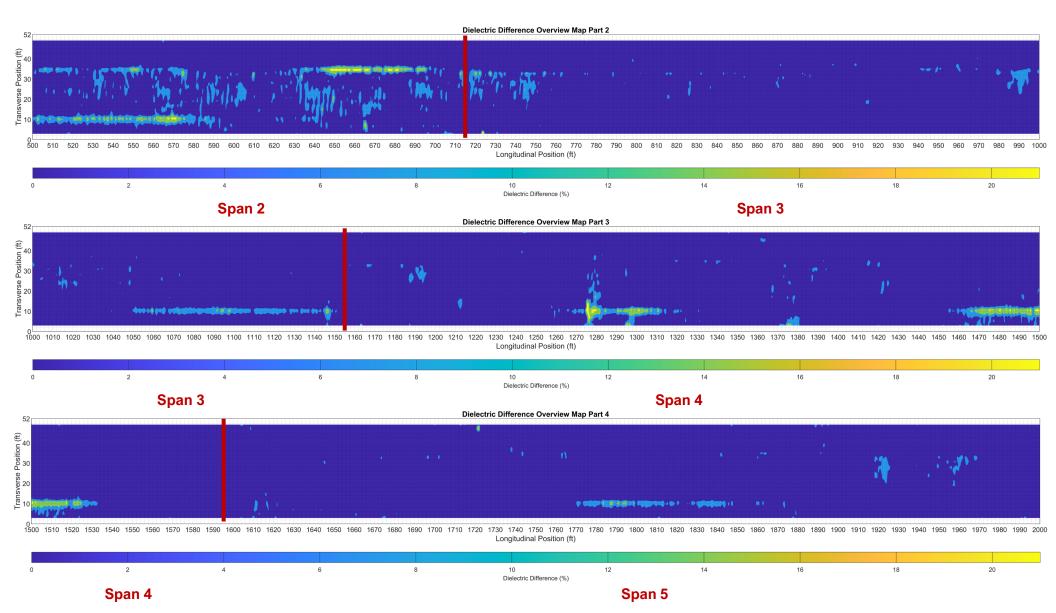
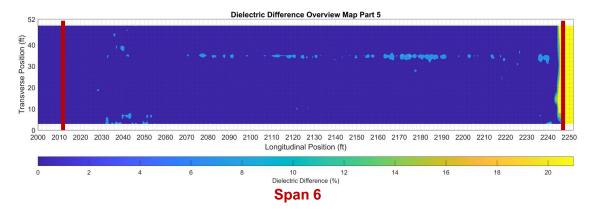
Dielectric Difference from Average Bridge Dielectric

The following plot illustrates the areas of the deck with an increased dielectric constant compared to the entire deck's average. A higher dielectric constant value in concrete indicates regions where free-roaming ions can move more easily, thereby creating a more conducive environment for the corrosion cycle. Elevated dielectric constant values are often associated with higher moisture content or the presence of salts, both of which can accelerate the degradation of the concrete and reinforcing steel, ultimately turning into corrode rebars and delamination. The results indicate relatively high dielectric along the construction joints of the overlay and areas of high dielectric difference within specific areas of overlay placements, possibly a result of variable conditions or processes occurred during construction of the overlay. These areas may need concentrated effort during future inspections for signs of delamination or spalling.

Percentage of Dielectric Increase Compared to the Average for the Deck			
	(0 – 7%)	[7% – 14%)	[14% – 21%)	>= 21%
Percentage of Surface Area	41.06%	6.57%	0.99%	0.56%

The bridge deck is generally in very good condition with isolated but higher levels of cracking in specific areas, as indicated in the plots, and with potential for future deterioration along overlay construction joints and within overlay placement areas as indicated above. The bridge would benefit from concentrated inspection of those areas in future inspections, including sounding and chloride sample testing. The cracking may warrant full deck sealing with a high molecular weight methacrylate or low modulus 100% solids epoxy sealer to extend the service life of the overlay.
