Bridge Deck Condition Report

Bridge 8302278 Southbound

June 3rd, 2025

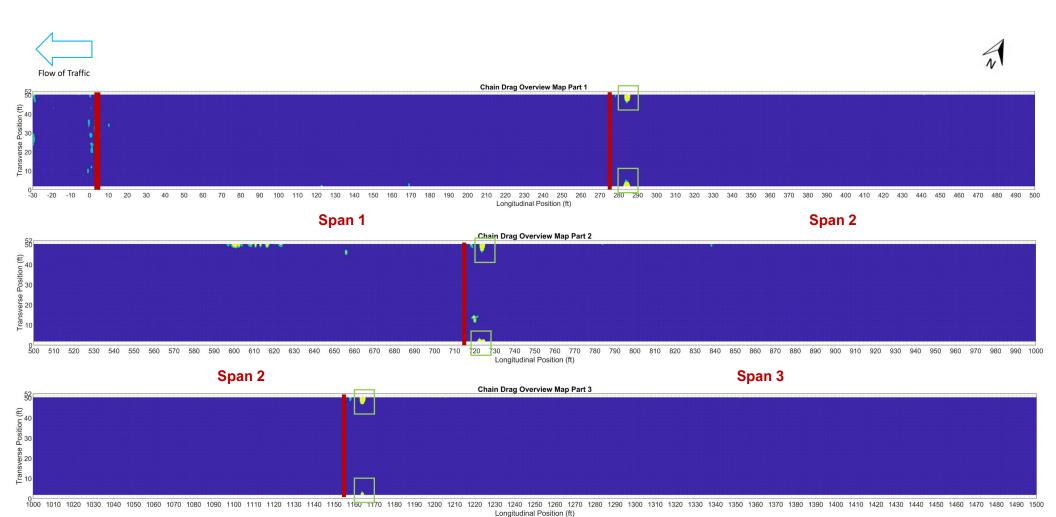
The figure below provides a map of the bridge deck deteriorating from chain dragging acquired by the high-speed data collection system. Overall, the Chain Drag results indicate that the deck is intact with very few isolated areas of incipient delamination, the edges of the deck, the vicinity of the approaches, and around the expansion joints. It should be noted that the approach slabs appear to have delaminated areas along the leading and trailing edges of the slabs. The areas marked by green rectangles are drainage grates and shall not be taken as delamination.

As noted above, areas of severe delamination are shown in yellow, while moderate areas are shown in green, with a blue background indicating the intact regions. The locations of the bents are marked in red. The small delamination or incipient delaminations are located in isolated areas on the edges of the deck and near the expansion joints at the bridge ends.

Delaminated	Intact	
0.12% (Severe: 0.018%, Moderate: 0.102%)	99.88%

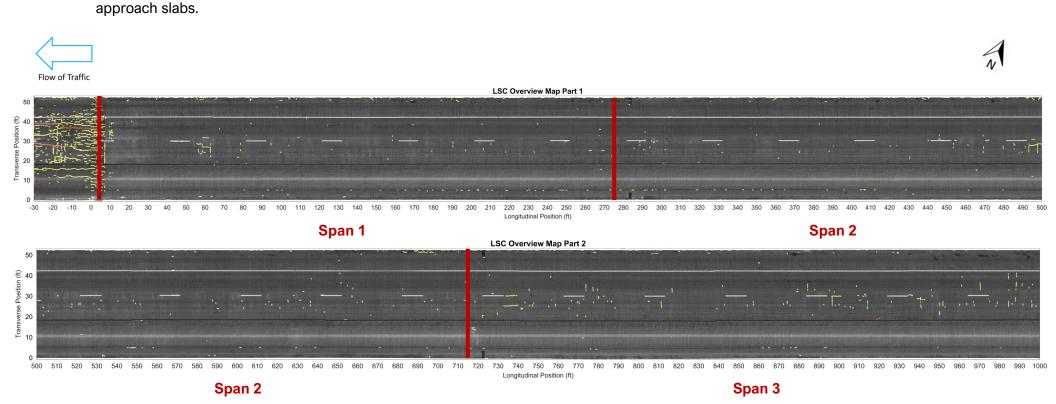
Overall, the results show a low amount of cracking throughout the surface of the deck. The low frequency of cracking correlates well with the low incidence of delamination from the automated chain drag results. It is interesting to note there are a few transverse cracks in the positive moment region of span 5. It should be noted that significant longitudinal and some transverse cracking shows up in both

The bridge deck is generally in very good condition, with only minor cracking observed in the overlay and minimal evidence of delamination or debonding between the overlay and the substrate. The service life of the overlay could be extended through targeted or full-depth crack sealing using high molecular weight methacrylate or low modulus epoxy. While the approach slabs may also benefit from sealing, the extent of cracking suggests that more aggressive maintenance measures may be required to preserve their condition. Future inspections should pay particular attention to the areas surrounding the deck joints, deck drain inlets, and construction joints within the overlay.

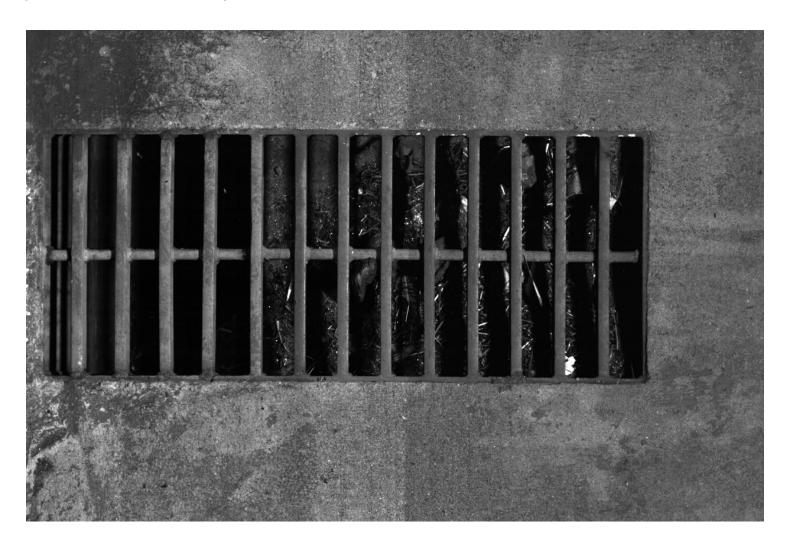
Visual inspection of the surface images indicates that some of the drainage grates are partially clogged with debris and vegetation, which may hinder effective water drainage.

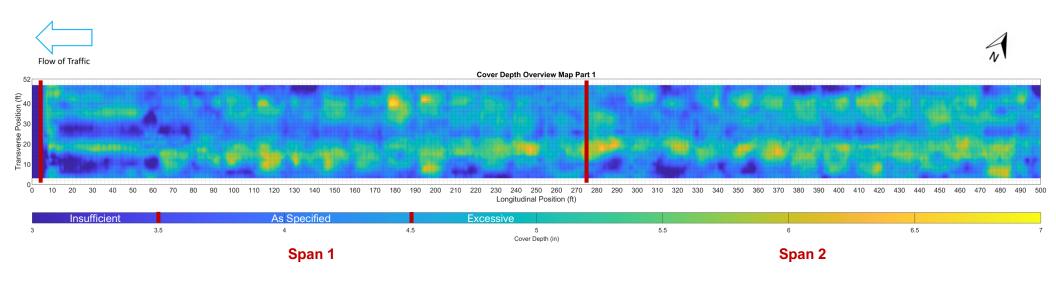
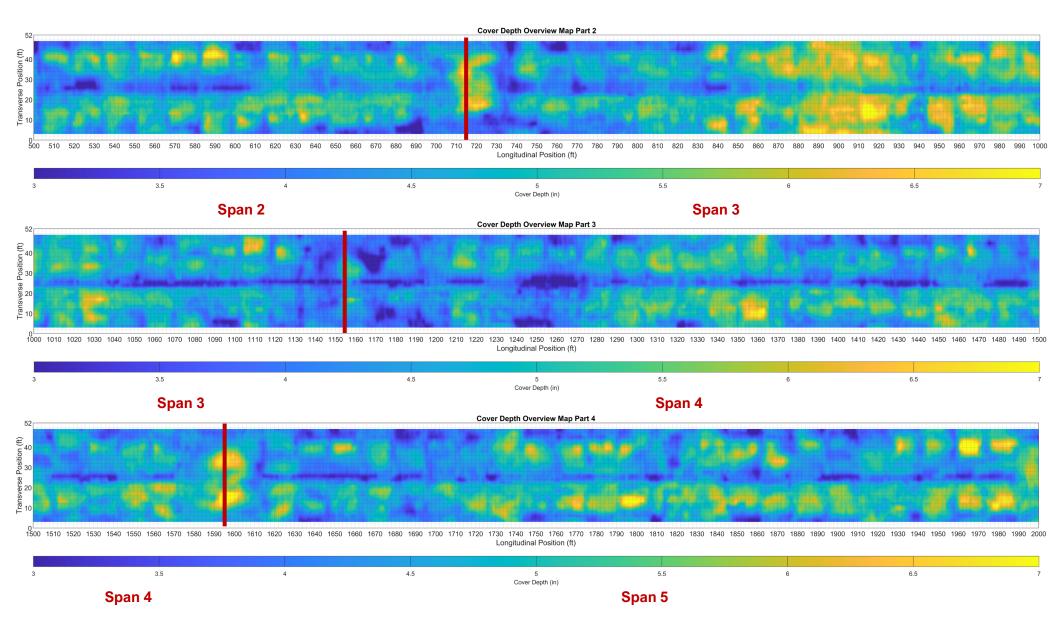
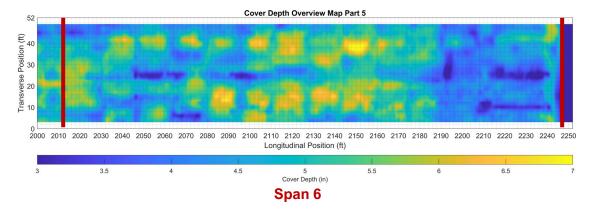
It is worth noting that the field data indicates the average cover depth to be at 4.69" across the entire bridge deck with standard deviation of 0.76". Physical samples from the deck will be used to further calibrate these numbers.

Insufficient	Sufficient	Excessive	
Lower than 3.5 in.	Between 3.5 in. and 4.5 in.	Higher than 4.5 in.	
4.37%	38.18%	57.45%

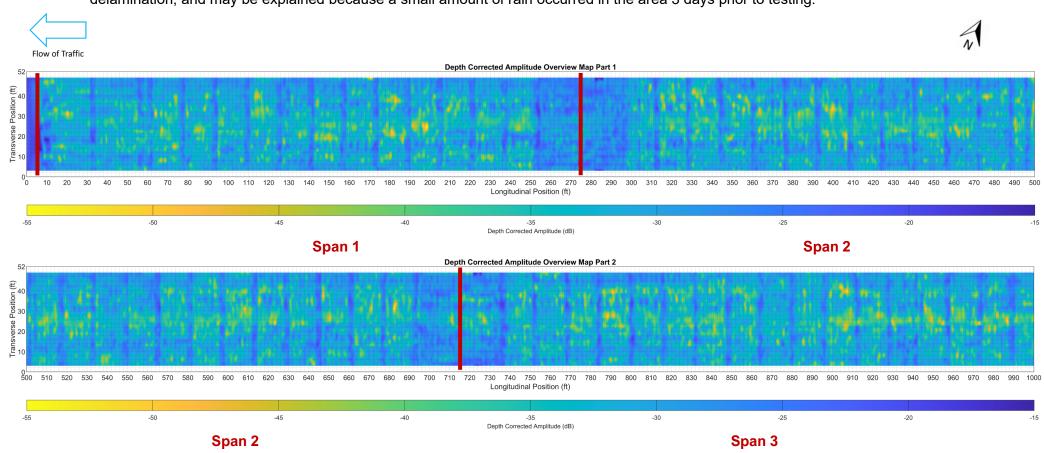
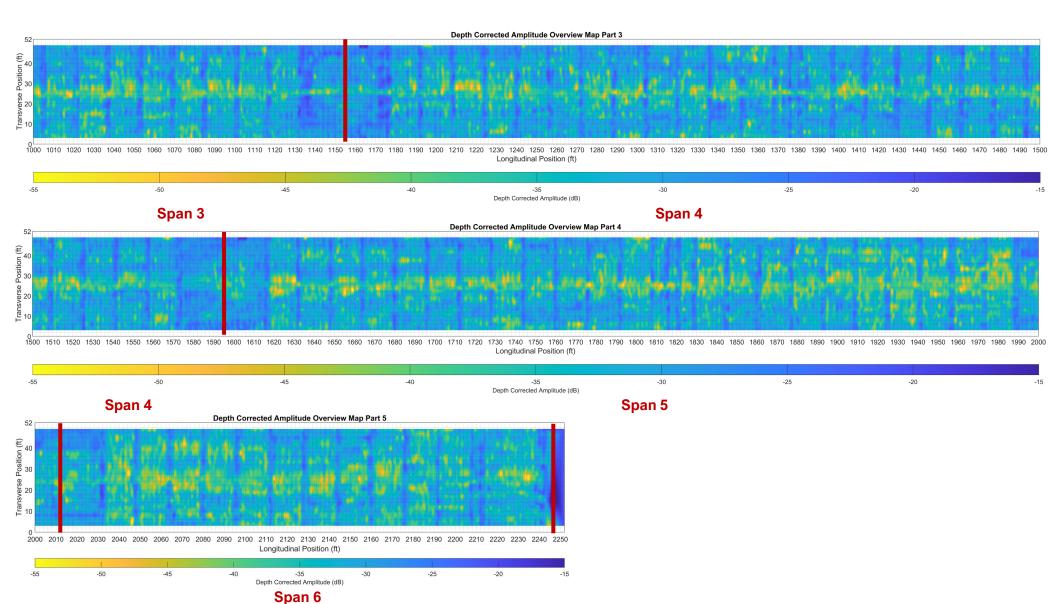
The figure below provides a map of the depth-corrected amplitude data. This data is a relative measure of moisture and chloride ingress into the concrete deck. Given the relative nature of GPR data, it is difficult to make absolute conclusions, but it is helpful to examine how the presence of moisture and chlorides vary spatially across the bridge. Overall, the results indicate about half of the surface areas has good to fair levels of moisture ingress throughout the deck, with 46.39% of the deck reflecting high signal attenuation, which historically correlates with areas of higher moisture ingress. This does not appear to be consistent with the low levels of cracking and delamination, and may be explained because a small amount of rain occurred in the area 3 days prior to testing.

Poor	Fair	Good	
Lower than -31 dB	Between -31 dB and -24 dB	Higher than -24 dB	
46.39%	47.46%	6.15%

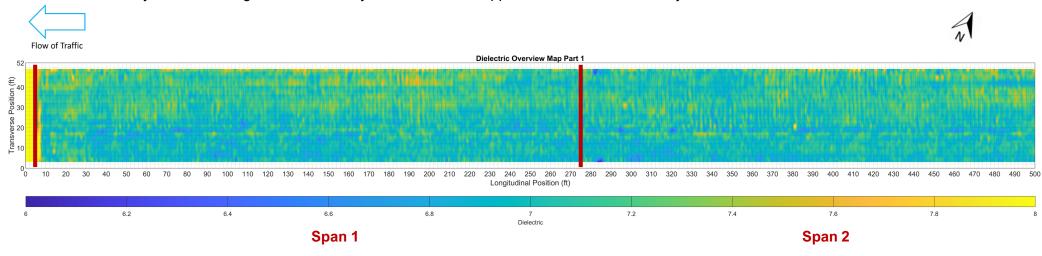
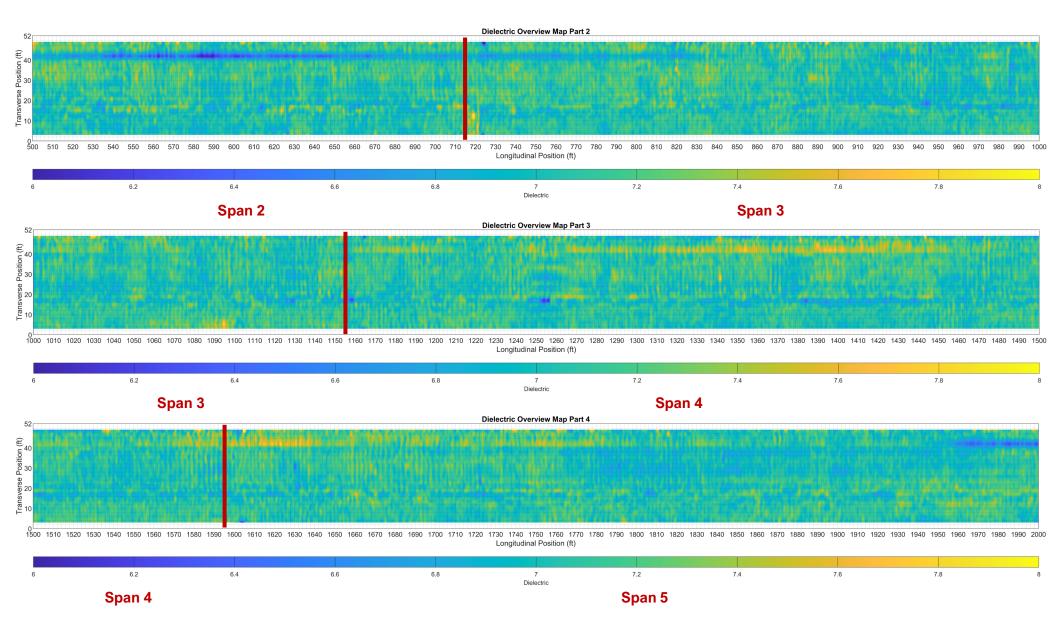
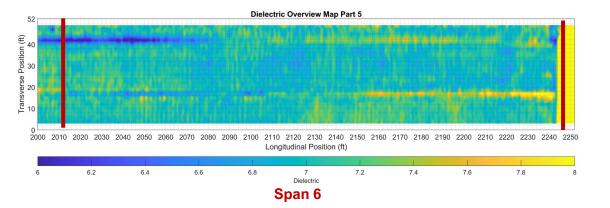
The results indicate that approximately 5% of the deck shows a higher potential for future delamination, extending beyond the small, isolated areas currently exhibiting signs of delamination. The zones with elevated potential are primarily aligned with the construction joint lines from the previous overlay placement. It's worth noting that these results may be slightly elevated due to rainfall that occurred three days before testing, as moisture may have remained trapped within the construction joints.

Below Average (OK)	Average for the Deck (OK)	Higher than Average (Potentially Contaminated)
Lower than 7 Between 7 and 7.5		Higher than 7.5
28.71%	65.55%	5.74%

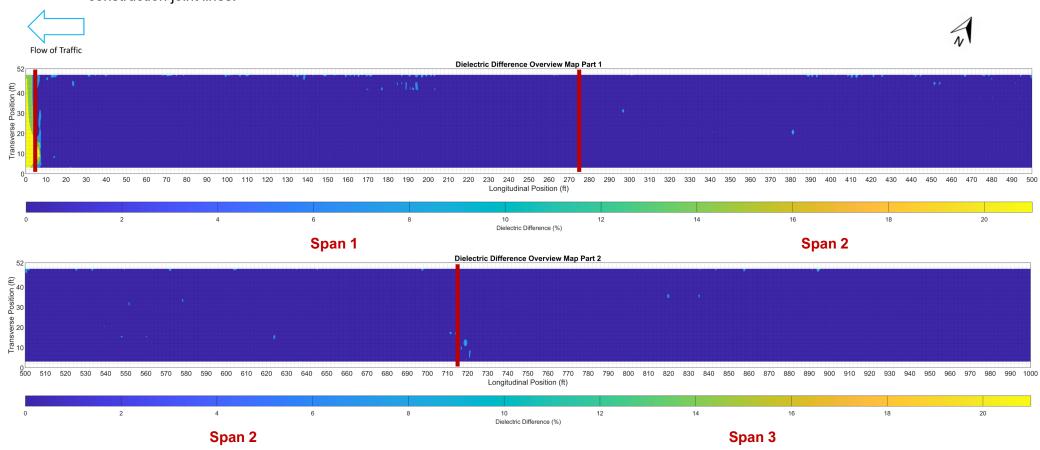
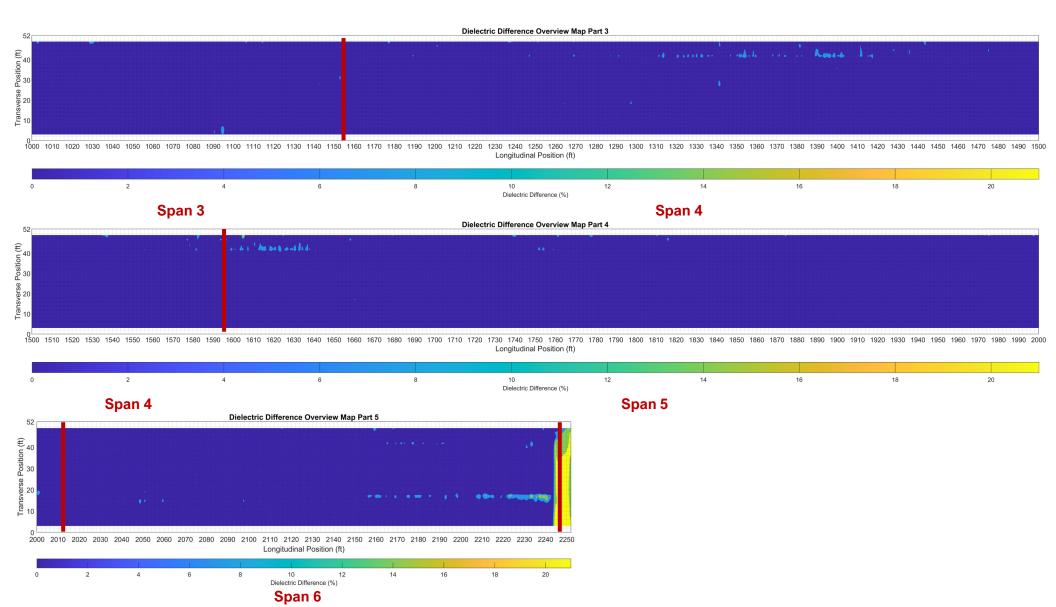
The following plot illustrates the areas of the deck with an increased dielectric constant compared to the entire deck's average. This is considered another representation of the data captured in the previous section. A higher dielectric constant value in concrete indicates regions where free-roaming ions can move more easily, thereby creating a more conducive environment for the corrosion cycle. Elevated dielectric constant values are often associated with higher moisture content or the presence of salts, both of which can accelerate the degradation of the concrete and reinforcing steel, ultimately turning into corrode rebars and delamination. The results show a small percentage of the deck with some potential for future delamination, again mostly concentrated along the overlay construction joint lines.

Percentage of Dielectric Increase Compared to the Average for the Deck			
	(0 – 7%)	[7% – 14%)	[14% – 21%)	>= 21%
Percentage of Surface Area	46.47%	2.11%	0.27%	0.37%
