UNDERWATER BRIDGE INSPECTION REPORT

SFN: 3102491	c36 Pier Walls: 2	Bridge Number: HAM-50-02.080
Substructure: 3	c42 Scour: 3	Inspection Date: 07/17/2020
Channel: 3	c51 Alignment: 3	Division: District 8
	c53 Hydraulic Opening: 2	River: Whitewater River

Structure ID #: HAM-50-02.080, Route 50 over the Whitewater River Date: 07/17/2020

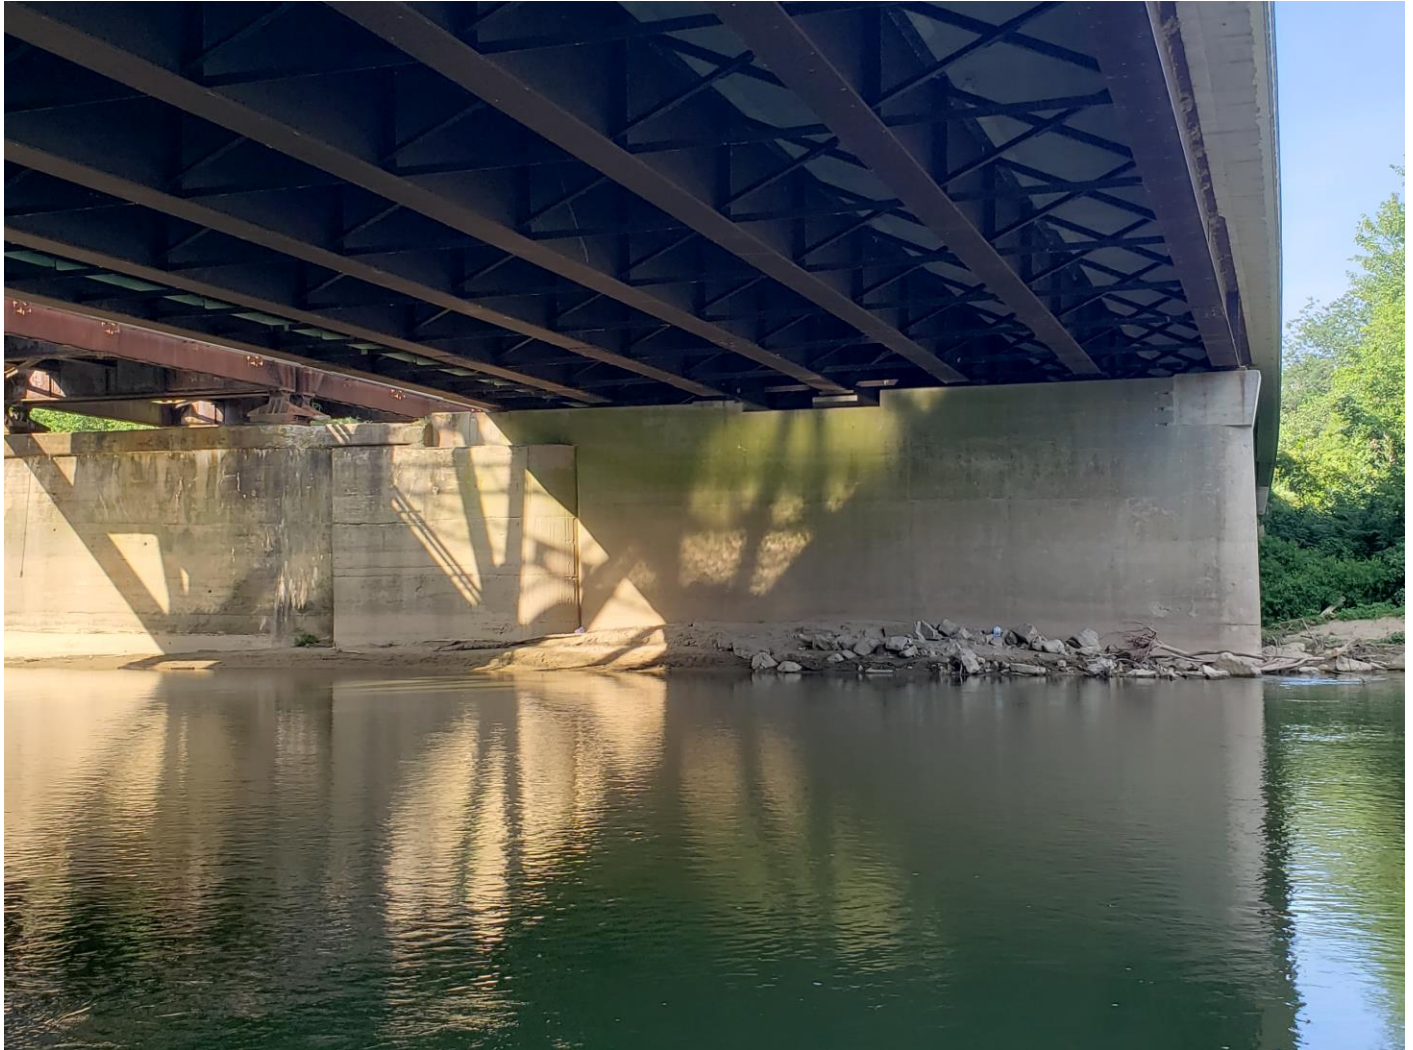
Description: East Face of Pier 2

11. The west face approximately 15' from the upstream nose and 1' above the mudline. One spall 5" diameter 1" diameter.
12. The east face approximately 4' from the upstream nose and 3' above the mudline. One spall 1.6' wide x 1' tall x 1/4" deep.

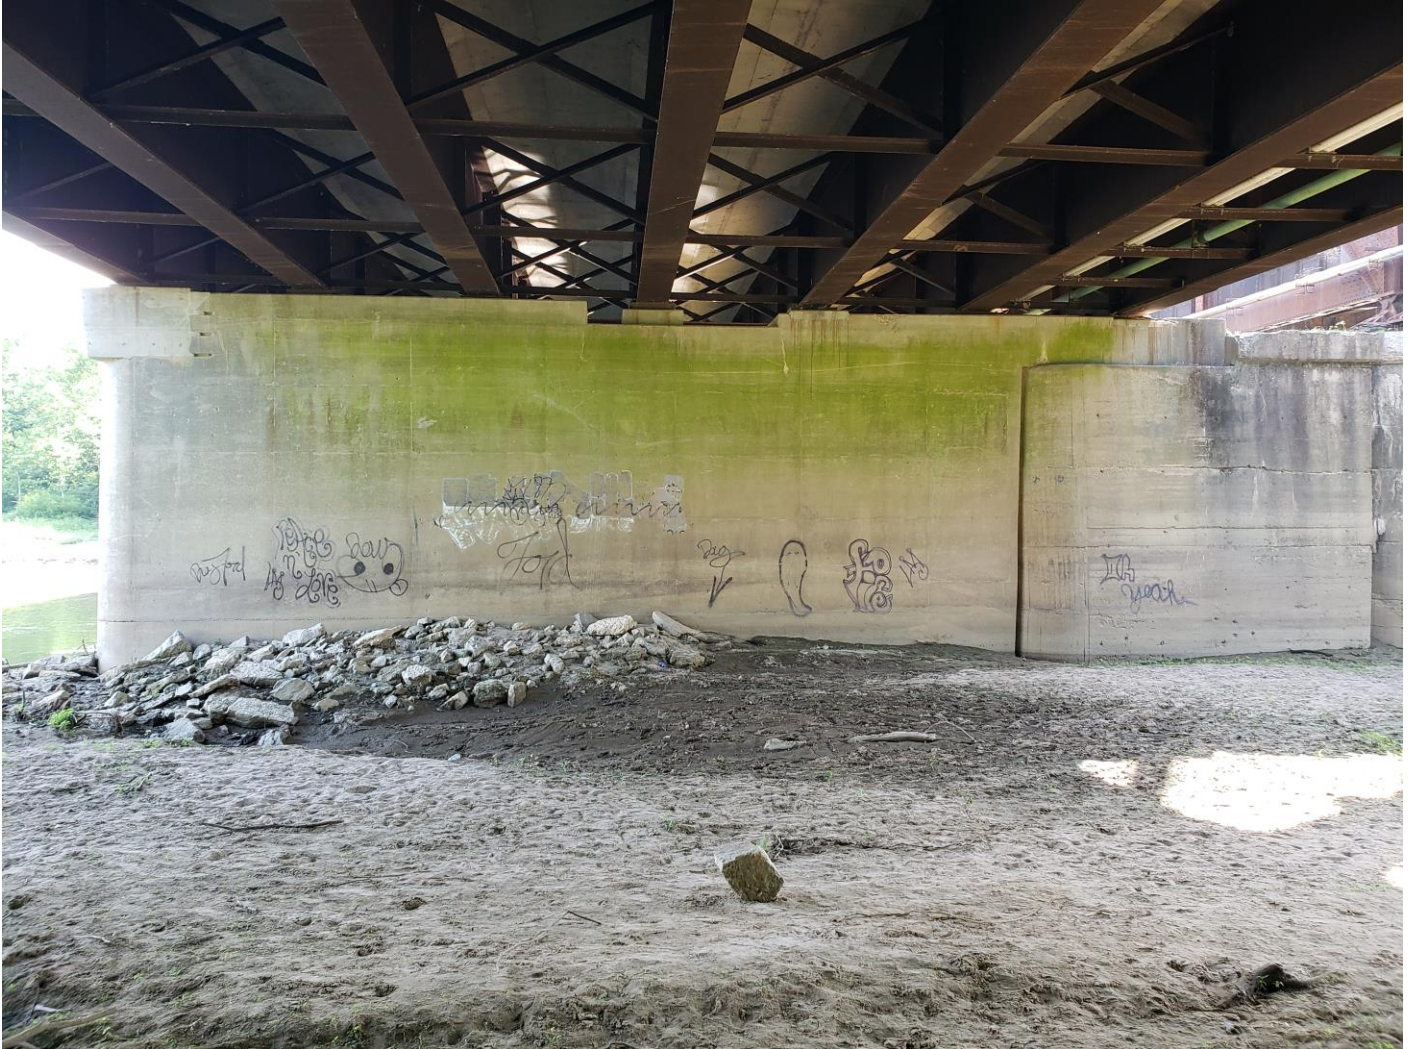
Description: West Face of Pier 2

10. The west face of the abandoned traction bridge pier has several various spalls approximately 0' to 3' above the mudline line. The spalls are approximately 5" diameter and up to 1" deep.

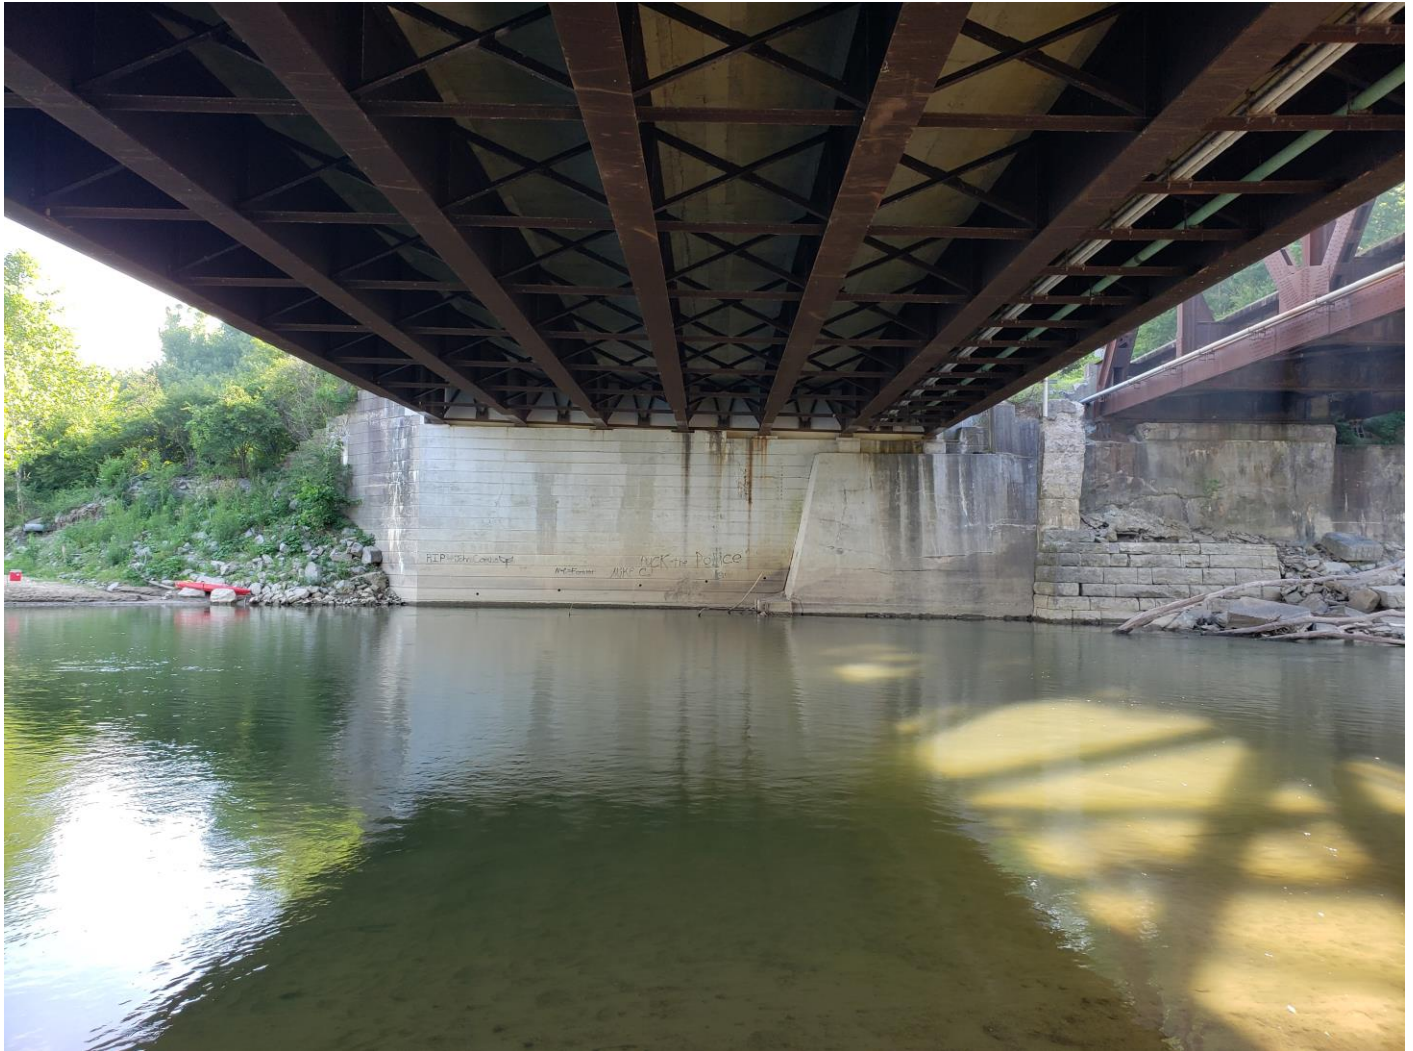
Description: East Abutment

The east abutment at the abandoned traction bridge is undermined. The vertical height of the undermined area was up to 18" and penetration of approximately 7'. Deep foundation wood piles were exposed. Due to buildup of tree debris in the water around the exposure area, we could not determine the number of piles or the full extent of the undermined area below the east abutment of the traction bridge.

1. Light marine growth (algae). Approximately 10% of the substructure unit was cleaned below the water line.
2. Visibility approximately 1.5'.
3. No foundation or footing exposure of the newer portion of the abutment. Undermining of the abandoned traction bridge abutment was found with wood pile exposure. Due to heavy build-up of tree debris in the water, the diver could not determine the number of exposed piles or the full extent of the undermined area.

8. Approximately 20' from the upstream corner of the abutment a 4' wide x 3' tall spall was observed out of the water.
9. Heavy tree debris accumulation as well as old wood pile and a 4x12 timber wall found in front and along the abandoned traction bridge abutment.

10. The sheet pile wall found at the nose of the abandoned traction bridge abutment is heavily corroded within the splash zone.

Remove tree debris on east abutment and determine the extent of the undermining. Implement scour countermeasures.

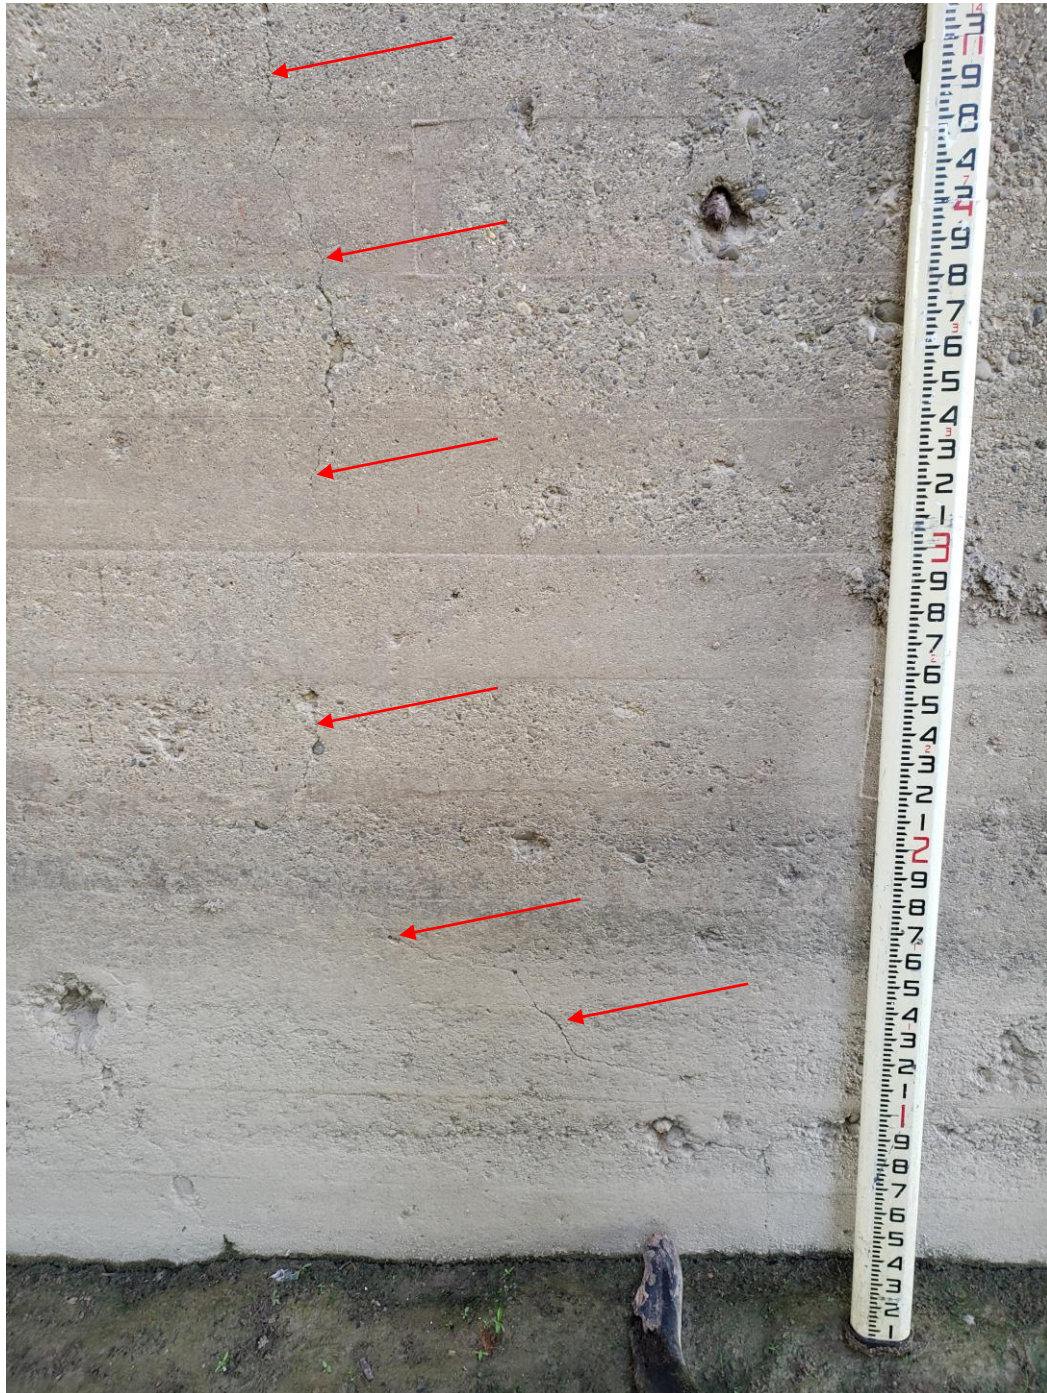
7. Minor scaling in the typical splash zone area.
8. Isolated to the upstream nose; construction joint has spalling of the edges and a gap of up to 1".
9. The west face of the abandoned traction bridge pier has a vertical crack 7' from the rear nose. The crack is approximately 1/8" wide max and is from the mudline up 6.5' to the first construction joint (see photo log page 10). No evidence of the crack on the east face.

Description: **Crack, West Face of Pier 2 Traction Bridge (no sign of crack on east face)**

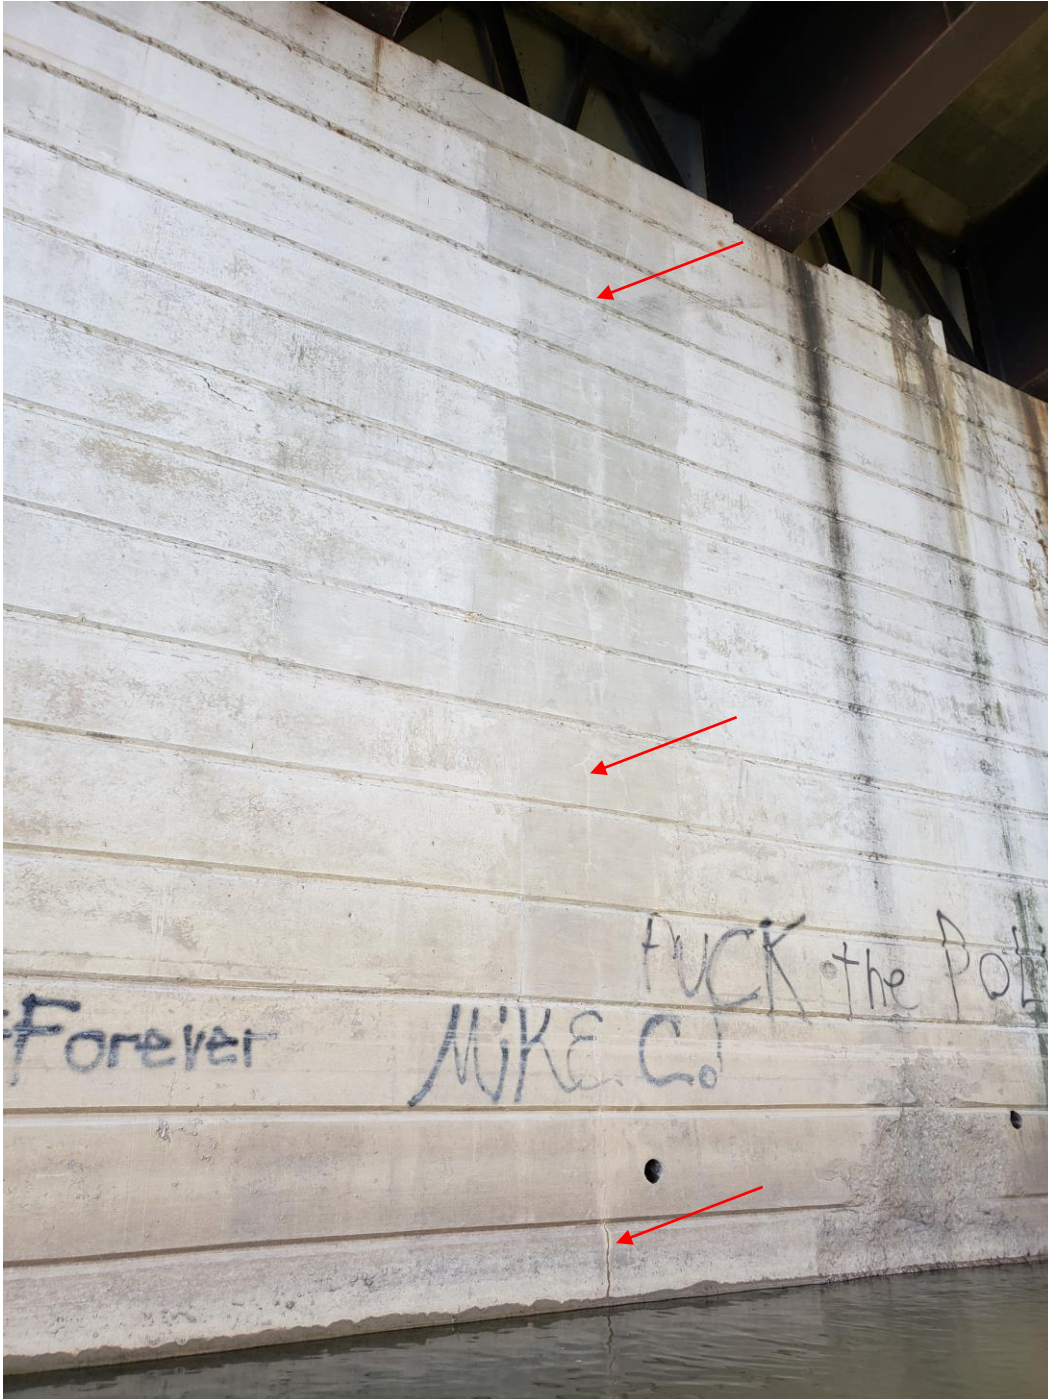
6. No significant defects were observed to be present below the waterline.
7. Approximately 15' from the upstream corner of the abutment a full height vertical hairline crack (max 1/16" wide) was observed from the mudline to the top of the abutment (see photo log).

Description: Full Height Hairline Crack, East Abutment (max 1/16" wide)

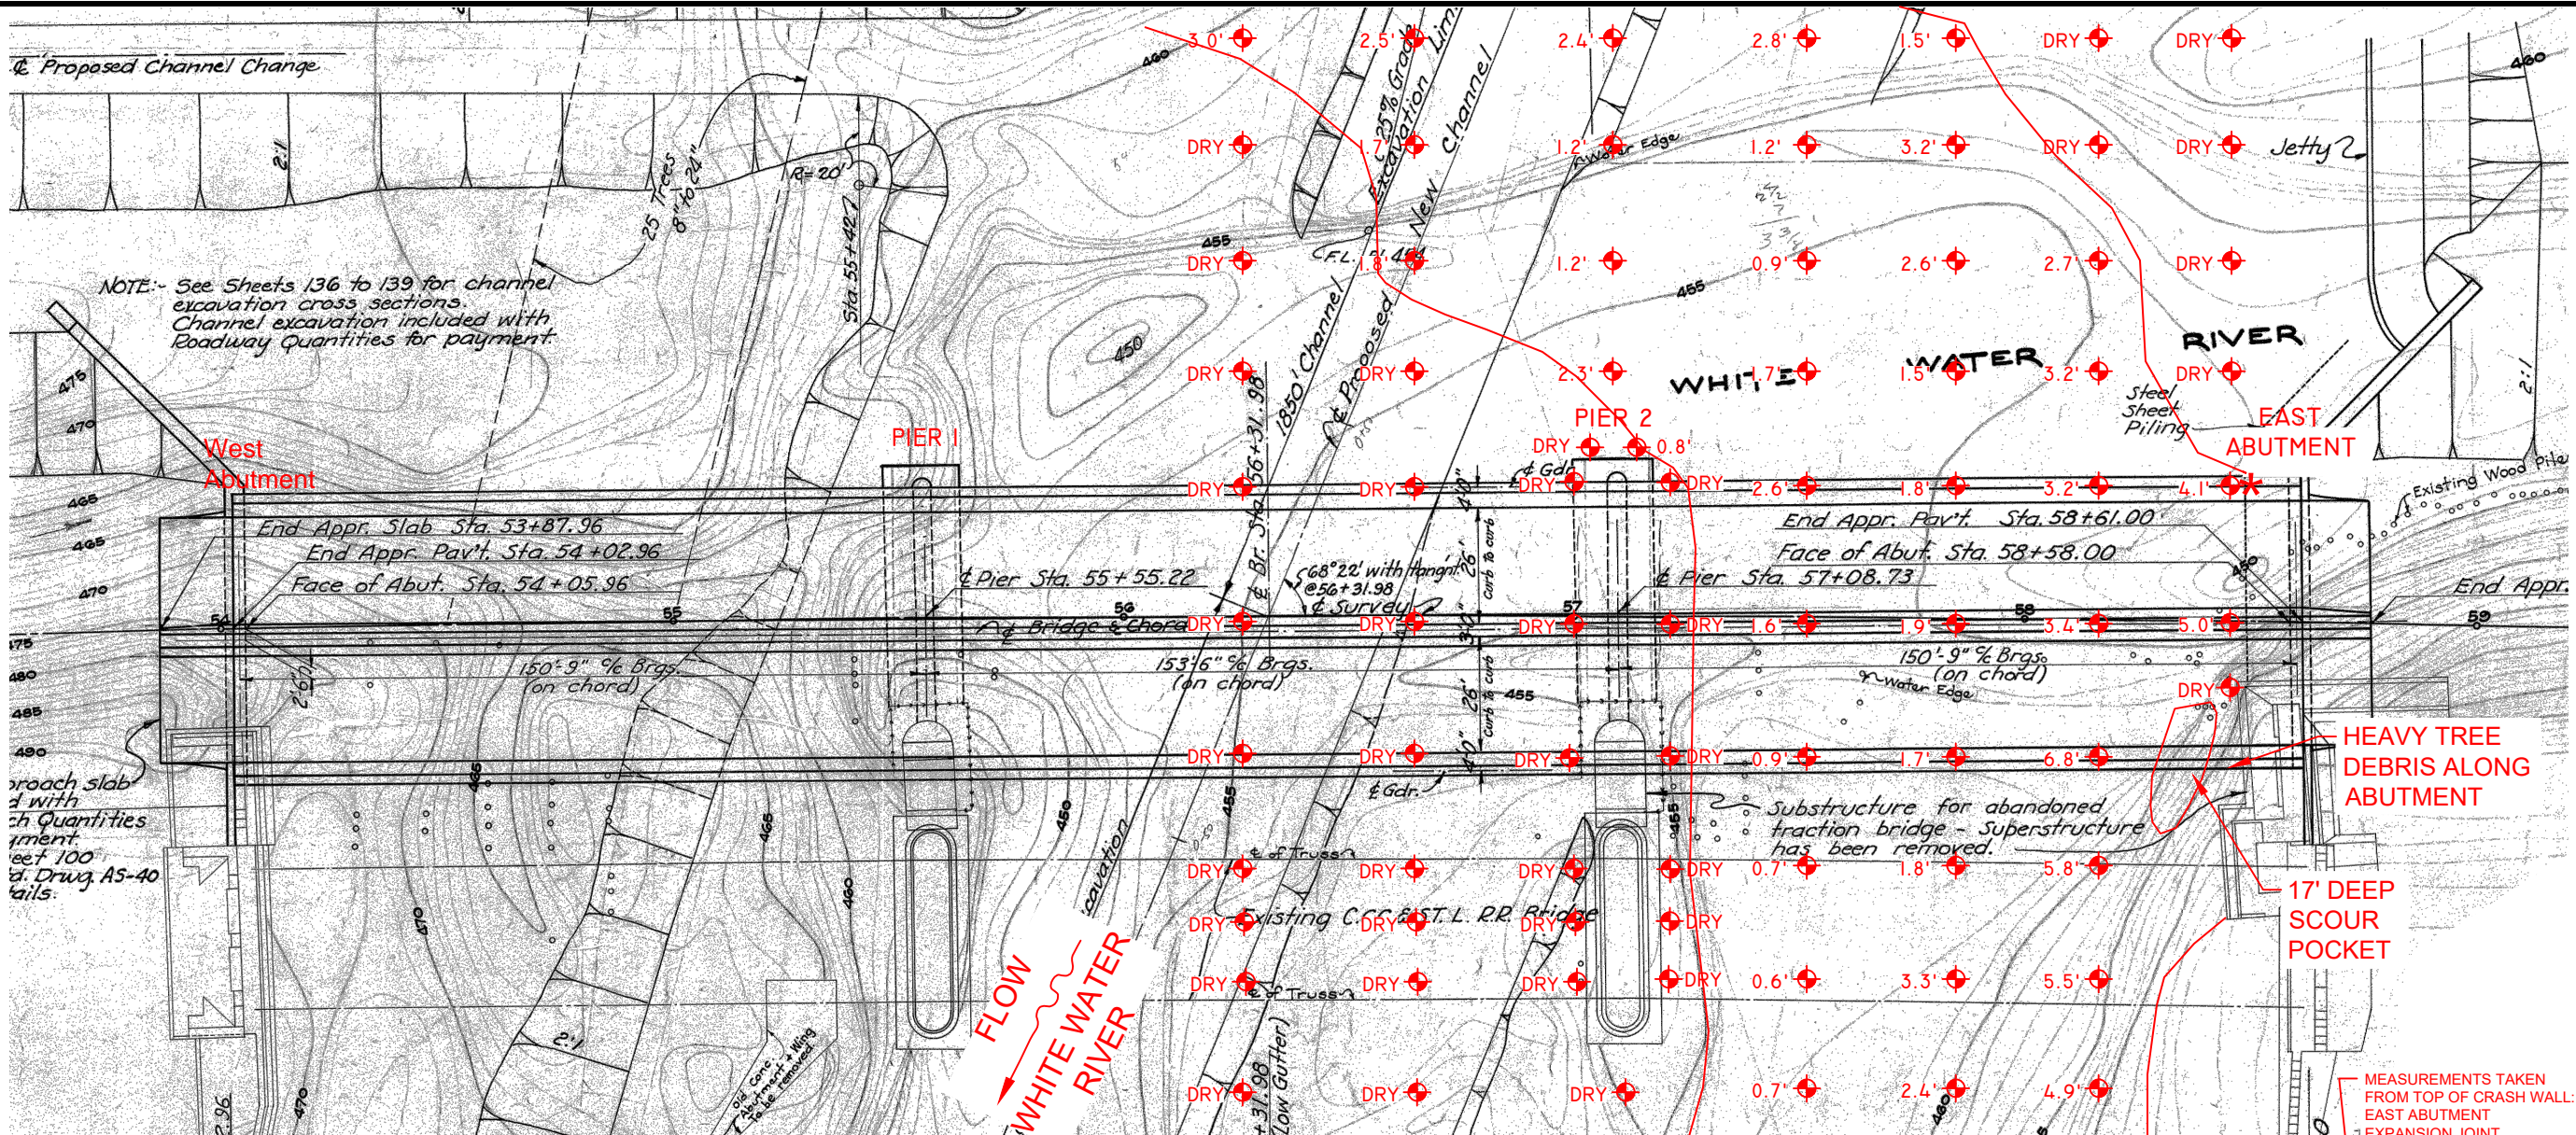
CROSS-SECTIONAL DEPTH PLAN (PARTIAL)
 BRIDGE NO. HAM-50-02.80
OHIO DEPARTMENT OF TRANSPORTATION-DISTRICT 8
 EXISTING C.C.C. & ST. L. R.R. BRIDGE OVER WHITE WATER RIVER
 HAMILTON COUNTY, OHIO

The channel has shifted to the east since initial construction, and the main channel is directed at the east abutment. A scour pocket has developed toward the downstream end of the east abutment between the abutment face and ¼ span. The approximate dimensions are 30' long x 15' wide x 17' deep. Heavy buildup of tree debris has collected in the scour area and along the downstream face of the east abutment.
