UNDERWATER BRIDGE INSPECTION REPORT

SFN: 3101924	c36 Pier Walls:	1	Bridge Number: HAM-27-1848R
Substructure: 7	c42 Scour:	1	Inspection Date: 08/06/2019
Channel: 6	c51 Alignment:	1	Division: District 8
	c53 Hydraulic Opening:	1	River: Great Miami River

Route: US 27

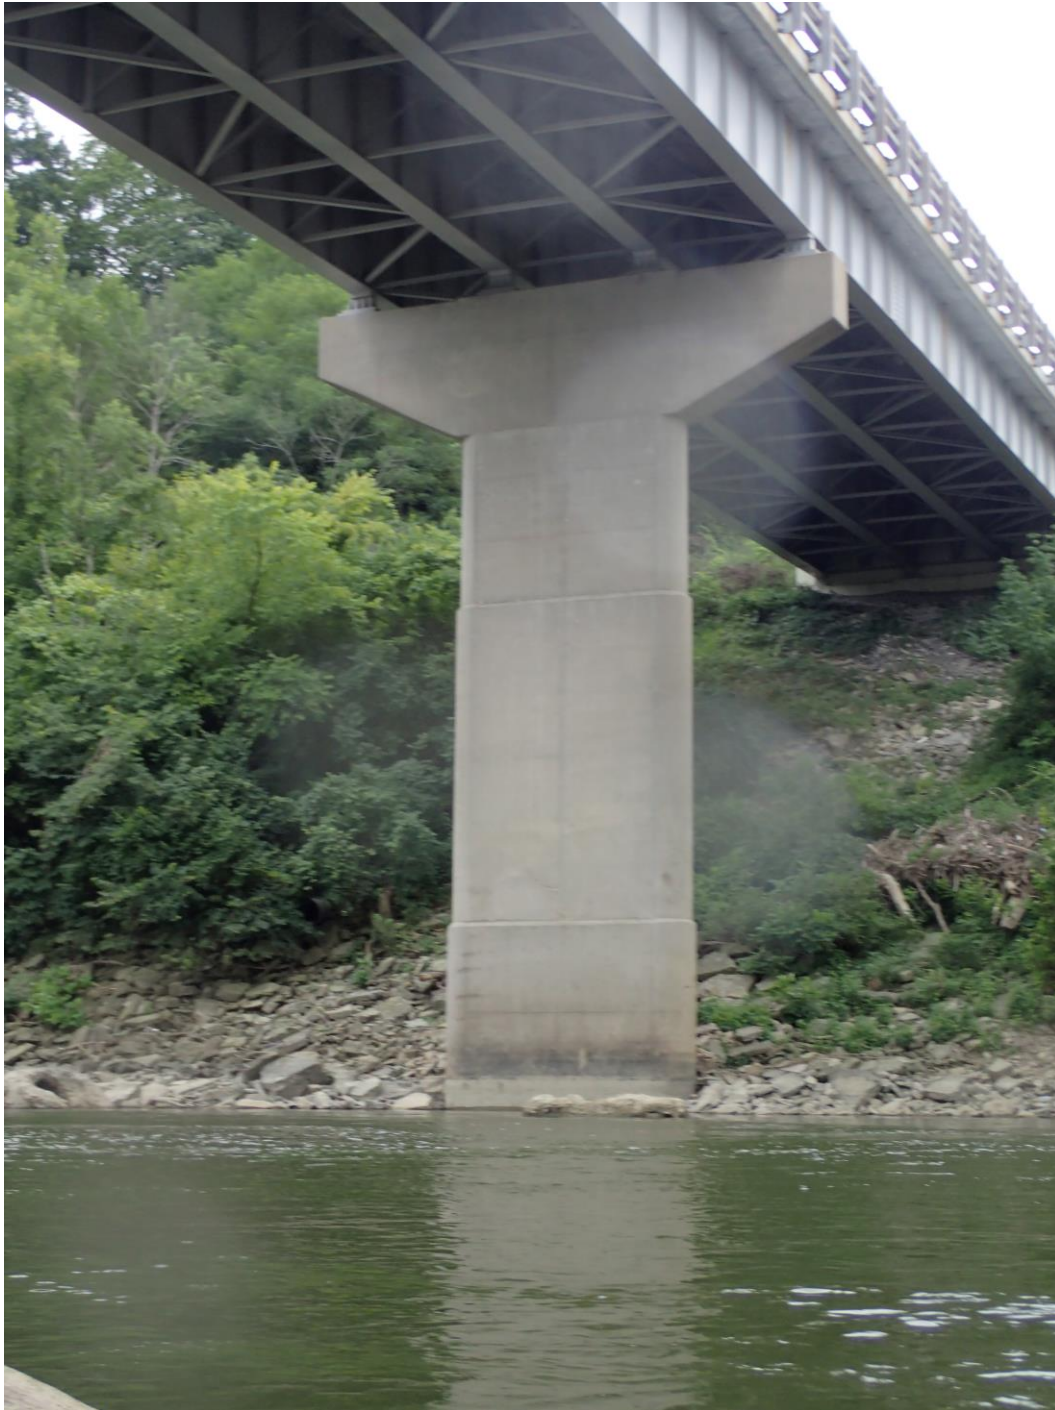
Description: **Pier 1R**

1. Pier 1R was primarily in the water with only a small portion on the north side in the water, with water depths less than 2'.
2. Light marine growth (algae). Approximately 10% of the substructure unit was cleaned below the water line.
2. Visibility less than 1'.
3. No foundation or footing exposure.
4. The bottom substrate around the base of pier 1L consisted of cobbles and boulders.
5. Hammer soundings of the concrete were performed along the entire length of the pier; no areas of unsound concrete (delaminations, voids, etc.) were noted.
6. Three large spall/damage areas believed to be from impact were noted on the north face approximately 3' to 5' downstream of the upstream nose. The damaged area was less than 12" in diameter and less than 1/2" in depth.
6. No significant defects were observed below the waterline.

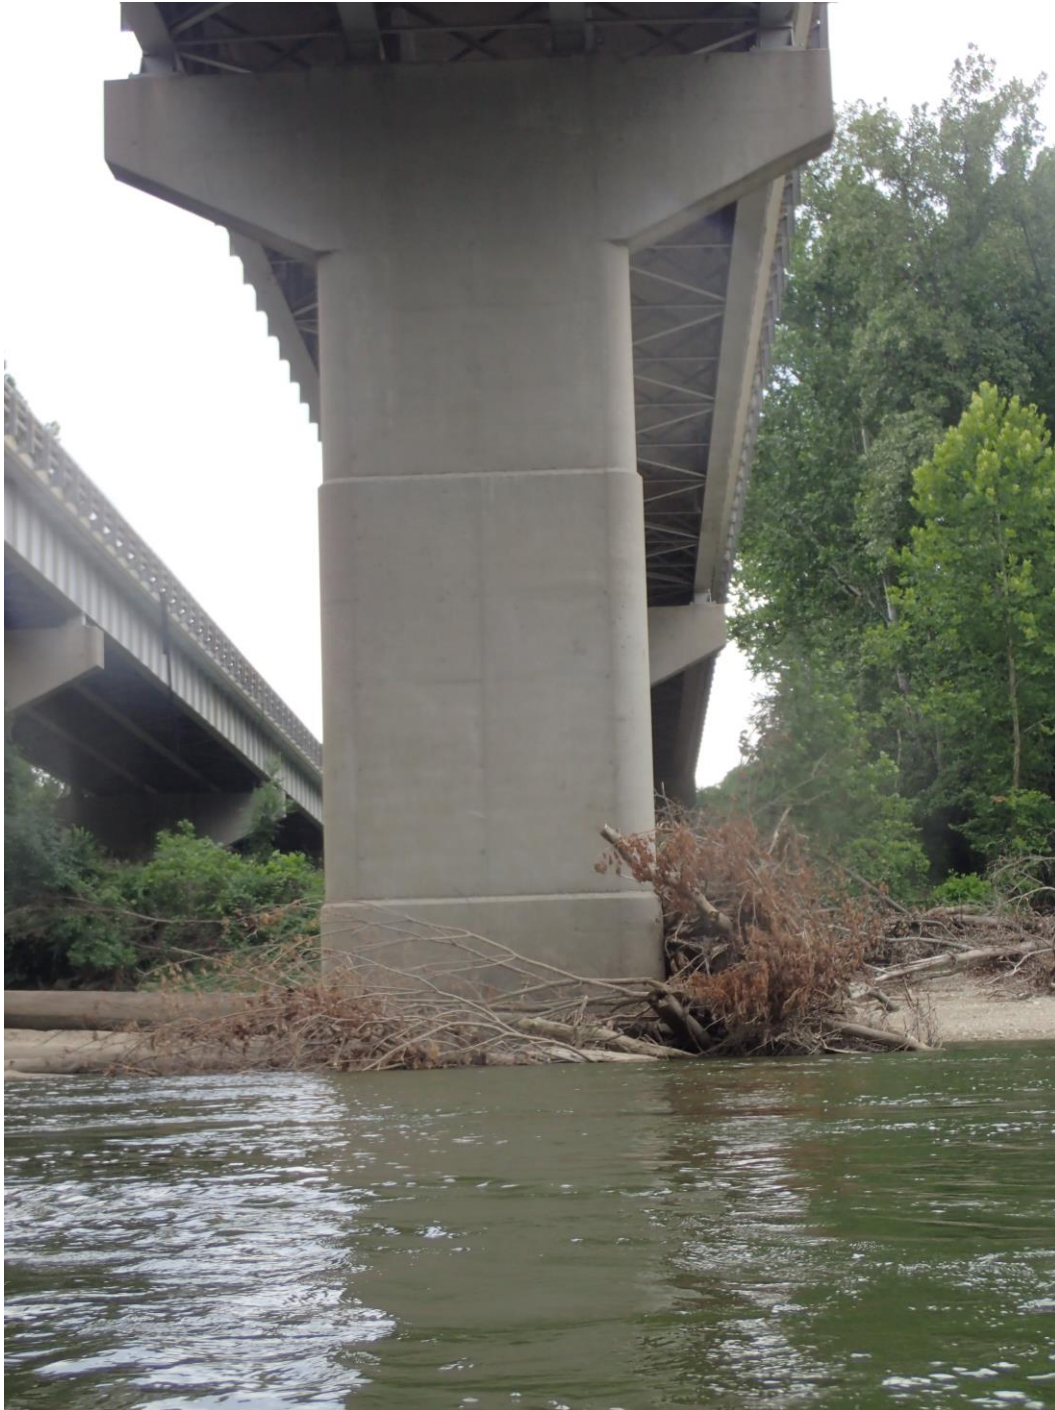
1. Extremely heavy tree debris was noted on the upstream nose and along both the north and south face. The debris was very dense and prevented inspection.
2. Local scour was noted on the upstream nose of pier 2R. The scour pocket noted measured approximately 20' in diameter and approximately 4' in depth.

Description: **Pier 2R South Face**

Remove debris from pier 2R.

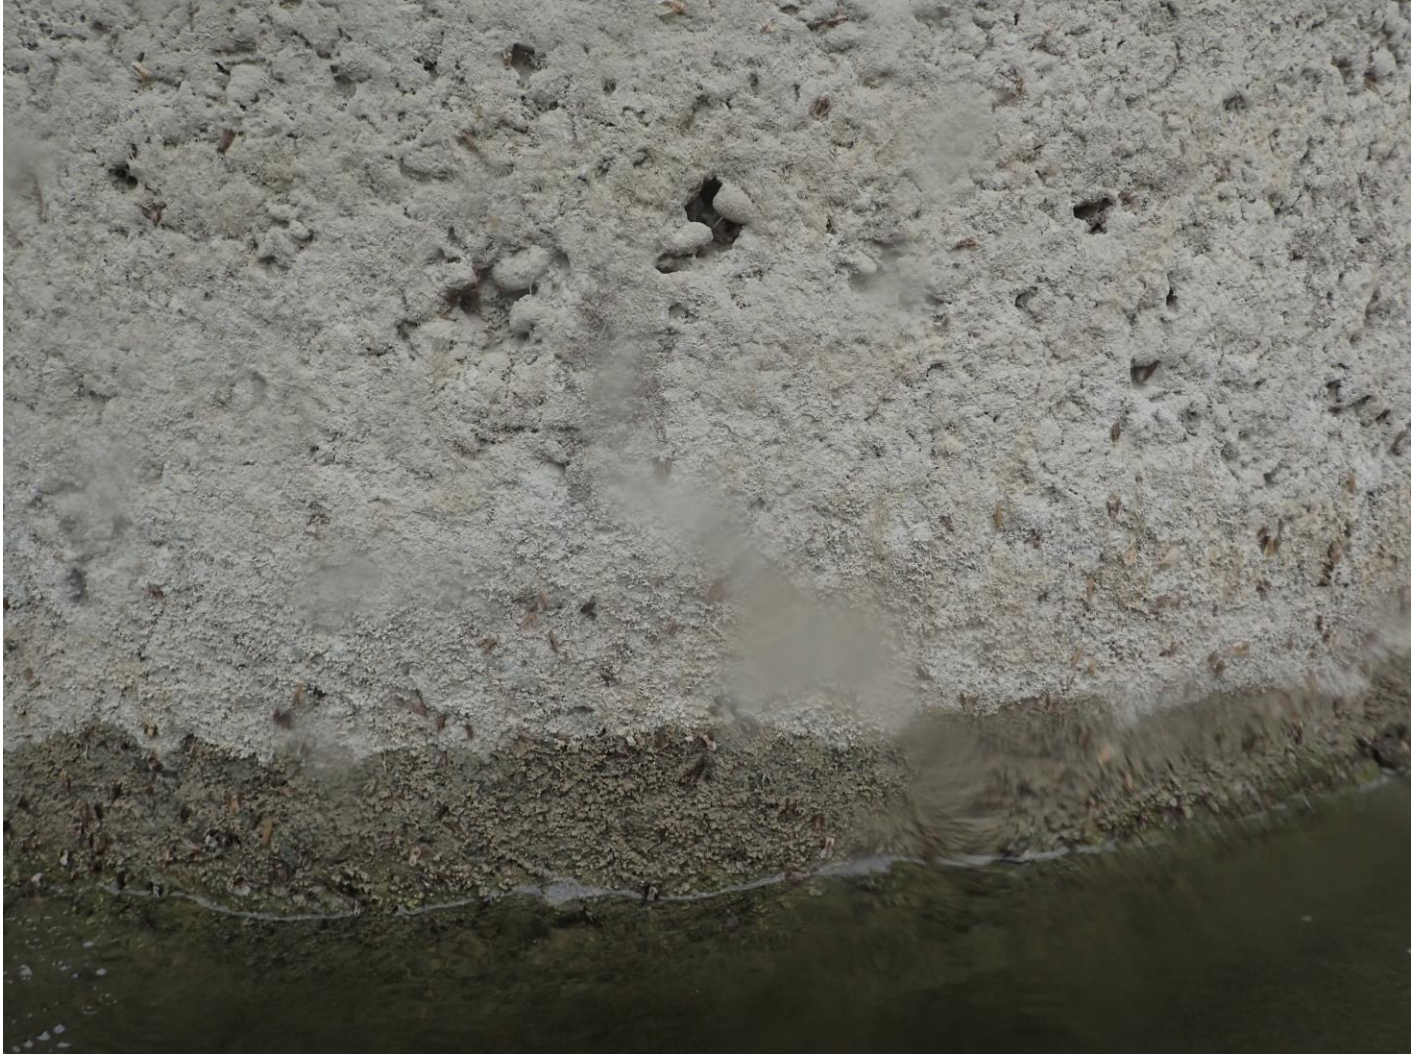
No significant changes since the last inspection in 2014. The concrete at and below the waterline was found in good condition with no significant distress.

Description: Typical Concrete Condition At Waterline

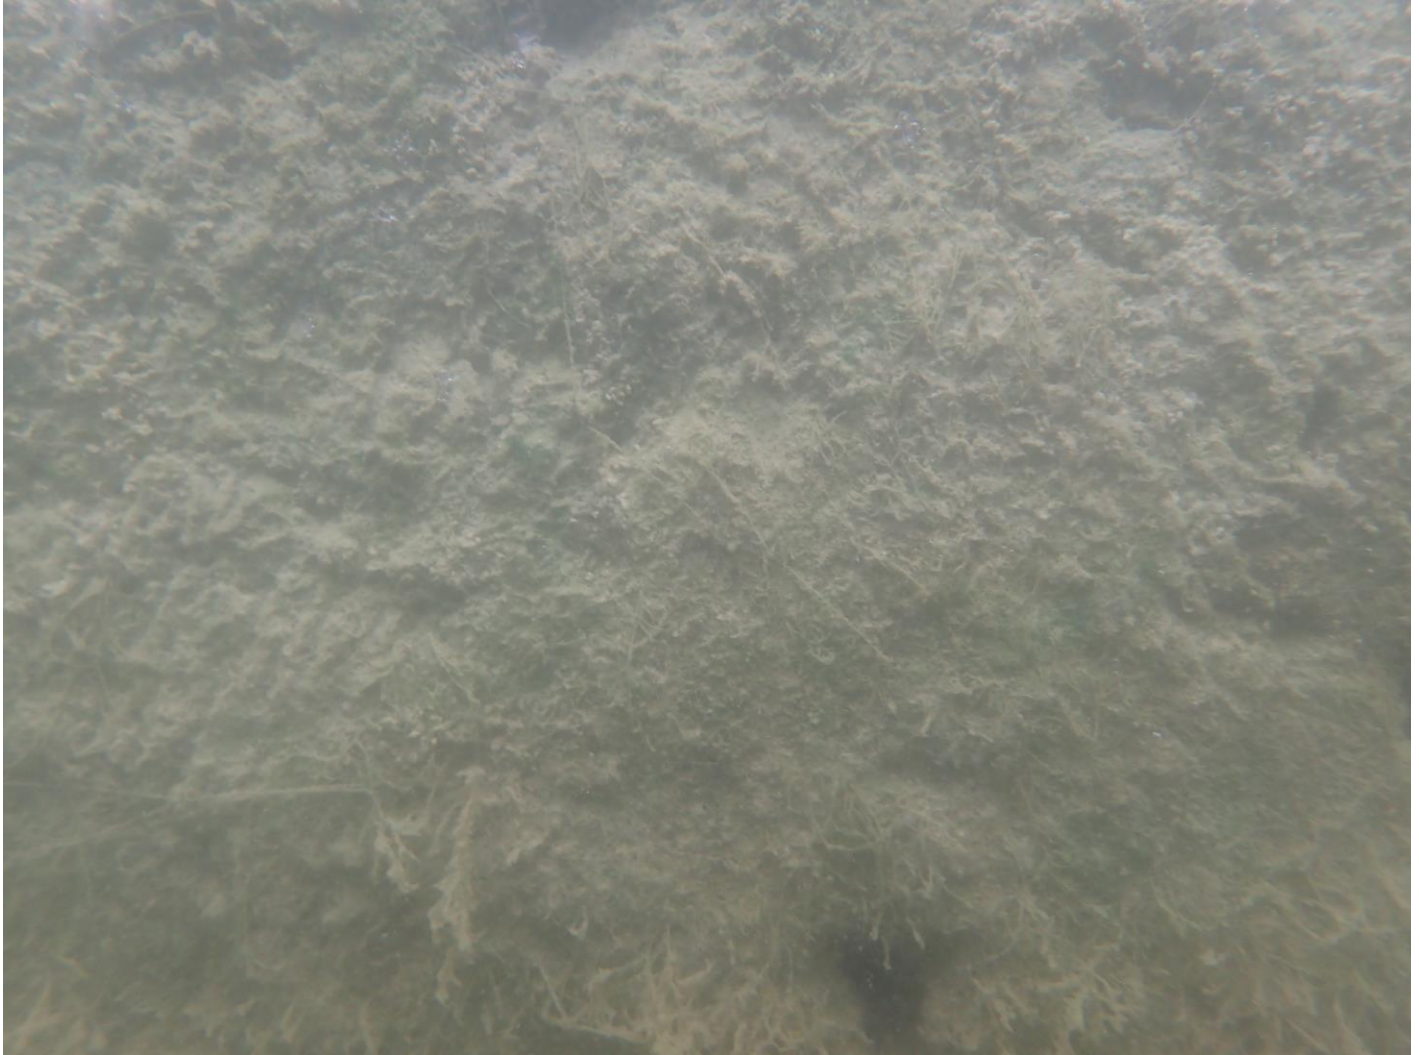
Description: **Typical Concrete Condition Below Water**

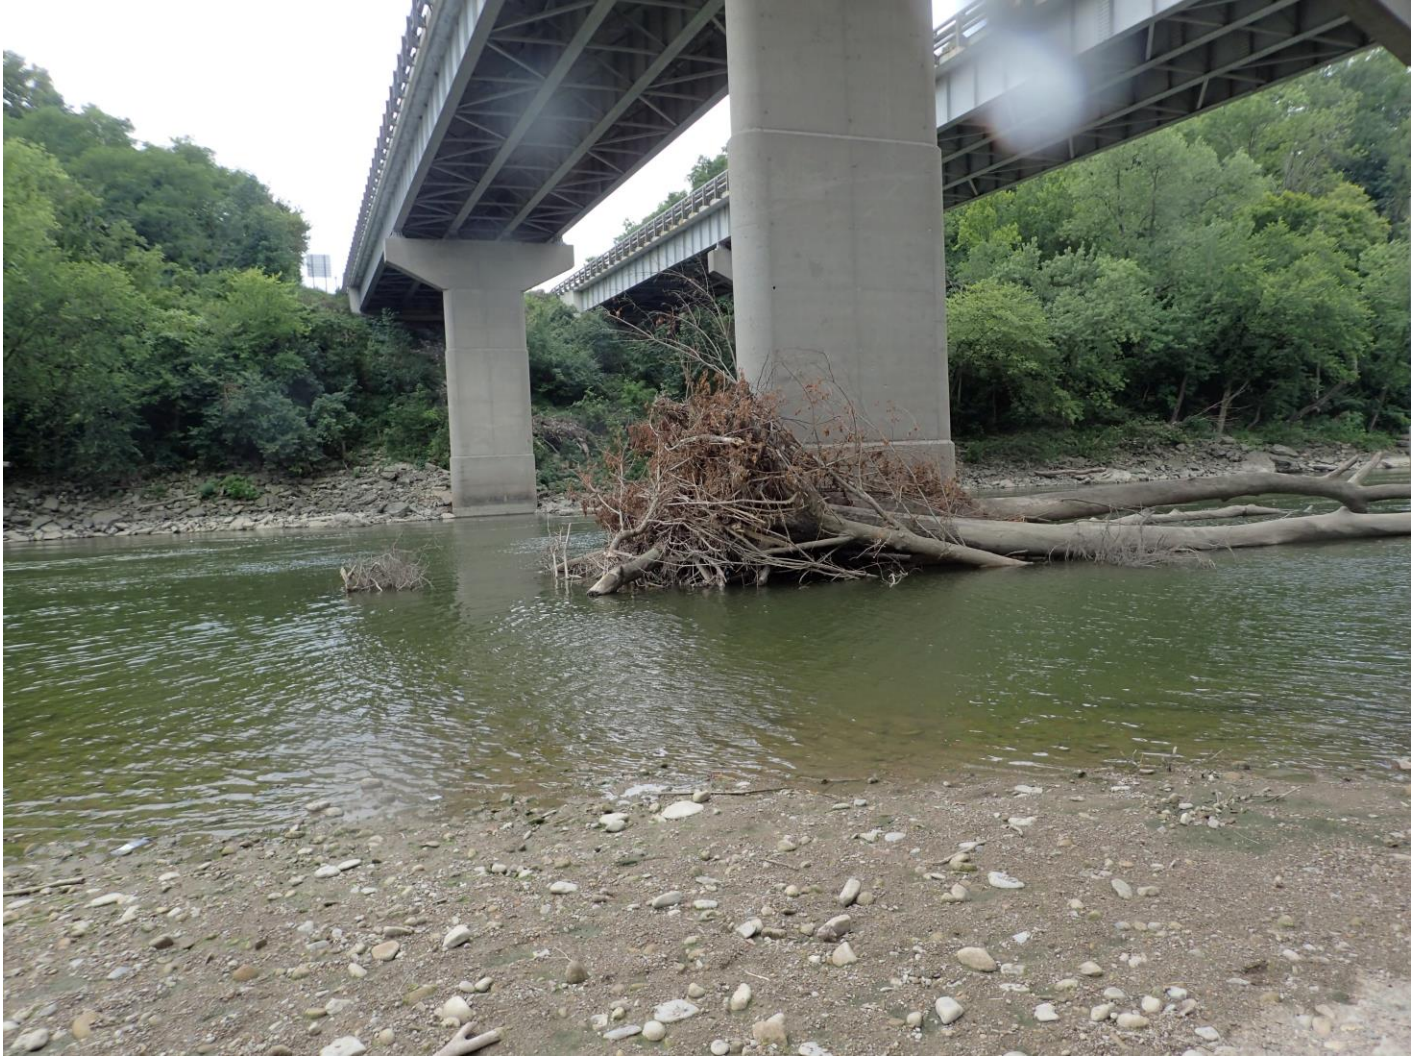
Local scour was noted on the upstream nose of pier 2R. The scour pocket noted measured approximately 20' in diameter and approximately 4' in depth. The scour pocket was located upstream of the large debris build-up. Extremely heavy debris was noted on the north side of pier 2R.

Description: **Pier 2R, Heavy Debris Upstream Face and both North and South Faces**

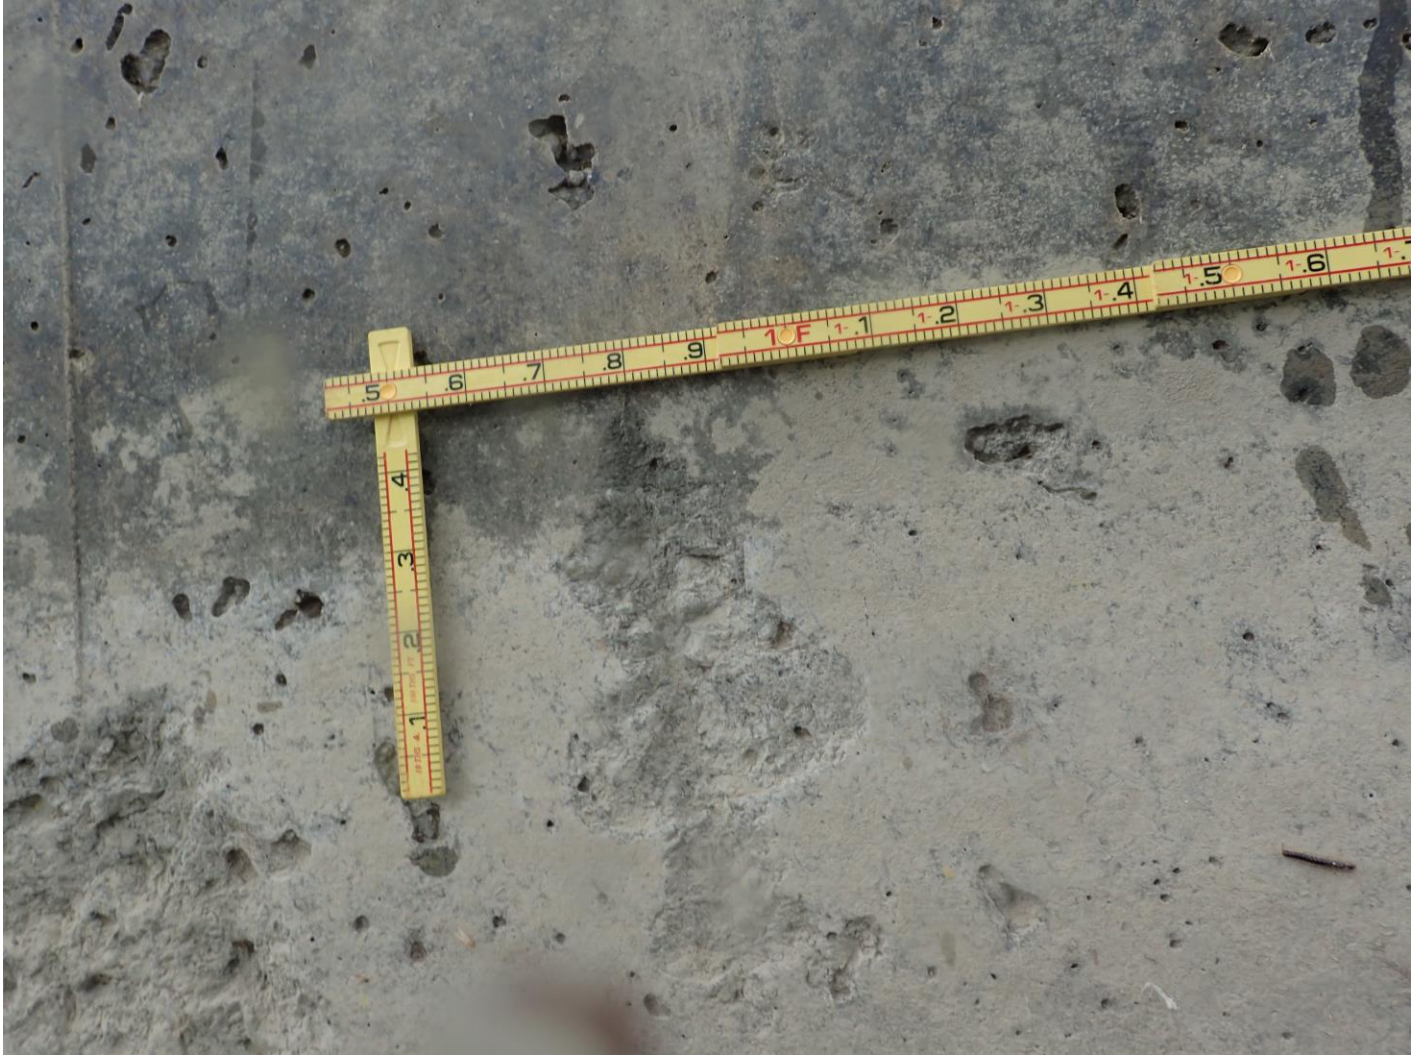
Description: Pier 1R, Spall/Damage 1

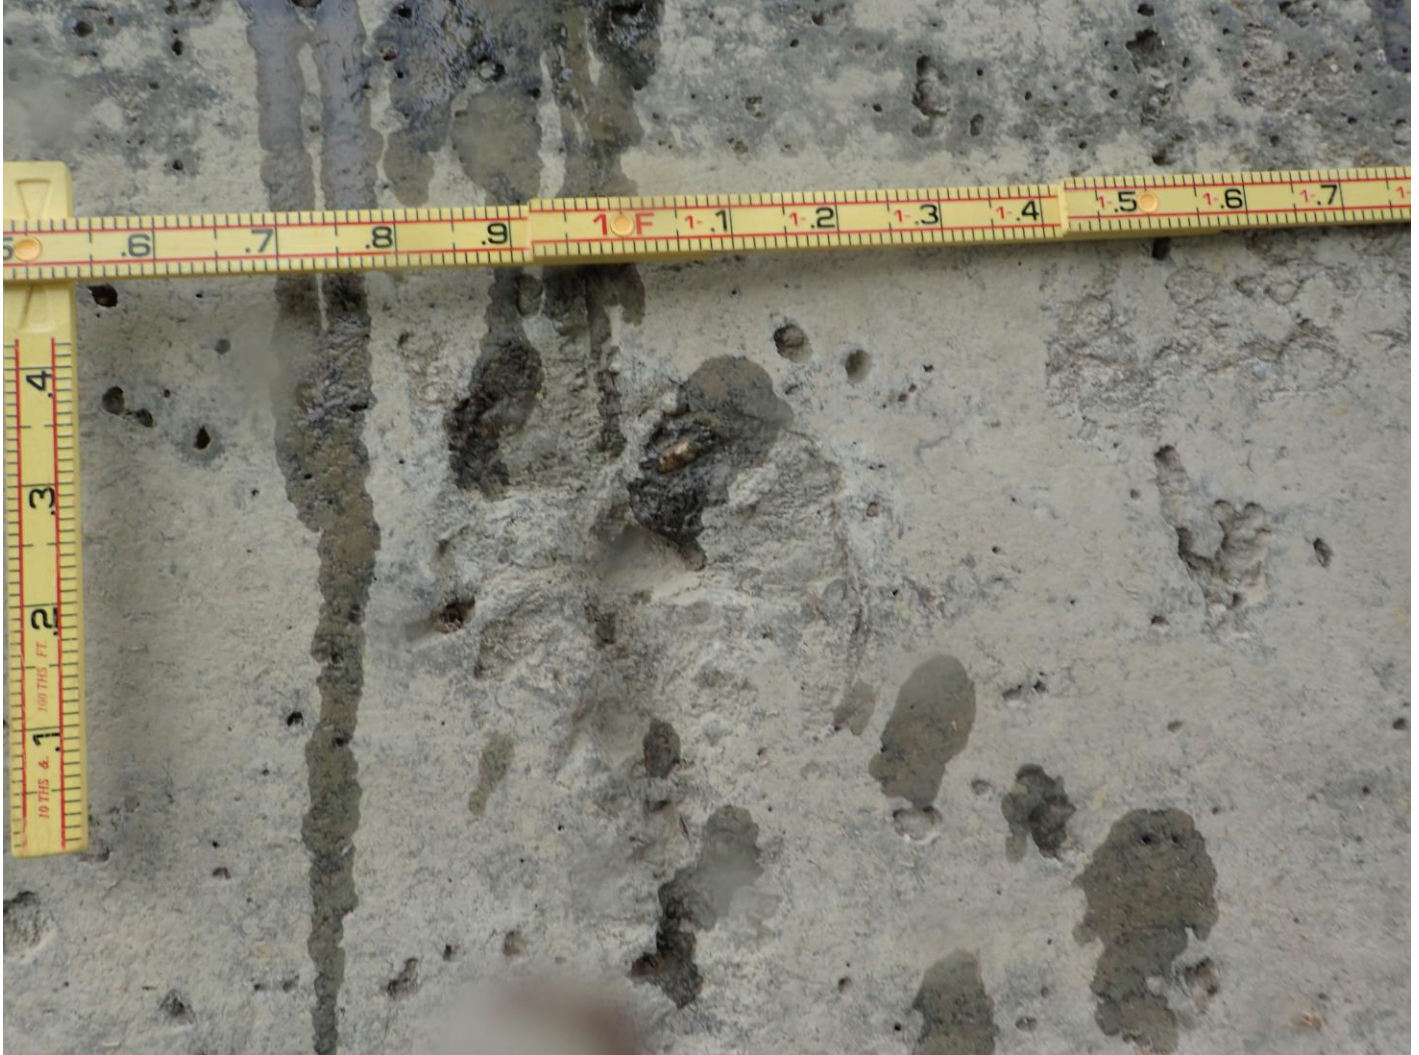
Description: Pier 1R, Spall/Damage 2

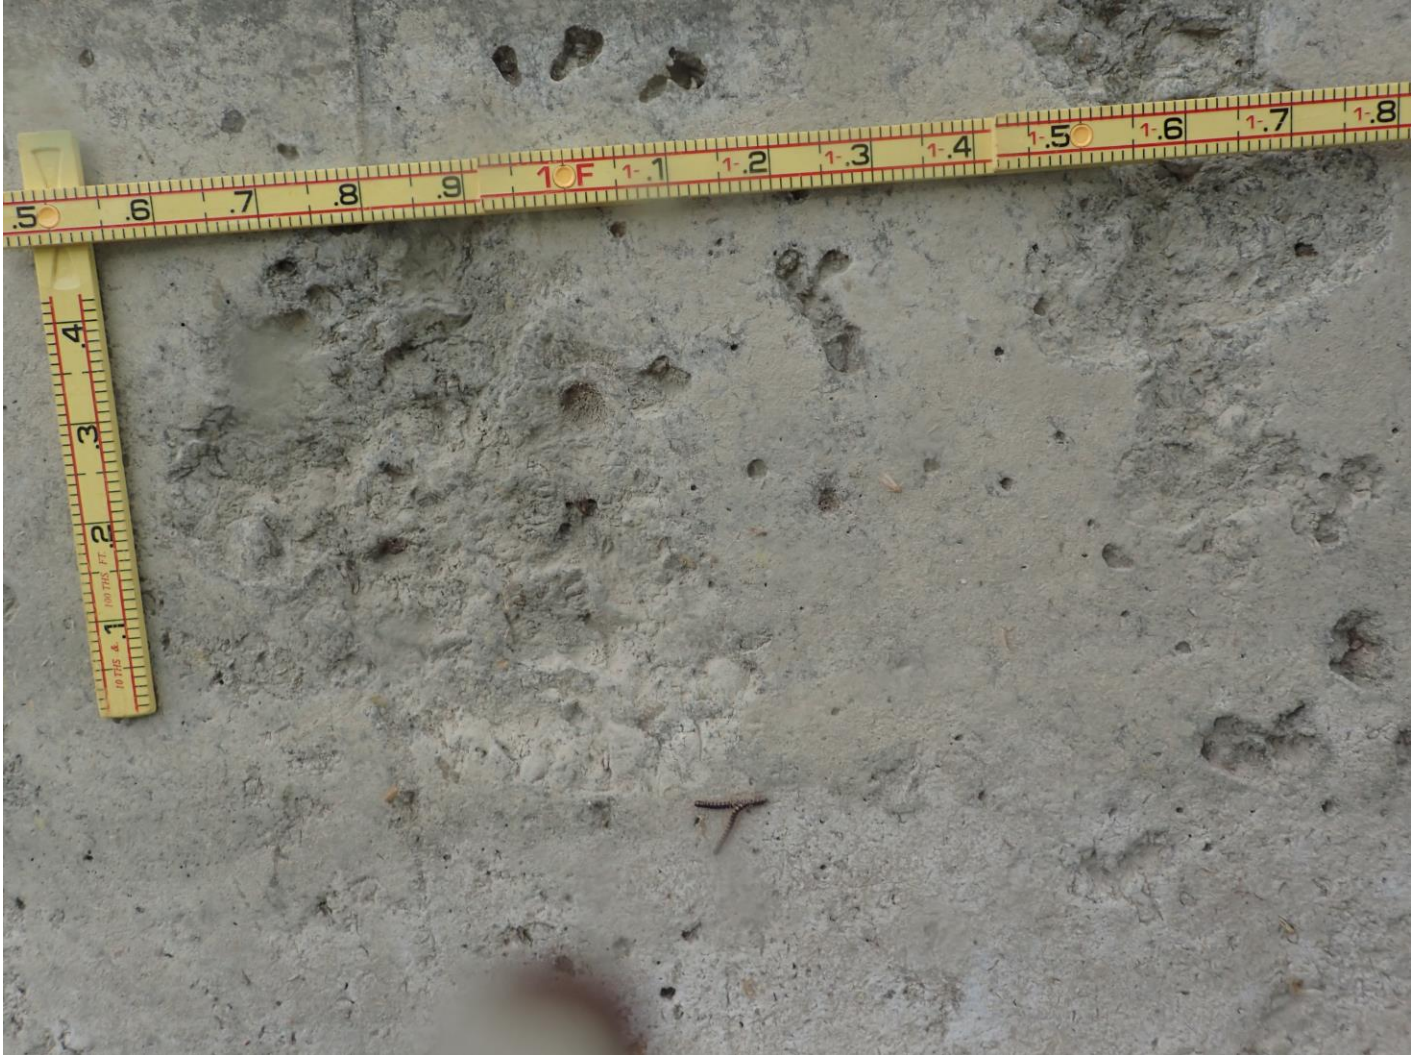
Description: Pier 1R, Spall/Damage 3
