UNDERWATER BRIDGE INSPECTION REPORT

SFN: 3102548	c38 Pier Columns:	1	Bridge Number: HAM-50-0376R
Substructure: 8	c42 Scour:	1	Inspection Date: 08/30/2019
Channel: 6	c51 Alignment:	2	Division: District 8
	c53 Hydraulic Opening:	1	River: Great Miami River

Structure ID #: HAM-50-0376R, US 50 over Great Miami River Date: 08/30/2019

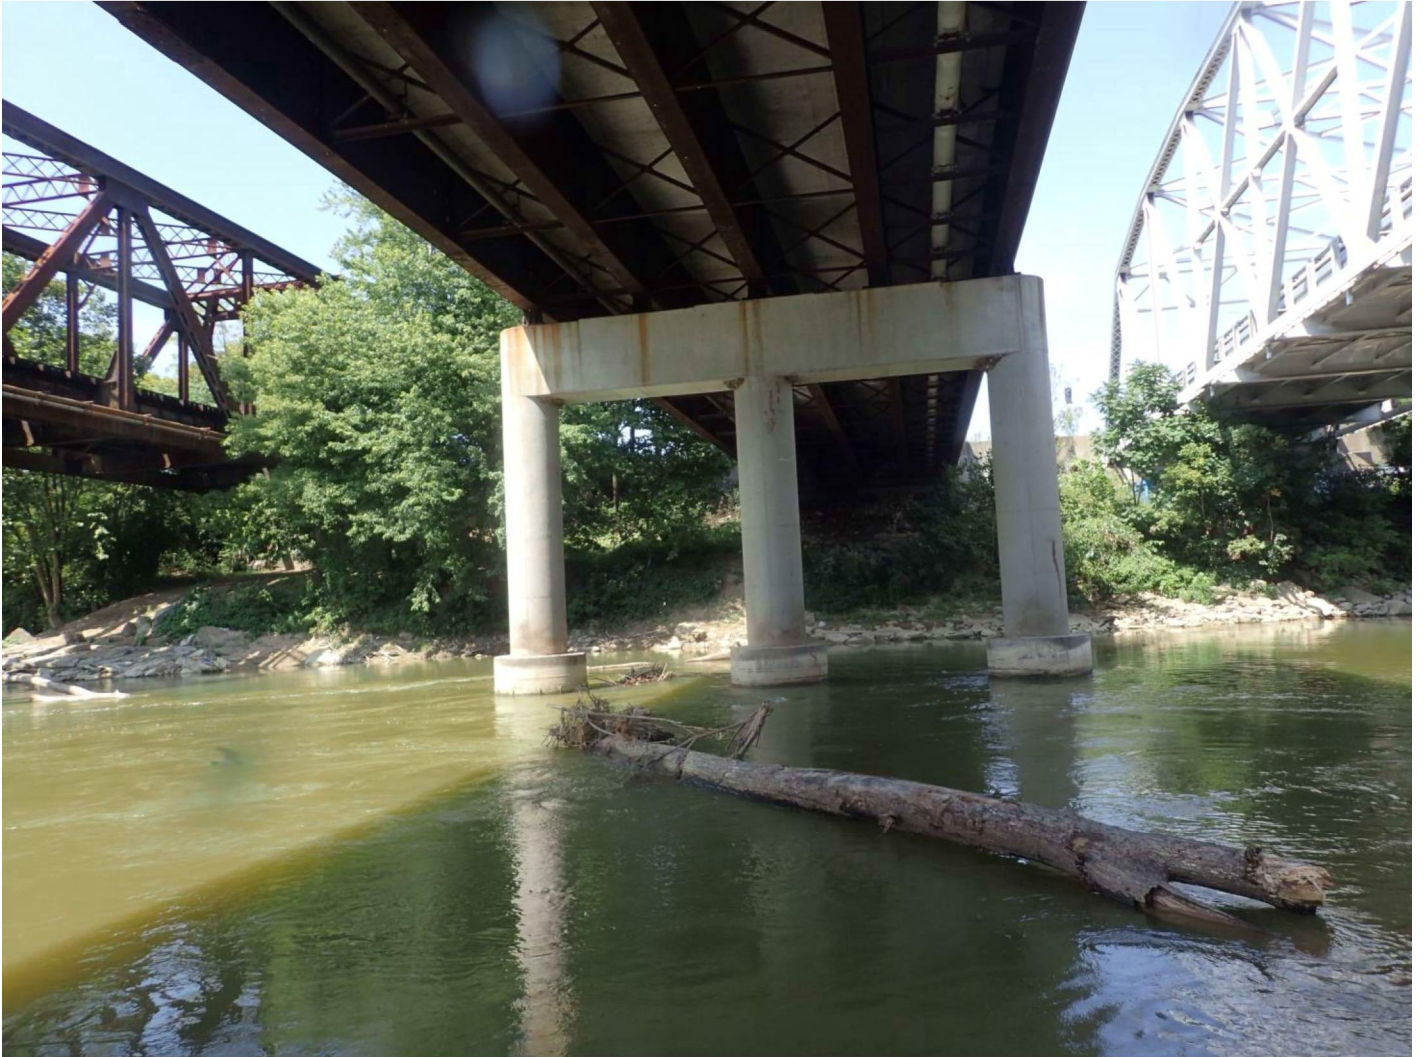
Description: **Pier 1 and West Abutment (Abutment 1)**

1. Light marine growth (algae).
2. Visibility less than 6".
3. No foundation or footing exposure.
4. The bottom substrate around the base of pier 1 consists of silty sand, gravel and cobbles.

5. Hammer soundings of the exposed concrete were performed along the entire length of the pier columns; no areas of unsound concrete (delaminations, voids, etc.) were noted.

6. The drilled shaft columns are encased in steel casing and at the time of the inspection approximately 10" of the steel casing was found to be above the water line.

7. The steel casing was noted to be lightly corroded, with minor pitting.
8. The concrete condition at the interface between the cased and uncased portion was good.

9. Moderate to heavy tree debris was noted along the west side of column 1 (south column) and column 2 (middle column), including two large trees with root balls. The west side of these pier columns could not be fully inspected due to the tree debris. While these pier columns are encased in steel casing and the foundation of the pier are drilled shafts, we recommend the removal of the debris, as it could be a contributor to the channel degradation.

Remove tree debris from pier 1.

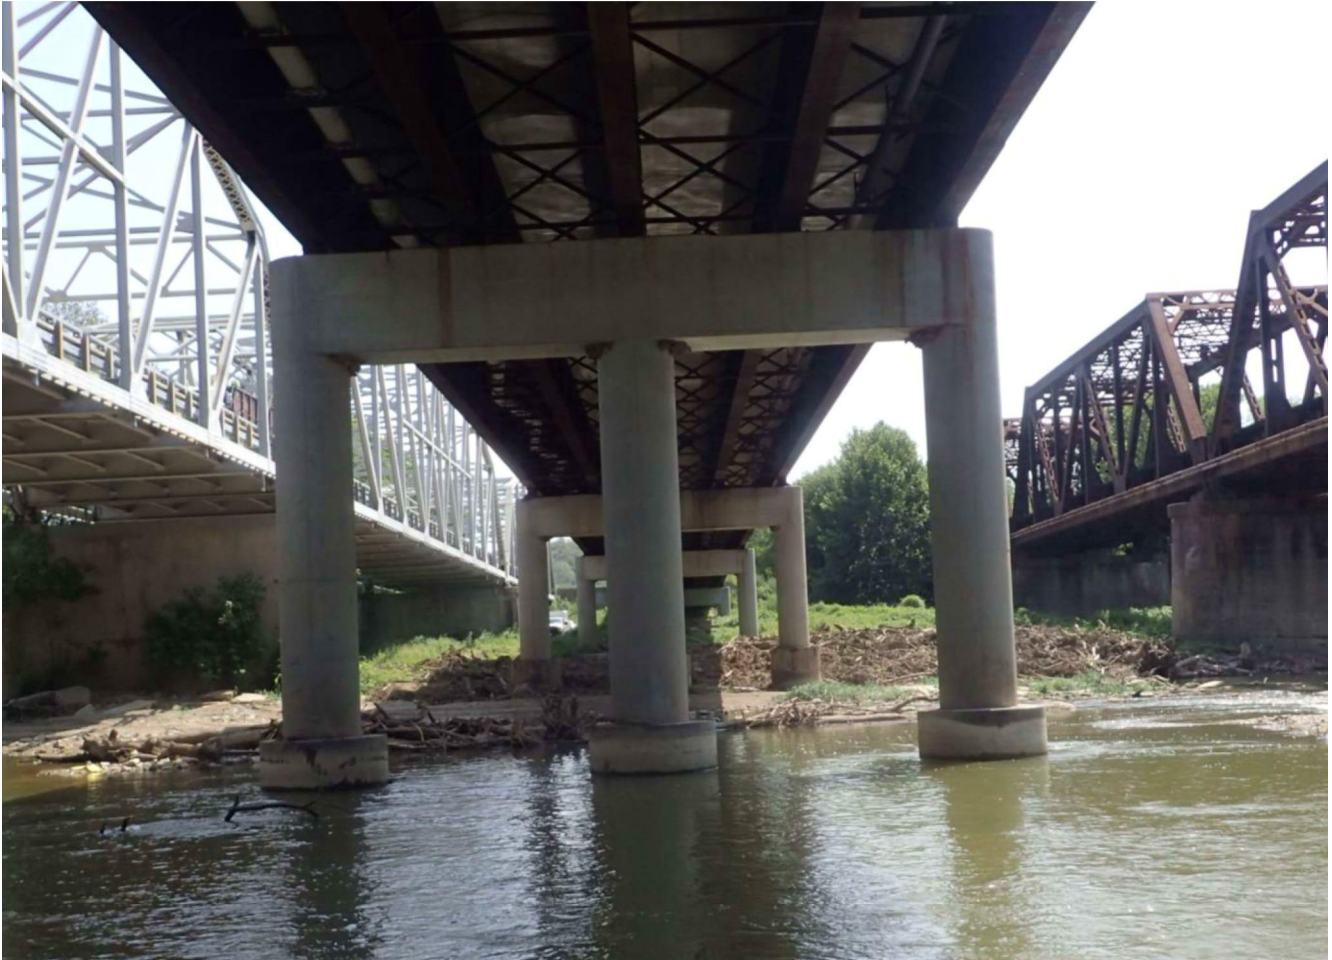
Description: **Pier 2**

1. Light marine growth (algae).
2. Visibility less than 6".
3. No foundation or footing exposure.
4. The bottom substrate around the base of pier 2 consists of silty sand, gravel and cobbles.
5. Hammer soundings of the exposed concrete were performed along the entire length of the pier columns; no areas of unsound concrete (delaminations, voids, etc.) were noted.
6. The drilled shaft columns are encased in steel casing and at the time of the inspection approximately 10" of the steel casing was found to be above the water line.
7. The steel casing was noted to be lightly corroded, with minor pitting.
8. The concrete condition at the interface between the cased and uncased portion was good.

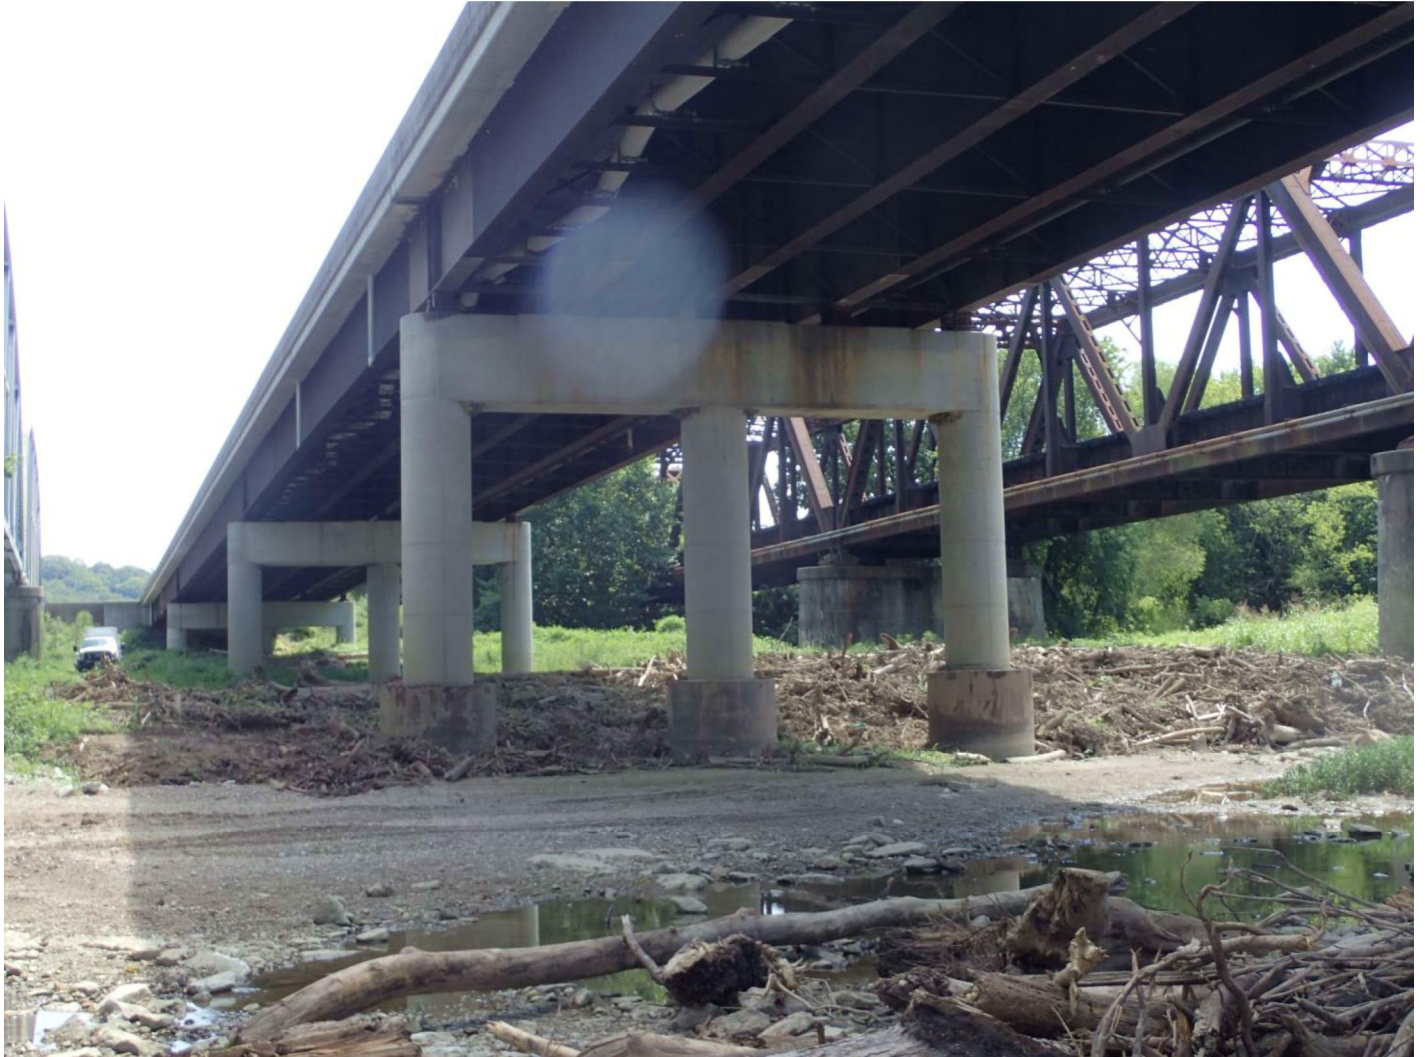
Description: Piers 3, 4 and 5

1. Not inspected; out of water.

1. Not Inspected; out of water.

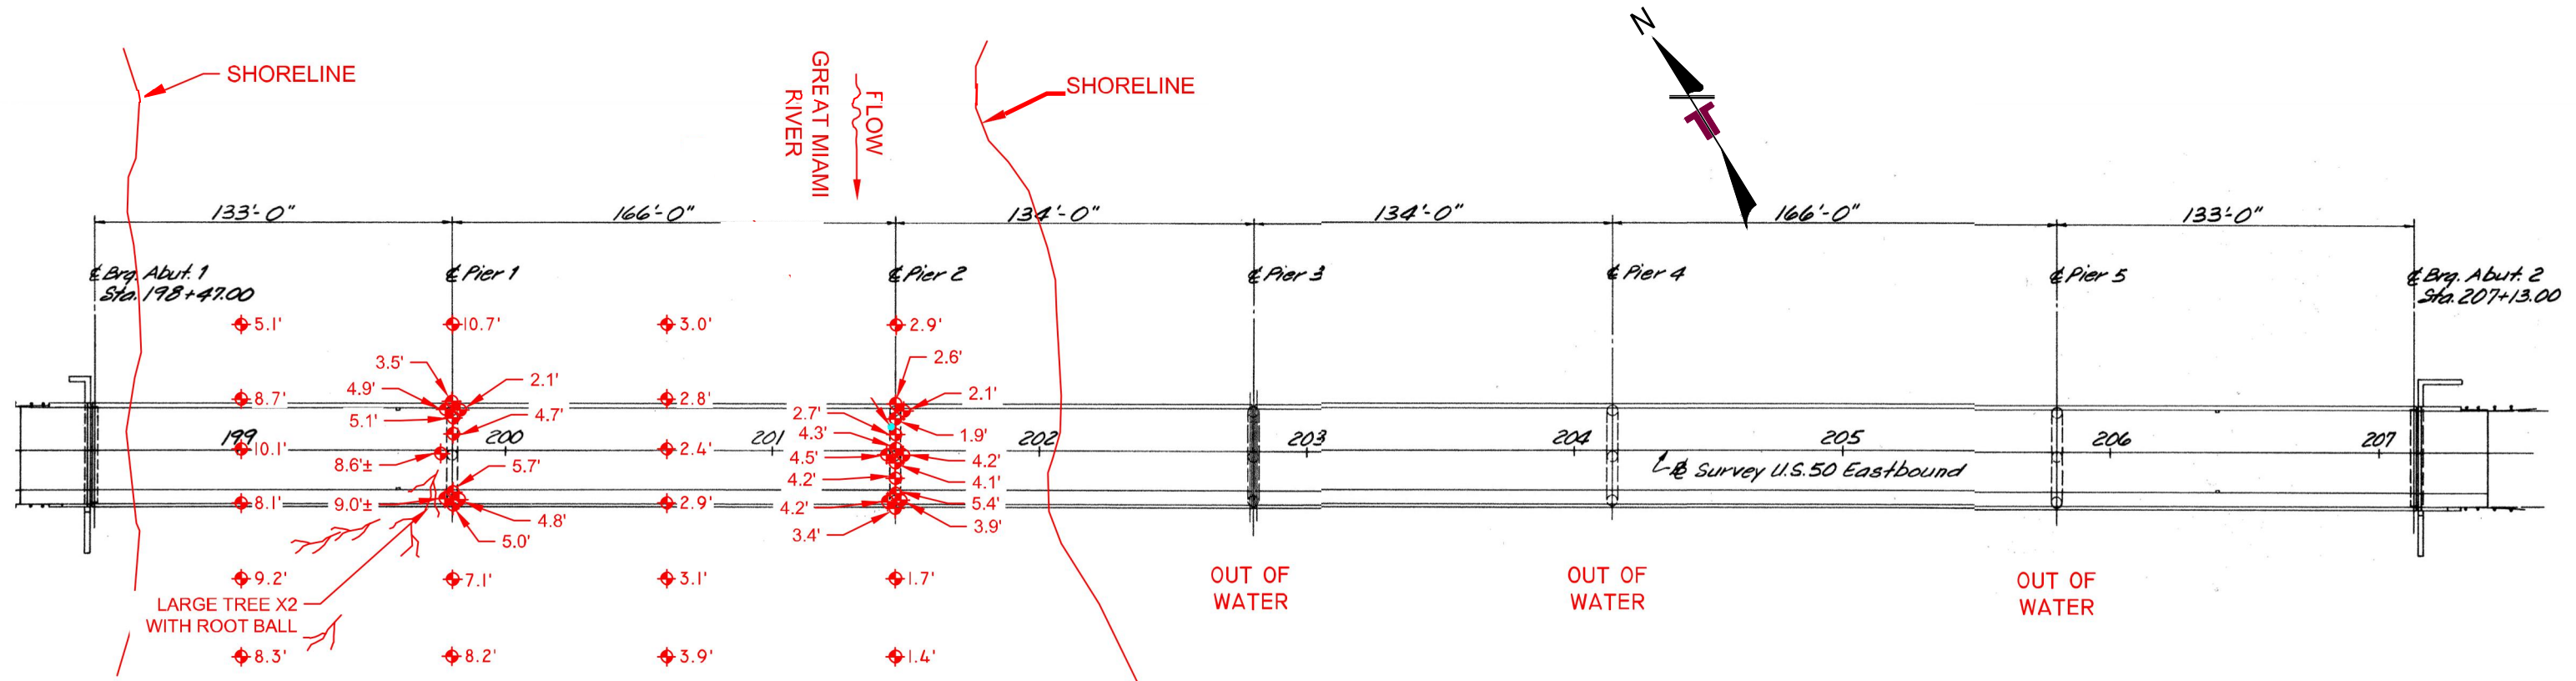
PARTIAL SOUNDING PLAN
NOT TO SCALE

It appears from the previous inspection report that the primary channel (west bank and pier 1) shows general degradation.

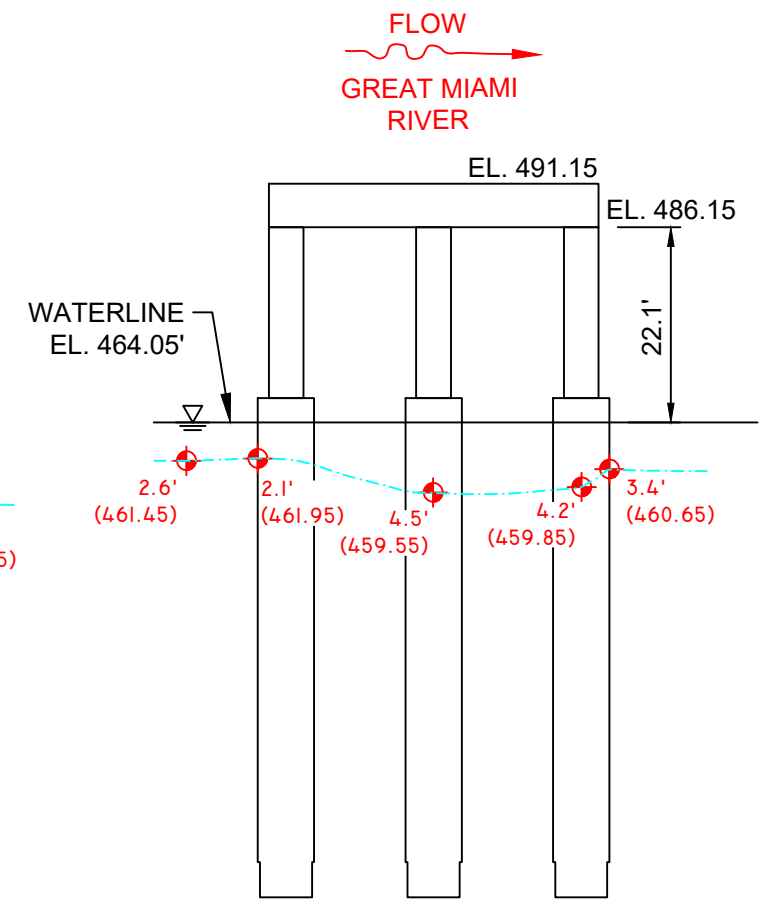
PIER 2R ELEVATION
NOT TO SCALE

AT THE TIME OF INSPECTION THE WATERLINE WAS LOCATED APPROXIMATELY 22.1 FEET BELOW THE BOTTOM OF BENT CAP AT PIER 2R. THIS CORRESPONDS TO A WATERLINE ELEVATION OF 464.05.
