2022 IN-DEPTH AND FRACTURE CRITICAL INSPECTION REPORT

BRIDGE NO. HAM-50-0376L

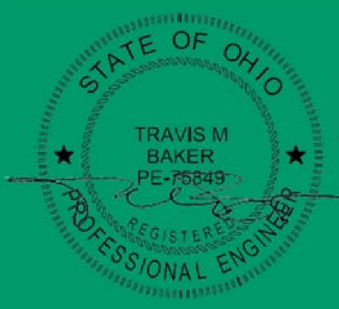
OHIO DEPARTMENT OF
TRANSPORTATION

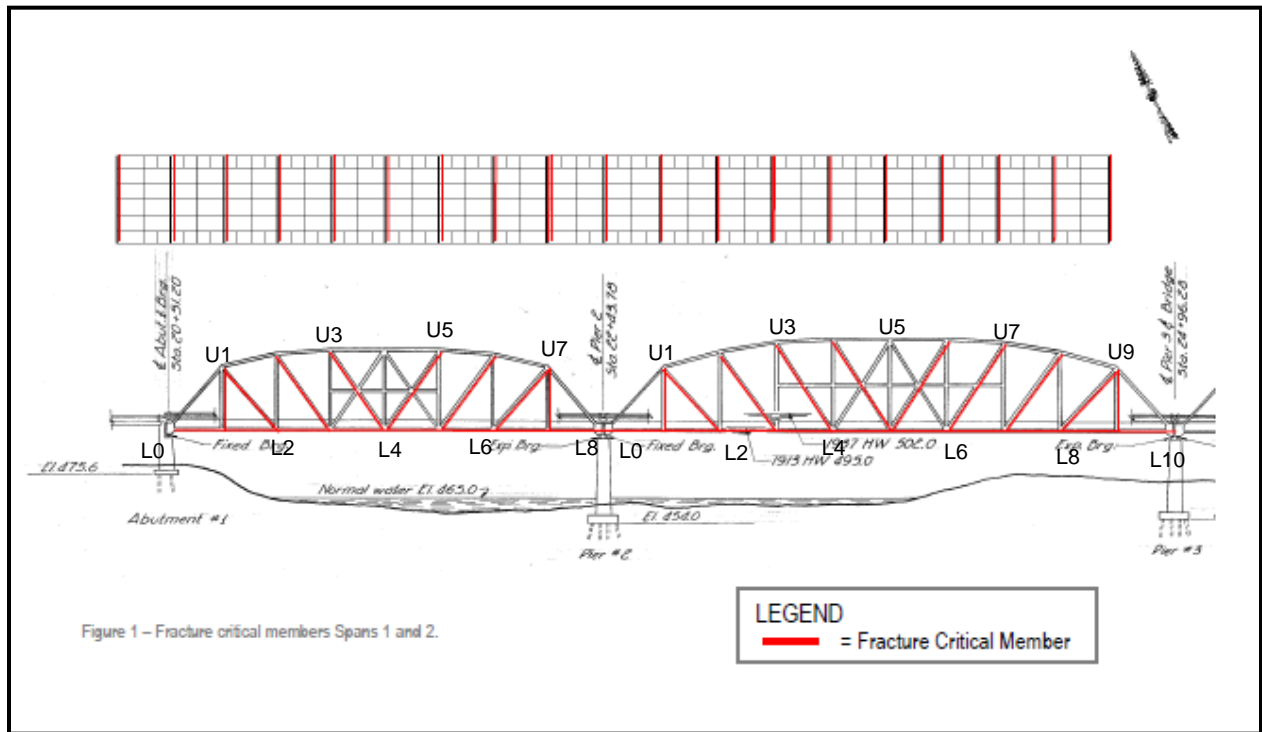
Figure 2- Plan and Elevation for Span 1 and 2

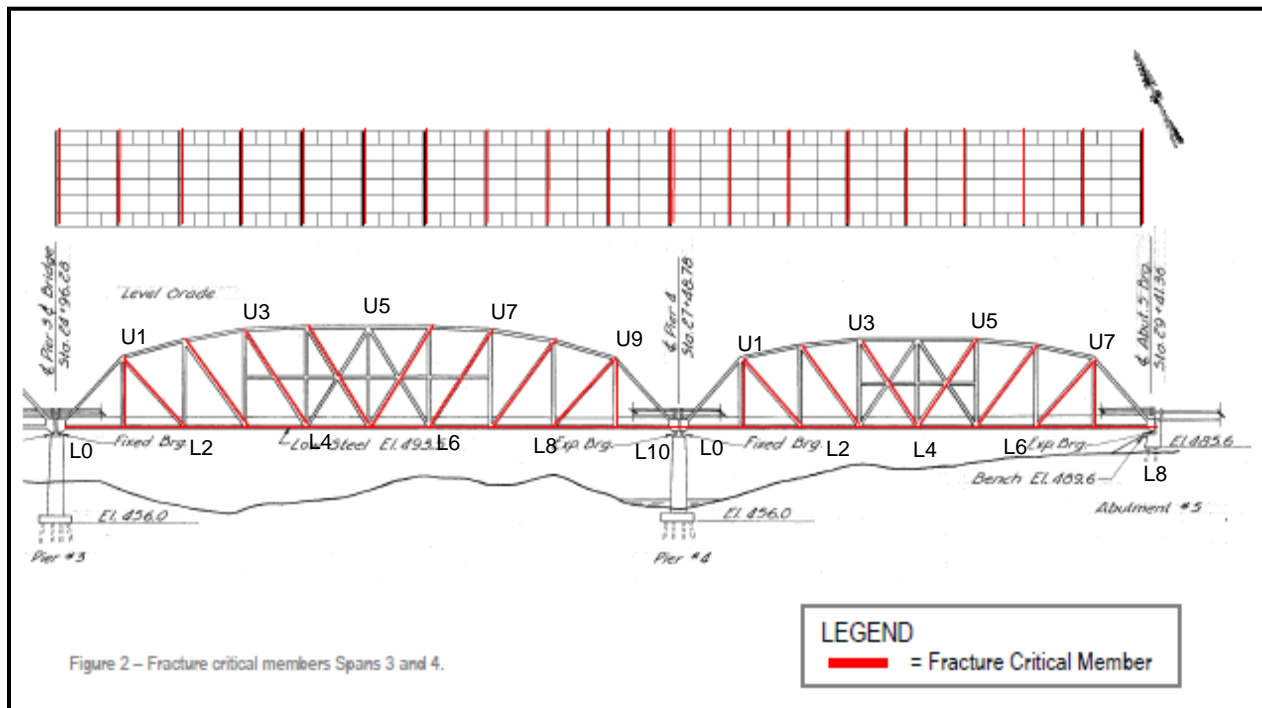
Figure 3- Plan and Elevation for Span 3 and 4

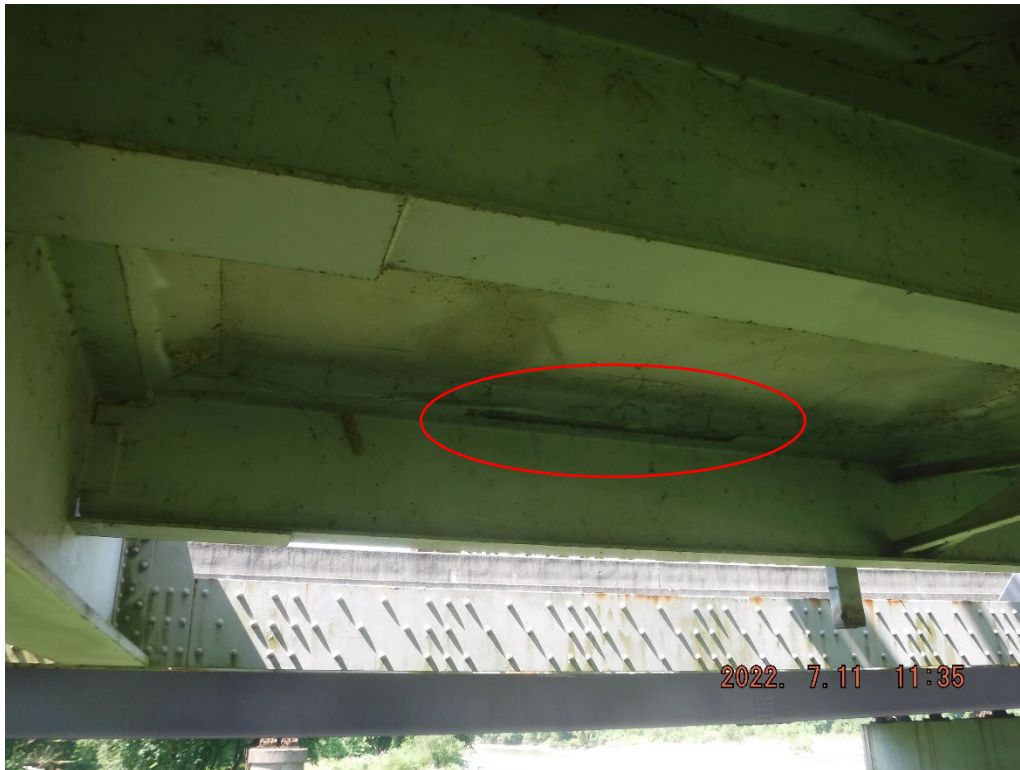
Photo 1: Typical haunch spall (Bay 5 in Span 3 shown)

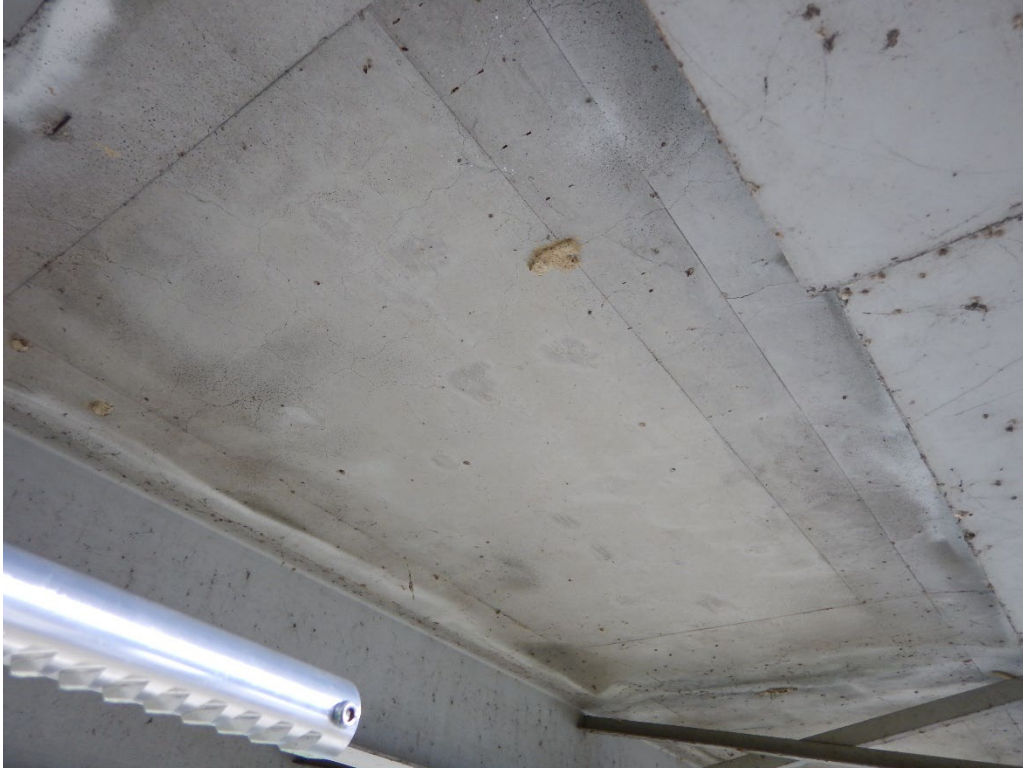
Photo 2: Typical map cracking throughout the deck underside (Span 1 shown)

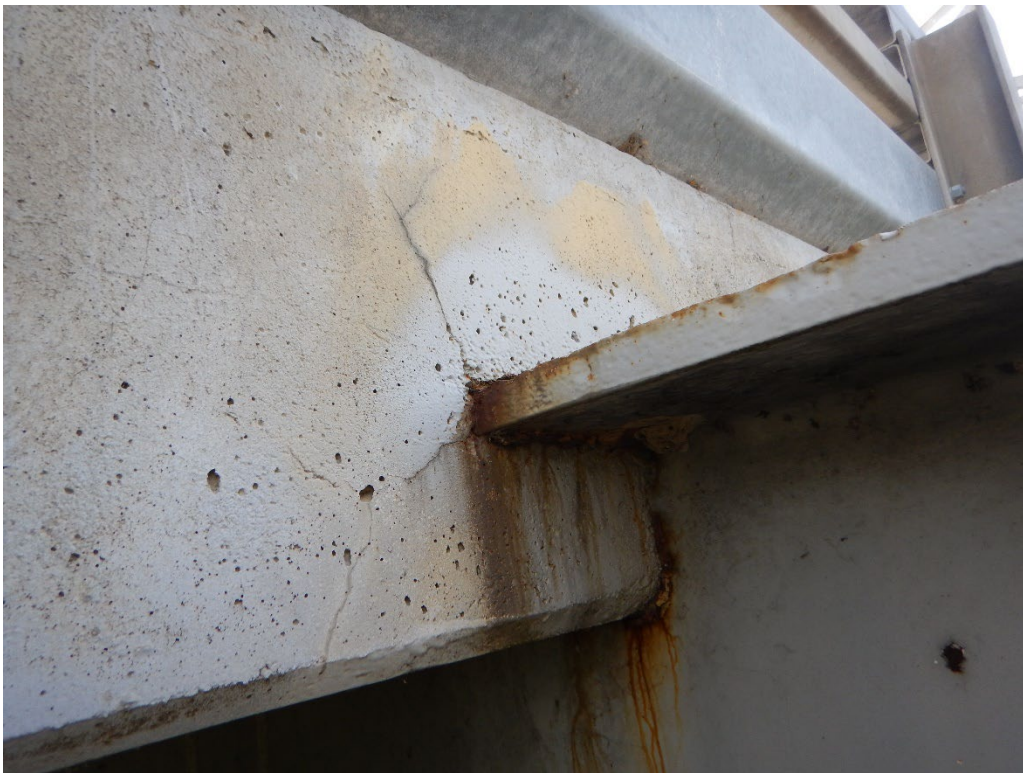
Photo 3: Hairline radial cracking in deck edge at Floorbeam 2 in Span1

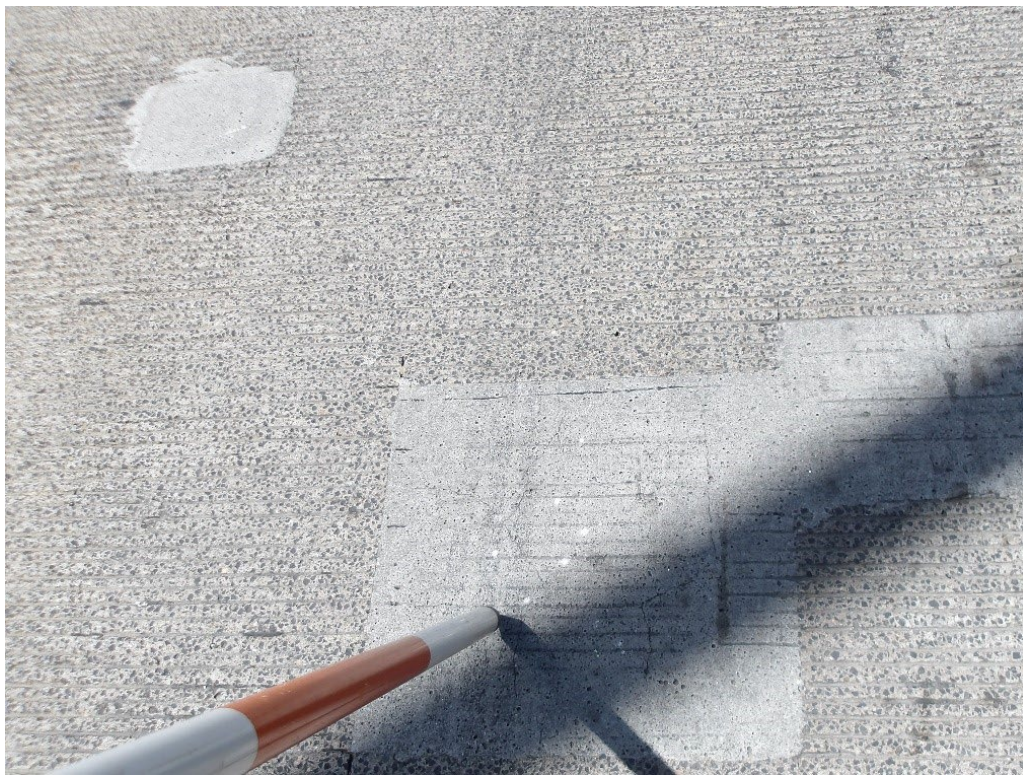
Photo 4: Deck patches with hairline cracks in Span 2

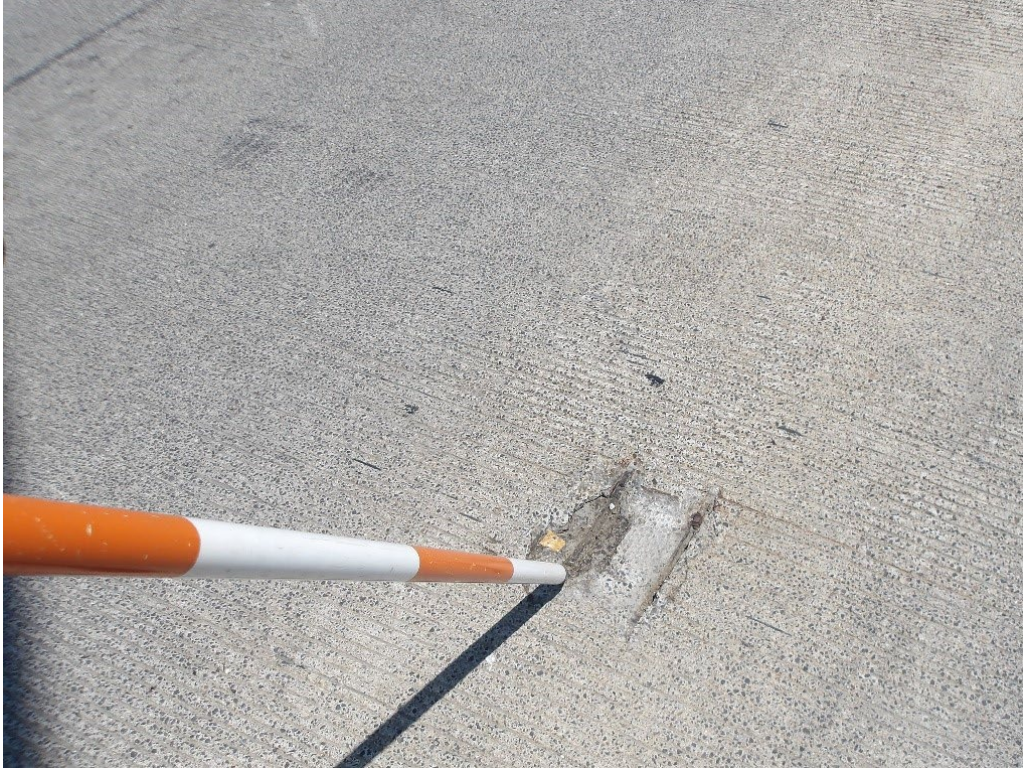
Photo 5: *Missing RPM in Span 1*

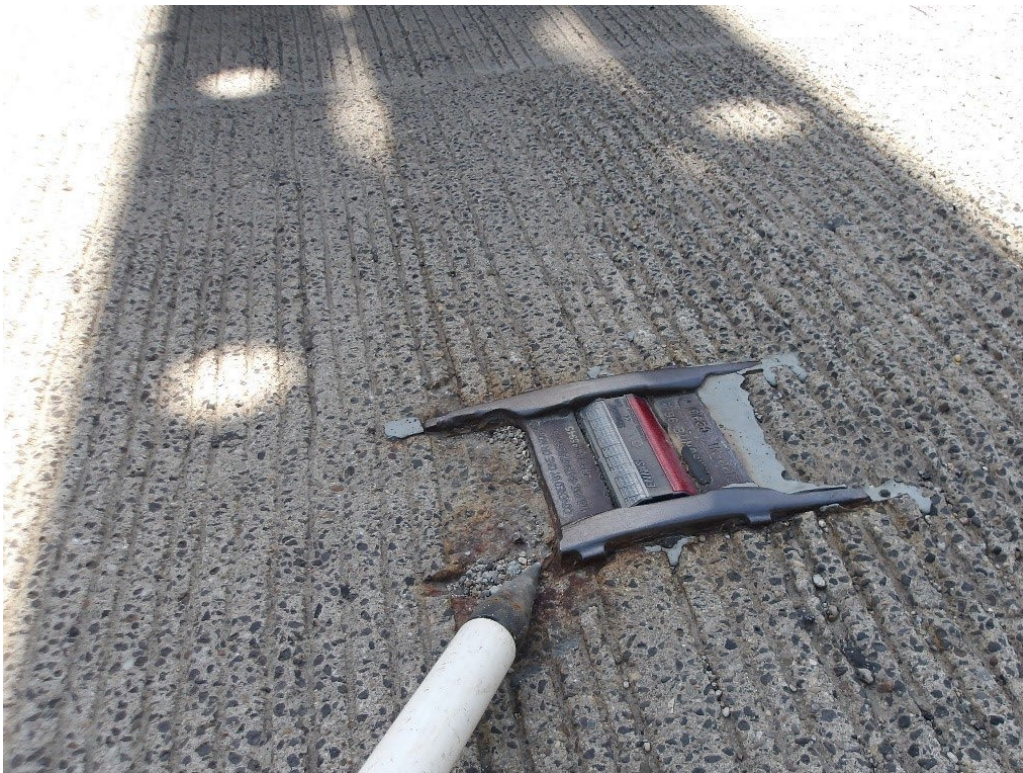
Photo 6: *Broken RPM with sharp metal edge in Span 4*

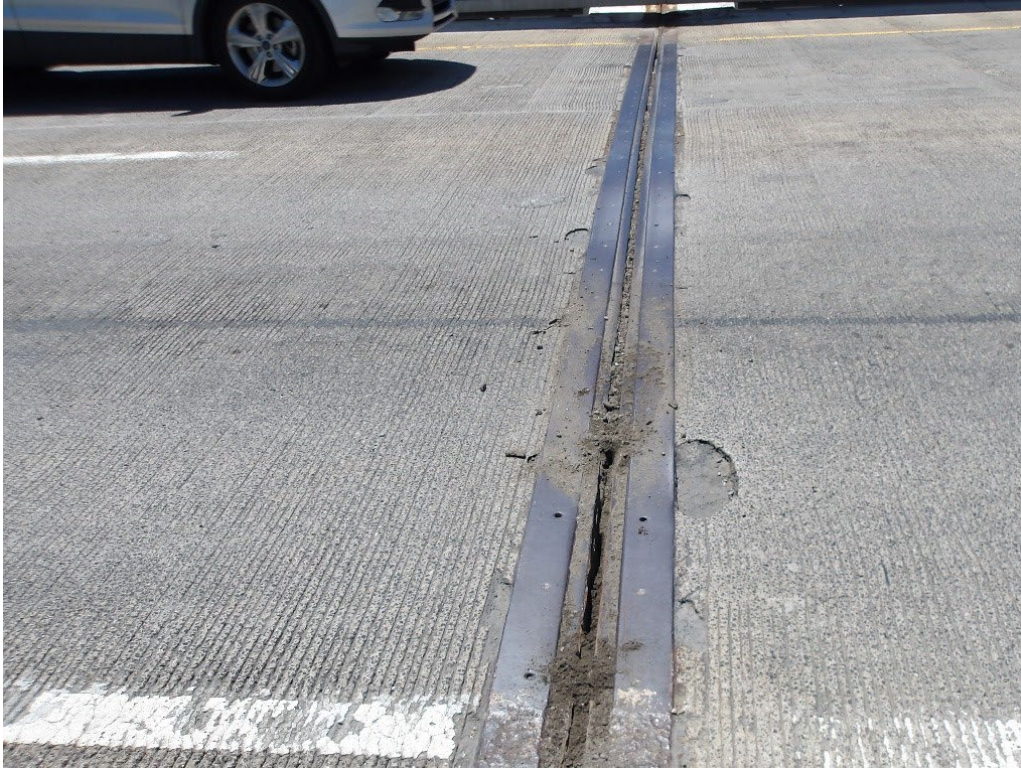
Photo 7: Isolated spalls adjacent to Pier 2 joint

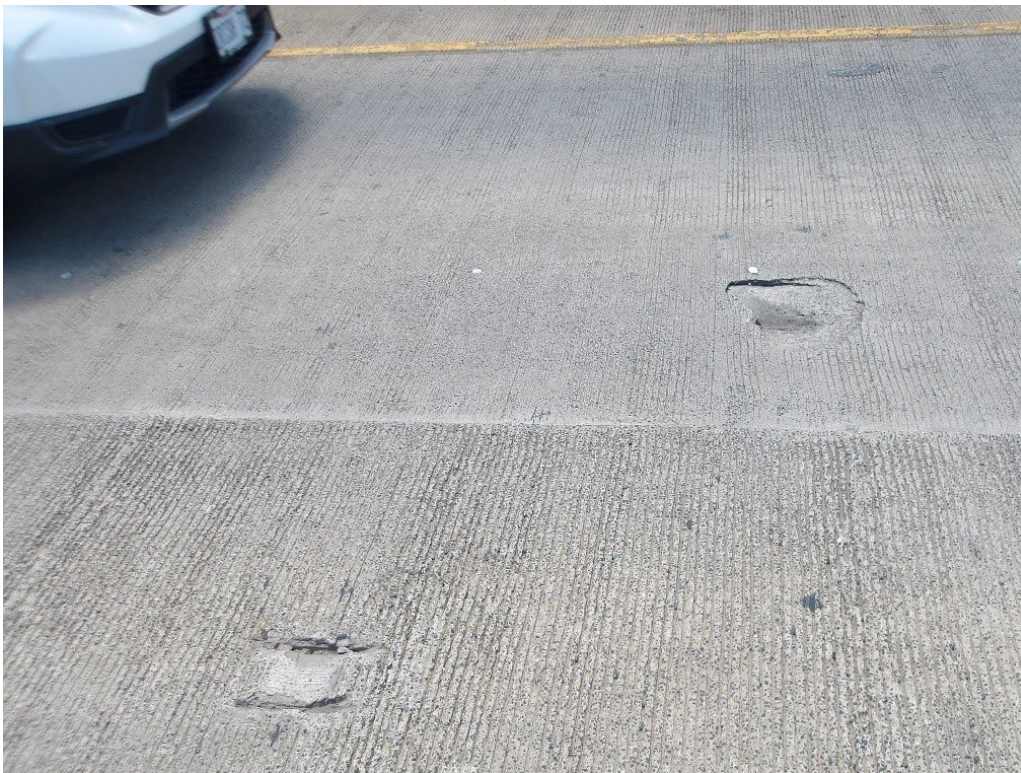
Photo 8: Missing RPM and 4 S.F. spall in south lane in Span 3

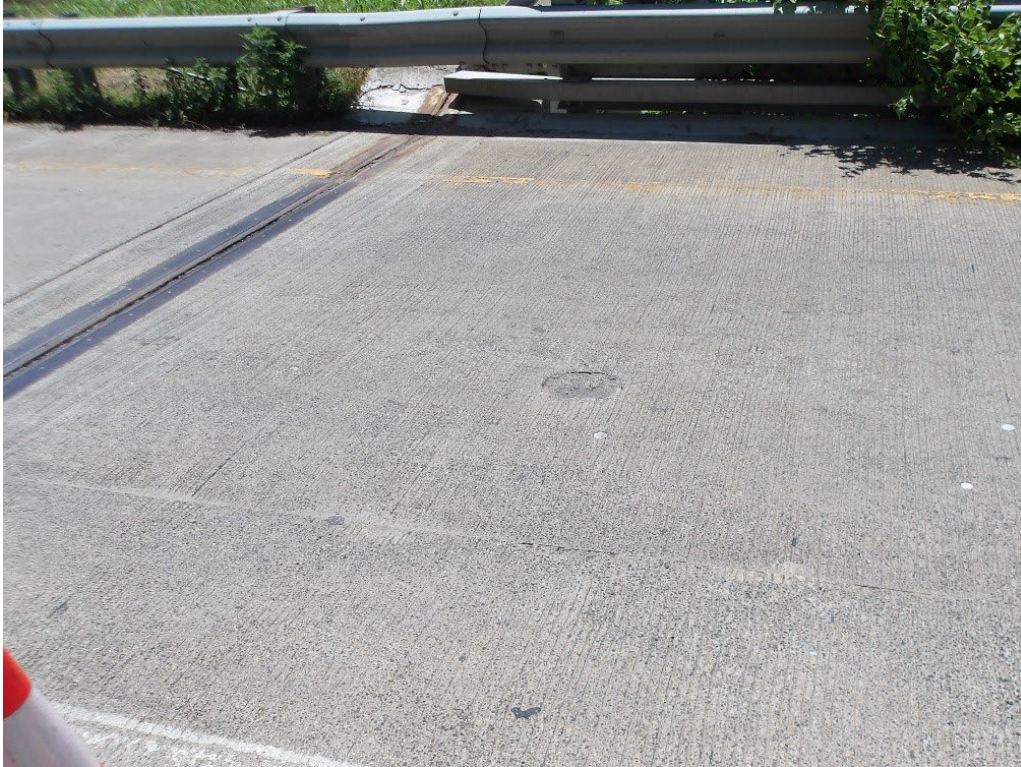
Photo 9: 1 S.F spall near centerline of Span 4

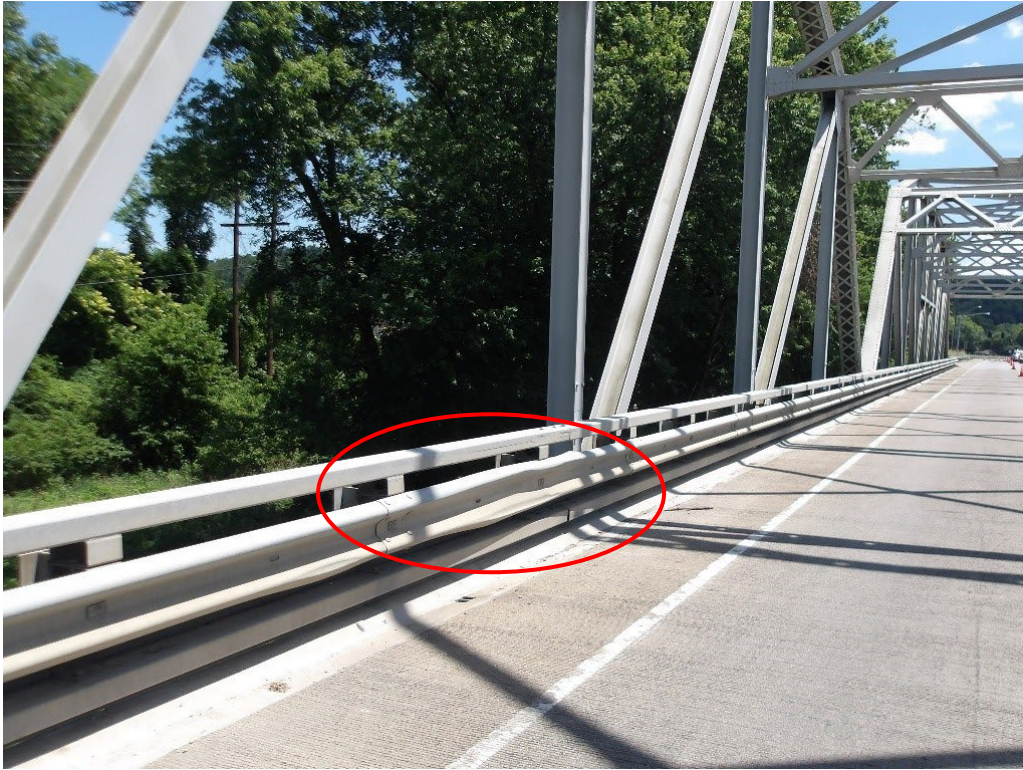
Photo 10: Impact damage to north railing in Span 3

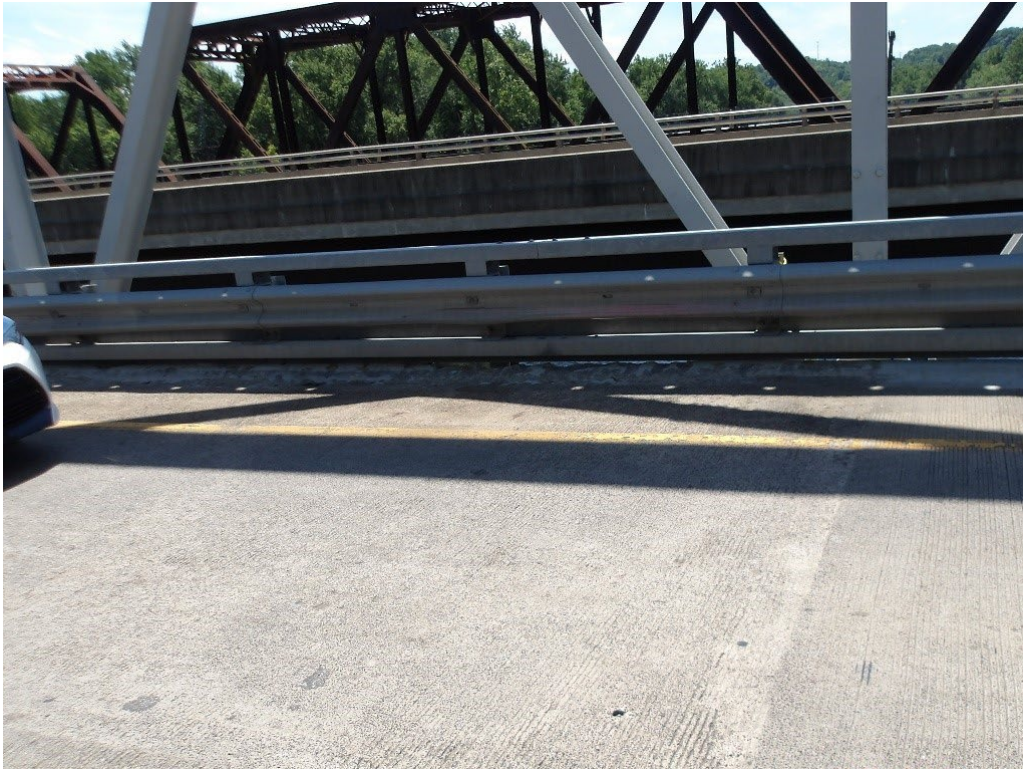
Photo 11: Curb spall at south railing in Span 2

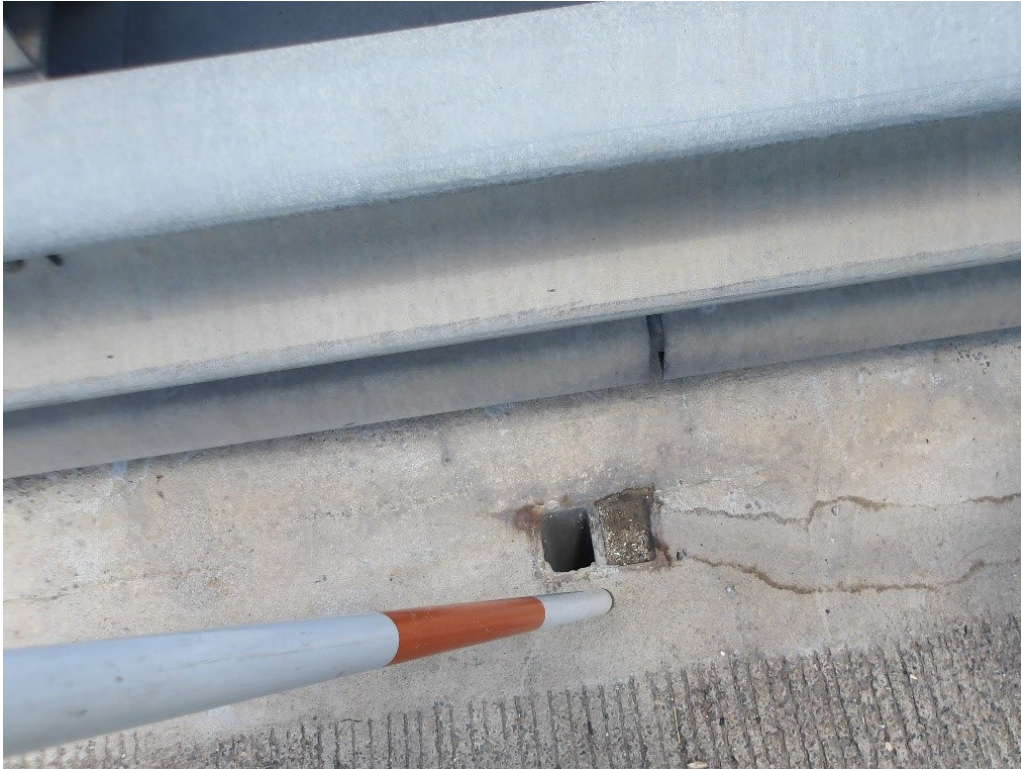
Photo 12: Partially clogged drain

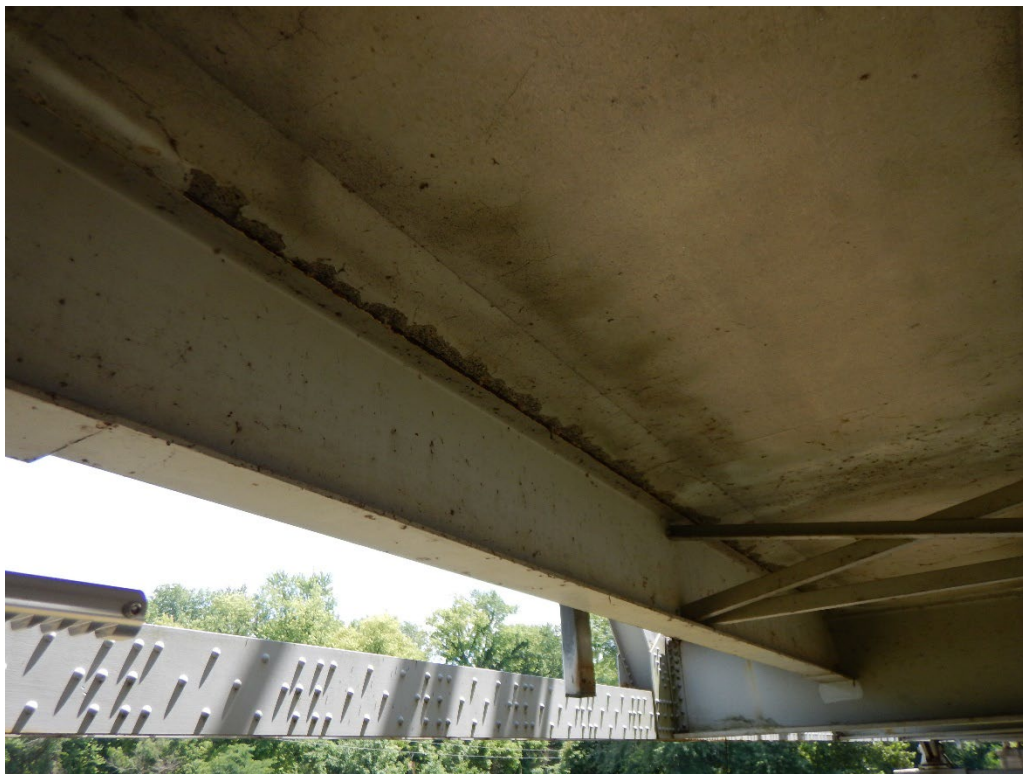
Photo 13: Typical stringer surface corrosion at haunch spalls

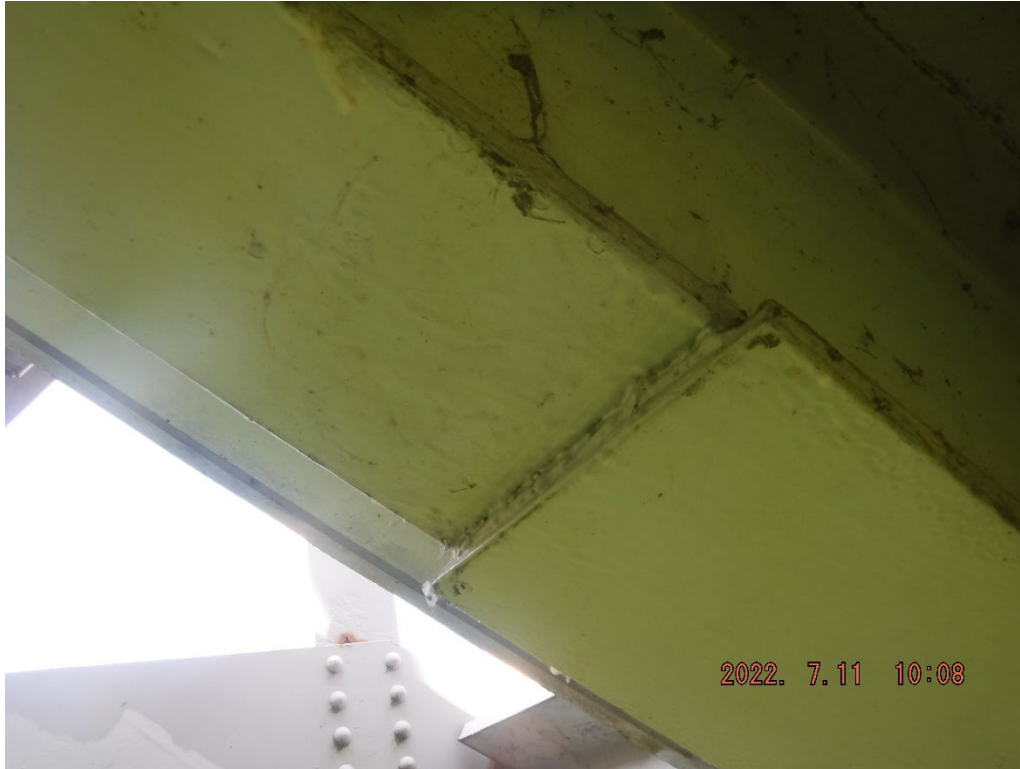
Photo 14: Typical poor quality weld between stringer and coverplate (S1 at FB6 in Span 3 shown)

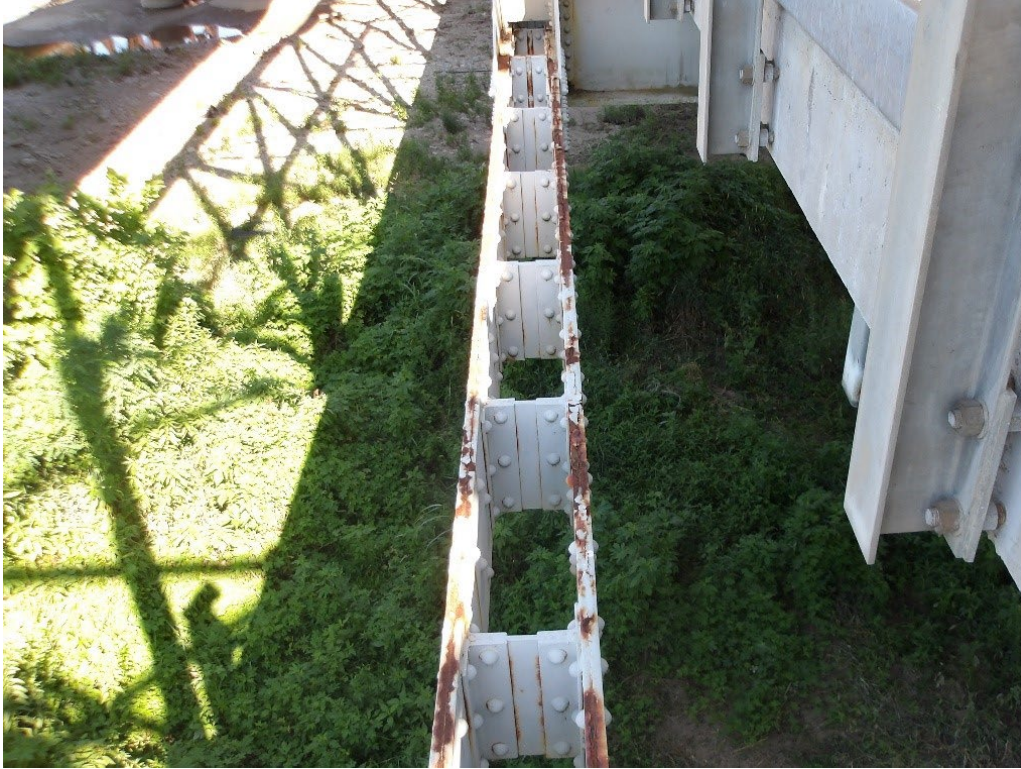
Photo 15: Typical pack rust between lower chord plates (L6L7, Span 3, South Truss shown)

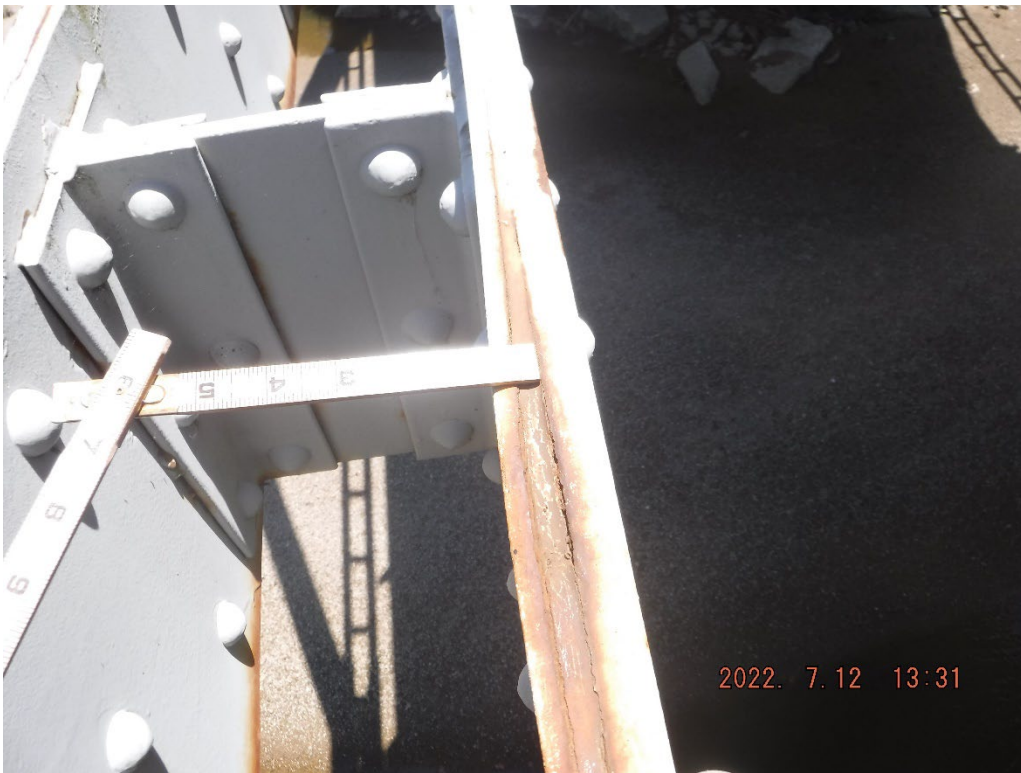
Photo 16: Active pack rust up to 1/2" thick on L7L8, Span 2, North Truss

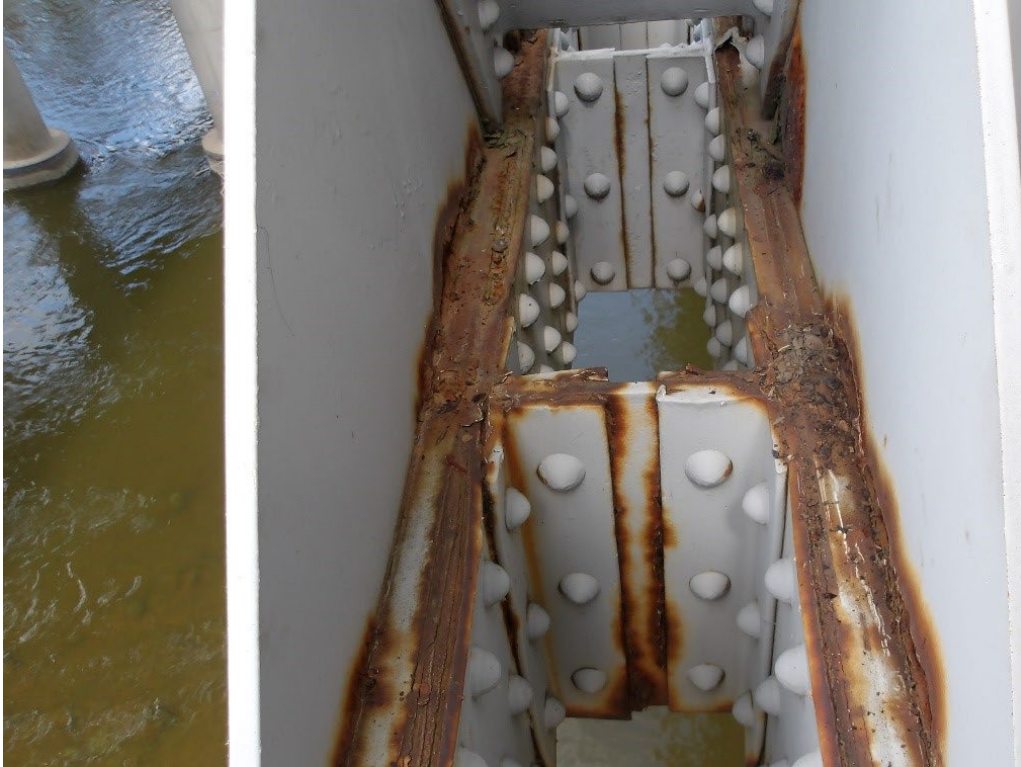
Photo 17: Active pack rust at L7, Span 2, South Truss

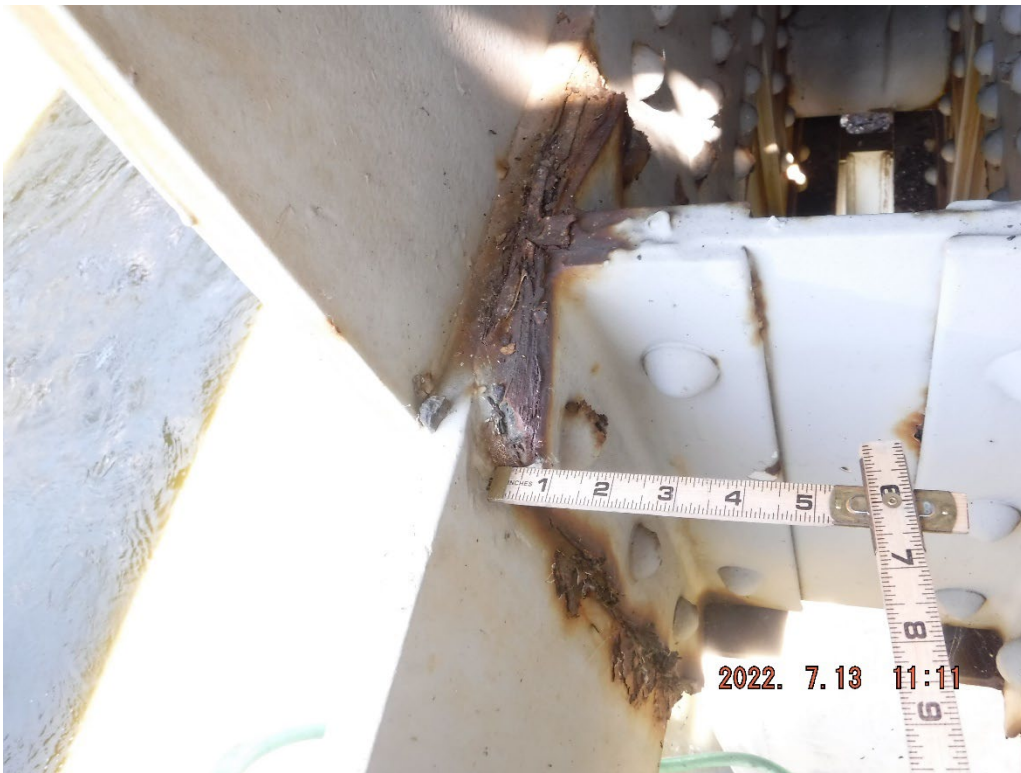
Photo 18: Pack rust up to 3/4" thick at LOL1, Span 2, South Truss

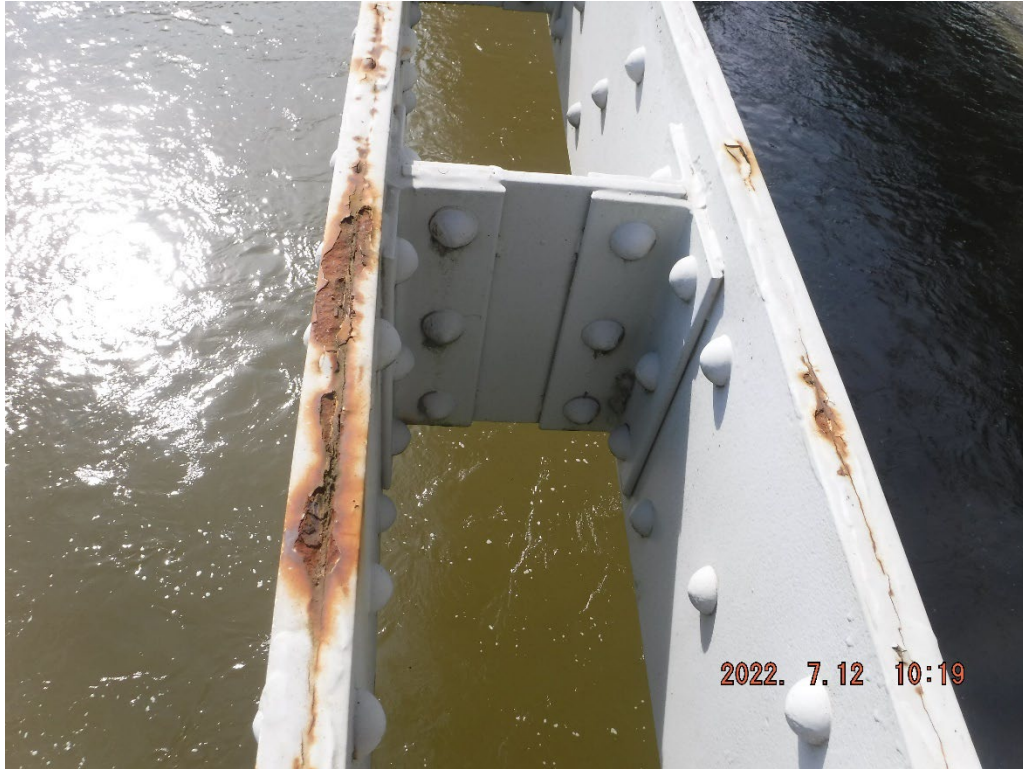
Photo 19: Active pitting on plate edges, L3L4, Span 1, North Truss

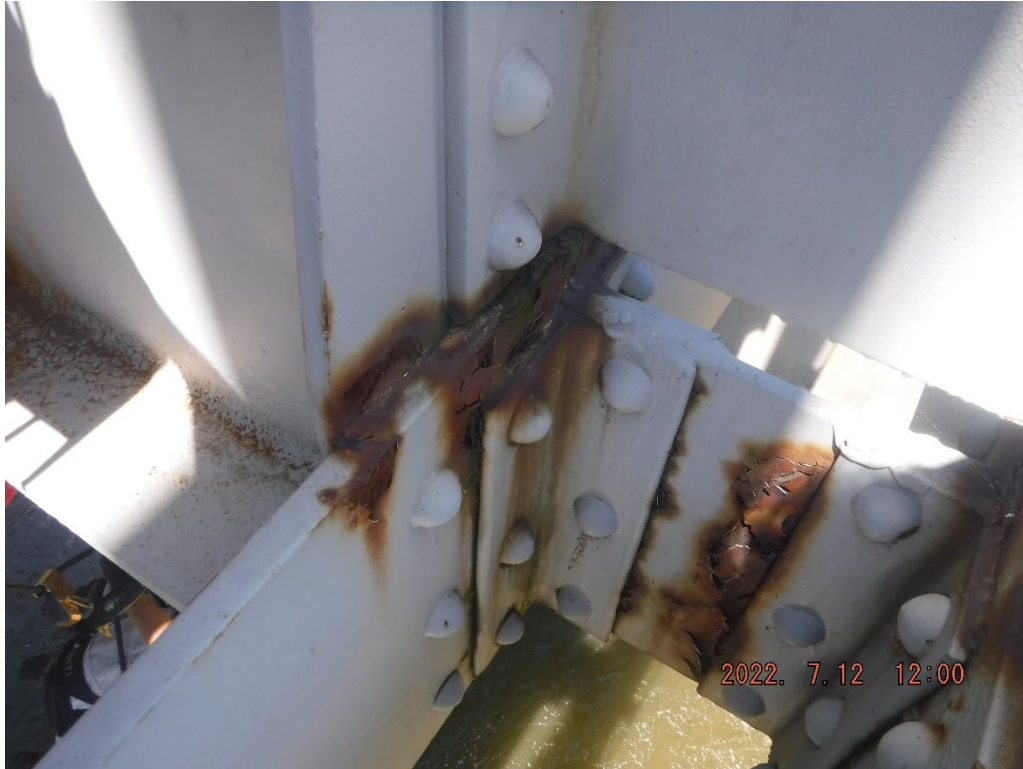
Photo 21: Laminating corrosion on L1L2, Span 2, North Truss

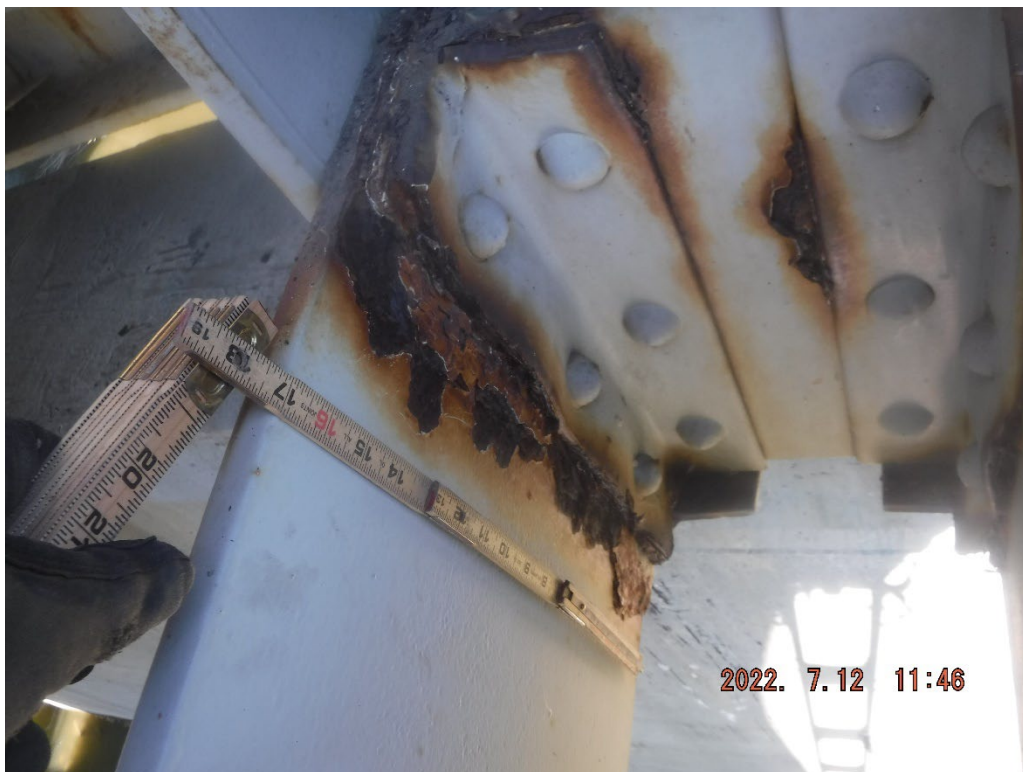
Photo 22: Active laminating corrosion with section loss up to 1/8" deep x full plate width on L0L1 at L0, Span 2, North Truss

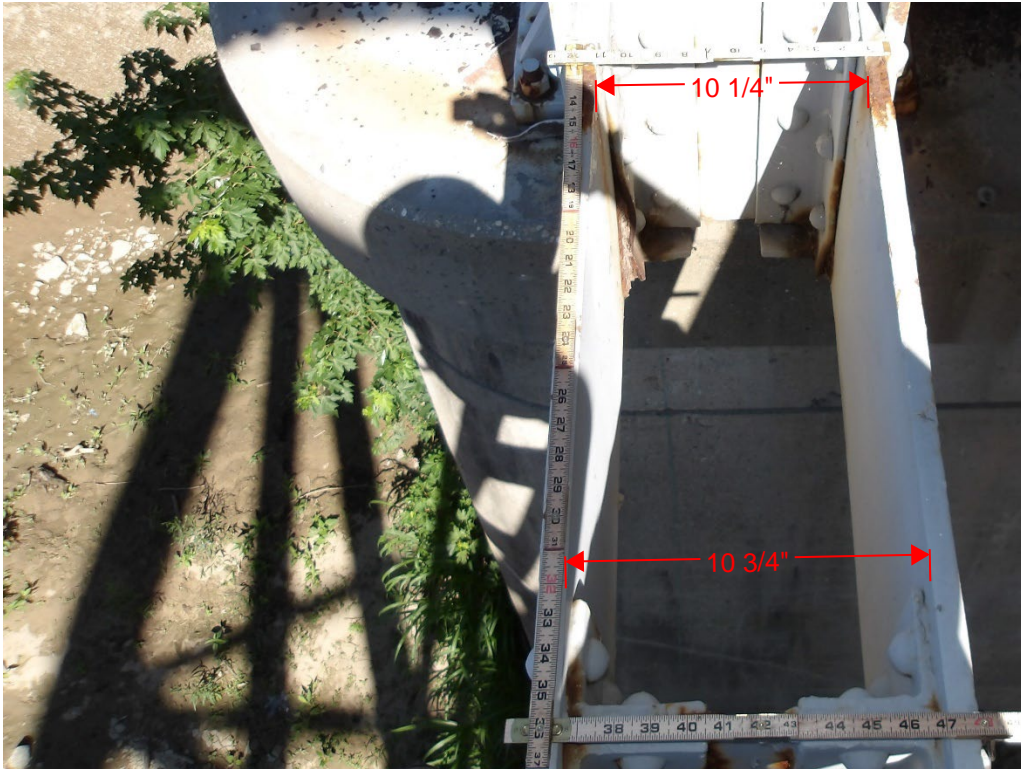
Photo 23: Inconsistent diaphragm dimensions causing bowing in LOL1 at L0, Span 3, South Truss

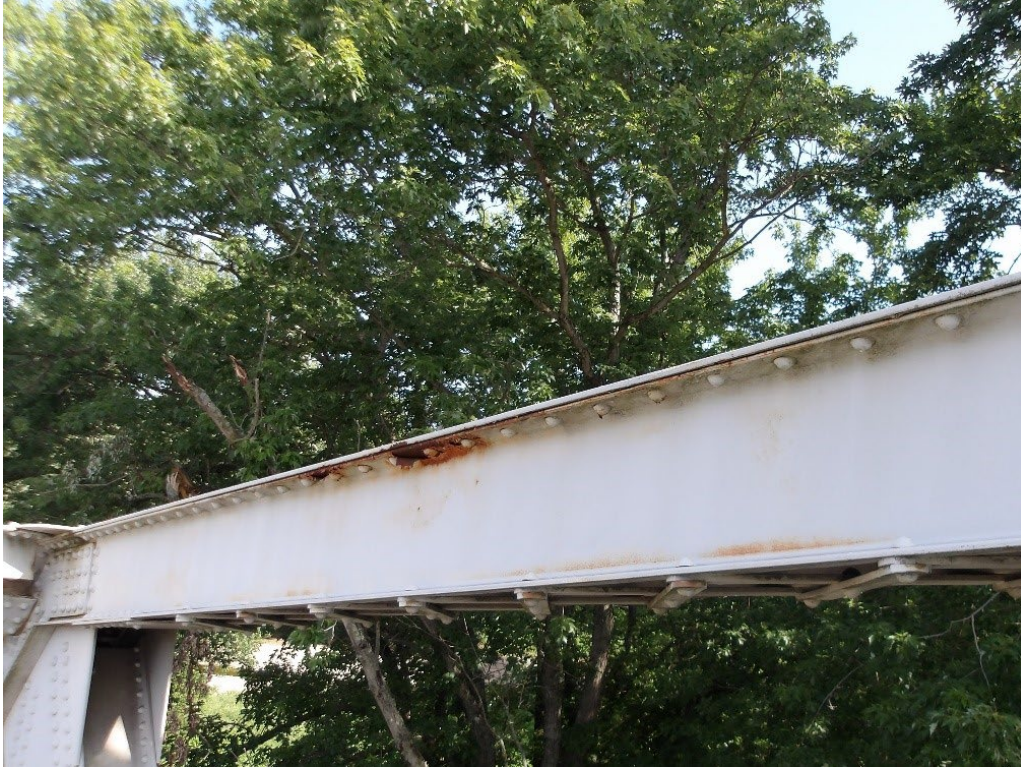
Photo 26: Active corrosion on U1U2, Span 4, North Truss

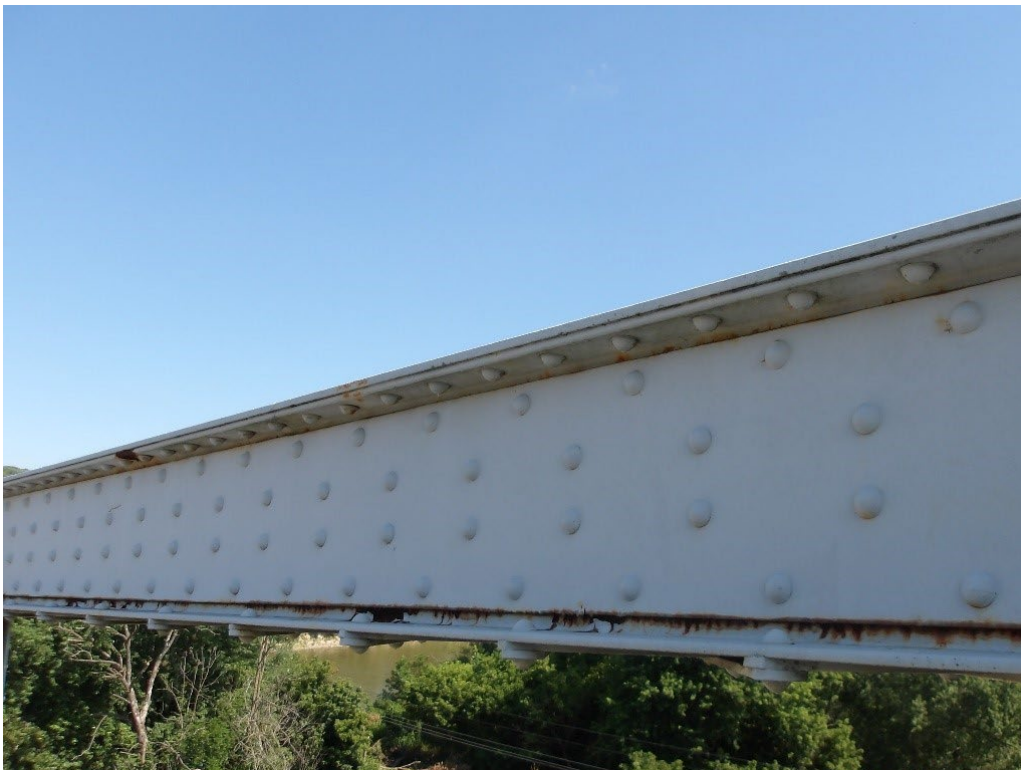
Photo 27: Corrosion on upper chord channel and web plate, U3U4, Span 3, North Truss

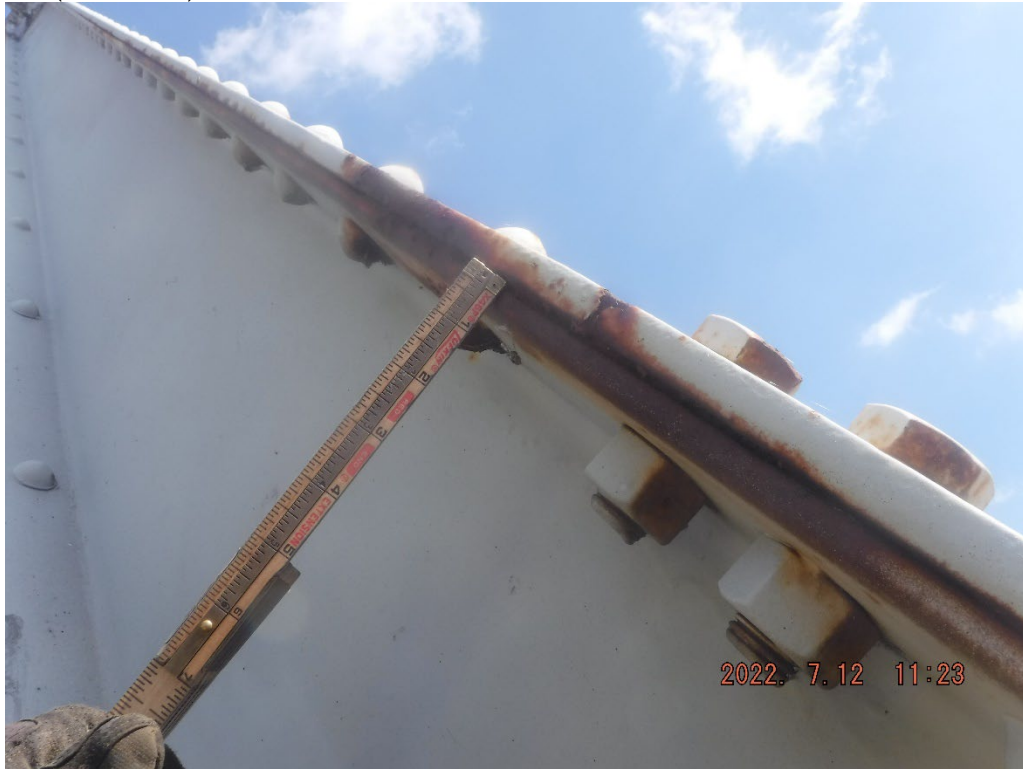
Photo 28: Active pack rust up to 1/8" thick in U7L8, Span 1, North Truss

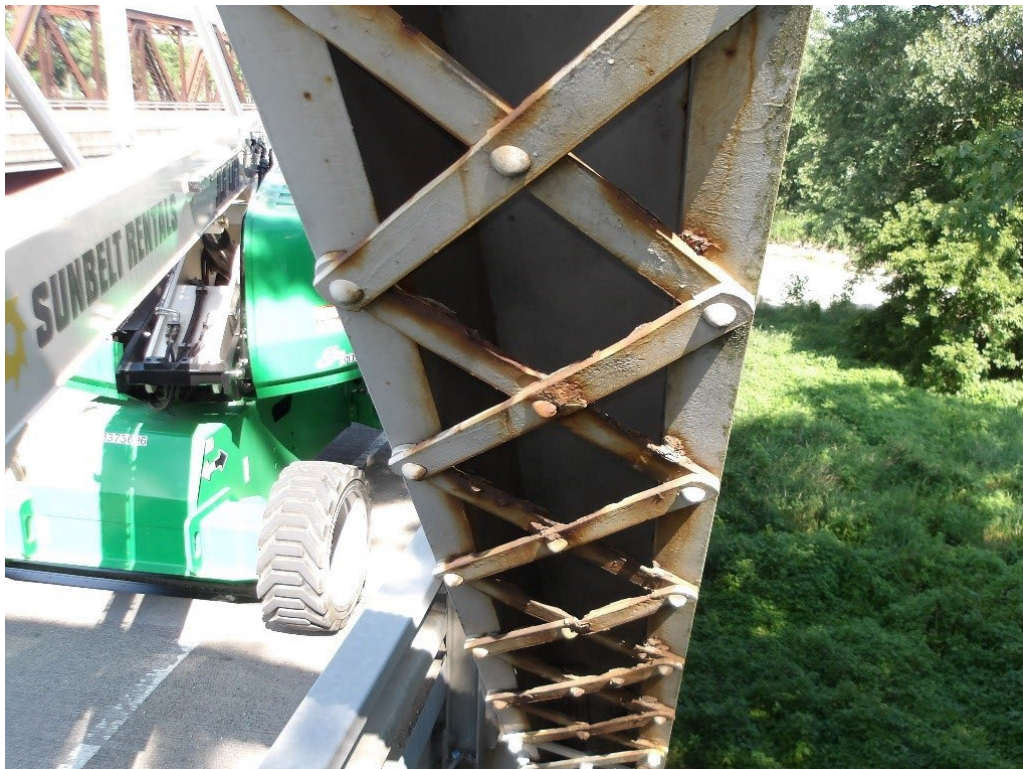
Photo 29: Active corrosion with section loss up to 1/8" deep on lacing of LOU1, Span 4, North Truss
