2022 IN-DEPTH AND FRACTURE CRITICAL INSPECTION REPORT

BRIDGE NO. HAM-50-0376L

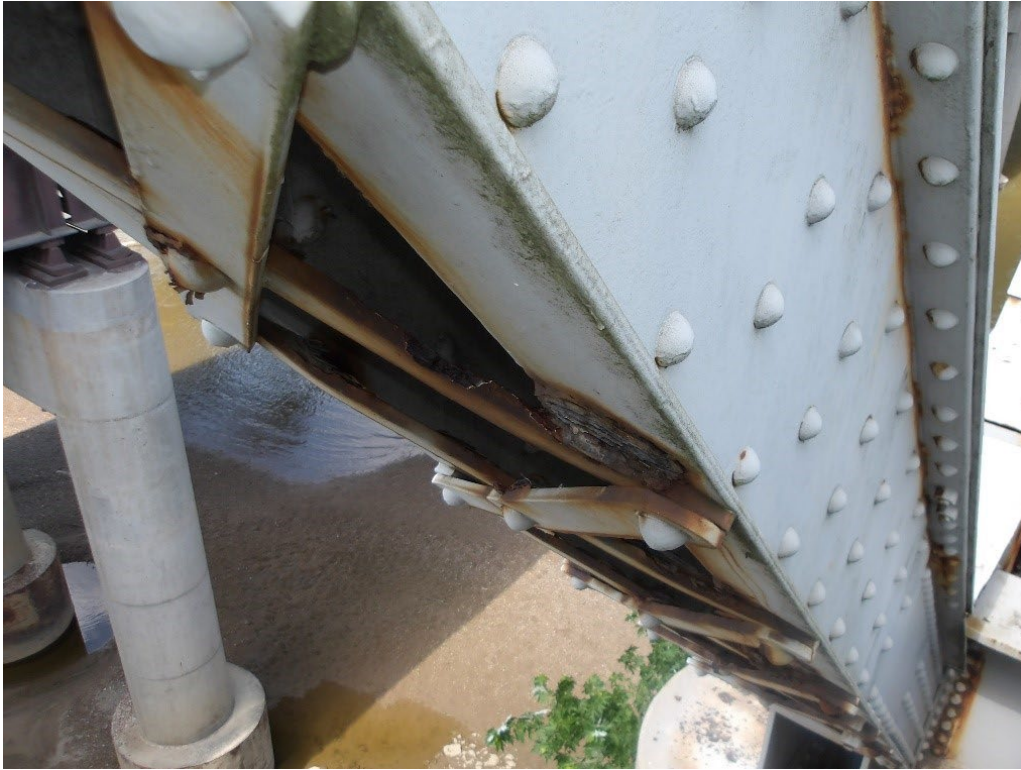
Photo 30: Pack rust up to 3/16" thick under lacing bars of LOU1, Span 3, South Truss

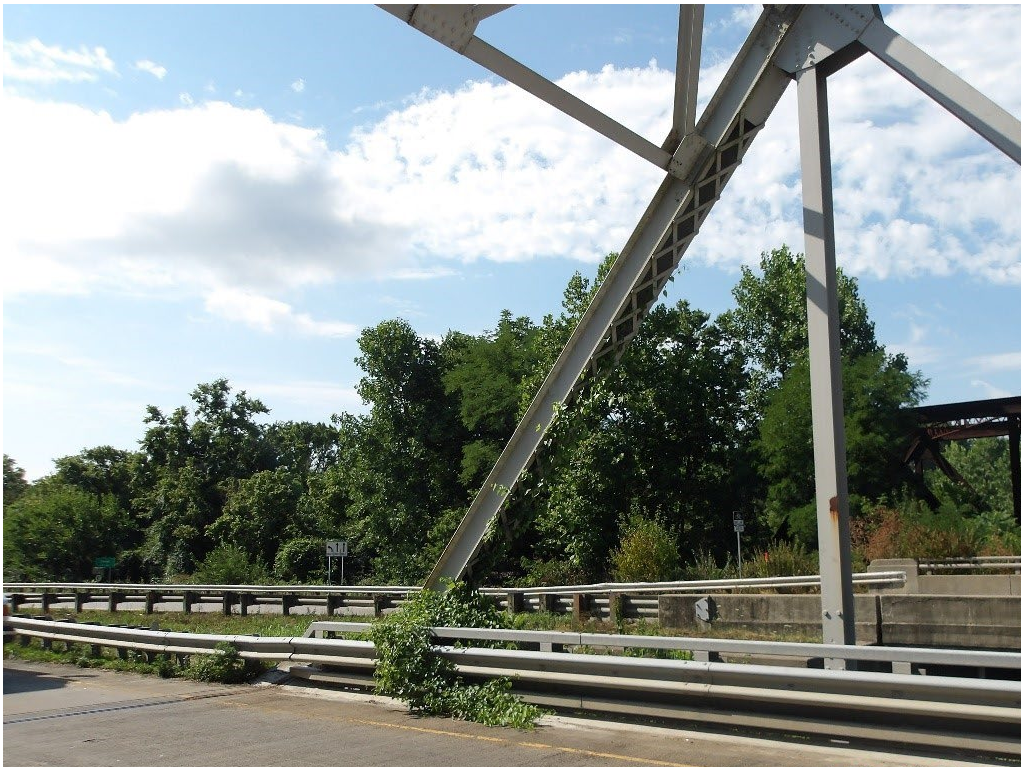
Photo 31: Vegetation grown on end post LOU1, Span 4, South Truss

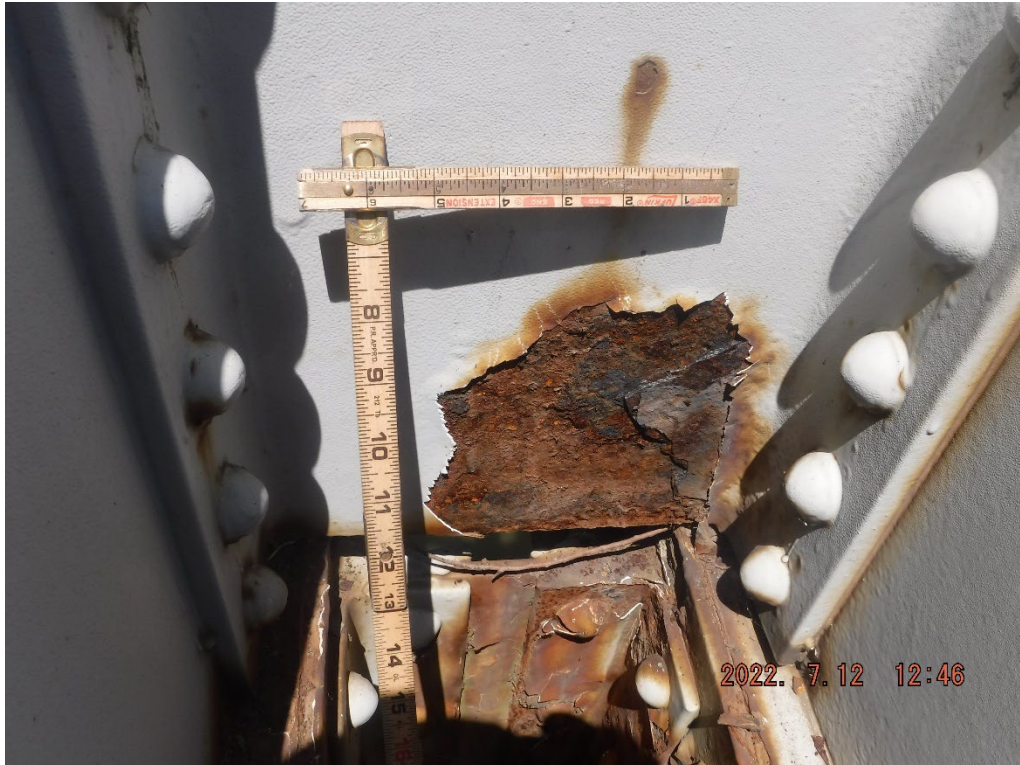
Photo 32: Active pitting with section loss up to 1/16" deep at L3U3 on Span 2, North Truss

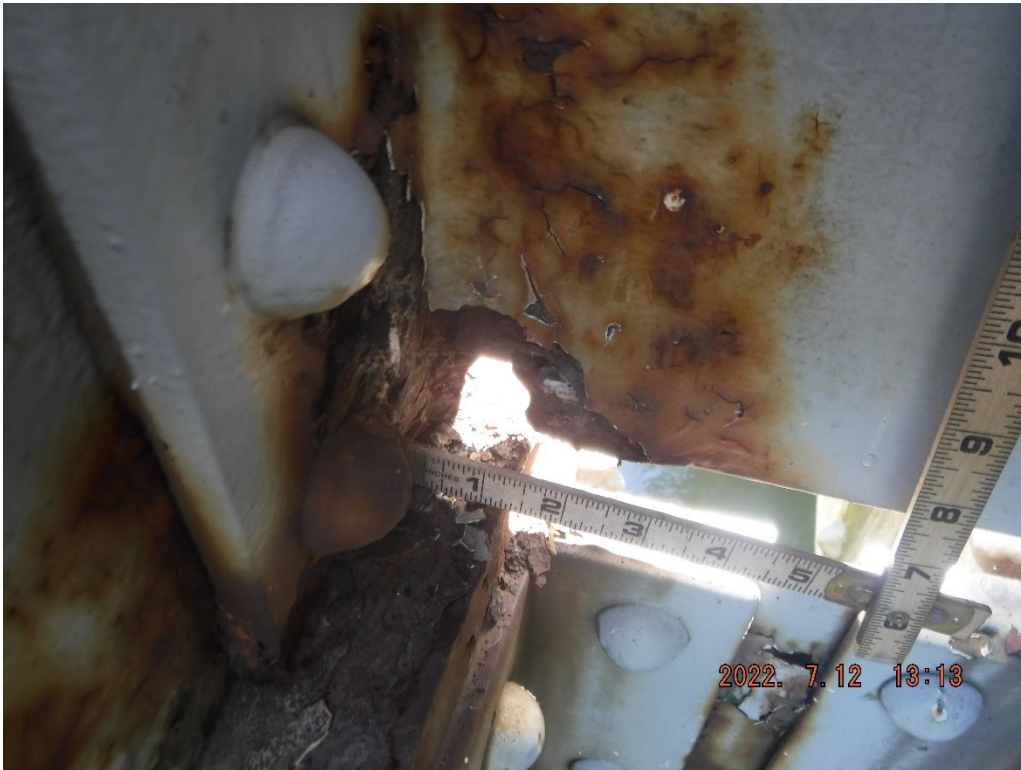
Photo 34: 1" Diameter corrosion hole at L6U6, Span 2, North Truss

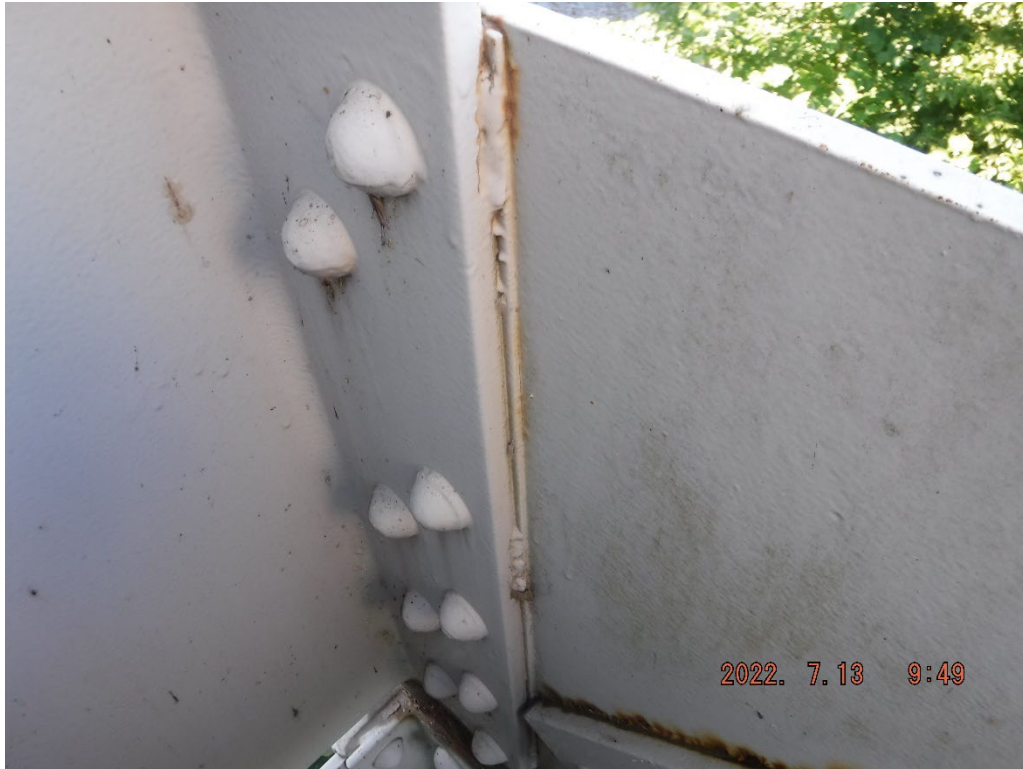
Photo 35: Undercut tack welds between the vertical and fill plate, L2U2, Span 1, South Truss

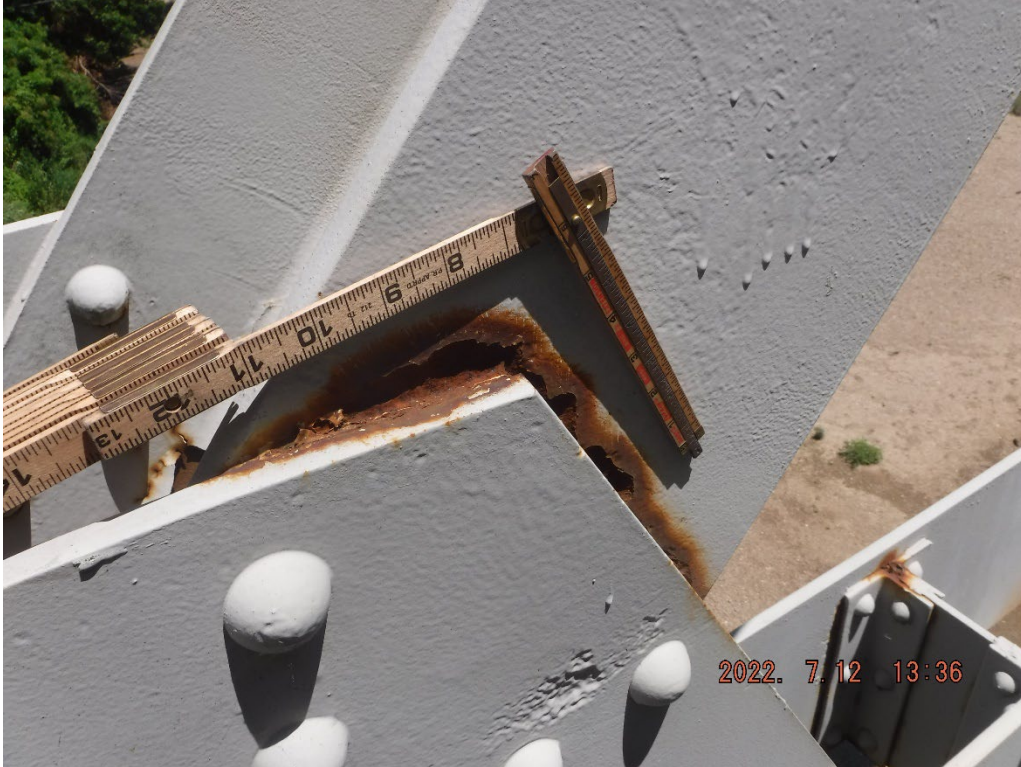
Photo 38: Active pitting up to 3/16" deep on L8U9, Span 2, North Truss

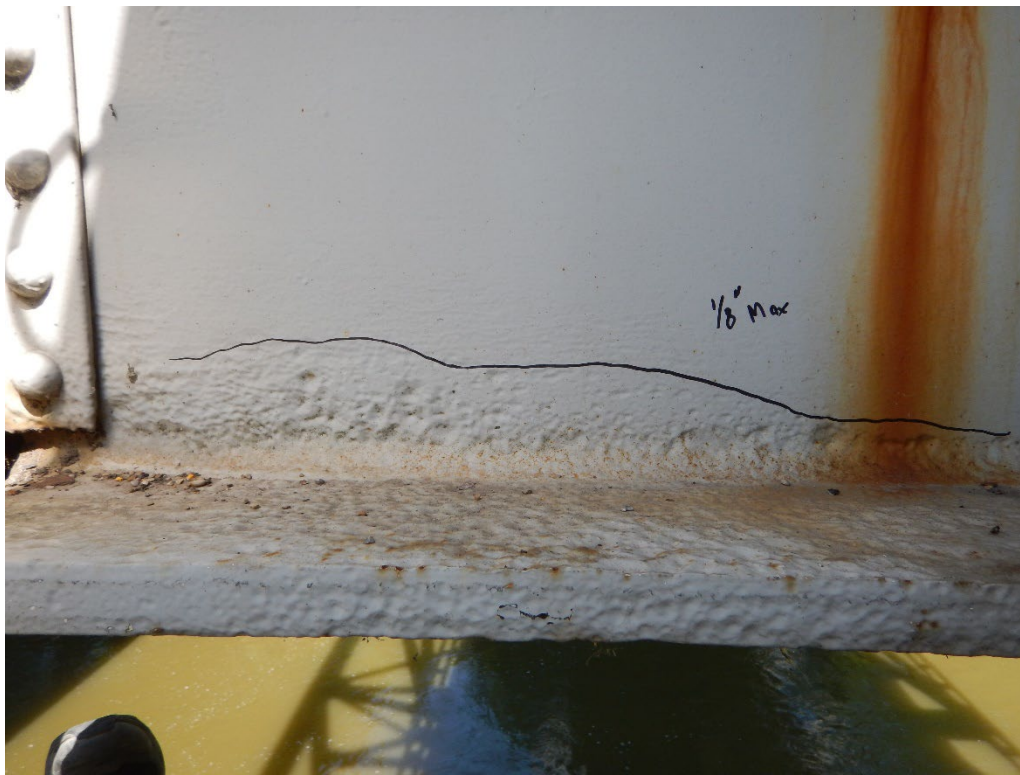
Photo 42: Pitting up to 1/8" deep in FB6, Span 1

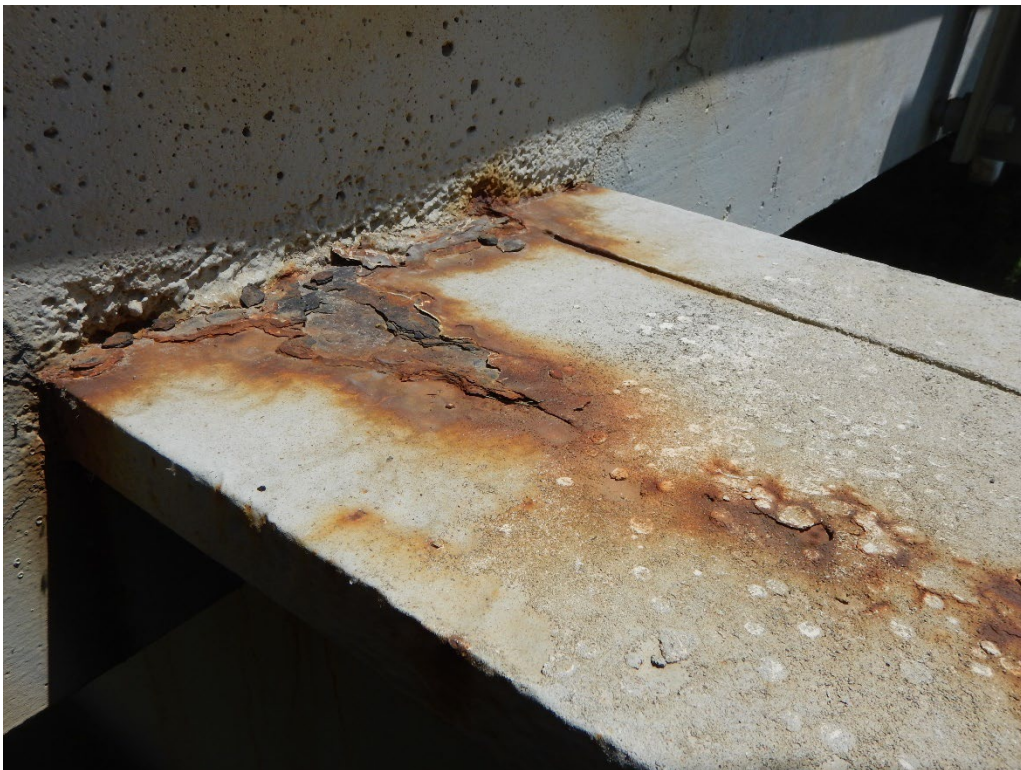
Photo 44: Laminating corrosion on top flange of FB 5, Span 3, South end

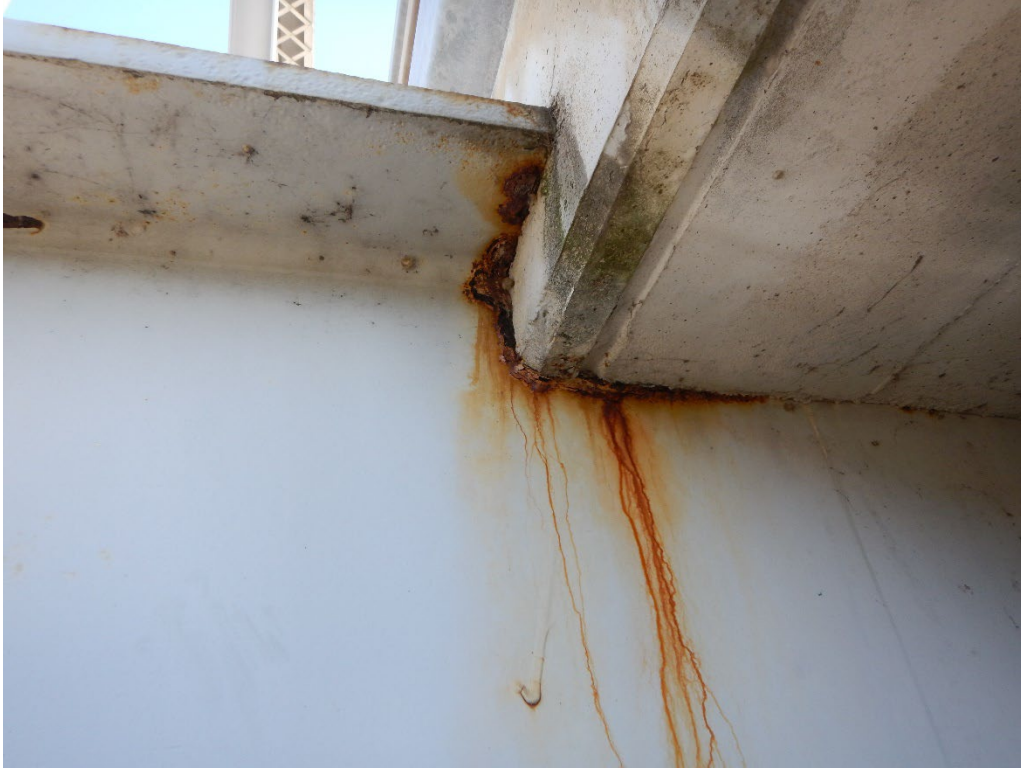
Photo 45: Typical corrosion on top flange and web at the deck penetration at FB 9, Span 2, South end

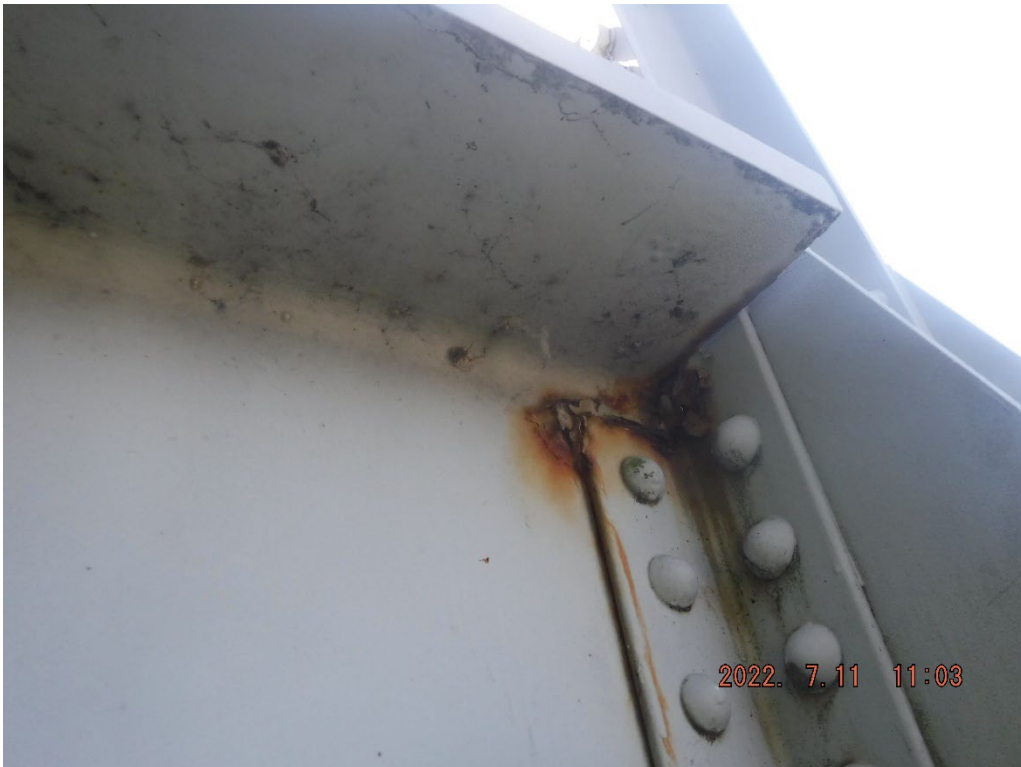
Photo 46: Laminating corrosion and pack rust at FB7 connection to gusset plate, Span 3, South end

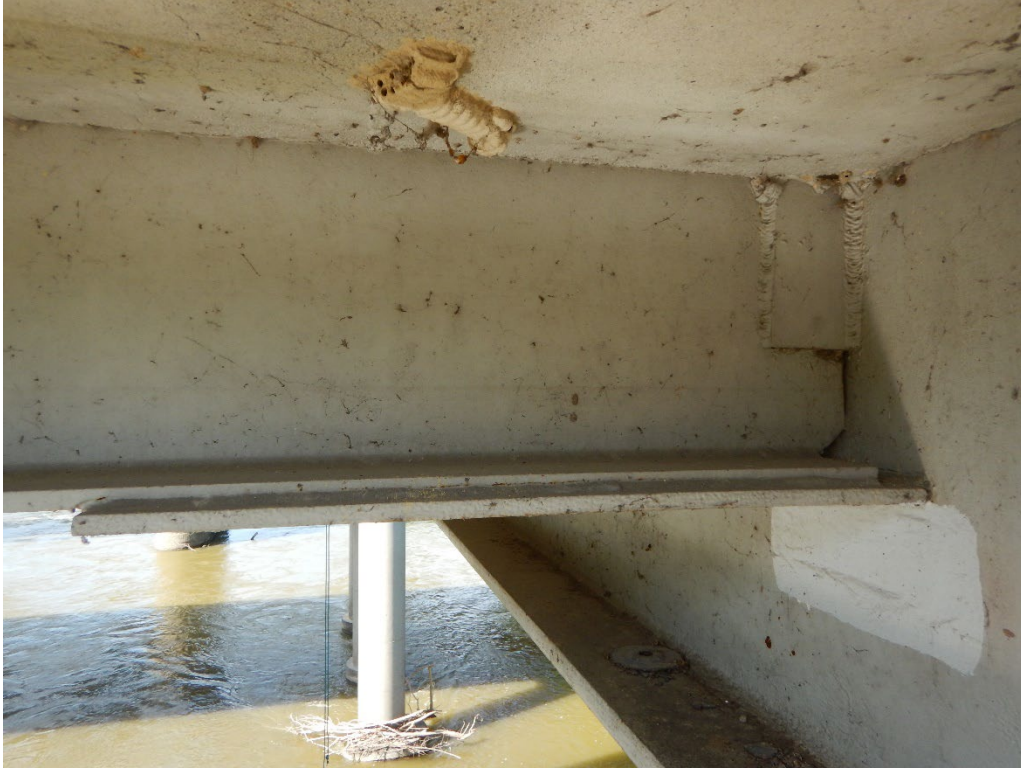
Photo 47: Stringer 1 connection to Floor Beam 2, Span 2

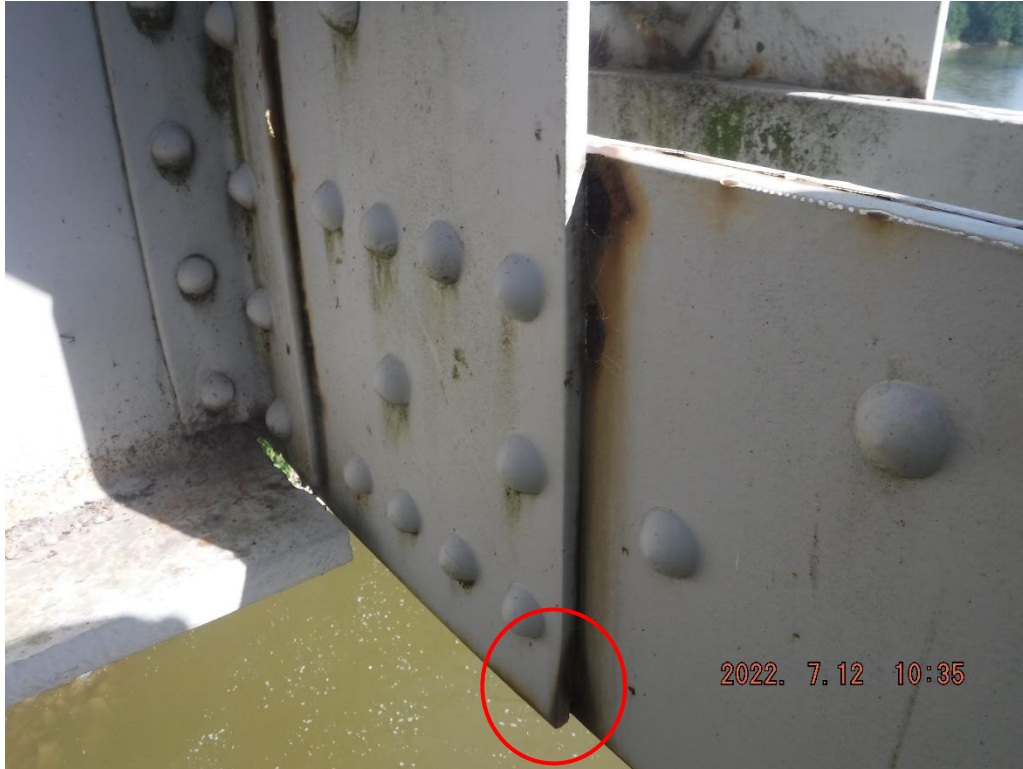
Photo 48: Pack rust deforming L4 gusset plate up to 1/4" in Span 1, North Truss

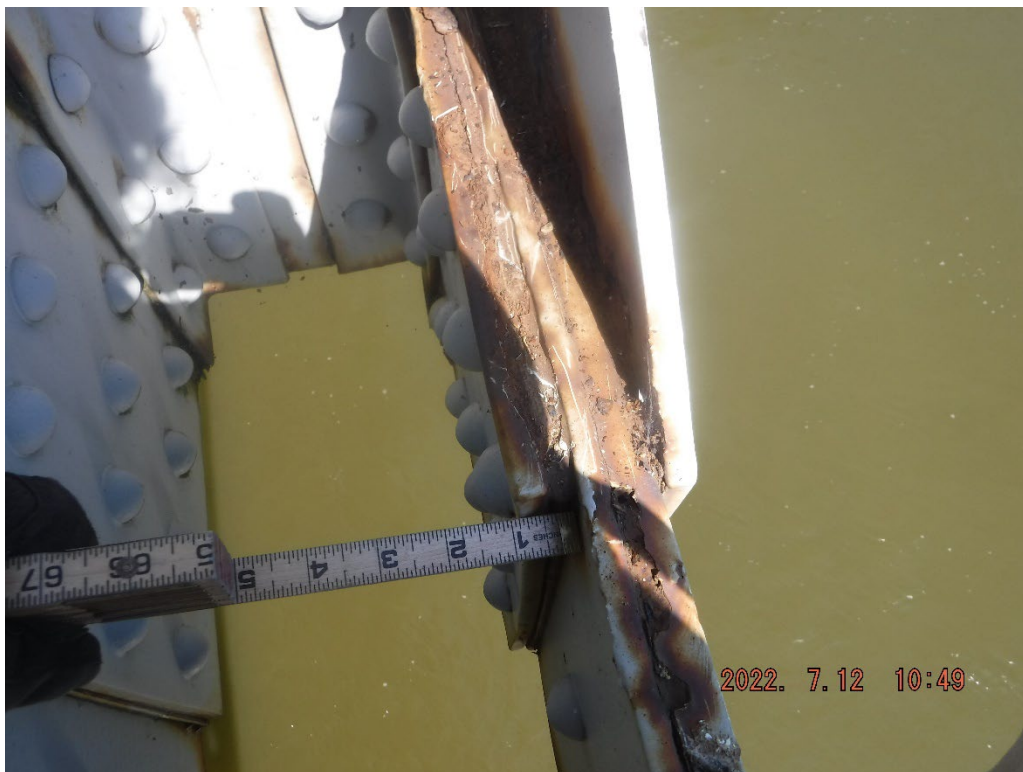
Photo 49: Active pack rust up to 3/8" thick at L5 splice plate, Span 1, North Truss

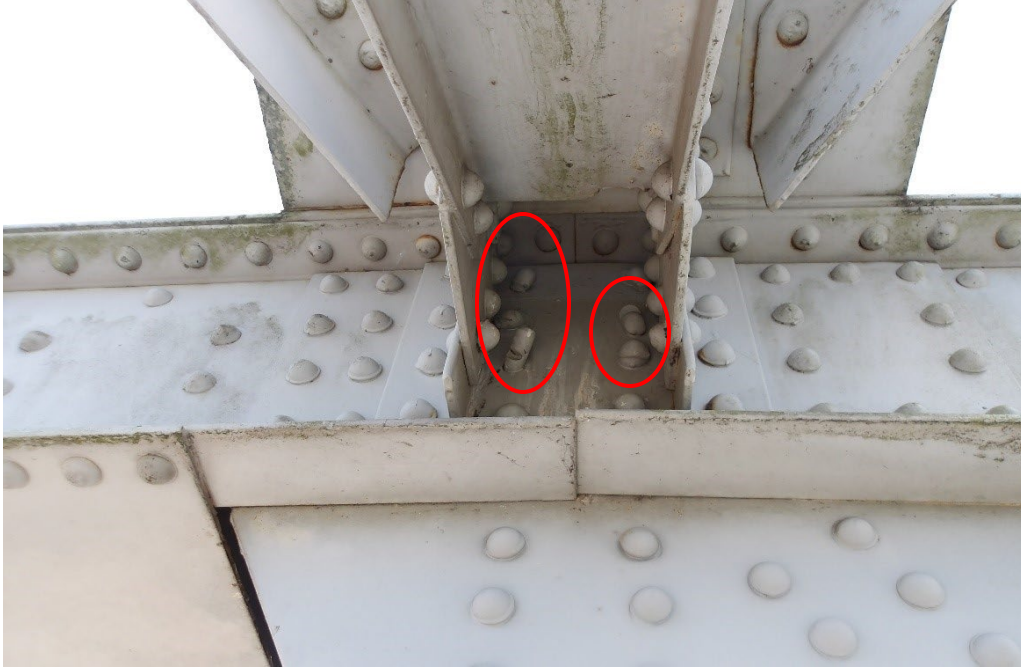
Photo 50: Improperly installed rivets at U6, Span 2, South Truss

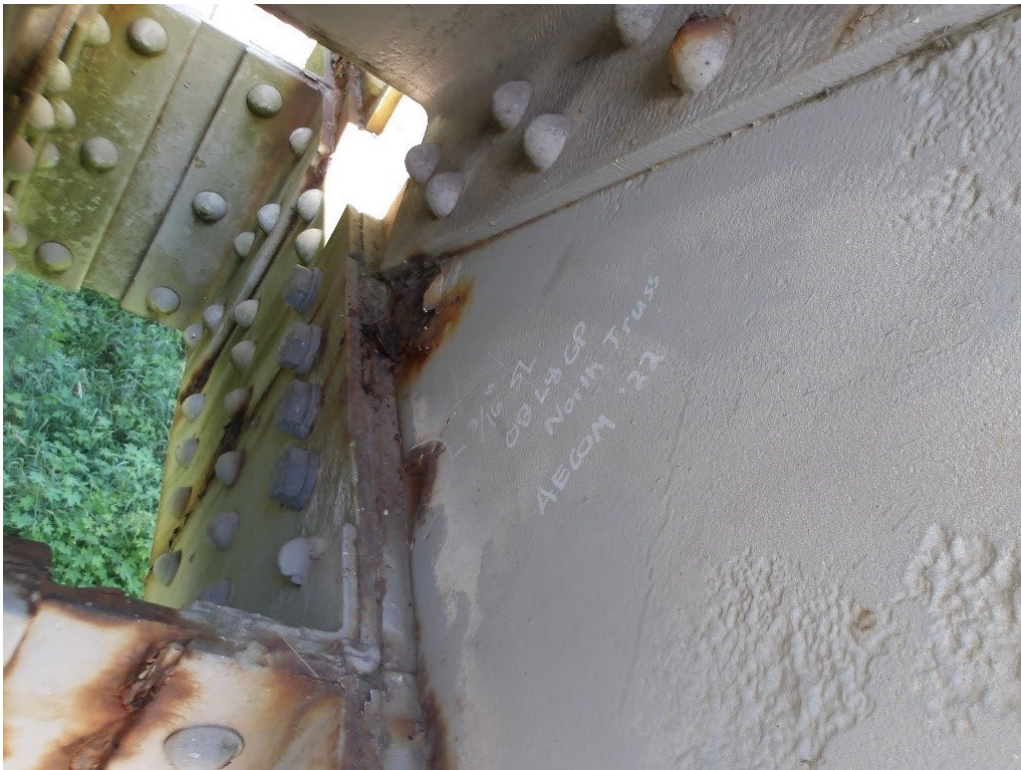
Photo 51: Pitting in L8, Span 3, North Truss

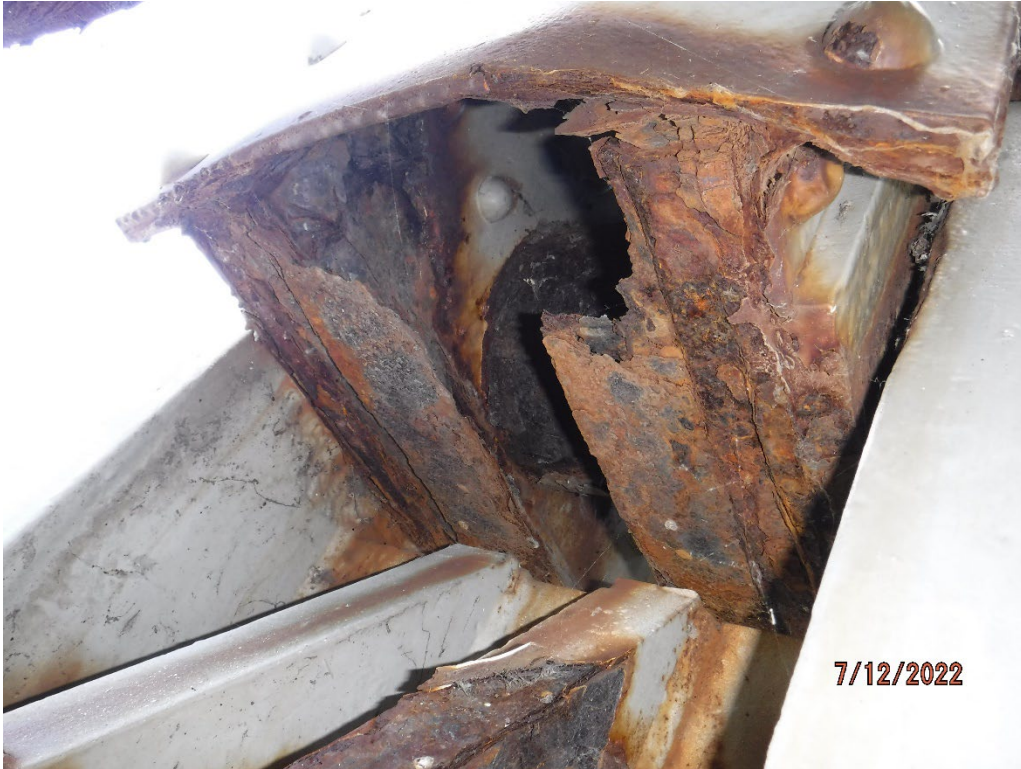
Photo 52: Corrosion holes in L0 gusset plate stiffening angles and bowed side cover plate behind Pier 2 bearing, Span 2, North Truss

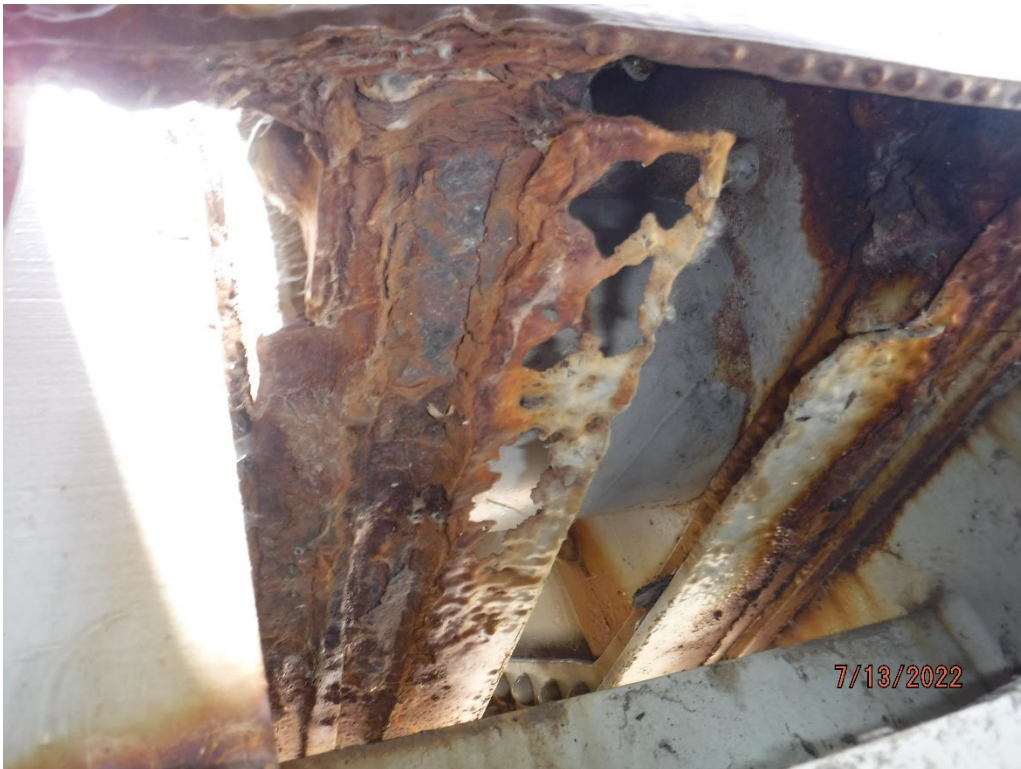
Photo 53: Corrosion holes in L0 gusset plate stiffening angles behind Pier 3 bearing, Span 3, North Truss

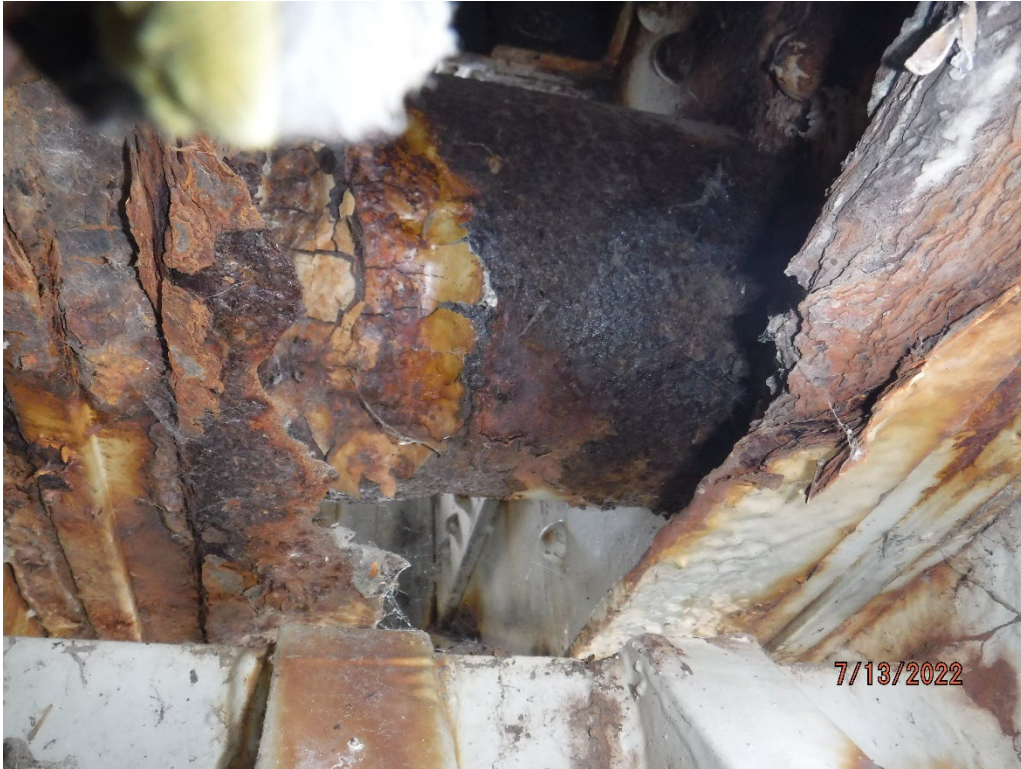
Photo 54: Laminating corrosion on the south bearing pin at Span 3, Pier 3

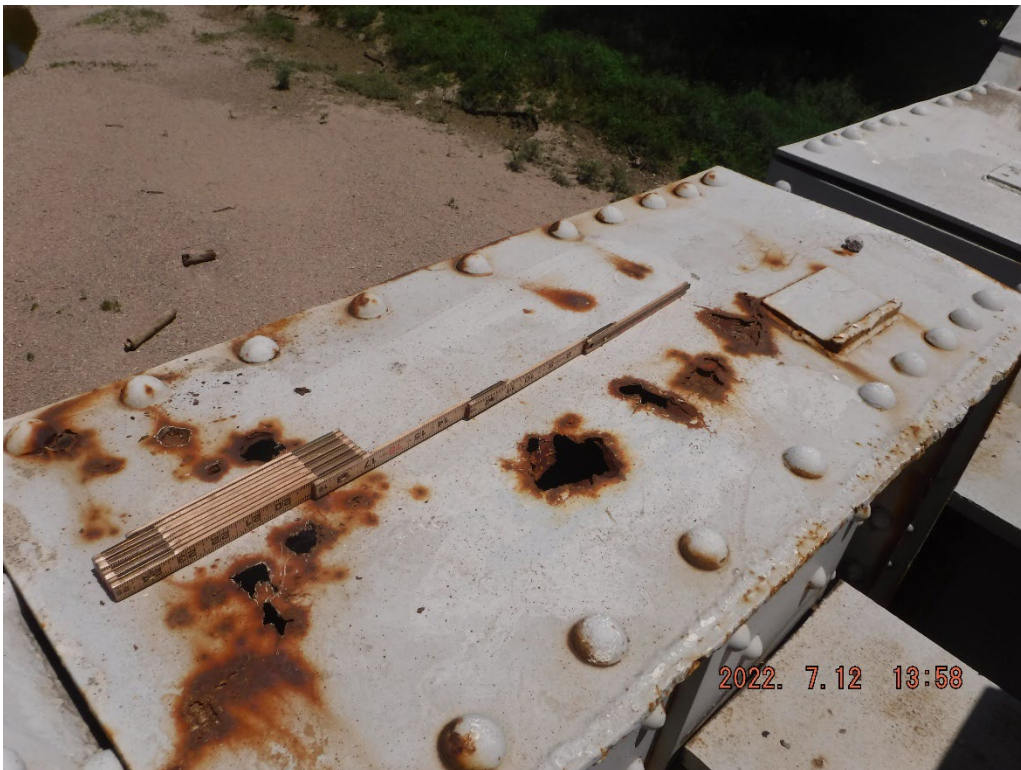
Photo 55: Corrosion holes in top cover plate of L10, Span 2, North Truss

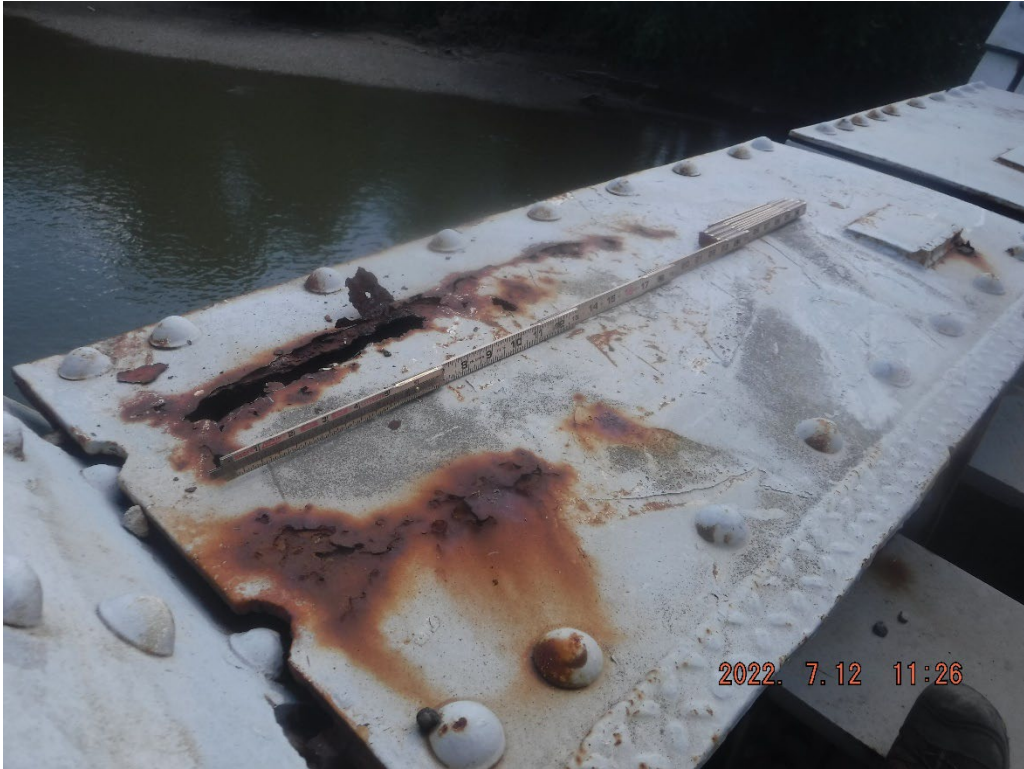
Photo 56: Corrosion holes in top cover plate of L8, Span1, North Truss

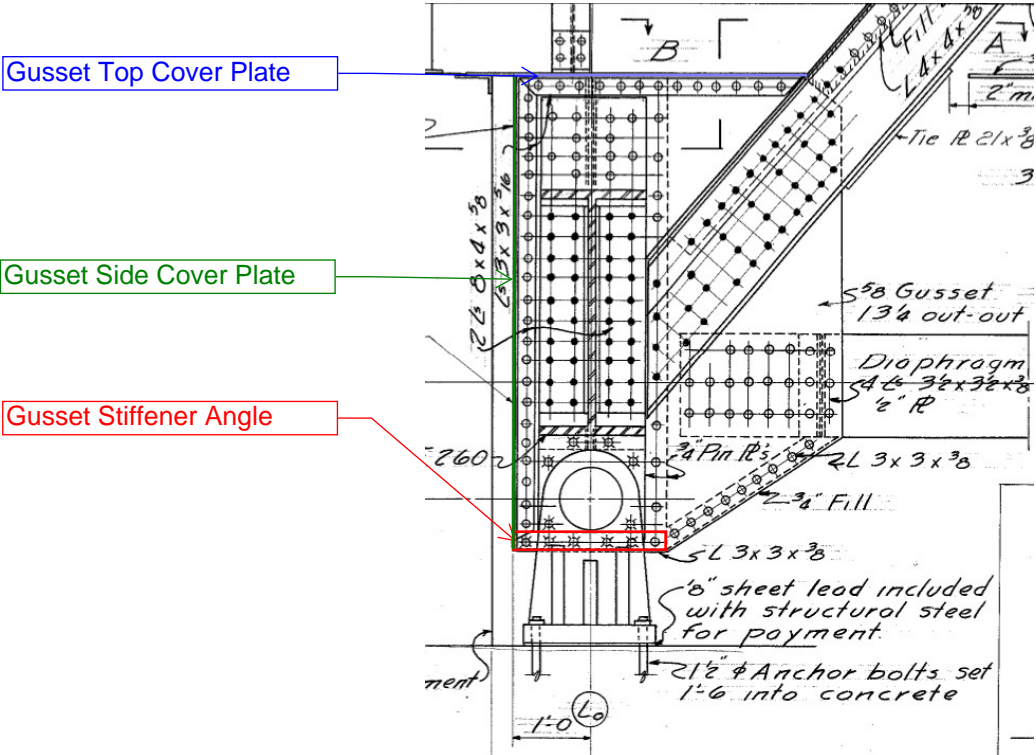
Figure 4- Typical gusset configuration at truss bearing

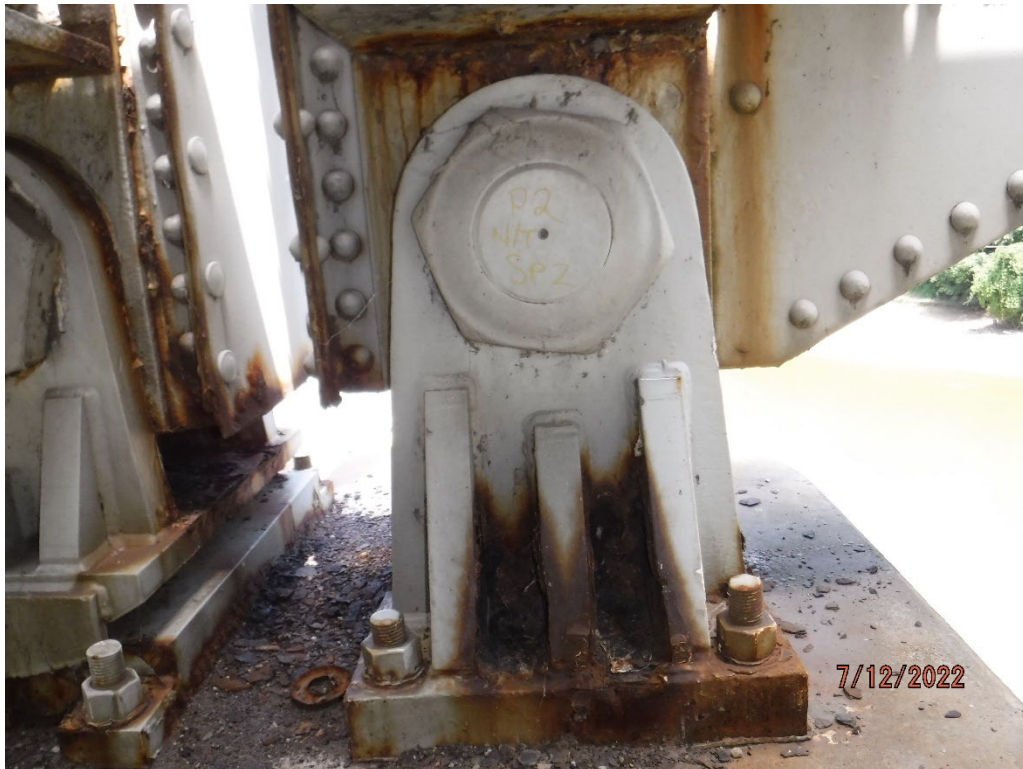
Photo 58: Active corrosion with minor section loss on North bearing, Span 2, Pier 2

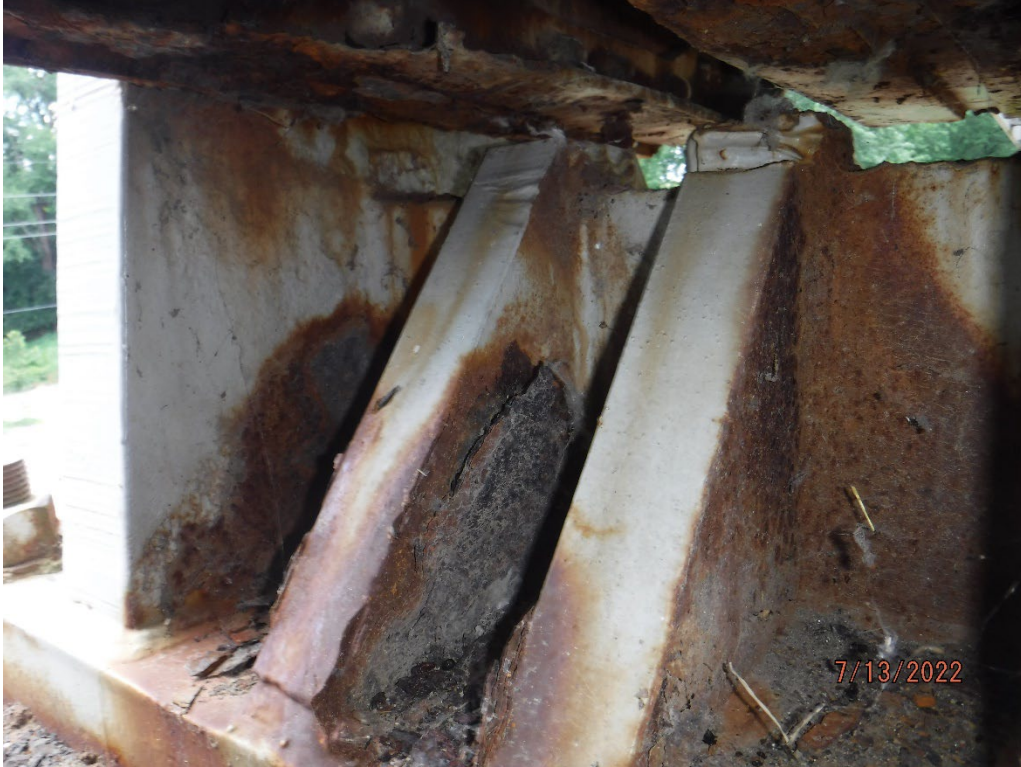
Photo 59: Laminating corrosion with section loss at North bearing, Span 3, Pier 3

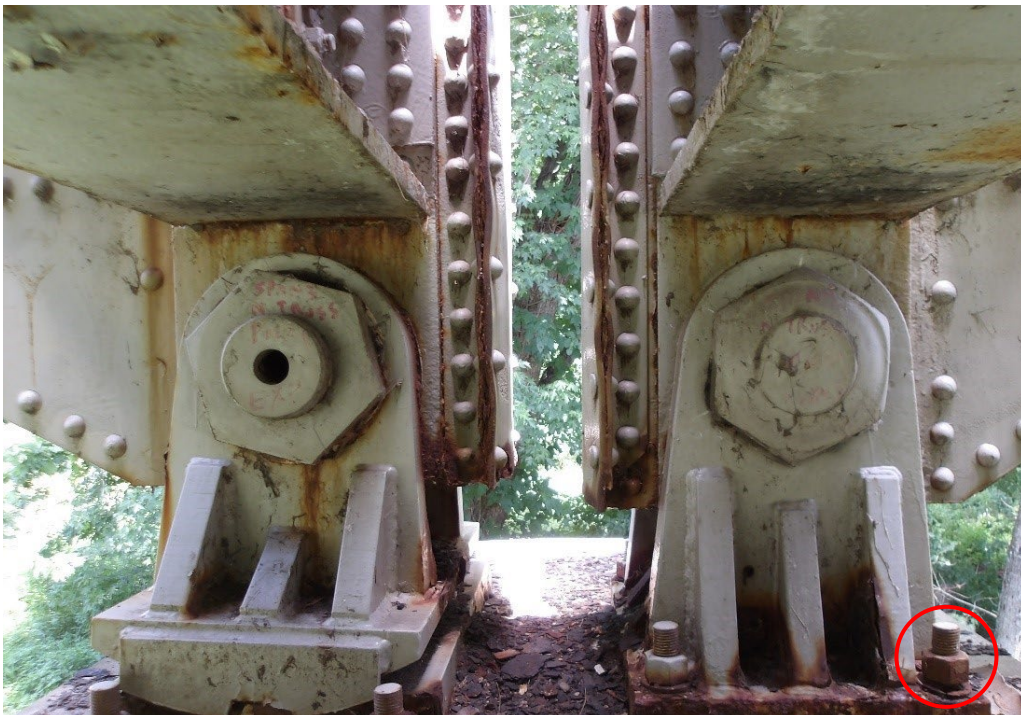
Photo 60: Loose anchor nut and laminating corrosion at North bearings, Pier 4

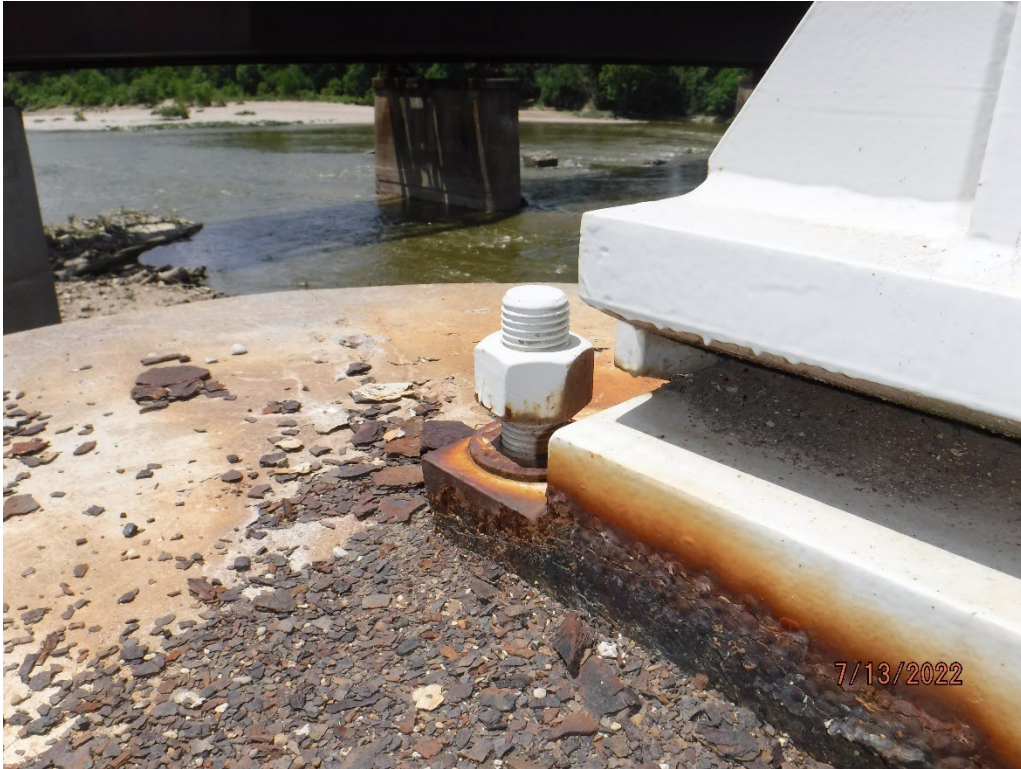
Photo 61: Loose southeast anchor nut at South bearing, Span 2, Pier 3

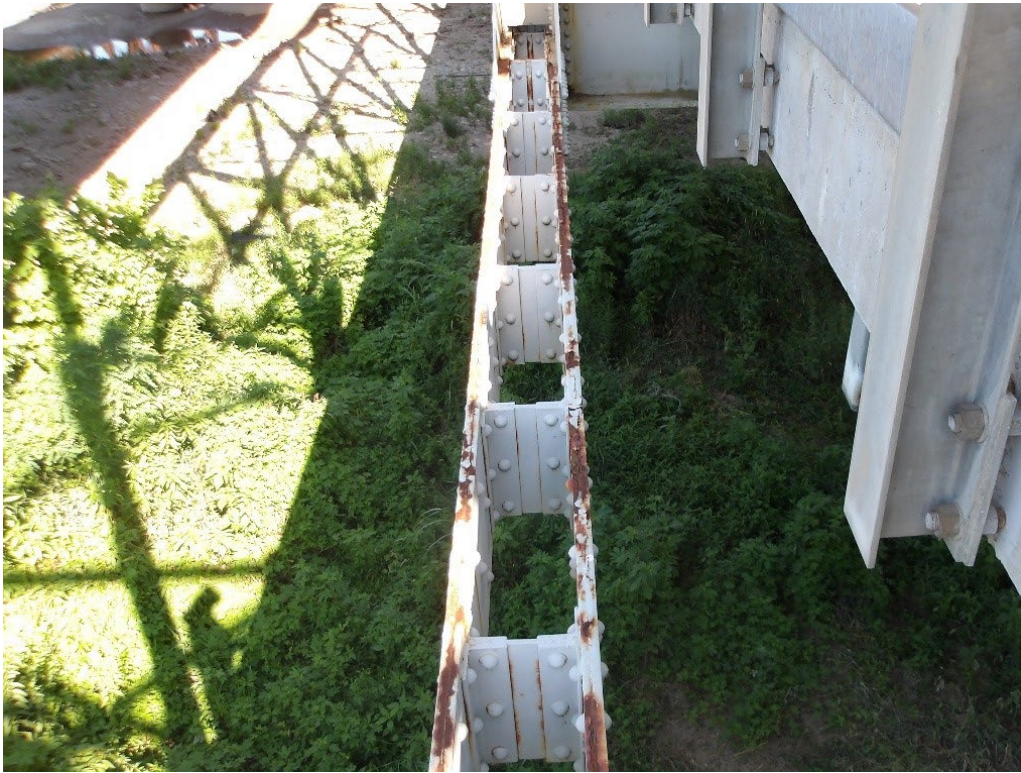
Photo 62: Typical lower paint condition (L6L7 at Span 3, South Truss shown)

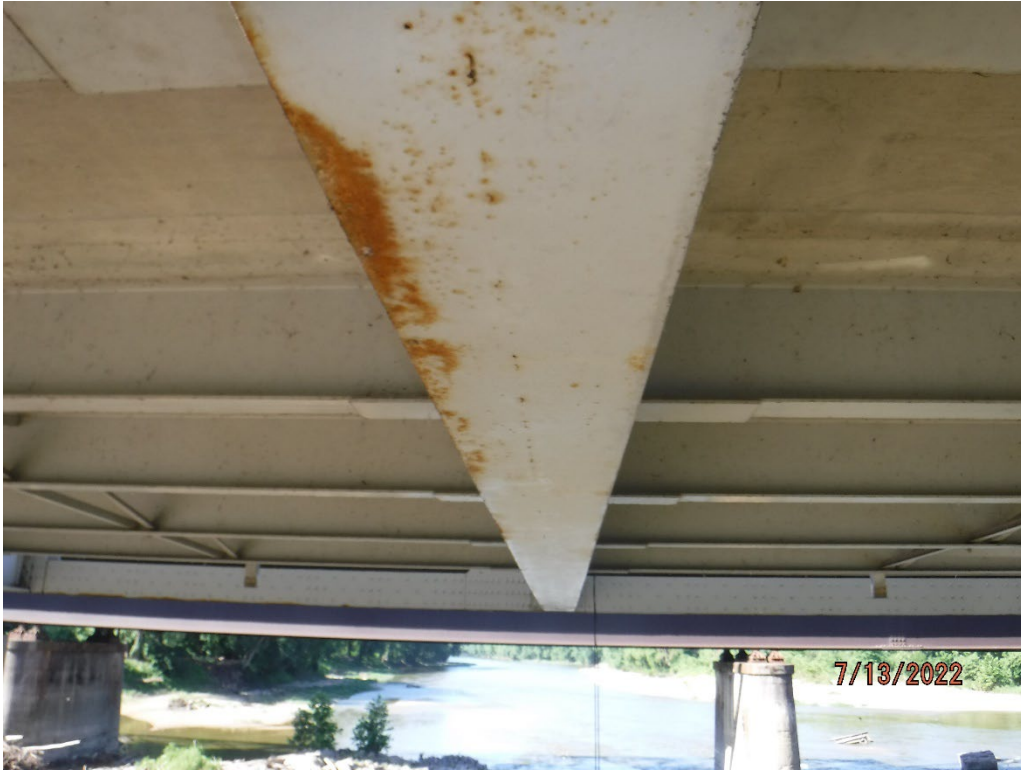
Photo 63: Typical floorbeam freckling corrosion (FB7, Span 2 looking South shown)

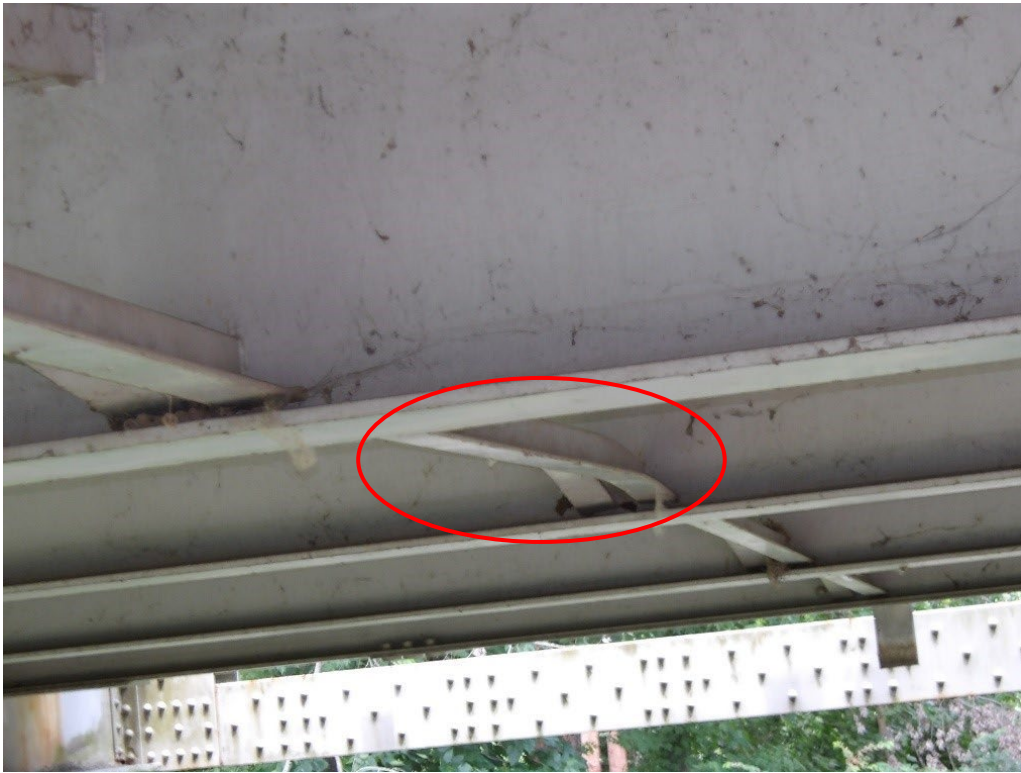
Photo 64: Bent stringer cross frame between FB4 and FB5 in Span 4

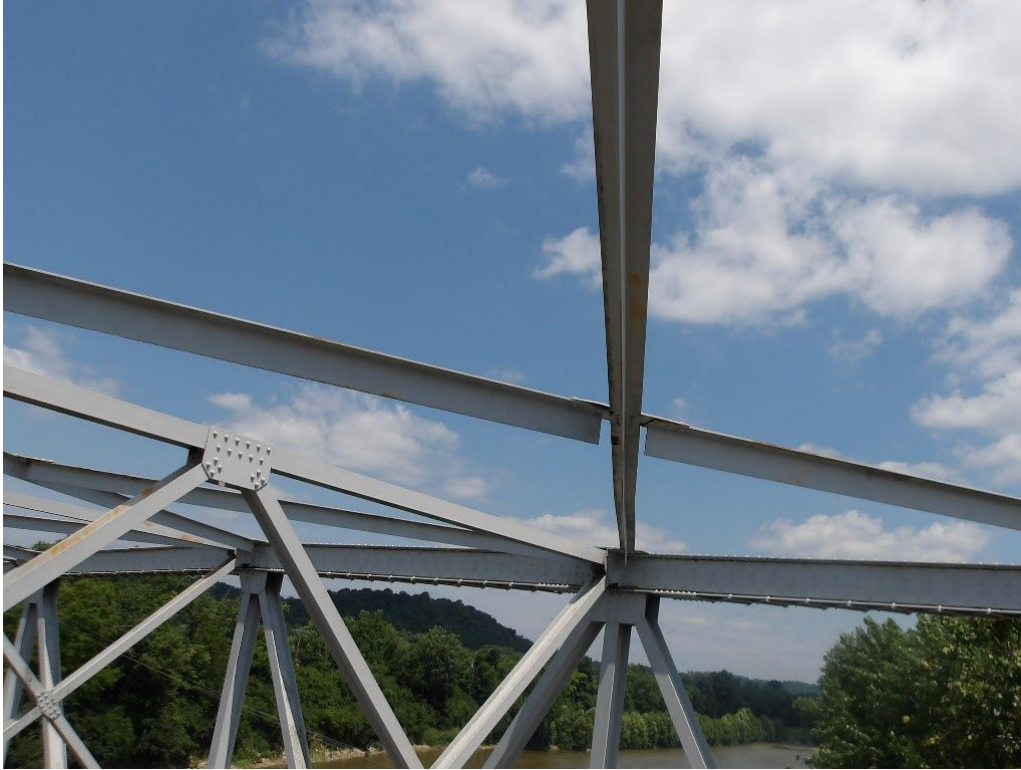
Photo 65: Bent lateral bracing at U5U6 on Span 2
