2022 IN-DEPTH AND FRACTURE CRITICAL INSPECTION REPORT

BRIDGE NO. HAM-50-0376L

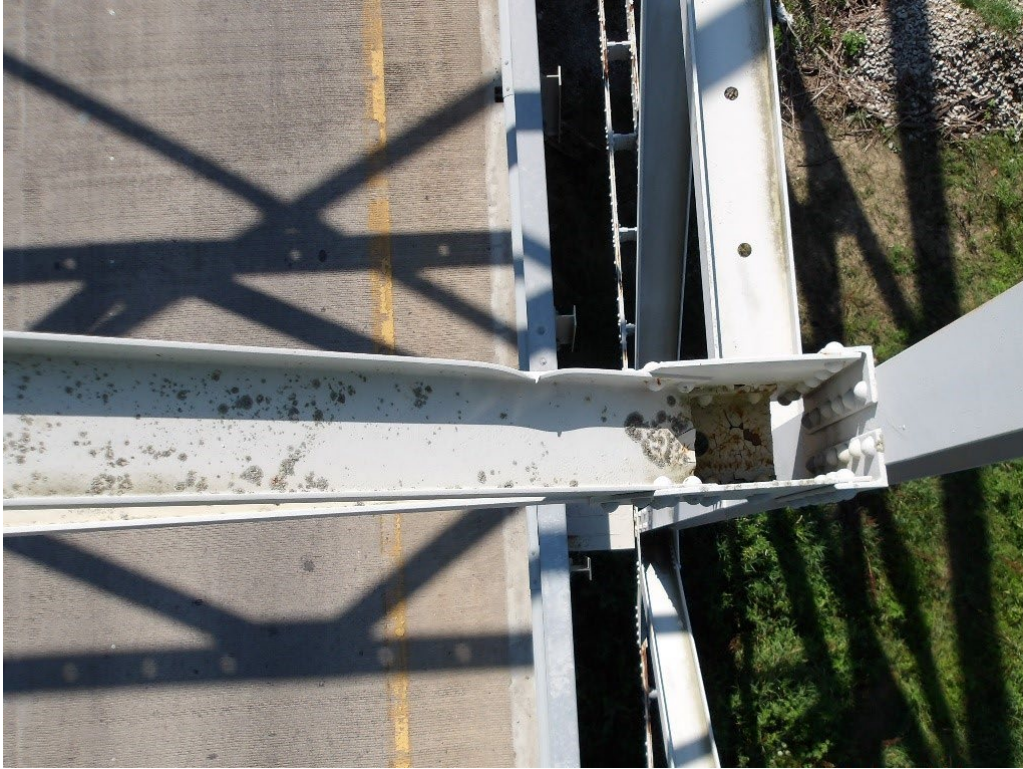
Photo 66: Impact damage of the sway bracing member in Span 4 below U3

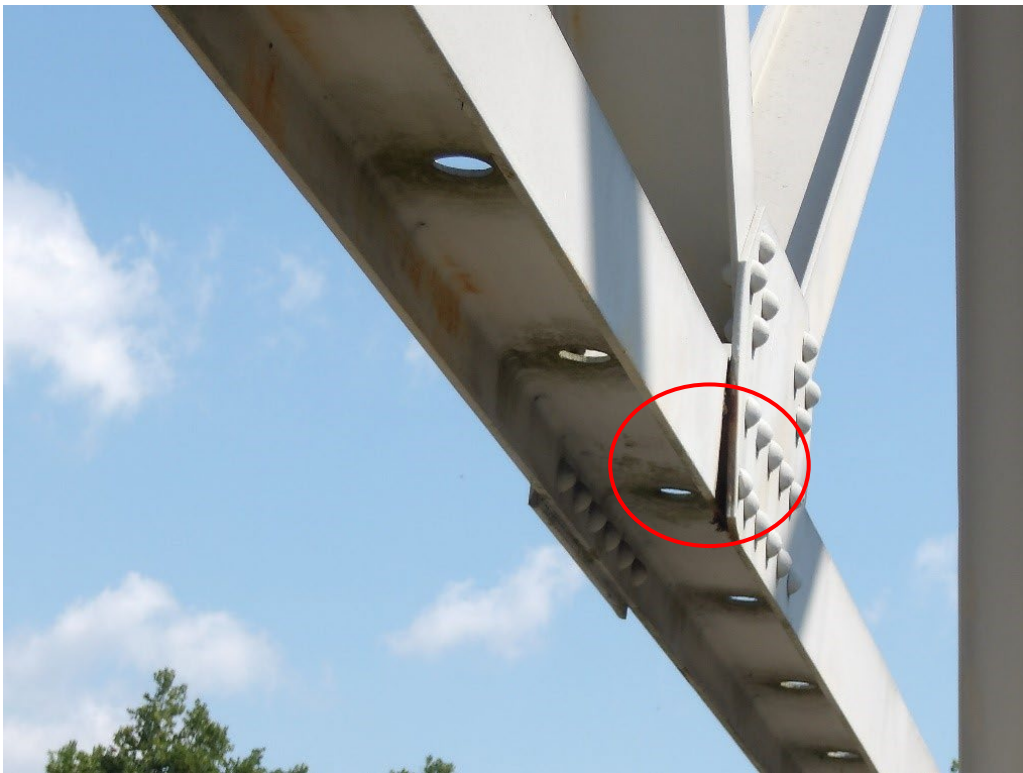
Photo 67: Warped sway brace gusset plate at PP4 in Span 3

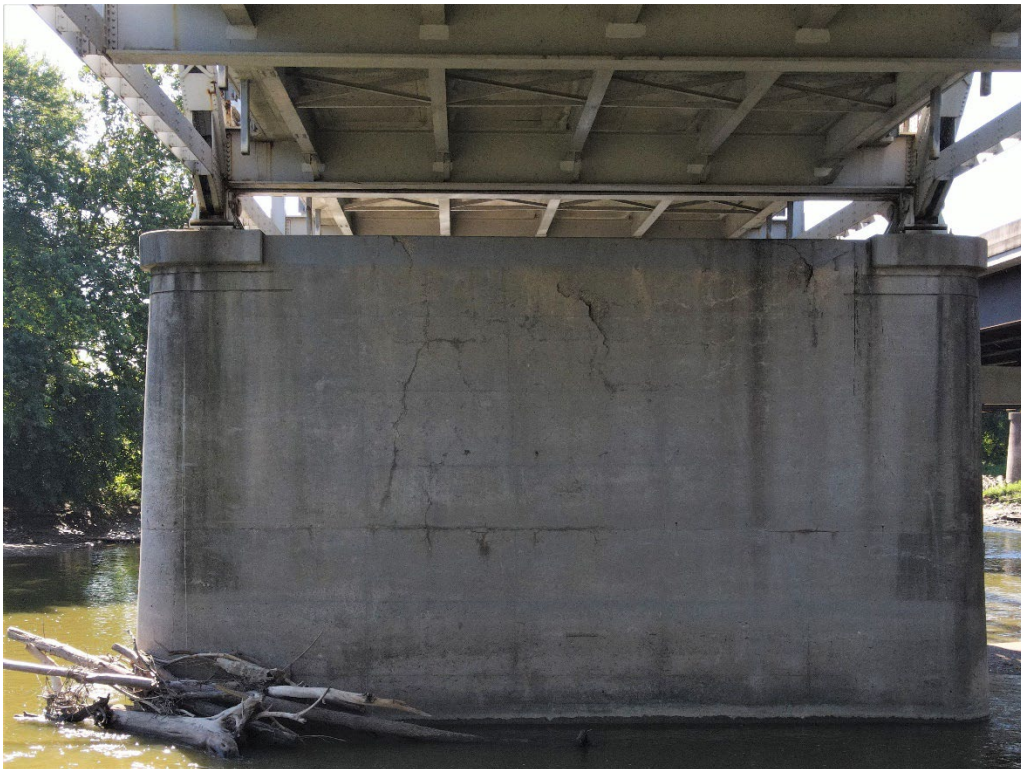
Photo 68: Cracks and delaminations on west face of Pier 2

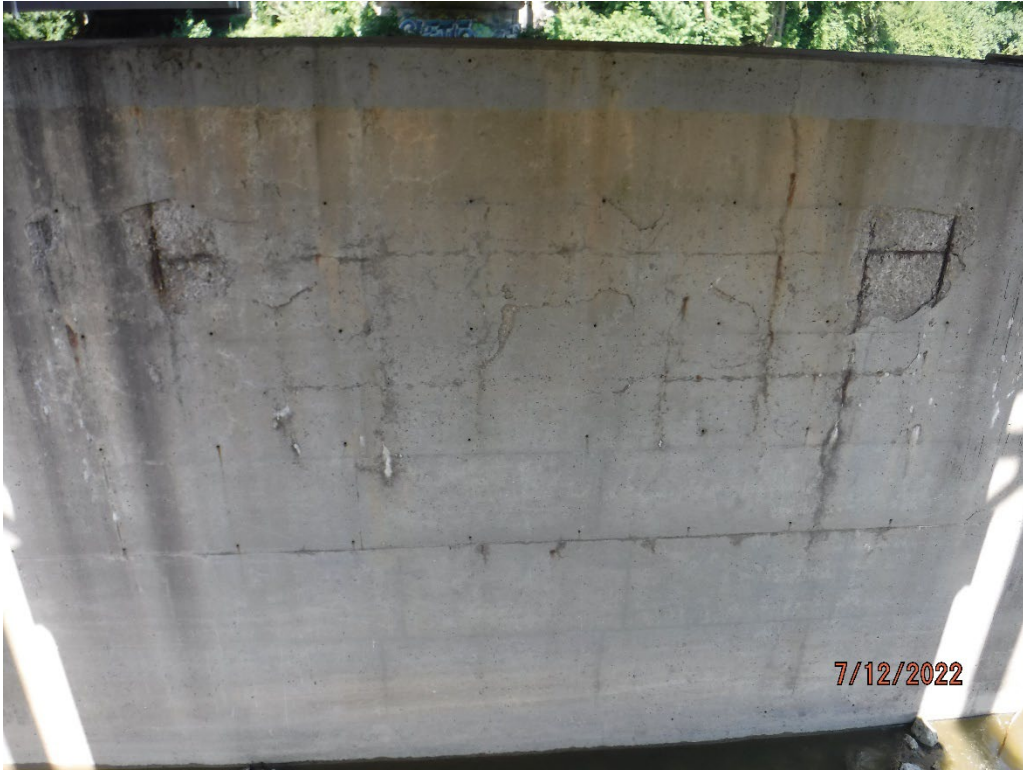
Photo 69: Delaminations and spalls with exposed rebar on east face of Pier 2

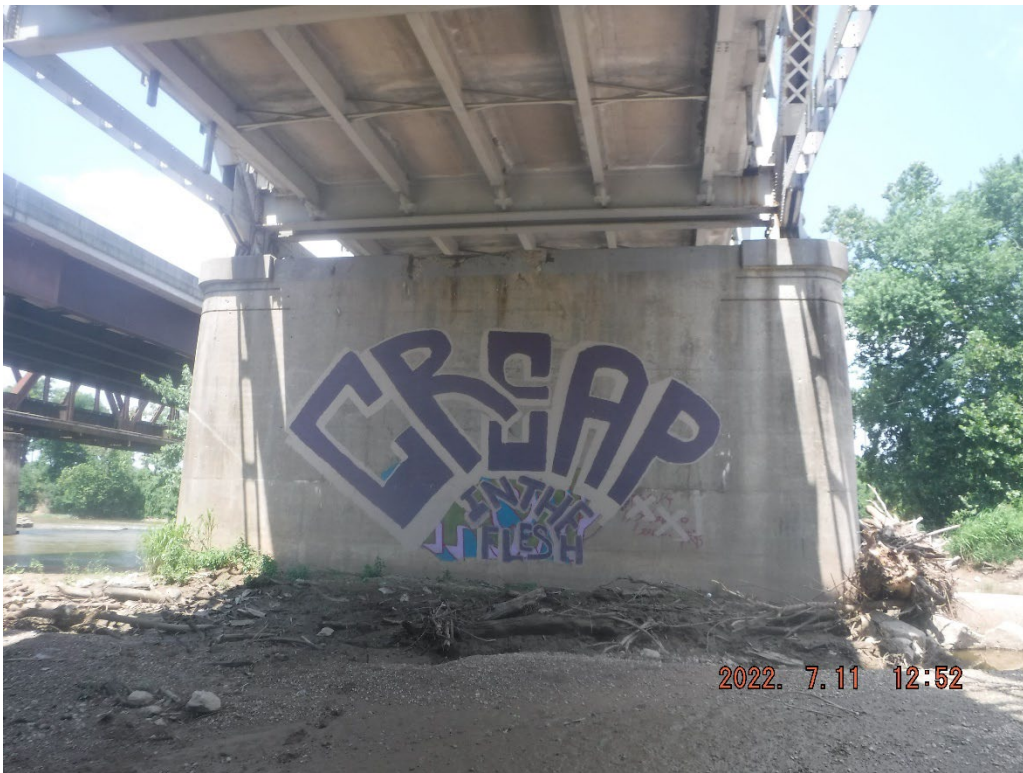
Photo 70: West face of Pier 3

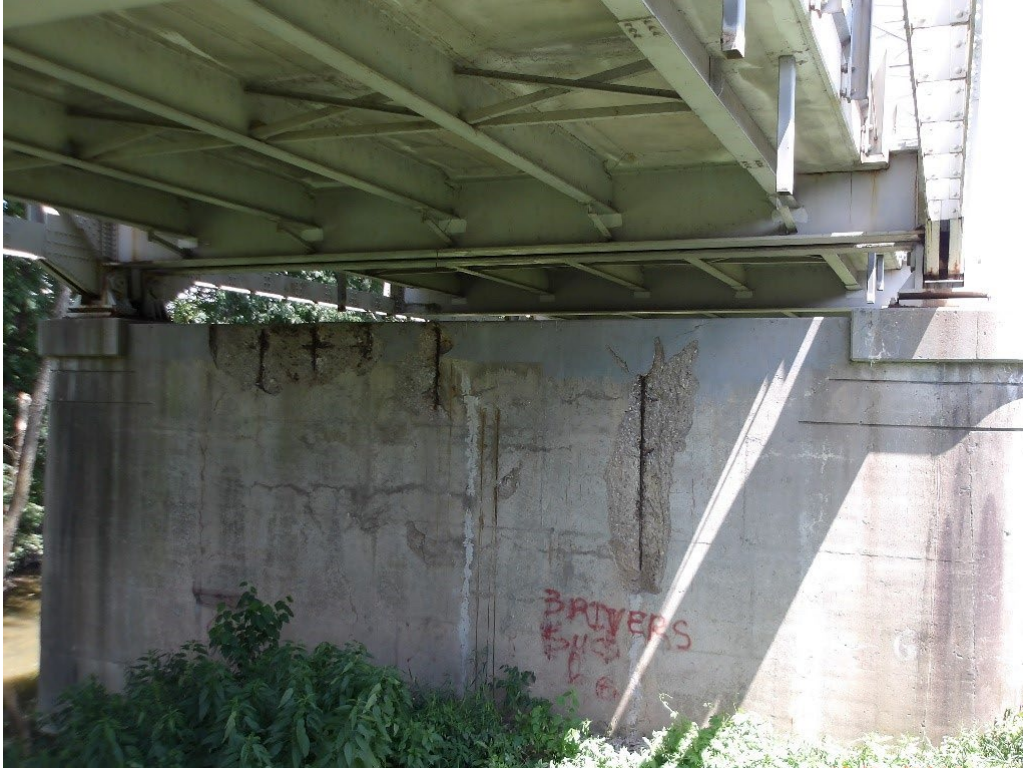
Photo 71: Widespread spalls with exposed rebar on the west face of Pier 4

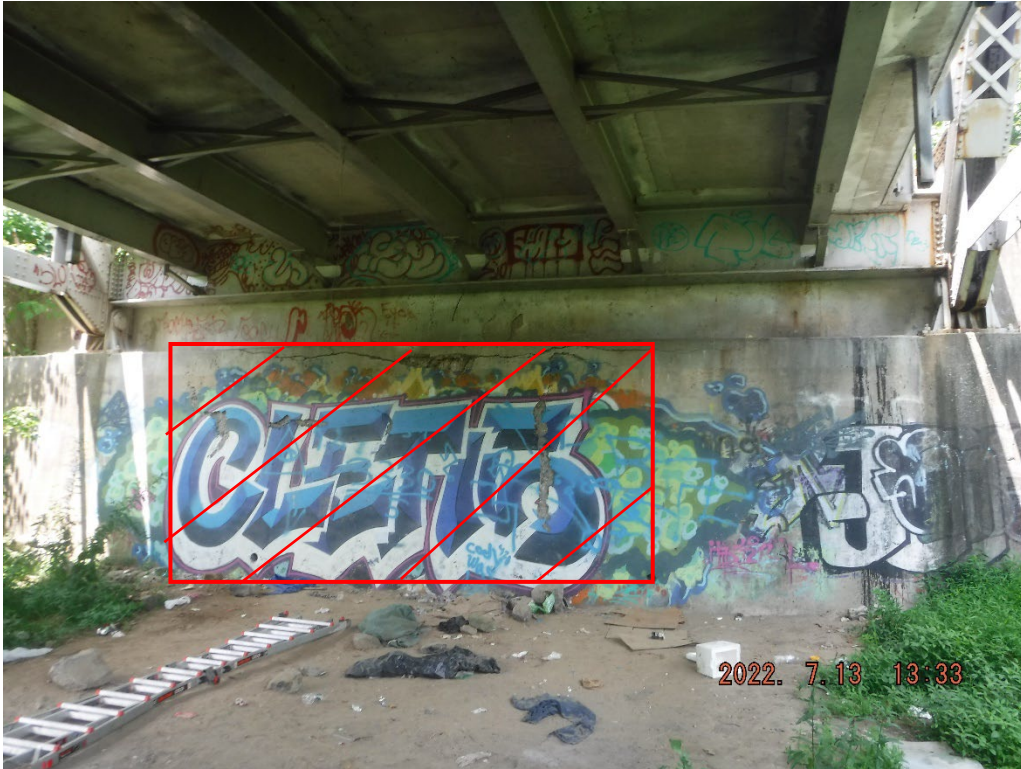
Photo 72: Extents of delaminations on Rear Abutment

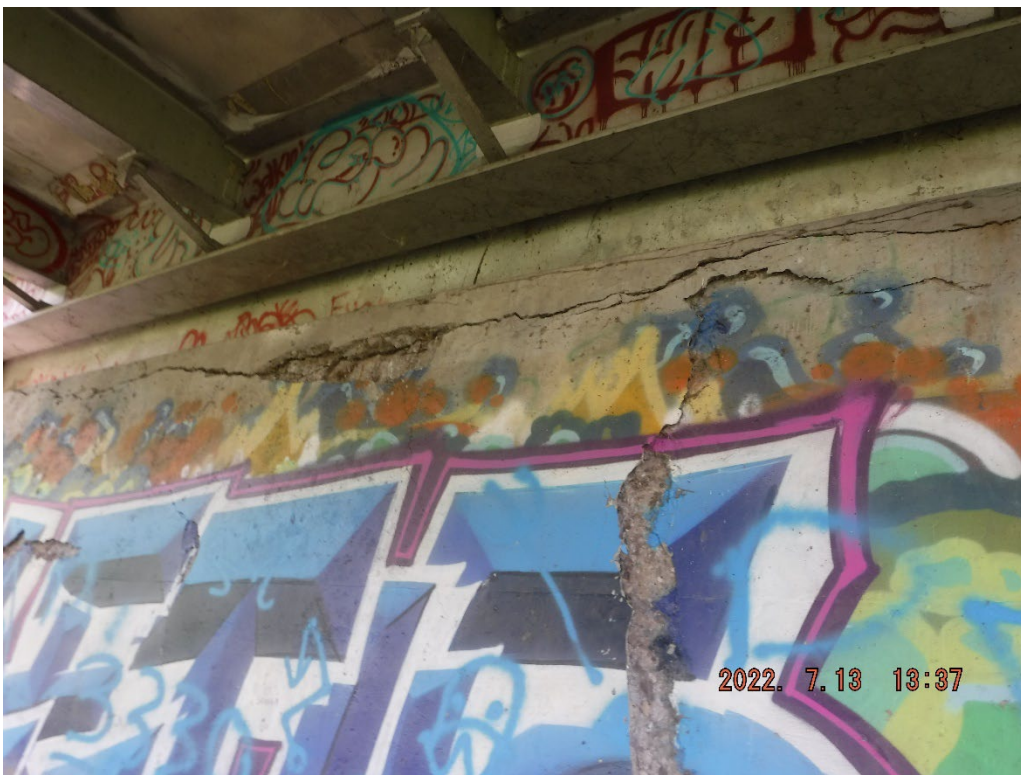
Photo 73: Spalls, cracks and delaminations on Rear Abutment

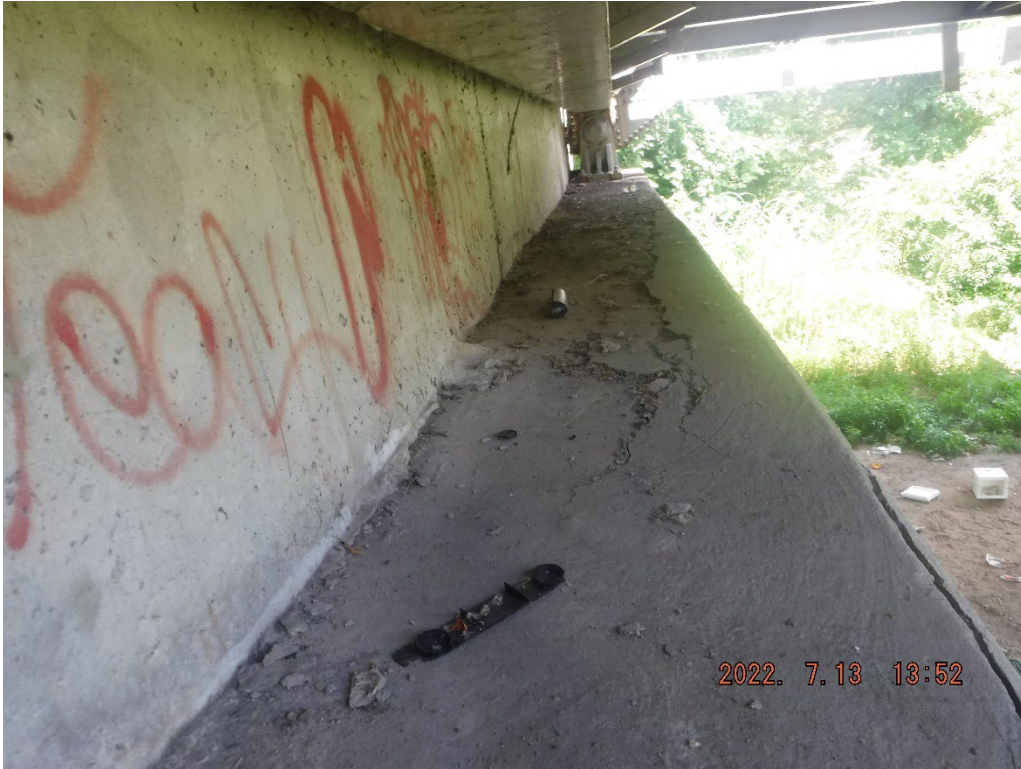
Photo 74: Rear Abutment seat looking North

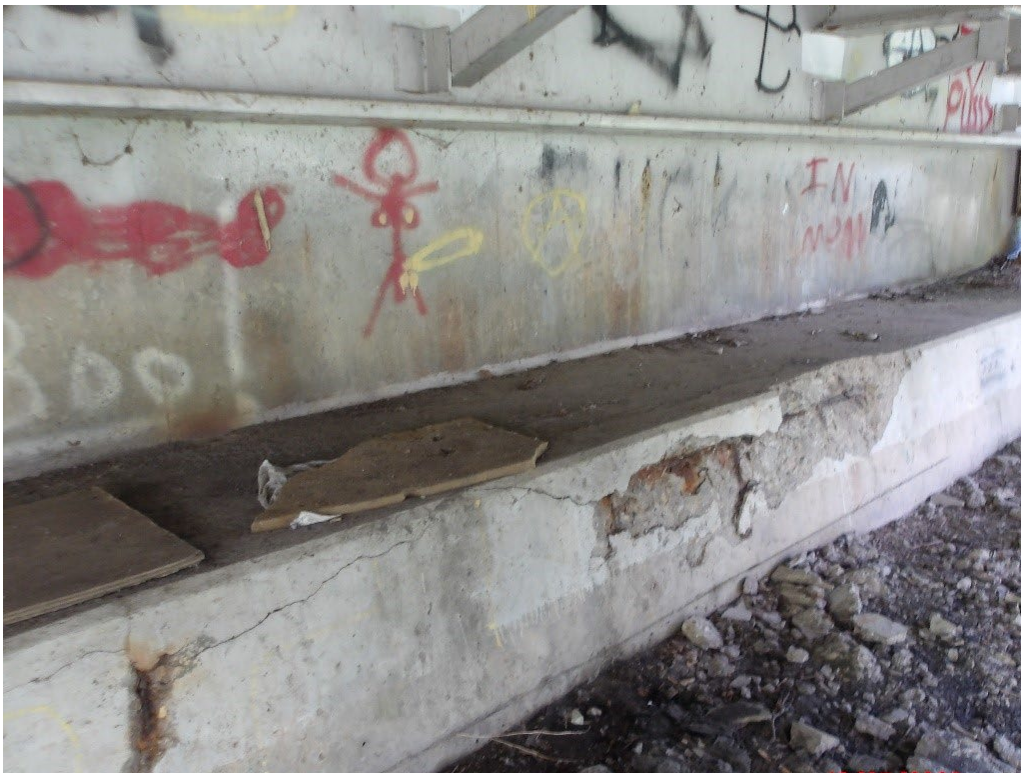
Photo 75: Spalls with exposed rebar at Forward Abutment

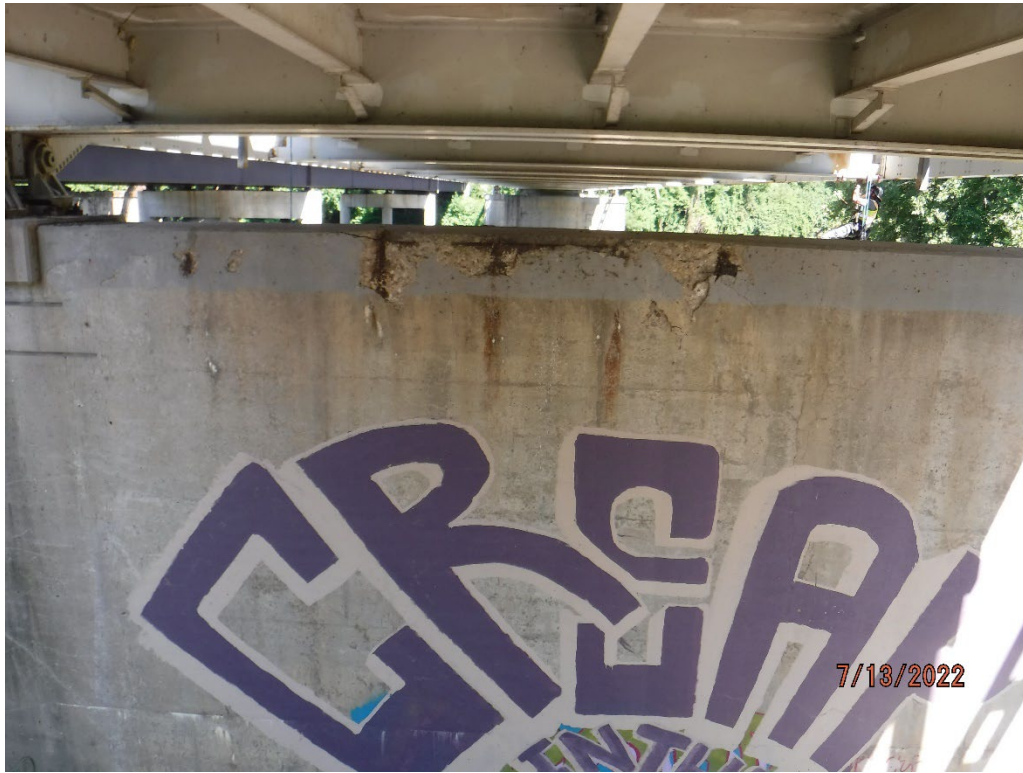
Photo 76: Spall with exposed rebar on east face of Pier 3 cap

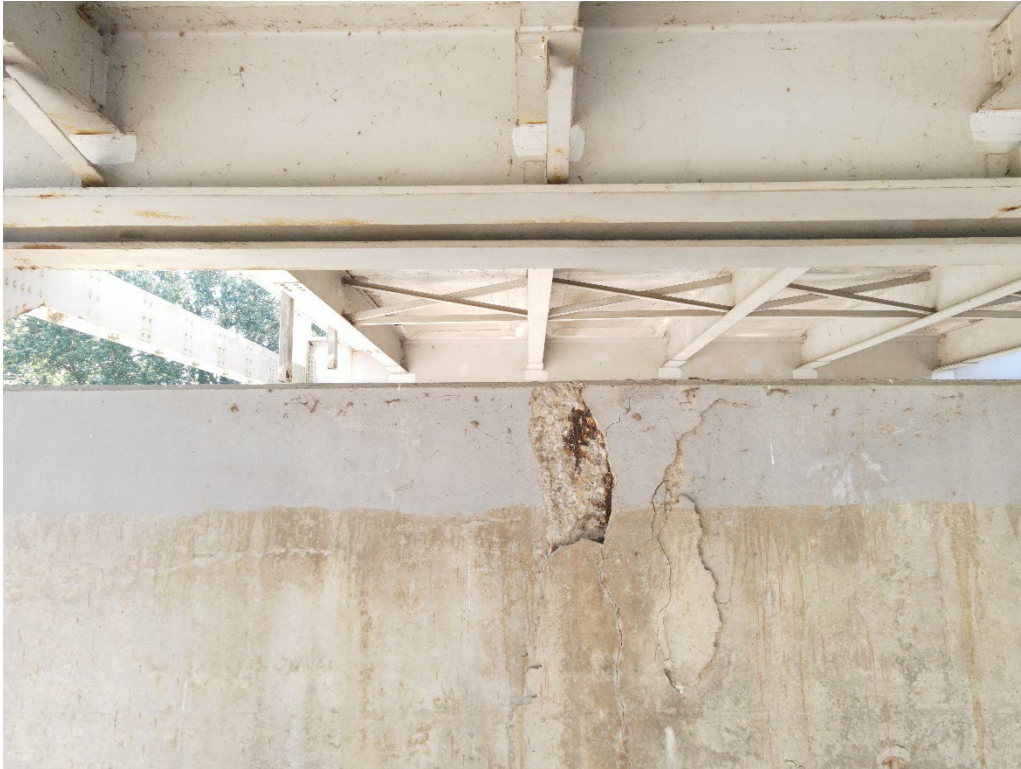
Photo 77: Spall with exposed rebar on west face of Pier 3 cap

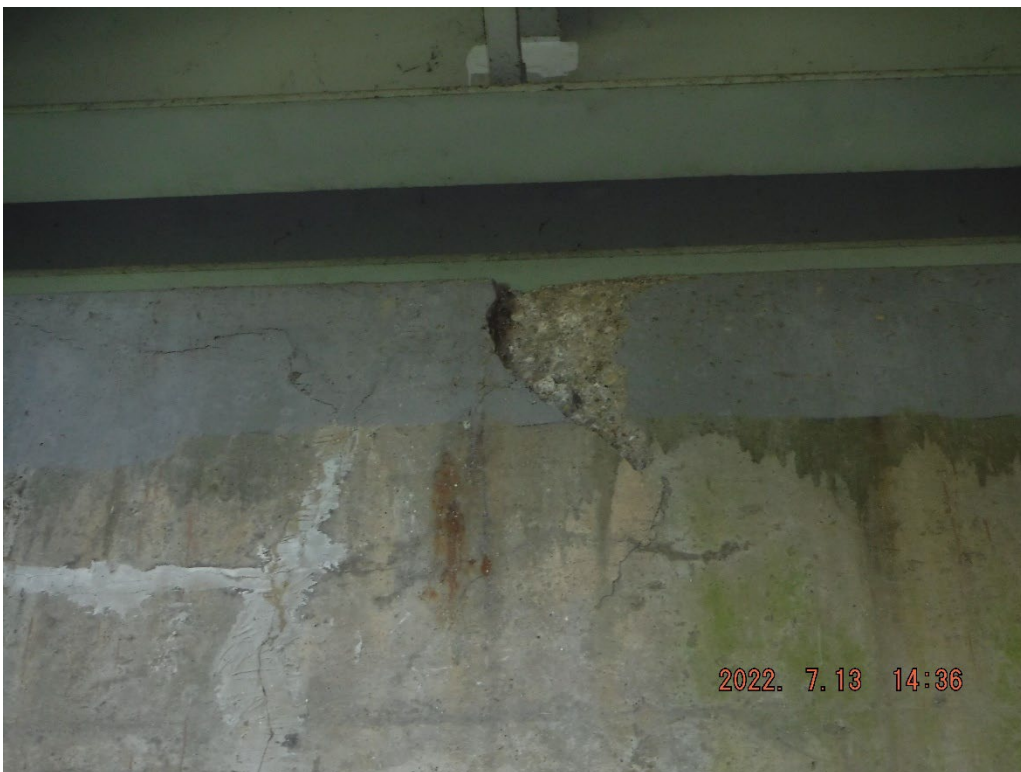
Photo 78: Spall on east face of Pier 4 cap

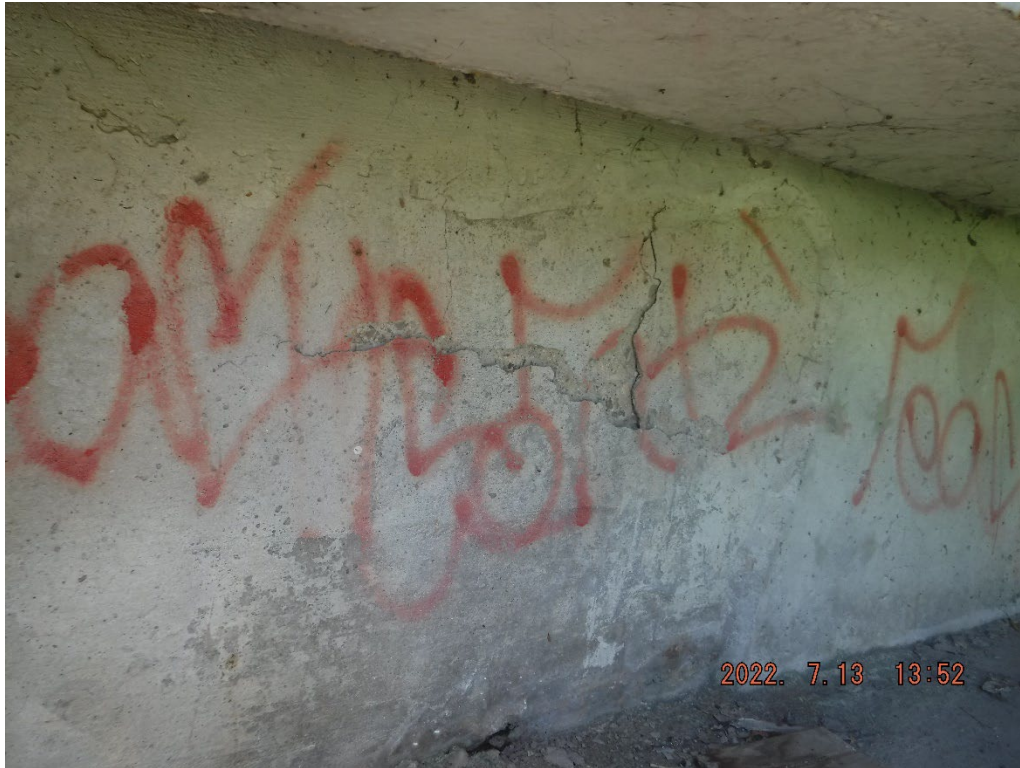
Photo 79: Cracks and delaminations in Rear Abutment backwall

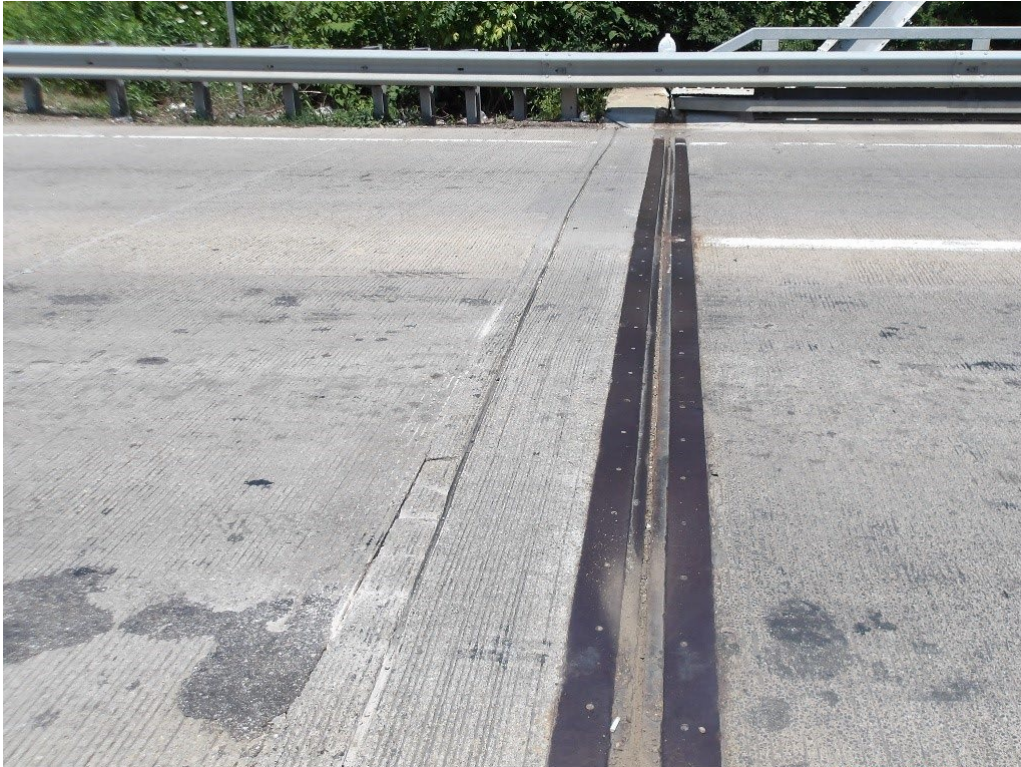
Photo 80: Asphalt patches and longitudinal cracks in Rear Approach Slab near abutment joint

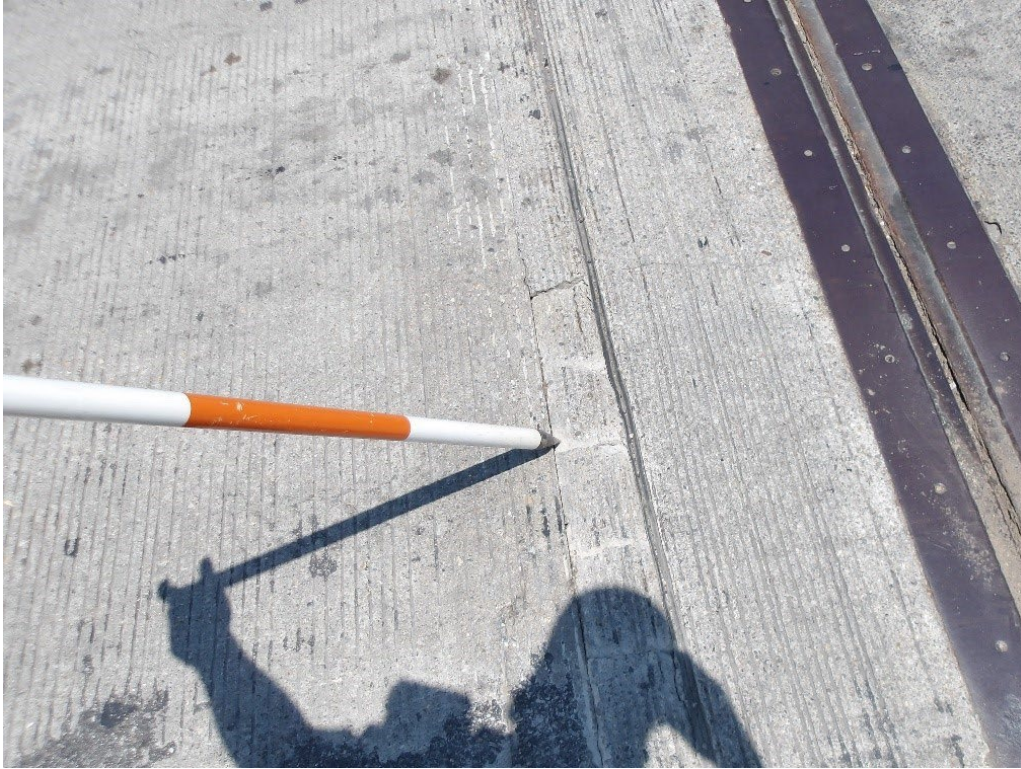
Photo 81: 3 S.F. of cracking with broken up concrete in Rear Approach Slab adjacent to abutment joint

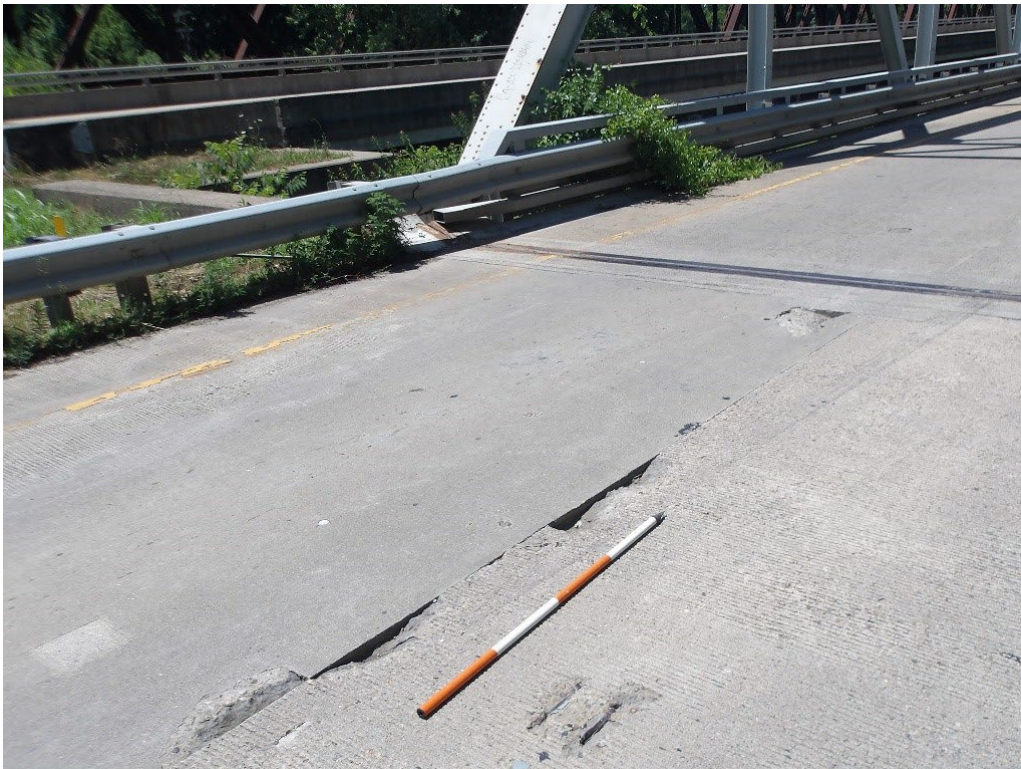
Photo 82: Spalls in Forward Approach Slab

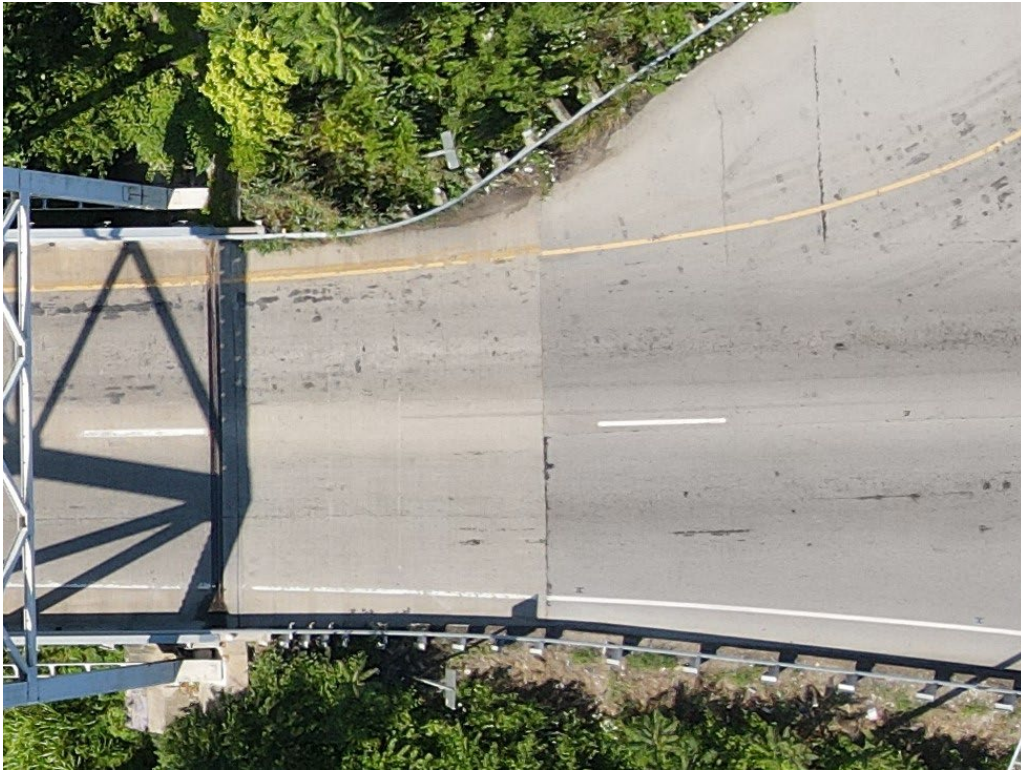
Photo 83: Forward approach wearing surface

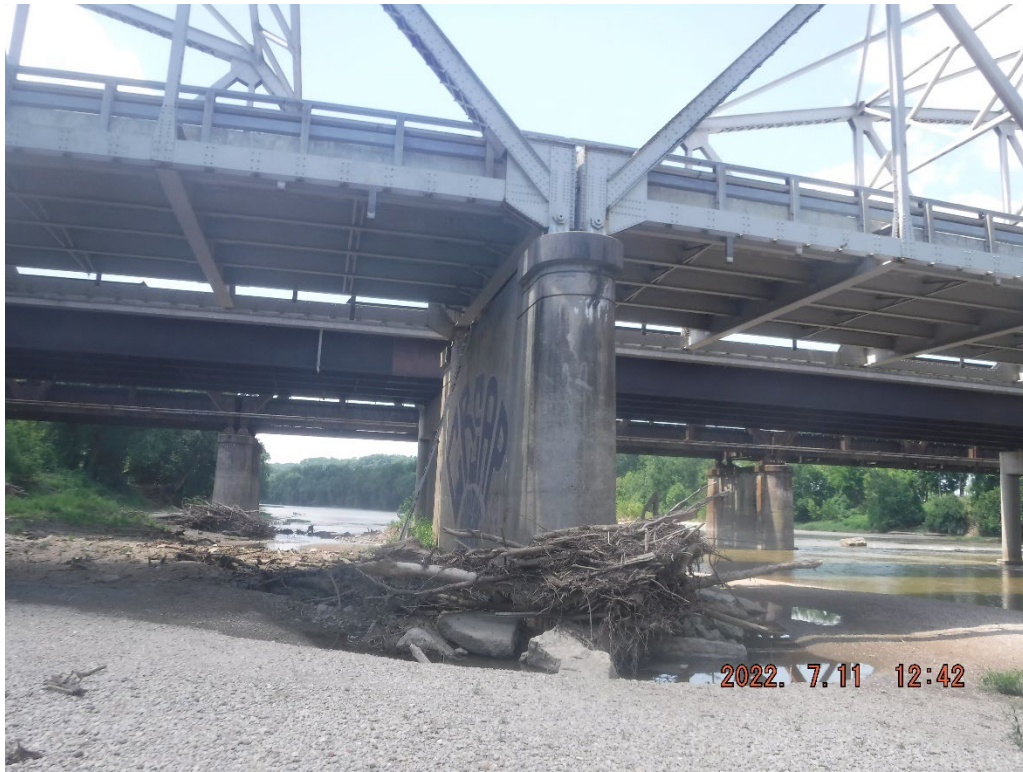
Photo 84: Scour and debris around Pier 3

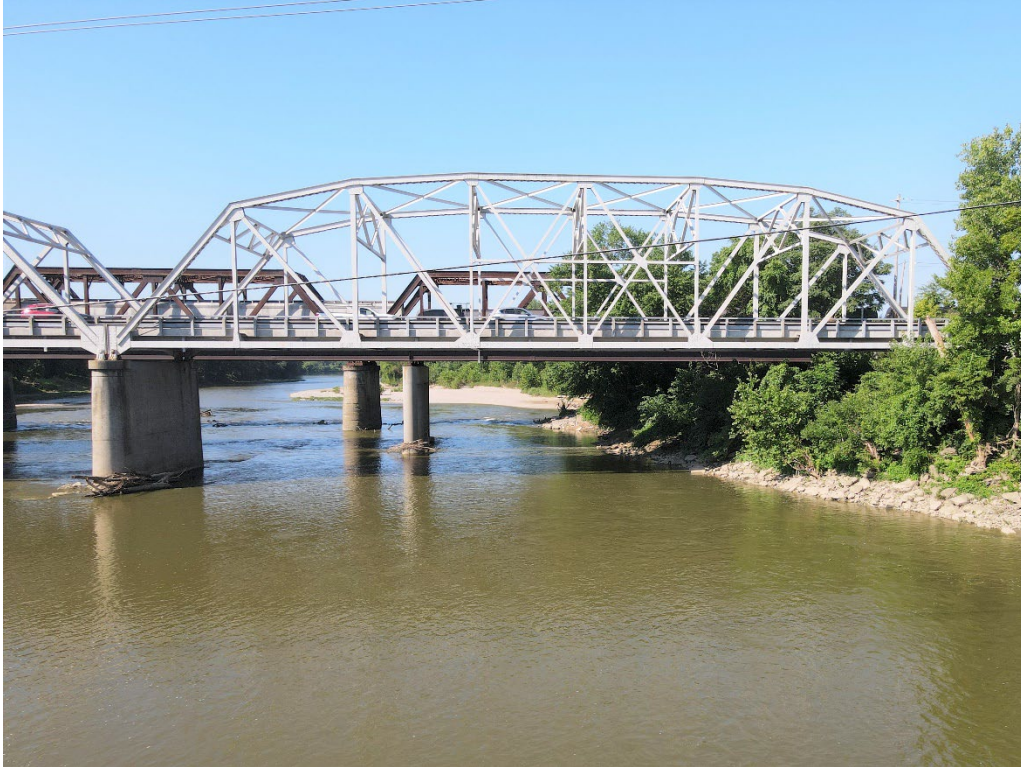
Photo 85: Channel under Span 1

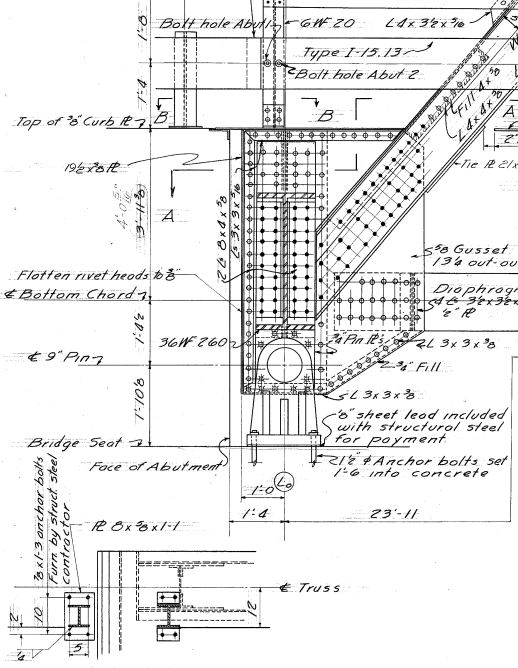
Note:
 All rivets 5/8 unless noted
