2022 In-Depth Element Level and Fracture-Critical Inspection Report

BRIDGE NO: HAM-50-2180N

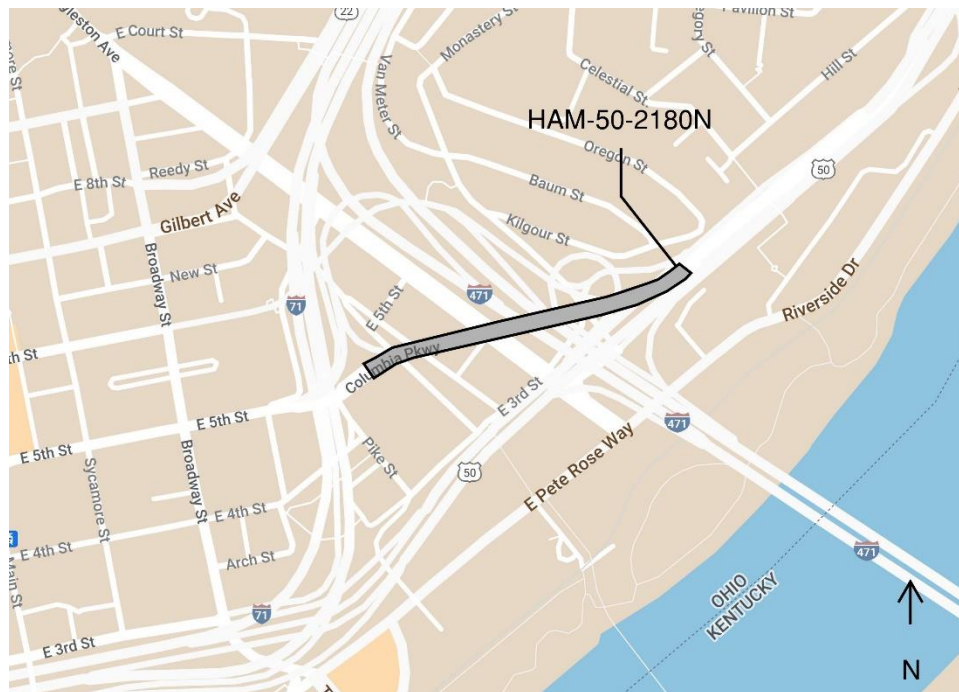
Figure 1: Location Map

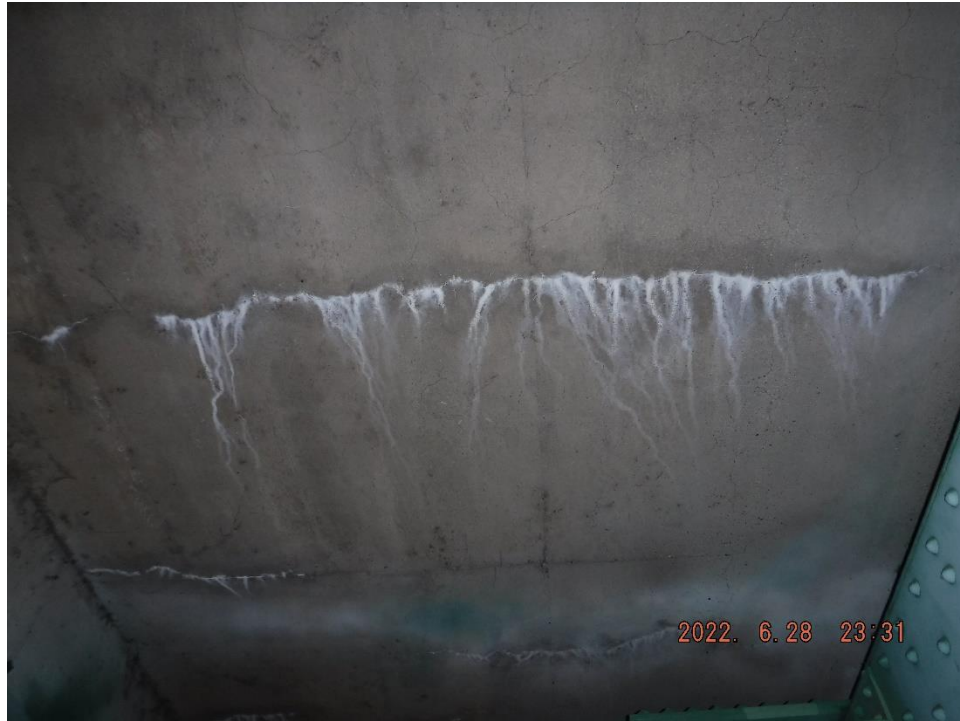
Photo 1: Typical transverse and map cracking between cantilever overhang brackets (South overhang, Span 8, between U29 and U30 shown)

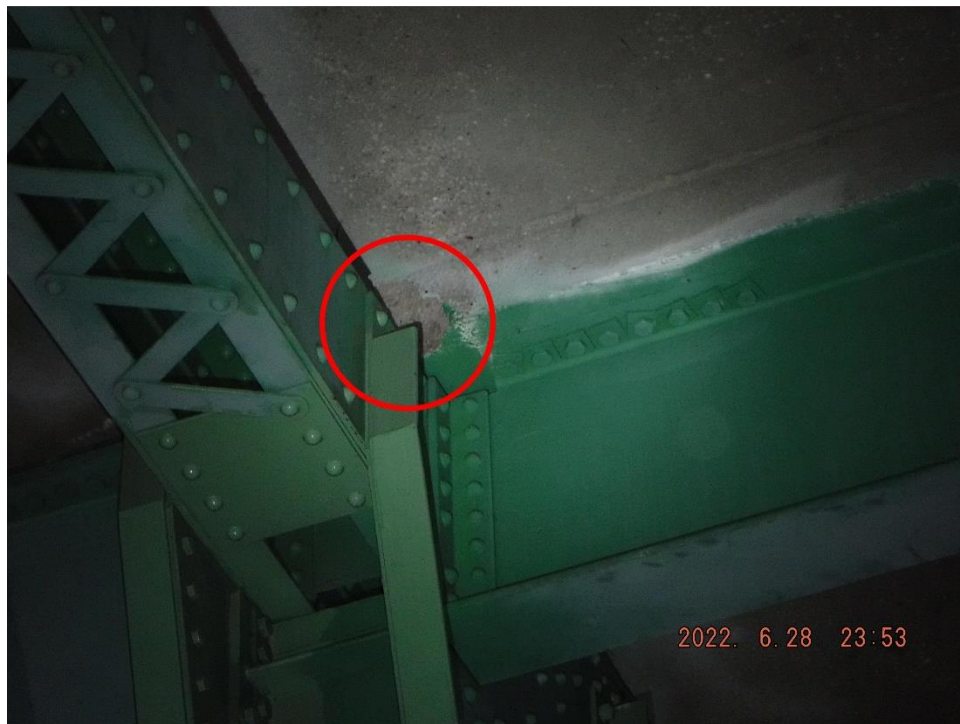
Photo 2: Example of an isolated haunch spall (South Truss, Span 8, North Face of U27 shown)

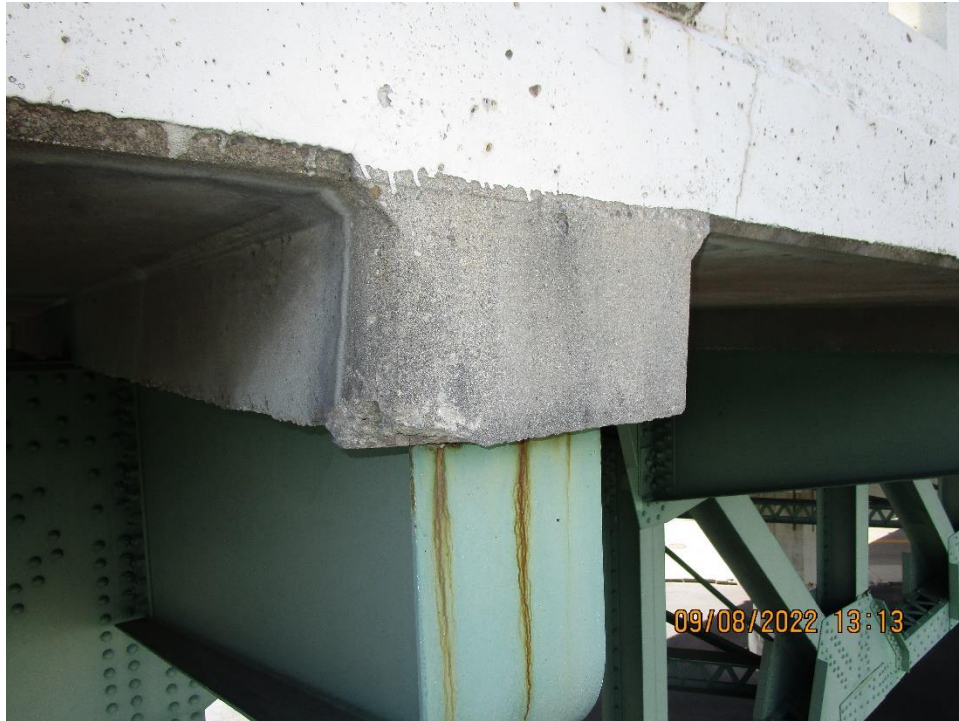
Photo 3: Example of haunch before the delaminated concrete was removed (Bracket 9 at Pier 6 shown)

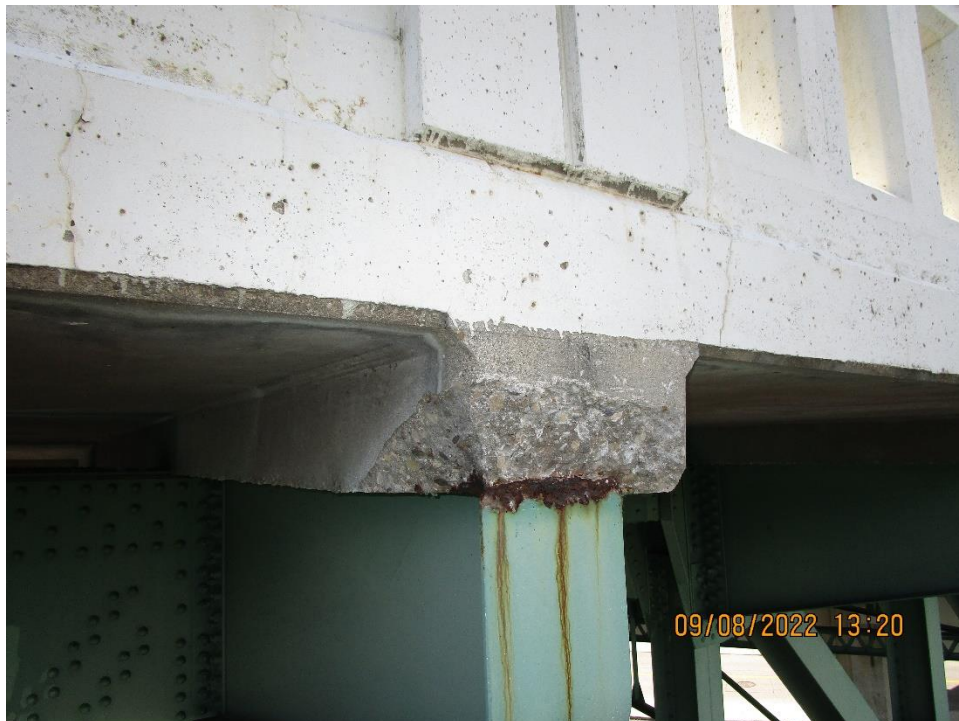
Photo 4: Example of haunch after the delaminated concrete was removed (Bracket 9 at Pier 6 shown)

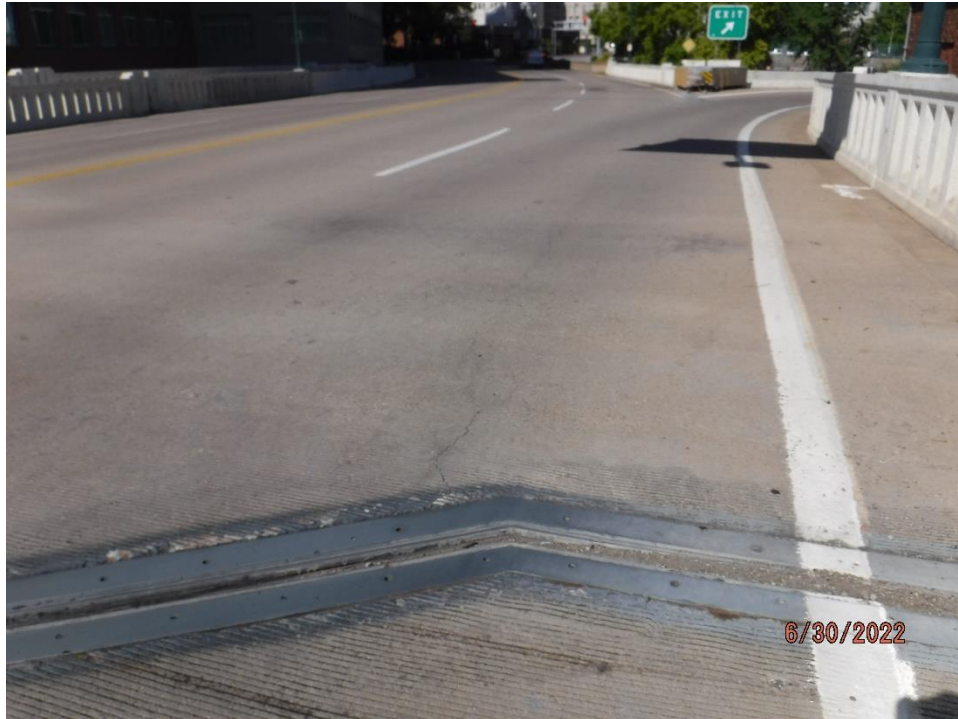
Photo 5: Wearing surface with typical cracks

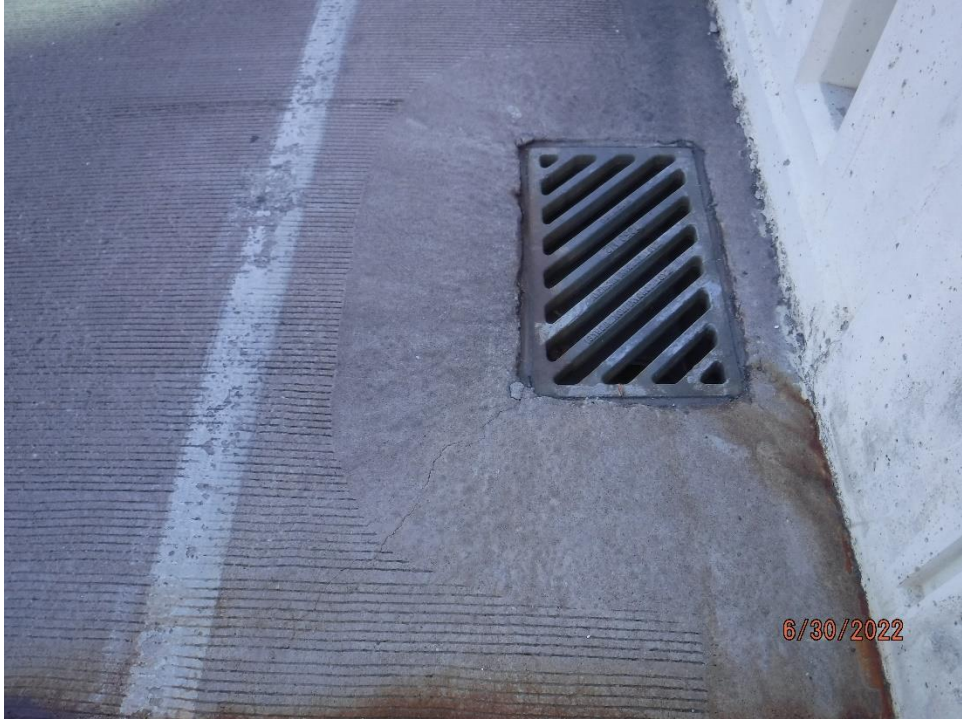
Photo 6: Typical radial cracks at drainage grate

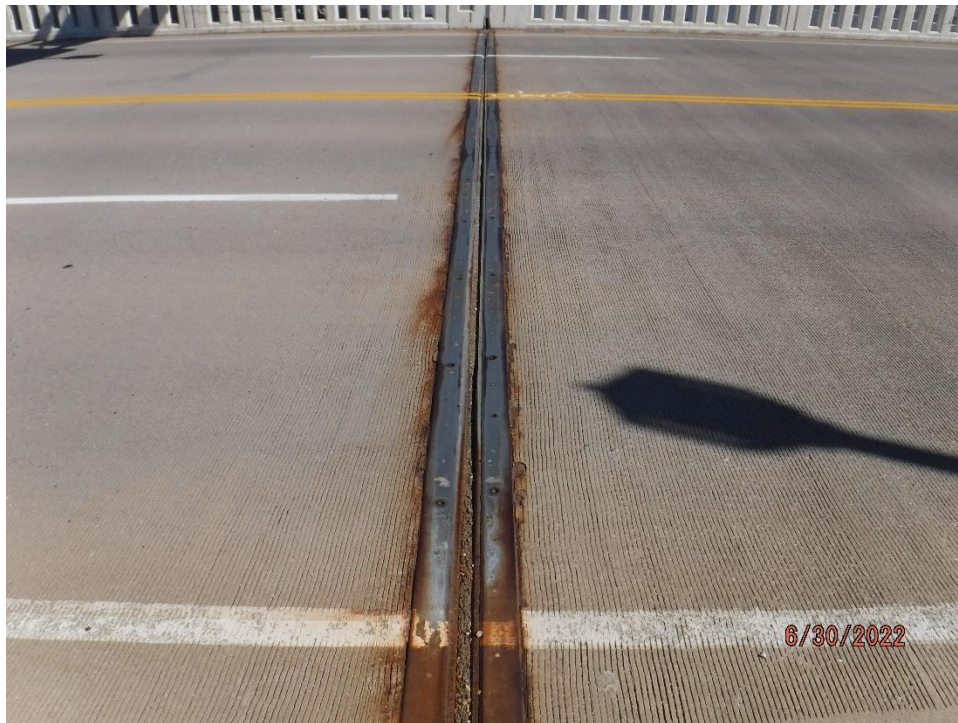
Photo 7: Typical expansion joint surface corrosion and debris fill (Pier 13 shown)

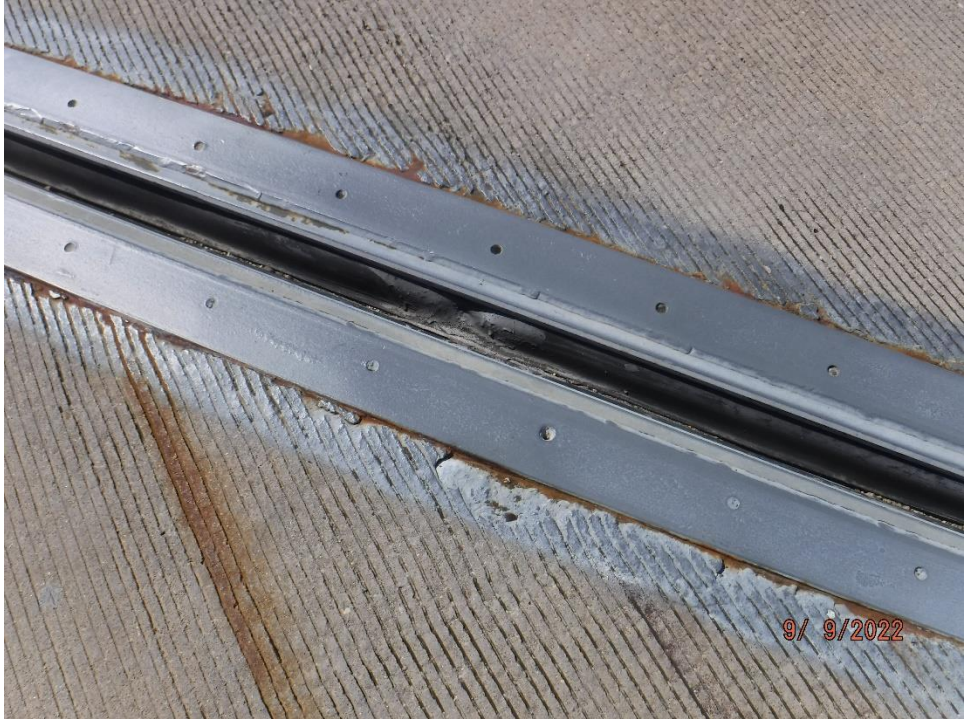
Photo 8: Tear in expansion joint seal material (Pier 7 shown)

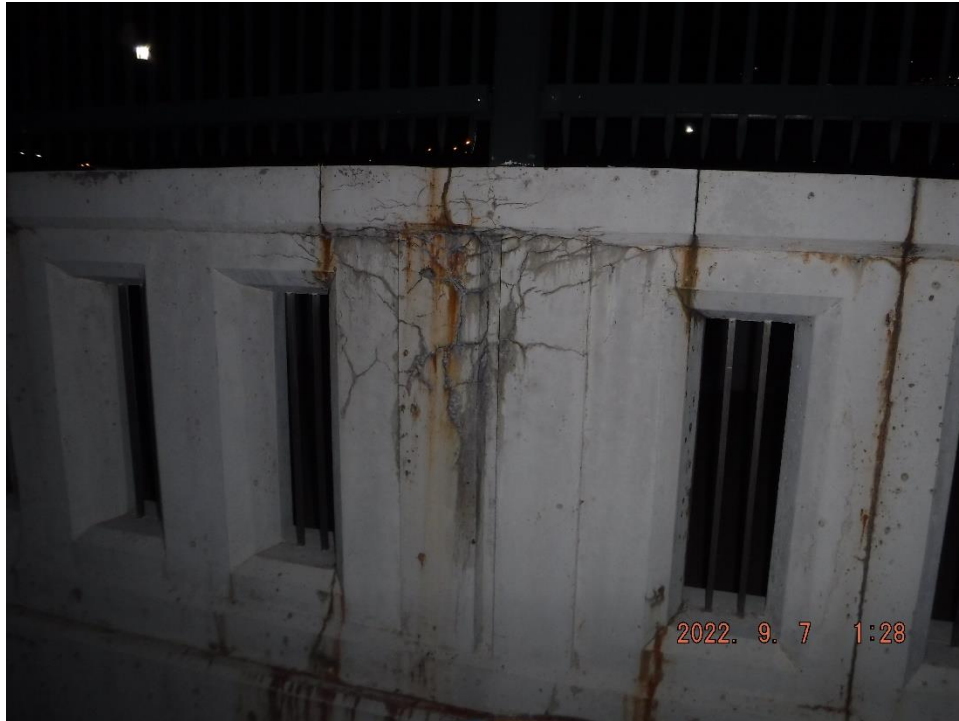
Photo 10: Cracking and rust staining on exterior face of bridge railing (South Railing, Span 9 shown)

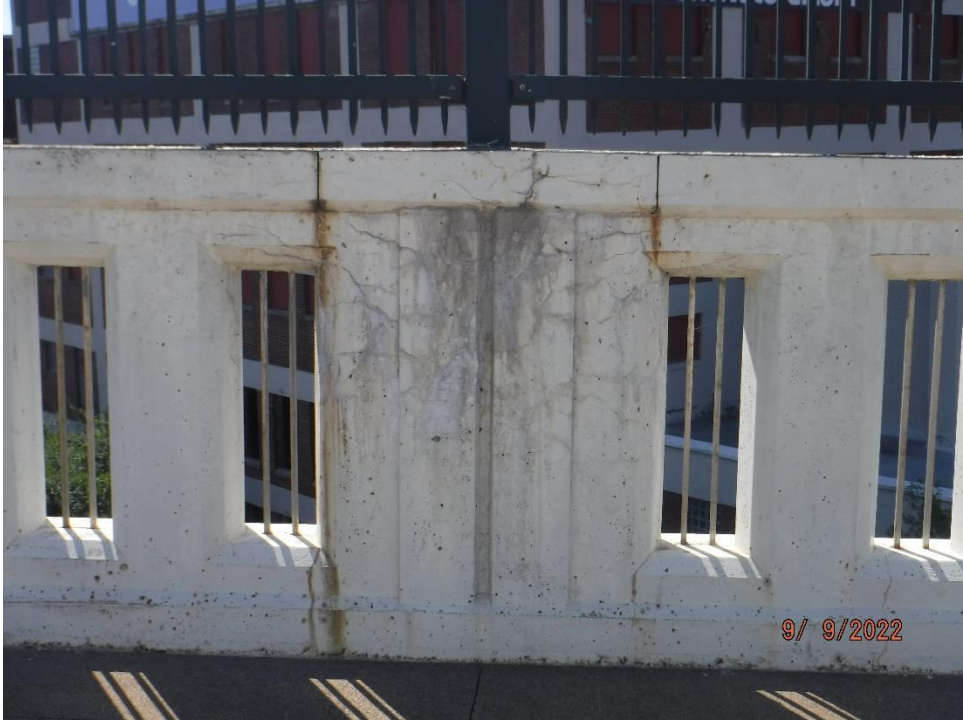
Photo 11: Cracking and rust staining on interior face of bridge railing (South Railing Span 7 shown)

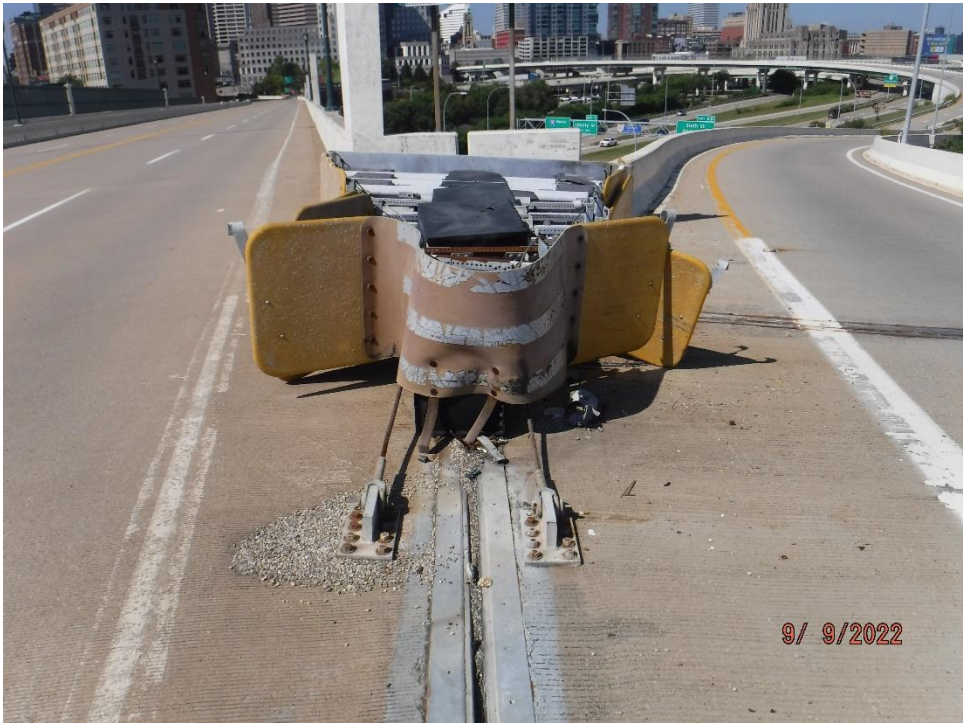
Photo 12: Example of impact attenuator damage (East Attenuator shown)

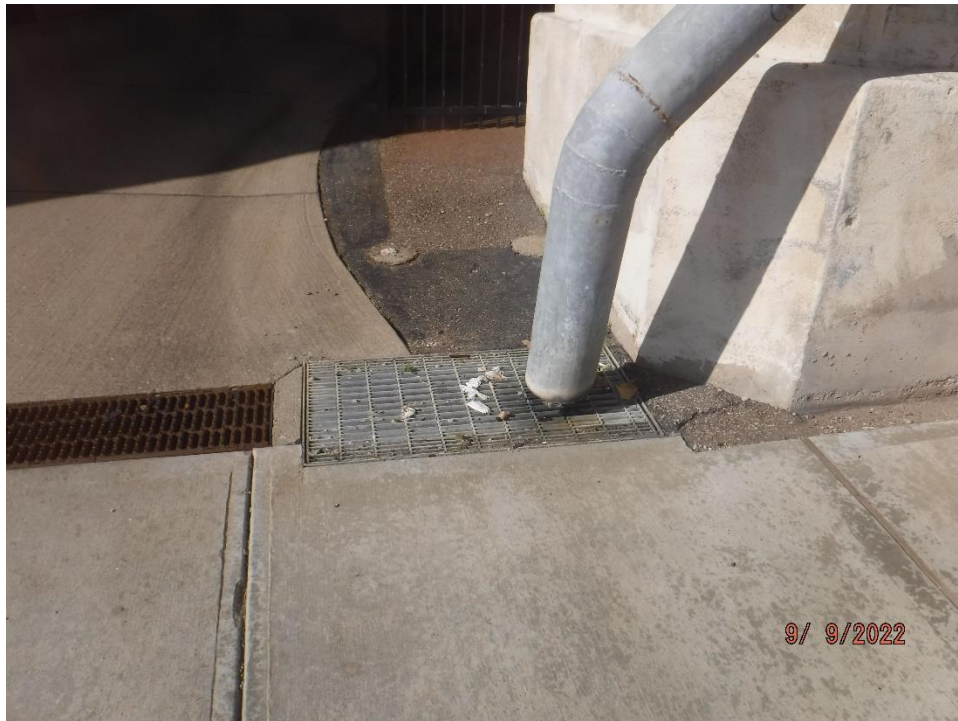
*Photo 13: Example of debris in drainage grate at ground termination
(Column 3 of Pier 3 shown)*

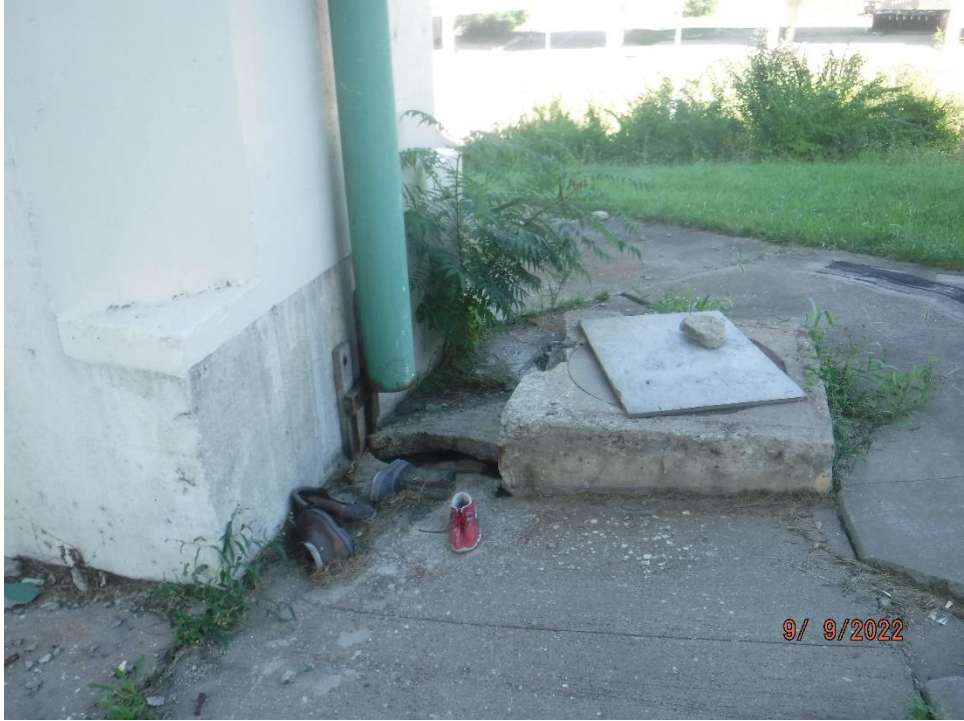
Photo 14: Example of broken ground termination and undermining of the slope protection (Column 1 at Pier 12 shown)

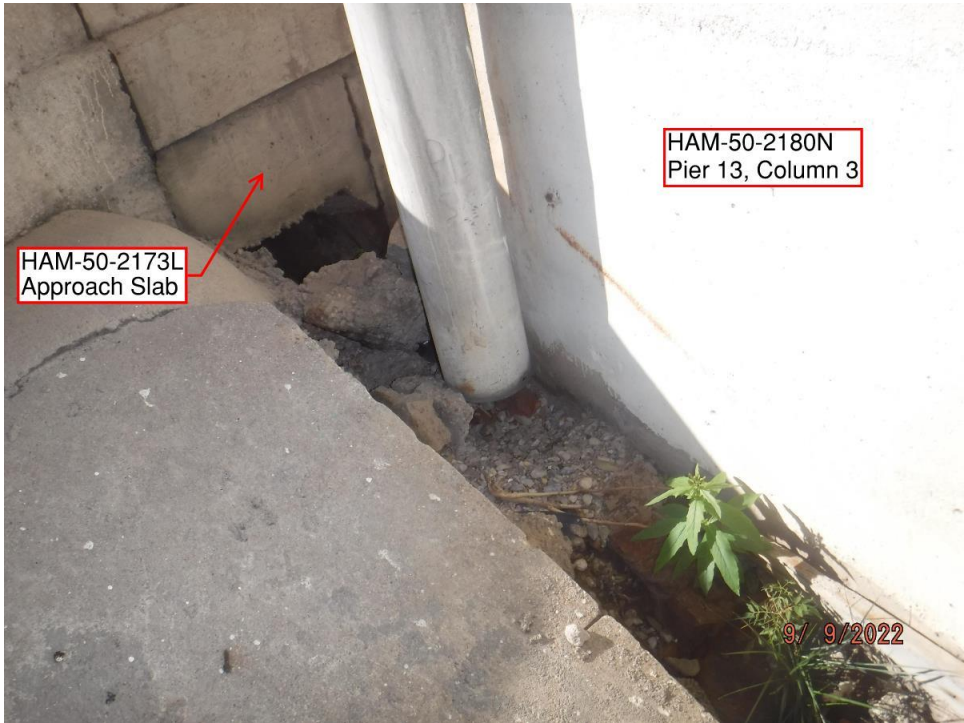
Photo 15: Broken ground termination and undermining of approach slab of adjacent structure (HAM-50-2173L) at Column 3 of Pier 13

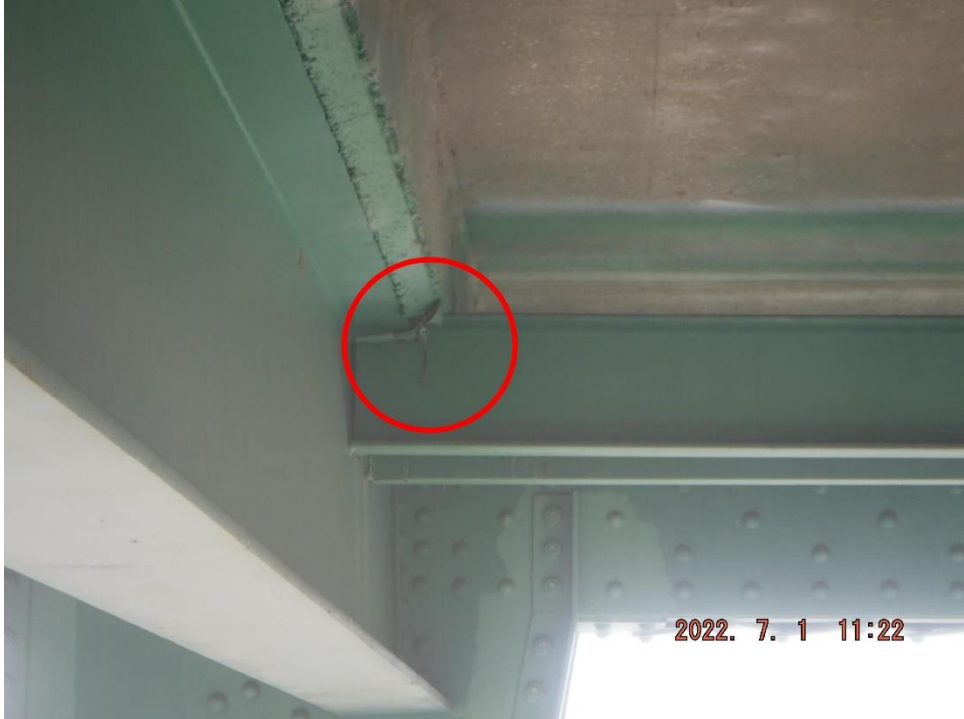
Photo 16: Cracked drainage support channel at the south end of Pier 9

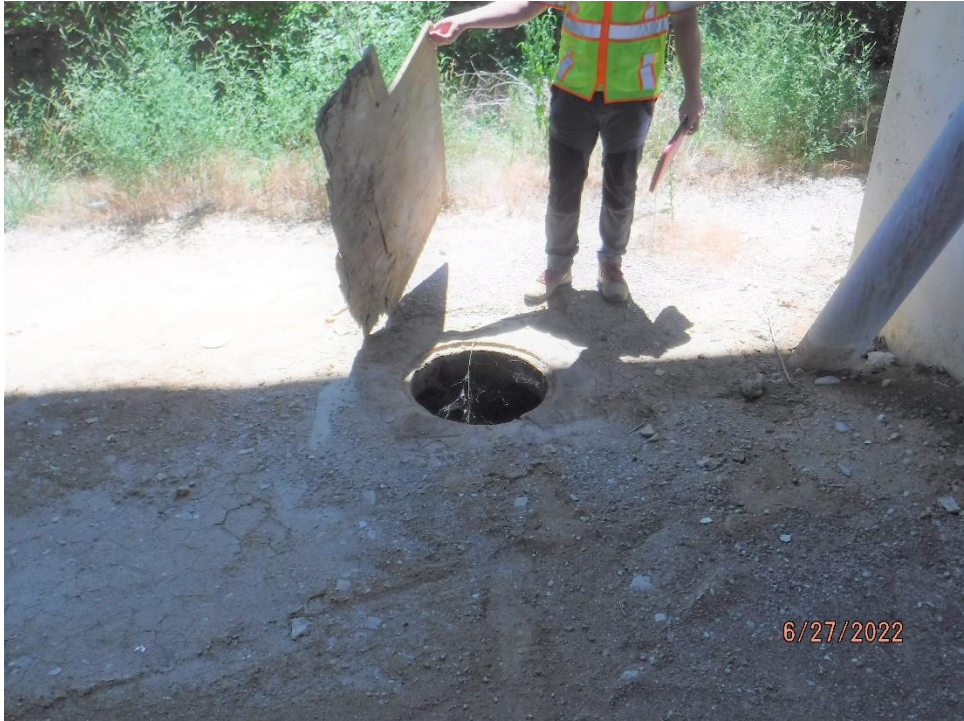
Photo 17: Open manhole covered with plywood, East of Column 3 at Pier 15

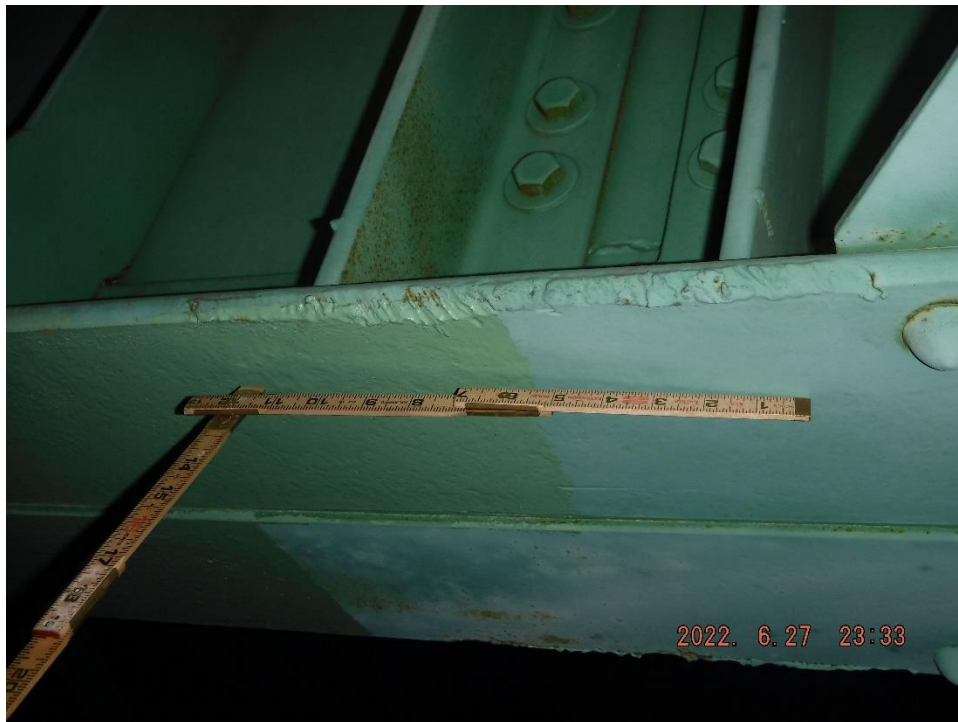
Photo 18: Example of girder scrape (Center Girder, Span 14 shown)

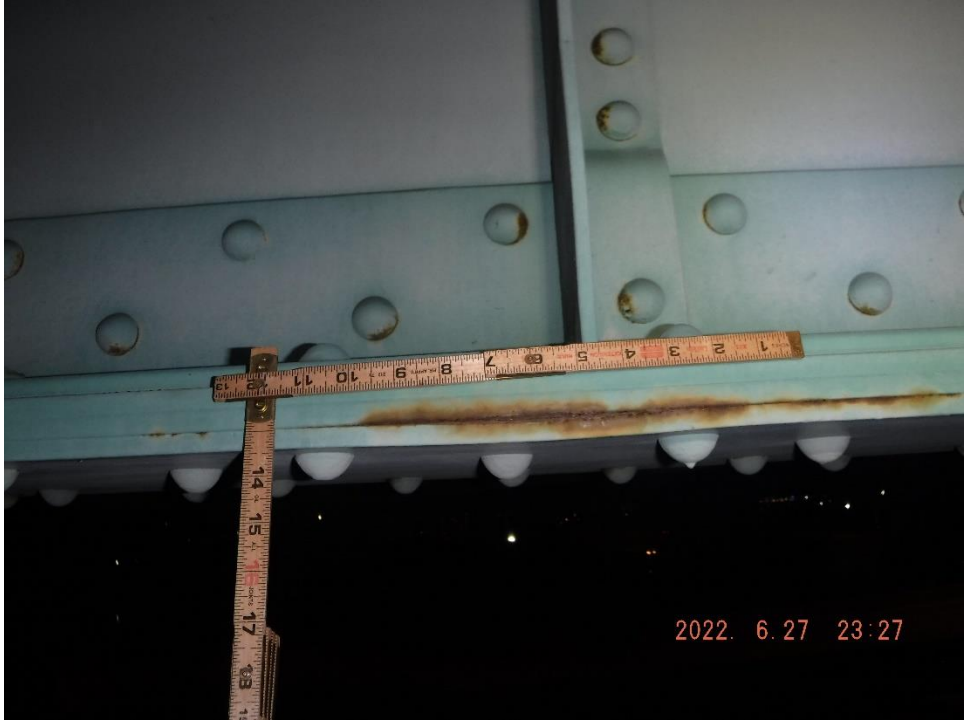
Photo 21: Example of active pack rust between flange plates (North Girder, Span 14 near midspan shown)

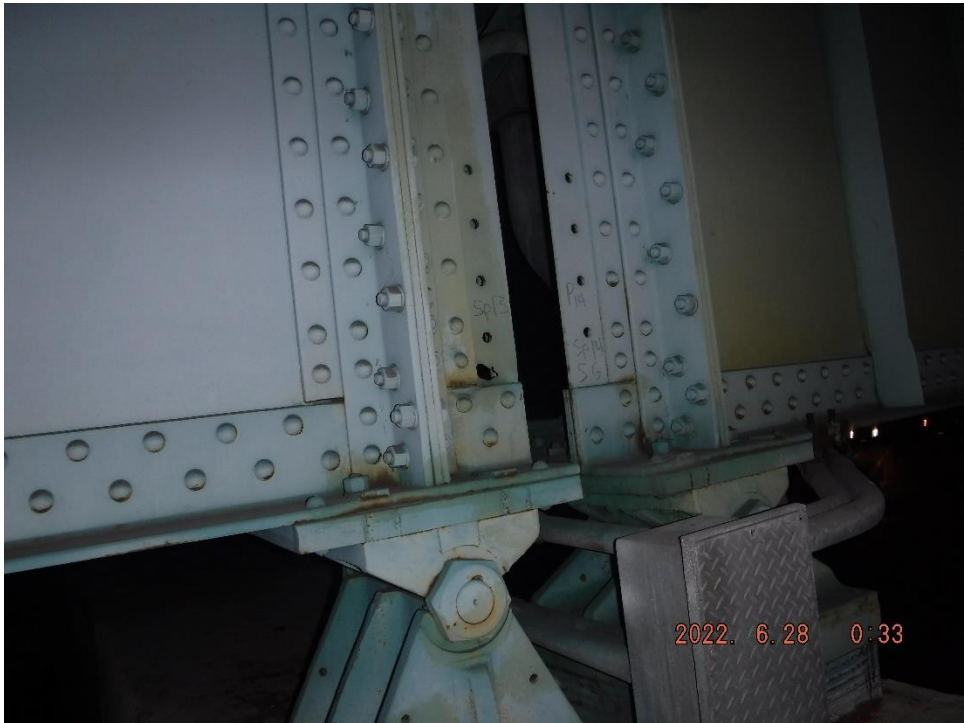
Photo 22: Example of mis-drilled holes (South Girder, Span 13 at Pier 14 shown)

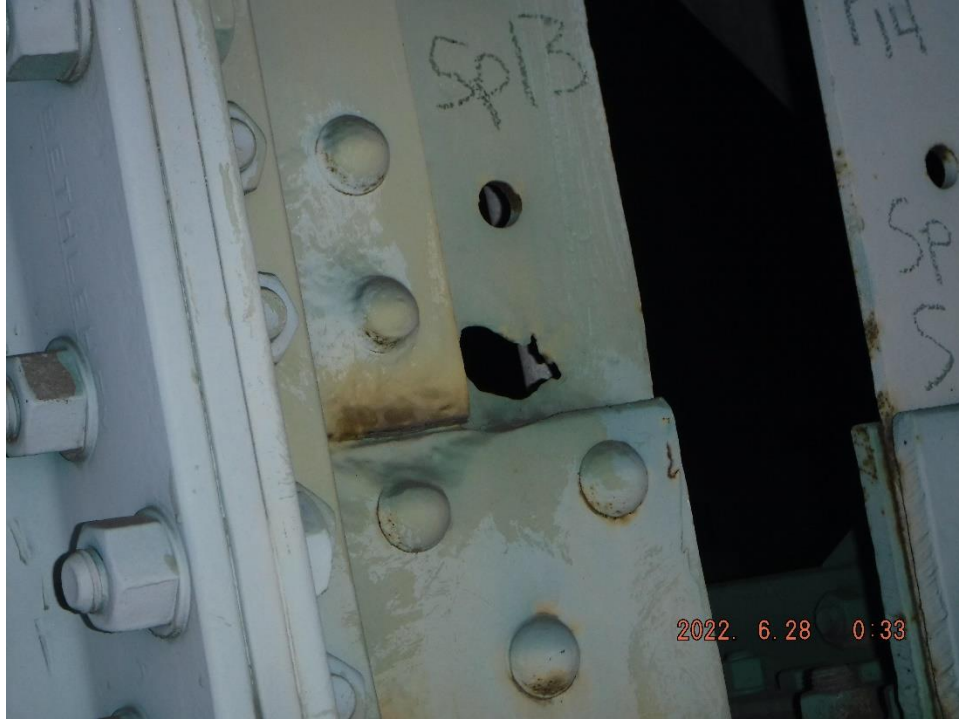
Photo 25: Corrosion hole in the web on South Girder, Span 13 at Pier 14

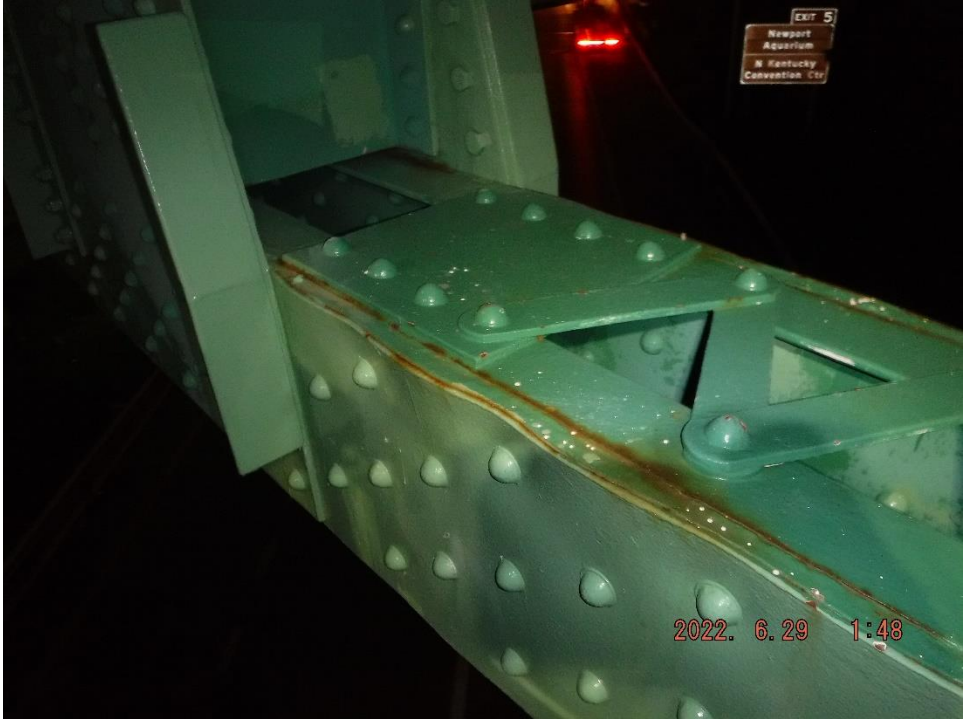
Photo 26: Example of widespread pack rust and out of plane plate bending (North Truss, Span 8, L28-L29 Web shown)

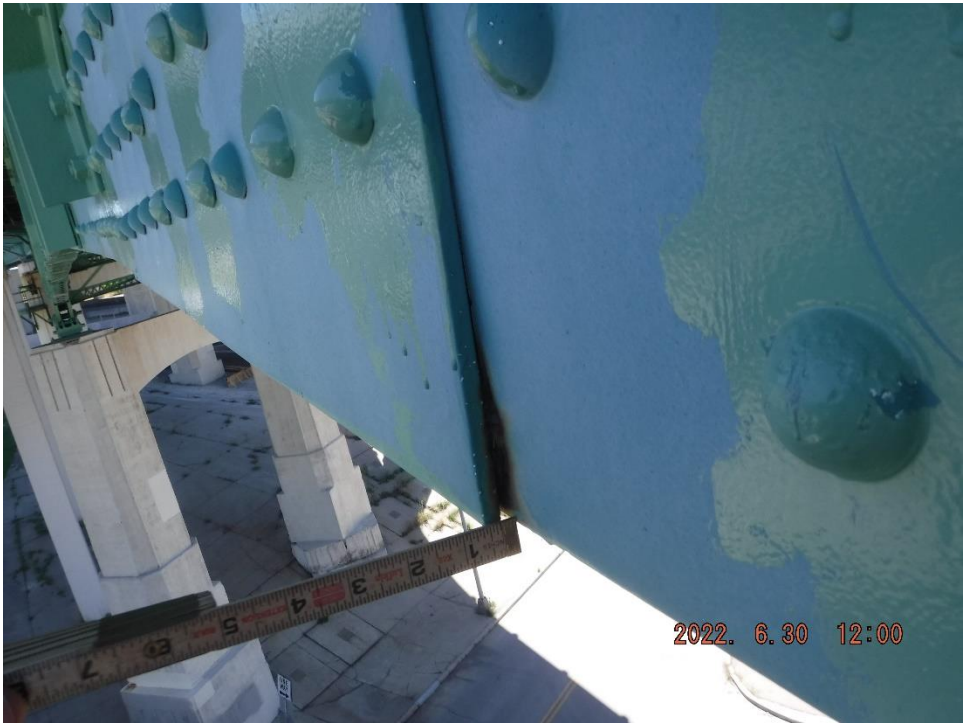
Photo 27: Example of splice plate separation due to pack rust (North face of North Truss, Span 10, at L16 shown)

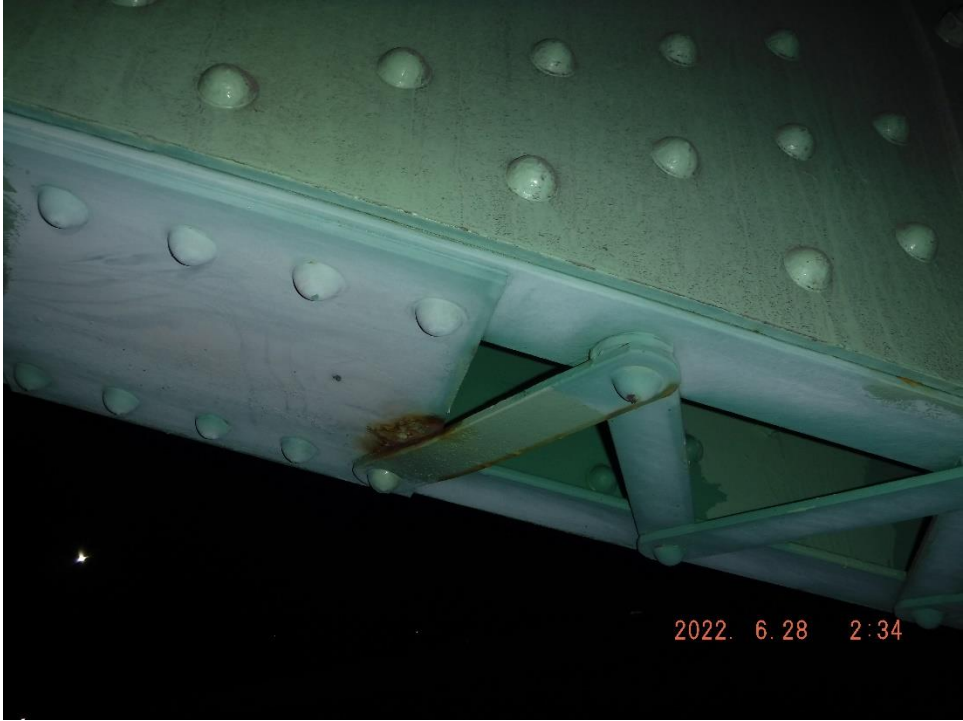
Photo 28: Example of surface corrosion on lacing bar and tie plate (North Truss, Span 9 at L43 shown)

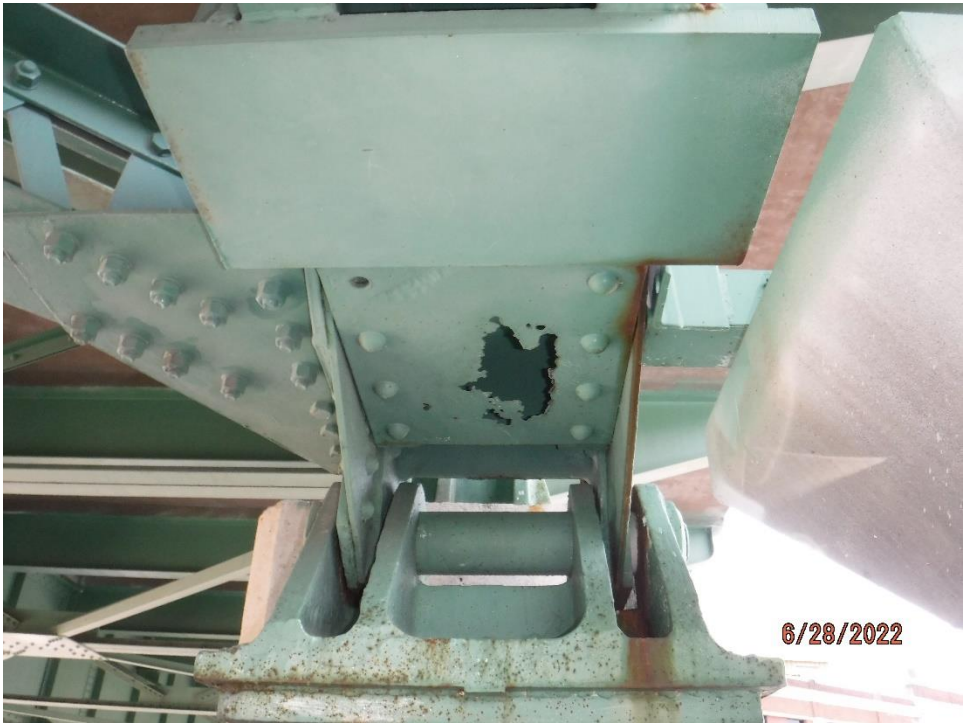
Photo 29: Example of corrosion hole and mis-drilled holes on batten plate (North Truss, Span 5, L0-L1 shown)

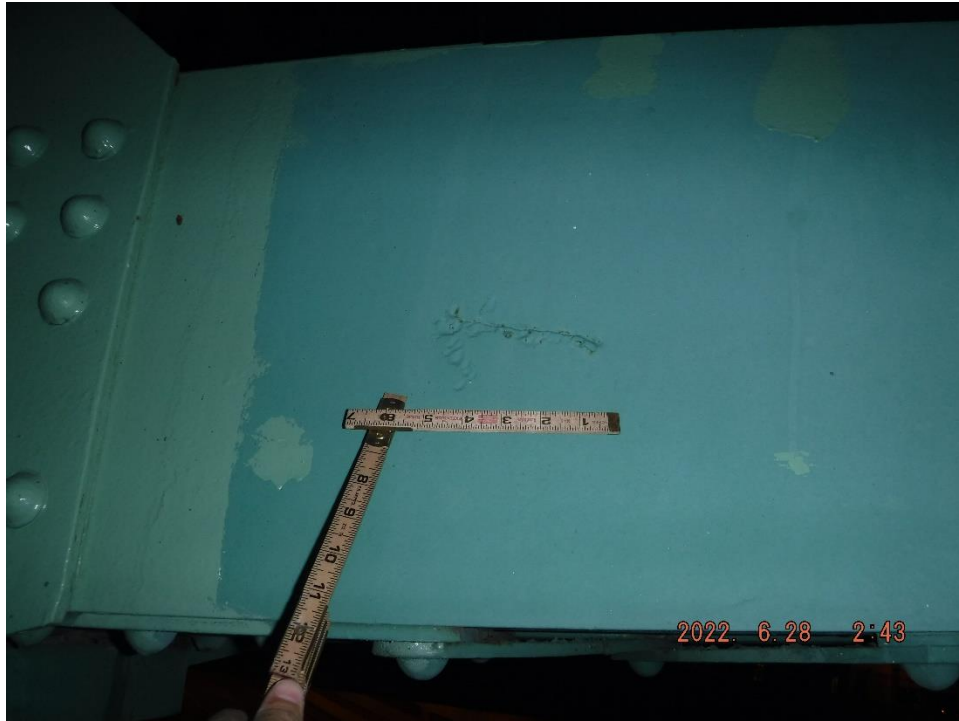
Photo 30: Example of gouge in member web (Center Truss, Span 9, L42-L44 shown)

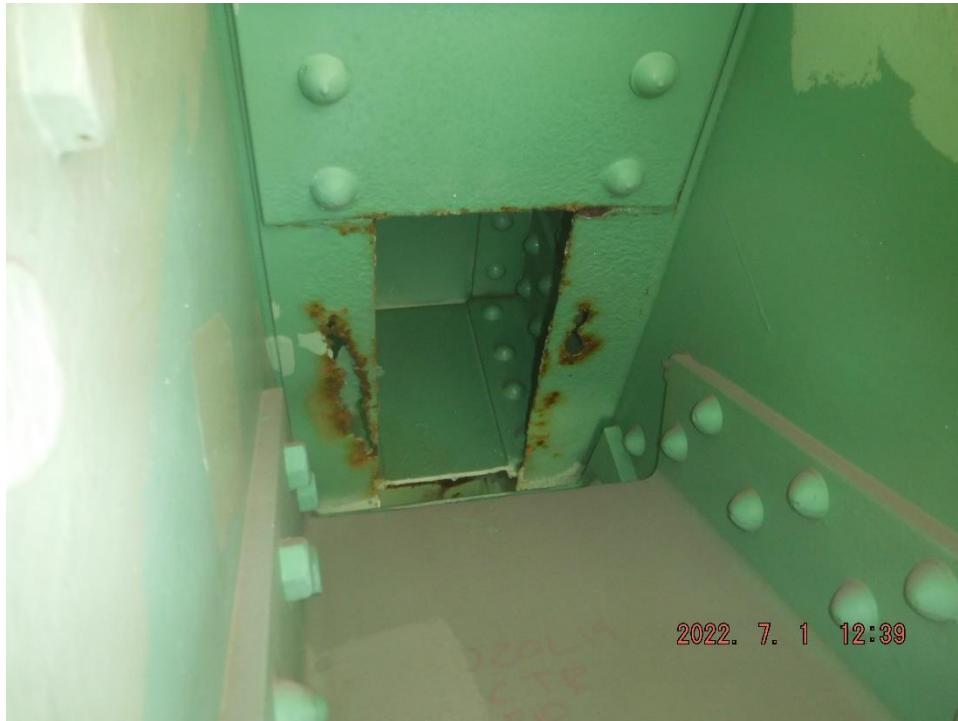
*Photo 32: Example of reactivating corrosion hole on member top flange
(South Truss, Span 10, U20 shown)*

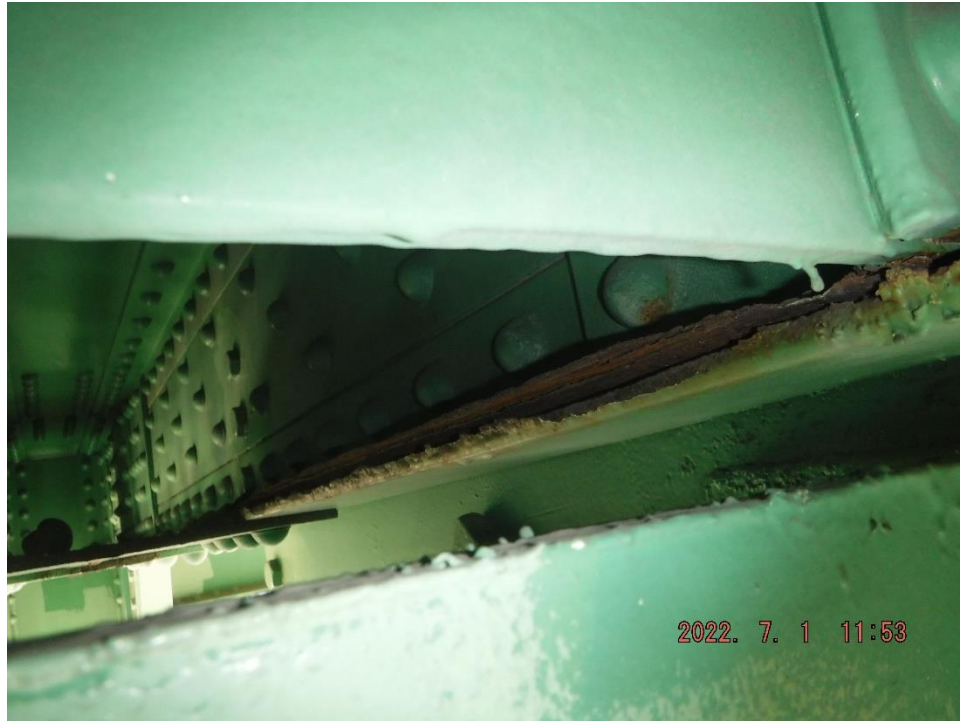
Photo 33: Example of laminating corrosion on member bottom flange (Center Truss, Span 9, U43-U44 at U43 shown)

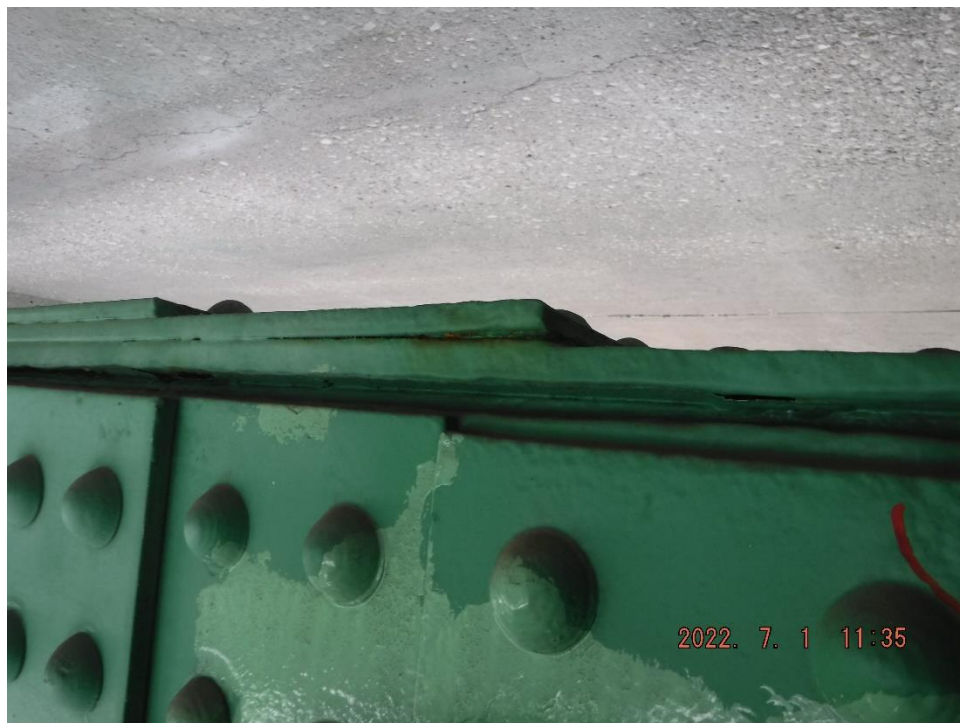
Photo 34: Example of pack rust and splice plate deformation (Center Truss, Span 9, U35-U36 at U36 shown)

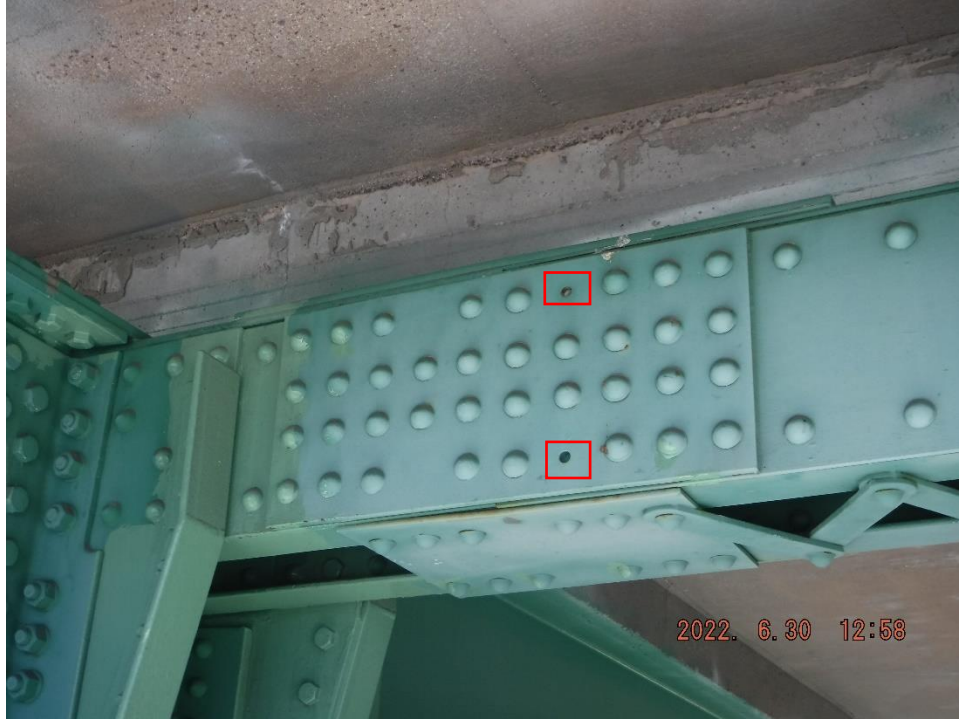
Photo 35: Example of mis-drilled holes and bent cover plate due to missing fill plate (South Truss, Span 10, U10-U11 shown)

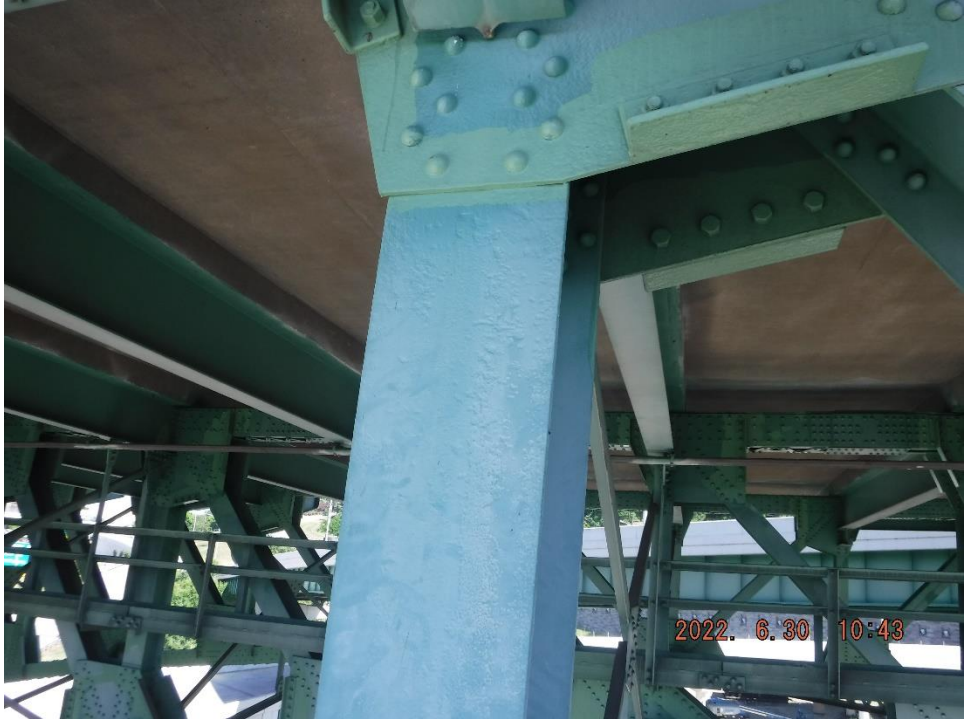
Photo 36: Painted-over pitting on the outside face of the member flange (South Truss, Span 10, L18-U18 shown)

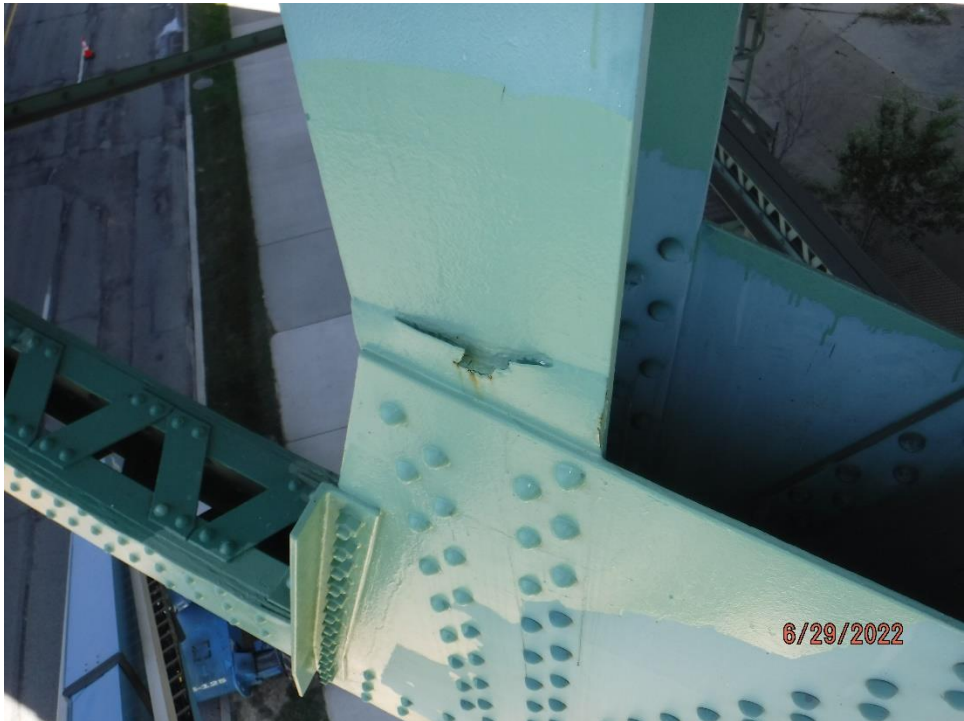
Photo 37: Fill plate cracked and deformed due painted-over pack rust between fill plate and member (South Truss, Span 7, L13-U13 shown)
