2022 In-Depth Element Level and Fracture-Critical Inspection Report

BRIDGE NO: HAM-50-2180N

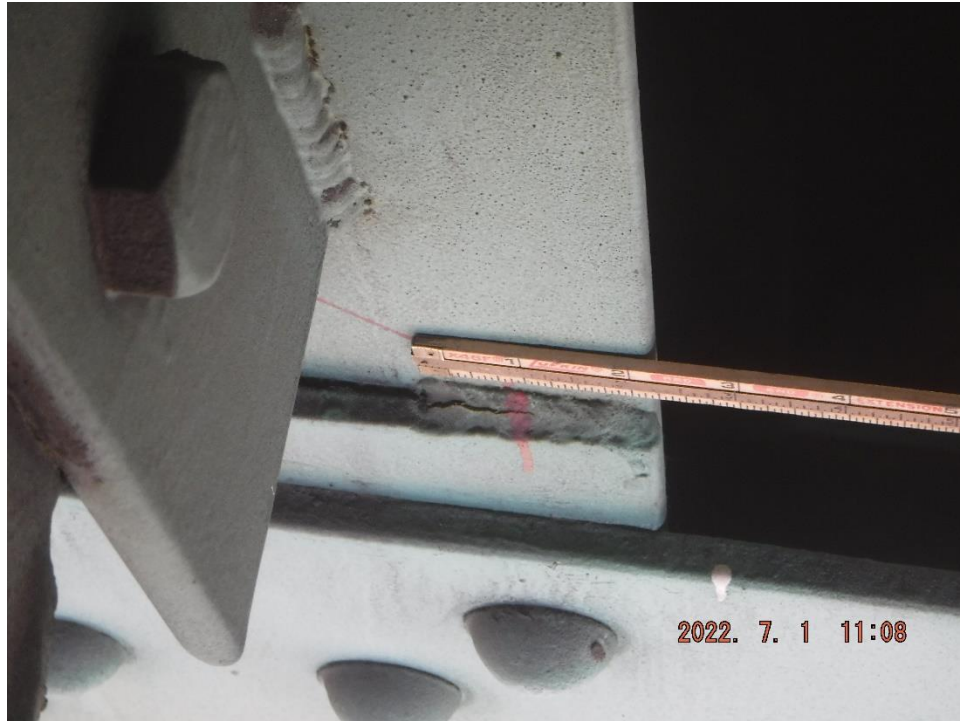
Photo 38: Cracked tack weld on fill plate (Center Truss, Span 8, L25-U25 shown)

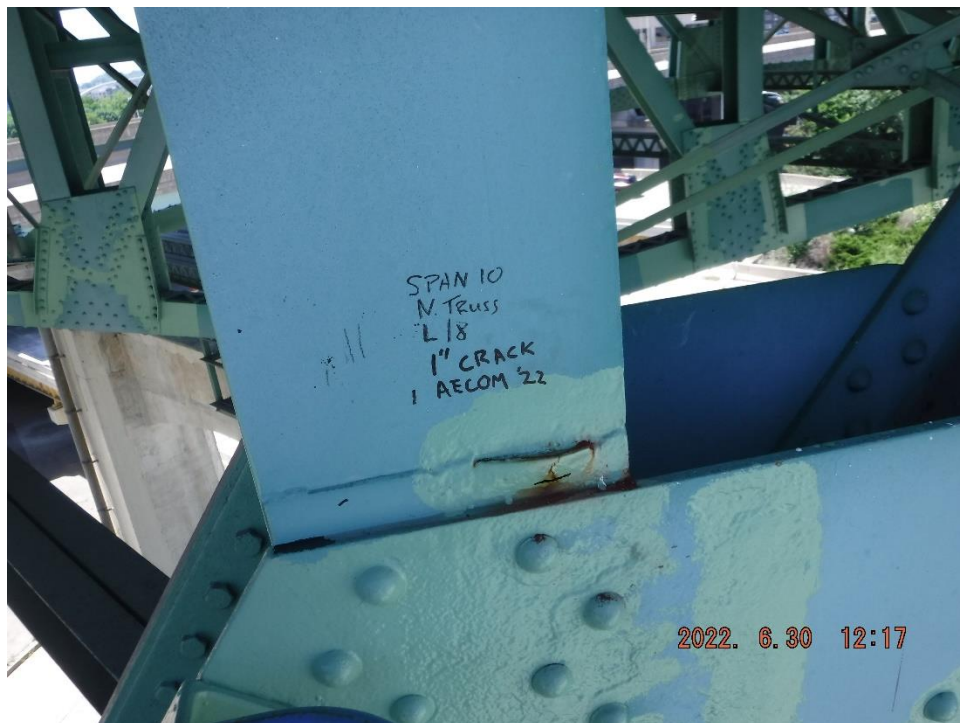
Photo 39: Active pack rust behind cracked tack weld and fill plate (North Truss, Span 10, L18-U18 shown)

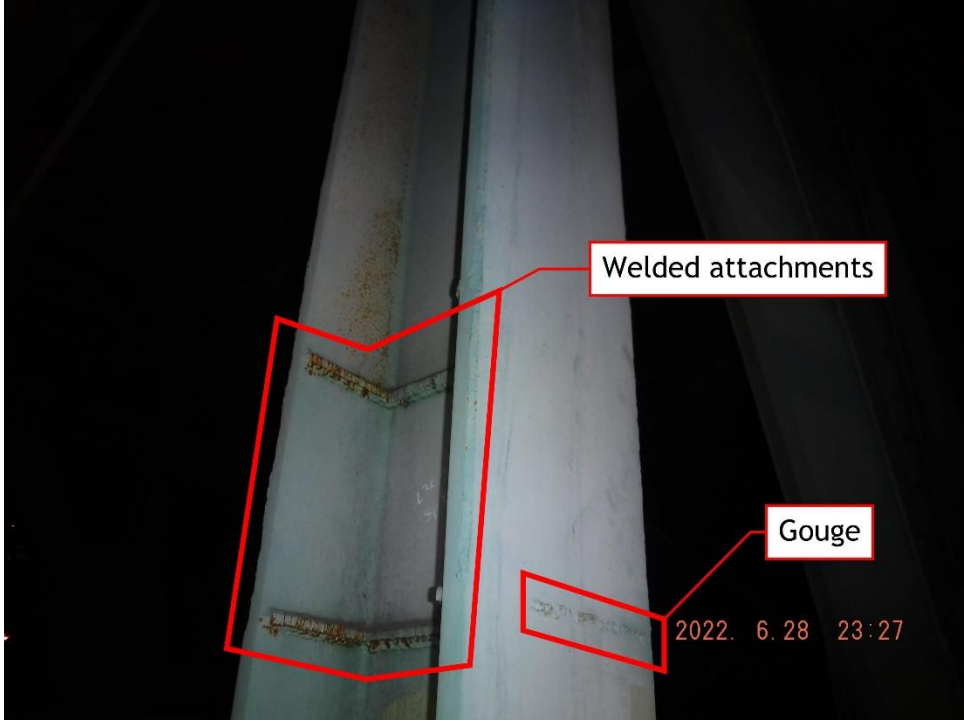
Photo 40: Welded attachment remains and gouge in member flange (South Truss, Span 8, L30-U30 shown)

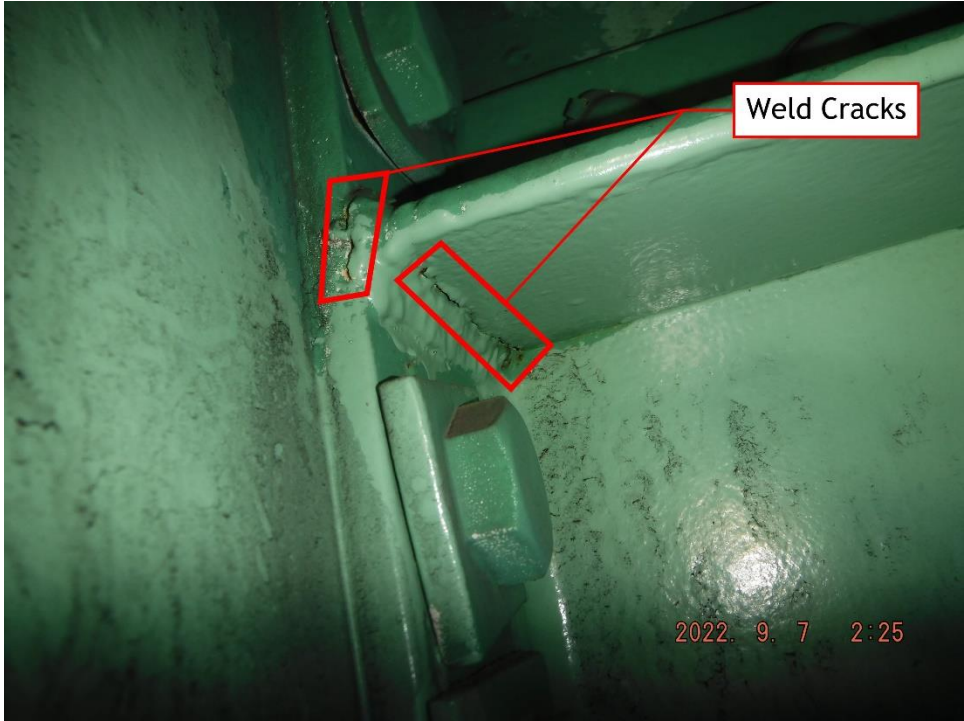
Photo 41: Cracked weld on web stiffener at U37 on member U37-L37

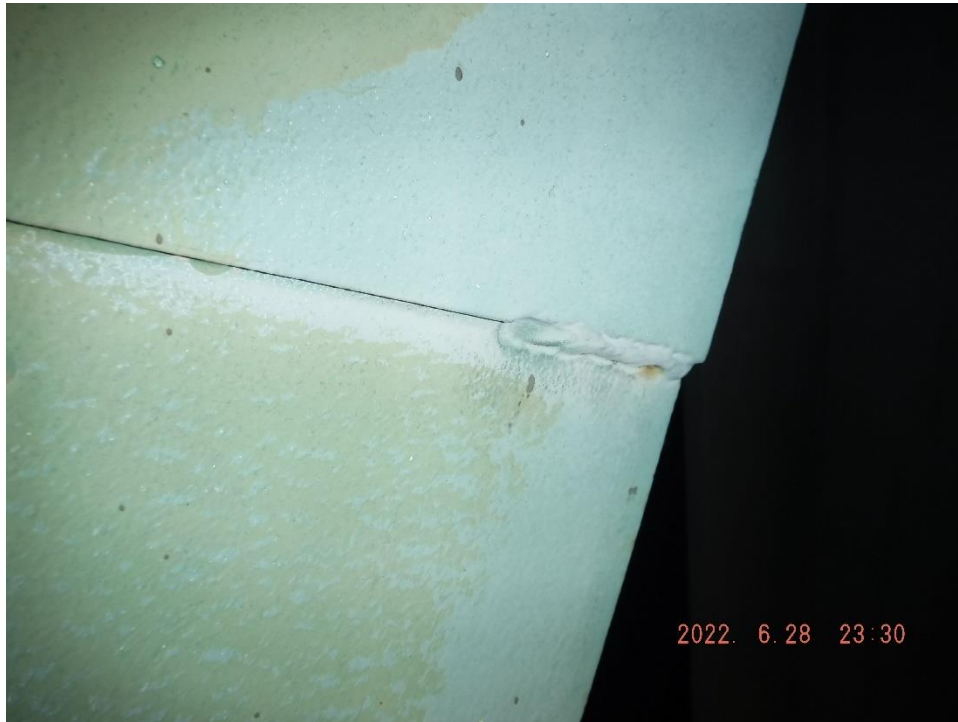
Photo 42: Undercut tack weld on fill plate (South Truss, Span 8, L29-U30 at U30 shown)

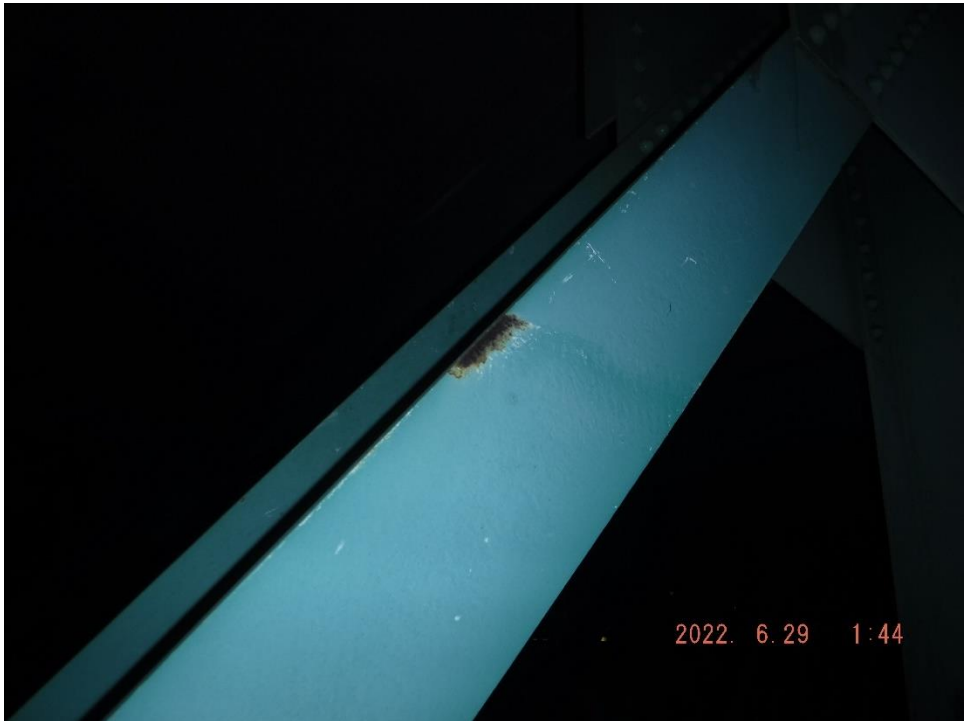
Photo 44: Active surface corrosion on the flange of U20-L21 in Span 8 of the North Truss

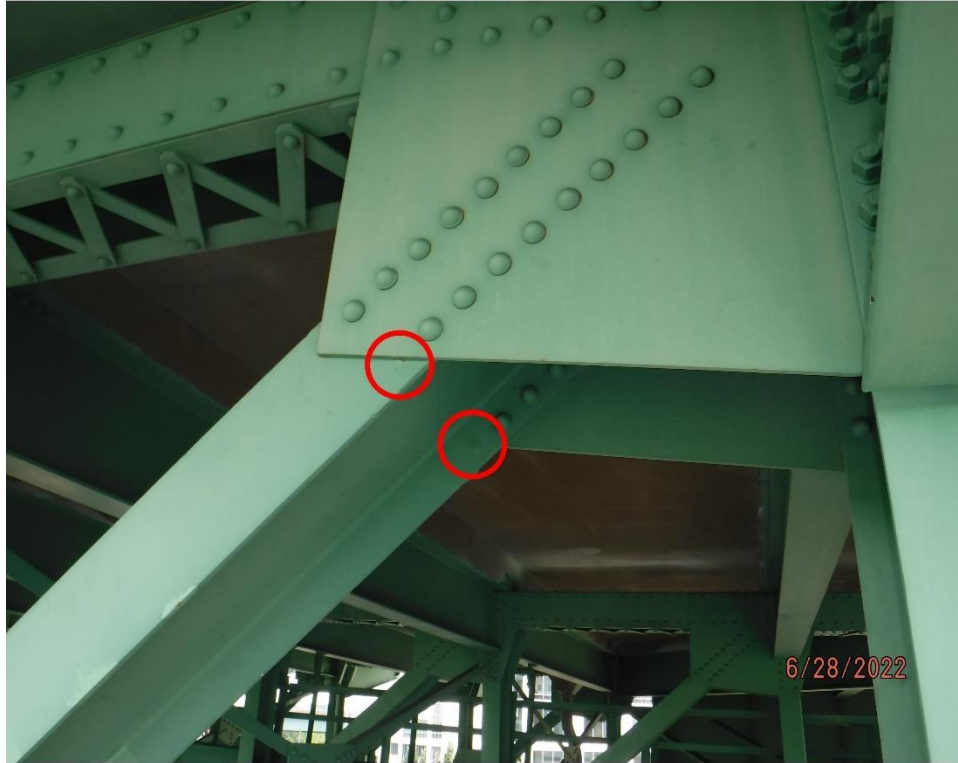
Photo 45: Mis-drilled holes in the member flange filled with plug welds at U3 on U3-L4 in Span 5 of the North Truss

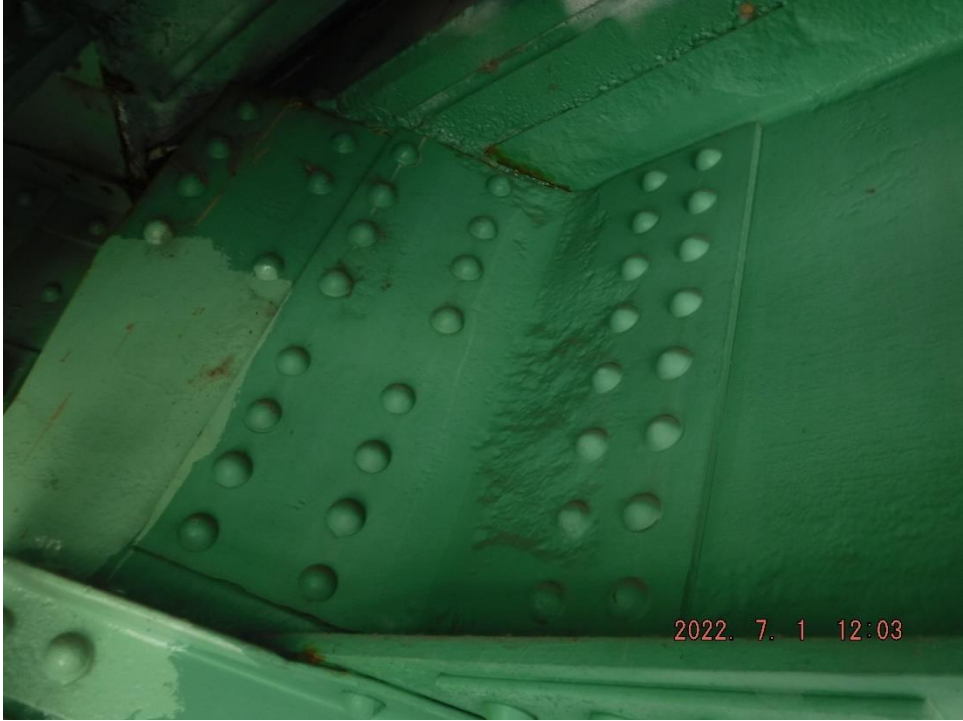
*Photo 46: Painted-over section loss in connection plate and top flange
(Center Truss, Span 10, South Bay at U20 shown)*

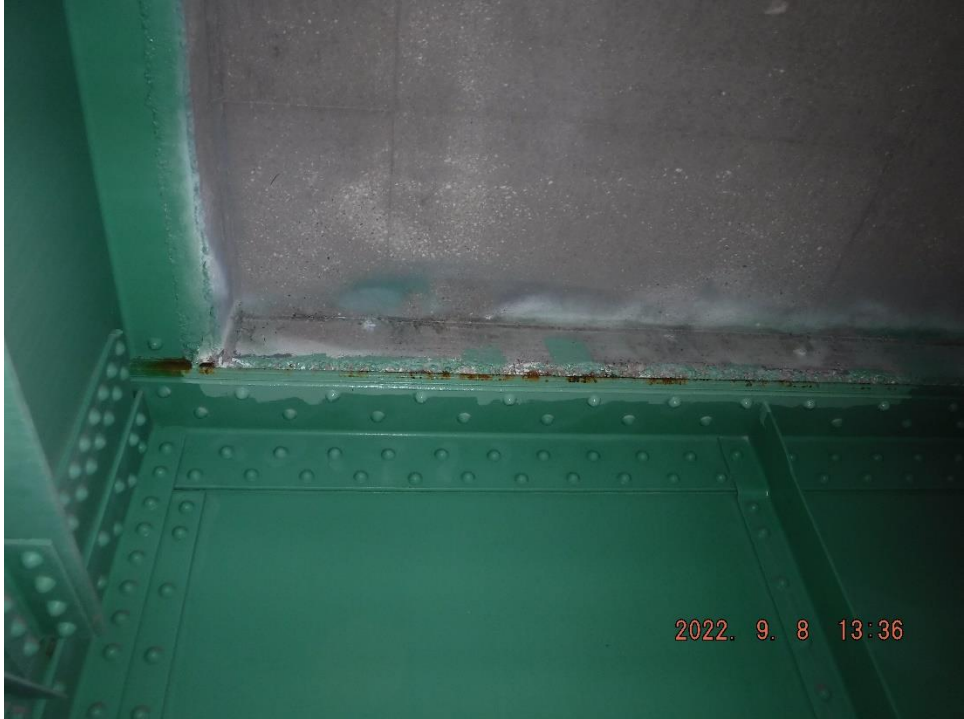
Photo 48: Example of laminar corrosion between the floor beam and concrete haunch (Span 1 shown)

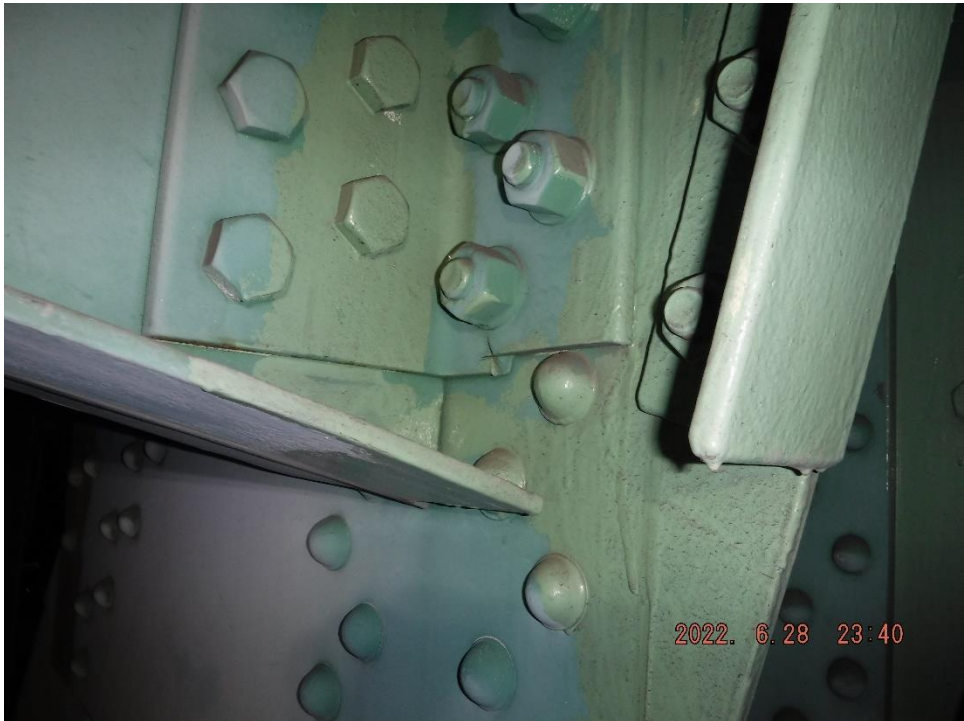
Photo 49: Field cut cantilever bracket connection angle (Span 8, South Truss at U27 shown)

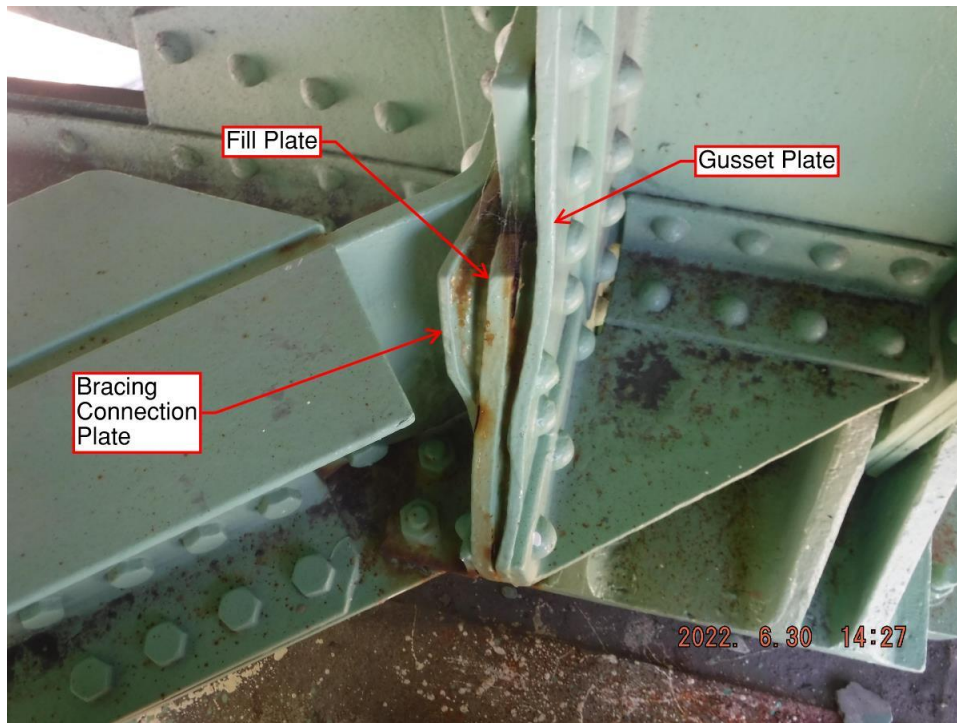
Photo 51: Reactivating pack rust between gusset, fill plate, and bracing connection plate (Span 11, North Truss, L0, South Gusset behind bearing shown)

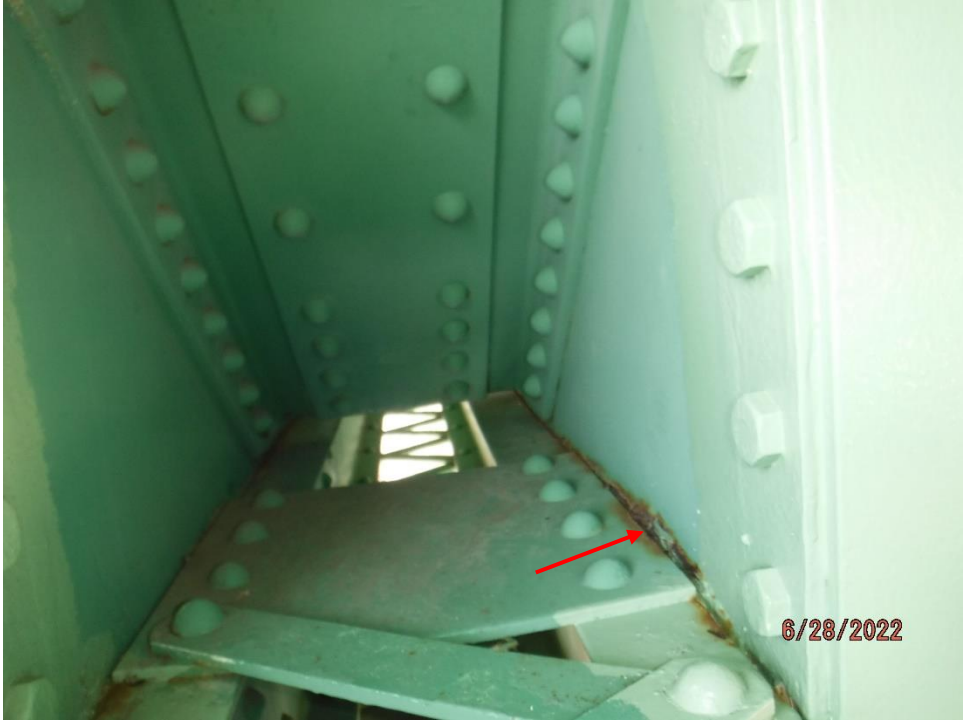
Photo 52: Reactivating pack rust between gusset and lower chord (Span 5, North Truss, L1, South Gusset shown)

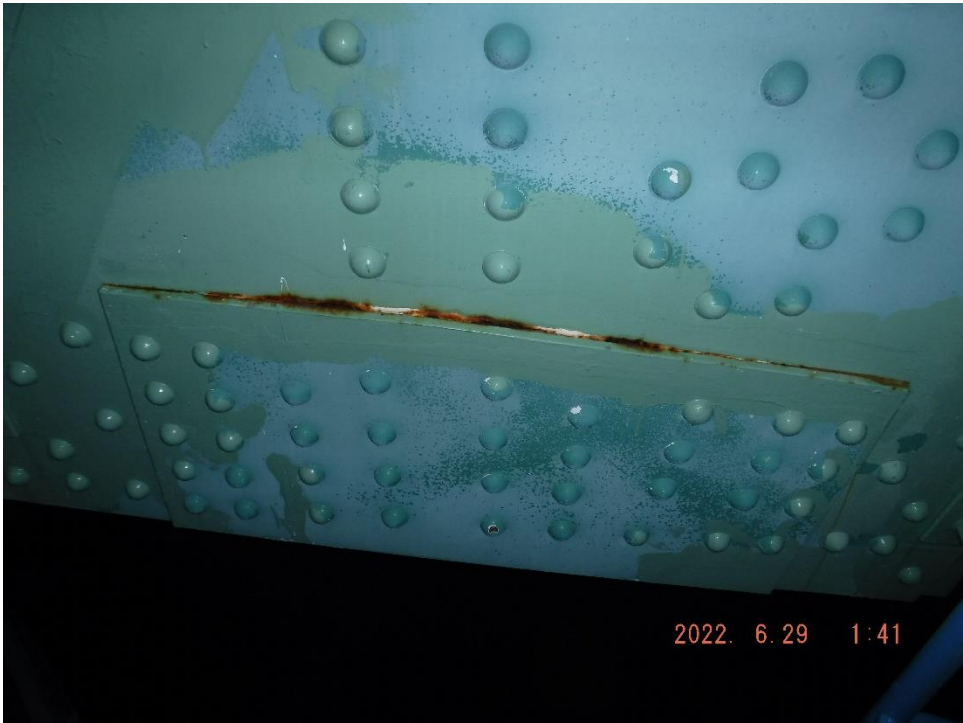
Photo 53: Pack rust between gusset plate and splice plate (Span 8, North Truss, L20, North Gusset shown)

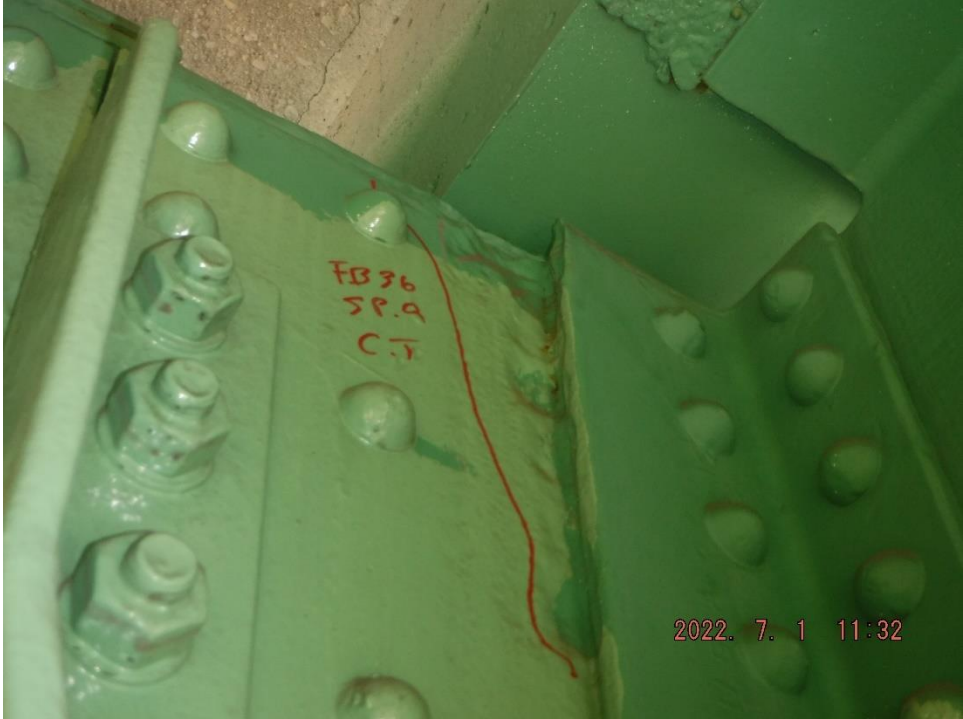
Photo 54: Painted-over pitting on gusset plate at floor beam connection (Span 9, Center Truss, U36, South Gusset shown)

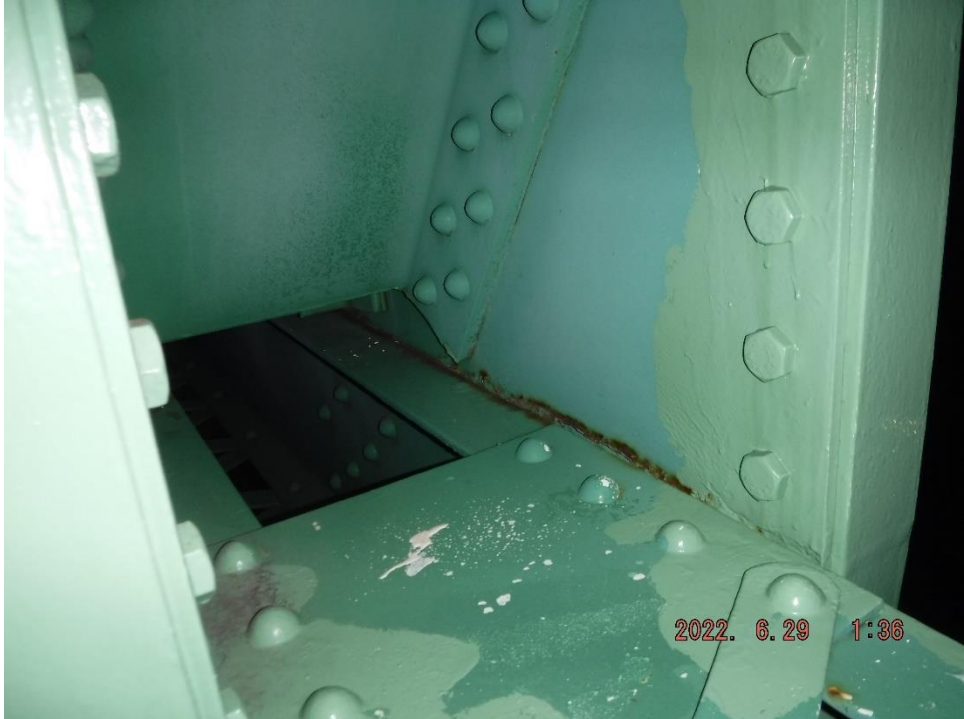
Photo 56: Laminar corrosion along member flange on inside face of gusset plate (Span 8, North Truss, L19, South Gusset shown)

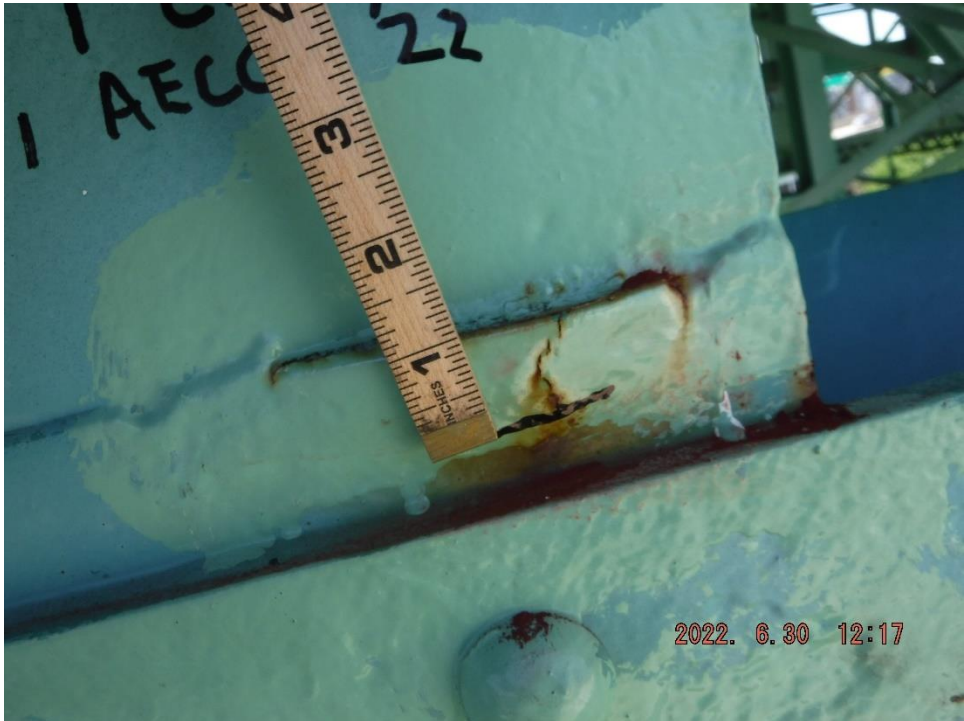
Photo 57: Cracked tack weld and fill plate with pack rust (Span 10, North Truss, L18, North Gusset shown)

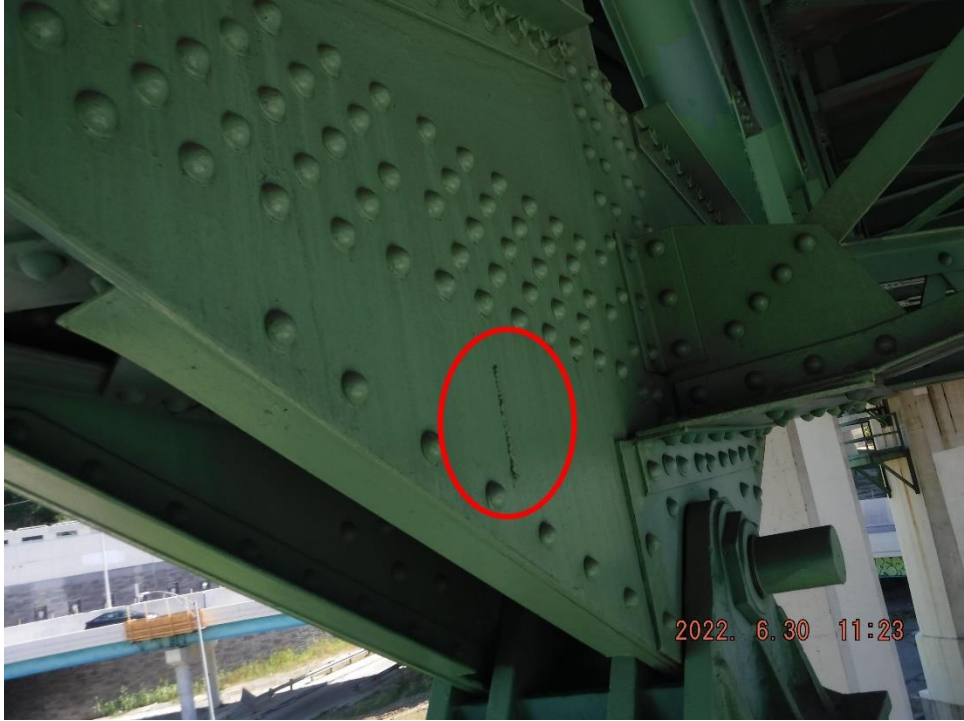
Photo 58: Gouge in gusset plate where attachment was previously welded (Span 10, North Truss, L8, South Gusset shown)

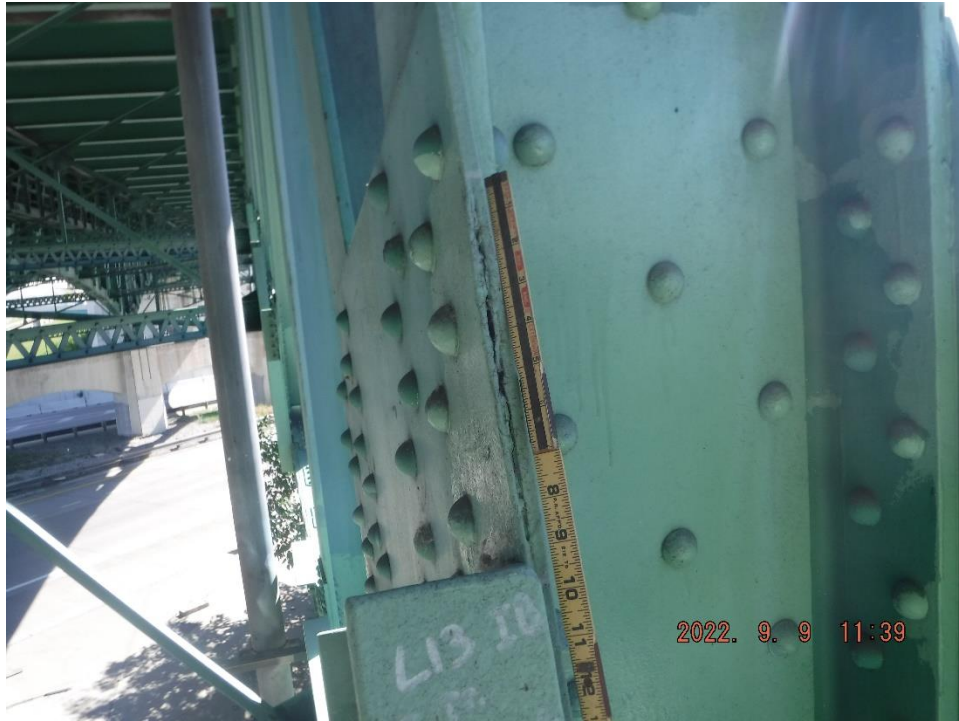
Photo 60: Laminar tear in the North Gusset Plate at L13 in Span 7 of the South Truss

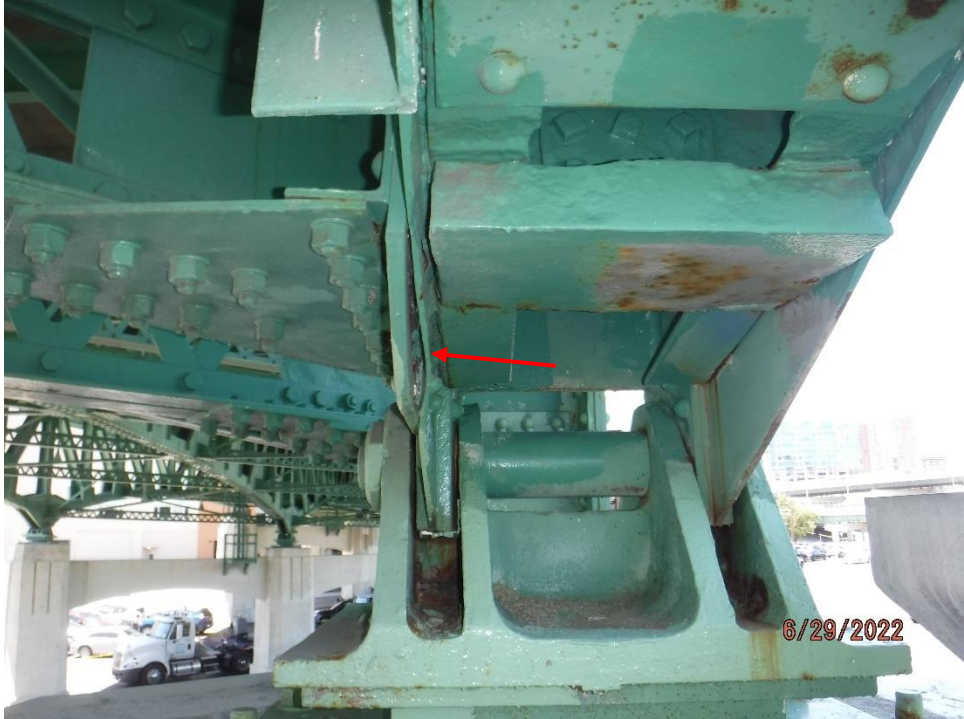
Photo 61: Section loss on gusset plate and bowing due to pack rust at bearing connection (Span 7, North Truss, L0, South Gusset shown)

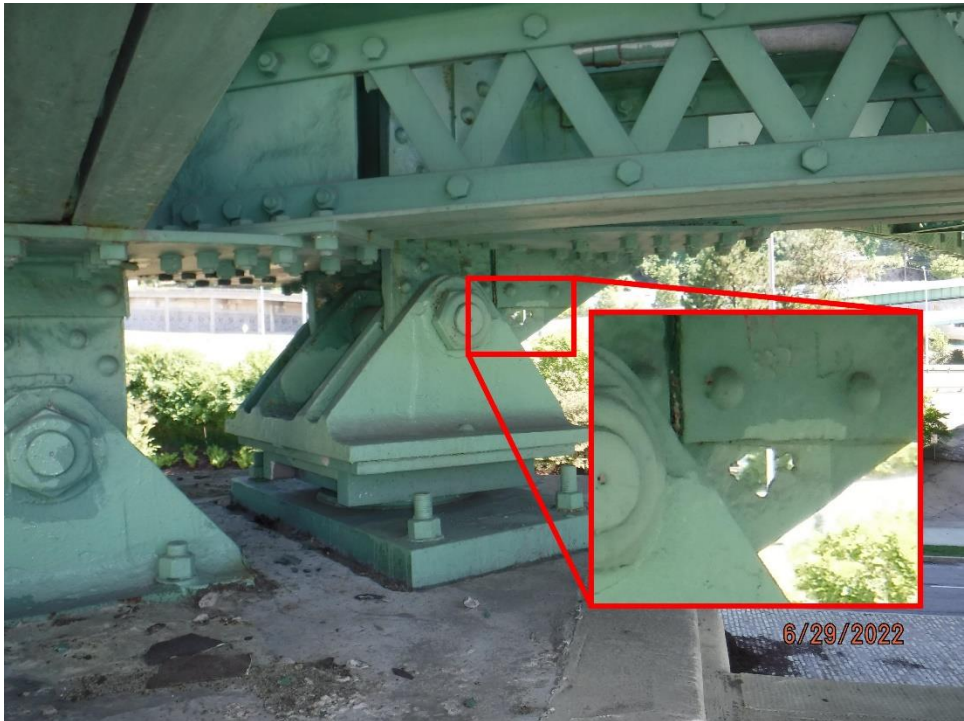
Photo 62: 3-in diameter corrosion hole in the South Gusset Plate of L0 in Span 7 of the Center Truss

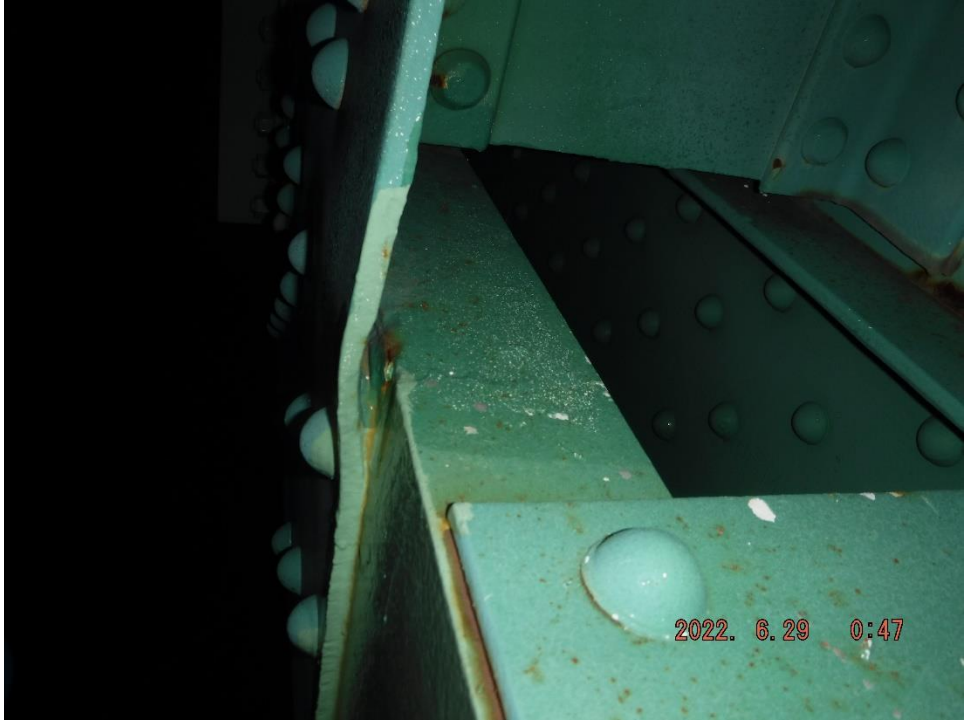
Photo 63: Free edge localized deformation with pack rust at unrepaired gusset edge (Span 8, North Truss, L25, North Gusset shown)

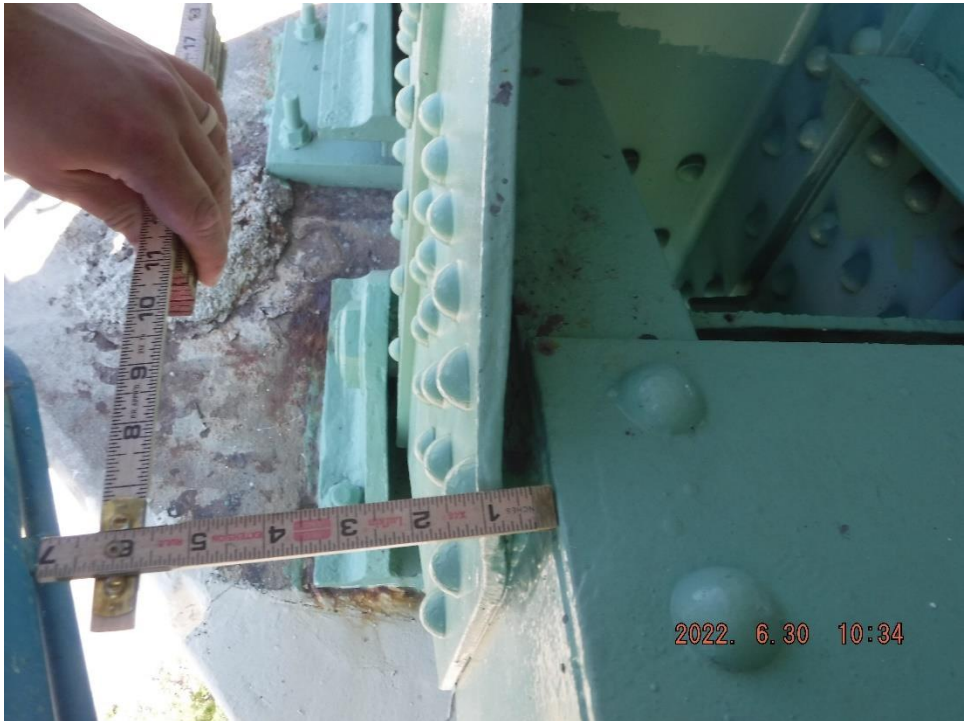
Photo 64: Free edge localized deformation with pack rust at unrepaired gusset edge (Span 10, South Truss, L20, South Gusset shown)

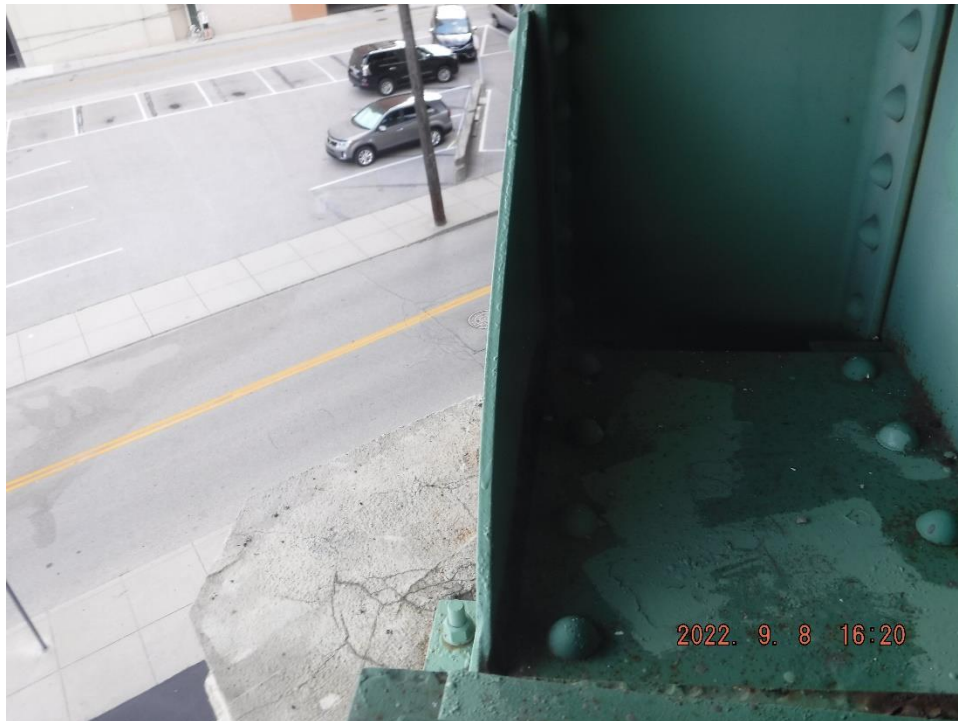
*Photo 65: Free edge bowing with pack rust at unrepaired gusset edge
(Span 5, South Truss, L0, South Gusset shown)*

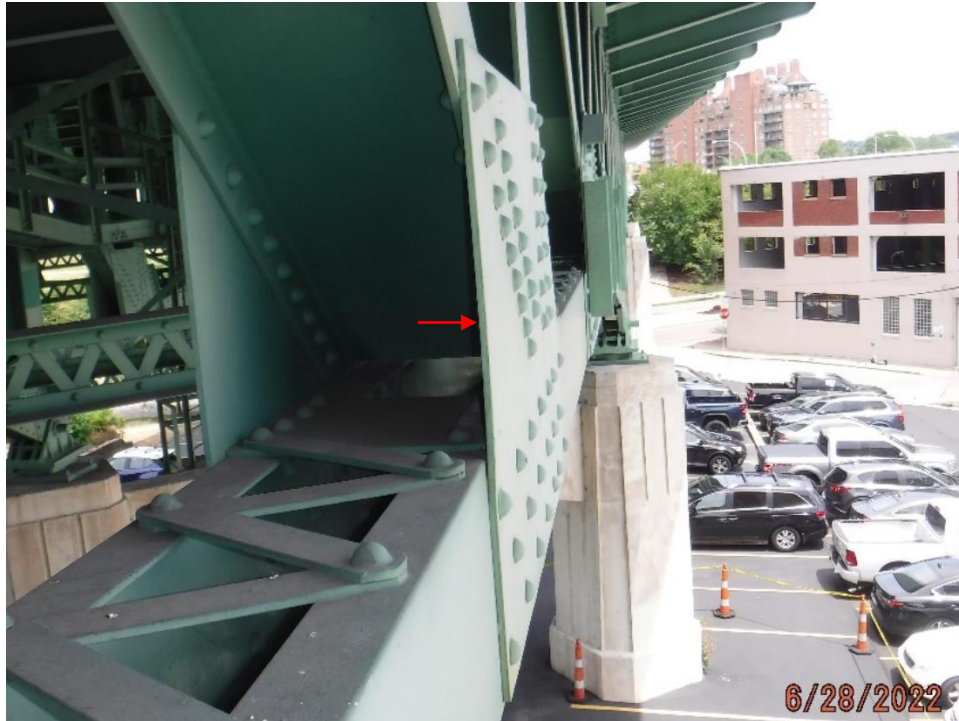
Photo 66: Minor free edge bowing without pack rust at unrepaired gusset edge (Span 5, South Truss, L3, South Gusset shown)

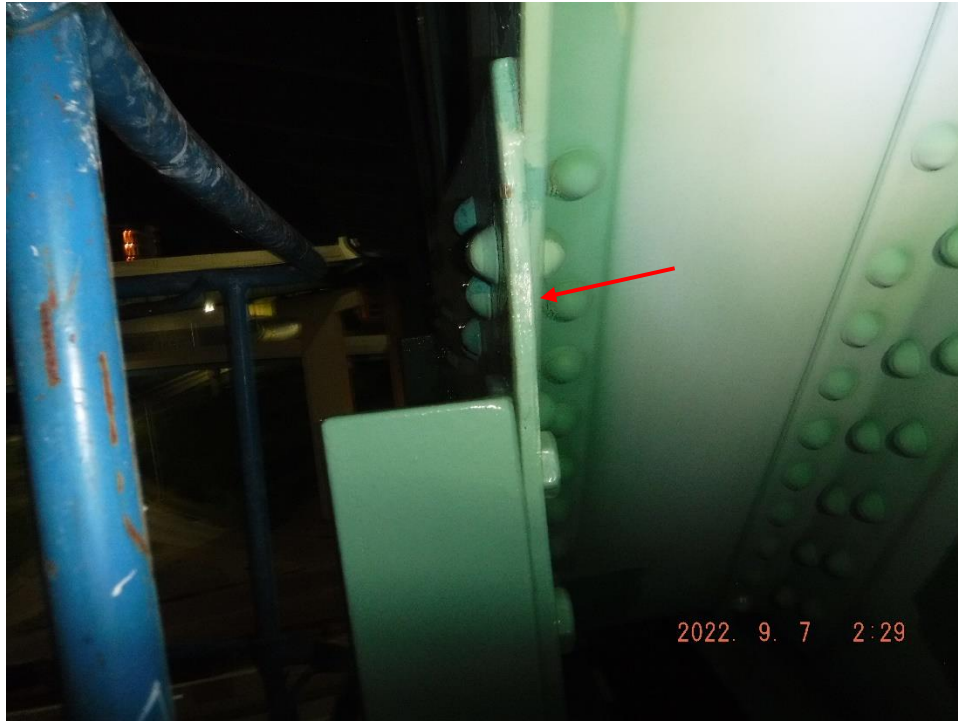
Photo 67: Free edge bowing at repaired gusset edge (Span 9, North Truss, L37, North Gusset shown)

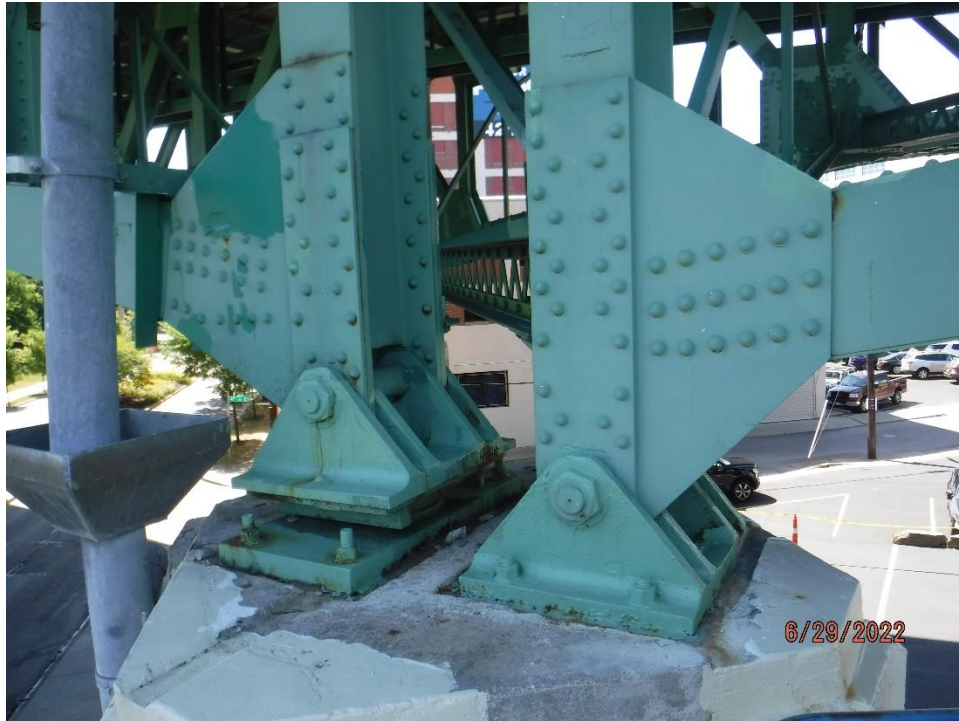
Photo 68: Painted-over pitting and surface corrosion on bearings (North Truss at Pier 7 shown)

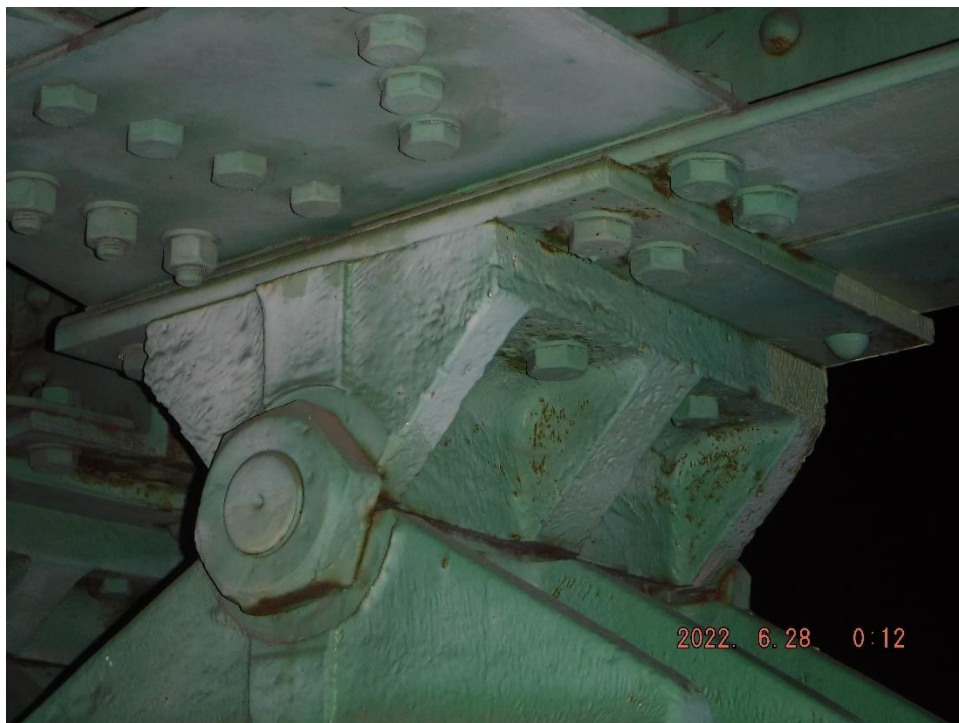
Photo 69: Painted-over pitting on bearing (North Girder, Span 13, at Pier 13 shown)

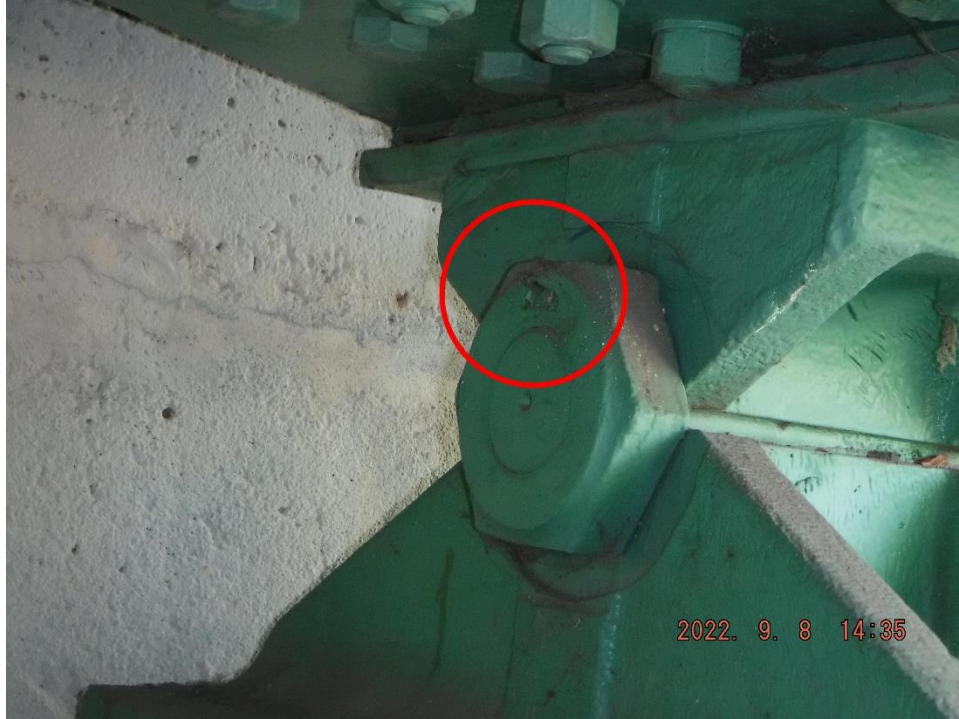
Photo 74: Manufacturing defect on the North Bearing at the West Abutment

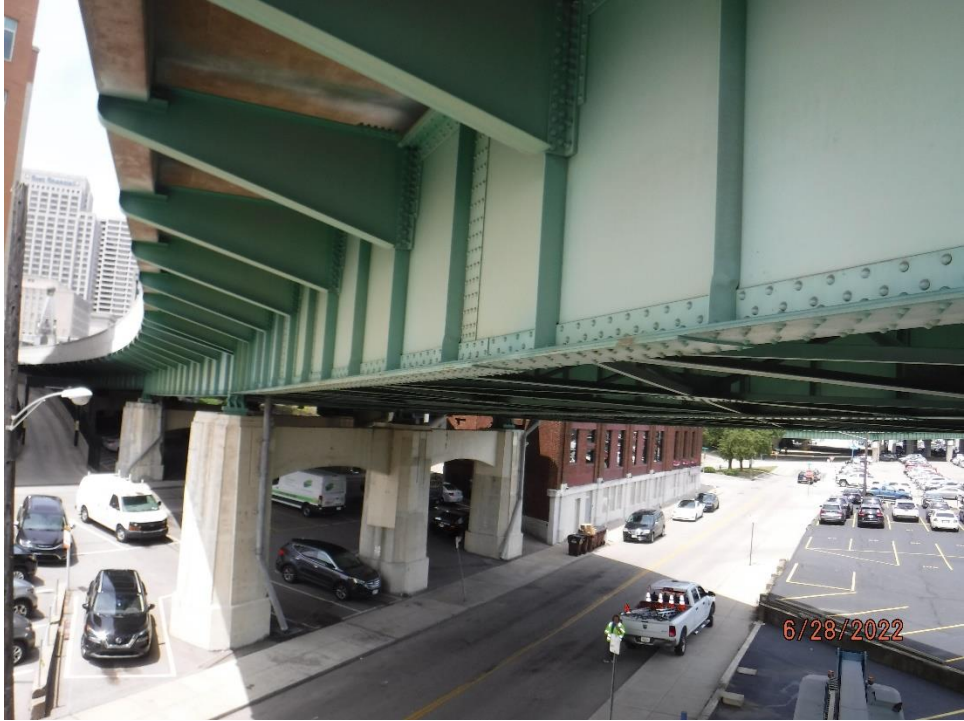
Photo 75: Typical paint condition on girder spans (Span 4 shown)

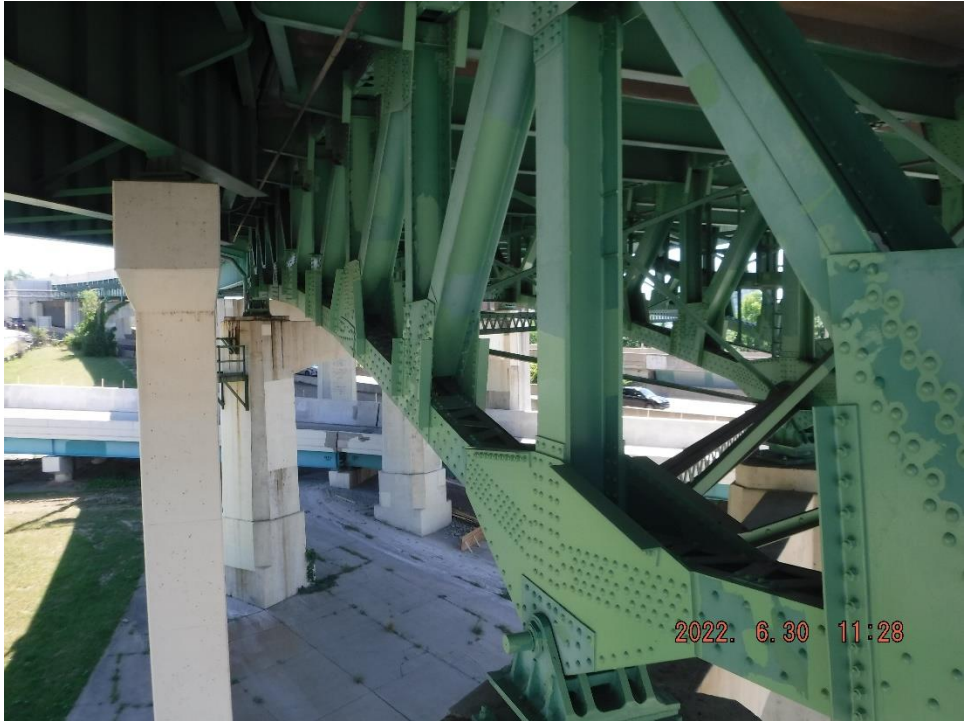
Photo 76: Typical paint condition on truss (North Truss, Span 10 shown)

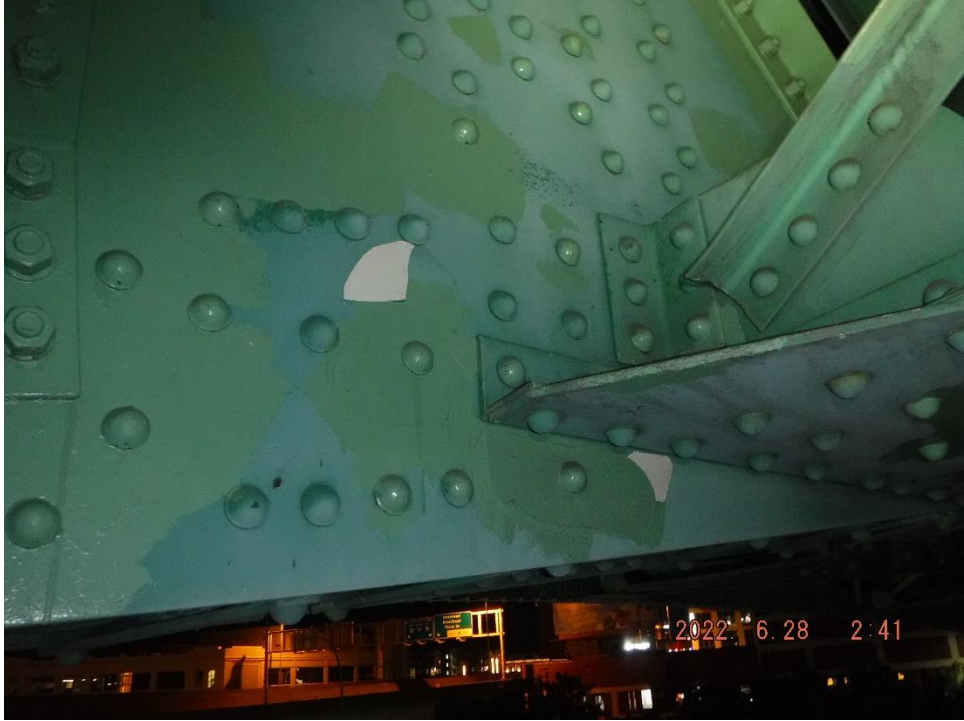
Photo 77: Chipped paint on gusset plate (Center Truss, Span 9, L42 shown)

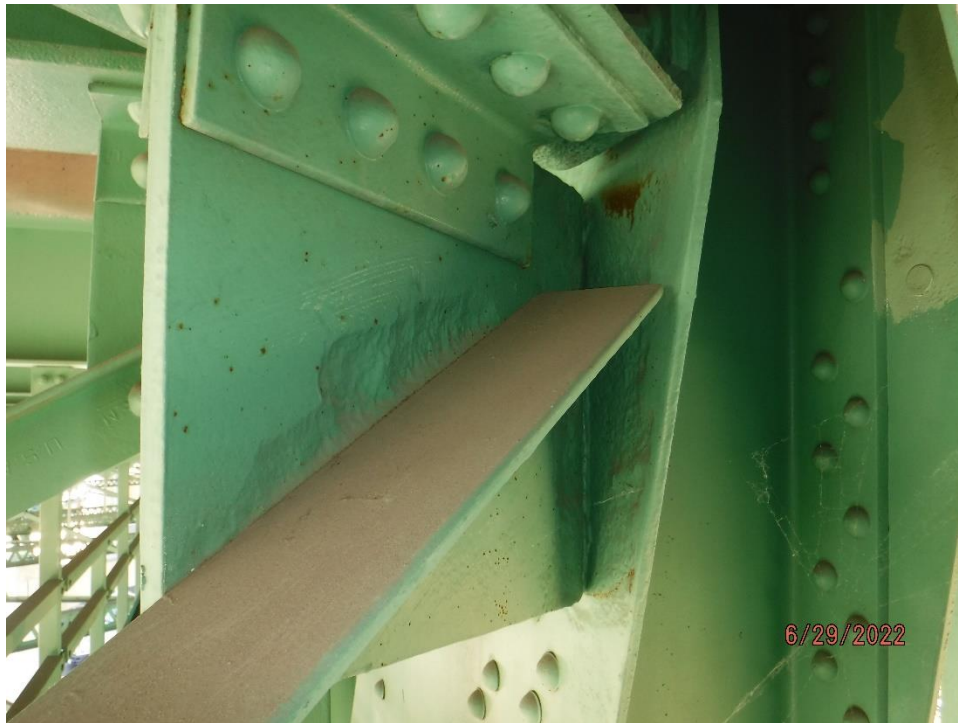
Photo 79: Painted-over pitting on connection plate (Center Truss, Span 7, U0 shown)
