2022 In-Depth Element Level and Fracture-Critical Inspection Report

BRIDGE NO: HAM-50-2180N

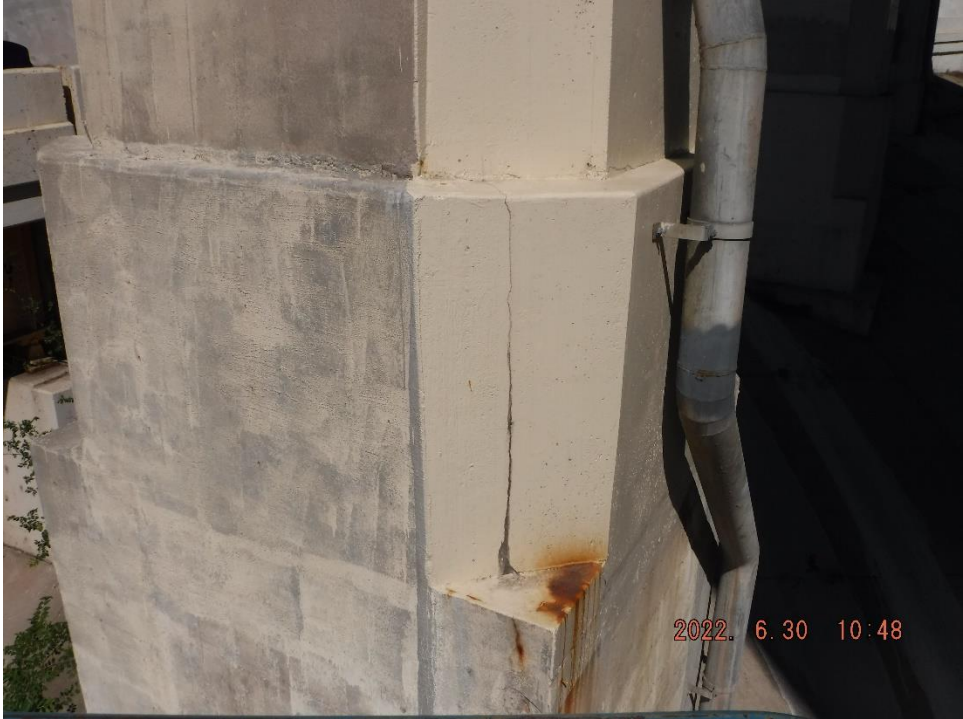
Photo 82: Vertical crack in the South Column of Pier 10

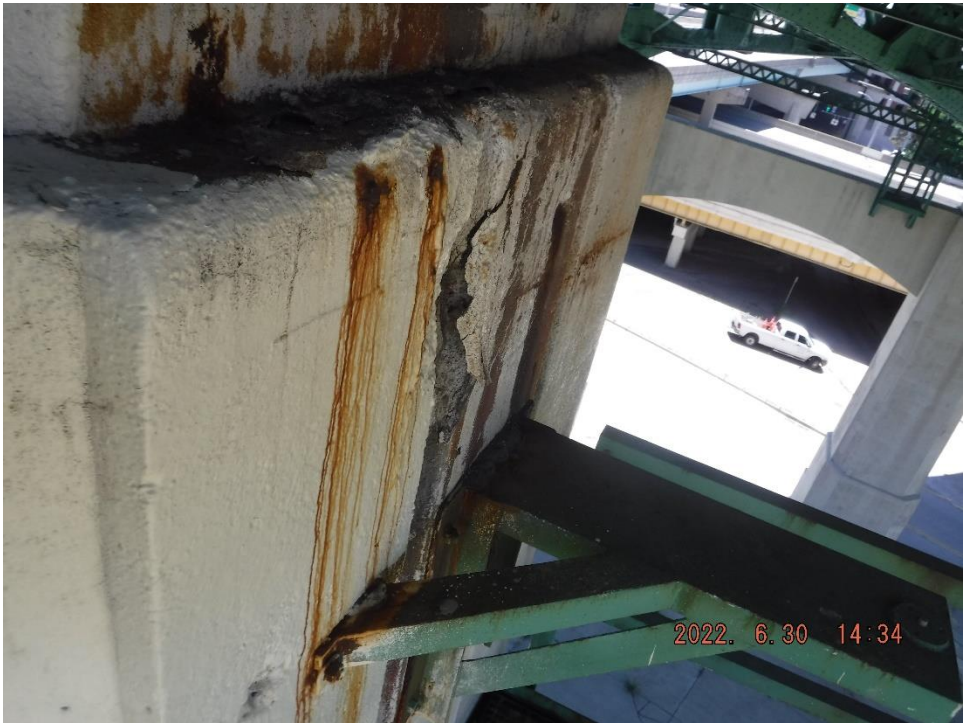
Photo 83: Spall with rust staining on the North Column of Pier 12

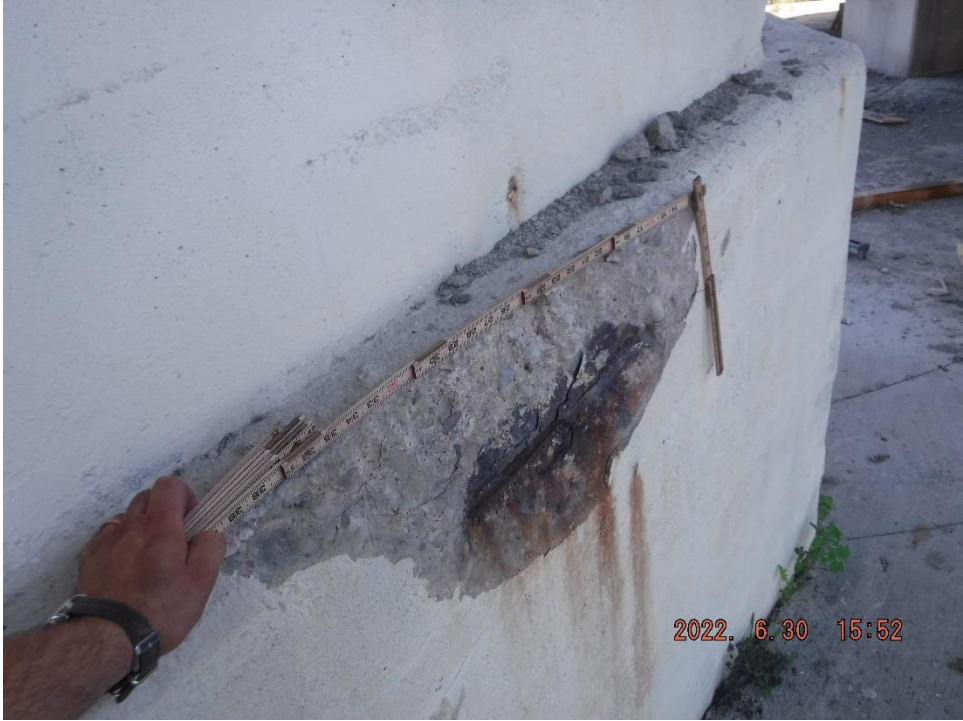
Photo 84: Spall with exposed reinforcement on the Center Column of Pier 13

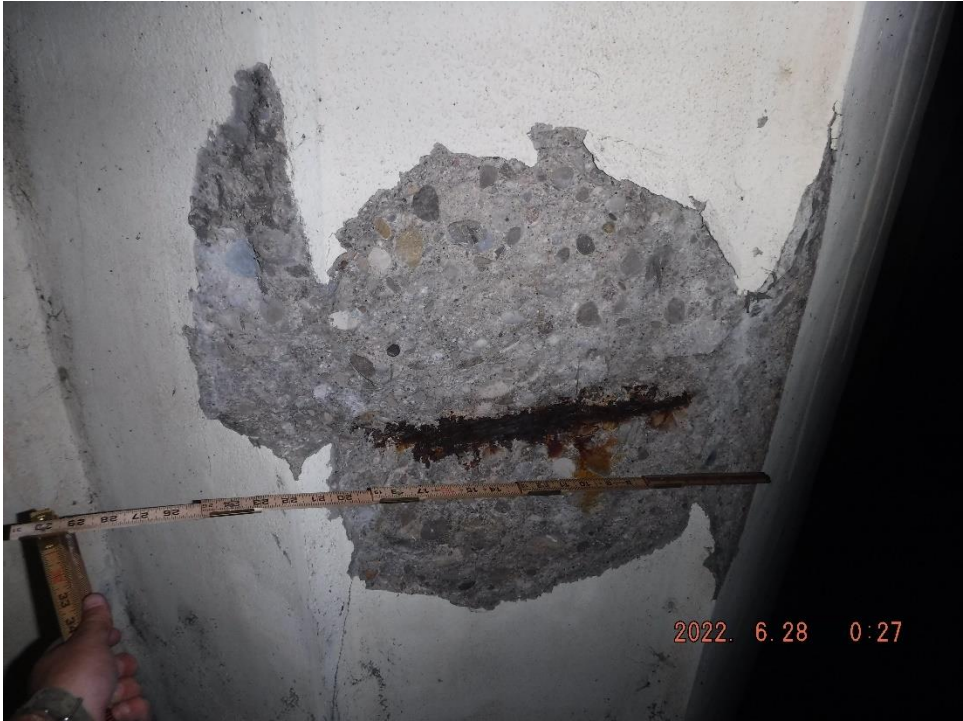
Photo 85: Spall with exposed reinforcement on the Center Column of Pier 13

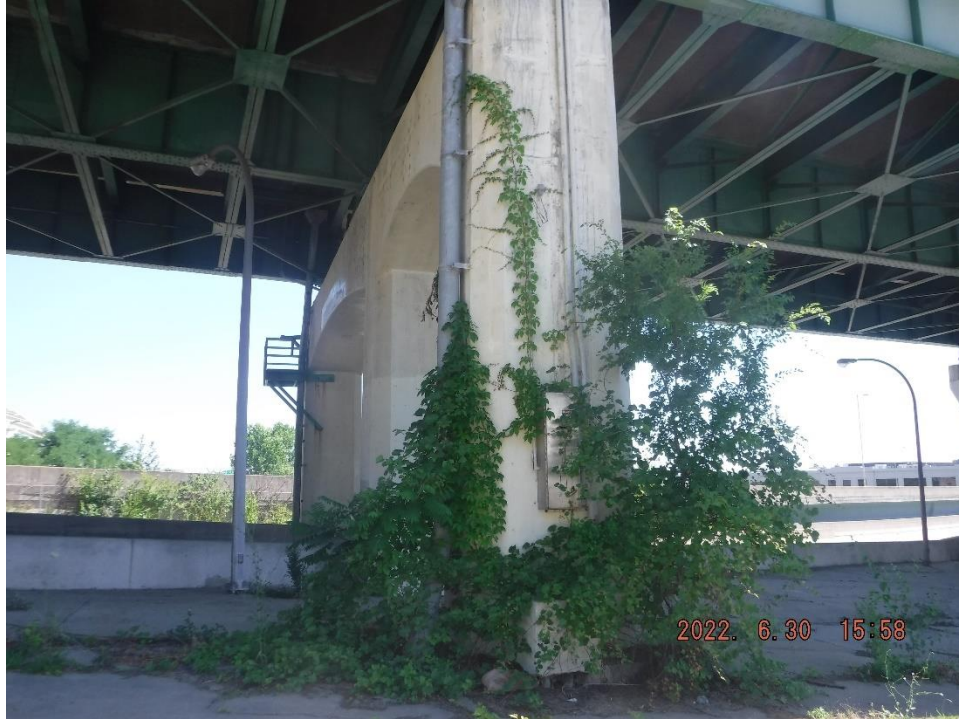
Photo 86: Vegetation growing on the North Column of Pier 14

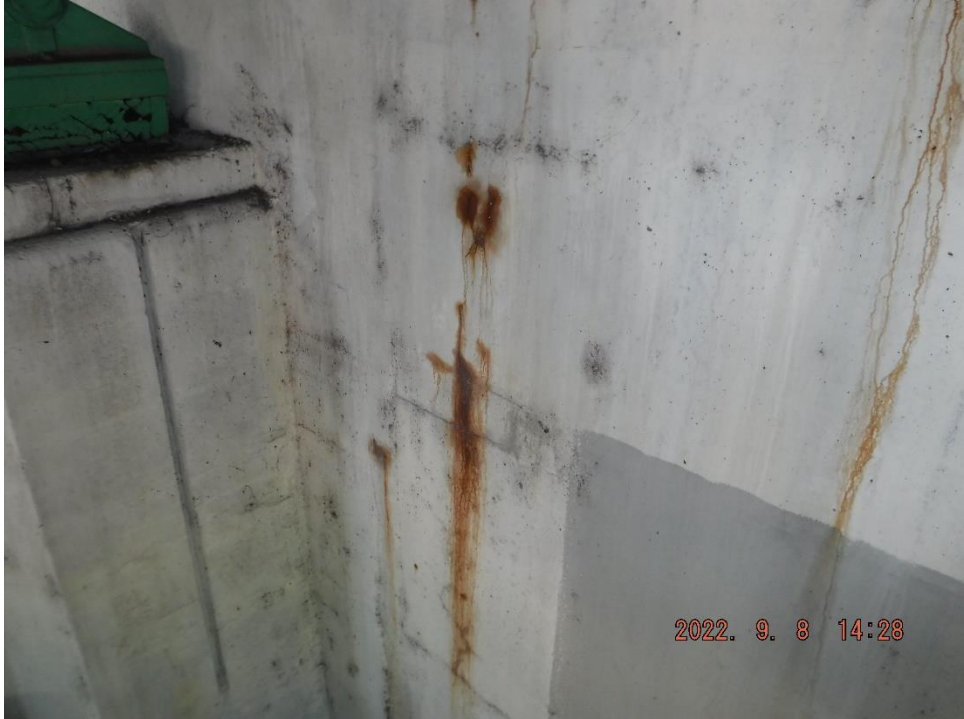
Photo 87: Hairline map cracking with rust staining on the Rear Abutment

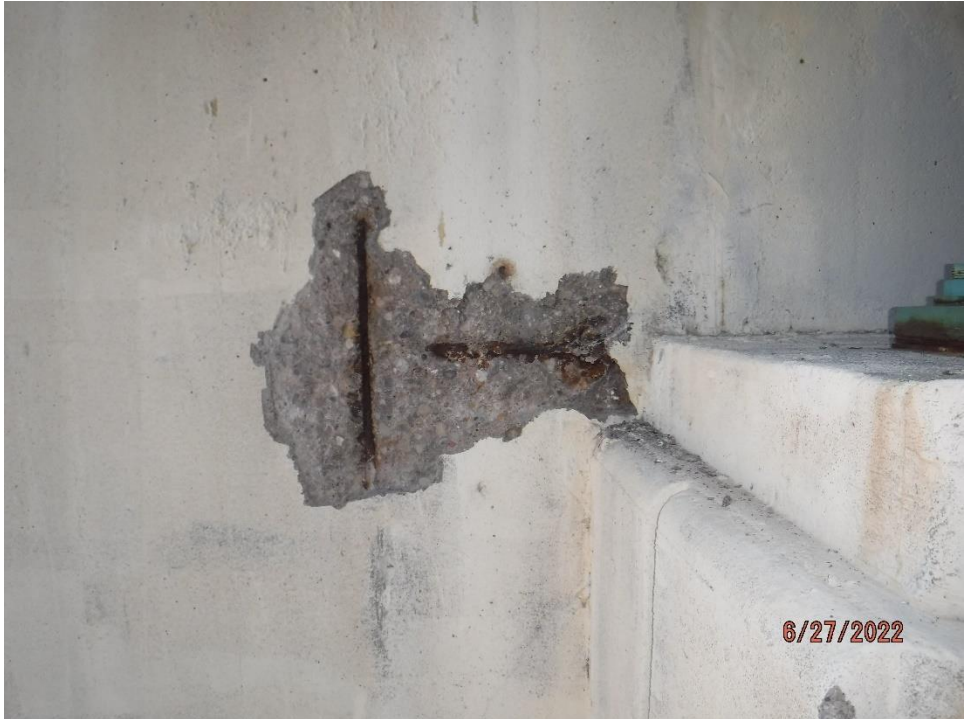
Photo 88: 2 SF spall with exposed reinforcement adjacent to the North Girder on the Forward Abutment

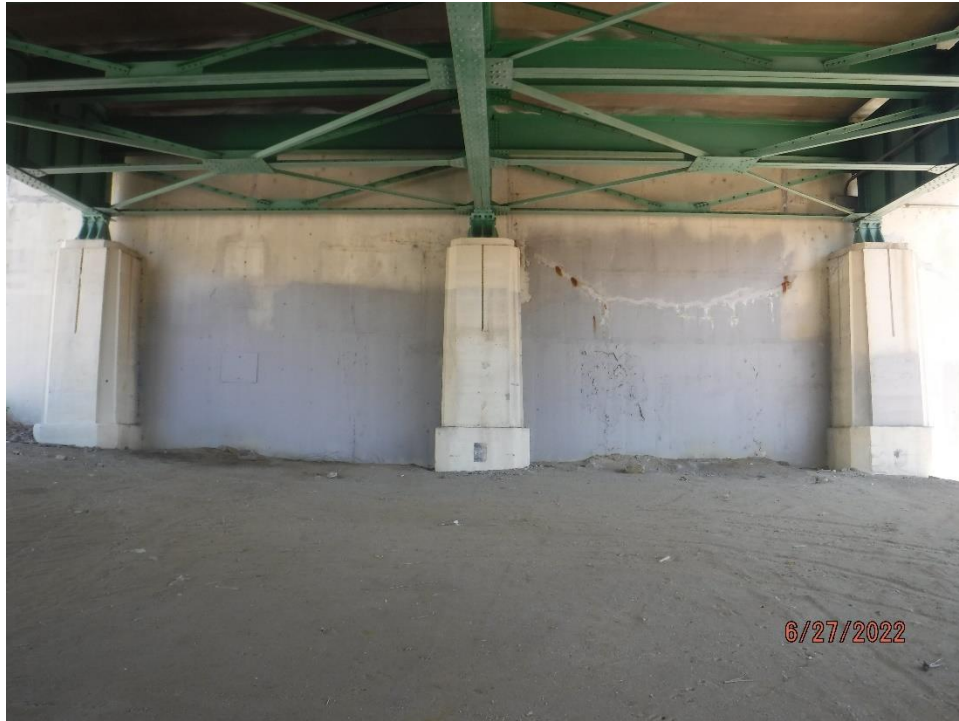
Photo 89: Sealed horizontal crack and map cracking on the Forward Abutment

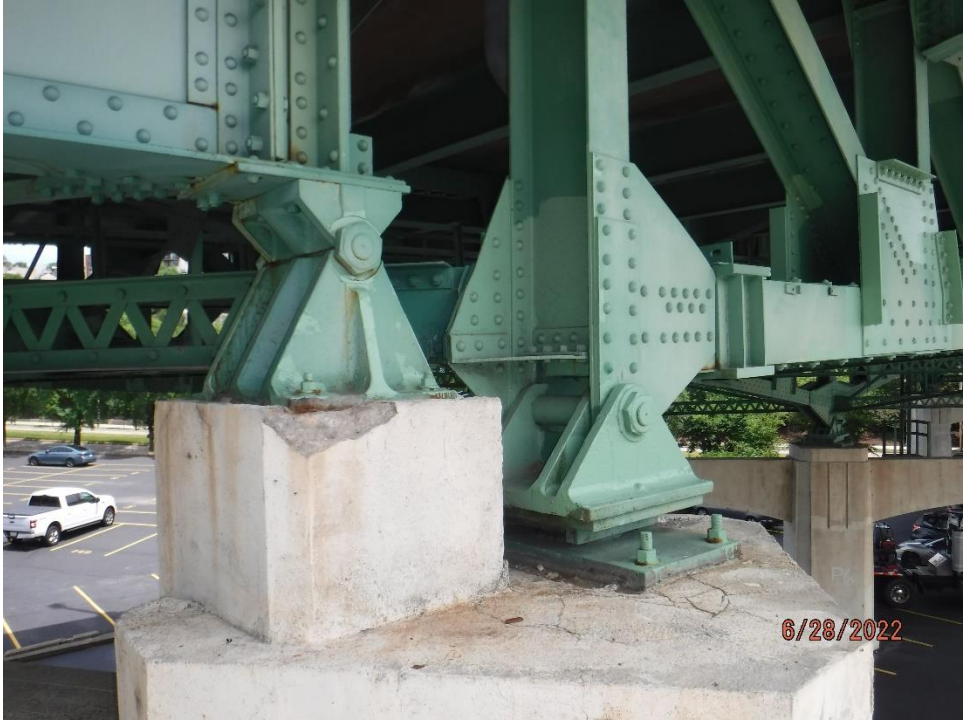
Photo 90: 1' x 6" spall beginning to undermine the Span 4 Bearing of the South Truss at Pier 5

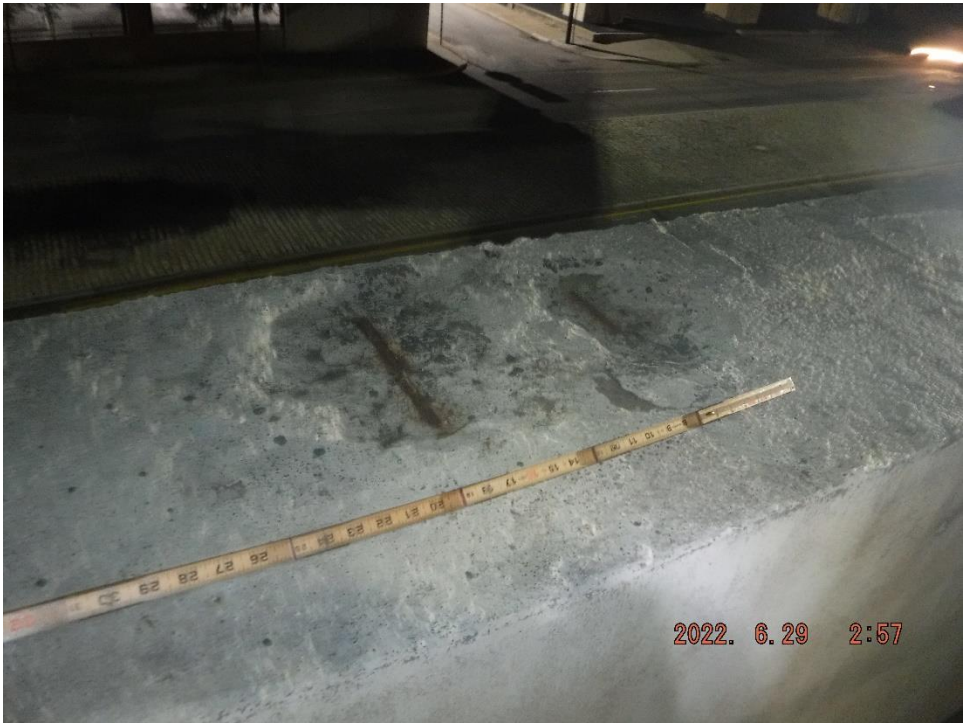
Photo 91: 2' x 1' spall with exposed reinforcement on the top face of Pier 8 Cap between the Center and South Columns

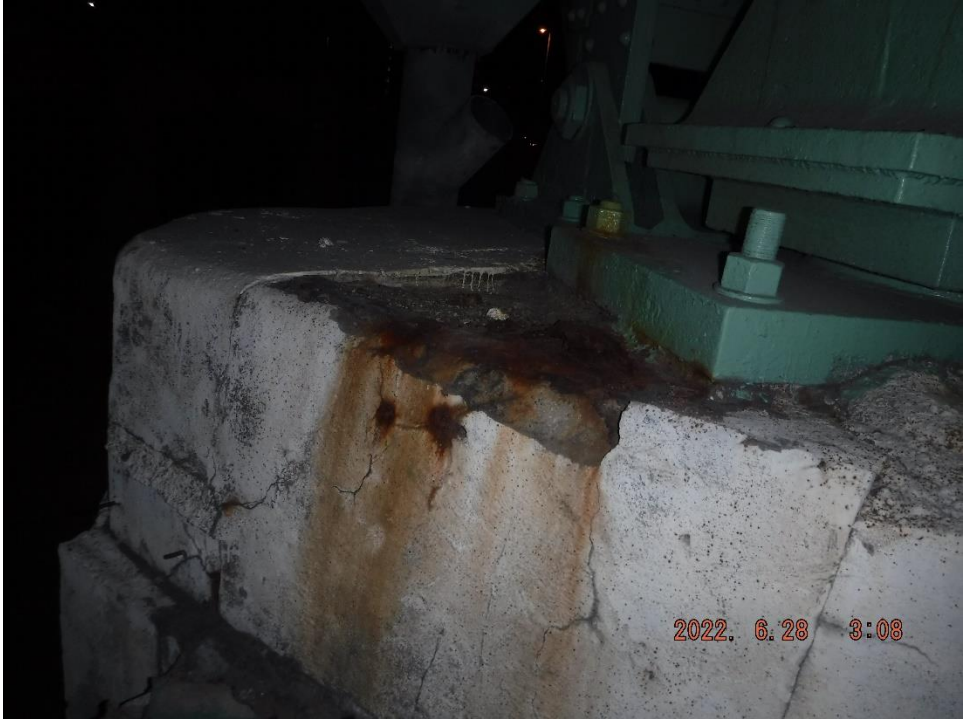
Photo 92: Spall beginning to undermine the Span 9 Bearing at the South Truss at Pier 10

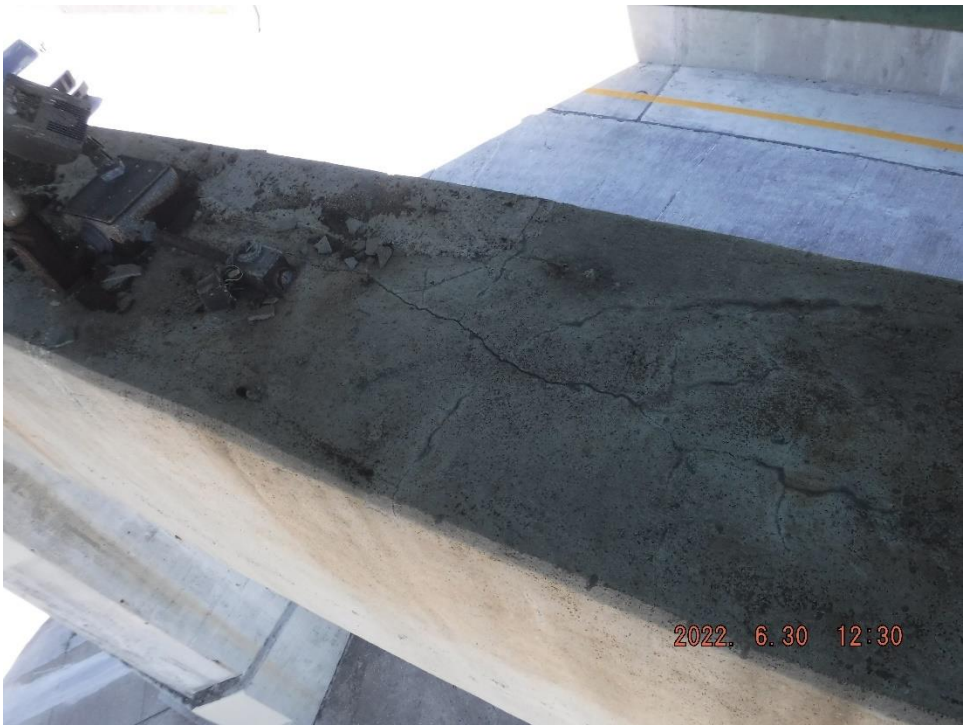
Photo 93: Map cracking on the top face of the Pier 10 Cap between the Center and South Columns

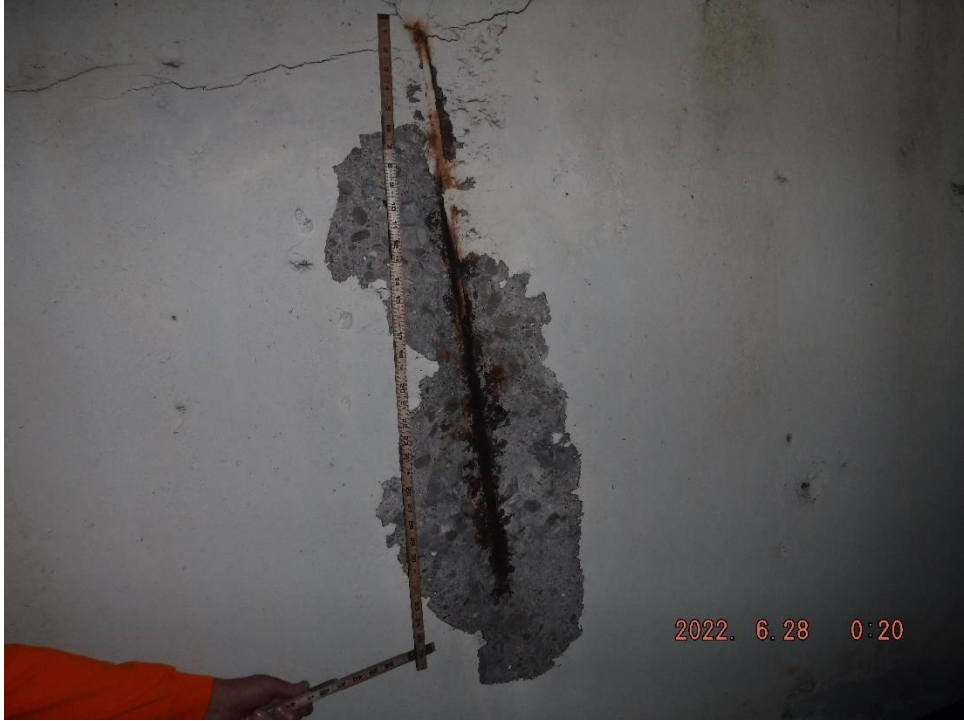
Photo 94: 3' x 1' spall with exposed reinforcement on the east face of the Pier 13 Cap between the North and Center Columns

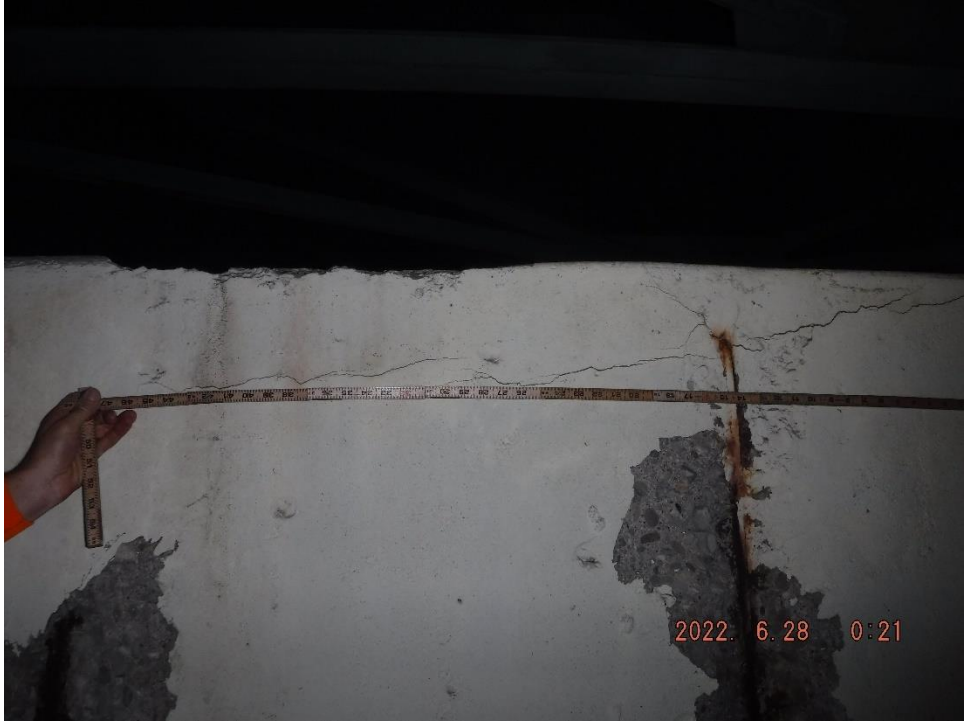
Photo 95: 4' long delamination on the east face of the Pier 13 Cap between the North and Center Columns

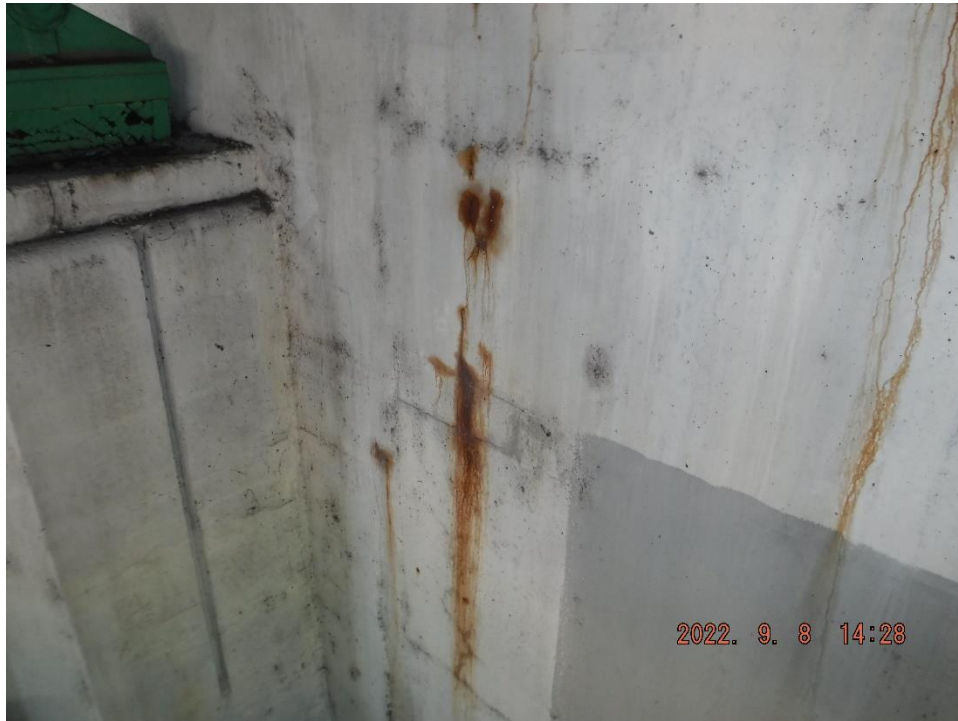
Photo 96: Cracks with efflorescence and rust staining on the rear abutment backwall

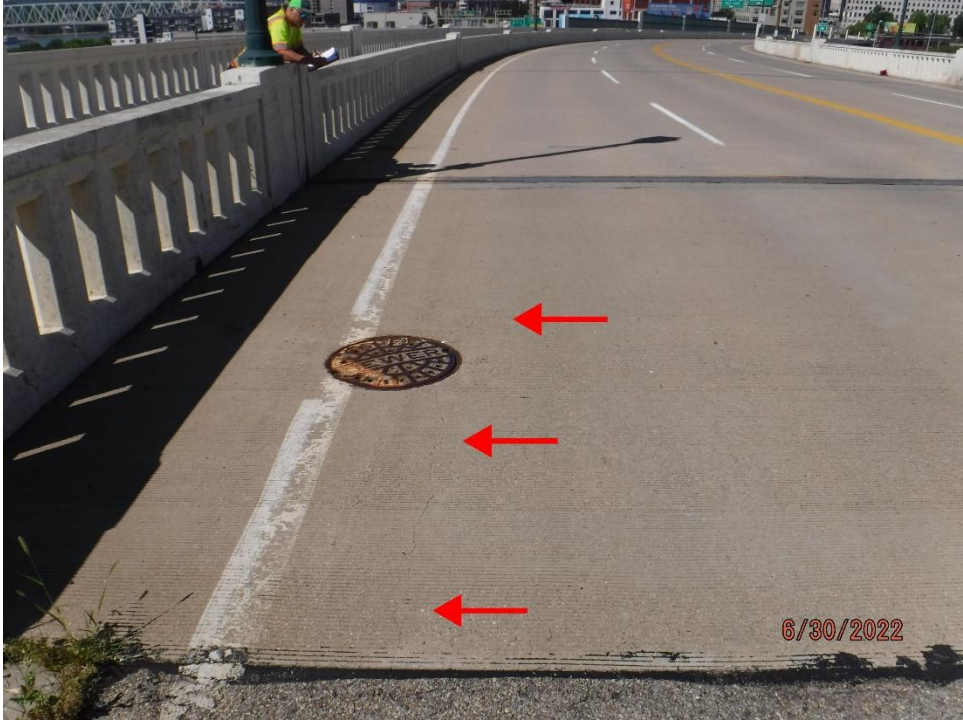
Photo 97: East Approach Slab with cracks propagating from drainage structure

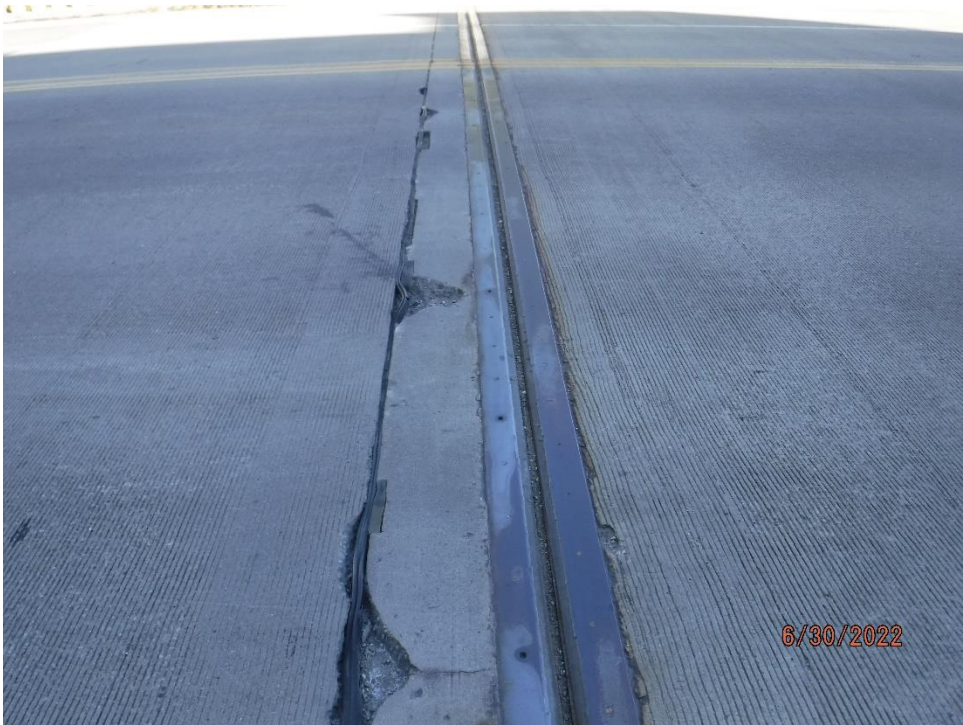
Photo 98: Spalls in the West Approach Slab at the expansion joint

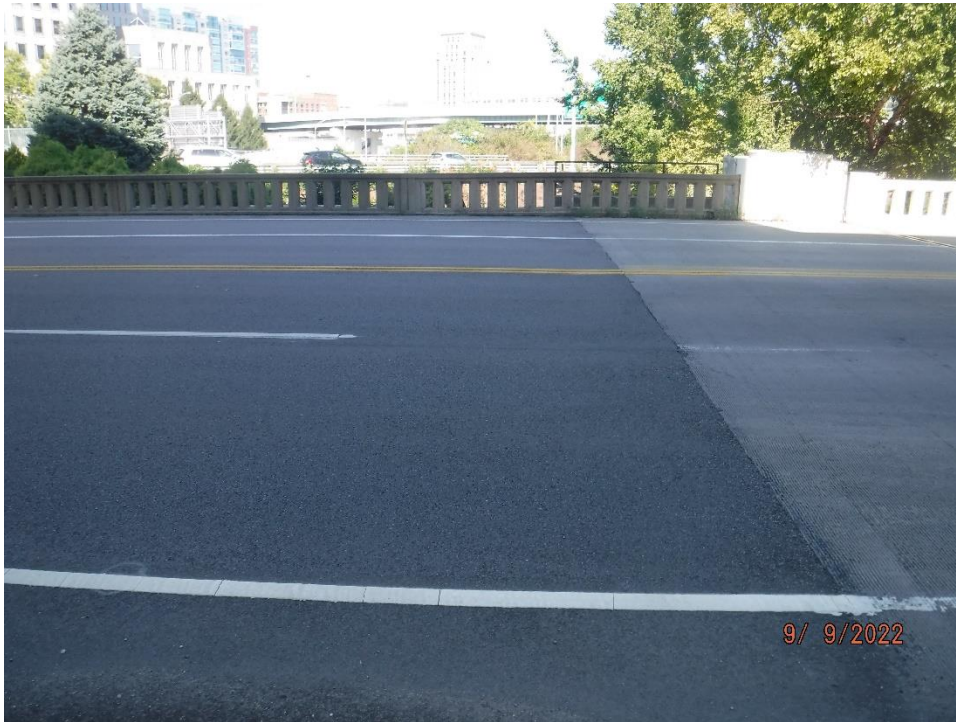
Photo 99: West approach pavement and transition

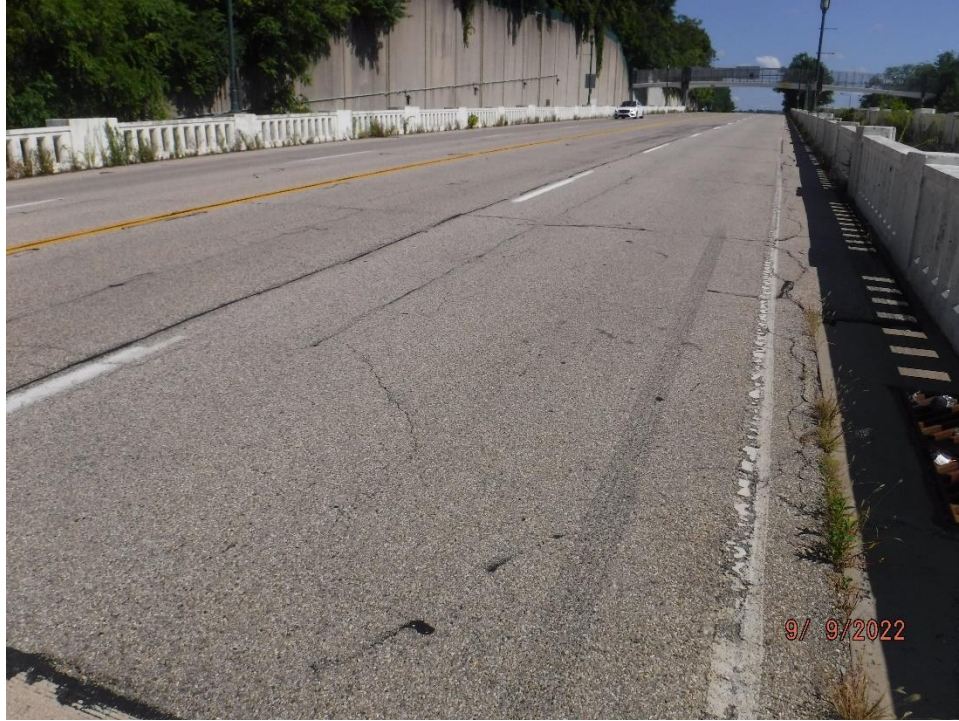
Photo 100: East approach pavement with unsealed cracks in the travel lanes and near the south edge

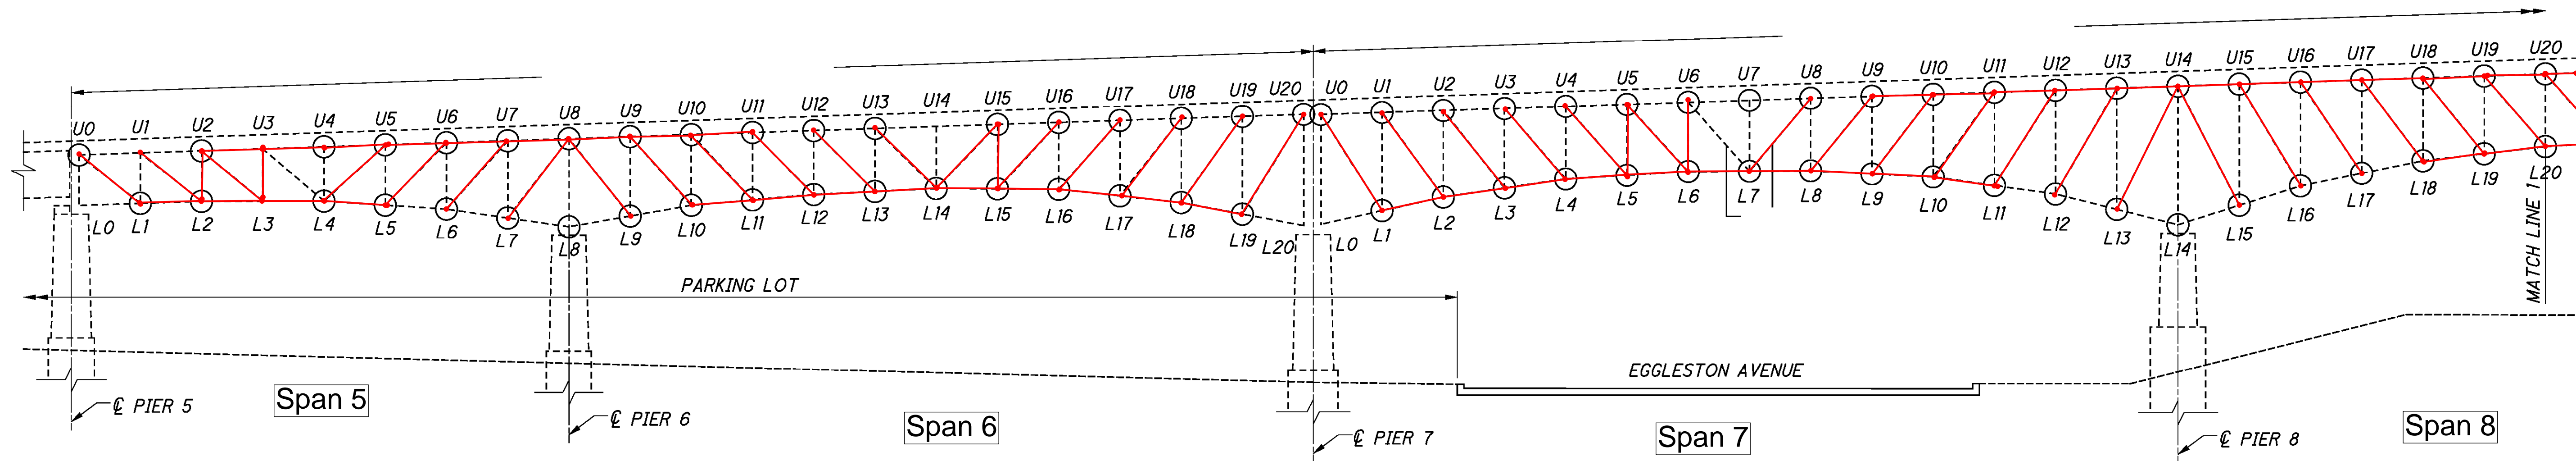
PART ELEVATION - TRUSS SPANS

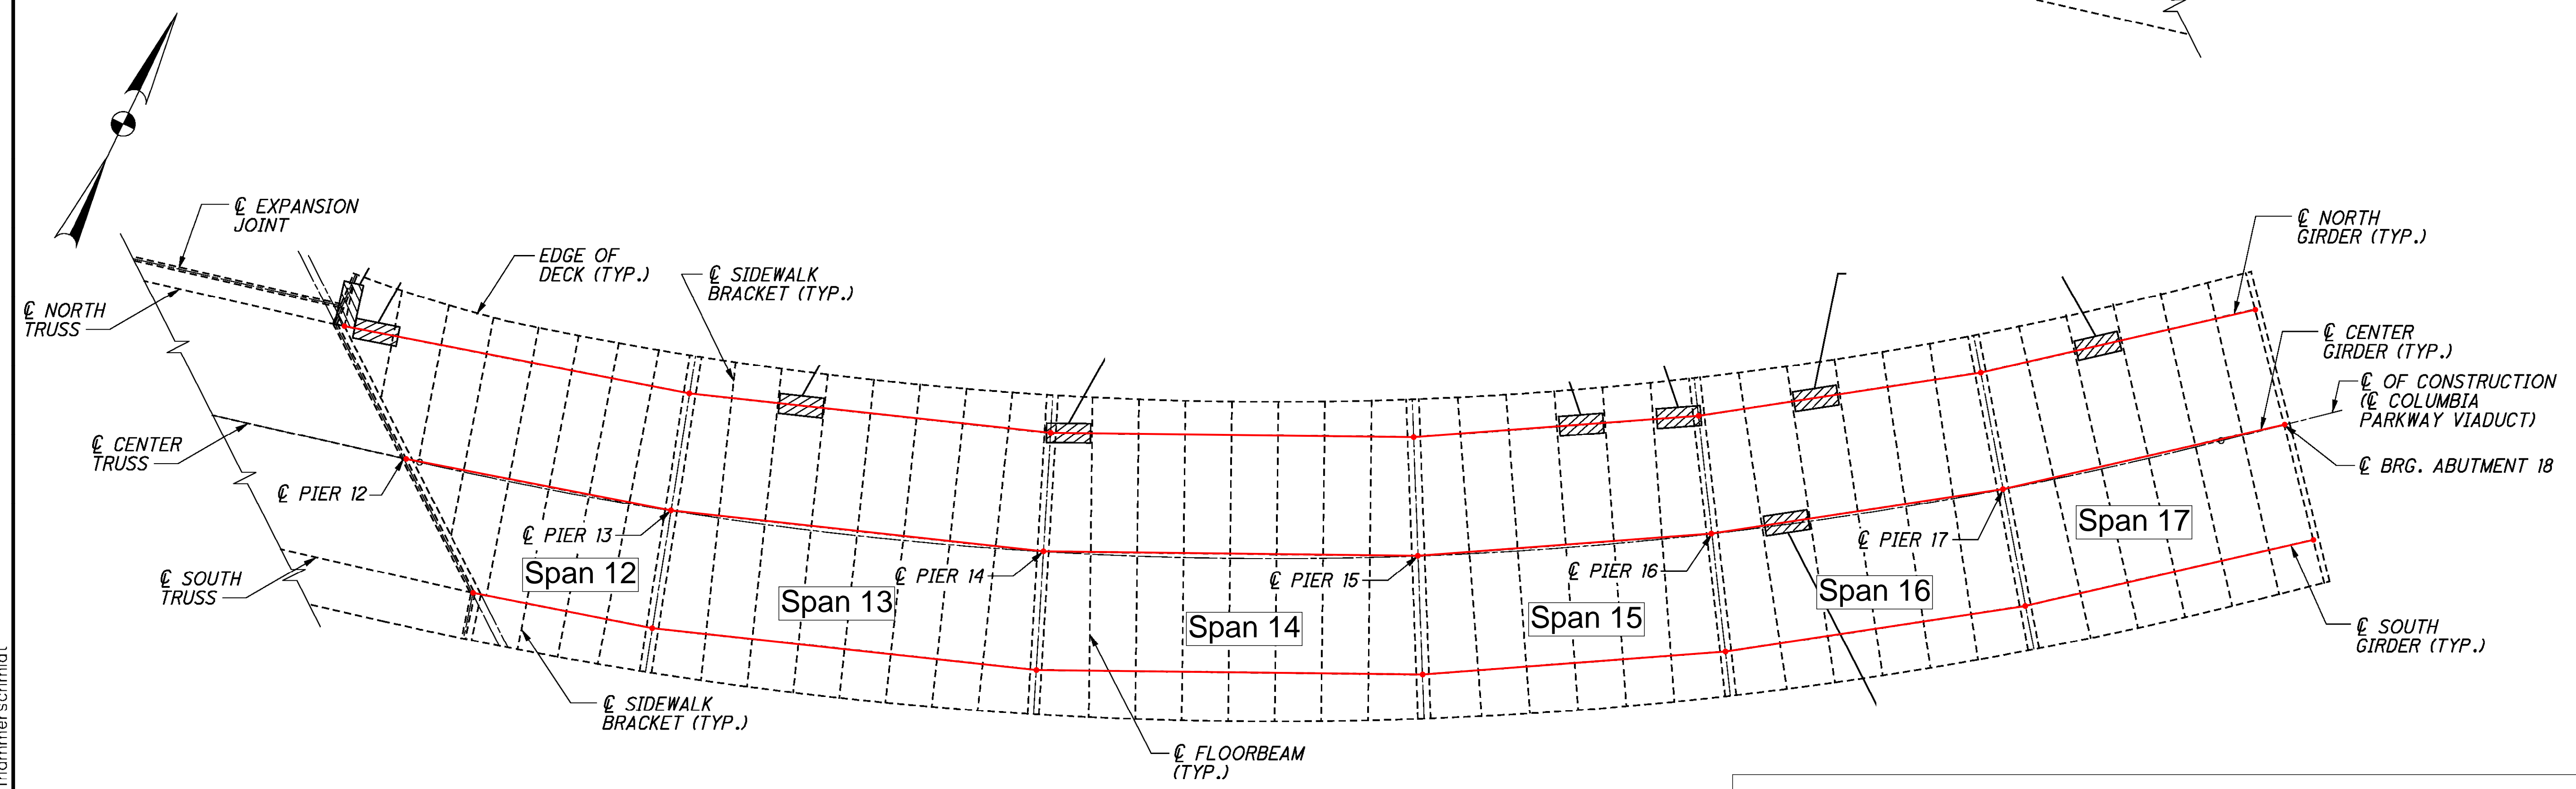
PART FRAMING PLAN - SPANS 12 THRU 17
