2023 IN-DEPTH INSPECTION REPORT
BRIDGE NO: HAM-71-0000R, SFN 3105970
VAR-DISTRICT 8 Bridge Inspections
Brent Spence Approach Bridges

Cincinnati, Ohio

September 11th – September 19th, 2023

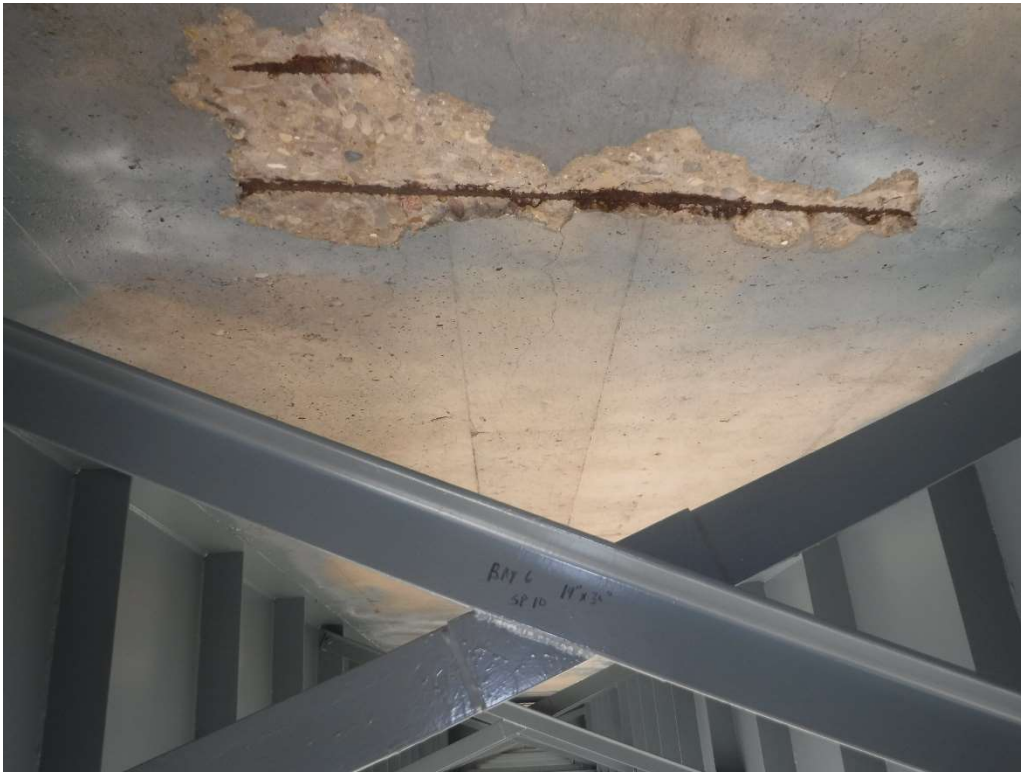
There are isolated areas of delaminated concrete with spalls with exposed reinforcing in various spans. In Span 10A there is a 5' Long x 2' Wide deep spall with 2 exposed transverse bars in Bay 6 (See Photo 1). In Span 13C, Bay 1 there is a 32" Long x 20" Wide x 1" Deep spall. In Span 14C, Bay 1 there is a 42" x 24" x 3" Spall with 4 exposed transverse and 1 longitudinal bar. In Span 16D, near Pier 15C, Bay 4 there is a 24" x 24" spall with 2 exposed longitudinal reinforcing bars.

Photo 1- Bay 6, Span 10, Spalling with Exposed Rebar, 6SF

- Repair spalls and delaminations on the underside of deck. Span 10A underside had delaminated concrete that was not able to be safely removed due to painters vehicles being parked underneath.

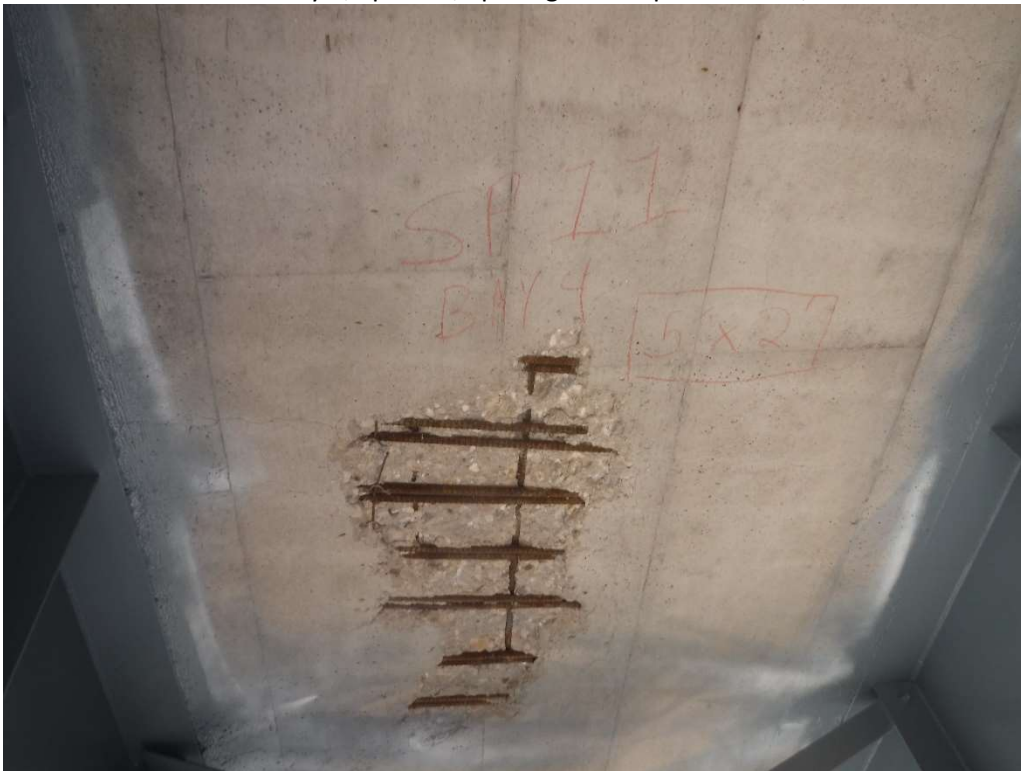
Photo 2- Span 11, Bay 4, 10SF Spall with Exposed Rebar

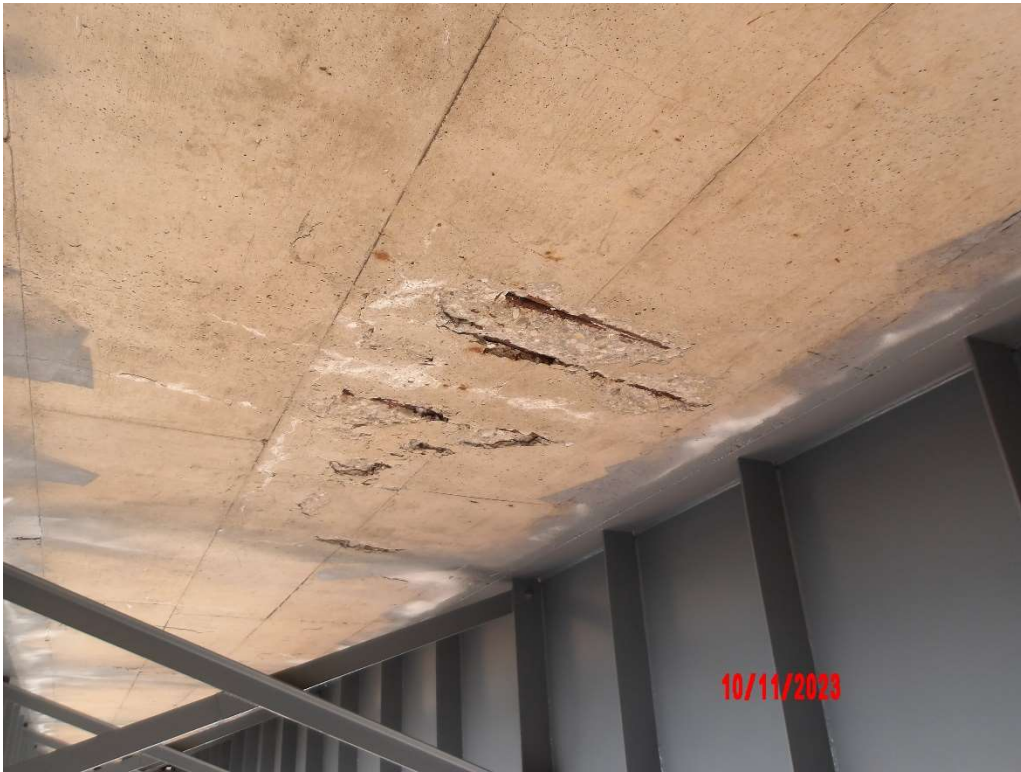
Photo 3- Span 12, Bay 4, 15 SF Spalling with Exposed Rebar

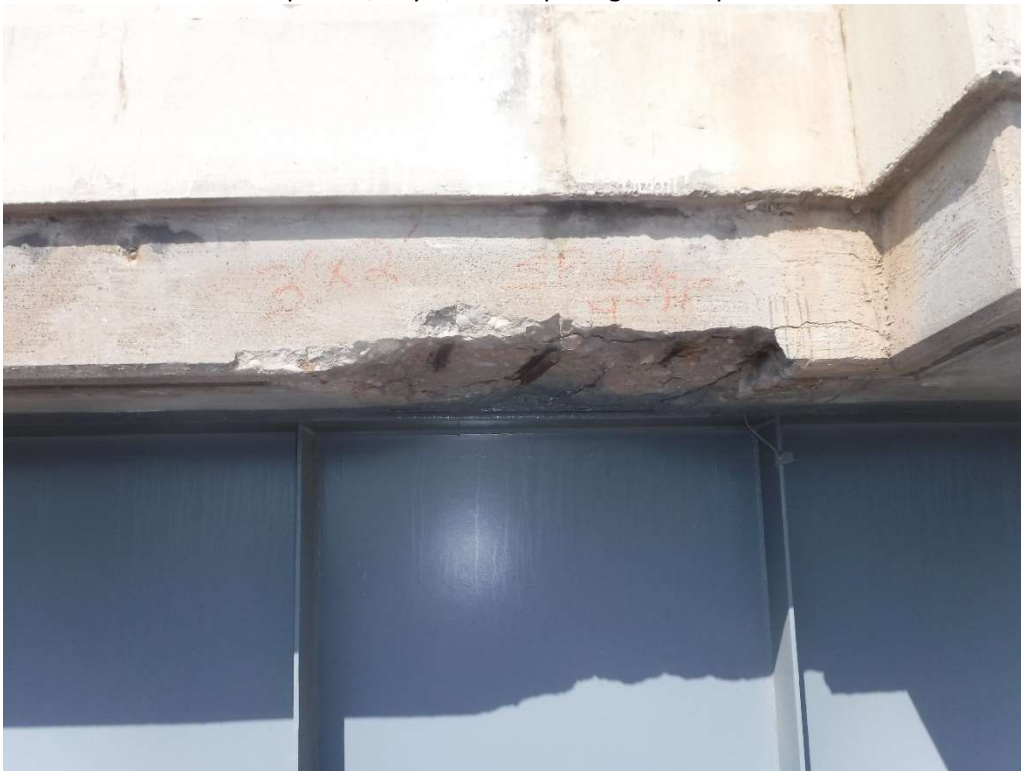
Photo 4- Span 12, Overhang, 6SF Spall with Exposed Rebar

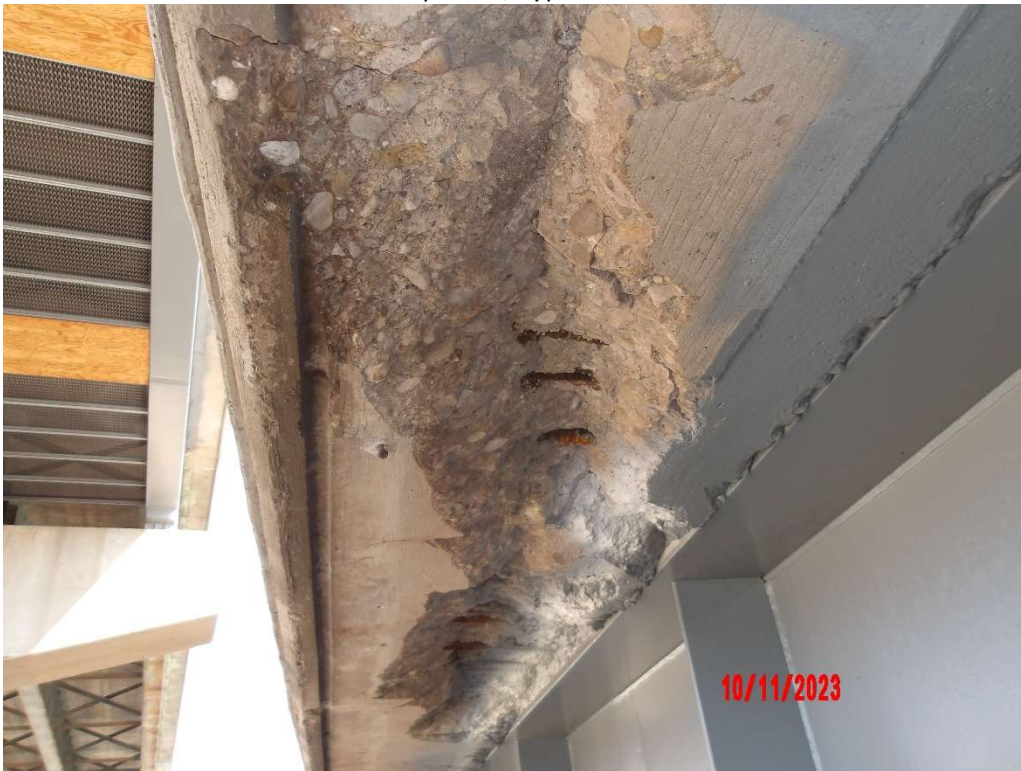
Photo 6- Girder A, Span 14, 8'x7'x6" Spall with Exposed Rebar

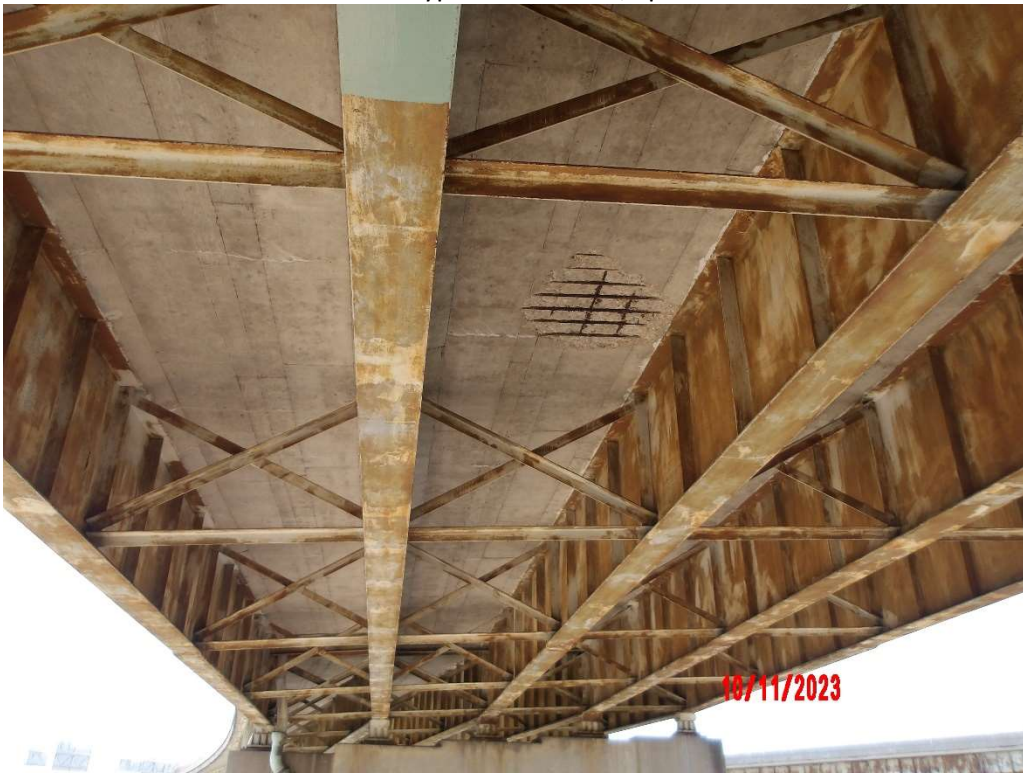
Photo 8- Typical Underside, Span 20, Spalling with Exposed Rebar

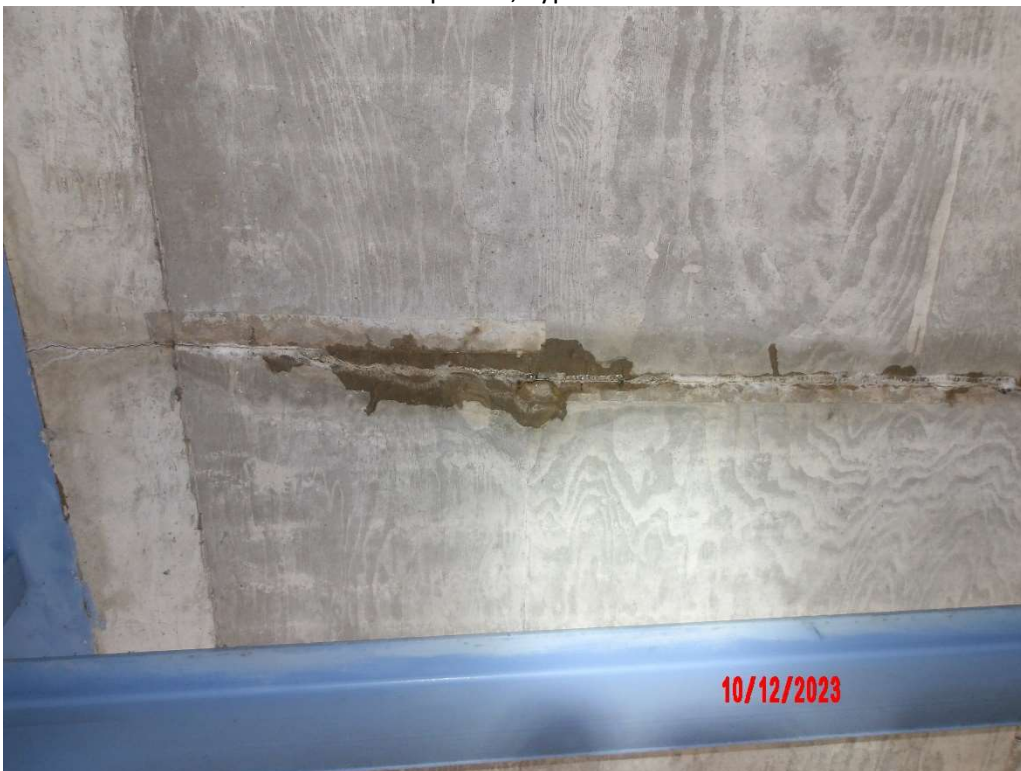
Photo 12- Span 23, Transverse Crack, Leaking Water

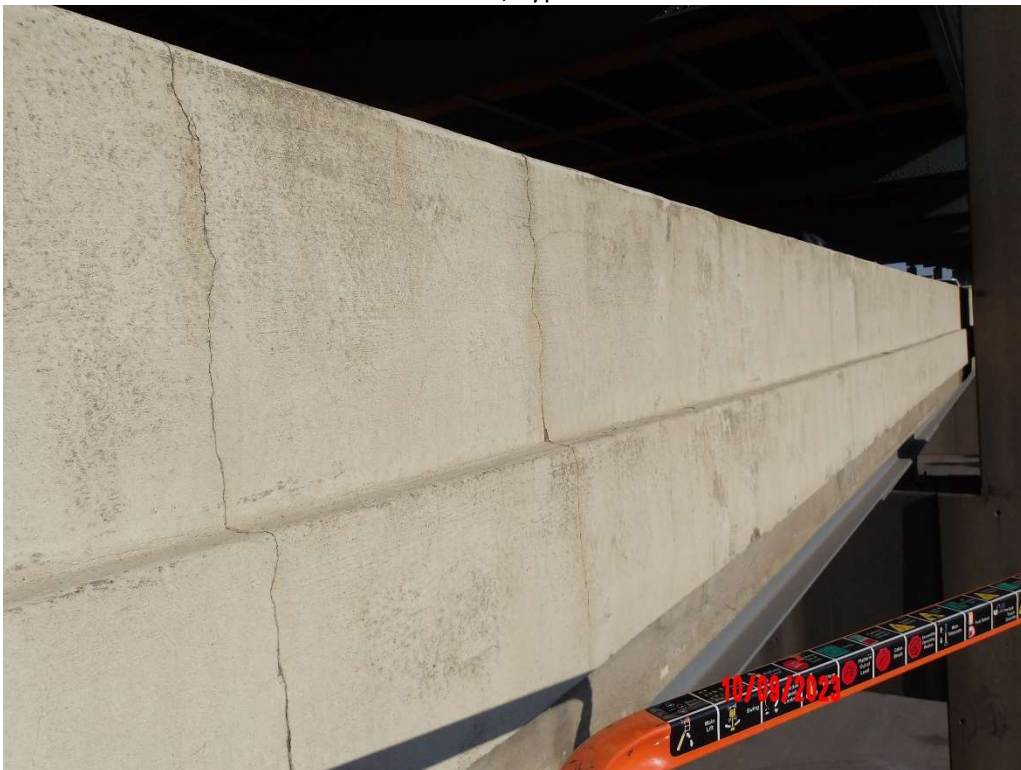
Photo 20- Typical Barrier Cracking

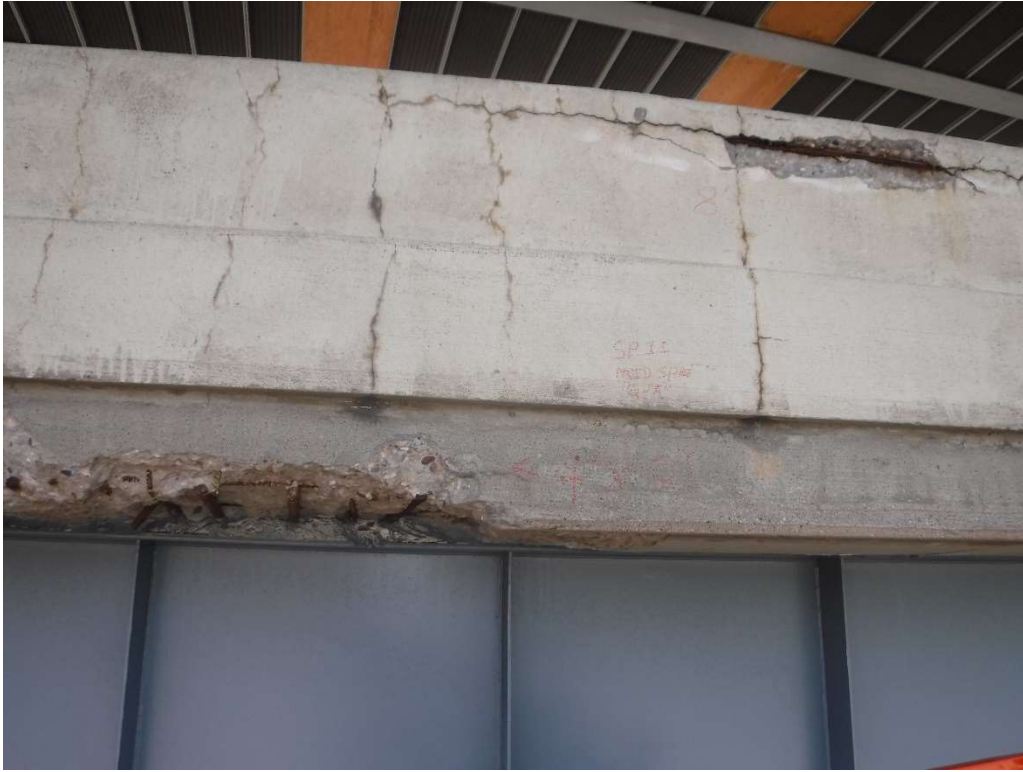
Photo 21- Span 10, Barrier, Typical Spalling and Cracking

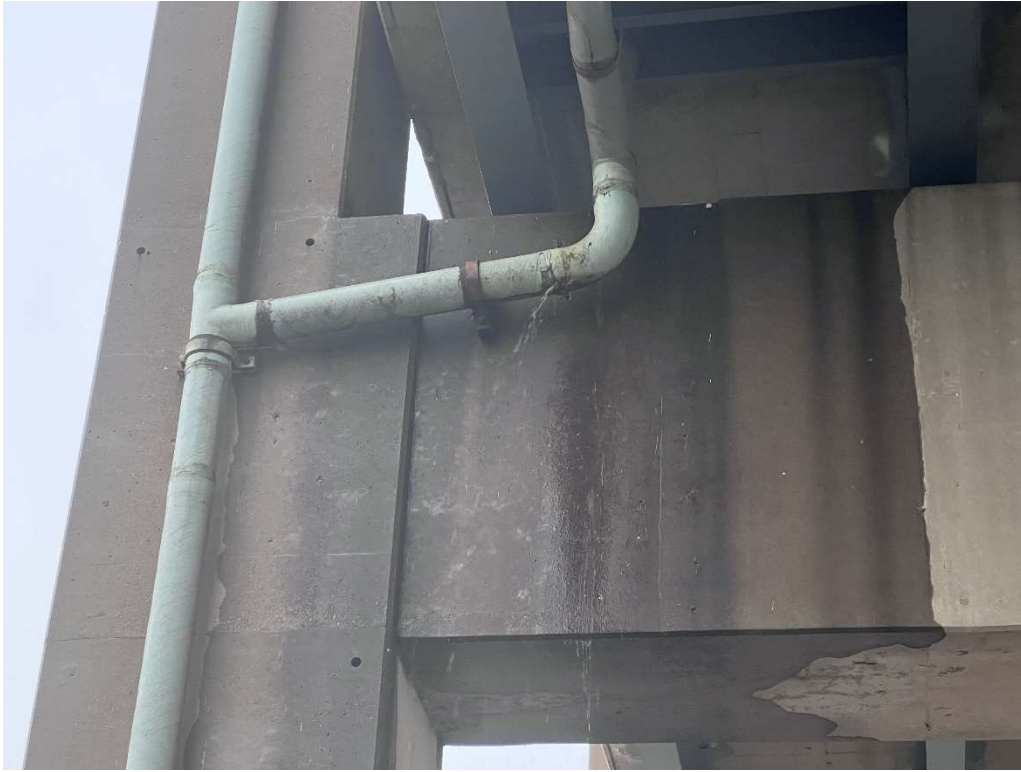
Photo 23- Drainage, Leaking on Substructure, Pier 3

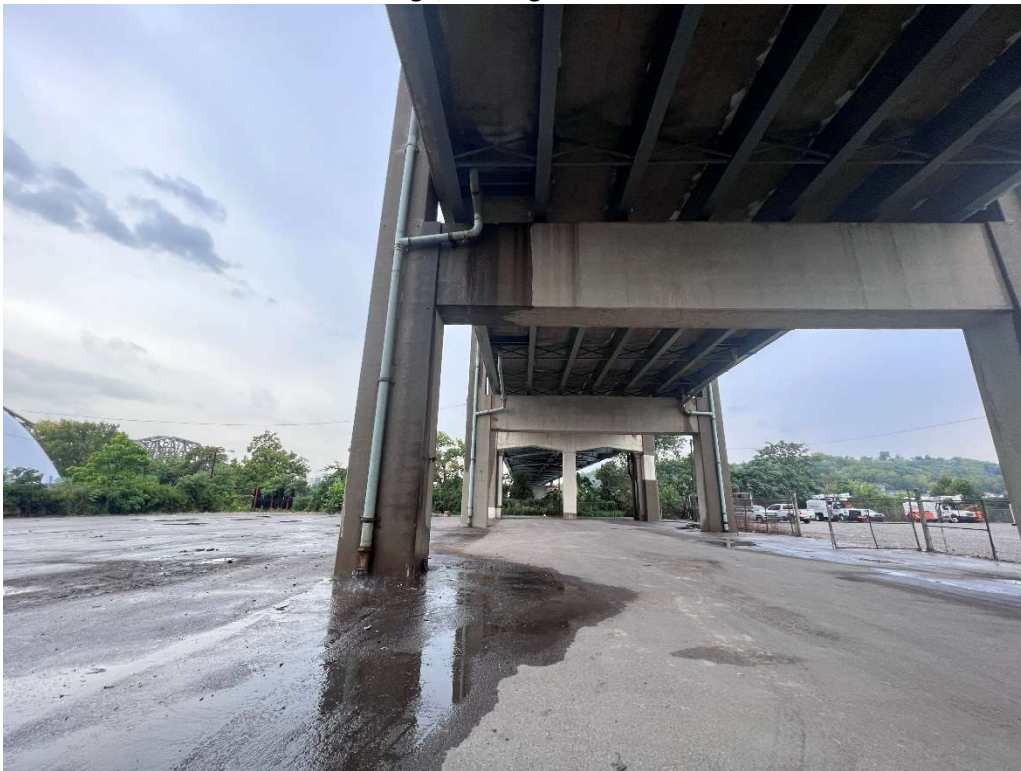
Photo 24- Drainage, Leaking on Substructure, Pier 3

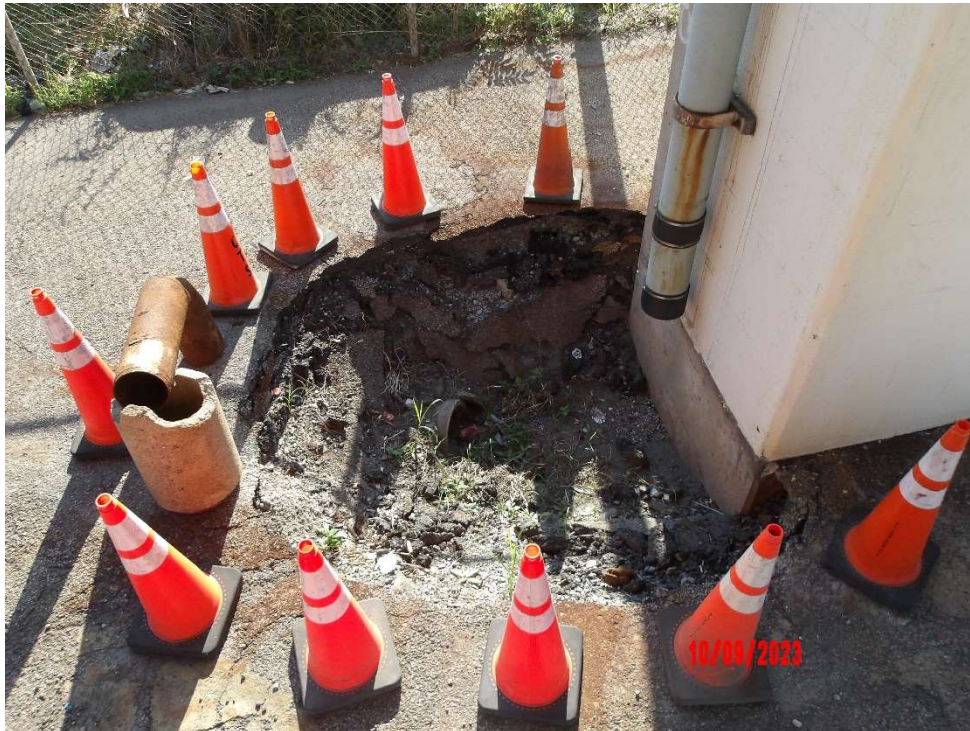
Photo 25- Pier 4, Column 2, Drain Failure with 8' Diameter Erosion Hole up to 4' Deep

- Replace drainpipes and fix 8' diameter x 4' deep hole at Pier 4A Column 2.

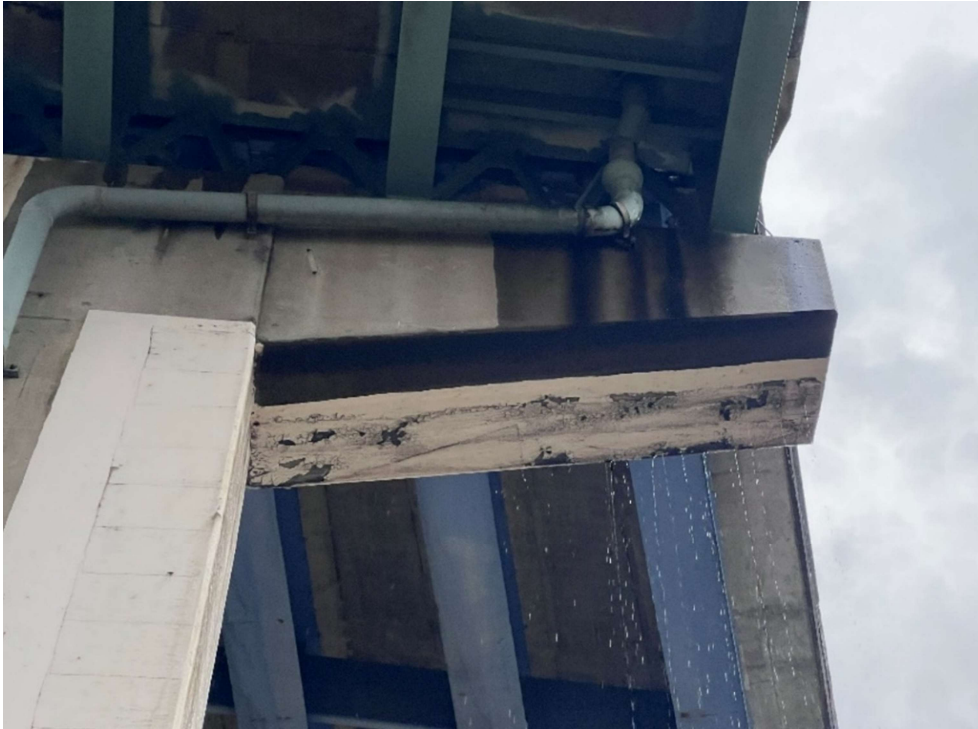
Photo 26- Drainage, Leaking on Substructure, Pier 25

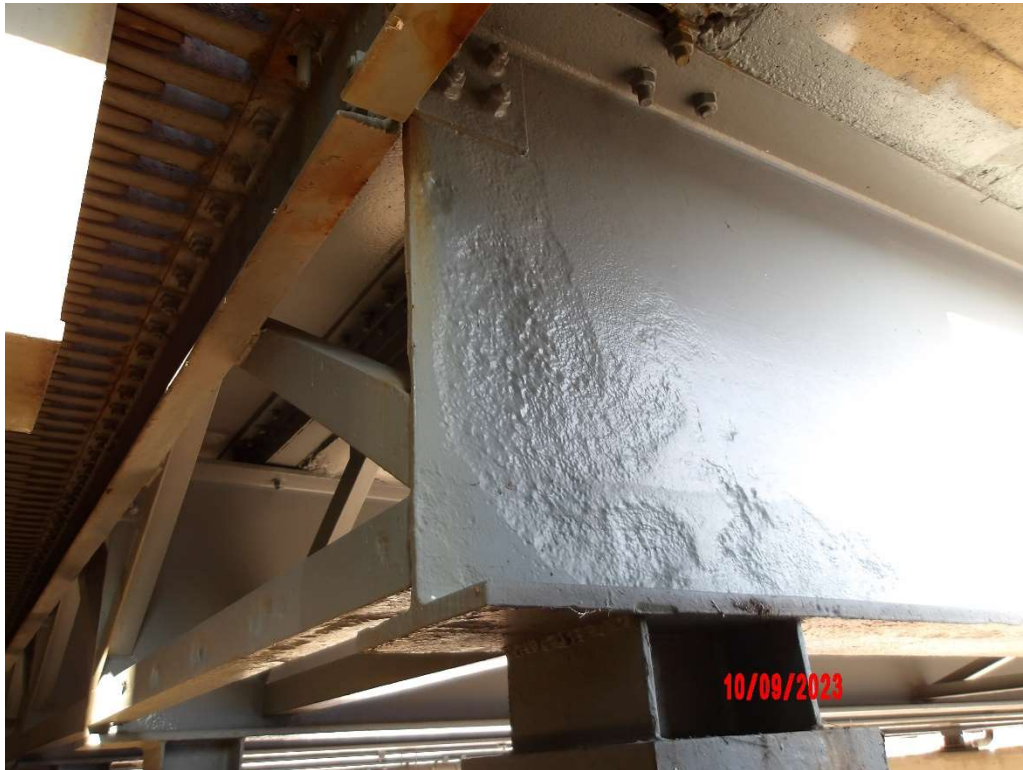
Photo 27- Girder A, Pier 0, Bottom Flange and Web, Up to 3/8" Section Loss, 9' L

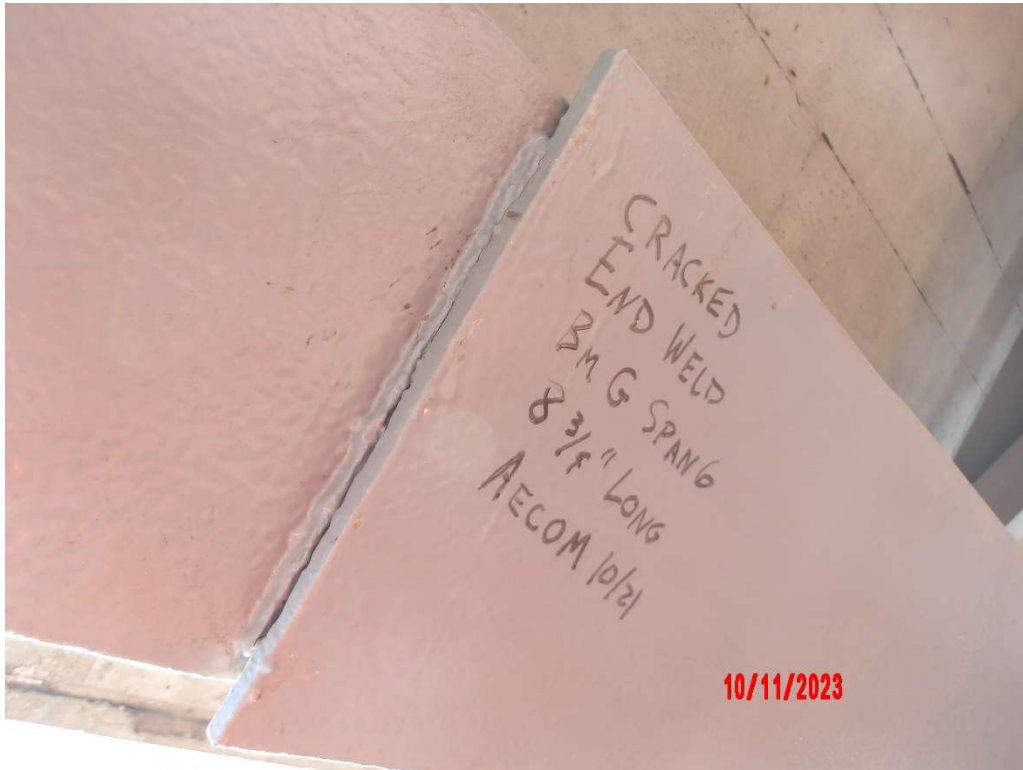
Photo 38- Girder G, Span 6, Completely Cracked End Weld on Bottom Flange

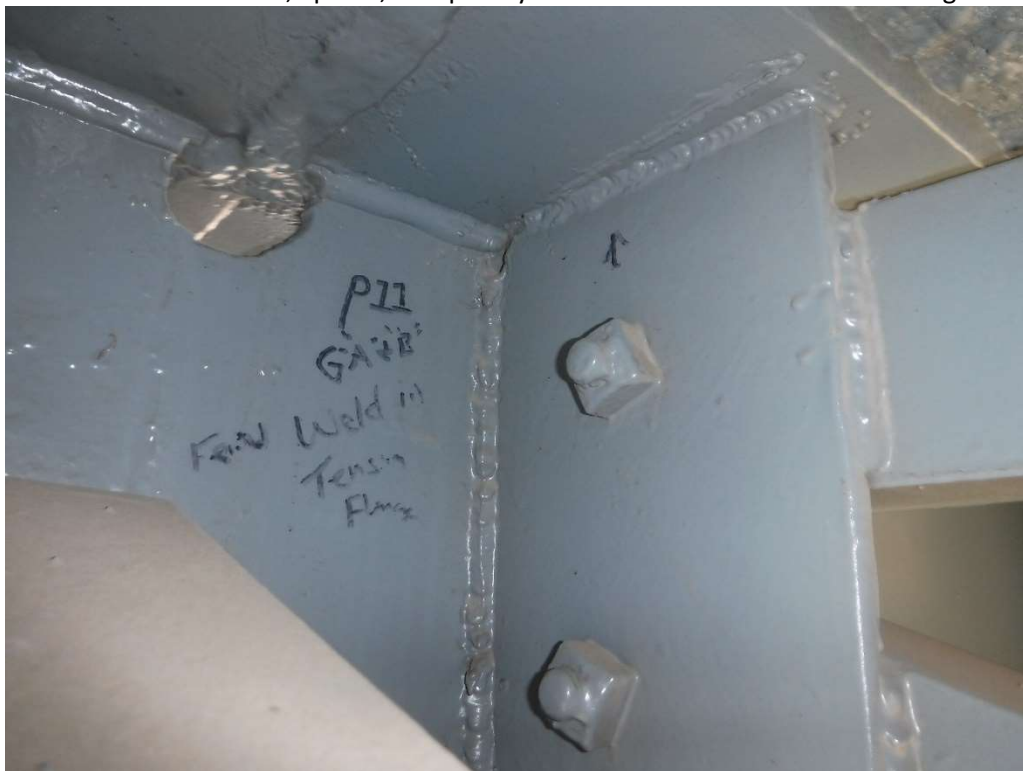
Photo 39- Girder A, Pier 11, Field Welds in Tension Flange

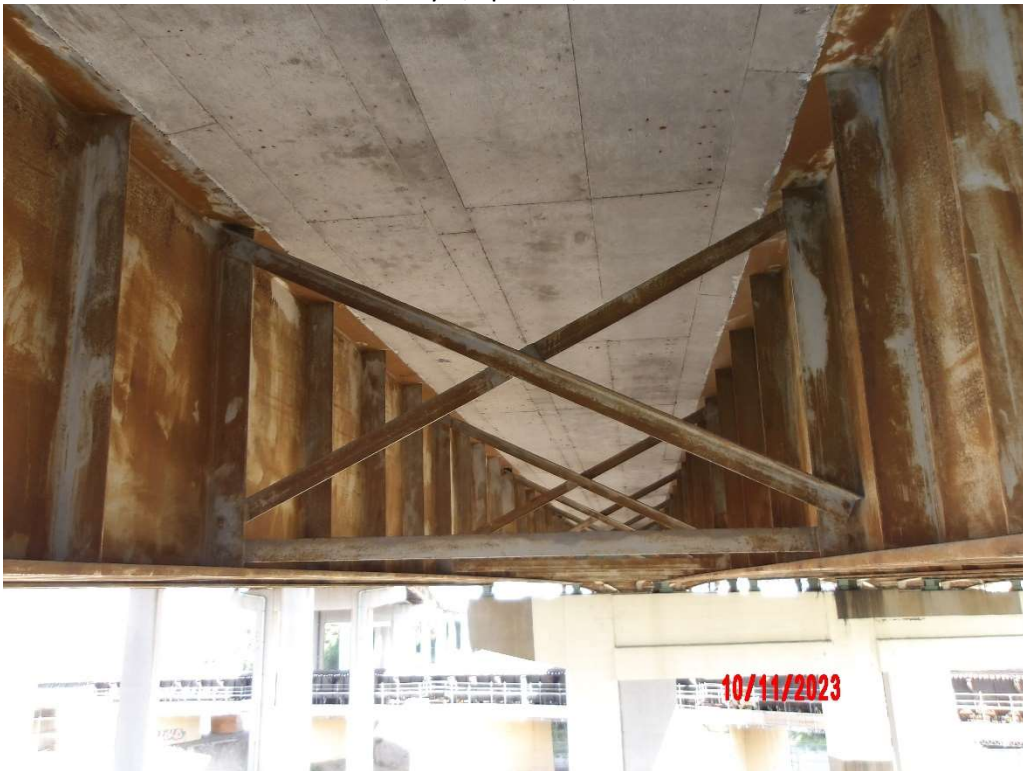
Photo 45- Span 15, Typical Condition, Paint Failure

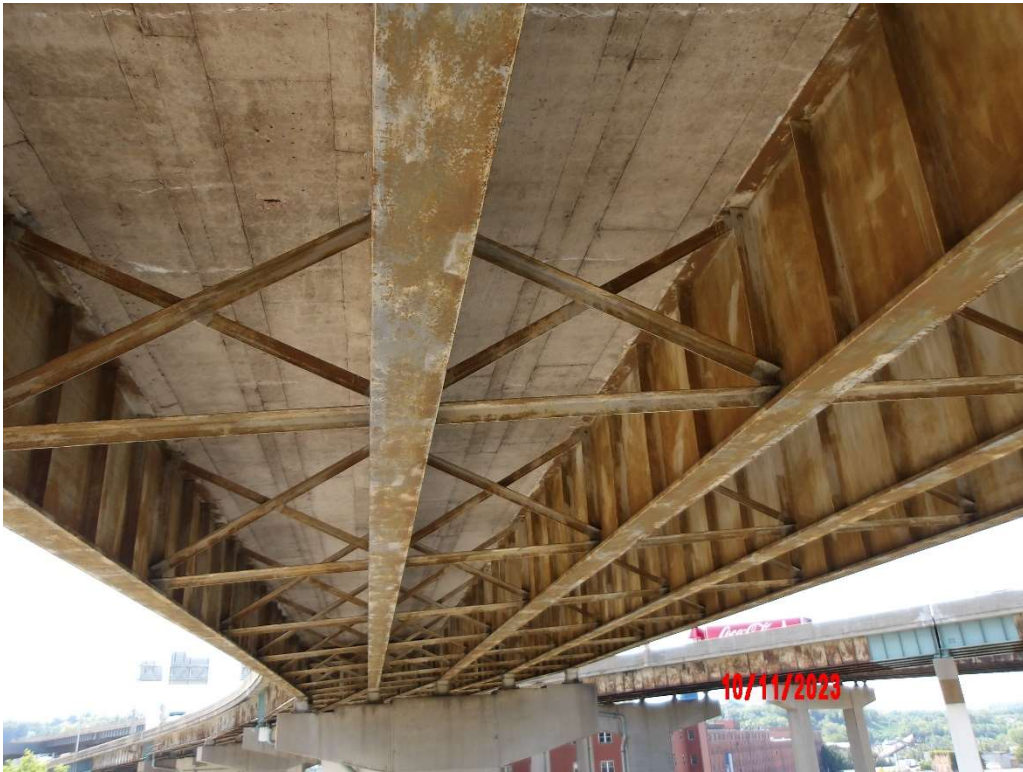
Photo 46- Span 19, Typical Condition, Paint Failure

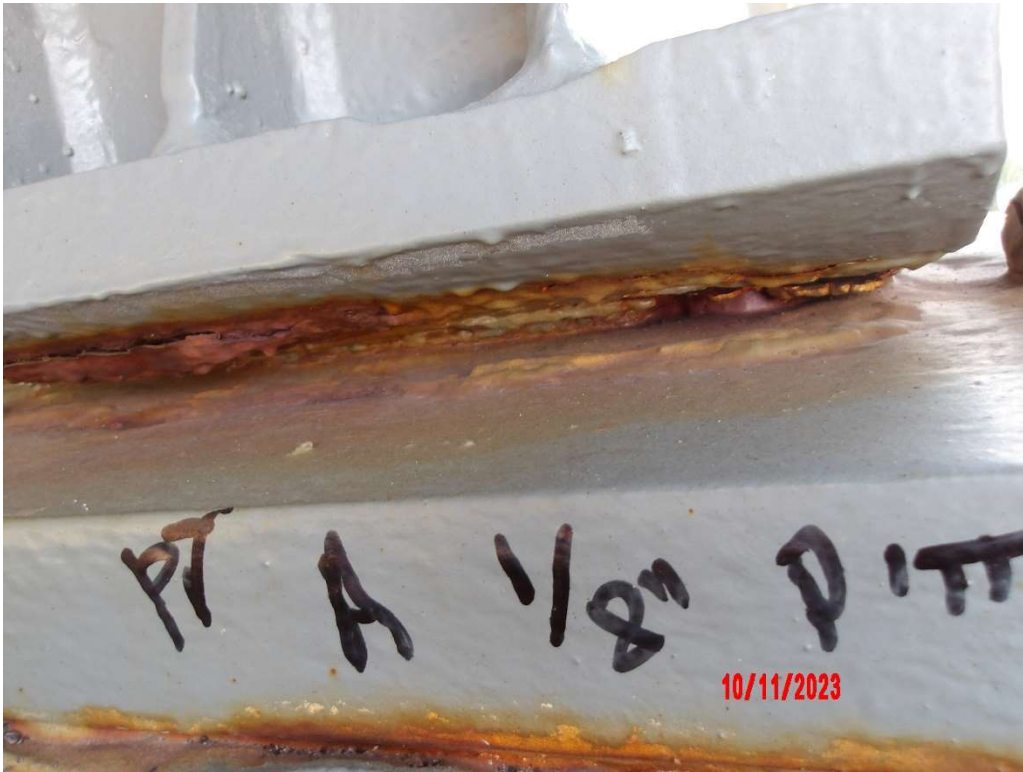
Photo 51- Pier 7 Bearing A, 1/8" Pitting

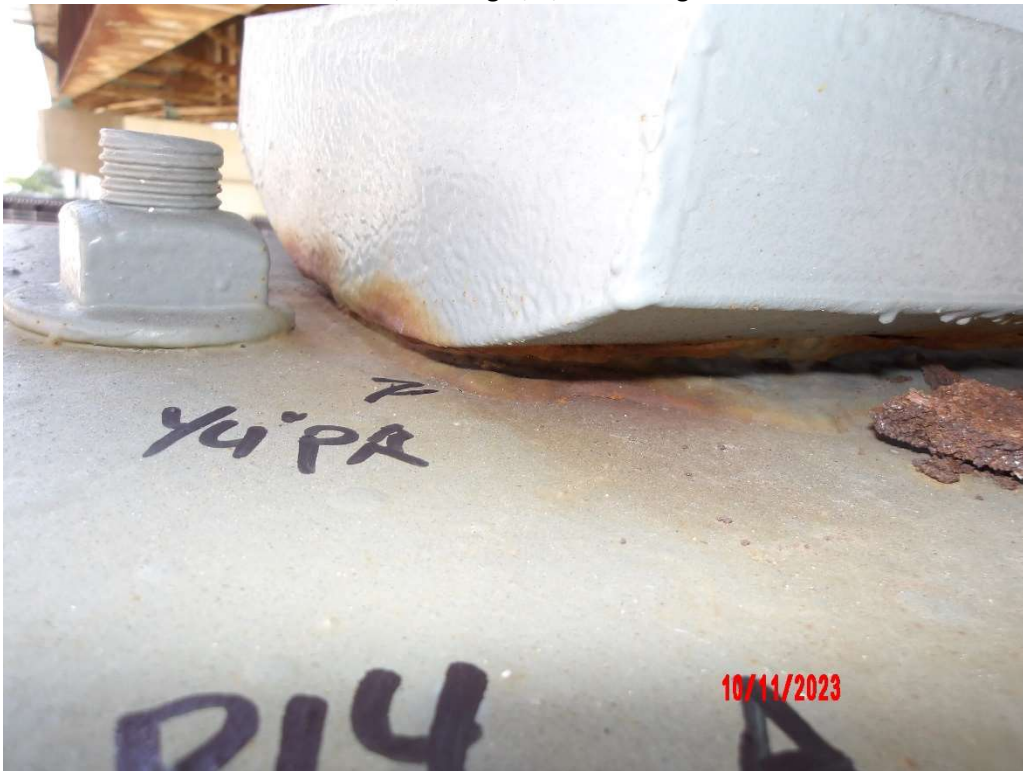
At Pier 14C, the previously noted pack rust between the rockers and the masonry plates has been blasted away, and all 14 bearings exhibit pitting. The Girders B and C bearings have exposed pintles with a ½" gap between rockers and masonry plates, indicating the bearings could be resting on the pintles (See Photos 51). The rotation of the rockers varied from 1° to 7° and temperatures ranged from 50°F to 75°F (See Photo 56)

Photo 54- Pier 14, Bearing A, 1/4" Pack Rust

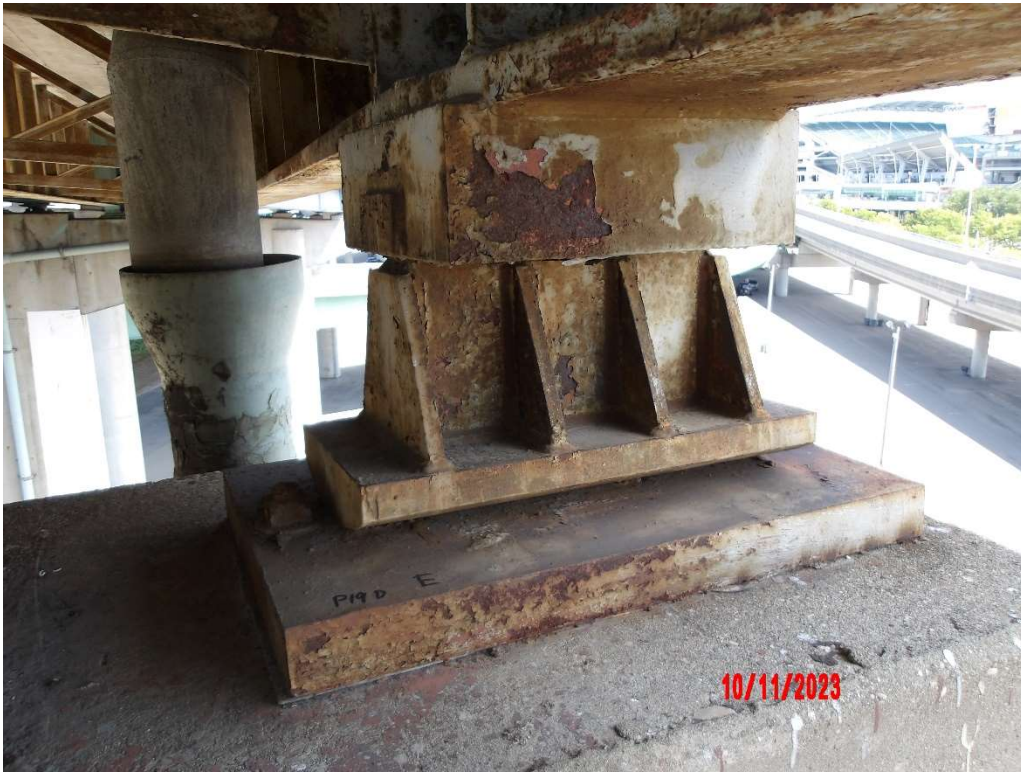
Photo 55- Pier 19D, Bearing E, Minor Corrosion

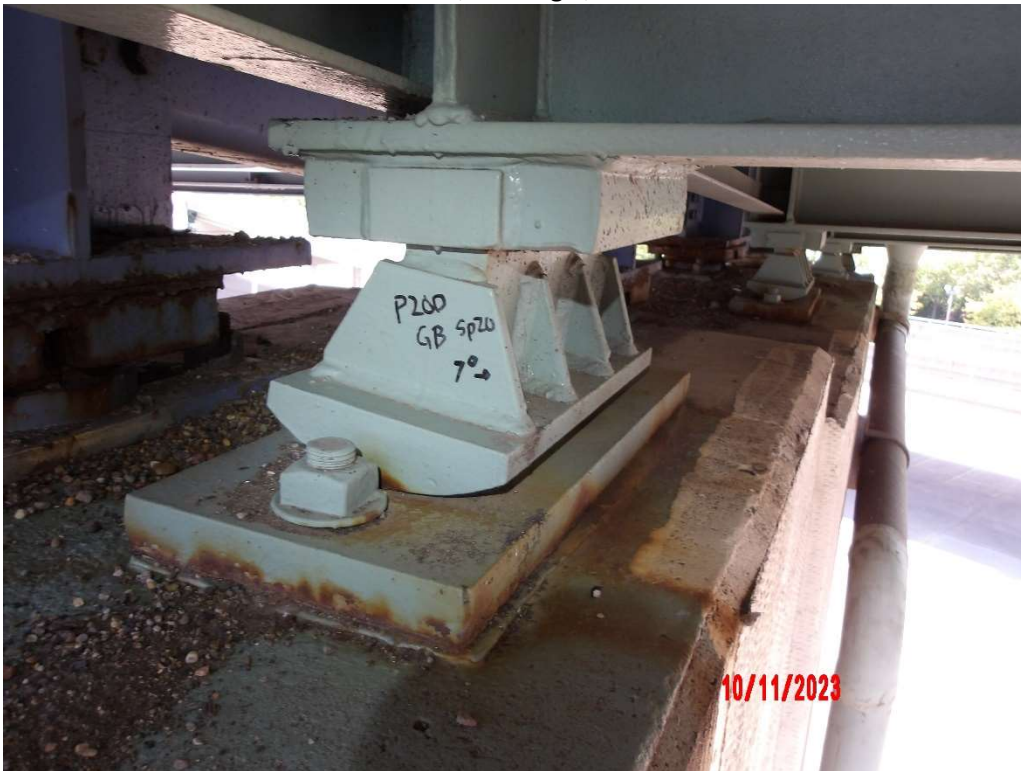
Photo 56- Pier 20D, Bearing B, Span 20, 7 degree in contraction.

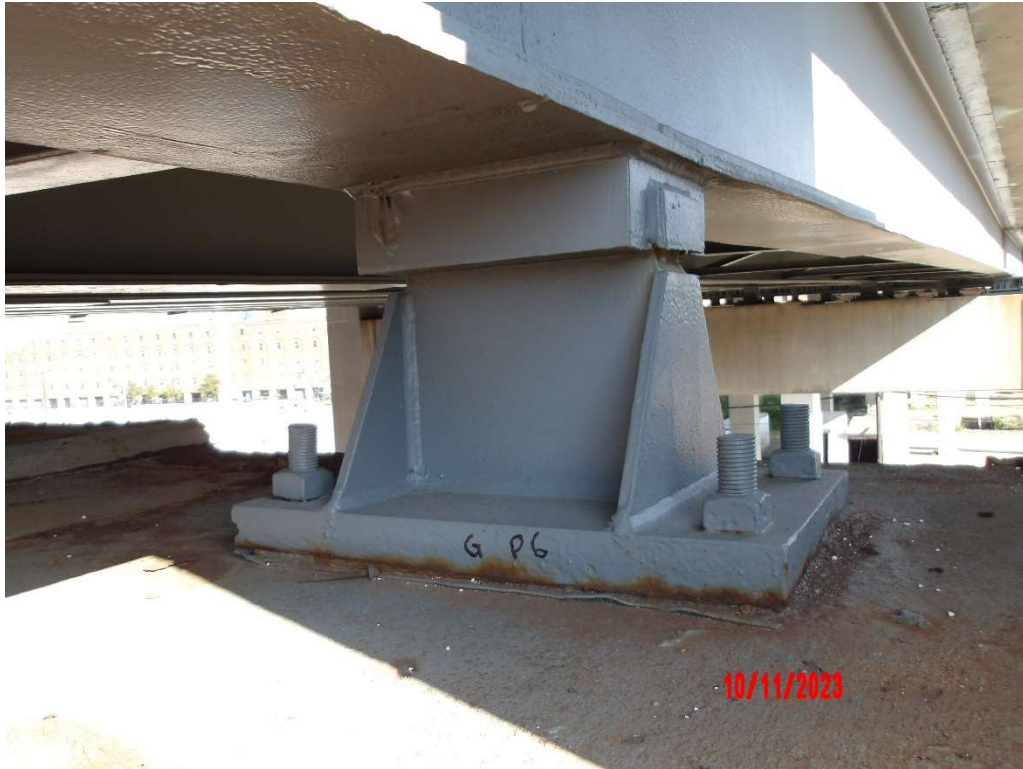
The Fixed Bearings are in SATISFACTORY (6) condition overall. The fixed bearings south of Pier 14C were painted as part of the 2021 paint contract. The remaining steel fixed bearings typically exhibit paint failure and moderate corrosion throughout. The fixed bearings at Pier 13C for Girders 8, C, D, and E have loose anchor nuts. (See Photo 58) Girder G fixed bearing at Pier 6A in Span 7A has pitting on the masonry plate. (See Photo 57)

Photo 57- Pier 6 Bearing G

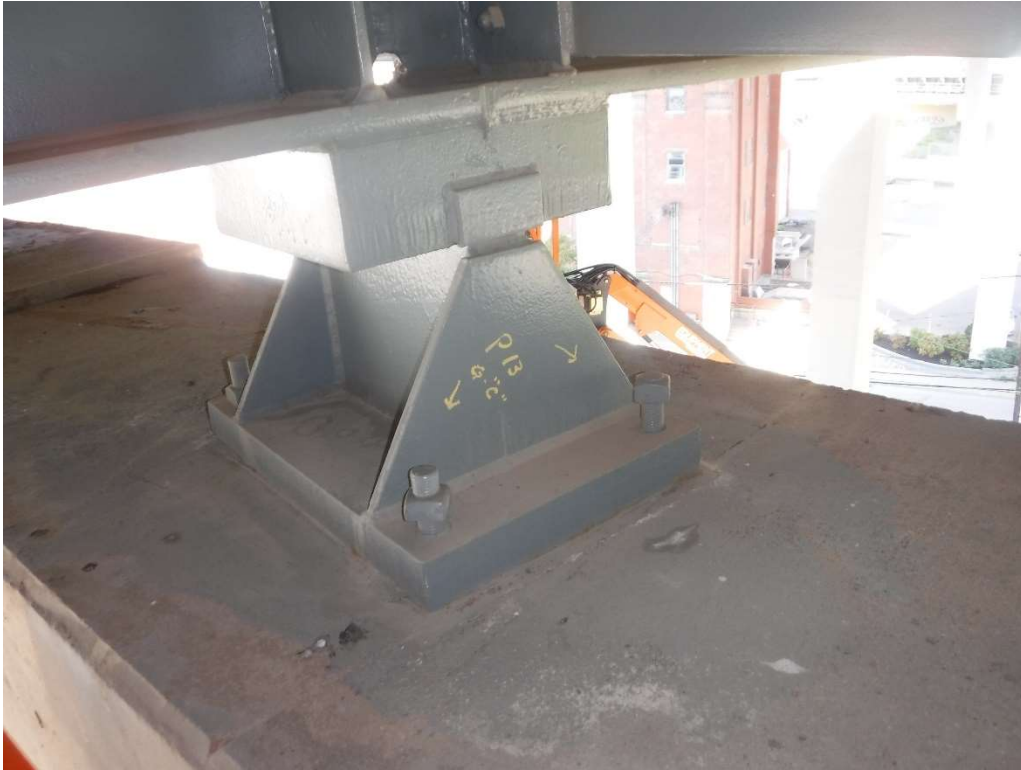
Photo 58- Pier 13, Bearing C, Loose Anchor Bolts

- Tighten loose anchor bolts for Girders B, C, D, and E at Pier 13C.
- Replace leaking strip seal expansion joints at Piers 20D and Pier 5.

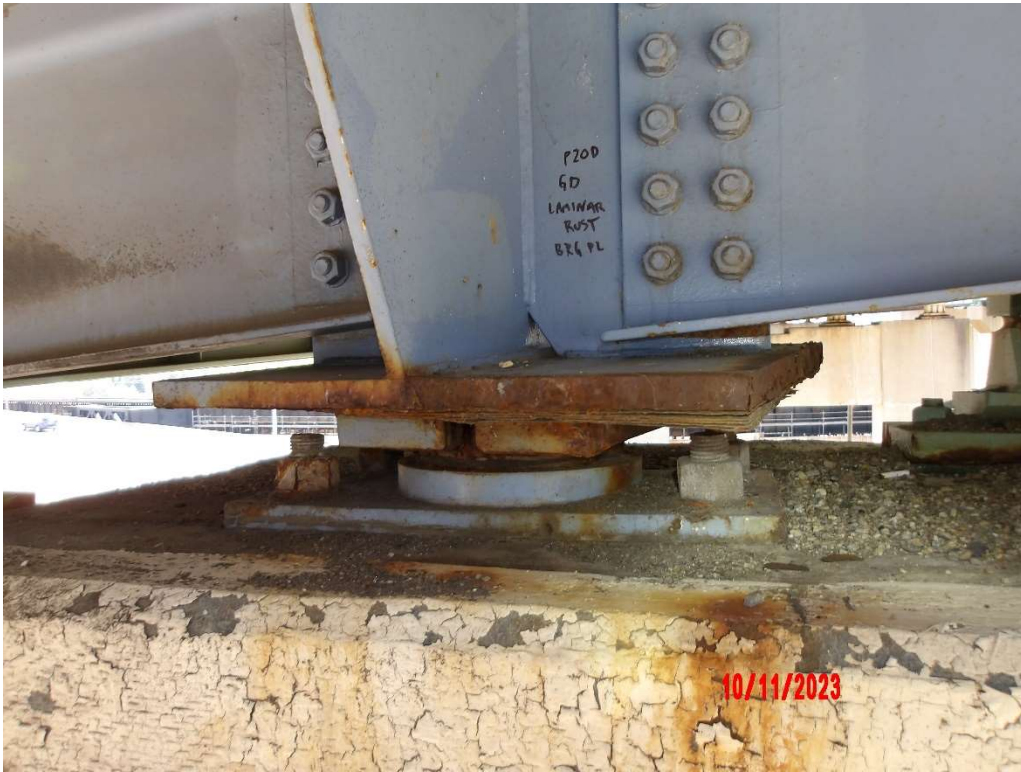
The Pot Bearings are in FAIR (5) condition overall. The reconstructed spans' pot bearings typically exhibit minor paint failure and moderate corrosion throughout. There are a few instances of elastomeric bulging or “walking out”. There is active corrosion with section loss of the anchor plates on the pot bearings for Girders B, C, D, E, and F at Pier 20D. (See Photo 60).

Photo 60- Pier 20D, Bearing D, Typical Laminar Rust, 1/8" SL Bearing Plate

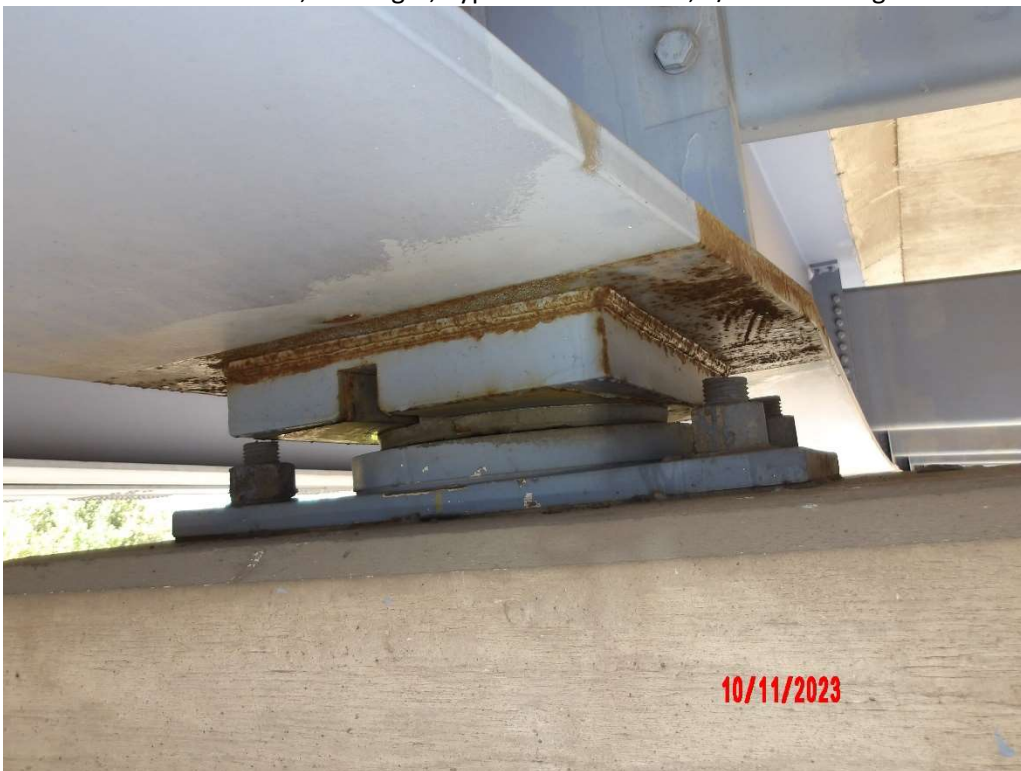
Photo 61- Pier 1C, Bearings Typical Freckled Rust

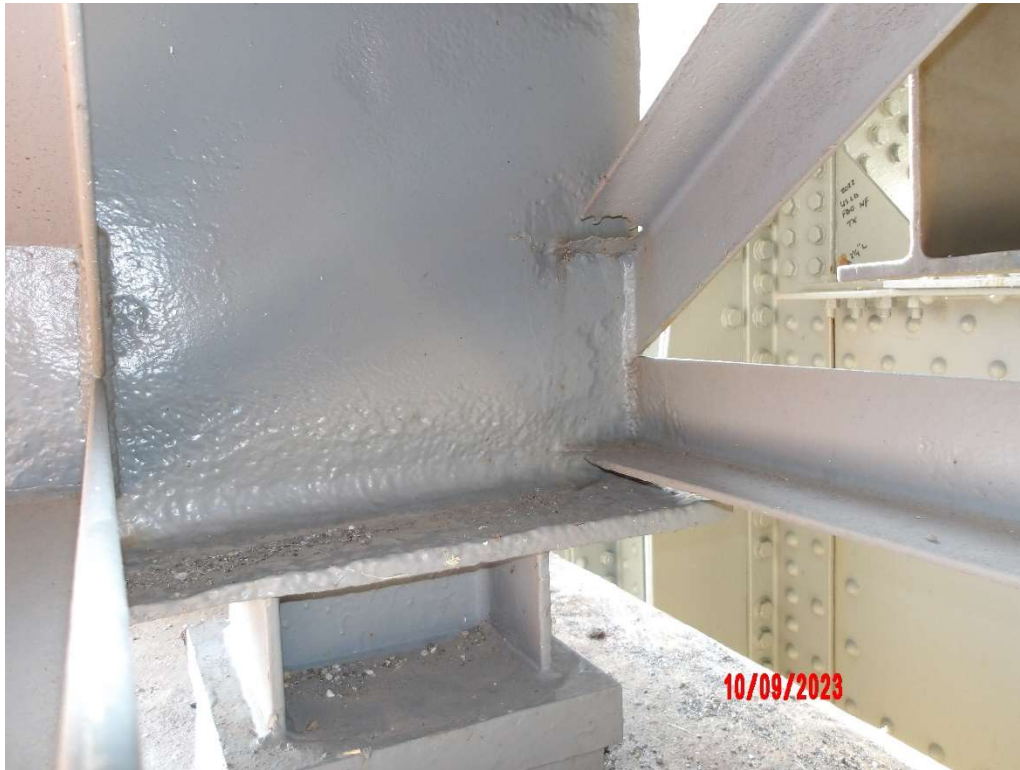
Photo 62- Cross Frames, Pier 0, Typical Section Loss

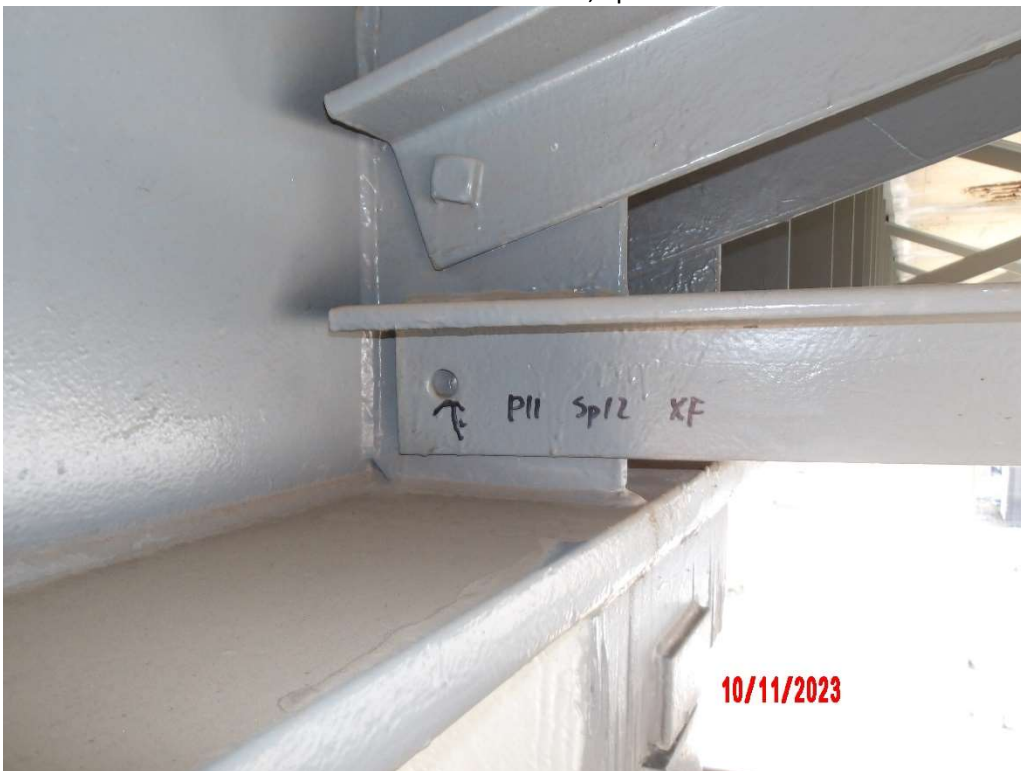
Photo 64- Cross Frame, Pier 11, Span 12, Typical Welded Details, Missing Bolts
