2023 IN-DEPTH INSPECTION REPORT
BRIDGE NO: HAM-71-0000R, SFN 3105970
VAR-DISTRICT 8 Bridge Inspections
Brent Spence Approach Bridges

Cincinnati, Ohio

September 11th – September 19th, 2023

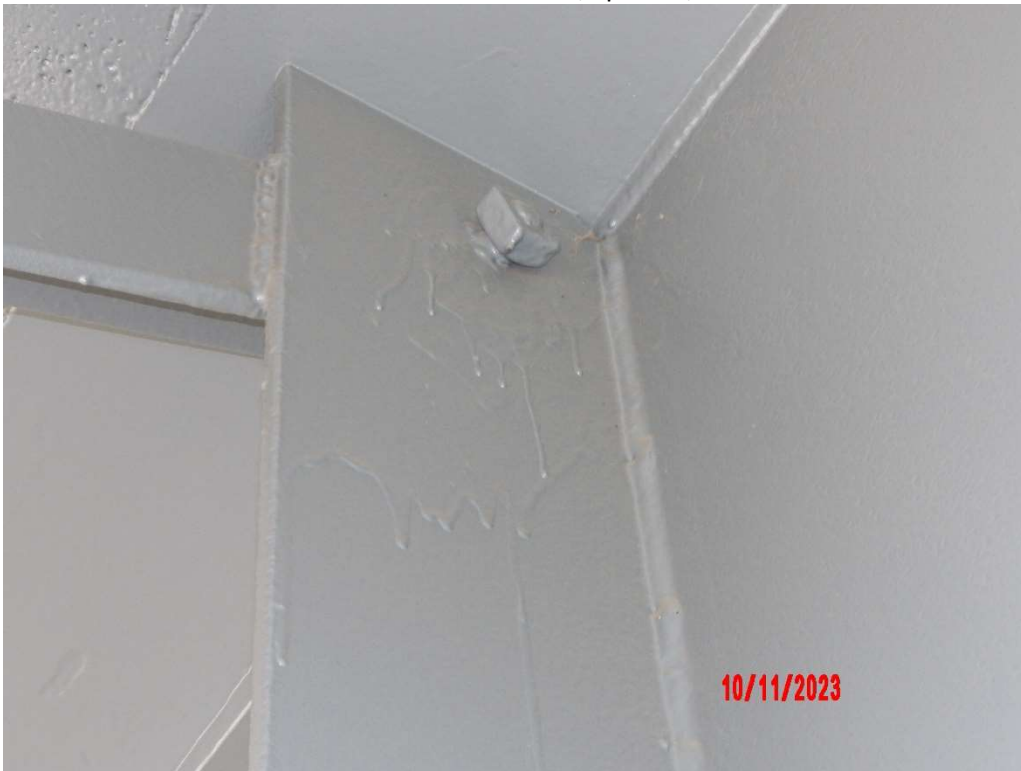
Photo 68- Cross Frame Loose Connection, Bay 6, Span 14

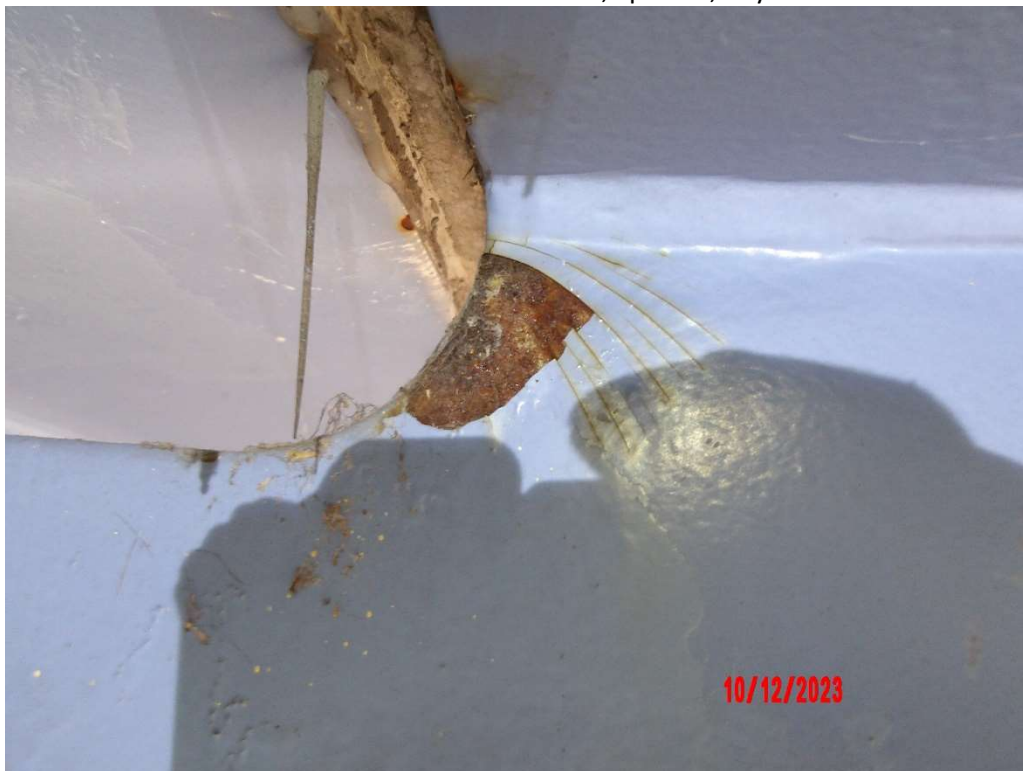
Photo 70- Cross Frame, Span 24, Bay 3, Coping Detail with Paint Cracking

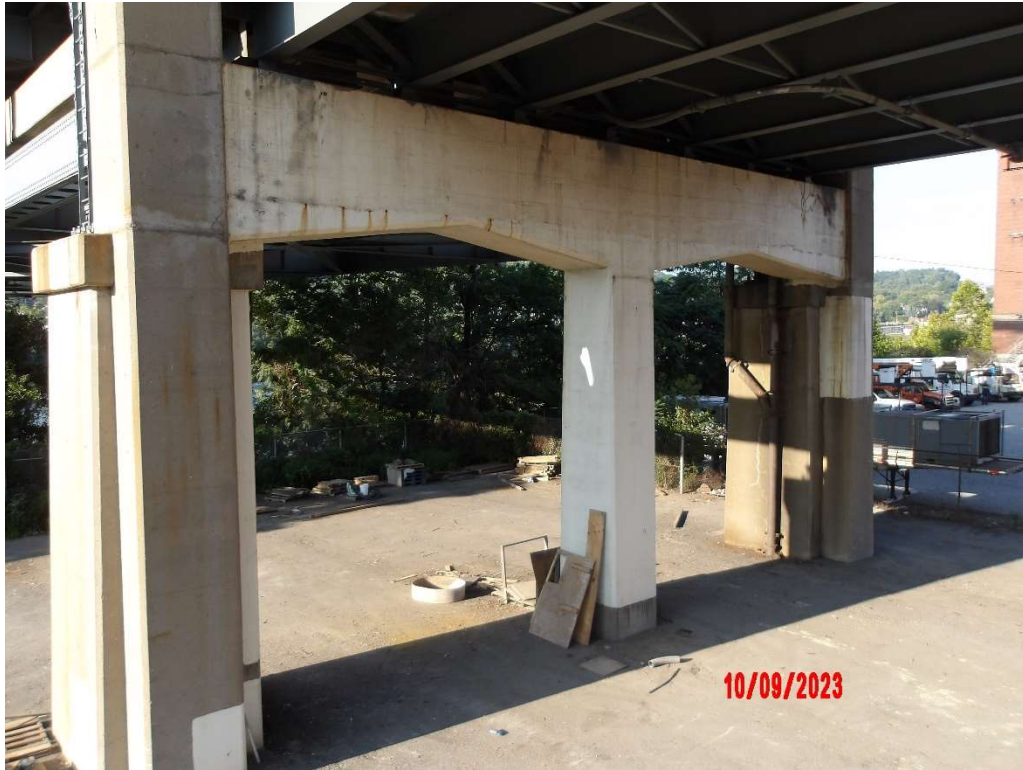
Photo 80- Pier 0, Front Face, FRP Wrap Delaminations and Staining

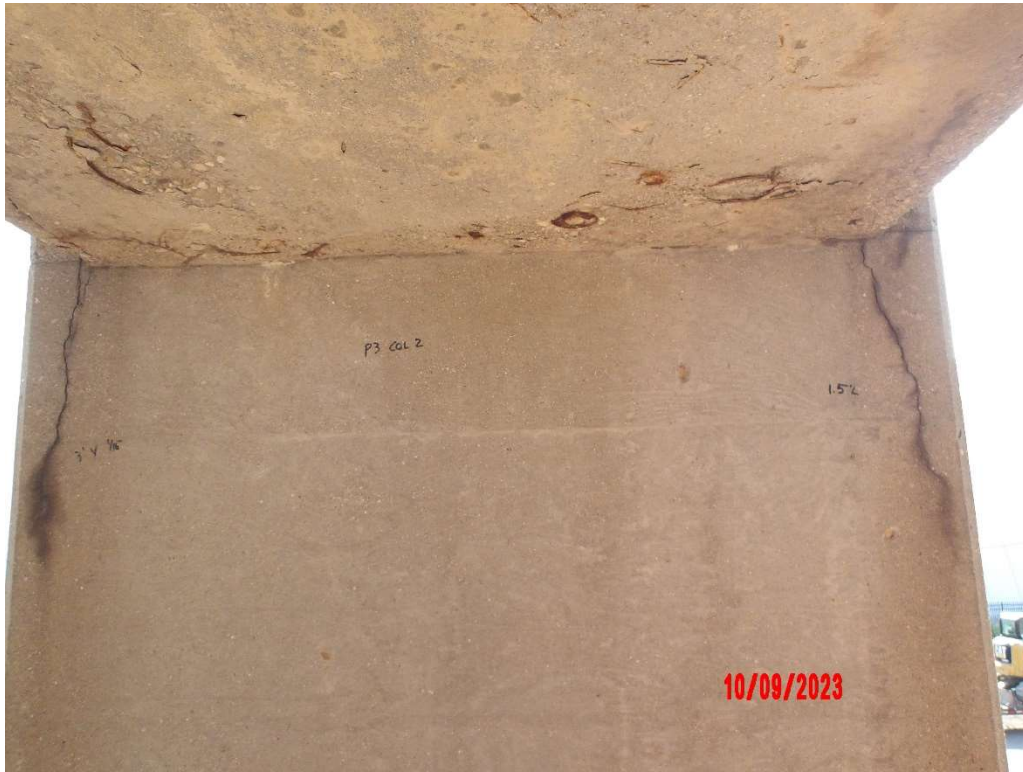
At Pier 1, west column, there is wide map cracking 53” vertical x 6” wide at the southeast corner. There are various other small spalls without any exposed reinforcing mainly on the corners including Piers 1A, 5A, 6A, and 19D. There is also moderate cracking and exposed rebar due to lack of cover common throughout. Pier 3, Column 2 has vertical cracking extending from the cap (See Photo 81)

Photo 81- Pier 3, Column 2, Vertical Cracking 3'x1/16"W and 1 1/2' x 1/16"W

- Patch concrete spalls and seal wide concrete cracks on pier caps and pier columns.
- Clean Repair broken ground wire on Pier 13.

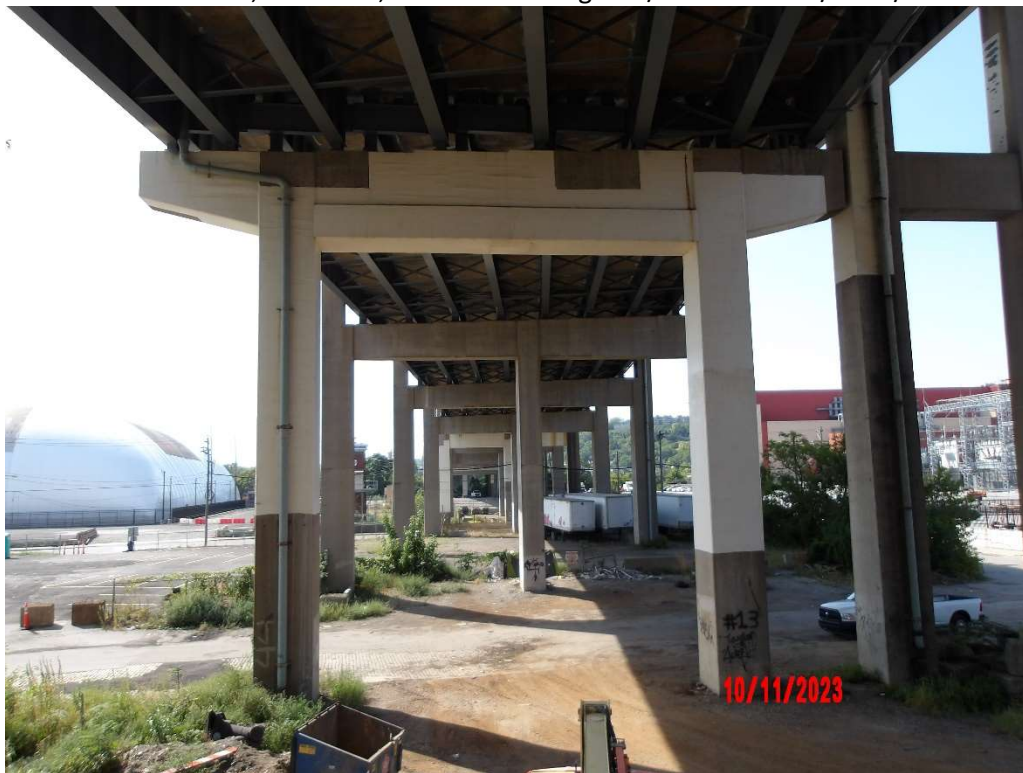
Photo 82- Pier 12 FF, FRP Wrap Delaminations

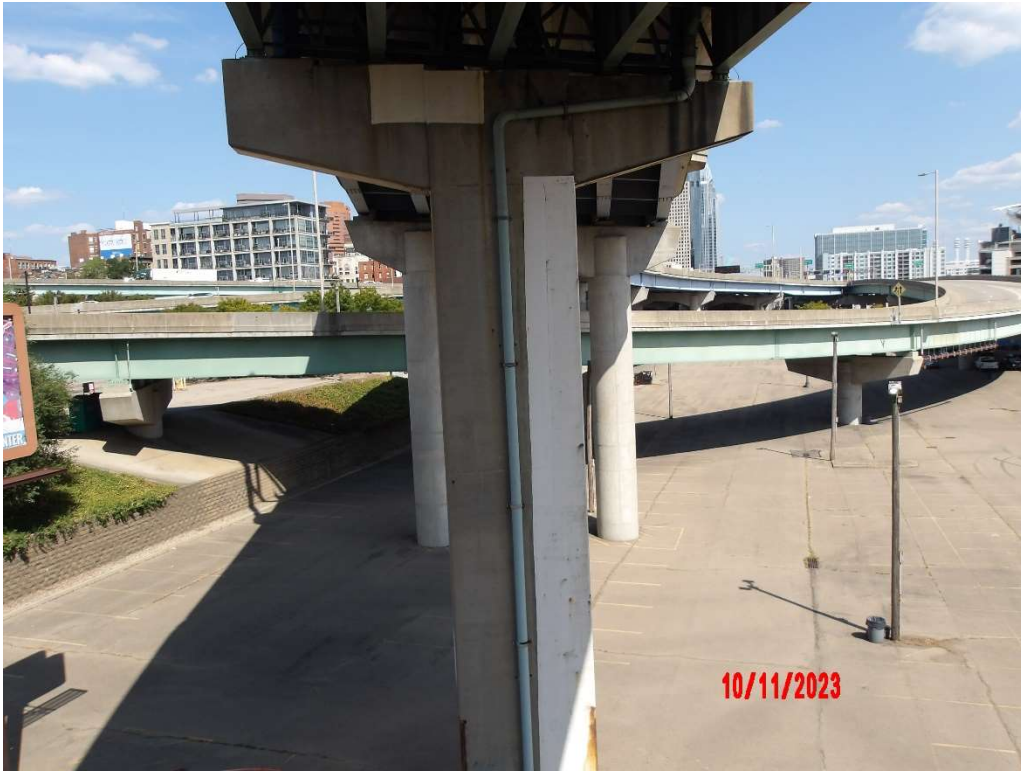
Photo 84- Pier 20D Back Face, Note FRP Wrap Delaminations

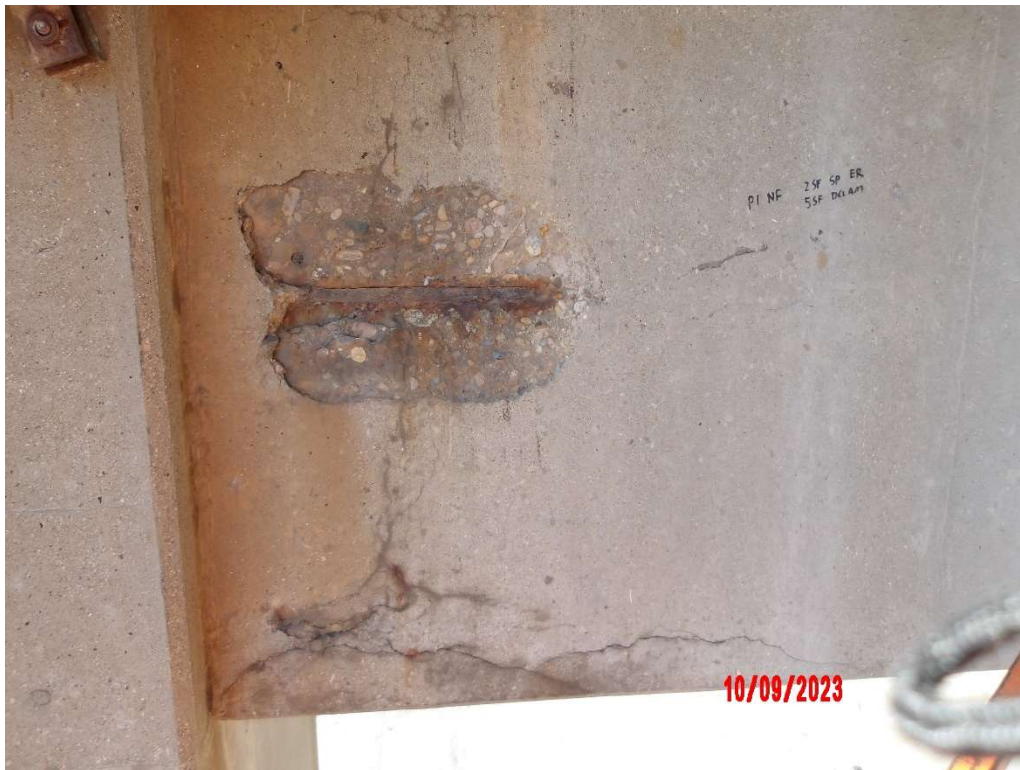
Photo 86- Pier 1, North Face Cap, Spall 2SF, Delaminations 5SF

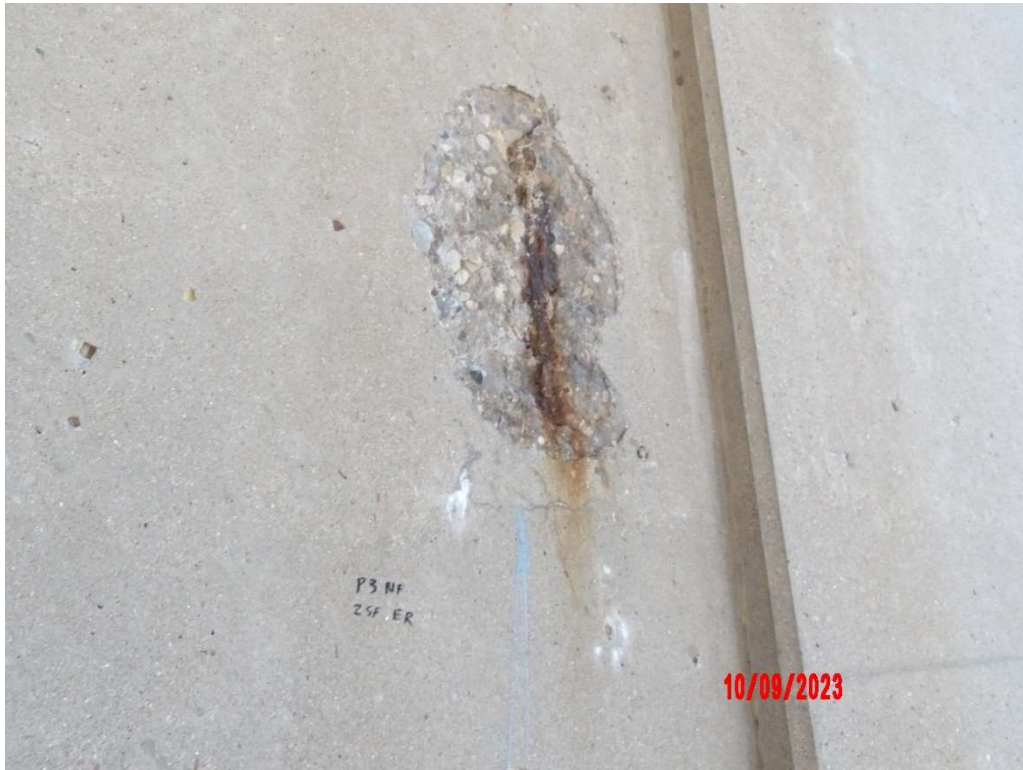
Photo 87- Pier 3, North Face Cap, 2 SF Spall with Exposed Rebar

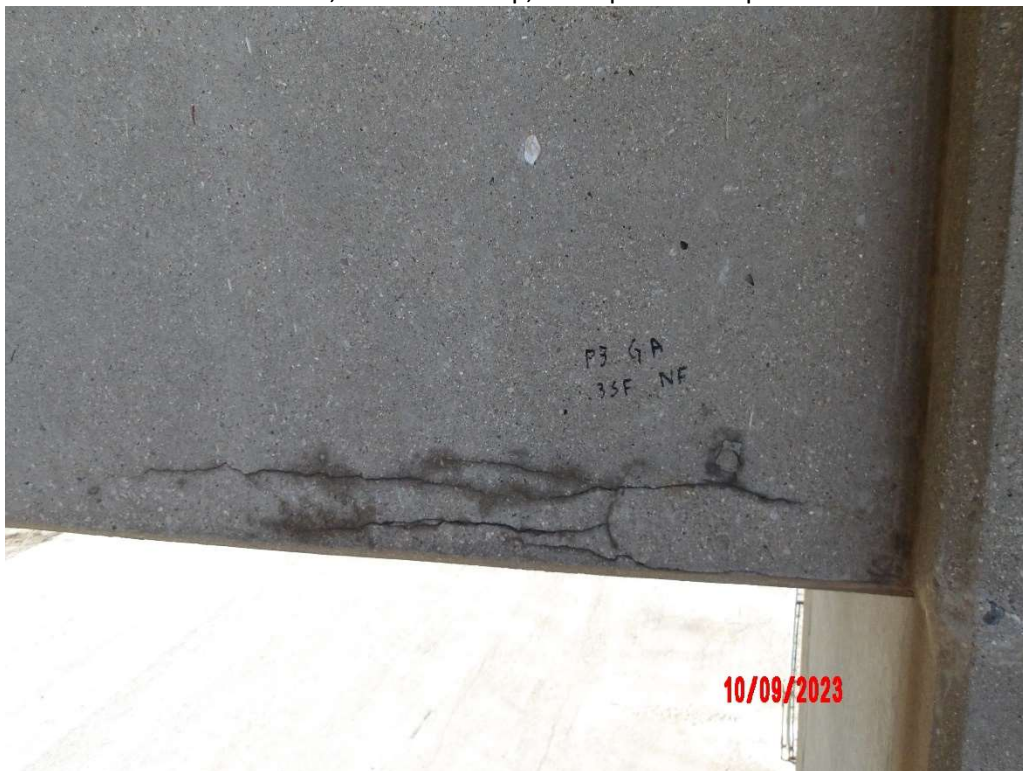
Photo 88- Pier 3, North Face Cap, 3 SF Delamination

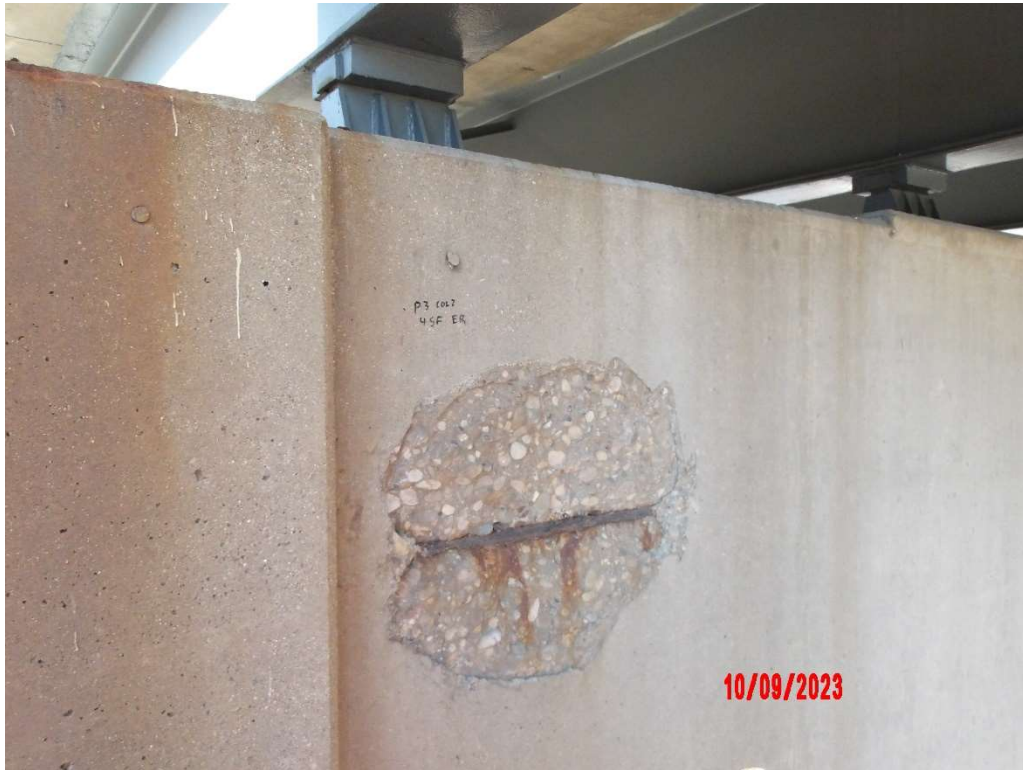
Photo 89- Pier 3, Column 2, 4 SF Spall with Exposed Rebar

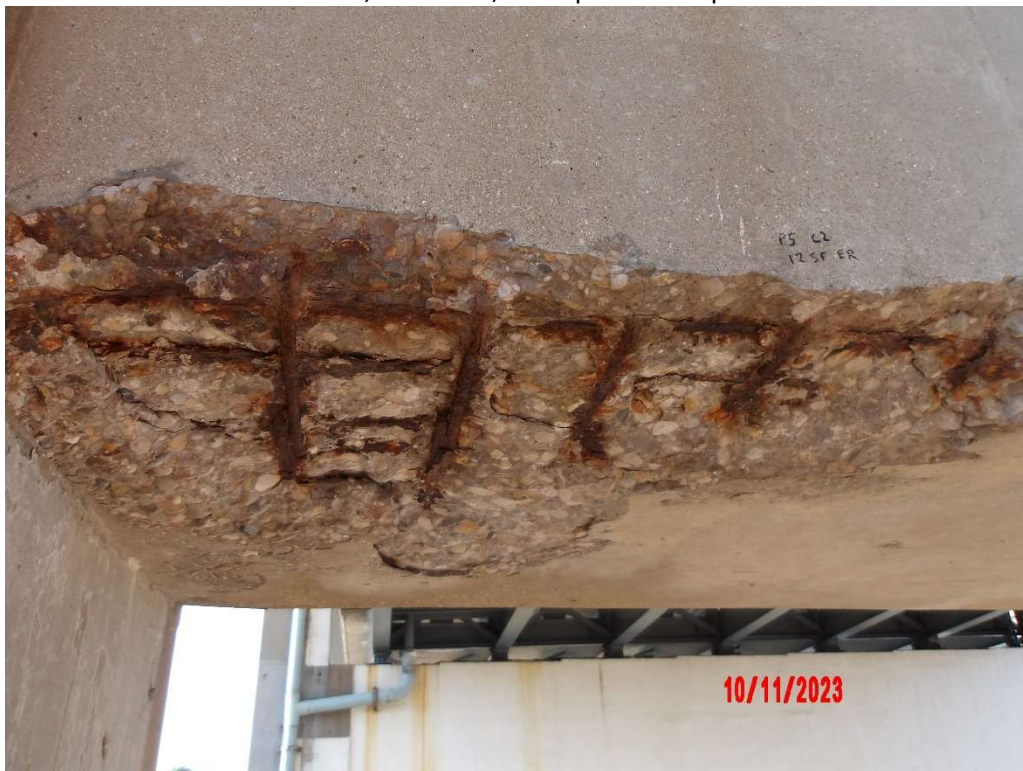
There is a heavy spall on Pier 5 cap on the pedestal for Girder 8, as well as wide cracking in Girder A Pedestal (for the bridge just north of Span 5) and on the east nose of the cap. There is also moderate width cracking above Column 2. The cap has debris and evidence of a leaking joint above.

Photo 90- Pier 5 Cap at Column 2, 12 SF Spall with Exposed Rebar

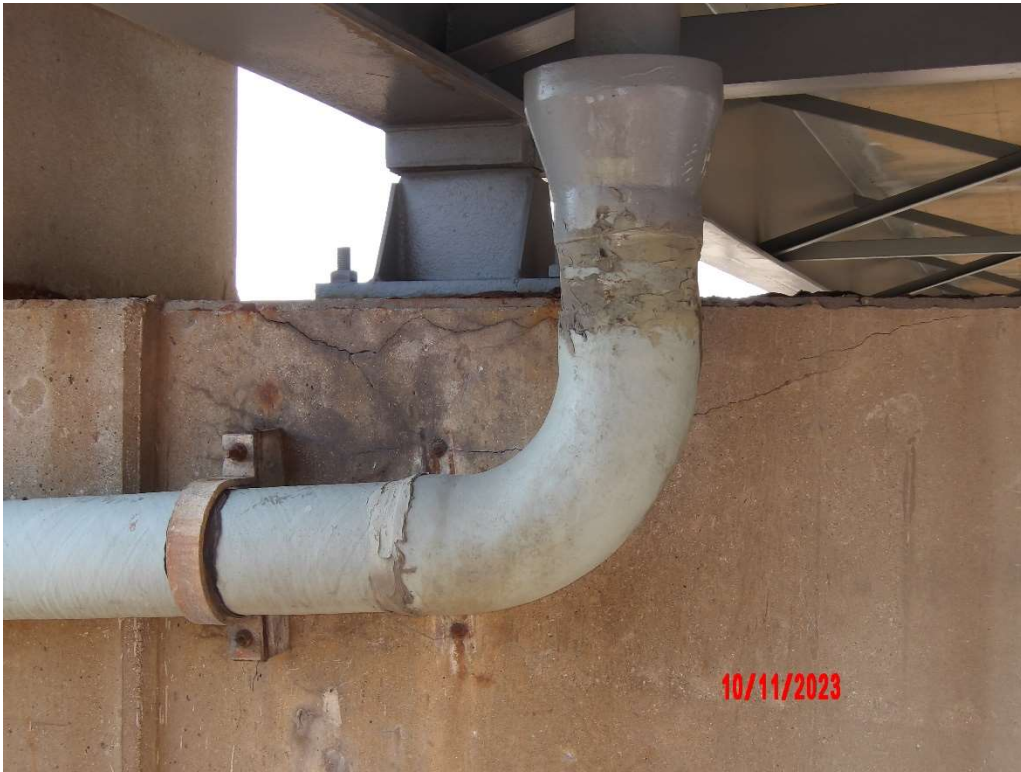
Photo 91- Pier 6, Cap North Face, 6 SF Cracking $\sim 1/32$ " Wide

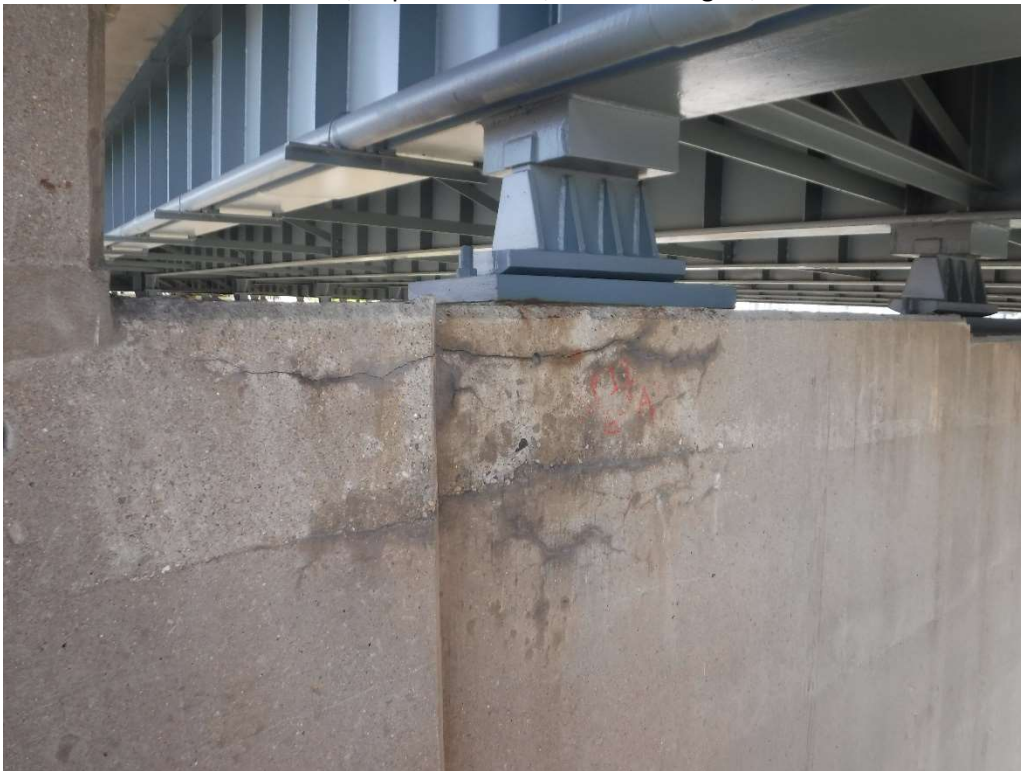
Photo 92- Pier 11, Girder A, Delamination 8 SF

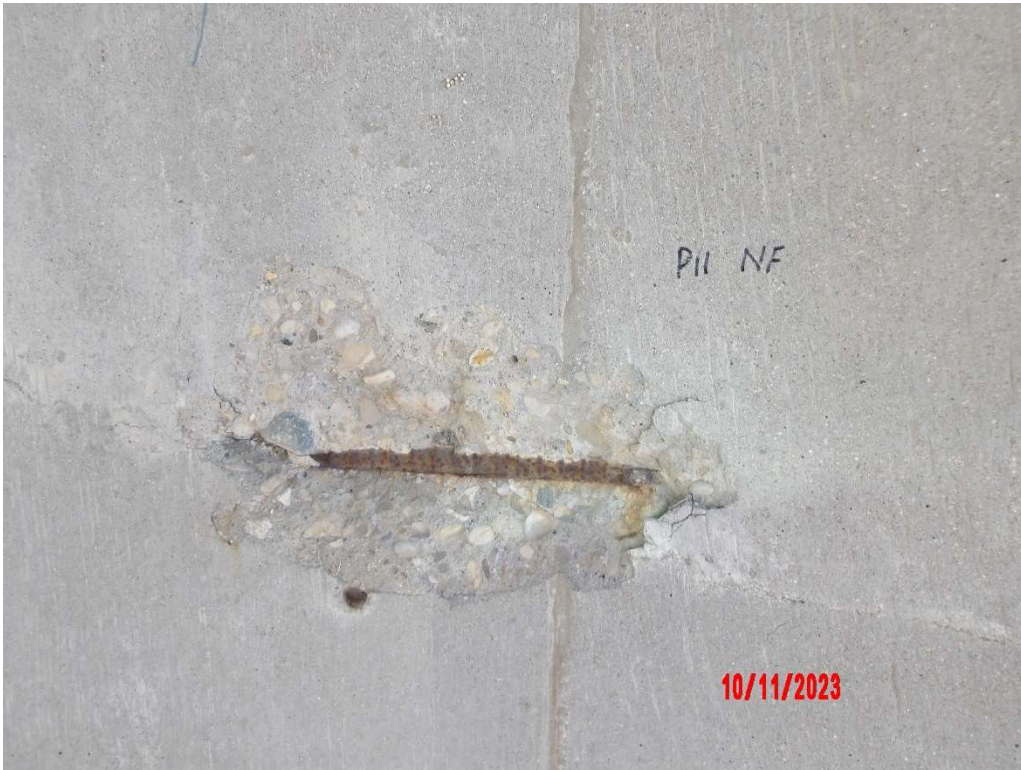
Photo 93- Pier 11, Northface of Cap, 2 SF Spall with Exposed Rebar

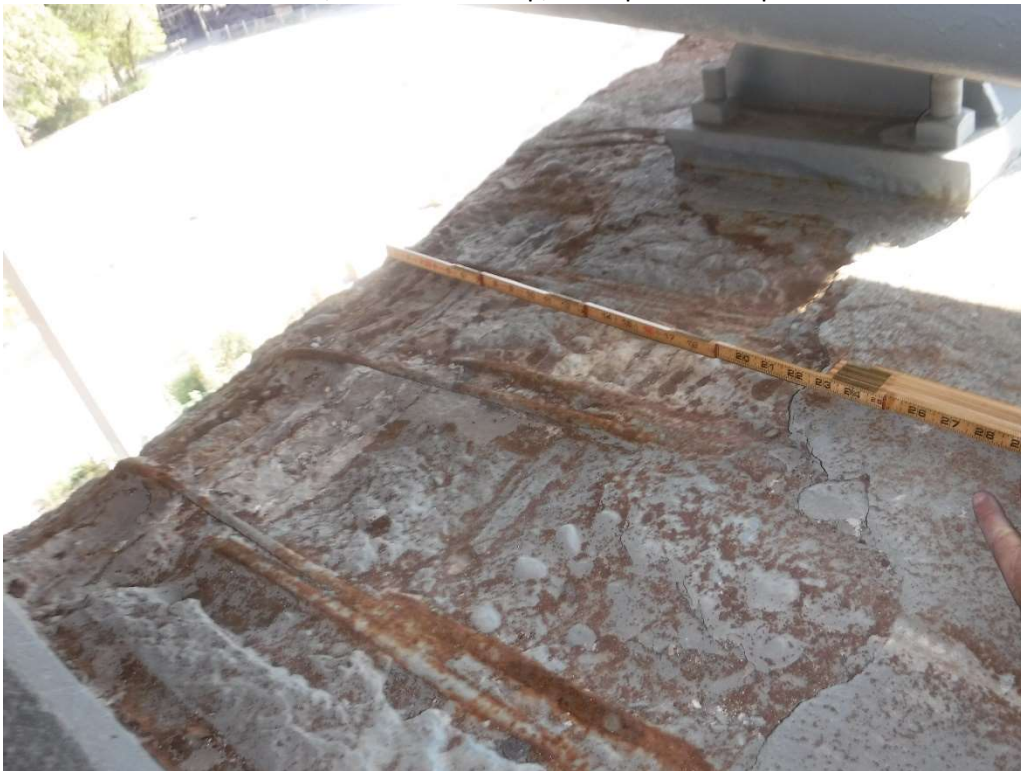
Photo 94- Pier 11, Top Cap, Near Girder H, Spalling with Exposed Rebar 14SF

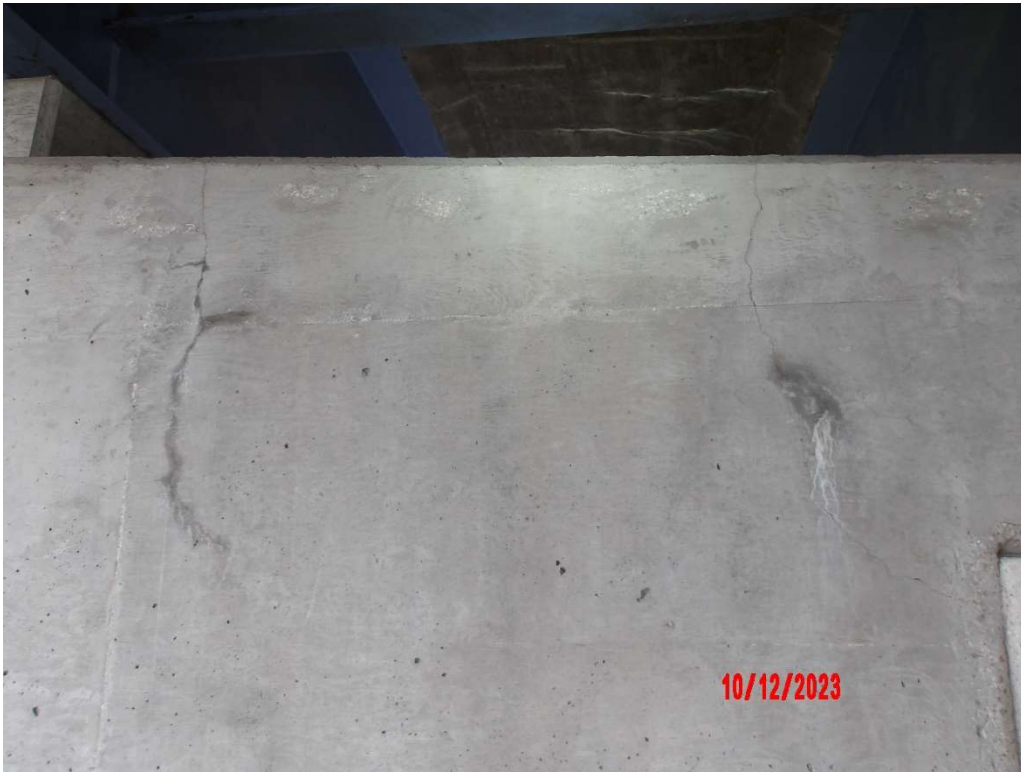
Photo 95- Pier 2C, Vertical Cracking 2' L at 2' Spacing

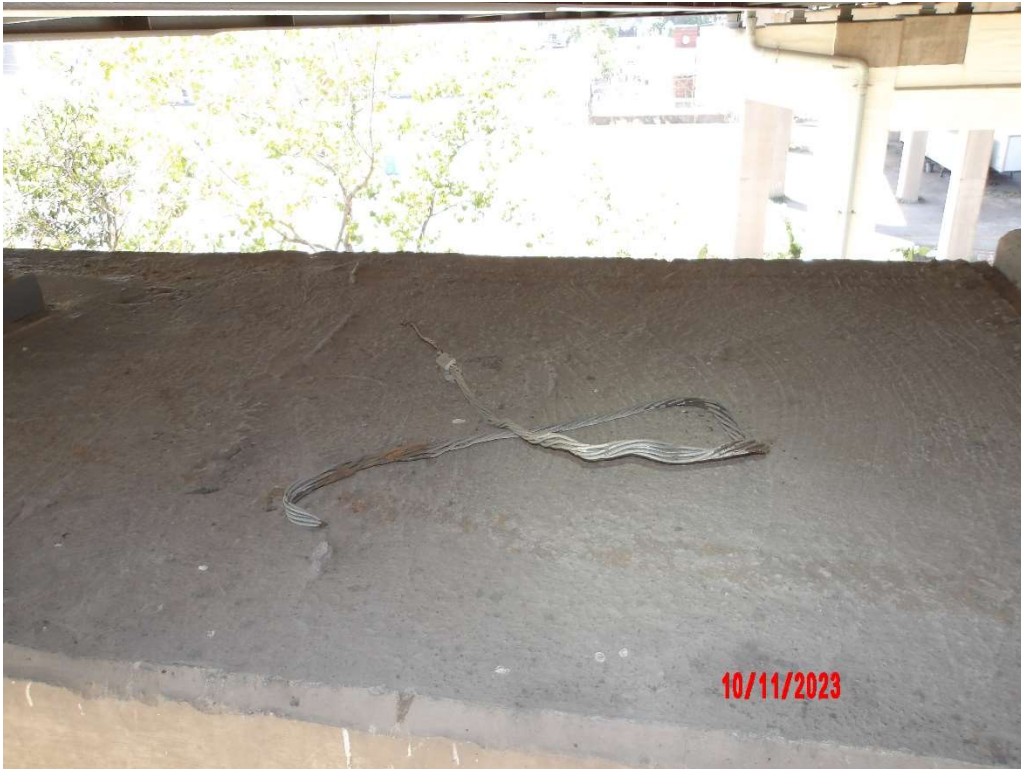
Photo 96- Disconnected Ground Wire on Pier 13

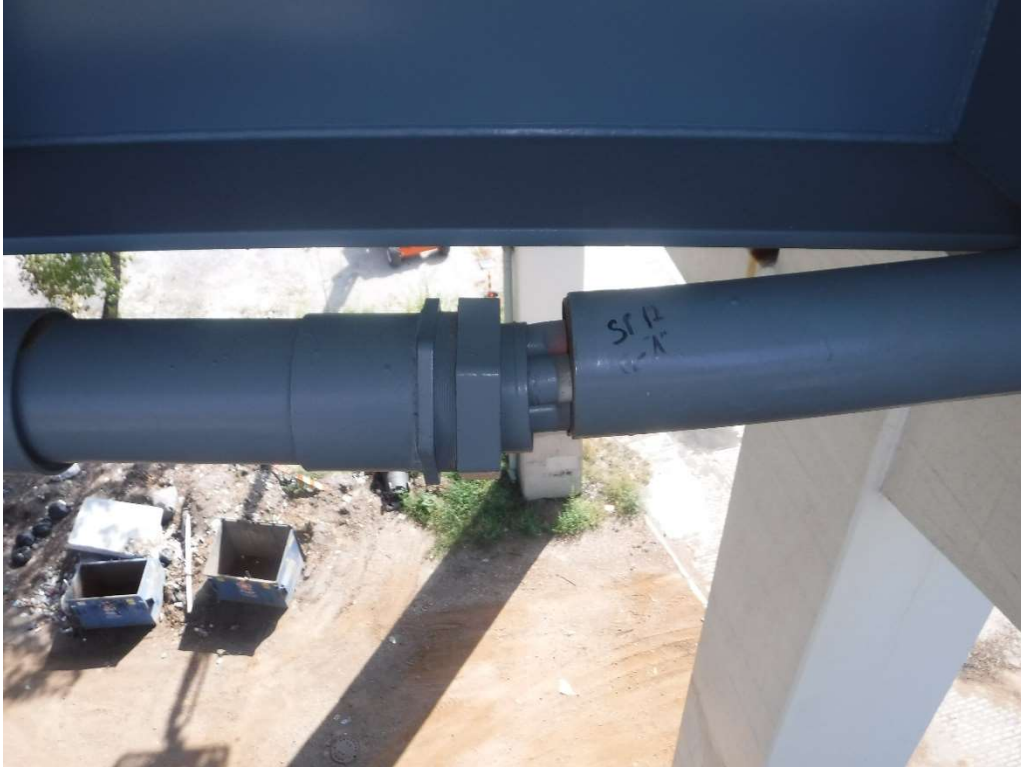
The utilities on the structure are in GOOD (7) condition. There is an electrical conduit that is attached to Girder A from the River Pier to Pier 13C that has been painted as a result of the 2021 paint contract. There is a lighting conduit attached to the girders in Span 16D. There are lighting conduits that extend from the ground to the superstructure on the outside columns of Pier 14C. The steel conduit near Pier 12C on the west overhang has an open joint (See Photo 99). There is light surface rust on the electrical junction box and the bracket that's attached to Girder A at Pier 13C.

Photo 99- Span 12, Conduit Broken under Girder A
