ODOT District 8  
2023 In-Depth Element Level  
Inspection Report

December 1, 2023

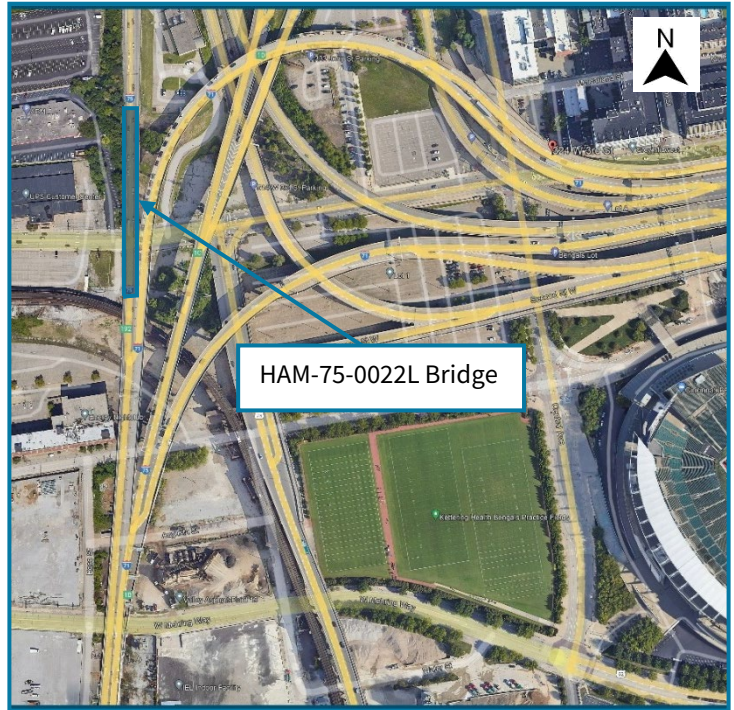
HAM-75-0022L (SFN 3108791) is a six-span structure that carries two lanes of I-75 southbound traffic over West 3rd Street in Cincinnati, Ohio, on the north approach of the Brent Spence bridge (see [Location Map](#)). The structure is 428.3' long, was constructed in 1963, and rehabilitated in 2017. It is a six-span structure consisting of a variable-width reinforced concrete deck on five continuous steel plate girders supported by reinforced concrete substructure units. The substructure consists of six cap-and-column reinforced concrete piers and one reinforced concrete stub abutment. Steel cross frames are welded to the transverse stiffeners of the girders. Selected sheets from the design plans are attached in [Appendix B](#).

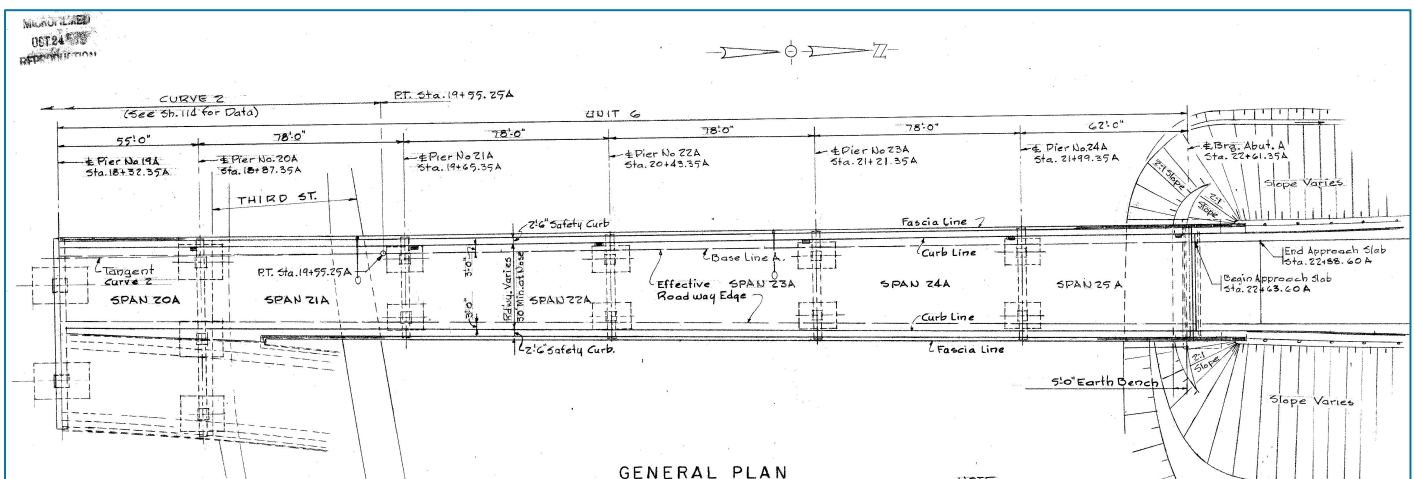
Figure 1 - HAM-75-0022L General Plan (taken from 1960 original plans)

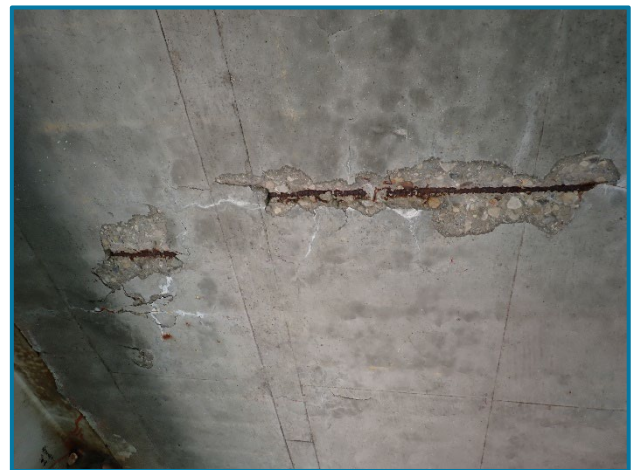
Photo 1 – Isolated delamination/spall with exposed reinforcement and adjacent typical hairline transverse cracks in the deck underside (looking up and south between Girders B and C in Span 23A).

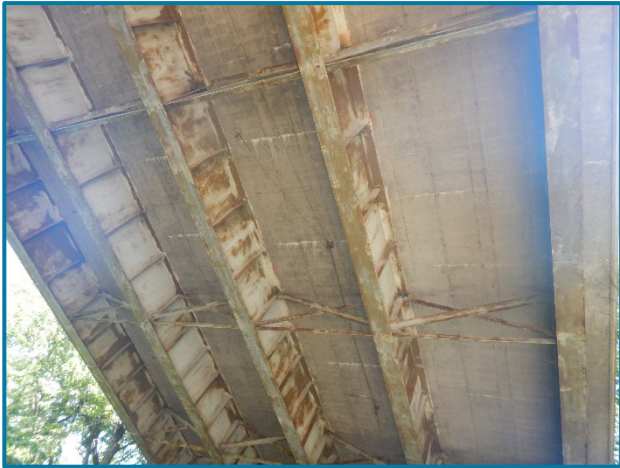
Photo 2 - Typical transverse cracks throughout the deck underside in the interior bays in Span 24A (looking northwest).

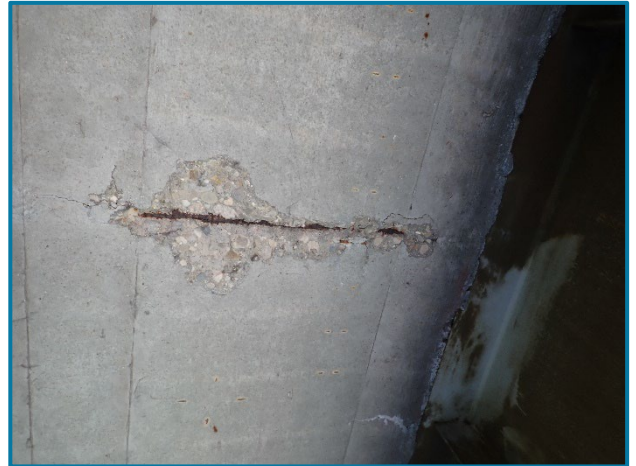
Photo 3 - 24" wide by 12" long by 1" deep spall with exposed reinforcement in the deck underside between Girders D and E in Span 24A (looking south).

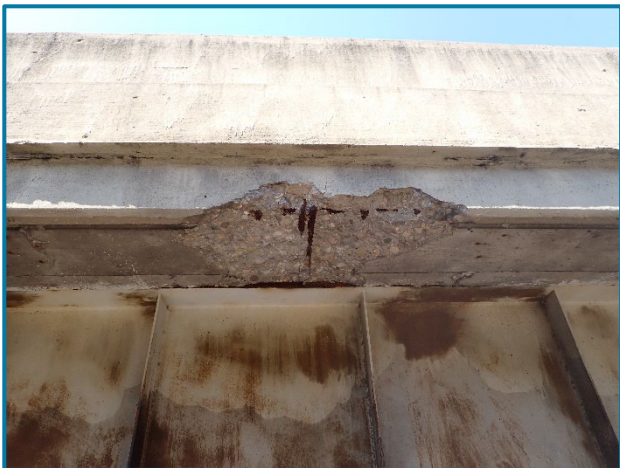
Photo 4 - 36" long by 24" wide by 4" deep spall with exposed reinforcement in the east overhang in Span 22A (looking west).

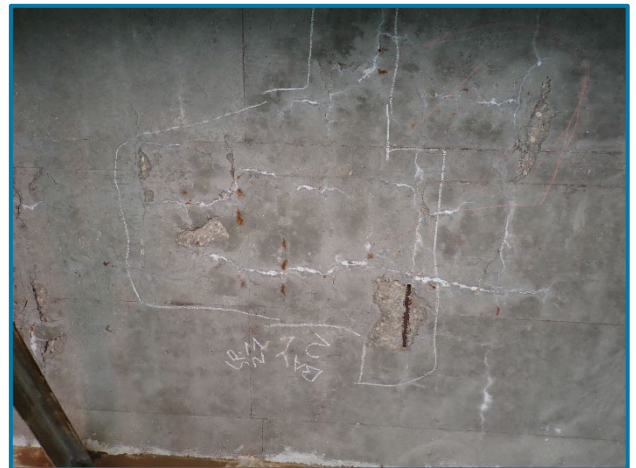
Photo 5 - 8' long by 8' wide by 1" deep spall with exposed reinforcement and surrounding delaminations in the deck underside between Girders B and C in Span 23A (looking south).

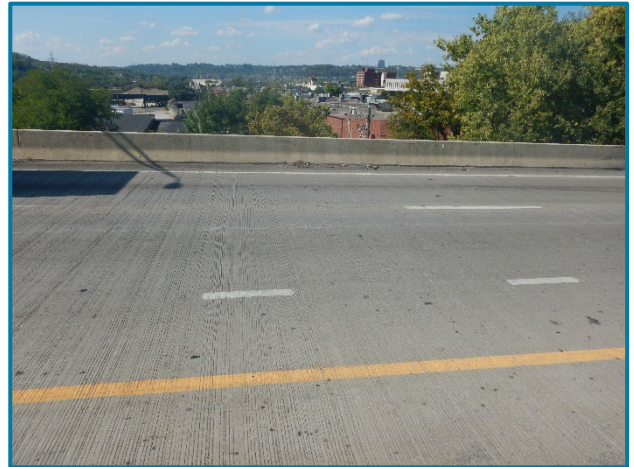
*Photo 6 – Typical wearing surface (looking west in Span 24A at midspan).*

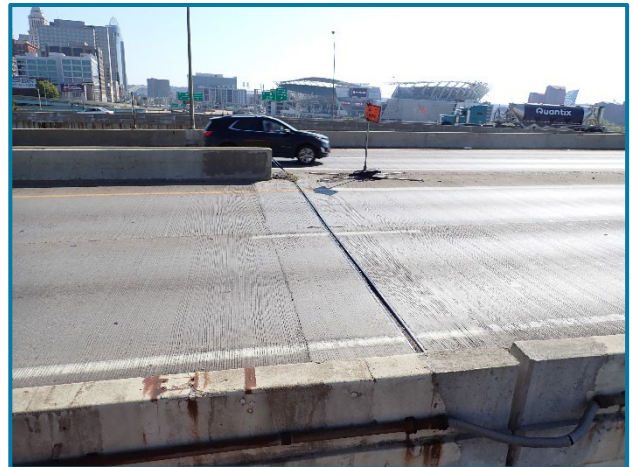
*Photo 7 – Typical expansion joint at Pier 19A (looking east).*

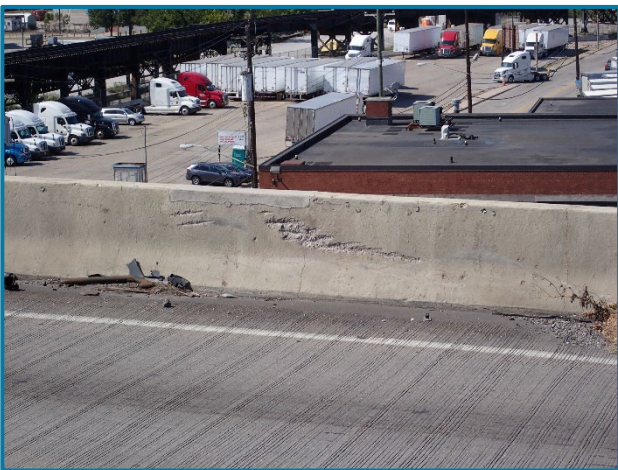
*Photo 8 – Shallow spall on the interior face of the west railing in Span 22A at midspan (looking west).*

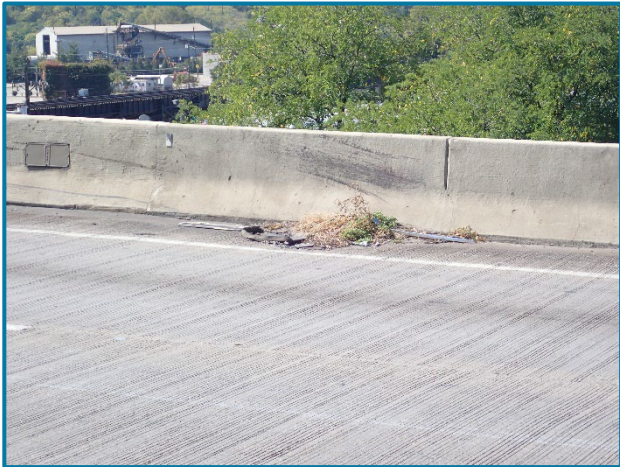
Photo 9 – Clogged scupper in the west shoulder on the top of deck at Pier 23A (looking southwest).

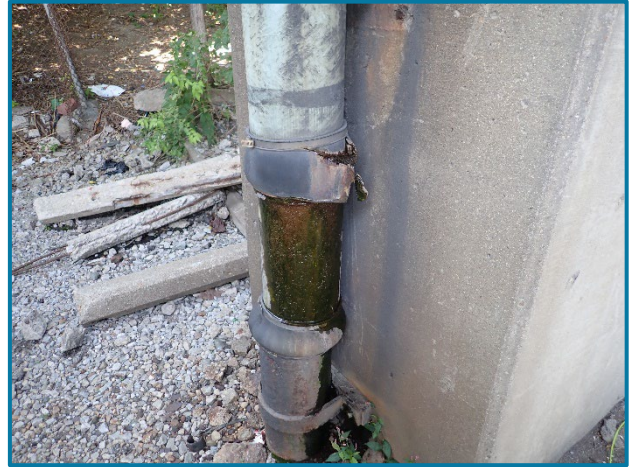
Photo 10 – Bulging and cracked drainage coupling gasket at the base of Column 1 on the south face of Pier 23A (looking northwest).

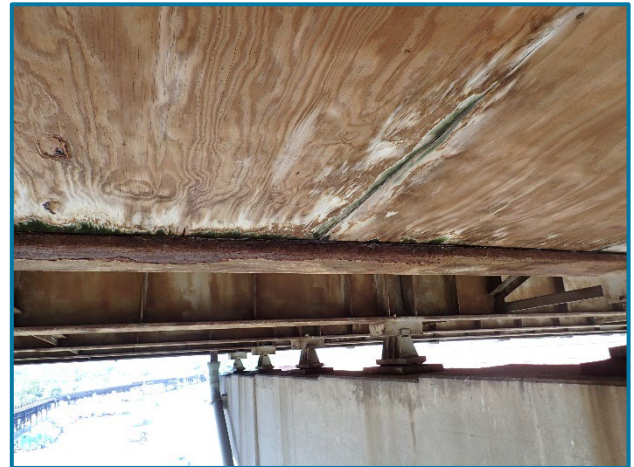
Photo 11 – Laminate corrosion with up to 1/8" section loss in the bottom flange of Girder E in Span 20A near Pier 20A (looking east).

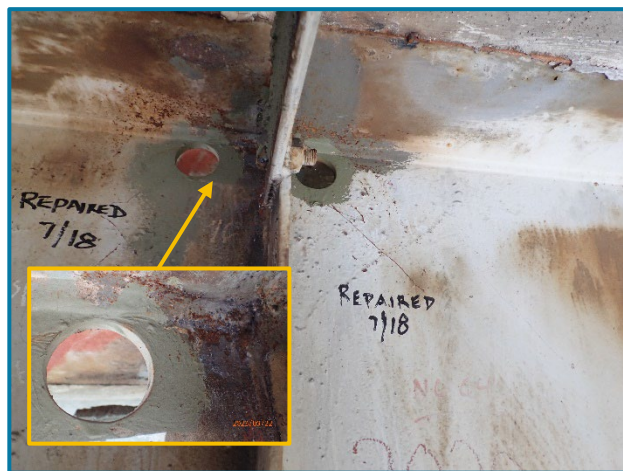
Photo 13 – Typical crack arrest hole in the web of Girder C near top flange (looking west in Span 23A at midspan).

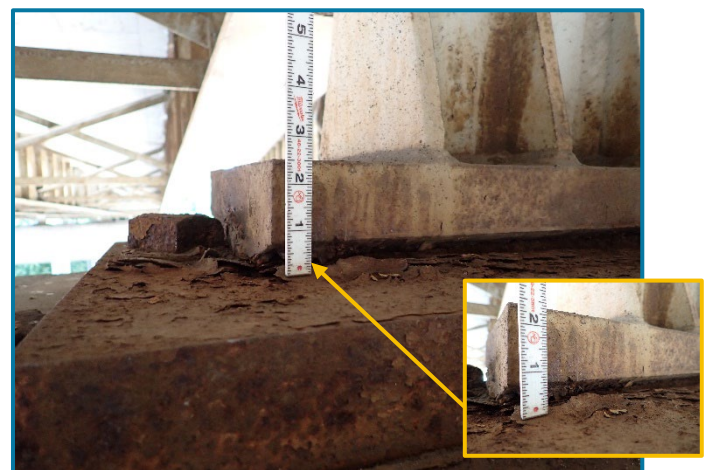
Photo 12 – 1/4" thick pack rust between the masonry plate and rocker bearing of Girder E at Pier 20A (looking southwest).

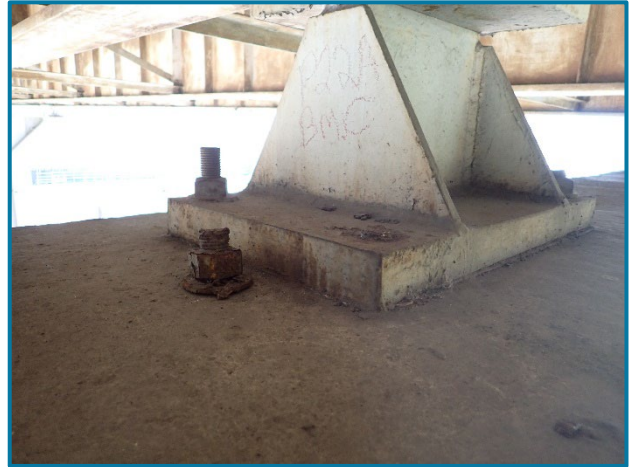
*Photo 14 – One broken anchor bolt at the northeast corner of the Girder C bearing at Pier 22A (looking southwest).*

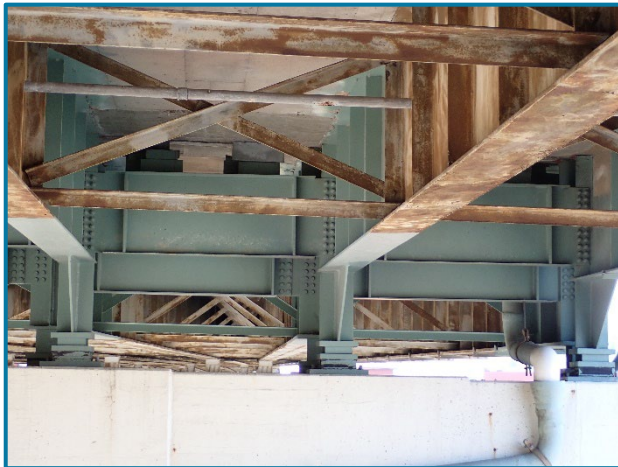
*Photo 15 – Typical steel protective coating condition of the girder ends at Pier 19A (looking southeast).*

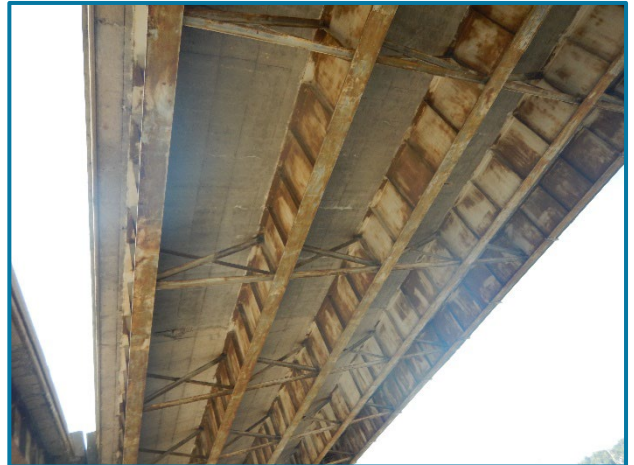
*Photo 16 – Typical steel protective coating condition of all steel members in Span 21A (looking southwest).*

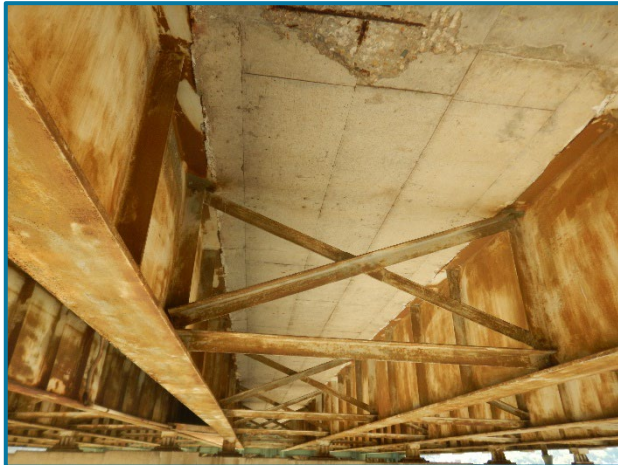
Photo 17 – Typical crossframe with minor surface corrosion and paint failure (looking south in Span 21A between Girders D and E).

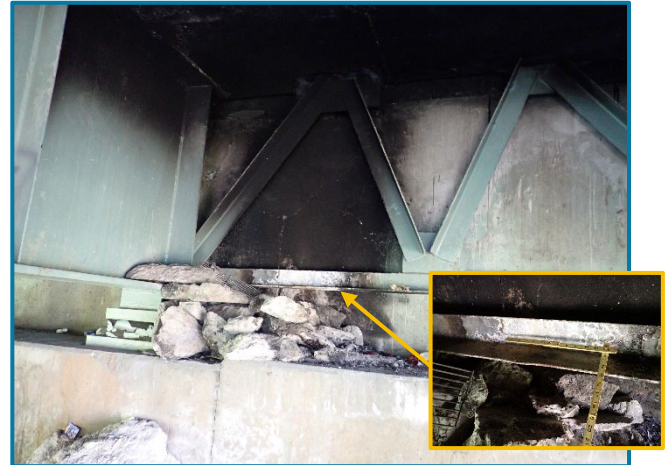
Photo 18 – Fire damage to the end crossframe between Girders C and D at Abutment A (looking northwest).

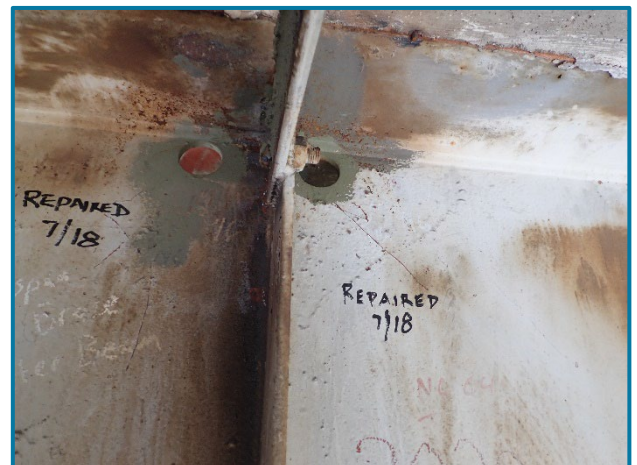
Photo 19 – Typical crack arrest hole repairs in east face web of Girder C at the midspan crossframe connection (looking west in Span 23A).

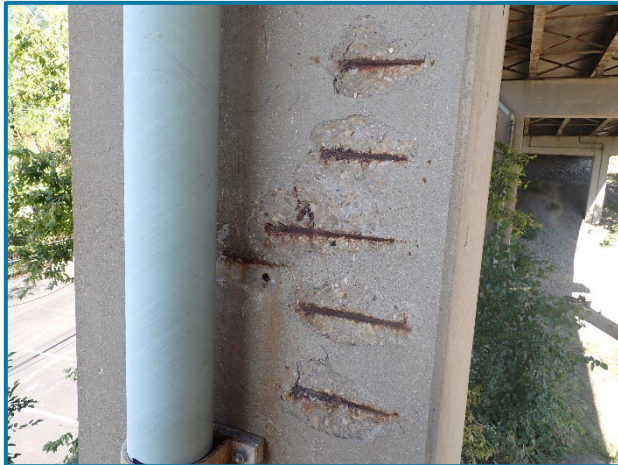
Photo 20 – Spalls with exposed reinforcement on the south face of Column 1 at Pier 22A (looking north).

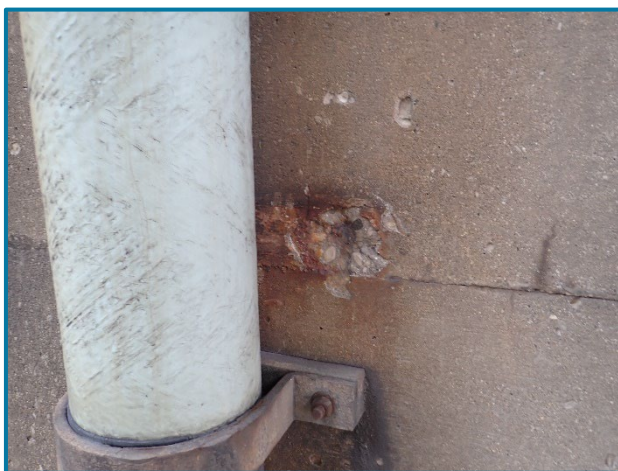
Photo 21 – 6" diameter spall near the drainage support bracket on the south face of Column 1 at Pier 23A (looking north about 15' above the ground).

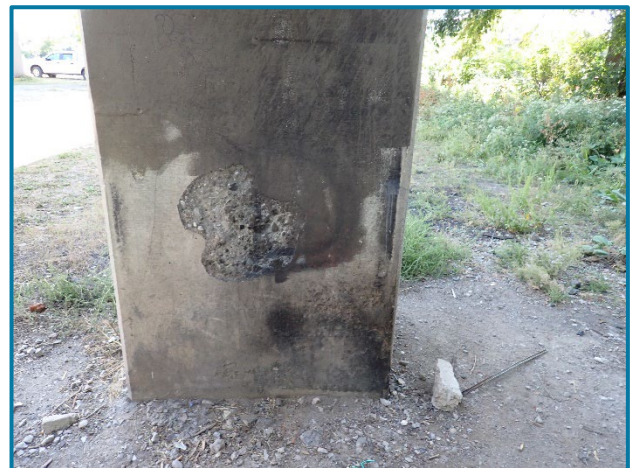
Photo 22 – 20" diameter by 1" deep spall on the north face of Column 2 at Pier 23A (looking south near the base).

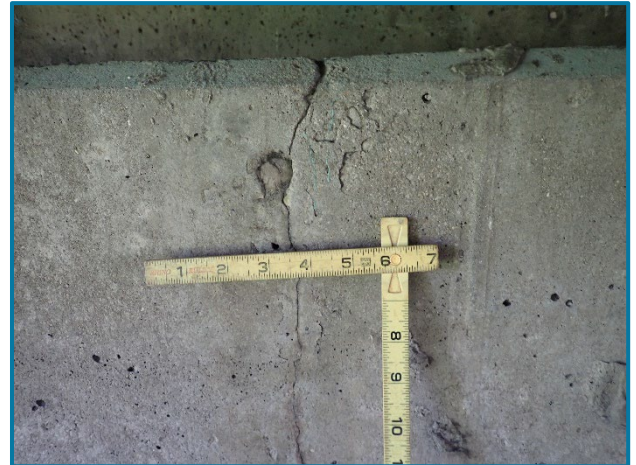
Photo 23 – Isolated vertical hairline crack in the abutment seat below Girder B in Span 25A (looking north at the south face of Abutment A).

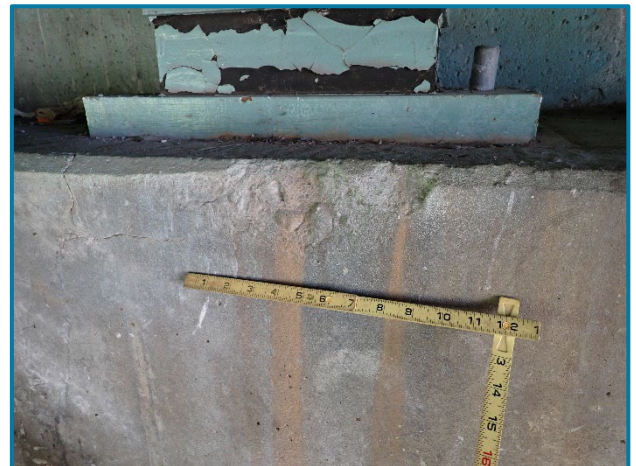
Photo 24 – Shallow edge spall on the Abutment A bearing seat at Girder D (looking north).

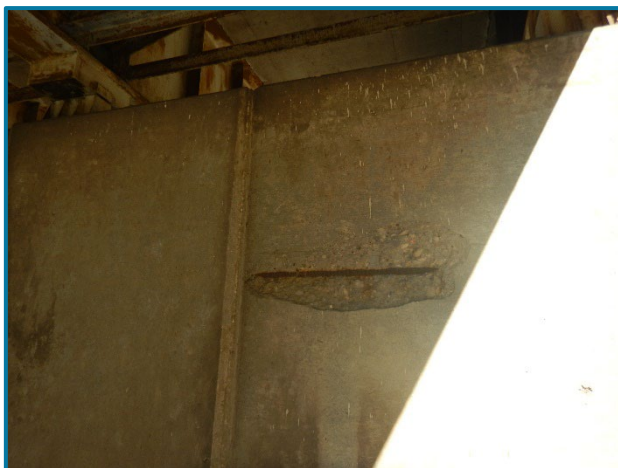
Photo 25 – 2' wide by 1' high by 2" deep spall with exposed reinforcement on the south face of the Pier 21A cap between Girders D and E (looking north).

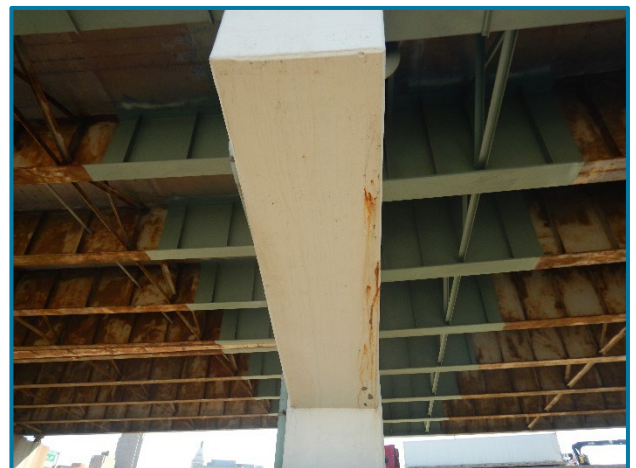
Photo 26 – Area of delamination, cracking, and rust staining on the underside of the Pier 19A cap (looking east at the west end of the cap).

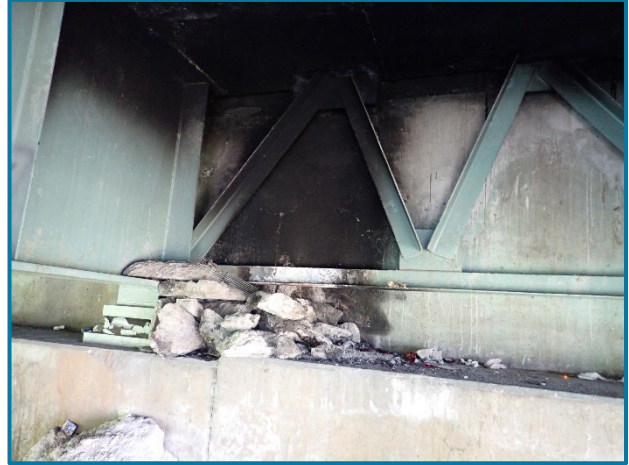
*Photo 27 – Fire damage with discoloration and cracking on the Abutment A backwall between Girders C and D (looking northwest).*

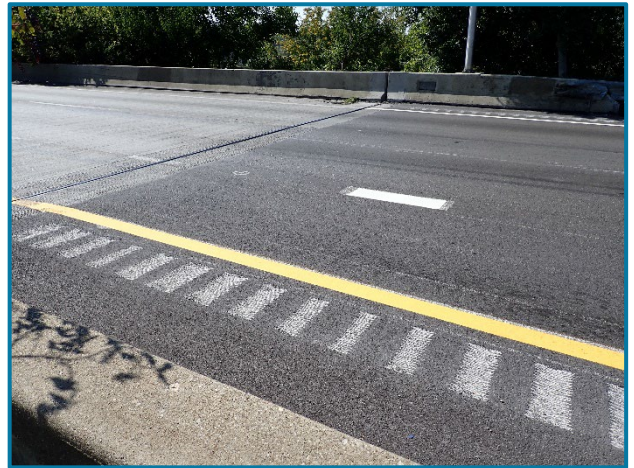
Photo 28 – New asphalt wearing surface overlay on the north approach slab (looking southwest).

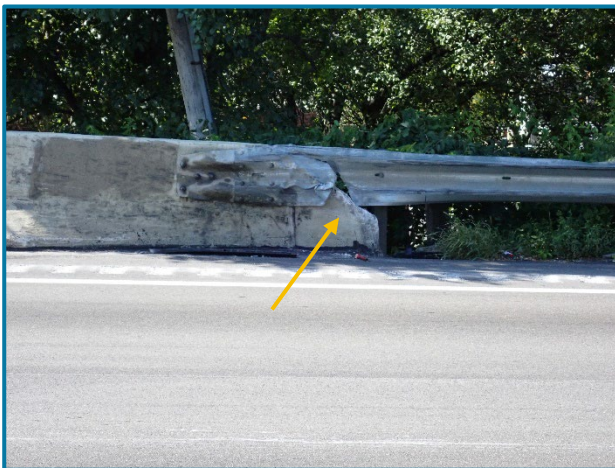
Photo 29 – Impact damage to the approach guardrail at the transition to the concrete railing on the west side of the north approach (looking west). Note the spall at the end of the concrete railing.

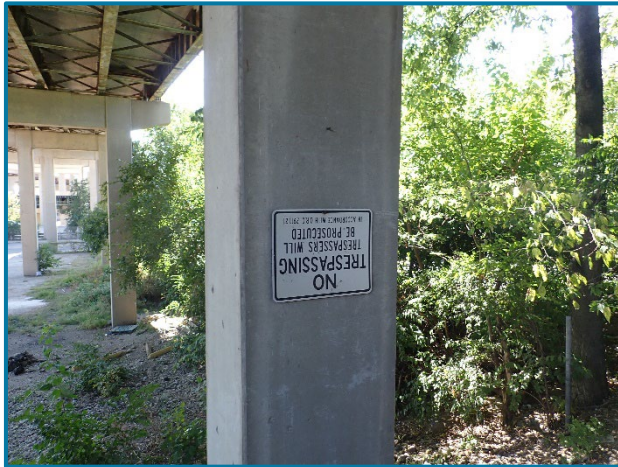
Photo 30 – “No Trespassing” sign partially detached and hanging upside down on the north face of Column 1 at Pier 24A (looking south).

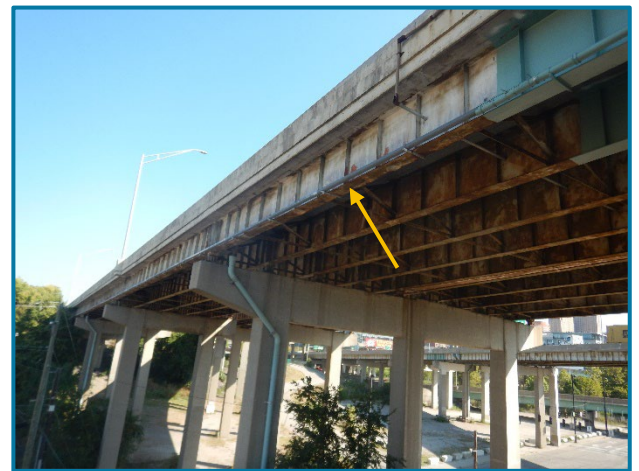
Photo 31 – Conduit along the exterior bottom flange of Girder A (looking northeast).

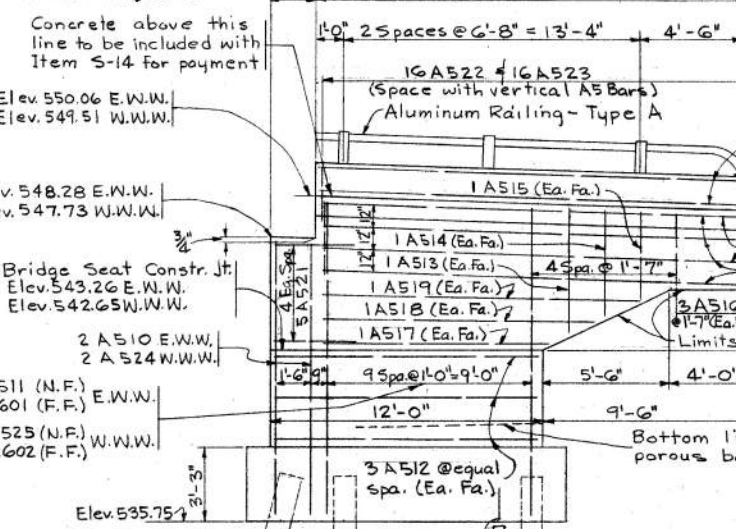
ELEVATION CC  
East Wingwall Shown, West Wingwall Opposite Hand Except as Noted.

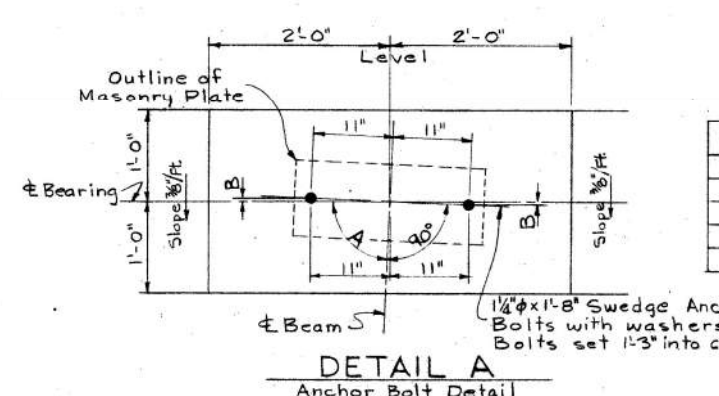
Notes:  
Omit anchor bolt on fascia side of Brm. A and Brm. E.
