2023 IN-DEPTH INSPECTION REPORT
BRIDGE NO: HAM-75-0022R, SFN 3108805
VAR-DISTRICT 8 Bridge Inspections
Brent Spence Approach Bridges

Cincinnati, Ohio

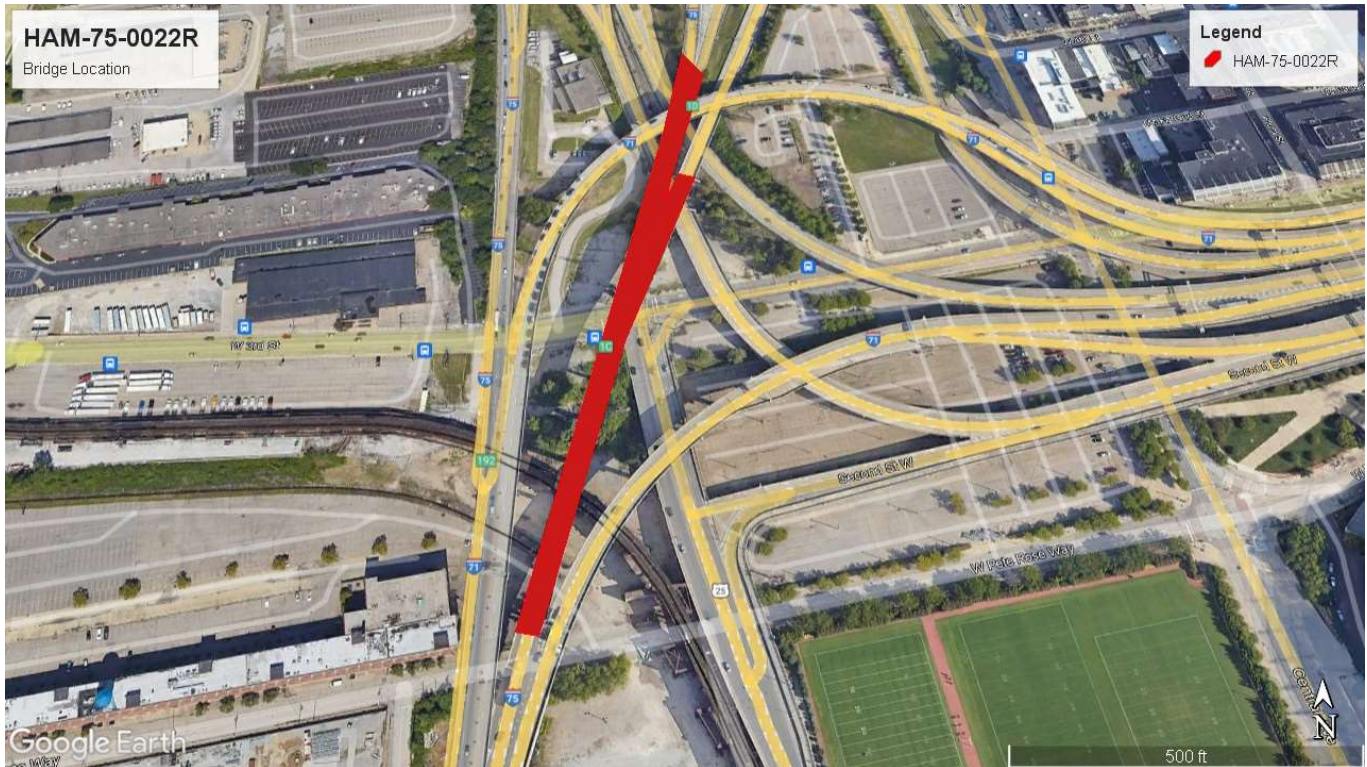
Figure 1: Location Map

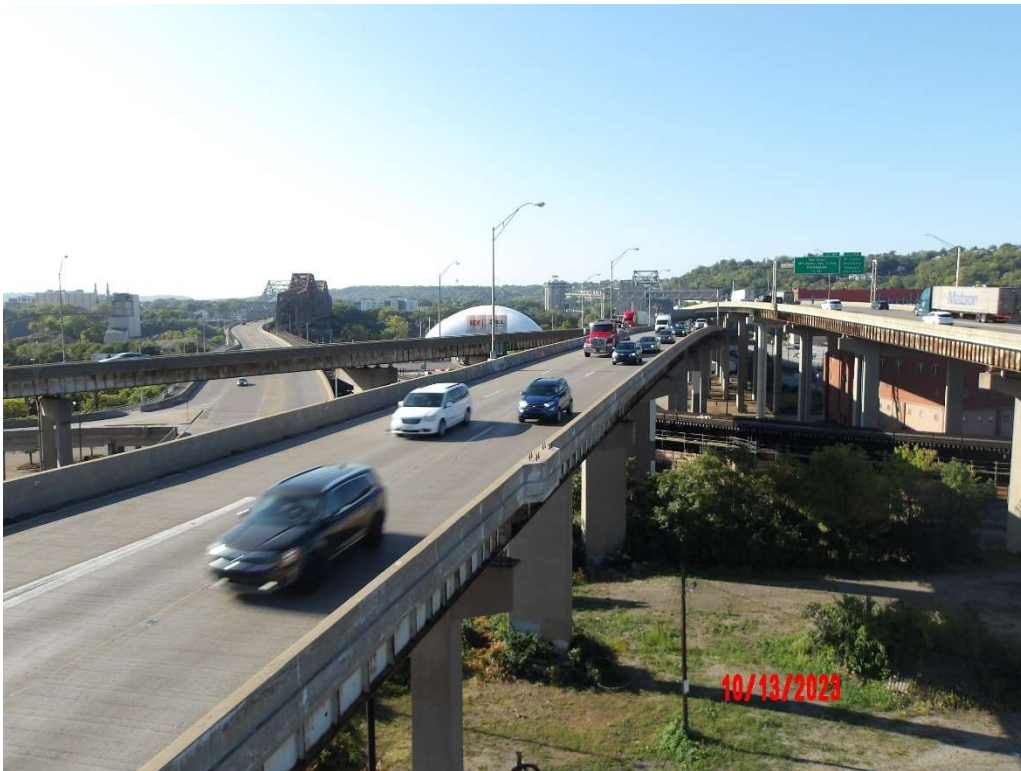
Photo 1- Bridge Deck, Typical Condition

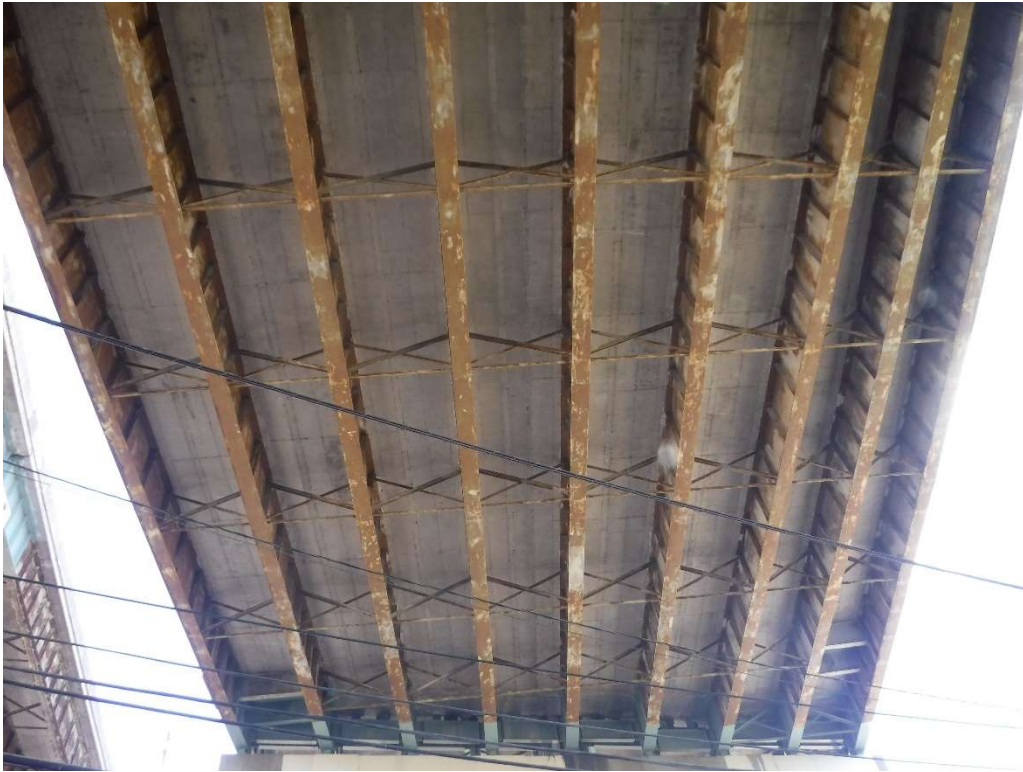
Photo 2- Typical Underside, Span 15

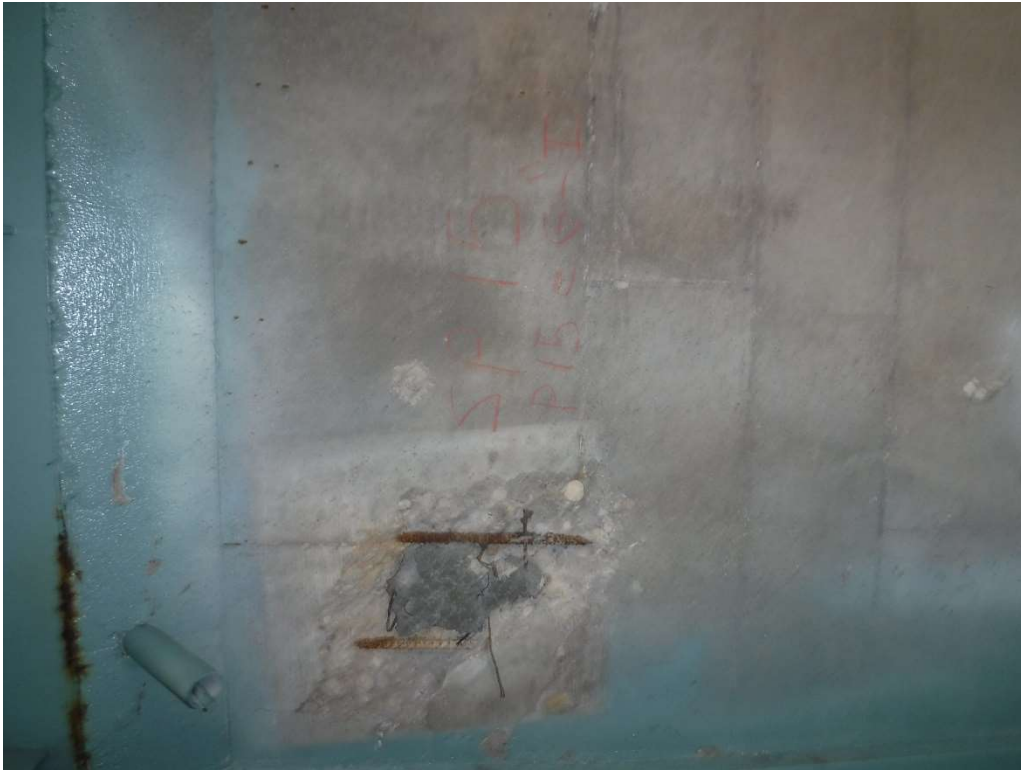
Photo 4- Span 15 2SF Spall with Exposed Rebar

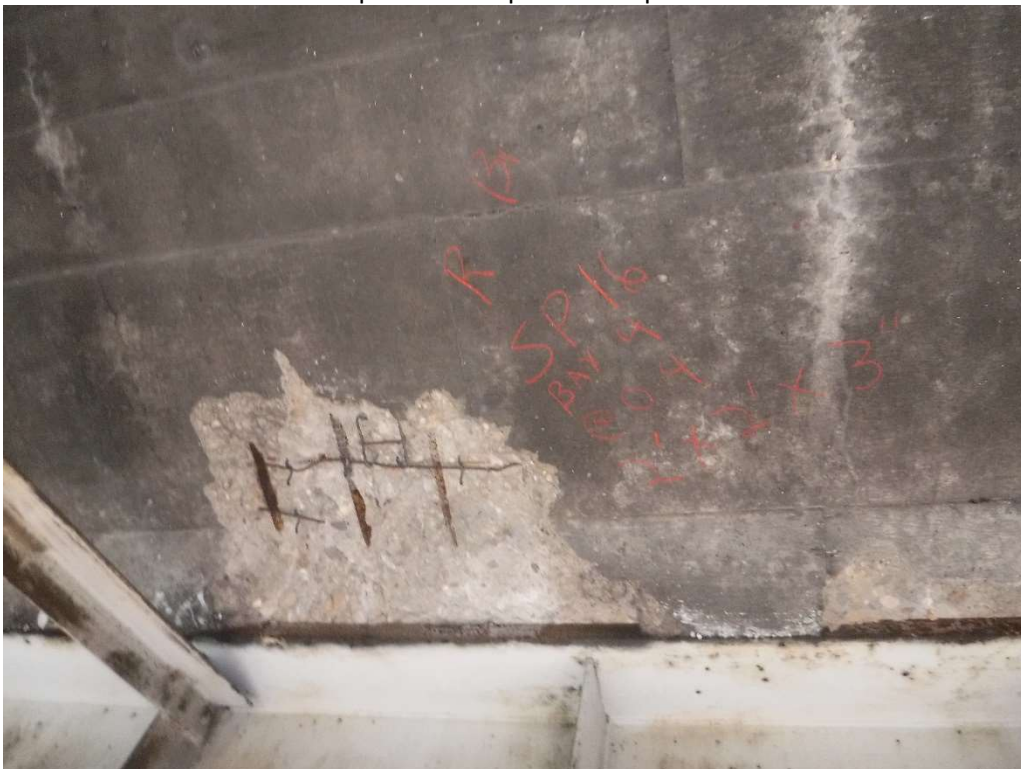
Photo 5- Span 16, Bay 4, 4SF Spall with Exposed Rebar

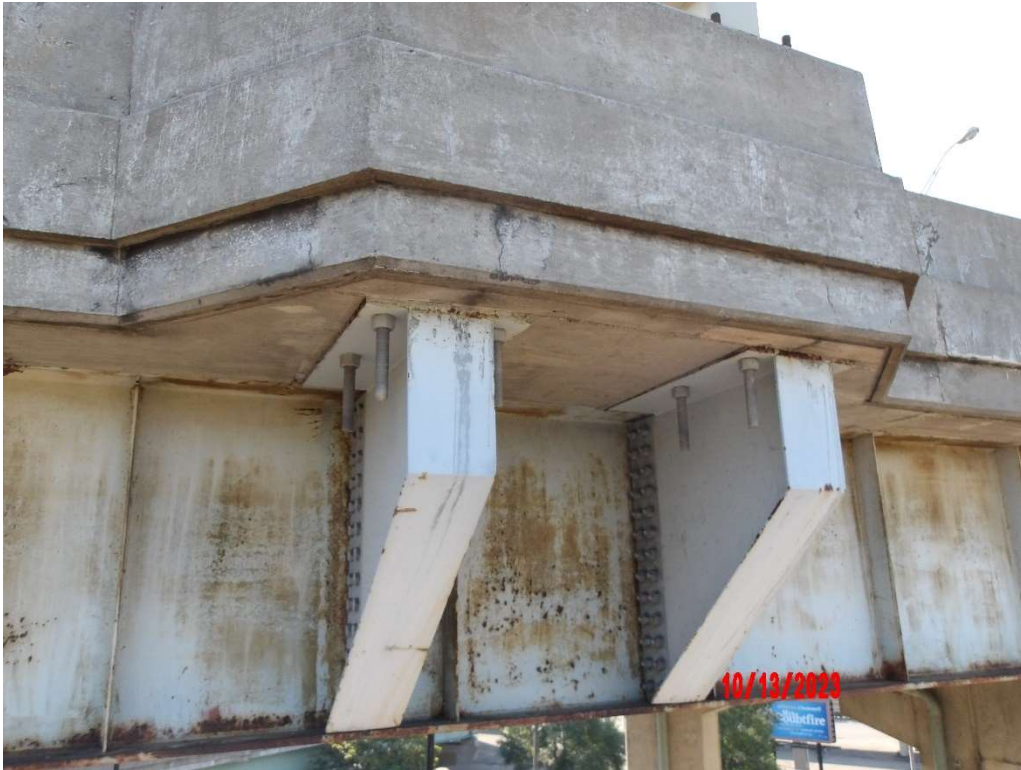
Photo 6- Span 23J, Sign Bumpout Detail

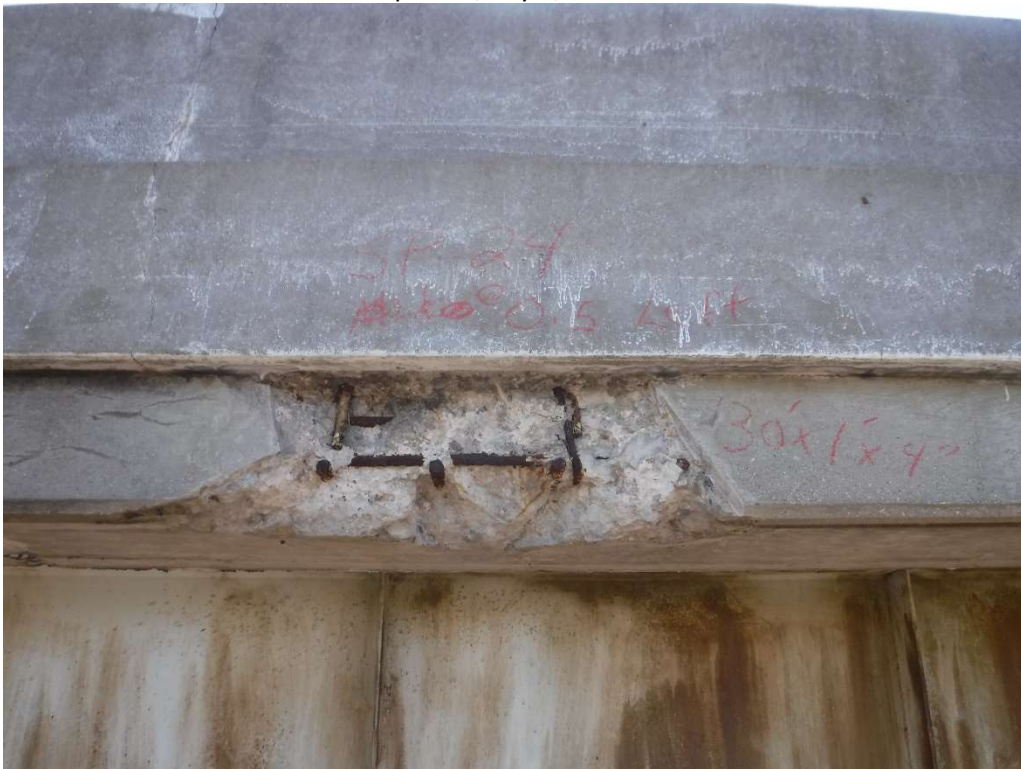
Photo 9- Span 24, Overhang, Spall with Exposed Rebar

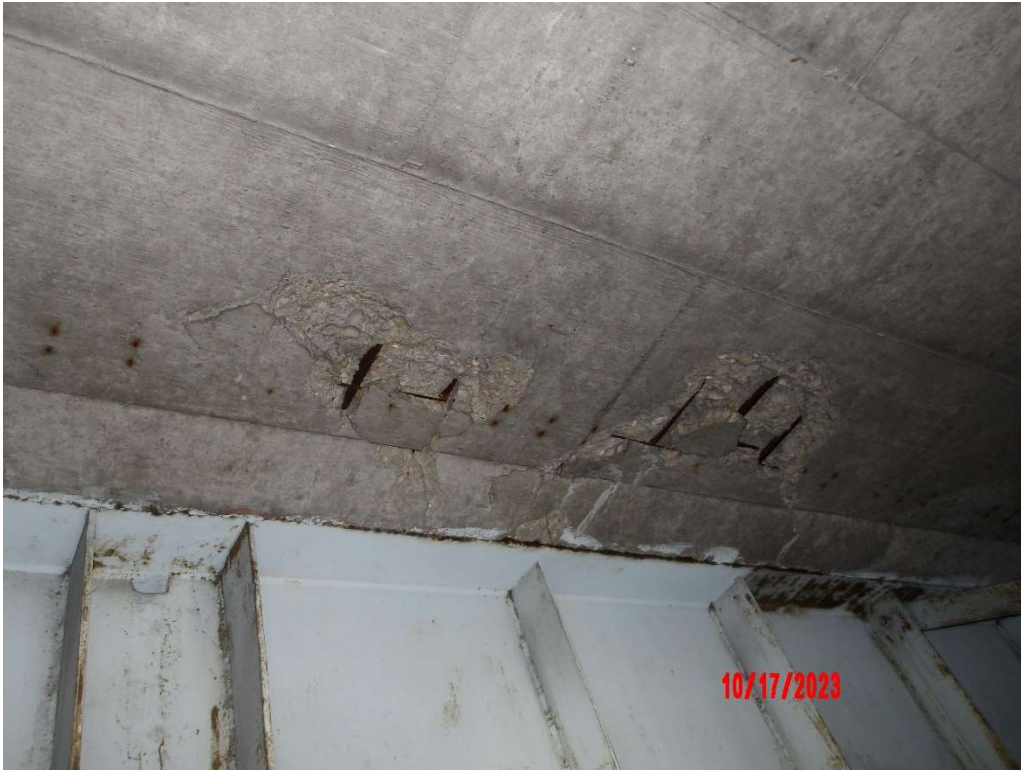
Photo 10- Span 29, 9SF Spall with Exposed Rebar

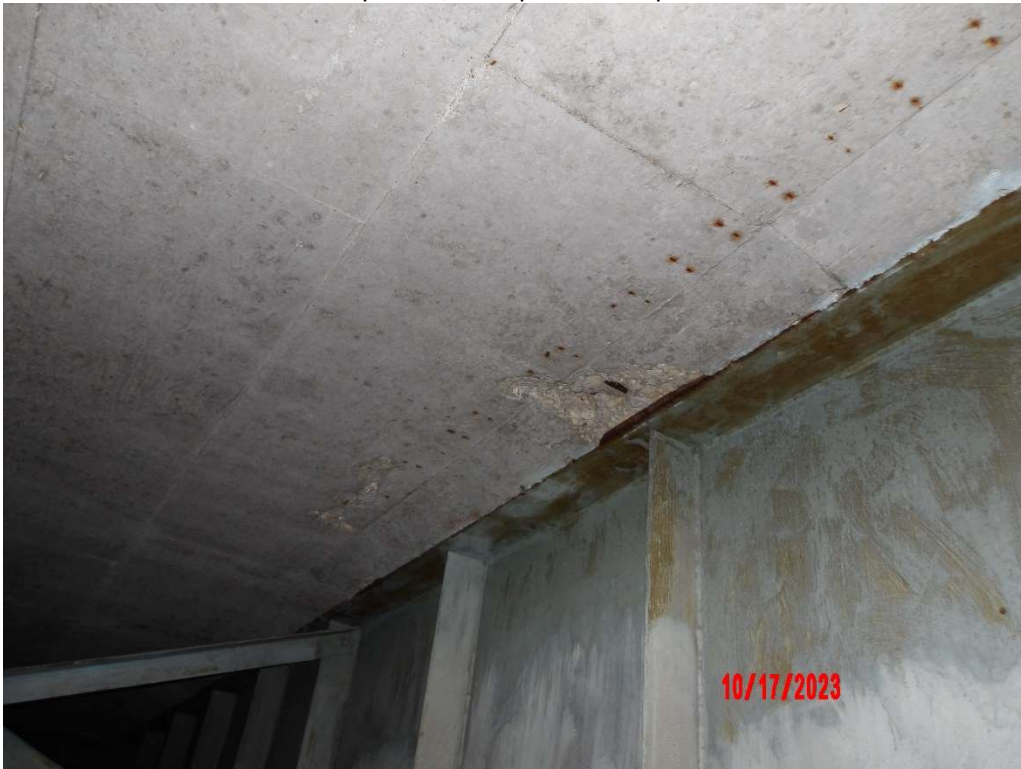
Photo 11- Span 29, Bay 1, 2SF Spall with Exposed Rebar

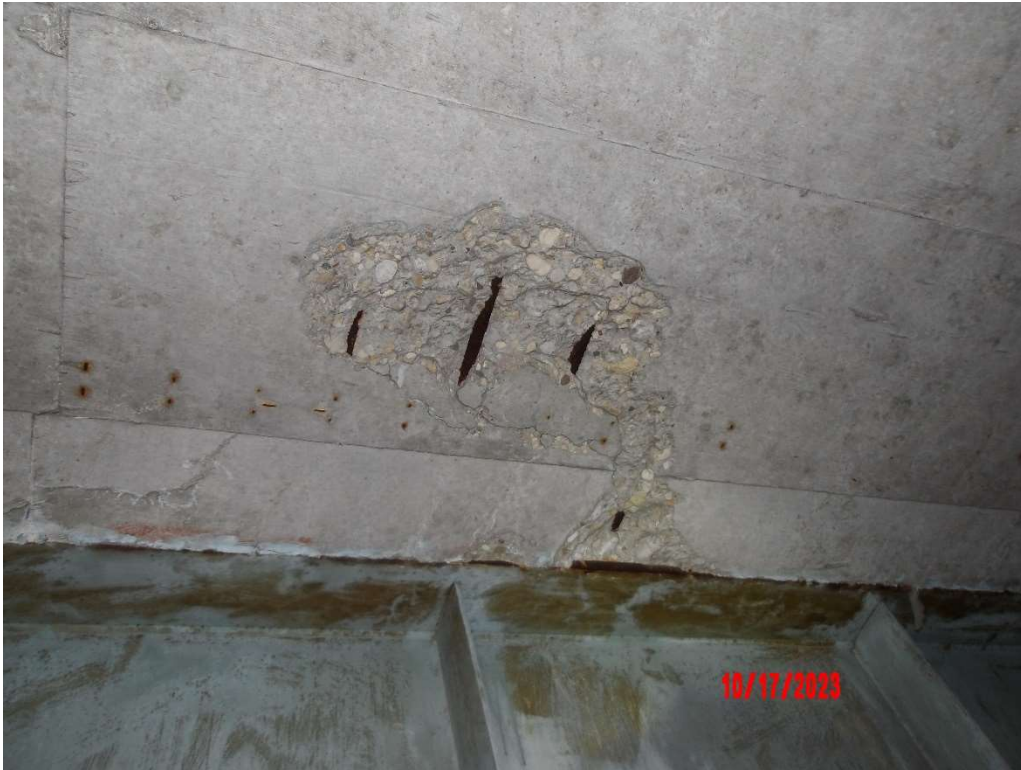
Photo 12- Span 29, Bay 1, 5SF Spall with Exposed Rebar

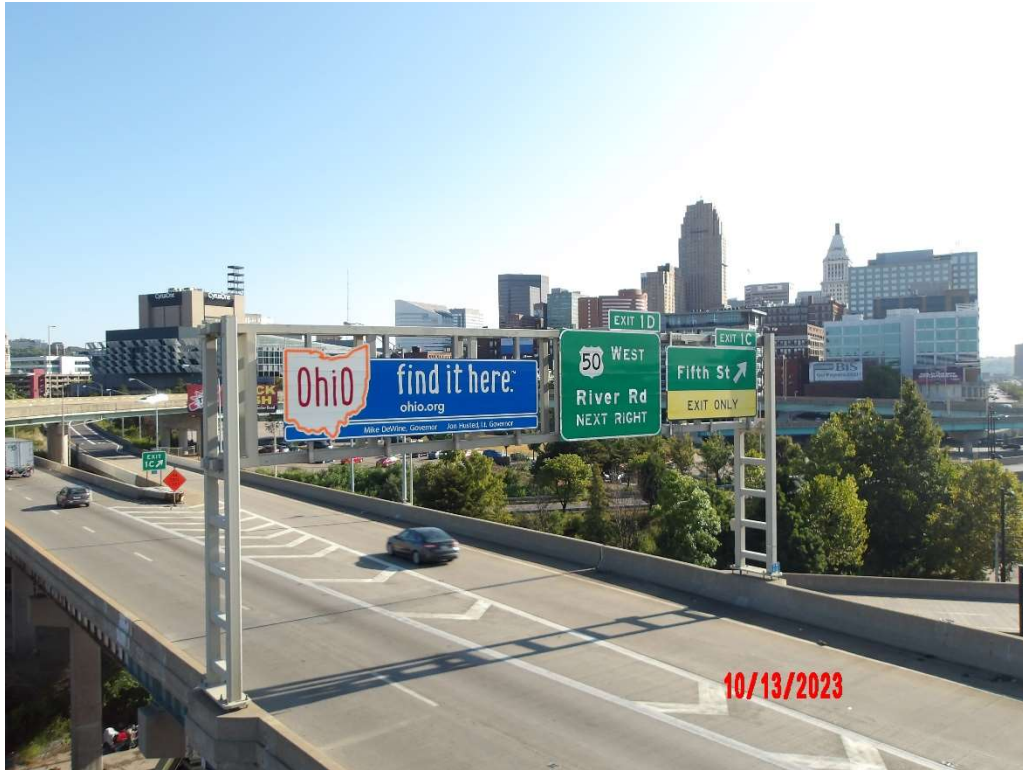
Photo 13- Typical Wearing Surface Conditions

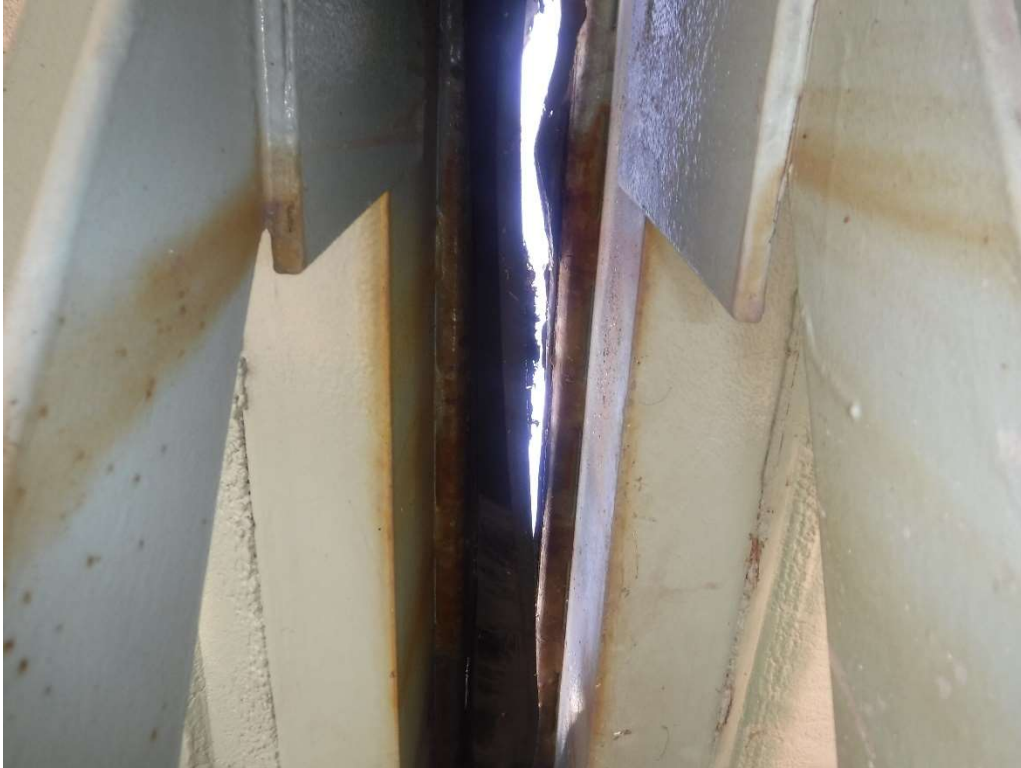
Photo 14- Joint Failure, Pier 23 near Girder E

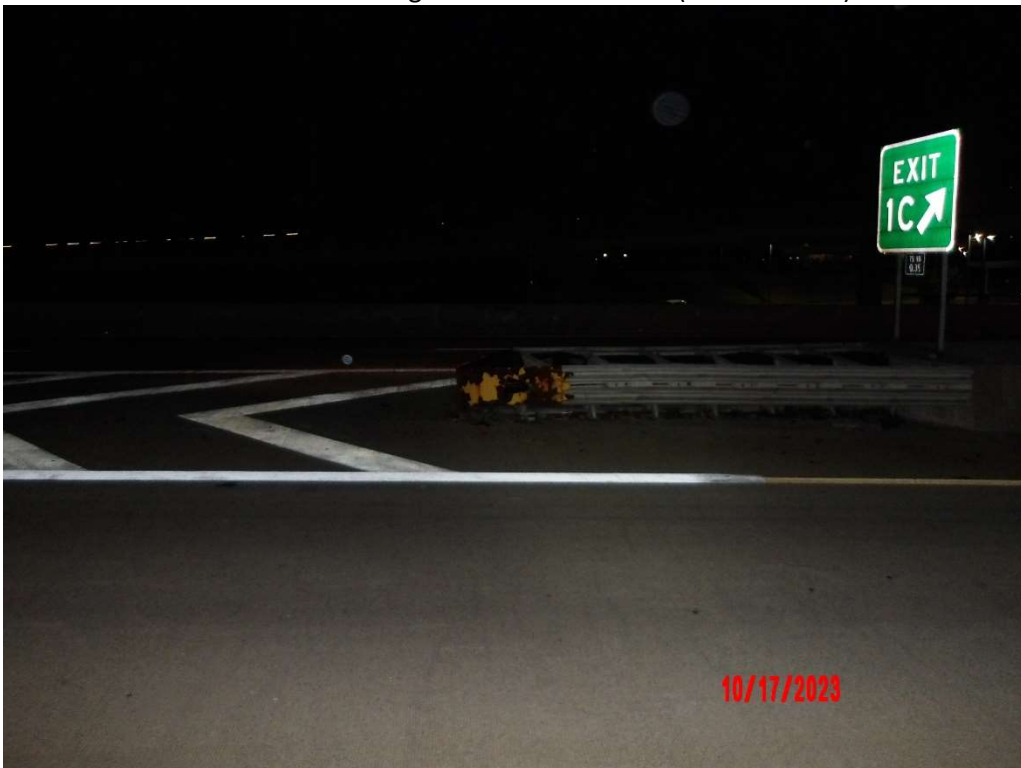
Photo 15- Deck, Smashed Attenuator on Guardrail near Exit 1C

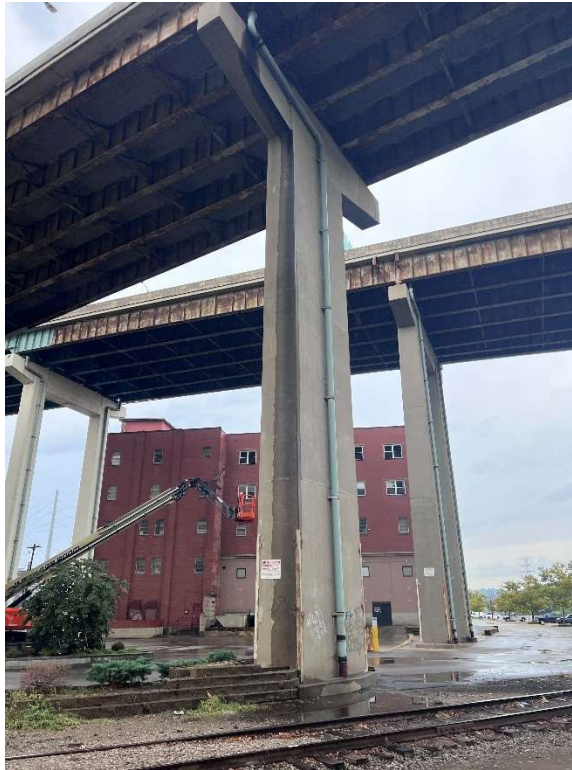
Photo 16- Drainage, Leaking on Substructure, Pier 16C

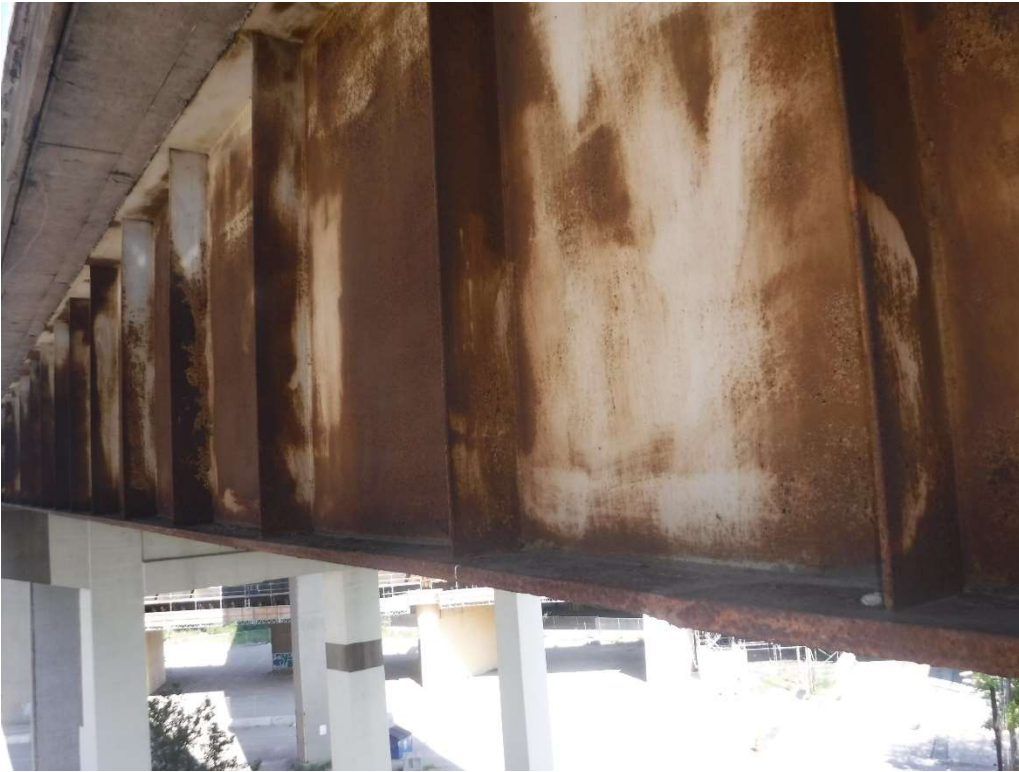
Photo 17- Span 15, Girder A, Typical Paint Failure and Active Corrosion

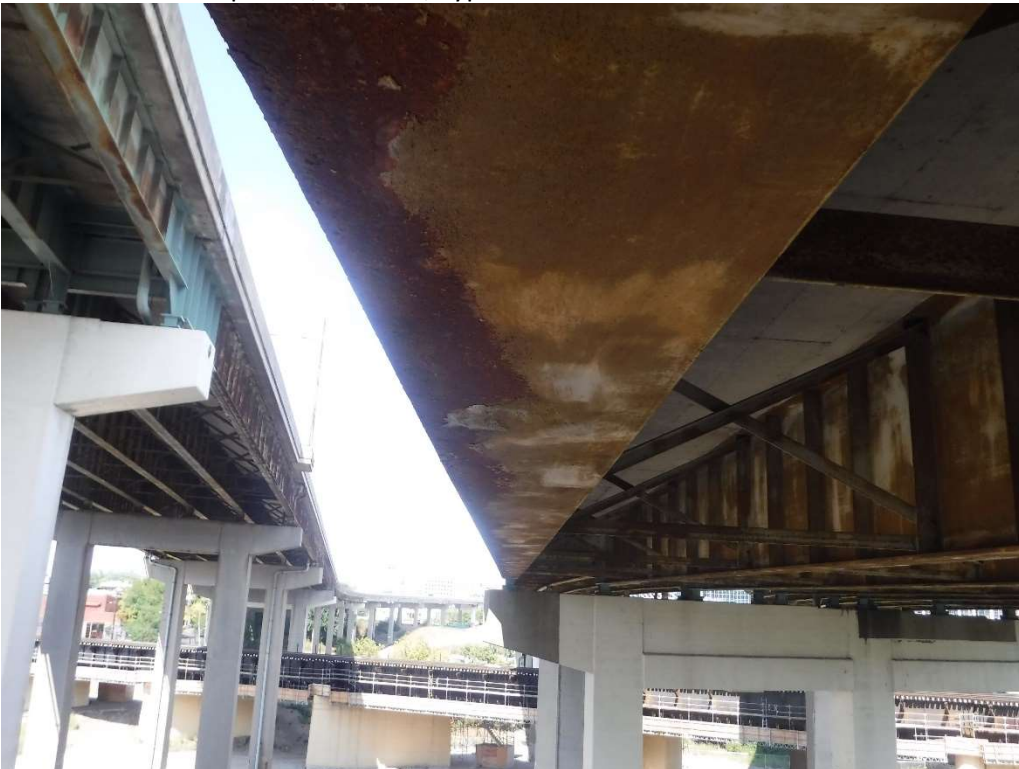
Photo 18- Span 15, Girder A, Typical Paint Failure and Active Corrosion

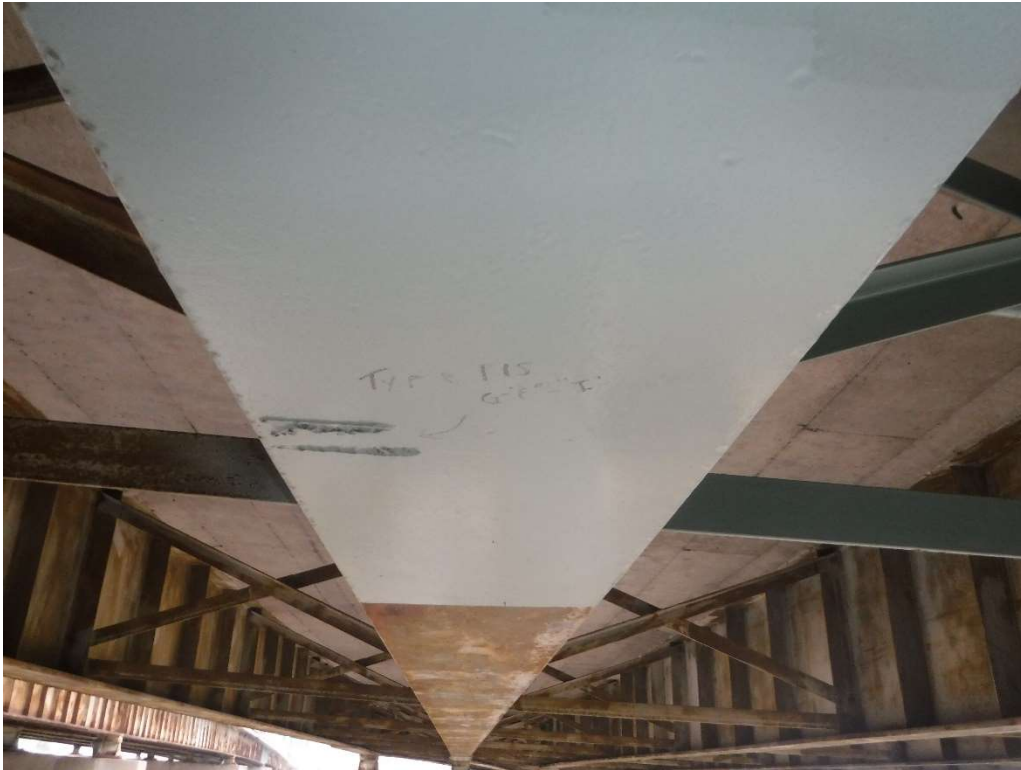
Photo 19- Girder F, Span 16, Typical Weld Remnants on Girders

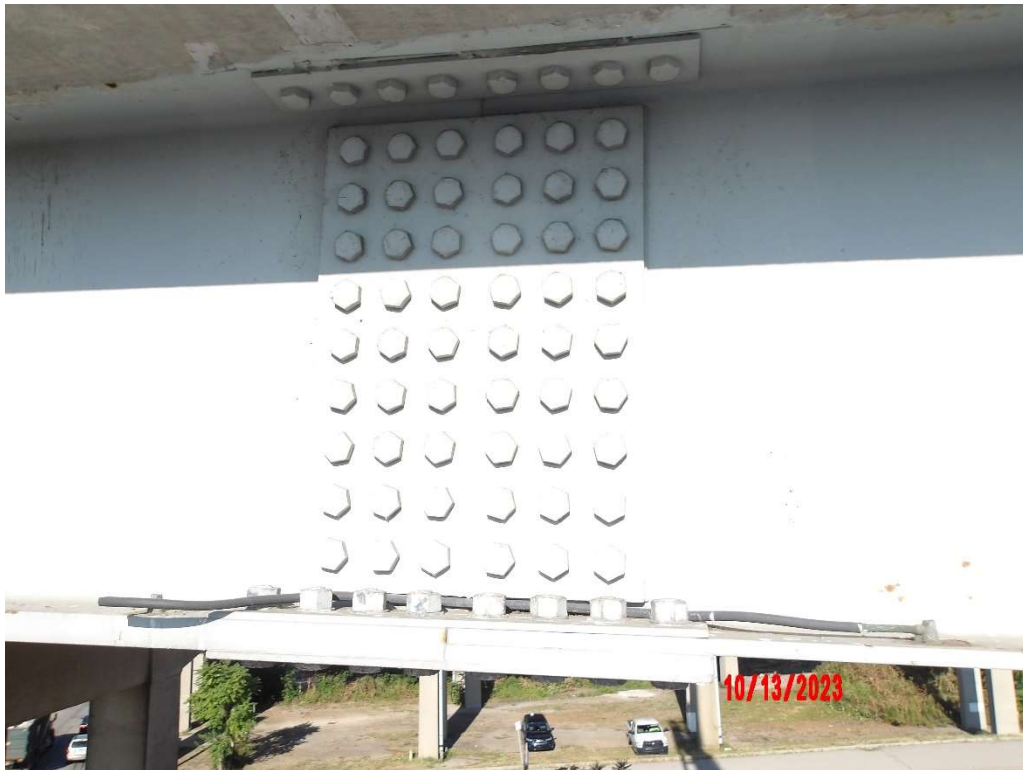
Photo 23- Typical Ground Wire, Span 23C, at Fascia Splices in Good Condition

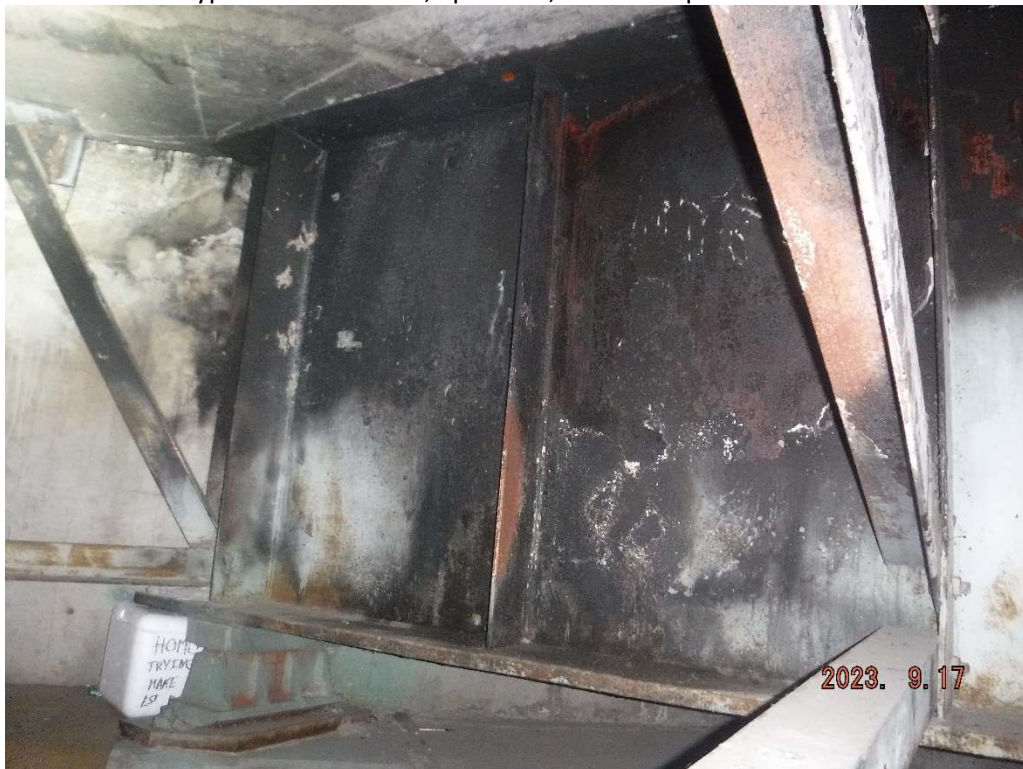
Photo 24- Fire Damage under Structure, Bay 3, Span 29

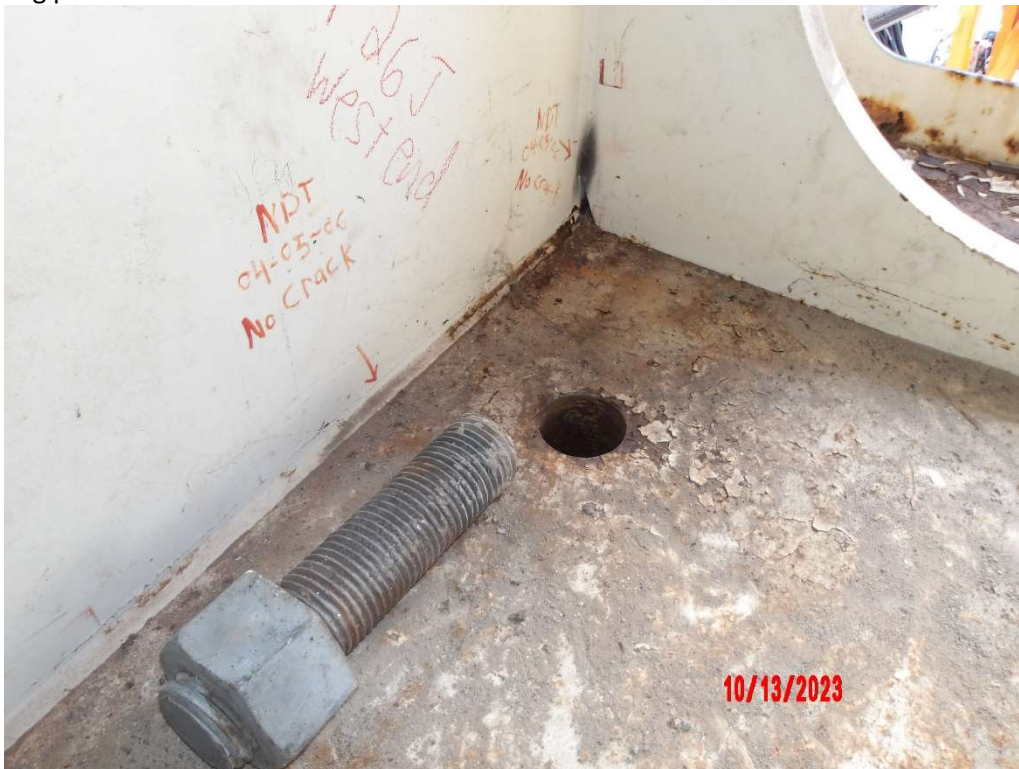
Photo 25- Pier 26J, West End, Bearing Anchor Bolt Removed

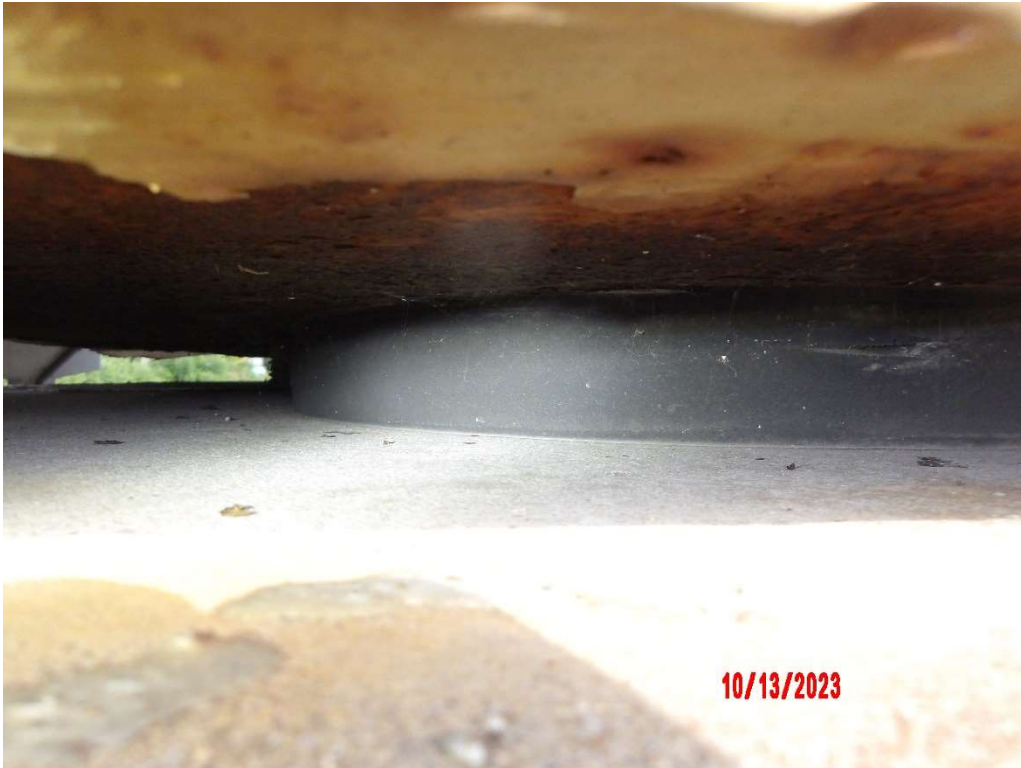
Photo 26- Pier 26J, West End, Bearing Slight Bulge at Opposite Location of Missing Bolt

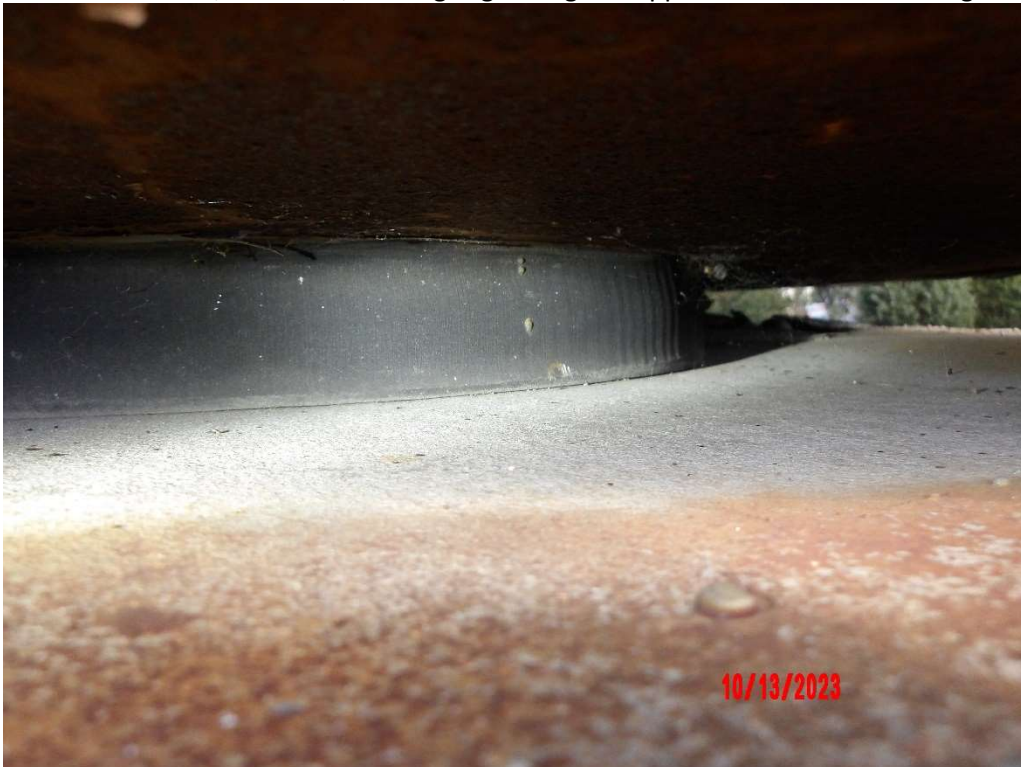
Photo 27- Pier 26J, West End, Bearing Slight Gap under Bearing at Location of Missing Bolt

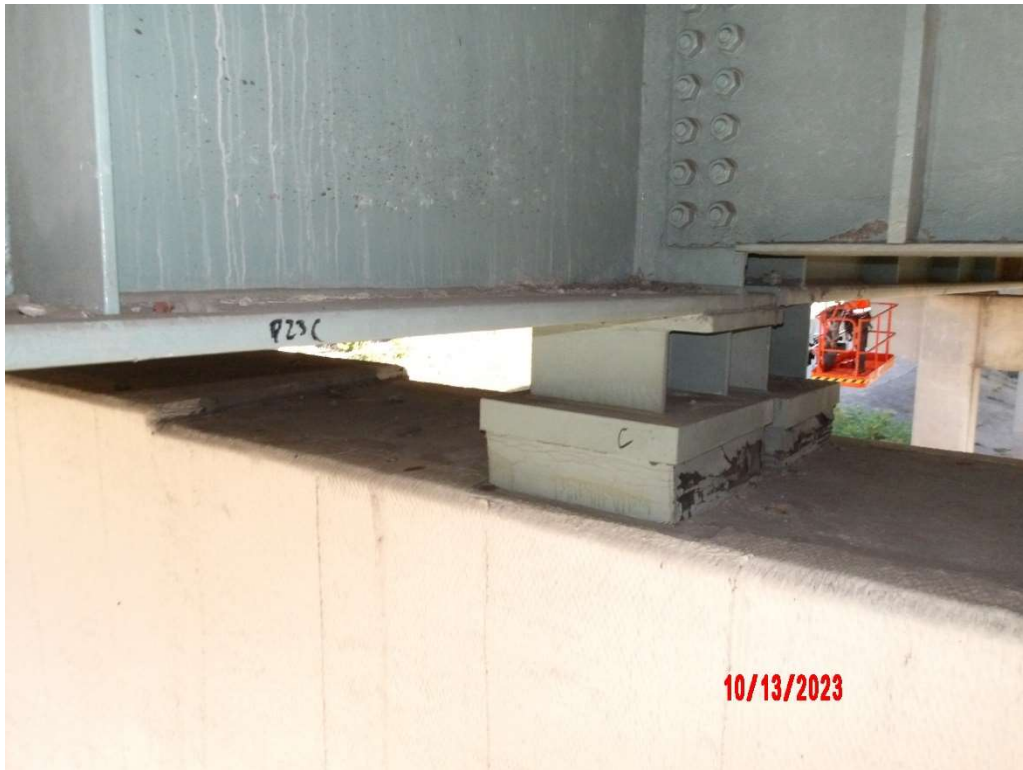
Photo 28- Bearing C, Pier 23J

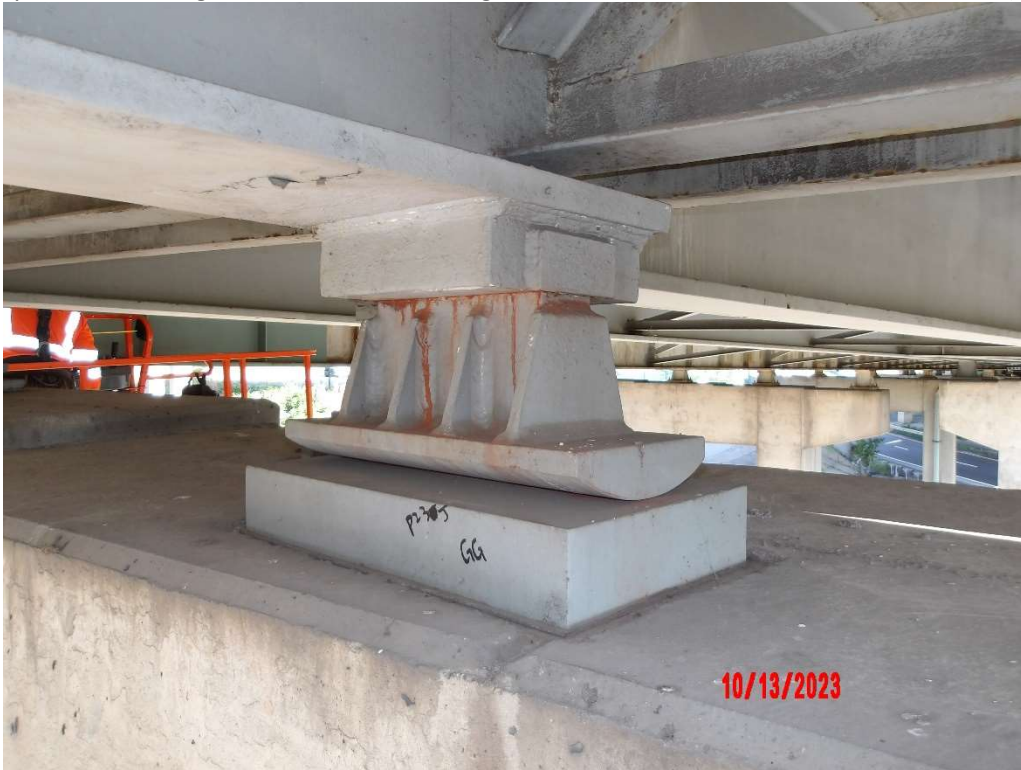
Photo 30- Bearing G, Pier 23J

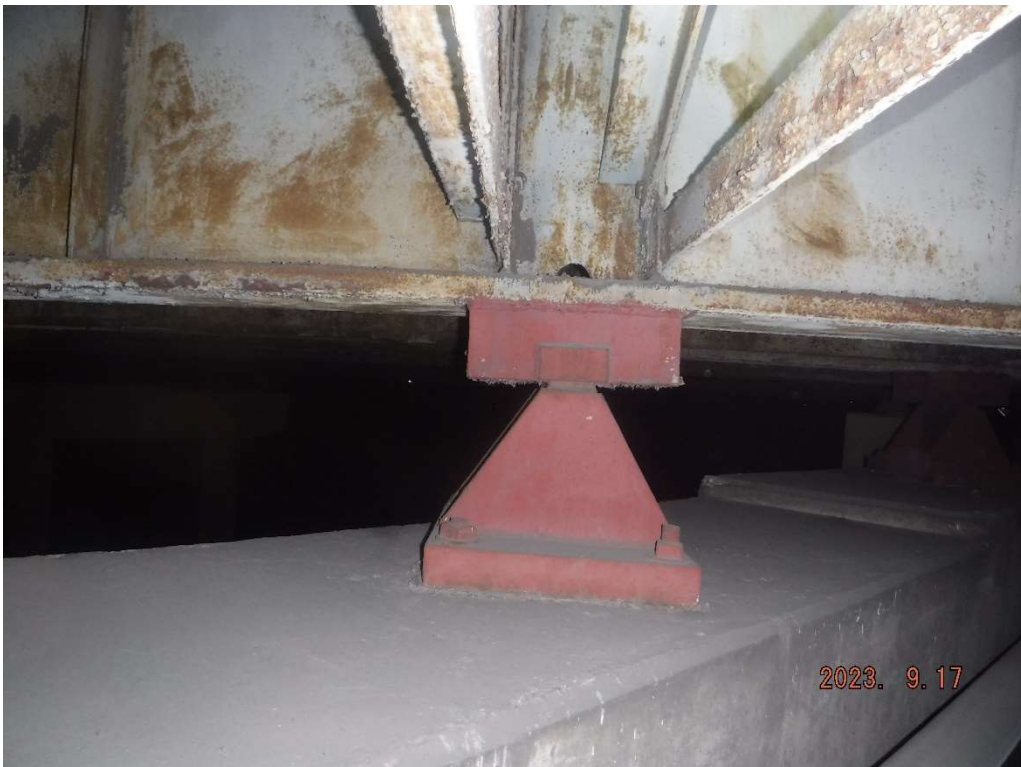
Photo 35- Pier 29, Bearing C, Typical

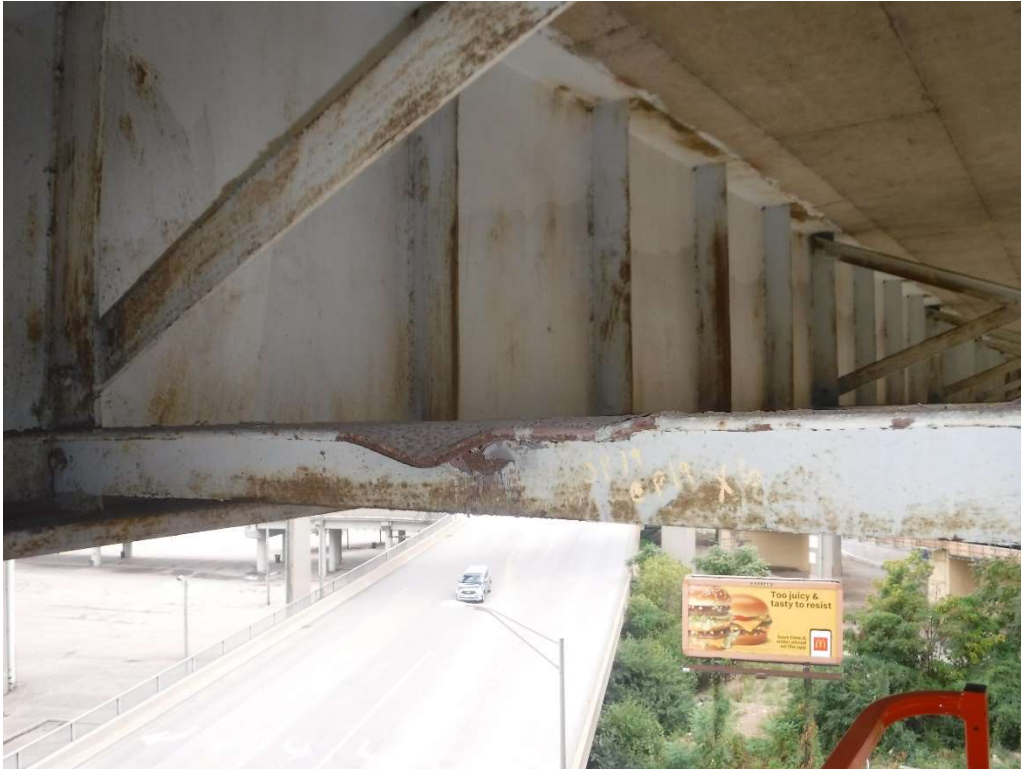
Photo 36- Cross Frame #6, Span 19, Bent

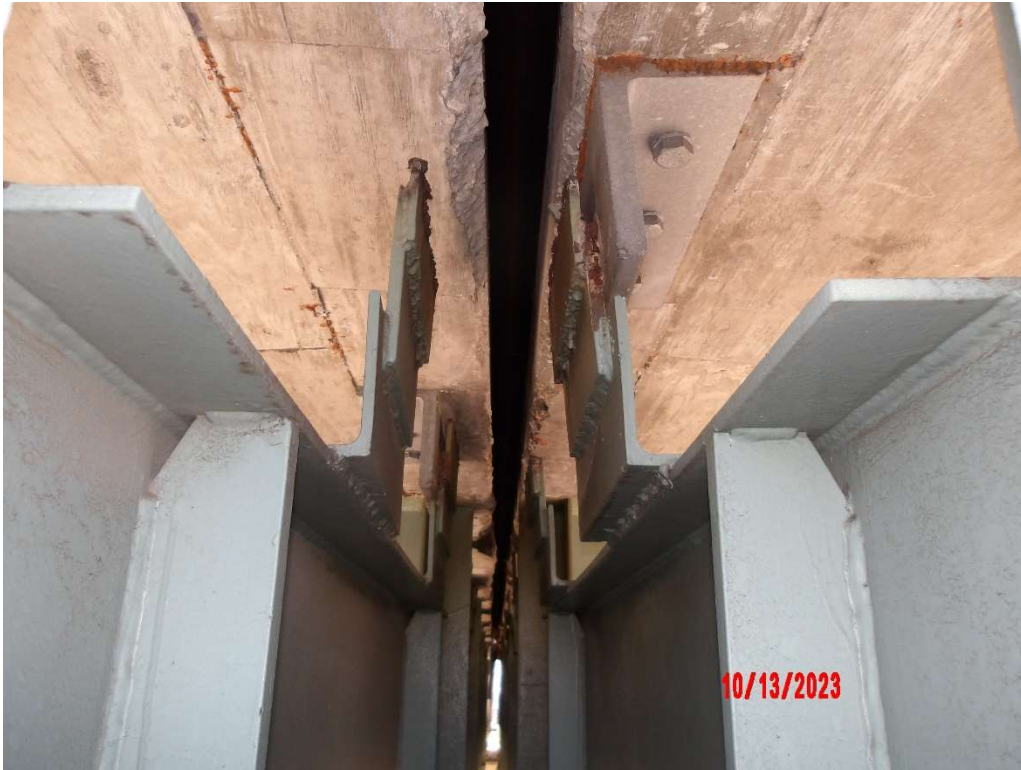
Photo 37- Cross Frames, Pier 23J, Welded Retrofit for Joint Replacement Remnants

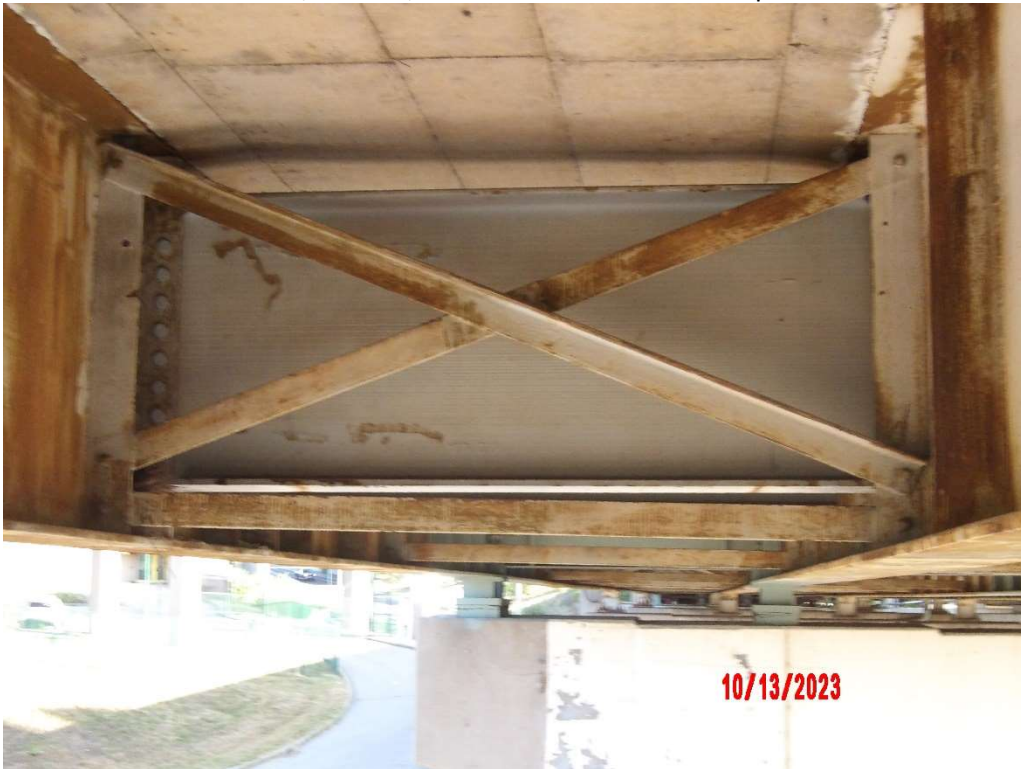
Photo 38- Span 23J, Bay 1, Cross Frame Retrofit

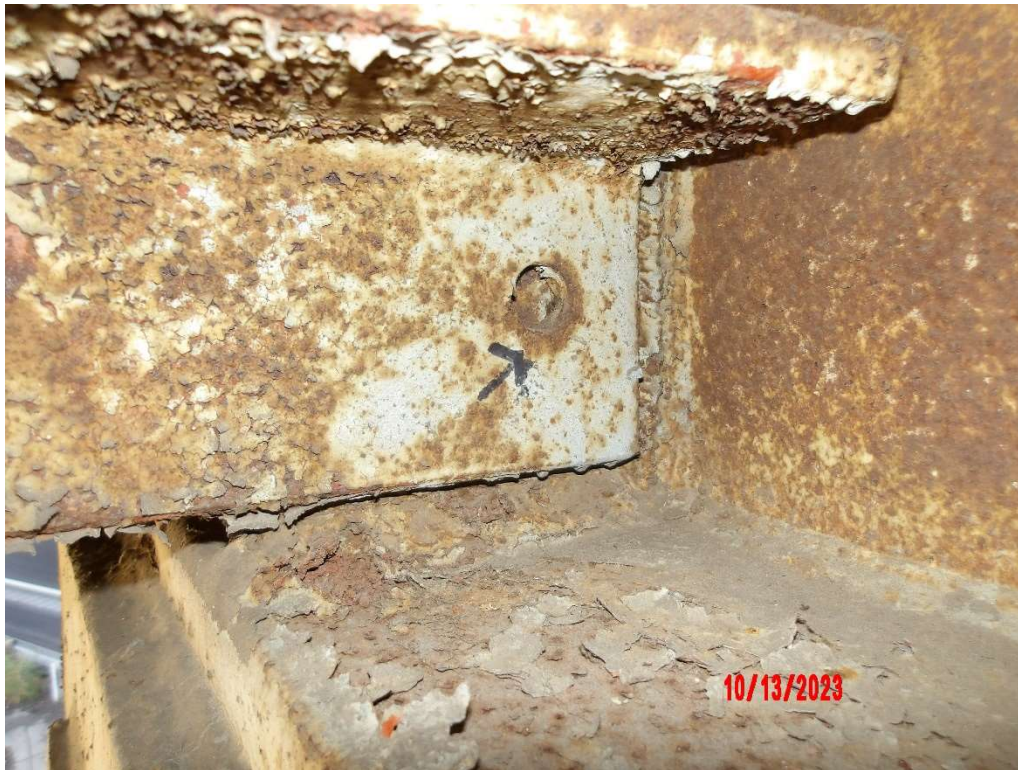
Photo 39- Span 26, Cross Frame, Missing Bolt Typical
