2023 IN-DEPTH INSPECTION REPORT
BRIDGE NO: HAM-75-0022R, SFN 3108805
VAR-DISTRICT 8 Bridge Inspections
Brent Spence Approach Bridges

Cincinnati, Ohio

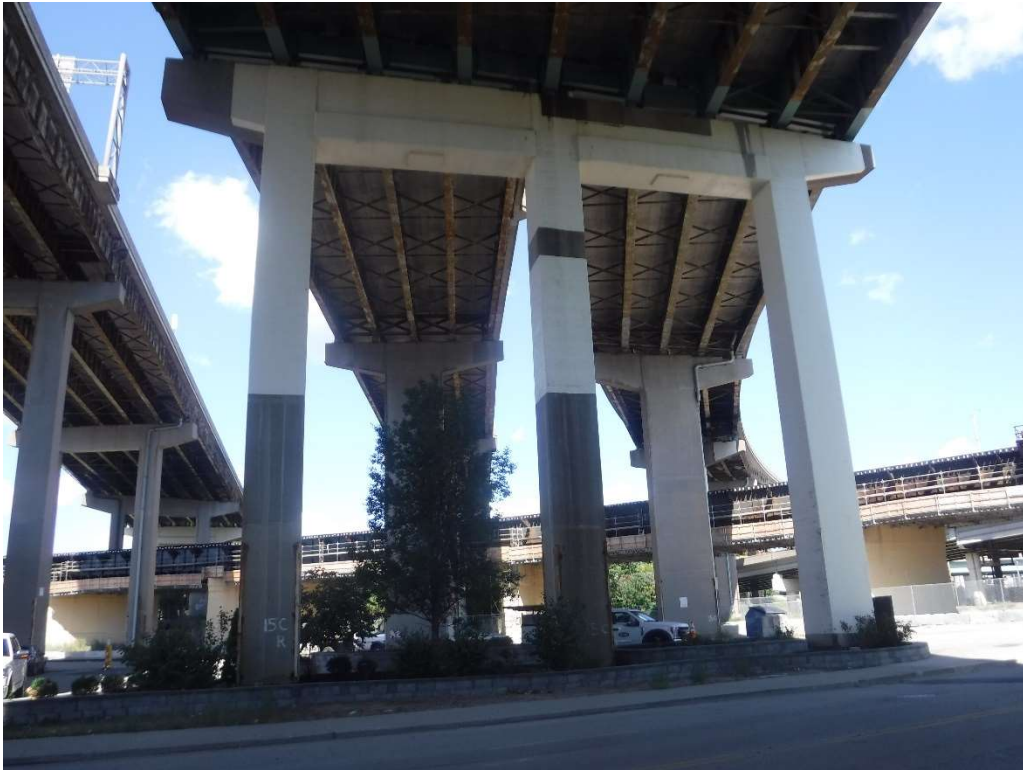
Photo 40- Pier 15 Back Face

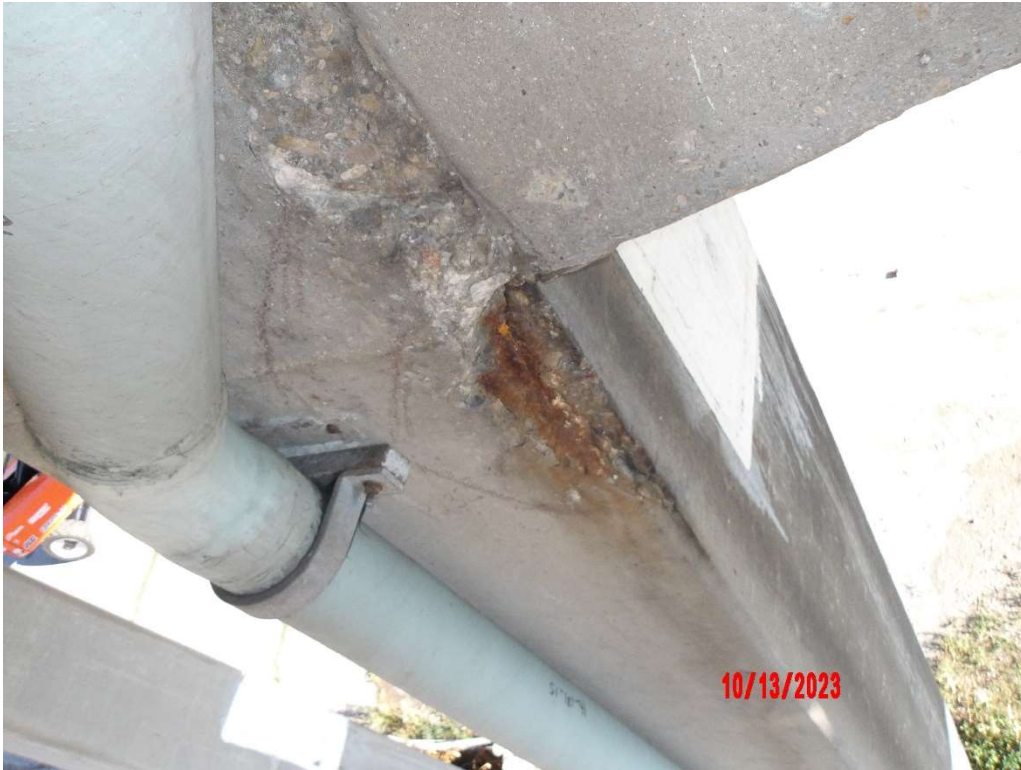
Photo 45- Pier 23C, Column 3, Spall with Exposed Rebar 3SF

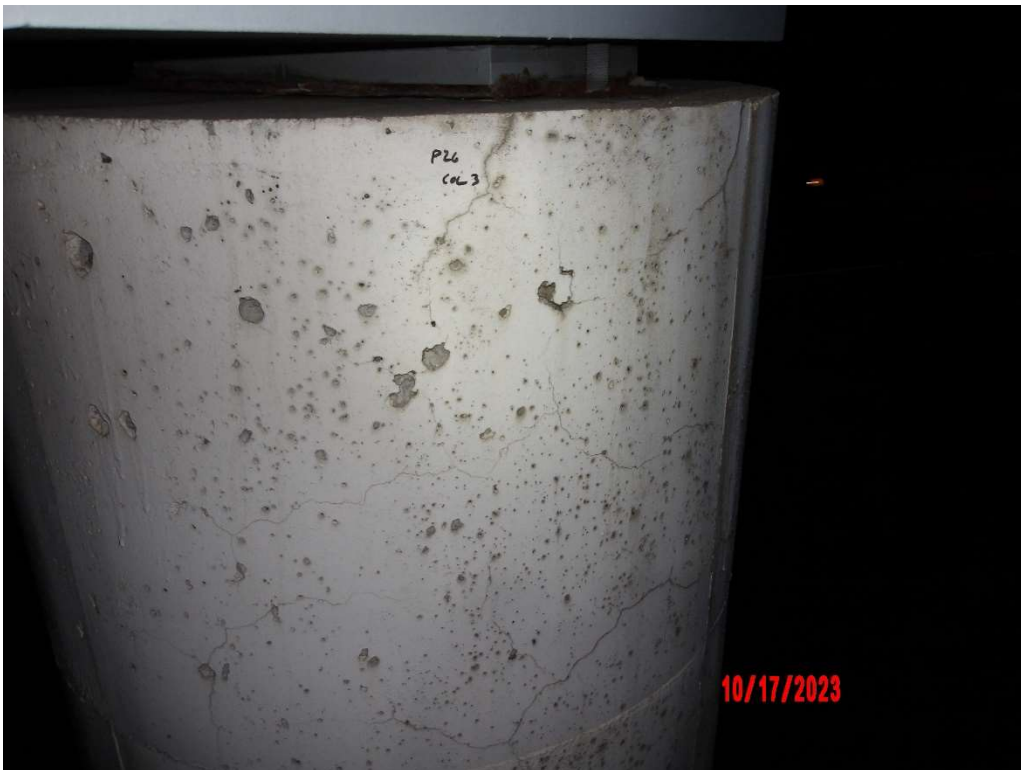
Photo 46- Pier 26J, Column 3, Heavy Map Cracking

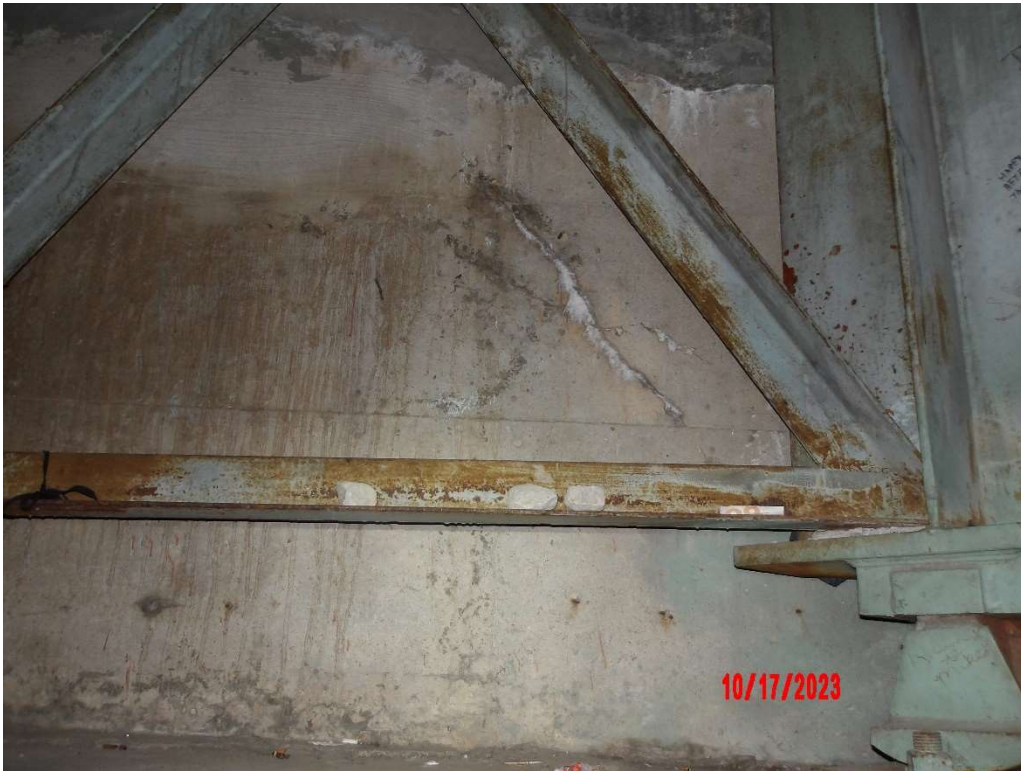
Photo 47- Abutment C, Bay 4, Crack in Backwall

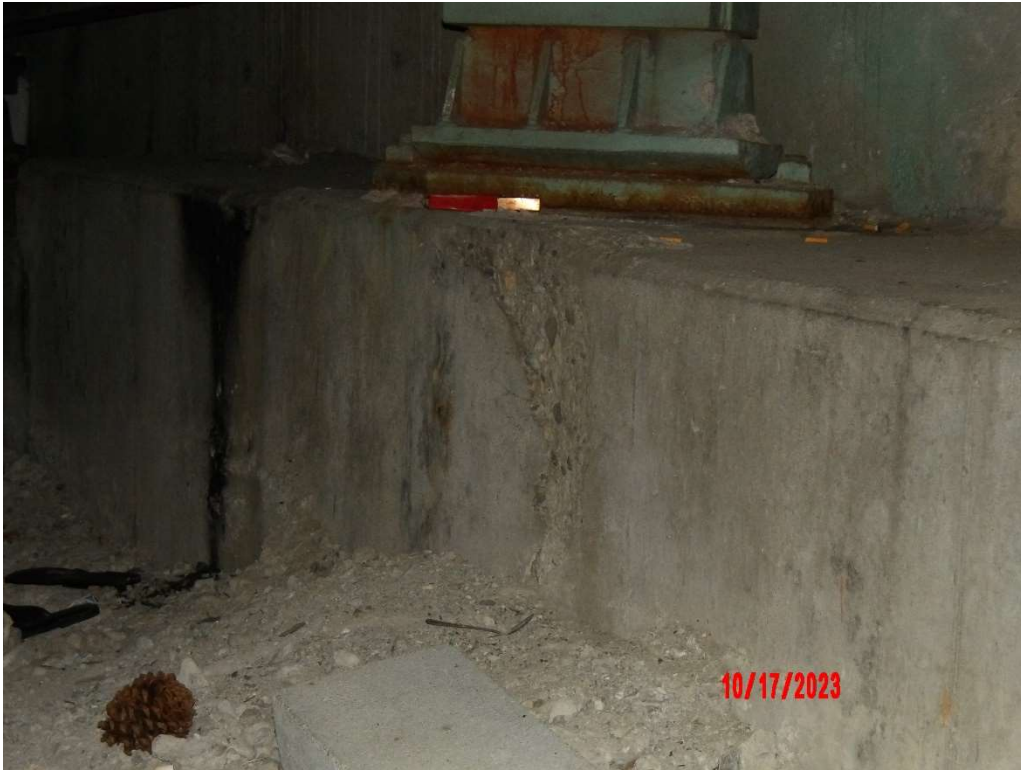
Photo 48- Abutment C, Bearing D, Spall in Abutment

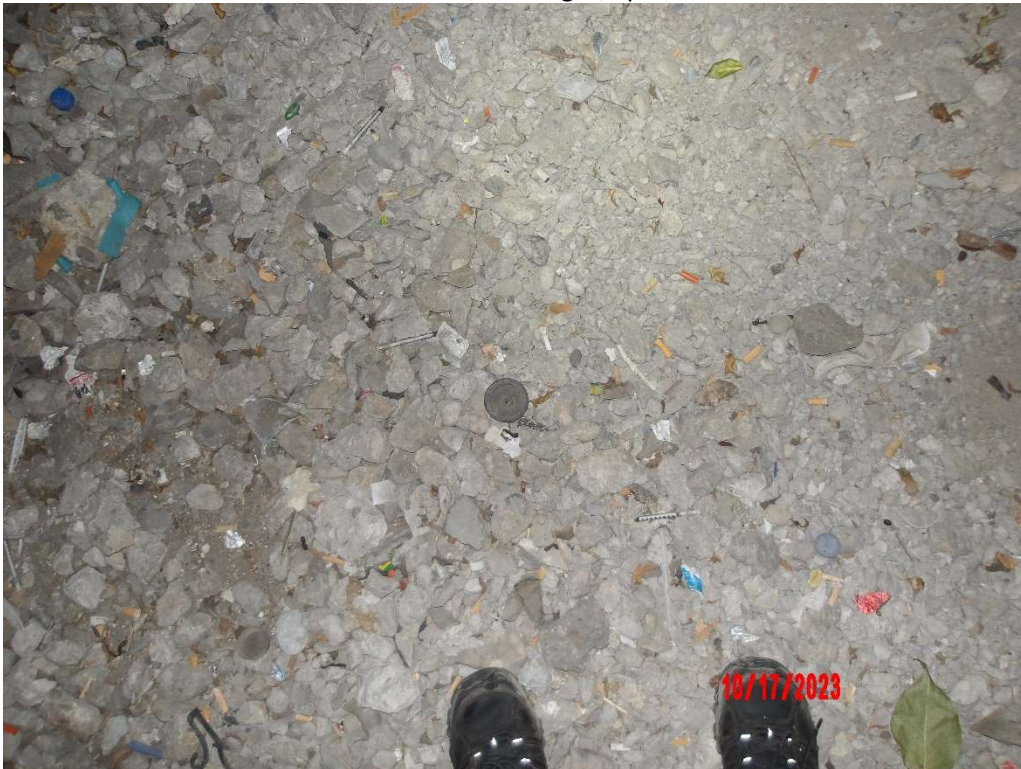
Photo 49- Span 29, Abutment C, Homeless Debris with Lots of Needles

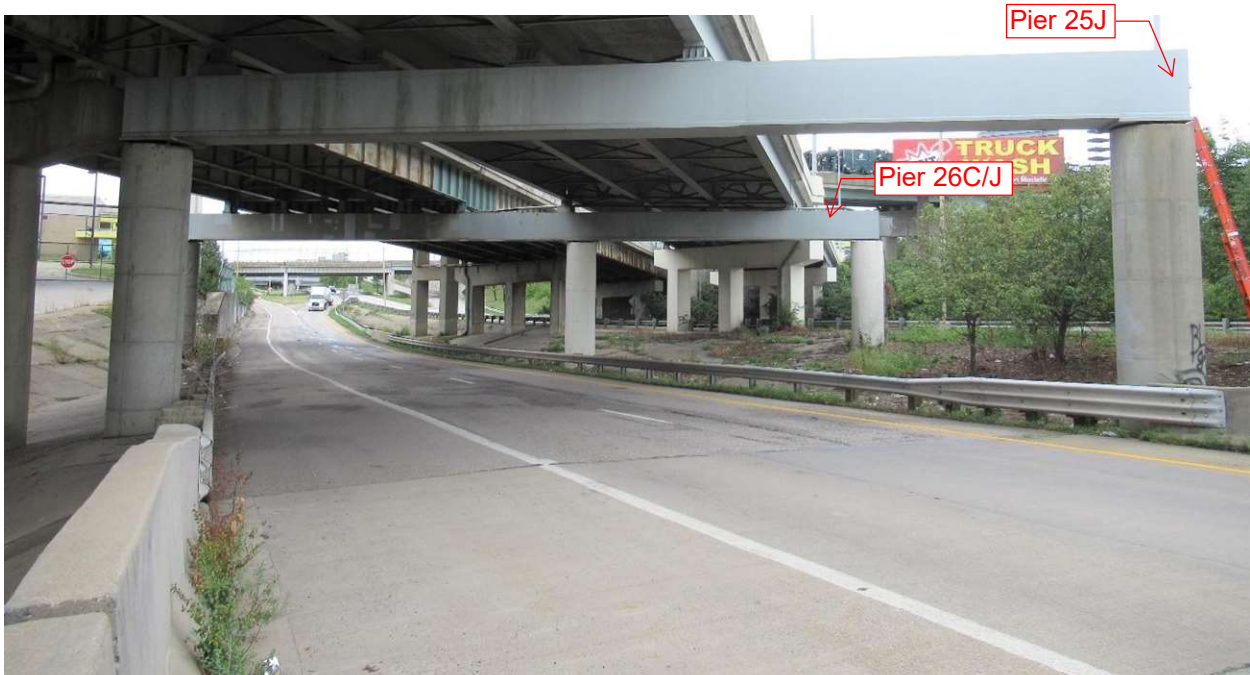
Photo 50- Fracture critical steel box pier cap members looking north

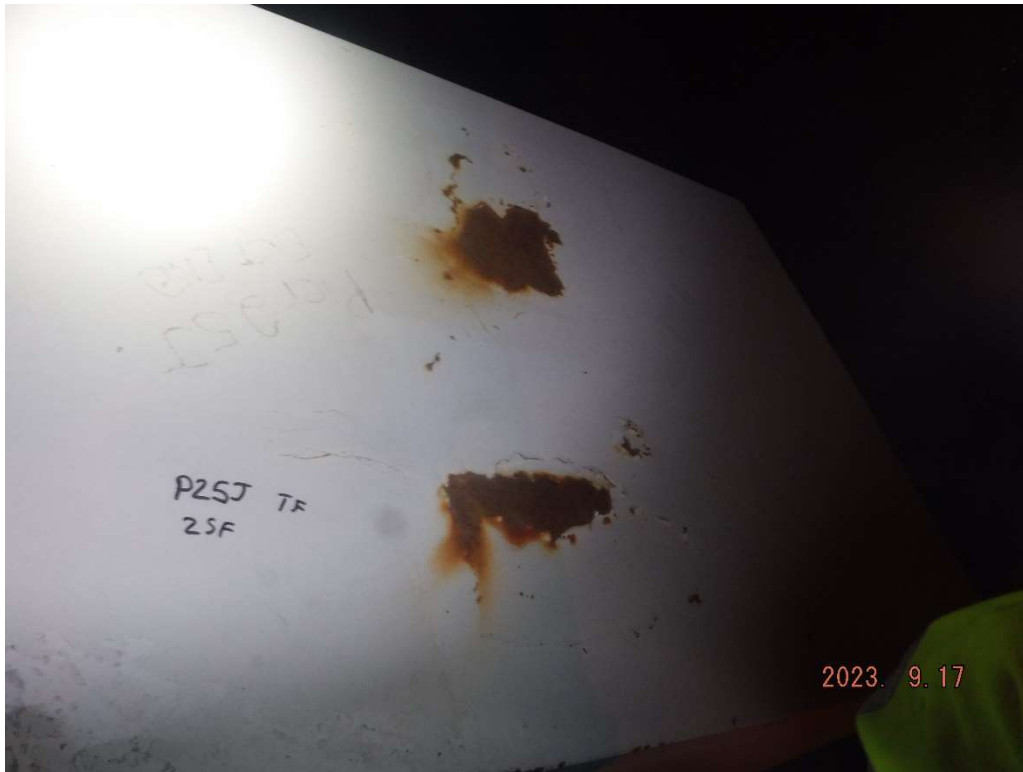
Photo 51- Pier 25J, Top Flange, 2 SF Active Corrosion

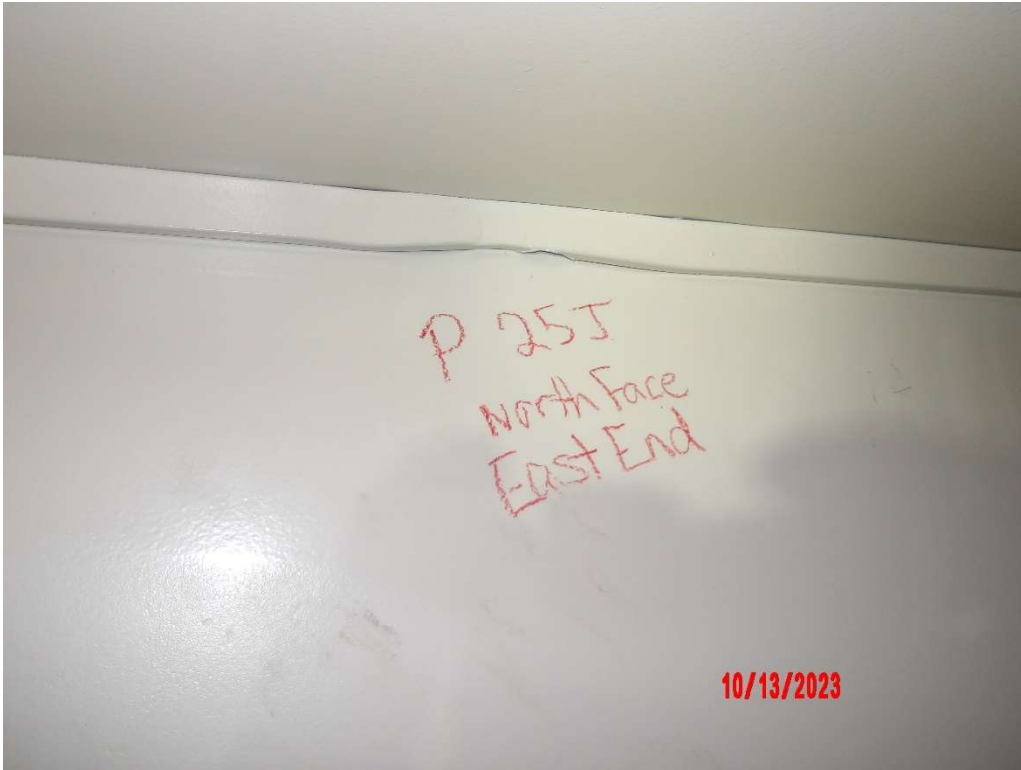
Photo 52- Pier 25J, North Face, East End, Deformed Backing Plate

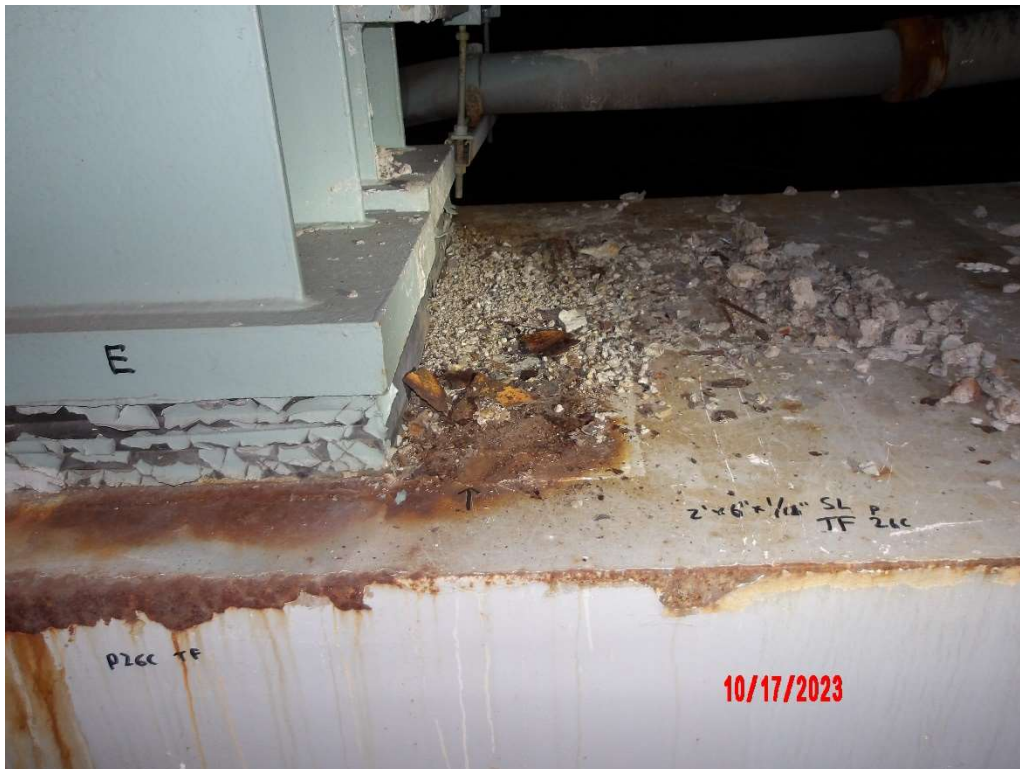
Photo 57- Pier 26C, Top Flange, 2' x 6" x 1/16" SL

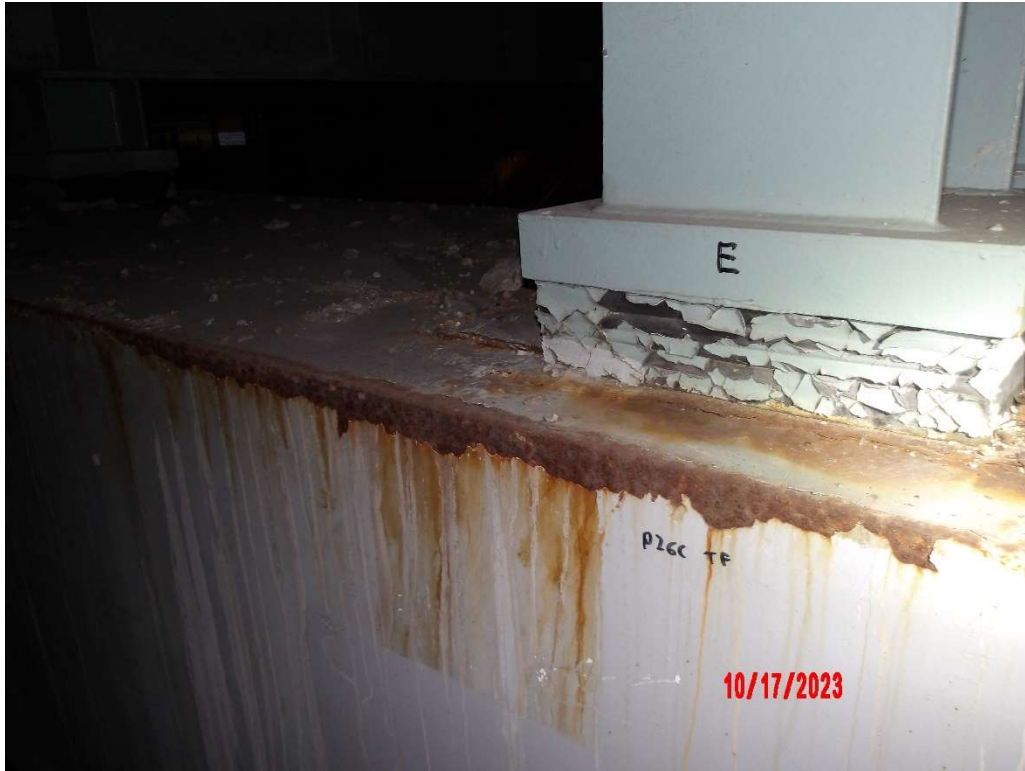
Photo 58- Pier 26C, Top Flange, Active Corrosion

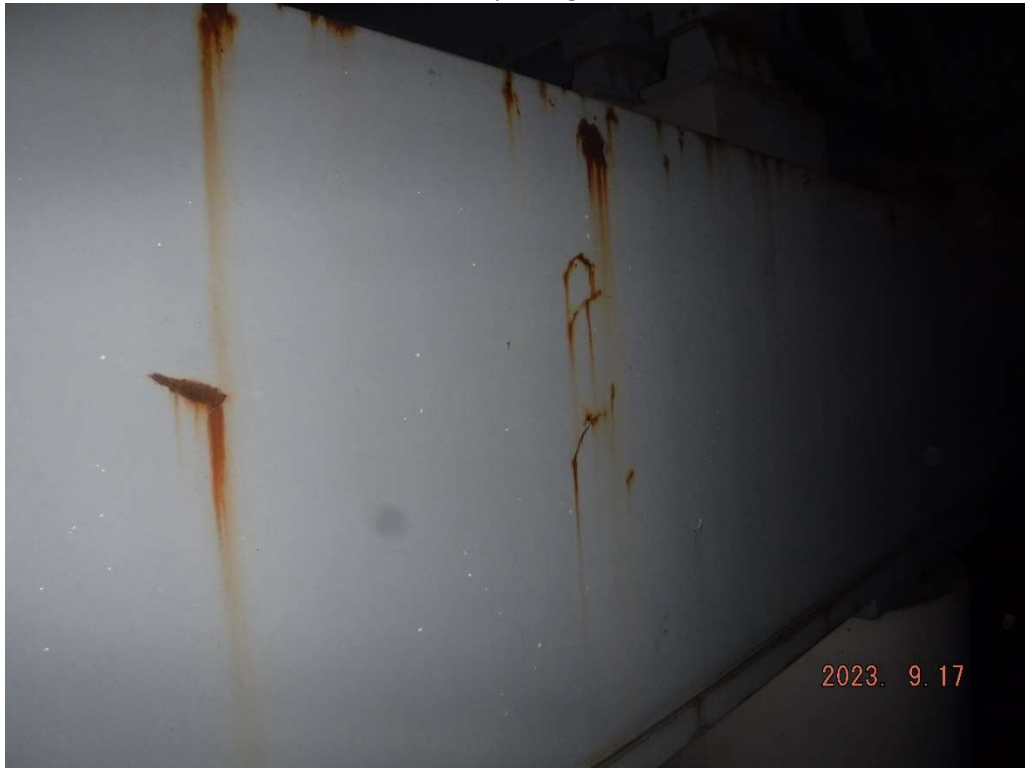
Photo 59- Pier 26C-Pier 26J, South Face, Scrapes and Active Corrosion

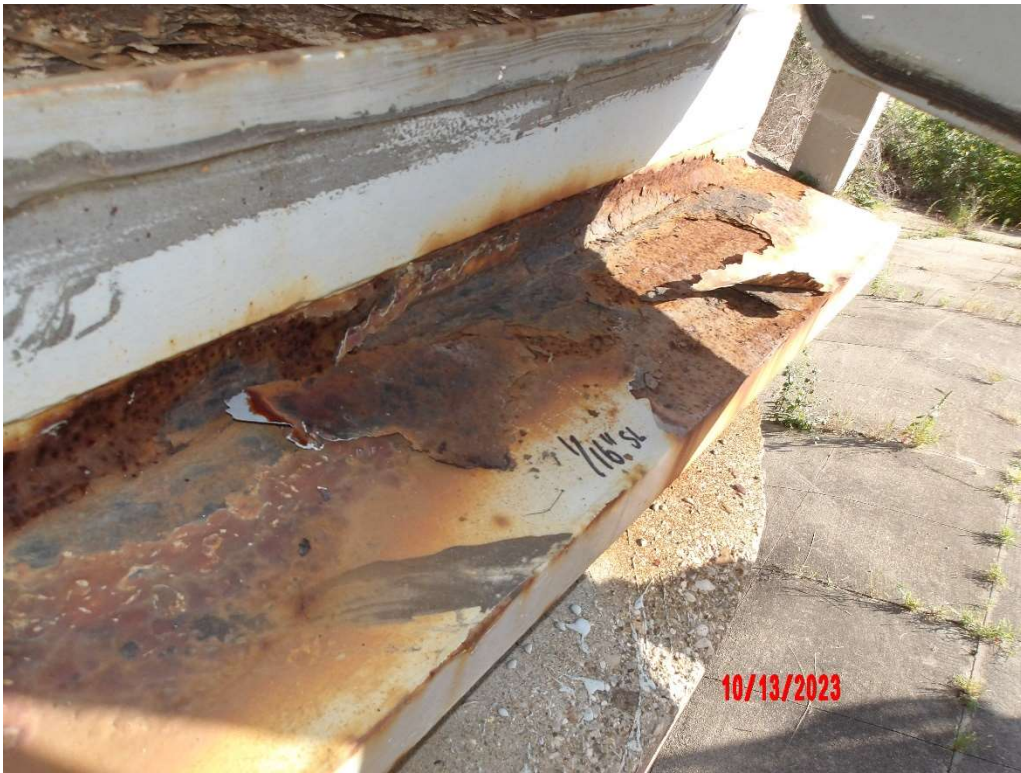
Photo 60- Pier 26J, West End, Up to 1/16" Section Loss Bottom Flange

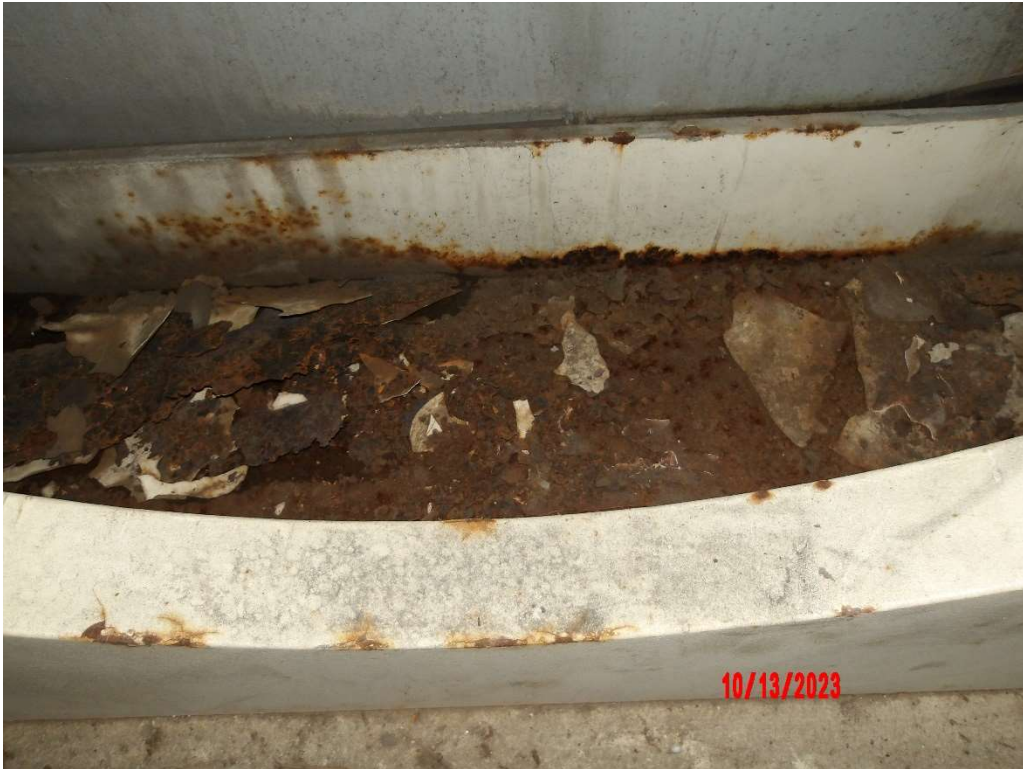
Photo 61- Pier 26J, East End, Moderate Corrosion to Bottom Flange with Paint Failure

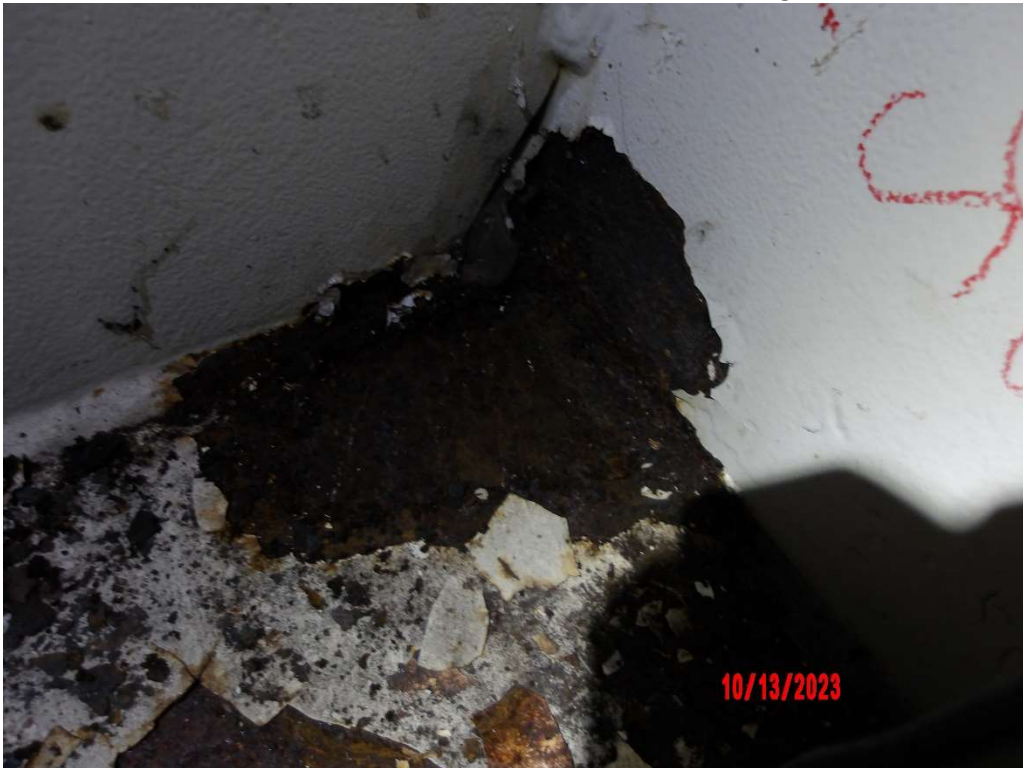
Photo 62- Pier 26J, South Web, Stiffener 17, Moderate Corrosion,

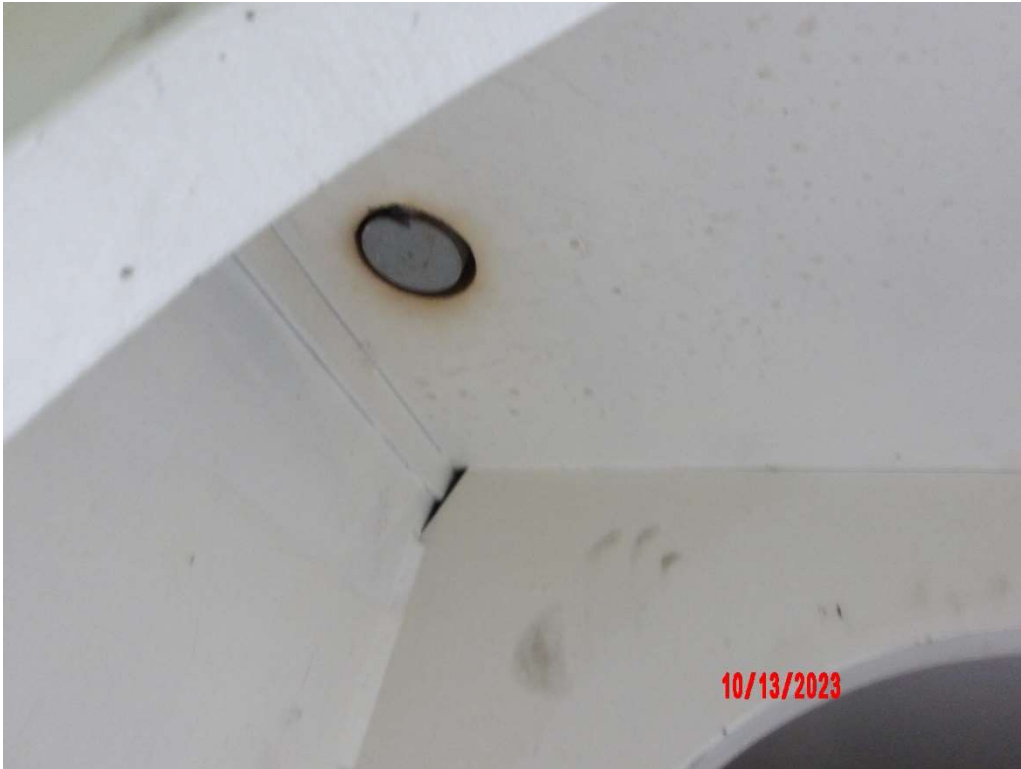
Photo 63- Pier 26J, Stiffener 12, Drill Holes in Top Flange

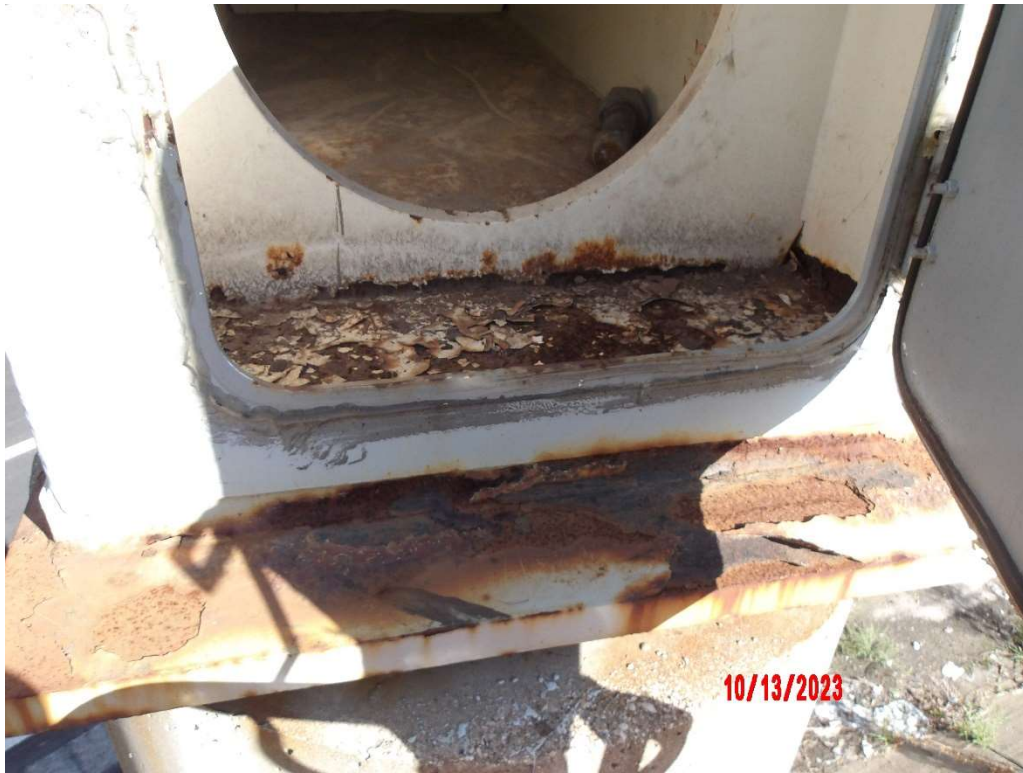
Photo 65- Pier 26J, West End, Moderate Corrosion to Bottom Flange with Paint Failure

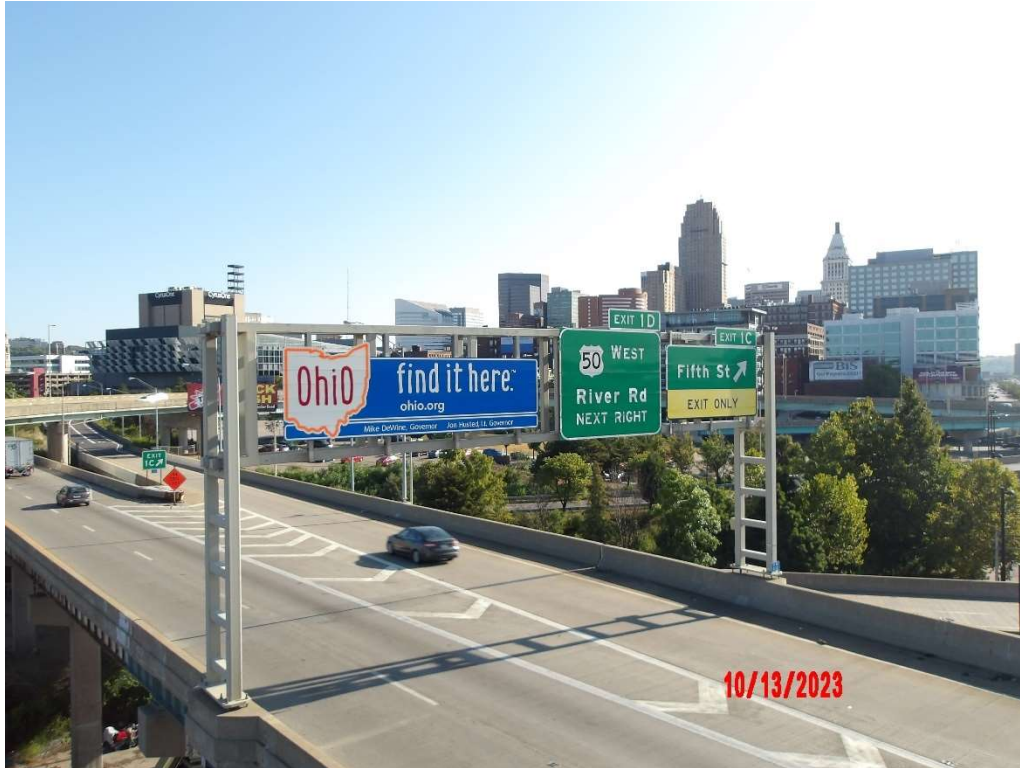
Photo 67- Sign Support

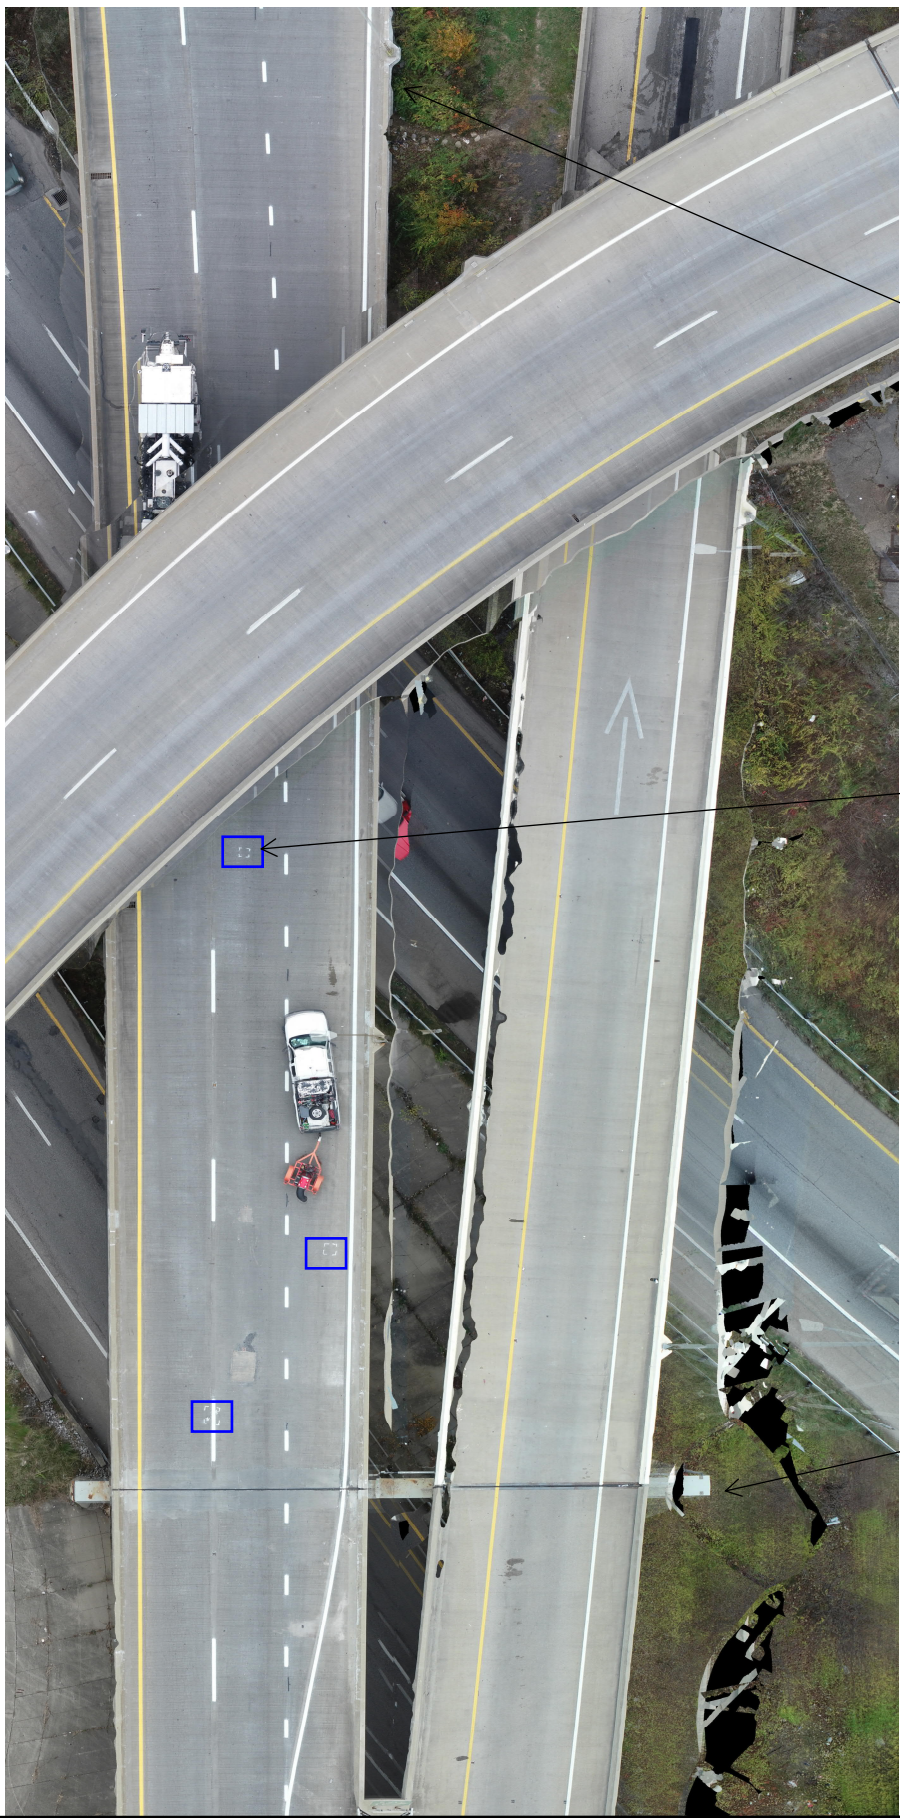
Wearing Surface Delaminations Identified by ODOT
December, 2020
